TECHNICAL DEVELOPMENT REPORT NO. 312

BIRD INGESTION TESTS
OF AN
ALLISON T-56 TURBINE ENGINE
(CIVIL MODEL 501-D13)

May 1957

CIVIL AERONAUTICS ADMINISTRATION
TECHNICAL DEVELOPMENT CENTER
INDIANAPOLIS, INDIANA

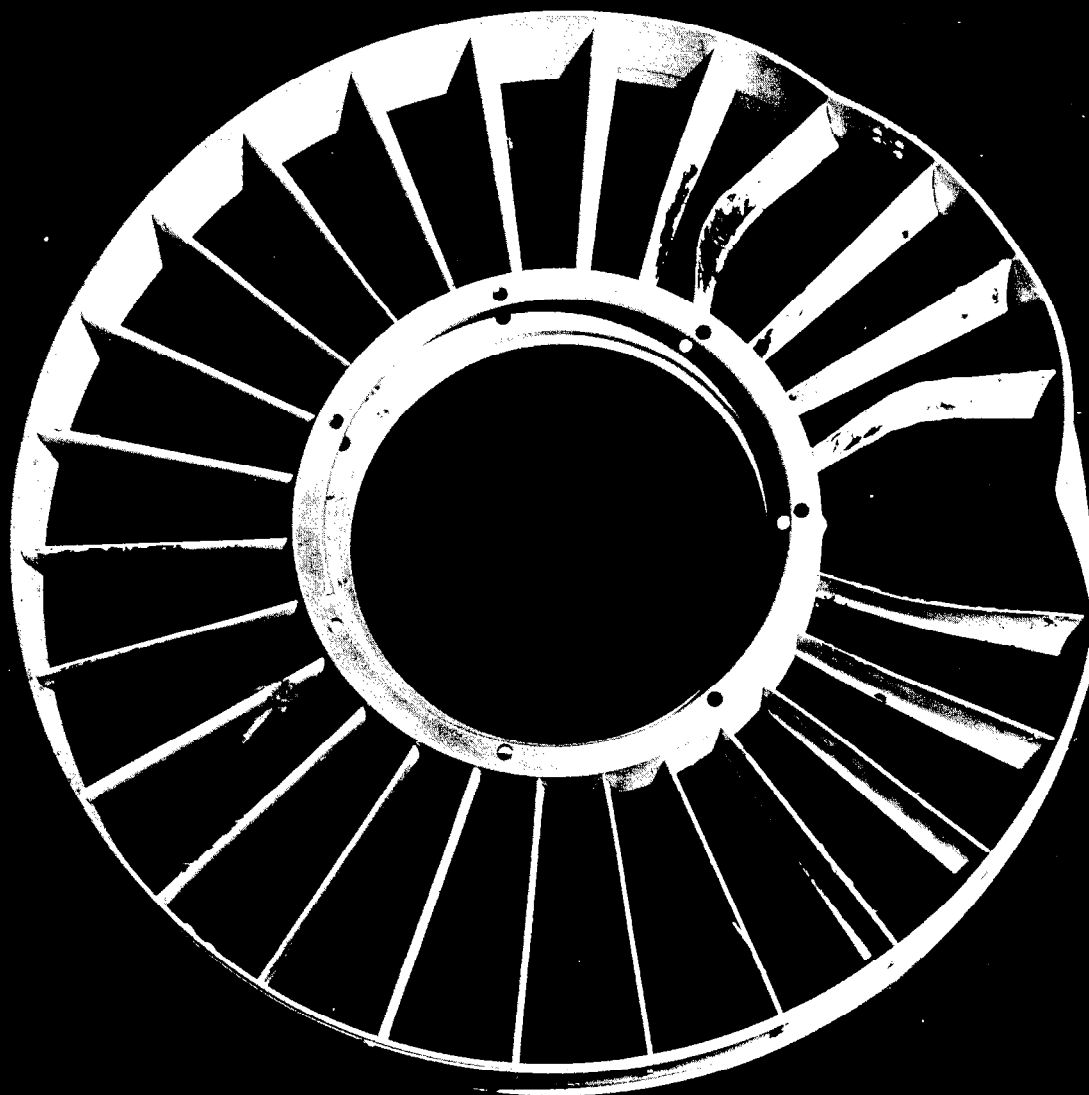
Fig. 2 Test No. 13 - 8/28/56 - Projectile Velocity 335 mph

During the initial tests a dummy engine incorporating a production guide-vane ring was tested. This guide-vane ring, as damaged in the tests, is shown in Fig. 2. The bird carcass velocity at which failure of this assembly occurred was used as a factor in determining the maximum bird carcass velocities for the running-engine tests. For the running-engine tests an external supply of oil together with a cooling unit was used. The JP-4 fuel was stored in an external 200-gallon tank and was delivered at a pressure of 20 to 30 pounds per square inch (psi) to the engine through 3/4-inch copper tubing. A turbine-engine ground-starting unit was utilized in the tests. Figure 3 shows the complete engine test arrangement. The engine appears at the left while the barrel of the compressed air gun for propelling the chicken carcasses into the engine appears at the right. The control panel and engine instrument arrangements are shown in Fig. 4.

These tests were performed on a dummy engine to determine the velocity at which prohibitive structural damage would occur to the inlet guide vanes. It was found that a direct hit would cause prohibitive damage in the velocity range of 335 to 380 mph. It was decided that tests on the running engine should be limited to velocities under 320 mph to prevent excessive damage to the compressor section which could result if pieces of the inlet guide vanes were forced through the compressor section. It was found, furthermore, that a bird strike directly into the air inlet duct of this engine at speeds of 320 mph or greater will deform the duct considerably, necessitating repairs. This air inlet duct is not an engine part, but is a part furnished by the airframe manufacturers. The results of two tests at a carcass velocity of 330 mph are shown in Figs. 6 and 7. Figure 8 shows the results of a test at a carcass velocity of 380 mph.

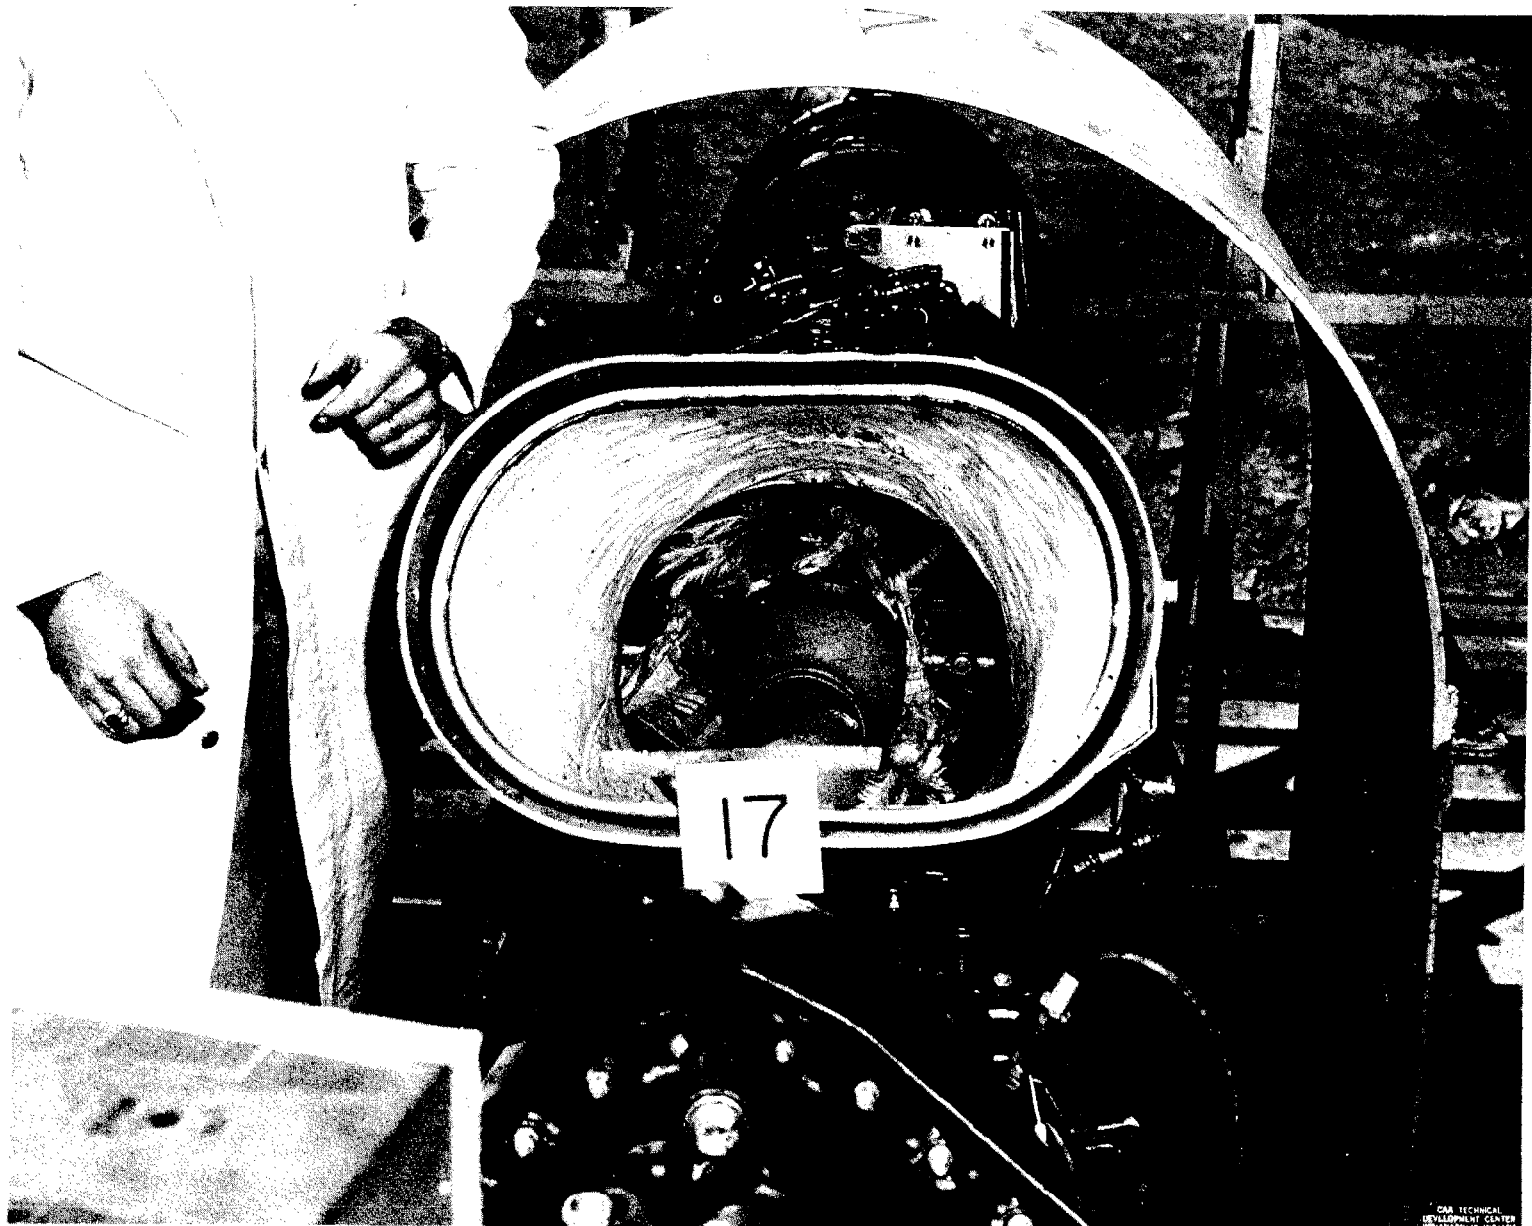
Fig 9 Test No. 17 - 9/6/56 - Projectile Velocity 177 mph

The carcass was propelled into approximately the right hand section of the engine inlet as viewed from the front of the engine. The engine flamed-out due to air passage blockage. The rear edges of 6 inlet vanes from the 12 o'clock to the 2:30 o'clock positions of the inlet were bent clockwise.

Several first-stage rotor blades were damaged slightly (nicked at the leading edge) and the edges toward the outer ring were bowed slightly. One inlet vane at a position of 11 o'clock was bowed.

The engine was started but excessive temperature at the turbine inlet was experienced during the run-up. The cover was taken off the compressor section to determine the cause of the excessive temperature. The stator blades of the last 4 stages which have a high solidity factor were found to be clogged near the casing with a fibrous material made up of chicken pin feathers, grease, and oil matted together. A considerable amount of this material was found clinging to the leading edges of the stator blades. Moreover, all of the rotor blades except those of the first stage, were coated on the under side with the fibrous material. Results of this test are shown in Figs. 9, 10, 11, and 12. Figure 9 is typical of the inlet air duct blockage encountered in these tests.

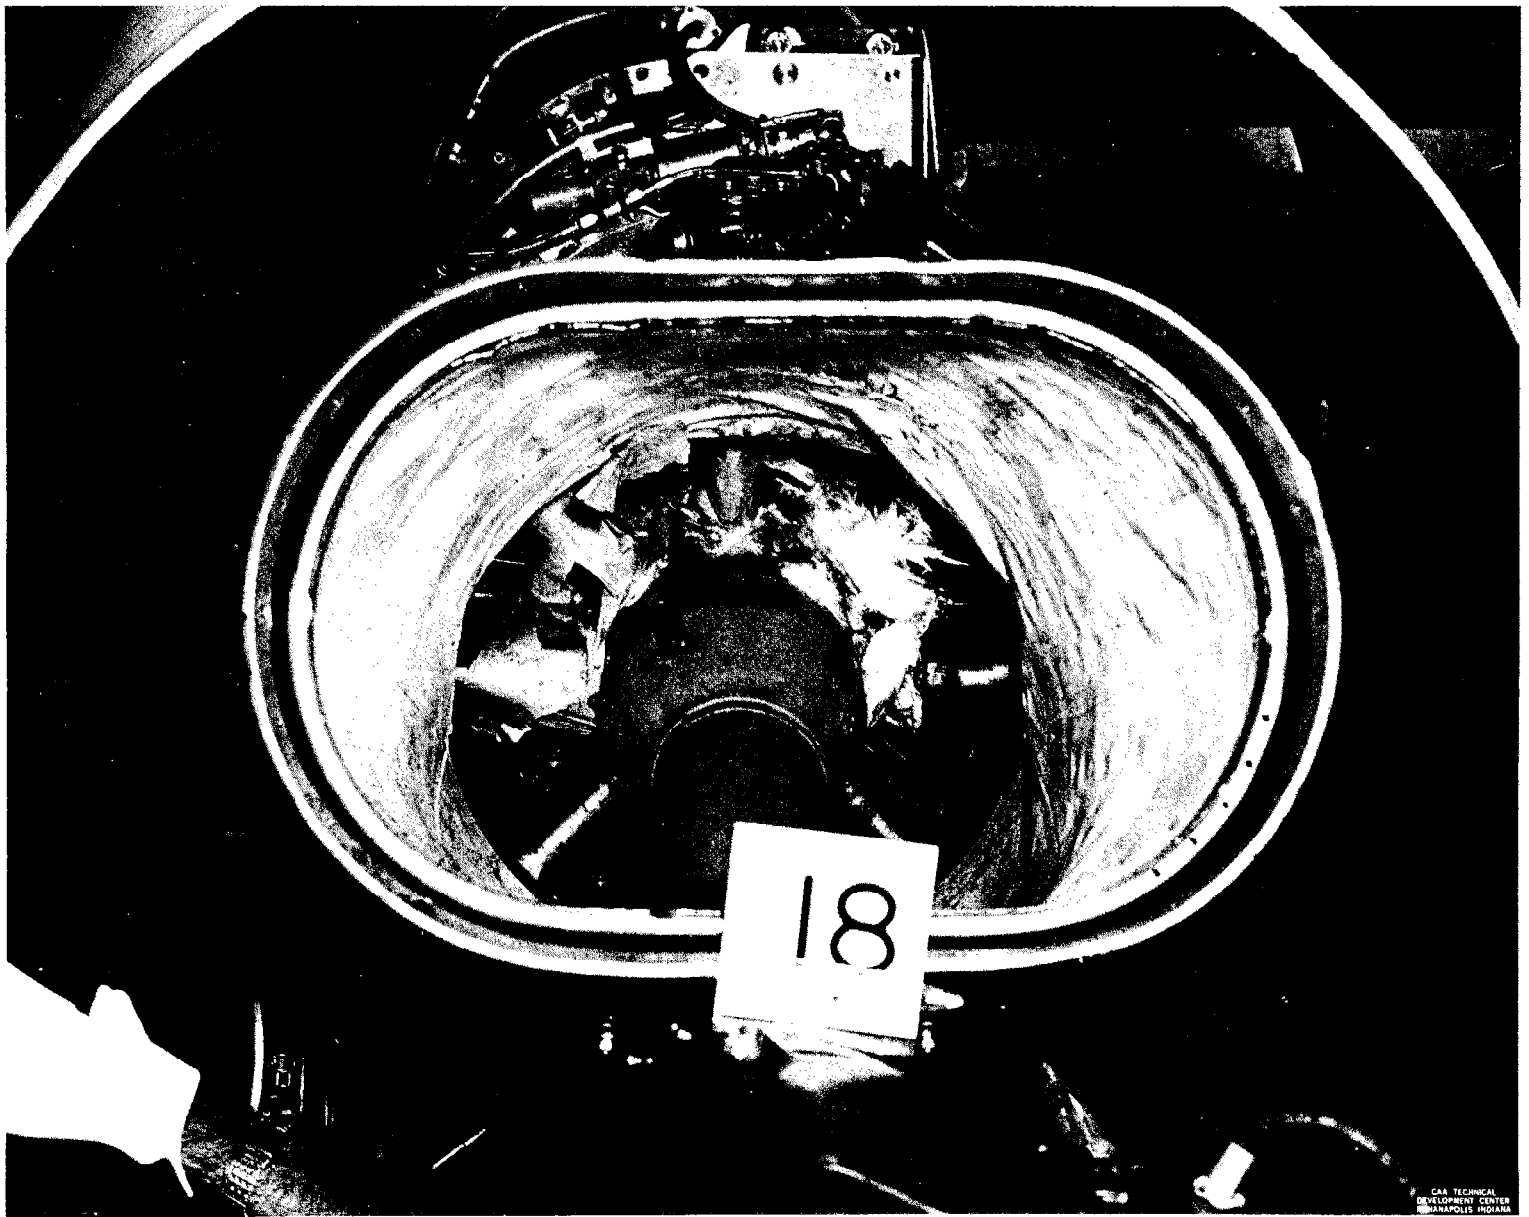
Fig. 13 Test No. 18 - 9/13/56 - Projectile Velocity 213 mph

Upon impact by the chicken carcass the engine "torched" (flamed-out and relighted itself in rapid succession). The engine then was stopped by the operator, rather than allowing it to "flame-out" as in Test No. 17. Major damage to the upper set of first-stage compressor stator blades was apparently caused by the solid parts of the bird collecting in the area between the first-stage rotor and stator blades. The entrance vanes and first-stage rotor blades were not damaged appreciably beyond the damage caused by the previous test. It appeared that the upper-half section of the first-stage stator blades had attempted to rotate along with the rotor blades. Some damage was detected between the second-stage rotor and stator blades to the extent that the trailing edges of a few of the rotor blades were bent counter-clockwise and the leading edges of a few stator blades were bent clockwise as viewed from the front of the engine. Views of the engine following this test are shown in Figs. 13 and 14. Figure 13 shows typical air duct blockage encountered in these tests.

After Test No. 18 the operational engine was returned to the Allison plant for replacement of damaged parts and for cleaning. At that

time the inlet guide-vane assembly was replaced by another production assembly which had been improved by better quality control. In addition, the 1 $\frac{1}{4}$ stator blade assemblies were replaced by new assemblies which were strengthened by the employment of a better method of brazing the ends of the stator blades to the inner and outer retaining rings.

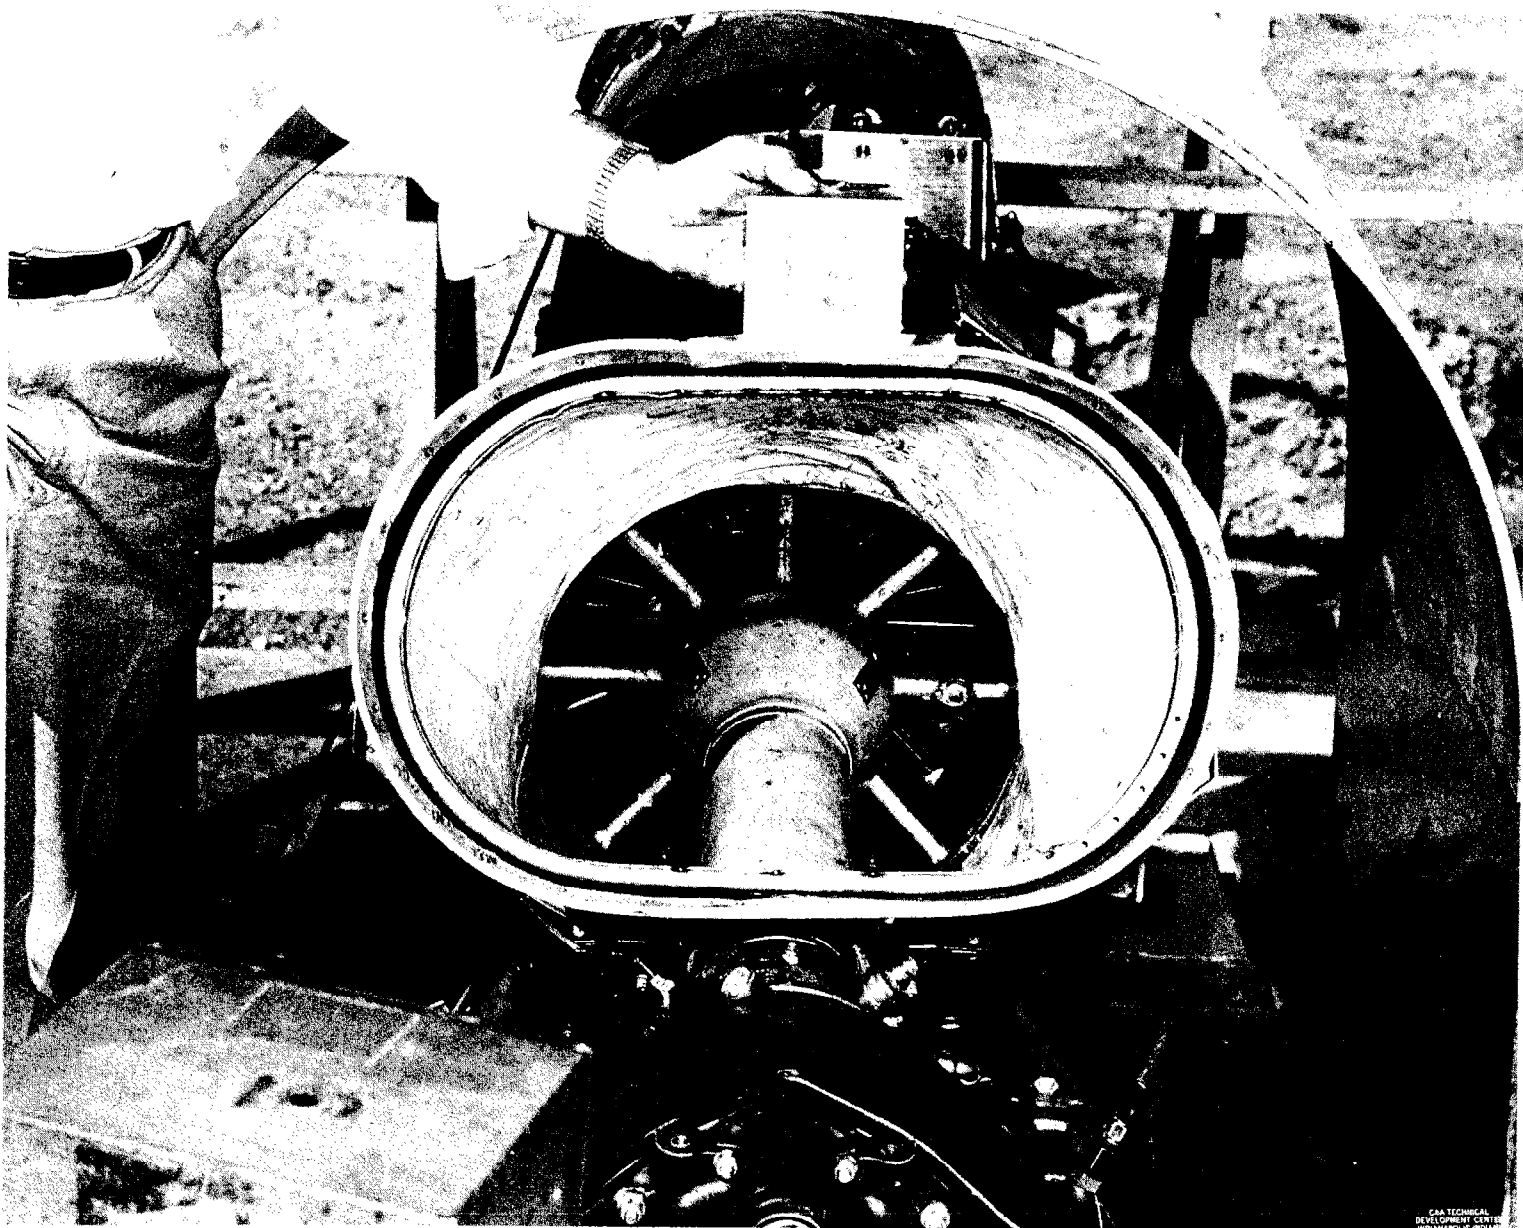
Fig. 15 Test No. 19 - 10/11/56 - Projectile Velocity 150 mph

The engine did not flame-out upon impact of the bird carcass but was shut down due to excessive temperature in the turbine inlet. The trailing edges of the entrance blades were bent clockwise in three sectors. The leading edges of the first-stage rotor blades were bent counter-clockwise at the tips. The results of this test are shown in Fig. 15. This was the first test on the improved inlet guide-vane assembly.

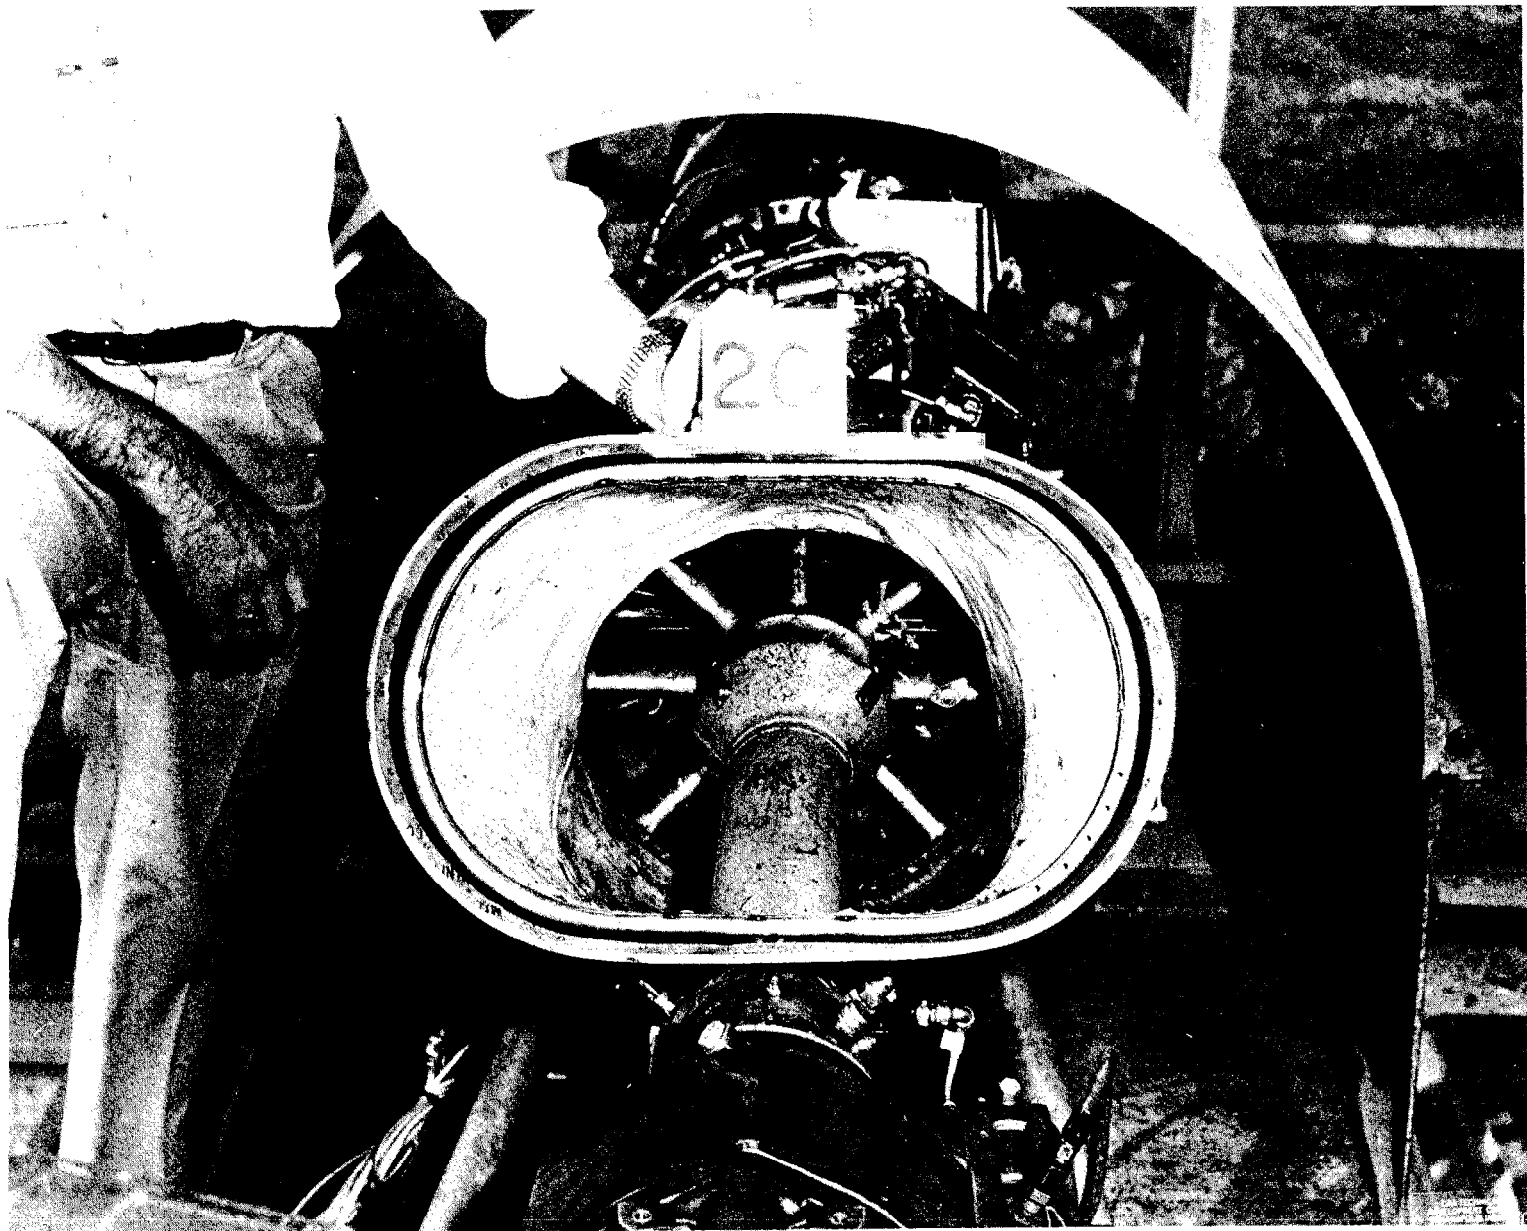
Fig. 16 Test No. 20 - 10/11/56 - Projectile Velocity 166 mph

The engine flamed-out upon impact by the bird carcass. No increased damage to the engine over that of previous tests was noted. A view of the engine through the air inlet duct following this test is shown in Fig. 16.

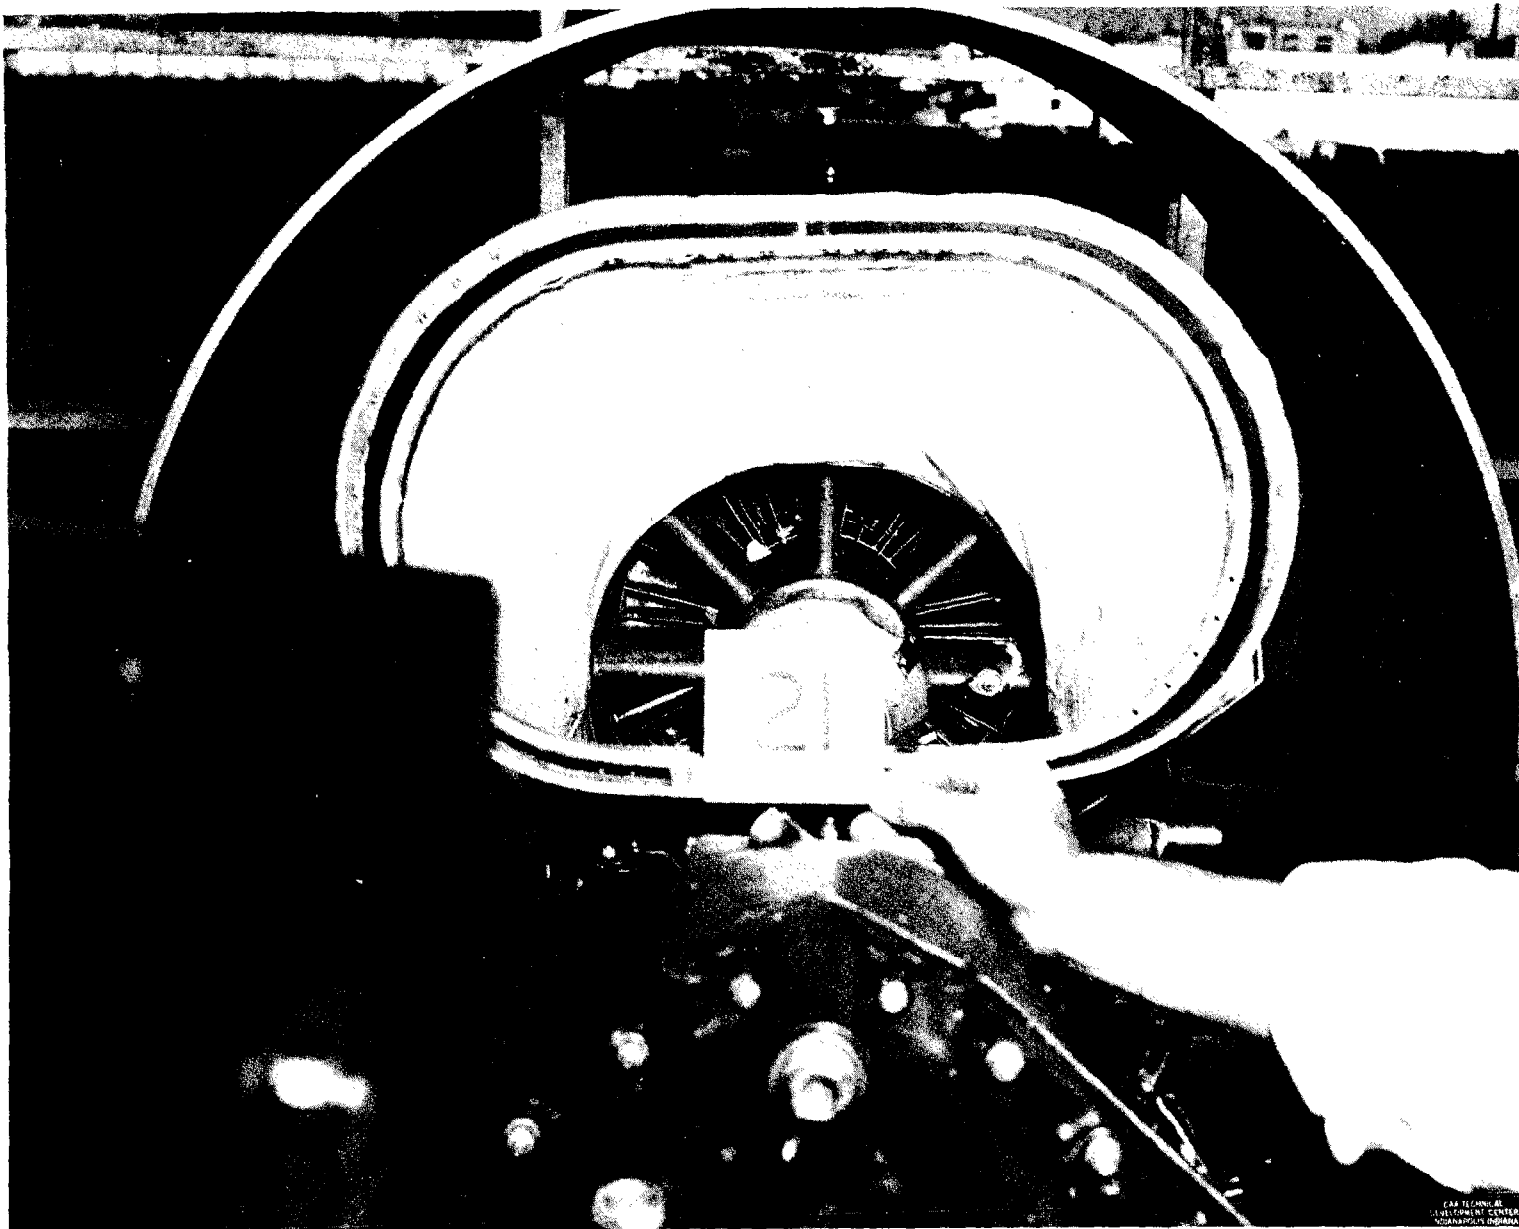
Fig. 17 Test No. 21 - 10/16/56 - Projectile Velocity 143 mph

The engine did not flame-out, but was shut down due to excessive temperature in the turbine inlet. There was slight structural damage to the inlet vanes near the 2:30 o'clock position as viewed from the front of the engine. The chicken and plug blocked off two sectors of the air inlet duct of the engine without flame-out. A view of the engine through the air inlet duct following this test is shown in Fig. 17.

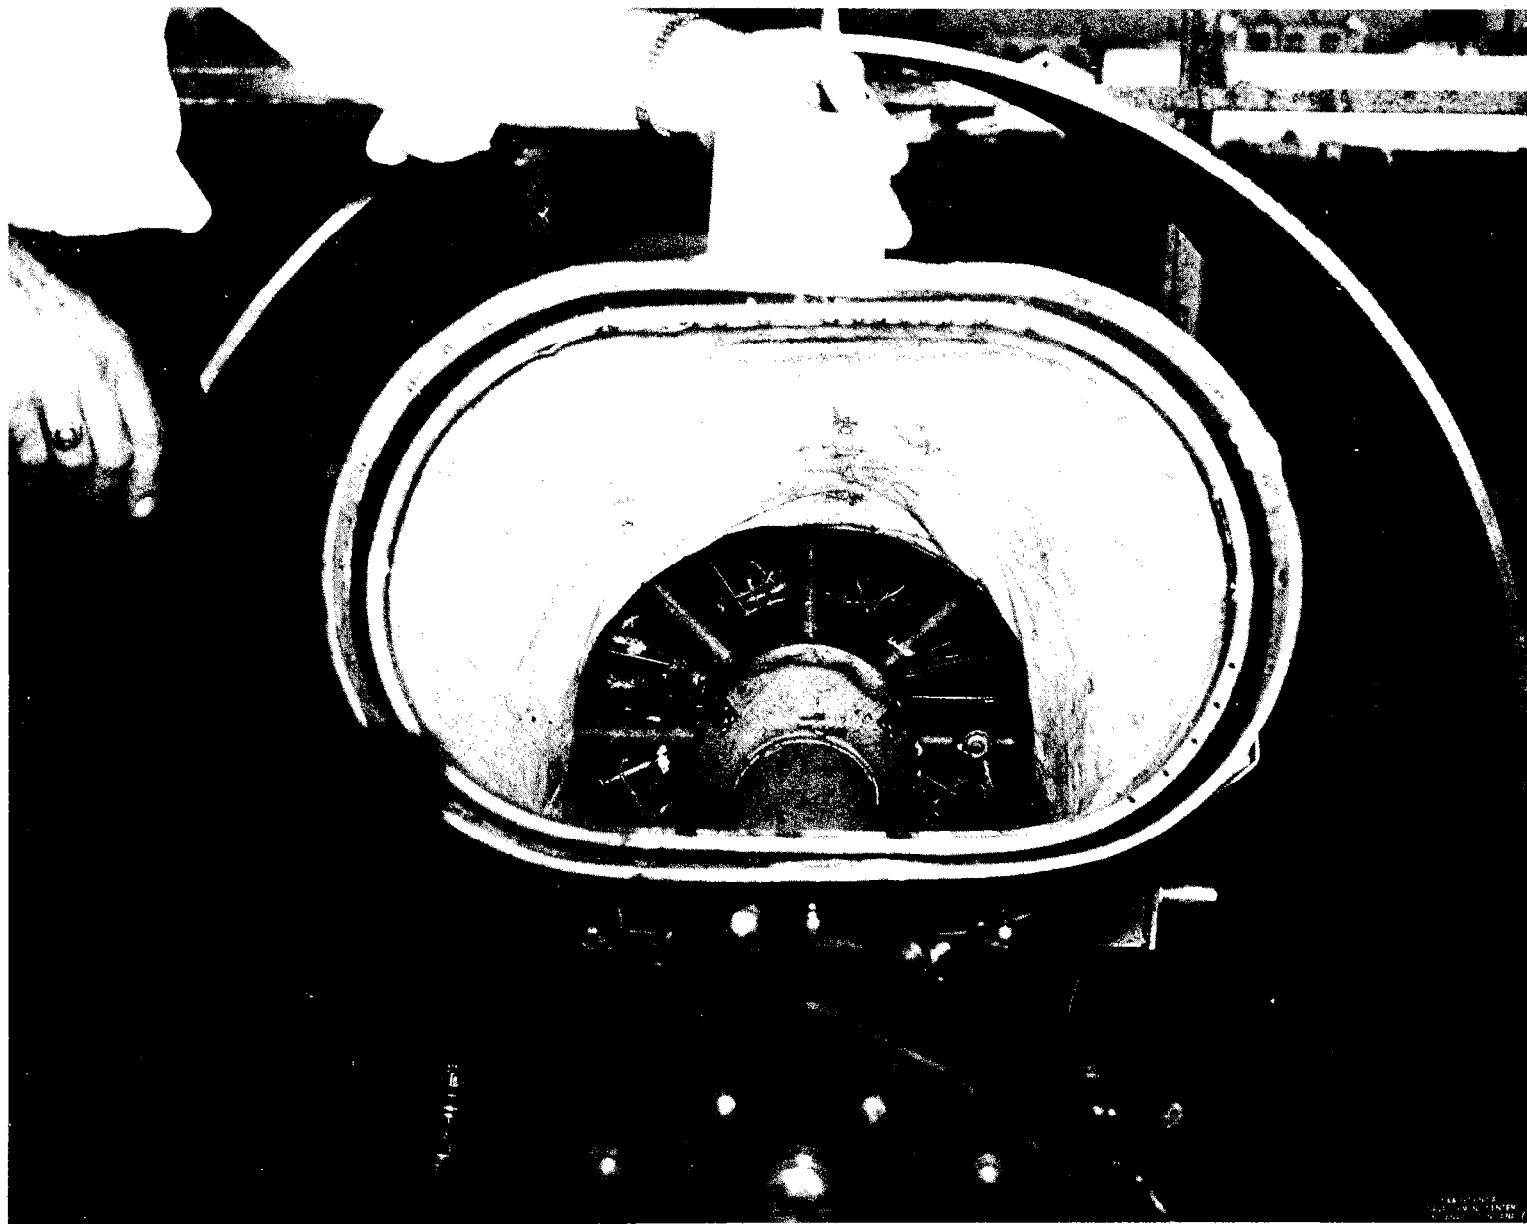
Fig. 18 Test No. 22 - 10/16/56 - Projectile Velocity 184 mph

The engine flamed-out upon impact of the chicken carcass. The damage to the engine progressed rearward to the first-stage stator blades. The tips of the first-stage rotor blades were bent further in the counter-clockwise direction as viewed from the front of the engine. Crushed walnut shells were used to clean the engine. A view of the engine through the air inlet duct following this test is shown in Fig. 18.

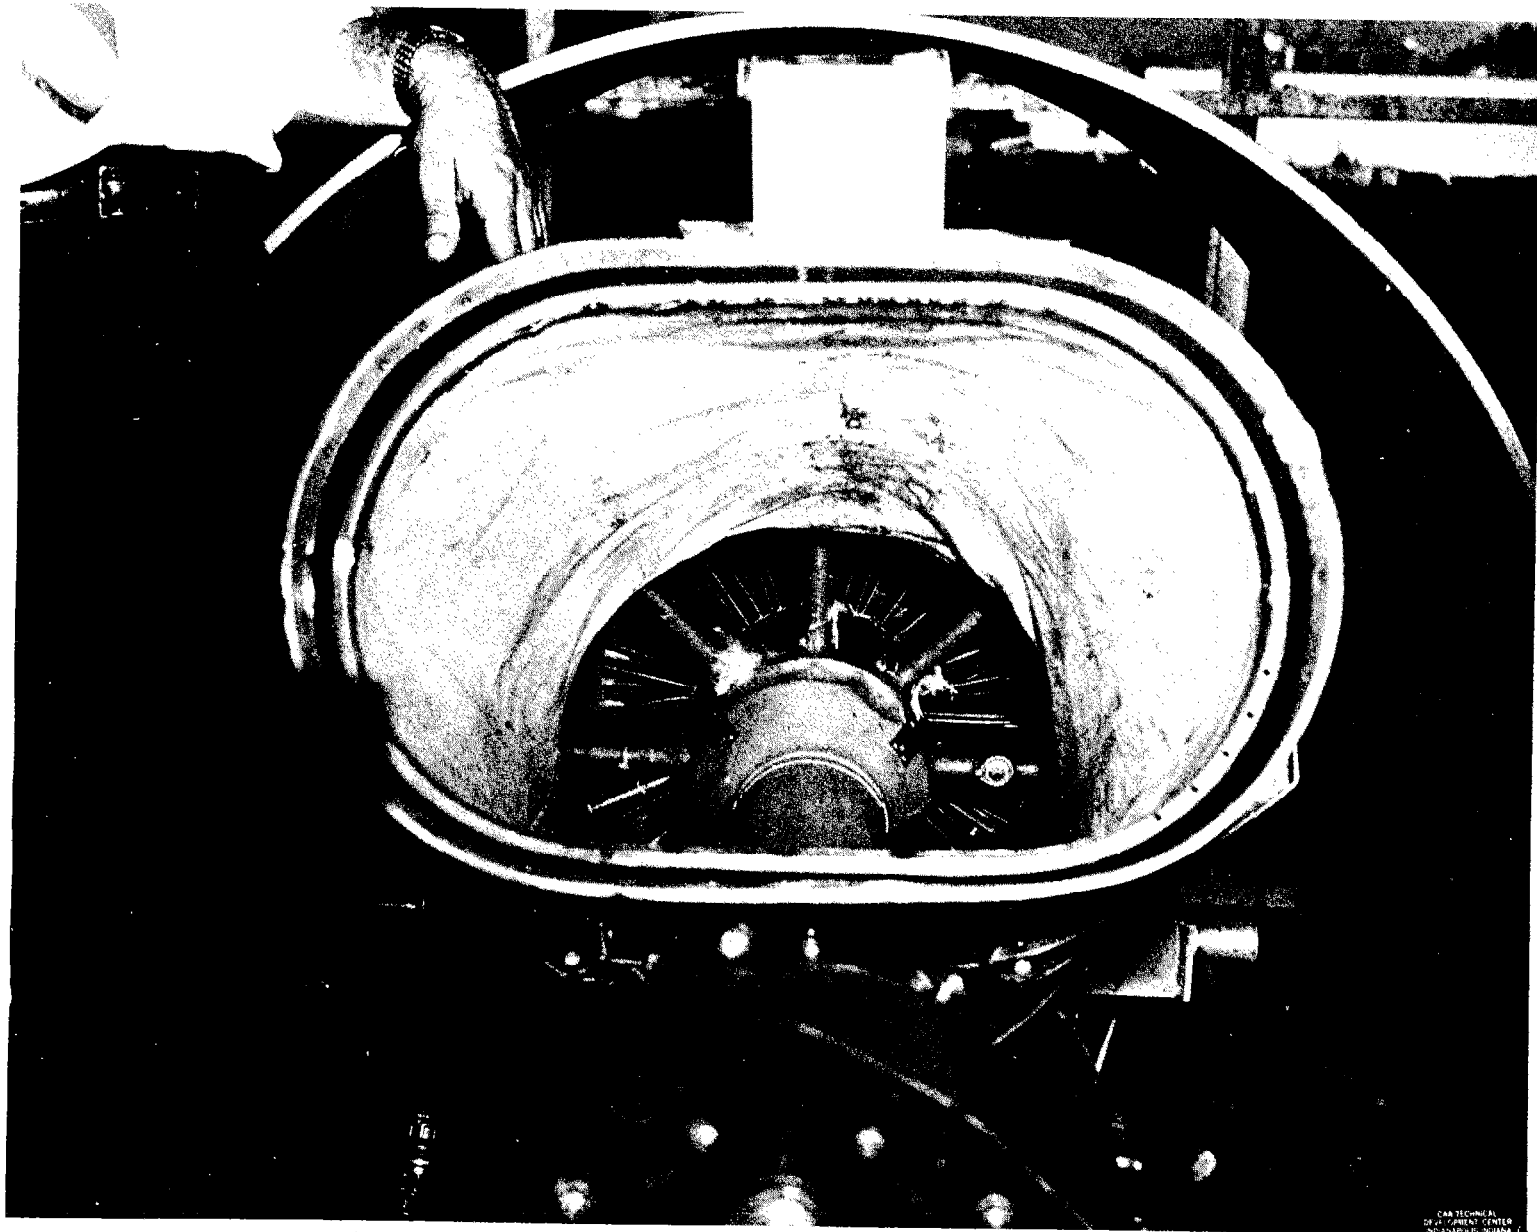
Fig. 19 Test No. 23 - 10/16/56 - Projectile Velocity 162 mph

The engine did not flame-out upon impact of the chicken carcass, but was shut down due to excessive temperature in the turbine inlet. The damage to the first-stage stator blades and the first-stage rotor blades was increased over the previous tests. The entrance vanes also suffered additional damage. See Fig. 19.

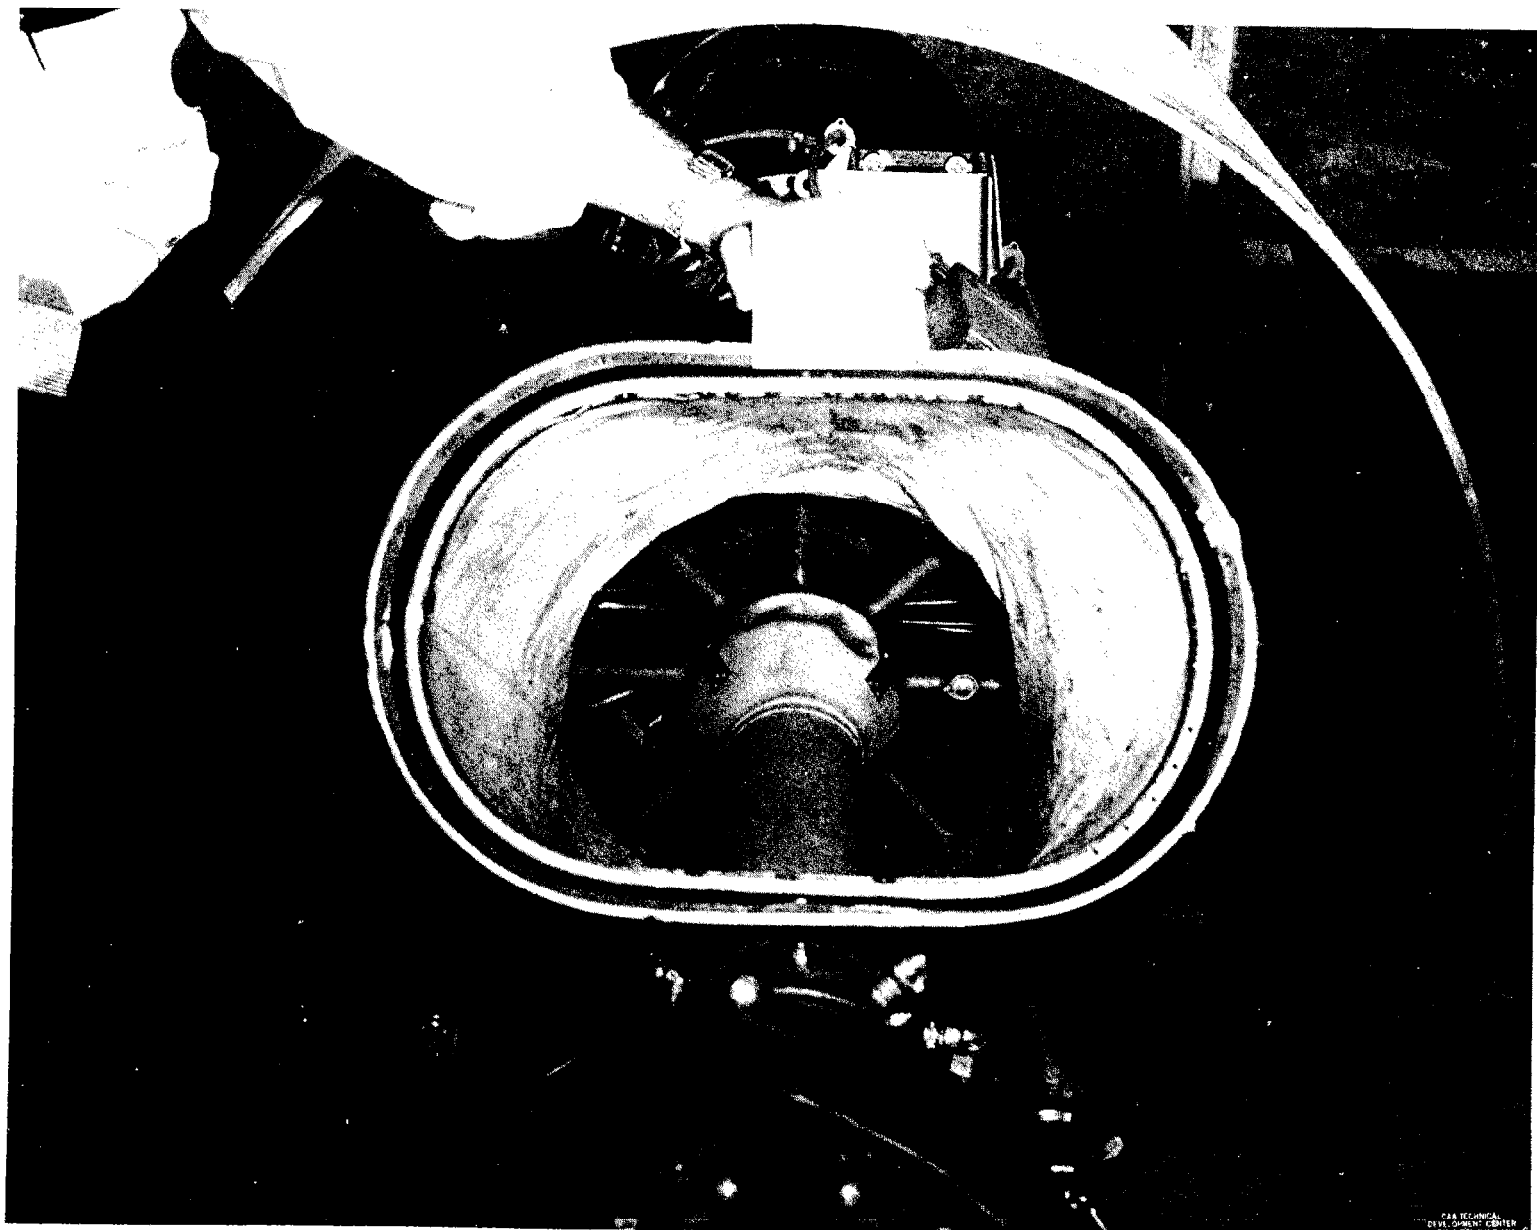
Fig. 20 Test No. 24 - 10/16/56 - Projectile Velocity 212 mph

The engine did not flame-out upon impact of the projectile, but was shut down due to excessive temperature in the turbine inlet. The engine ingested all of the Styrofoam plug and paper bag with no apparent increase in structural damage over that of previous tests. See Fig. 20.

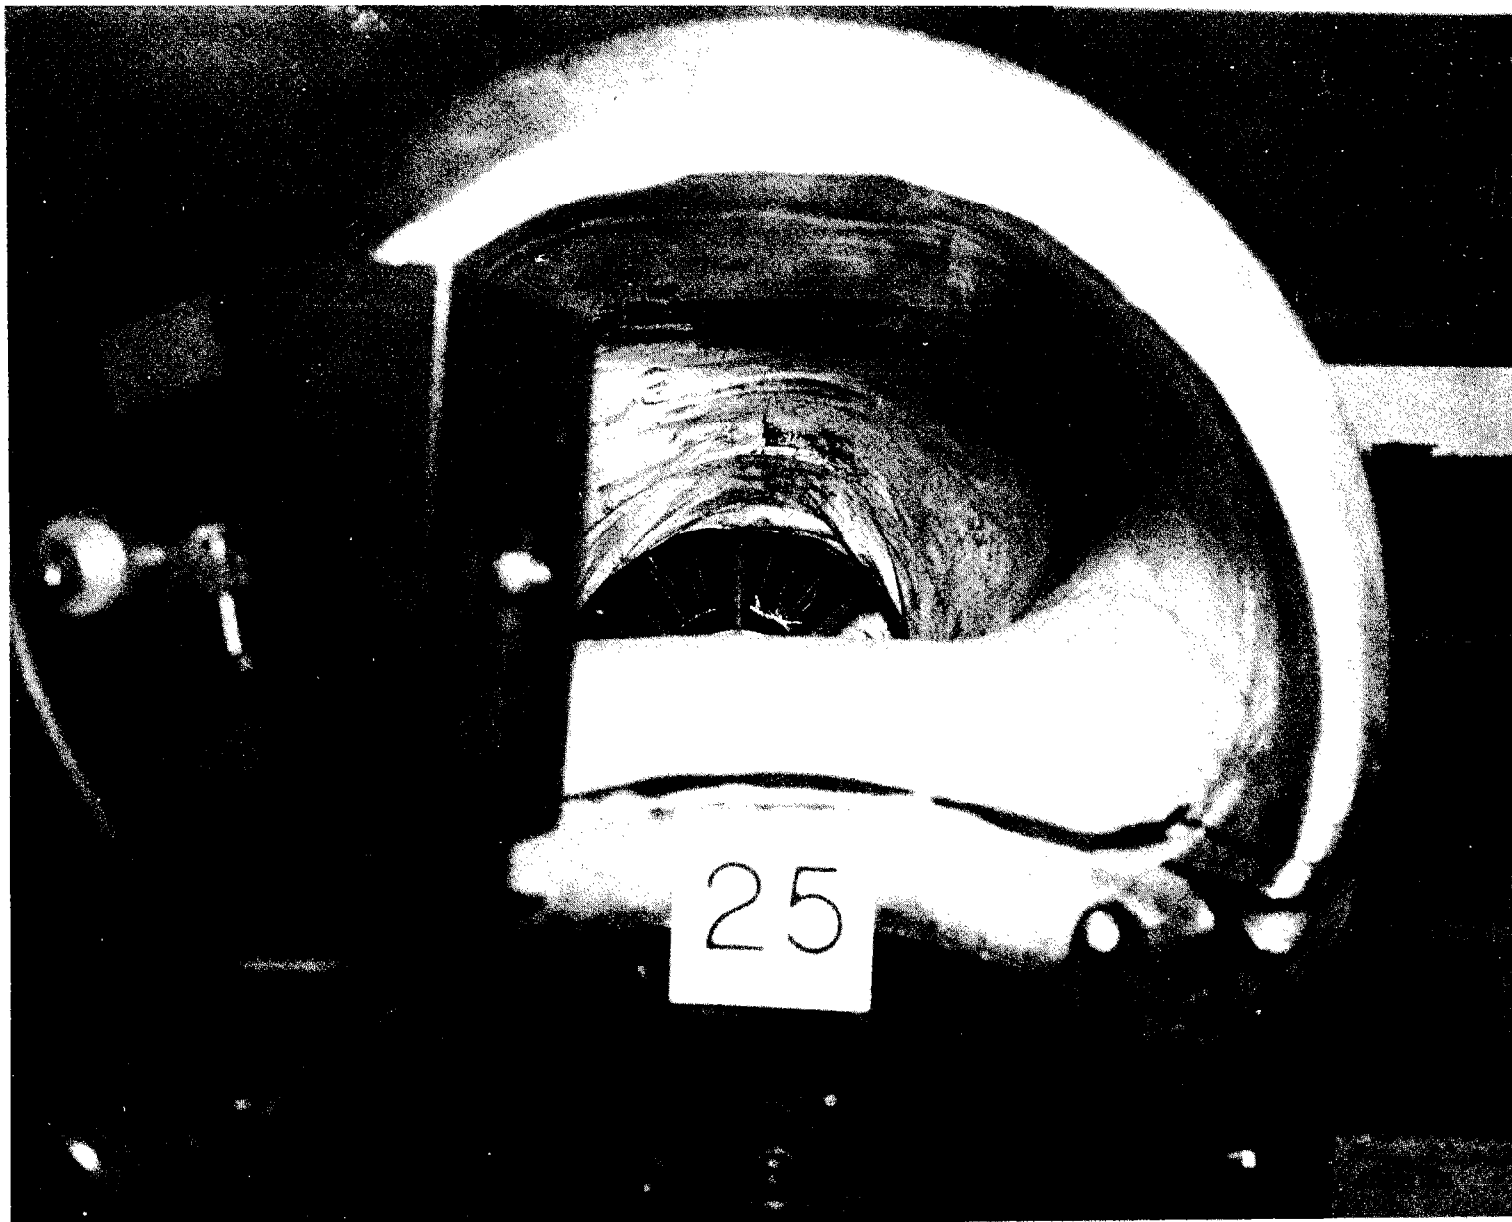
Fig. 21 Test No. 25 - 10/17/56 - Projectile Velocity 35 mph

Following the impact of the chicken carcass, excessive temperature was approached and the engine was shut down. No further damage to the engine was observed. See Fig. 21.

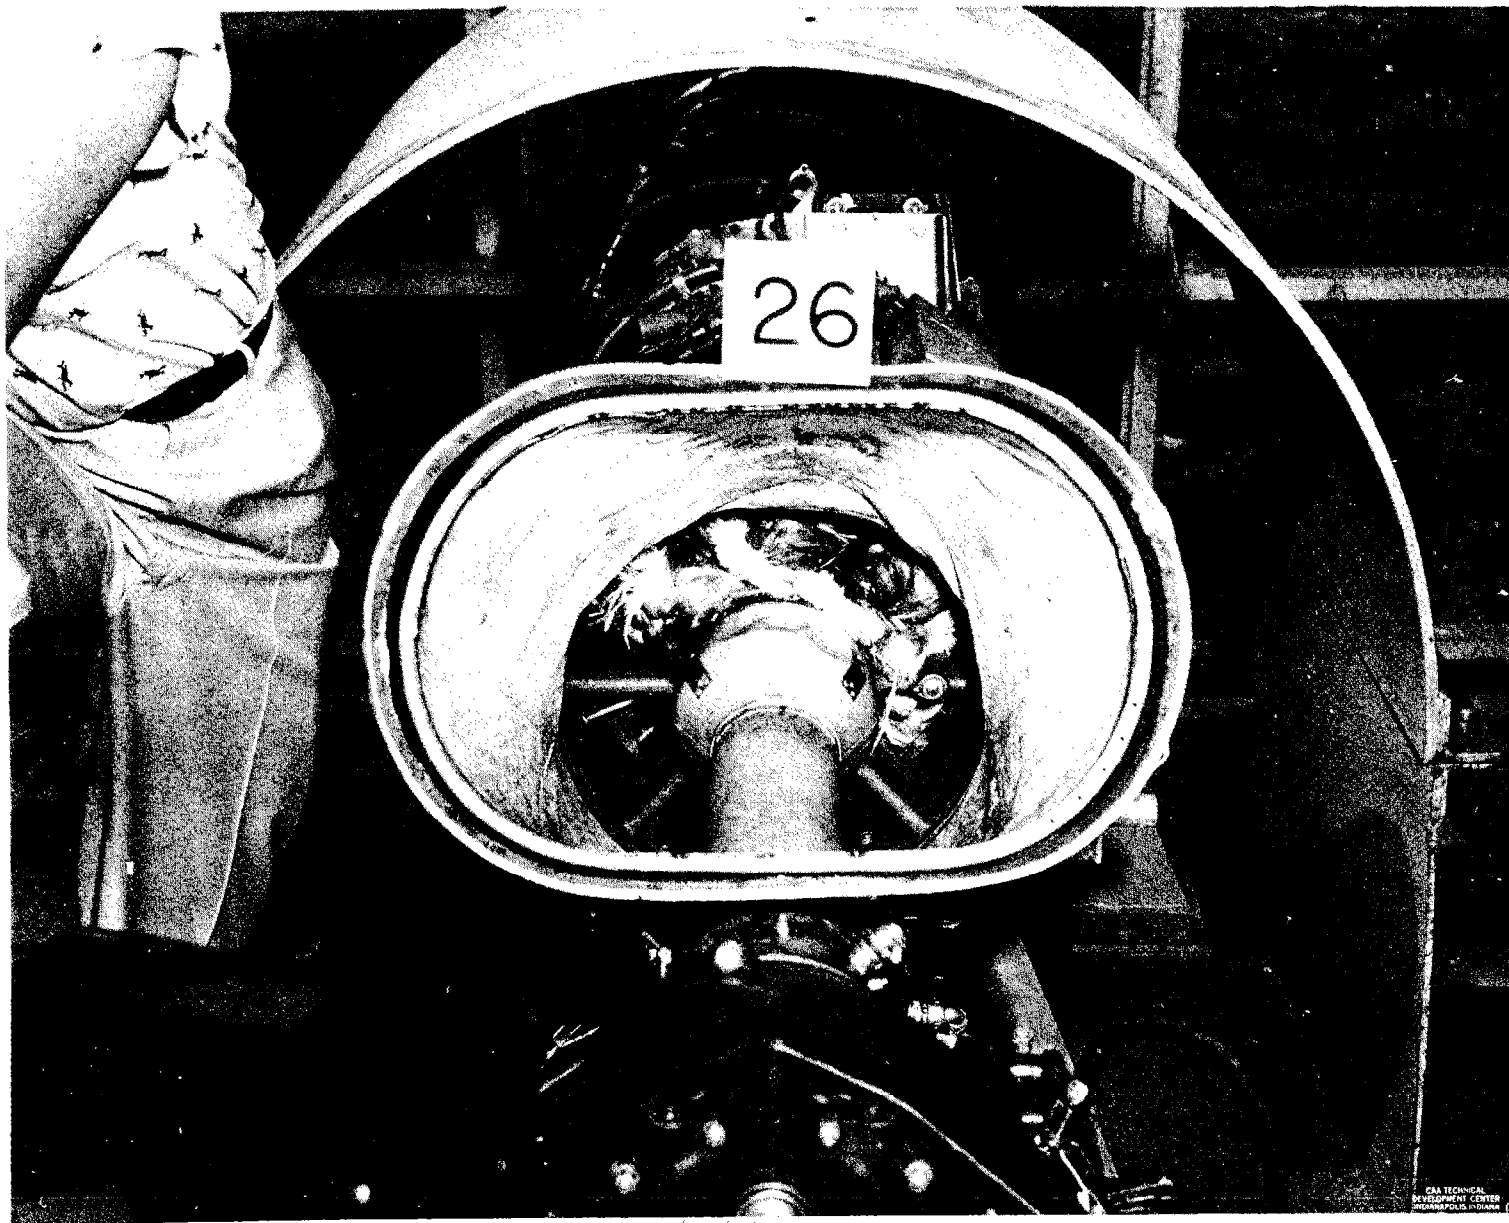
Fig. 22 Test No. 26 - 10/17/56 - Projectile Velocity 103 mph

The engine did not flame-out after impact of the chicken carcass, but was shut down due to excessive temperature in the turbine inlet. No further damage to the engine was observed. See Fig. 22.
