TECHNICAL DEVELOPMENT REPORT NO. 312

BIRD INGESTION TESTS
OF AN
ALLISON T-56 TURBINE ENGINE
(CIVIL MODEL 501-D13)

May 1957

CIVIL AERONAUTICS ADMINISTRATION
TECHNICAL DEVELOPMENT CENTER
INDIANAPOLIS, INDIANA

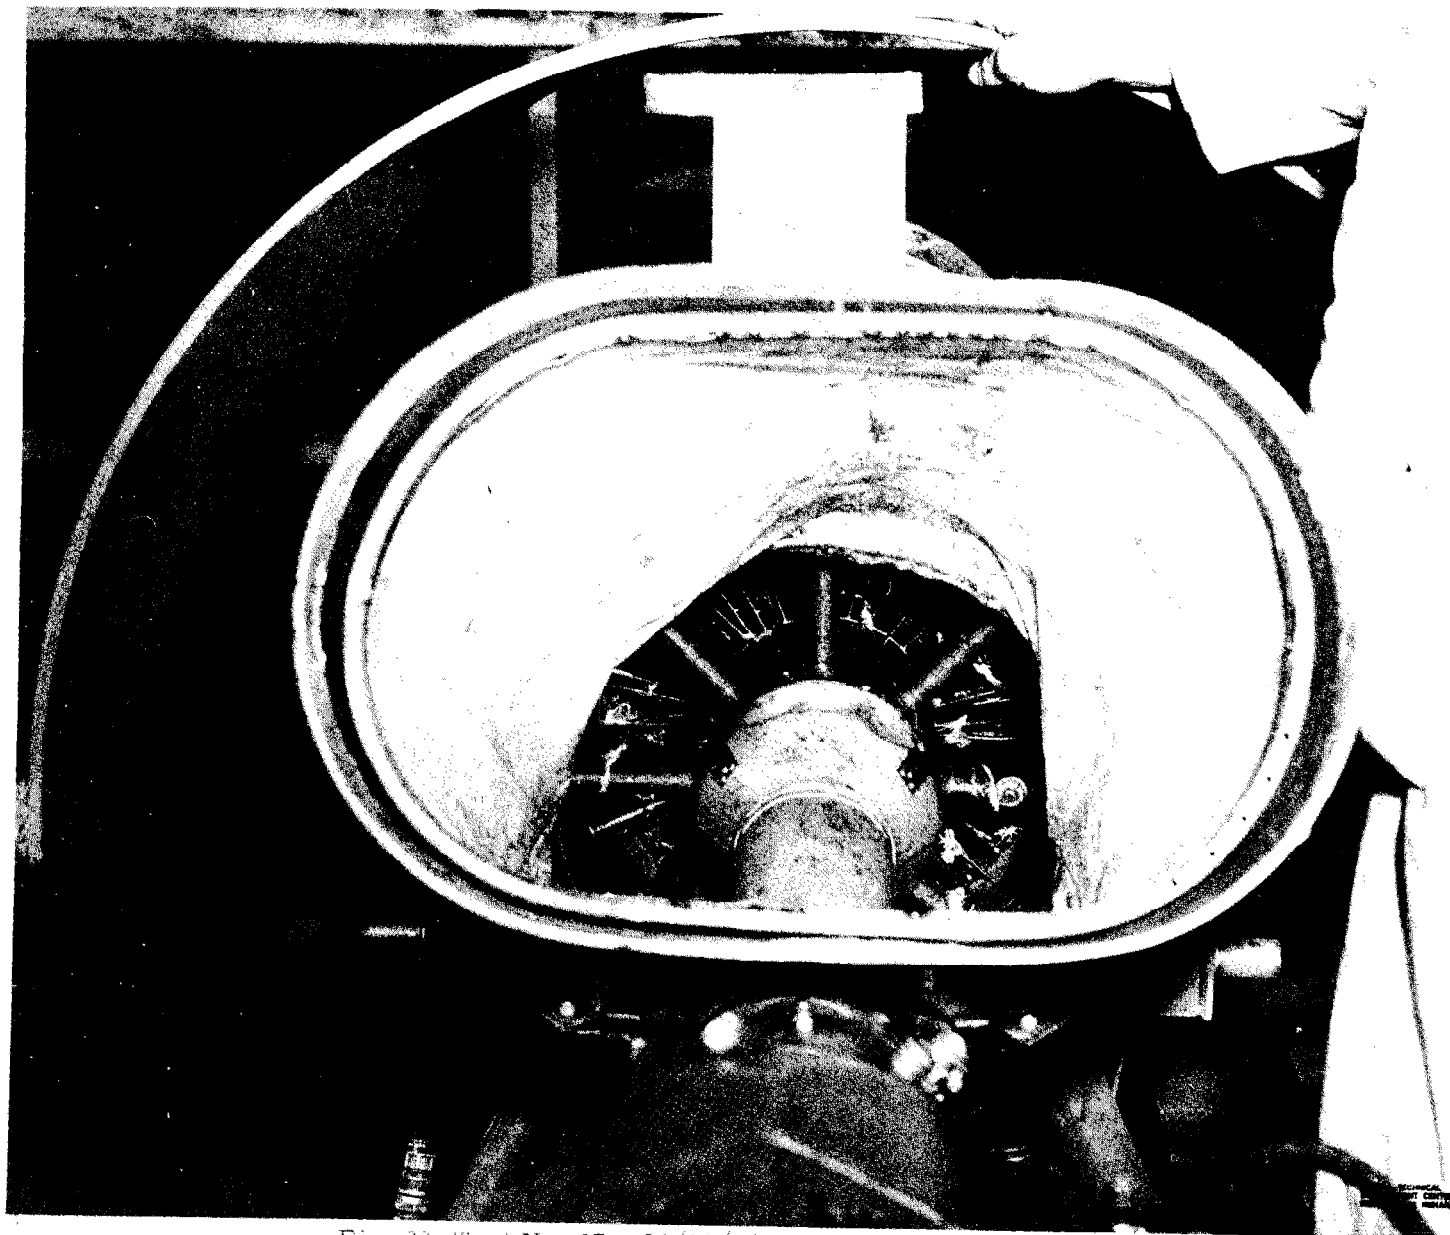
Fig. 23 Test No. 27 - 10/17/56 - Projectile Velocity 289 mph

The engine flamed-out shortly after impact of the chicken carcass. The first-stage stator blades in the upper section all were bowed into a U-shape at the center indicating that the blades attempted to rotate with the first-stage rotor blades. The tips of the second-stage rotor blades were bowed slightly and the leading edges of the second-stage stator blades were rolled back slightly. It is doubtful whether the engine could have been restarted after this test. See Fig. 23.
