Investigation of Fires Originating From an Aircraft Oxygen System

TECHNICAL DEVELOPMENT REPORT NO. 327

CIVIL AERONAUTICS ADMINISTRATION
TECHNICAL DEVELOPMENT CENTER
INDIANAPOLIS, INDIANA

March 1958

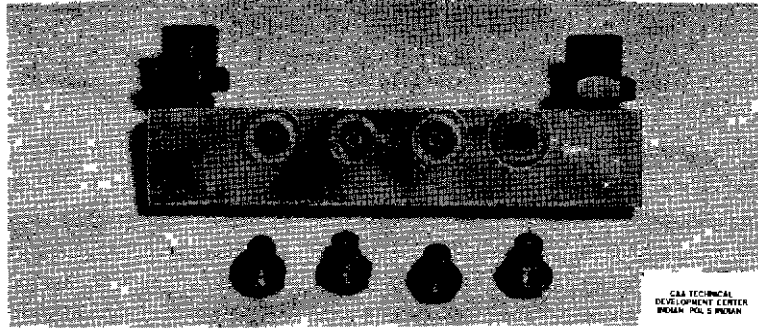
Fig 3 View of the Manifold After Tests During Which Valve Seats Were Destroyed

In the second series of tests, the oil-soaked cotton and the check-valve seat at the oxygen inlet were consumed, but the fire was not of sufficient intensity and duration to burn through the manifold block. Figure 3 shows the manifold block after it had been subjected to these tests. The damaged check-valve seats were replaced when necessary prior to each test.

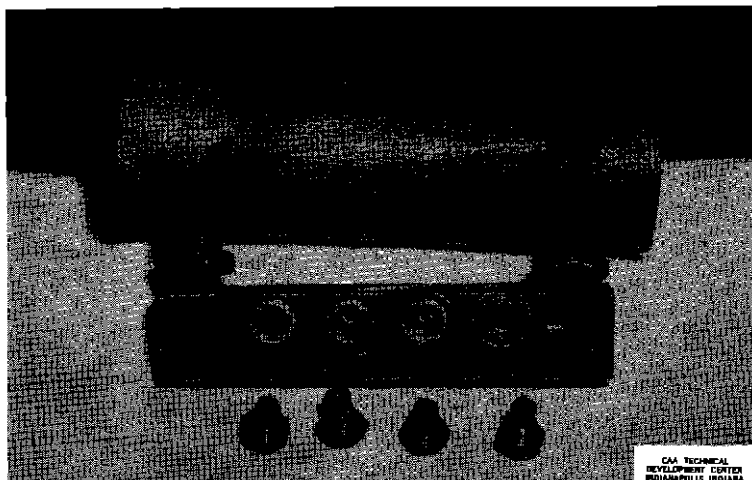
In the third series of tests, one of the outlet connections was made to leak slightly to allow the fire to burn through and ignite the cotton in the shield. Difficulty was encountered, however, in getting the fire to burn through the outlet connection. In several tests, the cotton inside the manifold and the check-valve seat at the oxygen inlet were consumed but the cotton outside the manifold was not ignited. In one test, ignition outside the manifold did occur and the fire which consumed the cotton was of sufficient intensity to burn a one-half-inch diameter hole through the shield. This is shown in Fig 4.

Fig 4 Damage to Manifold Shield

3 A protective shield of the material tested will not contain a fire which has burned through the manifold. Such a fire would be difficult to contain because of the presence of a large supply of oxygen.

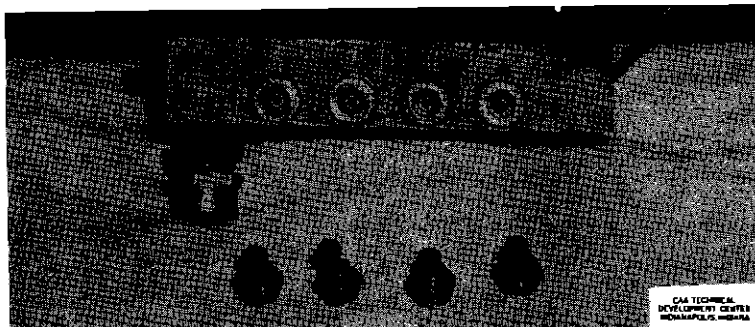
A final test was conducted in this series using a full cylinder of oxygen and a new manifold block. Oxygen was allowed to leak slowly from the outlet connection. The first time the cotton was ignited it burned for only a short time before going out. The cotton again was ignited and very shortly after the cylinder valve was opened, a loud explosion occurred. The manifold was blown off the support bracket and was found on the ground about 35 feet from its original position. One of the regulator outlet fittings was found a few feet from the manifold. The manifold was ruptured along most of the length of the main passage as shown in Fig 5. The aluminum was melted around the oxygen inlet to the main passage and there was some indication that the fire may have burned through the manifold before the explosion occurred. The check-valve seats were still in good condition and were not damaged by the fire as may be seen in Fig 6.

Fig 6 Condition of Check-Valve Seats
