TECHNICAL DEVELOPMENT REPORT NO. 342

BIRD-IMPACT TESTS OF THE  
BOEING MODEL 707 AIRPLANE EYEBROW WINDOW

April 1958

CIVIL AERONAUTICS ADMINISTRATION  
TECHNICAL DEVELOPMENT CENTER  
INDIANAPOLIS, INDIANA

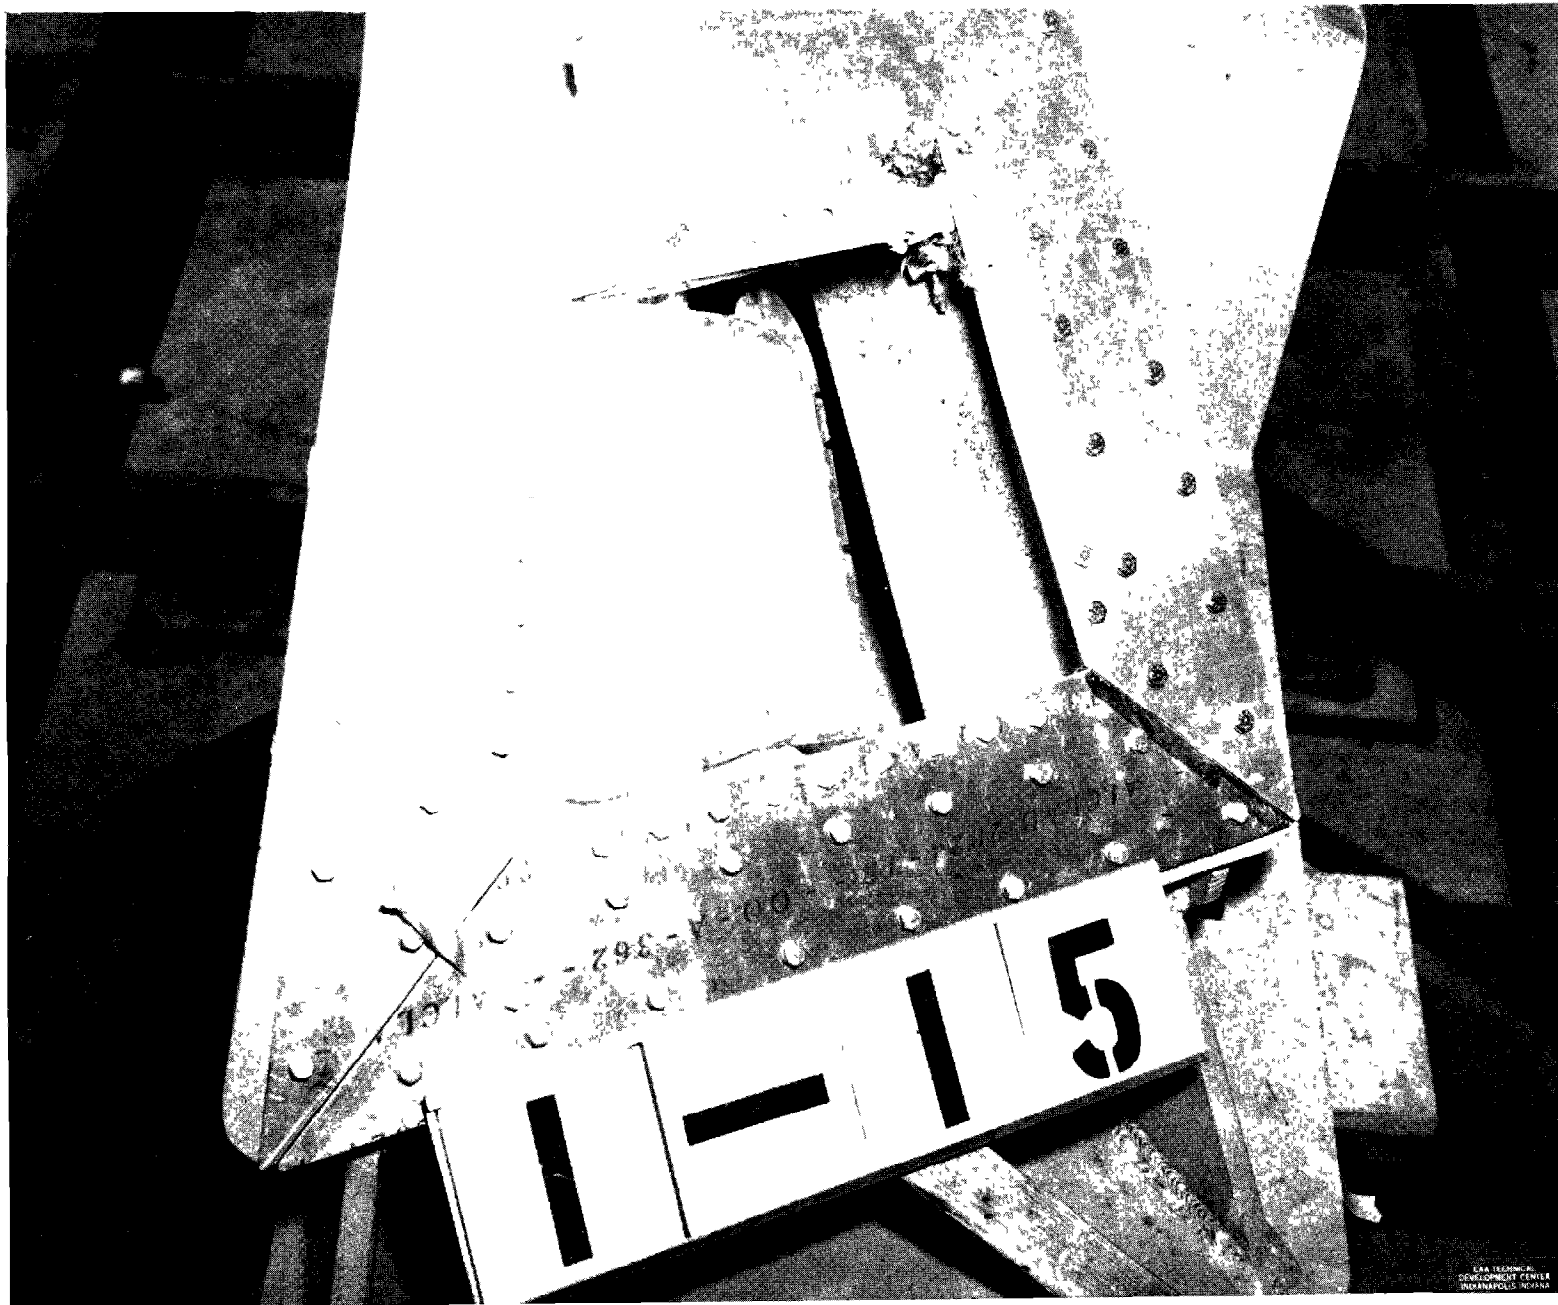
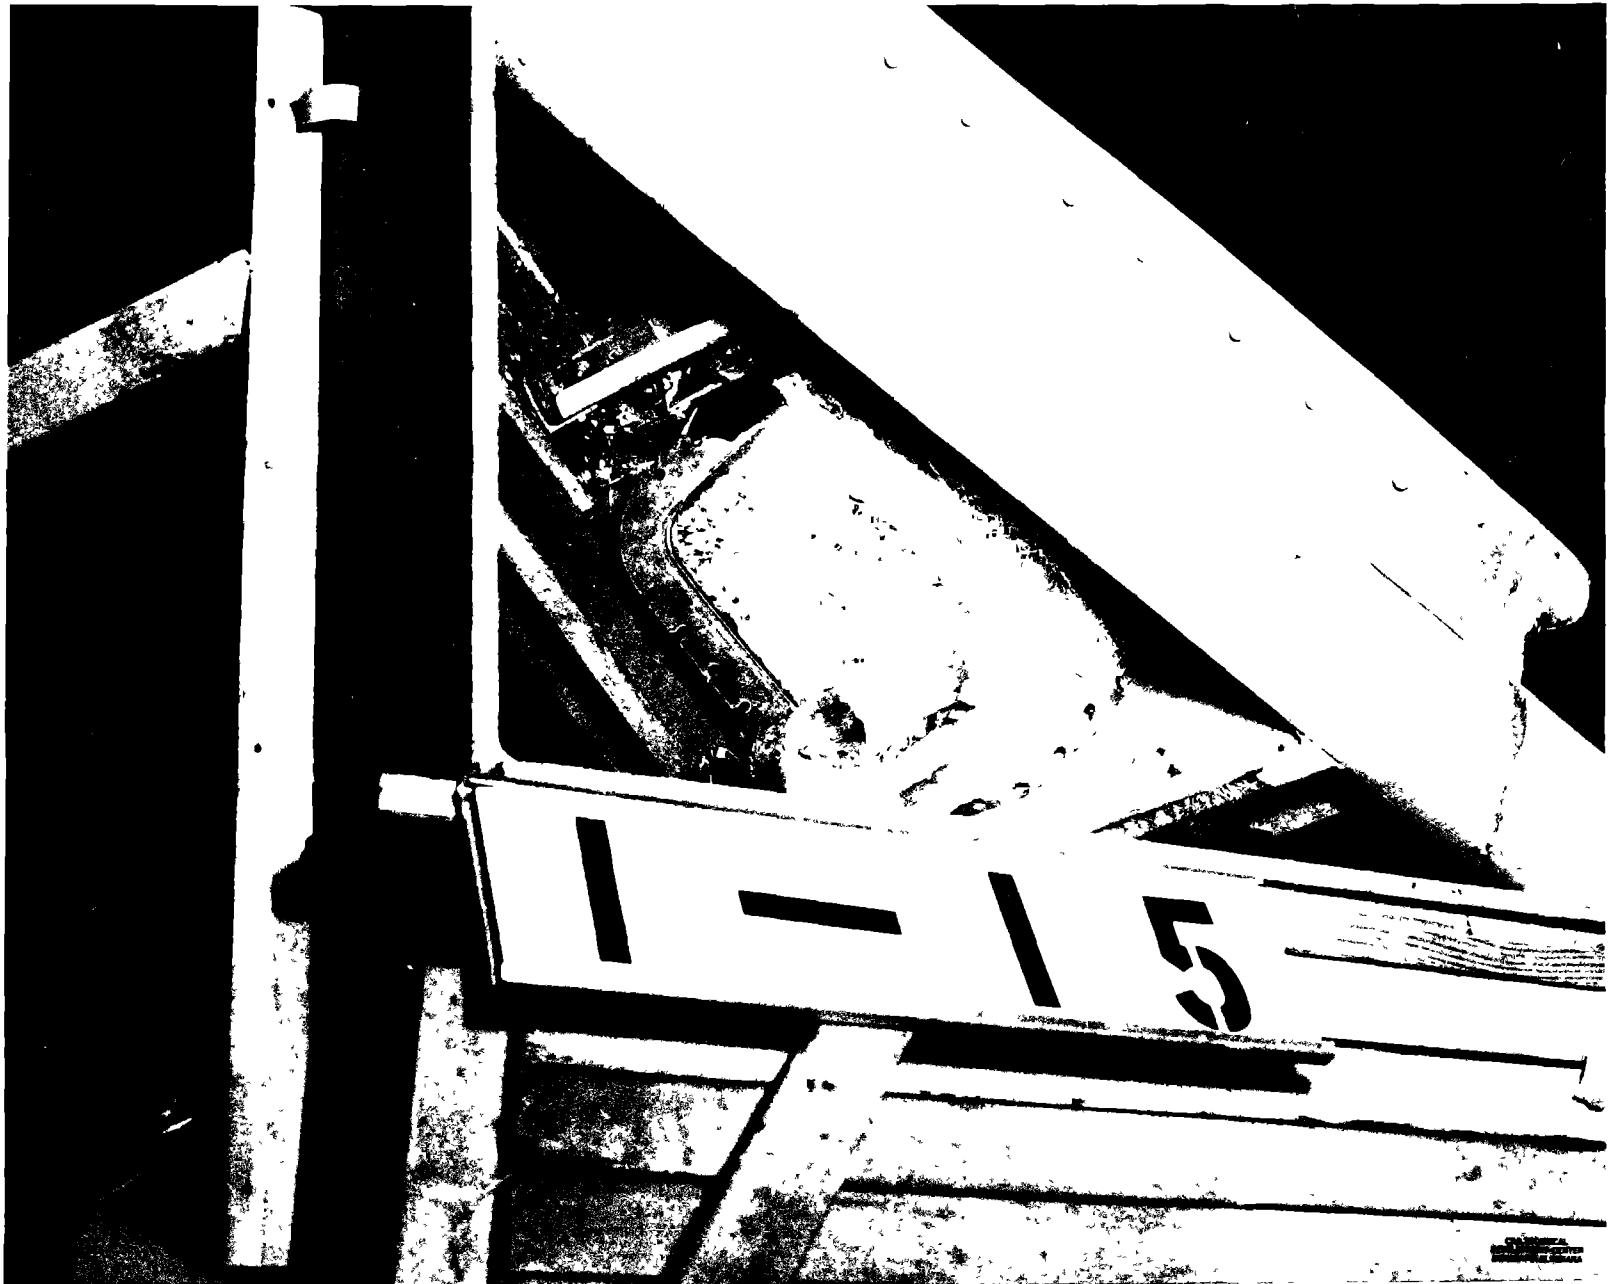
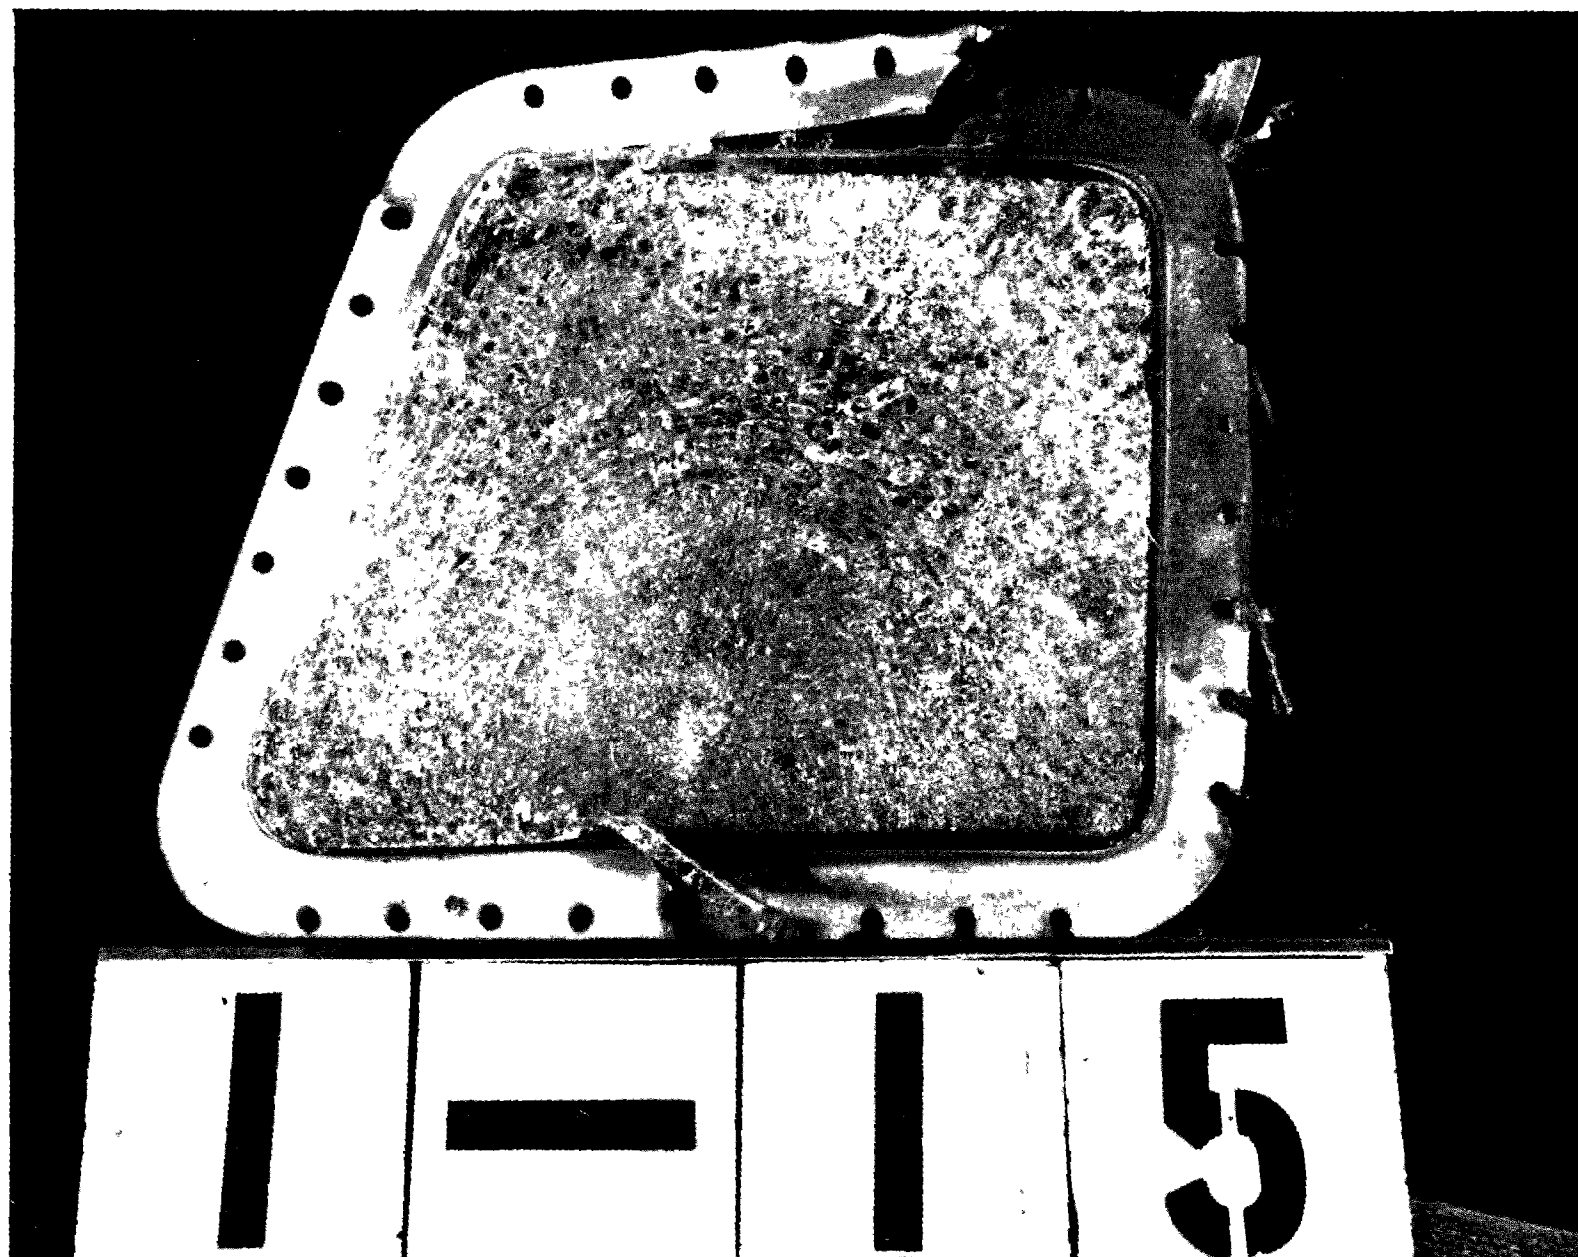
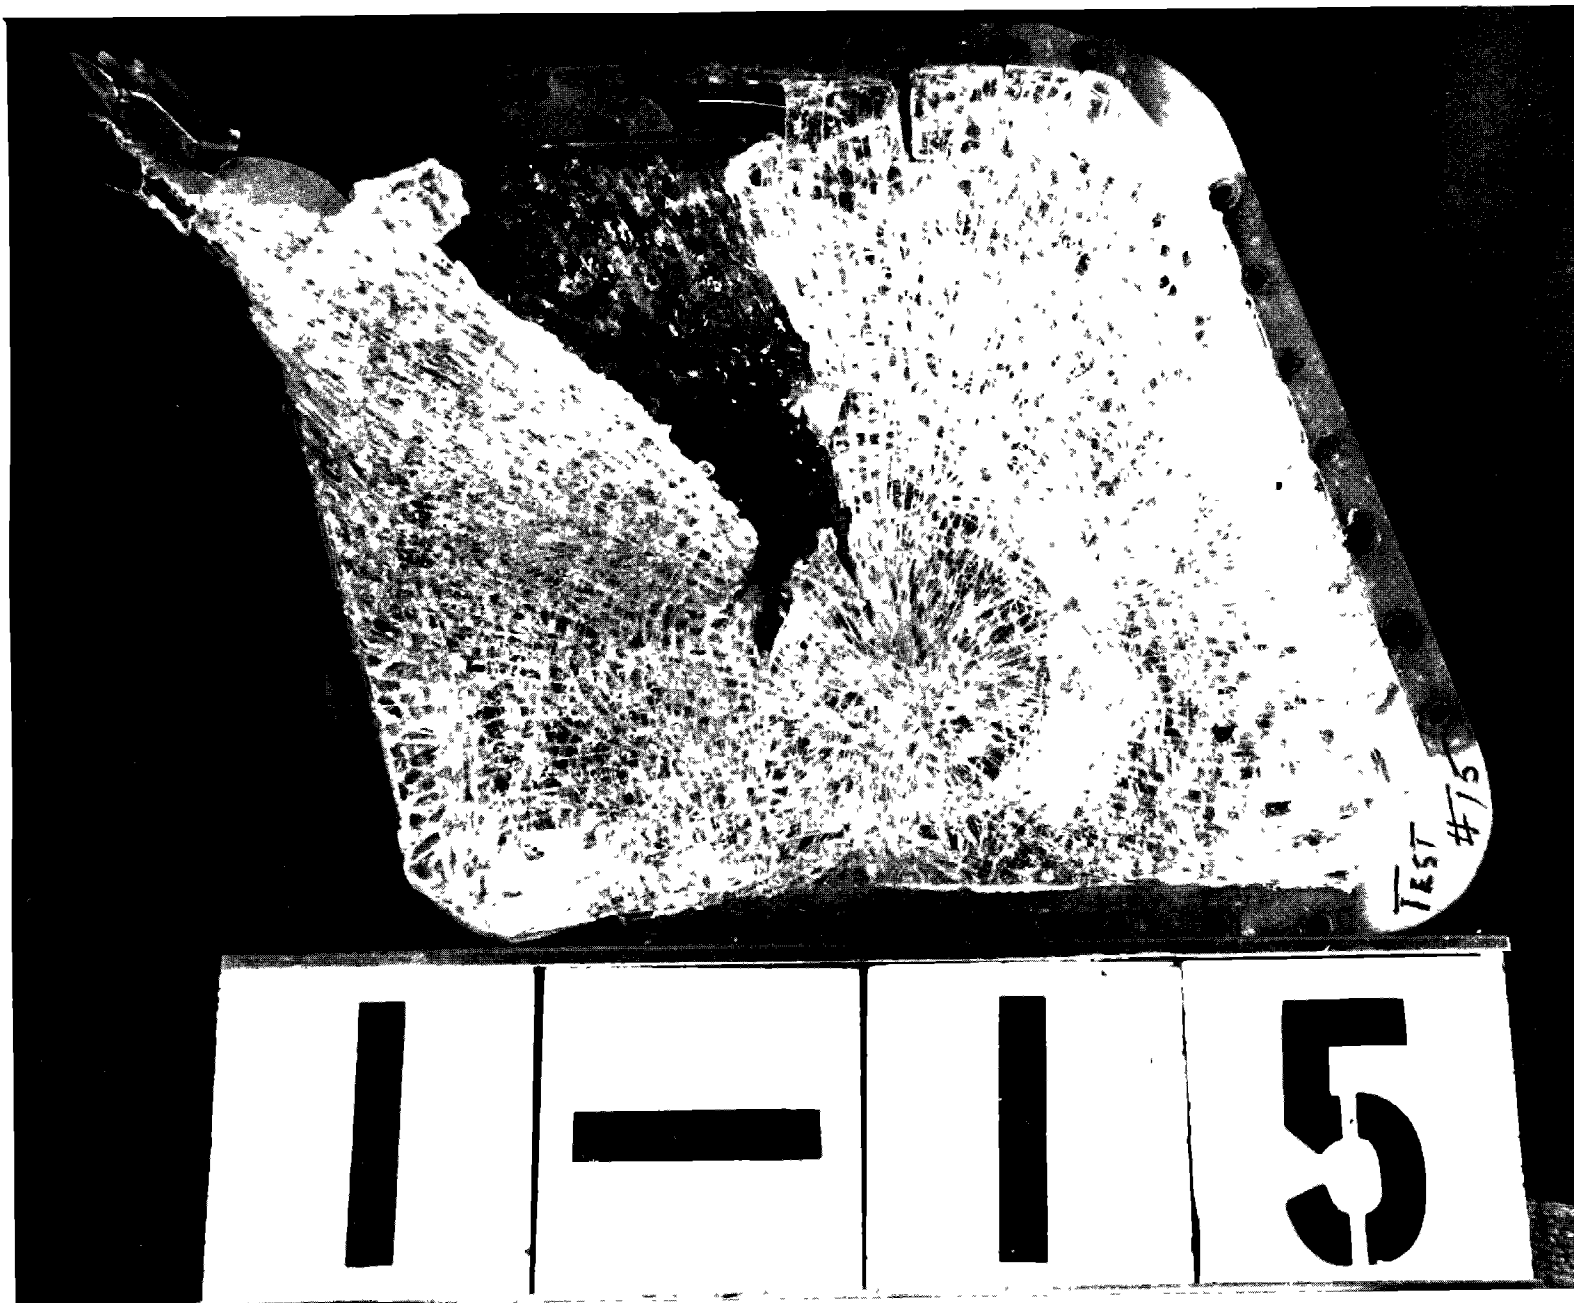
FIG. 6 TEST NO. 15. PROJECTILE VELOCITY 438 MPH

Bird-carcass penetration was experienced as the window failed along the upper, outboard, and lower sills. Details of the window failure are shown in Figs. 6, 7, 8, and 9. Both the outer vinyl layer, which incorporated a metal insert, and the inner vinyl layer tore out around all outboard sill

bolts and five bottom sill bolts. The outer vinyl layer sheared along the metal insert 5 inches along the top sill. The outer layer of vinyl pulled loose from the insert 2 inches outboard along the top sill and along the entire outboard sill. The inner layer of vinyl pulled loose along the top, outboard, and lower sills. Most of the 1/8-inch-thick inner face of glass adhered to the inner vinyl layer. The inner vinyl layer split open and allowed 1/4-inch-thick full-tempered glass fragments to spray into the "cockpit area," with enough energy to break the skin of the plucked chicken carcass. The upper, outboard, and lower sills bent inward slightly. Washer strips were not used because of the clearance problem with the edge of 1/8-inch-thick inner face glass. The window-bolt hole-edge distance was insufficient due to the clearance problem and this was the main cause of failure.

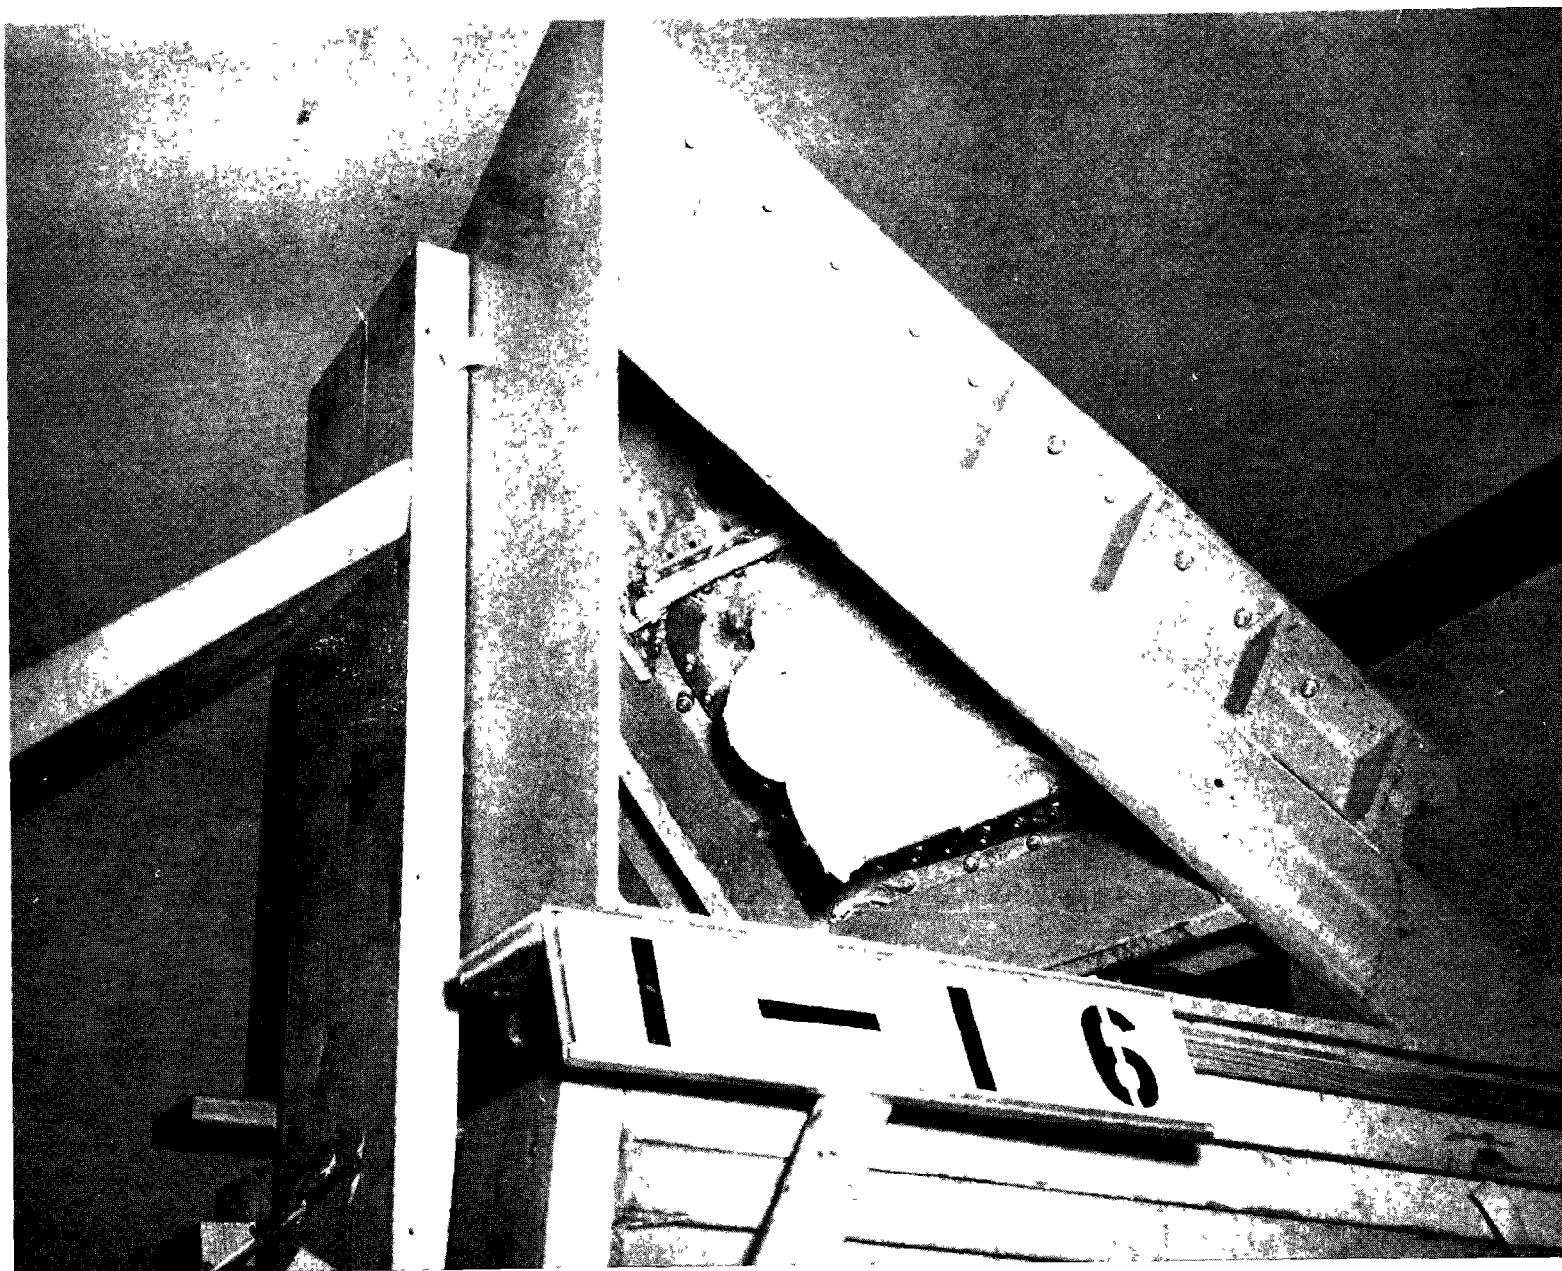
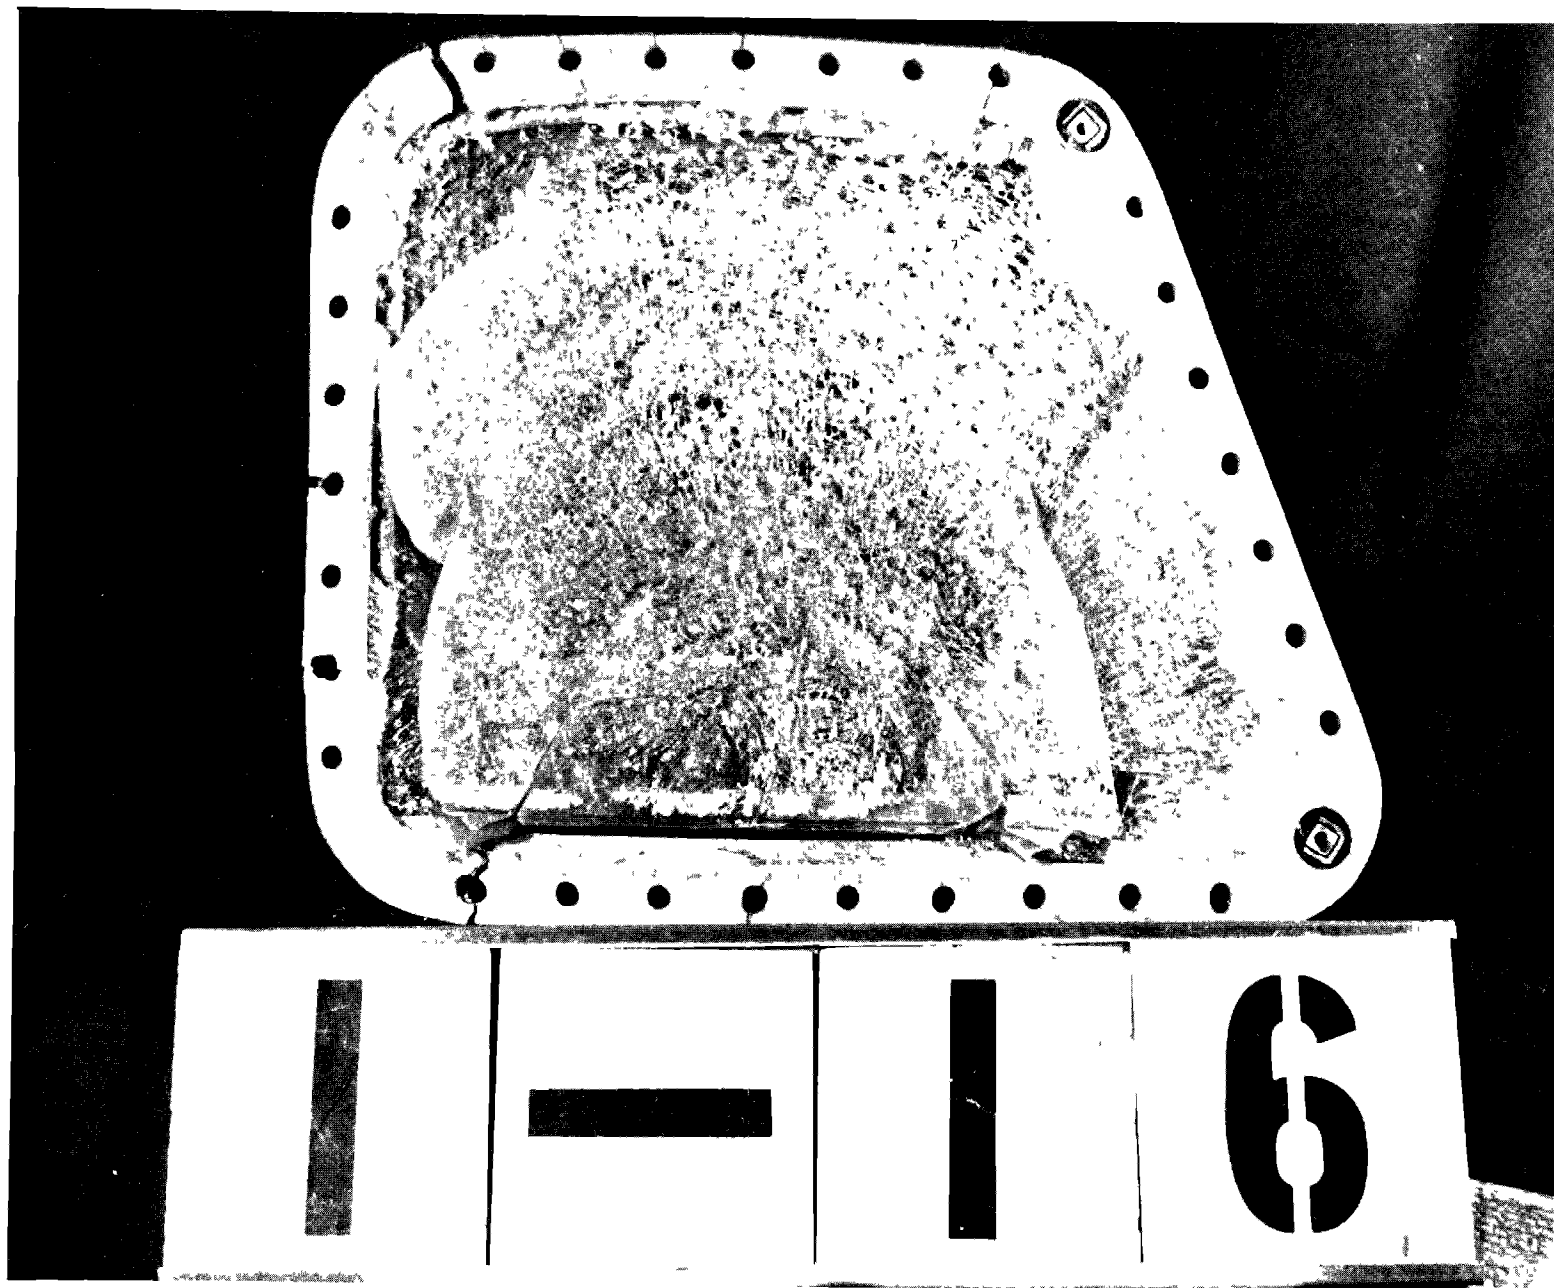
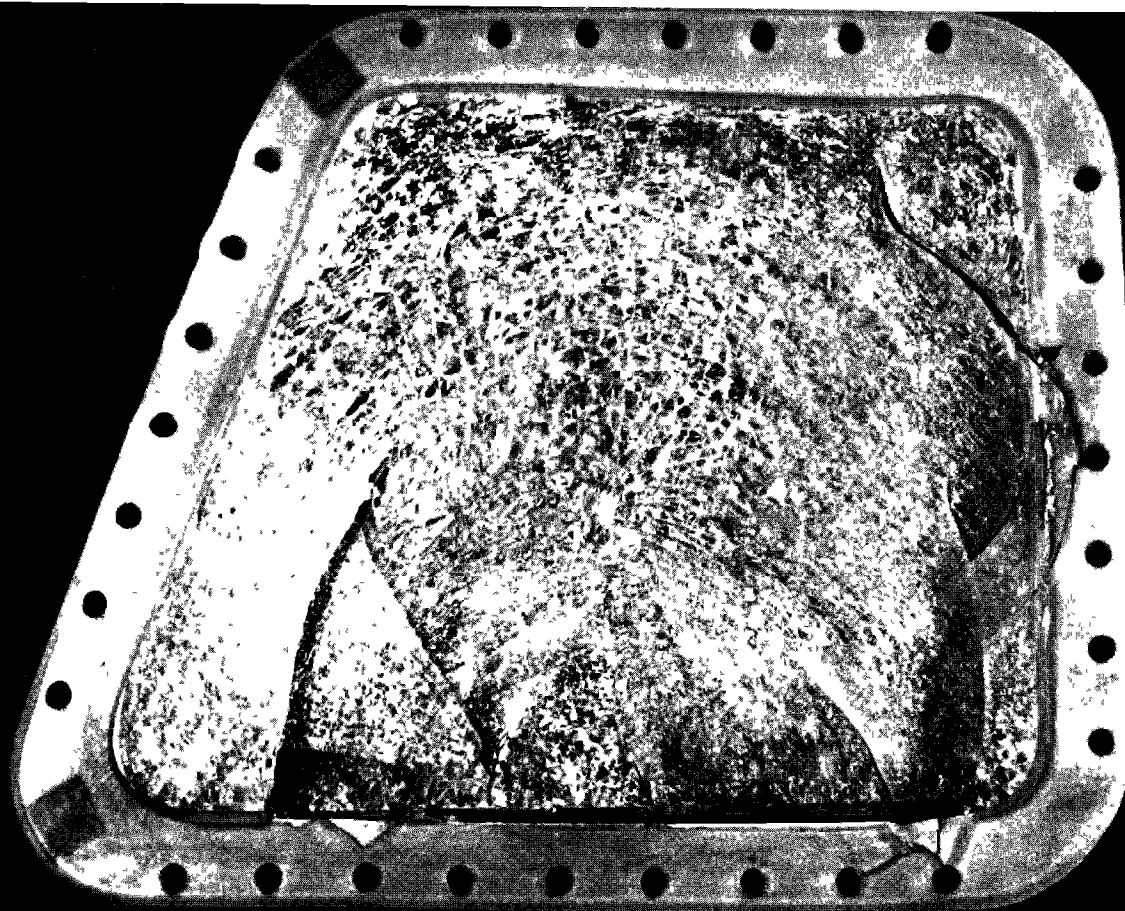
FIG 10 TEST NO. 10 PROJECTILE VELOCITY 100 MPH

Part of the carcass penetrated the window due to shearing of the vinyl, as shown in Figs. 10, 11, 12, and 13. No window-edge pullout was experienced. The bond between the Plex inner face and inner layer of vinyl caused the vinyl and Plex to fail in the same manner. Most of the 1/4-inch-thick full-tempered glass fragments entered the "cockpit area," but the velocity of the fragments was noticeably lower than that experienced with the original Boeing 707 eyebrow window. It is believed that the vinyl temperature around the window edge was low due to the transfer of heat from the vinyl into the adjacent sill structure which was relatively cold. The outside temperature was 52° F. Upper and lower sills were bent inward slightly.

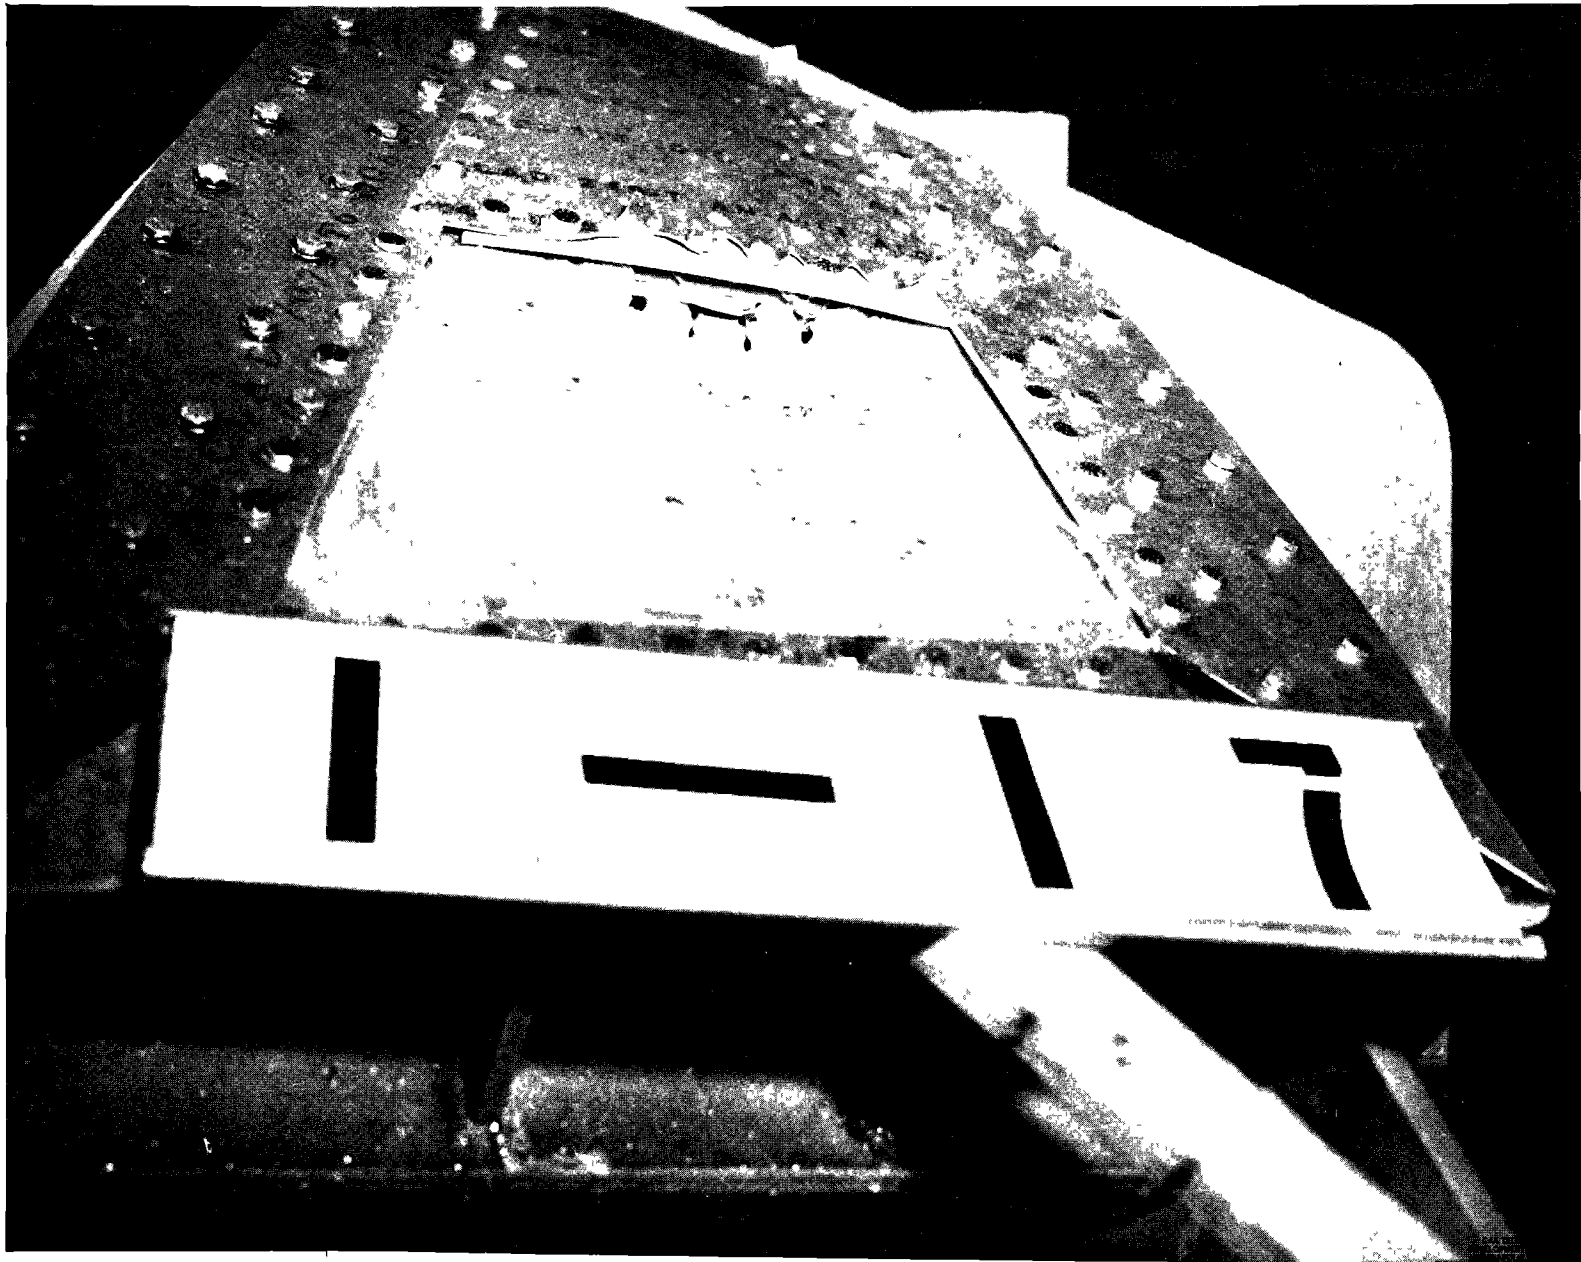
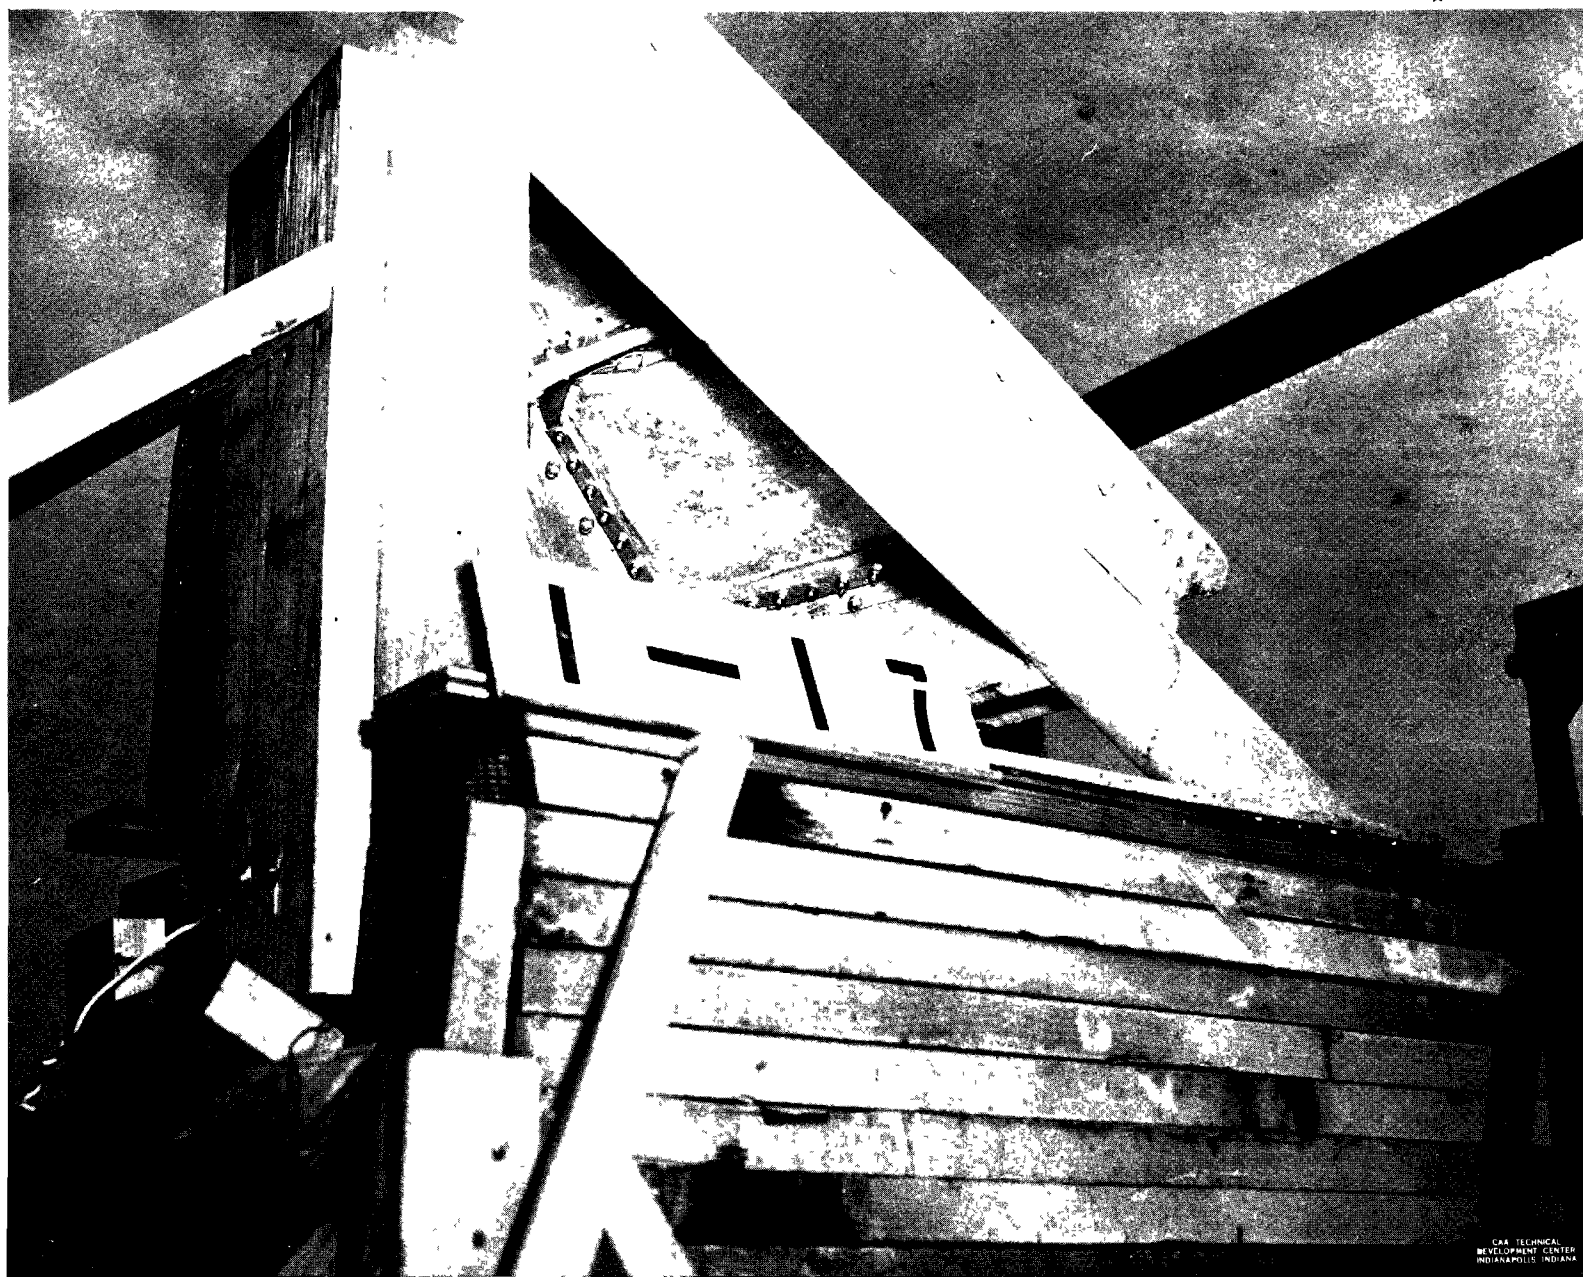
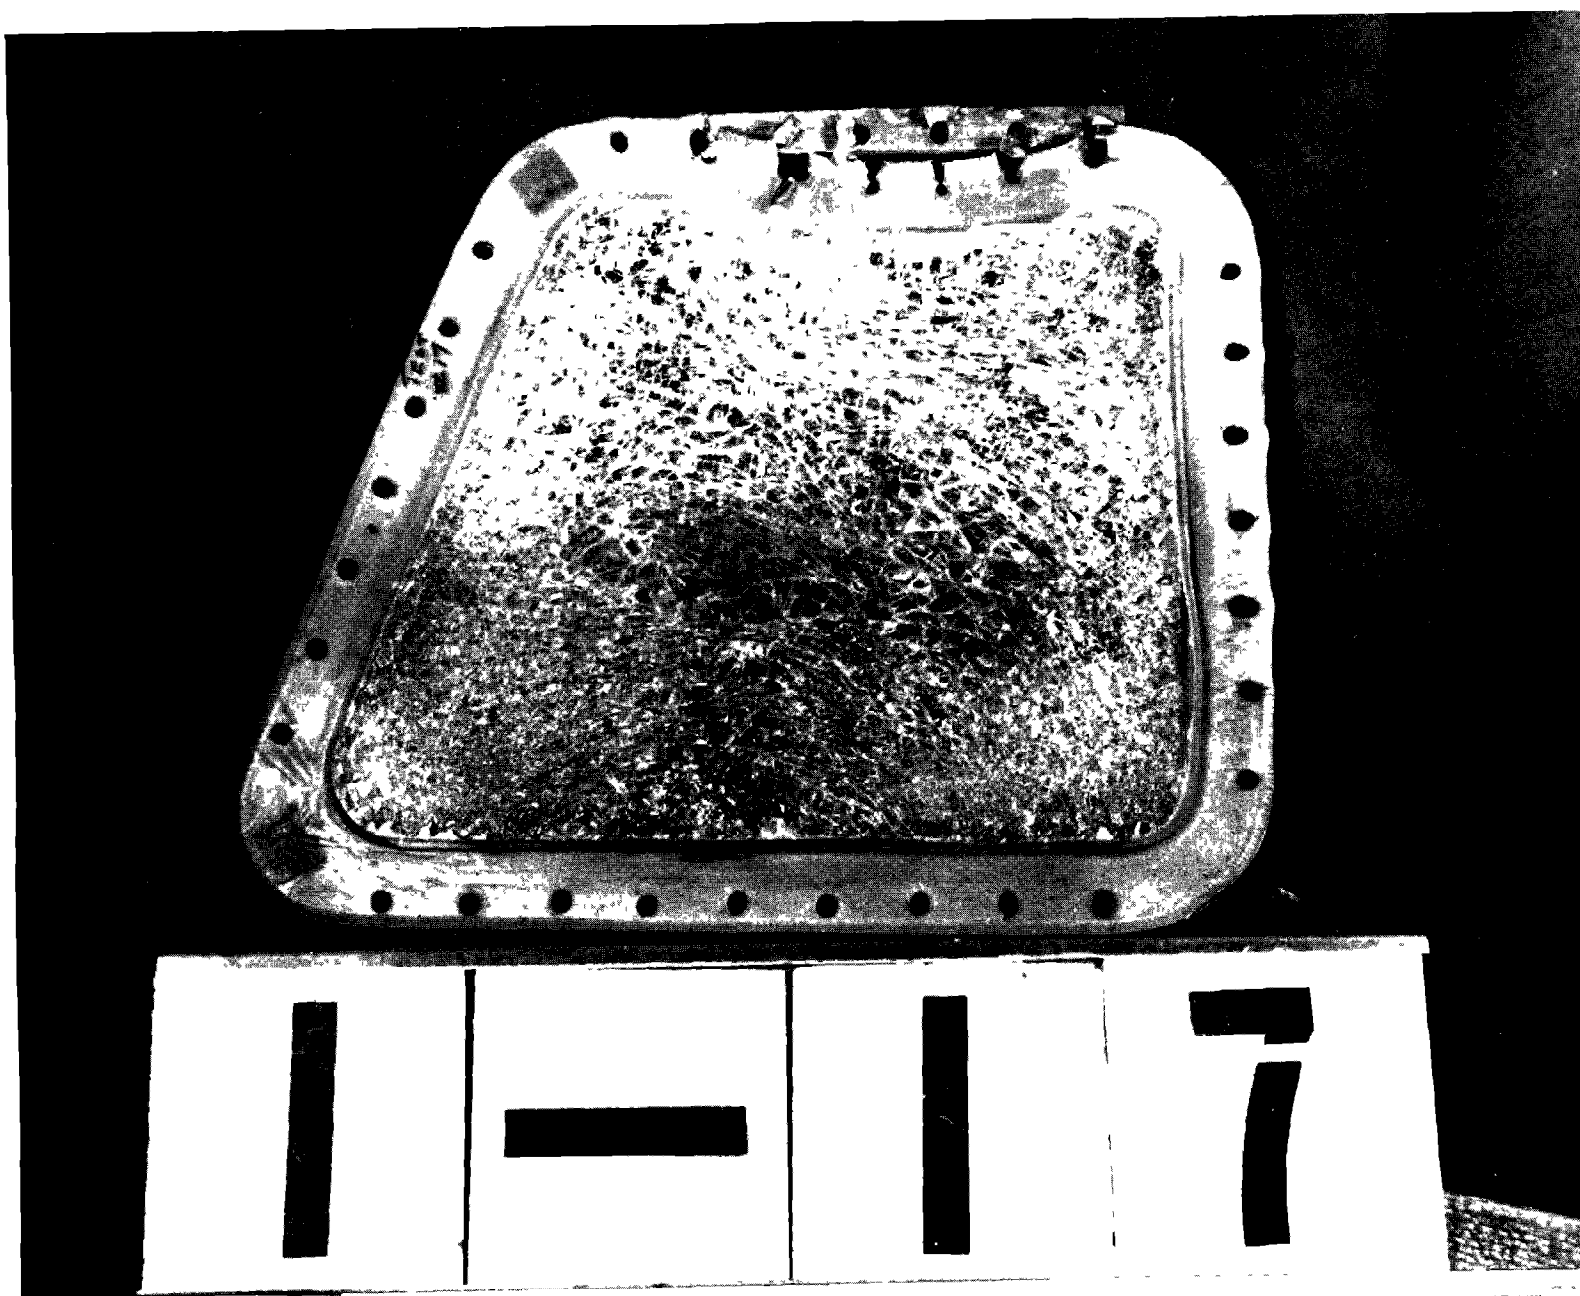
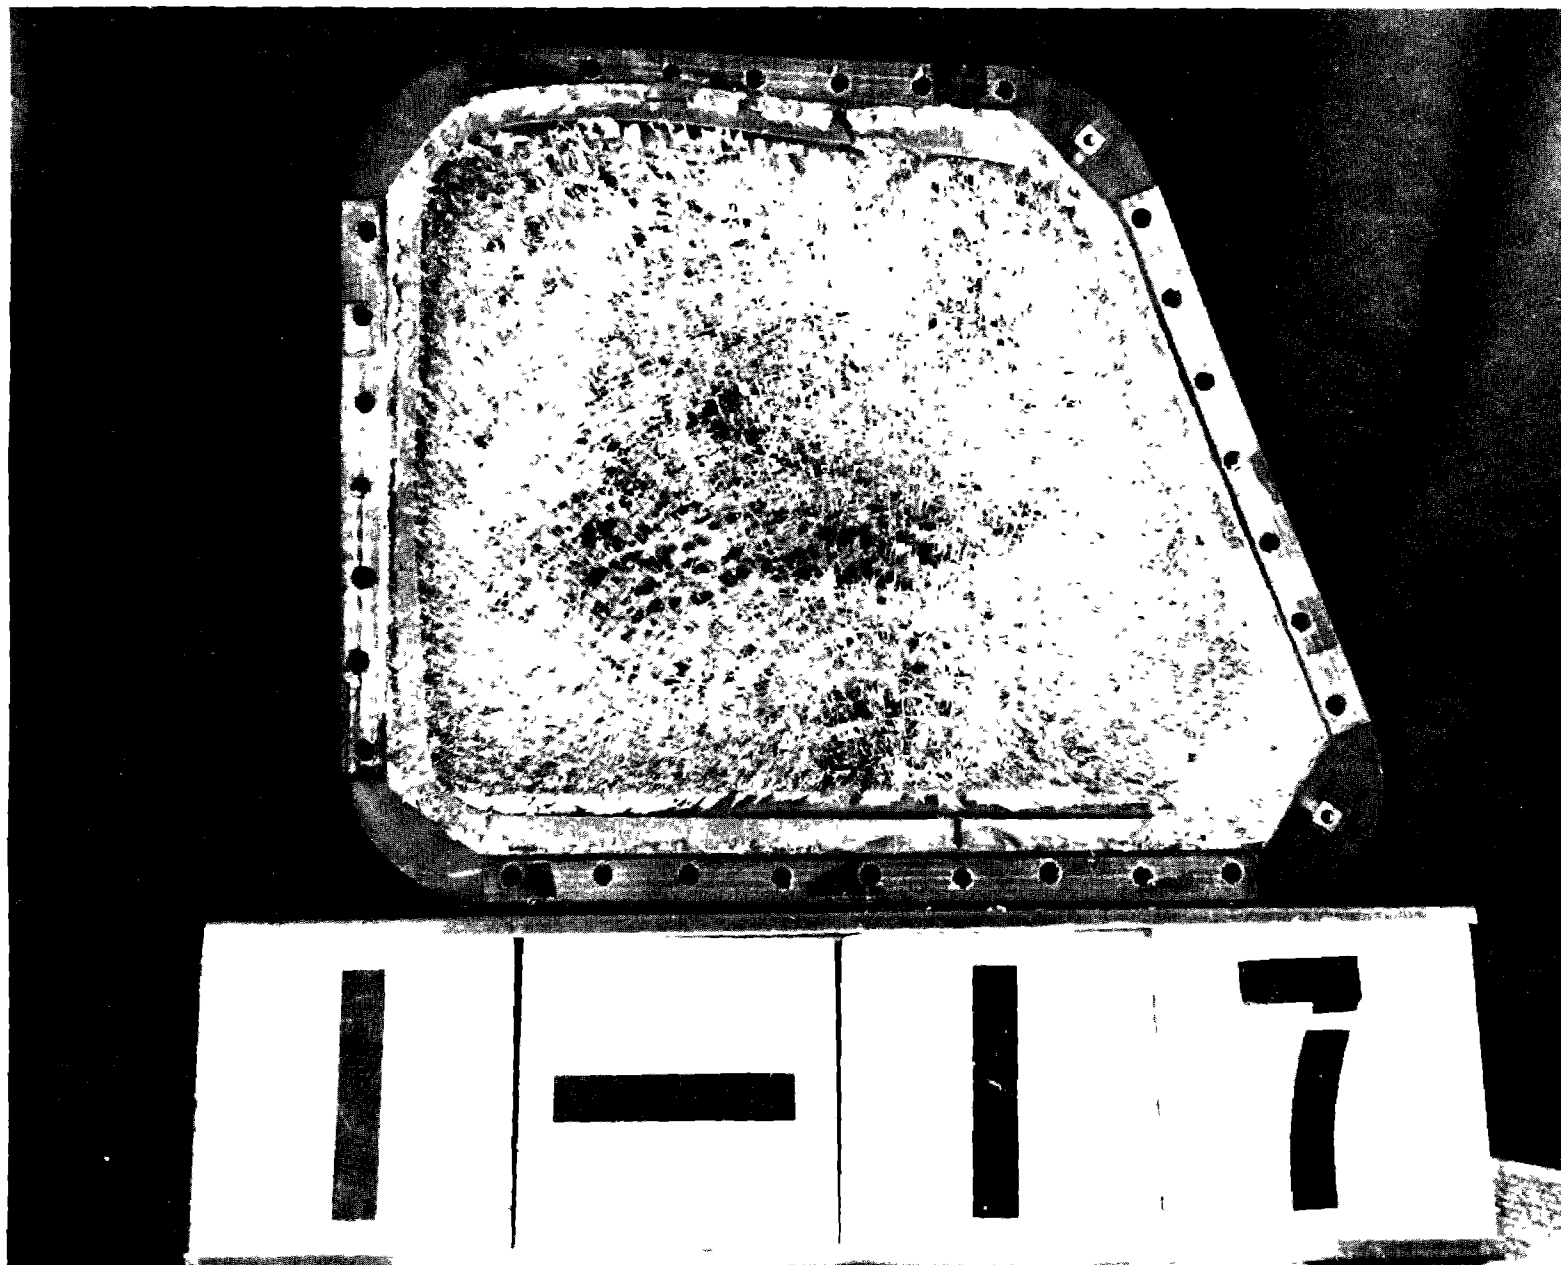
FIG 14 TEST NO. 17. PROJECTILE VELOCITY 384 MPH

The window tested was of the original design consisting of 1/8-inch-thick semitempered glass, 5/16-inch-thick, 21 parts plasticized vinyl and 1/4-inch-thick full-tempered glass. There was slight penetration by the bird carcass through an opening at the top sill, as shown in Figs. 14, 15, 16, and 17. The hydraulic action of the carcass in passing between the window and upper sill forced the window edge downward, with the result that

the vinyl and metal insert pulled loose from the top sill bolts. A chicken carcass, used to simulate the pilot's head, suffered several severe lacerations due to flying glass, as shown in Fig. 18.
