TECHNICAL DEVELOPMENT REPORT NO. 342

BIRD-IMPACT TESTS OF THE  
BOEING MODEL 707 AIRPLANE EYEBROW WINDOW

April 1958

CIVIL AERONAUTICS ADMINISTRATION  
TECHNICAL DEVELOPMENT CENTER  
INDIANAPOLIS, INDIANA

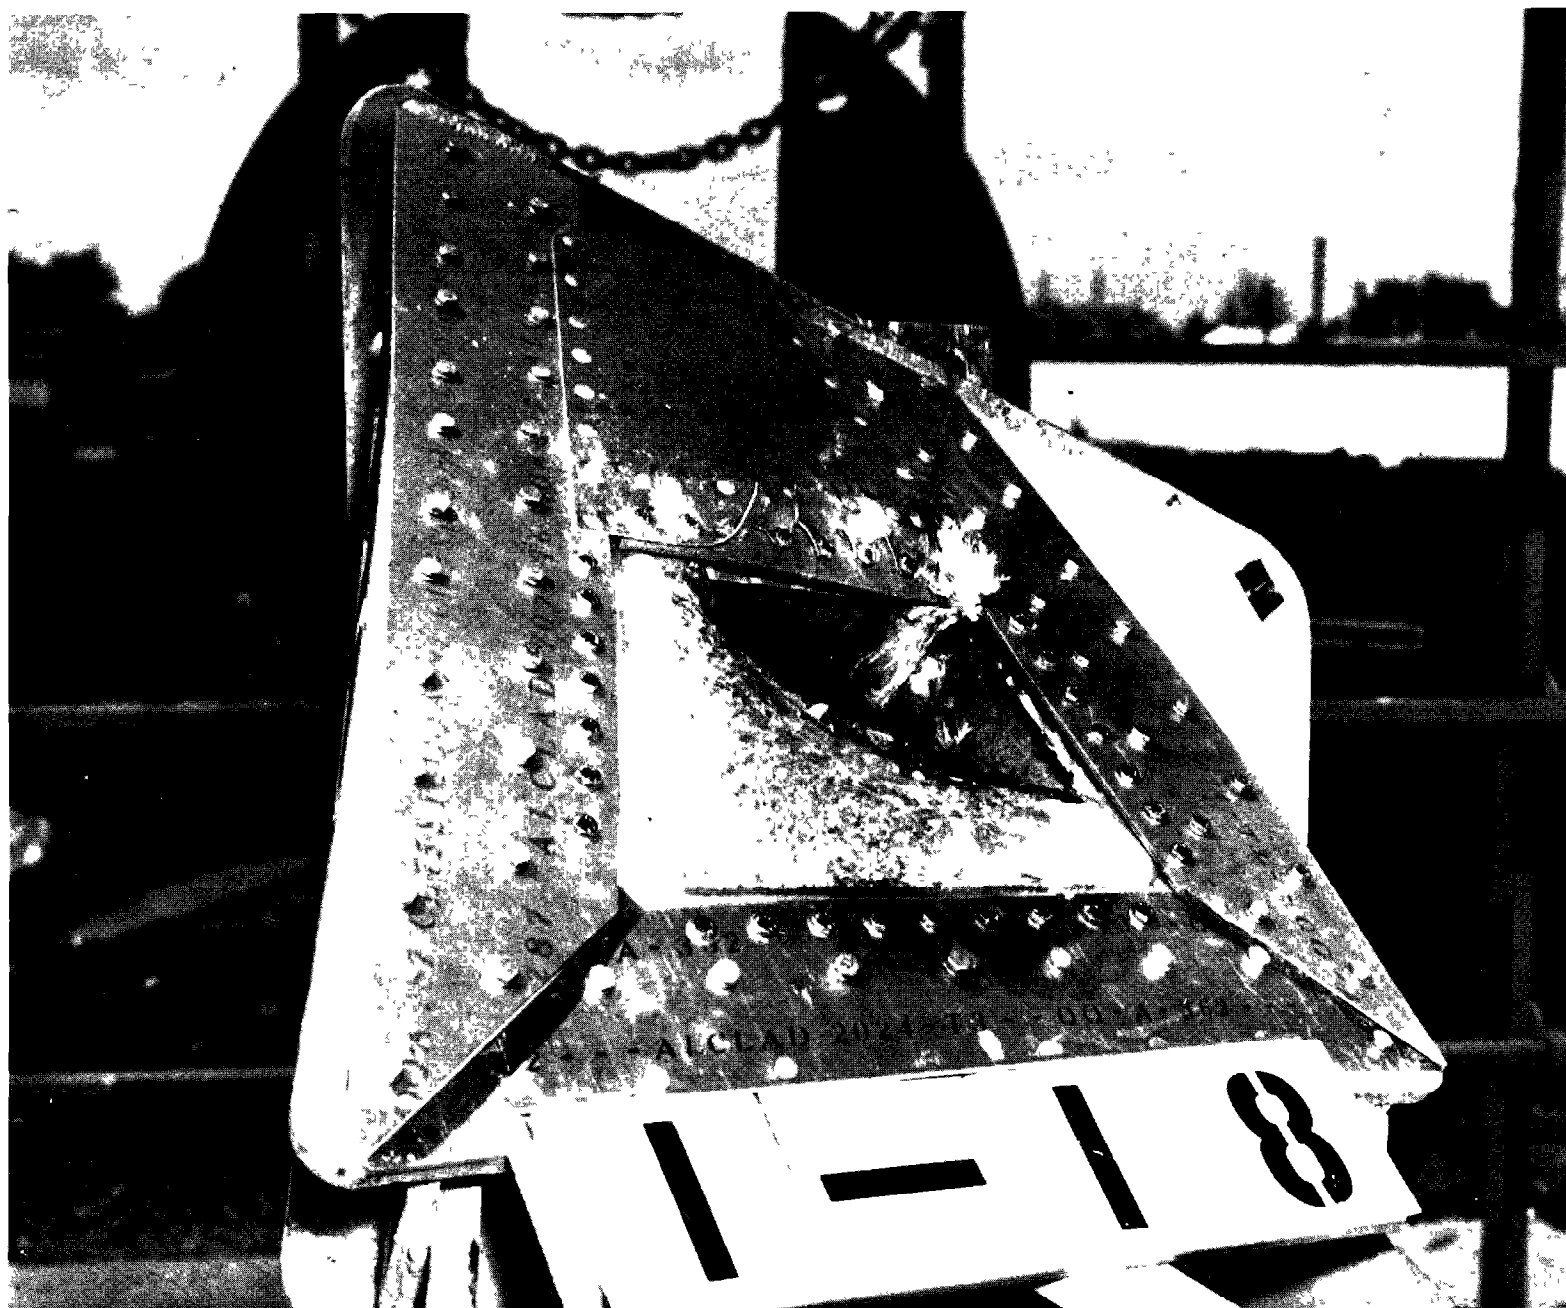
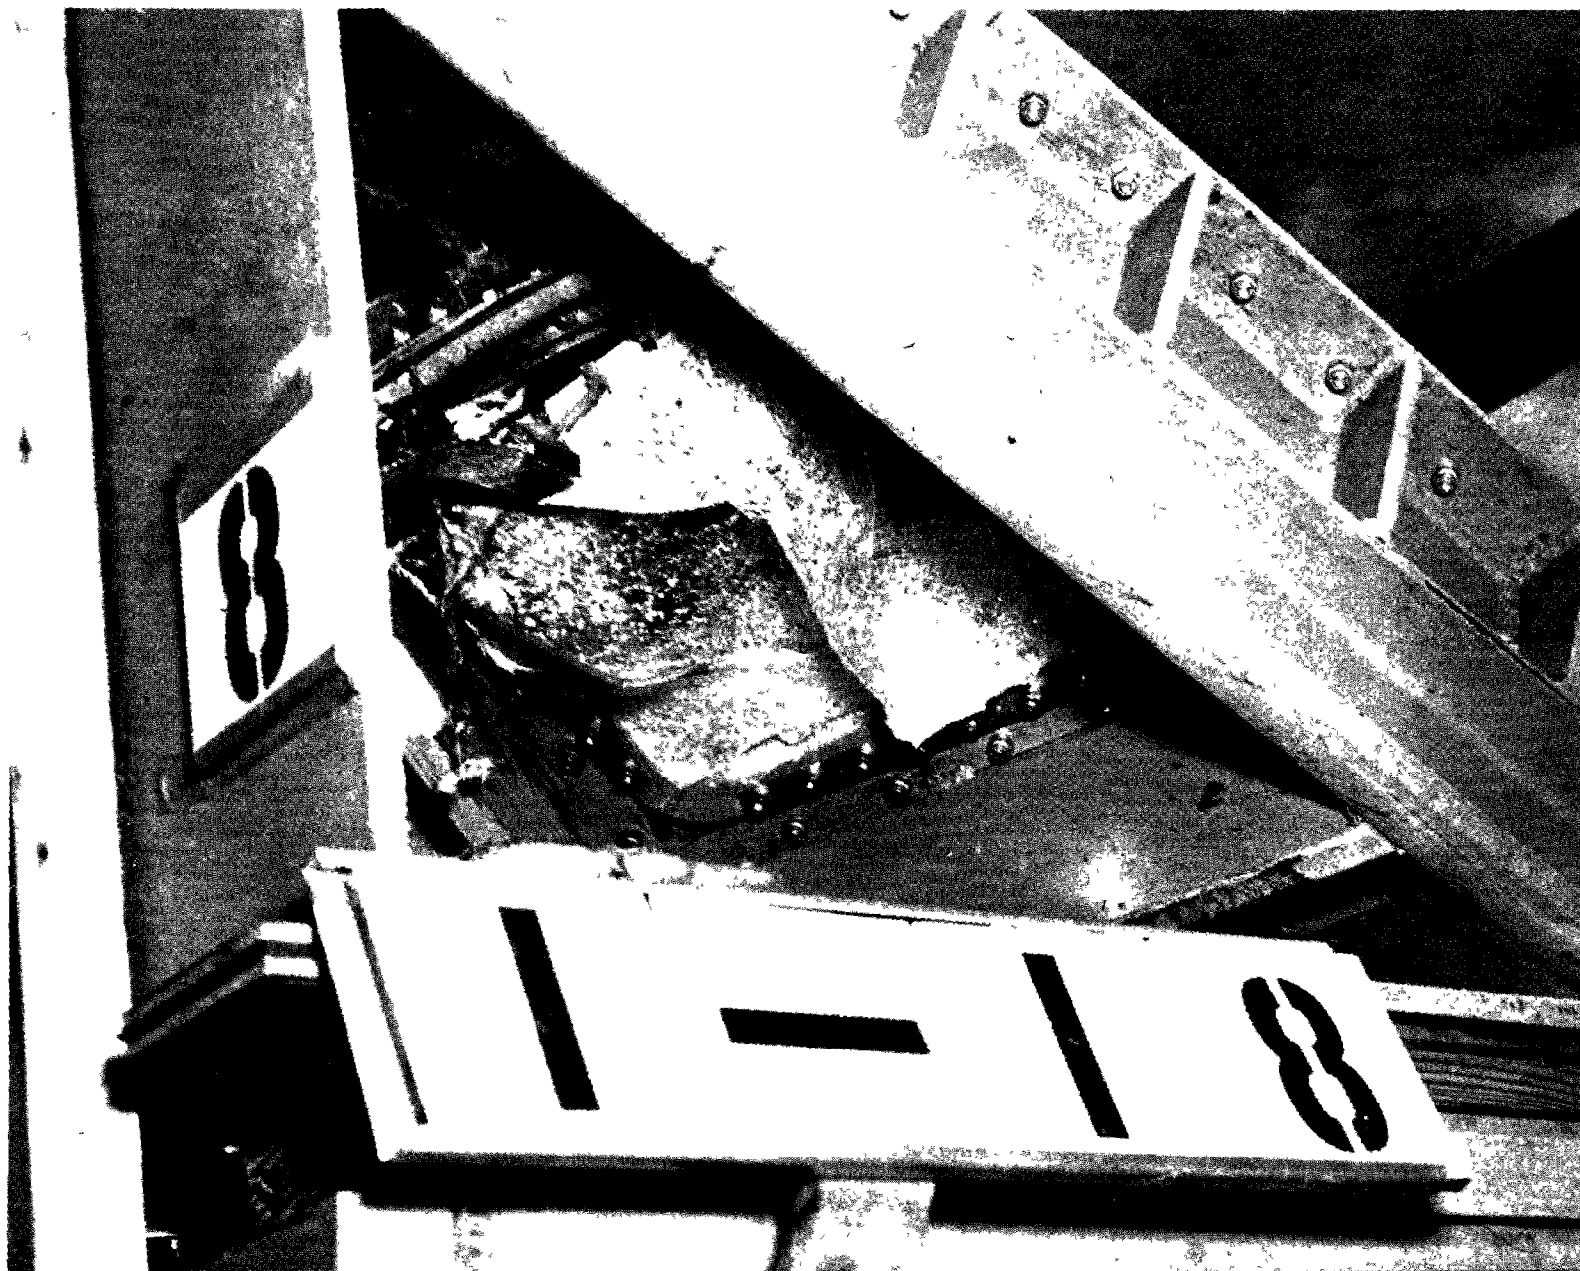
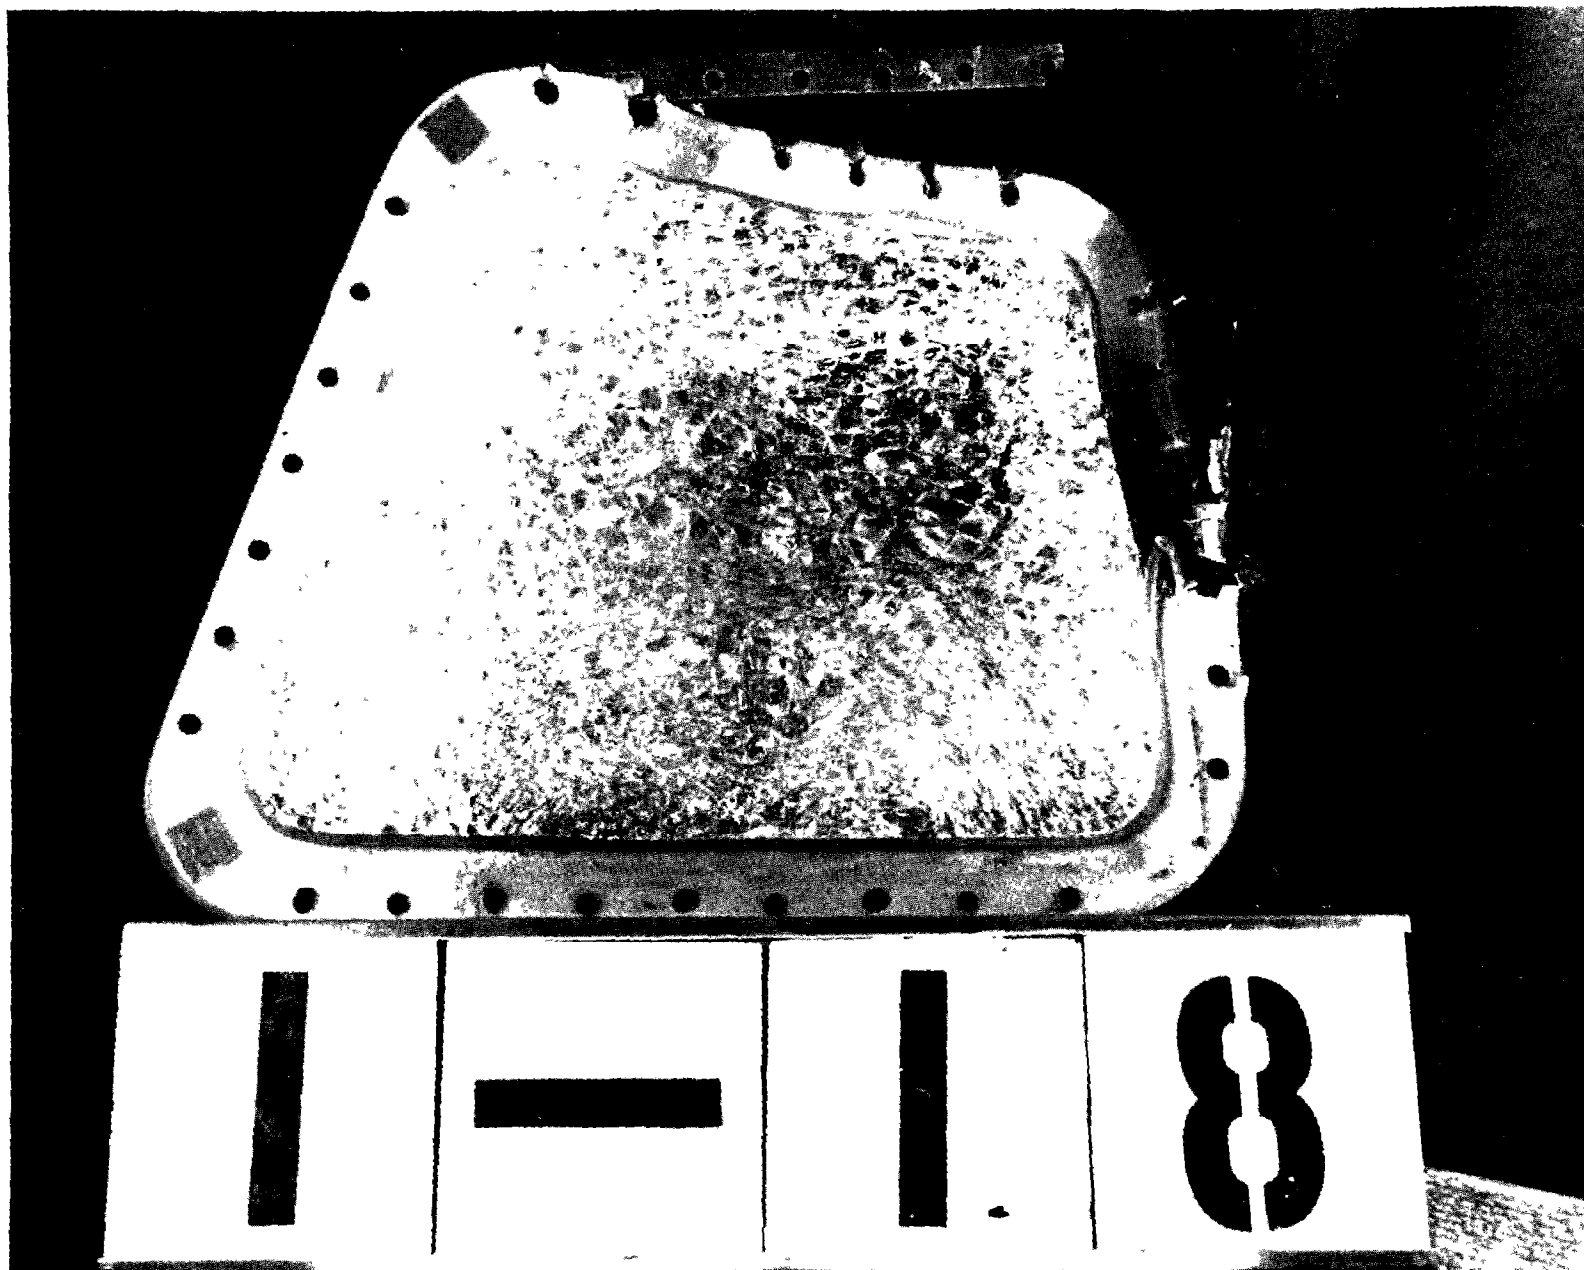
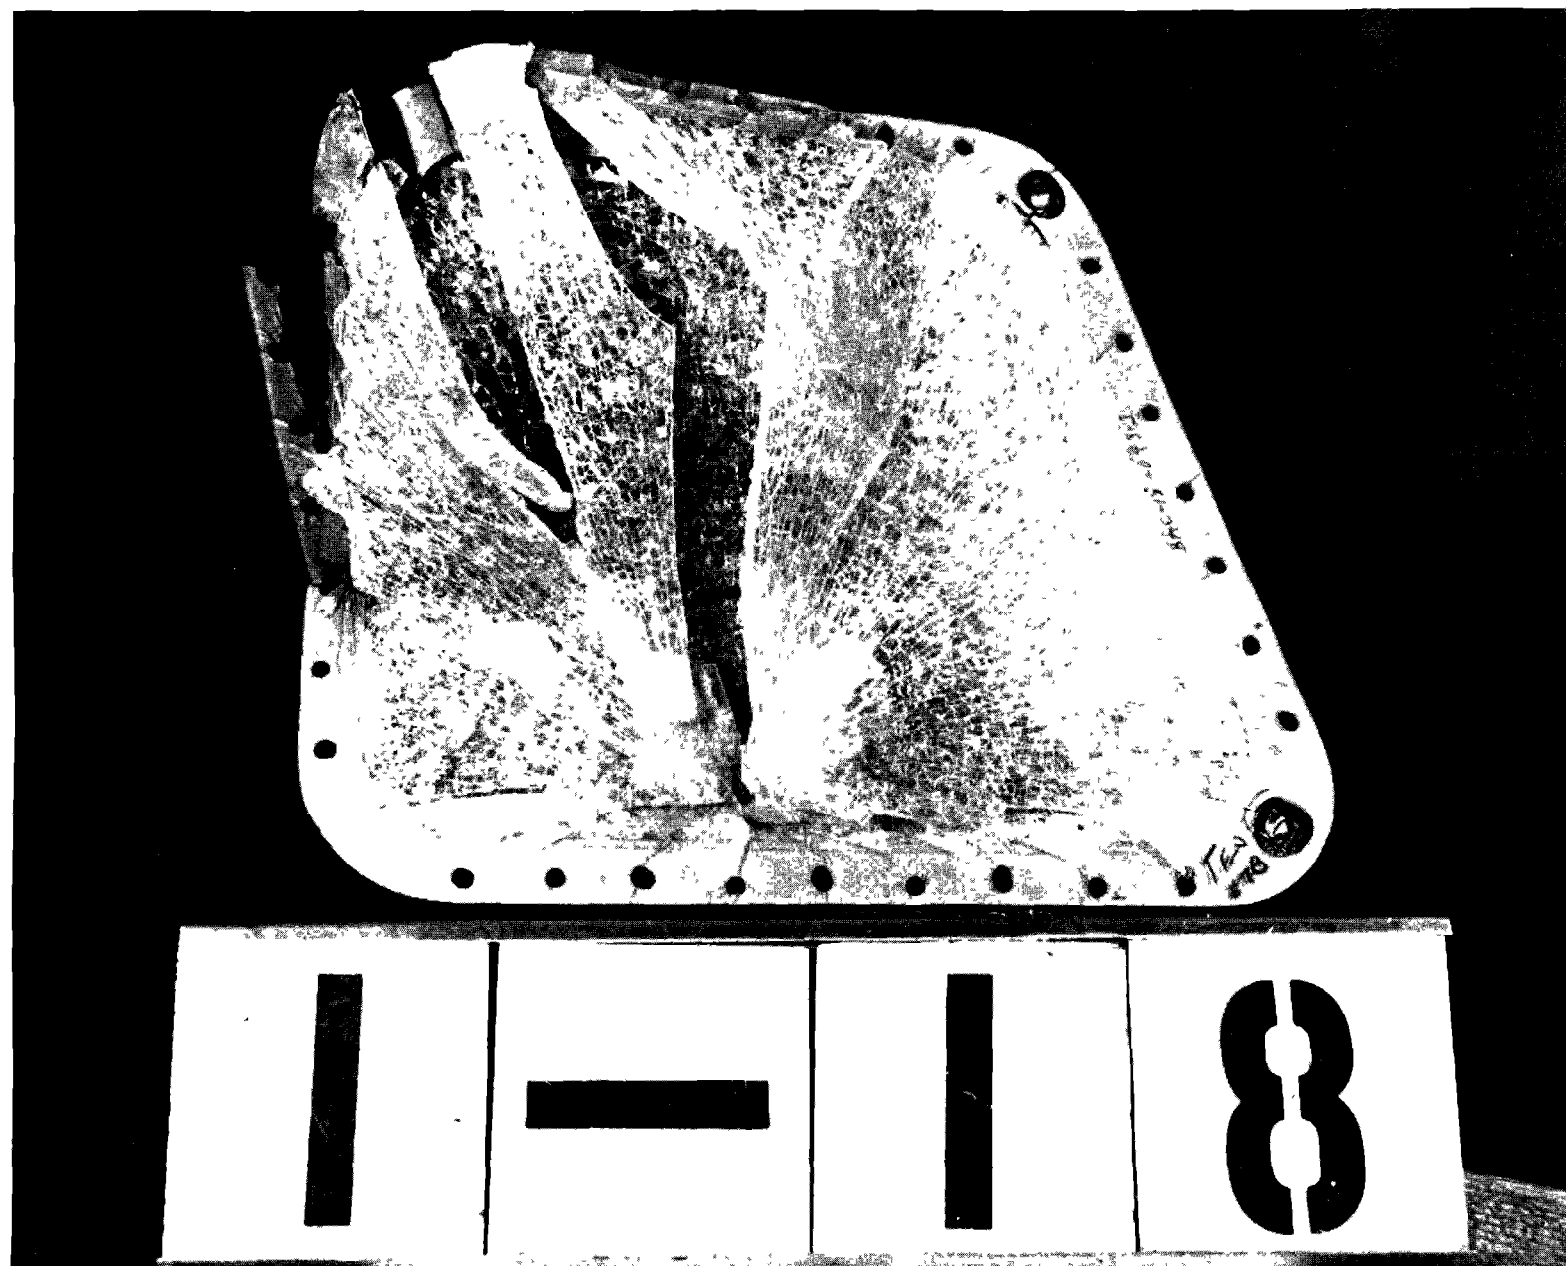
FIG. 19 TEST NO. 18. PROJECTILE VELOCITY 402 MPH

Part of the carcass penetrated the window as the window edge pulled loose from the bolts along the top sill and outboard sill, as shown in Figs. 19, 20, 21, and 22. The inner vinyl-Plex-55 laminated layers tore open at two places and allowed the 1/4-inch-thick full-tempered glass fragments to be propelled against a clay dome which simulated the top of the pilot's head. The glass fragments either imbedded themselves or left impressions in the clay to a depth of 3/32-inch. A view of the clay dome following the test is shown in Fig. 23.

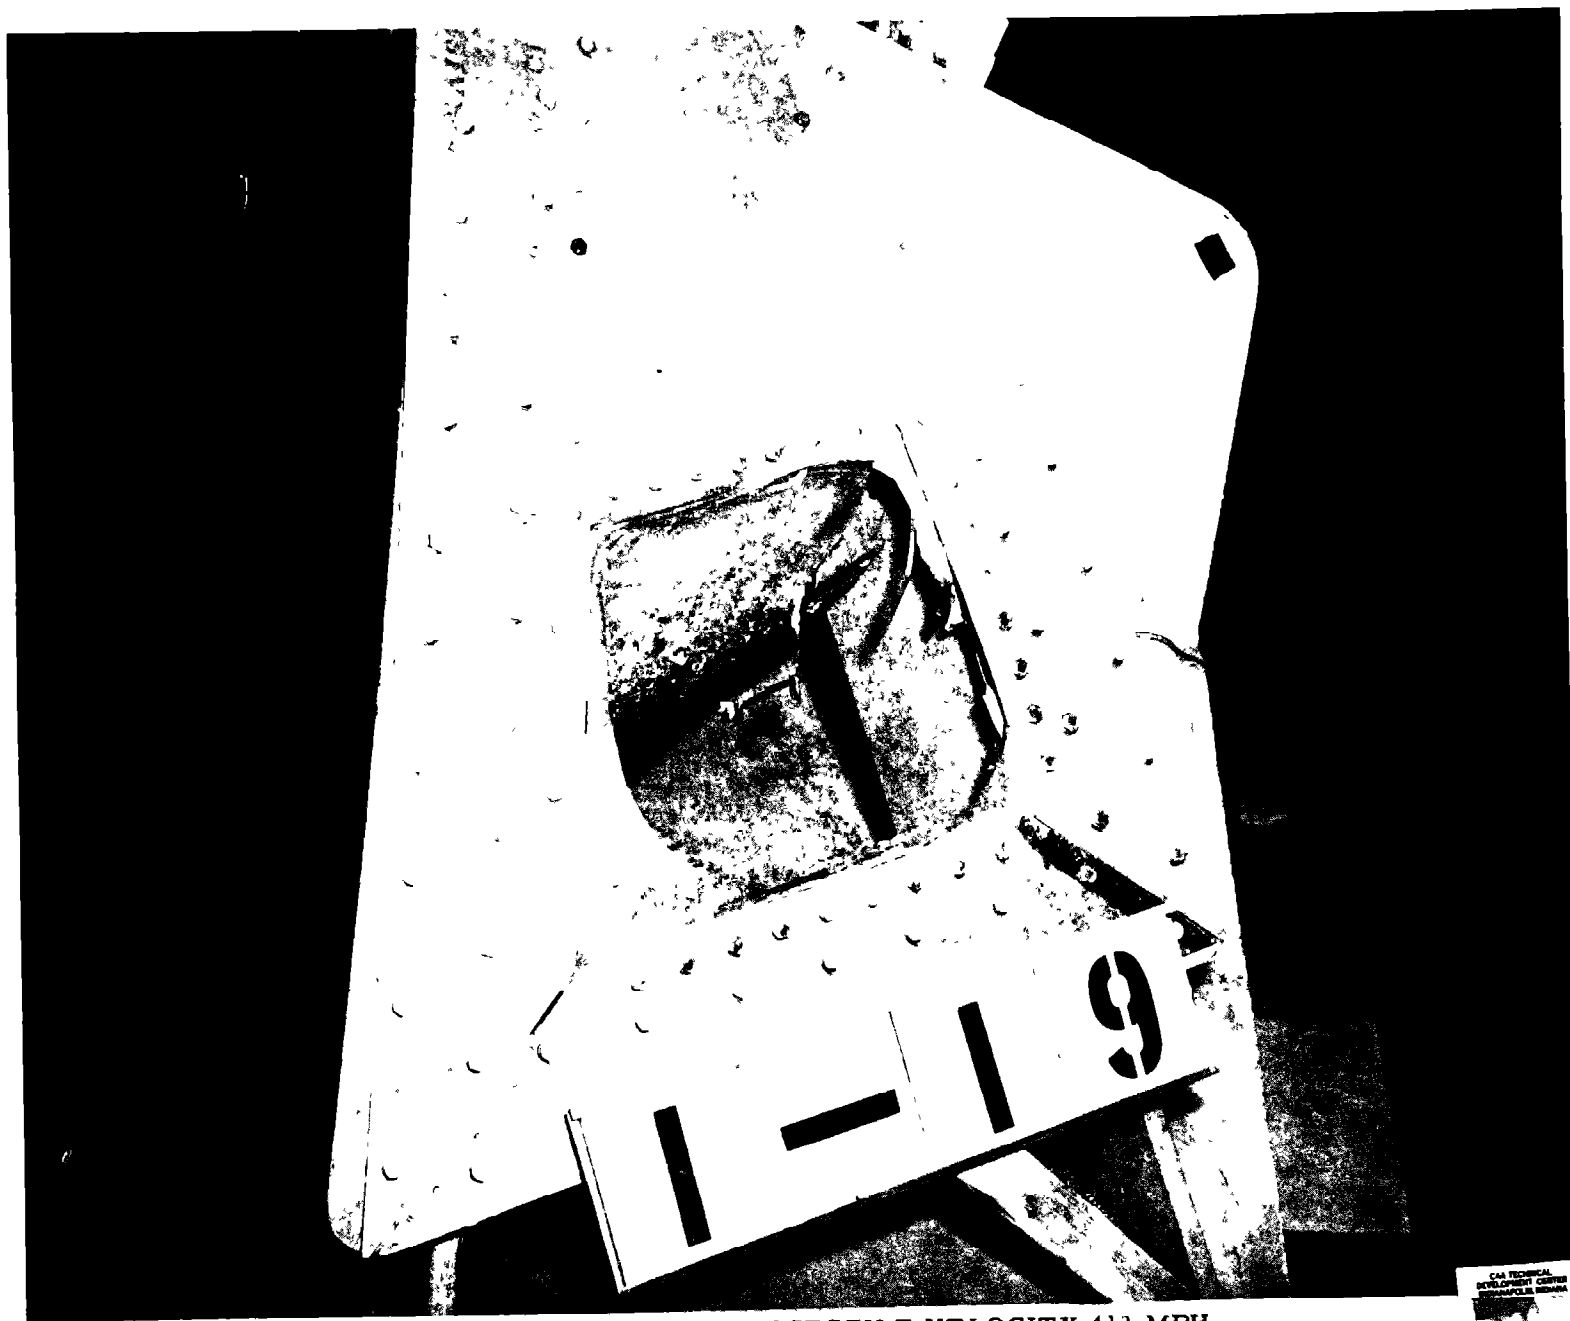
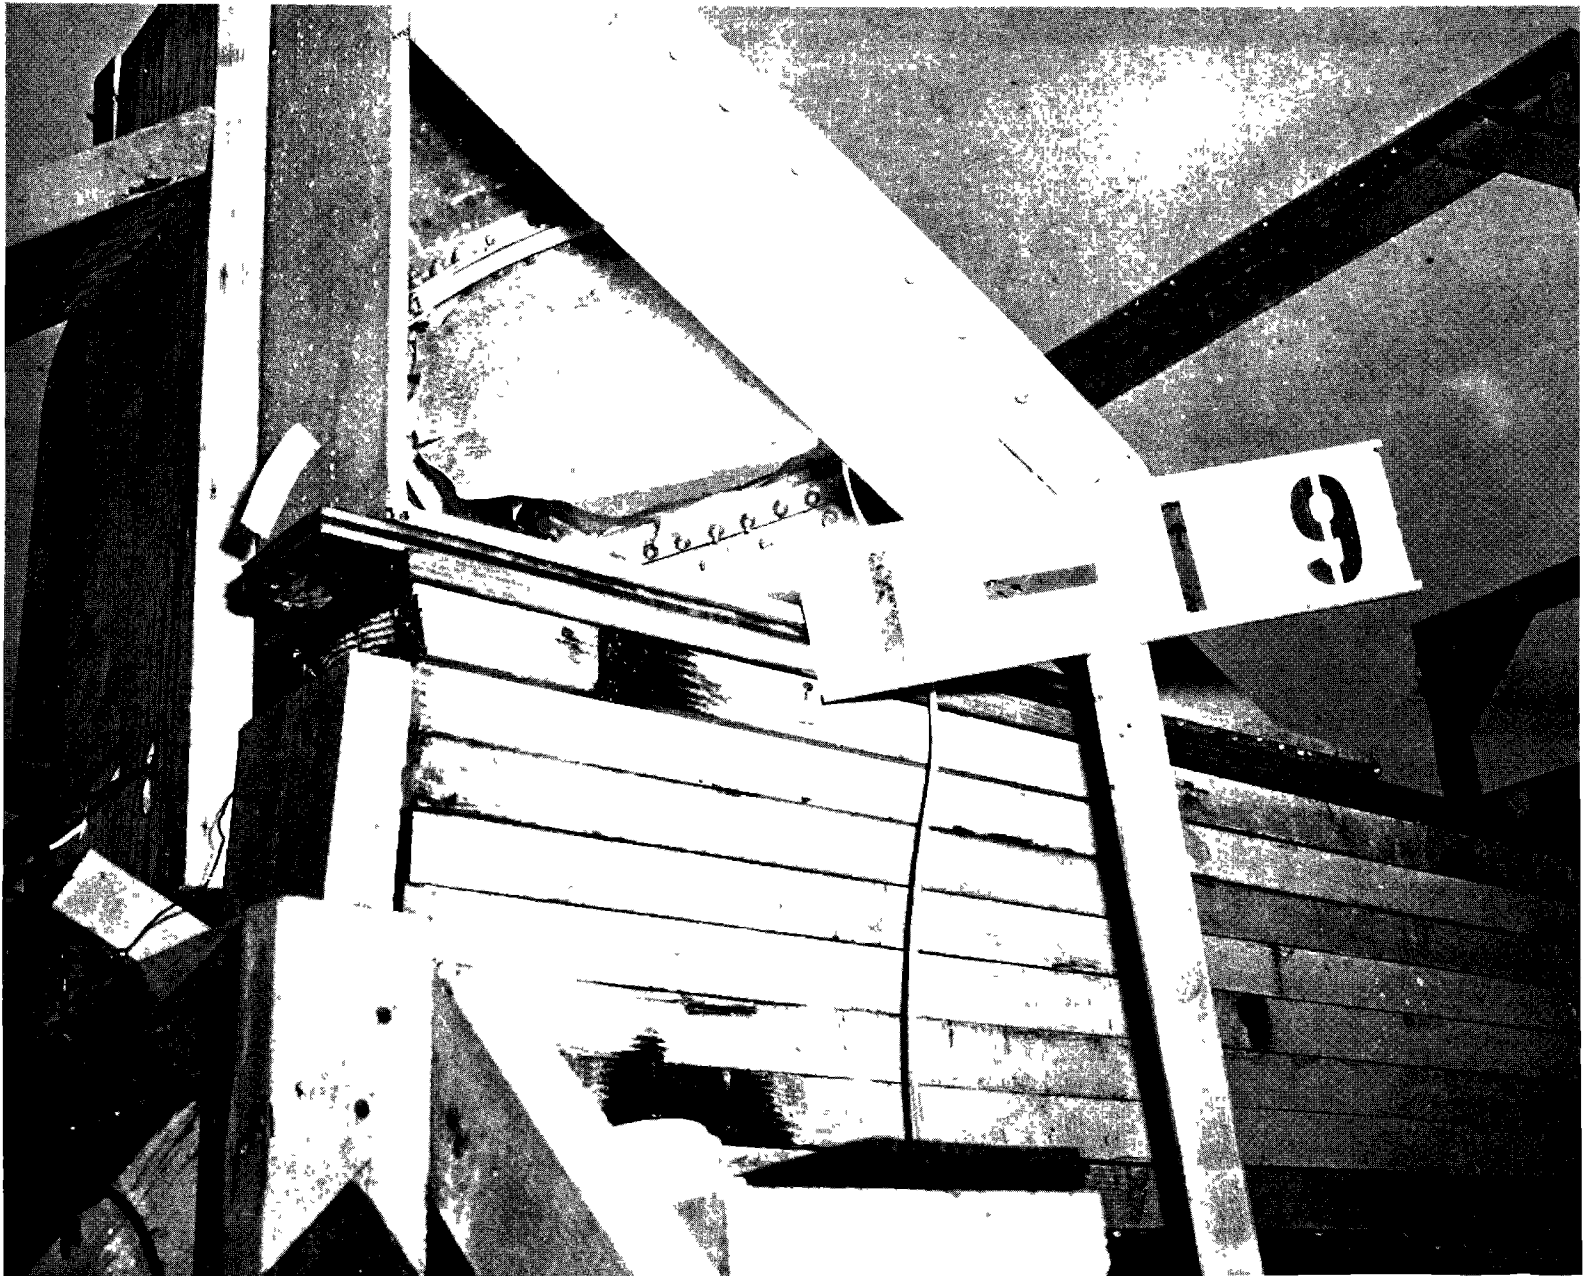
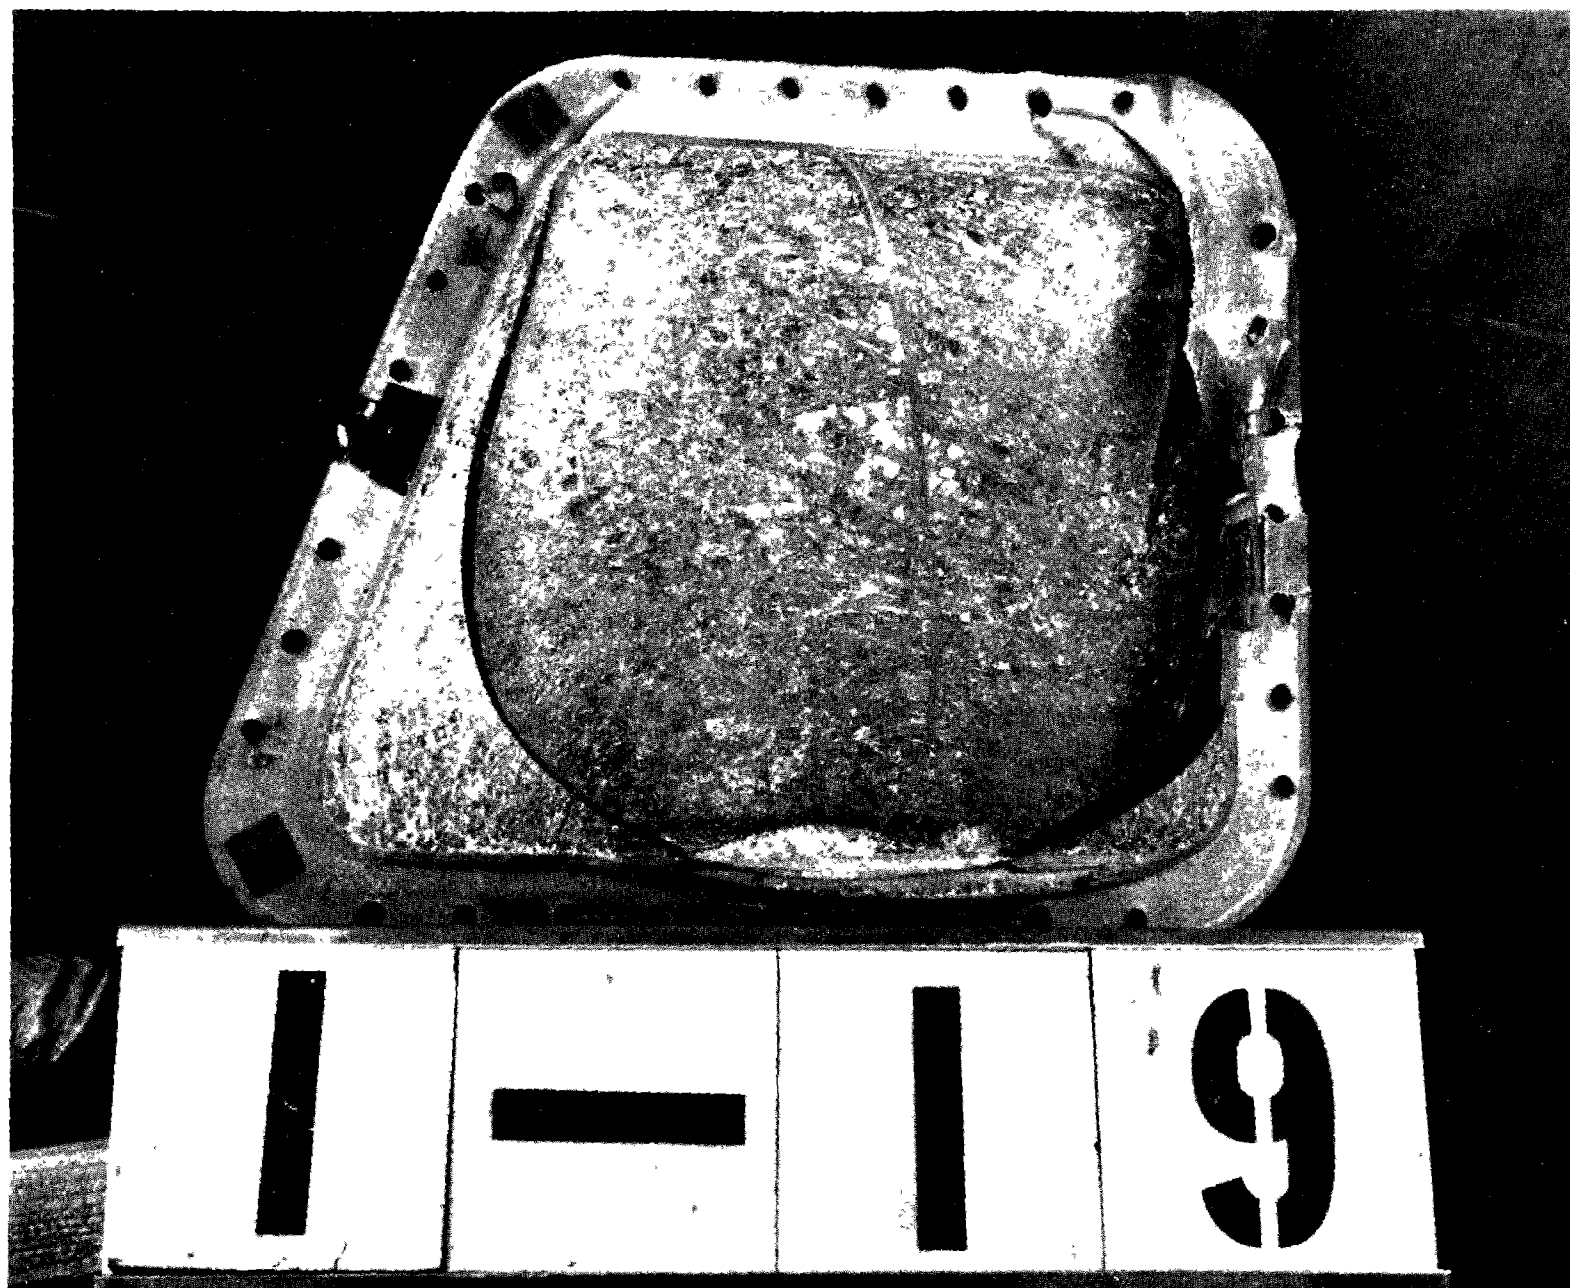
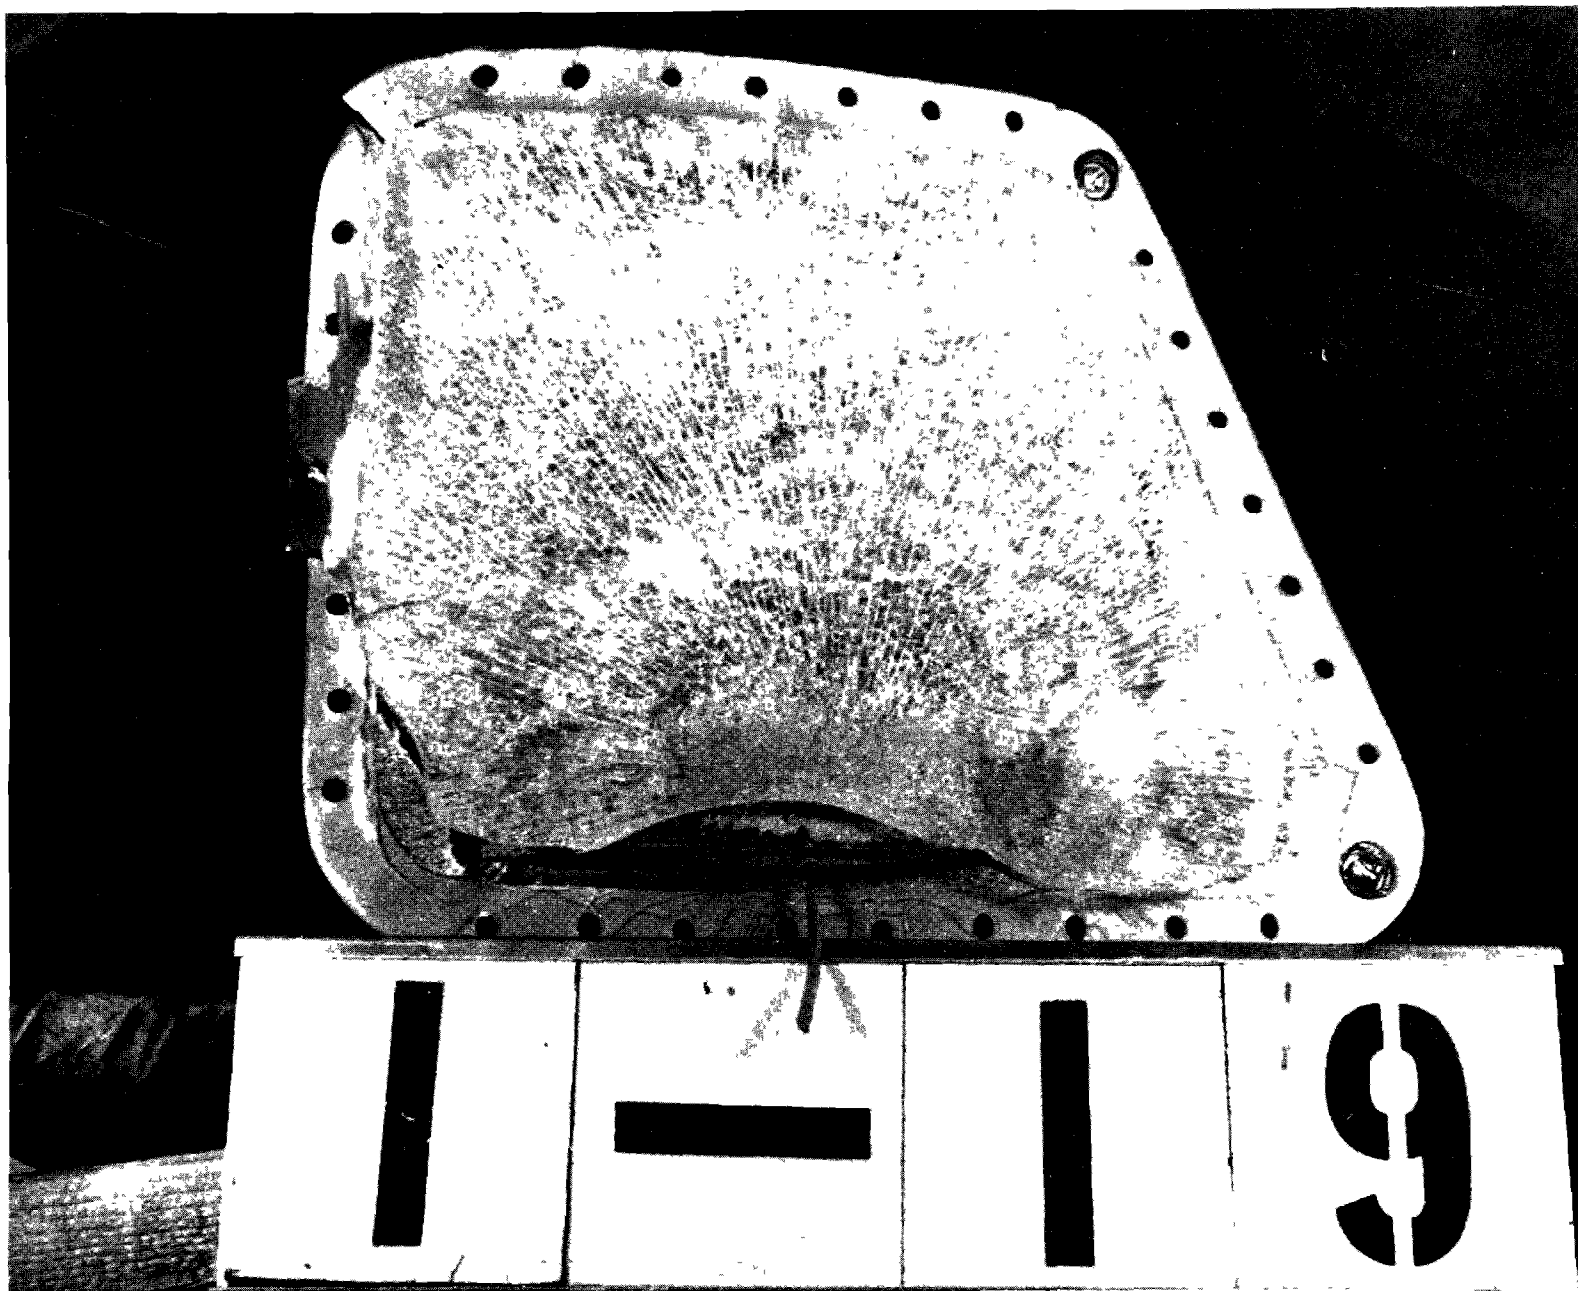
FIG. 24 TEST NO. 19. PROJECTILE VELOCITY 412 MPH

Part of the carcass penetrated the window as both vinyl interlayers sheared along the outboard sill, bottom sill, and outboard from the inboard sill as shown in Figs. 24, 25, 26, and 27. Twenty per cent of the inner face of the Plex-55 tore loose from the inner vinyl layer. Two pieces of acrylic imbedded themselves in the clay dome used to simulate the top of the pilot's head. The clay dome was pitted from several pieces of glass or acrylic. This is shown in Fig. 28. The top sill bent downward approximately 1 inch. Failure indicates that the vinyl adjacent to the sills was below optimum temperature.
