TECHNICAL DEVELOPMENT REPORT NO. 342

BIRD-IMPACT TESTS OF THE  
BOEING MODEL 707 AIRPLANE EYEBROW WINDOW

April 1958

CIVIL AERONAUTICS ADMINISTRATION  
TECHNICAL DEVELOPMENT CENTER  
INDIANAPOLIS, INDIANA

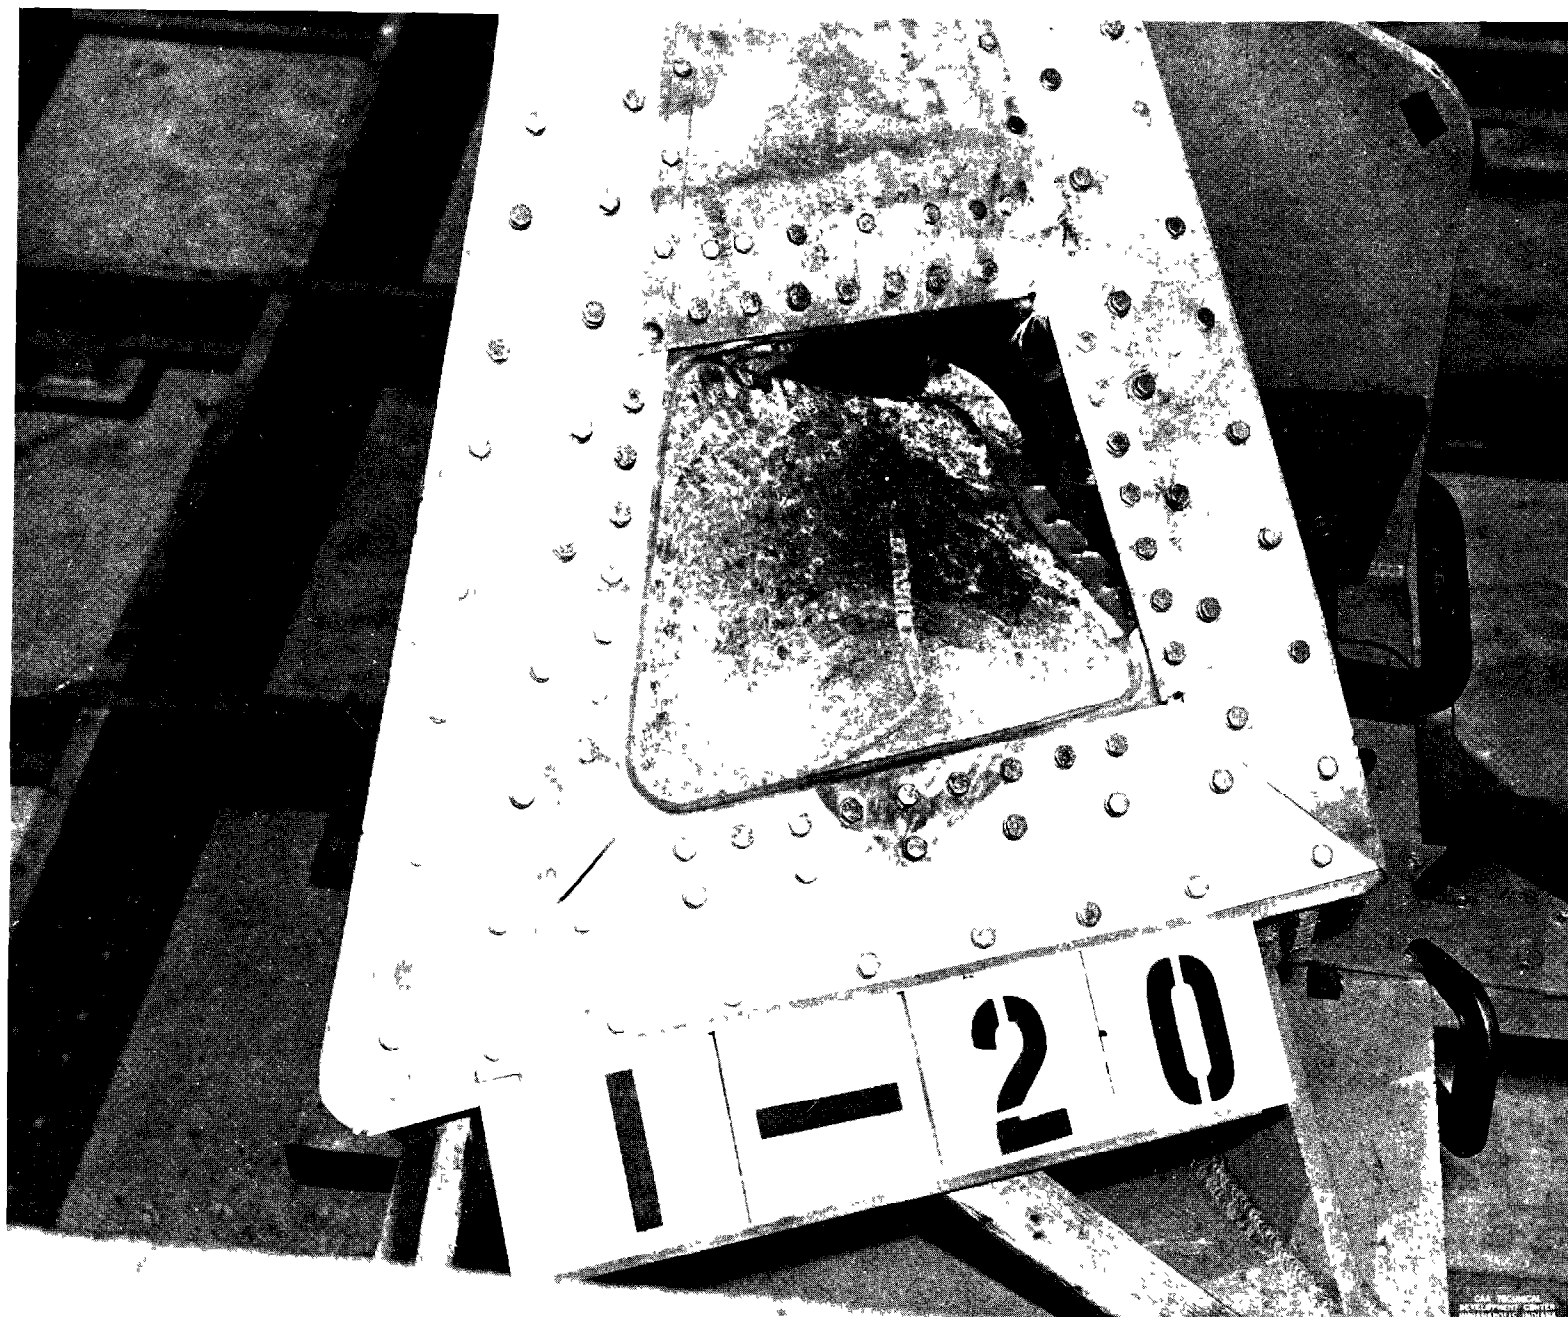
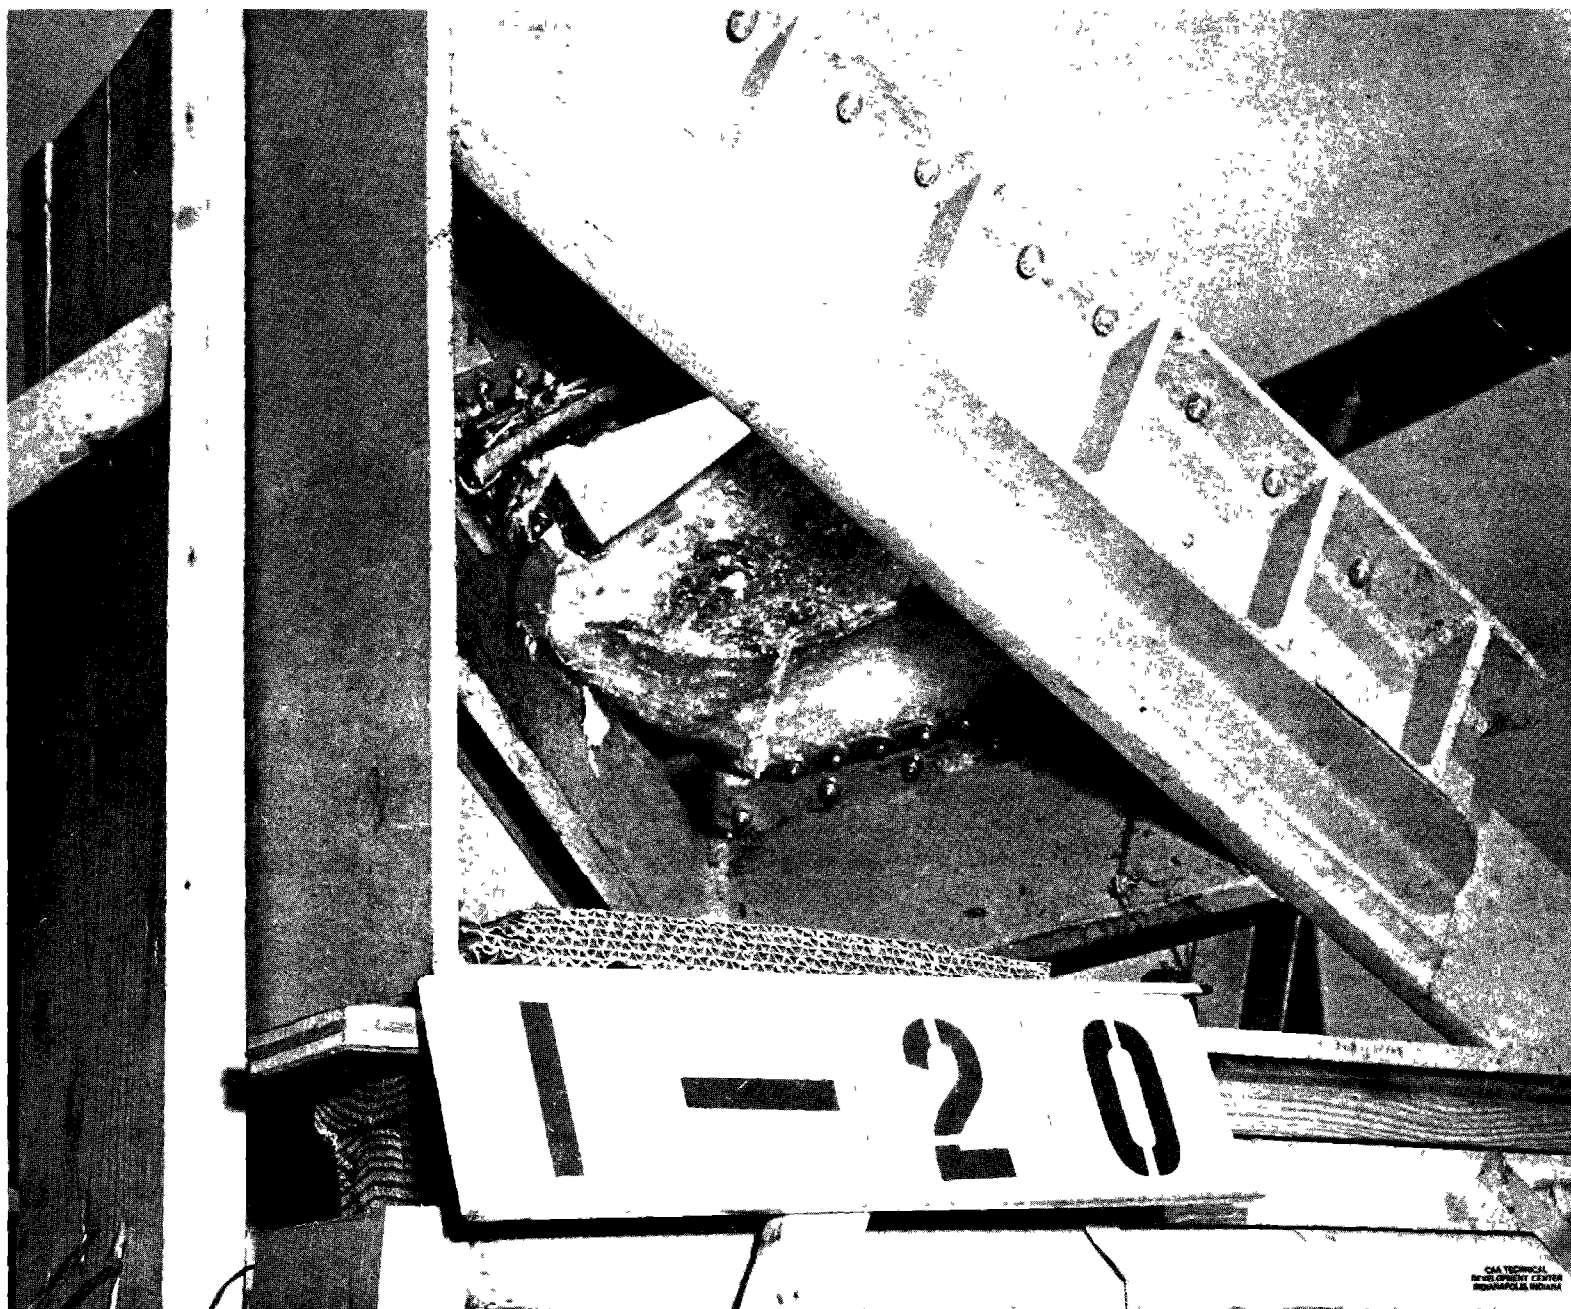
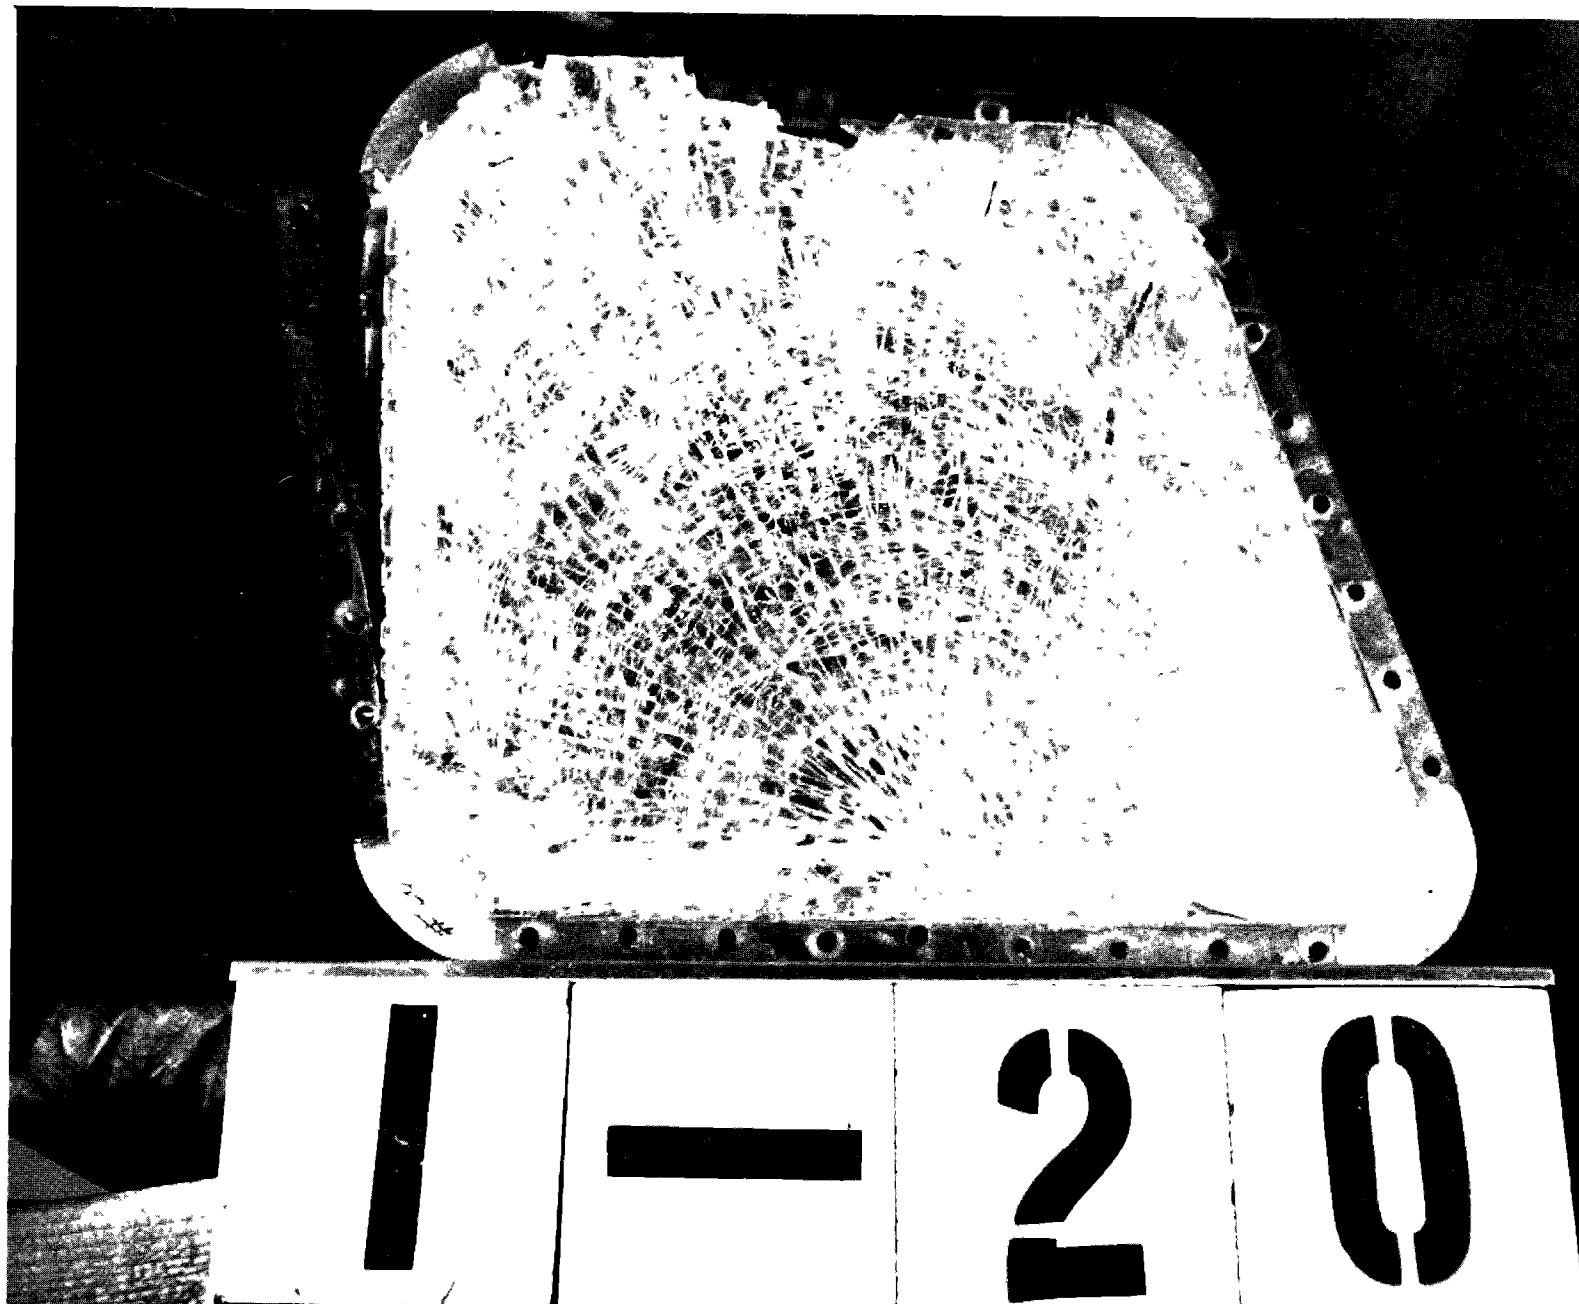
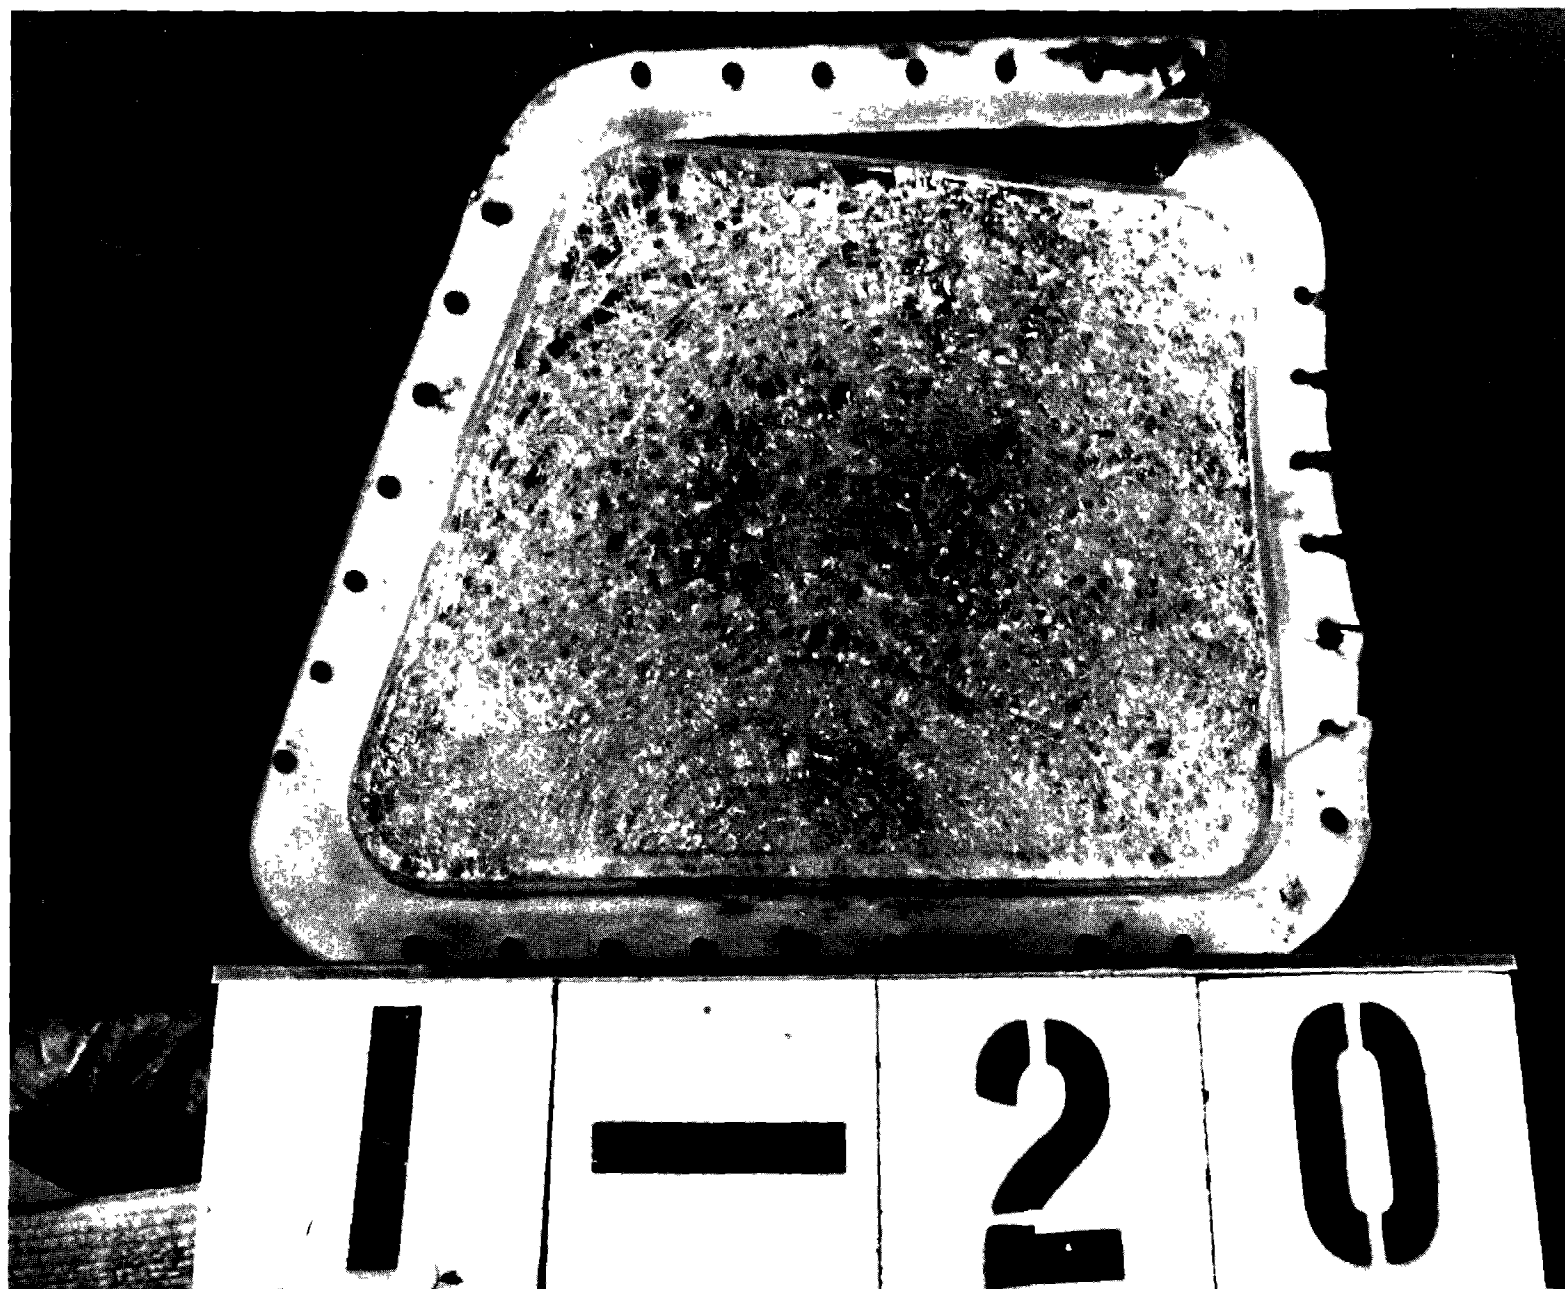
FIG 29 TEST NO. 20 PROJECTILE VELOCITY 405 MPH

Part of the carcass penetrated the window as both vinyl interlayers sheared along the top sill and the window edge tore out around the bolts

along the outboard sill, as shown in Figs. 29, 30, 31, and 32. All four sills bent inward under the force of the impact. Most of the 1/4-inch-thick full-tempered glass fragments were contained between the two layers of vinyl. The 1/8-inch-thick inner face of semitempered glass adhered almost entirely to the inner layer of vinyl. The glass pattern on cardboard sheets placed behind the window indicates that one group of fine glass particles passed over the position of the pilot's head with high velocity, and one group struck the position of the pilot's head. The cardboard sheets are shown in Fig. 33.

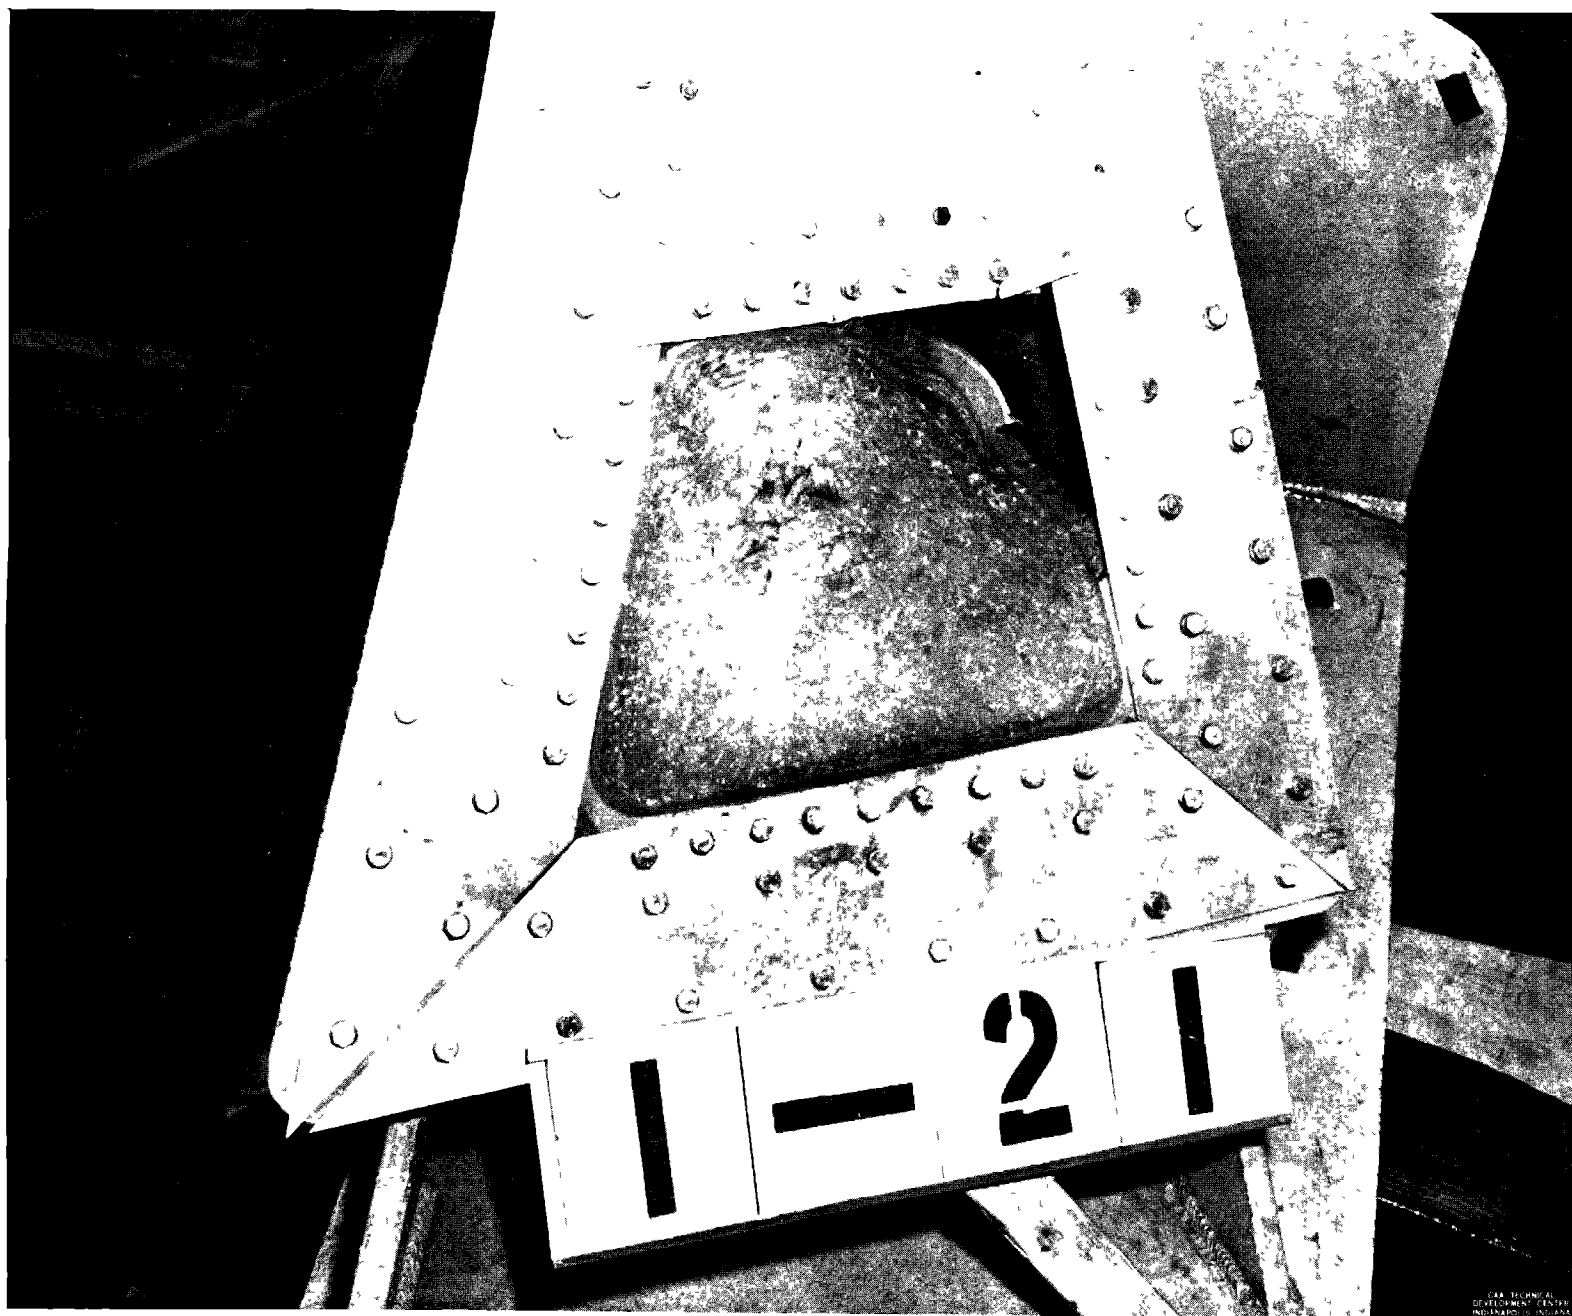
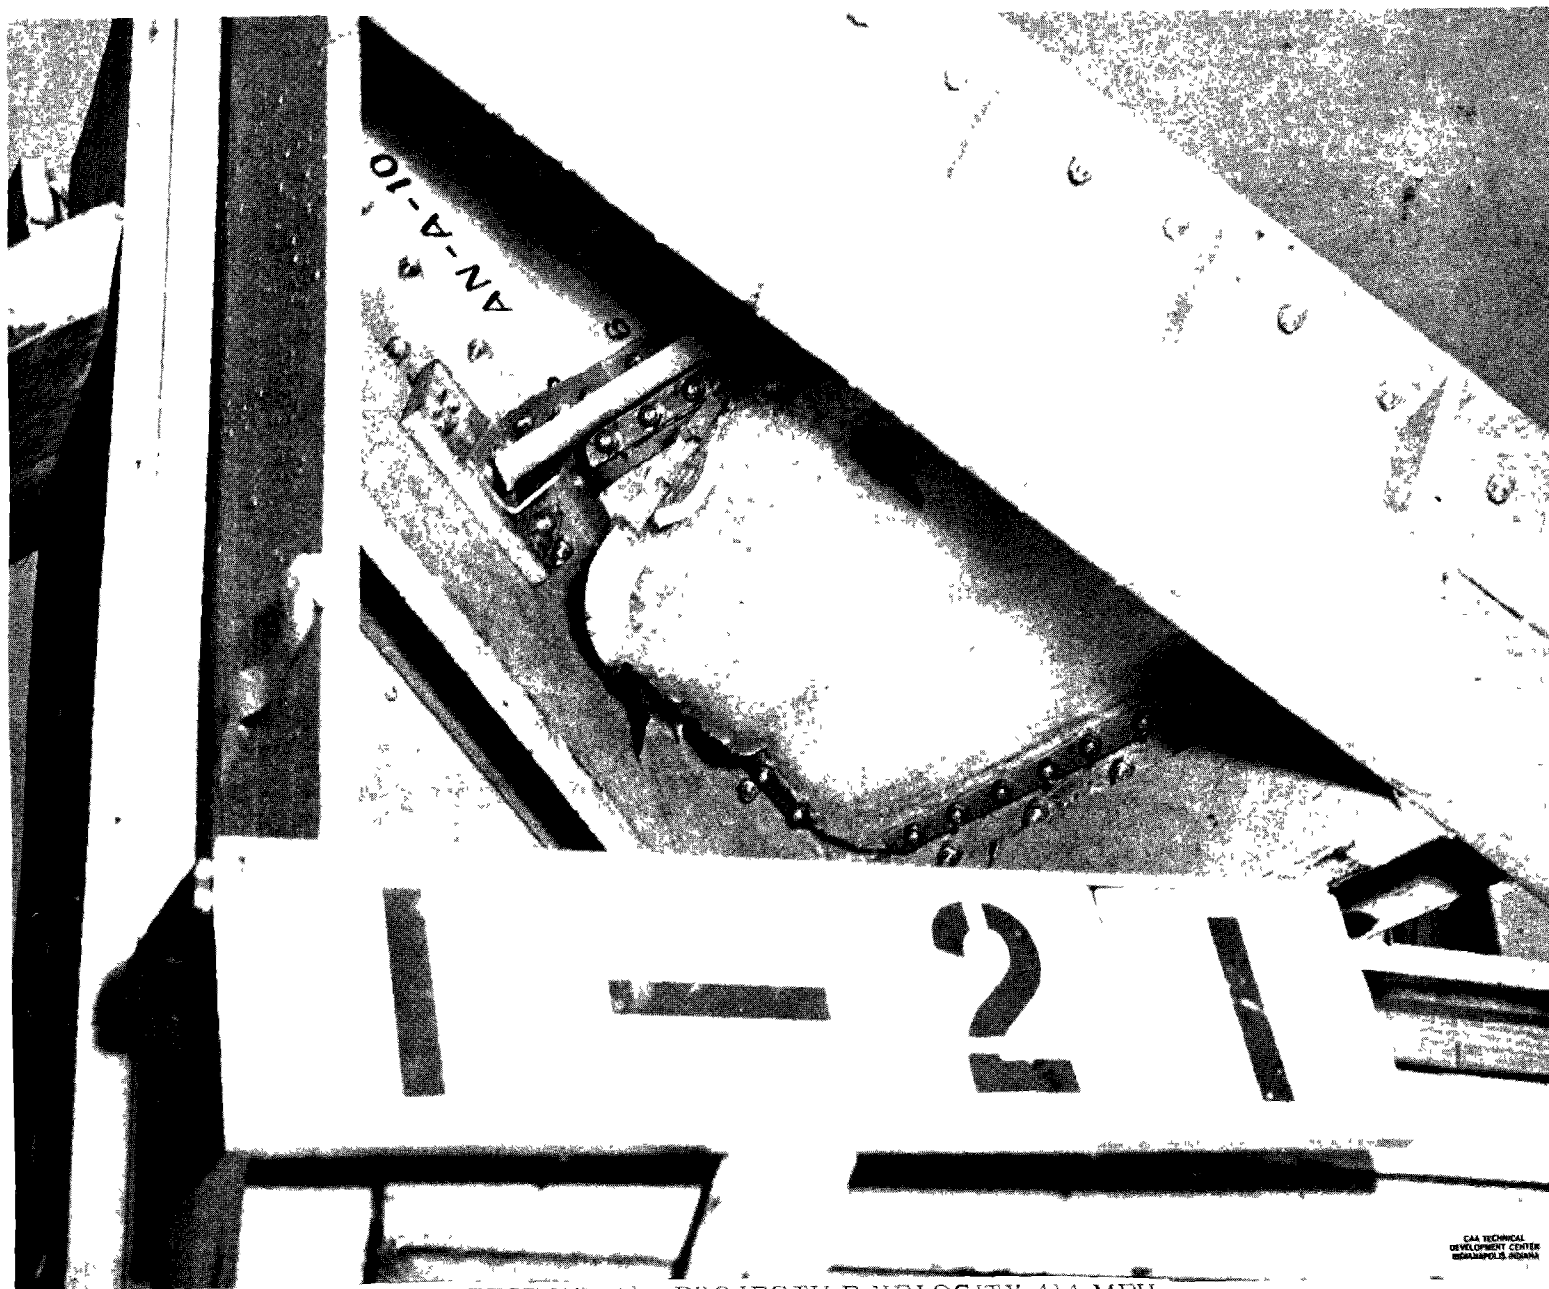
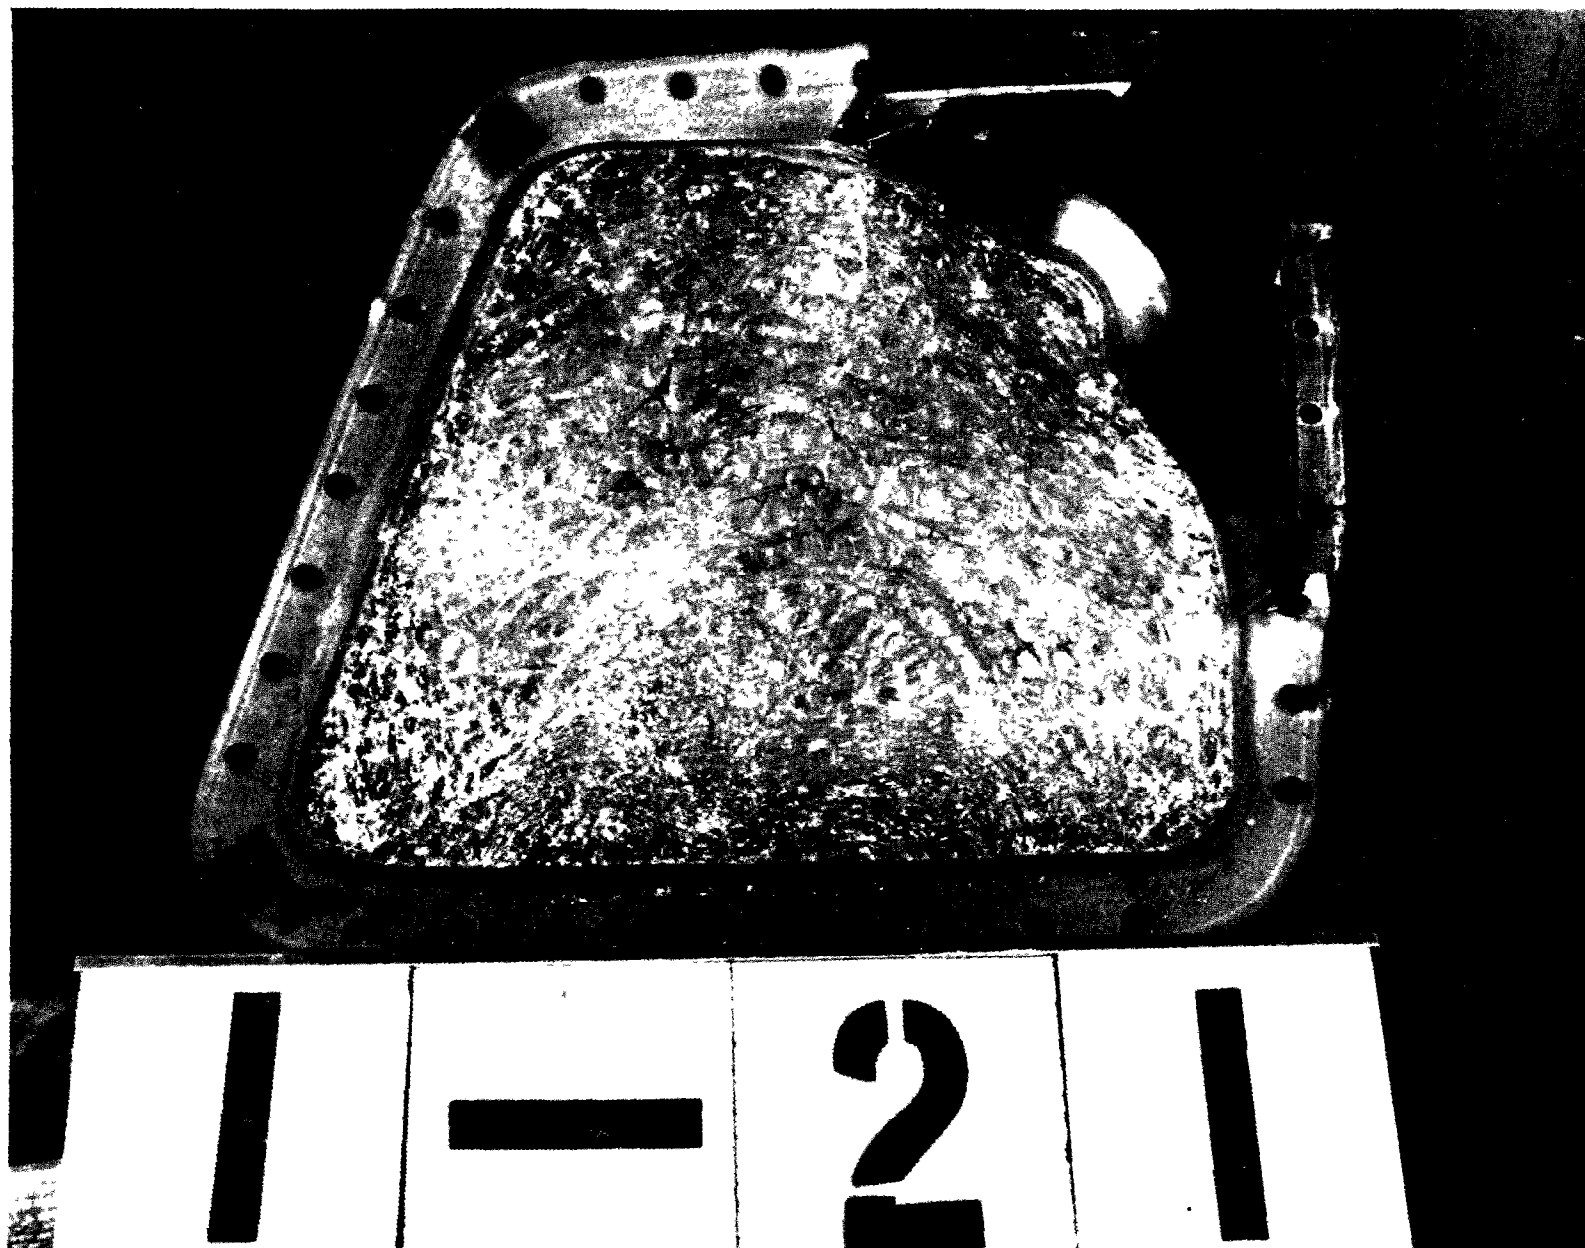
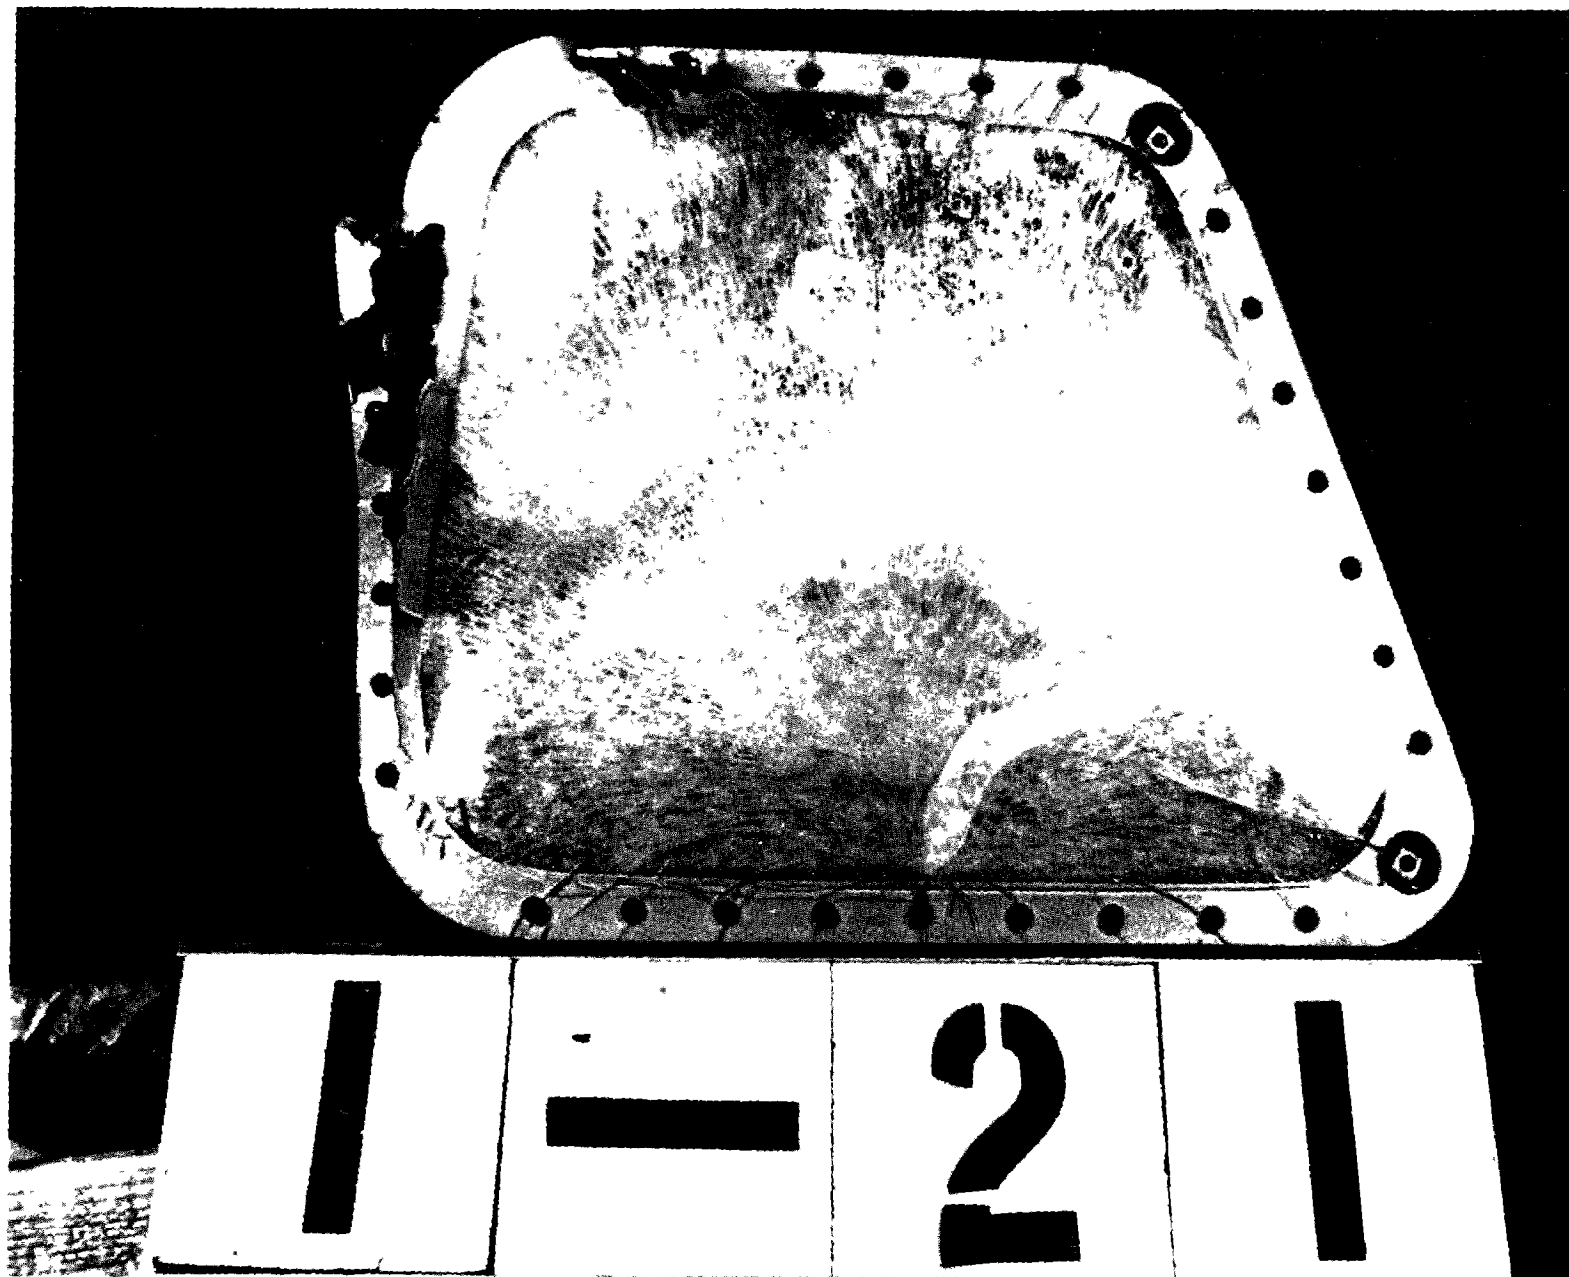
FIG. 34 TEST NO. 21. PROJECTILE VELOCITY 414 MPH

Penetration by part of the carcass was experienced as both vinyl interlayers and inserts pulled loose from bolts along the top and outboard sills, as shown in Figs. 34, 35, 36, and 37. Both metal inserts cracked approximately at the center of the top and outboard sills. Approximately 60 per cent of the Plex-55 departed from the inner layer of vinyl. This amount of delamination was considerably more than that which occurred in Test No. 19, the only other test in which delamination of Plex-55 for the vinyl interlayer was experienced. The vinyl interlayers confined most of the 1/4-inch-thick full-tempered glass fragments with only a few nuggets escaping into the cockpit area. Two Plex-55 fragments, approximately 4 inches long, knifed into the cardboard sheets, shown in Fig. 38, which were placed behind the window. One fragment passed over the pilot's head and the other struck in the vicinity of the pilot's head. All of the sills bent inward and the two 3/16-inch-diameter rivets, shown as D and E in Fig. 2, failed in tension. The window of this test was cold soaked at a temperature of -65° F. for 8 hours prior to being impact tested. This may have weakened the bond between the Plex-55 and vinyl, thereby resulting in the high degree of delamination of Plex-55 from the vinyl interlayer. There was no indication of any delamination of the Plex-55 from the vinyl prior to the test.
