TECHNICAL DEVELOPMENT REPORT NO. 342

BIRD-IMPACT TESTS OF THE  
BOEING MODEL 707 AIRPLANE EYEBROW WINDOW

April 1958

CIVIL AERONAUTICS ADMINISTRATION  
TECHNICAL DEVELOPMENT CENTER  
INDIANAPOLIS, INDIANA

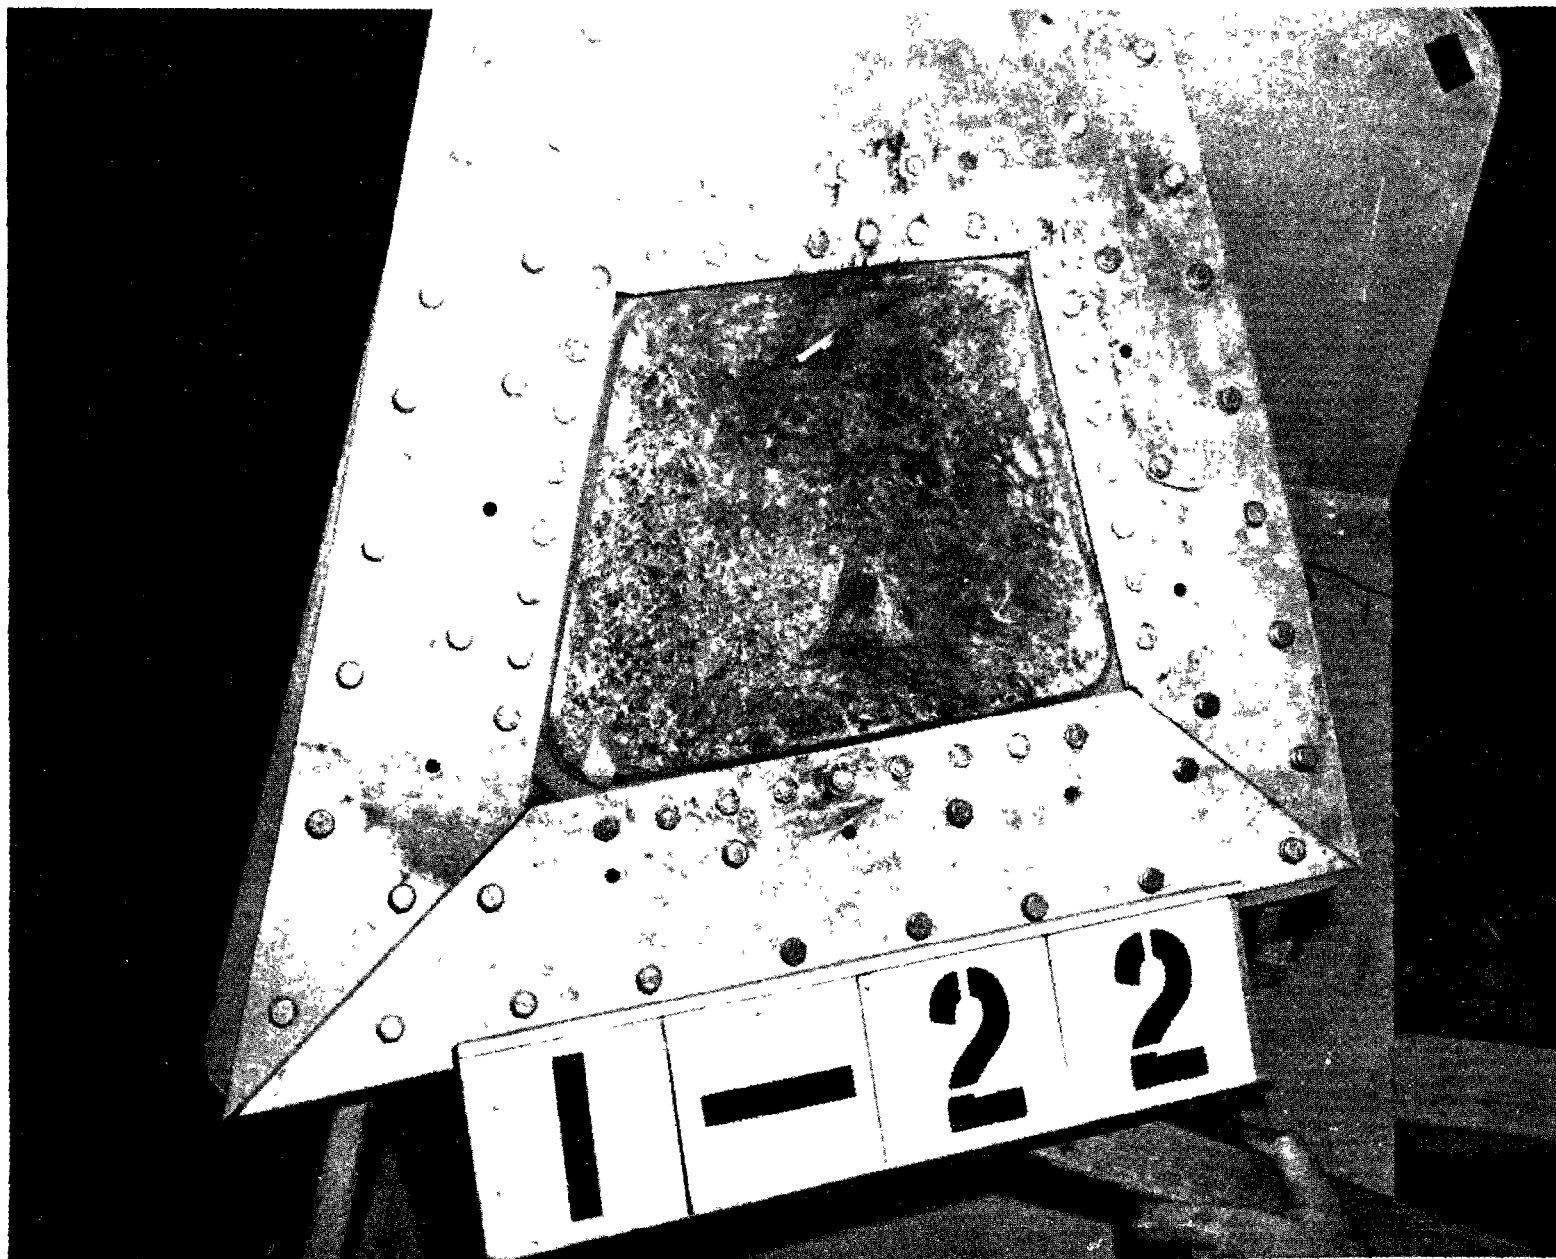
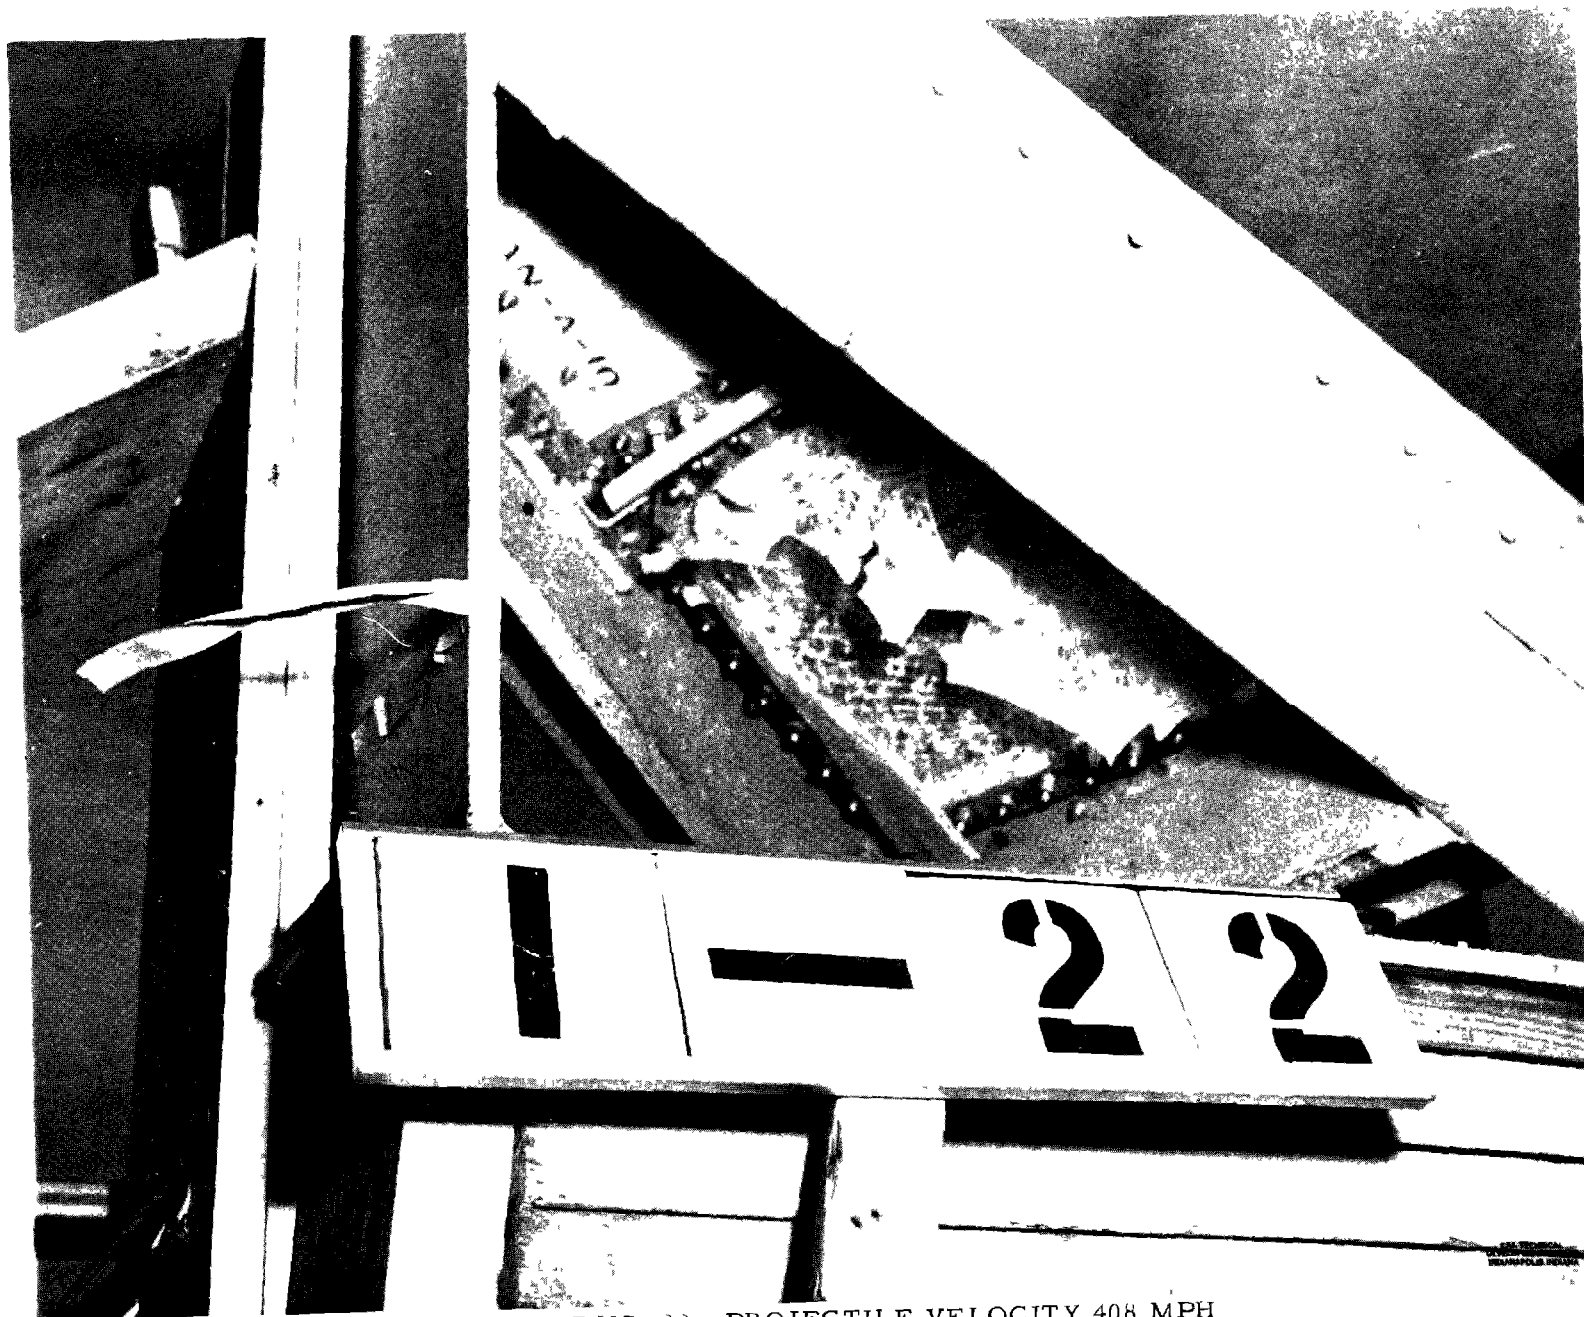
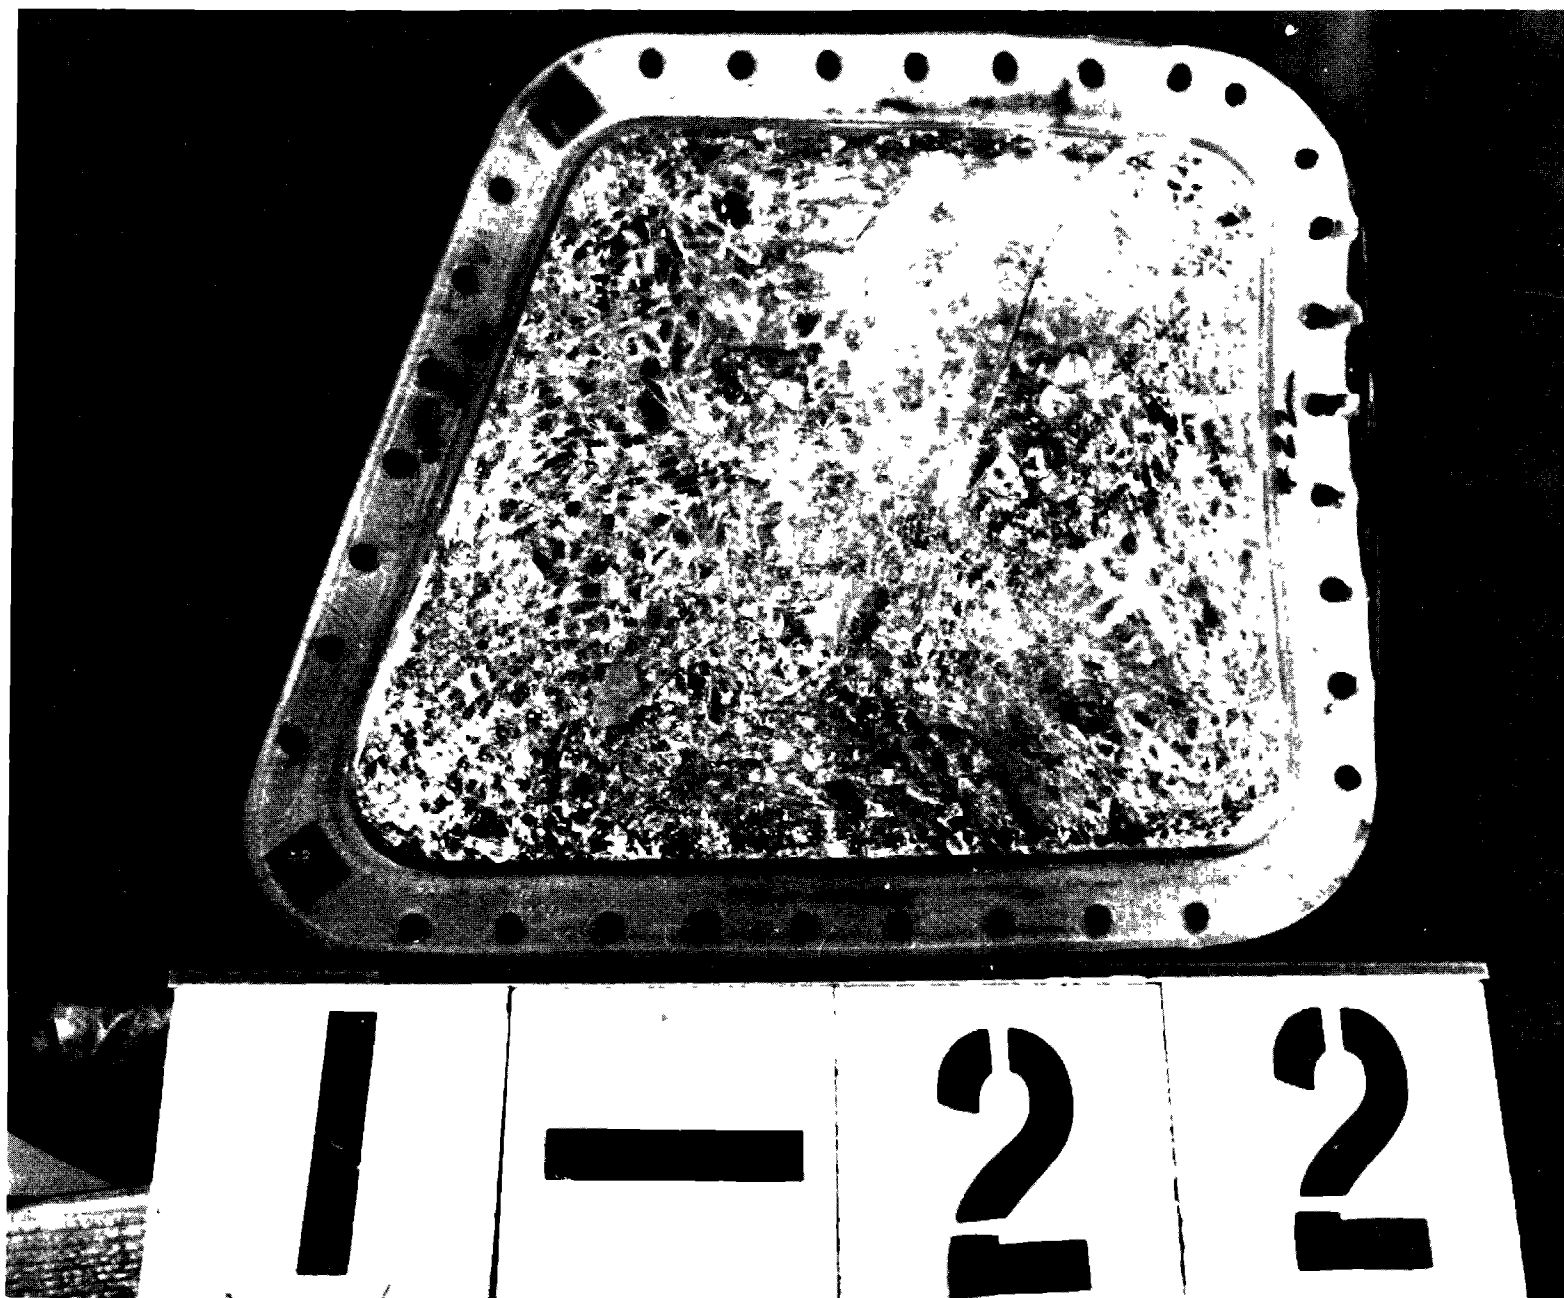
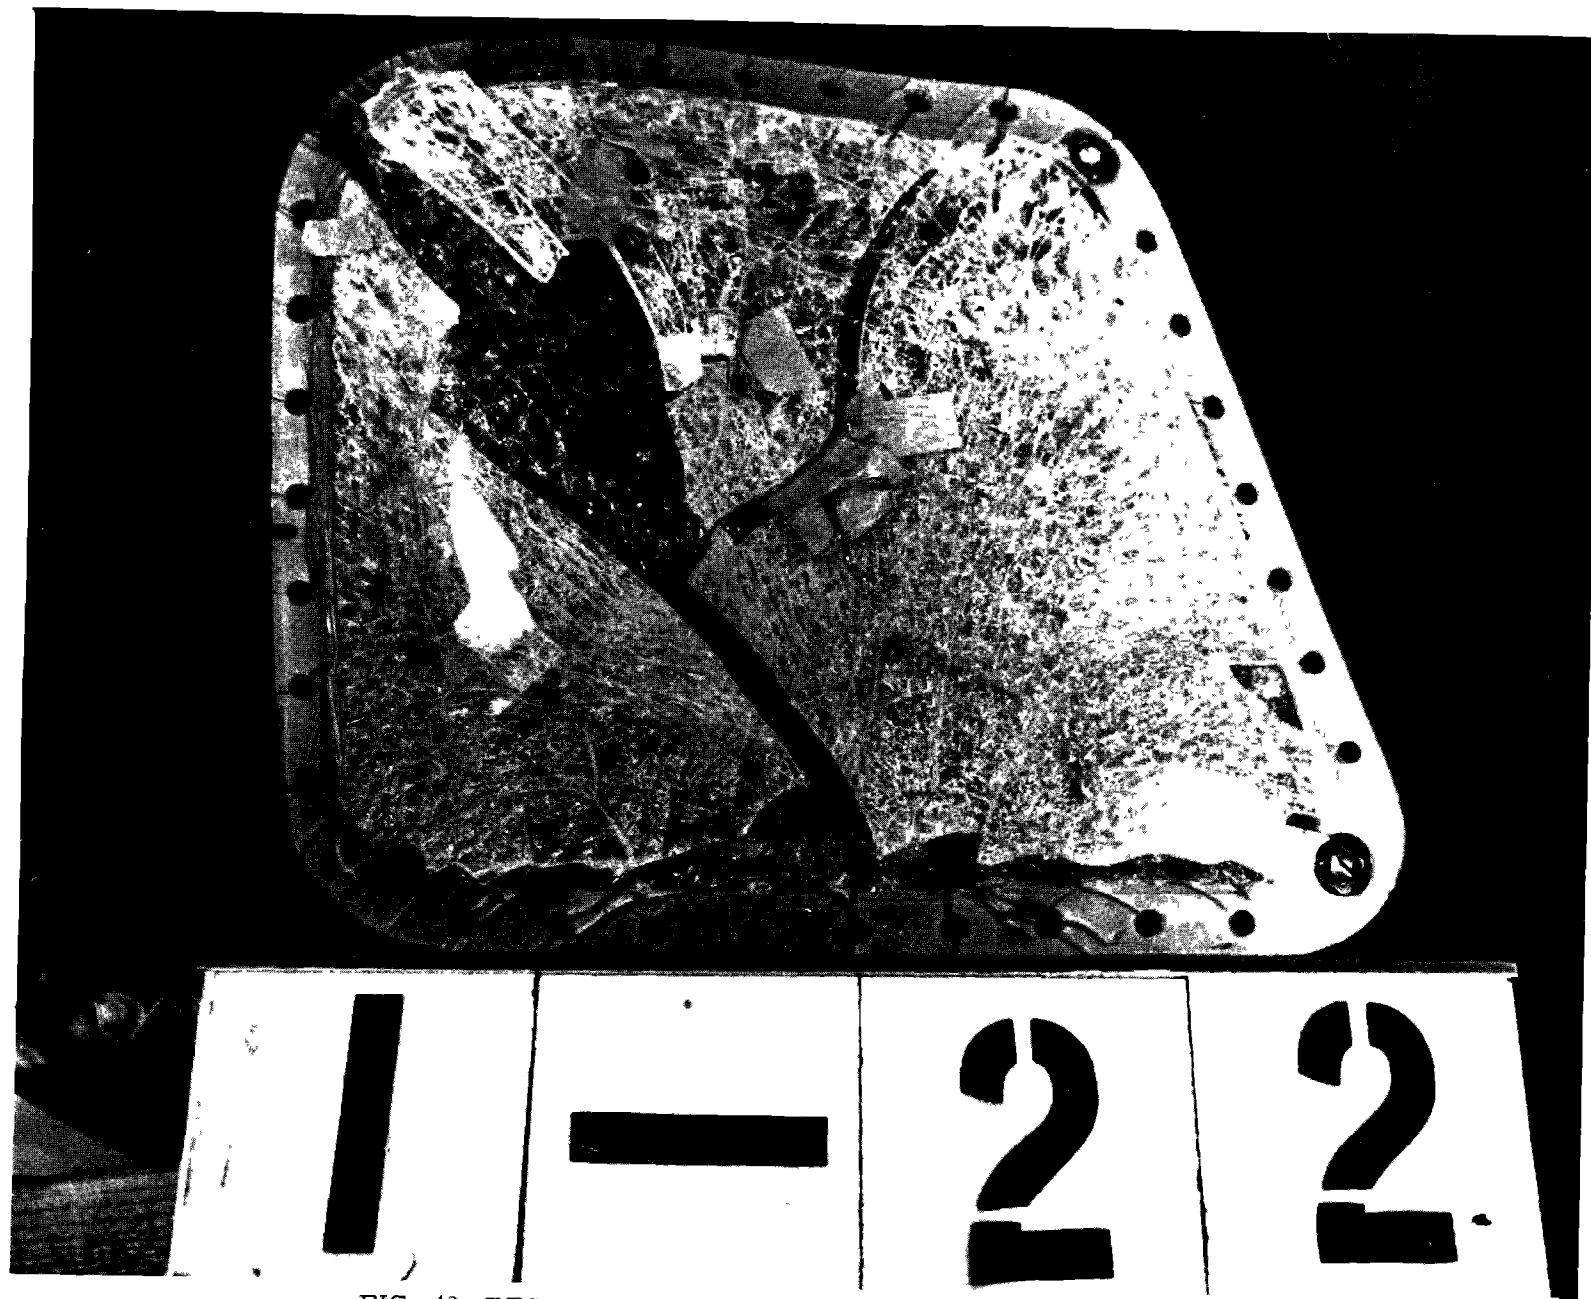
FIG. 39 TEST NO. 22. PROJECTILE VELOCITY 408 MPH

The carcass did not penetrate the window. The condition of the window is shown in Figs. 39, 40, 41, and 42. Two 1/4-inch-diameter bolts had

been added at K, as shown in Fig. 1. All top sill bolts bent inward approximately 3/8-inch. Both metal inserts cracked at two bolt locations at the center of the top sill, but tearout did not occur. The inner layer of vinyl and inner-face Plex-55 remained bonded together and the vinyl and Plex-55 tore open as one unit. Particles of 1/4-inch-thick full-tempered glass were propelled at a high velocity and imbedded themselves in the cardboard sheets placed behind the window. Of the flying glass which was imbedded in the cardboard, approximately one-half was directed toward the position of the pilot's head. This is shown in Fig. 43.

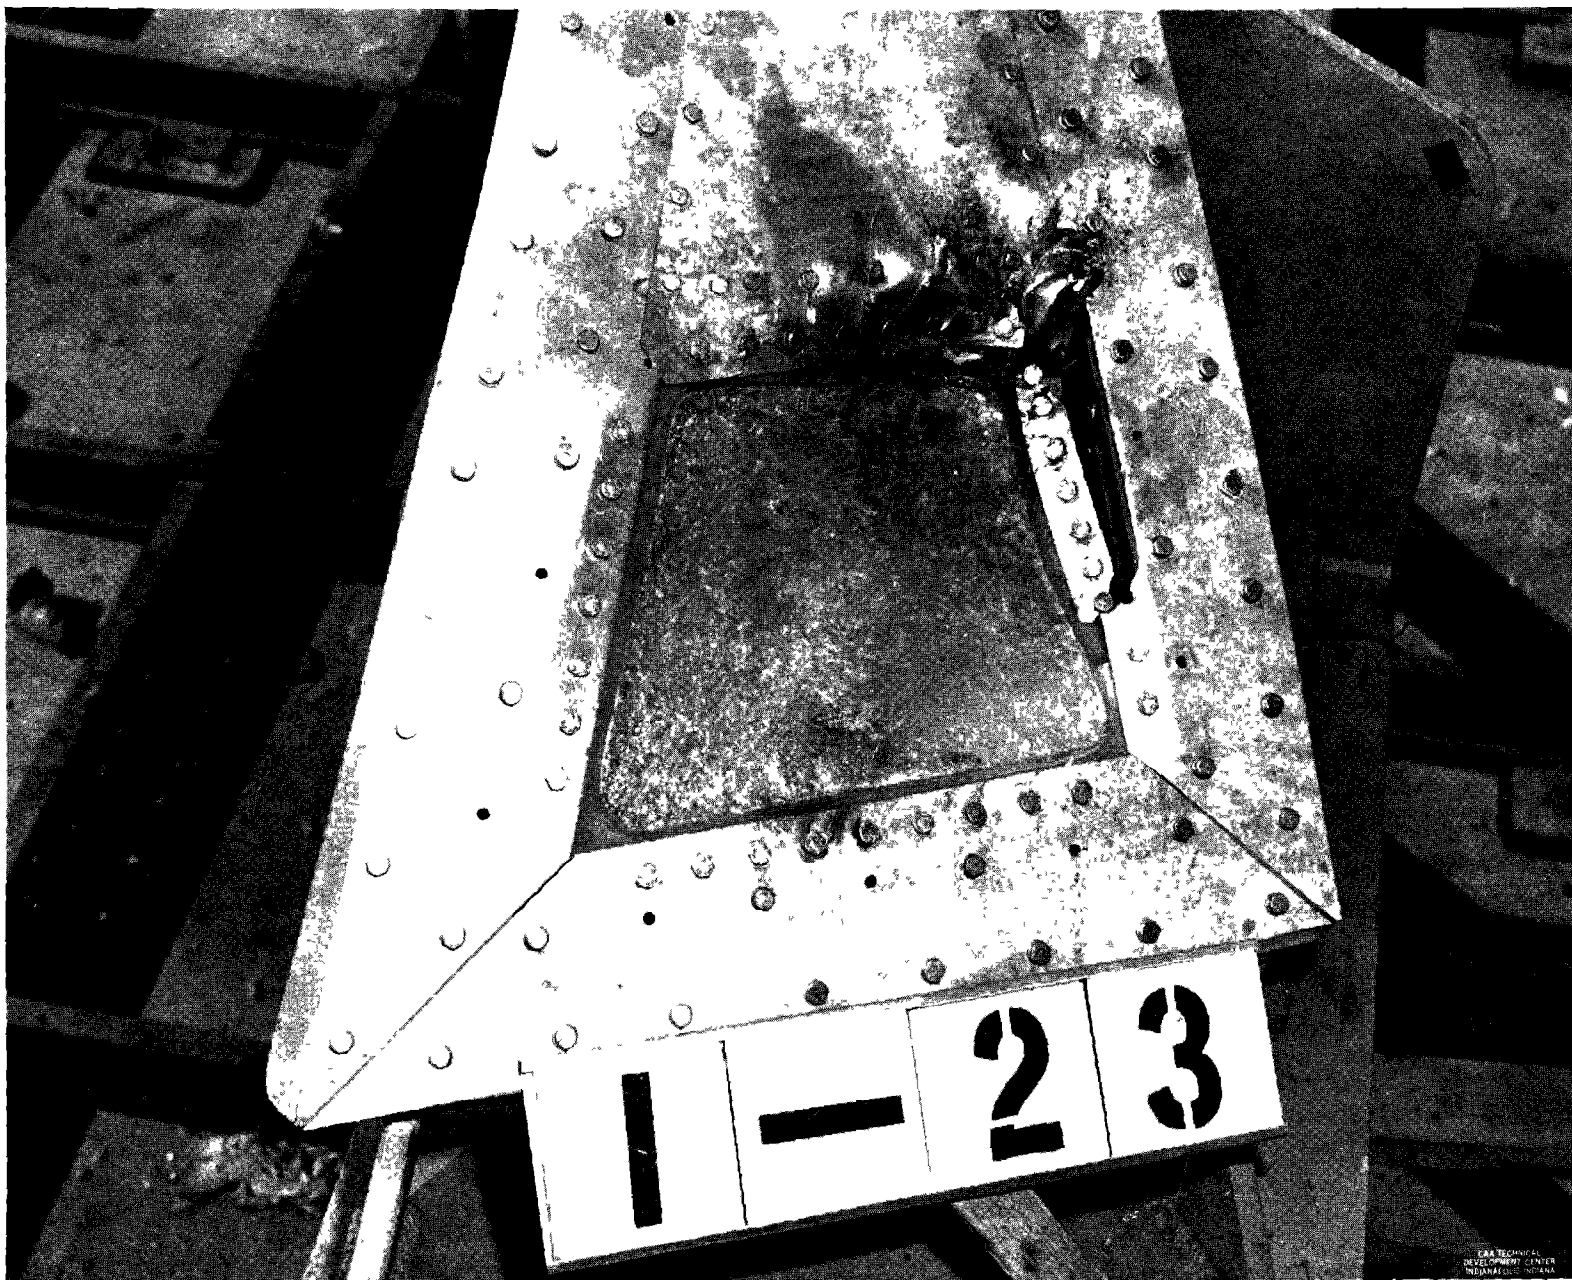
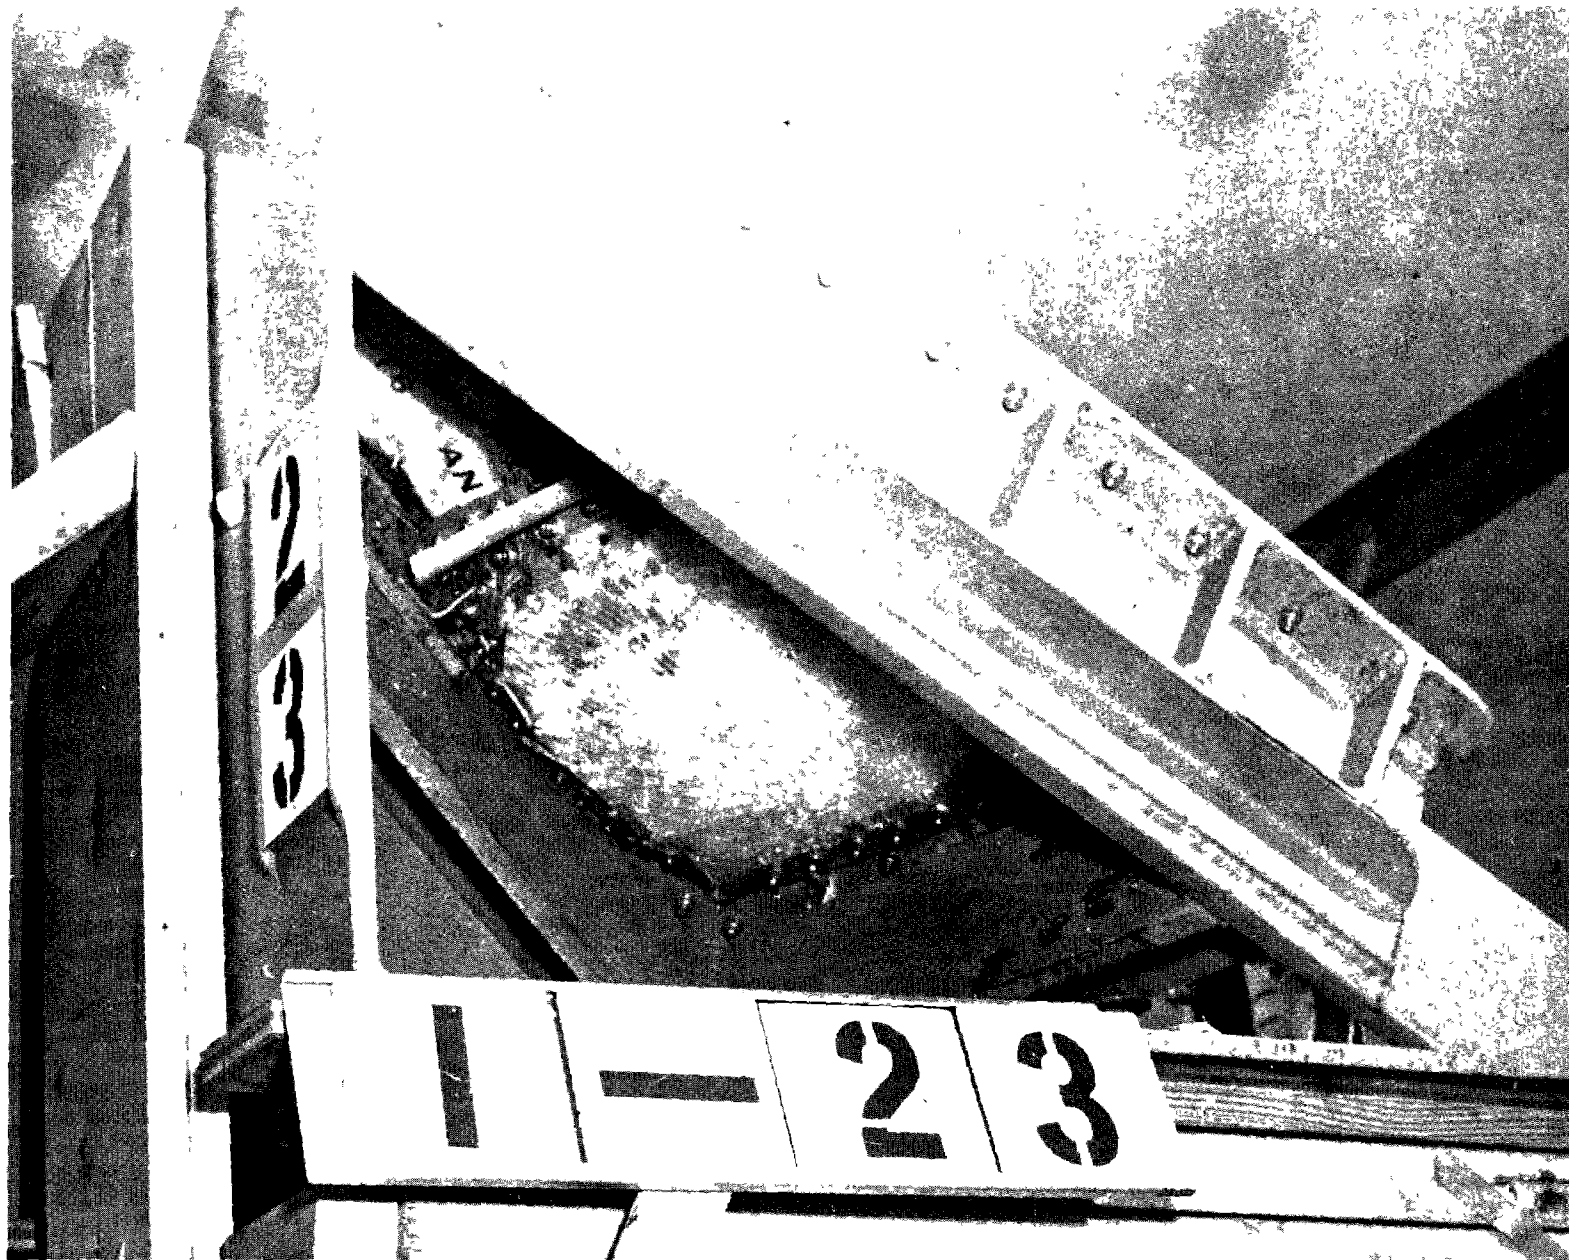
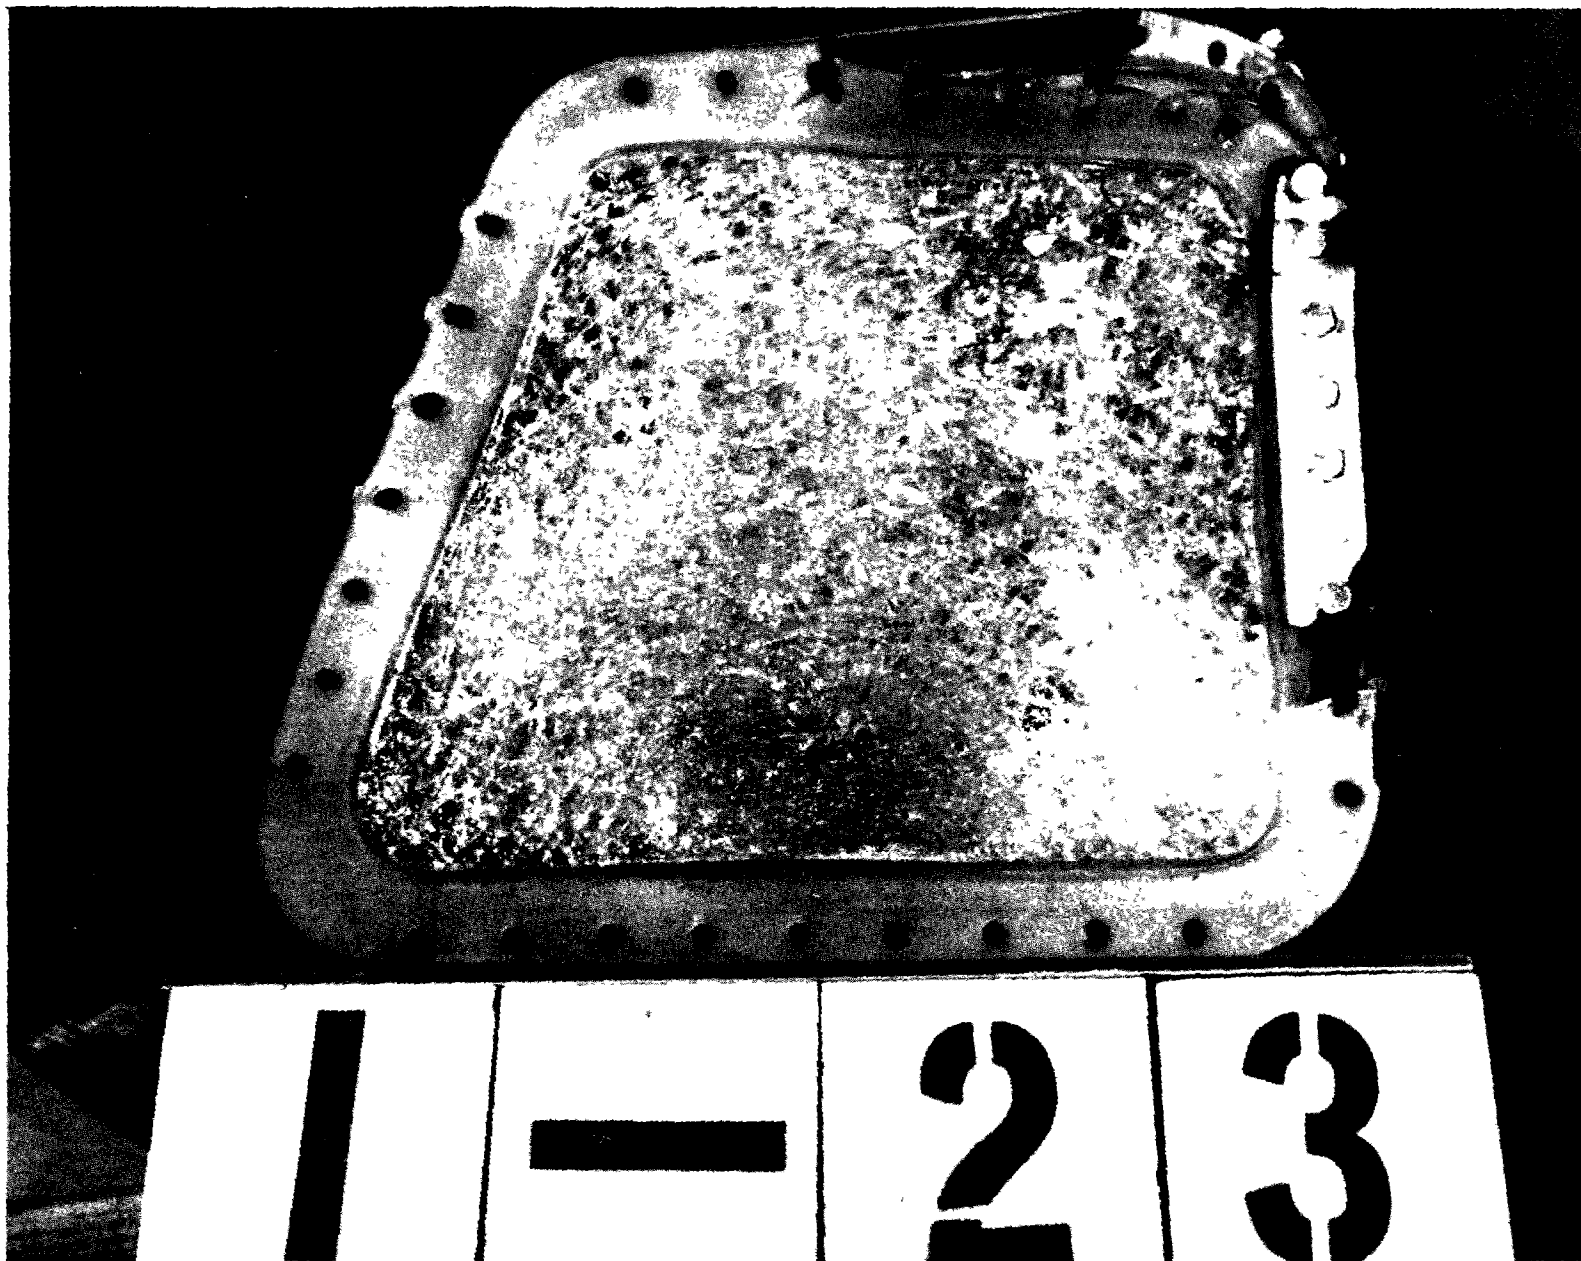
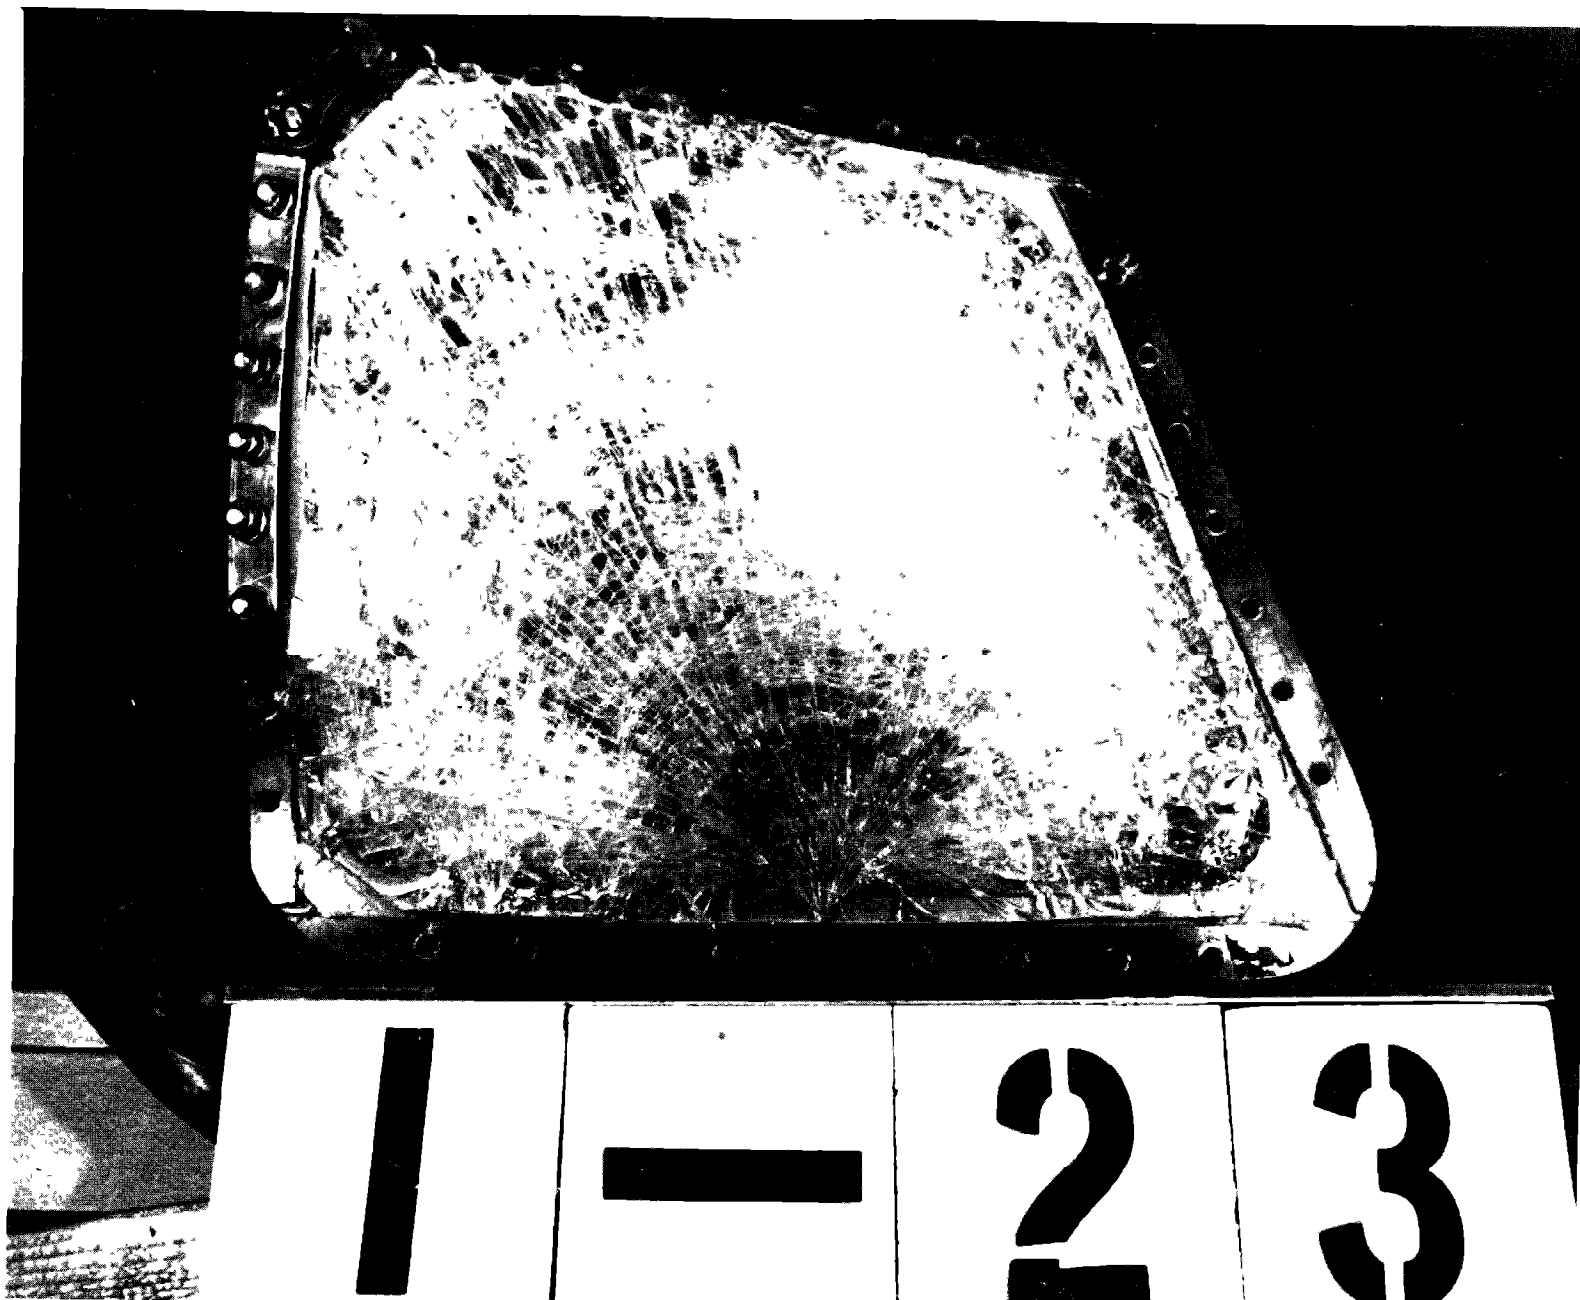
FIG. 44 TEST NO. 23. PROJECTILE VELOCITY 390 MPH .

There was slight penetration of the window as part of the outboard sill sheared and the top sill assembly failed partially, as shown in Figs. 44, 45, 46, and 47. The outer vinyl-metal insert edge lamination tore out around four sill bolts. Along the inboard sill the outer vinyl-metal insert edge lamination partially failed around four bolts. The inner layer of vinyl partially sheared approximately 9 inches along the inboard sill continuing approximately 5 inches along the top sill. The 1/8-inch-thick semitempered glass inner face remained laminated to the inner layer of vinyl. The glass fragmentation hazard associated with the 1/4-inch-thick full-tempered and 1/8-inch-thick semitempered glass particles was slight, as shown in Fig. 48.
