TECHNICAL DEVELOPMENT REPORT NO. 342

BIRD-IMPACT TESTS OF THE  
BOEING MODEL 707 AIRPLANE EYEBROW WINDOW

April 1958

CIVIL AERONAUTICS ADMINISTRATION  
TECHNICAL DEVELOPMENT CENTER  
INDIANAPOLIS, INDIANA

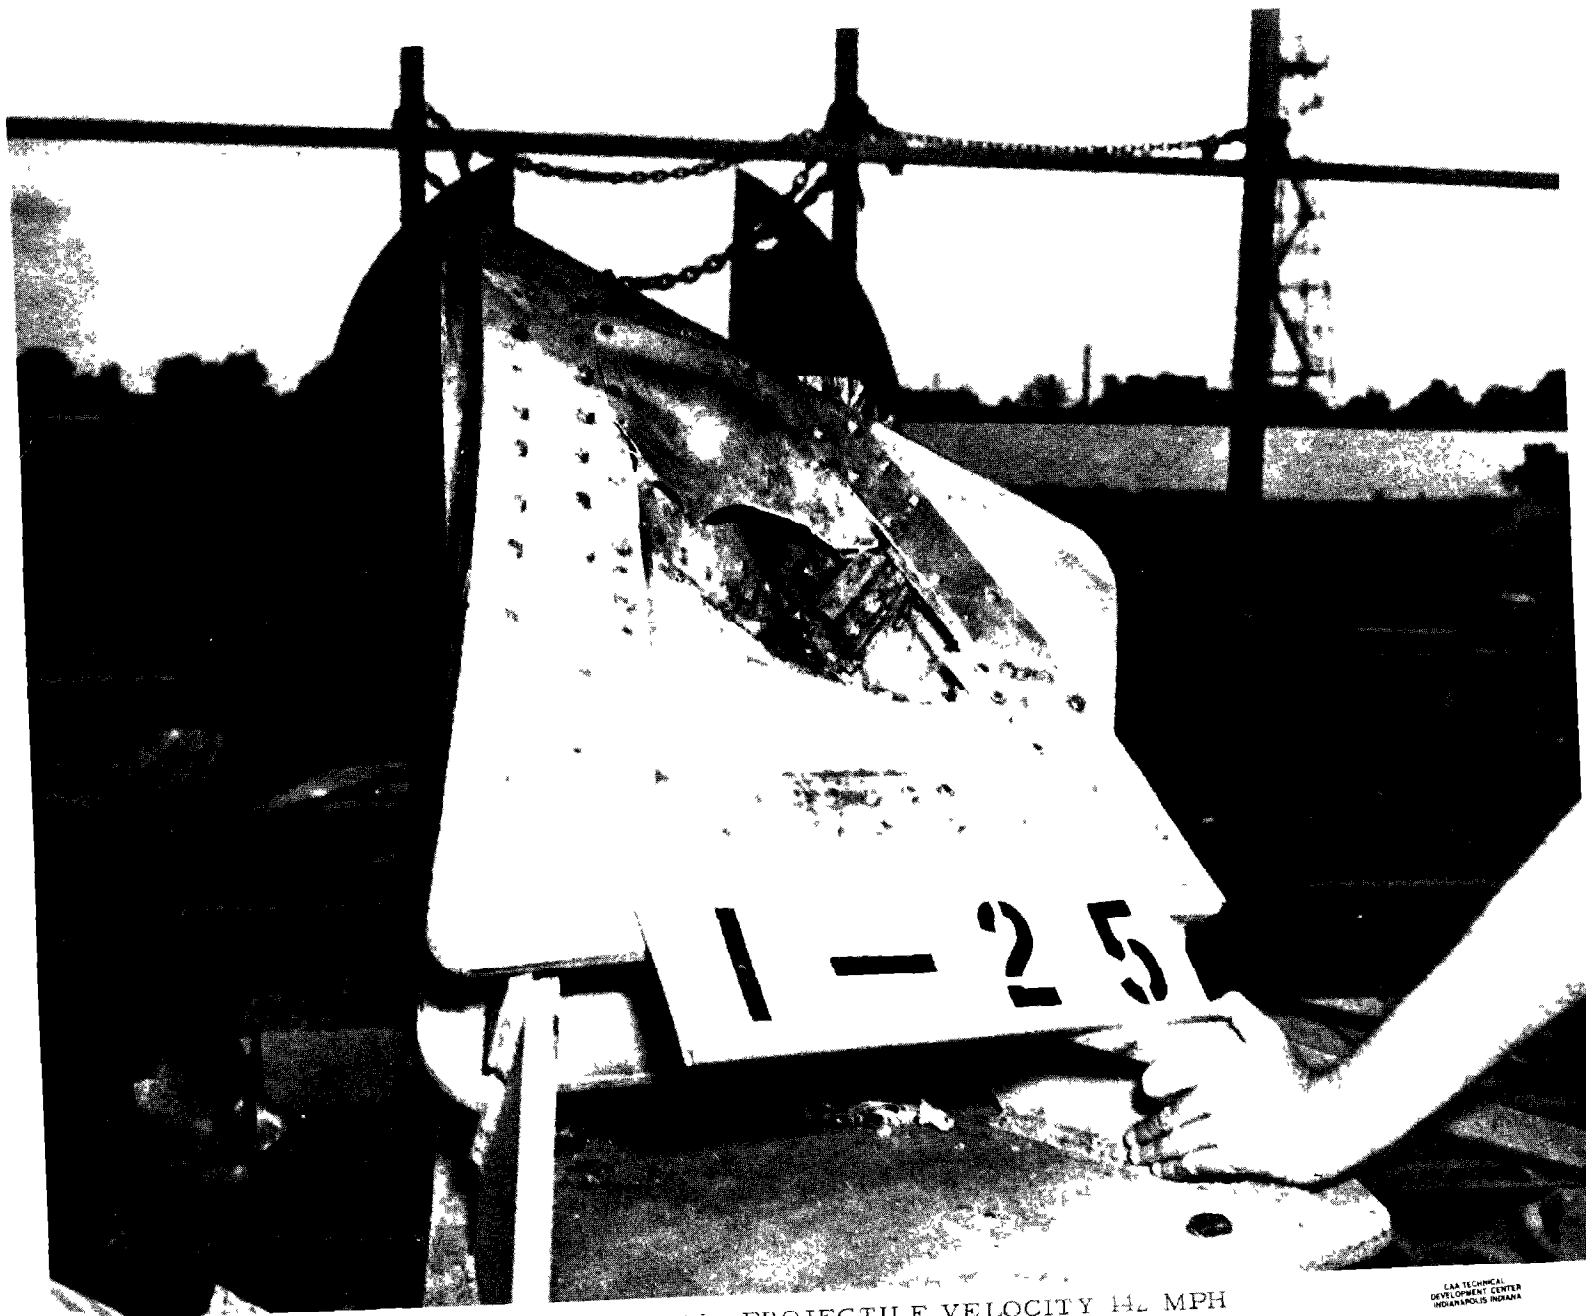
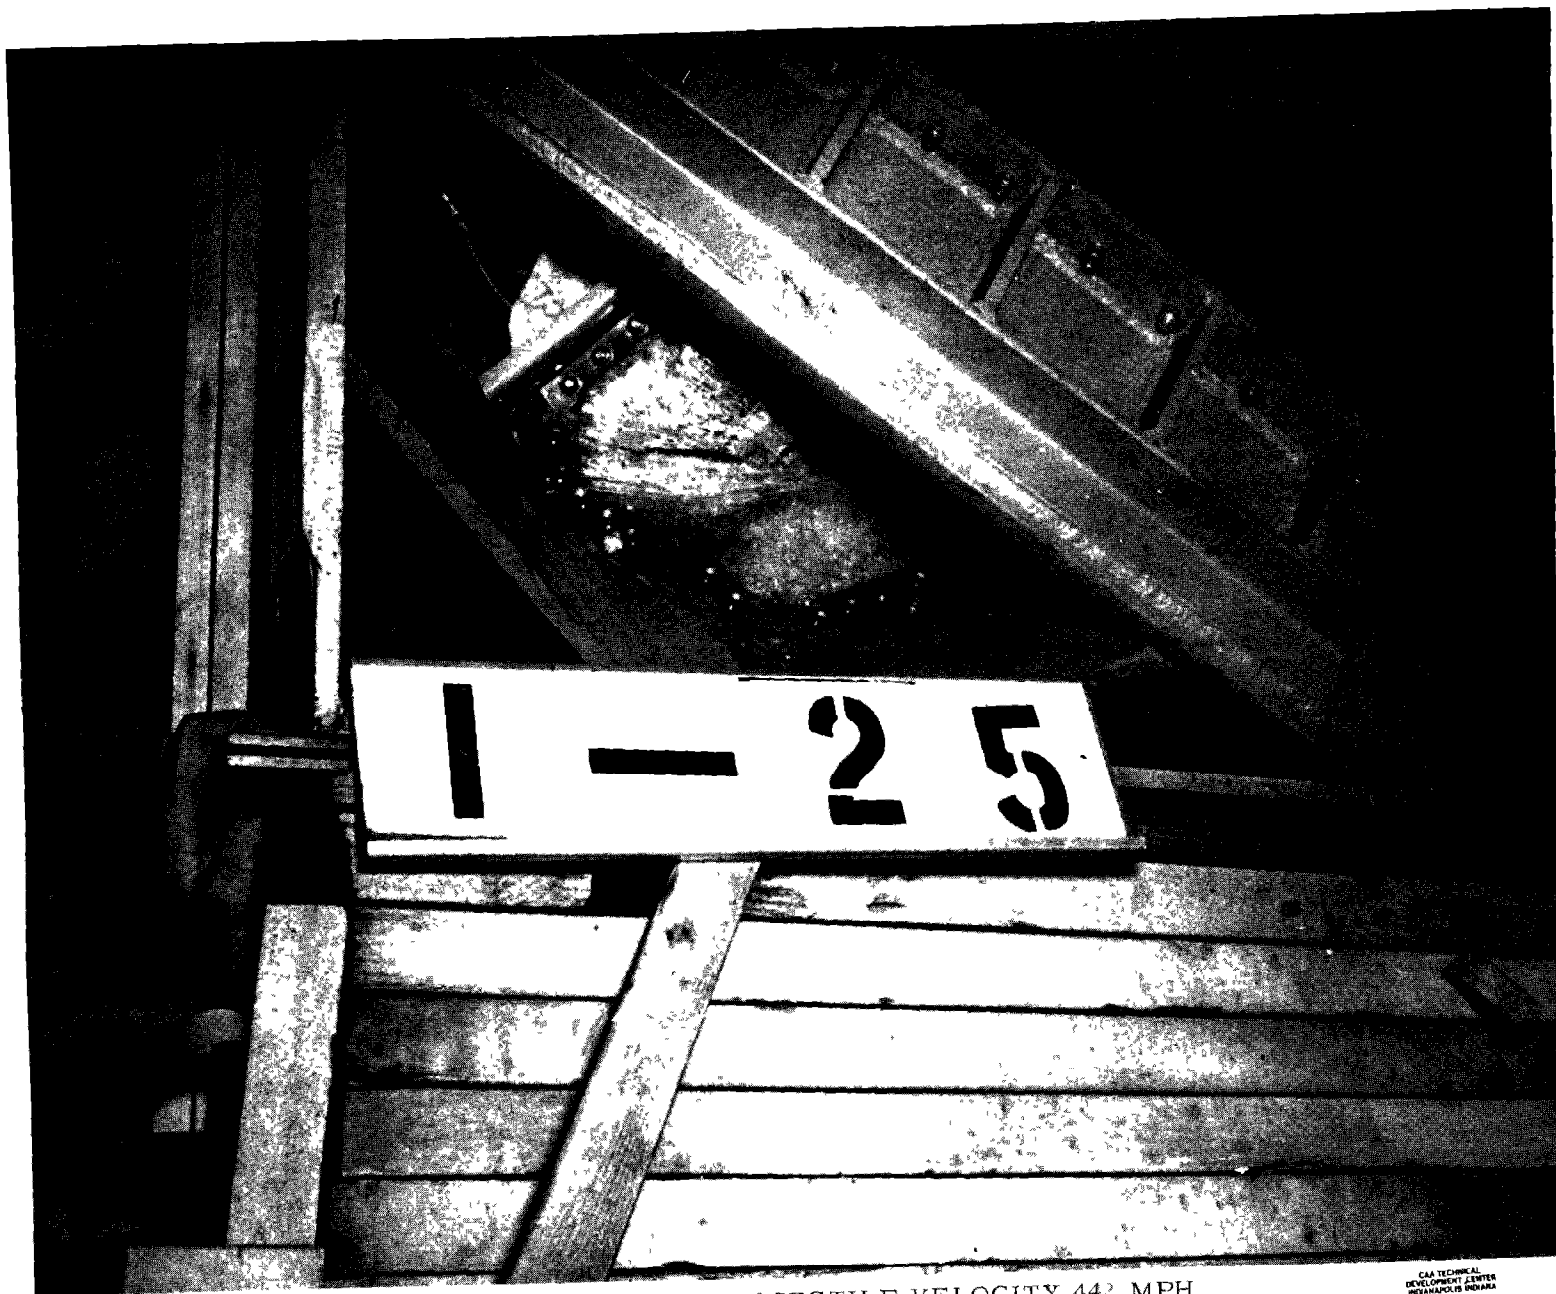
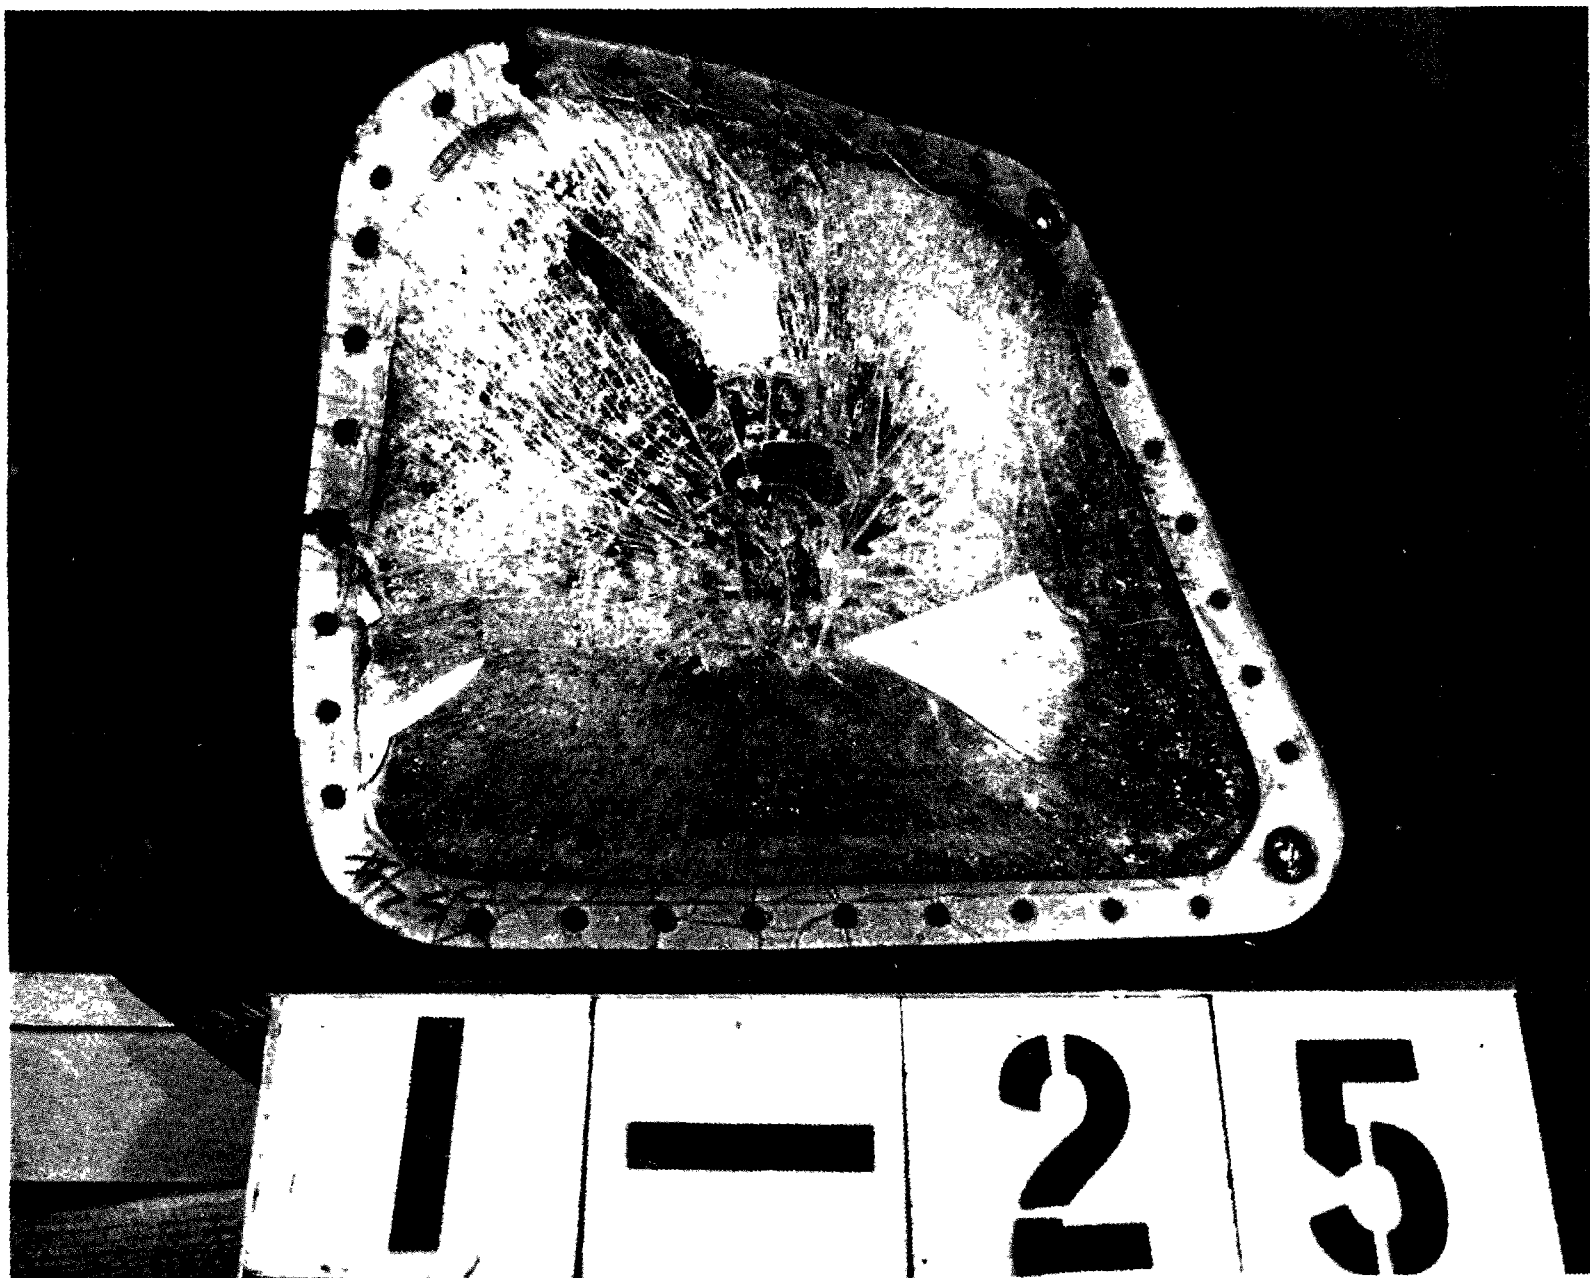
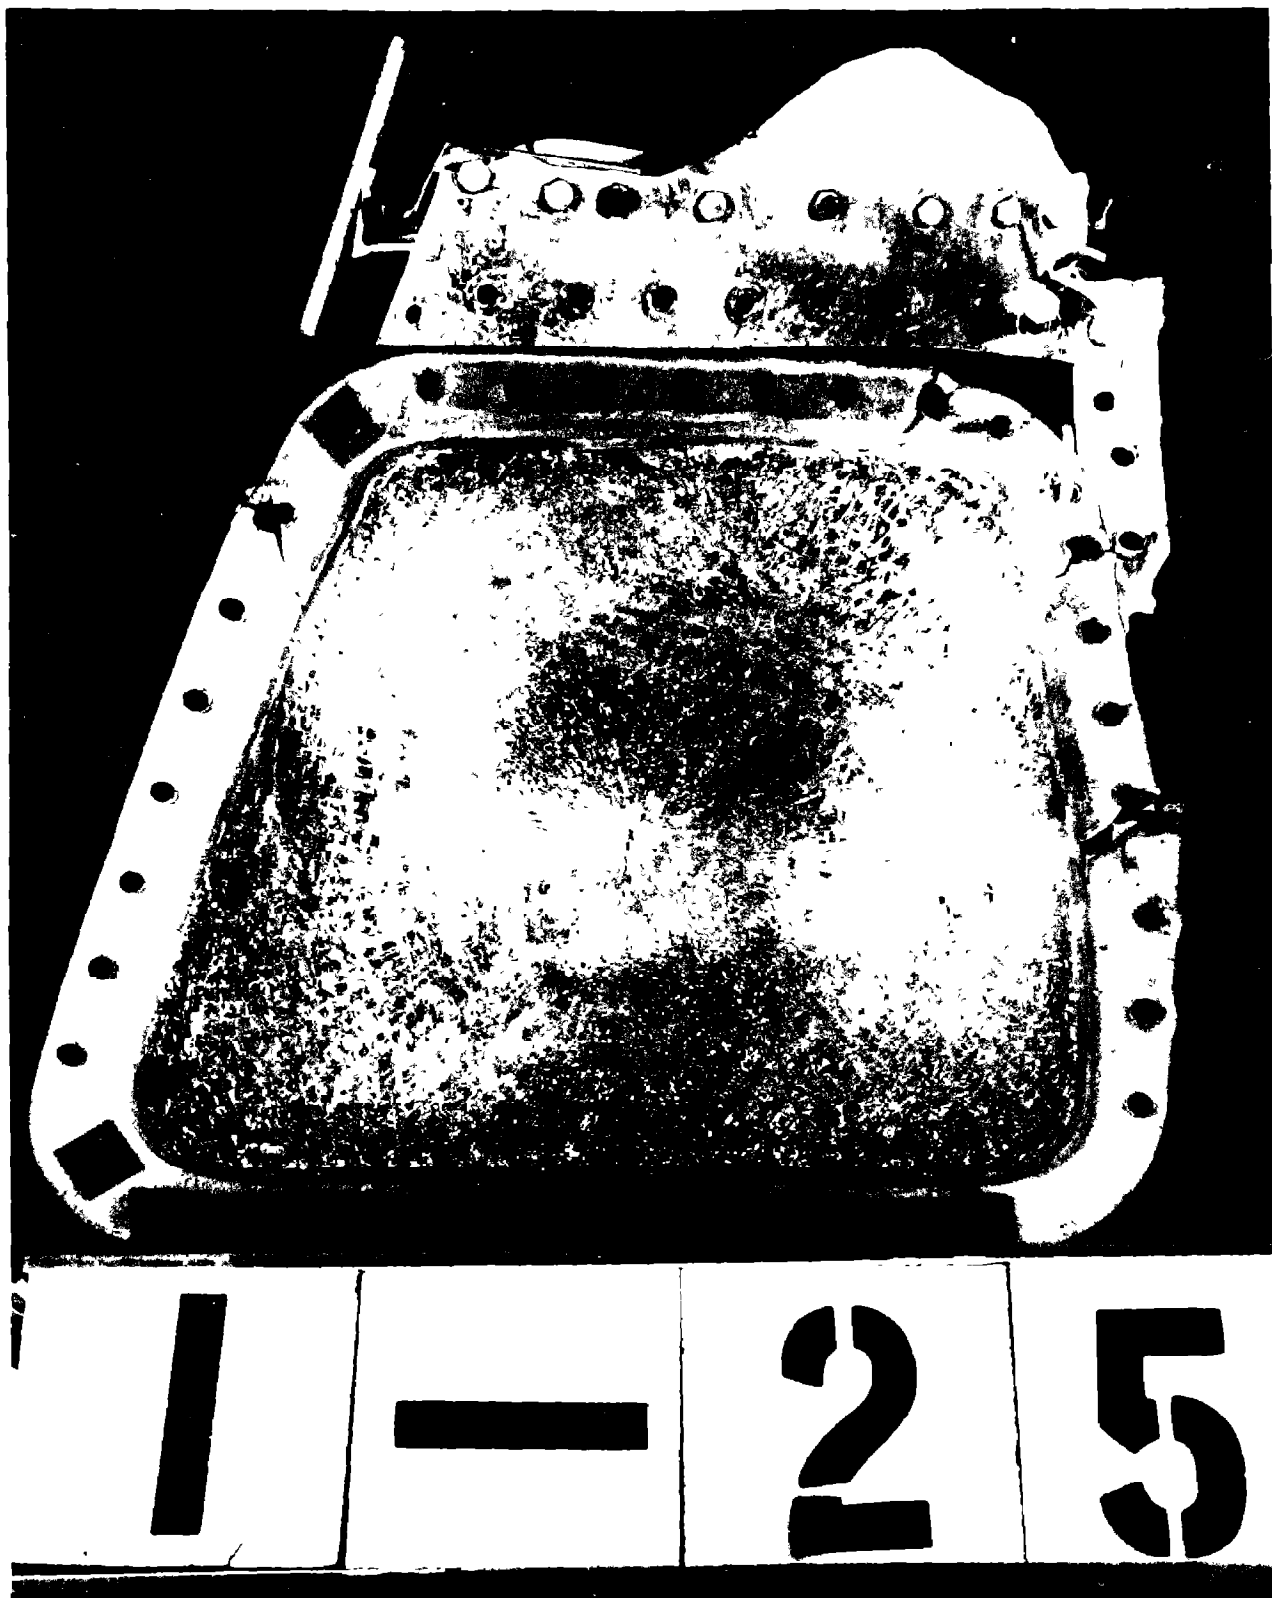
FIG. 54 TEST NO. 25. PROJECTILE VELOCITY 142 MPH

Part of the carcass penetrated the window as the top sill intercostal failed and one-half of the outboard sill failed as shown in Figs. 54, 55, 56, and 57. The two 3/16-inch-diameter rivets and one 3/16-inch-diameter bolt, shown as C, D, and E of Fig. 2, failed and permitted the remaining portion of the top intercostal sill to deflect rearward and downward. Parts of the carcass which penetrated the window extruded through the structure between the top sill and the attached skin, and passed over the position of the pilot's head. The Plex-55 inner face crazed, but did not depart from the inner-layer vinyl. The inner vinyl-Plex-55 laminate tore at the center of impact and from the top outboard corner toward the center of the window. A few 1/4-inch-thick full-tempered glass particles escaped through the tears in the vinyl-acrylic and impinged upon the floor and vertical wall of the test jig, as determined from high-speed film. Glass fragmentation from this window was less severe than in any of the previous tests.

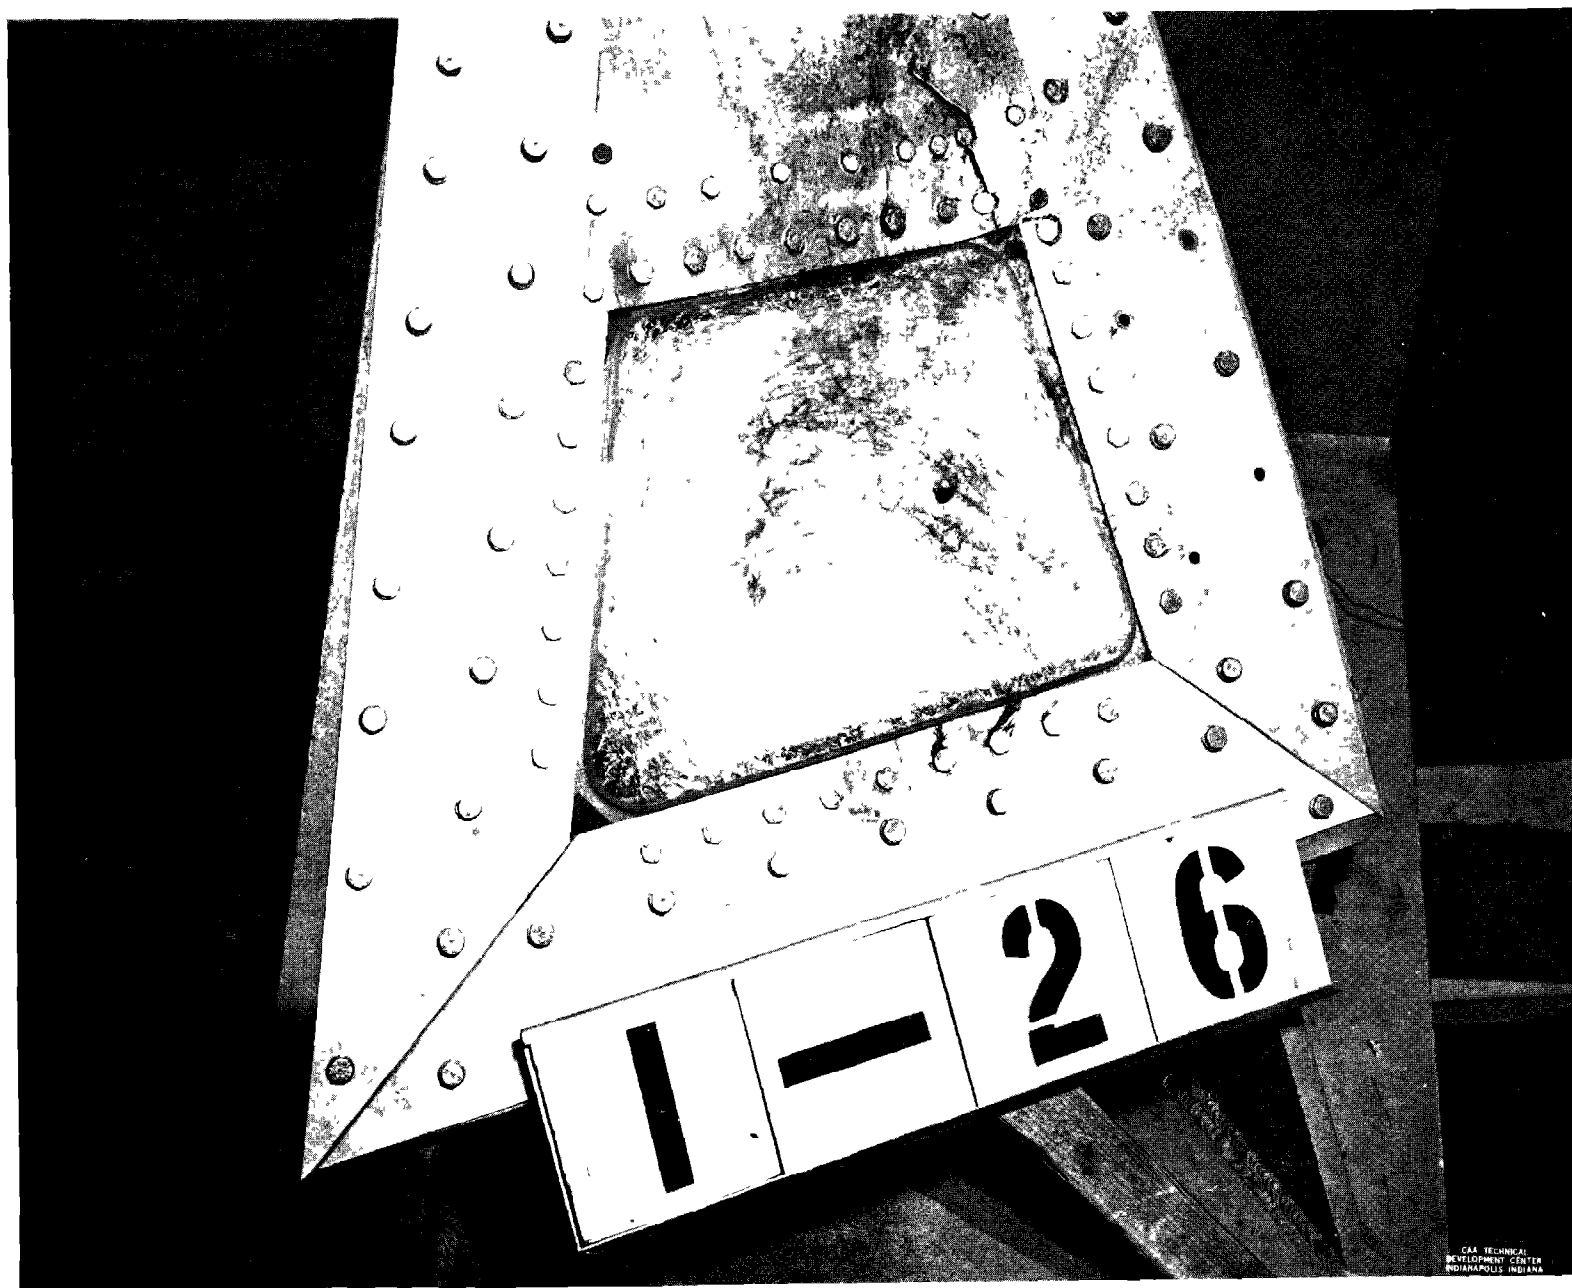
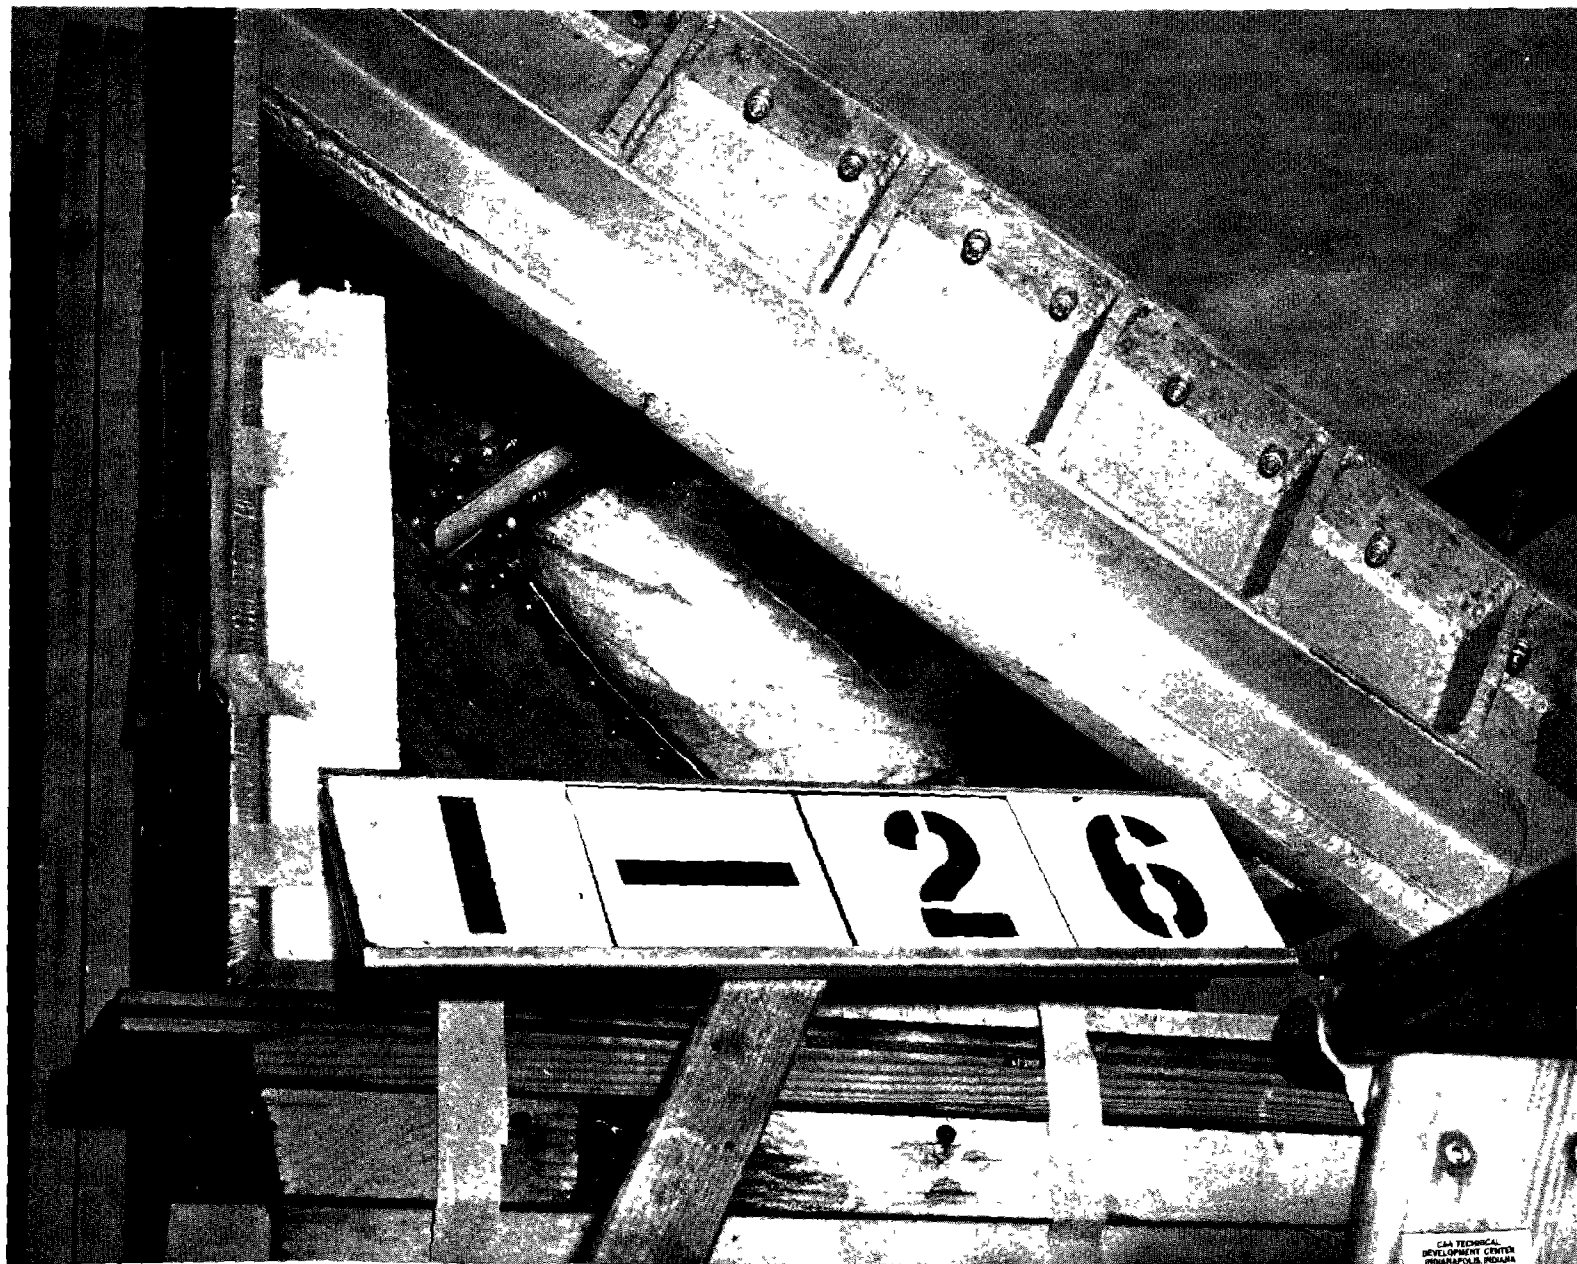
FIG. 56 TEST NO. 20. PROJECTILE VELOCITY 448 MPH

Parts Nos. 7 and 9, Fig. 2, were omitted for this test. There was no penetration through the window or adjacent structure, but a small part of the bird carcass penetrated through a tear in the skin above the top sill, shown in Figs. 58 and 59. The tee-shaped extrusion portion of the top intercostal sill assembly parted from the assembly, as shown in Fig. 60, and was held only by the top skin and the window edge. The inner face of the Plex-55

1. The Boeing 707 eyebrow window will resist the impact of a 4-pound bird with only a slight amount of penetration at 448 mph if a window design and supporting structure comparable to that utilized during Test No. 26 are used. Structural details of this combination are given in Table I.

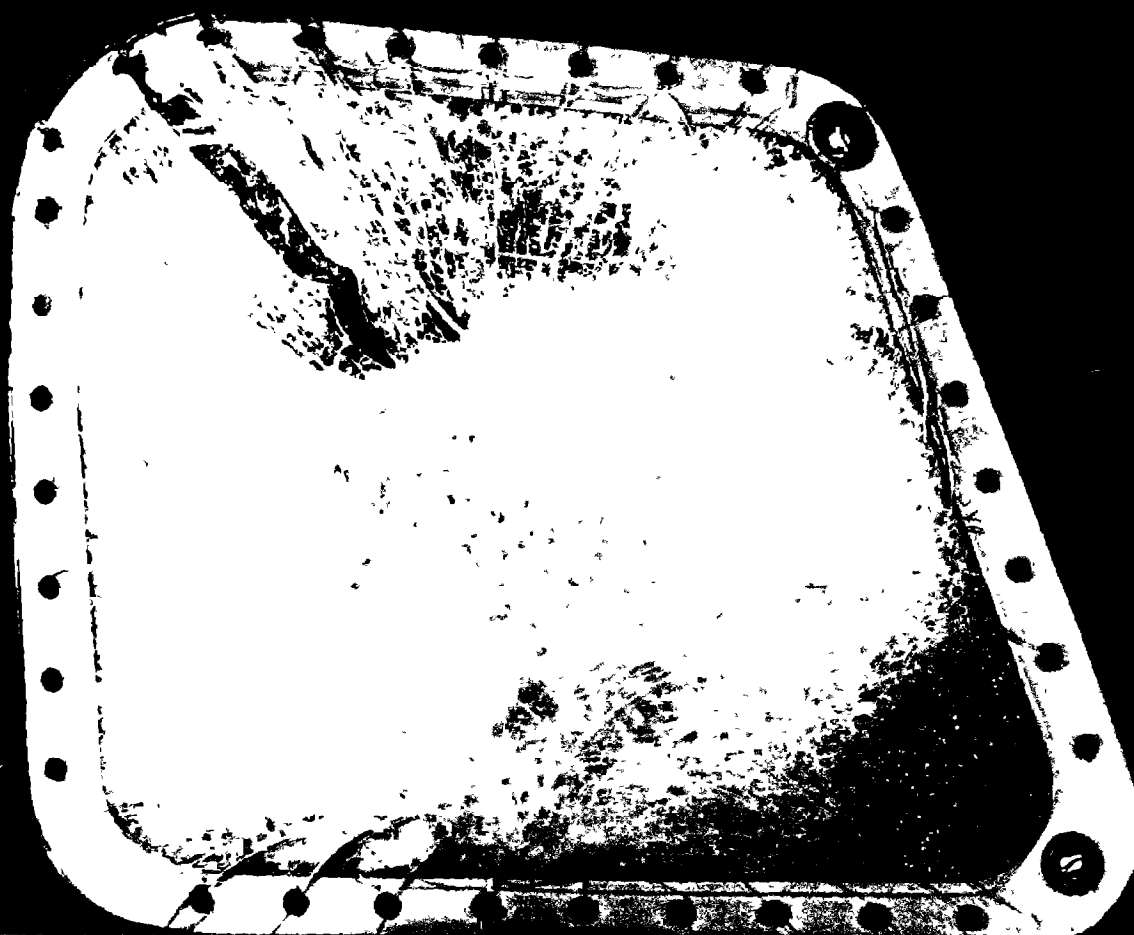
FIG 61 TEST NO 26 PROJECTILE VELOCITY 448 MPH

remained laminated to the inner layer of vinyl. The vinyl-Plex-55 laminate tore for a length of 5 inches from the upper inboard corner diagonally toward the center of the window, as shown in Fig. 61. Some 1/4-inch-thick full-tempered glass particles escaped through the tear and penetrated the Styrofoam boards, predominately at two positions. One position was above and to the left of the pilot's head while the other was at the pilot's head level, but to the left. One small glass particle penetrated the Styrofoam board to a depth of 1/8-inch near the position of the pilot's head. In addition, there were several extremely small indentations in the Styrofoam board at the pilot's head position. The Styrofoam boards, after the test, are shown in Fig. 62.
