TECHNICAL DEVELOPMENT REPORT NO. 348

BIRD IMPACT TESTS OF THE DOUGLAS  
MODEL DC-8 AIRPLANE WINDSHIELD

May 1958

CIVIL AERONAUTICS ADMINISTRATION  
TECHNICAL DEVELOPMENT CENTER  
INDIANAPOLIS, INDIANA

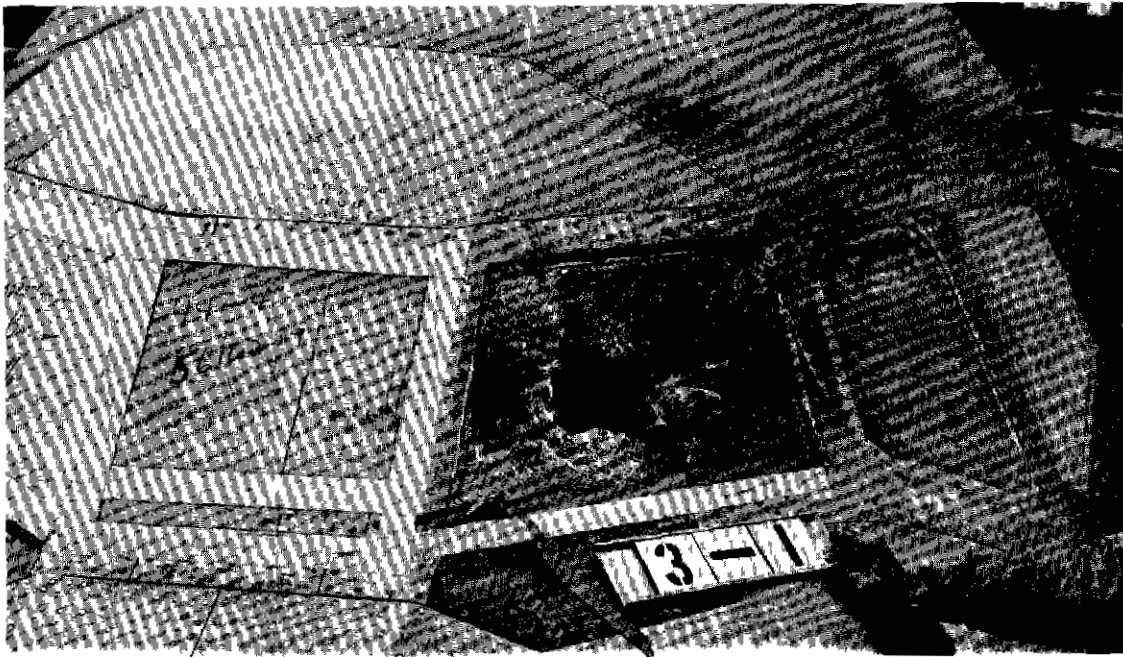
FIG 9 TEST NO. 1 - EXTERIOR PANEL, PROJECTILE VELOCITY - 408 MPH

The carcass hit the window about one inch below the target point. Both the outer and inner window panels were penetrated by a major portion of the carcass. No failure of the sill or retaining structure occurred. Most of the carcass which penetrated the window passed to the right of the pilot, although a few particles impinged upon the pilot's face, chest, and right shoulder area. Three particles of full-tempered glass about 1/4-inch on edge penetrated into the right shoulder of the pilot. The outer corner of the right glass lens in the goggles worn by the pilot was broken by flying windshield fragments, and glass particles from this lens impinged upon the pilot's eye socket area. There was no left lens in the goggles. Small particles and slivers of semitempered glass impinged lightly upon the pilot's face, chest, and shoulder area. The copilot was struck by numerous small particles of semitempered glass, but none were imbedded deeply in the clay and could be removed by gentle brushing. Upon examination of the vinyl failure which occurred, it was determined that the window was not properly heated when tested. The control box for the Electropane heating units then was examined, and it

was found that it was not operating properly. In final analysis, this was not considered to be a valid test of the impact strength of the side window and supporting structure because of the low vinyl temperature. Results of this test are shown in Figs. 9, 10, and 11.

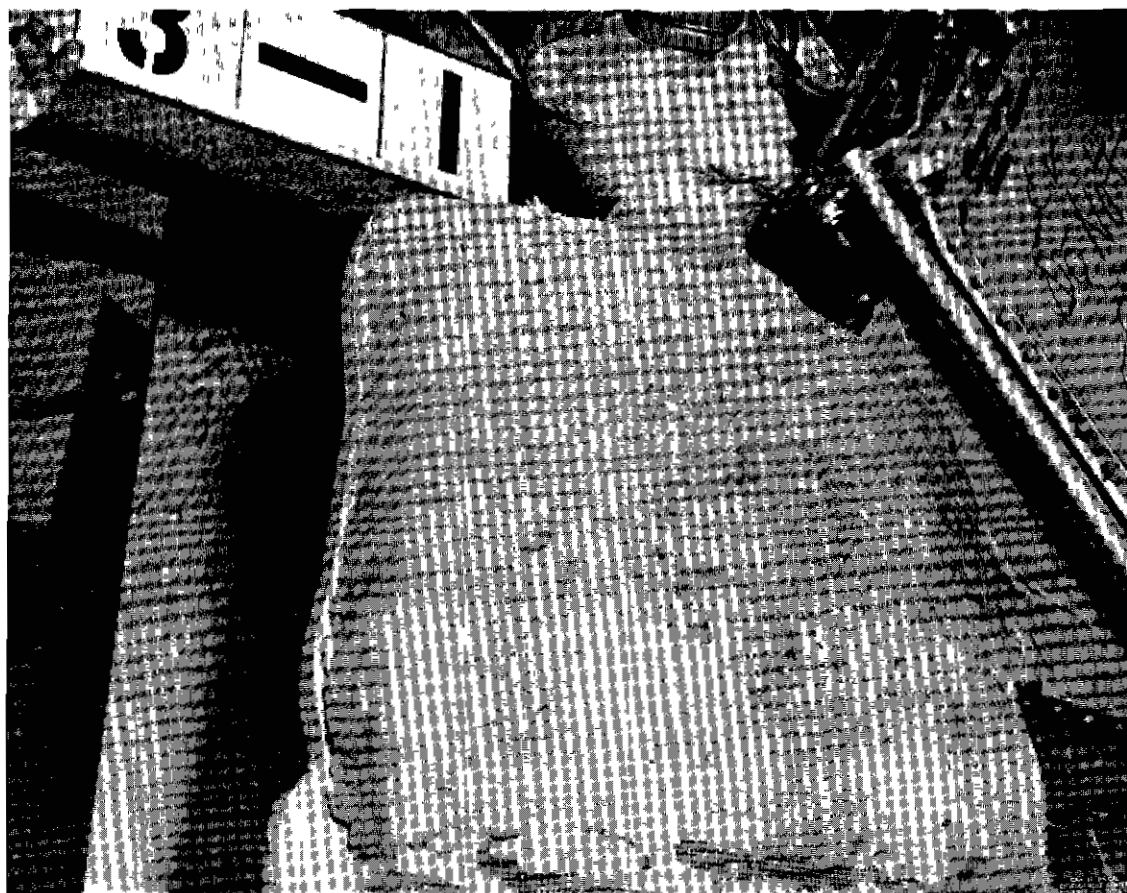
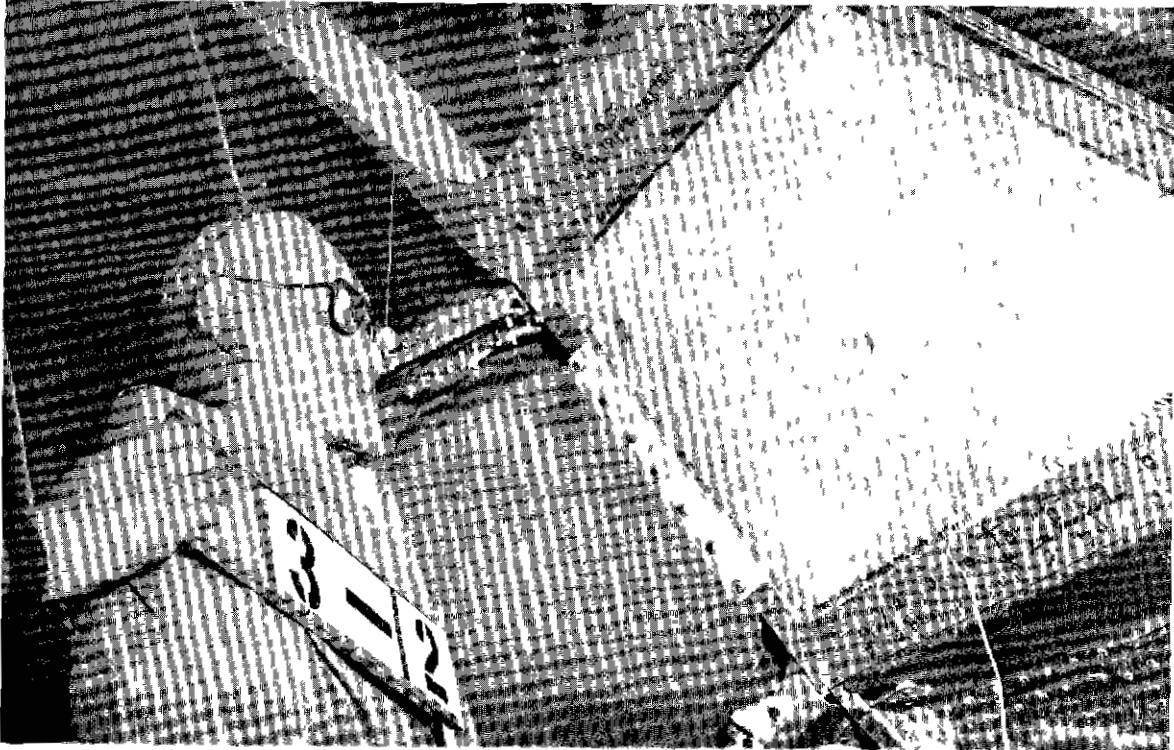
The carcass hit about one inch below the target point. None of the carcass penetrated into the cockpit area. The vinyl in the exterior window panel sheared for a length of 11 inches along the inboard edge, for a length of 11 inches along the top edge, and for a length of 8 inches along the cornerpost edge. There was no failure of the vinyl in the interior window panel. No failure of sill and retaining structure occurred. The upper center doubler plate for the outer panel warped outward about 1/8-inch. Fine sharp-edged particles of semitempered glass from the aft face of the interior window panel impinged upon the pilot's face below eye level and upon his clothing in the chest area. None of the glass imbedded in the exposed clay parts of the pilot's body; that is, the face and neck, and no penetration or tearing of the cloth shirt occurred. The sun glasses worn by the pilot remained intact and undamaged. Results of this test are shown in Figs. 12 and 13.

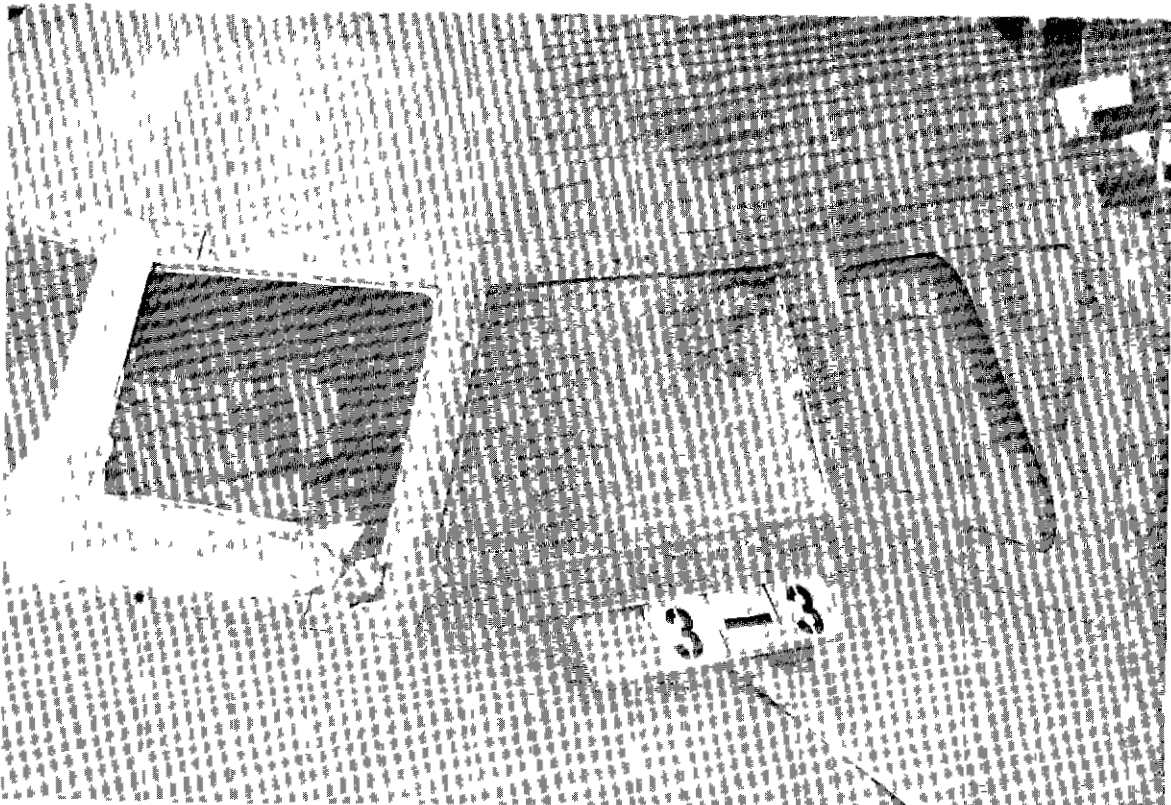
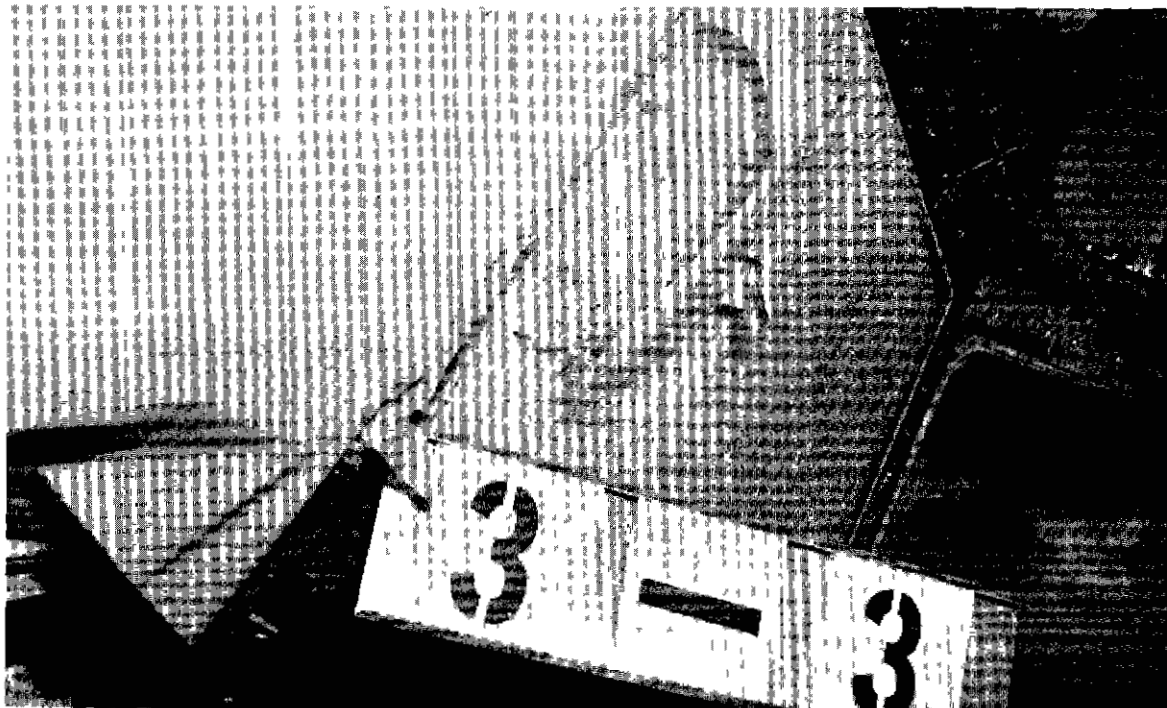
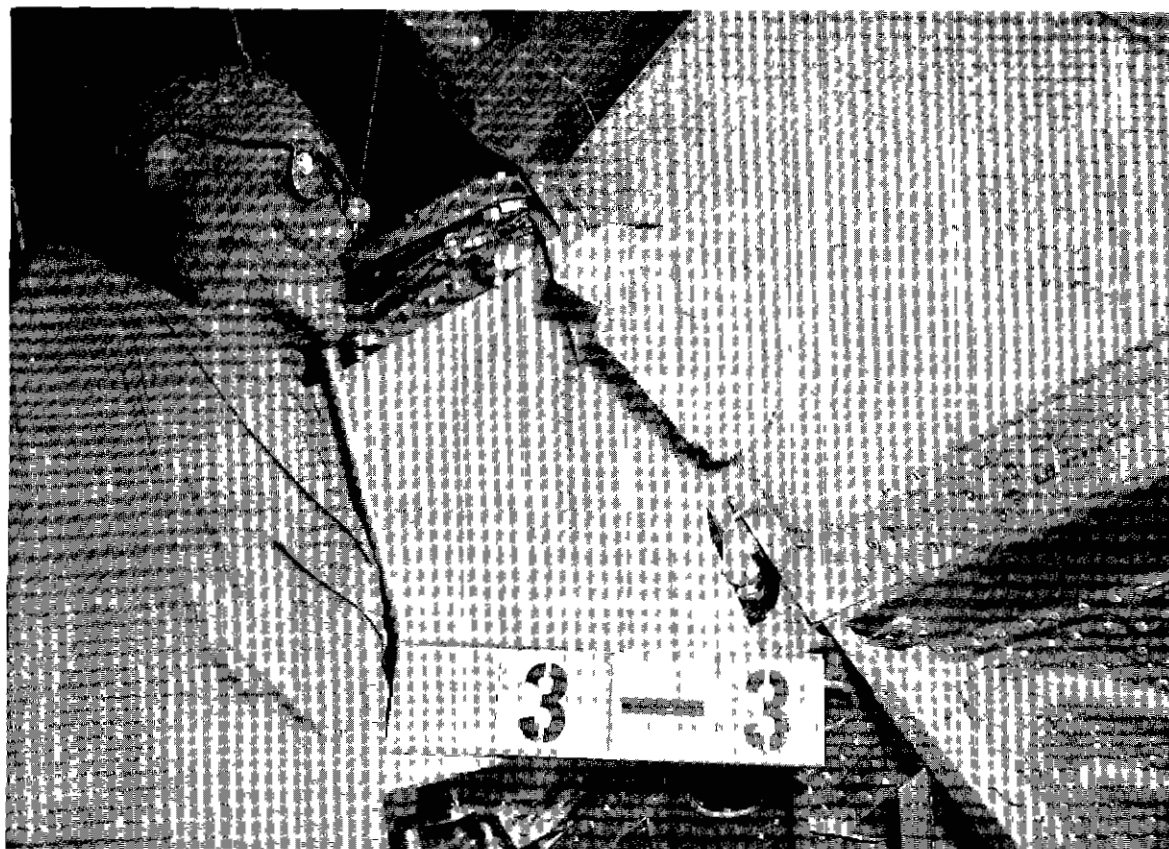
The projectile hit about two inches below the target point. None of the chicken carcass penetrated into the cockpit area. The exterior window panel vinyl tore for a length of four inches along the top sill metal insert toward the upper left corner and downward about four inches along the cornerpost sill metal insert, as shown in Fig. 14. The vinyl in the interior window panel failed primarily along the cornerpost edge, as shown in Fig. 15. The relative positions of the two vinyl breaks were such that penetration by the bird carcass was prevented. The interior panel vinyl temperature was lower than optimum for maximum impact strength, which apparently resulted in the failure of this interlayer. The pilot's face was pelted slightly by flying glass. At the level of the pilot's upper lip, small slivers of glass imbedded about 1/64-inch in the clay. One 3/8-inch-long sliver of glass imbedded itself about 1/64-inch along the left side of the bridge of the pilot's nose. The sun glasses worn by the pilot remained intact and were not damaged in any manner. The pilot is shown in Fig. 16. Numerous small particles of semitempered glass impinged upon the clothing of both the pilot and copilot. None of these penetrated the cloth.

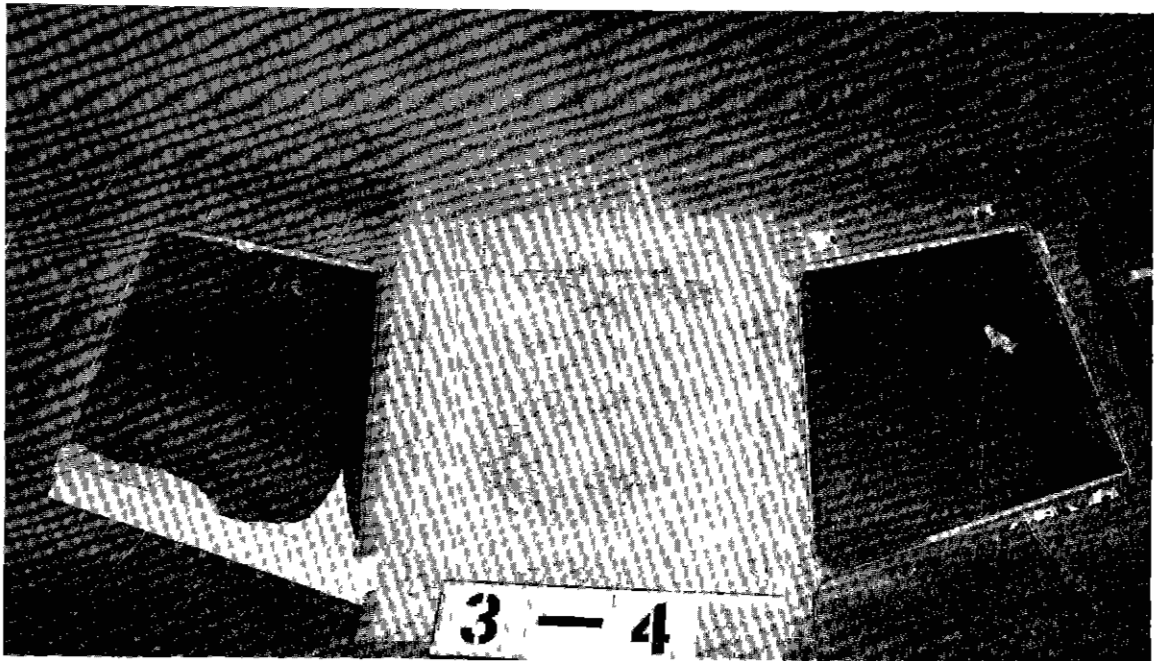
FIG 17 TEST NO 4 - EXTERIOR PANEL, PROJECTILE VELOCITY - 426 MPH

Penetration of a slight amount of chicken-carcass entrails was experienced as the vinyl tore for a length of 14 inches along the top sill metal insert of the exterior window panel, as shown in Fig. 17. A piece of

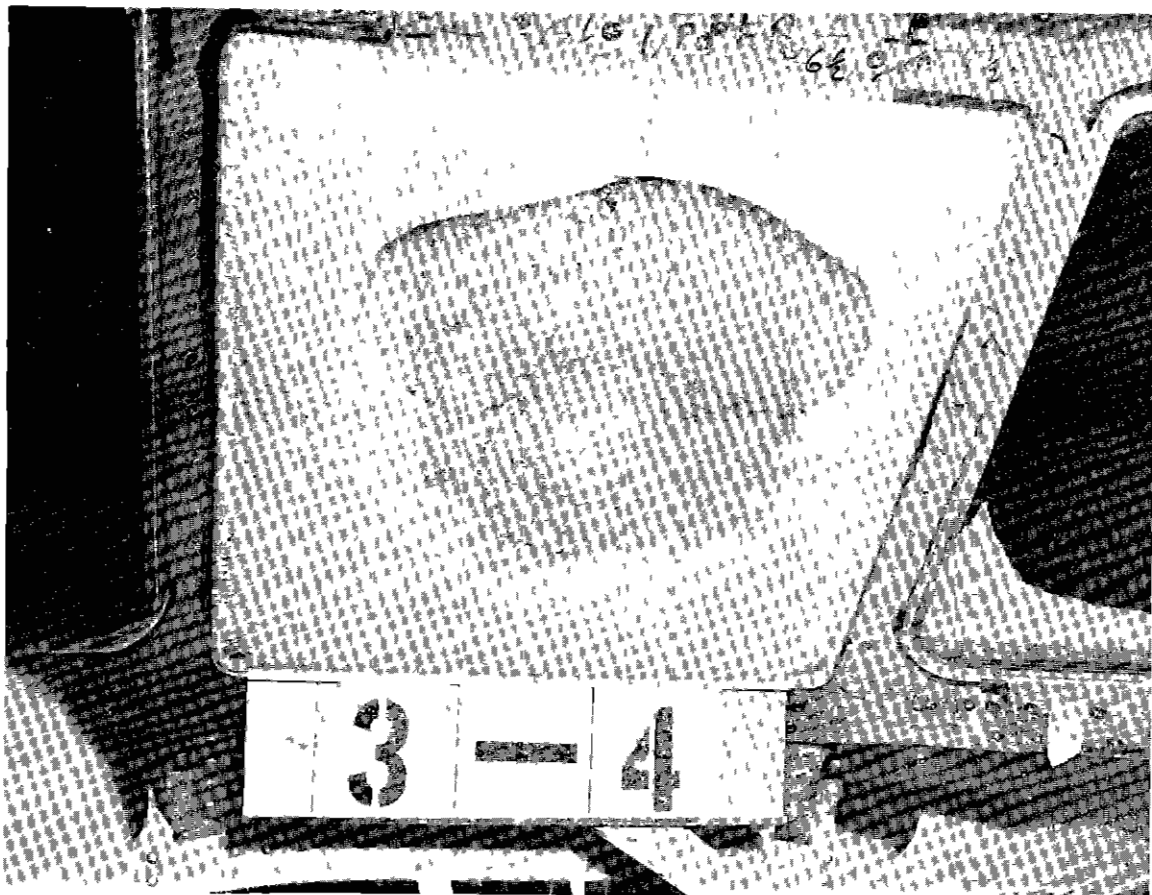
FIG 18 TEST NO 4 - INTERIOR PANEL, PROJECTILE VELOCITY - 426 MPH

the interior window panel about 13 inches wide and 13 1/2 inches long tore out, as shown in Fig. 18. Apparently, this panel was too low in temperature for maximum impact strength. The location of the breaks in the exterior and interior panels was such that the small amount of carcass which penetrated the exterior panel was almost entirely contained by the interior panel. The piece of the interior window which tore out was propelled aft between the pilot and copilot to a location near the aft bulkhead of the cockpit structure. Small particles of glass impinged upon the pilot's and copilot's clothing, but none penetrated. The semitempered glass from the aft face of the interior window and full-tempered glass sandwiched between the panels was propelled predominantly in a plane normal to the window and downward into the aisle between the pilot and copilot. No glass was propelled at either pilot or copilot at eye level, and the glasses worn by the two clay figures were undamaged. No apparent damage to the window sills was noted, although the top center doubler plate retaining the outer window was warped outward slightly.

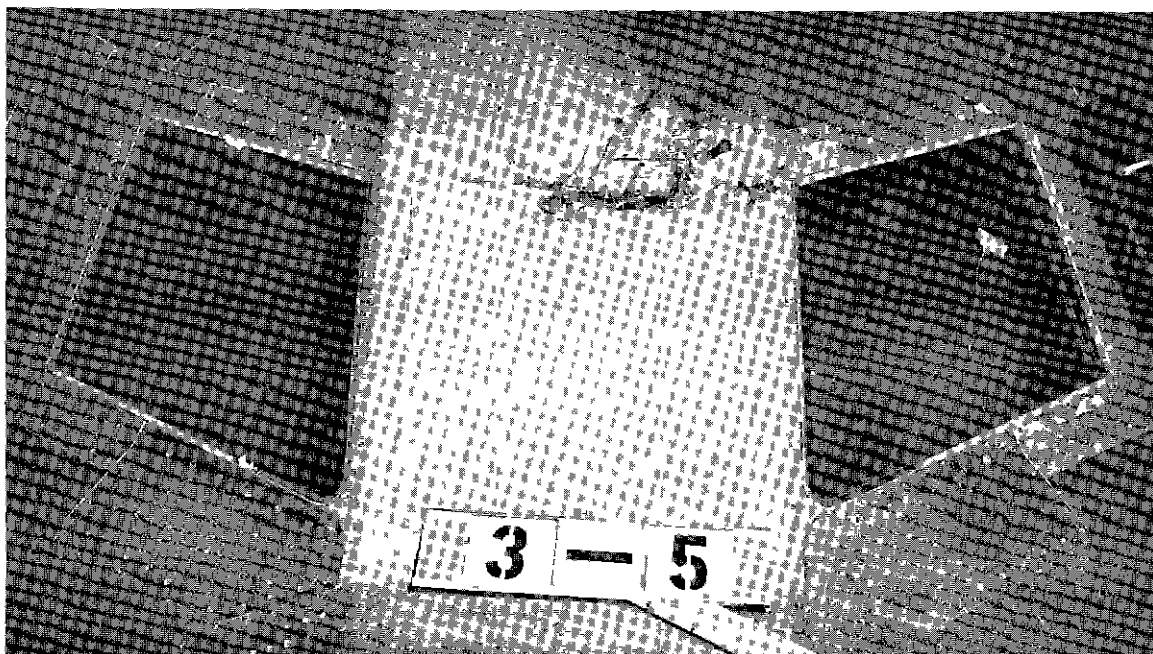
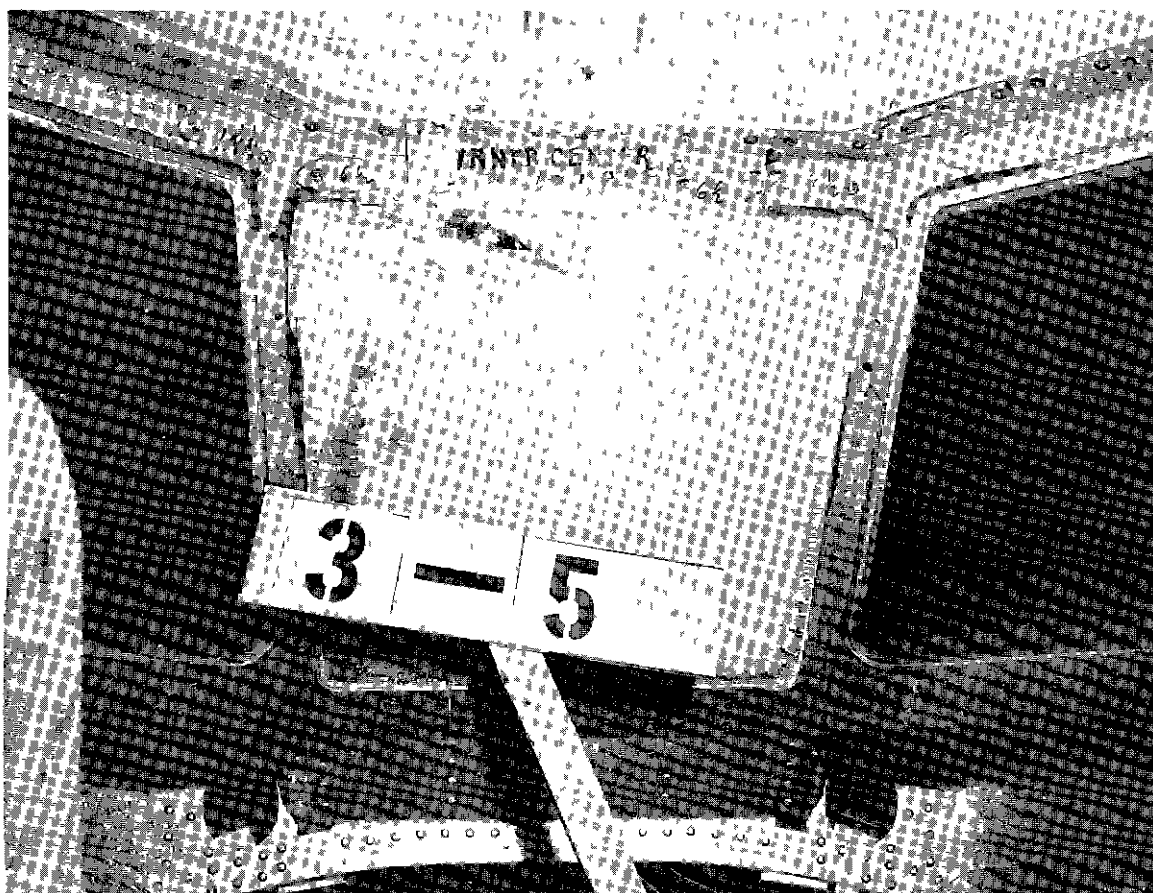
The chicken carcass struck about two inches below the target point. The vinyl in both the exterior and interior panels tore for a length of nine inches along the upper metal insert parallel to the top sill, as shown in Figs. 19 and 20. This failure was located predominantly at the left center portion of the window. Part of the bird carcass extruded through the tear in the vinyl interlayers. The right shoulder area of the pilot was struck by particles of semitempered glass and bird carcass as shown in Fig. 21, but none penetrated the clothing of the pilot. The small amount of glass which departed from the aft face of the interior panel was propelled predominantly downward between the pilot and copilot. The upper doubler retaining plate for the exterior window panel was bent upward and inward as four top sill bolts failed. Failure of the interior panel during this test apparently was due to a low vinyl interlayer temperature.

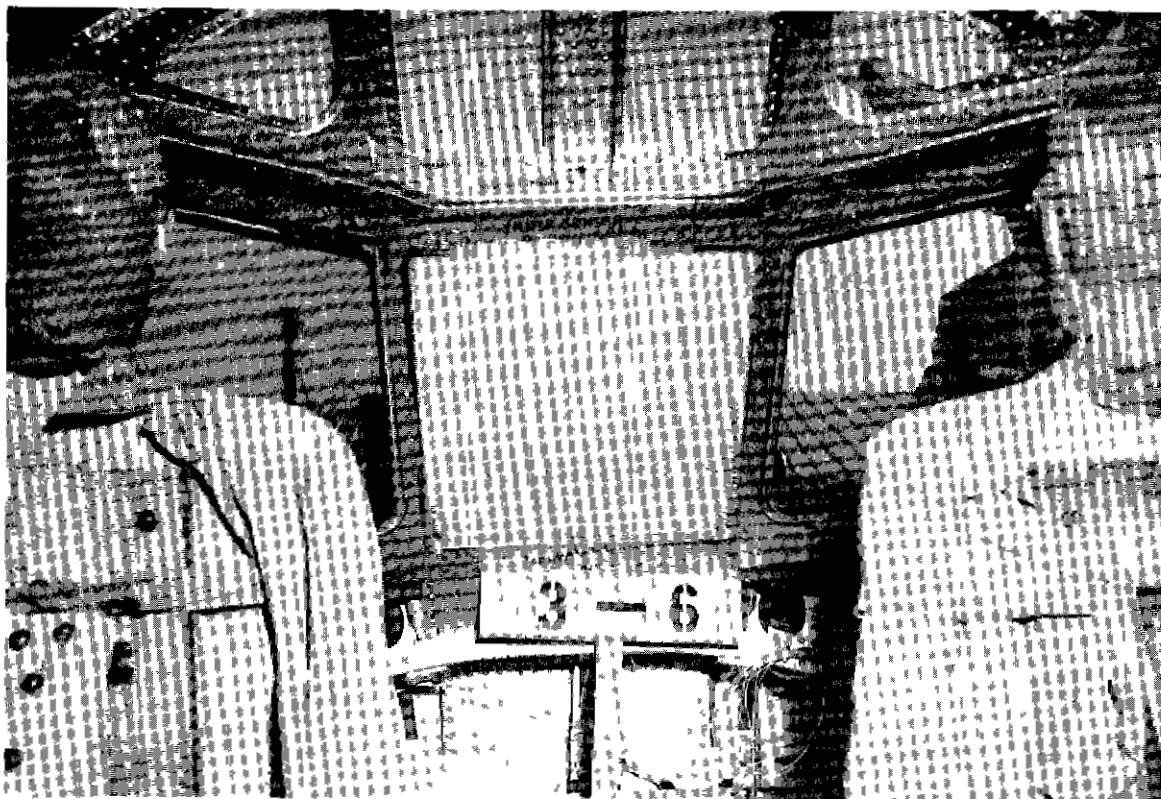
FIG 22 TEST NO 6 - INTERIOR PANEL, PROJECTILE VELOCITY - 405 MPH

The chicken carcass hit about 1/2-inch below the target point. None of the carcass penetrated into the cockpit area as the interior window panel remained intact. See Fig. 22. The vinyl pulled away from the metal insert of the exterior window panel for a length of nine inches along the top edge, as shown in Fig. 23. The metal insert cracked for a length of seven inches along the top edge of the exterior window panel. The small amount of glass which departed from the aft face of the interior window panel was directed predominantly downward and normal to the plane of the window. A few particles of glass impinged upon the lower faces of the pilot and copilot, but did not penetrate the clay. Figure 24 shows the pilot after this

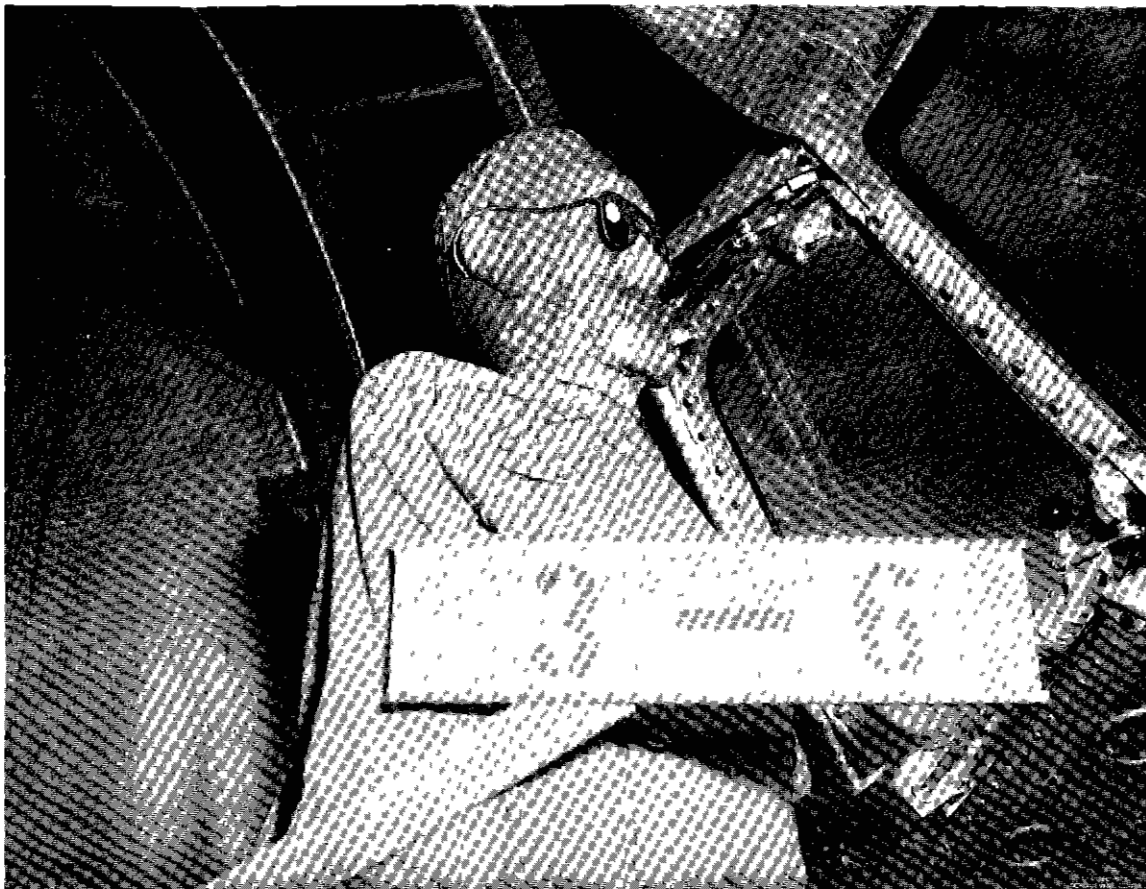
FIG 24 TEST NO 6 - PILOT, PROJECTILE VELOCITY - 405 MPH

test. One-half of the upper doubler plate tore free as four retaining bolts failed. After this test, it was noticed that the upper sill edge was bent inward about 1/4-inch.

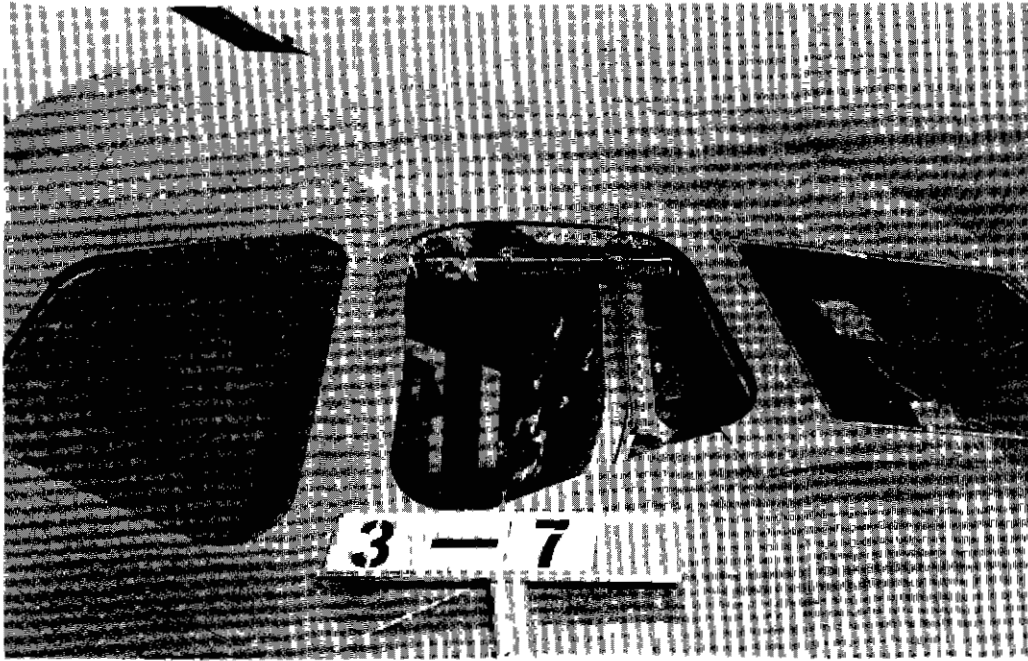
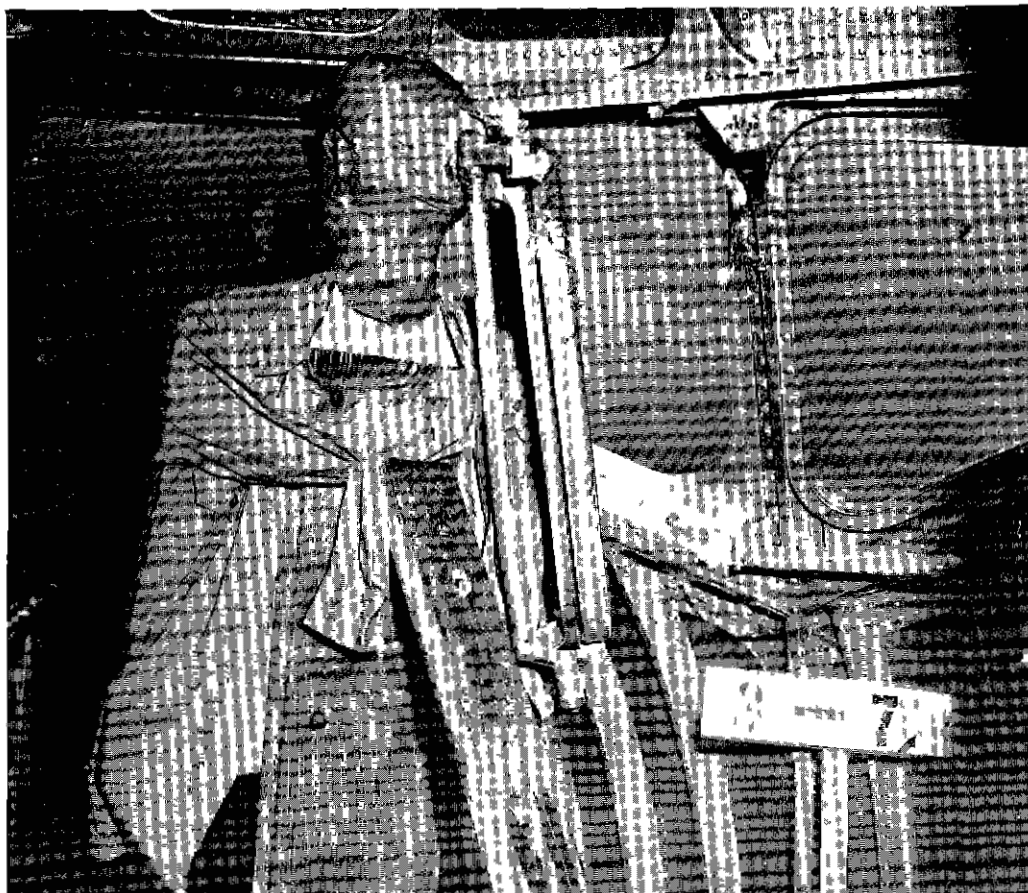
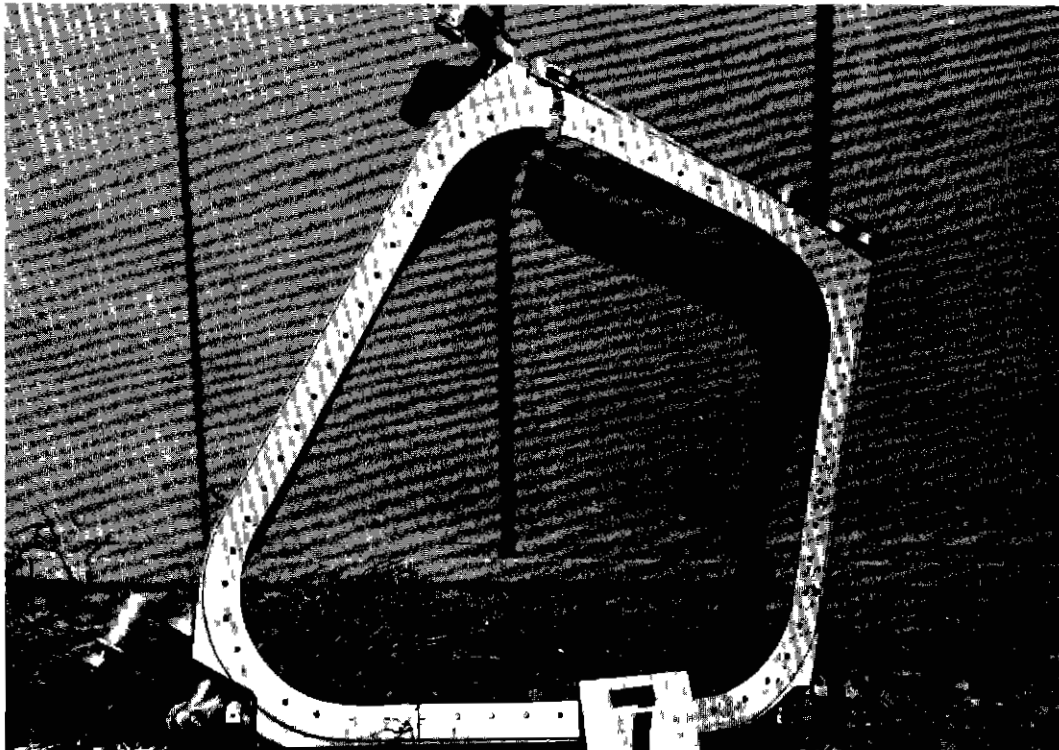
Upon impact, the window opened as the latching mechanism failed and the window swung inward about the upper and lower forward track retaining points, allowing a considerable portion of the bird carcass to enter the cockpit aft of the copilot. The copilot was hit a severe blow in the back of the head as the window frame swung inward. Neither the exterior nor interior stretched Plex-55 window panels ruptured. The window frame cracked just forward of the upper aft corner at a location which had been weakened by machining a clearance recess for a latching mechanism nut. High-speed pictures of the test indicated that the window frame was forced open by hydraulic action of the carcass at the upper aft corner, and subsequent warping of the window frame allowed the upper and lower window latches to slip from their normally closed positions. Results of this test are shown in Figs. 25, 26, and 27.

1. The window design incorporating two stretched Plex-55 panels as shown in Douglas Aircraft Co. Drawing No. 5616457, Revision A, failed in Test No. 7 at a bird-strike velocity of 400 mph. The window frame cracked, allowing the window to unlatch and swing inward into the back of the co-pilot's head. This design was revised by adding a fixed bar which rigidly retained the aft window edge, as shown in Fig. 6. The design, as revised, failed during Test No. 10 at 386 mph as both acrylic panels shattered. The penetration velocity of this window is considered to be well below 386 mph.

The retaining arrangement for the clear-view window failed in Test No. 7, allowing the window to rotate inward about its forward upper and lower track attachment points. To prevent this, a retaining bar was added to fix the aft edge of the window frame in the closed position as shown in Fig. 6. During the next test on the clear-view window, with the retaining bar mounted by utilizing existing doubler plate retaining bolts through the post located between the clear-view and aft windows, it was found that, upon impact, the outside doubler plate peeled back, snapping off the bolt heads. This forced the retaining bar to depart from its fixed position, thereby permitting the aft edge of the window to open inwardly. To correct this condition, the number of bolts through the retainer was doubled, with every other bolt extending only through the aft post bolting flange and retainer bolting edge as shown in Fig. 6.

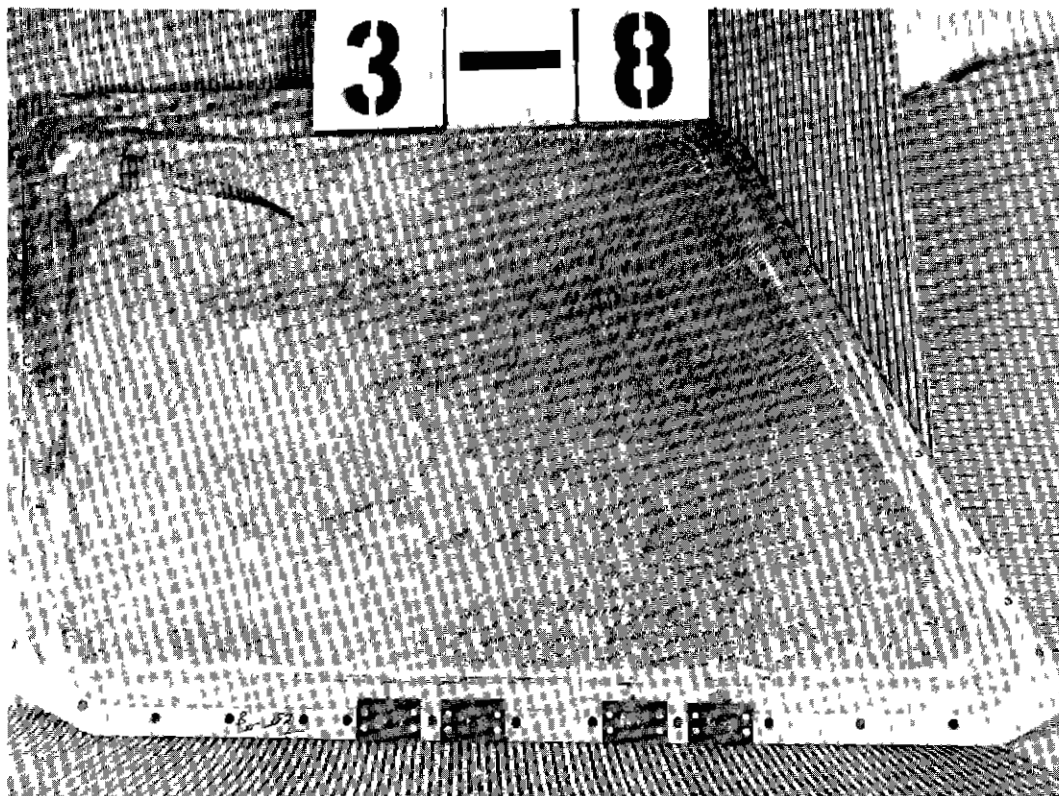
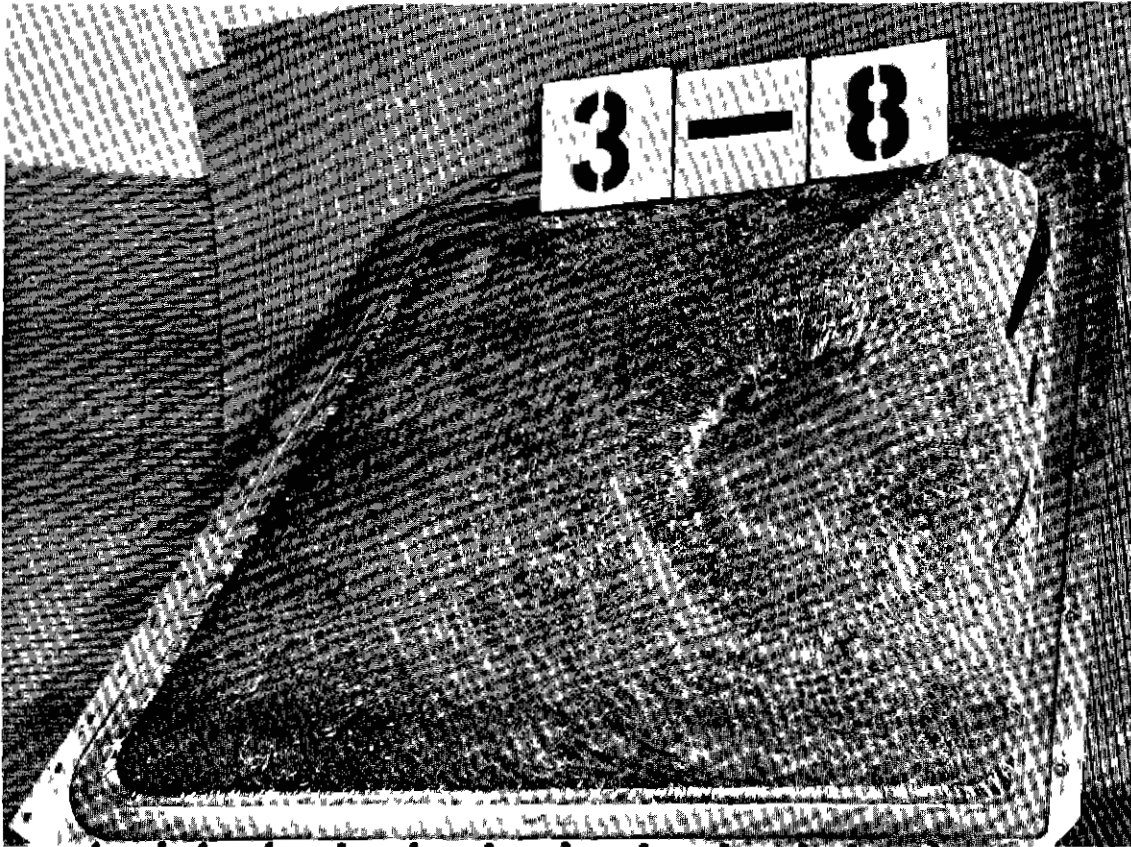
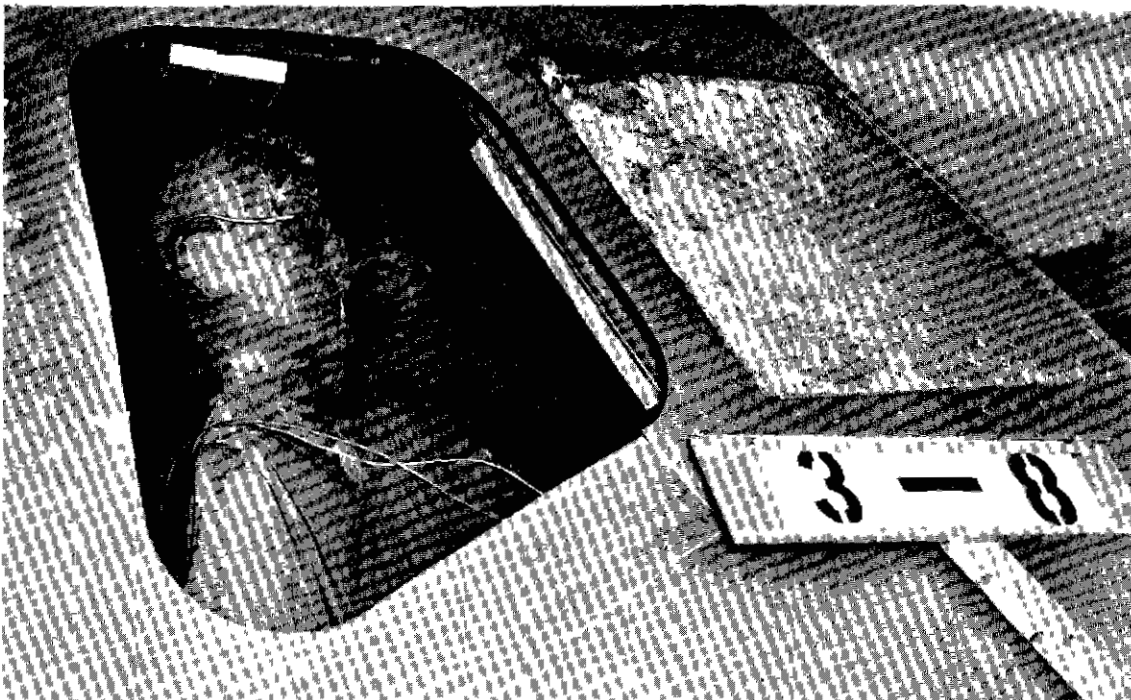
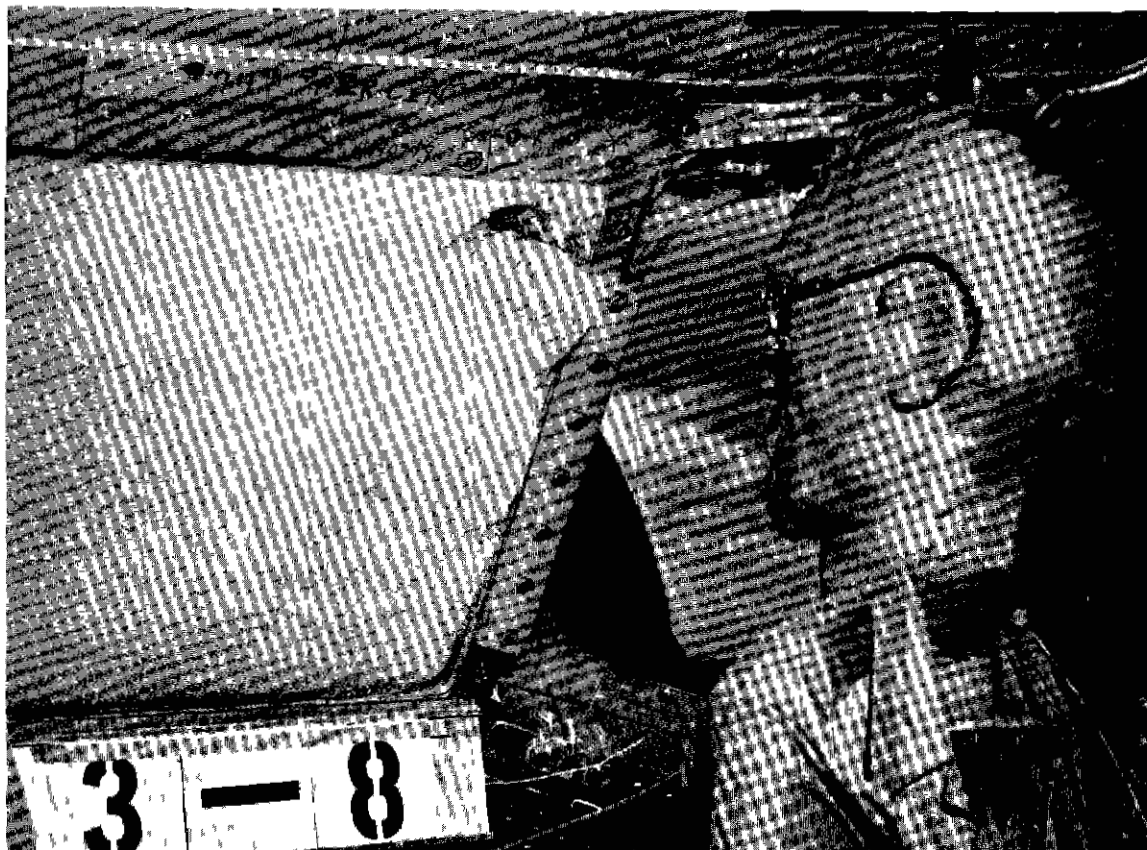
The carcass hit about two inches below the target point. A considerable amount of bird carcass entered the cockpit area. The vinyl in the exterior window separated from the metal edge attachment, then tore for a length of six inches near the upper sill, continuing around the corner and downward along the cornerpost sill for a length of five inches, as shown in Fig. 28. The penetration of the bird then tore the vinyl interlayer of the interior window for a length of five inches along the upper sill and continued around the corner and downward along the cornerpost sill for a length of six inches, as shown in Fig. 29. A second tear in the interior panel vinyl five inches in length and slightly outboard of the first tear contributed further to the failure. The copilot was struck directly in the face and upper chest area by bird entrails and particles of semitempered and full-tempered glass, as shown in Figs. 30 and 31. The glass particles had sufficient energy to imbed themselves in the clay face of the copilot and penetrate through the cloth shirt and imbed themselves in the left shoulder area. The sun glasses worn by the copilot were severely damaged as the glass lenses were broken and particles of the lenses were driven into the eye socket area. It appeared that most of the damage to the copilot was caused by the full-tempered glass nuggets which were released by failure of the interior window. Inspection of the break in the vinyl interlayers indicated that the vinyl in the area of the failure was at a lower temperature than that required for best results.

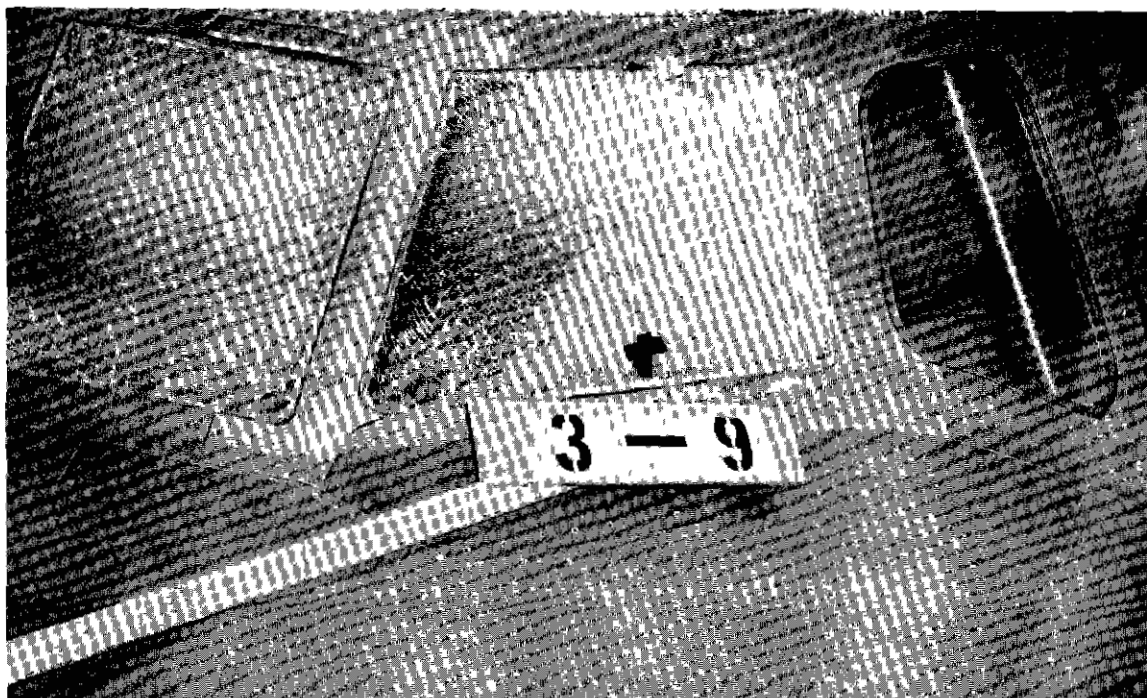
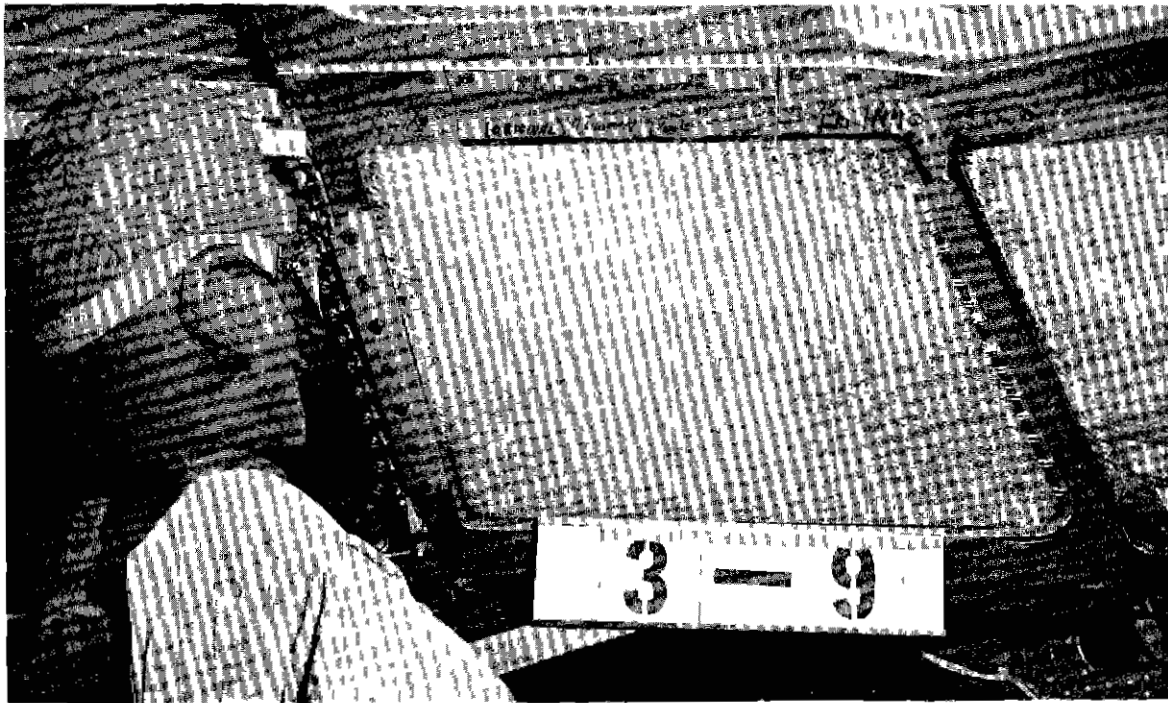
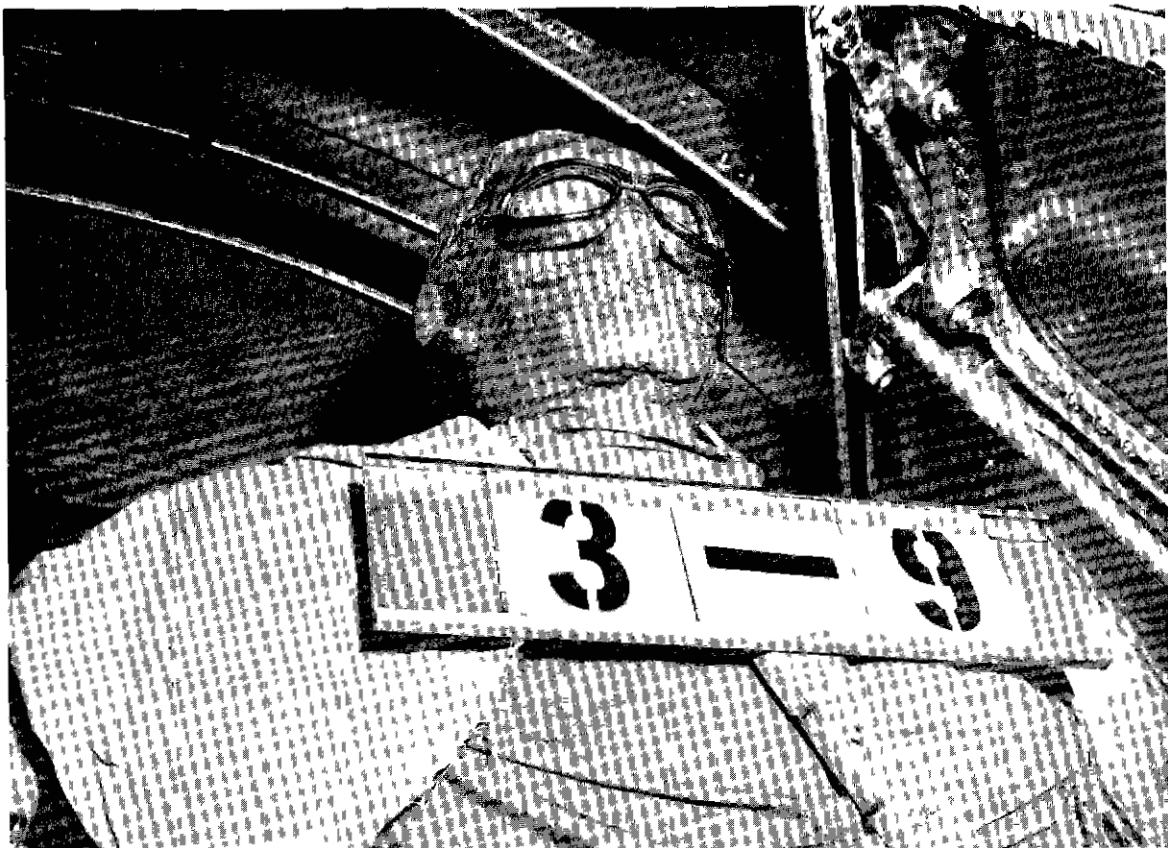
The chicken carcass hit two inches inboard of the target point. None of the bird carcass entered the cockpit area. The vinyl interlayer in the exterior window tore for a length of five inches from the upper outboard corner downward parallel to the cornerpost sill. There was no vinyl failure of the interior window panel. Relatively few particles of semi-tempered glass departed from the aft face of the interior window panel. The glass which was accelerated rearward struck the pilot in the face from the neck level up to the point of the nose. The right lens of the pilot's goggles was scarred slightly by flying glass but remained undamaged otherwise. The lens material was cut from 0.020-inch-thick cellulose acetate sheet. The edge of the upper outer doubler retainer for the exterior panel was warped outward slightly. Results of this test are shown in Figs. 32, 33, and 34.
