TECHNICAL DEVELOPMENT REPORT NO. 348

BIRD IMPACT TESTS OF THE DOUGLAS  
MODEL DC-8 AIRPLANE WINDSHIELD

May 1958

CIVIL AERONAUTICS ADMINISTRATION  
TECHNICAL DEVELOPMENT CENTER  
INDIANAPOLIS, INDIANA

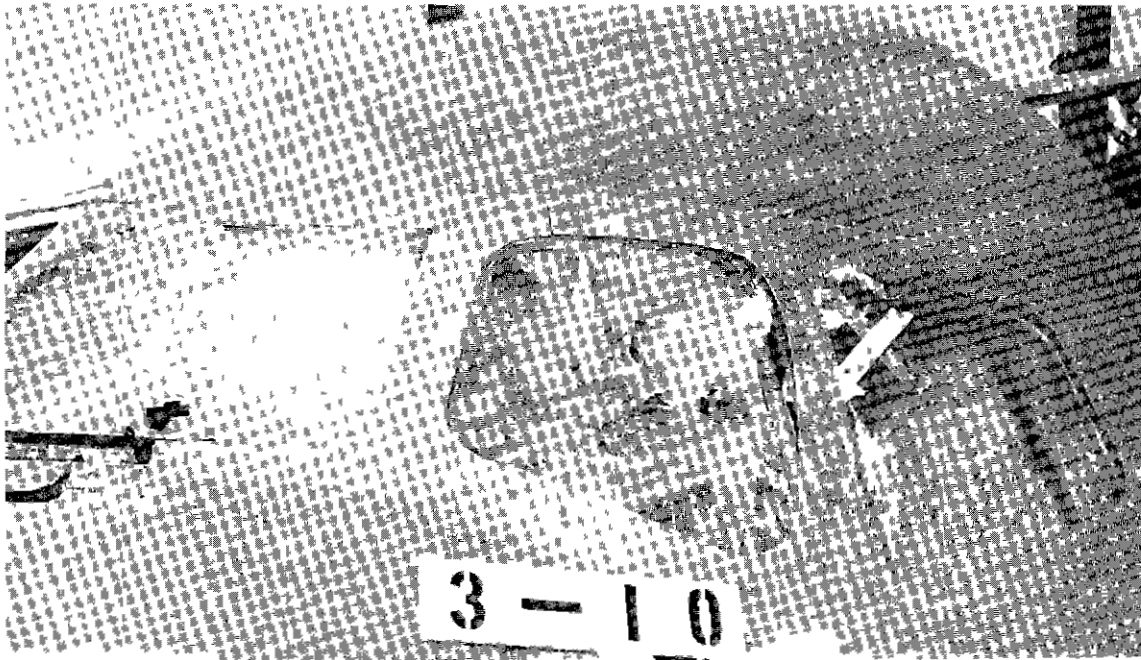
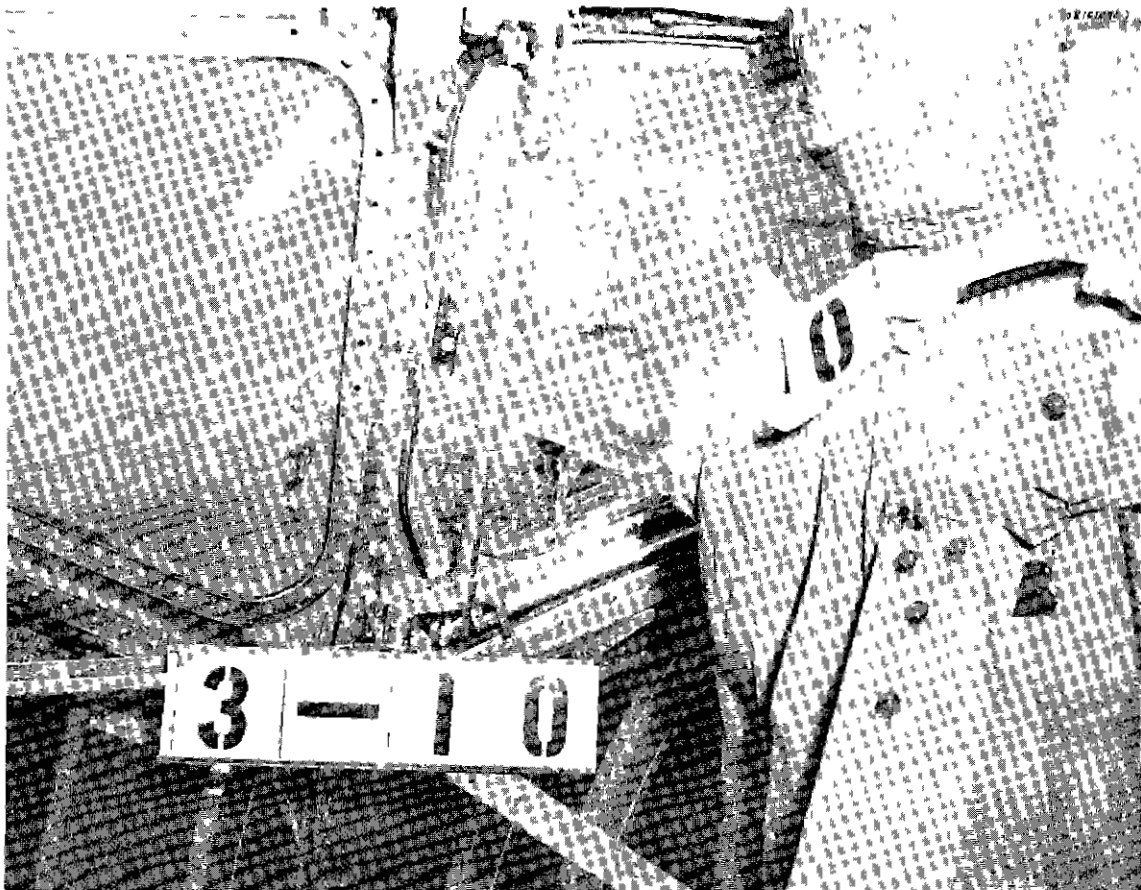
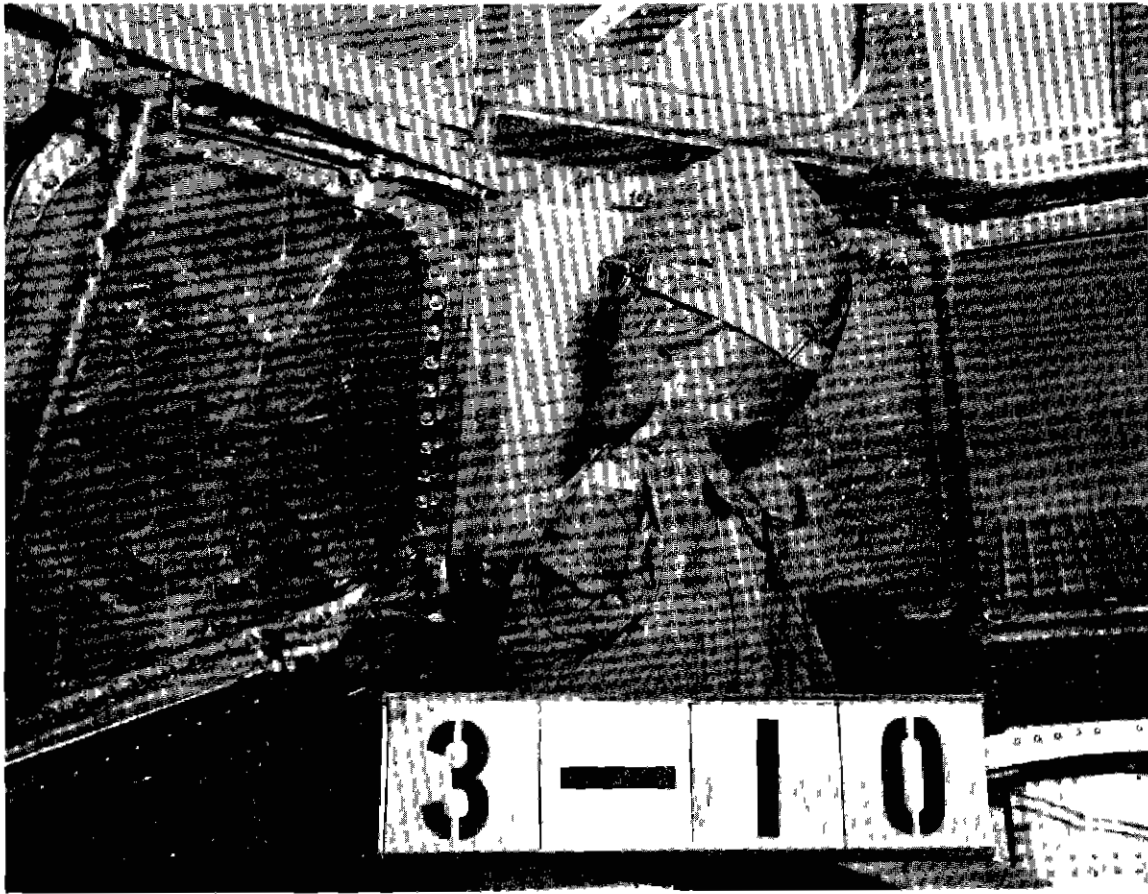
Prior to this test the aft edge of the window frame was held rigidly in place by incorporating a retaining bar mounted as shown in Fig. 6. Upon impact, both the interior and exterior outer stretched Plex-55 panels shattered, allowing partial penetration of the carcass. As the carcass traveled rearward, it forced the aft doubler plate outward and the aft window frame inward. As the doubler plate bent outward, bearing failure of the doubler plate in combination with tension failure of the bolts fastening the aft window frame retaining bar allowed the retaining bar to fly inward behind the pilot. None of the pieces of Plex panels which were shattered struck the pilot, because the pieces that entered the cockpit area were directed aft and outward toward the aisle passing behind the pilot. That part of the carcass which impinged upon the left side and back of the pilot extruded into the cockpit between the aft post and the window frame. The force of the impact moved the window frame slightly rearward, disengaging the lower forward hook and forward retaining bar. Results of the test are shown in Figs. 35, 36, and 37.

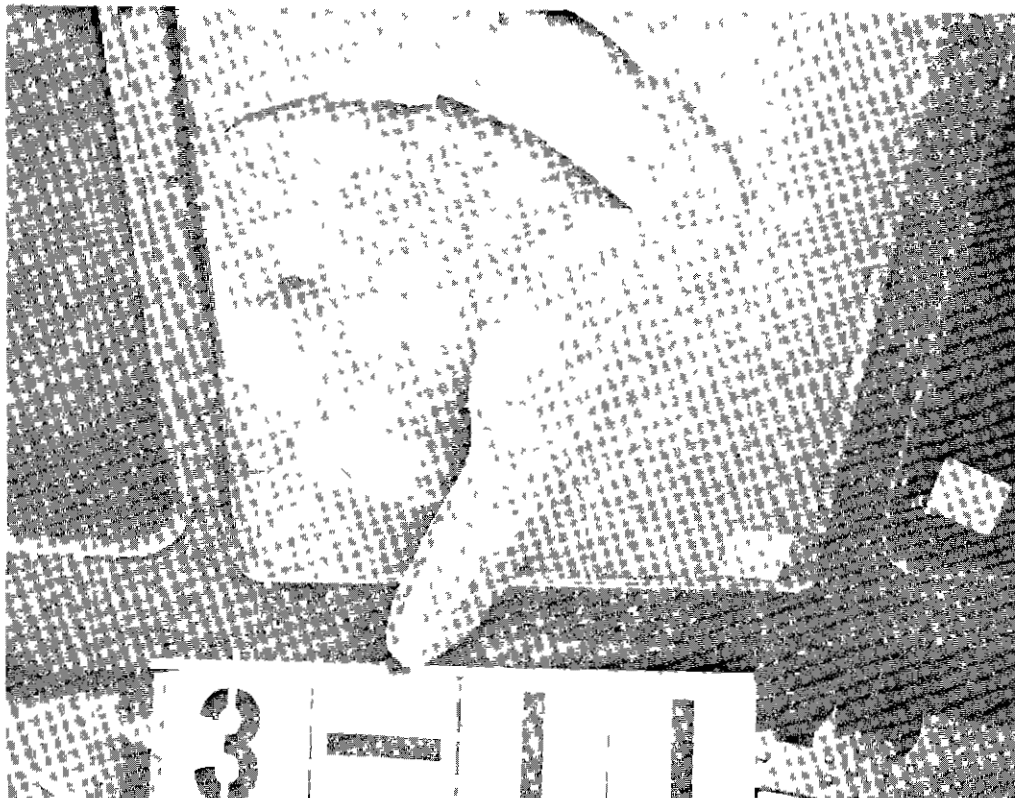
FIG 39 TEST NO 11 - INTERIOR PANEL, PROJECTILE VELOCITY - 444 MPH

The carcass struck about three inches below the target point. A slight amount of the bird carcass entered the cockpit area and passed between the pilot and copilot positions. The exterior window failed as the vinyl interlayer pulled away from the metal insert for a length of 13 inches from right center into the upper left corner of the window. This failure continued around the upper left corner and downward a length of five inches parallel to the left centerpost sill, as shown in Fig. 38. The vinyl in the inner window failed in such a manner that a large circular-shaped glass-vinyl-glass flap, approximately 12 inches in diameter, and hinged parallel to the right centerpost sill, was formed. See Fig. 39. The failures of the two

vinyl interlayers were so positioned with respect to each other that the bird carcass which entered the cockpit was turned 90° downward from its line of flight. Small particles of glass impinged upon the pilot and copilot, but did not imbed themselves in the clay. Most of the glass which departed from the window was directed downward between the pilot and copilot positions. Failure of the exterior window appeared to be due to faulty fabrication. Apparently, failure of the interior window was caused partly by its inability to absorb the added amount of energy imparted to it when the exterior window failed excessively, and partly by its below-minimum vinyl temperature.

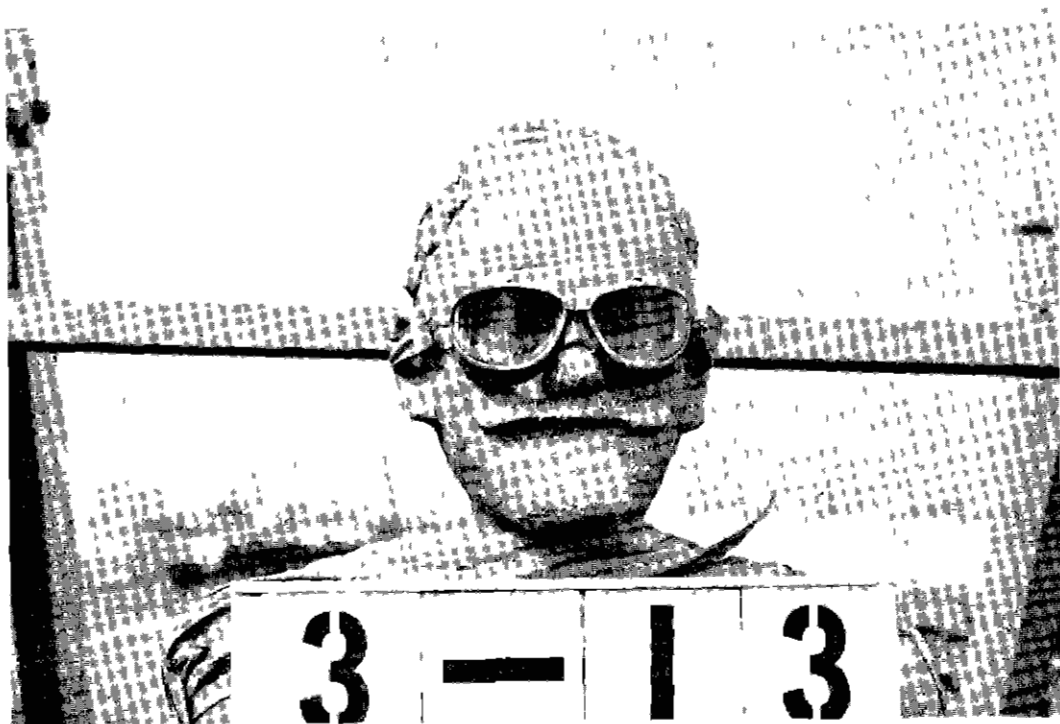
FIG 47 TEST NO. 13 - PILOT, PROJECTILE VELOCITY - 482 MPH

The carcass hit two inches inboard of the target point. None of the bird carcass entered the cockpit. The exterior window panel failed as the metal insert sheared along the top edge for a length of five inches toward the upper outboard corner, and the vinyl sheared along the cornerpost edge downward a length of eight inches from a point two inches inboard of the upper outboard corner, as shown in Fig. 44. No vinyl failure of the interior window panel occurred. See Figs. 45 and 46. Numerous particles of semitempered glass which departed from the aft face of the interior window were directed toward the pilot's face from chin to eyebrow level. The glass particles, which were sliver-like with sharp edges, penetrated into the clay about 1/32-inch. The pilot's goggles remained intact except for numerous scratches on both of the 0.020-inch-thick cellulose acetate lenses caused by flying glass particles. See Fig. 47 for the glass-impingement pattern on the pilot's face.

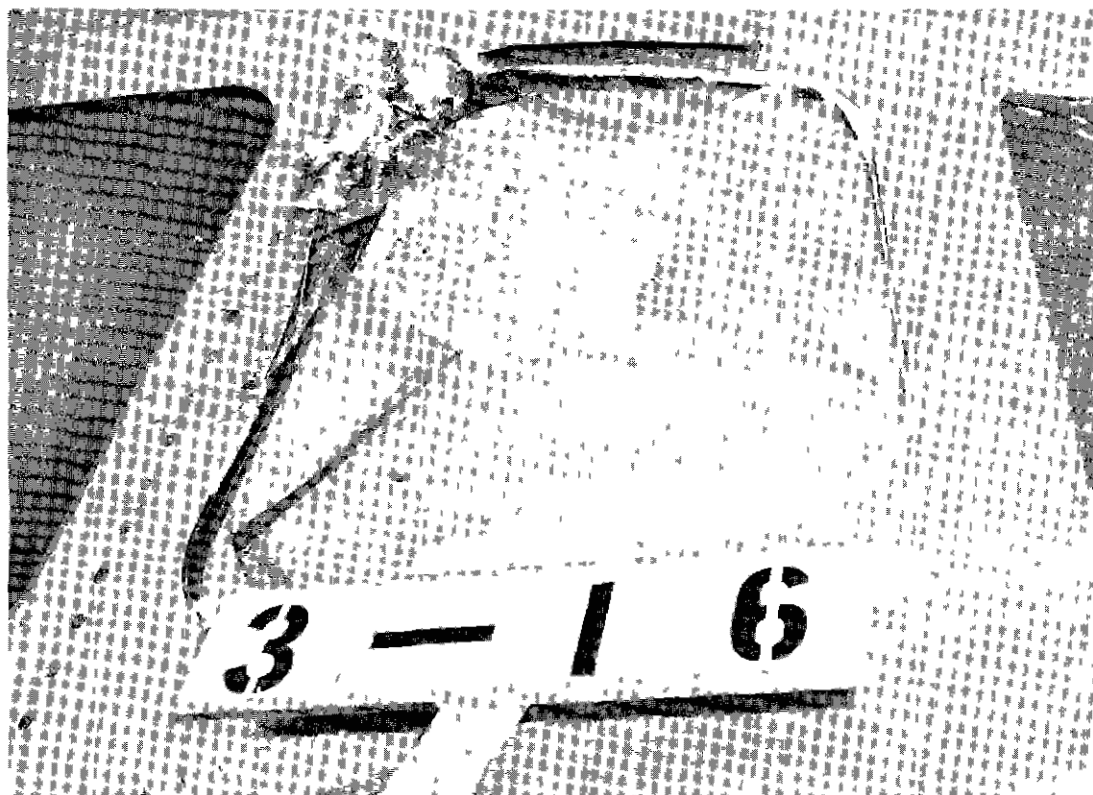
FIG 54 TEST NO 16 - EXTERIOR PANEL, PROJECTILE VELOCITY - 404 MPH

Prior to this test the method for retaining this window was revised to incorporate twice the number of bolts, every other bolt fastening the retaining bar directly to the aft post flange only, as shown in Fig. 53. In addition, heat was applied to the interior glass-vinyl-glass window panel by heating the cockpit area to a temperature of 100° F. Upon impact, the external stretched Plex-55 window panel failed, as shown in Fig. 54. The

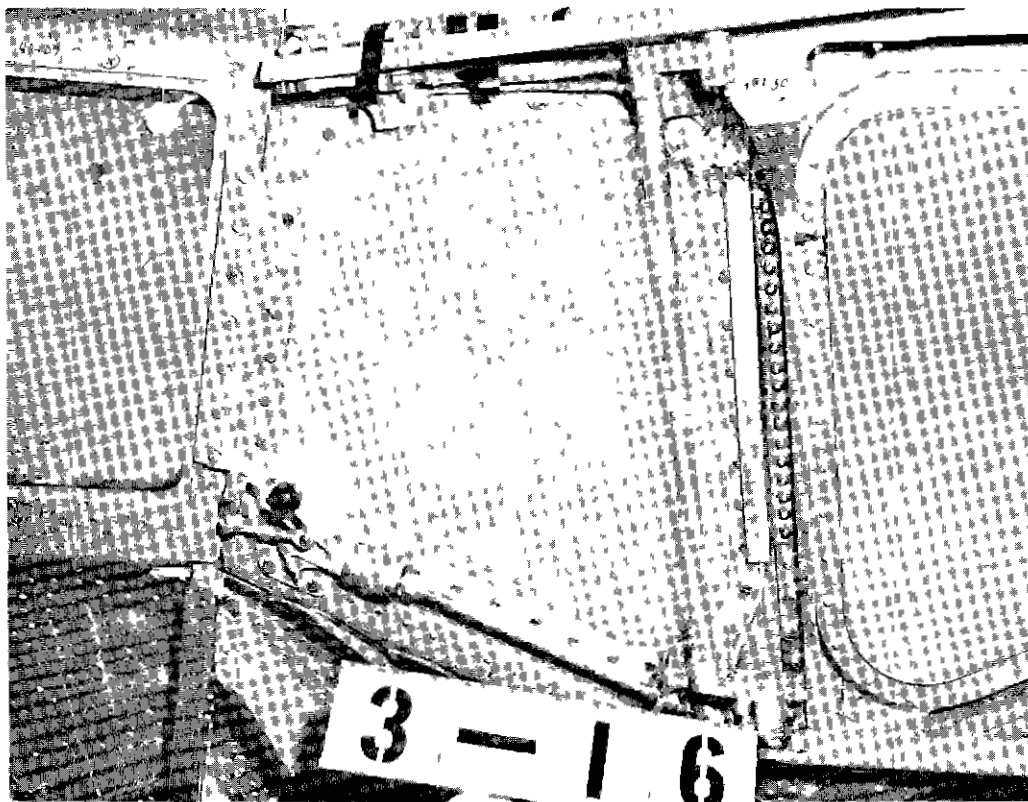
FIG 55 TEST NO 16 - INTERIOR PANEL, PROJECTILE VELOCITY - 404 MPH

interior glass-vinyl-glass window panel resisted penetration, as shown in Fig. 55. A small amount of bird-carcass entrails extruded through, between the window sill and the window frame near the upper aft corner. Hydraulic action of the bird carcass forced the aft doubler plate outward, snapping off one bolt head. A few small particles of semitempered glass from the aft face of the interior window panel impinged upon the left side of the copilot's face, as shown in Fig. 56, but only two small particles imbedded themselves in the clay to any degree. The copilot's goggles were undamaged. There was no indication that any glass had been propelled at the copilot at eye level.

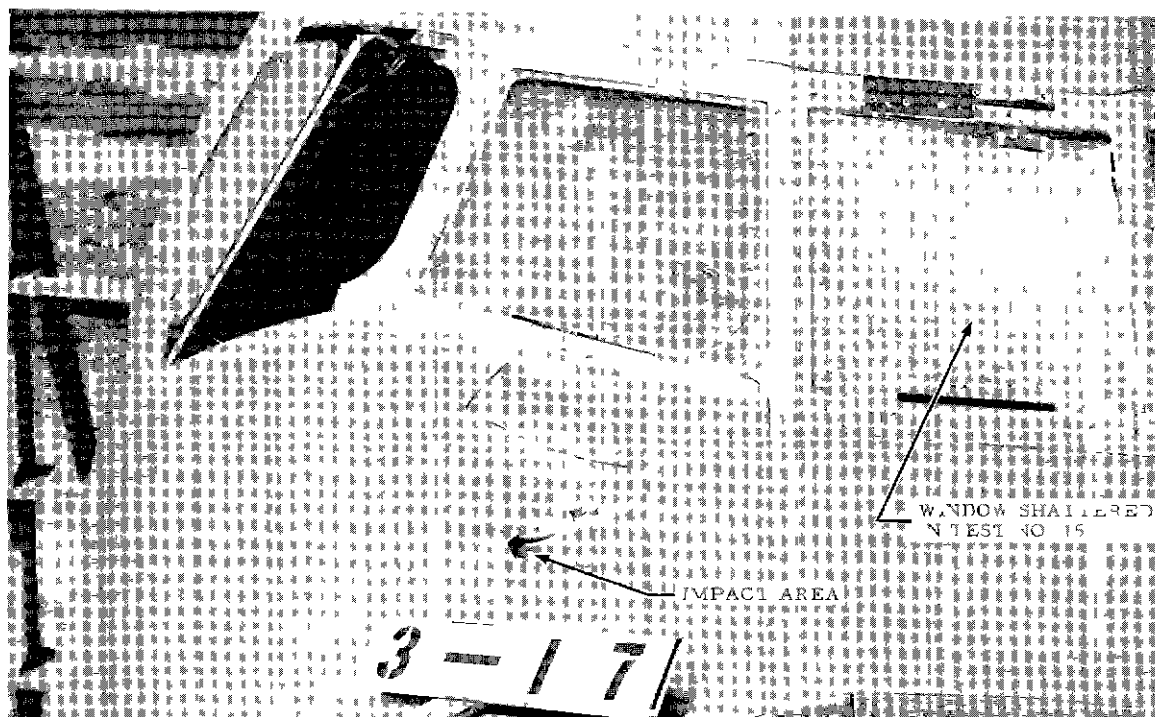
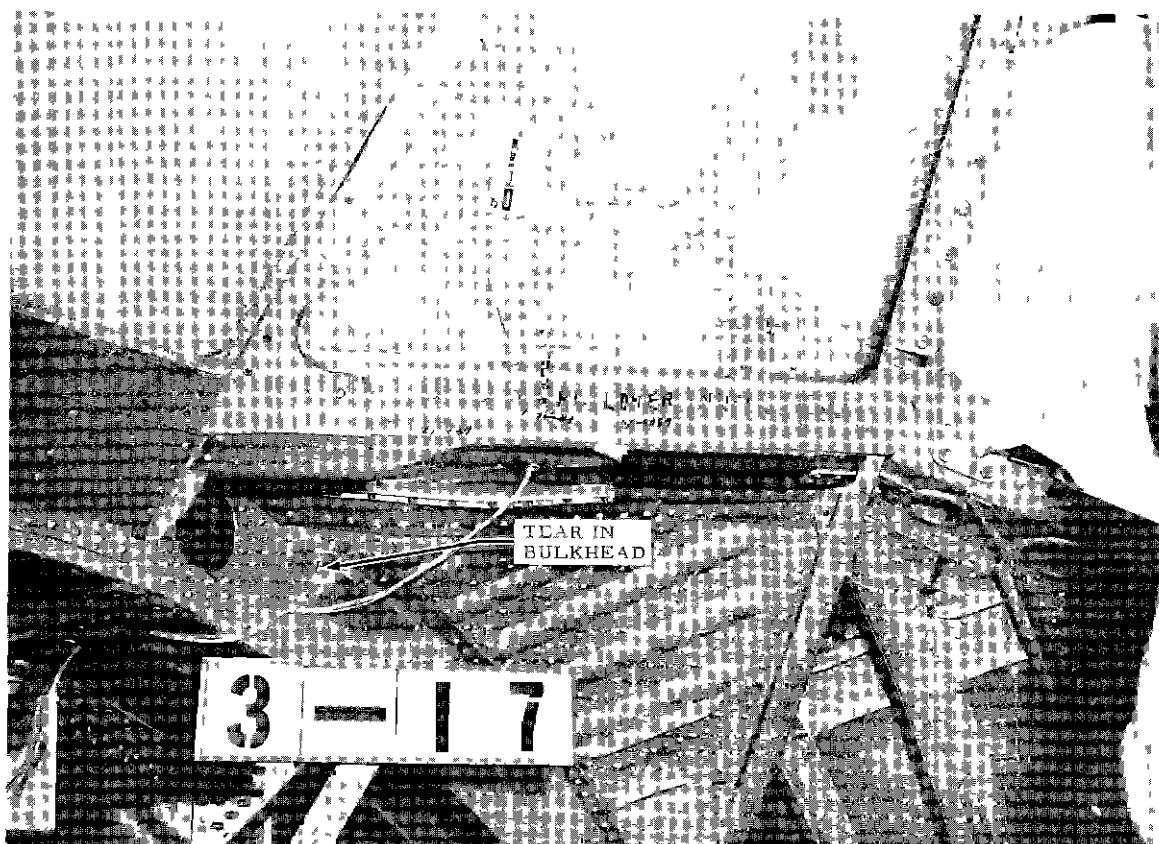
The bird carcass struck slightly below the target point. The fuselage was dented inward about one inch forward of frame station 123. The 0.051-inch-thick aluminum skin tore horizontally 5 1/2 inches along the forward frame edge and longitudinally 1 1/2 inches forward of the frame. Nine rivets attaching the skin to the frame failed. The deck of the airplane was deformed quite noticeably from the point of impact aft to the window sill. The frame sustained a tear through its flanged radius downward 2 1/2 inches. Three lower sill window retaining 1/4-inch bolt heads failed. Both the forward semitempered glass face of the external side window and the aft semitempered glass face of the interior side window were cracked severely by the impact. The forward face of the external side-window panel was cracked prior to the test, but sustained additional damage during the test. No glass departed from the aft face of the interior window. A very small amount of carcass extruded through the tear in the skin and impinged upon the copilot at waist height. Results of this test are shown in Figs. 57 and 58.

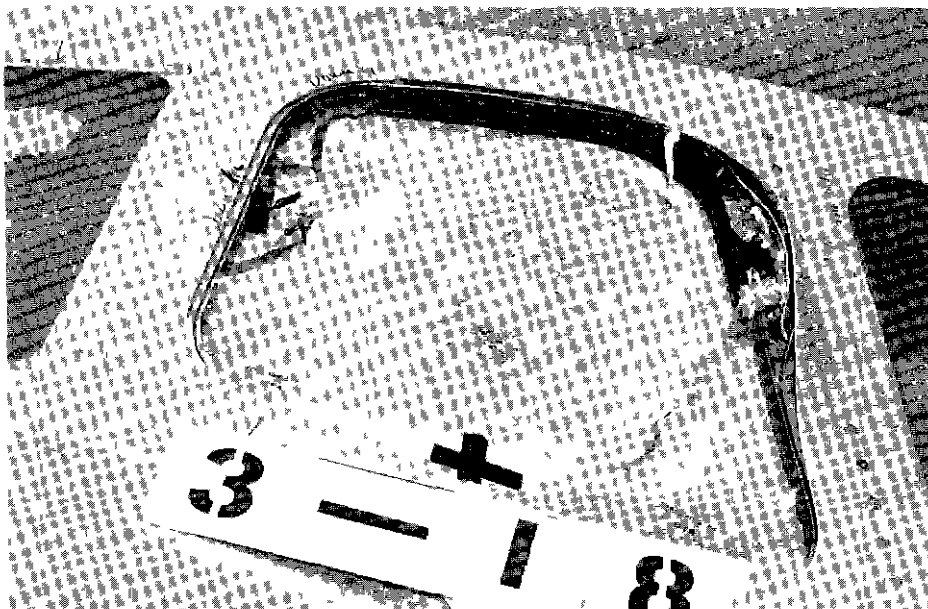
FIG 59 TEST NO 18 - EXTERIOR PANEL, PROJECTILE VELOCITY - 448 MPH

The bird carcass hit near the forward edge of the window frame, which would be considered the critical strike area as far as flying glass is concerned. The external Flex-55 window panel failed as shown in Fig. 59. The vinyl of the interior window did not fail, preventing penetration. See Fig. 60. A small portion of the bird carcass extruded through the structure between the window frame and aft post into the cockpit. The window frame cracked near the upper aft hinge point as in Test No. 7. The aft frame fixed retainer remained intact. The center section of the aft outer doubler facing plate bowed outward as in previous tests of this window, and two retaining bolt heads failed in tension. Numerous semitempered glass particles from the aft face of the interior window impinged upon the left side of the pilot's head from neck level to above the left ear, as shown in Fig. 61. Only two of these particles were imbedded to any degree in the clay. The pilot's eye area was untouched as the goggles with 0.020-inch-thick plastic

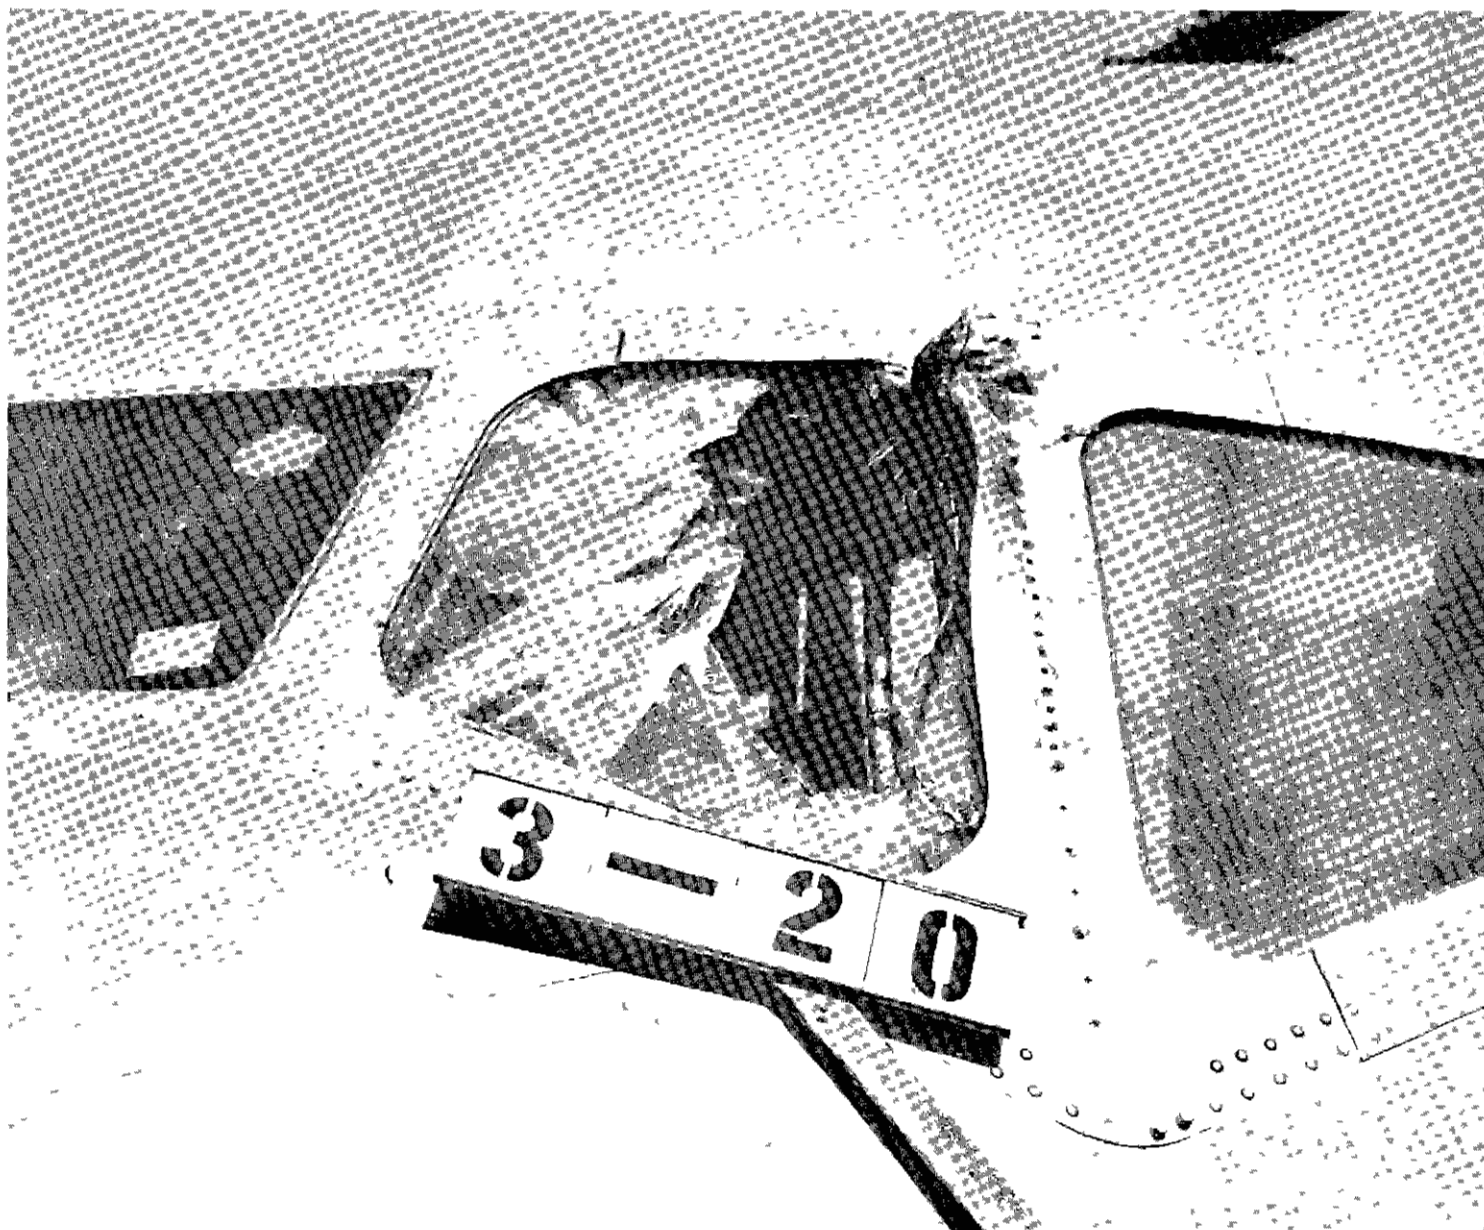
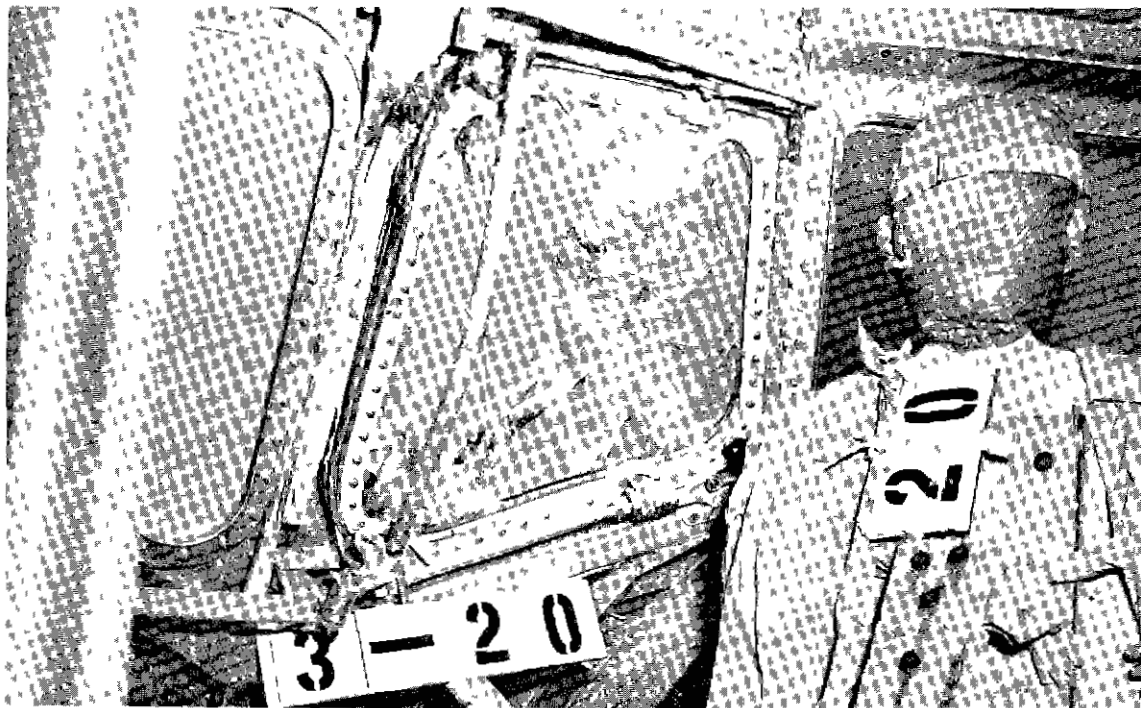
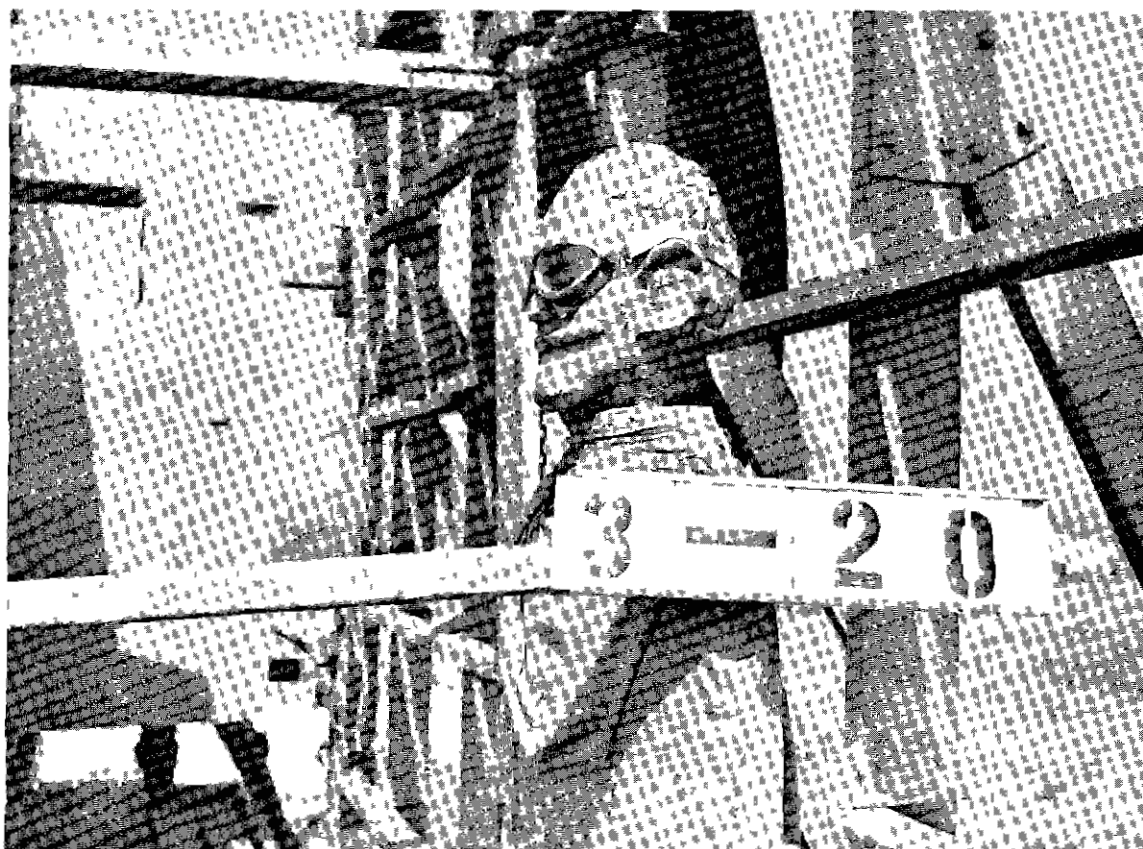
The clear-view window used in this test incorporated a flat, 1/4-inch-thick Plex shield mounted approximately 1 inch inboard of the interior stretched Plex-55 panel. Upon impact, all three Plex panels shattered, allowing part of the bird carcass to enter the cockpit area. The aft window frame fixed retaining bar failed completely in bending and tension as the aft window edge was forced inward. None of the remaining window-frame retainers failed. The left side of the pilot's face was marked in one or two places where pieces of Plexiglas had struck. In addition, the left side of the pilot's face was struck by numerous particles of bird-carcass entrails. The pilot's goggles were untouched by flying window fragments. There was one gash about 1 1/2 inches long and 1/2-inch deep in the back of the pilot's head on the left side, indicating that one large piece of Plexiglas had been hurled in that direction. The Plex shield was totally destroyed by the impact. Results of this test are shown in Figs. 65, 66, and 67.

5. The window design incorporating two stretched Plex-55 panels and a 1/4-inch-thick Plex protective shield mounted inboard of and parallel to the interior panel, as shown in Douglas Aircraft Co. Drawings Nos. 5616457, Revision A, and EO 5654977, proved to be more hazardous to pilot personnel than did the same window with no shield. Upon impact at 386 mph during Test No. 19, the Plex shield shattered completely and one or more Plex-55 fragments struck the back of the pilot's head with sufficient energy to indent the clay with a gash 1 1/2 inches long, 1/2-inch deep, and 1/4-inch in width.
