# **Determination of Means To Safeguard Rotary-Wing Aircraft From Powerplant Fires in Flight**

**Fire-Detection and Fire-Resistance Studies  
of a Sikorsky H-5A Helicopter**

**TECHNICAL DEVELOPMENT REPORT NO. 351**

**February 1959**

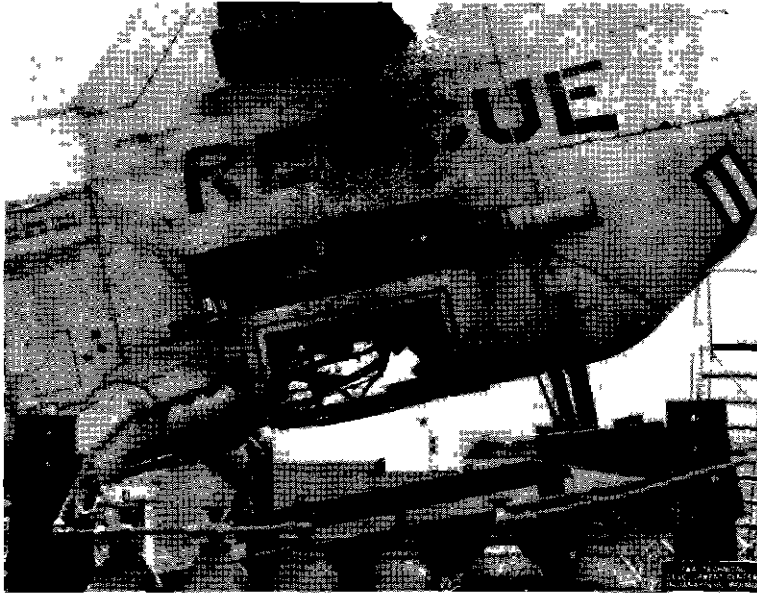
Fig 5 Engine Accessory Section - Flame Paths During Normal Flight

In the accessory compartment, fire paths were observed visually through Plexiglas windows placed in the compartment cowling as shown in Fig 5. Flame paths observed during simulated normal flight conditions showed that a fire in the accessory section had flame paths moving in the aft-to-forward direction, whereas, in the autorotative descent condition, the flame paths traveled in the forward-to-aft direction.

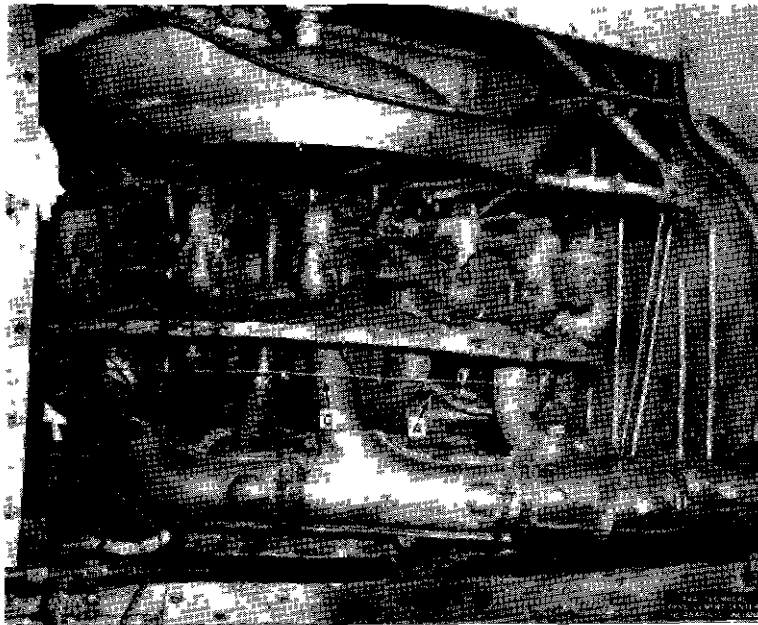
Fig 6 H-5A Helicopter Engine Power Section Showing Location of Fire Detector Elements A, B, and C

Edison continuous-type fire detectors were placed at different stations in the powerplant zones. Sustained test fires of 5 to 10 seconds' duration were ignited at each location during simulated normal and autorotative flight conditions, and the response time of each variously located detector for each test fire was recorded. Power section compartment fire-detection elements were 10 feet long and were positioned as shown in Fig 6.

An analysis of the detection results disclosed that, of 55 fires during simulated normal flight, detector C sensed all fires with an average response time of 4.6 seconds, B sensed 82 per cent with an average response time of 45 seconds, and A sensed 64 per cent with an average response time of 4.0 seconds. See Table II. Also, an analysis of the detection results disclosed that, of 71 fires during simulated autorotative flight, detector location C sensed 69 per cent of the fires with an average response time of

5 0 seconds, location A sensed 58 per cent with an average response time of 6 0 seconds, and B sensed 51 per cent with an average response time of 7 5 seconds See Table III

1 The best location for a fire detector in the engine power section was found to be location C, shown in Fig 6 and described in Table II.

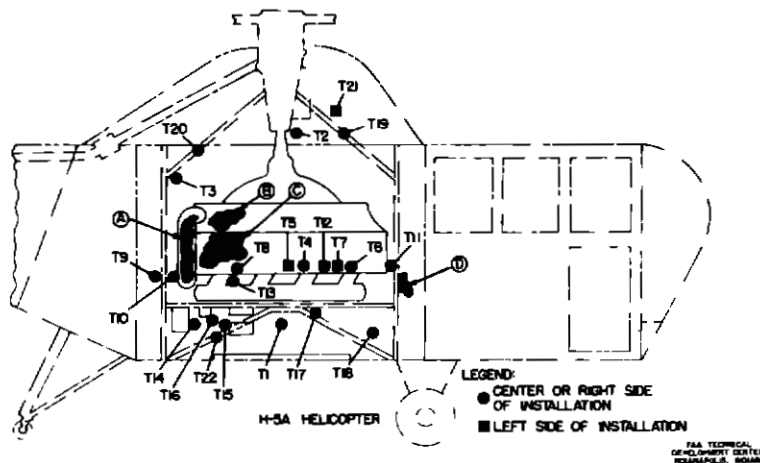
**Fig 13 Thermocouple Locations Used for 3 0-GPM Gasoline Fires**  
**Shaded Areas Show Damage Caused by First 3 0-GPM Fire.**

Area	Damaged Area (inches)	Aluminum Skin Thickness (inches)	Location of Damage
A	5 by 22	0 030	Air cooler duct
B	12 by 18 1/2	0 060	Skirt section of cowling assembly
C	3 by 6	0 040	Batter and hydraulic pressure panel (right hand).
D	3 1/2 in dia	0 040	Alighting gear fairing (right hand)
E	1 by 4	0 040	Recognition lights panel (right hand).

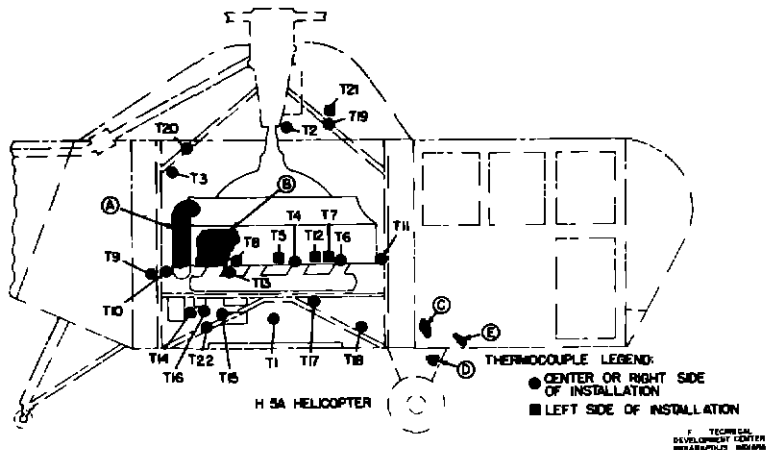
Fig. 15 Shaded Areas Showing Damages Caused by Second 3.0-GPM Gasoline Fire

Area	Damaged Area (inches)	Aluminum Skin Thickness (inches)	Location of Damage
A	5 by 22	0.030	Oil duct
B	4 by 8	0.060	Spinner and spider section of engine cowling assembly
C	16 by 18	0.060	Skirt section of cowling assembly
D	6 by 7	0.040	Lower rear portion of forward fuel-tank panel (right-hand side).

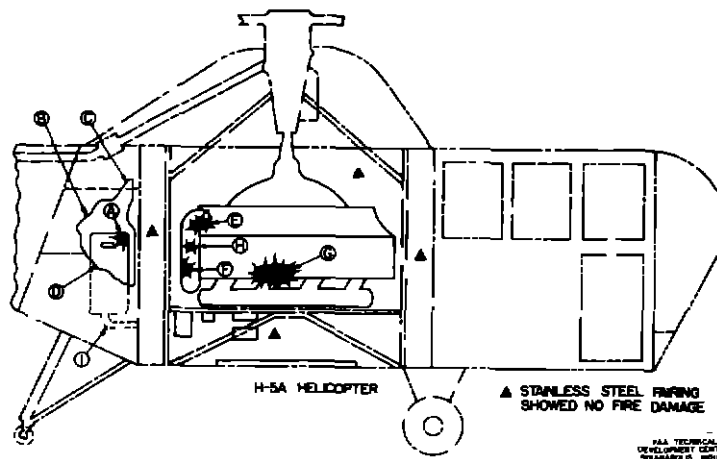
Fig 17 Shaded Areas Showing Damage Caused by 3.0-GPM Gasoline Fire of 5 Minutes' Duration

first minute of the test fire and then shut down. Fire damage is listed in Table VIII and a pictorial presentation of the damaged areas is shown in Fig 17. Temperatures recorded during this test are shown graphically in Fig 18. The helicopter, prior to this 5-minute fire, is shown in Fig 19. The damage incurred by the 5-minute fire is shown in Figs 20 and 21. Flame impingement past the stainless steel panels burned a hole through the aluminum skin of the fuel and oil compartments. A section of the oil tank also was burned away. The oil contained within the tank did not ignite, apparently, the main body of oil dissipated the heat.

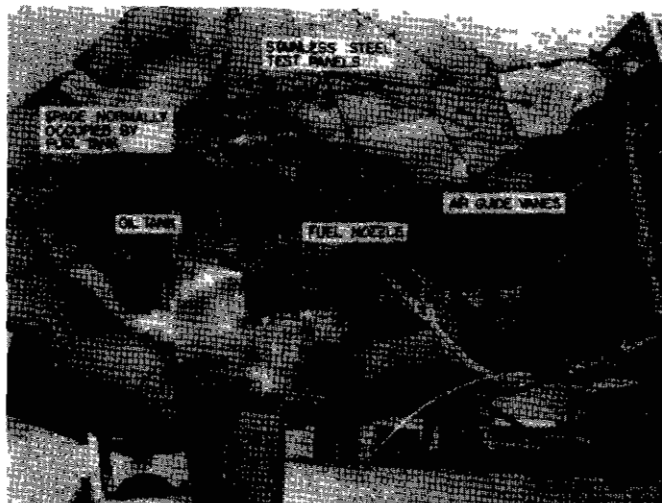
Area	Damaged Area (inches)	Aluminum Skin Thickness (inches)	Location of Damage
A	3 by 7	0.125	Oil tank
B	14 by 21	0.040	Right-hand supporting panel for center cone
C	3 by 4	0.040	Right-hand radio panel
D	9 by 13	0.040	Right-hand support panel for bottom cone
E	5 by 12	0.060	Spinner and spider section of engine cowling assembly
F	3 by 12	0.060	Right rear skirt of cowling assembly
G			Minor damage around fire nozzle
H	3 by 6	0.060	Upper left section of cowling assembly
I			Oil outlet hose. Hose burned through causing small leak.

Fig 20 H-5A Helicopter - Damage Caused by 3 0-GPM Gasoline Fire of 5 Minutes' Duration

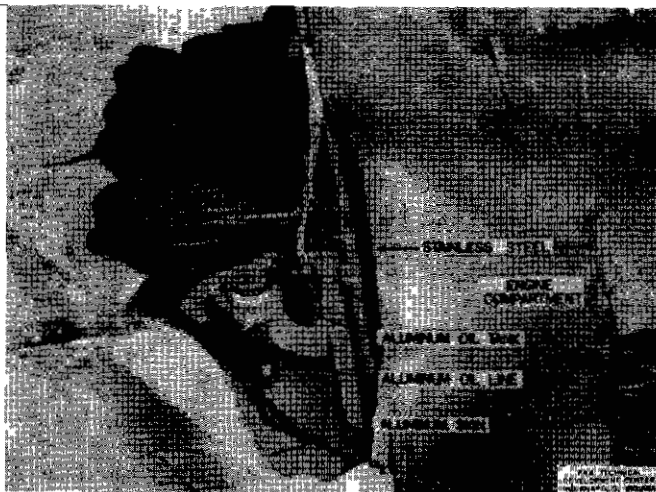
Fig 21 H-5A Oil Tank Compartment Damage Caused by 3 0-GPM Gasoline Fire of 5 Minutes' Duration
