# **A Study of the Helicopter Crash-Fire Problem**

**TECHNICAL DEVELOPMENT REPORT NO. 354**

**FEDERAL AVIATION AGENCY  
TECHNICAL DEVELOPMENT CENTER  
INDIANAPOLIS, INDIANA**

**February 1959**

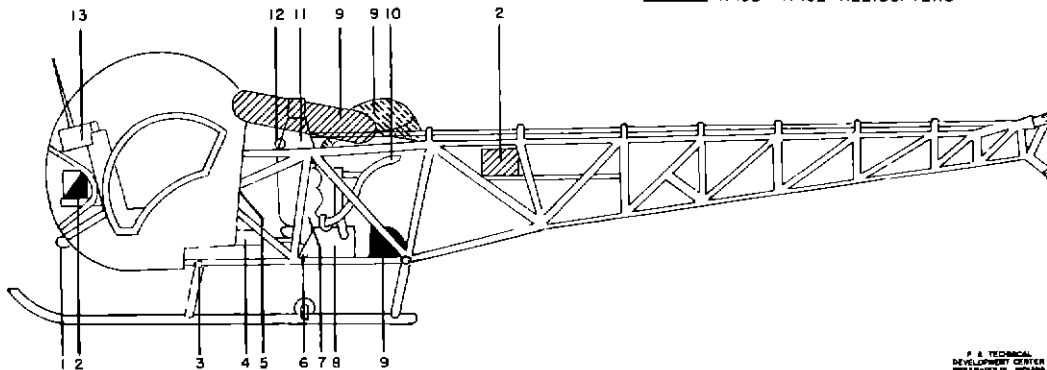
Fig 1 Bell Helicopter Model 47 (HTL, H-13)

10 The small single-rotor aircraft such as the H-13, Fig 1, and H-23, Fig 2, have the main rotor clutch unit and gear box attached directly to the engine. If this type of helicopter rolls on its side during a crash, the main rotors will contact the ground, imposing intermittent negative torque on the engine itself. The resulting engine vibration can be sufficiently severe to cause accessories to separate from the engine, thereby increasing the fire hazard. The engine also may continue to run for some time after the crash unless it is shut down by the operator.

1 The small helicopter, Figs 1 and 2, generally has all electrical components within the engine compartment and in close proximity to both fuel cells and fuel lines. These components could provide an ignition source if damaged during a crash.

2 Electrical components which are not a part of the accessory, but are located in the lower part of the engine compartment, are vulnerable to initial impact damage. See Figs 1 and 2.

4 Engine accessories are located on the bottom side of upright or angled engines as shown in Figs 1, 2, 3, and 4. These accessories, in some types of helicopter accidents, are immediately susceptible to impact damage. Where electrical, oil, and fuel-pump accessories are side by side, ignition and flammable fluid sources are present in very close proximity to one another.

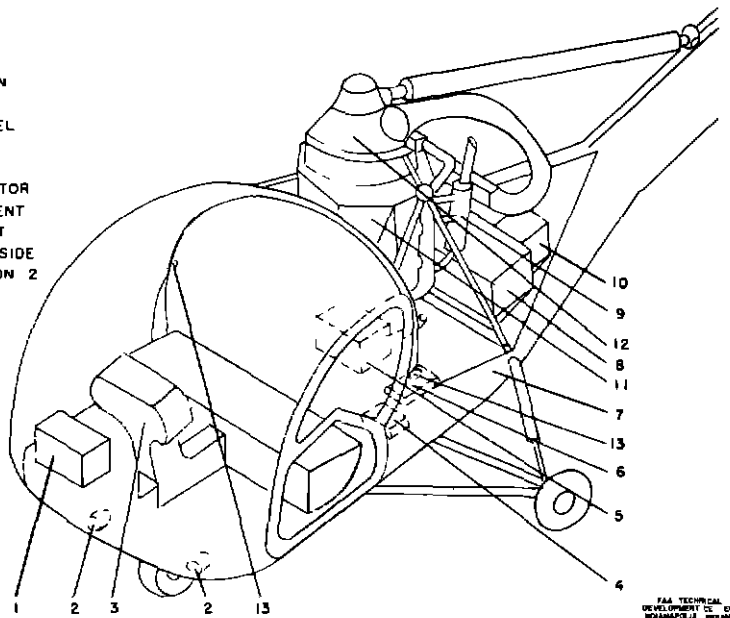
Fig 2 Hiller Helicopter 12B (HTE, H-23)

6 The engine is located directly over a bottom fuselage fuel cell in one type of helicopter. See Fig 2. Impact forces during a crash could cause this engine to be displaced into the cell.

7 Fuel cells located in the bottom of the helicopter fuselage, Figs 2, 3, and 4, are vulnerable to direct-impact damage and rupture when a landing-gear failure occurs. These fuel-cell locations are undesirable from a crash-fire prevention standpoint.

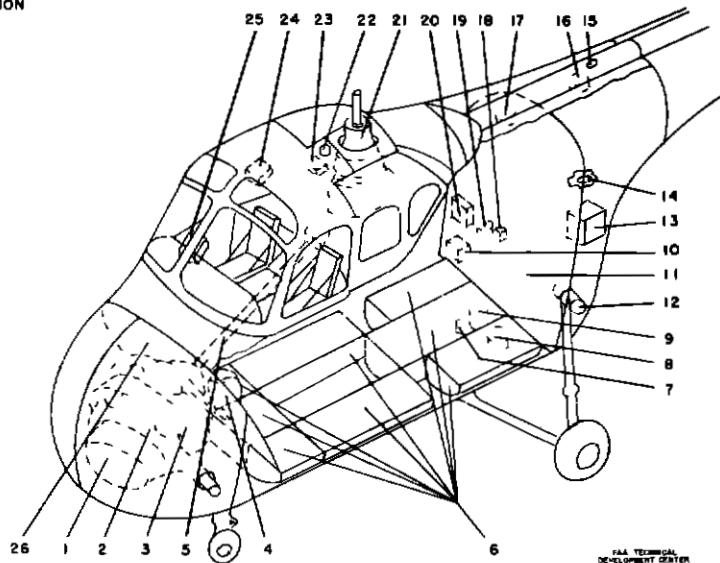
Fig 3 Sikorsky Helicopter S-55(HO4S, HRS, H-19)

3 In some types of helicopters, Figs 3 and 4, the landing gears are attached to the fuselage structure in areas where failure of the landing gear could lead to fuel-cell puncture.

5 Oil cells and hydraulic reservoirs of dry sump engines often are located on the engine side of the firewall. See Figs 3, 5, and 6. Oil or hydraulic fluid spilled from a ruptured tank and ignited either on the engine hot surfaces or by electrical sources could provide an additional ignition source for the main fuel supply.

10 External landing lights are sometimes located on the bottom section of the helicopter fuselage as shown in Figs. 3, 5, and 6. These lights are susceptible to damage during a crash when a landing gear fails. The heated lamp filaments have been known to ignite flammable fluids during an aircraft crash.
