# **A Study of Ignition Hazards and Fire-Resistance of the Boeing 707 Powerplant**

**TECHNICAL DEVELOPMENT REPORT NO. 357**

**CIVIL AERONAUTICS ADMINISTRATION  
TECHNICAL DEVELOPMENT CENTER  
INDIANAPOLIS, INDIANA**

**August 1958**

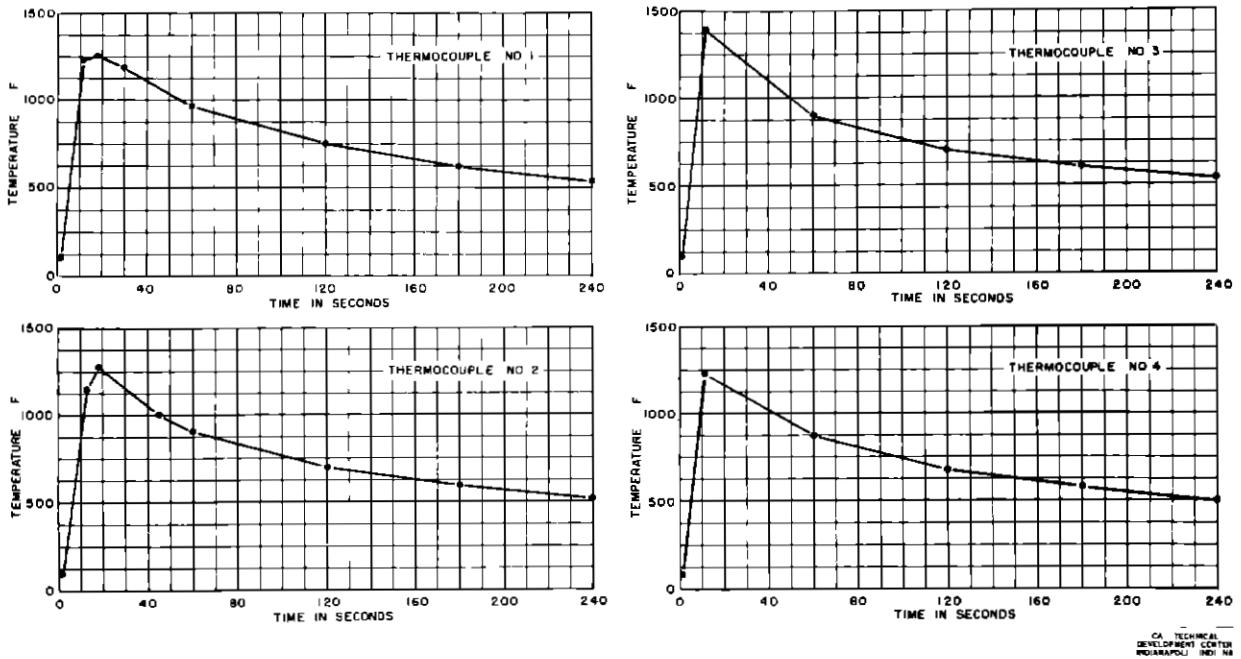
Table II gives a summary of the results for each test. At no time under conditions of testing was there any hot-surface ignition from the engine surfaces. During discharge of hydraulic fluid on the diffuser section, dense clouds of smoke were created indicating an approach to ignition temperature. During a normal start cycle, ignition of the hydraulic fluid did occur from hot surfaces of the blast tube and nozzle block of the fuel-air starter.

Fig 7 Time-Temperature History for the Hamilton-Standard FAS 450-3 Fuel-Air Starter

- 6 During the starting cycle, the fuel-air starter is an ignition hazard and will cause free fuel to ignite
7. The strut supporting the engine pod is of adequate length to prevent external flames from contacting the wing surfaces

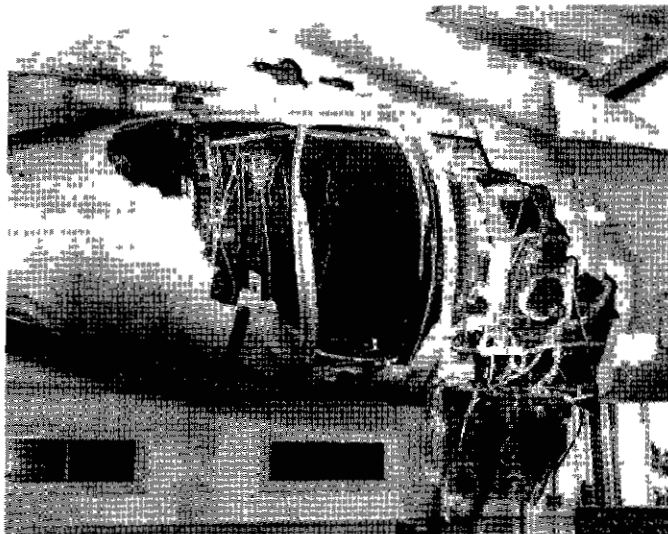
As a result of the simulated uncontrolled fire at Location E (see Fig 6), approximately 50 per cent of the right-hand door was destroyed. Photographs of the nacelle taken before and after the fire are shown as Figs 9 and 10. The area of destruction was located between nacelle stations 136 and 225. This fire, when first ignited, filled the entire compressor section with considerable flames shooting from the right-hand louver at nacelle station 168. The hinge line distorted at stations 155 and 163, allowing small jets of flame to escape and burn a hole of about two square inches' area in the strut skin at each of those stations. The nacelle contained the flames for two minutes after which time the right louver burned away. Disintegration began with the sharp edge of the louver and progressed rapidly into the nacelle skin just aft of the firewall. When the burner section was opened up to the airstream, the fire increased in intensity rapidly and a large portion of the door burned away. The fire balled up behind the exposed firewall and shot up to the strut and toward the under surface of the wing. None of the flames could penetrate the layer of air around the airfoil section and were carried away by the airflow. The flames burned through the strut skin in several areas, as shown in Fig 10 but flames did not enter the strut structure.

The flames struck the strut only during the early stages of the fire. As the hole next to the hinge line enlarged, flames ceased striking the strut and reached upward toward the wing. Considerable fuel was draining from the engine pod during the fire, being ignited and carried away in the airstream in trailing streamers.

Fig 10 Damage to Right-Hand Door and Strut as a Result of Simulated Uncontrolled Fire

- 7 Due to the low ventilation rate in the nacelle with no anti-icing air, only a small quantity of fuel could be burned
- 8 Continued exposure to flame and heat caused the hinge line to distort, allowing small flames to impinge on the strut

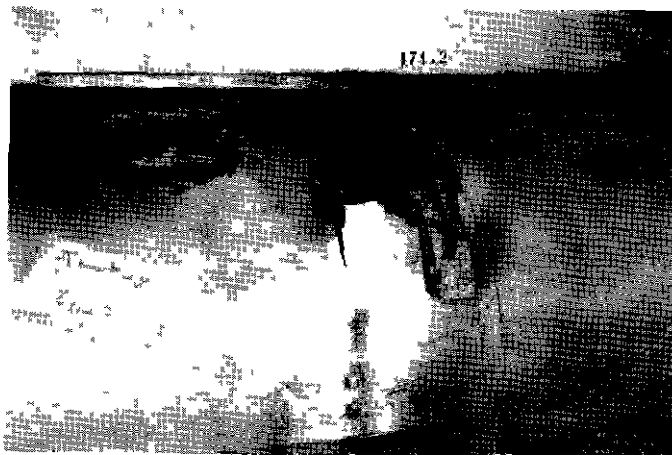
Fig 11 Damage to Left-Hand Nacelle Door as a Result of Louver Burn-Through

or left, door One hole about 12 inches in diameter burned through at the location of the outboard louver Figure 11 shows the hole in the skin resulting from the louver burnout On this side, as on the right side, the louver created a chimney effect which caused flames to torch out of the louver, resulting in early failure of the louver and metal surrounding it

- 9 The louvers in the nacelle doors created a chimney effect during a fire and failed when exposed to flames for more than two minutes
