FEDERAL AVIATION AGENCY

PERFORMANCE MEASUREMENTS ON THE AIRPORT AND AIRWAY SURVEILLANCE RADAR (AASR)

SUMMARY

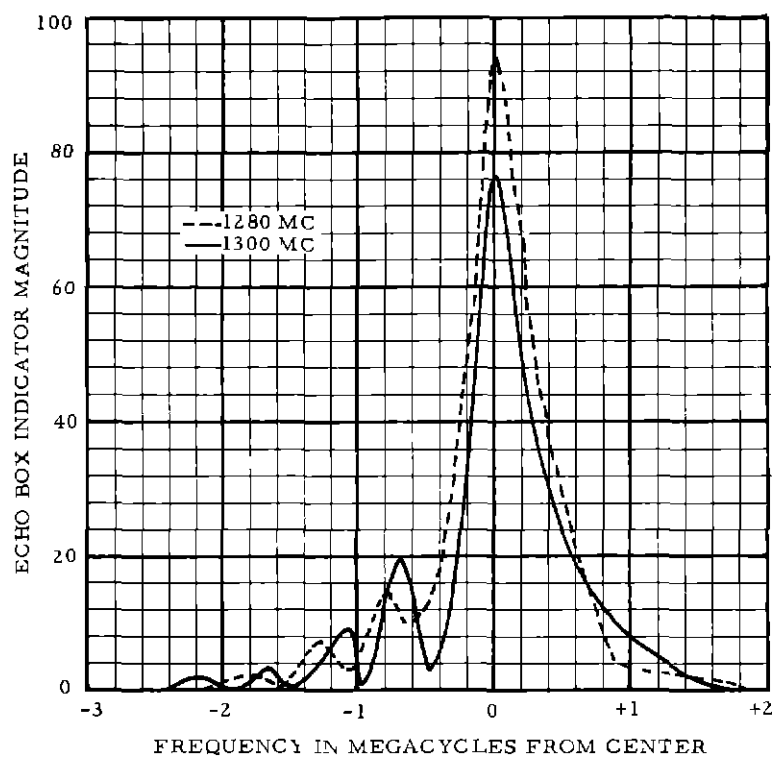
FIG 1 TRANSMITTER OUTPUT SPECTRUM

The magnetron stability and spectrum were analyzed by two methods; namely, (1) an echo-box plot of frequency versus output, and (2) a spectrum analyzer. It was found that the upper sidebands were attenuated much more than the lower sidebands. Four magnetrons were used, and the same characteristics were exhibited by each one. A plot of echo-box indicator readings versus frequency is shown in Figs. 1 and 1A. The spectrum as seen on a Vecton spectrum analyzer verified these data.

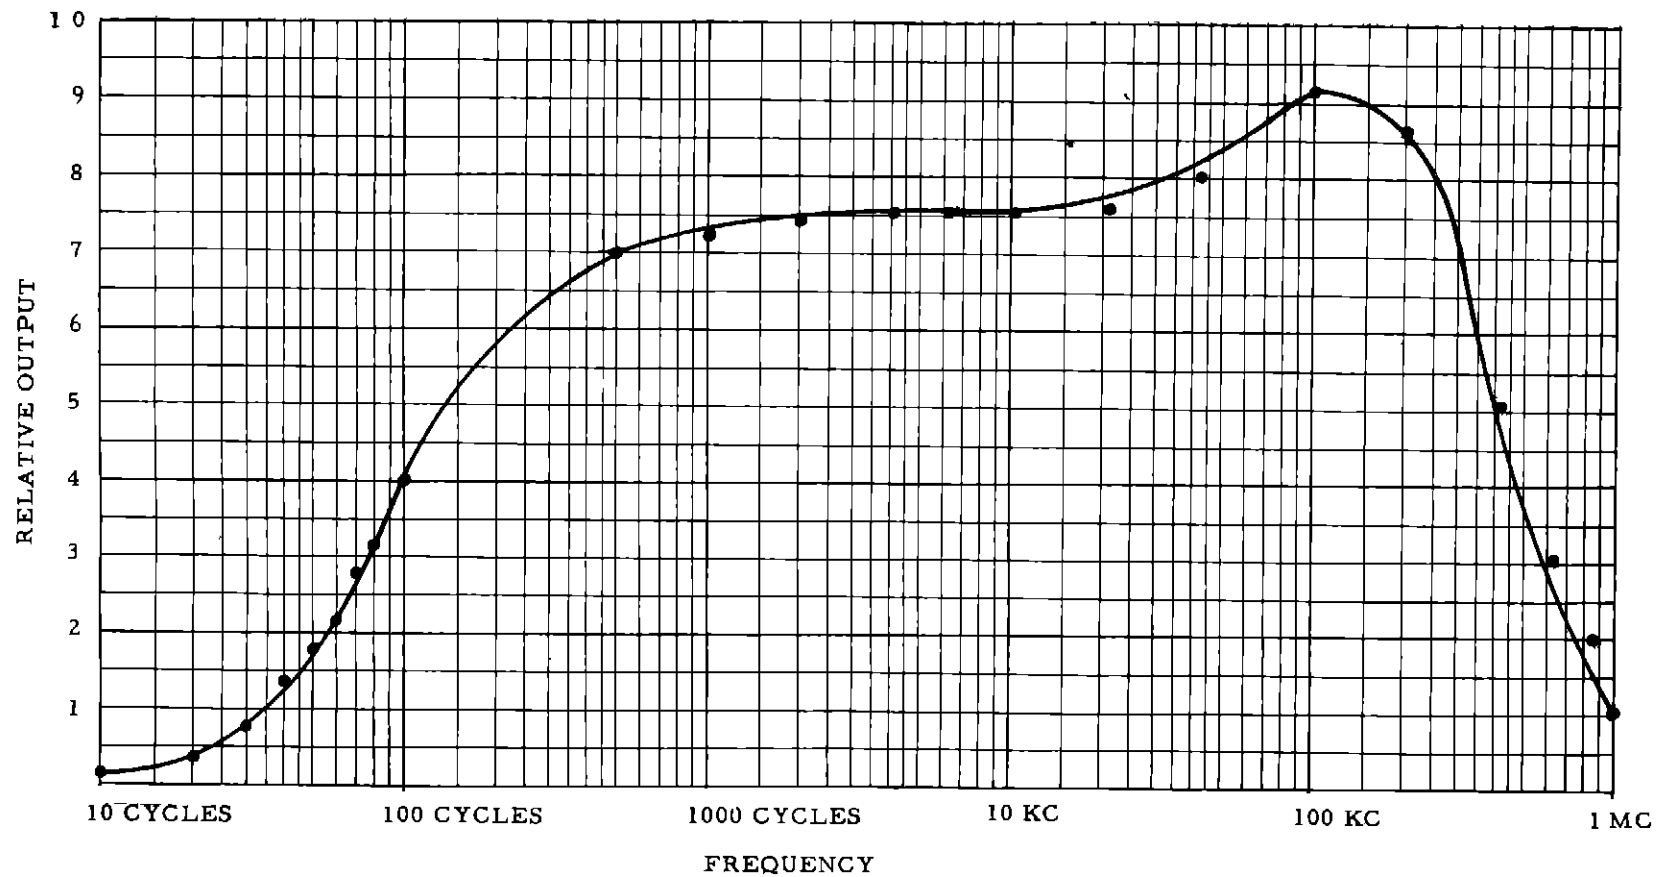
FIG 2 NORMAL VIDEO BAND PASS

of limit level. The intermediate frequency (i-f) bandwidth was 1.0 Mc with a center frequency of 30 Mc. The normal video bandwidth was 375 kc. The video frequency response curve is shown in Fig. 2.

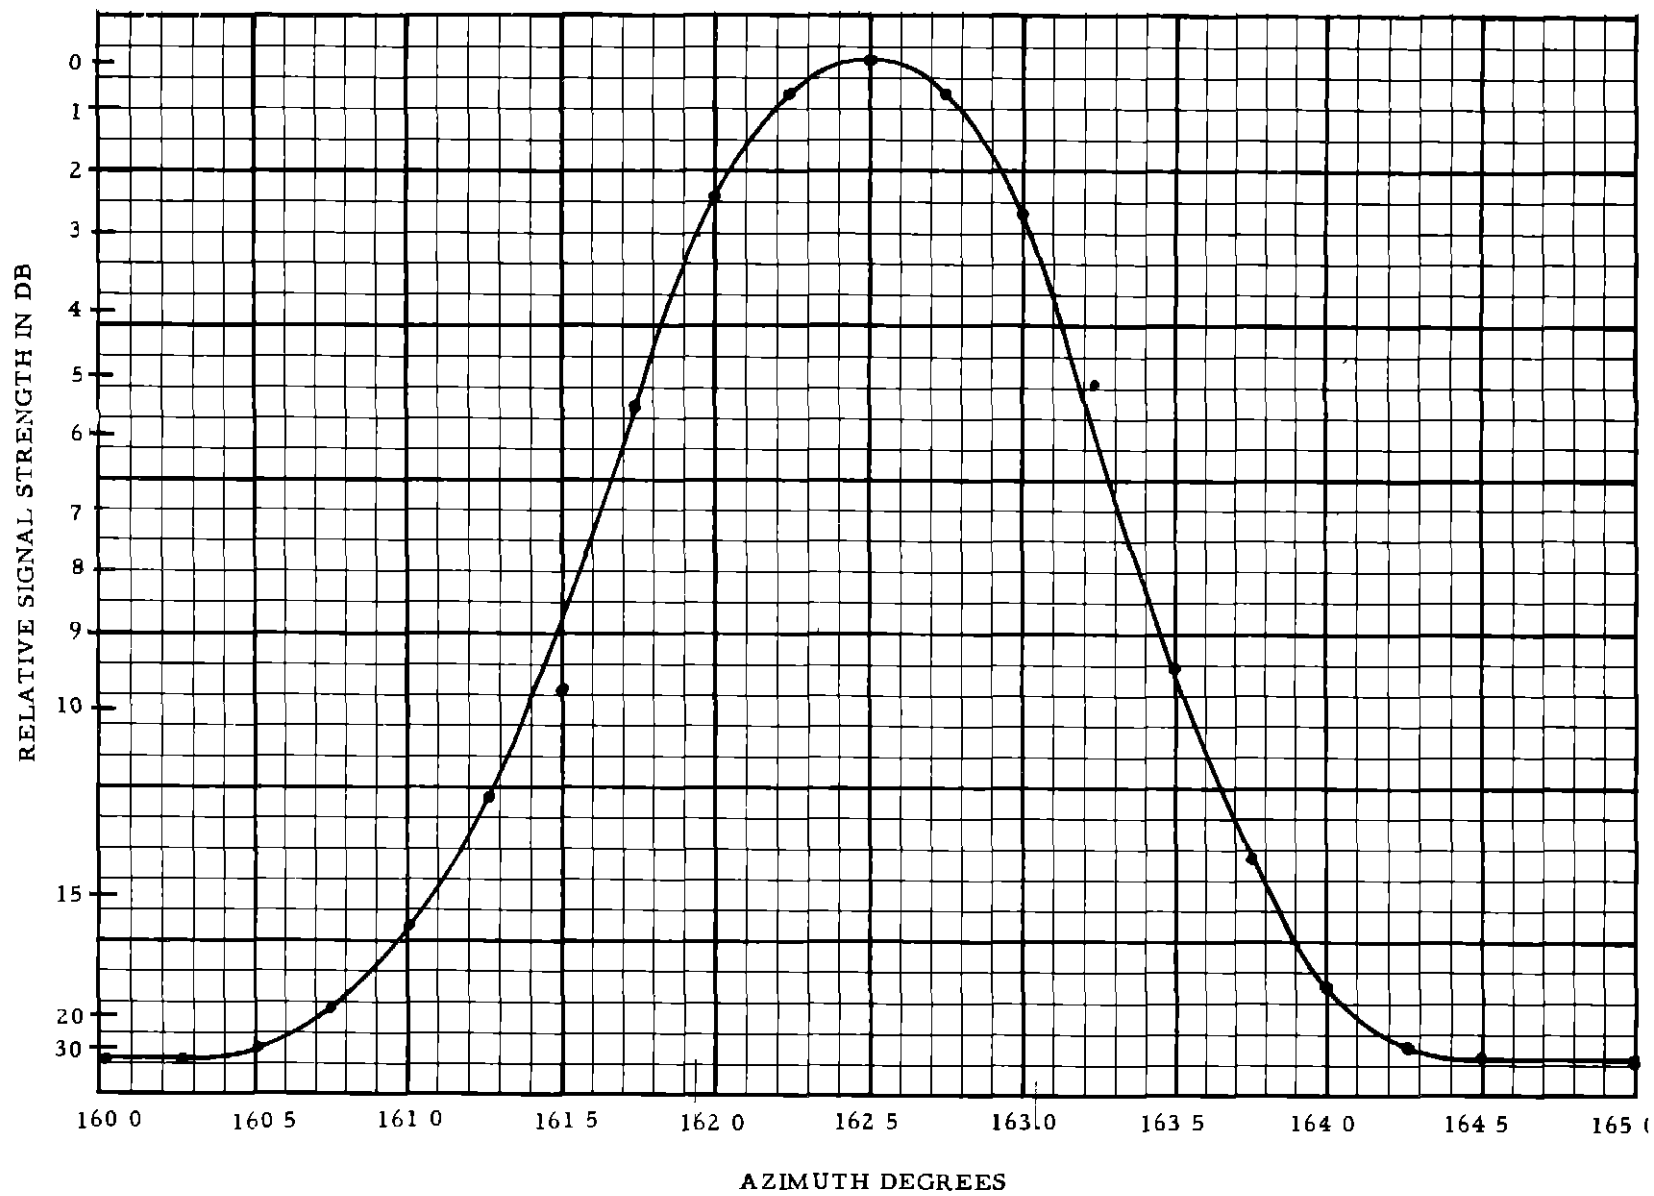
FIG 11 ANTENNA AZIMUTH PATTERN IN SPACE

A check of the relative field strength in the azimuth plane of the antenna was made. The beam width at the half-power points was approximately 1.1° . The antenna radiation pattern, in space, is shown in Fig. 11. A similar check with the antenna beam directed through a nearby tower, such as might be used to support microwave remoting antennas, yielded the radiation pattern shown in Fig. 12. The half-power beam width in this direction was approximately 1.0° . The difference in beam width is due, quite possibly, to measurement errors, however, it can be concluded that no serious deformation of the beam can be attributed to the proximity of the tower. The tower did cause a small amount of magnetron frequency pulling; however, the amount of pulling was not significant and in fact was difficult to measure.

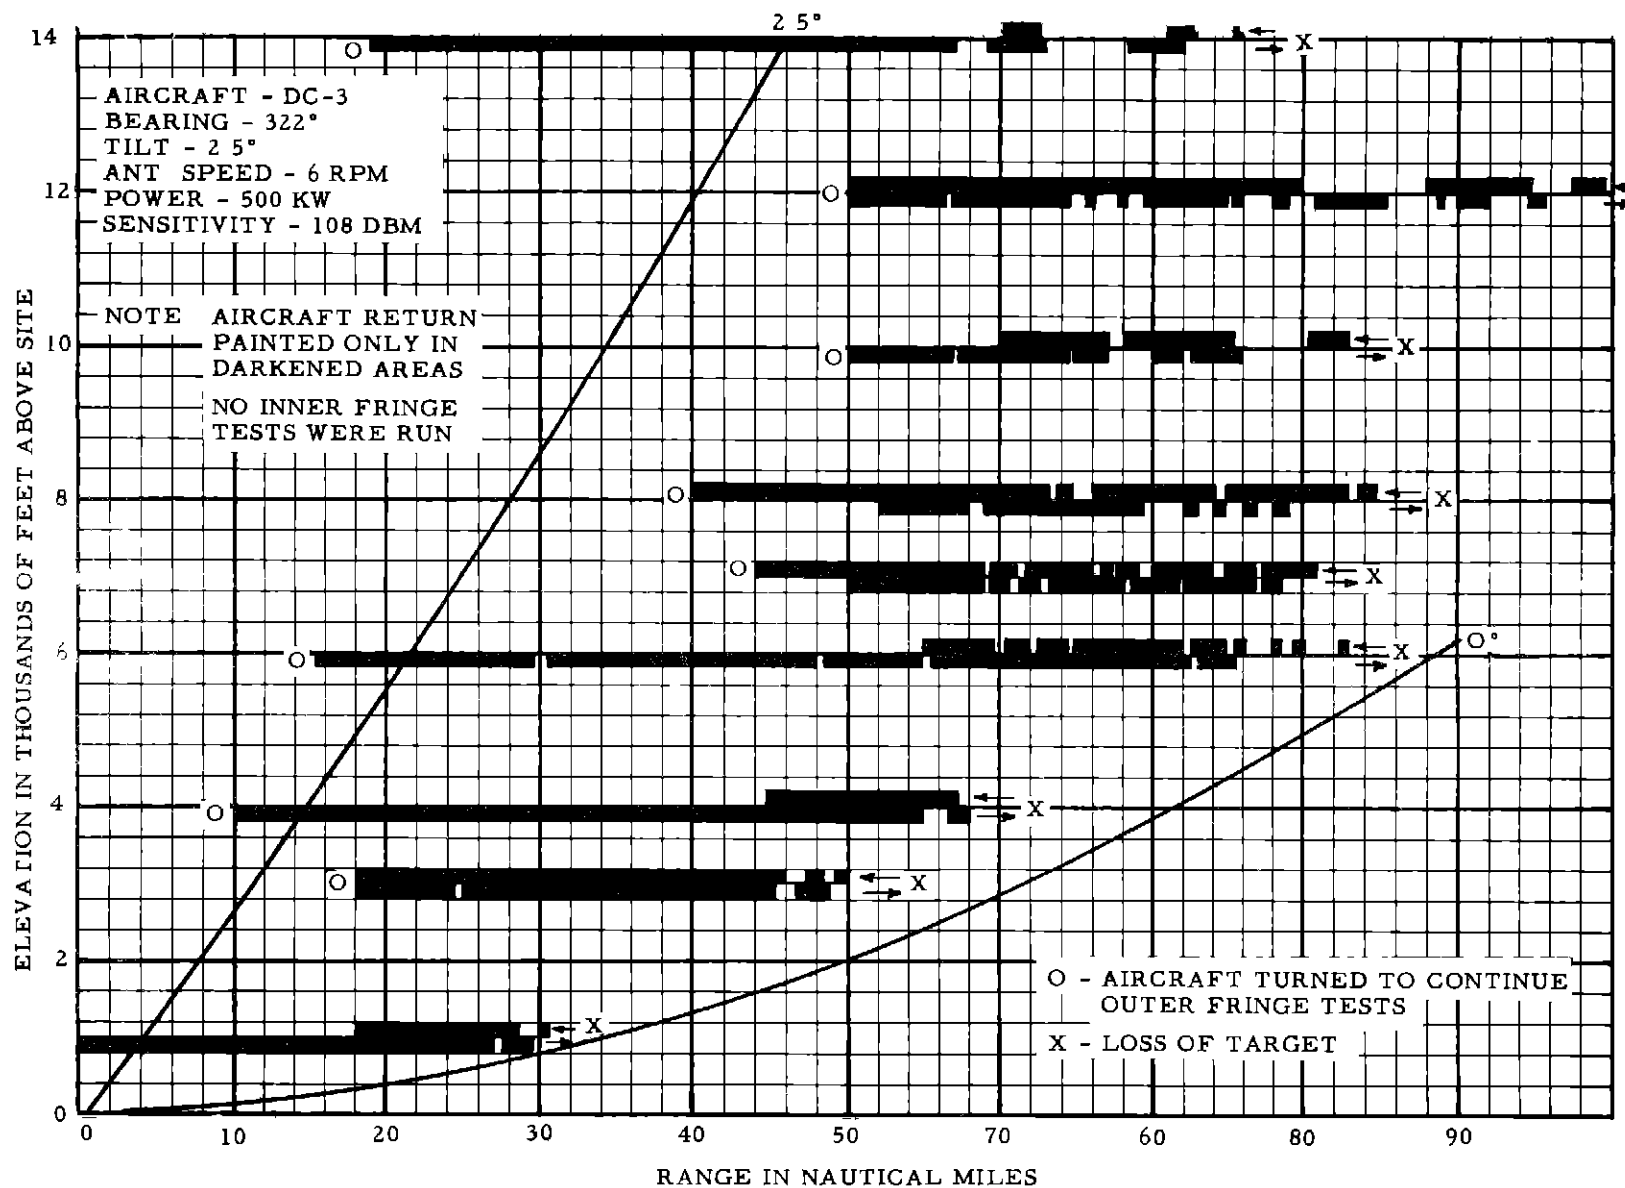
FIG 13 FLIGHT CHECK DATA

The results of the flight check are depicted in Fig. 13. A DC-3 airplane was flown in and out on the 322° radial of the Indianapolis VOR. The antenna rotation was set at 6 rpm and the electrical tilt was 2.5° above the horizon.

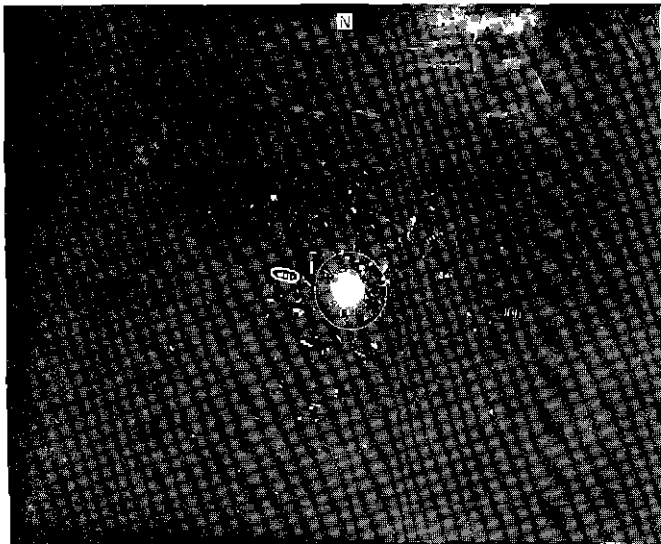
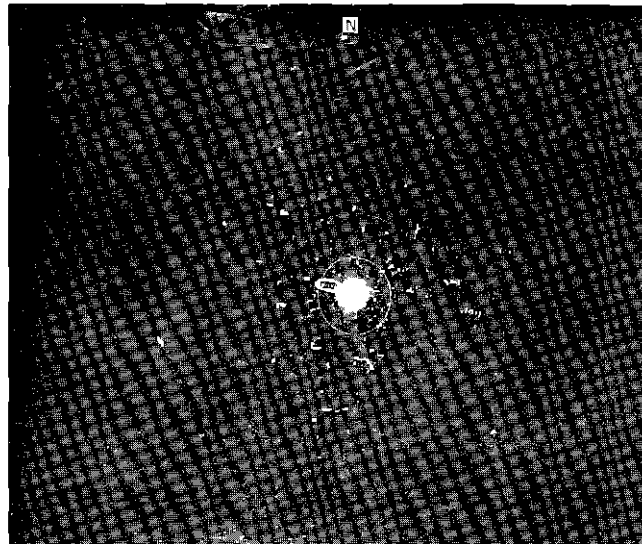
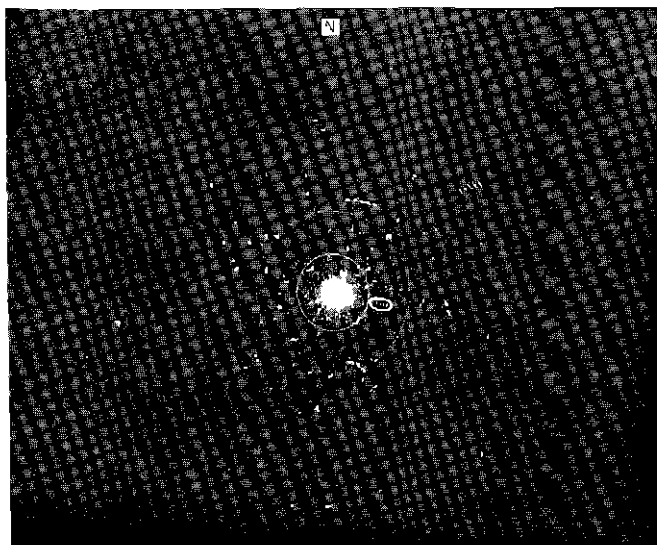
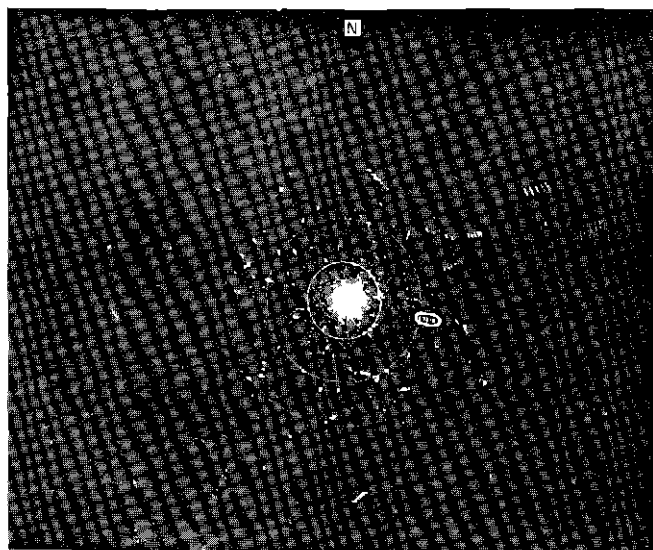
FIG 14 MTI PERFORMANCE—FLIGHT CHECK

Photographs of the MPI performance, when the aircraft was flying directly over the site at 1,000 feet, were obtained. These are shown in Figs. 14 and 15.

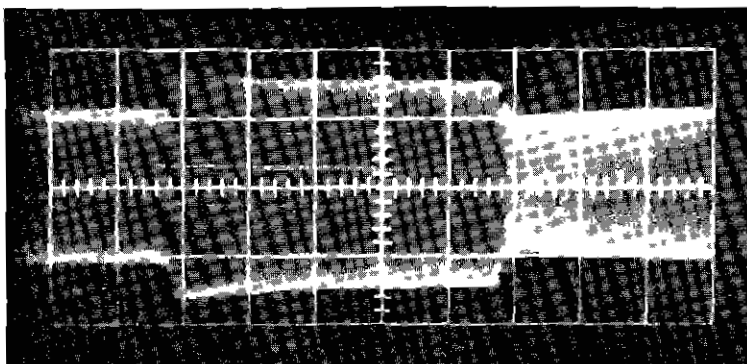
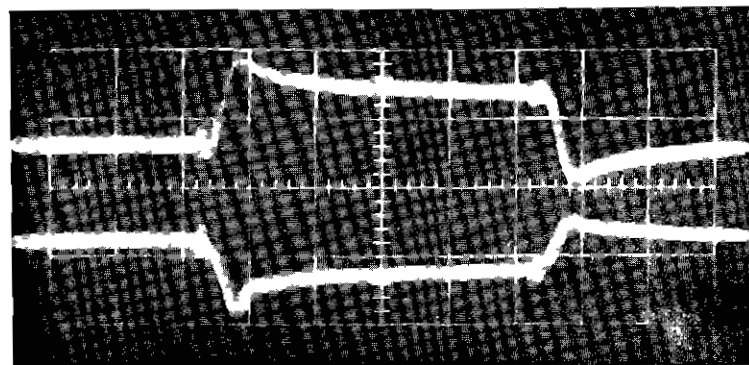
FIG. 16 MTI CANCELLATION VERSUS MODULATION

It was noted that the modulation percentage of the delay-line driver is an important factor in cancellation of the fixed targets. Figures 16 and 17 show this effect. The cancellation was good at 20 per cent modulation, but when it was raised to 33 per cent the cancellation was decreased somewhat. The normal modulation percentage is approximately 29 per cent.
