Fire-Extinguishing Studies of the Northrop F-89 Powerplant

TECHNICAL DEVELOPMENT REPORT NO. 365

CIVIL AERONAUTICS ADMINISTRATION
TECHNICAL DEVELOPMENT CENTER
INDIANAPOLIS, INDIANA

October 1958

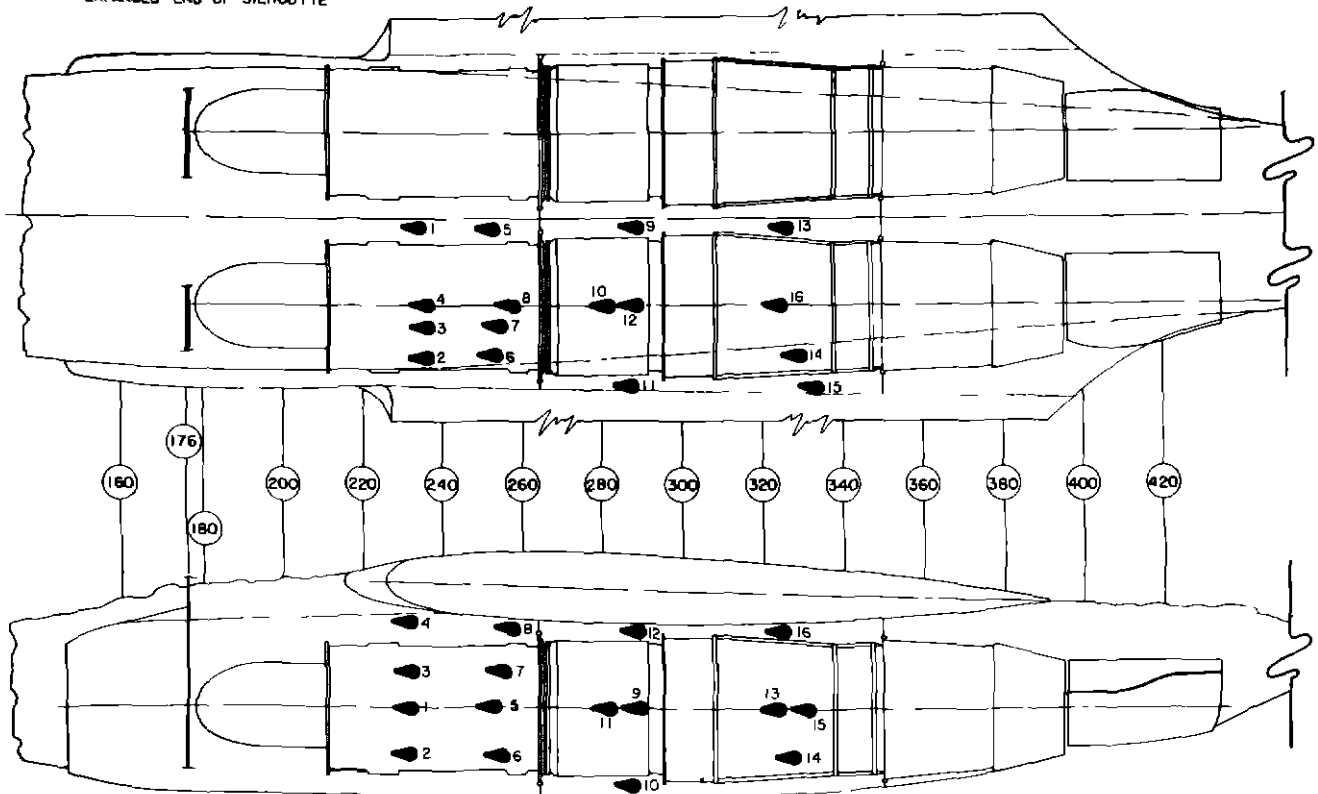
Fig 1 Test Fire Locations in Left Engine Bay of F-89 Aircraft

The location of the test fires was determined from F-89 accident reports and by a survey of the engine to indicate the areas where the greatest fire hazard existed. Sixteen locations were chosen as potential areas of fire, and throughout the series of tests, fires were ignited at these points to evaluate various agent distribution systems and several extinguishing agents. These locations are indicated and numbered in Fig. 1. Fires were not ignited at all 16 locations for all surveys, as failure to extinguish fires at any one location eliminated that particular extinguishing system configuration from consideration as a satisfactory system. As soon as the fact was established that a distribution system would not extinguish fires in any area, the system was redesigned or improved and the test series begun again. Because of the firewall separation between the compressor and burner sections, a fire was ignited in each section simultaneously to reduce the number of fires necessary and to make use of the agent which was discharged into both sections.

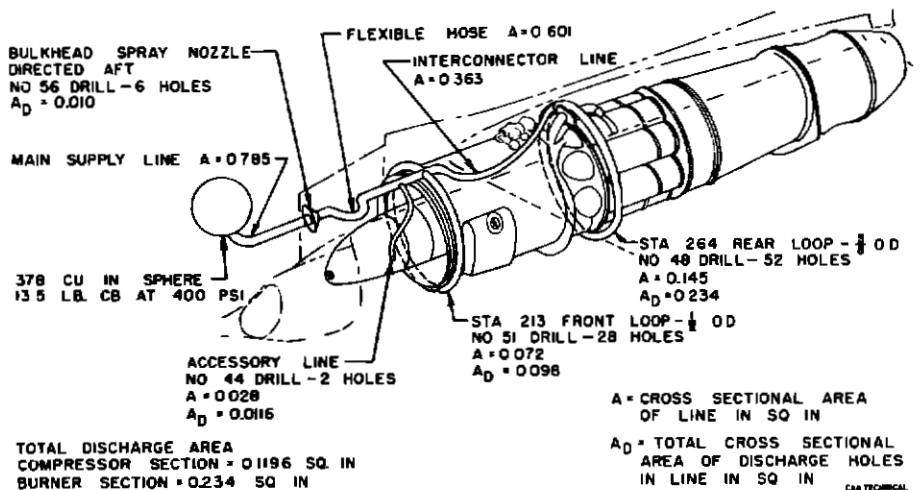
Fig 2 F-89 Powerplant Fire Extinguishing System

The latest production extinguishing agent distribution system used in F-89 aircraft was installed in the engine bay of the test article as shown in Fig 2. It consisted of a 378-cubic-inch spherical container connected to two discharge rings, one in the compressor section and one in the burner section. A spray nozzle was mounted on the aft side of the engine compartment forward bulkhead, integral with the main agent supply line, and directed aft. A small line extended down into the accessory section from the forward compressor loop. Line sizes, number and size of discharge holes, and cross-sectional areas of the various lines are indicated in Fig 2. The Air Force specified CB as the extinguishing agent. The quantity of agent required for each zone of the engine bay was computed from the formula²

Upon examination of the production perforated tubing discharge system after a number of fire tests, several deficiencies were noted. Several of the discharge holes were covered in the installation by mounting clamps used to hold the tubing in position on the engine. Metal shavings and burrs inside the discharge holes as a result of the drilling operation were forced back into the holes after discharge of the agent, resulting in restrictions of many of the holes. Repeated discharge of the bromochloromethane resulted in corrosion of some of the holes, thereby sealing them so that the agent could not pass through.

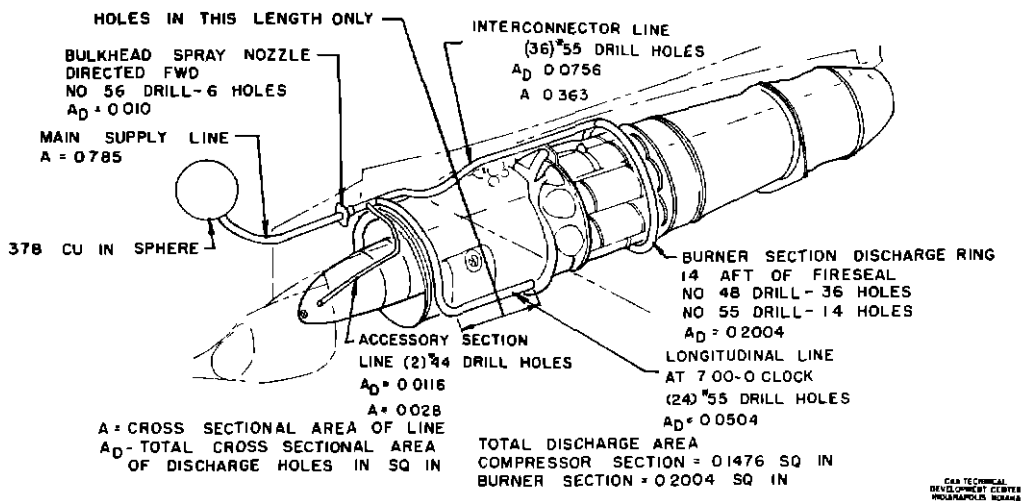
Fig 4 Modified Perforated Tubing Distribution System

In the series of tests involving the third modification, neither the standard charge of CB nor a 19.0-pound charge of CB in a 536-cubic-inch sphere gave complete extinguishment of all test fires. A standard charge pressurized to 600 psi did not extinguish the fire in the compressor section even though this higher pressure produced a tremendous mixing effect and the discharge could be heard above the engine roar. Flashback occurred in five instances, four during normal cruise conditions and one during taxi power.

1 In the burner section all of the holes discharging agent outward toward the engine bay doors and keel were sealed. Smaller holes were drilled at these locations directing the agent aft, thus reducing the total discharge area in the burner section by 0.043 square inch.

2 The discharge ring in the burner section was relocated 14 inches aft of the firewall separating the compressor and burner sections.

These latest changes are illustrated in Fig. 4. The fuel to the test fire was released at a rate of 0.475 gpm. In this series of tests, quantity, type, and pressurization of agent were varied to obtain a direct comparison of these factors, but the fill ratio was maintained at 50 per cent. The test procedure included engine shutdown prior to discharge of the agent. The results of the series of test fires conducted with this configuration are given in Table X. Pressurization was 400 psi in all tests except those noted in the table.

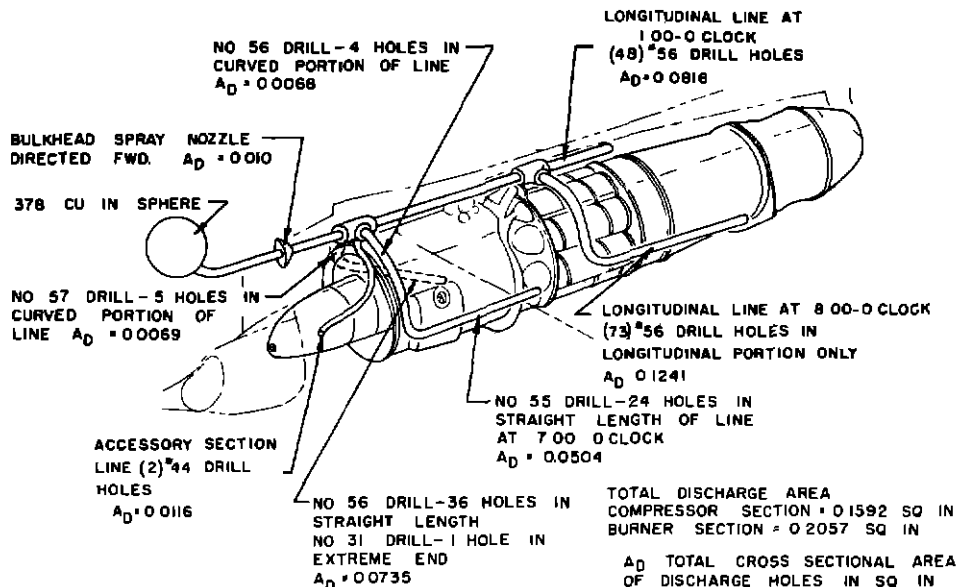
Fig 5 Final Configuration of Perforated Tubing Distribution System

In the last series of fire tests, as indicated in Table XIV, the fuel to the fire was increased to 3.73 gpm in six of the tests. With this quantity of fuel, an extremely severe fire existed in the engine bay and, upon the discharge of 13.5 pounds of CB, continued to burn with practically no abatement. For fires of this magnitude, on which 16.2 pounds of DB was used, however, extinguishment was instantaneous and there was no reignition even though raw fuel continued to be released into the engine bay. Three flashbacks occurred in the compressor section and one in the burner section during the fire tests in which CB was used.

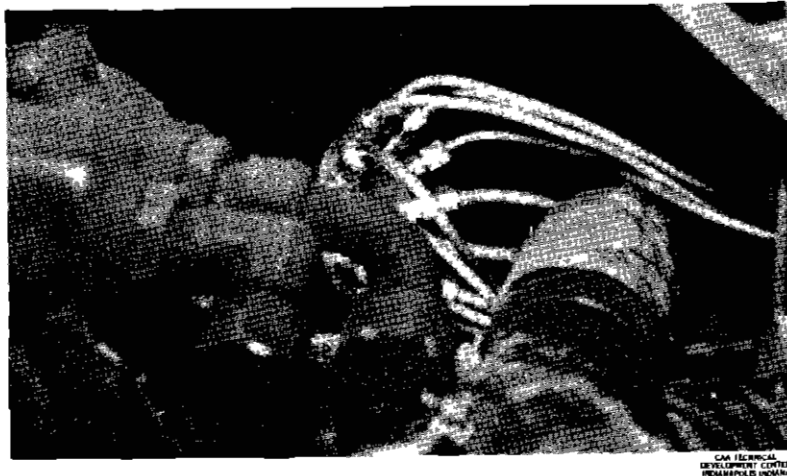
Fig 6 Distributor of HRD System with Discharge Lines Attached

In order to deliver the agent into all compartments of the engine bay simultaneously, the supply line from the agent container was routed to a specially fabricated distributor located at the midpoint of the engine. The distribution lines to areas of each compartment were connected to the distributor. The discharge ends of six open-end 1/4-inch o. d. lines were spaced equally around the circumference of the engine just forward of the firewall between the compressor and the burner compartments and pointed at 45° helically from a direct forward position. Six open-end 3/8-inch o. d. lines extended through the fire seal into the burner compartment and the ends were equally spaced around the circumference of the engine pointing 45° from a direct aft direction. Each of these 12 lines was connected directly to the distributor located at the midpoint of the engine. The 45° angle at the end of each line was used to impart a swirling and mixing action to the agent as it was discharged into the engine bay. The distributor with the lines attached is shown in Fig. 6. This system first was evaluated with CB but, because this type of system does not function at its peak efficiency using an agent with the physical characteristics of CB, the majority of the tests were run using DB.

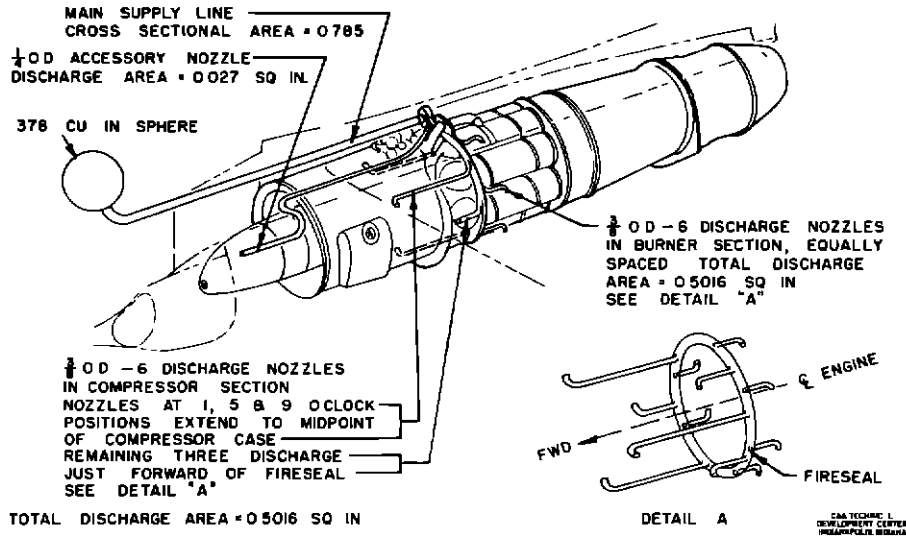
Fig 7 Final HRD System

This was the final HRD system evaluated and its design is illustrated in Fig. 7. After it was determined that 16.2 pounds of DB would extinguish a maximum fire in the engine bay, the amount of agent was decreased to determine the minimum quantity required for extinguishment. Extinguishment was accomplished with quantities of DB as low as 13.0 pounds, or a 40-per-cent fill ratio. However, there was no excess agent to cool the hot surfaces and the danger of reignition was great. The one test using 11.1 pounds of BT was not conclusive because it

extinguished the fire in the burner section but not in the compressor section, It was intended to investigate the capabilities of this agent further but at this point the doors on the engine bay of the test article had been burned away to the point where a tight seal could be maintained no longer Therefore, the fire tests on the F-89 test article were concluded

The 1/4-inch o.d. lines in the compressor section were replaced by 3/8-inch o.d. lines in the same position as the second HRD configuration. This more than doubled the discharge area in the compressor section. In the tests evaluating the HRD system, modification no. 2, the engine power remained at cruise setting for all runs. Both DB and BT were used in various fill ratios in a 378-cubic-inch sphere. Container pressurization was 400 psi. JP-4 fuel was introduced into each engine bay from multiple sources to obtain maximum dispersion, but for the purposes of these tests, it still was considered as being one fire in each section. Table XVII gives the test conditions and results for this configuration.
