TECHNICAL DEVELOPMENT REPORT NO. 374

**Bird Impact Tests of the
Douglas Model DC-8 Airplane
Eyebrow And Clear-View Windows**

FEDERAL AVIATION AGENCY
TECHNICAL DEVELOPMENT CENTER
INDIANAPOLIS, INDIANA

BIRD IMPACT TESTS OF THE DOUGLAS MODEL DC-8 AIRPLANE EYEBROW AND CLEAR-VIEW WINDOWS

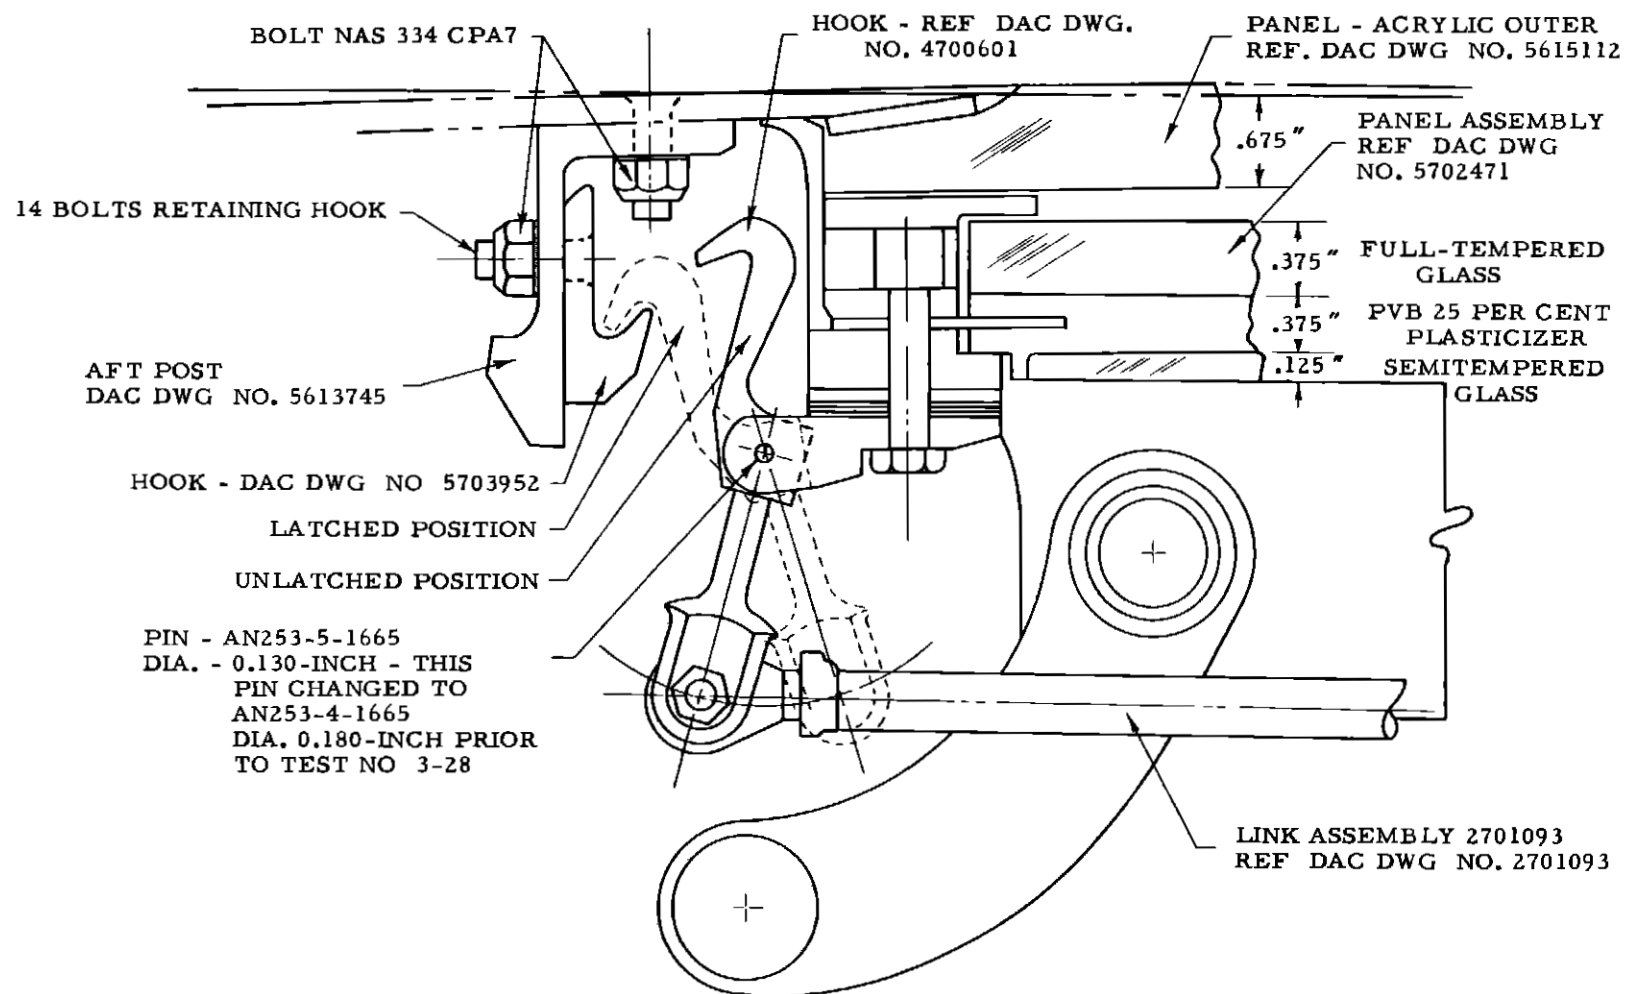
2. This same window configuration will resist penetration satisfactorily, and failure of the latching mechanism will not occur at a velocity as high as 481 mph provided the aft hook hinge pin is increased in diameter from 0.130-inch to 0.180-inch, as shown in Fig 3

FIG 3 SECTIONAL VIEW OF AFT SILL - CLEAR-VIEW WINDOW ASSEMBLY
REF DAC DRAWING NOS. 5613067 AND 5615112

The aft hook steel hinge pin size was changed from 0.130-inch to 0.180-inch diameter prior to Test No. 3-28.

Prior to this test, which involved the pilot's clear-view window, the hinge pin for the aft window latch was increased in size to 0.180-inch diameter, as shown in Fig. 3. The bird carcass hit approximately 2 inches below and 3 inches forward of the target point. The exterior panel shattered completely and the aft doubler plate facing was rolled back slightly as 13 fasteners failed. This is shown in Fig. 33. A small amount of bird carcass extruded through the opening at the upper aft corner of the window. That part of the carcass which extruded into the cockpit passed to the rear of the pilot. There was no penetration of the interior panel, as shown in Fig. 34. High-speed movies of this test indicated that flying glass from this panel was noticeably greater in both quantity and velocity compared with Test No. 3-26. None of the glass penetrated the pilot's head or clothing and none was directed toward the pilot's eye area. The track and latches were all functional. After impact, the window was opened and moved aft to check operation. See Fig. 34A.

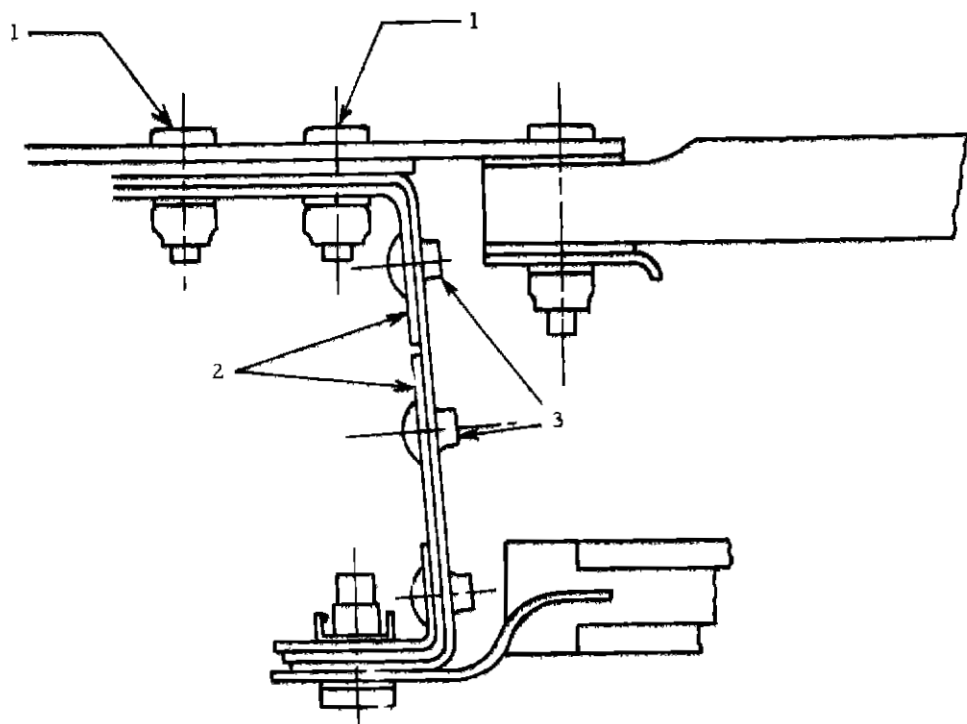
FIG 4 TEST NO 3-22

Prior to this test, which involved the pilot's eyebrow window, the aft sill-frame, DAC Part No. 5642814, was increased in strength as shown in Fig. 4. The projectile struck approximately 2 inches above the horizontal centerline of the window and immediately forward of the aft sill. This is a critical strike position relative to impact strength of the window arrangement. The exterior panel was shattered by the impact (see Fig. 14), and the aft sill retaining the panel fractured in one place and bent aft from the upper support intercostal sill, as shown in Figs. 15 and 16. The interior panel was not penetrated. When the sill-frame, DAC Part No. 5642814, modified as described previously, for the interior panel again fractured, part of the bird carcass entered the cockpit to the rear of the pilot similar to Test 3-21. This is shown in Figs. 15 and 16. A few particles of glass from the inner face of the interior window impinged upon the top and left side of the pilot's head. None penetrated the clay or was directed toward the pilot's eye area. The pilot, after being exposed to this test, is shown in Fig. 17.

TEST NO. 3-22

1. BOLT, S-2357169P5A, REPLACES RIVET, AN470AD6.
2. A SECOND FRAME, 5642814, WAS SPLIT AND ATTACHED TO THE ORIGINAL FRAME, 5642814.
3. RIVETS, AN470AD6, SPACED 1 INCH ON CENTER

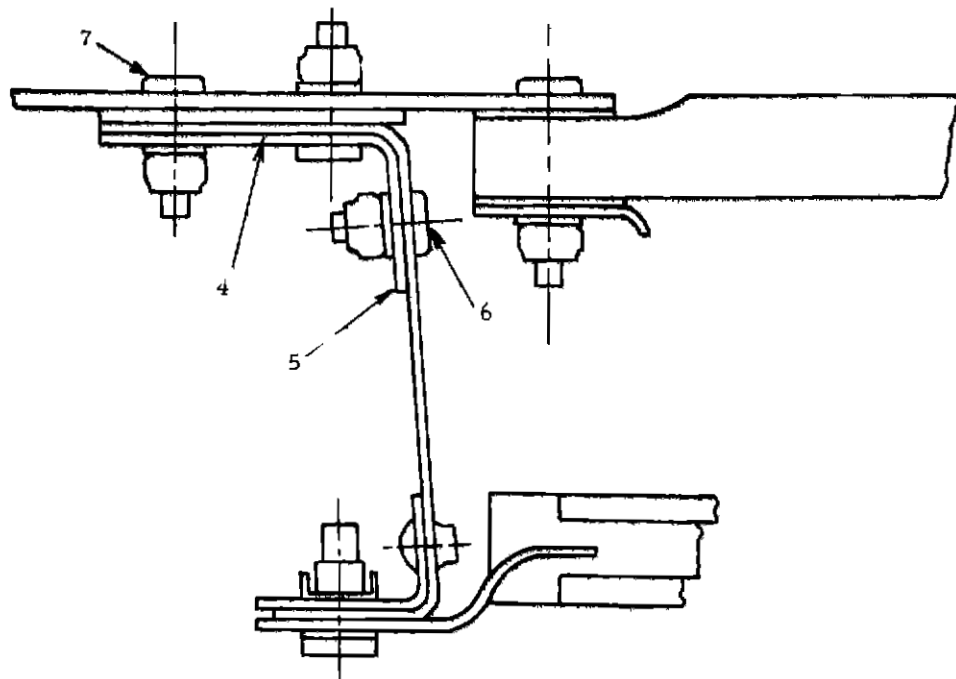
FIG 5 TEST NO 3-23

Prior to this test, which involved the copilot's eyebrow window, the aft sill-frame, DAC Part No. 5642814, was increased further in strength by replacement with a DAC fabricated 0.125-inch-thick frame as shown in Fig. 5, and the addition of a steel reinforcing axle. Also, the upper aft corner retaining arrangement for the interior window panel was strengthened by the addition of a 0.091-inch-thick, 7075S-T6 gusset, as shown in Fig. 18. The bird carcass projectile struck slightly above and approximately 4 inches aft of the target point. There was no penetration of the window and no fracture of the 0.125-inch 7075-T6 aft sill-frame retaining the interior window. See Fig. 18. The frame had a 3/8-inch-deep permanent set pocket centered approximately 5 3/4 inches below the upper sill heel line causing the frame heel to roll 1/4-inch aft. A slight bending tear occurred around five bolt heads retaining the gusset and aft window edge. See Fig. 18. The exterior panel was shattered as shown in Fig. 19. Relatively few particles of glass impinged upon the copilot's head, predominantly on the top and upper right side. Only a few particles penetrated the clay. See Fig. 20.

TEST NO. 3-23

4. FRAME, 5642814, INCREASED IN THICKNESS TO 0.125-INCH
5. STIFFENING ANGLE, 0.050-INCH-THICK CM ANNEALED STEEL.
6. BOLTS, S-2357169P5A, SPACED 1 INCH CENTER
7. BOLT, S-2357169P5A, REPLACES RIVET, AN470AD6.

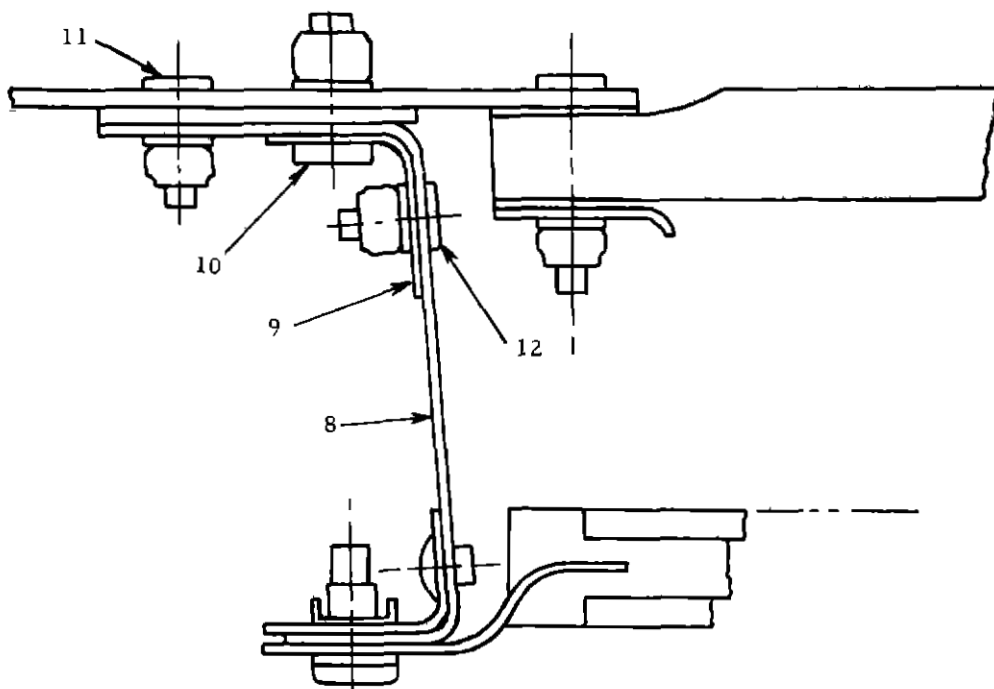
FIG 6 TESTS NOS. 3-24 AND 3-25

Prior to this test, which involved the pilot's eyebrow window, the aft sill-frame, DAC Part No. 5642814, was modified further by using all DAC fabricated increased gauge parts as shown in Fig. 6, including the upper aft corner gusset plate which had a material change from 7075S-T6 alclad to 2024S-T3 alclad. The carcass struck just forward of the target point, which was the window centroid. Upon impact, the exterior stretched Plex panel

TESTS NOS 3-24, 3-25

8. FRAME, 5642814, INCREASED IN THICKNESS TO 0.125-INCH.
9. STIFFENING ANGLE, 0.050-INCH-THICK CM ANNEALED STEEL, HEAT-TREATED TO 125,000 - 140,000 PSI.
10. BOLT, S-2356374P6A, REPLACES BOLT, S-2357169P5A.
11. BOLT, S-2357169P5A, REPLACES RIVET, AN470AD6.
12. BOLT, S-2357169P5A, SPACED 1 INCH ON CENTER.

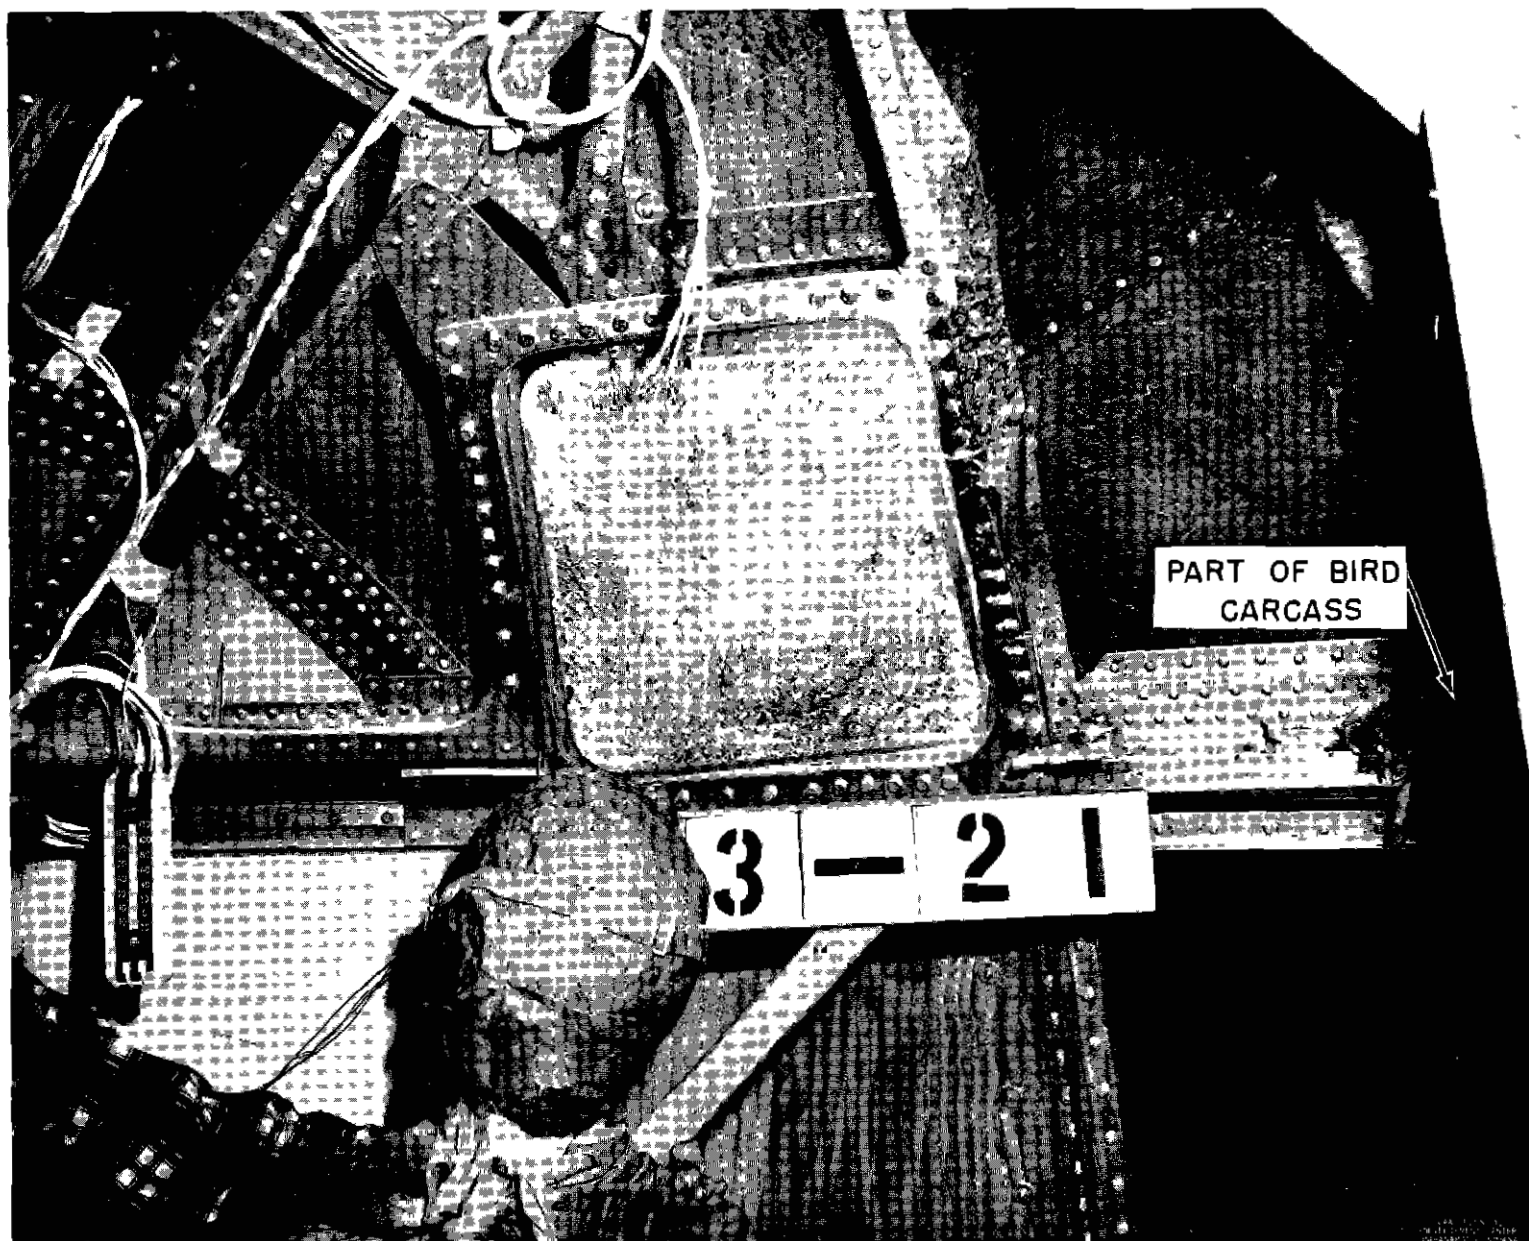
failure is shown in Figs. 11 and 12. That part of the carcass which entered the cockpit through the void caused by the fractures in the frame generally followed the contour of the fuselage aft of the window. This is shown in Fig. 11. Relative to flying window fragments, the strike position for this test was critical but only a few particles of glass struck the upper right side of the pilot's head. None of these particles penetrated the clay, but merely adhered to it. The copilot, after the test, is shown in Fig. 13.

FIG 11 TEST 3-21 - COPILOT EYEBROW WINDOW, INTERIOR VIEW -
PROJECTILE VELOCITY 388 MPH

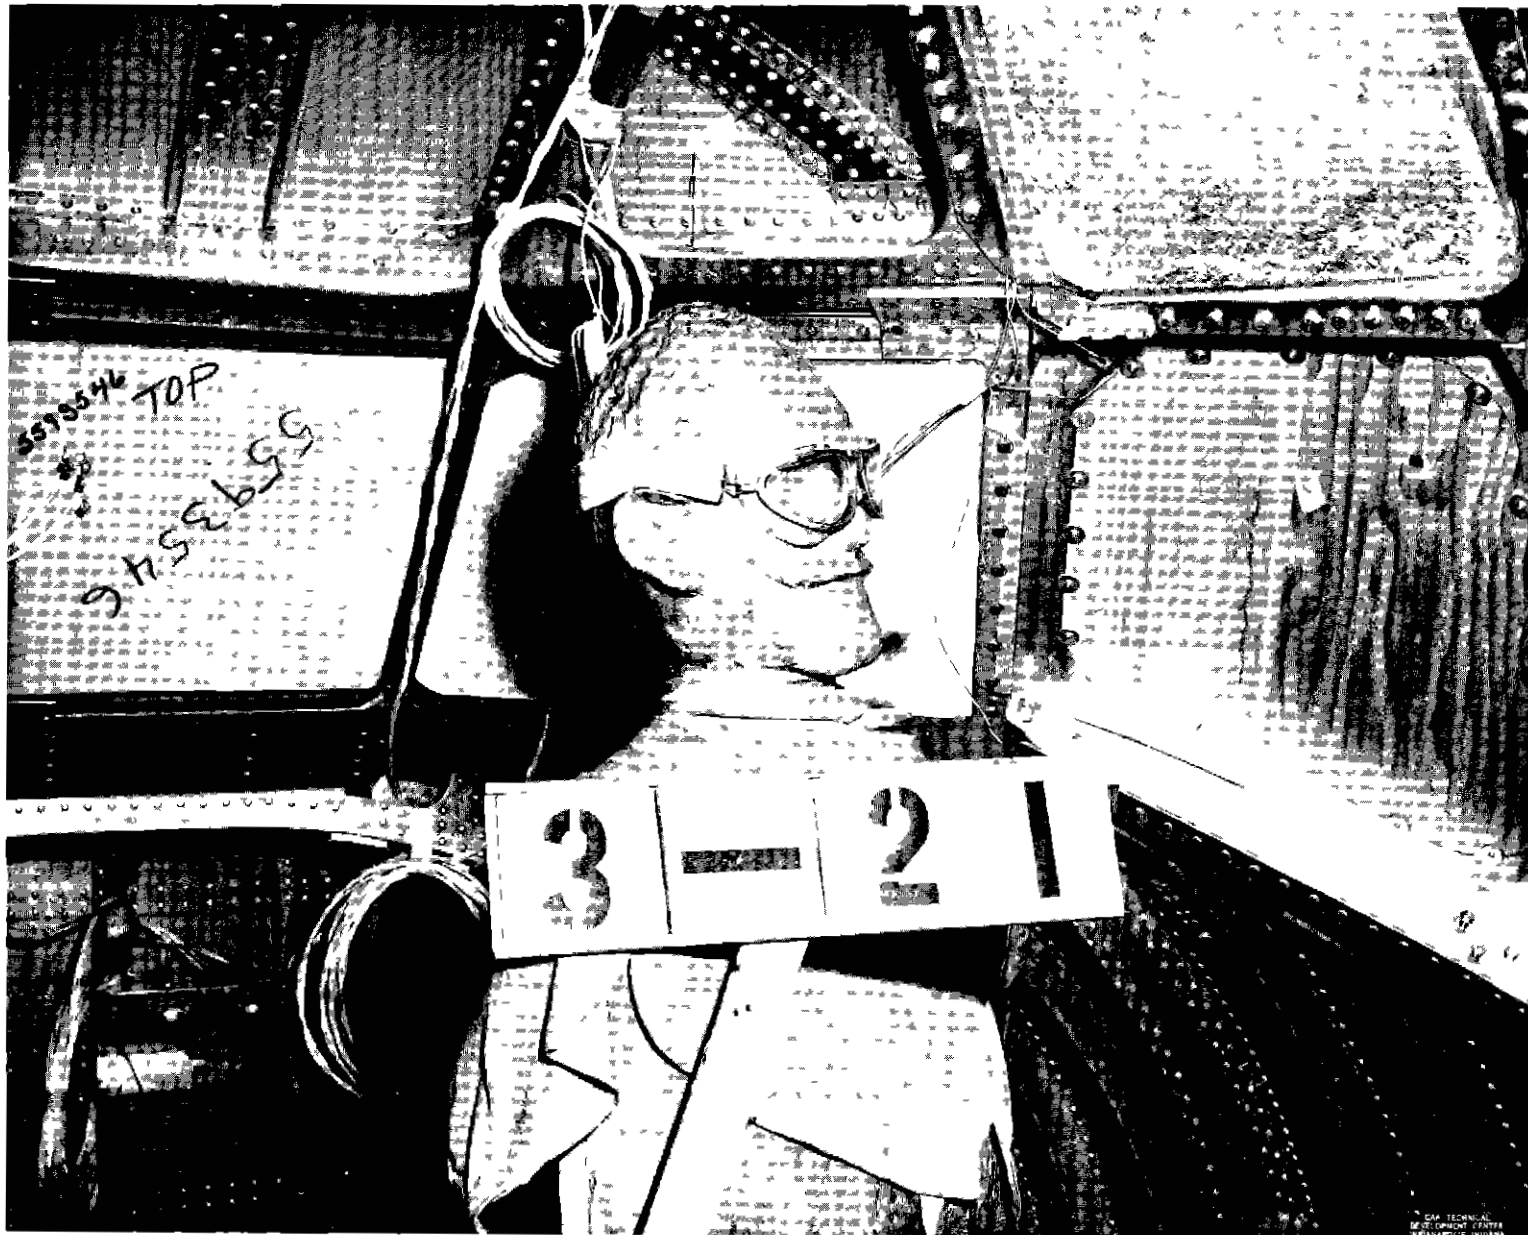
FIG 13 TEST 3-21 - COPILOT - PROJECTILE VELOCITY 388 MPH

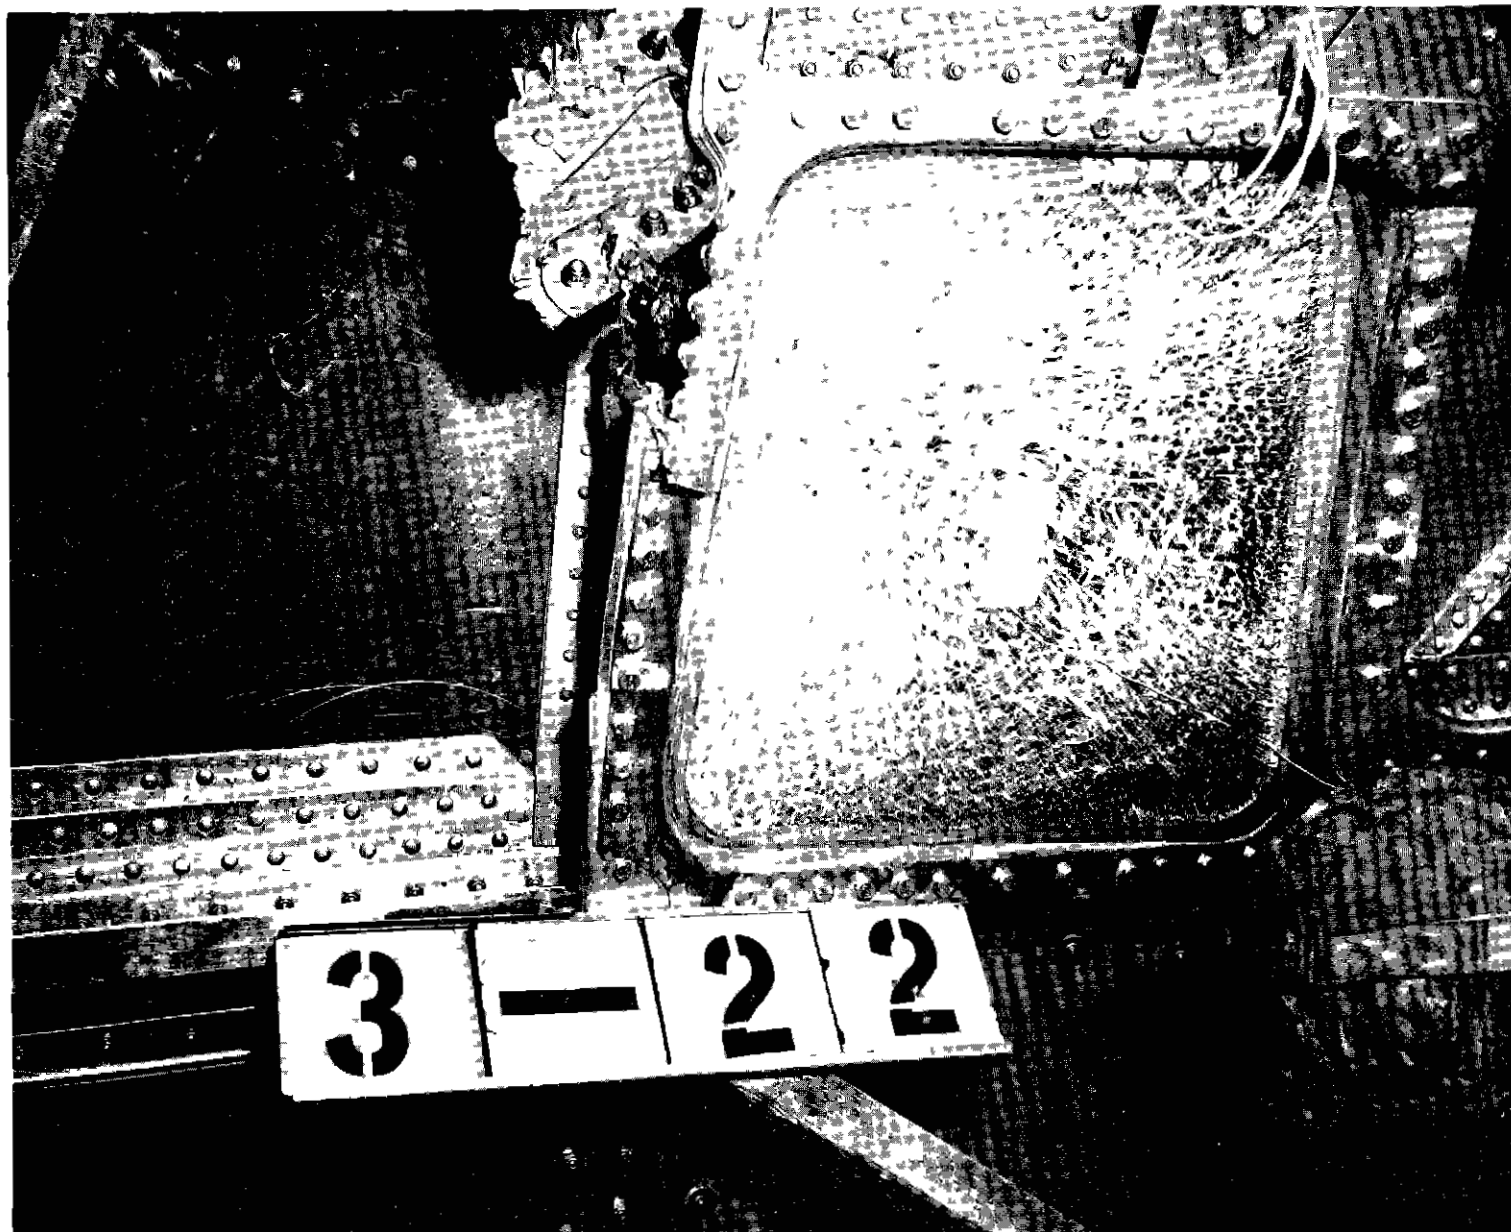
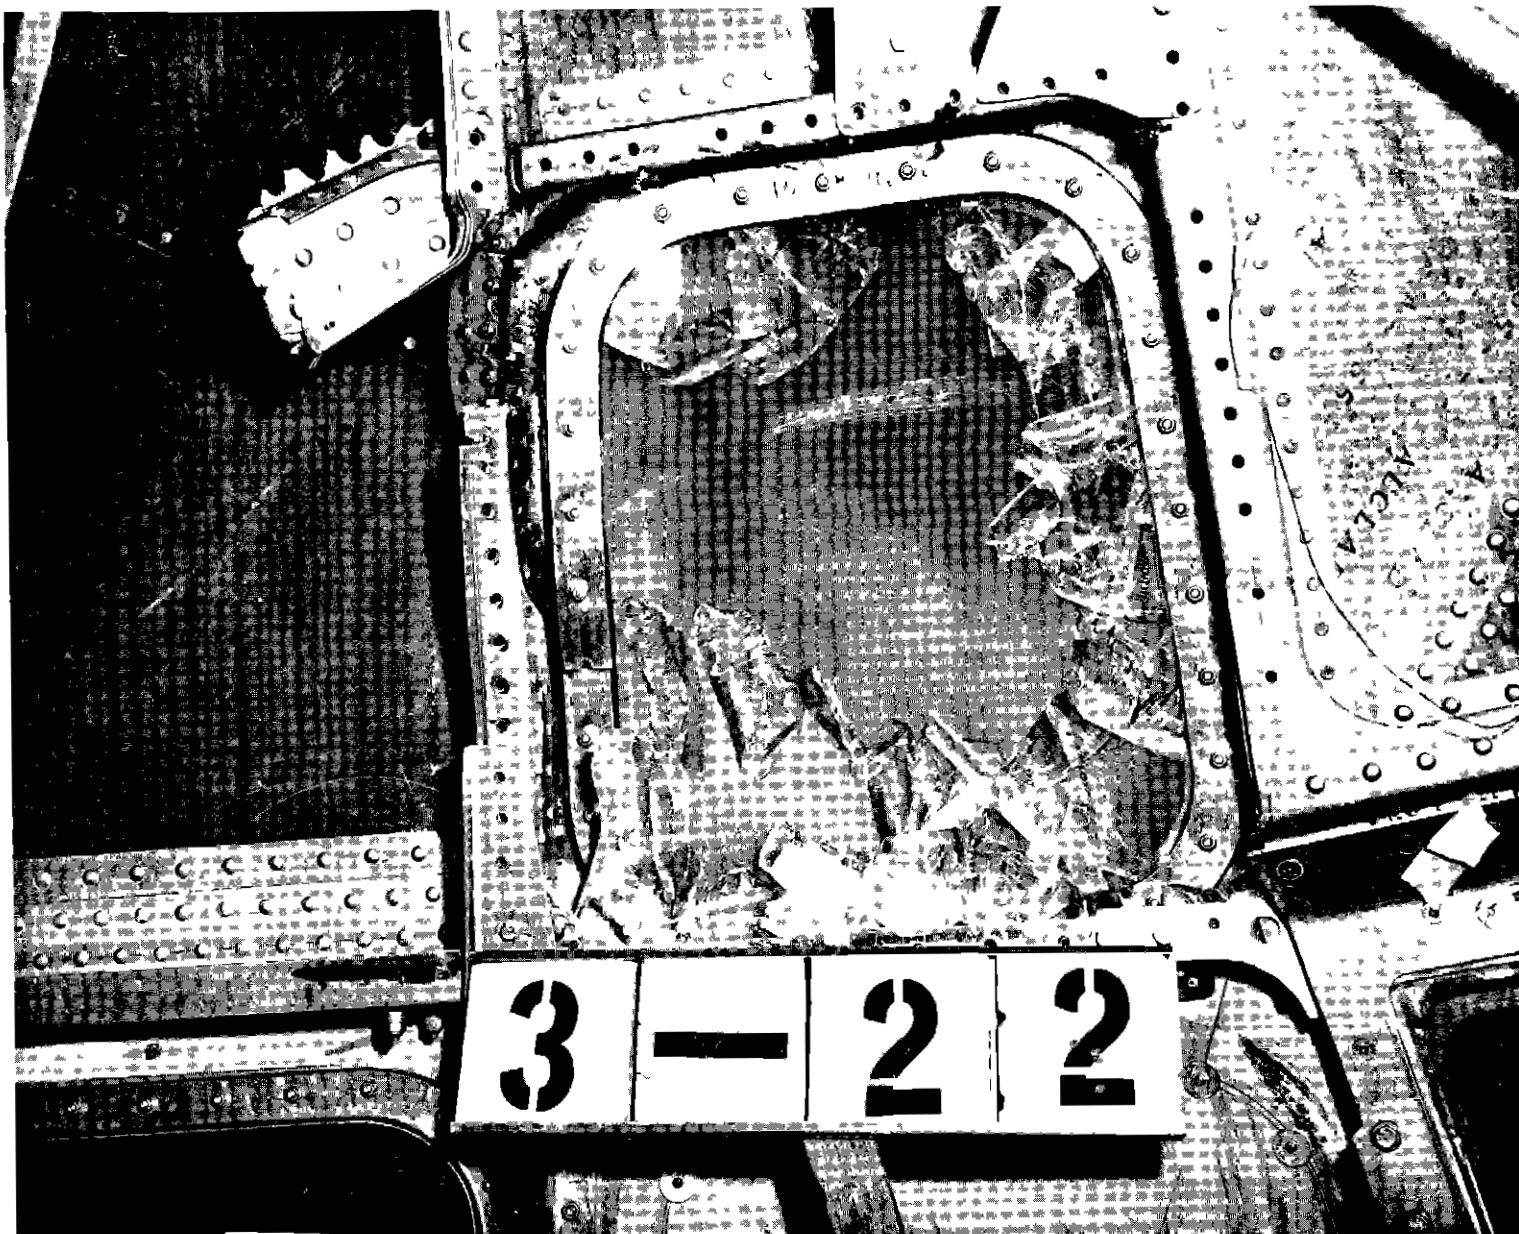
FIG 14 TEST 3-22 - PILOT EYEBROW WINDOW, EXTERIOR VIEW -
PROJECTILE VELOCITY 413 MPH

FIG 15 TEST 3-22 - PILOT EYEBROW WINDOW, INTERIOR VIEW -
PROJECTILE VELOCITY 413 MPH

FIG 16 TEST 3-22 - PILOT EYEBROW WINDOW, INTERIOR VIEW SHOWING
DAMAGED FRAME - PROJECTILE VELOCITY 413 MPH

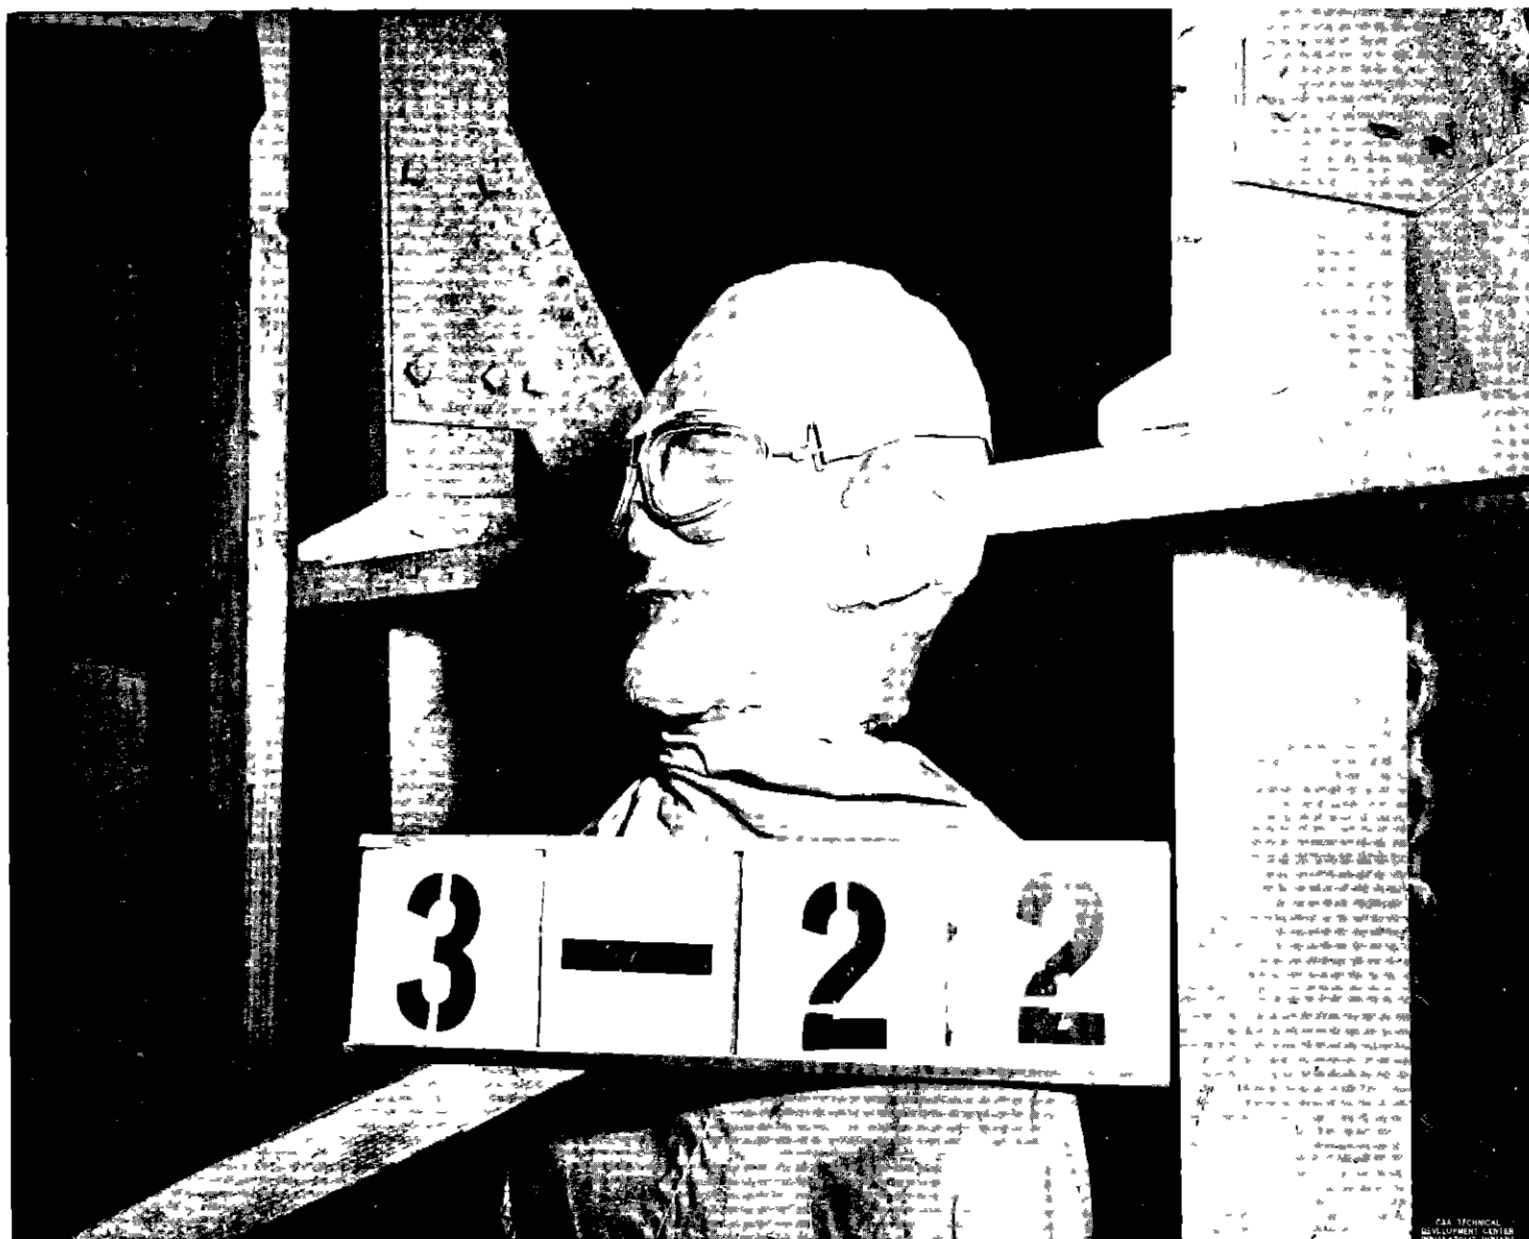
FIG 17 TEST 3-22 - PILOT - PROJECTILE VELOCITY 413 MPH

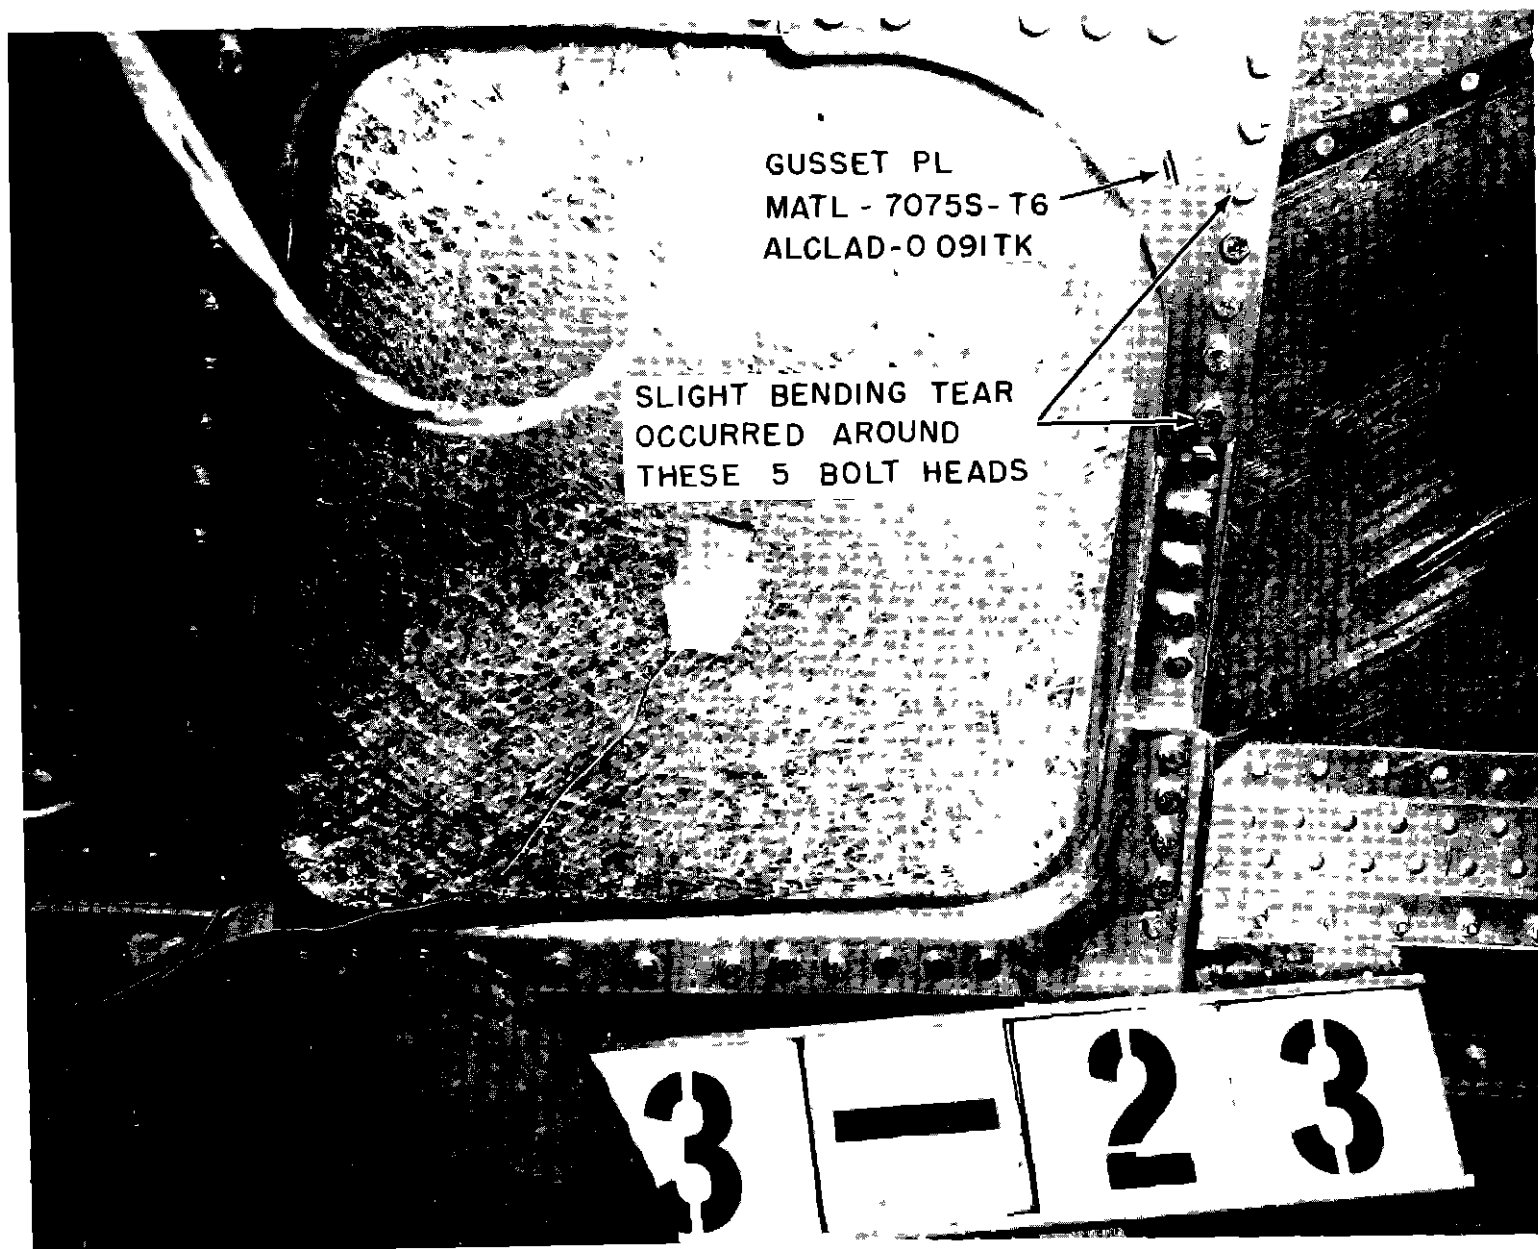
FIG 18 TEST 3-23 - COPILOT EYEBROW WINDOW INTERIOR VIEW -
PROJECTILE VELOCITY 397 MPH

FIG 19 TEST 3-23 - COPILOT EYEBROW WINDOW, EXTERIOR VIEW -
PROJECTILE VELOCITY 397 MPH

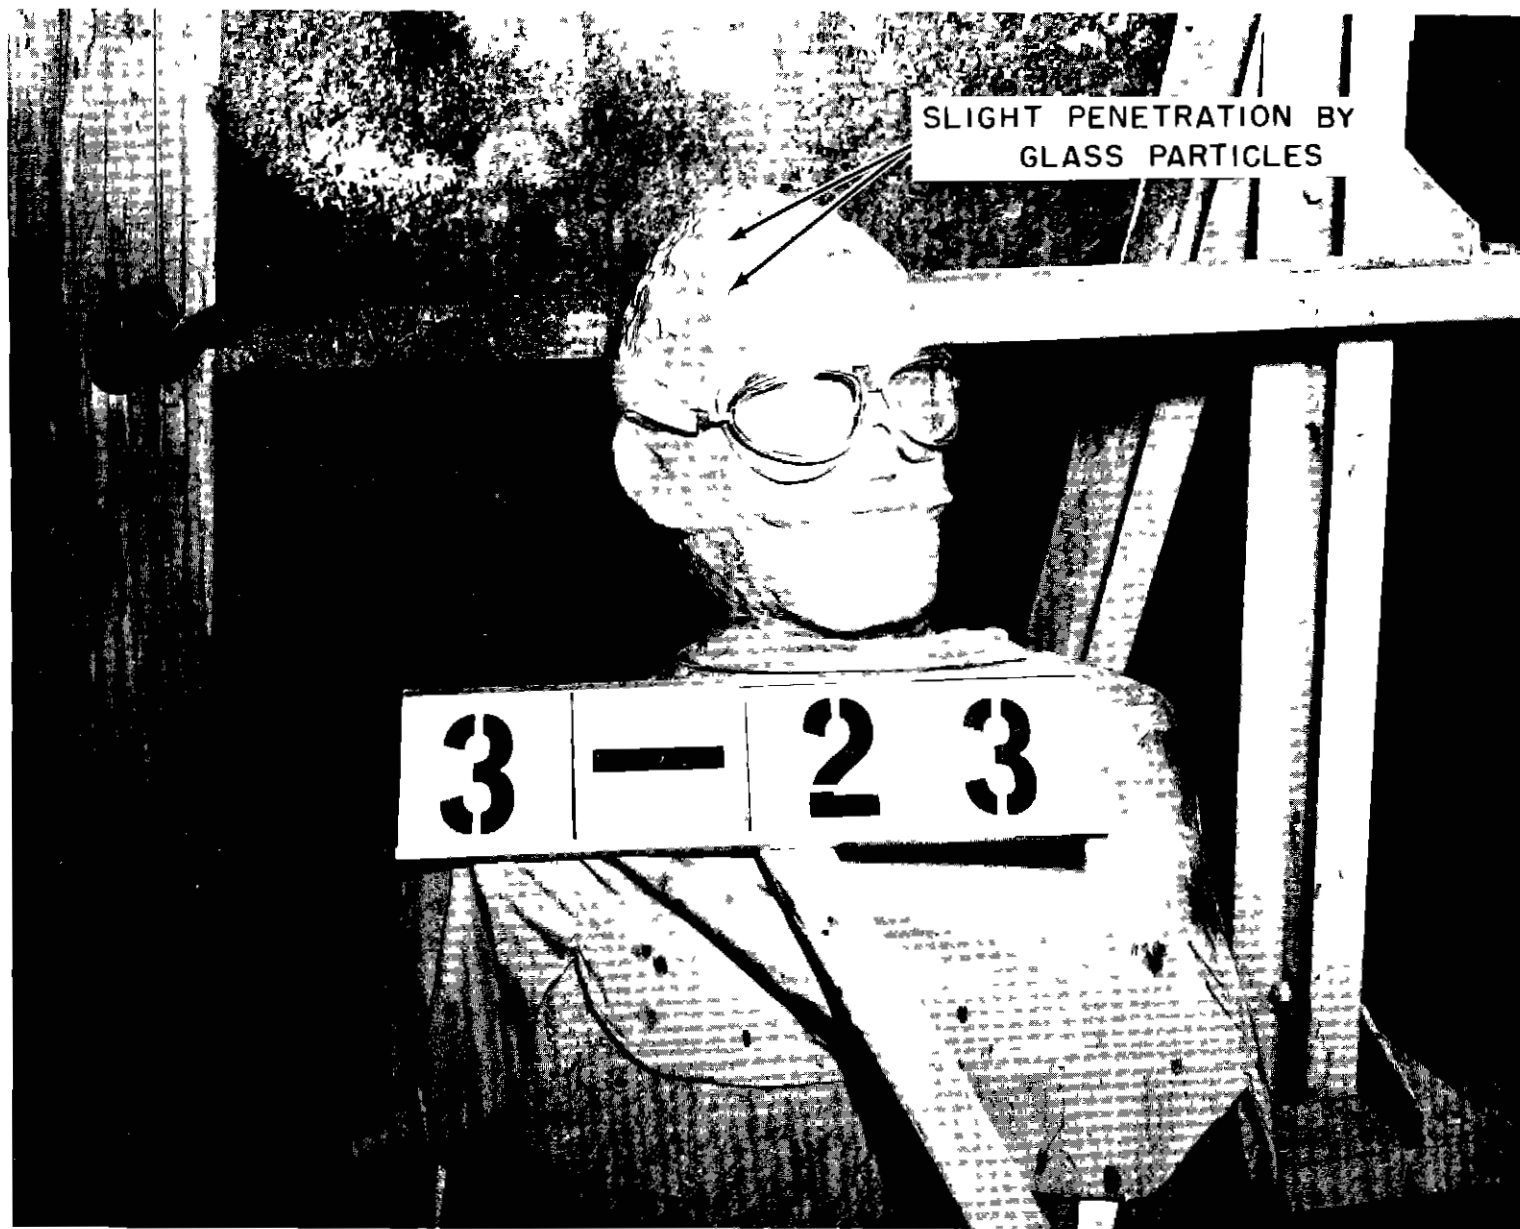
FIG 20 TEST 3-23 - COPILOT - PROJECTILE VELOCITY 397 MPH

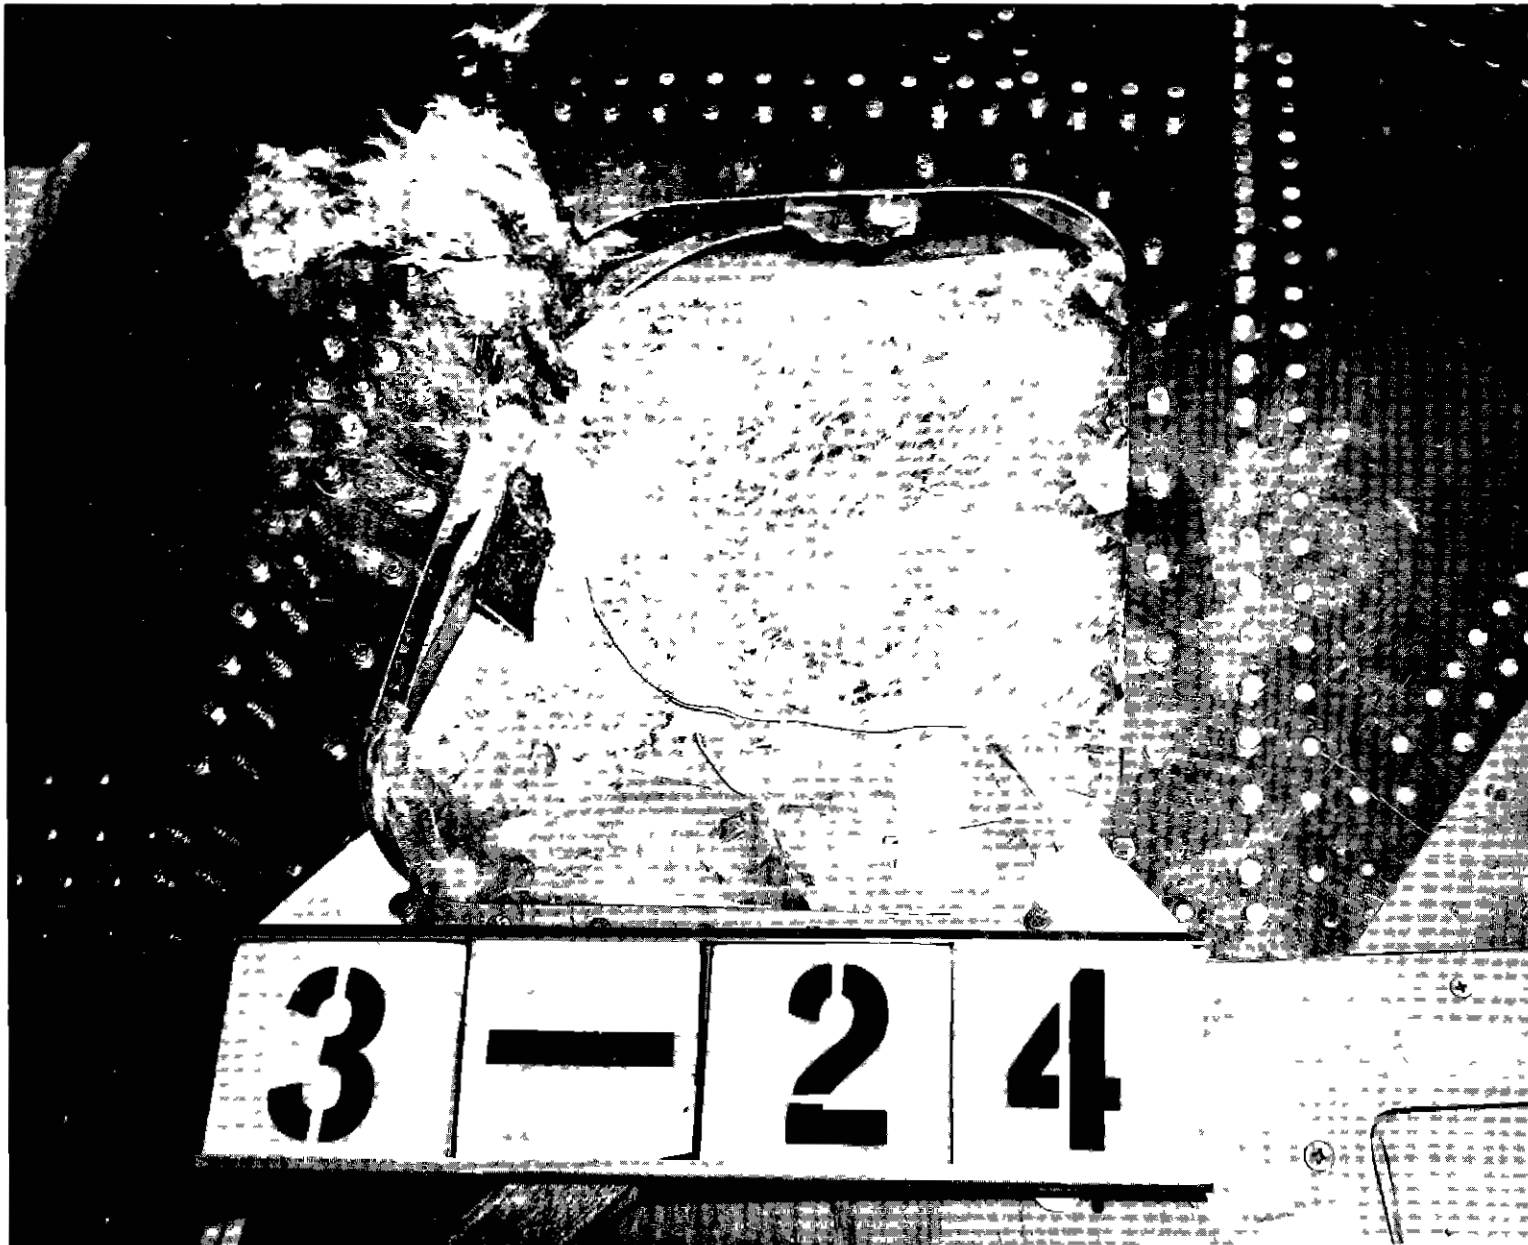
shattered and the skin and bolts retaining the panel were damaged, as shown in Fig. 21. There was no penetration of the interior panel although the vinyl interlayer delaminated for a 6-inch length along the aft sill, resulting in a slight tear in the vinyl. In addition, some bending tear occurred around the washers under the five lower bolt heads retaining the upper aft gusset plate. These two points of damage are shown in Fig. 22. Only a few particles of glass impinged upon the pilot's head. None penetrated the clay but merely adhered to it. The pilot is shown in Fig. 23.

FIG 21 TEST 3-24 - PILOT EYEBROW WINDOW, EXTERIOR WINDOW -
PROJECTILE VELOCITY 432 MPH

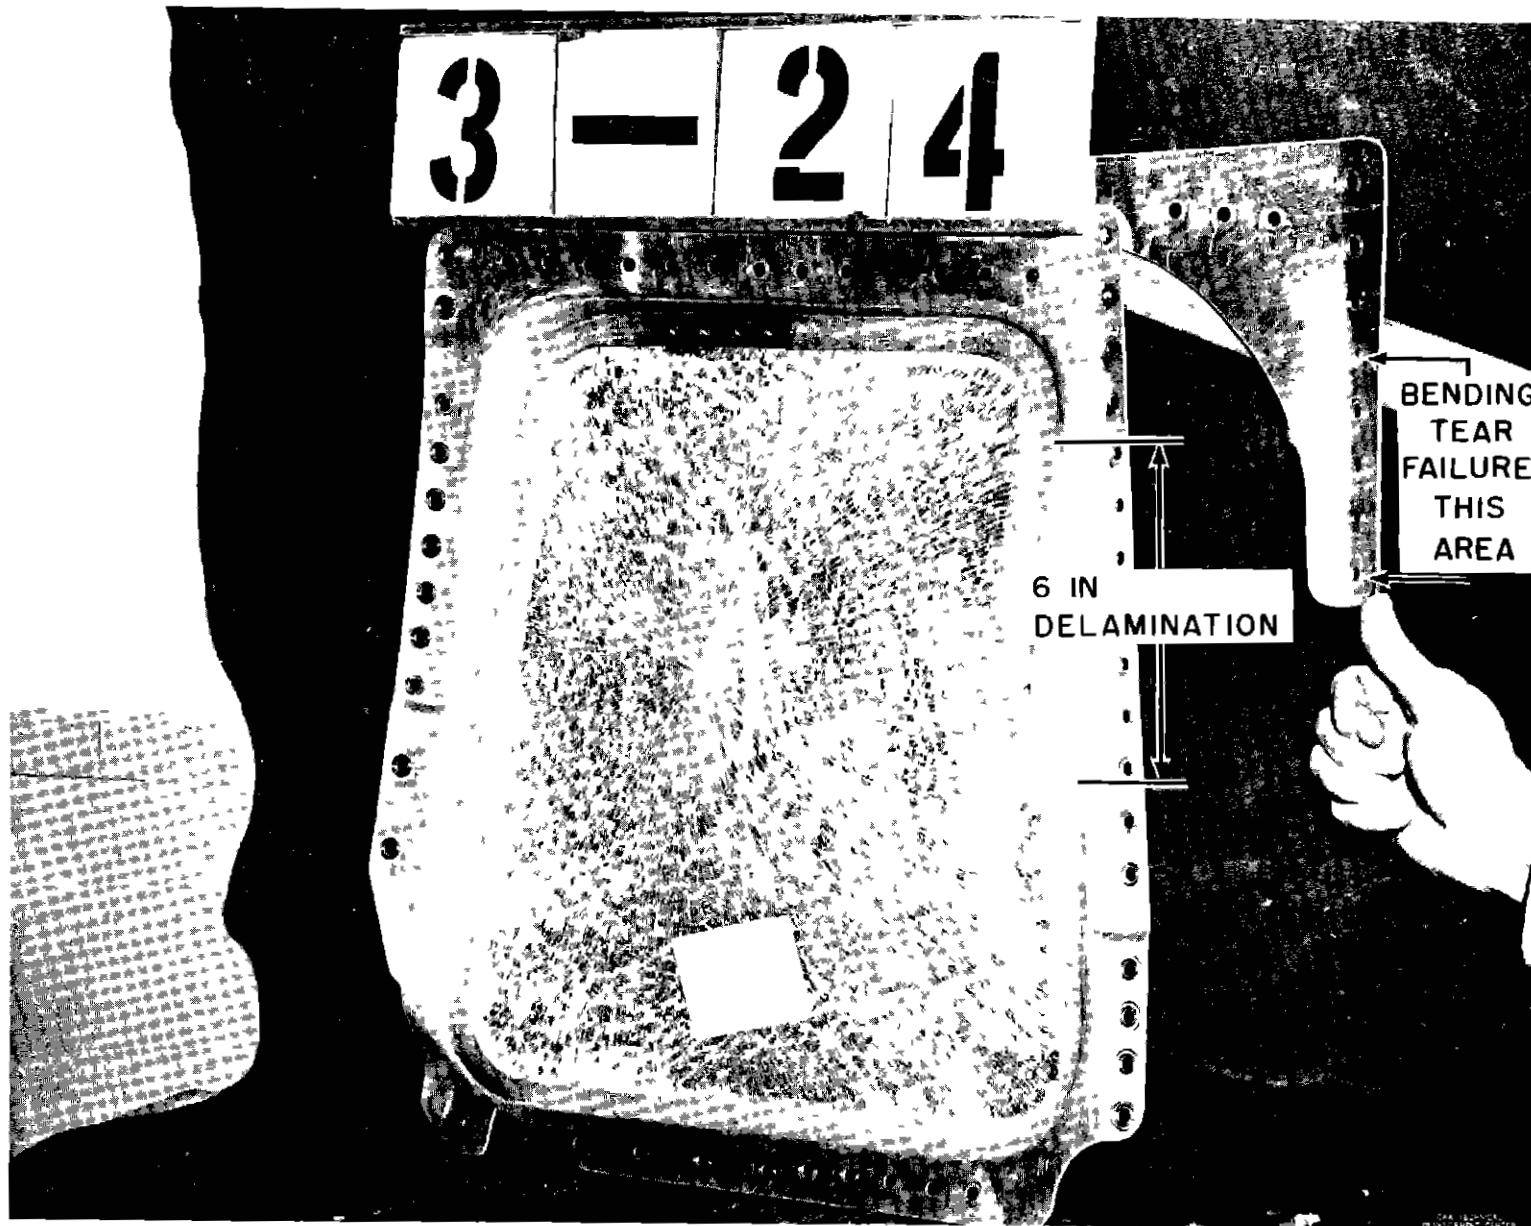
FIG 22 TEST 3-24 - PILOT EYEBROW WINDOW, INTERIOR PANEL -
PROJECTILE VELOCITY 432 MPH
