TECHNICAL DEVELOPMENT REPORT NO. 374

**Bird Impact Tests of the
Douglas Model DC-8 Airplane
Eyebrow And Clear-View Windows**

FEDERAL AVIATION AGENCY
TECHNICAL DEVELOPMENT CENTER
INDIANAPOLIS, INDIANA

BIRD IMPACT TESTS OF THE DOUGLAS MODEL DC-8 AIRPLANE EYEBROW AND CLEAR-VIEW WINDOWS

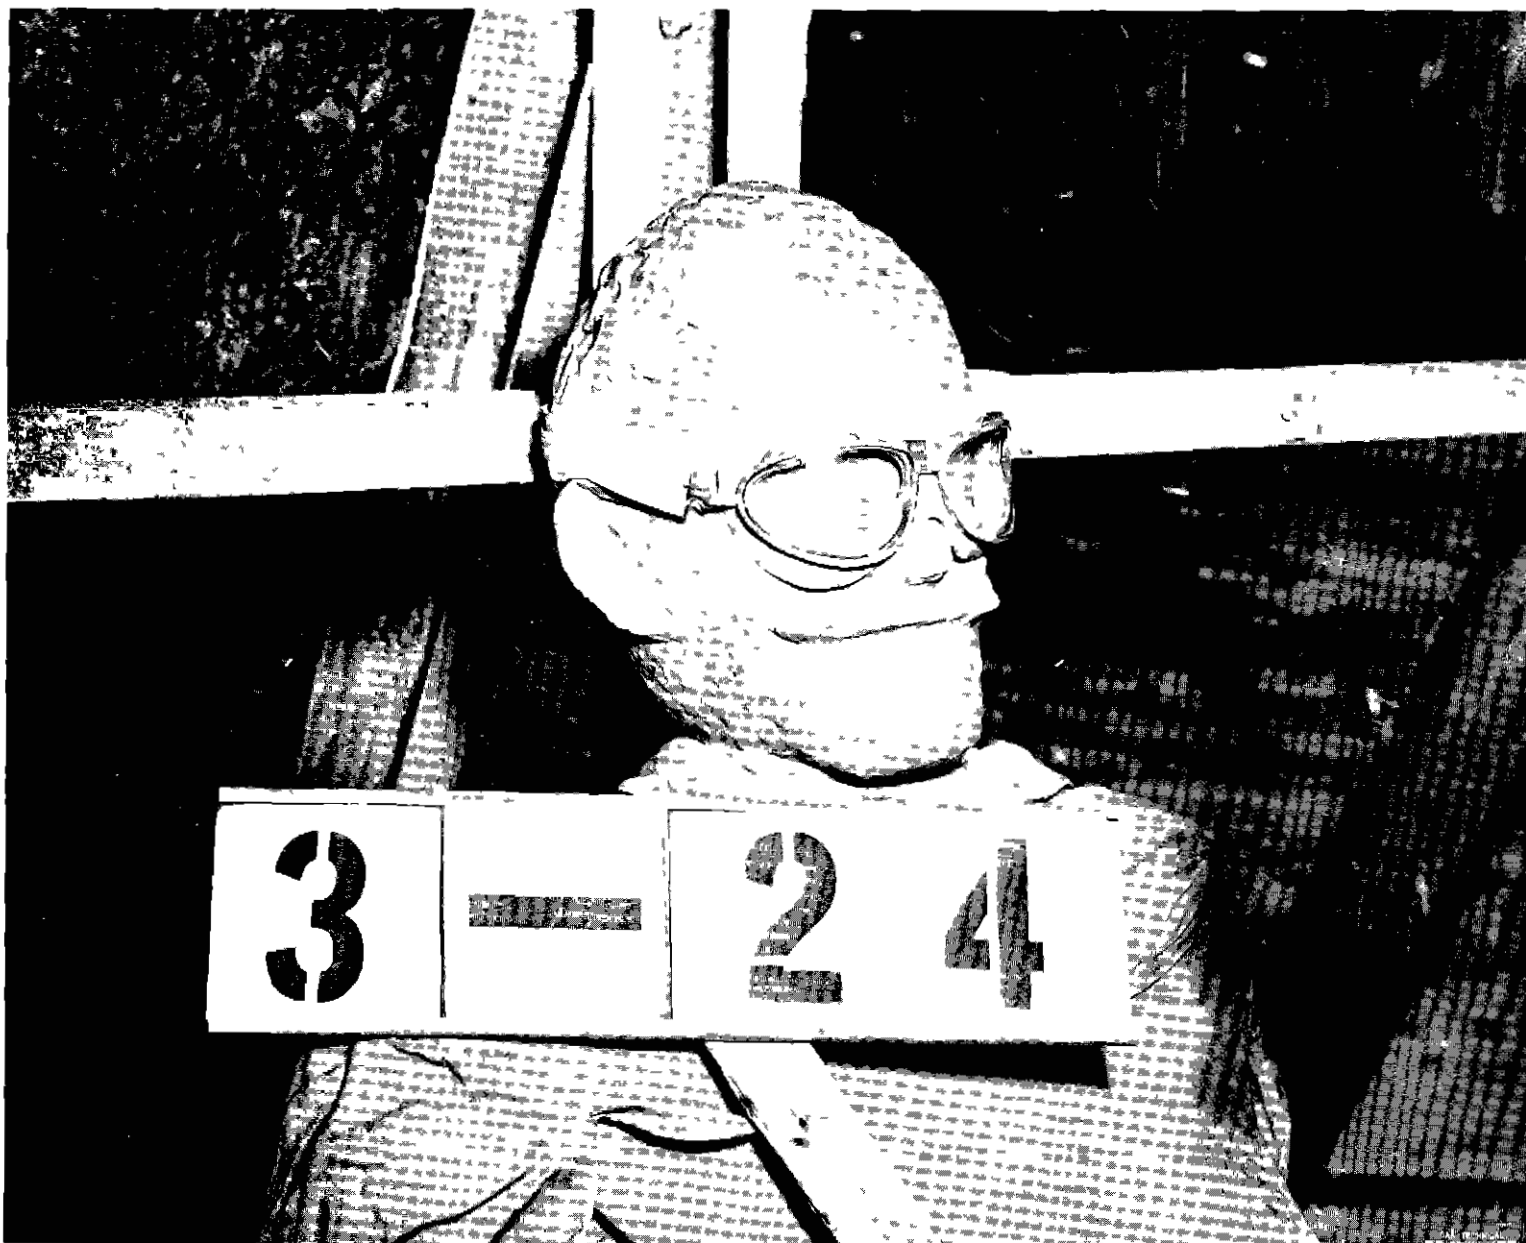
shattered and the skin and bolts retaining the panel were damaged, as shown in Fig. 21. There was no penetration of the interior panel although the vinyl interlayer delaminated for a 6-inch length along the aft sill, resulting in a slight tear in the vinyl. In addition, some bending tear occurred around the washers under the five lower bolt heads retaining the upper aft gusset plate. These two points of damage are shown in Fig. 22. Only a few particles of glass impinged upon the pilot's head. None penetrated the clay but merely adhered to it. The pilot is shown in Fig. 23.

FIG 23 TEST 3-24 - PILOT - PROJECTILE VELOCITY 432 MPH

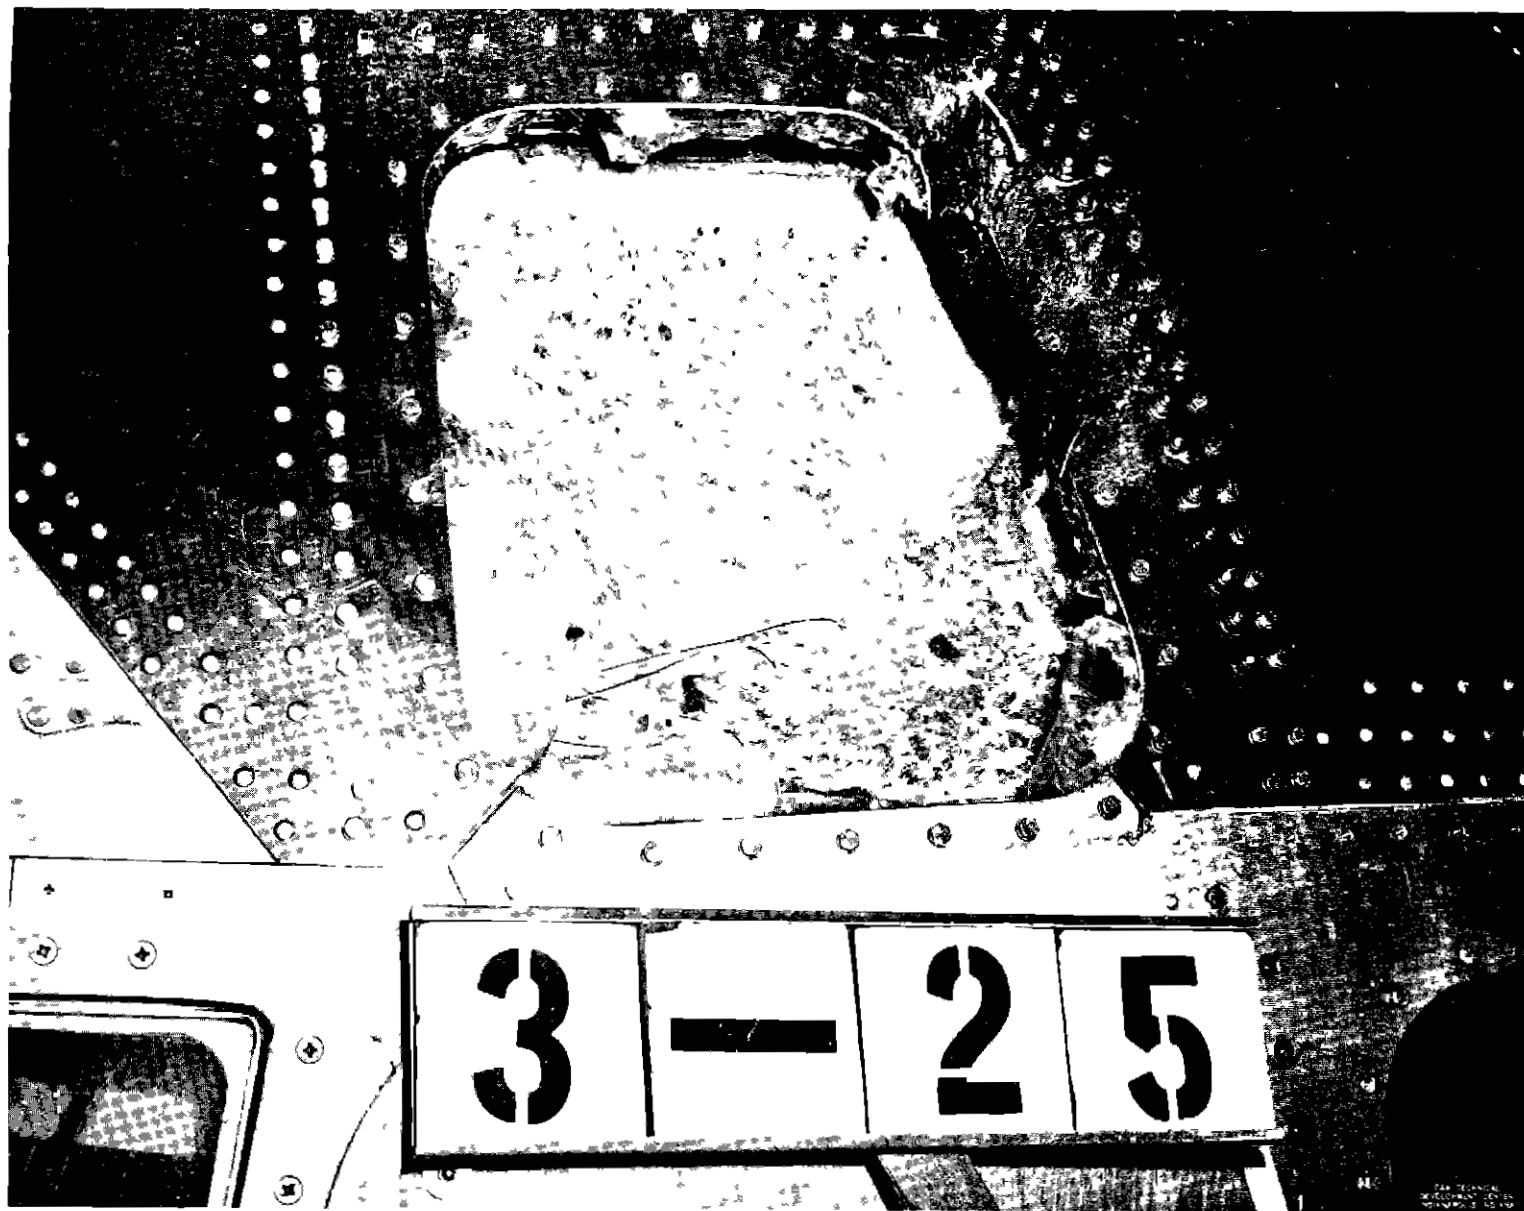
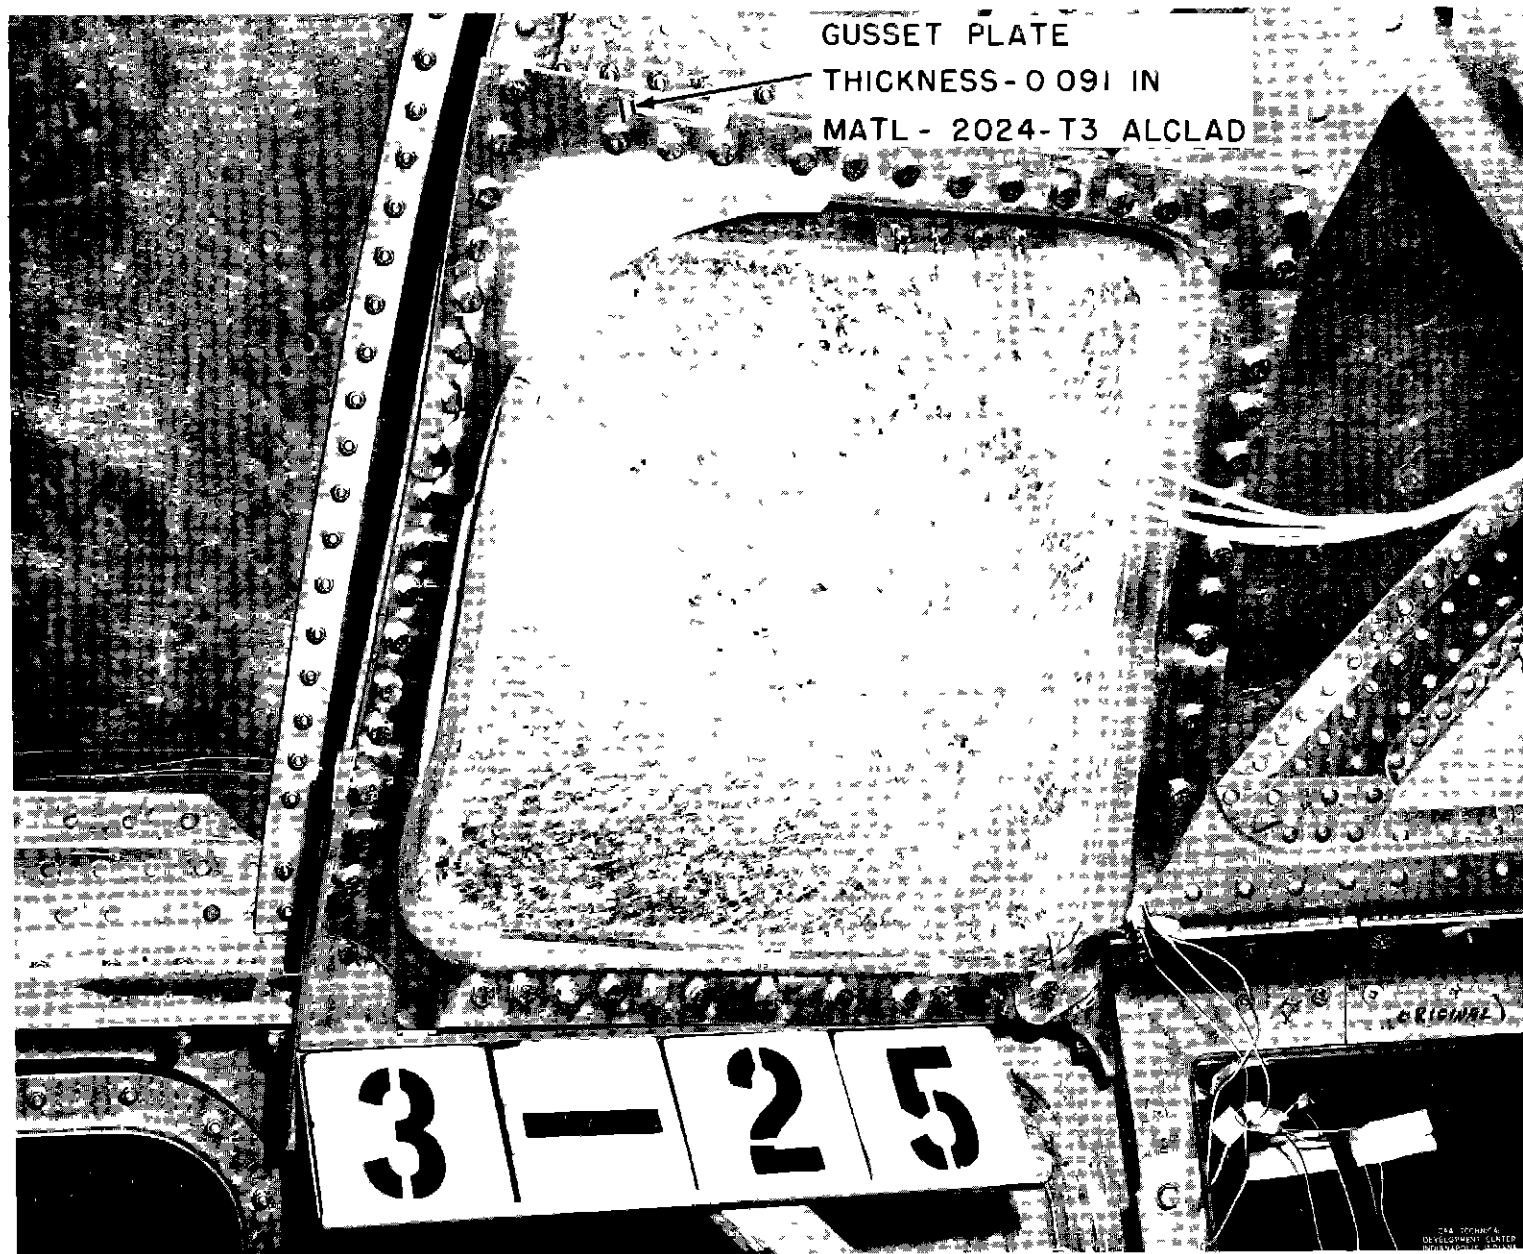
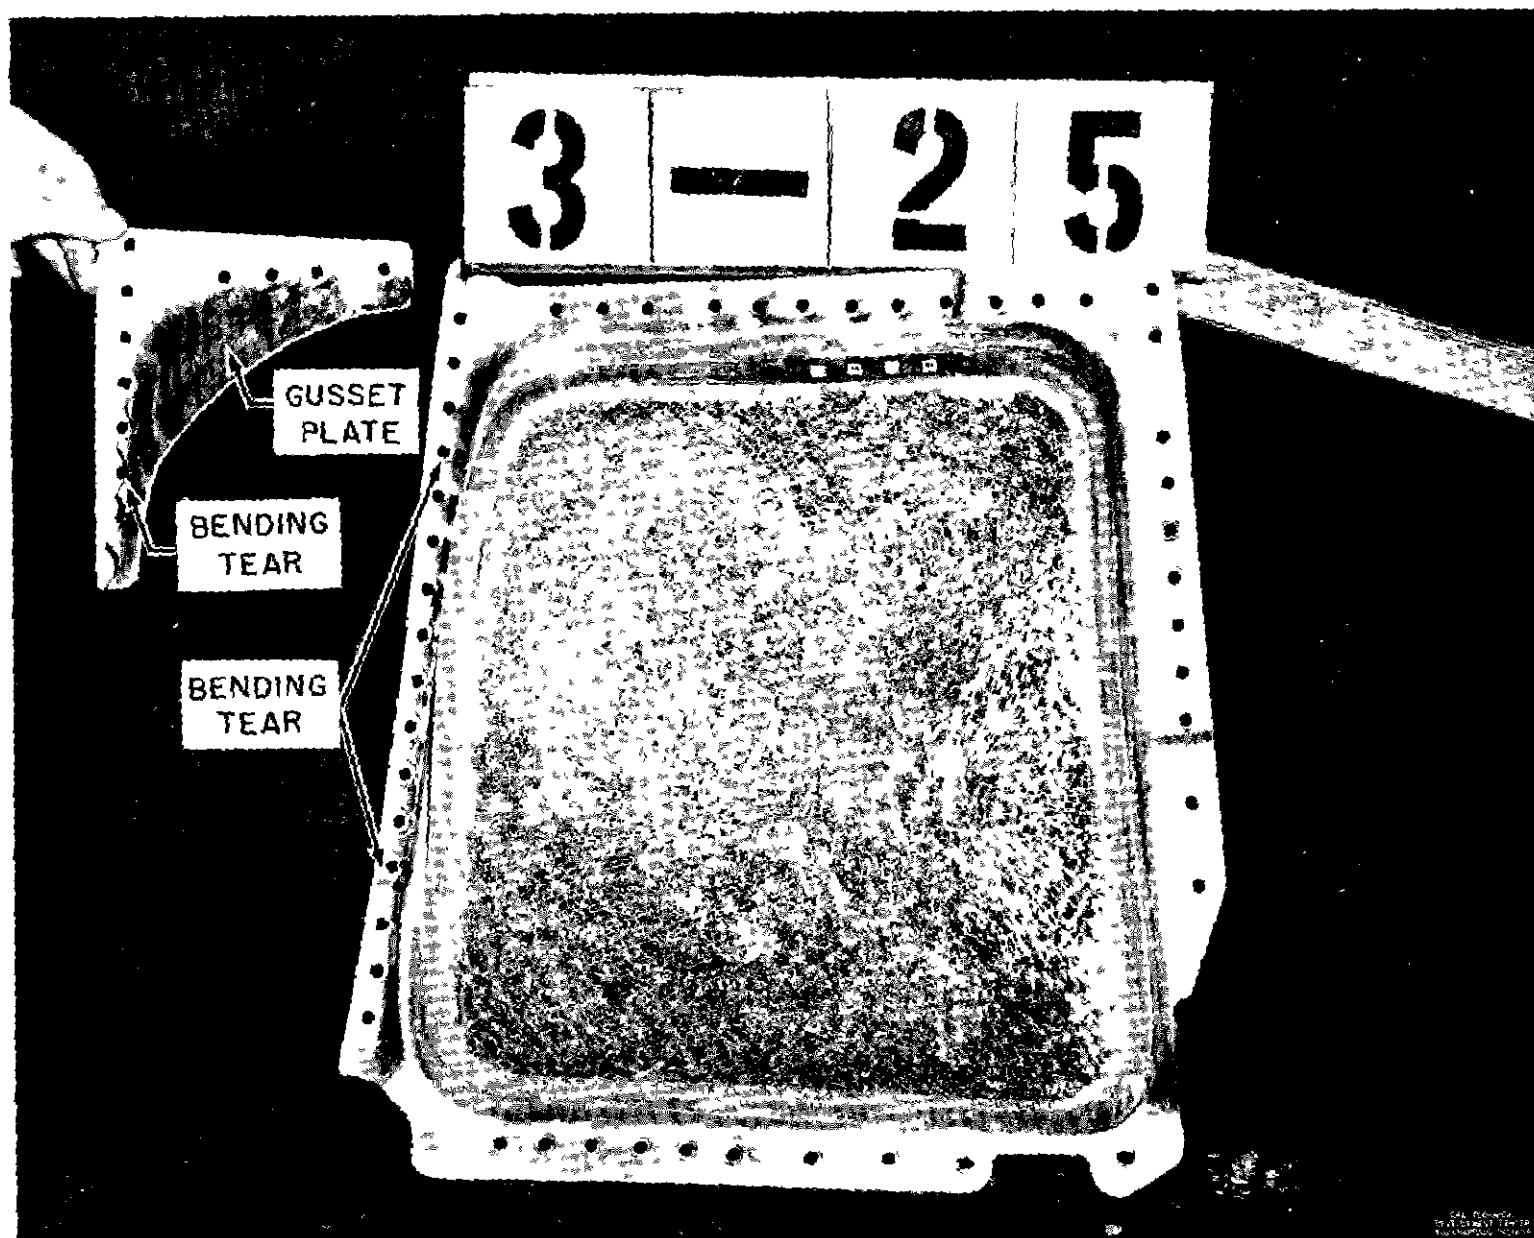
This test involved the pilot's eyebrow window. Modifications to the window supporting structure were identical to those of the preceding test. The carcass struck 3 inches forward and 2 inches below the target point. The exterior stretched Plex-55 panel was shattered and five bolts helping to retain the outer window failed in tension and bending as shown in Fig. 24. There was no penetration of the interior panel. See Fig. 25. A bending tear occurred around the 5 lower bolts bearing against the reinforcing gusset plate and around 11 bolts bearing against the aft window bolting edge. This is shown in Fig. 26. The interior panel vinyl interlayer delaminated for a length of 9 inches along the inner surface of the aft edge metal insert. The band between the metal insert and vinyl along the outer surface of the aft edge of the panel remained intact. A few particles of glass impinged upon the upper and back left side of the pilot's head. One sliver of glass about 1/4-inch long by 1/8-inch square at the large end penetrated the clay approximately 1/16-inch in this area. See Fig. 26A.

FIG 24 TEST 3-25 - PILOT EYEBROW WINDOW, EXTERIOR VIEW -
PROJECTILE VELOCITY 485 MPH

FIG 25 TEST 3-25 - PILOT EYEBROW WINDOW, INTERIOR VIEW -
PROJECTILE VELOCITY 485 MPH

FIG 26 TEST 3-25 - PILOT EYEBROW WINDOW, INTERIOR PANEL -
PROJECTILE VELOCITY 485 MPH

- b The upper and aft metal insert edge of the interior window is strengthened to equal that obtained by incorporating a 0.091-inch-thick 2024S-T3 gusset plate, as shown in Figs 24 and 26

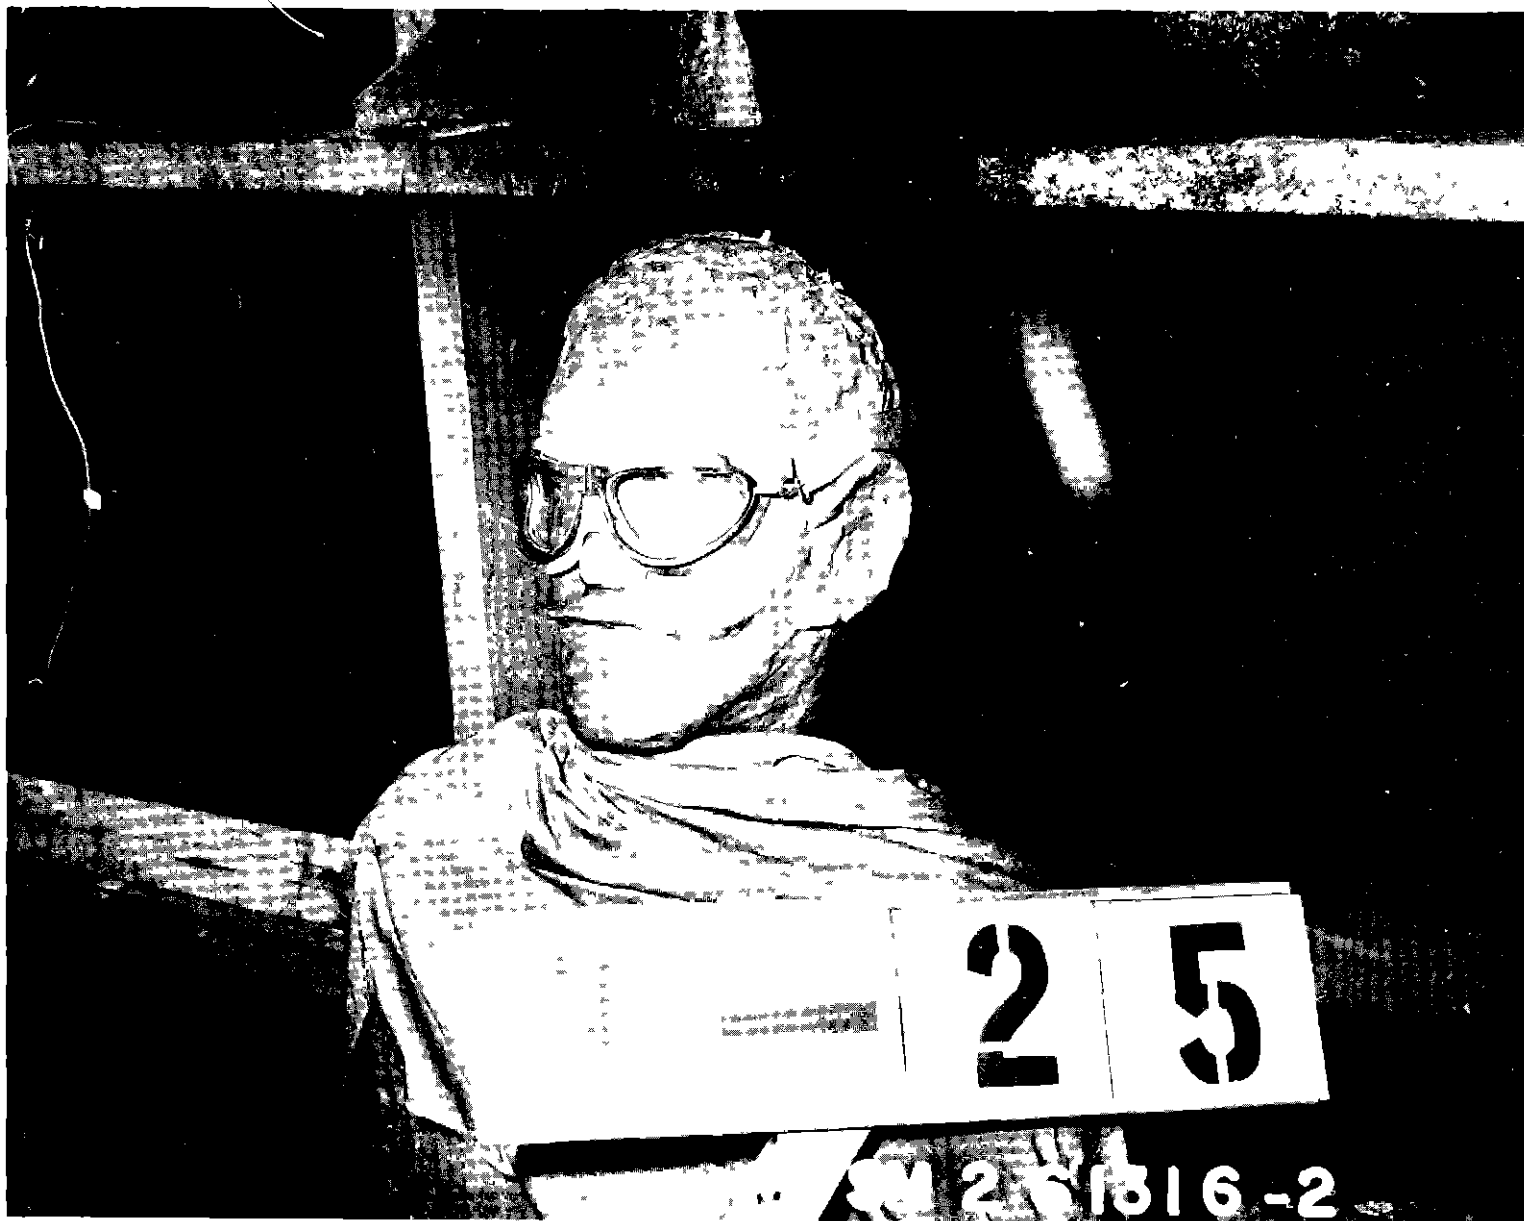
FIG 26A TEST 3-25 - PILOT - PROJECTILE VELOCITY 485 MPH

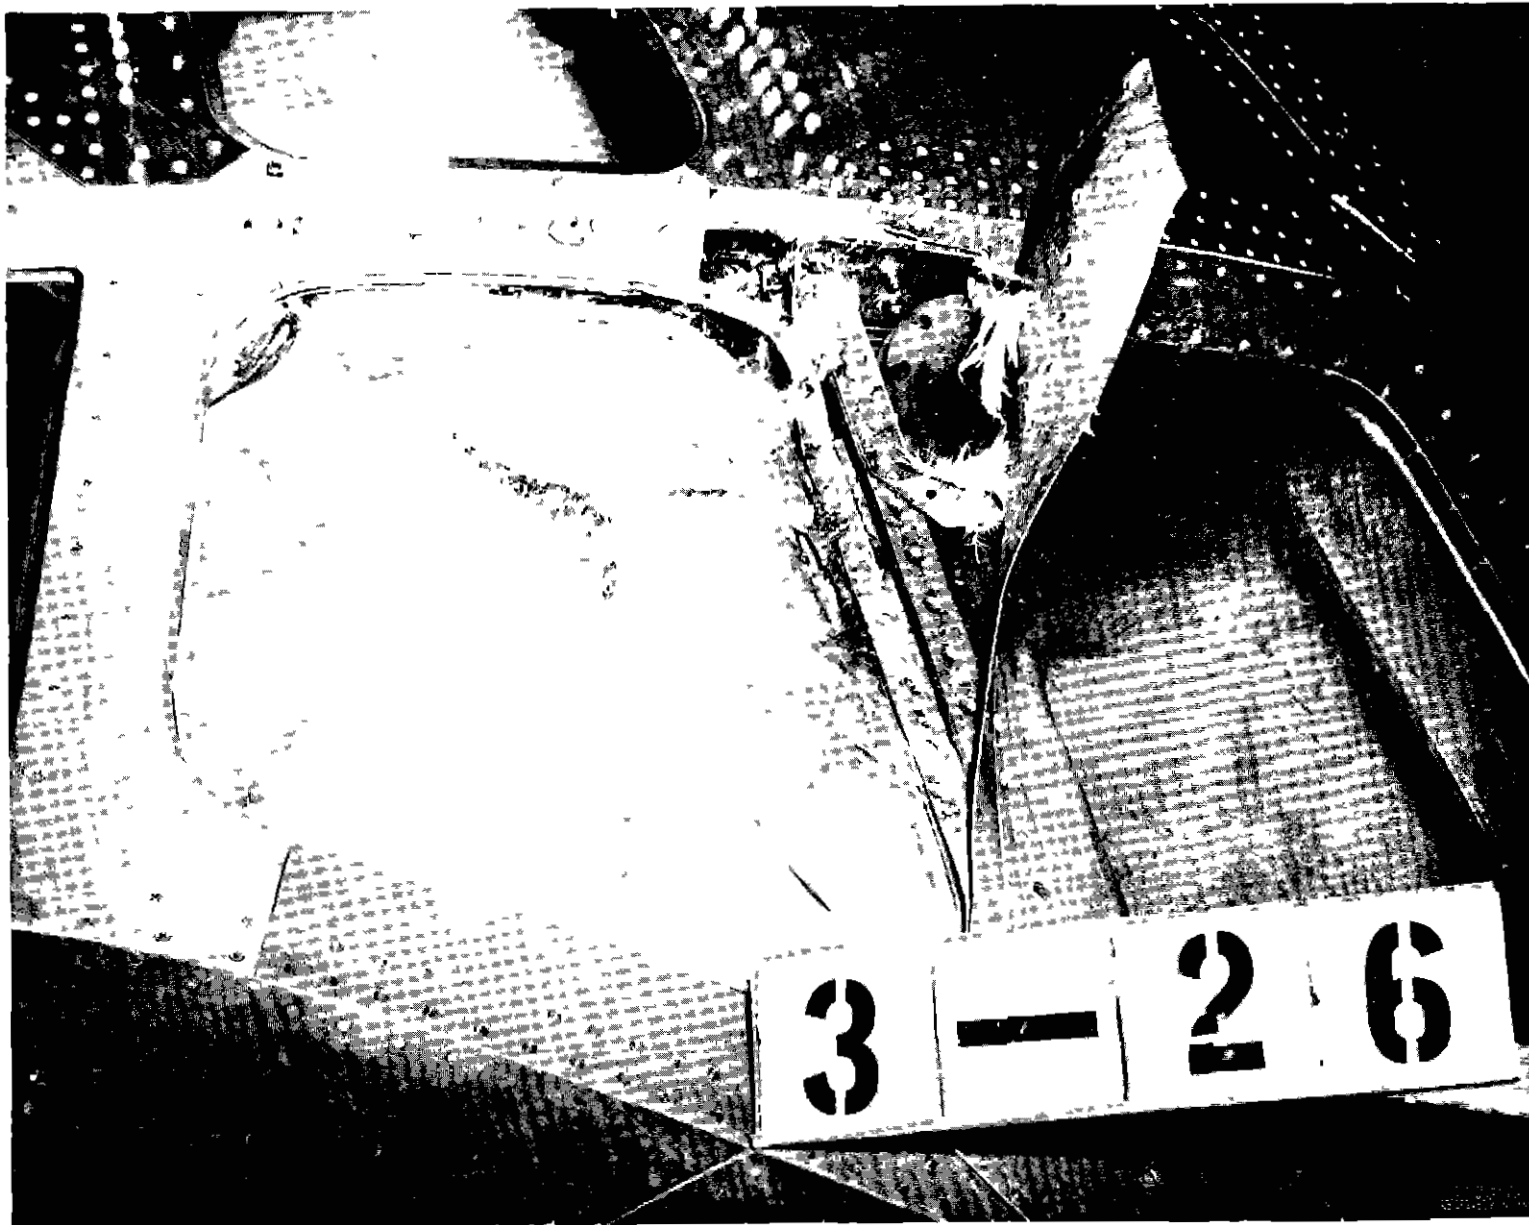
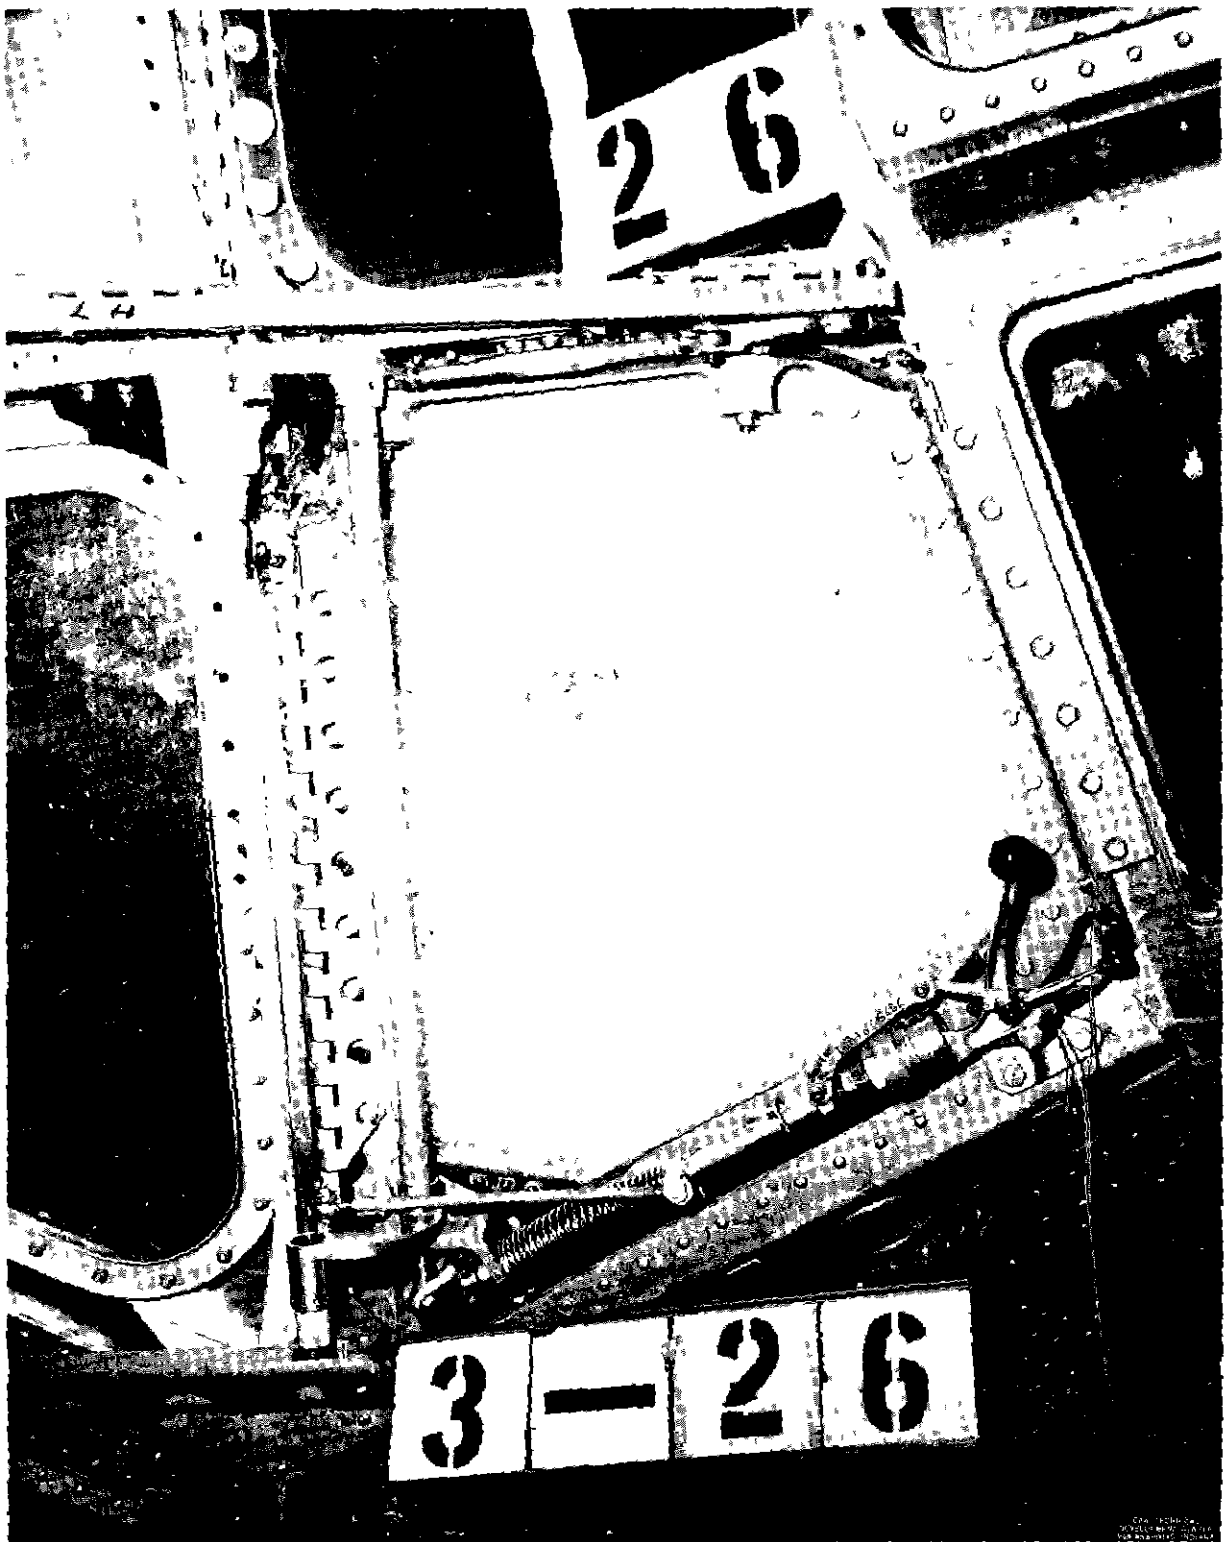
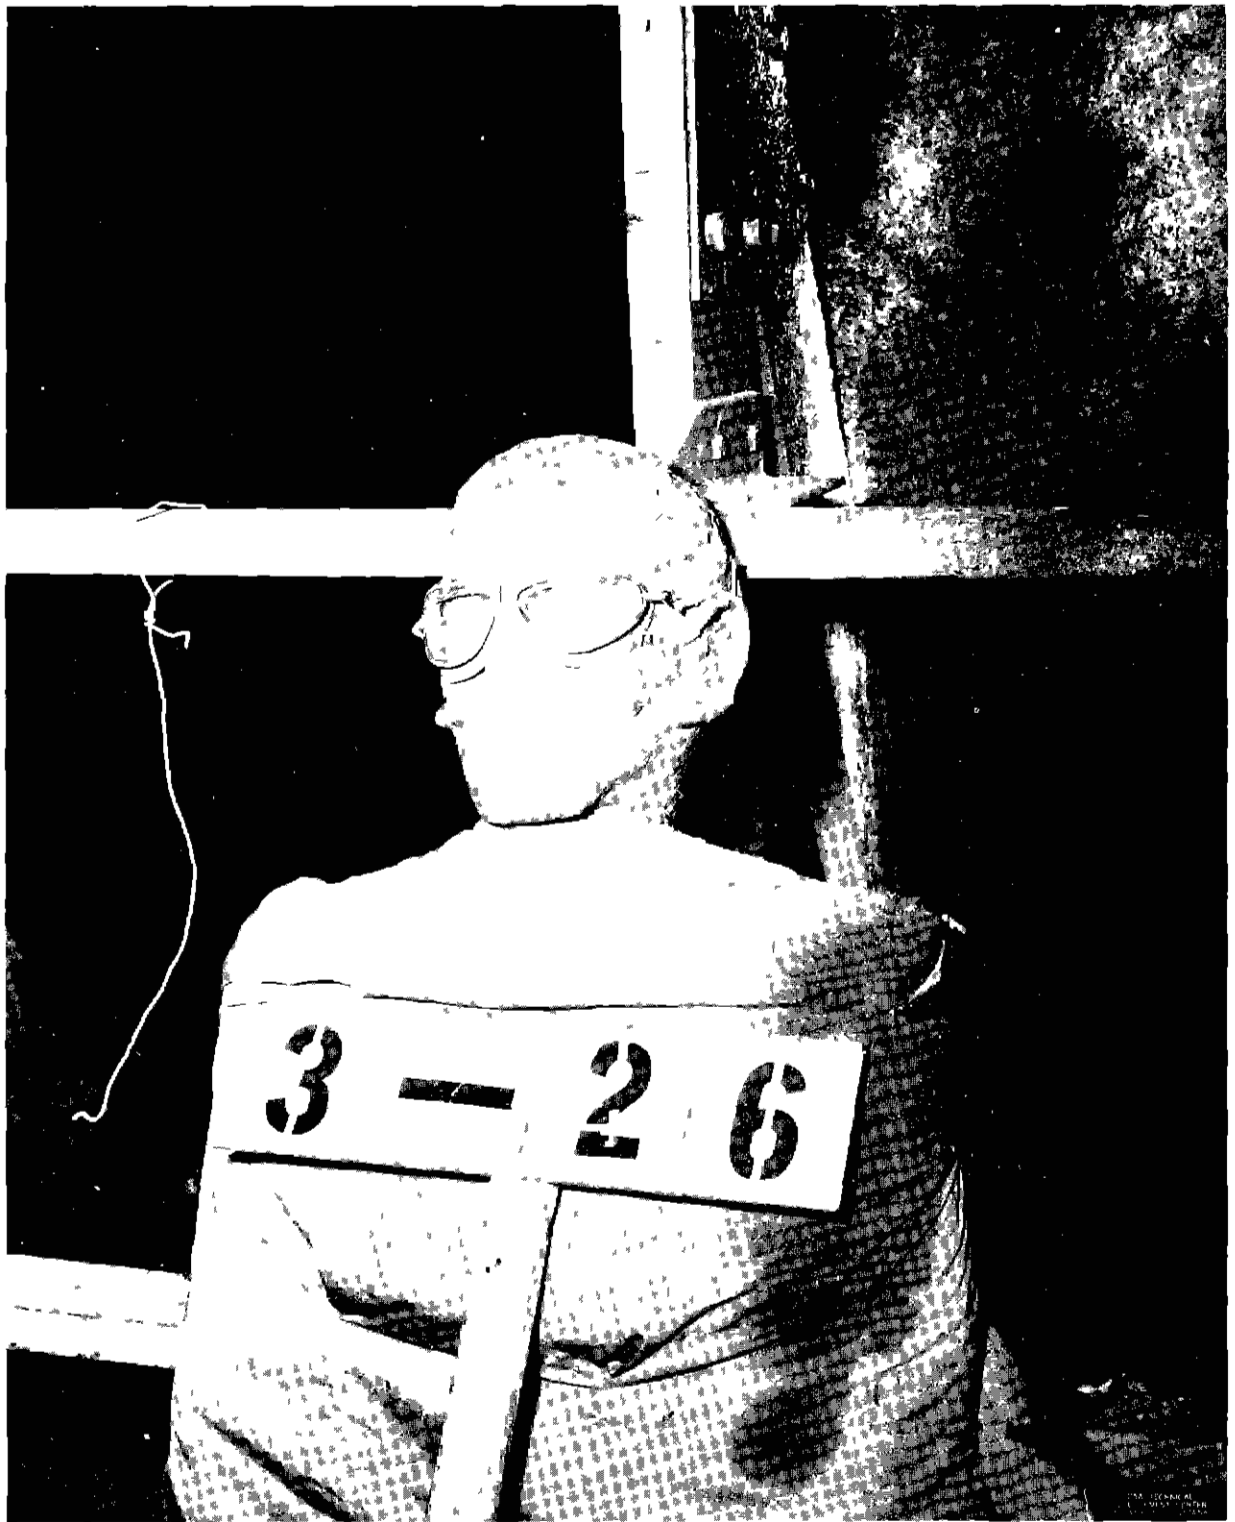
This test involved the pilot's clear-view window. The bird carcass struck the target point shattering the exterior stretched Plex-55 panel and the hydraulic pressure rolled back the aft sill doubler plate, as shown in Fig. 27. Eighteen fasteners retaining the doubler plate failed by forming tuliped heads which allowed them to pull through the doubler material. This action allowed a relatively small part of the bird carcass to enter the cockpit area aft of the pilot position. There was no penetration of the interior window as shown in Fig. 28. The amount and velocity of the glass particles departing from the inner face of the interior window was low. None of these particles penetrated either the pilot's head or clothing although a few particles of bird carcass impinged upon the pilot as shown in Fig. 29. The latching mechanism for the window remained fastened and was operable immediately after the test.

FIG 27 TEST 3-26 - PILOT CLEAR-VIEW WINDOW, EXTERIOR VIEW -
PROJECTILE VELOCITY 430 MPH

FIG 28 TEST 3-26 - PILOT CLEAR-VIEW WINDOW, INTERIOR VIEW -
PROJECTILE VELOCITY 430 MPH

FIG 29 TEST 3-26 - PILOT - PROJECTILE VELOCITY 430 MPH

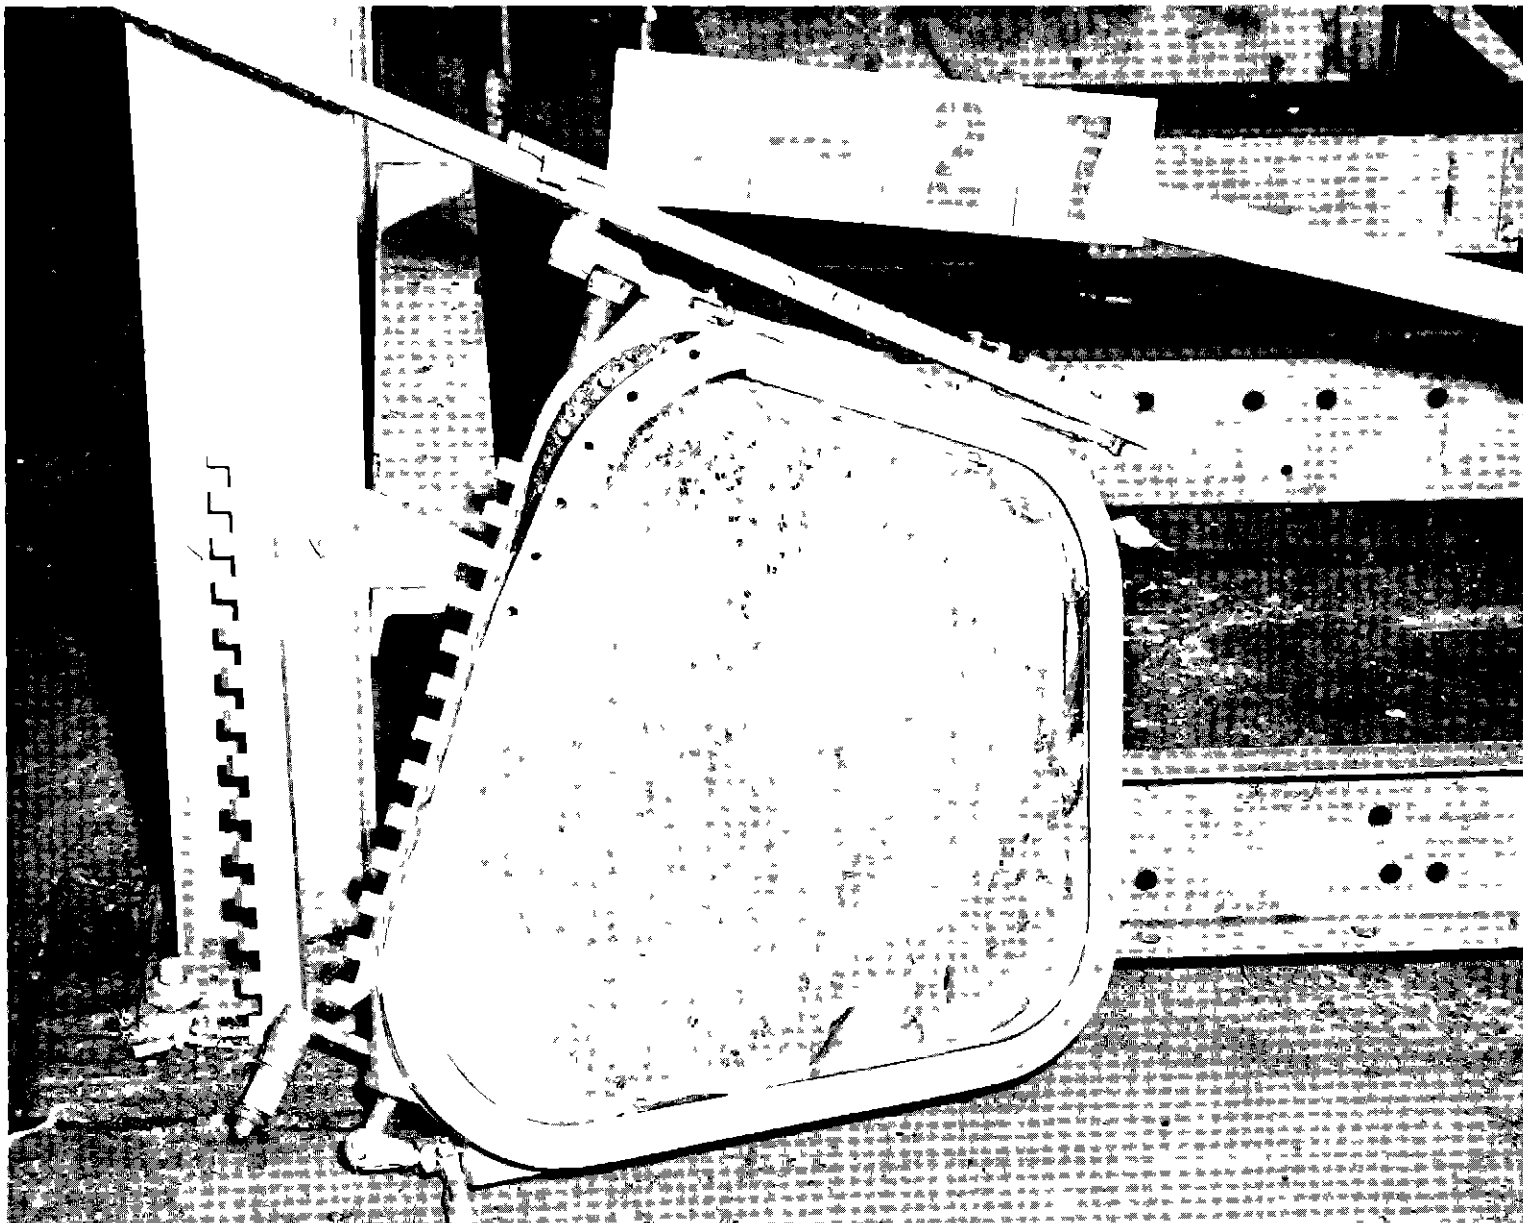
This test involved the copilot's clear-view window. The bird carcass hit approximately 3 inches forward of the target point. Upon impact, the exterior panel shattered and the interior panel remained intact, as shown in Fig. 30. The force of the impact loaded the aft window hook in such a manner that the 0.130-inch steel hinge pin failed in shear. As expected, the high-speed movies of the test indicated that failure occurred initially at the upper end of the hinge and progressed rapidly

FIG 30 TEST 3-27 - COPILOT CLEAR-VIEW WINDOW, EXTERIOR PANEL -
PROJECTILE VELOCITY 485 MPH

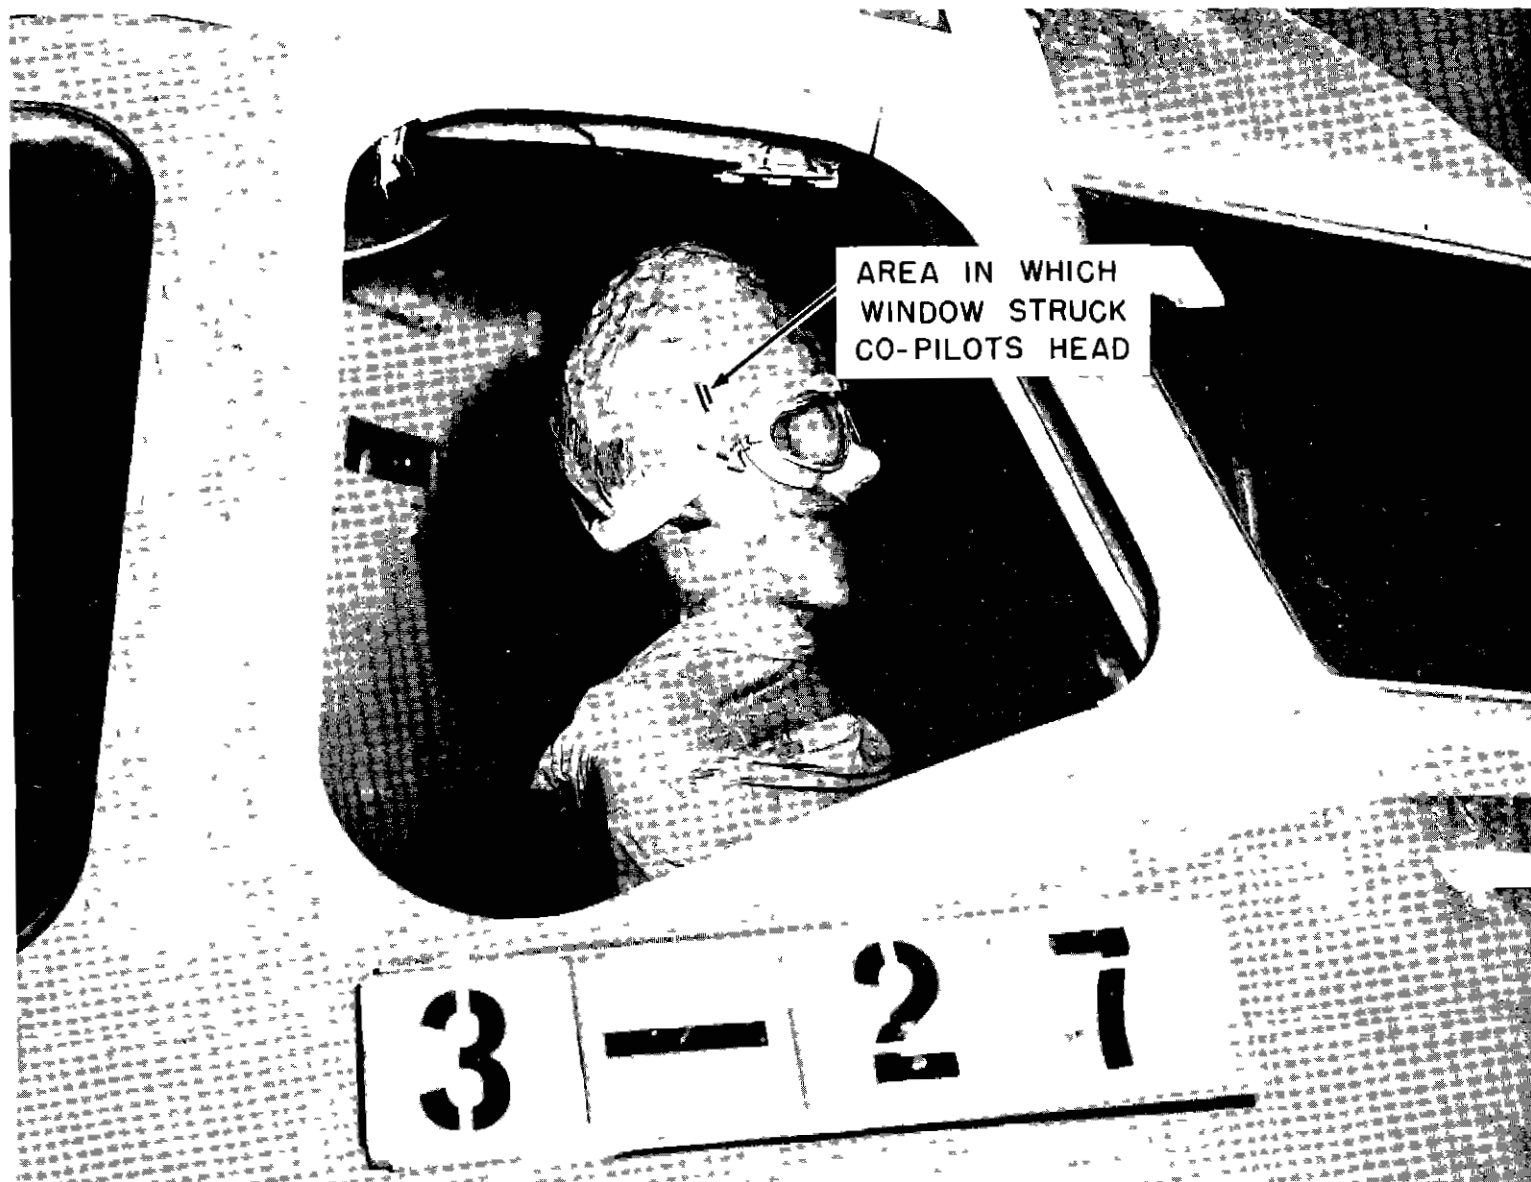
downward zipper fashion. This allowed the upper sill hook to unlatch and the window was forced inward striking the copilot a severe blow on the right side of the head, as shown in Fig. 31. The hook hinge halves were not damaged, however. The final disposition of the window and associated parts is shown in Fig. 32.

FIG 31 TEST 3-27 - COPILOT CLEAR-VIEW WINDOW, EXTERIOR VIEW -
PROJECTILE VELOCITY 485 MPH

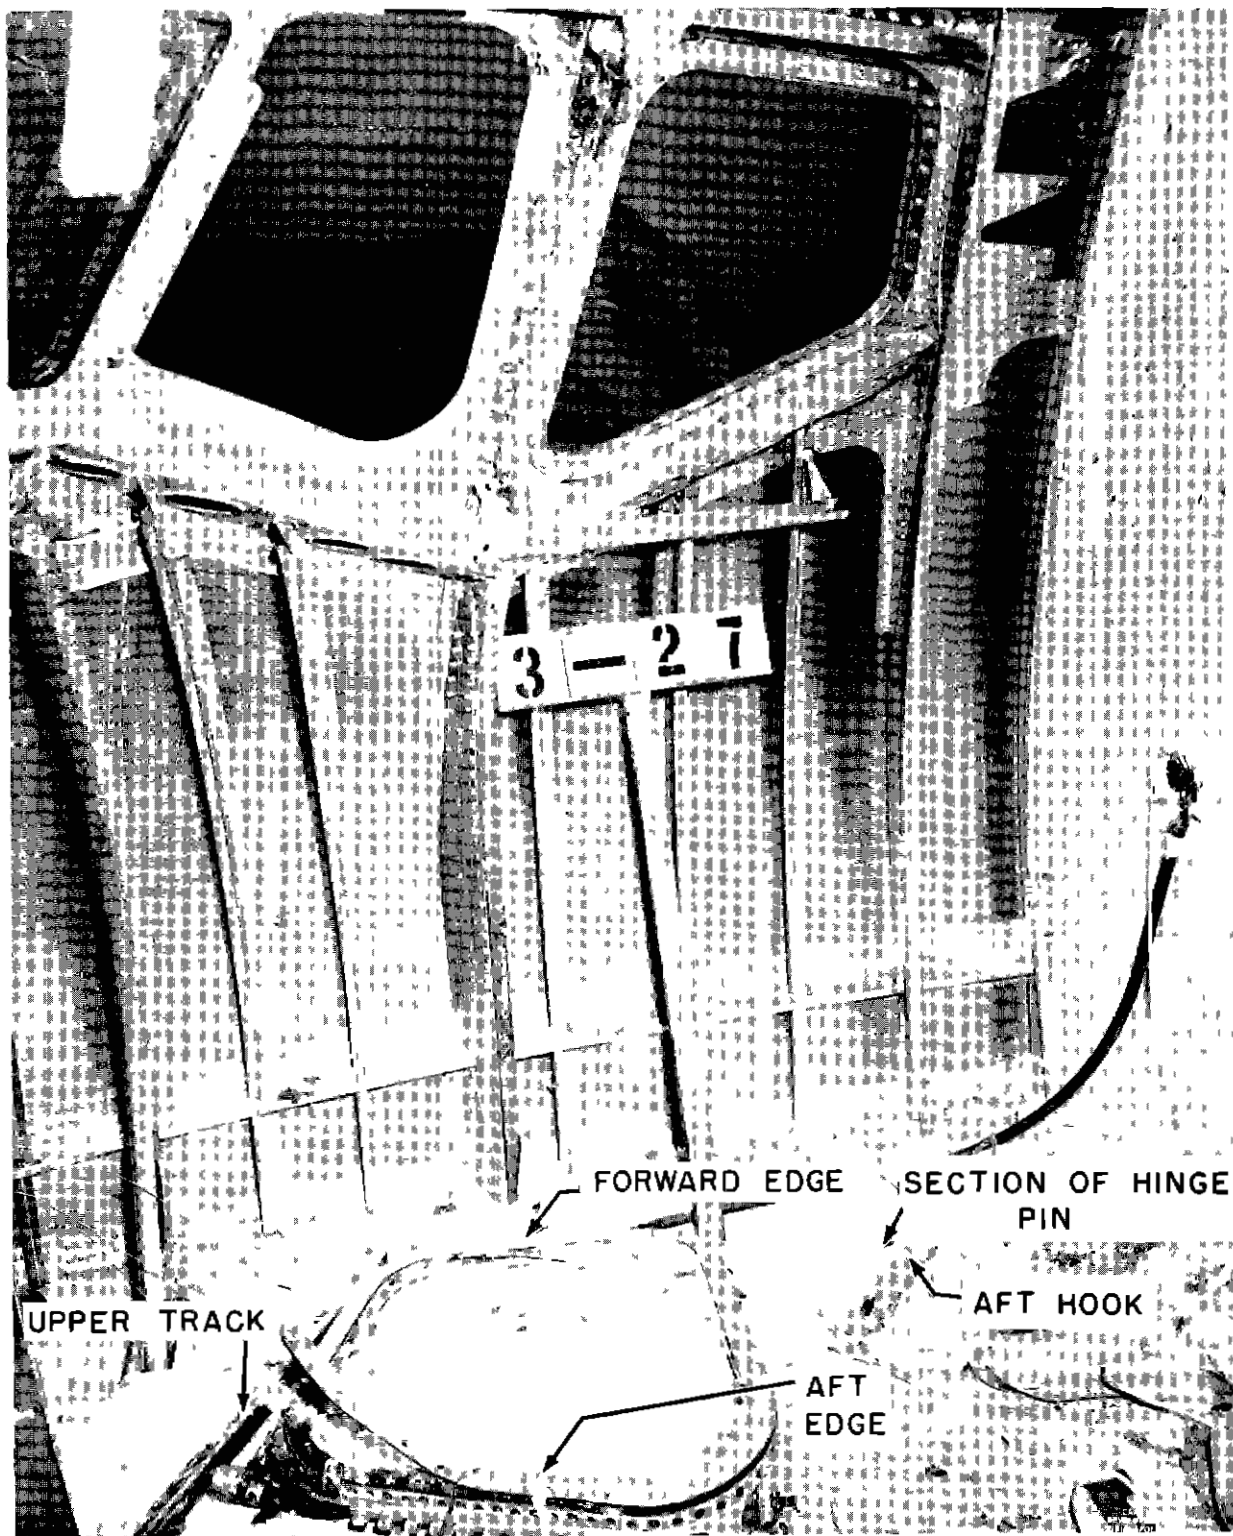
FIG 32 TEST 3-27 - COPILOT CLEAR-VIEW WINDOW, EXTERIOR VIEW -
PROJECTILE VELOCITY 485 MPH
