TECHNICAL DEVELOPMENT REPORT NO. 374

**Bird Impact Tests of the
Douglas Model DC-8 Airplane
Eyebrow And Clear-View Windows**

FEDERAL AVIATION AGENCY
TECHNICAL DEVELOPMENT CENTER
INDIANAPOLIS, INDIANA

BIRD IMPACT TESTS OF THE DOUGLAS MODEL DC-8 AIRPLANE EYEBROW AND CLEAR-VIEW WINDOWS

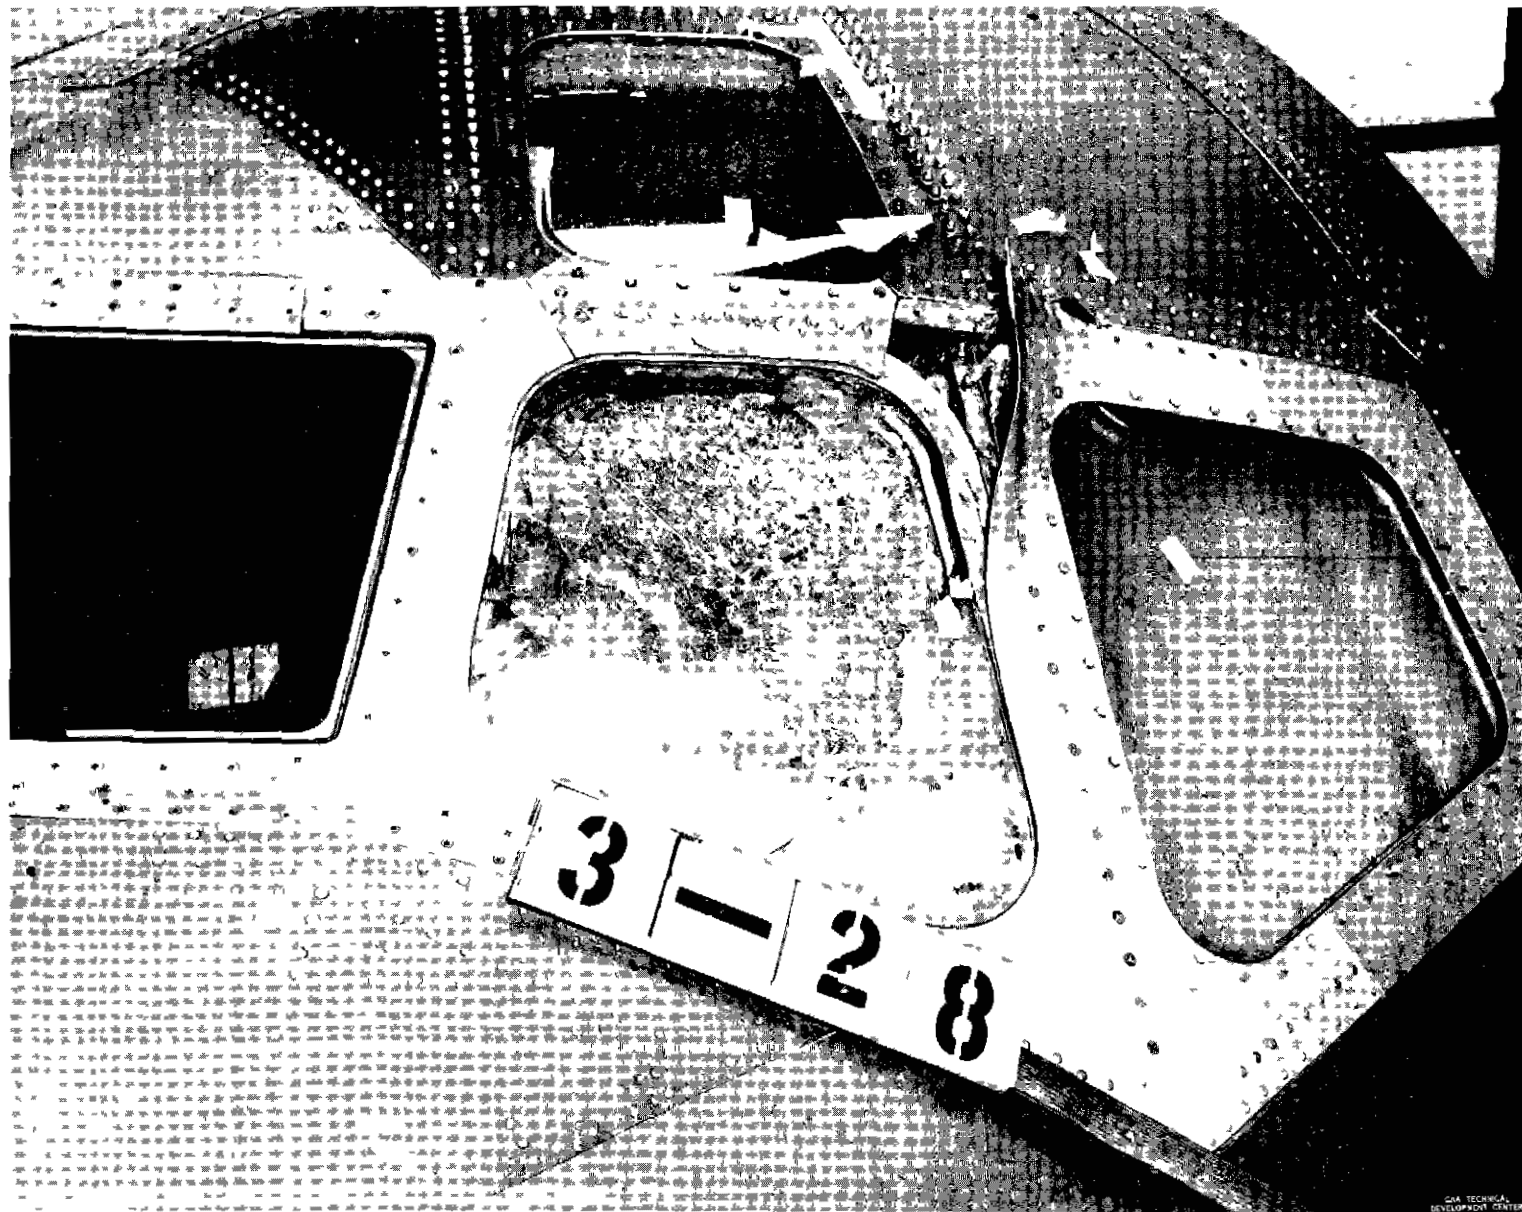
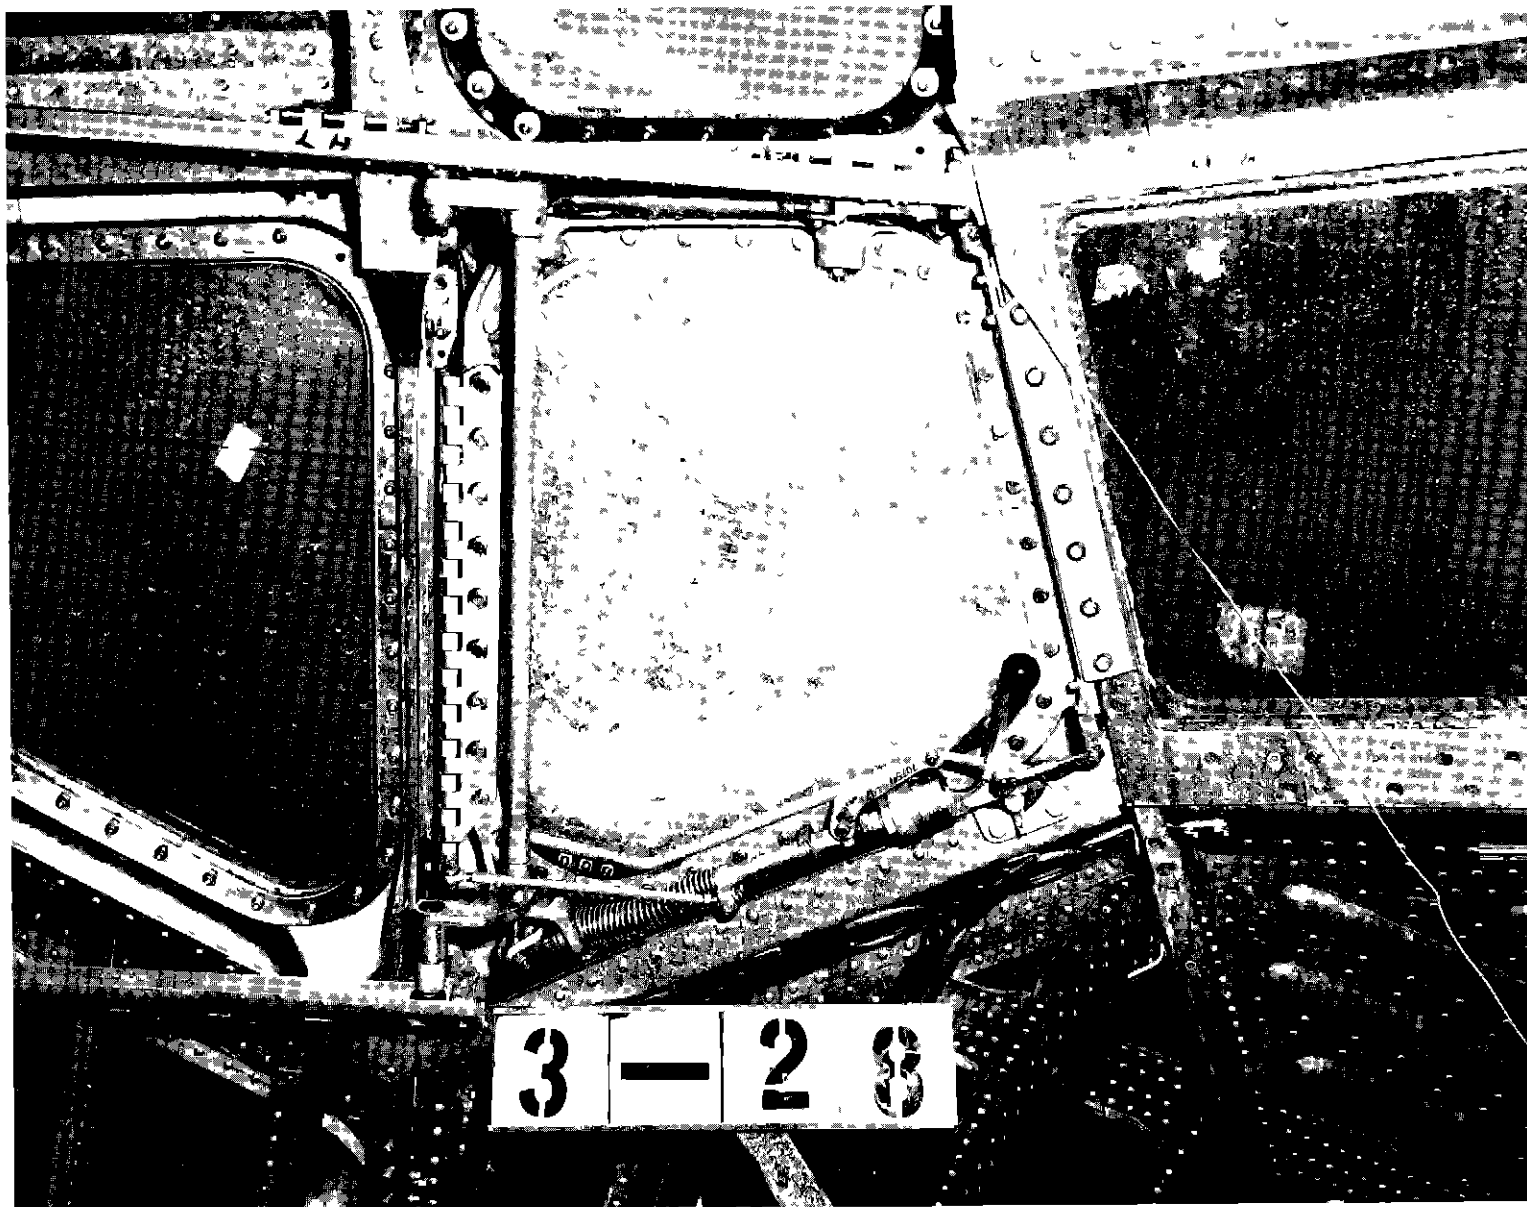
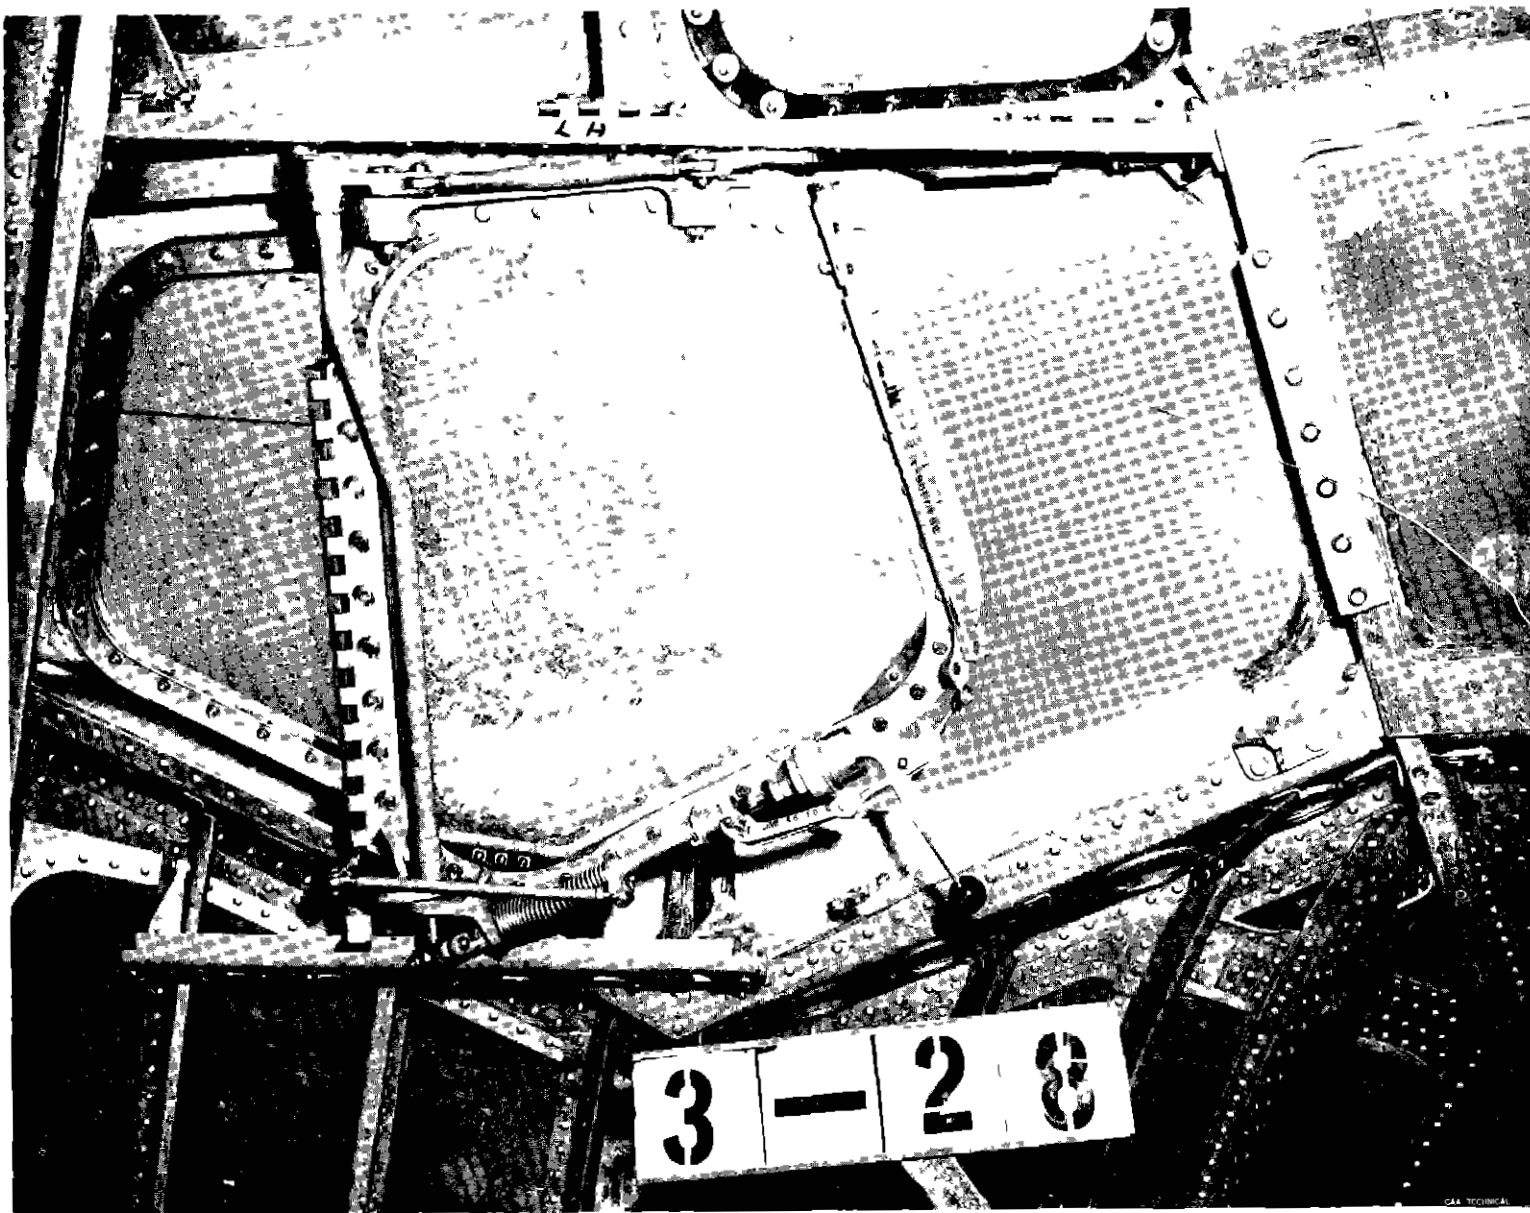
Prior to this test, which involved the pilot's clear-view window, the hinge pin for the aft window latch was increased in size to 0.180-inch diameter, as shown in Fig. 3. The bird carcass hit approximately 2 inches below and 3 inches forward of the target point. The exterior panel shattered completely and the aft doubler plate facing was rolled back slightly as 13 fasteners failed. This is shown in Fig. 33. A small amount of bird carcass extruded through the opening at the upper aft corner of the window. That part of the carcass which extruded into the cockpit passed to the rear of the pilot. There was no penetration of the interior panel, as shown in Fig. 34. High-speed movies of this test indicated that flying glass from this panel was noticeably greater in both quantity and velocity compared with Test No. 3-26. None of the glass penetrated the pilot's head or clothing and none was directed toward the pilot's eye area. The track and latches were all functional. After impact, the window was opened and moved aft to check operation. See Fig. 34A.

FIG 33 TEST 3-28 - PILOT CLEAR-VIEW WINDOW, EXTERIOR VIEW -
PROJECTILE VELOCITY 481 MPH

FIG 34 TEST 3-28 - PILOT CLEAR-VIEW WINDOW, INTERIOR VIEW -
PROJECTILE VELOCITY 481 MPH

FIG 34A TEST 3-28 - PILOT'S SLIDING WINDOW - PROJECTILE VELOCITY 481 MPH

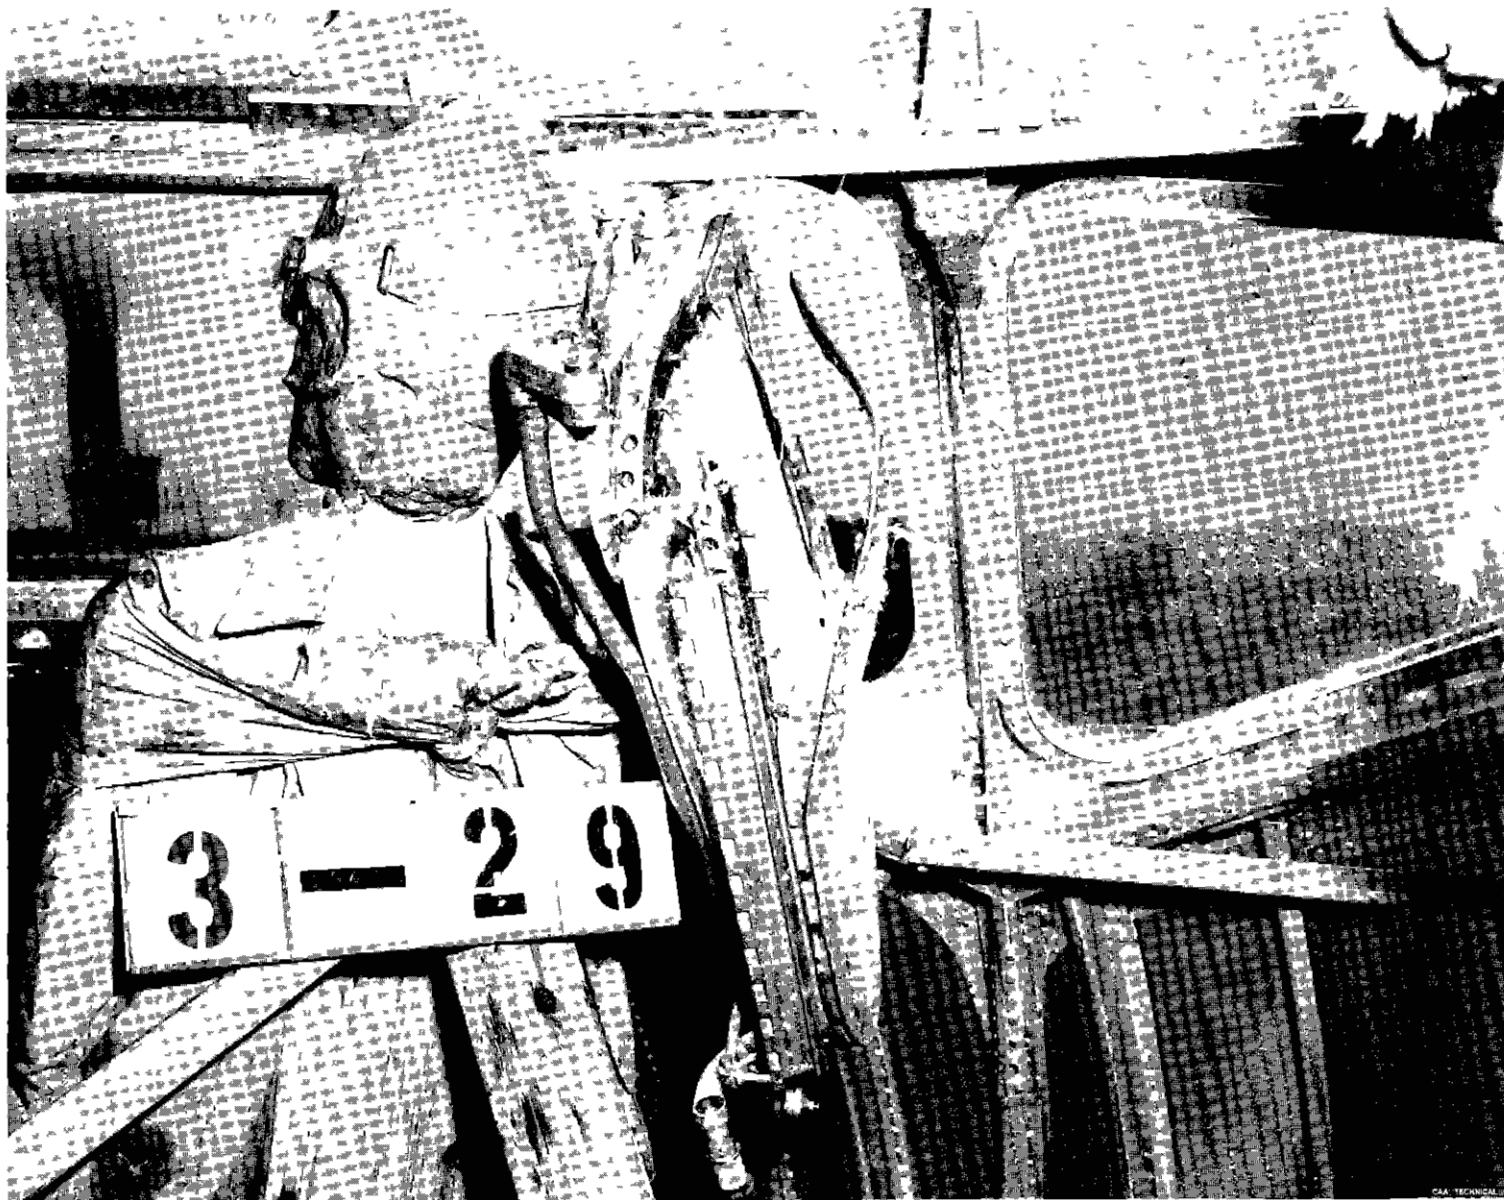
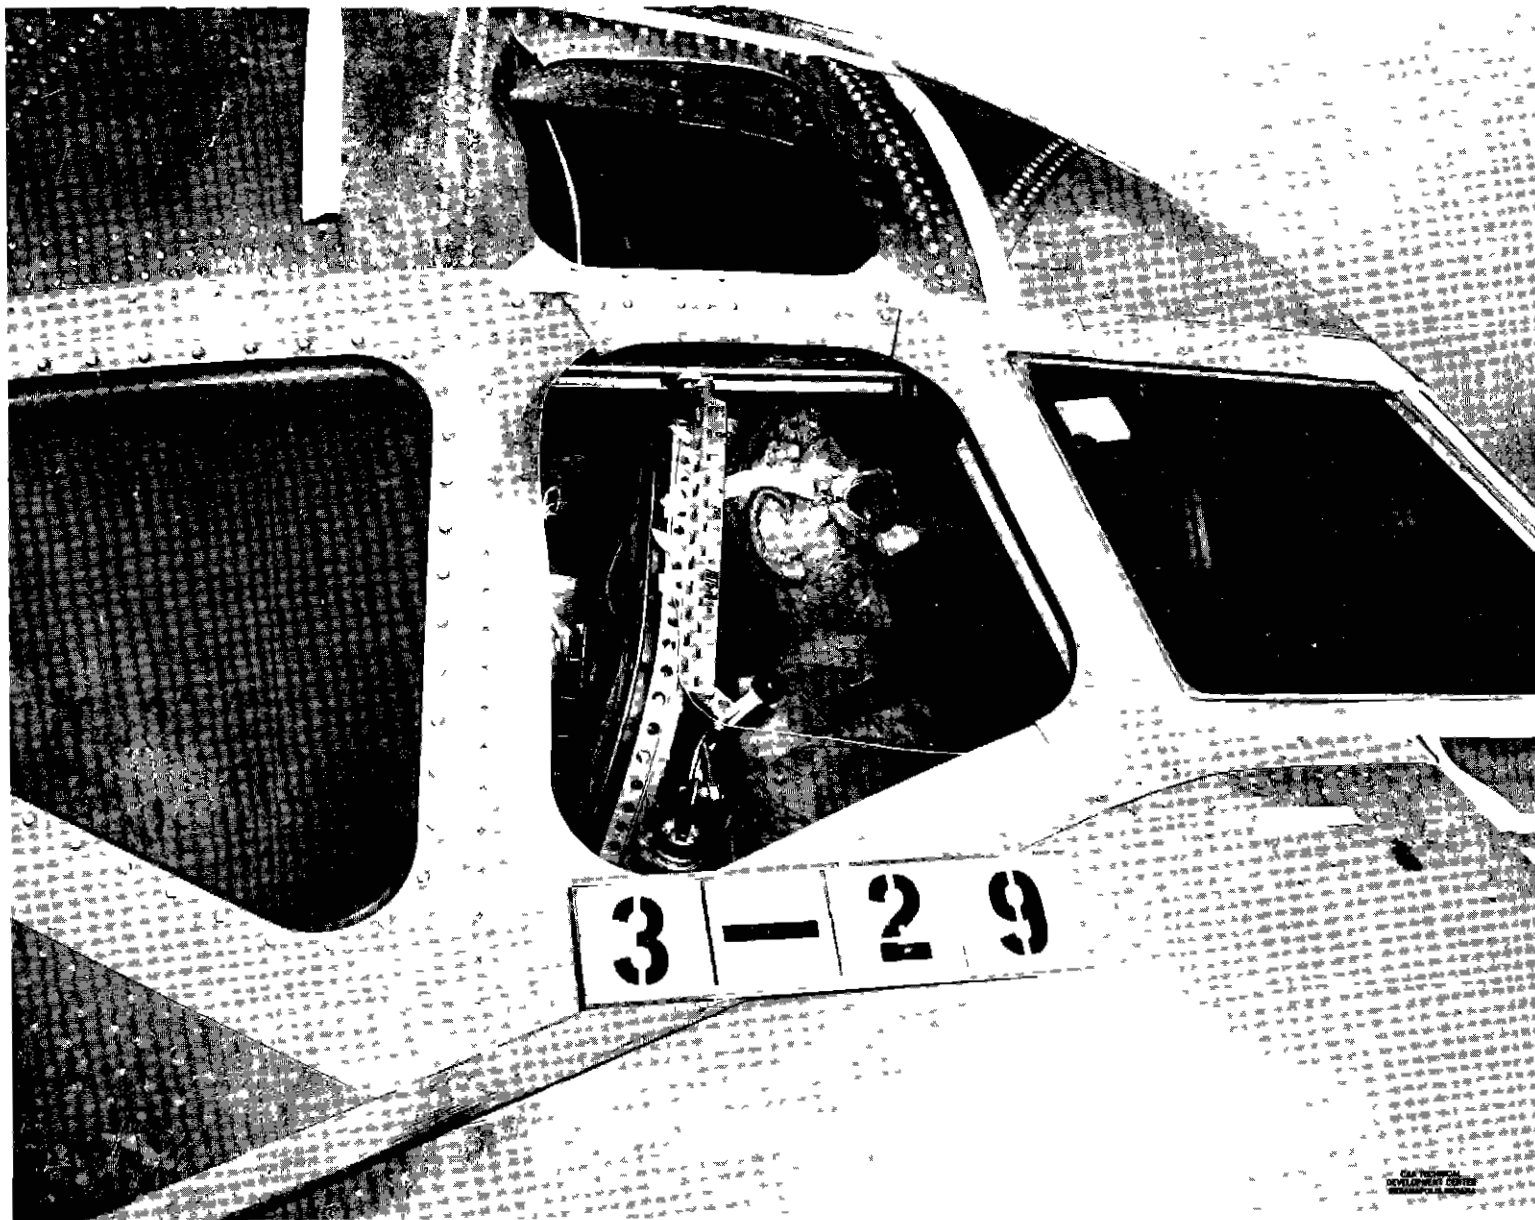
Prior to this test, which involved the copilot's clear-view window, the successful operation of the aft full-length latch suggested a possibility of the elimination of the upper sill latching hook, and DAC Part No. 3641243 was removed. Upon impact the two support points at the forward and aft latches were not sufficient to contain the bending of impact which resulted in fracture of the window frame. The window was forced open, hitting the copilot on the side of the head. See Fig. 35. High-speed movies of the test indicated that hydraulic pressure from bird carcass fluids forced the window inward at the upper aft corner. The excessive bending resulted in fracture of the window frame, as shown in Fig. 35, thereby allowing the aft hook to become disengaged. Inspection of the side of the copilot's head showed no large indentations in the clay, thereby indicating that the window frame had lost most of its kinetic energy at the time of contact. As shown in Fig. 36, the aft doubler facing was not damaged as severely as in tests in which the window remained locked in position.

FIG 35 - TEST 3-29 - COPILOT CLEAR-VIEW WINDOW - PROJECTILE VELOCITY 486 MPH

FIG 36 TEST 3-29 - COPILOT CLEAR-VIEW WINDOW - EXTERIOR VIEW -
PROJECTILE VELOCITY
