# Bridge Pile Repair Using Underwater Fiberglass Reinforced Plastic (FRP) Jacket and Steel Reinforced Grout

**William Schilling, Principal Investigator**  
AECOM Technical Services, Inc.

**February 2025**

Research Report  
Final Report 2024-28

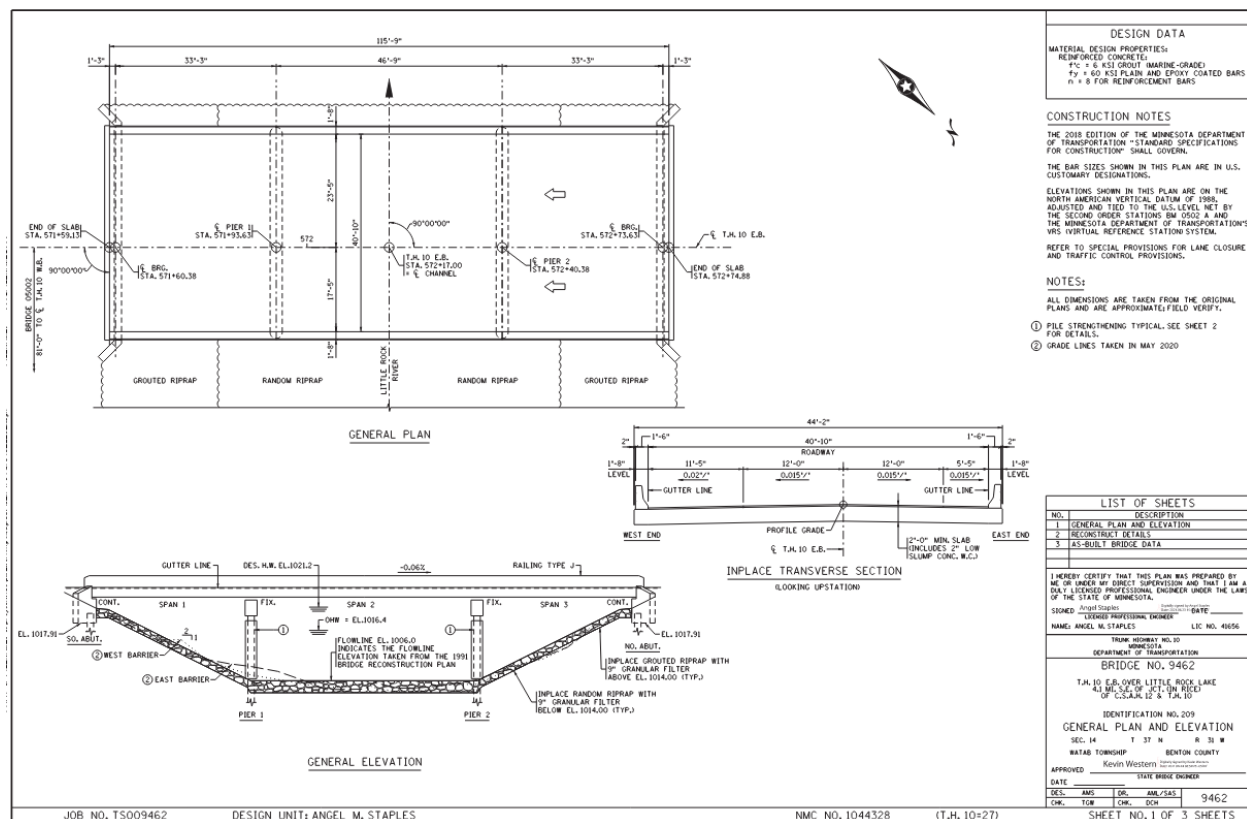
Figure 1.1: Bridge 9462 Plan and Elevation

In September 2019, the Minnesota Department of Transportation (MnDOT) performed a pile inspection on bridge 9462 carrying southbound traffic on U.S. Highway (US-10) over Little Rock Lake. Bridge 9462 was originally constructed in 1962 and widened with a new superstructure in 1992. The bridge is a three-span concrete continuous slab system. The abutments are supported by cast-in-place piling. The piers are open pile bents piers supported on cast-in-place piling 16-inch diameter with 0.25-inch thick steel pipe pile shell.

At the time of inspection in 2019, the water level was lower than normal due to work by the Department of Natural Resources (DNR) downstream on the Mississippi River. The inspectors found dime sized areas in the steel pipe piles where the infill concrete could be observed. MnDOT had the Bridge Office Fracture Critical Inspection team conduct an inspection with a D-meter and discovered severe pitting on all the original piles installed in 1962. The percent of section loss on the piling ranged from 40% to 70% in an area about five to six feet below the concrete pile cap.

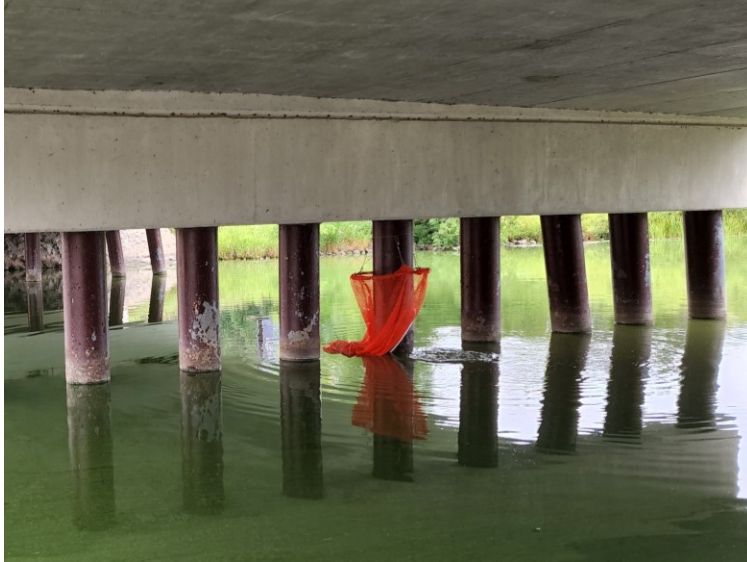
Figure 3.2: Diver underwater cleaning pile with netting wrapped around pile

1. Surface Preparation: Piles were thoroughly cleaned by using high-pressure (3500 psi to 4000 psi) water-blasting to remove marine growth, rust, and other contaminants. An orange netting with an opening of a quarter of an inch that was folded over onto itself to create two layers was placed onto the pile to catch any lead paint chips flaking off from the cleaning.

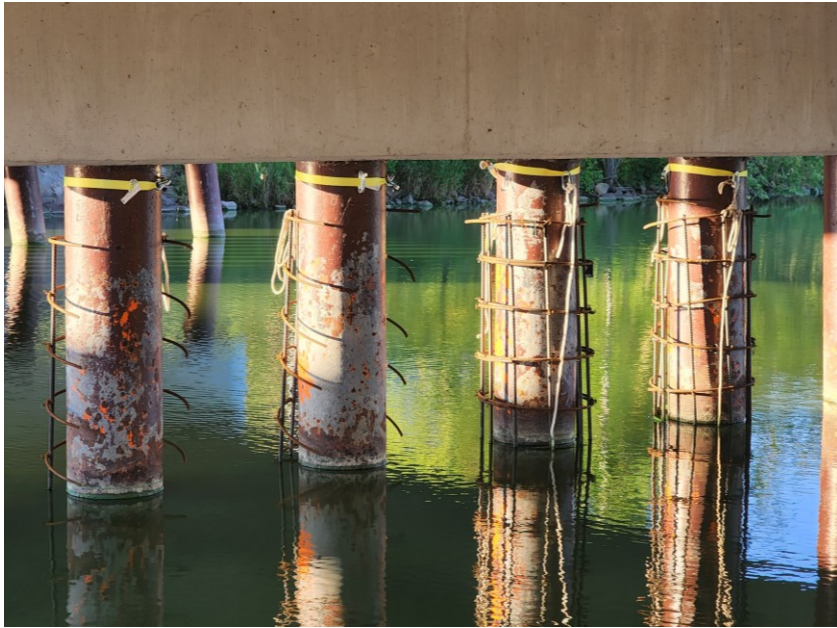
**Figure 3.4: Pier 2 (North) reinforcement cages**

3. **Reinforcement Cage Placement:** In order to install the reinforcement cages, the contractor placed a ratchet strap around each pile right under the pile cap. Quick Link D Shape Chains were attached to the ratchet strap with a piece of rope hanging from the Quick Link. The contractor pre-tied the reinforcement cages into two pieces on land. When half of the reinforcement cage was placed, the rope was tied to the top hoop of the cage to hang the reinforcement from the ratchet strap. The other half of the reinforcement cage was placed in a similar manner. The overlap of the hoop bars was to be 1'-0" per the plans. The reinforcement cage was adjusted with the ropes to get the hoop bars to align and to be tied.

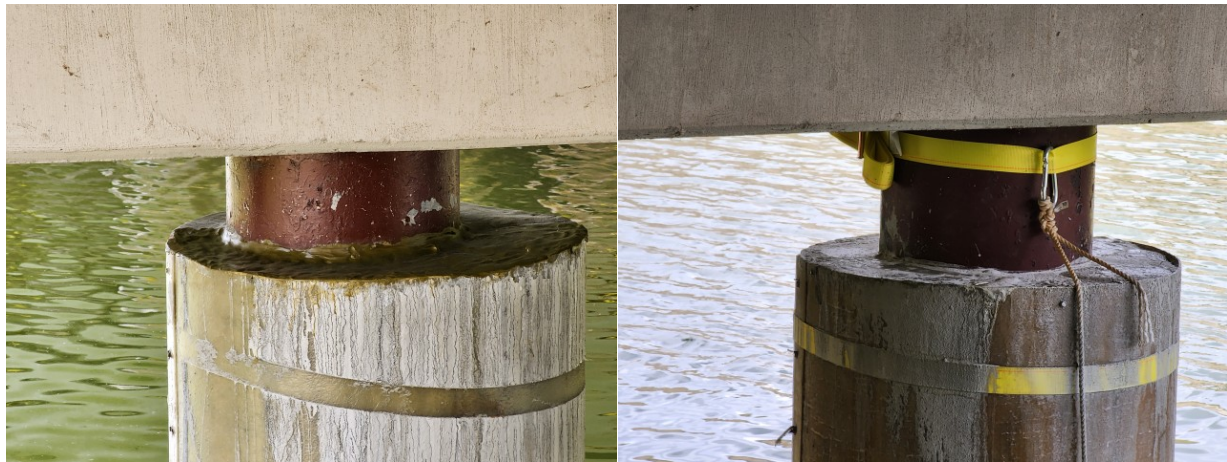
One notable observation is the concern for the placement of rebar. The reinforcement was suspended at the top of the pile and had no mechanical support, such as rebar chairs, to prevent it from swinging or leaning to one side. Although the rebar cage could have been adjusted during the six-inch bottom seal pour, the cage might not have met the required two-inch cover on the bottom, especially if the top of the cage was leaning to one side. This issue is particularly concerning for the Denso jackets, which appeared to be off centered compared to the Five Star jackets due to the installation of six-inch wood spacers on the Five Star jackets. Another reinforcement concern is on the battered piles. The cage was hanging vertical so the bottom of the cage may be touching the pile due to the batter of the pile.

**Figure 3.16: Denso Jacket (Left) & Five Star Jacket (Right)**

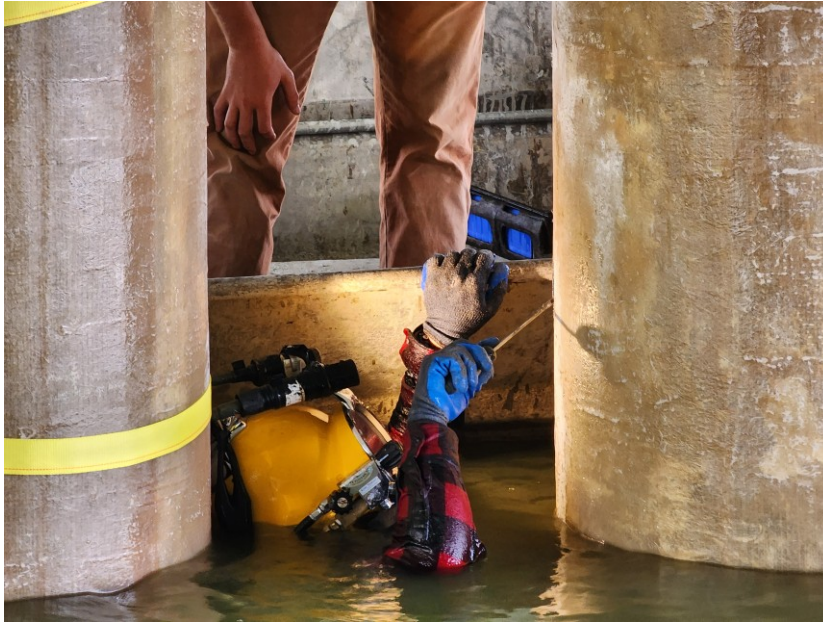
The Five Star jacket was observed to be more easily placed around the piles due to the jacket being more flexible. The jacket needed to be forced closed with ratchet straps which came with some issues. While forcing the tongue and groove joint together, some instances the diver needed a flat head screwdriver to get the tongue into the groove joint all the way down the joint of the jacket. This may have contributed to having a less than ideal seal on the joint. While pumping grout into the jacket, water was leaking out through the seam. If water can get out of the seam, water may get into the seam and

work the seam loose through freeze thaw cycle. The seam does have epoxy and screws to help hold the jacket together, but future inspections will help determine if a leaky seam during installation reduces the jackets life span.

**Figure 3.17: Diver using screwdriver on Five Star joint**

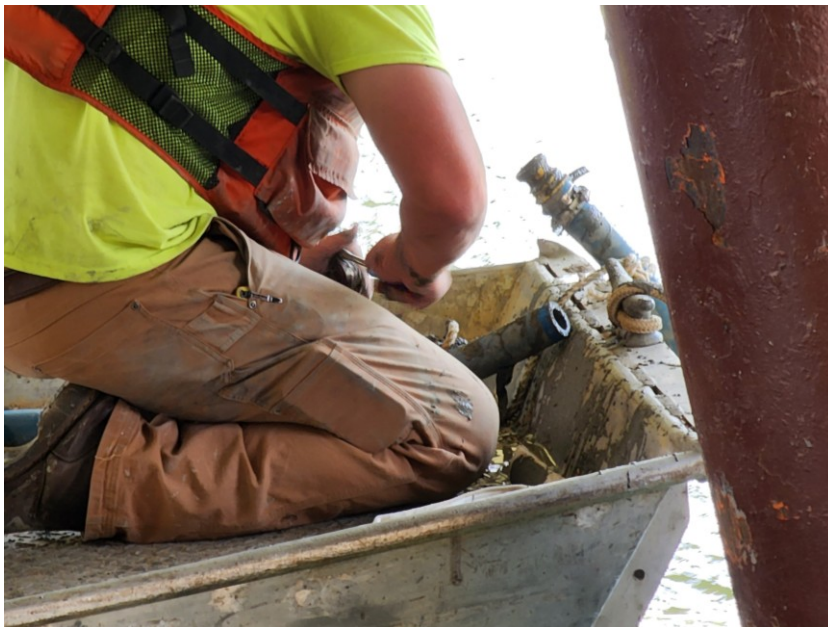
Both the Denso and Five Star products had minimal issues during grout pumping. Some minor issues were observed including the grout clogging the screen between the mixer and pump for the Denso grout. The screen needed to be removed and cleaned. The other issue was the grout line came apart at the hose connection. Both of these instances were rare occurrences, and neither was caused by the products.

**Figure 3.19: Grout line connection came apart**

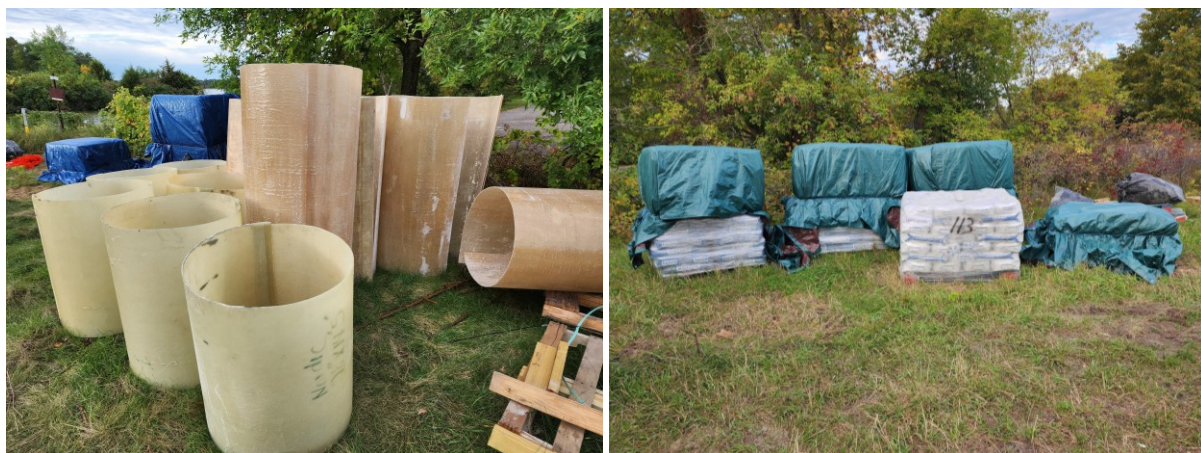
Figure 4.1: Scrap Pile Jackets (Left) & Left Over Five Star Grout (Right)

Nordic Group provided a potential cost-saving suggestion to conduct a dive inspection to get actual field measurements and conditions for the repair plans. Nordic Group estimated the cost for a dive inspection would be about \$4,000 for this bridge. The plans specified a jacket height of 14'-6", but upon an exploratory dive on the first day of work, it was determined the jackets would need to be trimmed. The Denso jackets required a reduction of 3'-0" and the Five Star jackets needed 5'-6" removed. As a result, excess reinforcement and grout were left over as well. Information provided from a detailed dive inspection prior to bidding would reduce the possibility of this occurring. The plans also called out riprap, assuming the riprap would need to be moved. This was factored into the cost estimation, but Nordic Group found that only minimal jack hammering was necessary to remove the riprap because the bottom of the waterway was mud. In the case of debris obstruction during the repair, "debris removal" can be considered under a change order for the project.

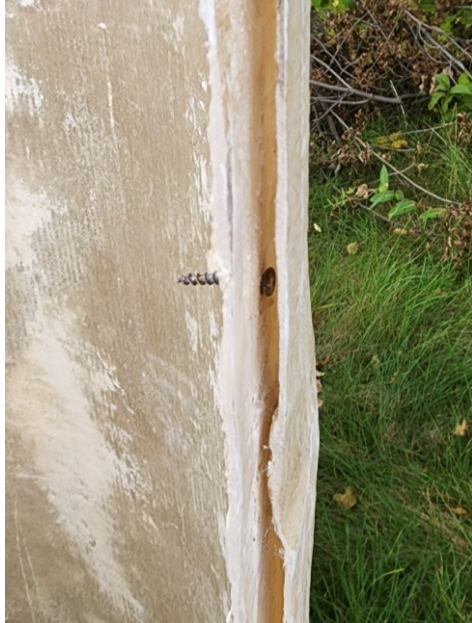
Nordic Group preferred the Denso product after the installation was completed. The Denso jacket's unique feature of closing on itself was highly appreciated, as it benefited the diver during installation, especially when water visibility was poor. The Denso product was described as visually better as one of the Five Star jackets had a screw on the inside wall of the groove joint.

**Figure 4.4 Five Star Jacket with screw in joint**

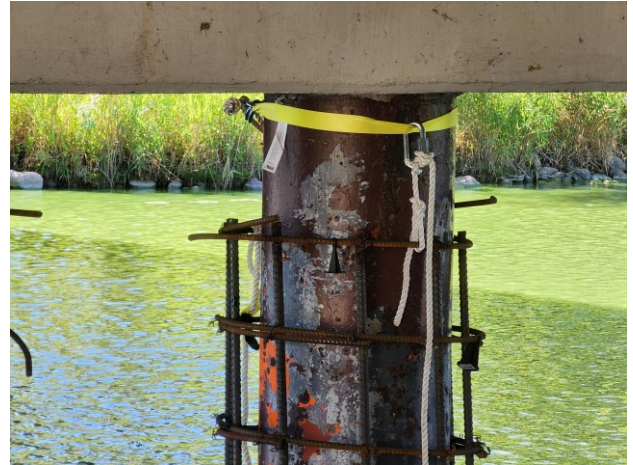
Figure A.4: Close-up of Hanging Rebar

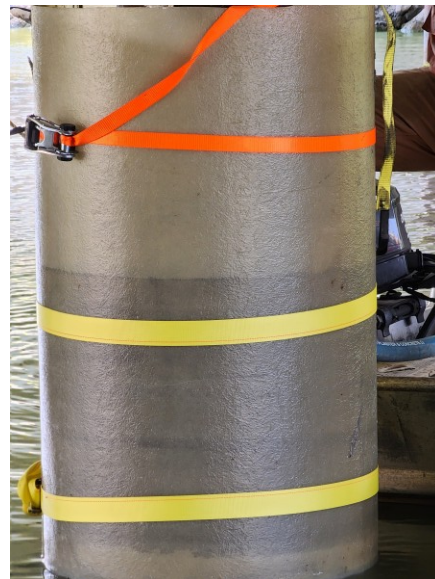
Figure A.17: Water Level Rising in Jacket During Grouting Operation
