CORROSION OF POST-TENSIONED TENDONS IN FLORIDA BRIDGES

Research Report No. FL/DOT/SMO/04-475

By: Rodney G. Powers¹ Alberto A. Sagues² and Yash Paul Virmani³

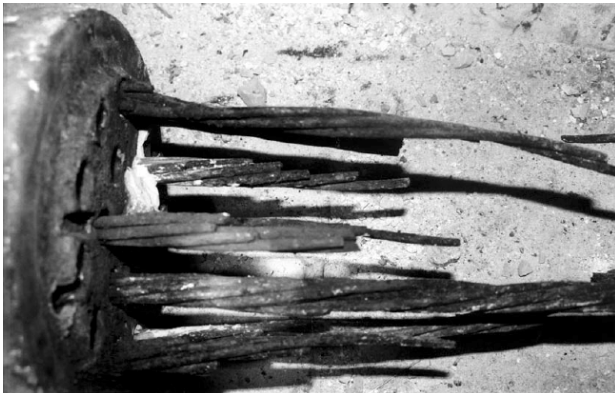
Corrosion of post-tensioned strands has been identified in two Florida Bridges. The first reported incident was at the Niles Channel Bridge (NC) in the Florida Keys (Powers 1999) followed by Mid Bay Bridge (MBB) in the Western panhandle (Corven, 2000). The superstructure of both bridges utilizes non-bonded (external) tendons arranged in a configuration such that the center lengths of the tendons are draped downward from the anchorages through deviation blocks along the length of the spans (Figure 1). The anchorage assembly is depicted in Figure 2. In both structures, the tendons failed in the anchorage region (Figure 3).

Figure 3 – Failed tendon-Niles Channel Bridge (June, 1999).

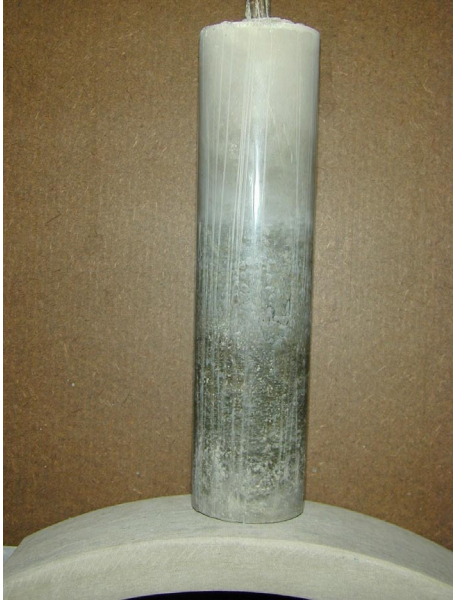
Figure 8 – Photograph depicting increasing chalkiness toward the top of the aluminum admixed grout (vibrated).

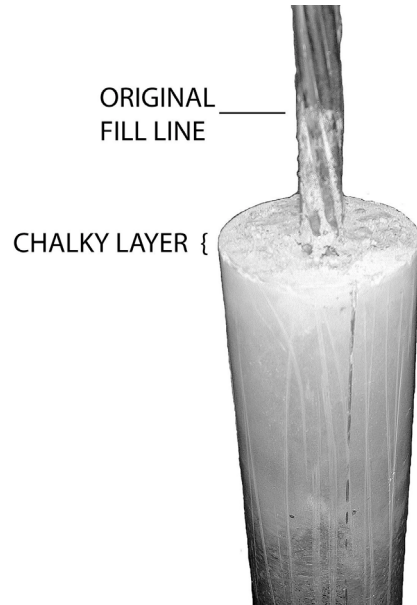
Figure 9 – Close-up photograph depicting large grout volume loss and heavy chalk development in the aluminum admixed grout (vibrated).

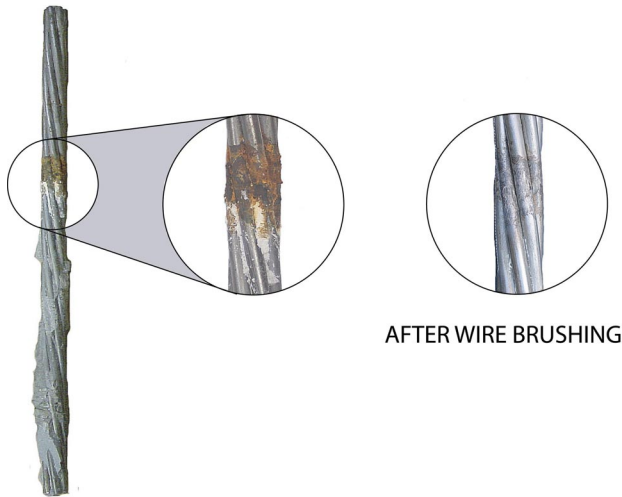
Condition of the Strands: The surfaces of the strands in contact with the grout were found to be unaffected during the experiment except for the area beginning approximately 2.5cm below the top of the grout and 2cm above the top of the grout. The area beginning approximately 2cm above the top of the grout and extending downward to approximately 1cm below the grout had heavy deposits of red to dark brown colored corrosion products (Figure 11). Extensive corrosion pitting was noted on the wire surfaces in the area coinciding with ~0.5cm above and below the

Figure 11 – Typical appearance of the strand upon removal from the mock-up.

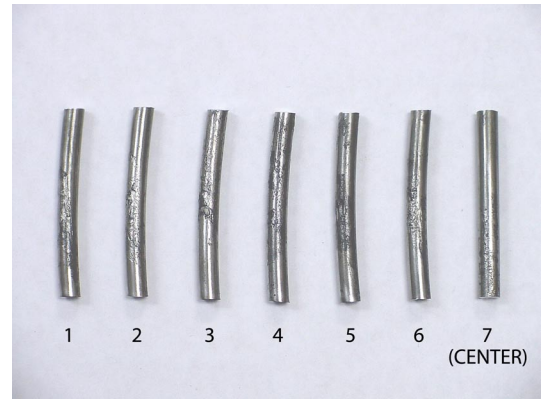
Corrosion of the strands (penetration depth as much as ~7% of a wire diameter) was severe in view of the relatively short duration of the tests and the low tolerance of a loaded system to localized reductions in cross section (Stauder 1998, Vermaas 2001). The corrosion morphology of the strands (Figure 12) is consistent with that of shallow pitting, constrained to a small region by local acidification from hydrolysis of ejected metal cations (Jones 1996), and protection of the surrounding region by local potential depression (Pedeferri 1996). An order-of-magnitude estimate of the total amount of corrosion in the strands can be made by assuming that each outer strand wire had an equivalent integrated pitted area $\sim 10 \text{ mm}^2$ with a depth $\sim 0.23 \text{ mm}$ (average depth from Figure 13). For 6 corroding wires in the 7 strands this corresponds to a total metal loss of $\sim 100 \text{ mm}^3$, or an anodic charge of $\sim 2,600 \text{ C}$ if the steel corroded as Fe^{++} . This value may be contrasted with the integrated value over time of the anodic macrocell current data in Figure 10 (the longest recharge event), which yields $\sim 1,200 \text{ C}$. While the corrosion charge estimate is subject to considerable uncertainty, the similarity of the macrocell and corrosion charges suggests that galvanic coupling with the anchorage accounted for much of the metal loss at the strands. Nominal corrosion current estimates from polarization resistance tests (Table 1) are available for moist conditions only for instances when the strands were cathodic early in recharge events 4 and 5. Nevertheless, these results also illustrate cases where the macrocell currents ($304 \mu\text{A}$ and $136 \mu\text{A}$) were a significant fraction of the estimated local cell action at the strands ($749 \mu\text{A}$ and $875 \mu\text{A}$ respectively).

Figure 12 – Typical appearance of the corrosion pits on the strands near the top of the grout.

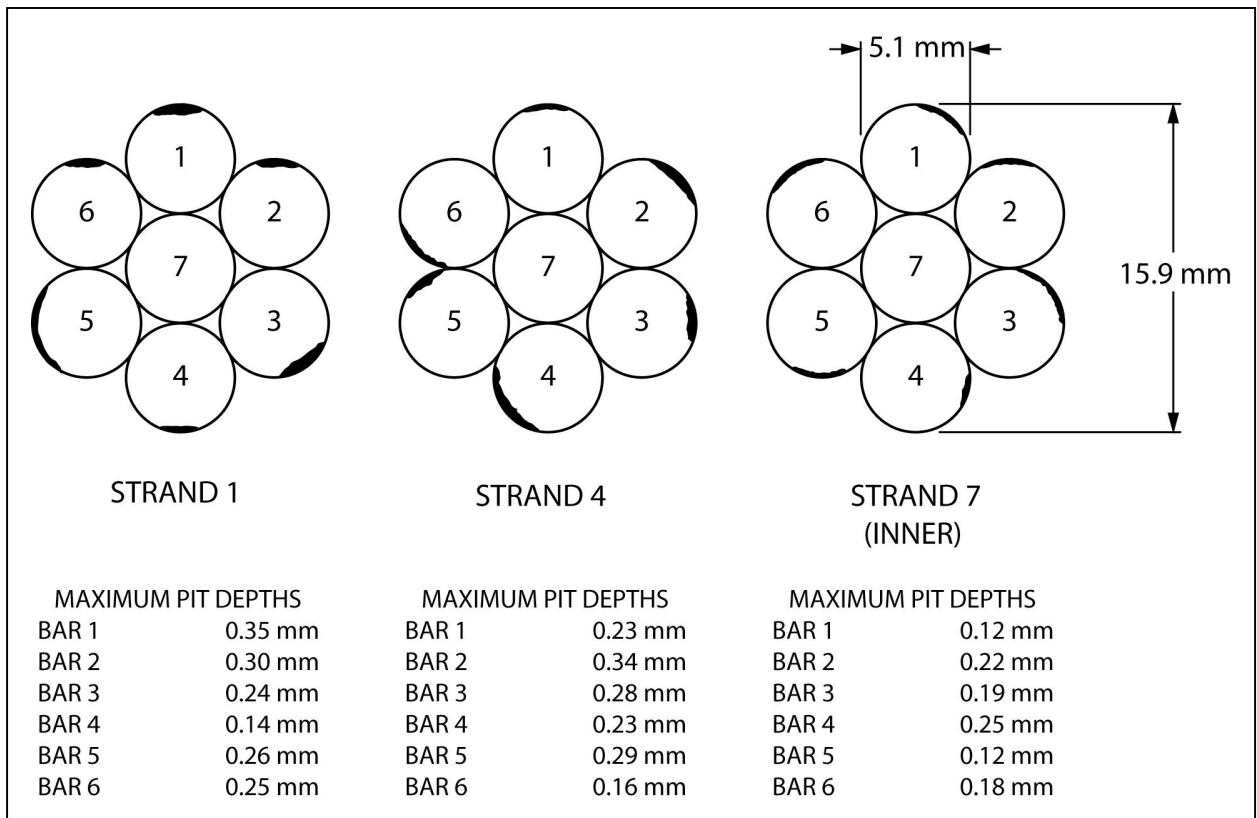
top of the grout. The grout immediately adjacent to the strands in the zone beginning at the top of the grout and extending downward approximately 3cm was soft and chalky and the pH was measured at 8.7 (+/-0.5). The individual wires of the three selected strands were separated for further examination. The previously mentioned corrosion pitting (near the top of the grout) was confined entirely to the outer surfaces of the individual wires. Although multiple pits existed along this ~1cm long affected zone, the area of heaviest attack was mostly centered at the area coinciding with the top of the grout. The typical appearance of the pitted areas is depicted in Figure 12, and a schematic representation of the maximum measured pit depth and relative sizes of the pits is presented (Figure 13) for each of the three strands examined.

Figure 13 – Schematic representation of the maximum observed corrosion pitting for each of the wires of the three selected strands.
