Structure and Infrastructure Engineering

Corrosion failure of post-tensioning tendons in alkaline and chloride-free segregated grout: a case study

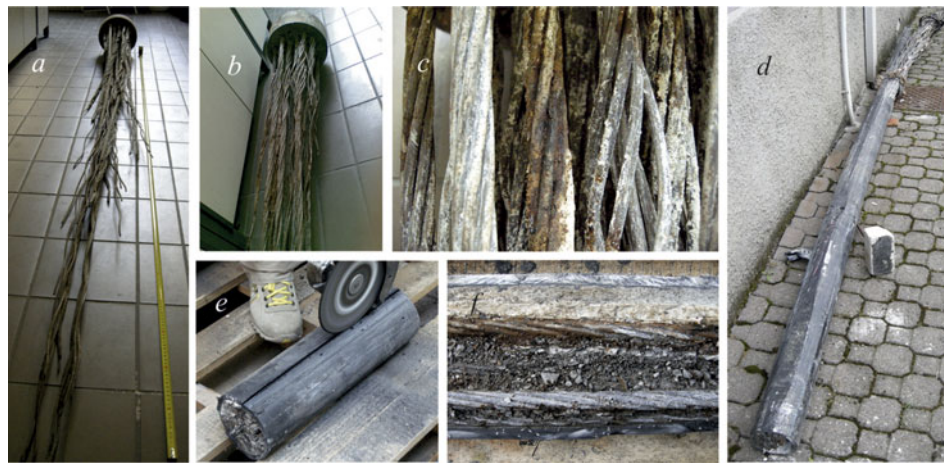
anchor head where the tendon failed, and a further portion that was near to the failure zone, but the injection grout was still present inside the duct (Figure 1). The visual observation of the failed strands near the anchor head (Figure 1(a)) showed the presence of corrosion products and many localised attacks (Figure 1(b)). This phenomenon occurred mainly in the parts where residues of a whitish unhardened paste were found on the surface of the steel (Figure 1(c)). All the corrosion attacks were localised, some of which were shallow while others were very penetrating. Localised attacks initiated preferentially at the regions of contact between the wires (Figure 2).

Figure 1. Portions of the failed tendon analysed in the laboratory.

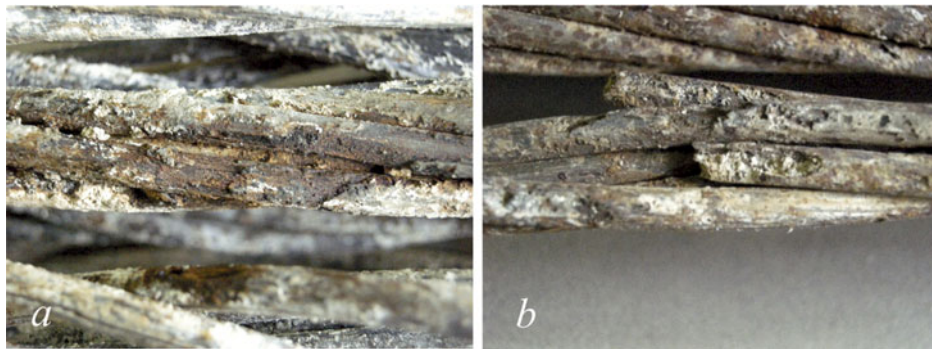
Figure 2. Examples of corrosion attacks observed on the surface of the strands.

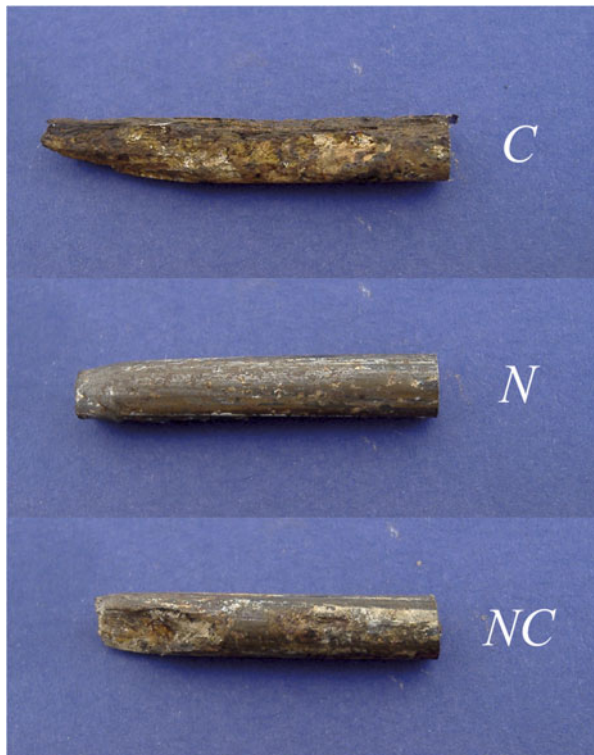
head), and the extent and depth of corrosion attacks. Corrosion attacks were randomly distributed along the length of inspected portion of the tendon. The rupture was classified as: C when most of the cross section was depleted by the corrosion, N when a clear ductile necking failure was observed and NC when a mix of corrosion and ductile final failure occurred. Figure 3 shows examples of the three types of failure.

Figure 3. Examples of the types of failure observed on the wires of the tendon failed in service.

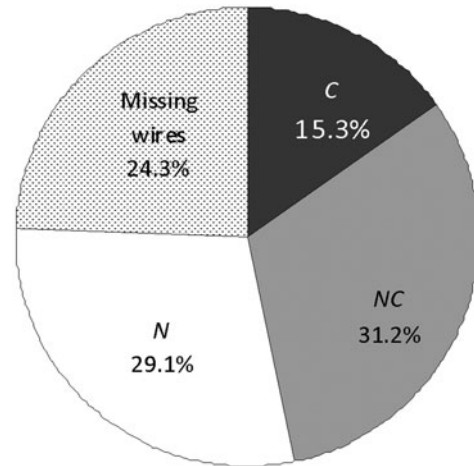
Figure 4 shows that about 15% of the wires had the cross section mainly consumed by corrosion attacks and, therefore, it may be assumed that they failed before the rupture of the tendon. Furthermore, for slightly more than 30% of the remaining wires, fracture may be attributed to partial corrosion (type NC). Wires that have undergone only necking and those that are missing constitute 53.4% of the total; for these wire, it is reasonable to assume that the cross section was essentially undamaged at the time of failure. Assuming, in the first approximation, that the condition for NC can be considered on average as a reduction of cross section due to corrosion of 50%, it may be estimated that the reduction in the whole cross section of the tendon due to corrosion attack occurred before the final failure was approximately 30%. Such a value can justify the collapse under service, taking into account that the post-tensioning force was equivalent to about 75% of the tensile stress of the steel.

Figure 4. Summary of the types of failure (C, corrosion; N, necking; NC, corrosion + necking) observed on the wires of the tendon failed in service.

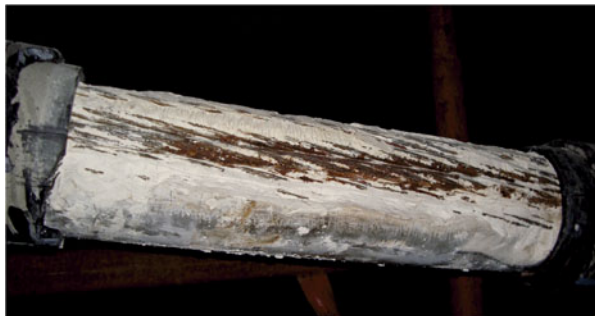
Figure 5. Example of an aperture in the duct of a tendon showing the whitish segregated grout embedding corroding strands.

on the surface of the strands that emerged from grout W (Figure 5), in few cases also deep penetrating attacks could be observed.

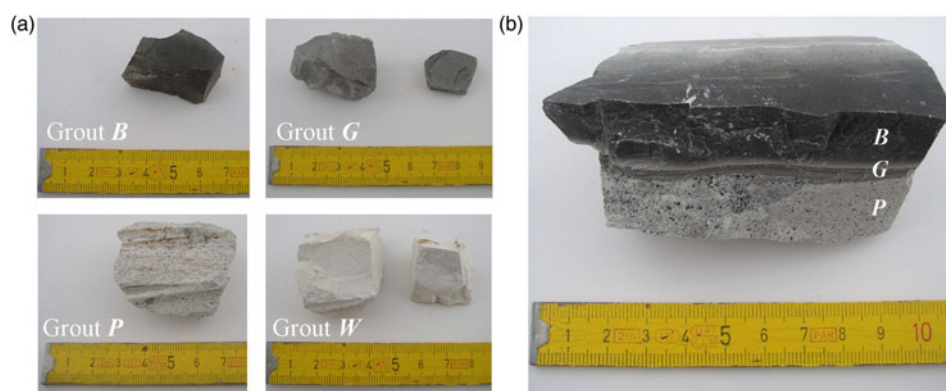
Figure 6 depicts the different aspect of the filling material found in the inspected tendons. On the basis of the

Figure 6. Different types of aspect of grout collected from the removed ducts of the inspected tendons (a) and example of stratification of the grout after segregation (b).

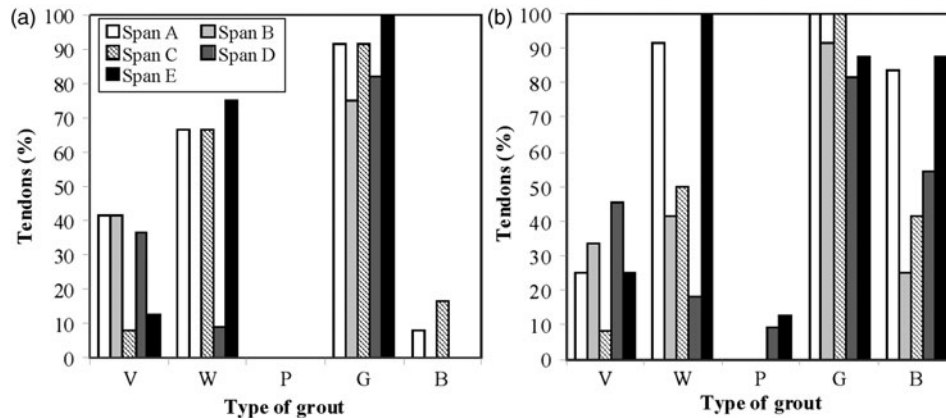
Figure 7 summarises the results of the inspections on the apertures, showing the percentage of tendons where the different types of grout were detected along the surface previously in contact with removed ducts. Data have been analysed separately for the apertures of the injection side (Figure 7(a)) and in the opposite side (Figure 7(b)) of the five spans (A–E) of the bridge. These graphs, while representing the results of a simplified analysis, which is subjective and limited to visual observation of the surface exposed after partial removal of the duct, show the coexistence of different types of grout in the tendons of the spans of the bridge.

Furthermore, it can be seen that the presence of W grout was higher in the side opposite to that of injection. In most cases, only traces of this grout were observed (usually in the form of a thin stripe on the top of the duct), but in few cases a remarkable amount of W grout was detected and embedded strands were covered by corrosion products or even showed localised attacks. Grout P could be rarely detected from the surface.

Figure 7. Percentage of tendons showing the presence (even only in traces) of the different types of grout (V, voids; W, unhardened whitish grout; P, light grey grout; G, grey hydrated grout; B, dark grey grout) in the apertures on the inclined parts of the injection side (a) and the opposite side (b).

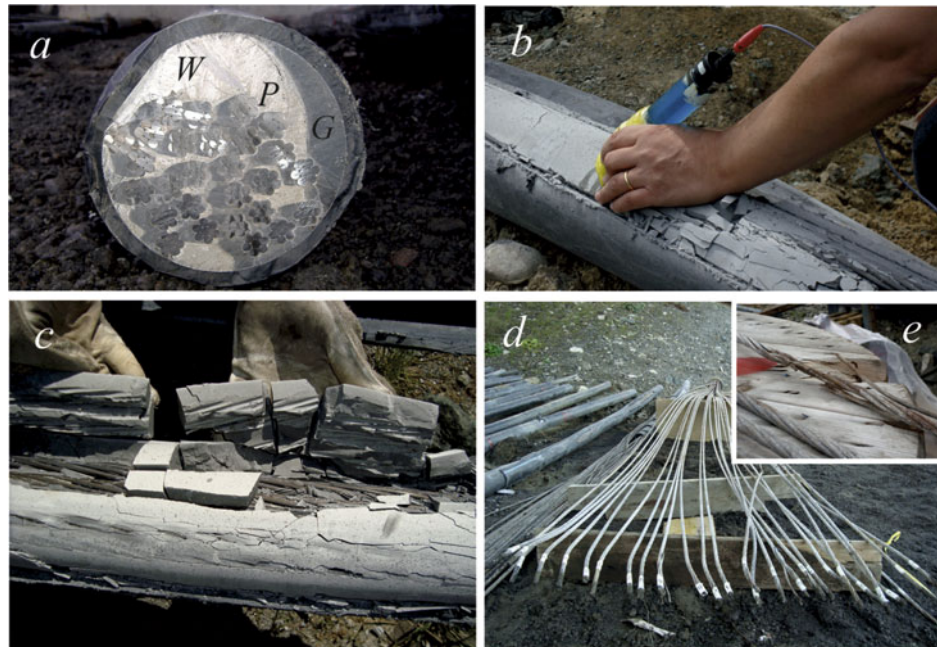
outside the bridge (Figure 8). Each cutting section was observed in order to detect the presence of different types of grout along the length of the tendon (Figure 8(a)). Then, in the two external segments with the anchor heads, the polyethylene duct was removed and the corrosion potential of steel strands was measured versus a Cu/CuSO₄ reference electrode (Figure 8(b)) before the grout could dry out. The filling material was observed in order to document the types of grout and their position and to collect samples for laboratory analysis (Figure 8(c)), and

Figure 8. Inspection of a tendon removed from the bridge: (a) types of grout observed on a cutting section, (b) measurement of the corrosion potential of steel strands, (c) inspection of the grout, (d) inspection of the steel strands and (e) detail of wires of a strand broken due to corrosion.

thereafter each single strand was removed and carefully checked (Figure 8(d)) to detect the presence of broken wires and corrosion attacks (Figure 8(e)).

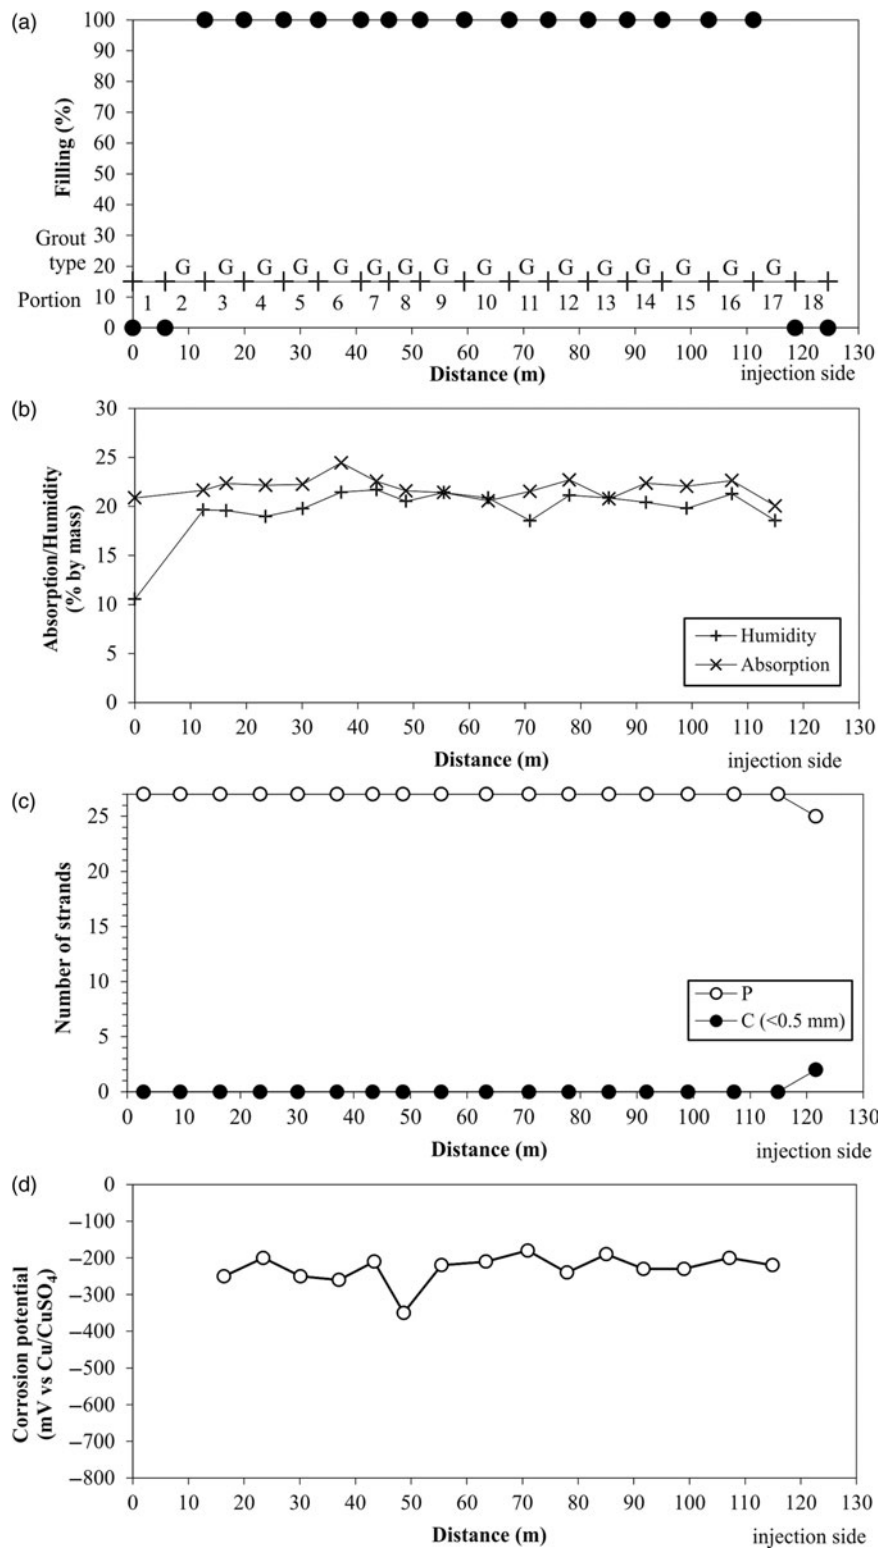
The filling was complete, except for the end portions with the anchor heads (#1 and #18), where, however, the grout was ejected as a result of the damage occurred during the removal operations. In all the other portions, only type G grout was found. Grout samples were collected from each segment of the tendon to measure the moisture content and the water absorption (Figure 9(b)). The moisture content of the grout at the time of sampling approached the absorption of the sample (equal to about 20% by mass, Figure 9(b)), i.e. the grout along the duct was still saturated with water. Figure 9(c) shows the results of the observation of the 27 strands along the length of the tendon, showing that most of the surface of the steel was in passive conditions, and only few attacks with a penetration depth lower than 0.5 mm were observed on one strand near an anchorage. Figure 9(d) shows that the corrosion potential of the steel embedded in the grout was in the range of $-250/-200$ mV versus Cu/CuSO₄ along the tendon.

The potential measurements, which were carried out immediately after the removal of the duct, showed that this technique is not able to detect those areas in which small localised attacks were present. Measured potential values were those typical of passive areas in water-saturated grout (Bertolini et al., 2013), while lower values of corrosion potential that are expected in the neighbourhood of localised attacks could not be detected by the reference electrode placed on the external surface of the grout.

Figure 9. Example of the results of inspection of a tendon: (a) filling degree and types of grout observed on the cut sections, (b) moisture content and water absorption of grout specimens taken from different segments, (c) number of passive wires (P) and corrosion attacks (C) and (d) corrosion potential of the steel strands.

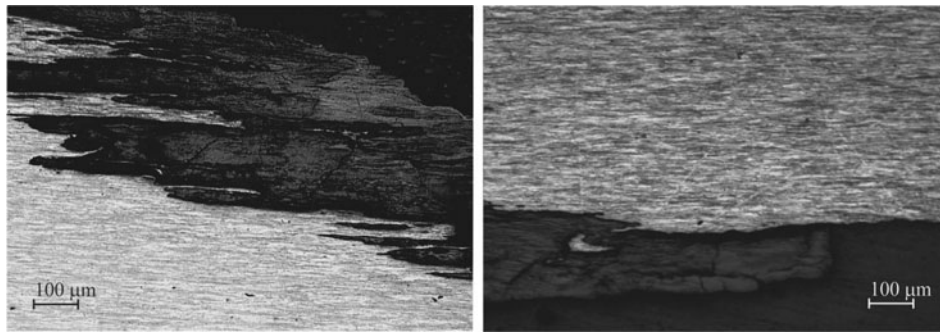
Corroded areas and fracture surfaces of representative samples of steel wires were observed. Figure 11(a), for example, shows the failure of a wire, which took place in correspondence of a localised corrosion attack. Figure 10 shows the thick layers of flaky corrosion products observed on metallographic sections. At the scanning electron microscope (SEM), the fracture surface, where it was not masked by corrosion products, was ductile and characterised by the presence of elongated dimples (Figure 11(b)).

Figure 10. Metallographic sections of corroded wires from the tendons failed under service.

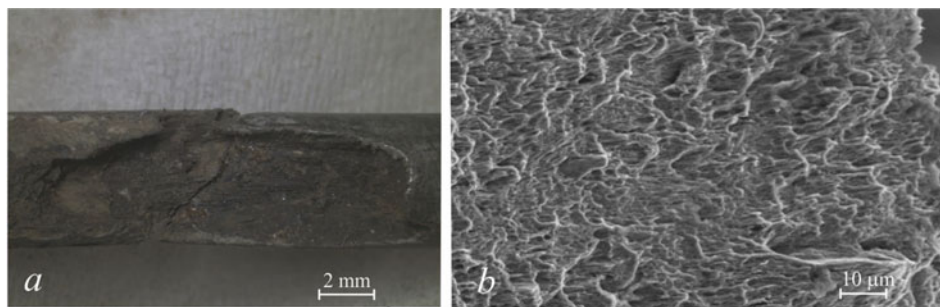
Figure 11. Stereomicroscope image of the two parts of a broken wire (a) and SEM image of the ductile fracture surface (b).
