Corrosion induced failures of post-tensioned bridges

Technical Report · May 2022

Trondheim – May – 2022

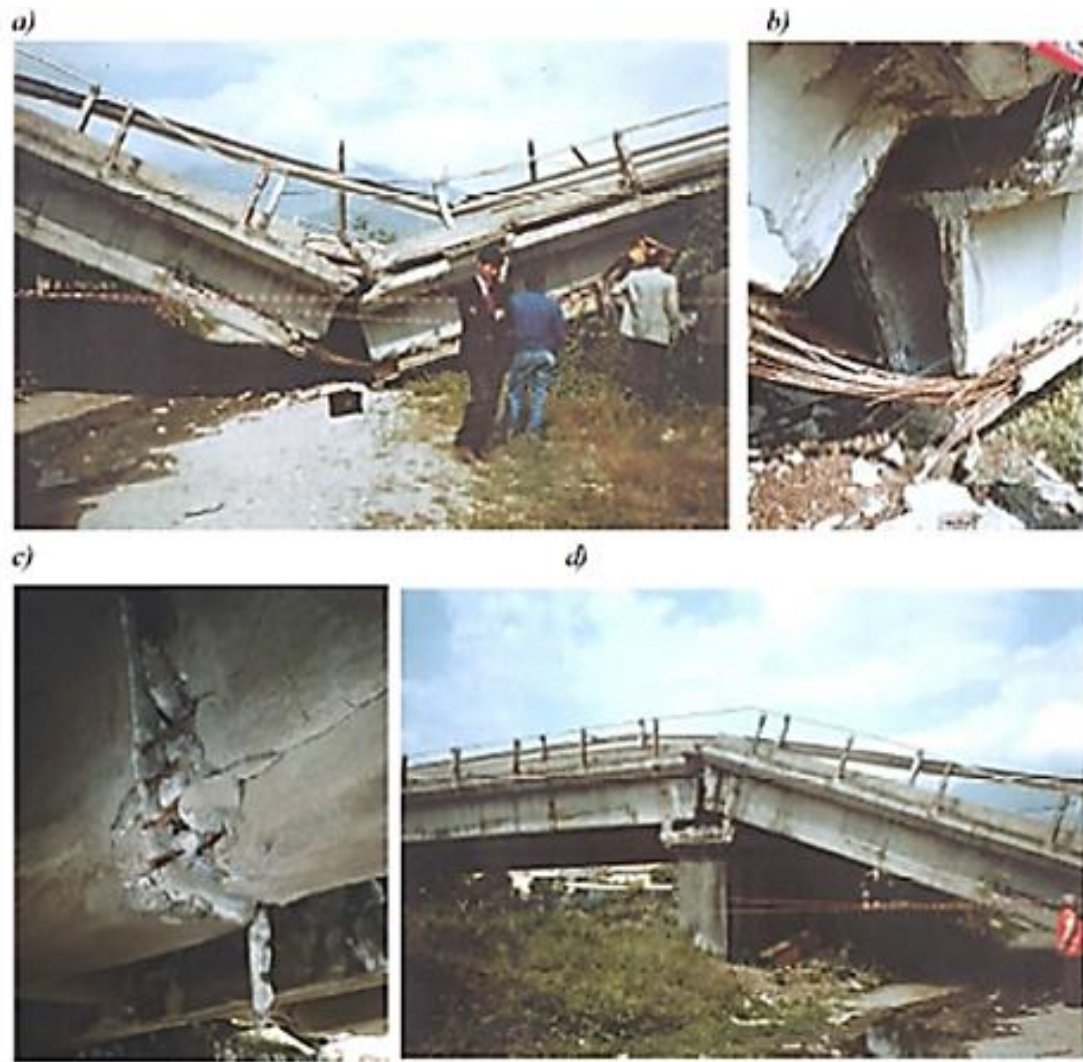
Figure 3.3.4. S. Stefano Viaduct (ID-2): a) collapse of the viaduct; b) slippage of cables; c) opening of joints; and d) rotation of the deck (Colajanni et al, 2016).

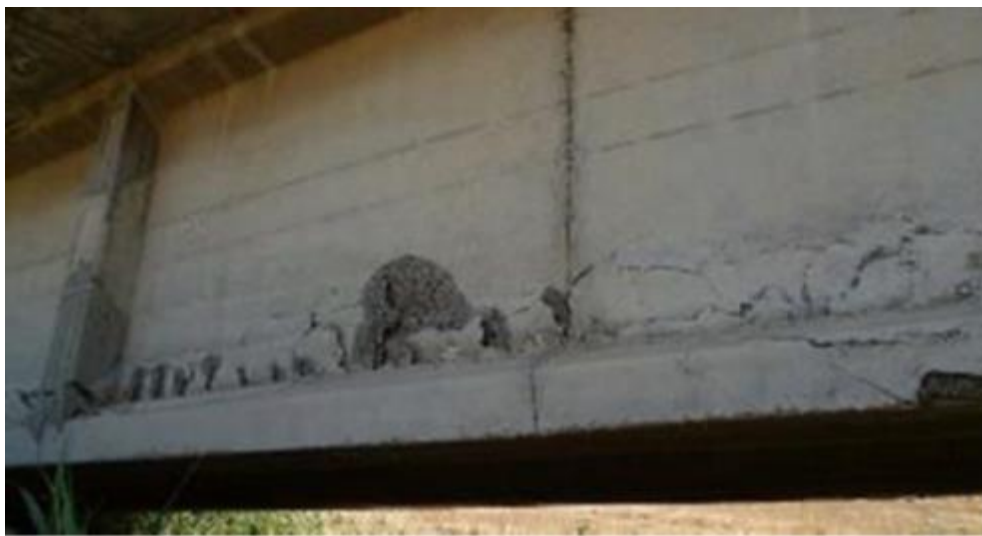
ID-4.8. Cracking in the other bridge spans (Anania et al, 2018).

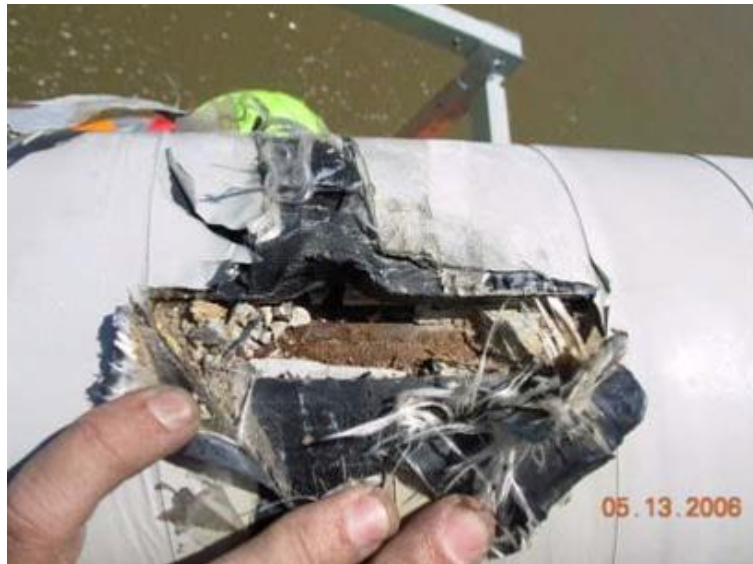
ID-10.2. Corrosion of wires at PE split (Mehrabi, 2009).

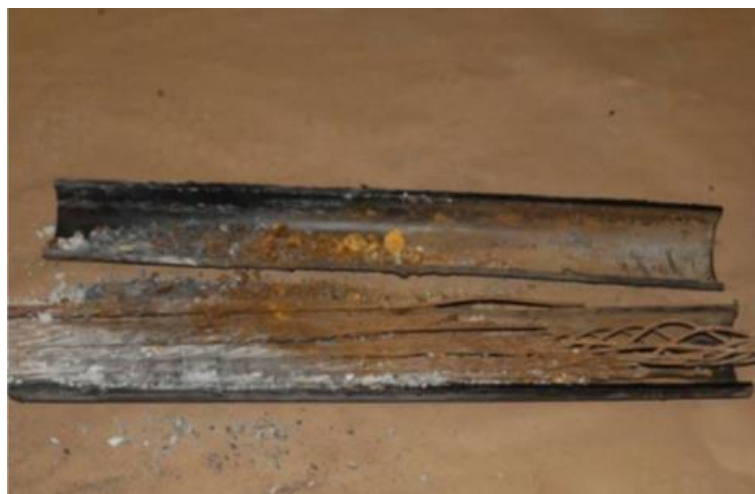
ID-15.3. Segment of failed tendon discovered in January 2011 with evidence of corrosion damage. Duct opened in laboratory during investigation (Ahern et al, 2018).

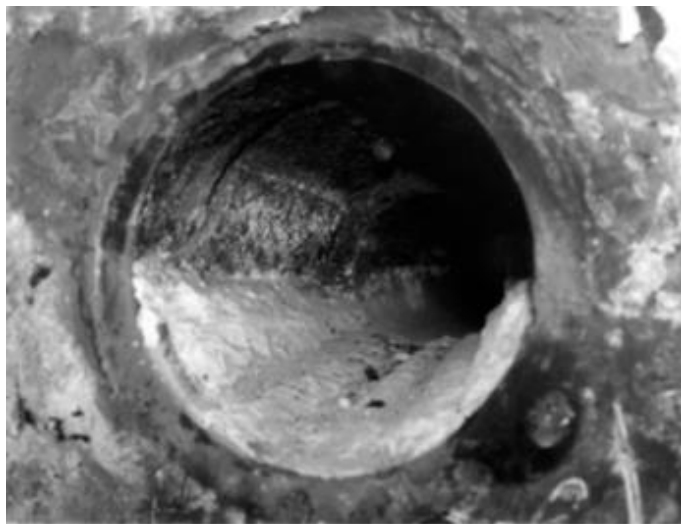
ID-17.2. Anchor at failed tendon showing chalky grout, partial grout filling and heavy corrosion (Powers et al, 2002).

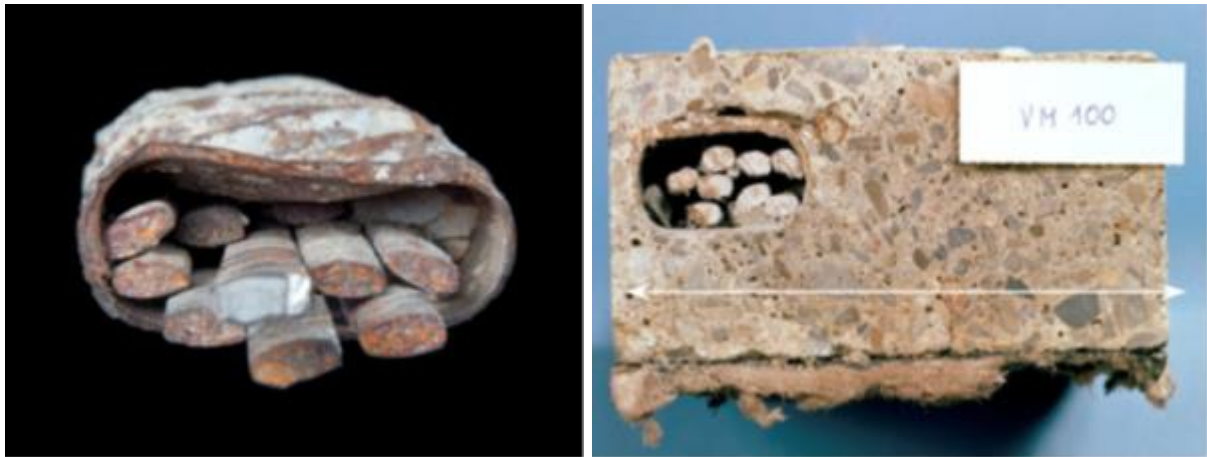
ID-19.7. Prestressing wires are almost not embedded in the protective grout (left) or insufficient grouted (right). Only one broken wire (left) shows a non-corroded brittle broken fracture surface. (Helmerich and Zunkel, 2014).

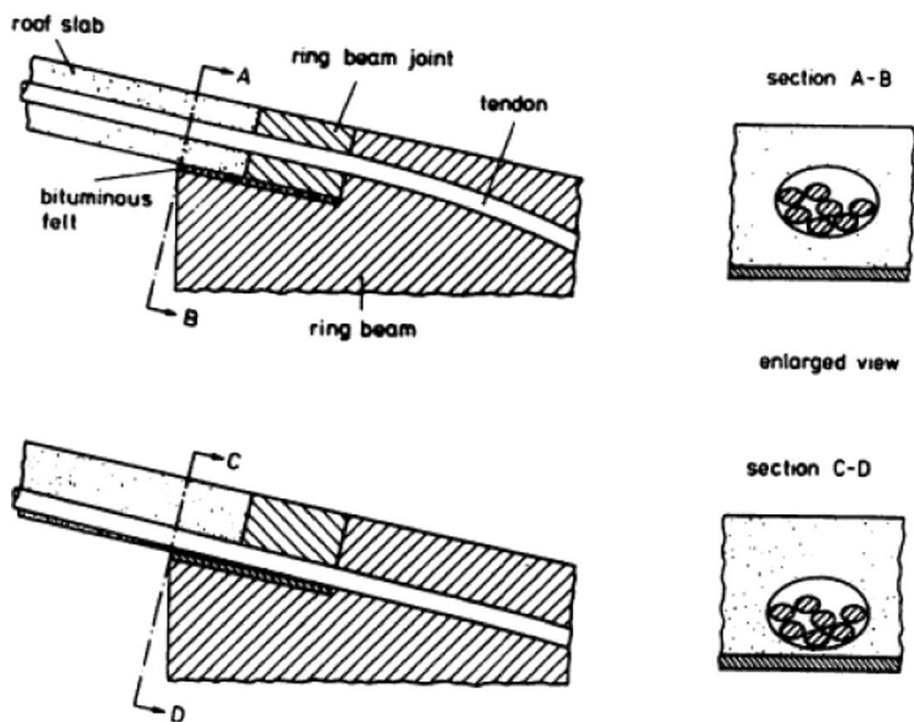
ID-19.8. Intended (upper) and real location (lower) of tendons (left) and wires in the tendon duct (right) (Helmerich and Zunkel, 2014).
