Corrosion induced failures of post-tensioned bridges

Technical Report · May 2022

NTNU
Norwegian University of
Science and Technology
Faculty of Engineering
Department of Structural Engineering

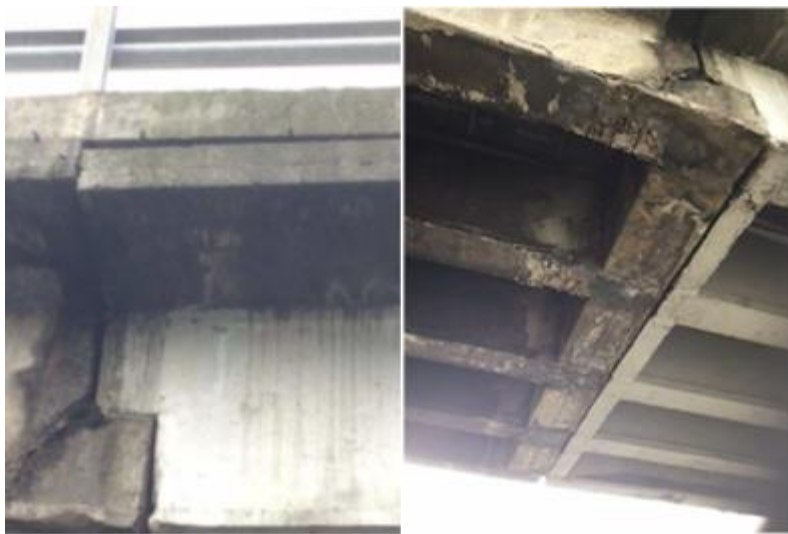
Figure 3.1.20. Annone Overpass (ID-21). Critical Gerber joint view before the collapse (Di Prisco et al, 2018).

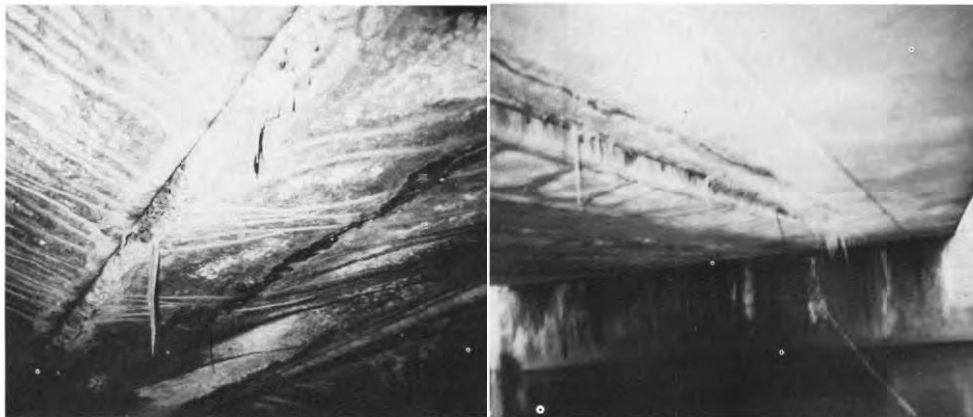
In Walnut Street Bridge (ID-31, see Section 2.2) stains were observed on the sides of the beams (Figure 3.1.22). The stains indicated that water had been seeping through the shear key joints between all beams. In addition, some of the beams were badly deteriorated with holes through the top flanges, crumbling concrete, and exposed strands (Murray and Frantz, 1992).

Figure 3.1.22. Walnut Street Bridge (ID-31). Stains on beams and ruptured strand hanging down into the river (Murray and Frantz, 1992).

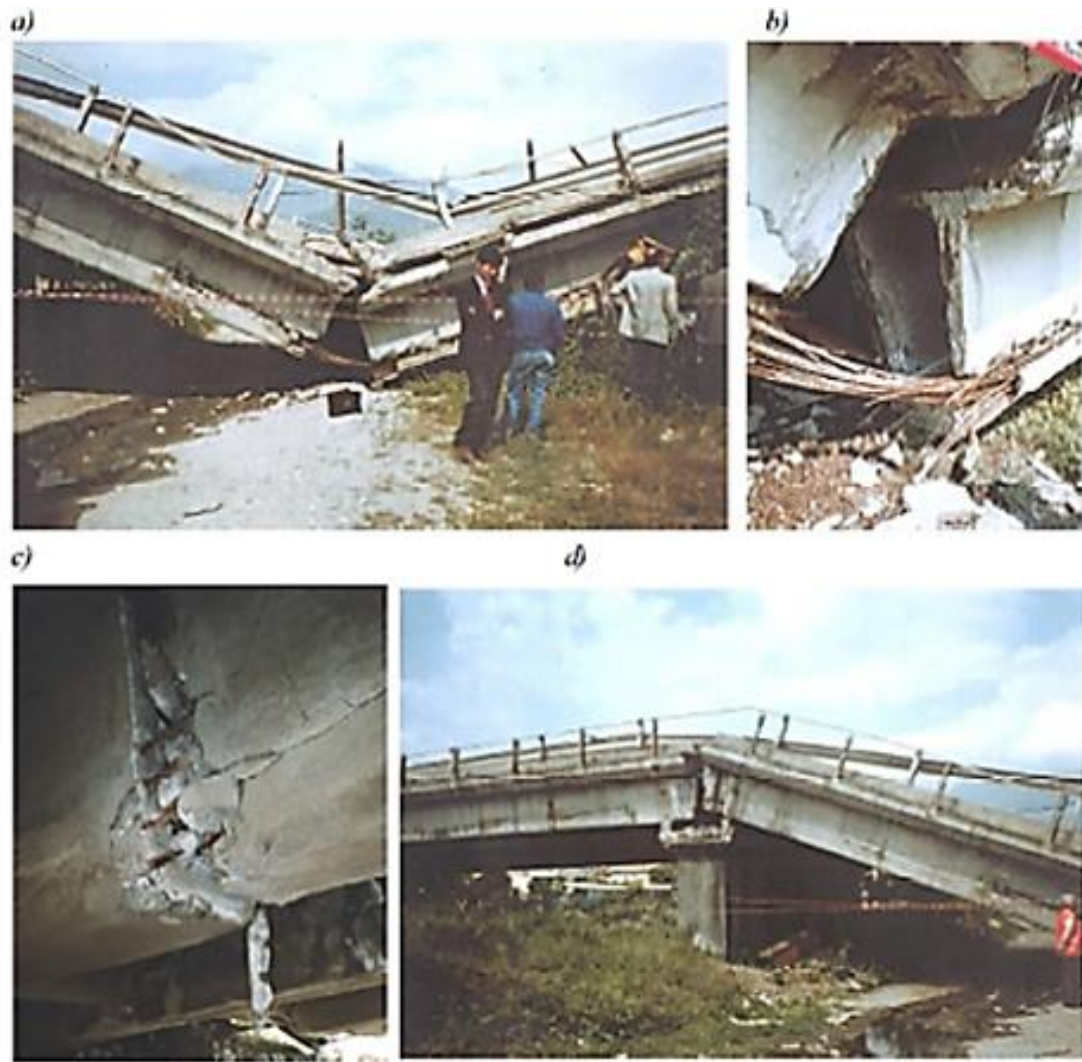
Figure 3.3.4. S. Stefano Viaduct (ID-2): a) collapse of the viaduct; b) slippage of cables; c) opening of joints; and d) rotation of the deck (Colajanni et al, 2016).

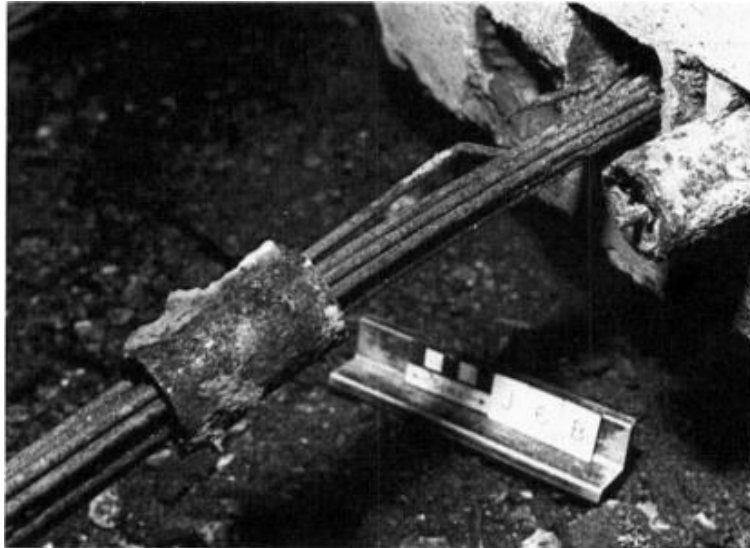
ID-1.4. Metal sleeve over longitudinal tendon: corrosion of tendons at joints (Woodward and Williams, 1988).

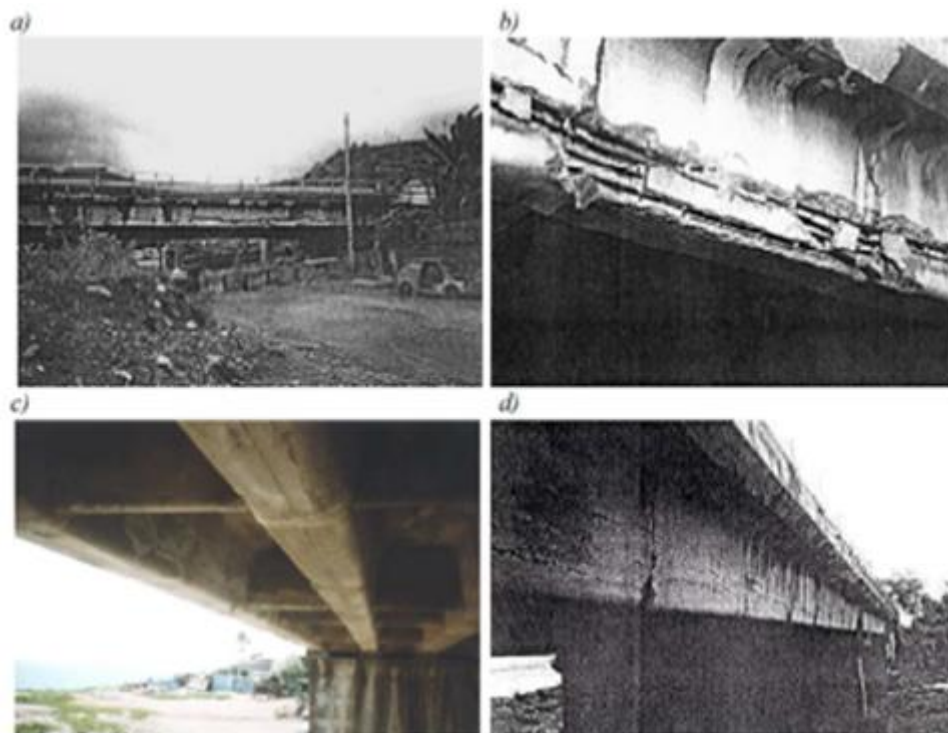
ID-2.2. S. Stefano Viaduct: a) beam shore side; b) details of corrosion phenomena on the shore side beam; c) bottom view of the deck; and d) damage on the beam mount side beam (Colajanni et al, 2016).

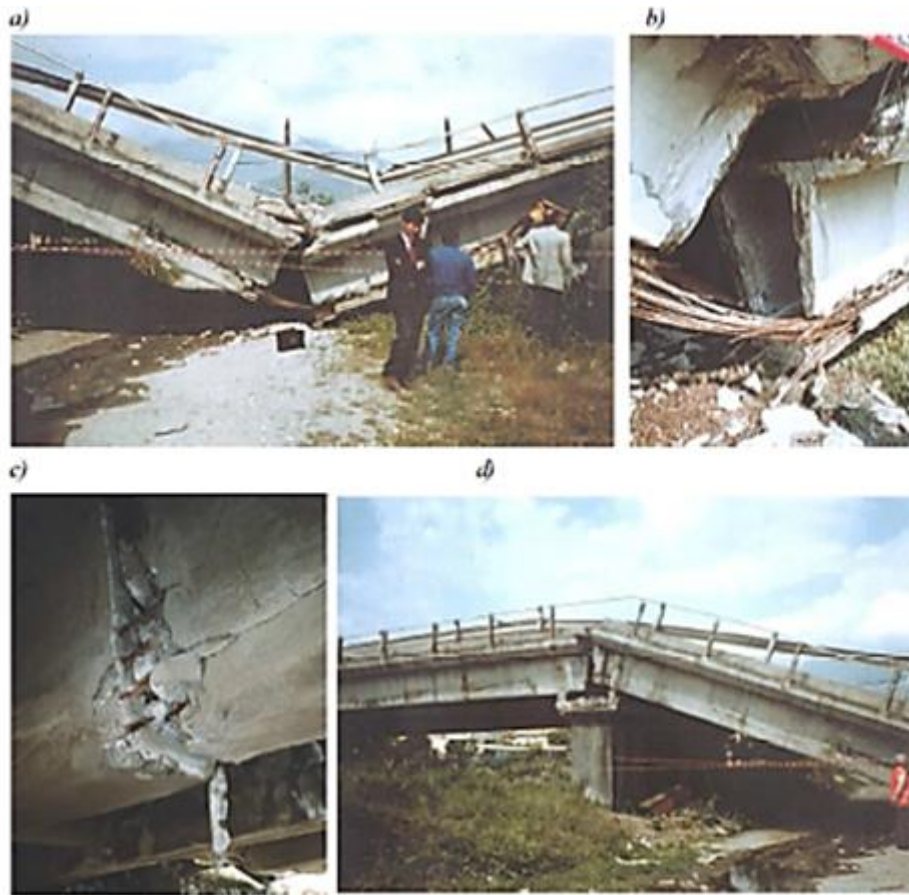
ID-2.3. S. Stefano Viaduct: a) collapse of the viaduct; b) slippage of cables; c) opening of joints; and d) rotation of the deck (Colajanni et al, 2016).

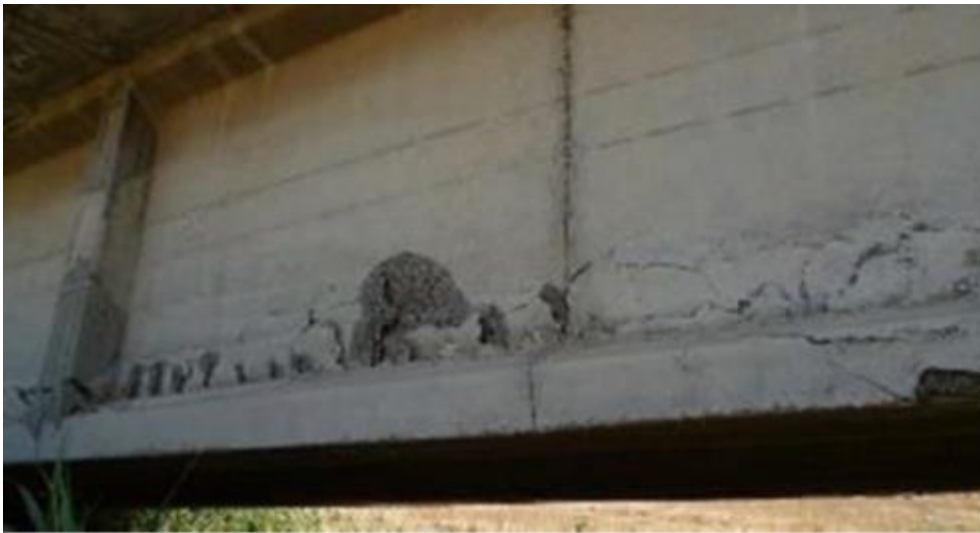
ID-4.8. Cracking in the other bridge spans (Anania et al, 2018).

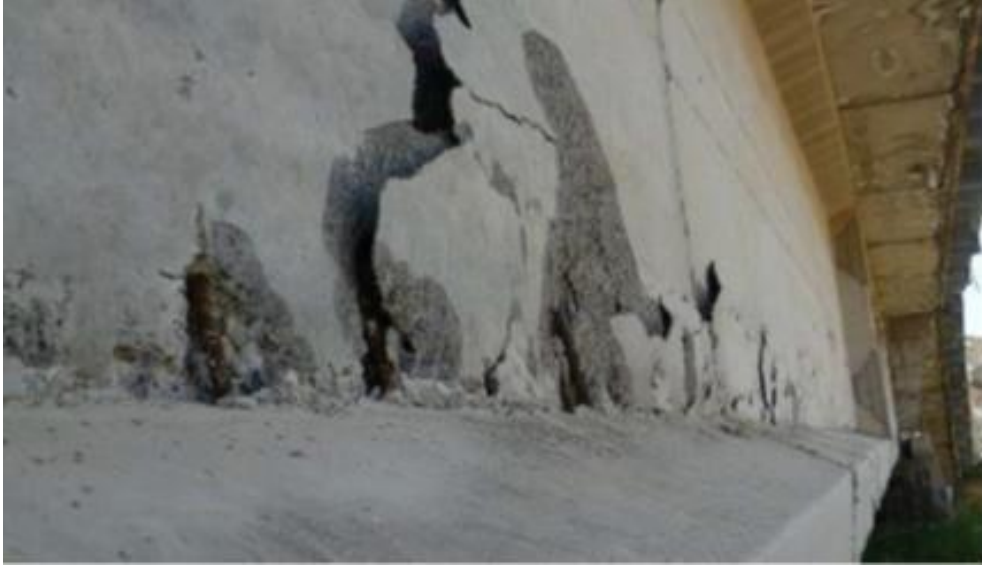
ID-4.10. Cracking on the bridge span due to tensile stress and to the expulsion of the stirrups (Anania et al, 2018).

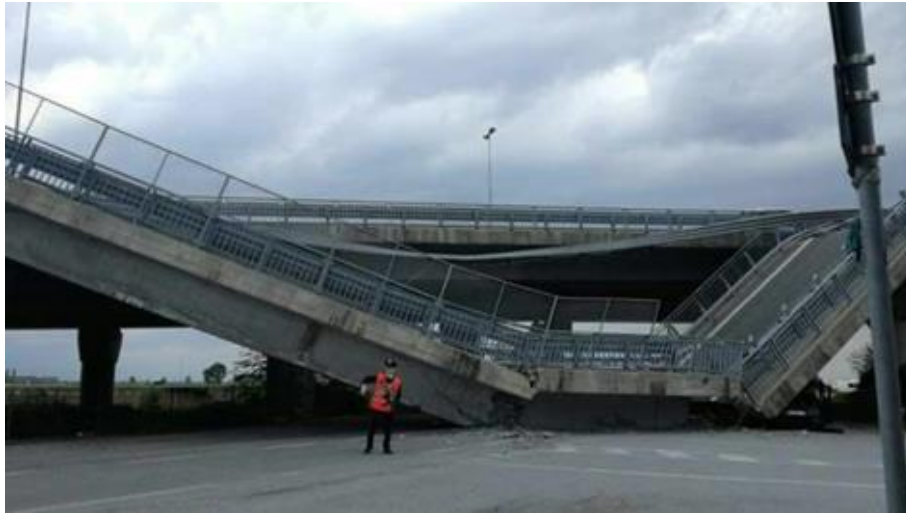
ID-5.1. Collapse mechanism of the bridge

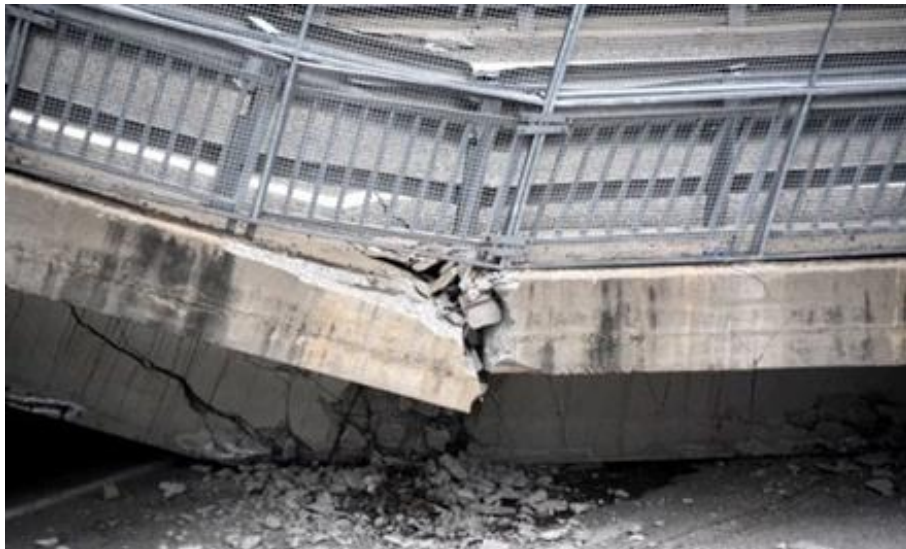
ID-5.2. Bridge beam: mid span fracture

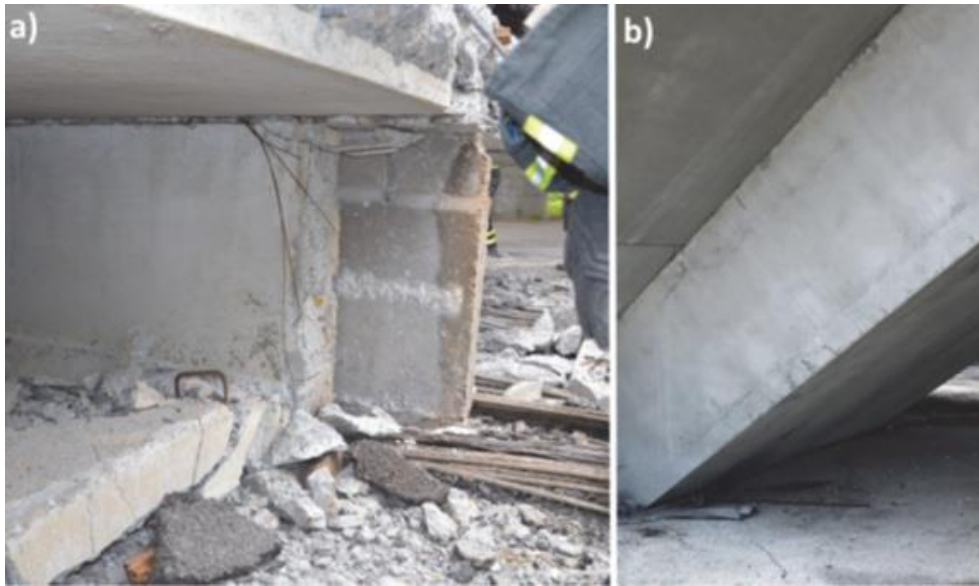
ID-5.4. Prestressing cables in the collapsed joint area (a); external concrete conditions (b) (Bazzucchi et al, 2018).

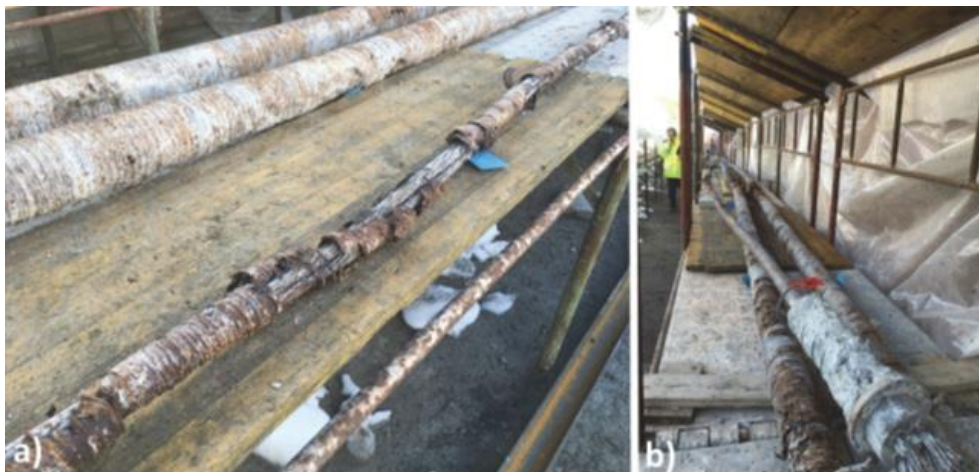
ID-5.5. Prestressing cables extracted and analysed. It is possible to note the direct correlation between grout content and oxidation rate of both sheathing and strands (Bazzucchi et al, 2018).

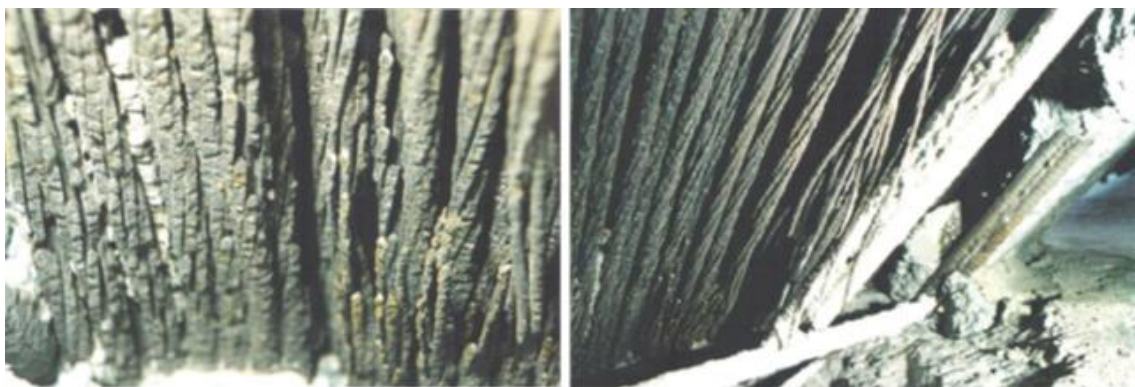
ID-6.6. Details of top part of the suspension cables, strongly corroded in 1991 (Nuti et al, 2020).

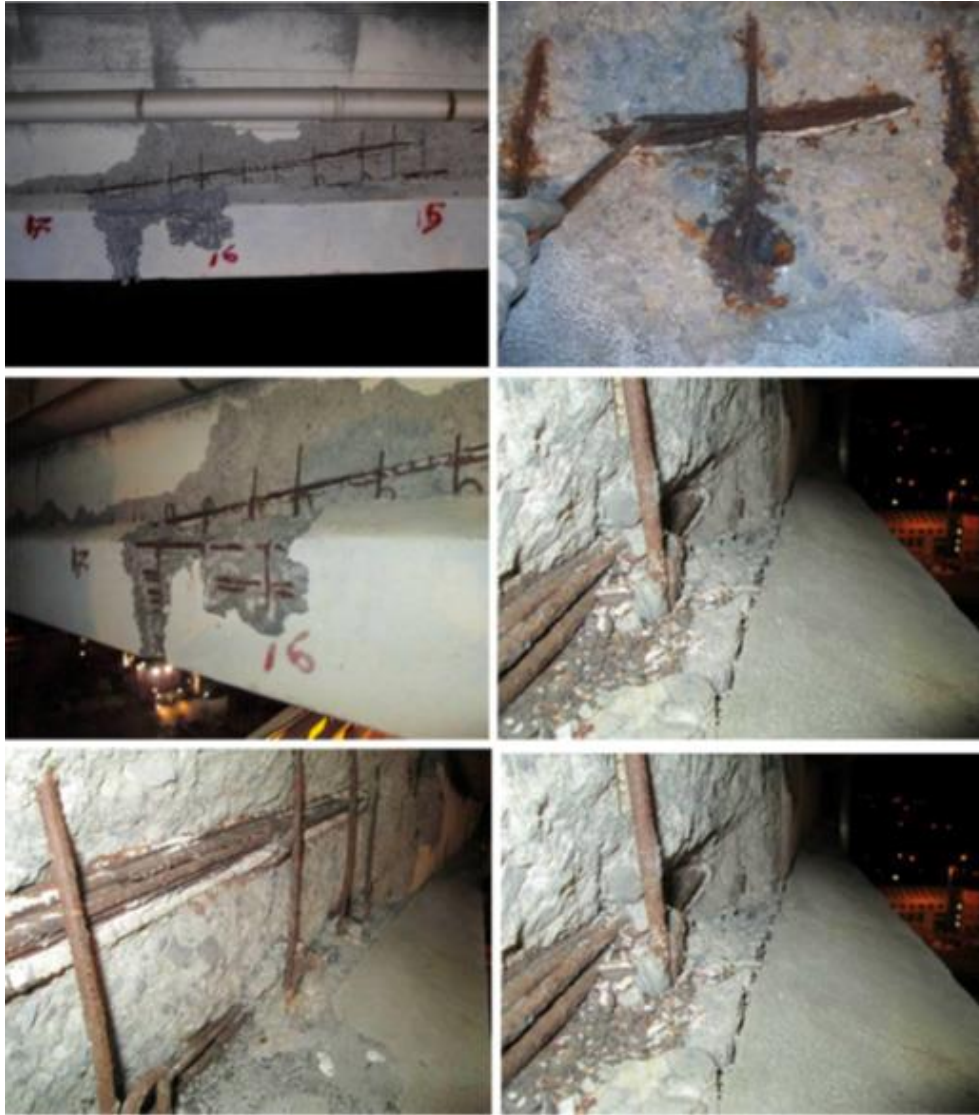
ID-6.7. View of cables toward the support in 2011 (top) and 2013 (middle). Zoom of the cables in 2013 (bottom) where corrosion and partial pitting can be appreciated (Nuti et al, 2020).

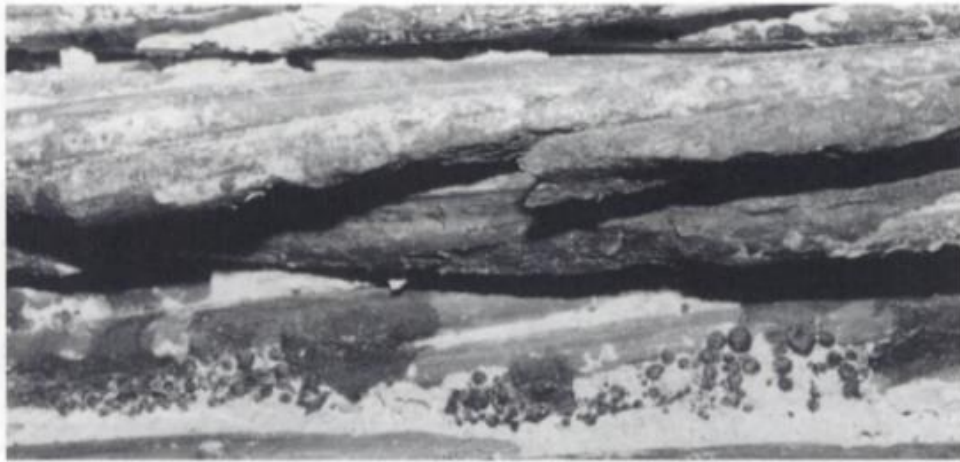
ID-7.4. Broken wire in one of the strands of Tendon 2 of Span 40-A (Venugopalan and Powers, 2003).

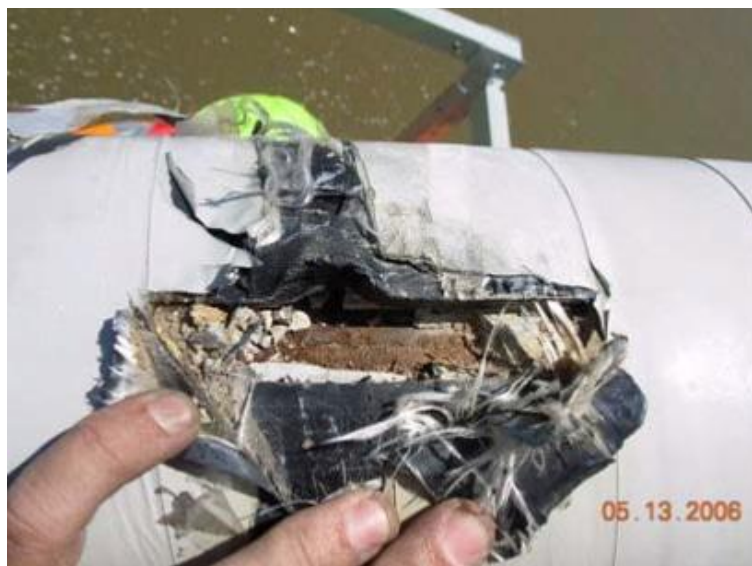
ID-10.2. Corrosion of wires at PE split (Mehrabi, 2009).

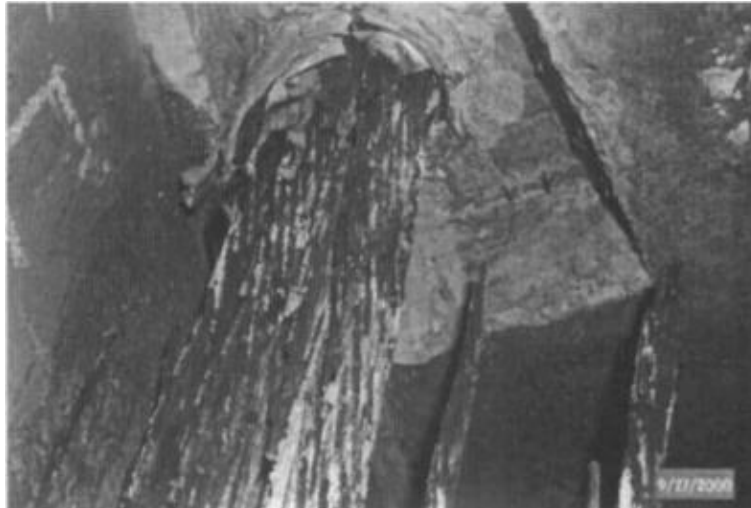
ID-11.5. Severe corrosion and failure just below the cap on the SE tendon in column 133 NB (Theryo et al, 2011).

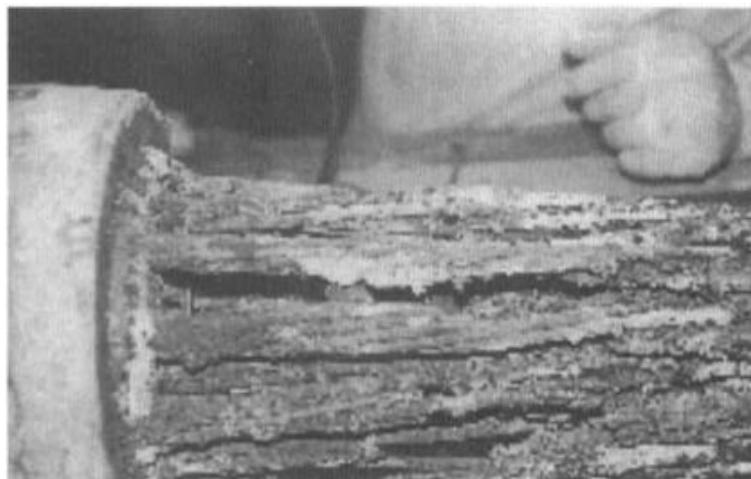
ID-11.6. Condition of strand inside the trumpet (Theryo et al, 2011).

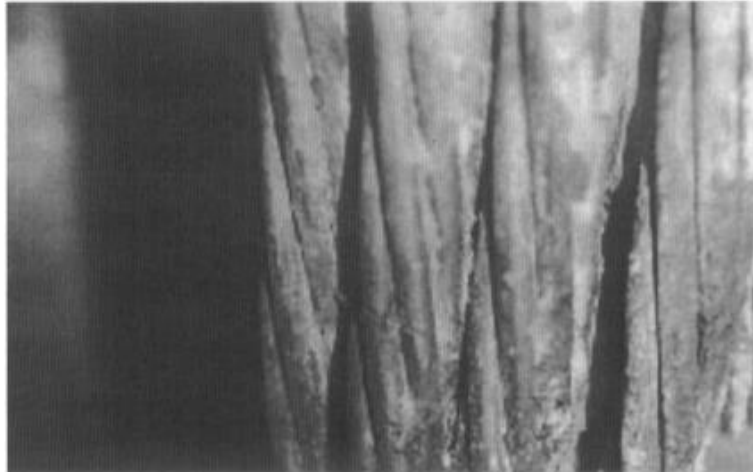
ID-11.8. Severe corrosion and strand failure in the NE tendon recess area at the bottom of segment 1 in column 131 SB (Theryo et al, 2011).

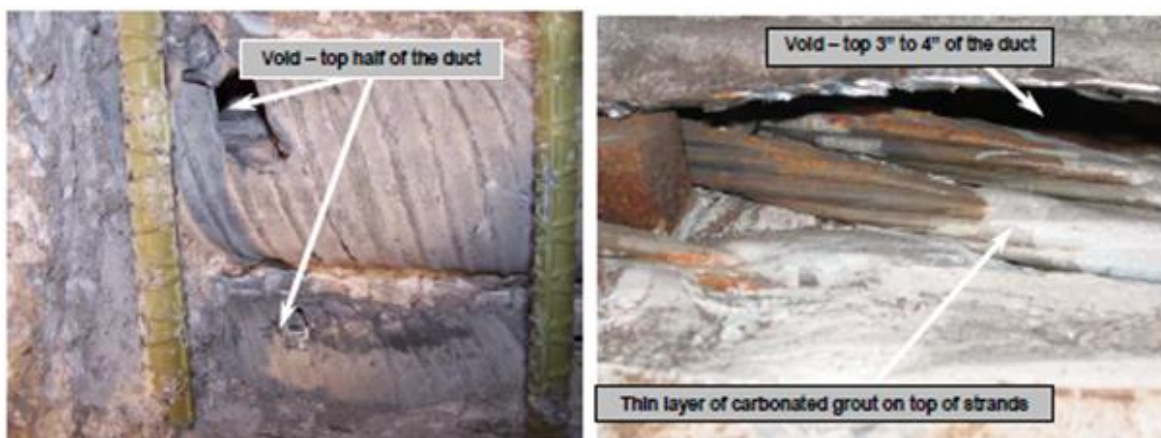
Figure 13.3. Voids (with a thin layer of chalky material) at different sections of the tendon. (Venugopalan, 2008).

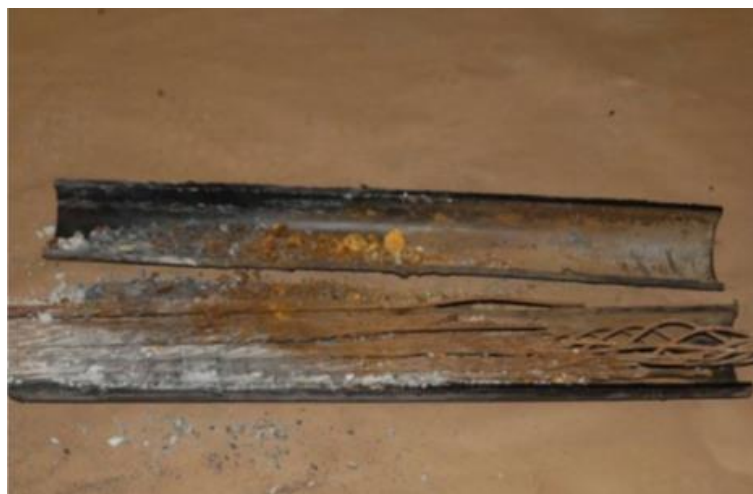
ID-15.3. Segment of failed tendon discovered in January 2011 with evidence of corrosion damage. Duct opened in laboratory during investigation (Ahern et al, 2018).

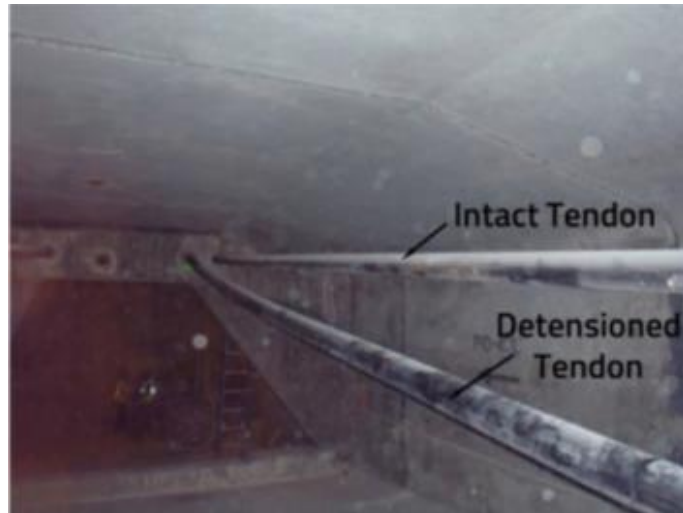
ID-15.4. Detentioned PT Tendon discovered in July 2011 (Ahern et al, 2018).

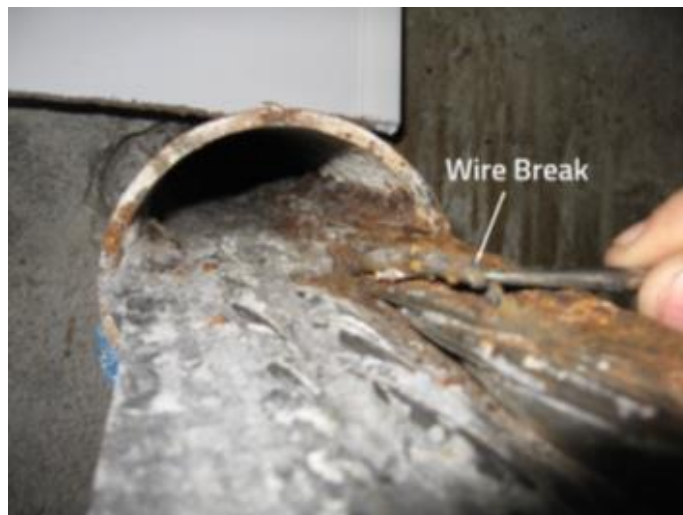
ID-15.4. Corrosion of strands and wire breaks identified in other external PT tendons (Ahern et al, 2018).

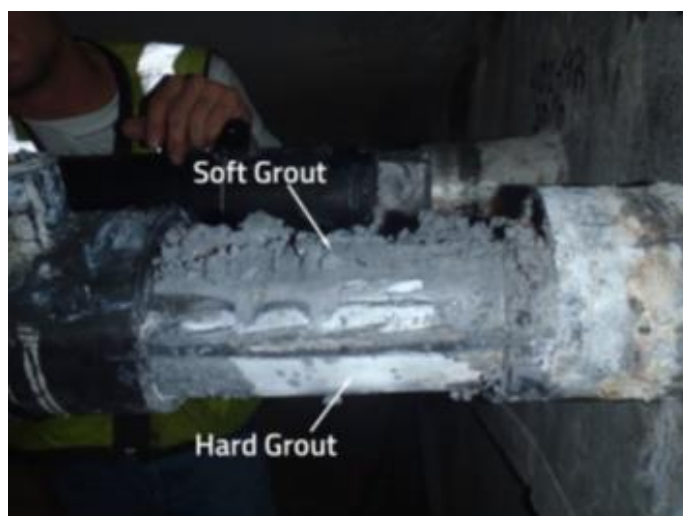
ID-15.5. Segregation of the grout material observed near the high points of the tendon profile (Ahern et al, 2018).

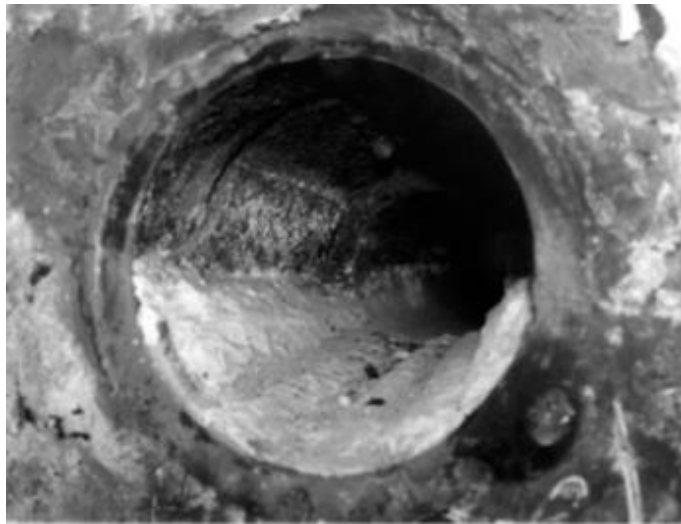
ID-17.2. Anchor at failed tendon showing chalky grout, partial grout filling and heavy corrosion (Powers et al, 2002).

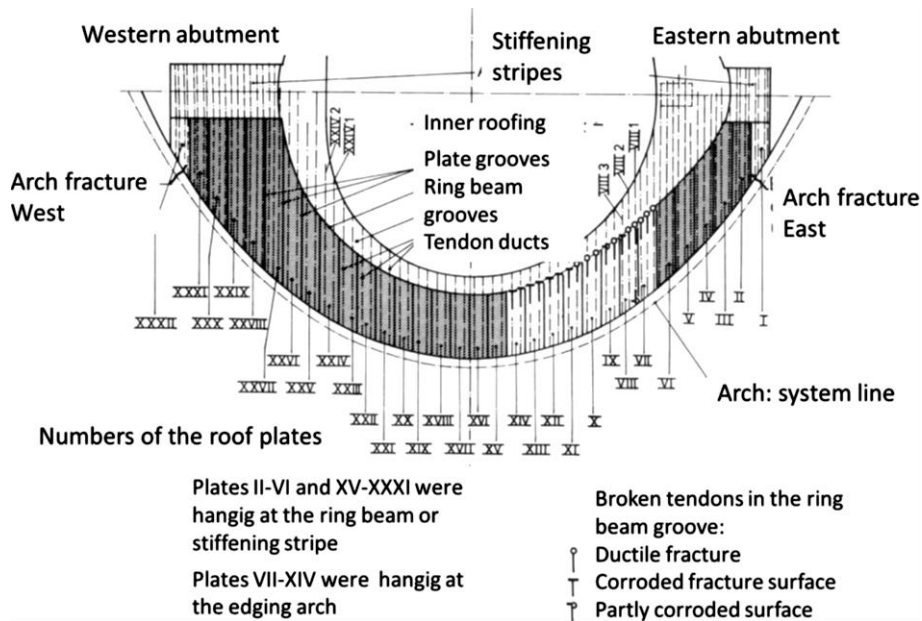
ID-19.4. Ground view with the location of corroded and broken tendons (Helmerich and Zunkel, 2014).

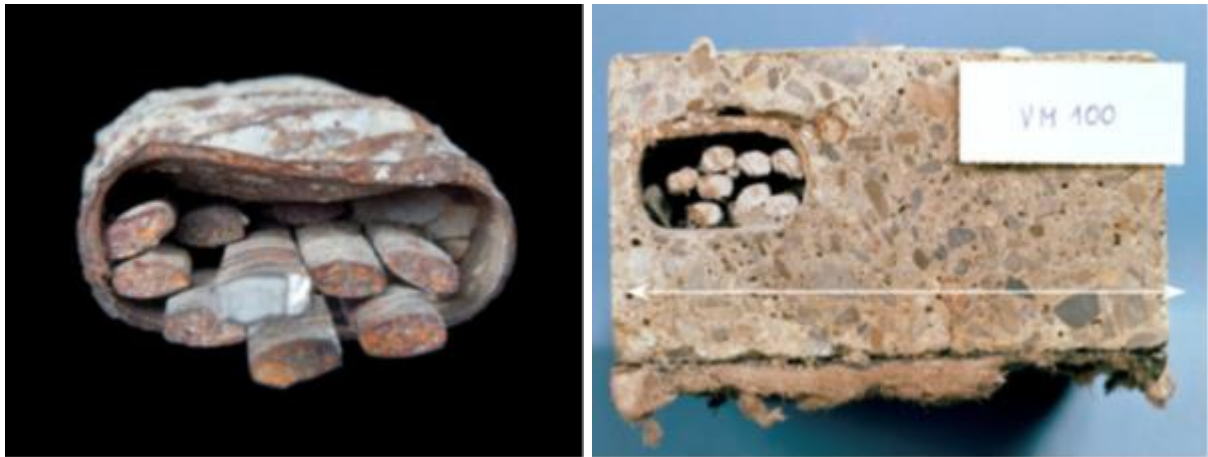
ID-19.7. Prestressing wires are almost not embedded in the protective grout (left) or insufficient grouted (right). Only one broken wire (left) shows a non-corroded brittle broken fracture surface. (Helmerich and Zunkel, 2014).

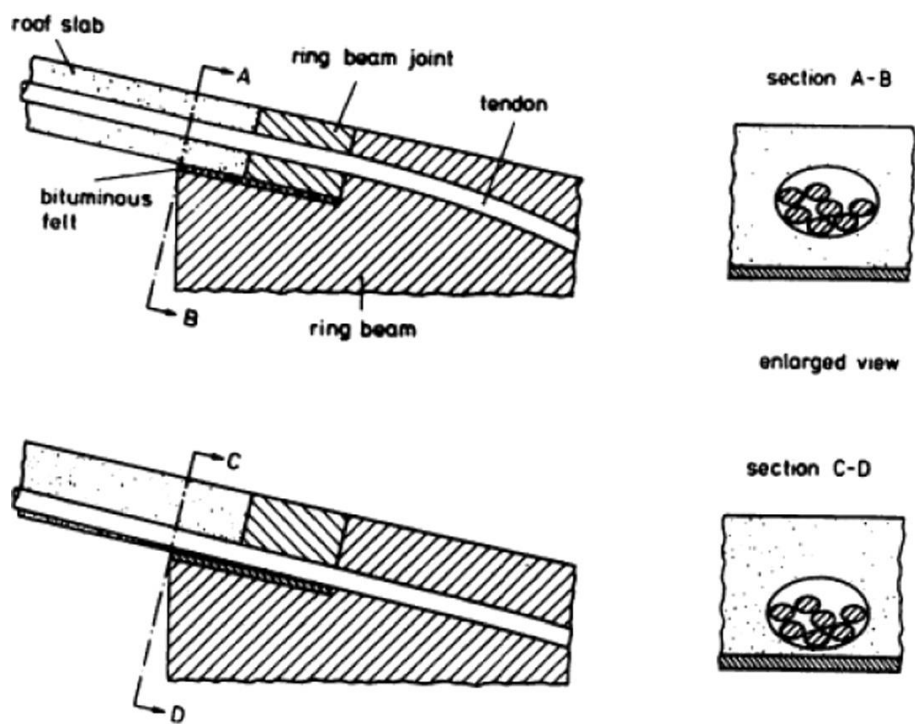
ID-19.8. Intended (upper) and real location (lower) of tendons (left) and wires in the tendon duct (right) (Helmerich and Zunkel, 2014).

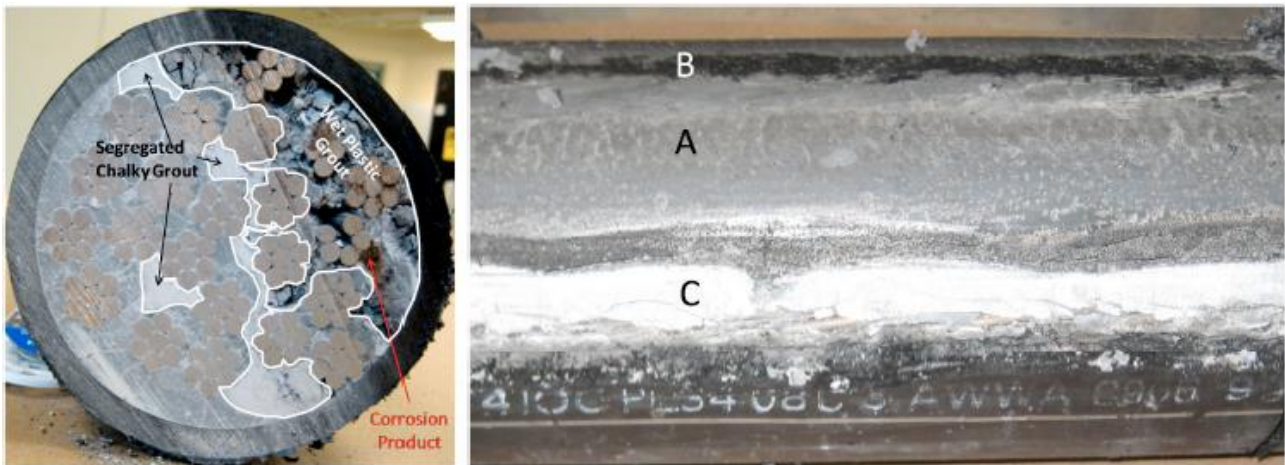
ID-20.3. Grout segregation appearance. (A) Wet plastic grout. (B) Dark band of sedimented silica fume. (C) White chalky grout (Permeh et al, 2016).

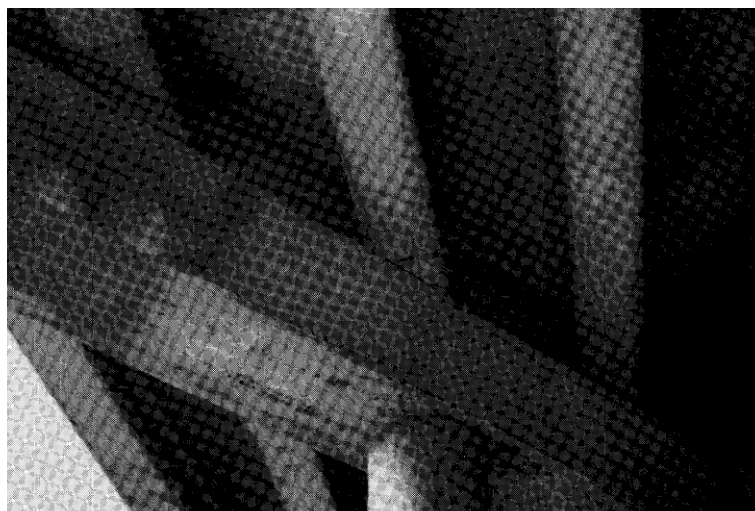
ID-32.3. Corroded strapping across bottom of girder on Harlem Avenue overpass. (Gustaferro et al,1983).

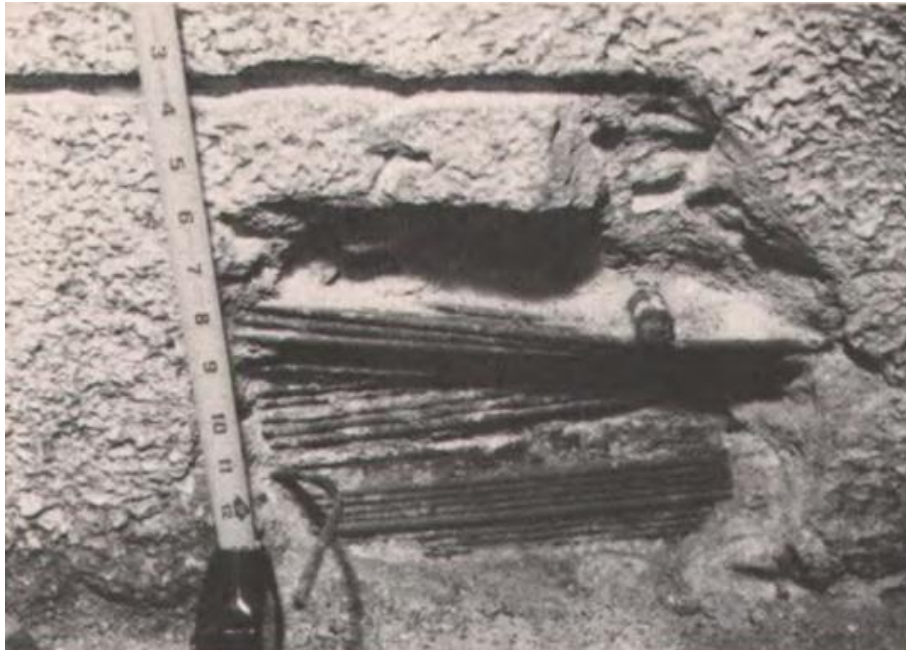
ID-42.1. Corroded wires bundled around a pipe. Shotcrete protection did not penetrate bundle and was not bonded to tank wall (Schupack and Suarez, 1982).
