## Experimental and Analytical Evaluation of Residual Capacity of Corrosion-Damaged Prestressed Concrete Bridge Girders

**Final Report VTRC 25-R18**

This report presents the results of testing of six corrosion-damaged prestressed beams removed from existing bridges during their demolition. Three beams were Type II AASHTO I-beams extracted from the Lesner Bridge in Virginia Beach, and three were 48 in wide by 27 in deep box beams extracted from the Aden Road Bridge near Quantico, Virginia. Prior to testing, the beams were visually inspected and two types of non-destructive evaluations were performed to identify corrosion activity: resistivity measurements and half-cell potential measurements. The beams were then tested in the lab to determine their flexural strength. Following testing, samples of strand were removed and tested to determine their tensile properties. Cores were taken from the Aden Road beams and from both the beams and decks of the Lesner Bridge beams to determine compressive strength. Powdered concrete samples were removed to perform chloride concentration tests.

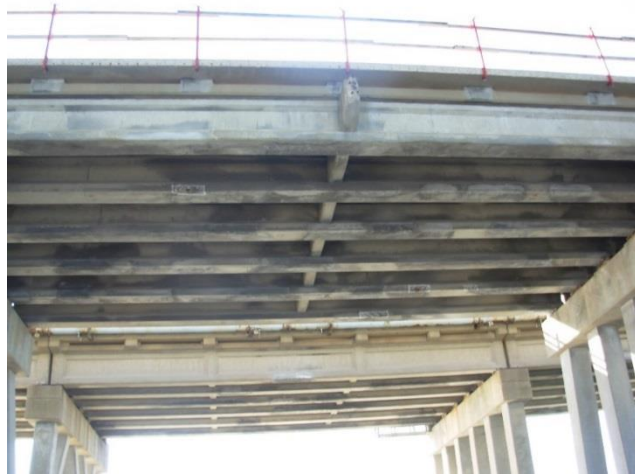
After almost 50 years of service, the bridge was demolished and replaced beginning in 2016. In the spring of 2017, nine beams were retrieved during the demolition process and delivered to Virginia Tech for testing. The slab between the beams was saw-cut to allow for the retrieval of beams to include a section of their cast-in-place composite deck. Figure 1 is a photograph of Span 7, showing the extent of deterioration in typical beams. The Lesner Bridge was repaired several times over the years, so patching is evident in many locations.

**Figure 1. Typical Deterioration on the Lesner Bridge**

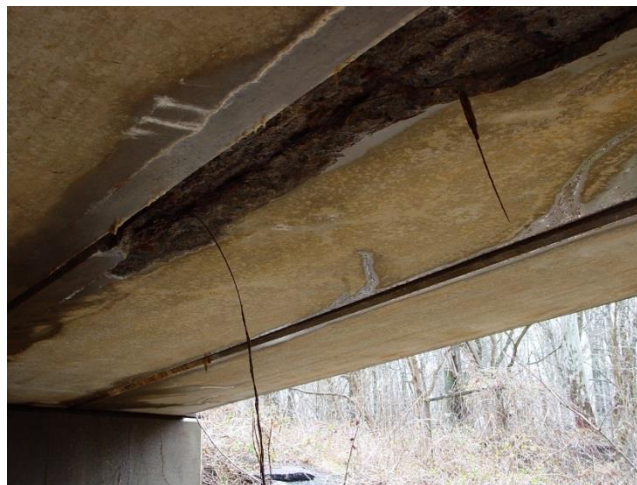
After slightly over 30 years of service, the joints had failed and the bridge was showing signs of severe deterioration, including exposed and fractured prestressing strands (see Figure 2). In 2013, the bridge was demolished and replaced. During demolition, six of the interior beams were transported to Virginia Tech for future testing, three of which were tested in this project. The Aden Road Bridge beams will be referenced by the names Box Beam 1 through Box Beam 6, but their original positions in the bridge is unknown.

**Figure 2. Typical Corrosion Damage on Aden Road Bridge**

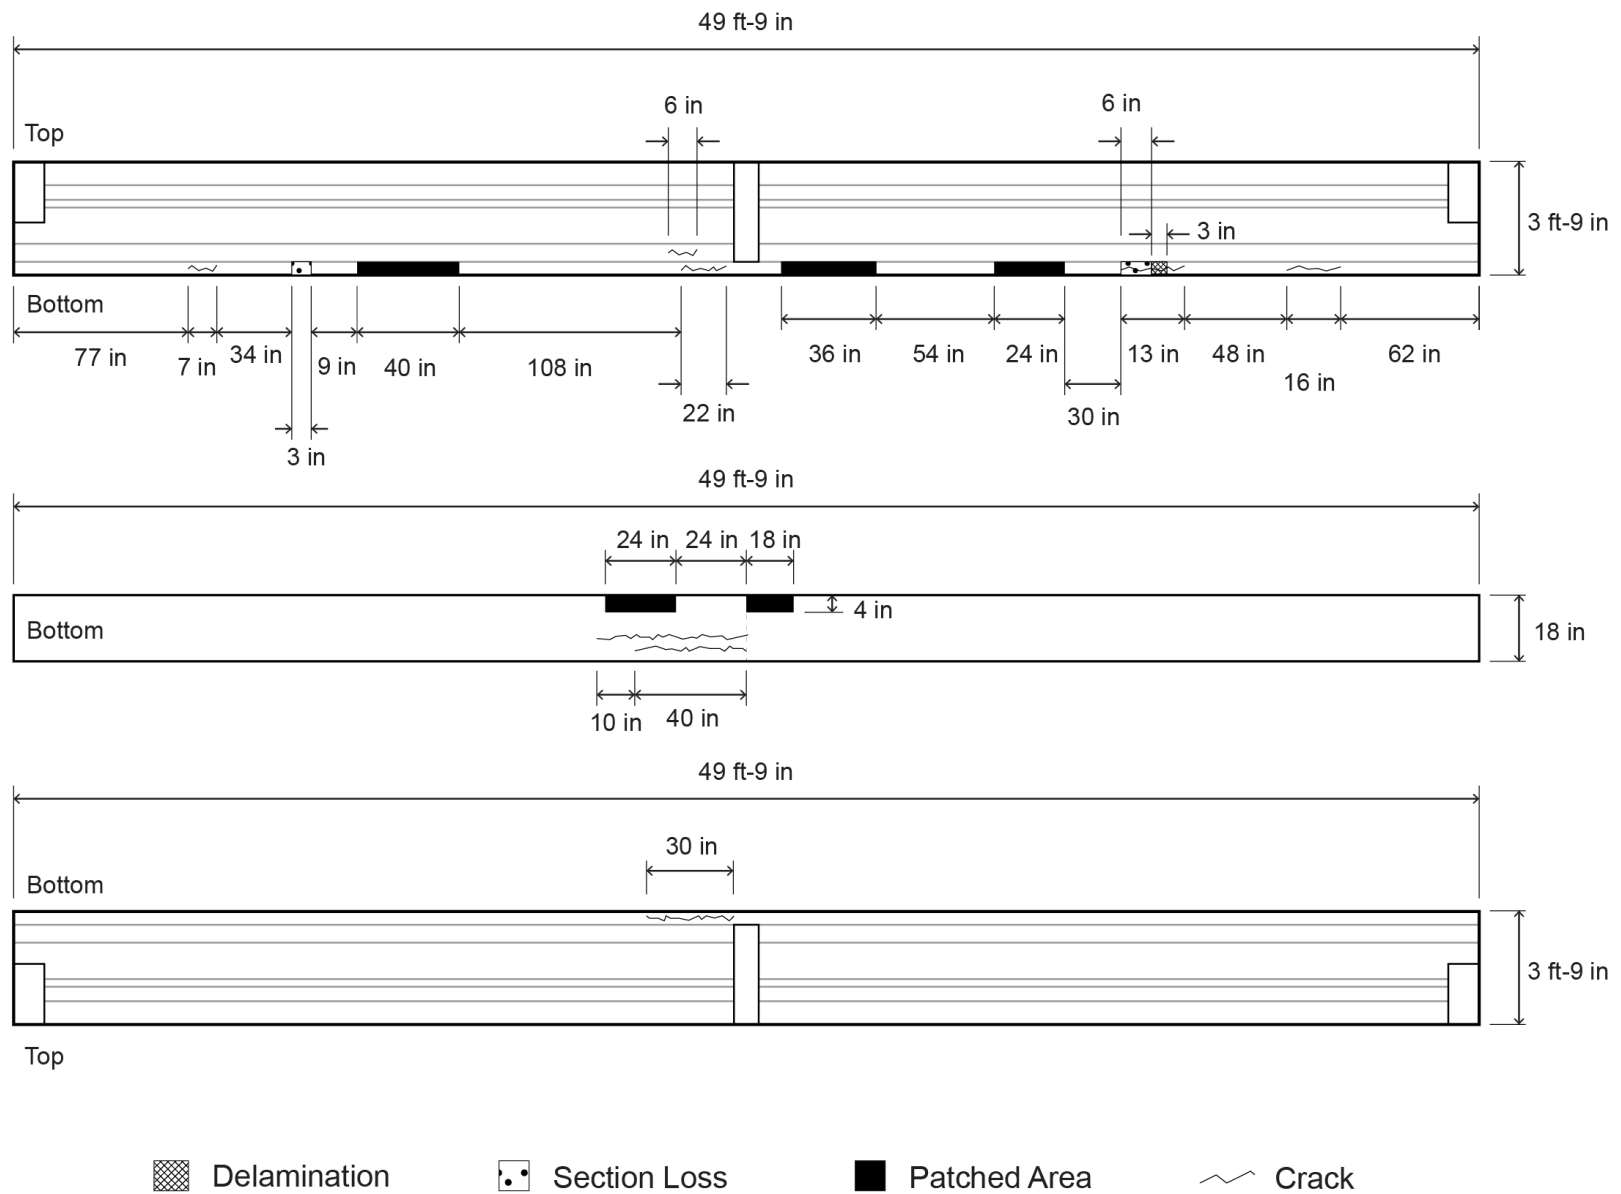
Figure 26. I-Beam 6 – Medium Condition

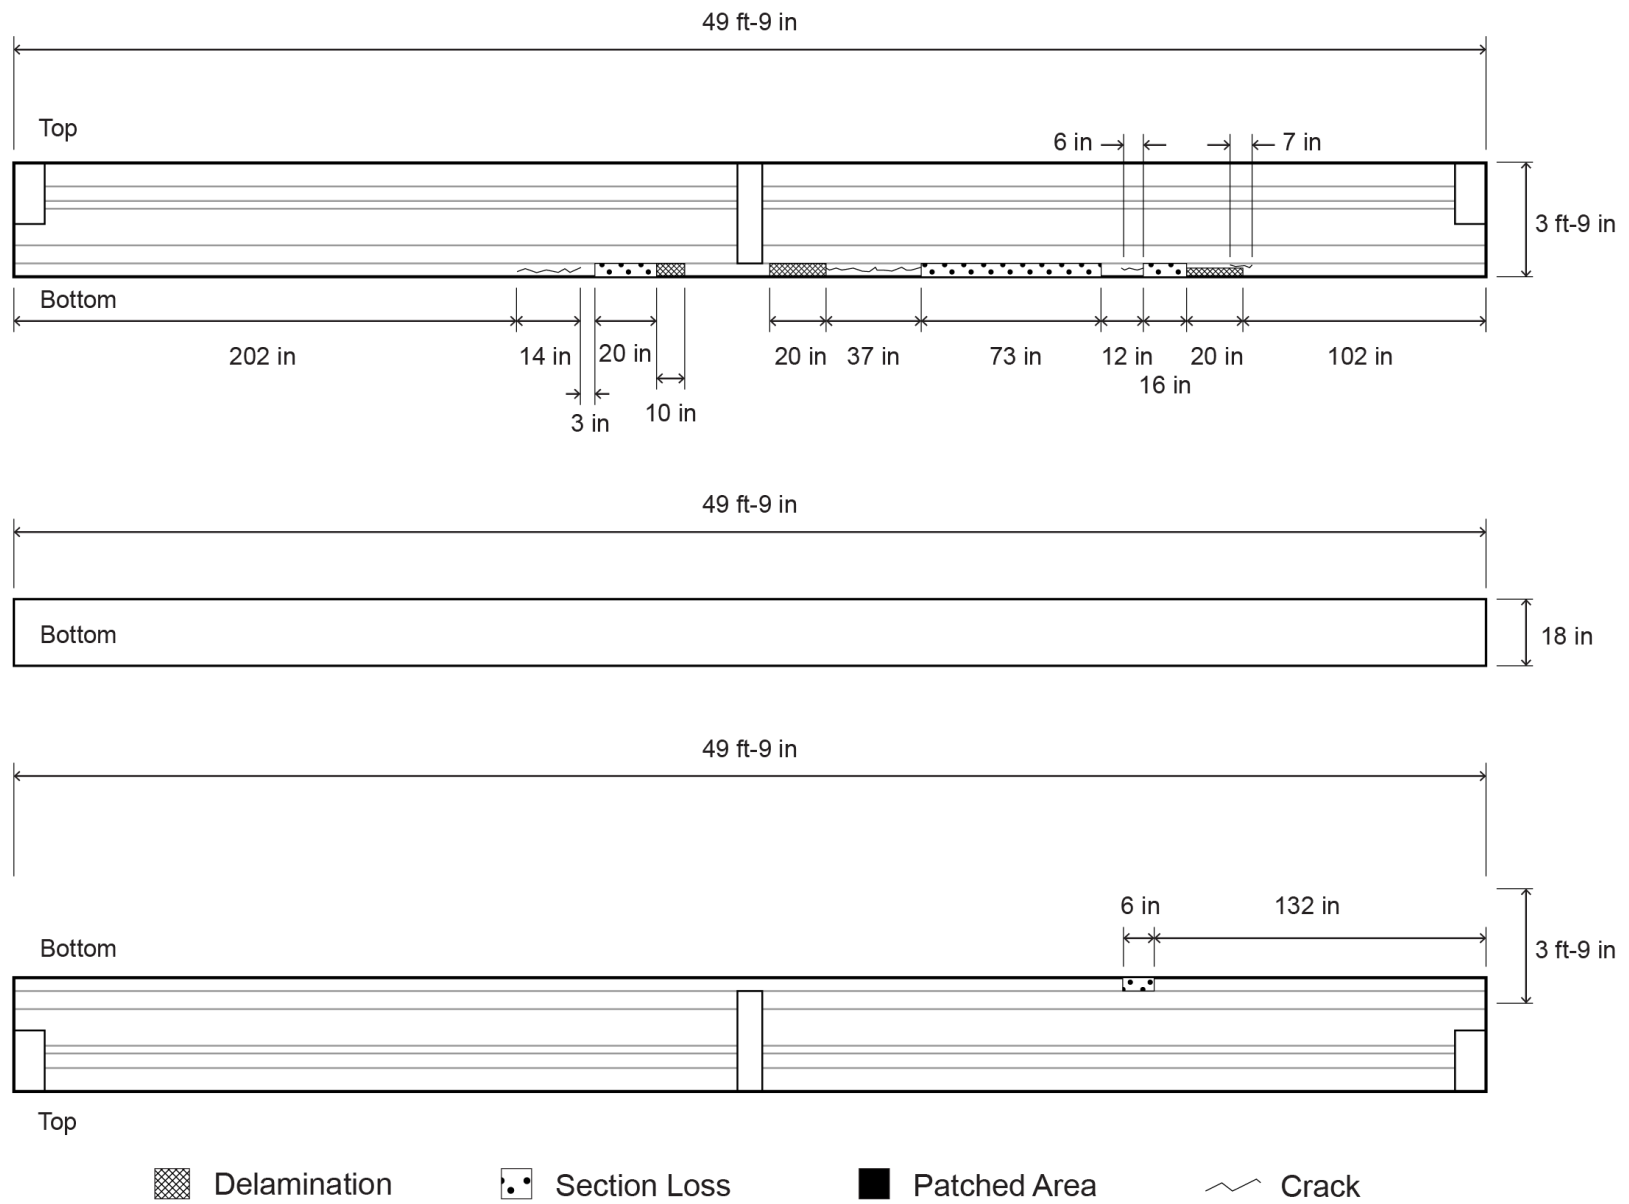
Figure 27. I-Beam 3 – Bad Condition

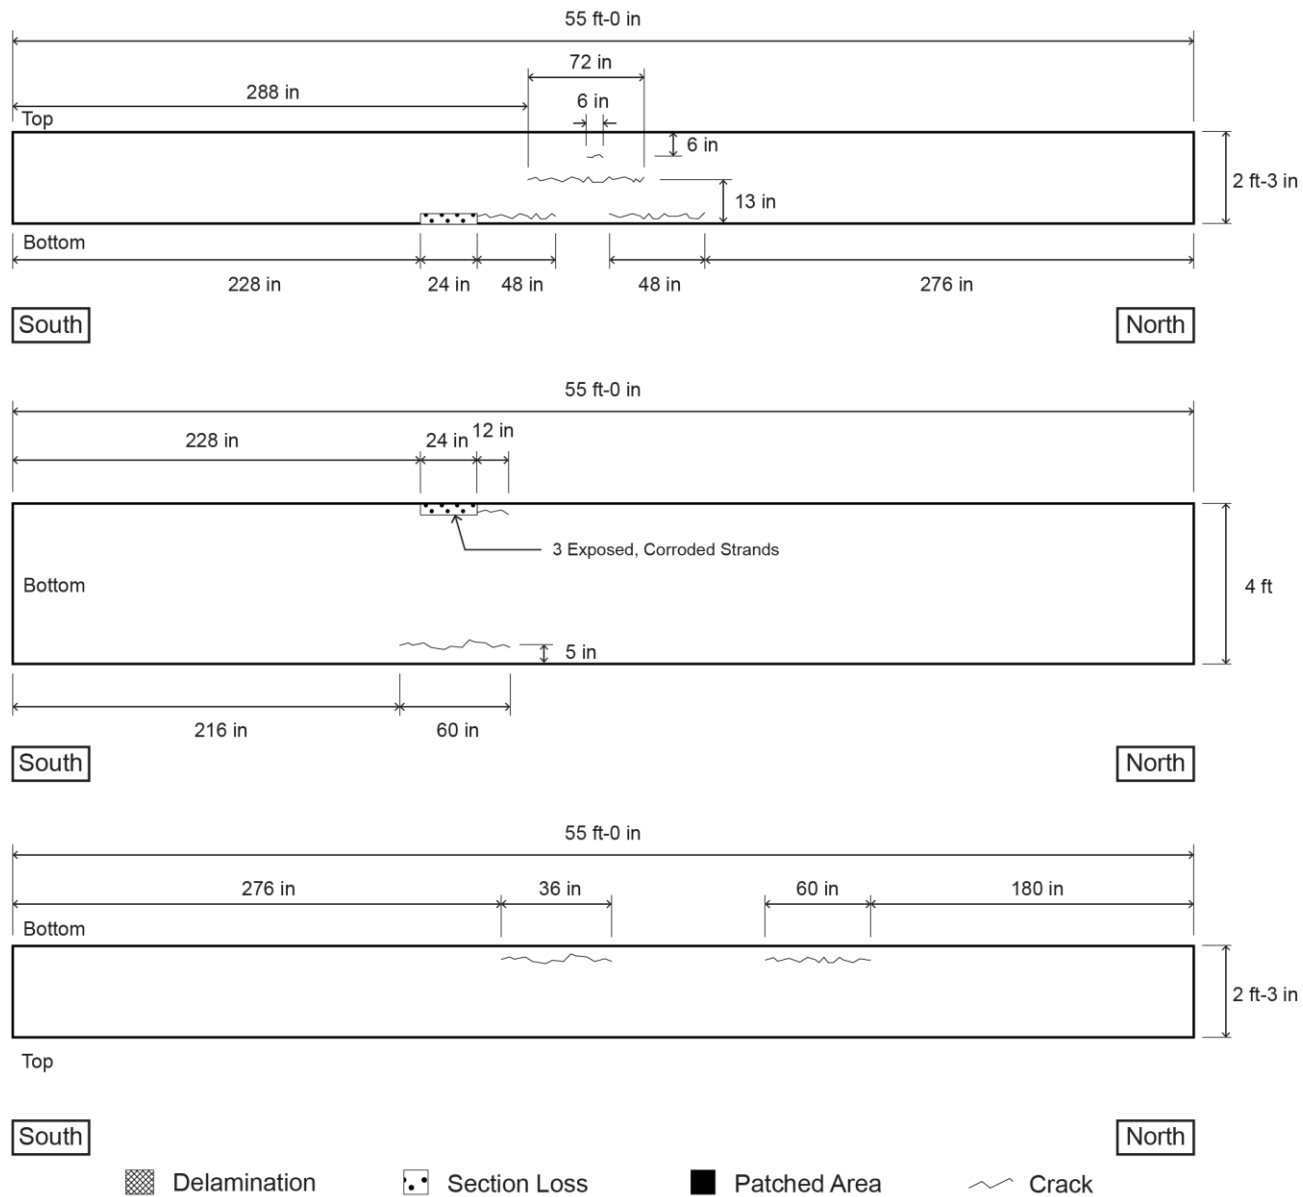
**Figure 28. Box Beam 1 – Good Condition**

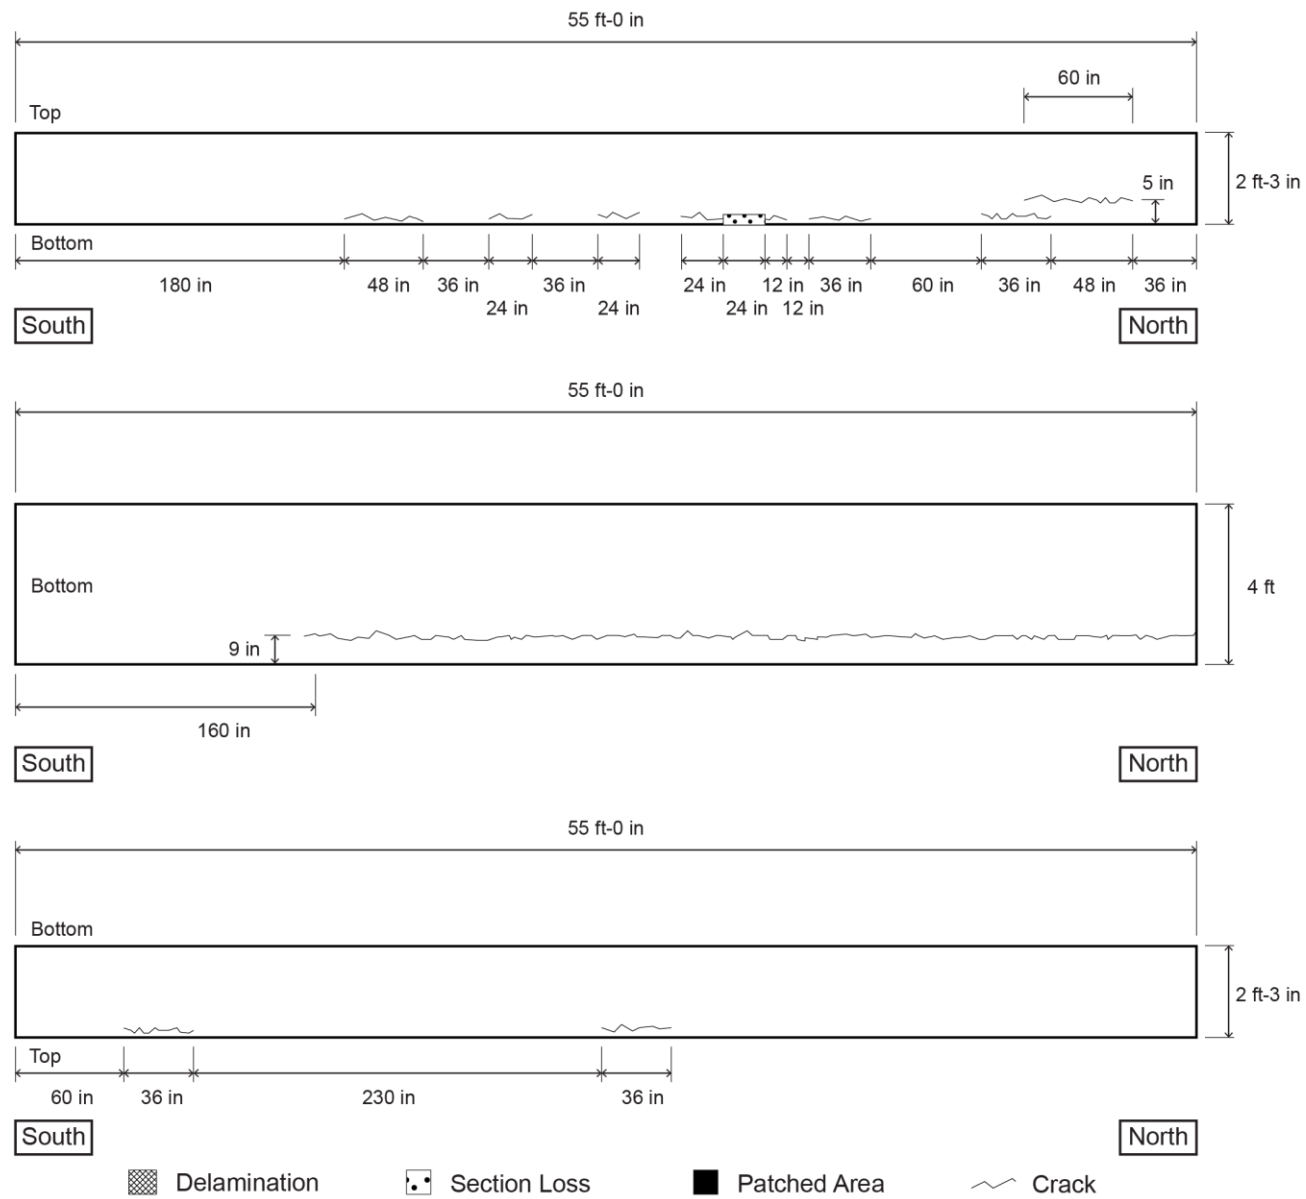
**Figure 29. Box Beam 4 – Medium Condition**

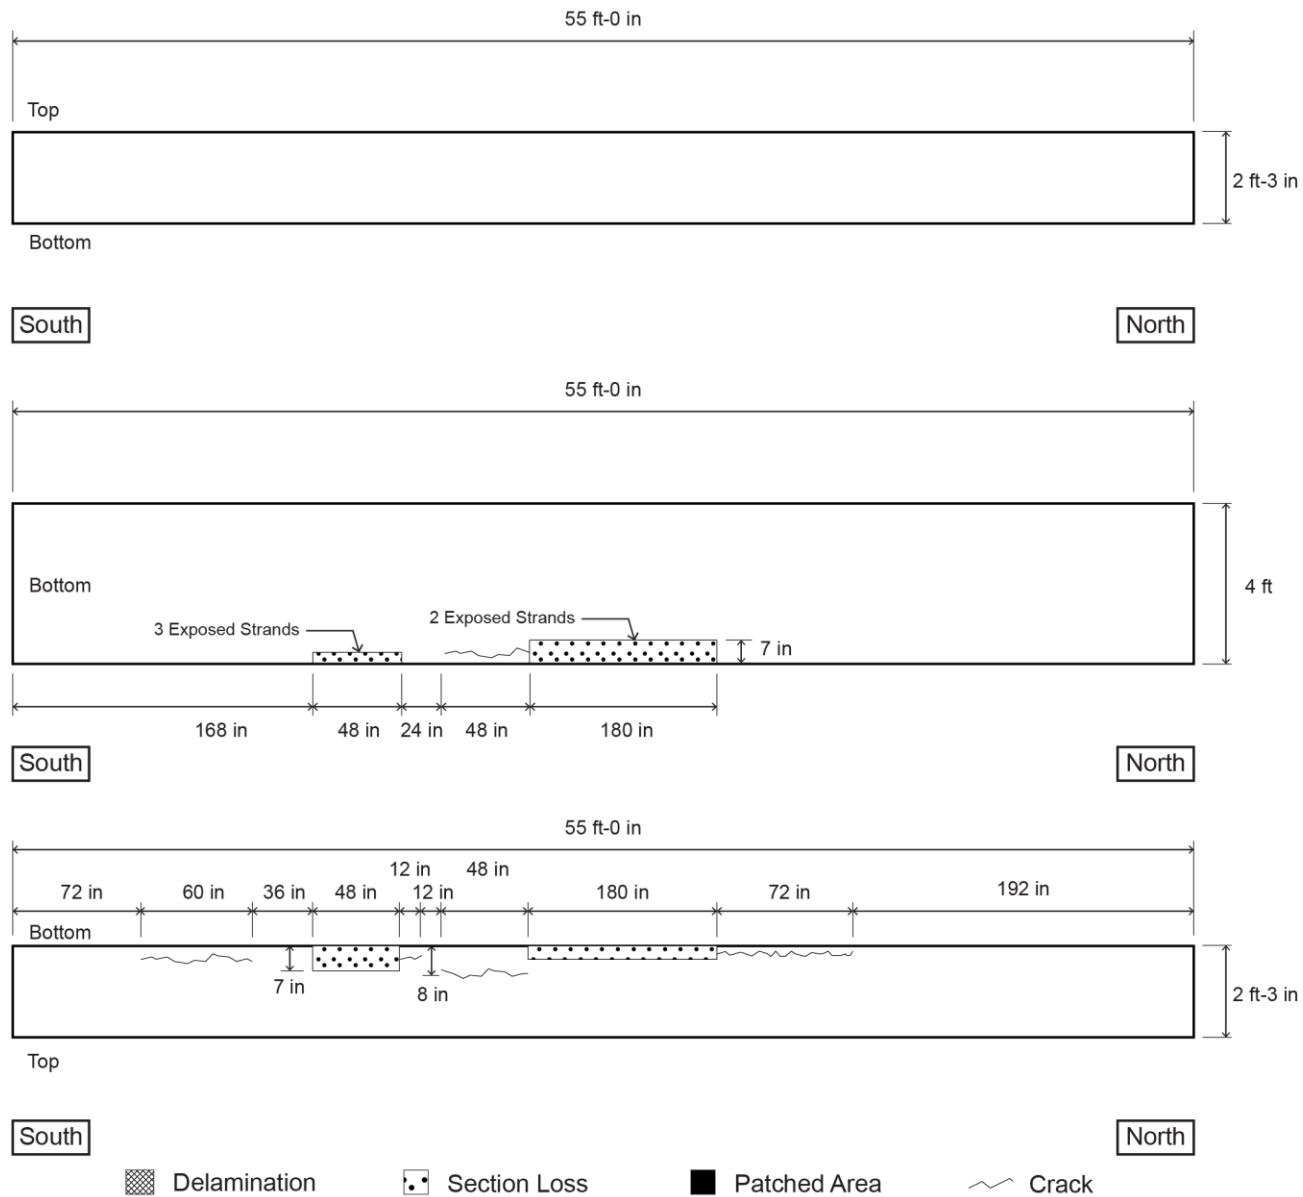
**Figure 30. Box Beam 2 – Bad Condition**

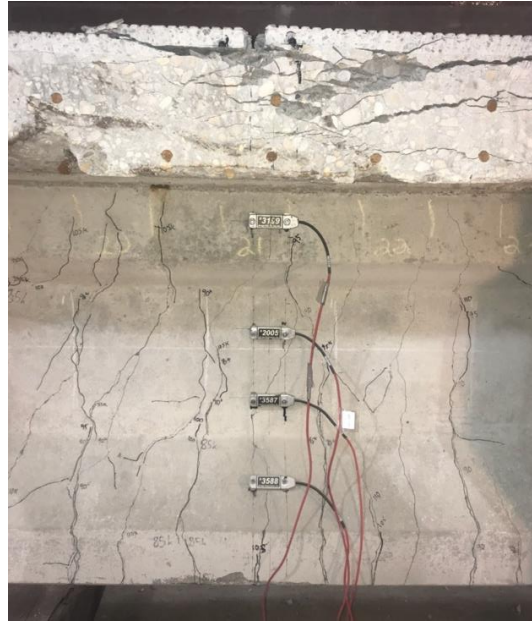
One week later, the beam was re-tested. The load was applied in increments of 20 kips until reaching 140 kips, at which point 10-kip increments were applied until the failure load of 190 kips with a deflection of 8.93 in. The failure was caused by crushing of the top slab as shown in Figure 43. The beam after testing is shown in Figure 44.

**Figure 43. Crushing Failure in Top Slab of I-Beam 7**

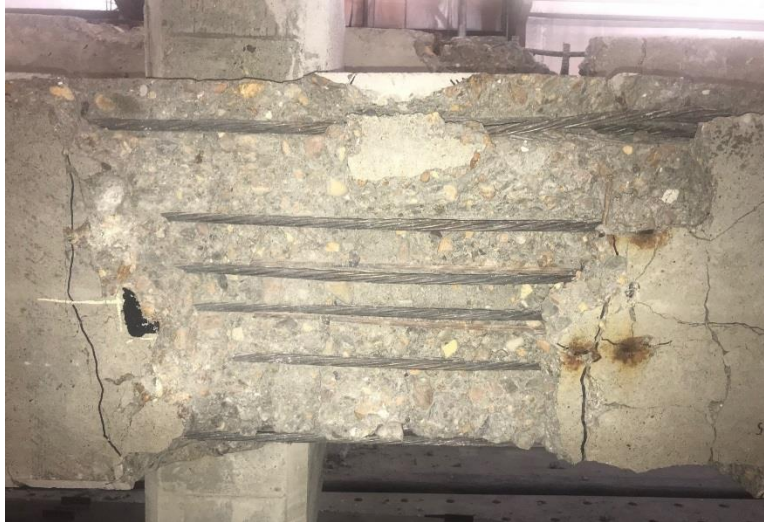
After testing, the concrete cover over the bottom strands was chipped to expose the strands. As can be seen in Figure 47, all strands were bright and shiny, showing no signs of corrosion.

**Figure 47. Bottom of I-Beam 7 after Testing**

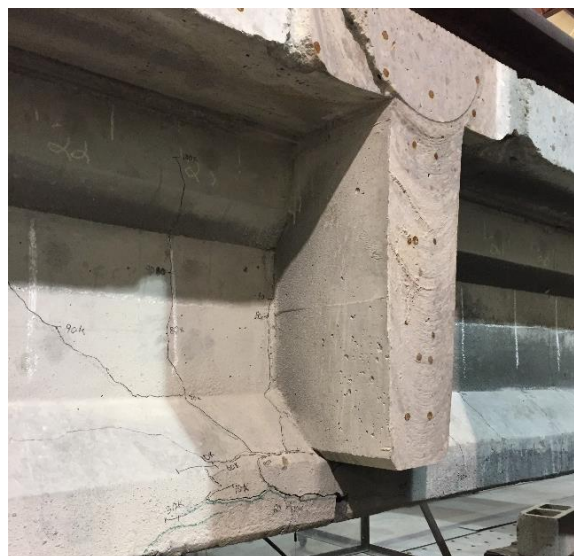
This beam was considered to be in medium condition. Near the mid-span on the bay side of the bridge there was a patch on the bottom flange that extended a few feet on either side of the mid-span diaphragm of the beam. Figure 50 shows the cracking that developed along the patch during testing.

**Figure 50. Cracking along Patch During Testing of I-Beam 6**

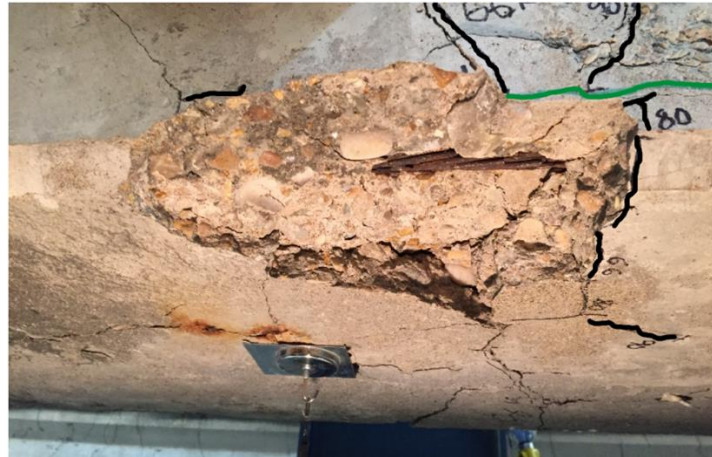
The opposite side of the beam showed very little sign of corrosion damage, except for one 8-in long hairline crack 2 in up on the bottom flange. As testing progressed, a spall occurred at the crack, revealing the corroded strand beneath (see Figure 51). Also in Figure 51, rust staining can be seen on the bottom flange; a post-test autopsy confirmed that the chairs supporting the reinforcement during concrete placement were in fact corroded. This type of staining was also seen on I-Beam 7 (see Figure 47).

**Figure 51. Hairline Crack Observed Prior to Testing (marked in green) Related to Corroded Strand Beneath on I-Beam 6**

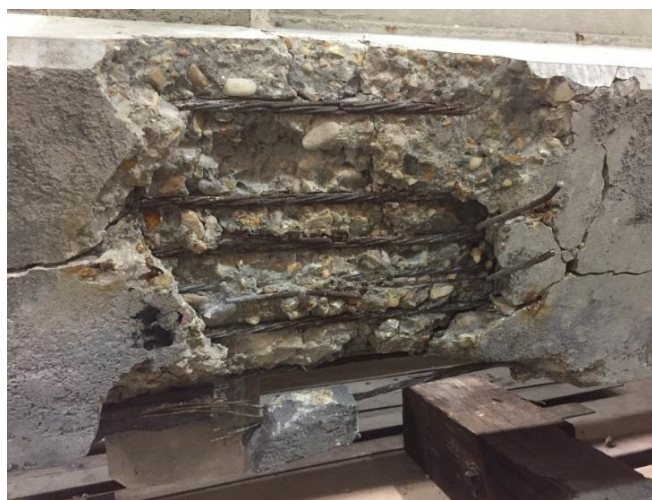
After testing was completed, the concrete on the bottom flange was removed to investigate the condition of the strands, as shown in Figure 52. Upon careful inspection, it was determined that five of the six bottom row strands showed signs of severe corrosion with most wires broken, apparently due to the aforementioned corrosion. A few wires appeared to have broken during testing and showed a shiny surface. Interestingly, the fourth strand, counting from the top of Figure 52, showed no evidence of corrosion damage. The bottom strand in the photo, still embedded in a piece of the patch material, showed evidence of being broken before testing, and most likely at the time the patch was applied. The strand in the same position, but in the second row, was also in the patch and was in similar condition.

**Figure 52. Bottom Flange of I-Beam 6 after Testing**

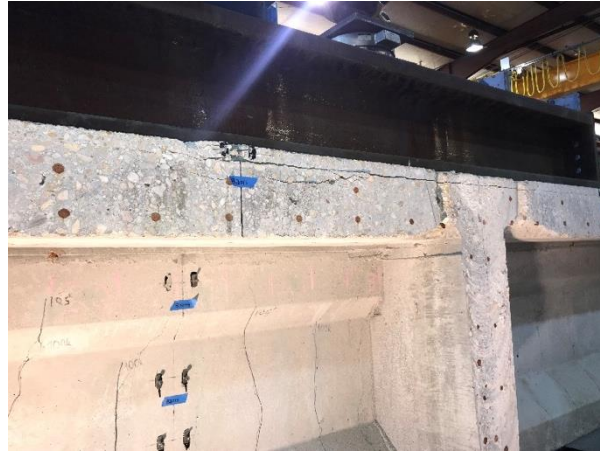
**Figure 55. Crushing of Top Flange at Failure of I-Beam 3**

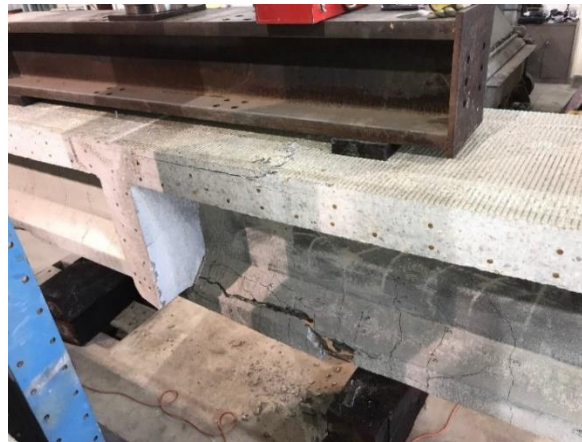
This beam was considered to be in poor condition, with considerable patching and spalling all along the bay side of the bottom flange. Figure 56 shows the top flange crushing at the completion of testing, and also the bottom flange cracking associated with the corroded strands and patching.

**Figure 56. I-Beam 3 after Testing**

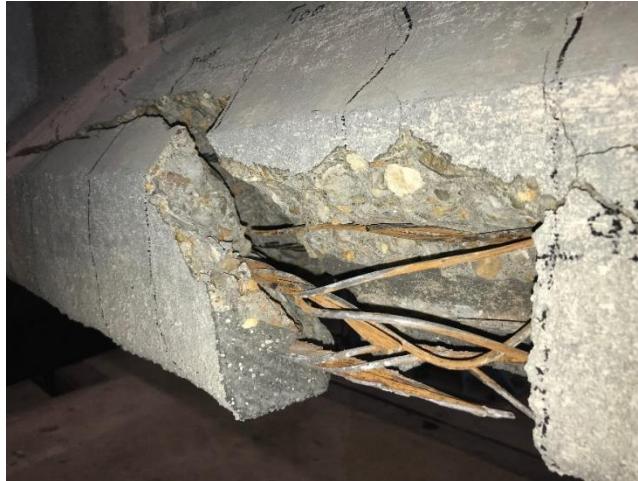
**Figure 57. Corrosion-Damaged Strands in and above Patch in I-Beam 3**

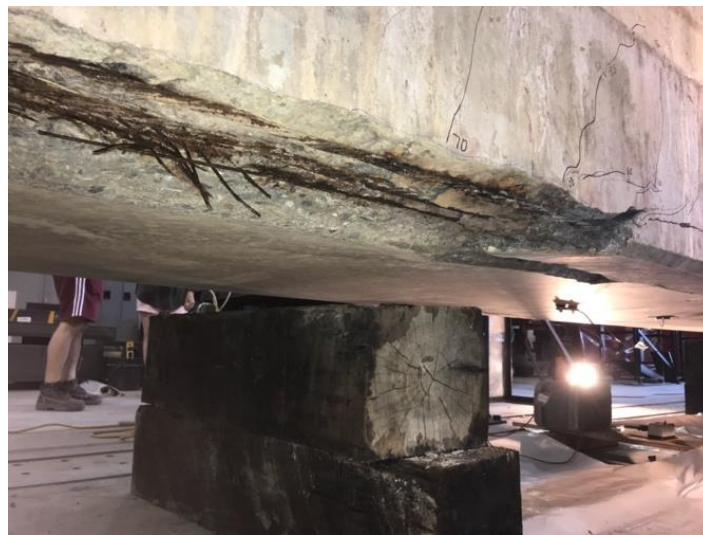
Before the test, severe corrosion was observed in the three bottom strands on the west side of the beam (see Figure 61). The cracks during the test were marked and the propagation was observed (see Figure 62 and 63). Figure 64 shows the beam at the completion of testing.

Figure 61. Condition of the West Side of Box Beam 1 Before the Test

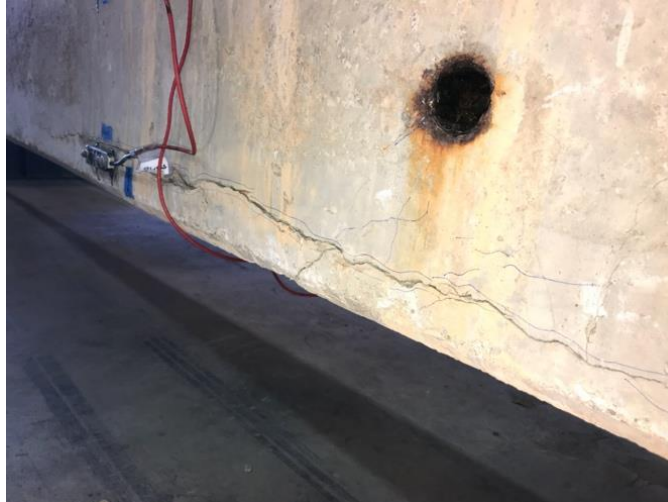
**Figure 62. Condition of the East Side of Box Beam 1 Before the Test**

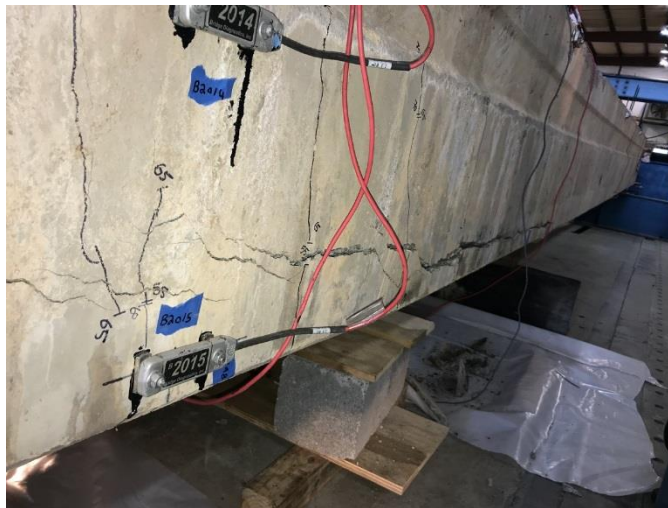
**Figure 63. Propagation of the Cracks of the East Side of Box Beam 1 During the Test**

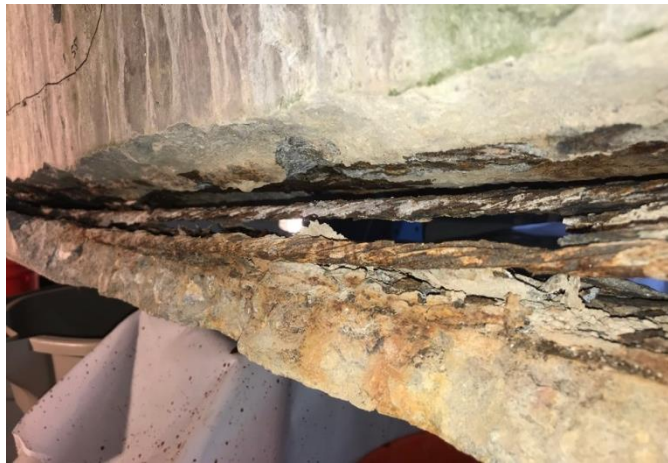
**Figure 70. Strand Condition for Box Beam 4 West Side**

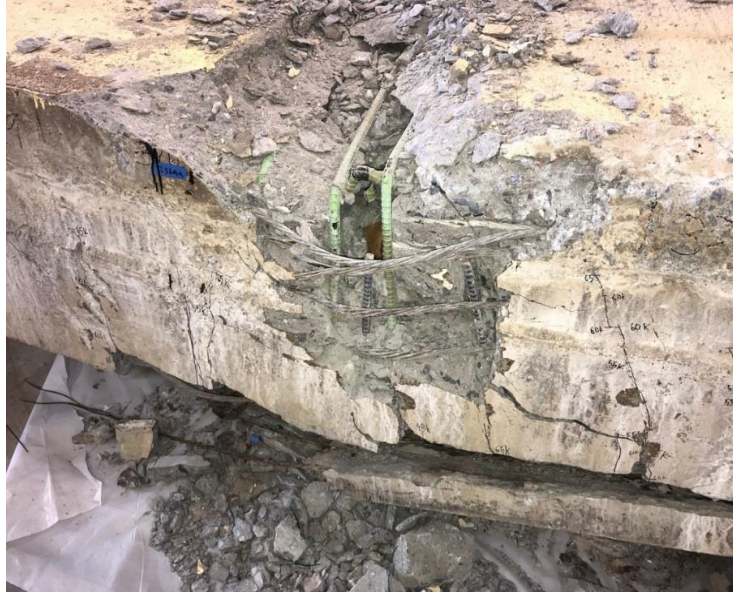
**Figure 72. Crushing of the Top Flange of Box Beam 2**

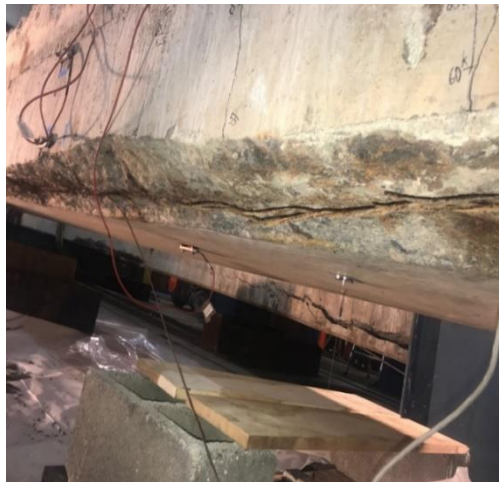
Figure 74 shows the very large deflection in the beam during the test. Figure 75 shows the severely corroded lower strand in the east side, which was observed before the test. After testing, the researchers found that the other strands were relatively undamaged.

**Figure 75. Corroded Strand on Bottom of Box Beam 2**
