Railroad Crossing Study

Study SD90-14
Volume II: Appendices

Prepared by
Department of Civil Engineering
SD School of Mines & Technology
Rapid City, South Dakota

January, 1992

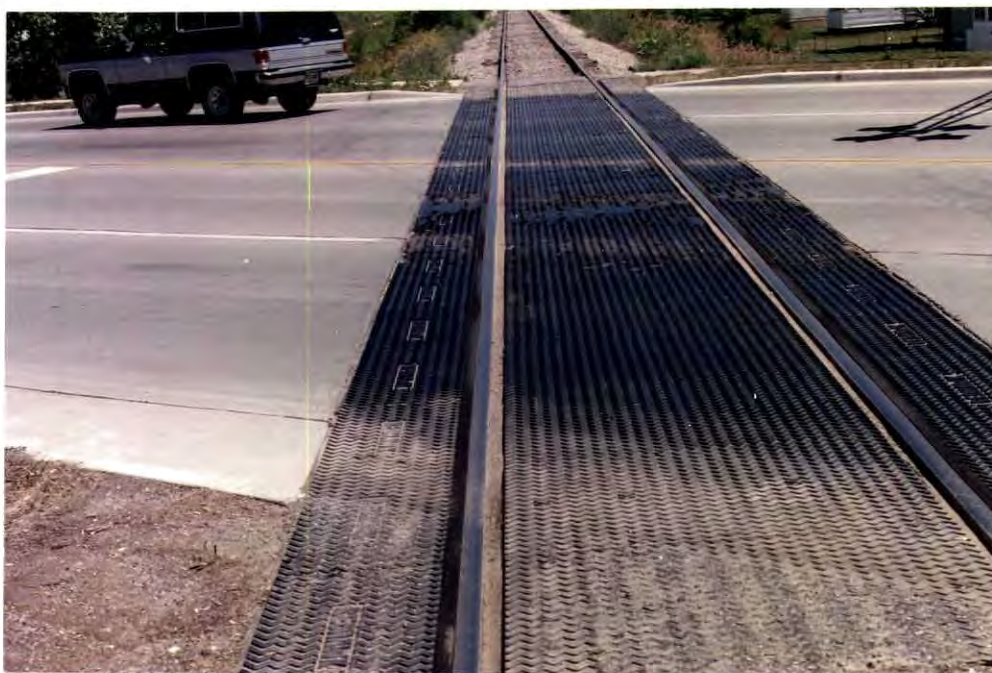
Photo 1. LaCrosse Street - Settlement of Crossing at RHS of Track and Panel Wear

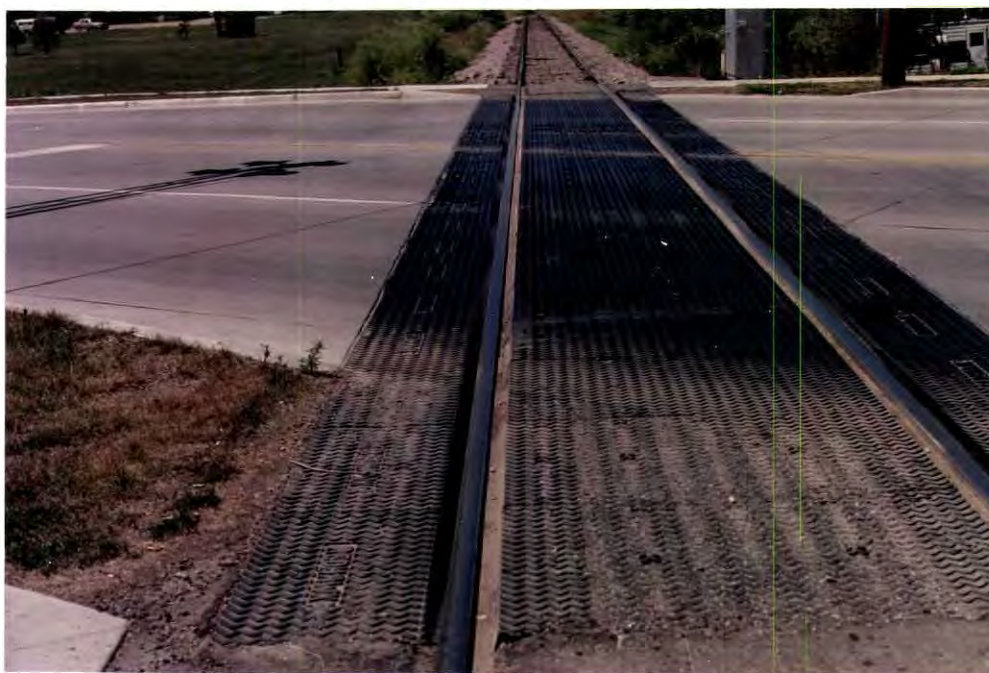
Photo 2. LaCrosse Street - Debris Collection between Track and Missing Fastener Protective Caps

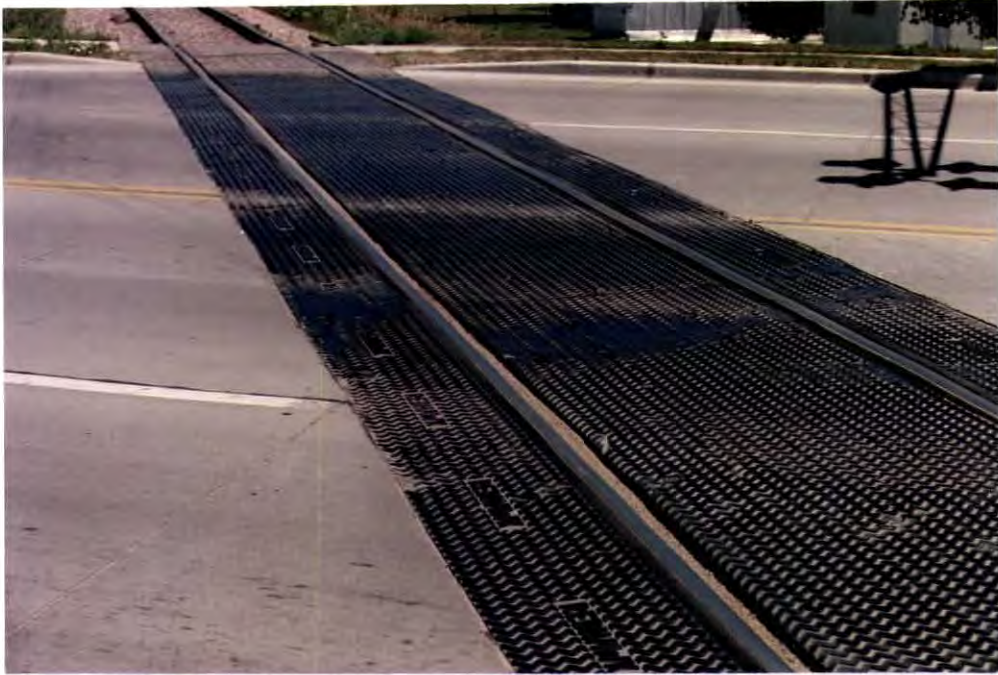
Photo 3. LaCrosse Street - Rubber Panels Damaged by Snow Plows

The wood headers are in good shape, although they have settled with the track. Minor chipping can be seen in the concrete on the approaches to the crossing. Snow plow damage is significant,

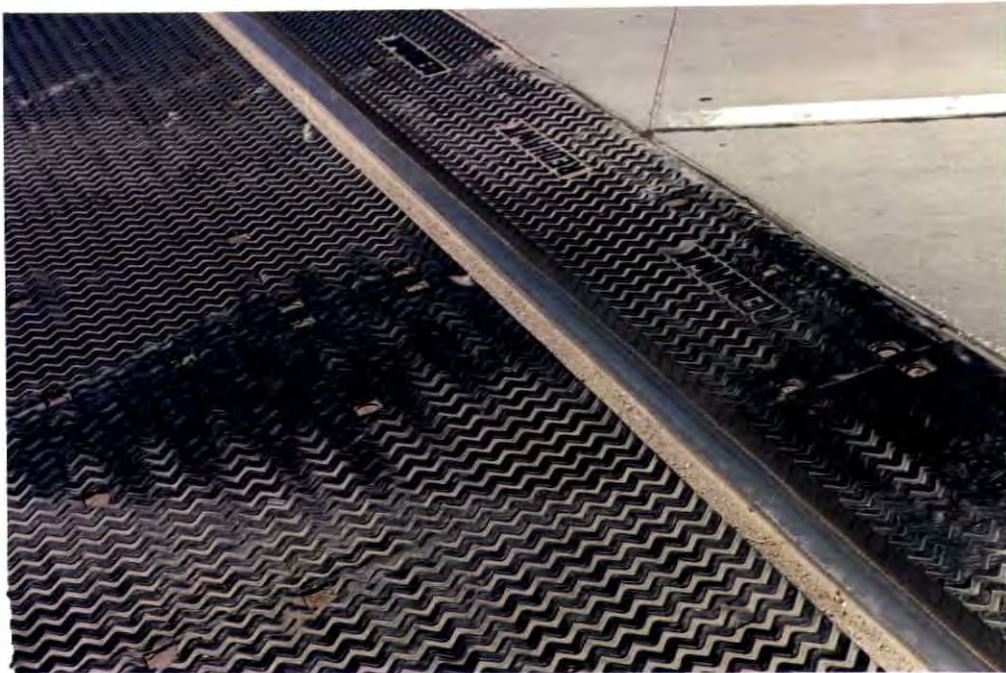
Photo 4. LaCrosse Street - Close Up Plow Damage

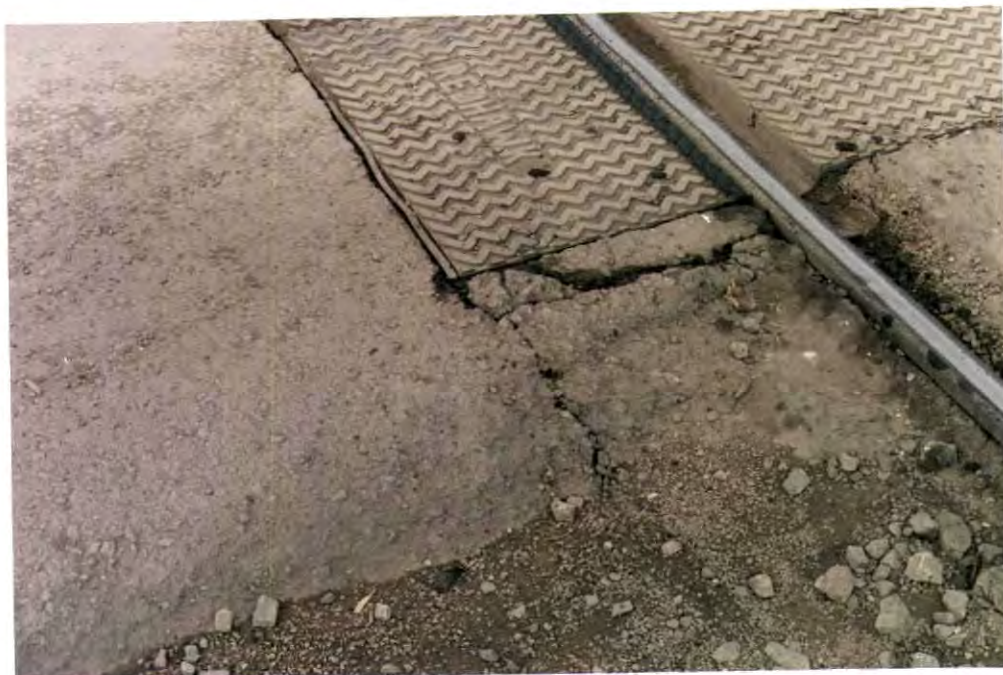
Photo 10. Maple Avenue - Cracking of Southeast Shoulder and Panel Wear

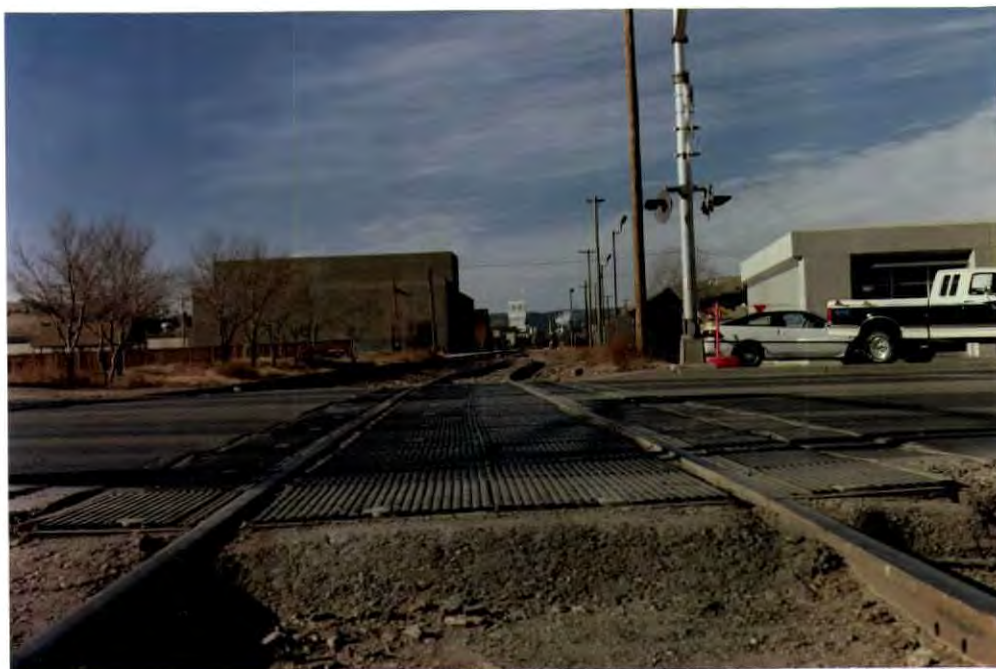
Considerable panel wear can be seen along the entire crossing (See Photos 11 and 12). Figure A10 shows that the differences in elevation within the crossing on the south track is up to one inch, and elevation differences on the approaches are as much as 1.5 inches. This is mainly due to rutting (Photo 11). The south rail has settled approximately 1 inch more than the north rail at the curb (See Figure A12). On the north track (Figure A11), the differences in elevation within the crossing are generally less, but failure of the panels can easily be seen on the east side of the crossing. The rail on the north track has settled about 1 inch compared to the adjacent pavement, and the settlement of the approach pavement in the wheel path is distinctly greater in between wheel paths (See Figure A13).

Photo 11. East Boulevard - Settlement of the Track and Pavement Rutting

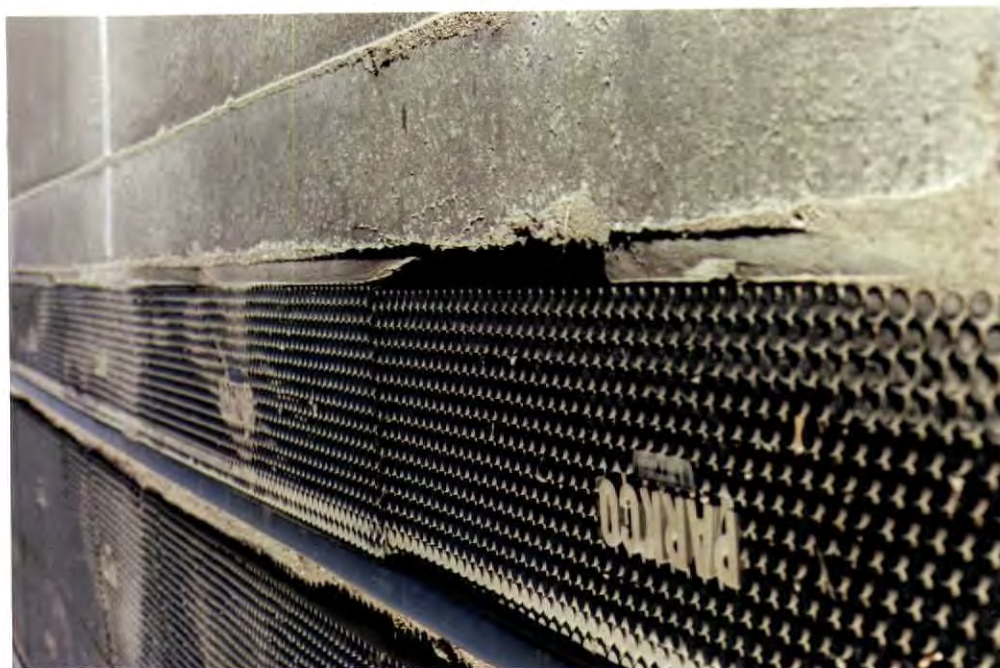
The wood headers are damaged (See Photo 12). This can be seen over most of the crossing along with loose rubber panels on the entire track. The center panels have popped up on the east side of the north track (See Figure A11 and Photo 11) and failure of the approaches is found along the entire track (See Photos 13 and 14). Debris collection next to the rail and the approach can be seen in Photo 14.

Photo 12. East Boulevard - Failed Joint Where Wooden Header is Missing and Damage Due to Traffic

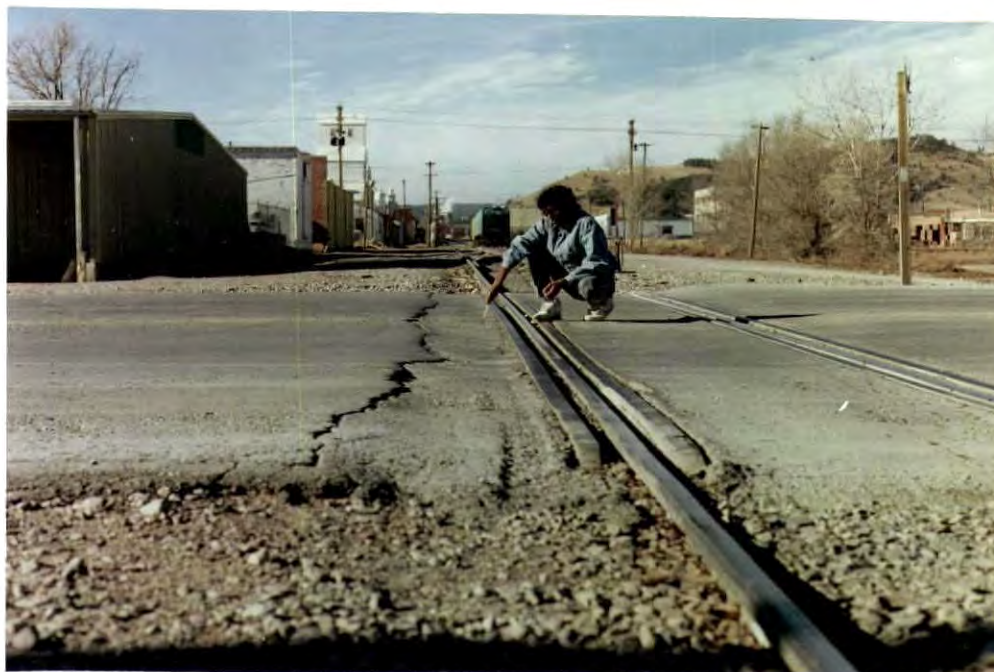
Photo 15. Third Street - Close View of Approach Settlement

Pavement cracks are seen all along the track (See Photo 15 through 17) and there is considerable debris collection between the rails.

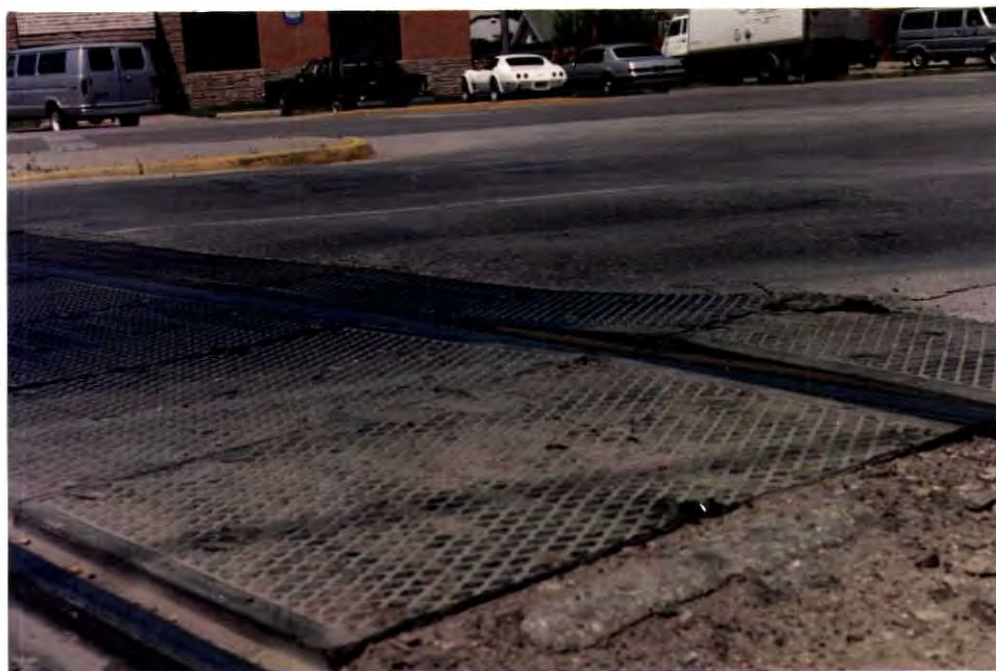
Considerable panel wear and loosening of panels was seen during the surveying (See Photos 18 and 20). Settlement of the track with respect to the approach can be seen in Figures A17 and A19. The contours in Figure A17 show the crossing may have been slightly elevated with respect to the road at the time of construction, as the elevation increases towards the crossing from both the north and the south. However, the contour map also shows that the track has settled in excess of one inch with respect to the approaches. The north outer panels on the east side of the crossing have popped out (Figures A18 and Photo 20). From the sections in Figure A19 it can also be seen that there is more settlement and pavement wear under the wheel path than in between the wheel paths. Panel deflection on the west side has also taken place at the wheel paths. The panels in this crossing

Photo 20. West Boulevard - Failed Rubber Panel

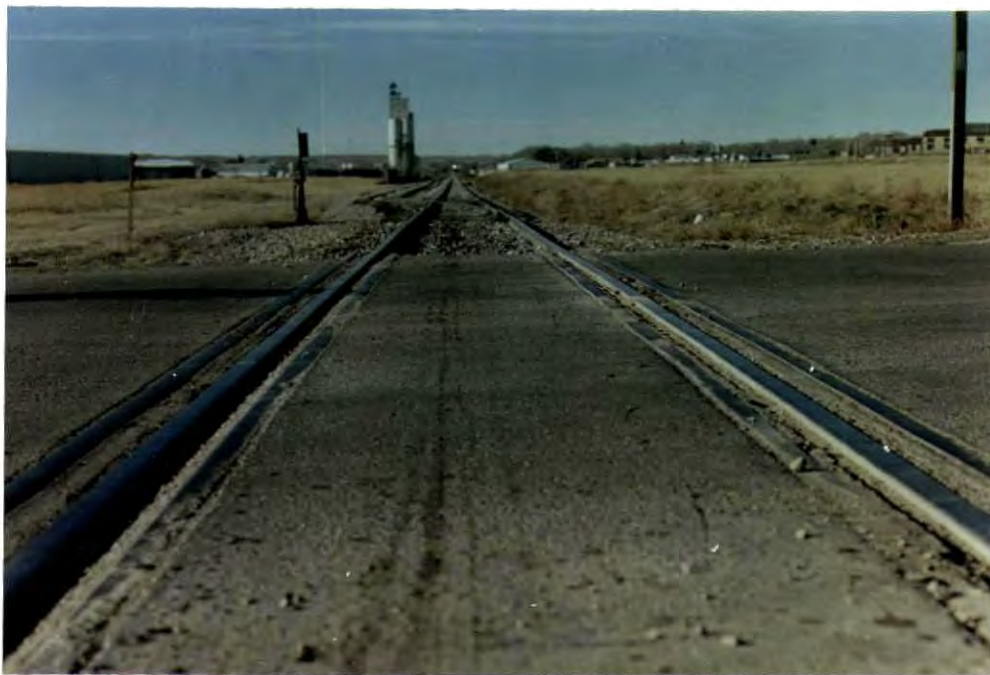
Photo 28. Indian Learning Center - Overall View

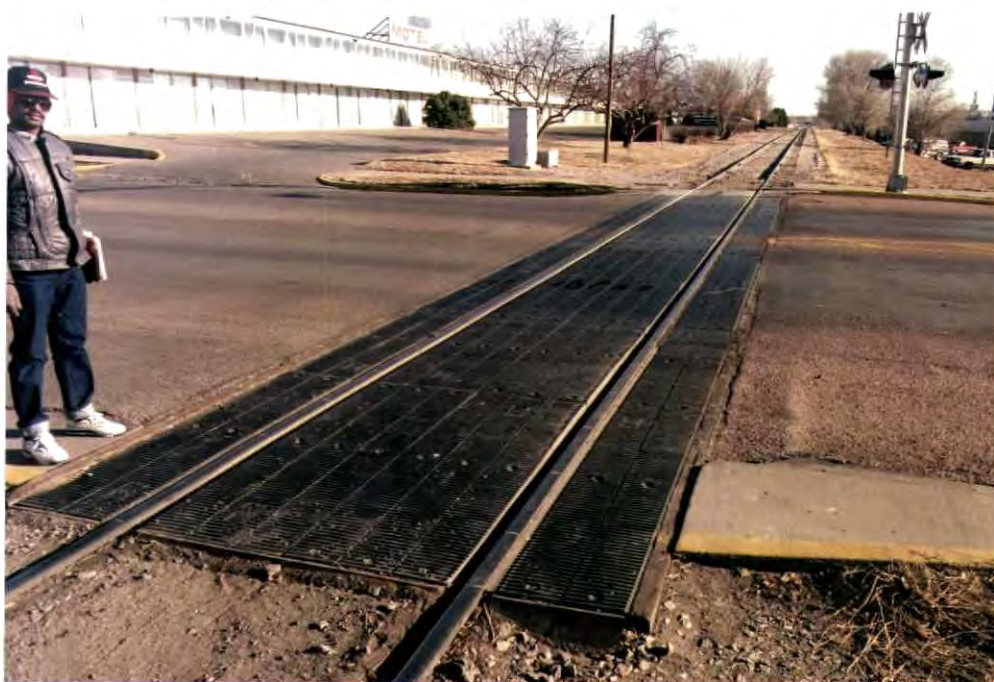
Photo 30. Central Avenue - Failure of the Pavement Along the Wood Header

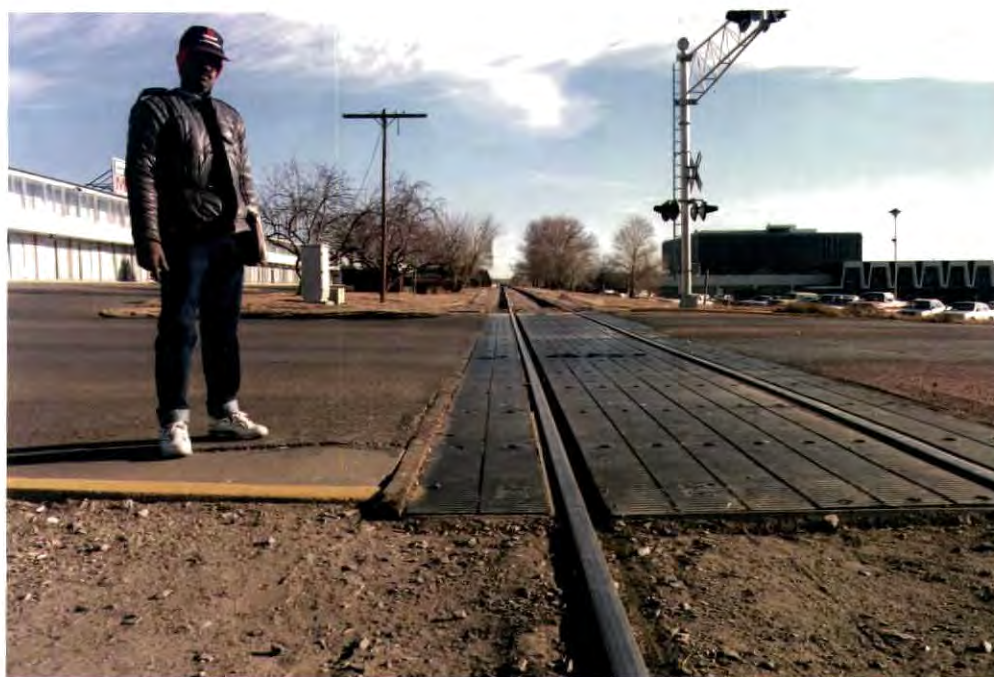
Photo 31. Central Avenue - Overall Settlement of Track.

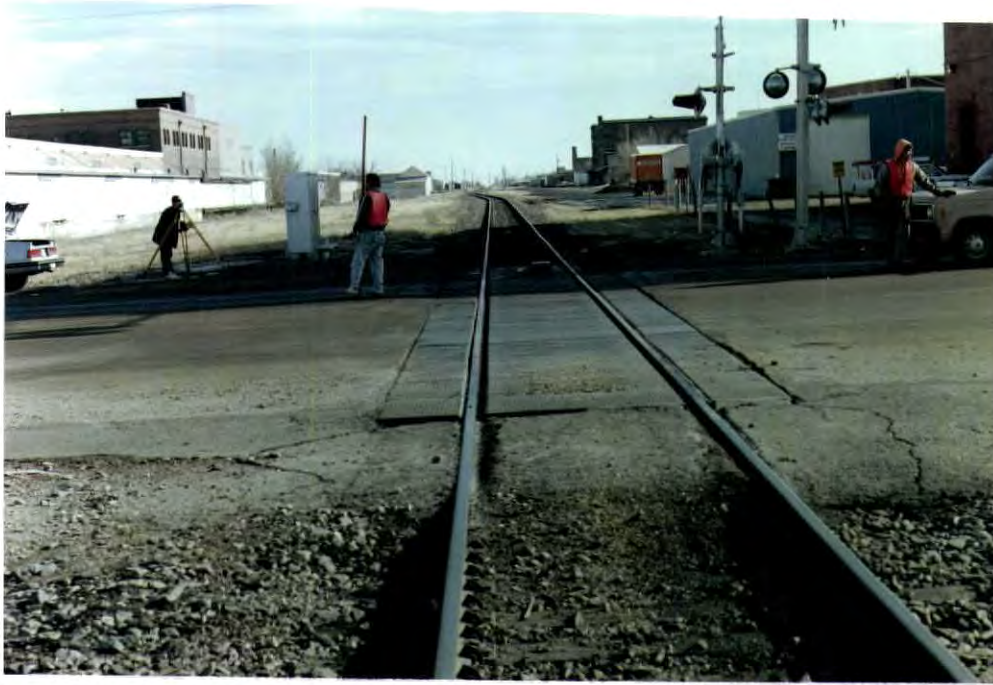
Photo 32. Main Street - Settlement of Track and Cracked Shoulder

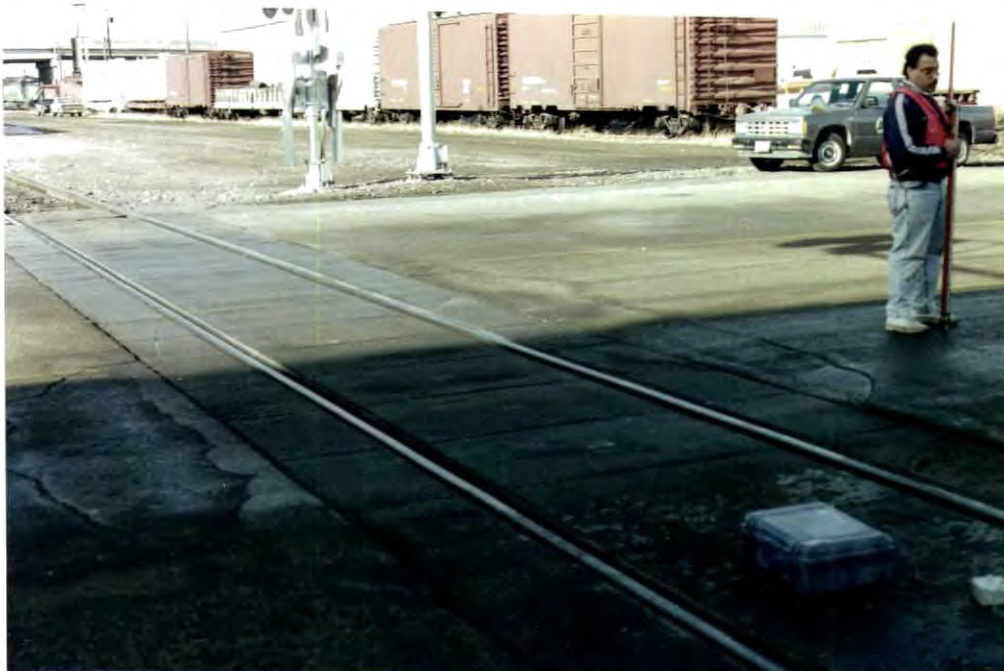
Photo 33. Main Street - Failure of Pavement at Approaches

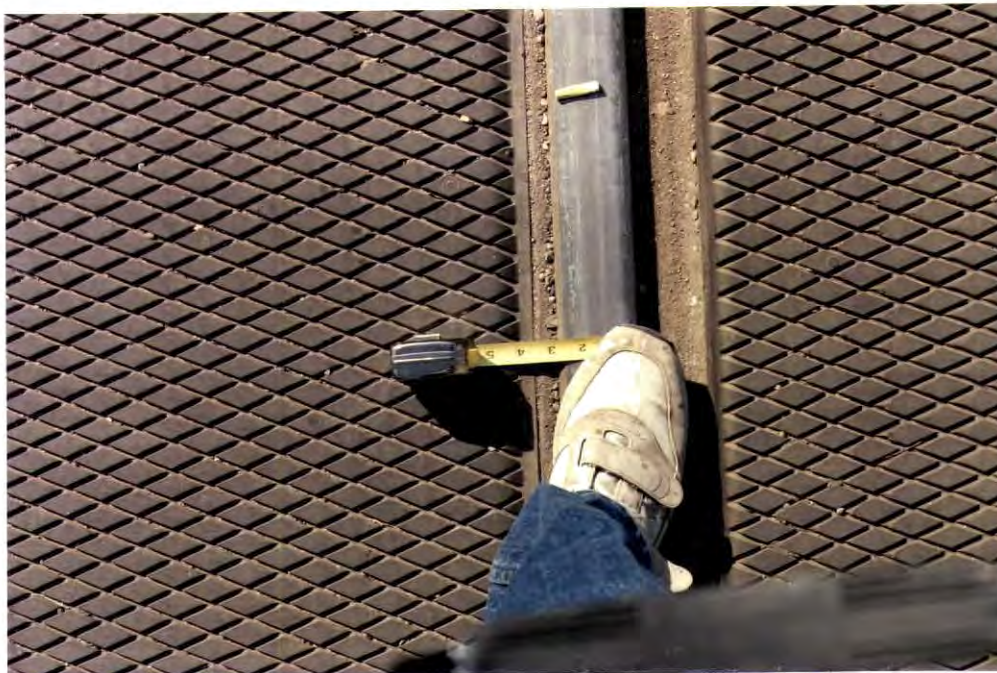
Photo 34. Main Street - Separation of Panels at Rail and Mud-Filled Track.

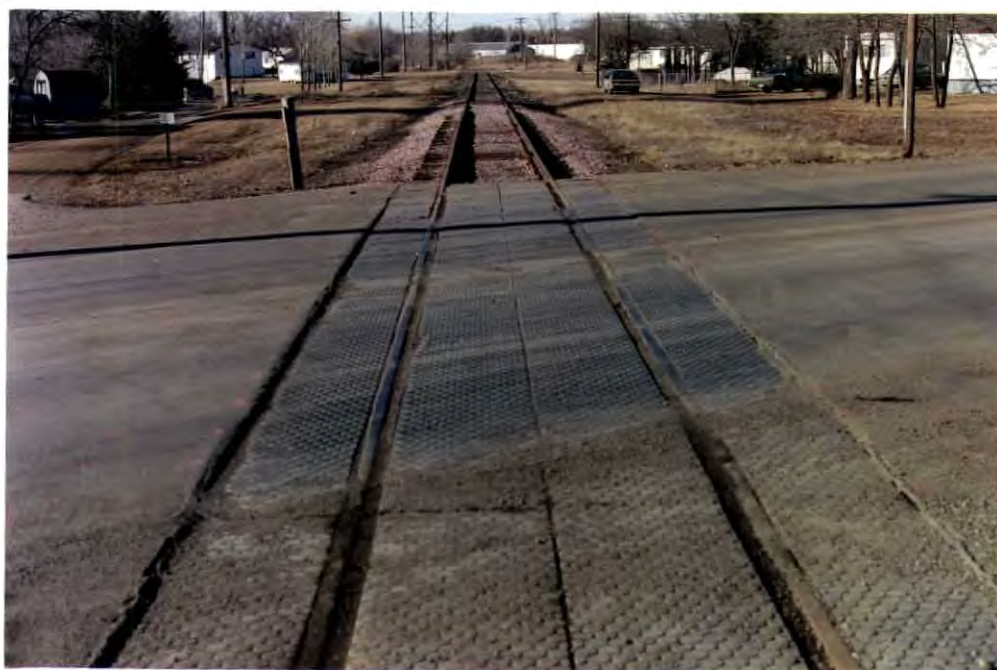
Photo 56. 11th Street - Overall Settlement of the Track

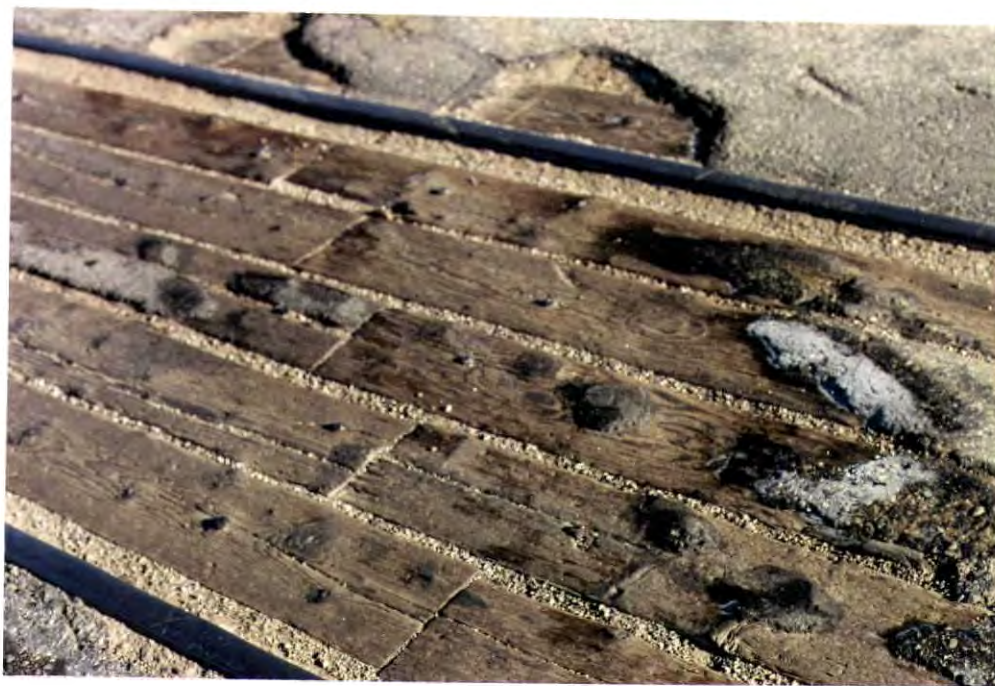
Photo 61. US 212 - Spalling off of Asphalt on Timbers

The photographs show that the crossing had once been paved but the asphalt is nearly worn down (See Photo 61). The eastern rail is uneven indicating either tie or spike failure. The timbers are worn down and the spikes are protruding up to 1/2 inch above the timbers (See Photos 61 and 63). The spaces between the timbers and the pavement and the spaces between the timbers and the rails are completely filled with sand. Both surface and subsurface drainage at this crossing is good and there is no evidence of pumping.

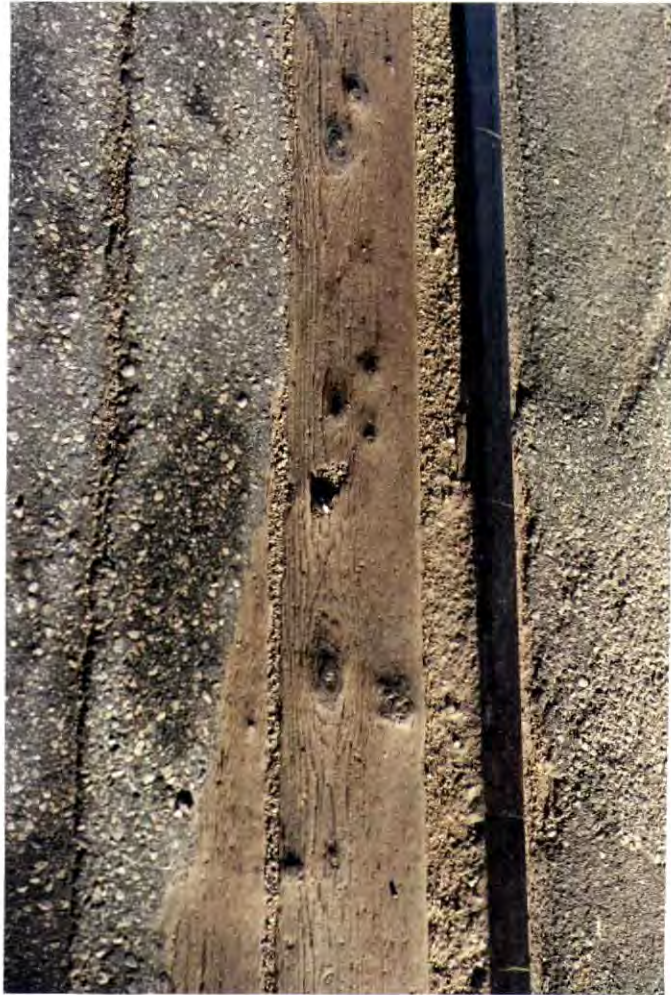
Photo 63. US 212 - Bolts Exposed by Timber Wear

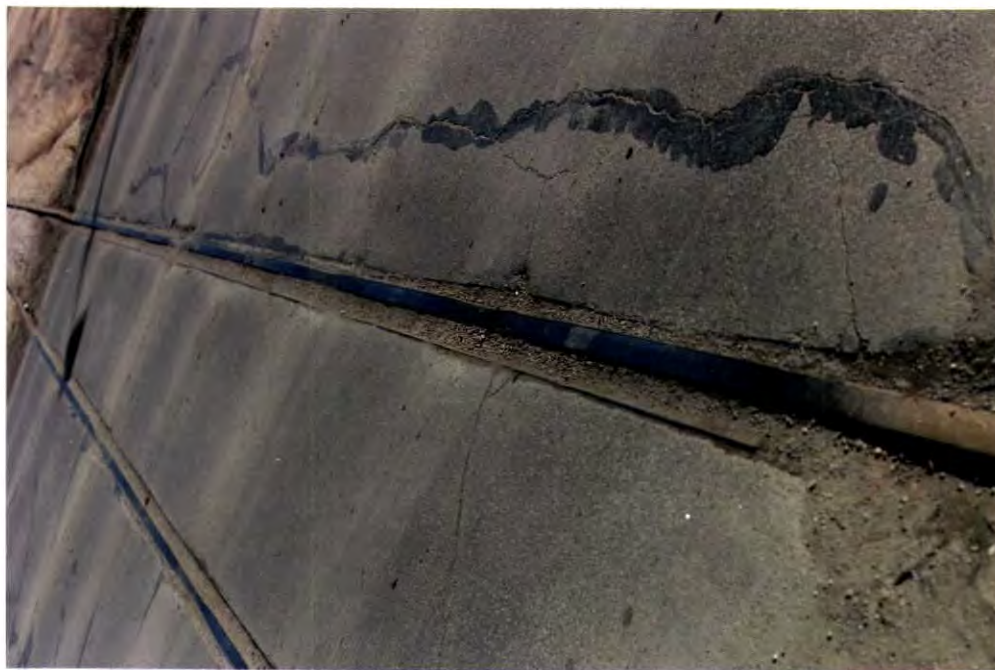
Photo 64. SD 20 and 10th Street West - Cracking Along Approach

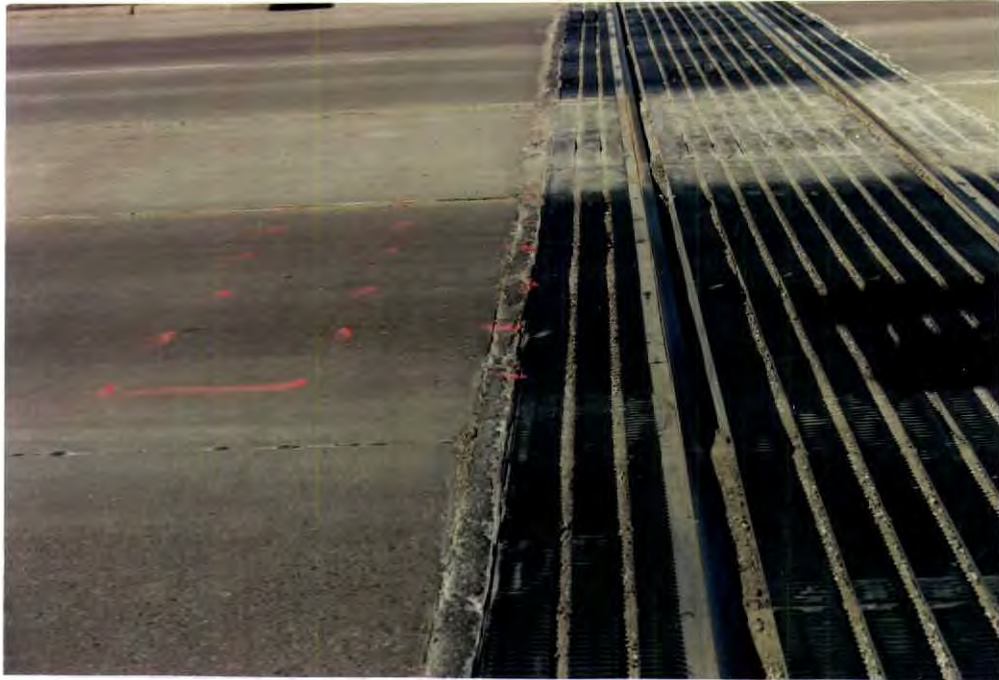
Photo 68. Minnesota Avenue - Failing Asphalt Header

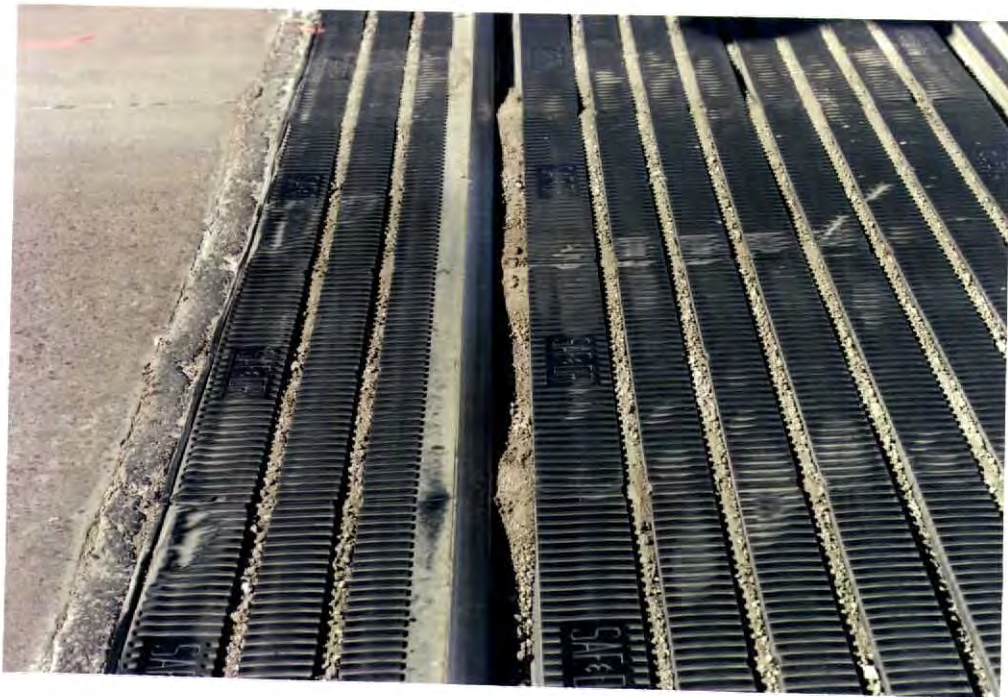
Photo 69. Minnesota Avenue - Collection of Debris Along the Rail

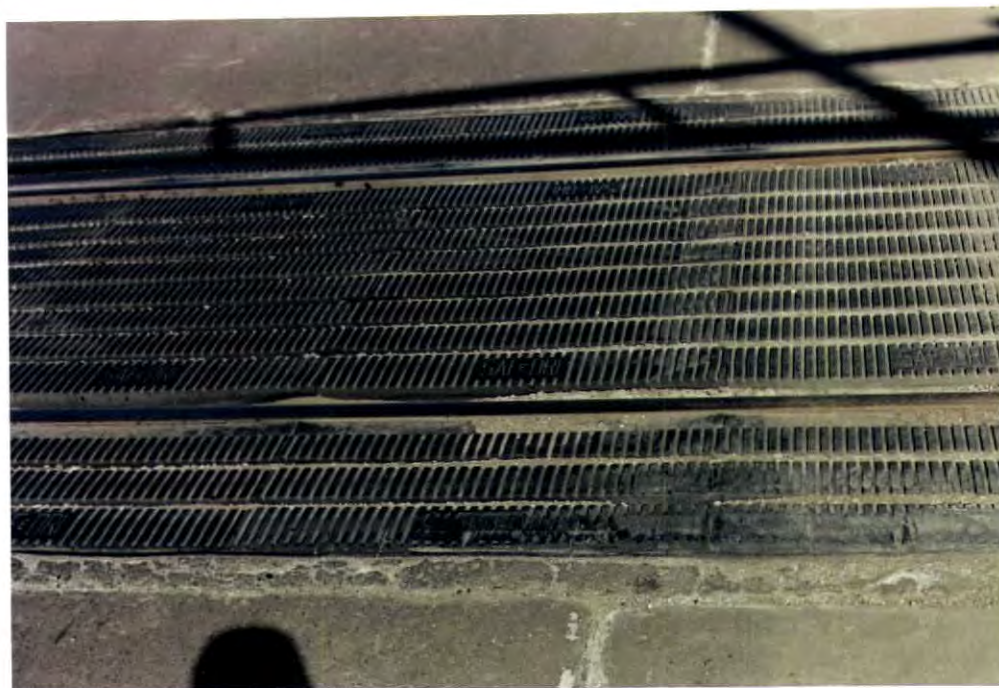
Photo 70. Minnesota Avenue - Worn and Damaged Panels

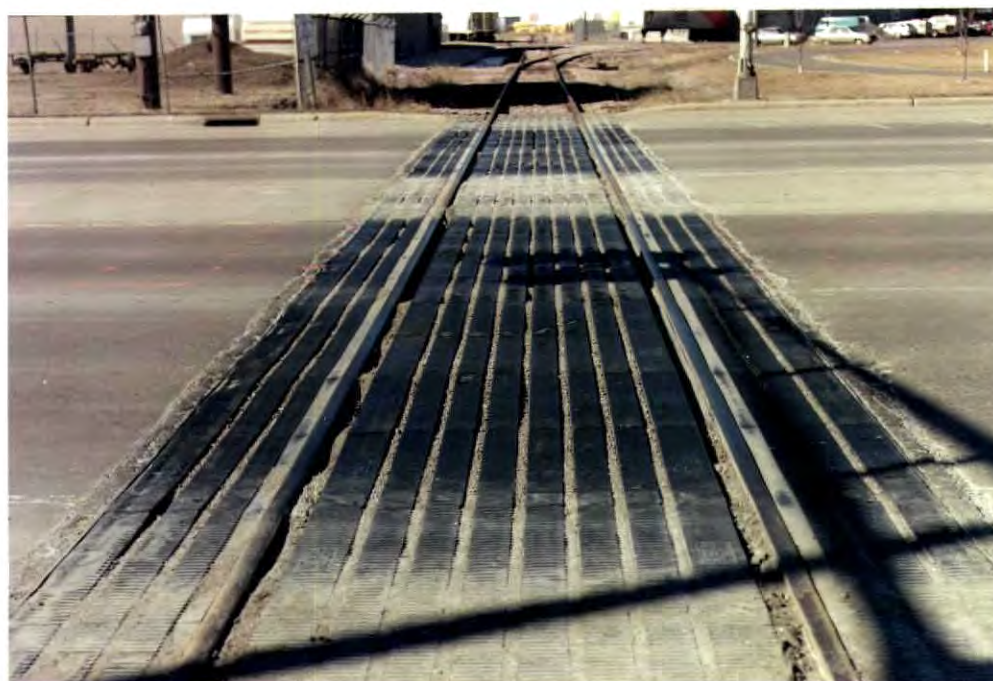
Photo 71. Minnesota Avenue - Overall View of Crossing
(Note Mud-Filled Panels)

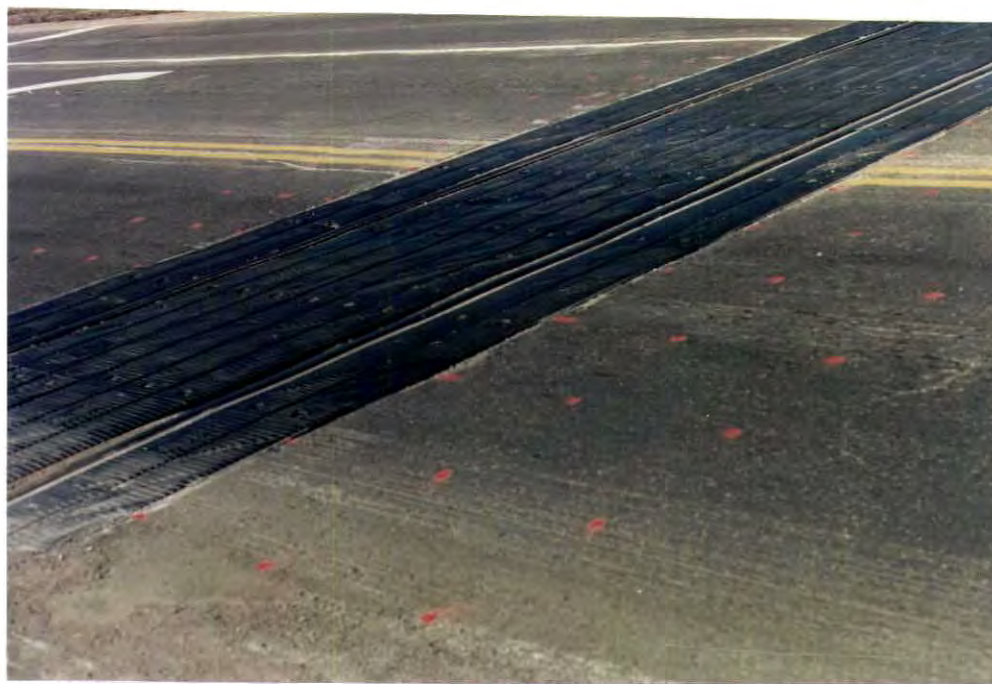
Photo 72. SD 38A - Approach Pavement Rutting

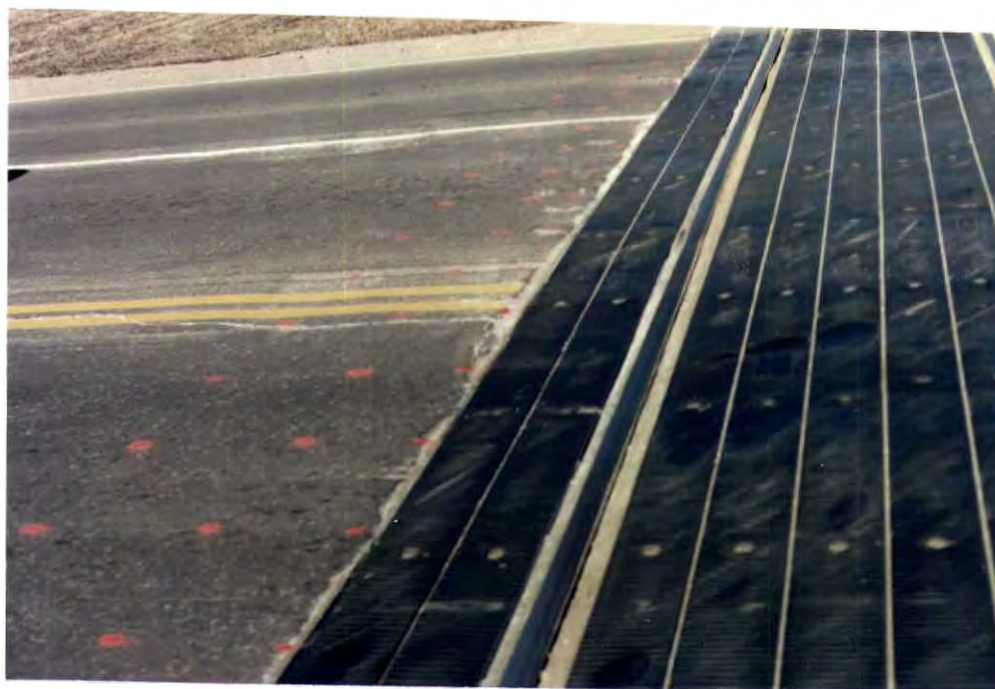
Photo 73. SD 38A - Panel Damage by Snow Plows

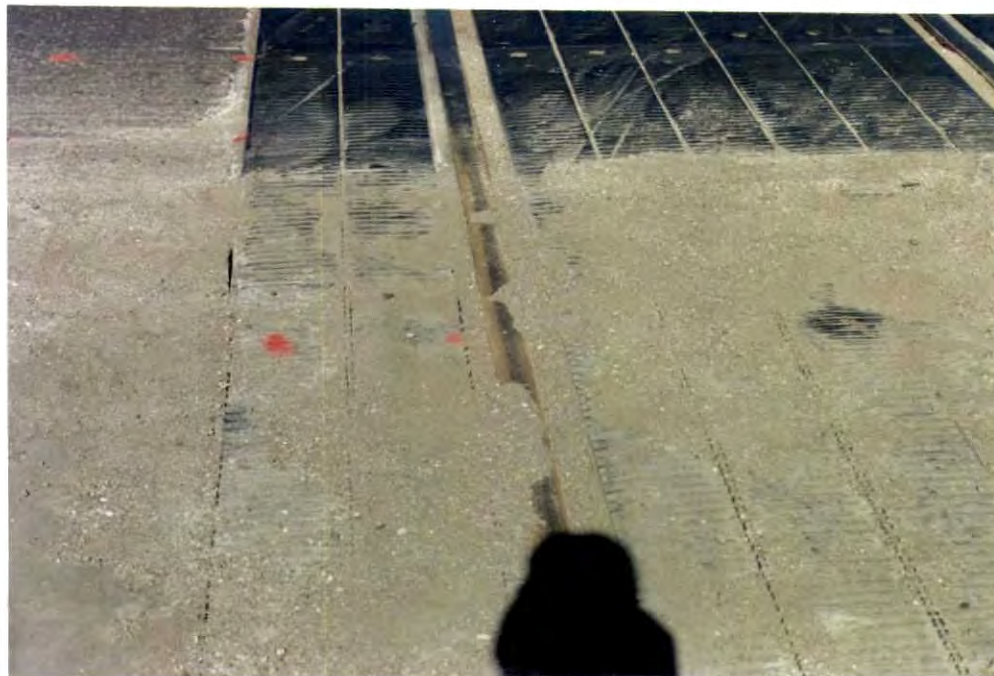
Photo 74. SD 38A - Debris Collected on the Track

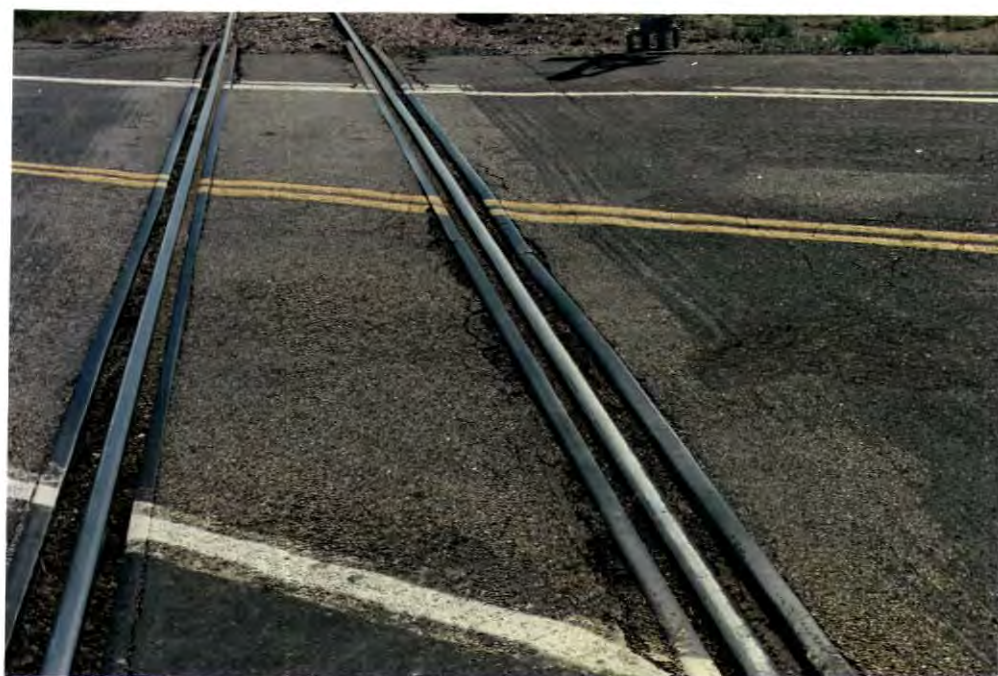
Photo 81. Cottonwood - Failure of Asphalt Near Mud Rail

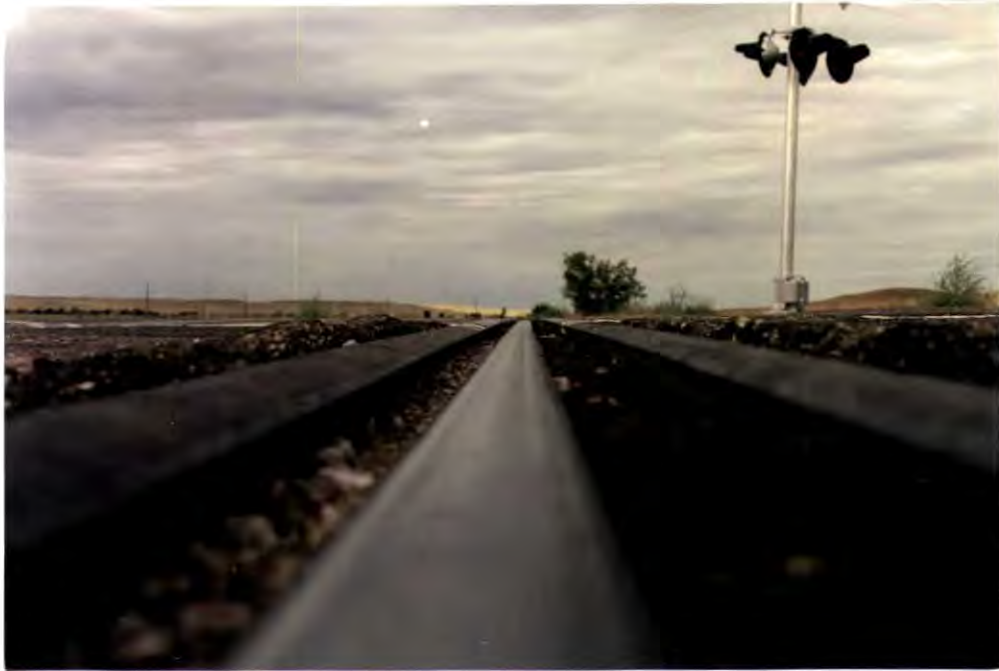
Photo 82. Cottonwood - Rail and Mud Rail Settlement

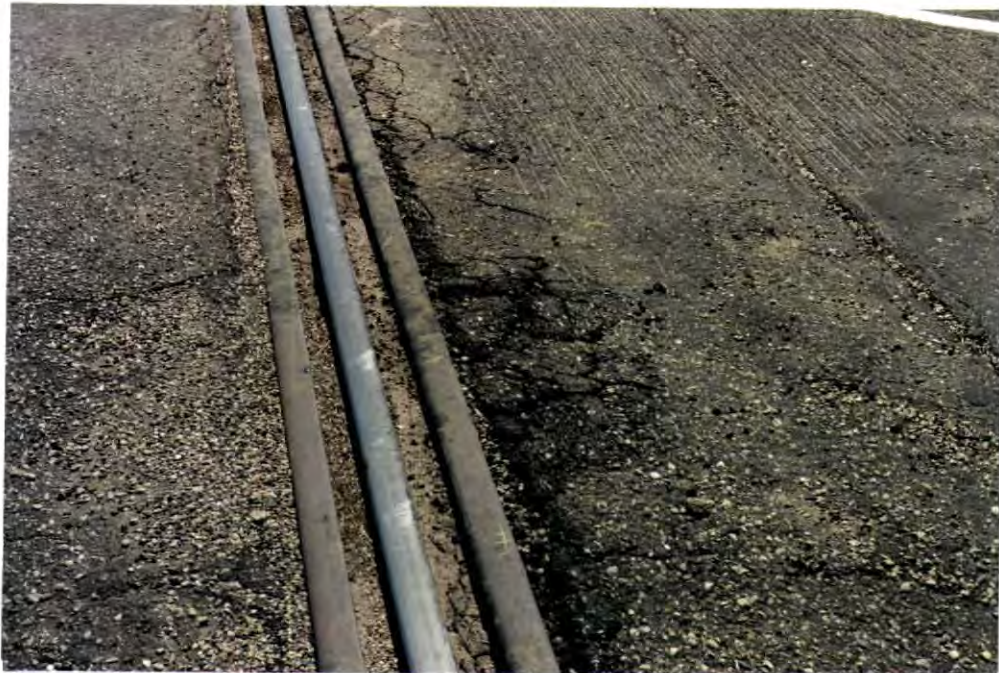
Photo 83. Cottonwood - Close-up View of Pavement Cracks

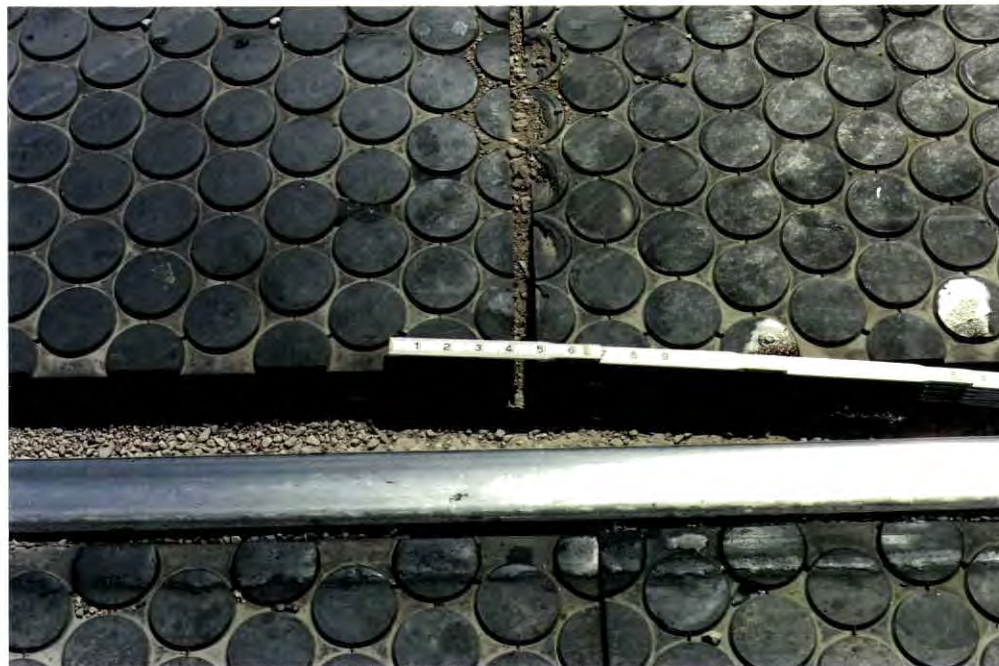
Photo 90. Service Road at DOT - Panel Wear and Panel Separation

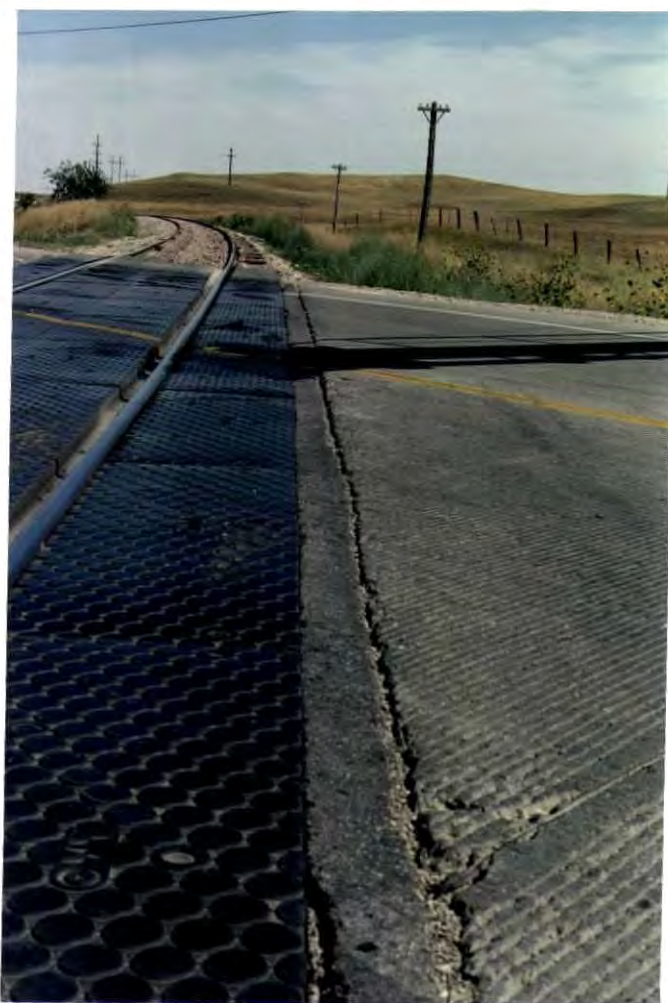
Photo 93. Service Road at DOT - Header Failure

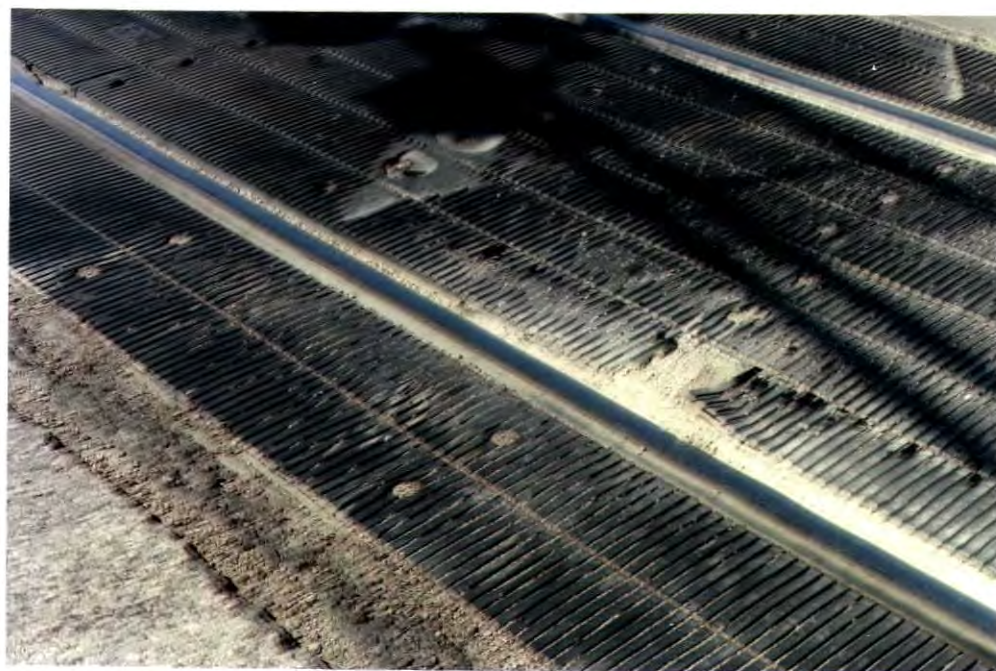
Photo 95. I-90 Loop at Exit 59 - Wear and Rubber Separation on Saf & Dri Panels
