Railroad Crossing Study

Study SD90-14
Volume II: Appendices

Prepared by
Department of Civil Engineering
SD School of Mines & Technology
Rapid City, South Dakota

January, 1992

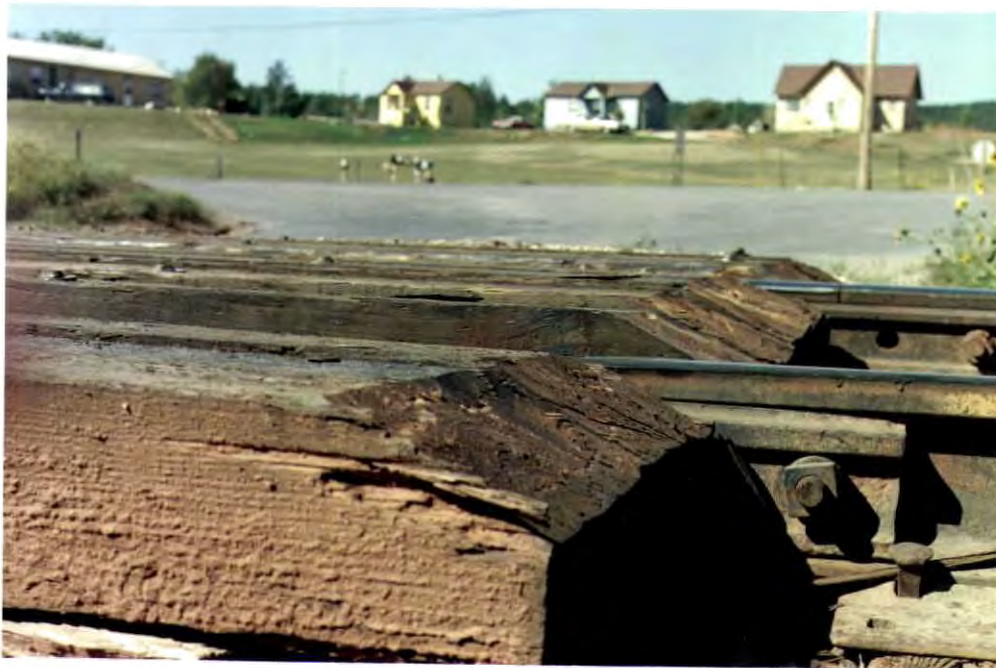
Photo 98. PC L 214 - Warped Timber, Loose Washers, and Joint Within the Crossing

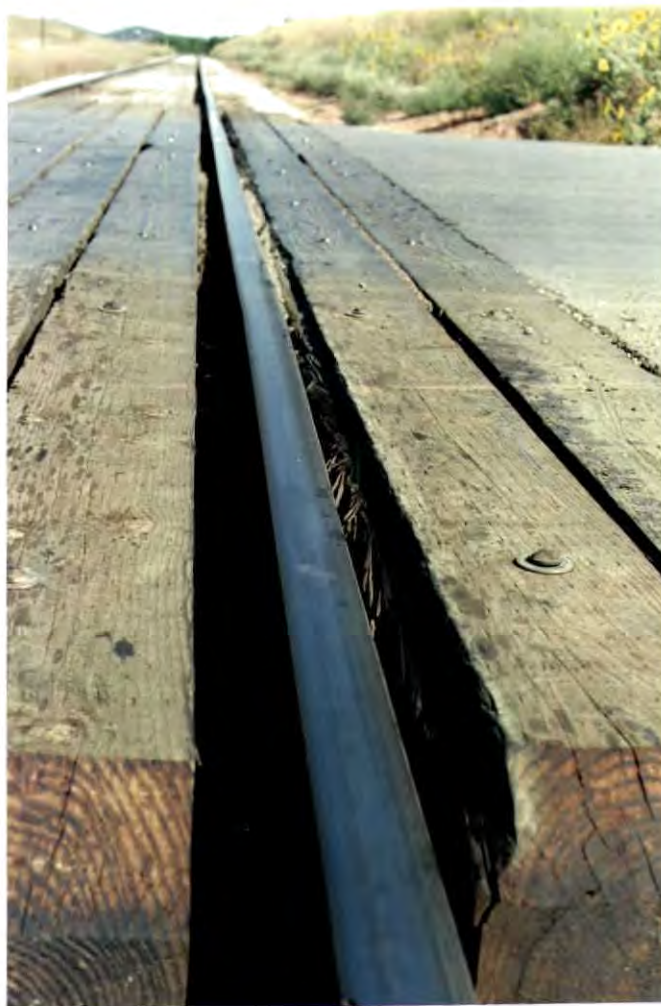
Photo 99. PC L 214 - Rail Traffic Damage to Timbers

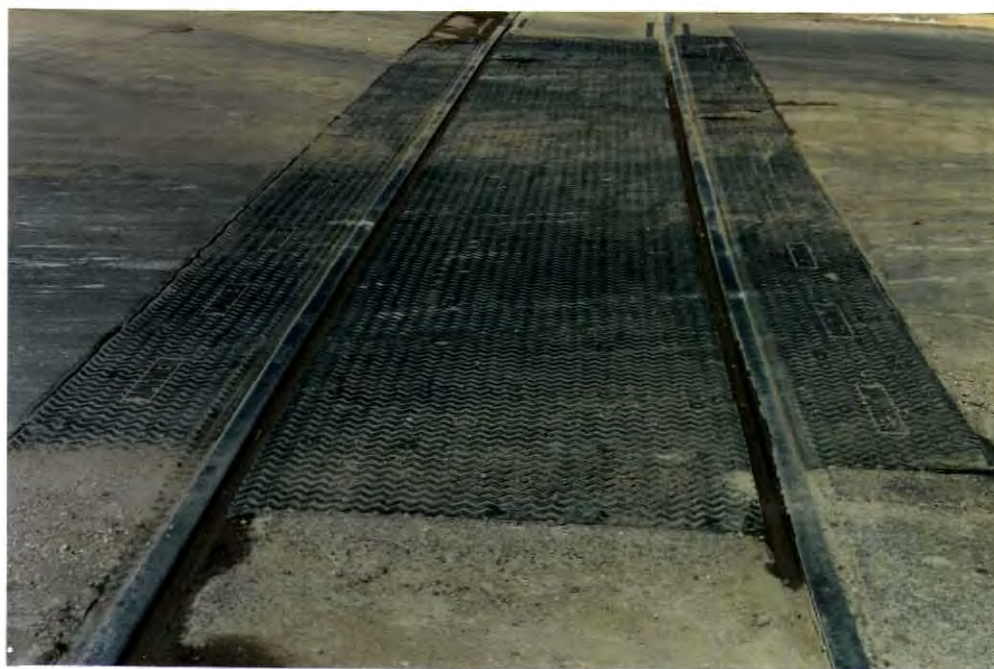
Photo 107. Entrance to Cement Plant - Plow Damage and Drainage

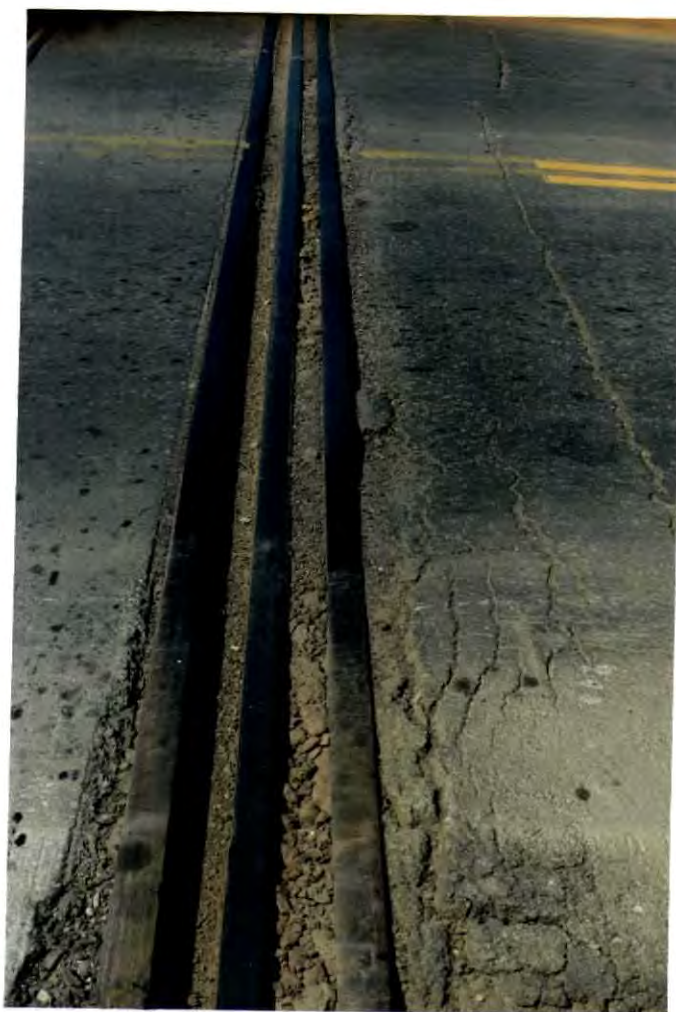
Photo 113. Cross Street - Cracking of Apron Parallel to Track

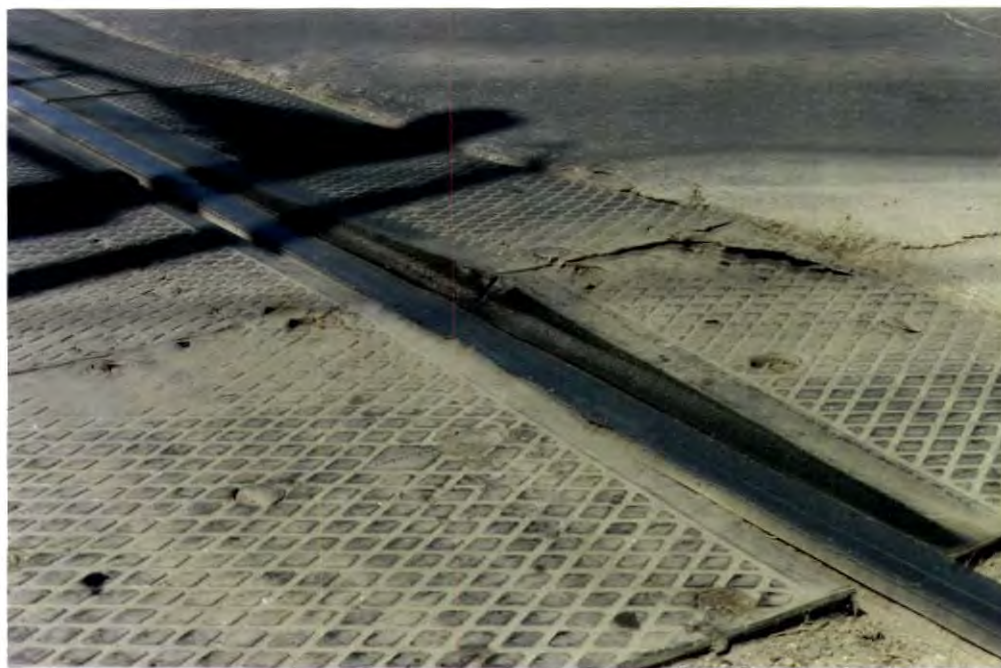
Photo 117. Tenth Street - Loose Rubber Panels

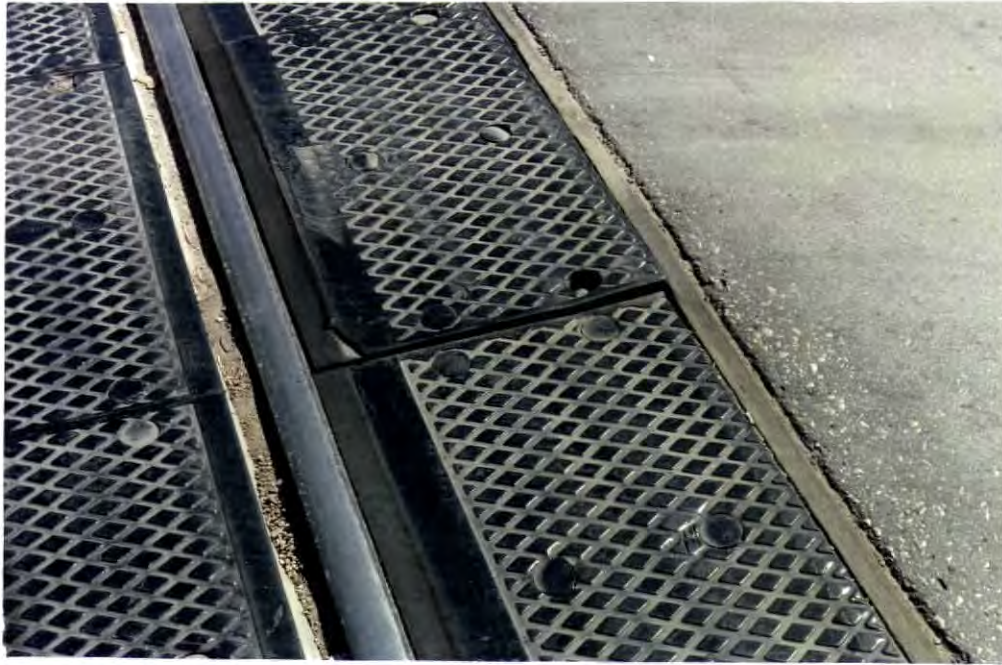
Photo 118. Tenth Street - Loose Rubber Panel

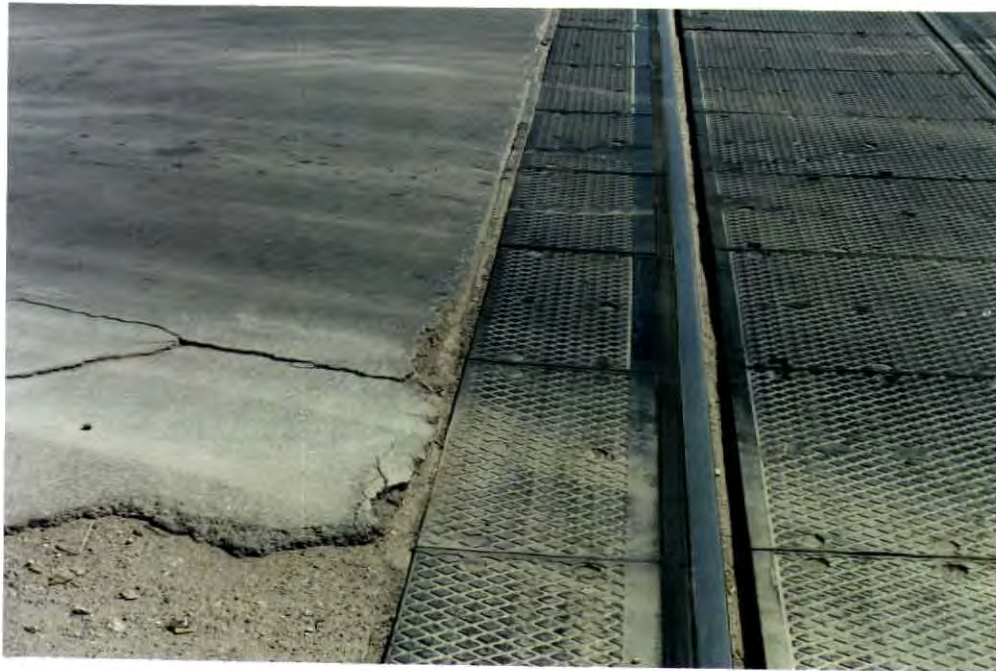
Photo 119. Tenth Street - Disintegrating Wood Headers

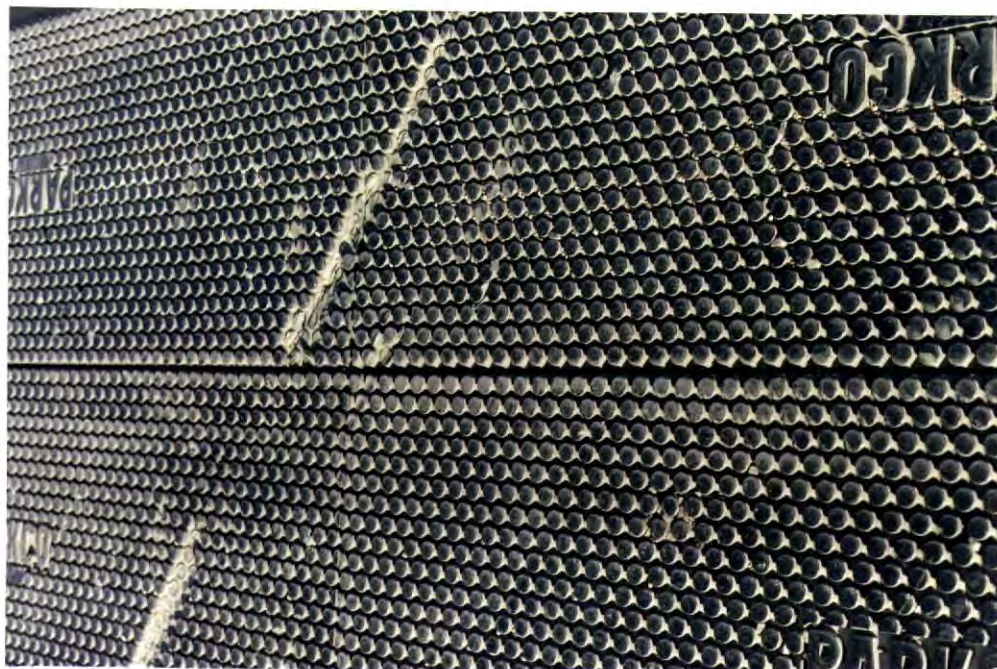
Photo 121. Milwaukee Street - Snow Plow Damage

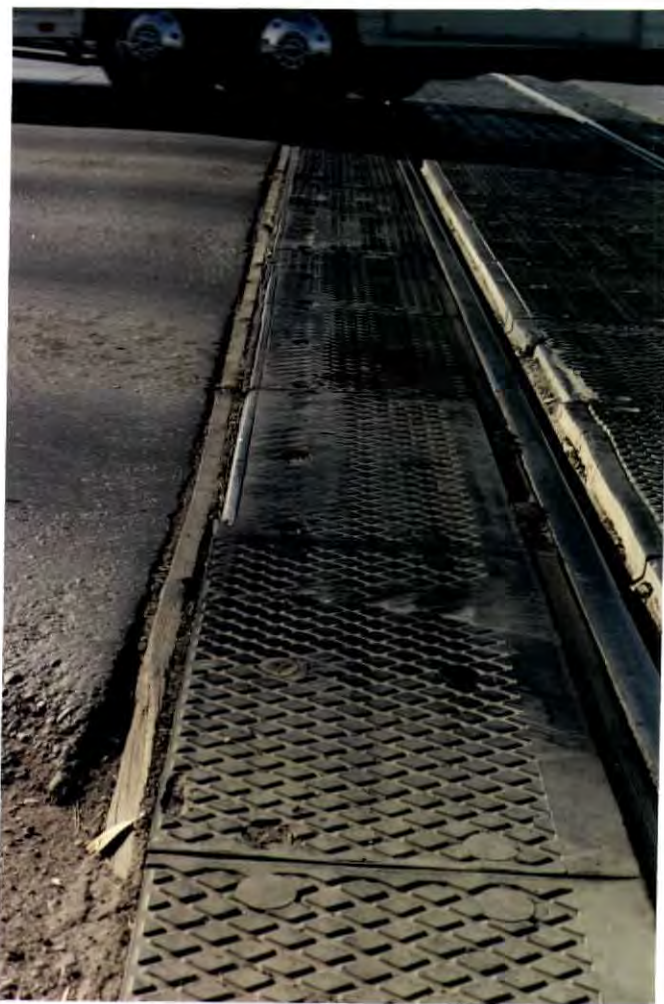
Photo 127. St. Patrick Street - Header Failure and Panel Wear

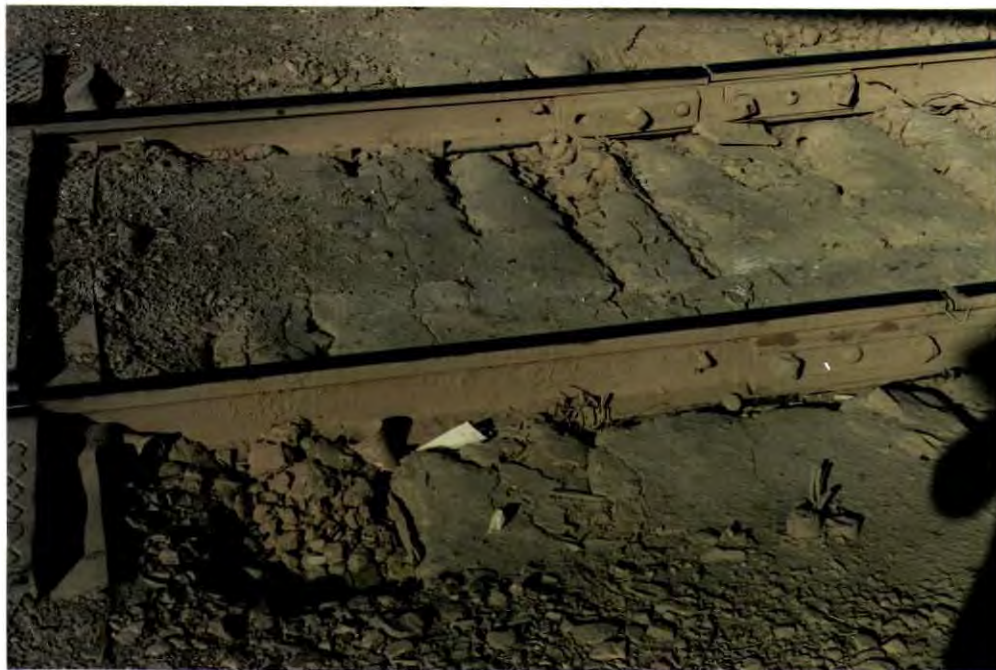
Photo 128. St. Patrick Street - Pumping and Rail Deflection at North End of Crossing

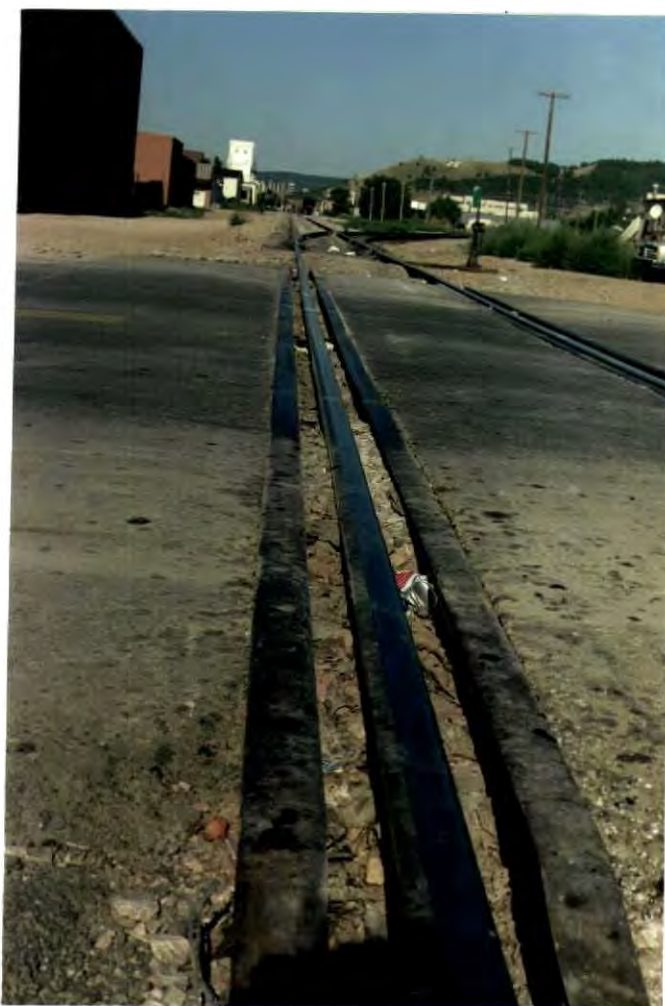
Photo 130. First Street - Mud Filled Spaces between Rails and Curved Apron and Asphalt between Rails

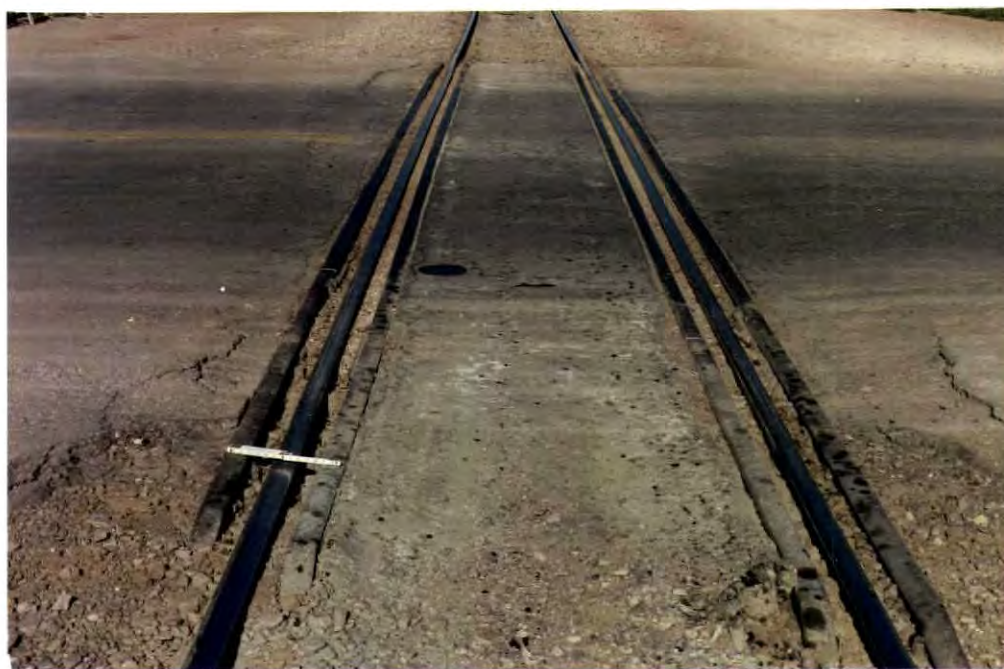
Settlement of the crossing is evidenced by cracking and tilting of the asphalt approach towards the track at both the north and south sides of the crossing (See Photo 131). The cracking is approximately 18 inches from the rails, which corresponds to the

Photo 131. Second Street - Crossing Settlement and Tilted Aprons

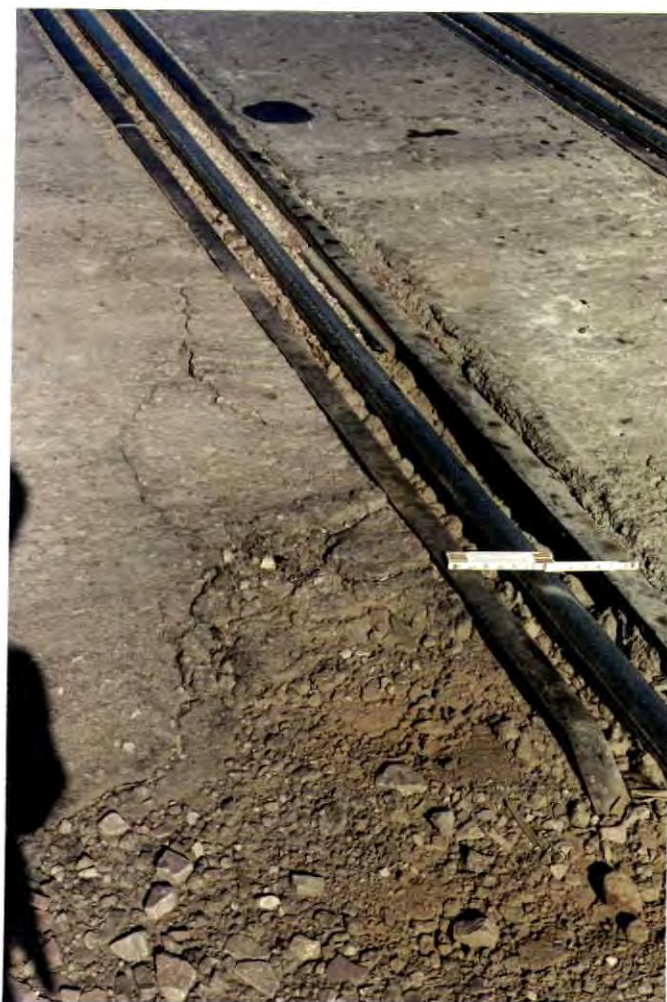
Photo 133. Second Street - Cracking of Apron and Pumping at Shoulder and Mud Rail Below Asphalt

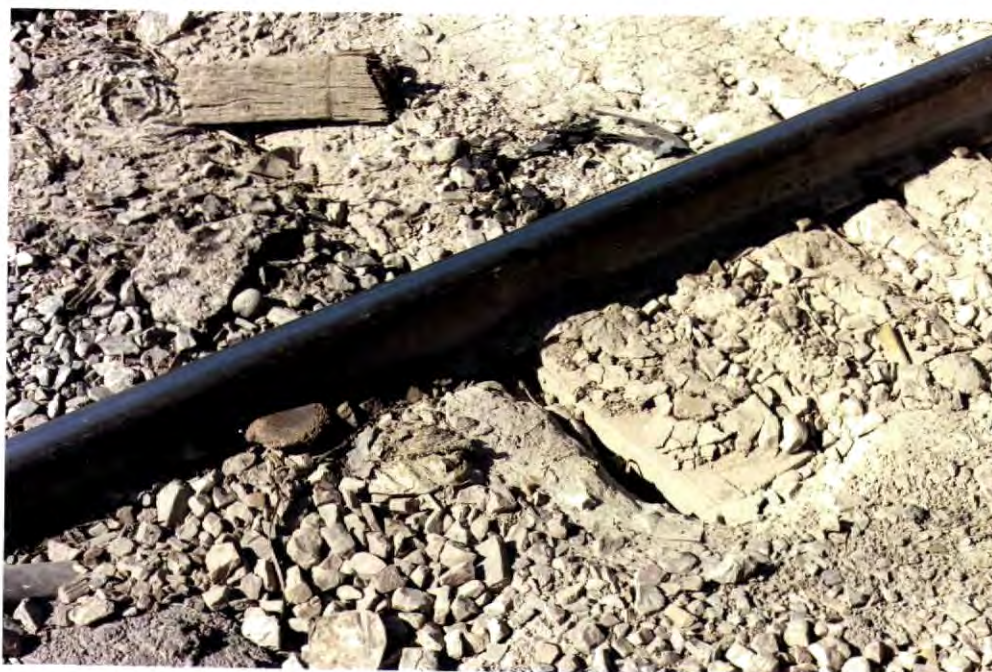
Photo 141. Seventh Street - Pumping and Tie Settlement

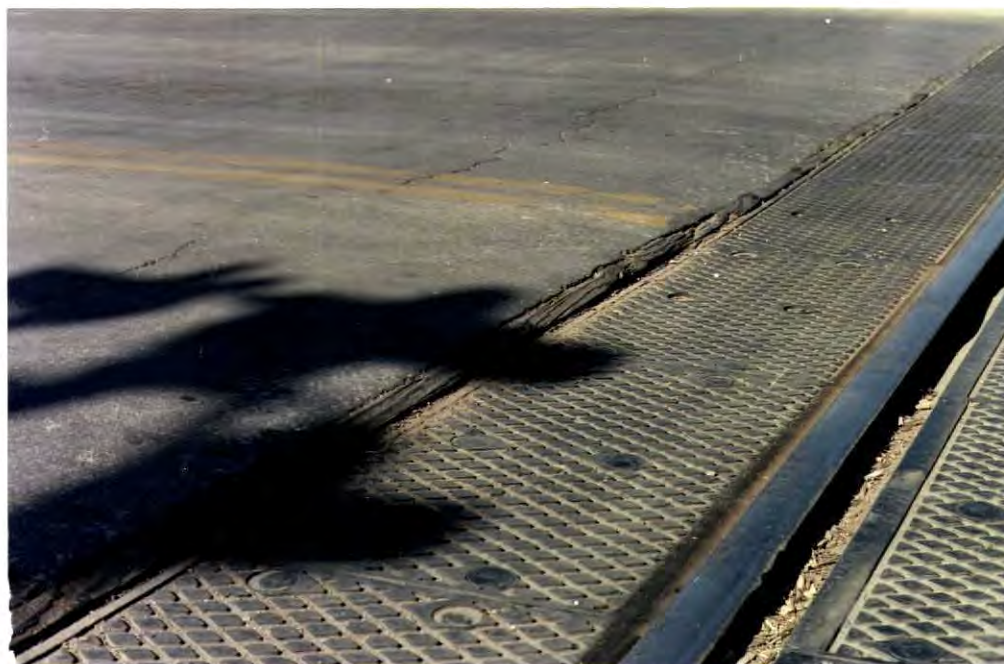
Photo 143. Mt. Rushmore Road - Worn Wood Headers

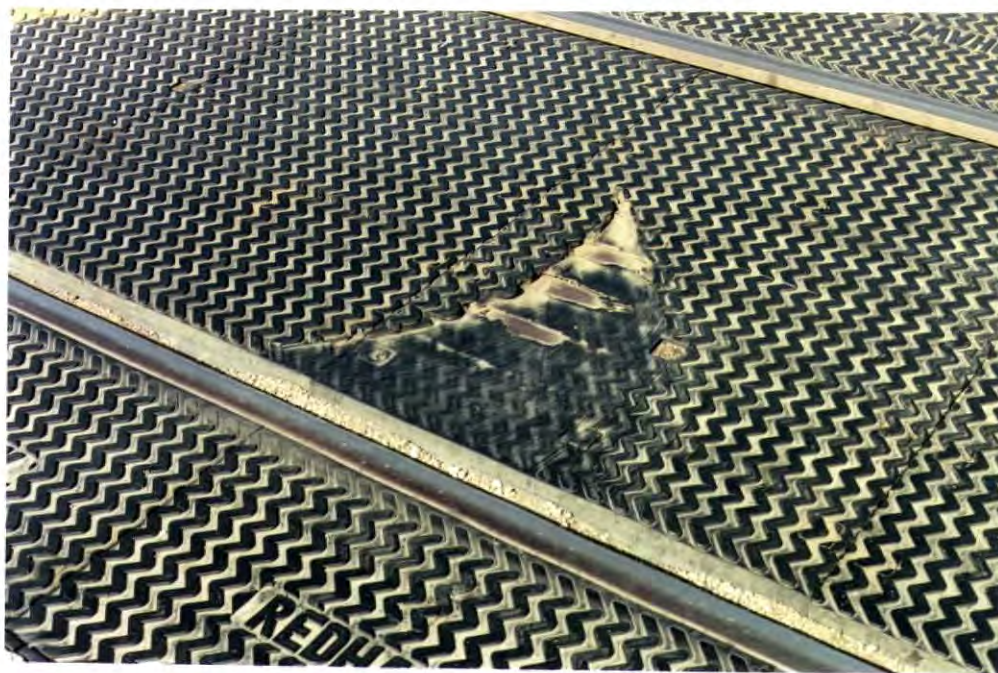
Photo 149. US Highway 14 at Blunt - Snowplow Damage, Rubber Torn Off Down to the Steel

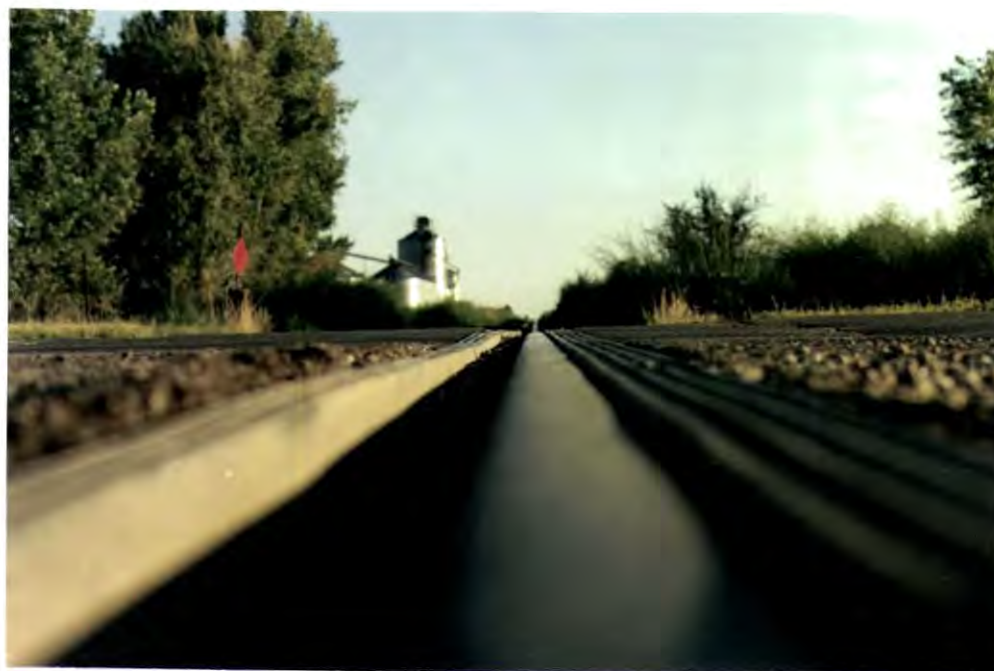
Photo 150. Northville - Rutting and Lack of Apron Settlement

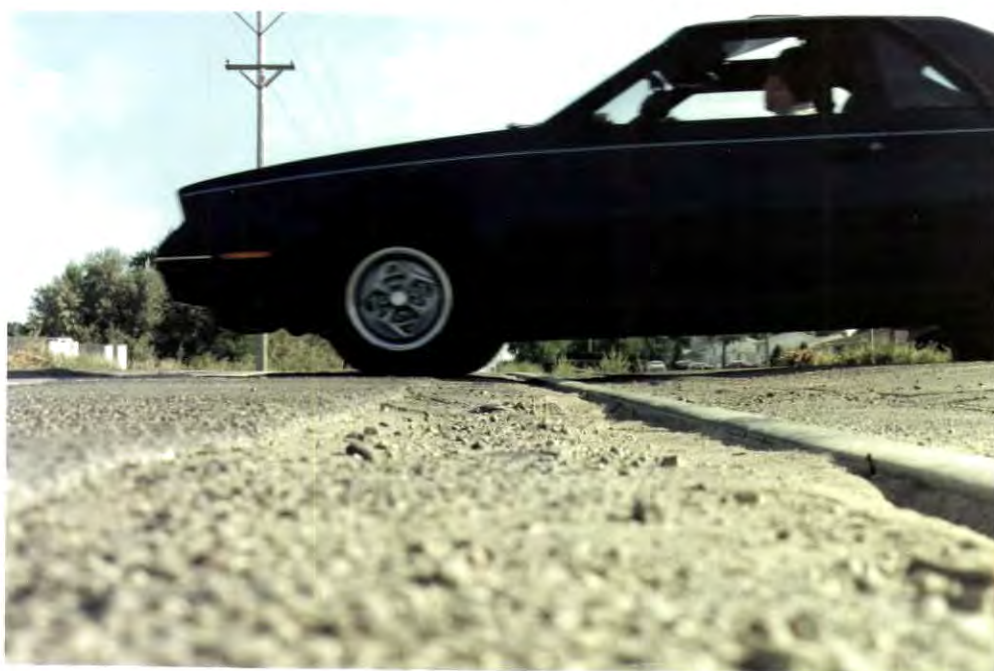
Photo 154. Aberdeen at 12th Avenue - Timber Headers Tilting Towards Rail

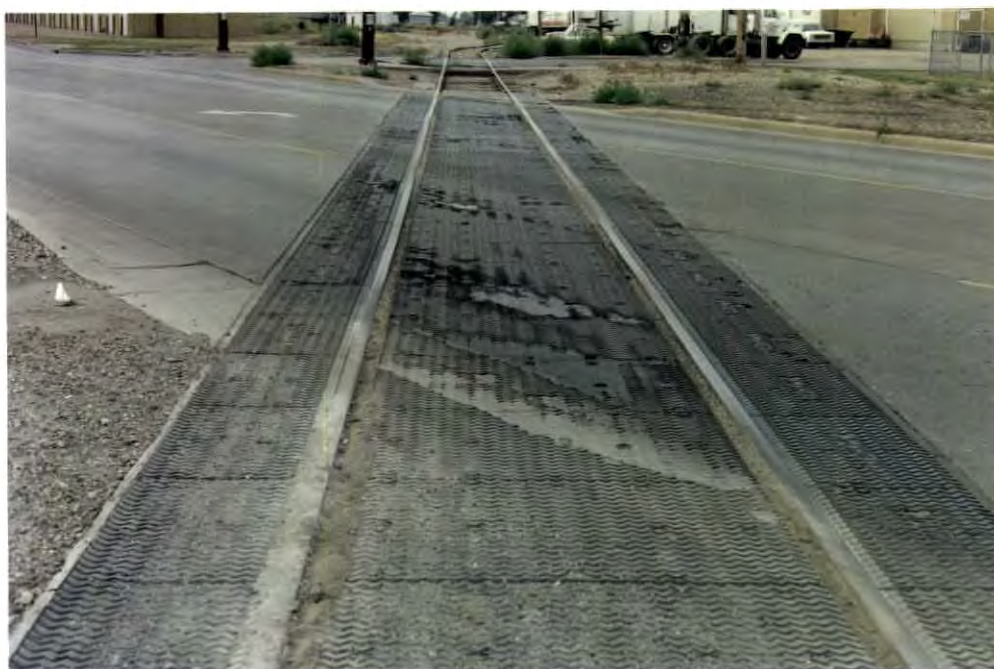
Photo 158. Aberdeen at Dakota Street - Snow Plow Damage

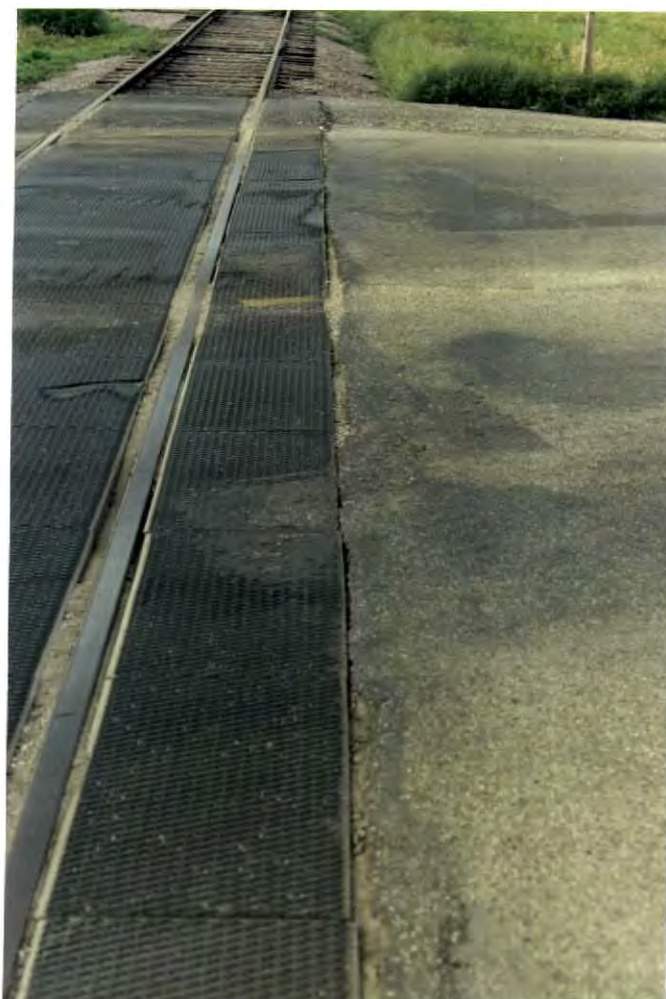
Photo 161. Aberdeen at 8th Avenue - Lateral Movement of Outer Panels and Snow Plow Damage

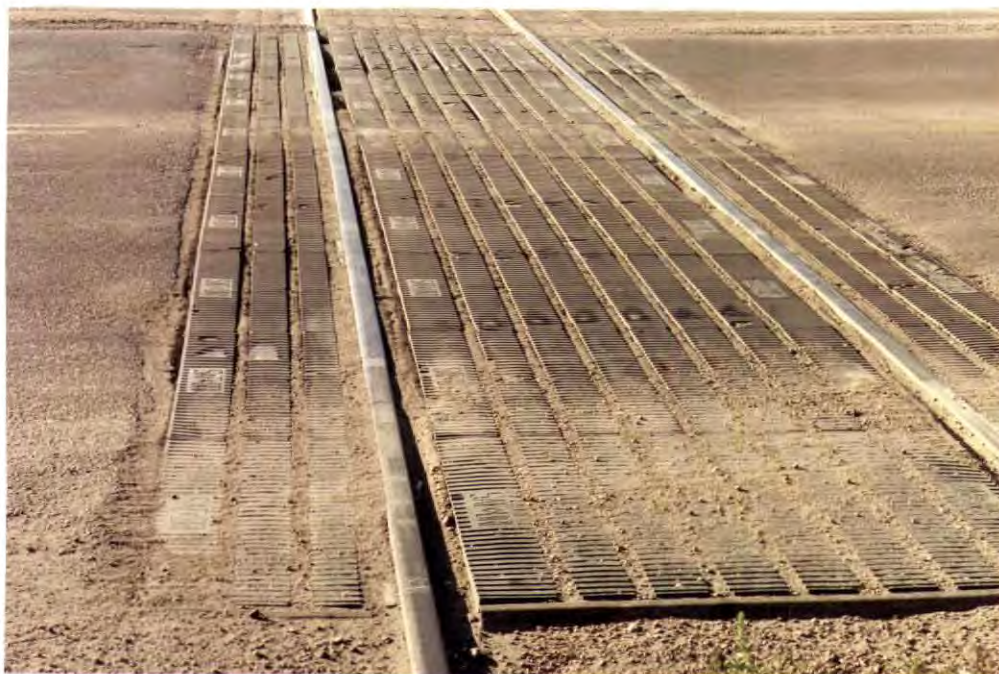
Photo 163. US 212 and Highway 281 at Redfield - Mud-Filled Rail and Lateral Panel Shifting

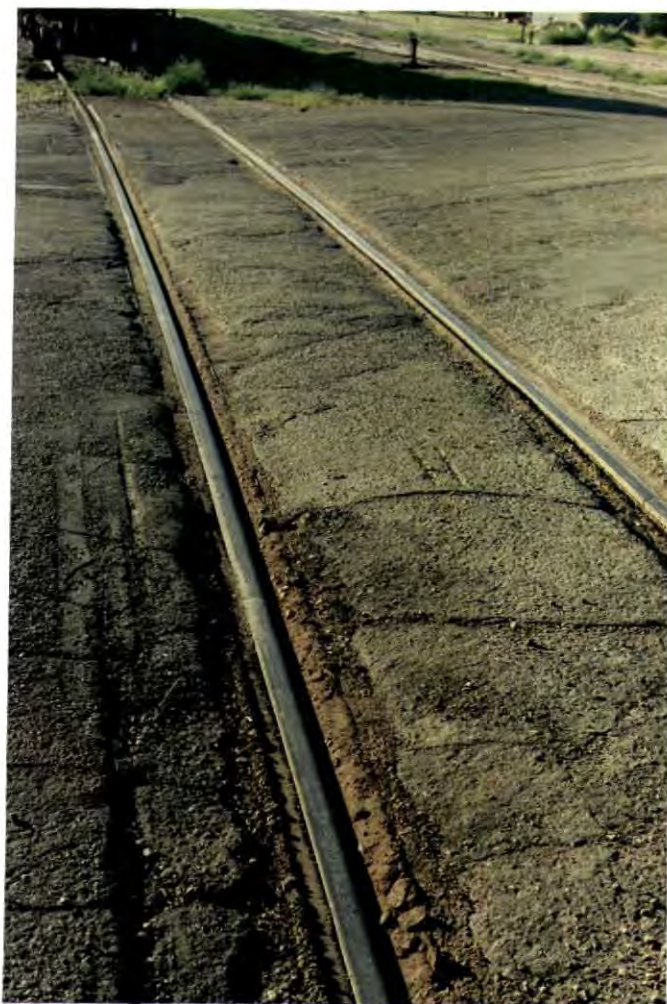
Photo 166. Redfield at 1st Street West - Track Settlement and Evidence of Pumping

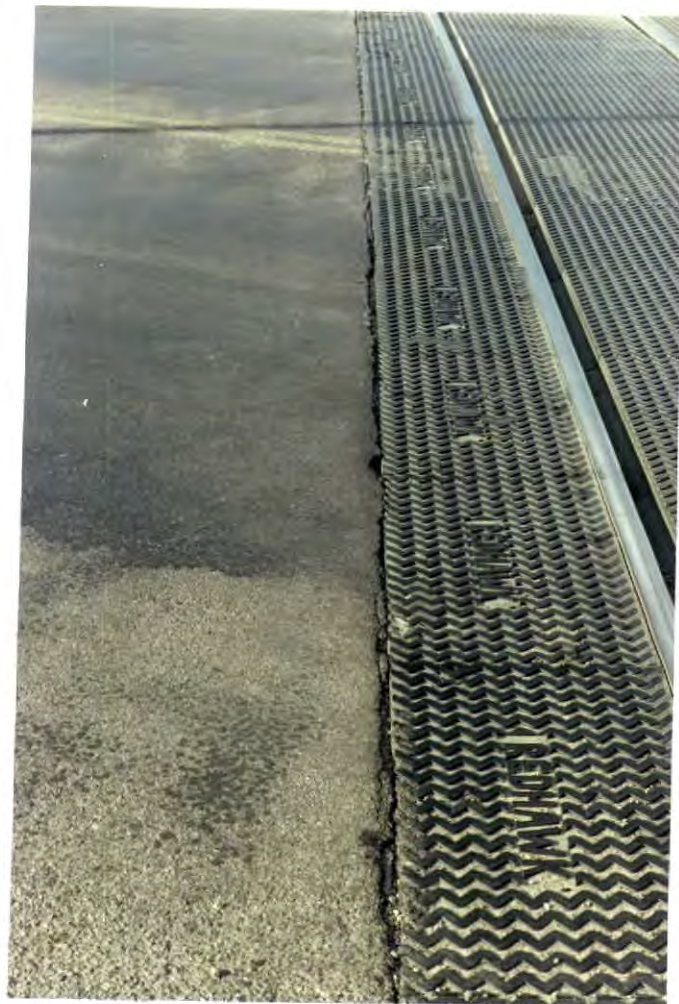
Photo 169. Watertown at First Street West - Condition of Asphalt Apron
