SD Department of Transportation
Office of Research

Highway Rock Slope Reclamation and Stabilization Black Hills Region South Dakota Part II, Guidelines

Study SD94-09-G
Final Report

Prepared by
GeoEngineers, Inc.
8410 154th Avenue Northeast
Redmond, Washington 98052

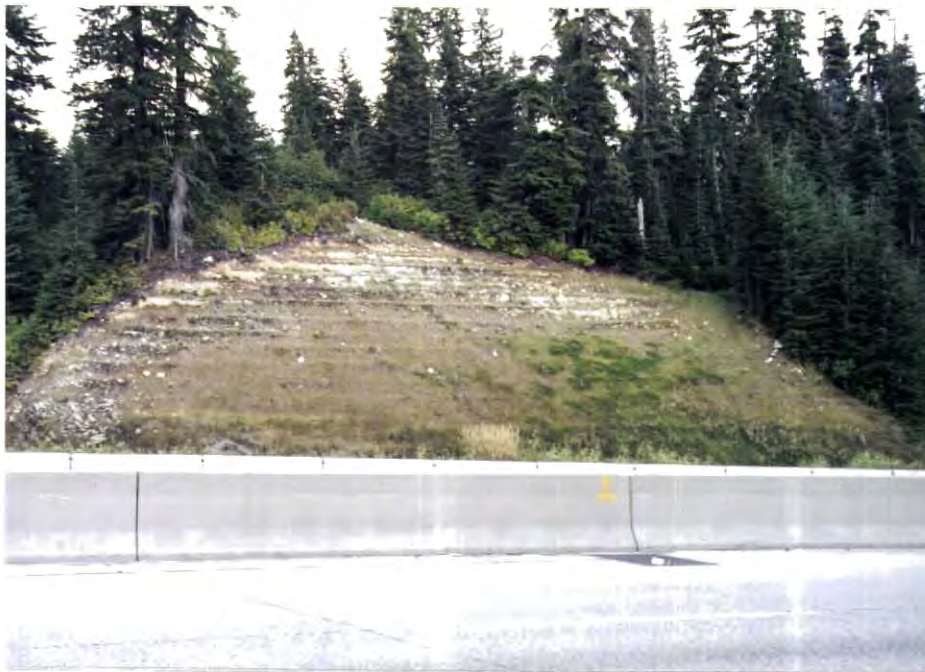
Photo II-2. Serrated slope in ravelling soils.

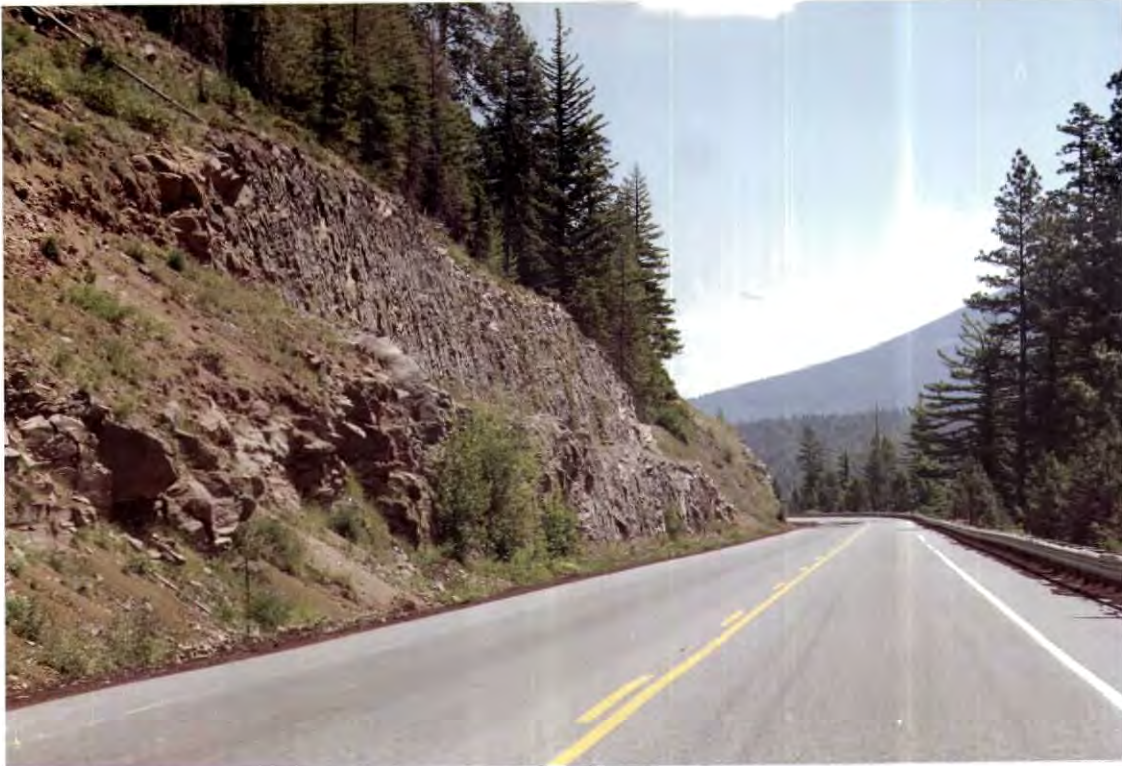
Photo II-3. Bench with vegetation getting established.

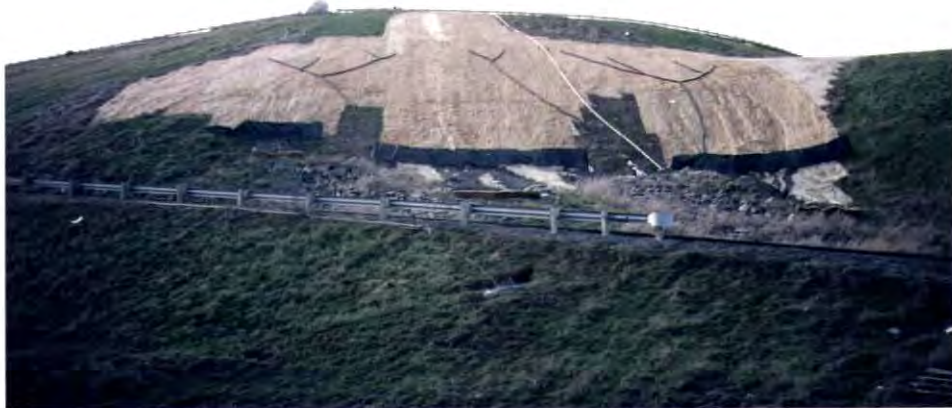
Photo II-13. Excelsior and polypropylene netting over seed and fertilizer.

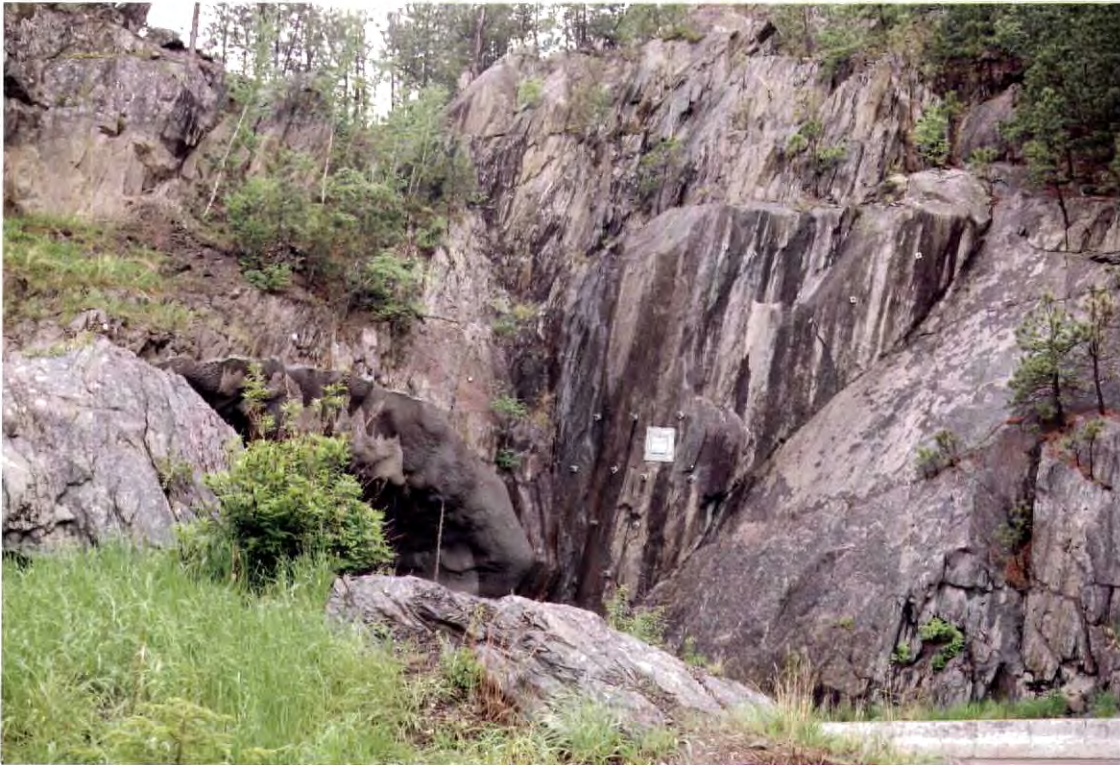
Photo II-19. Rock bolts stabilizing a wedge failure.

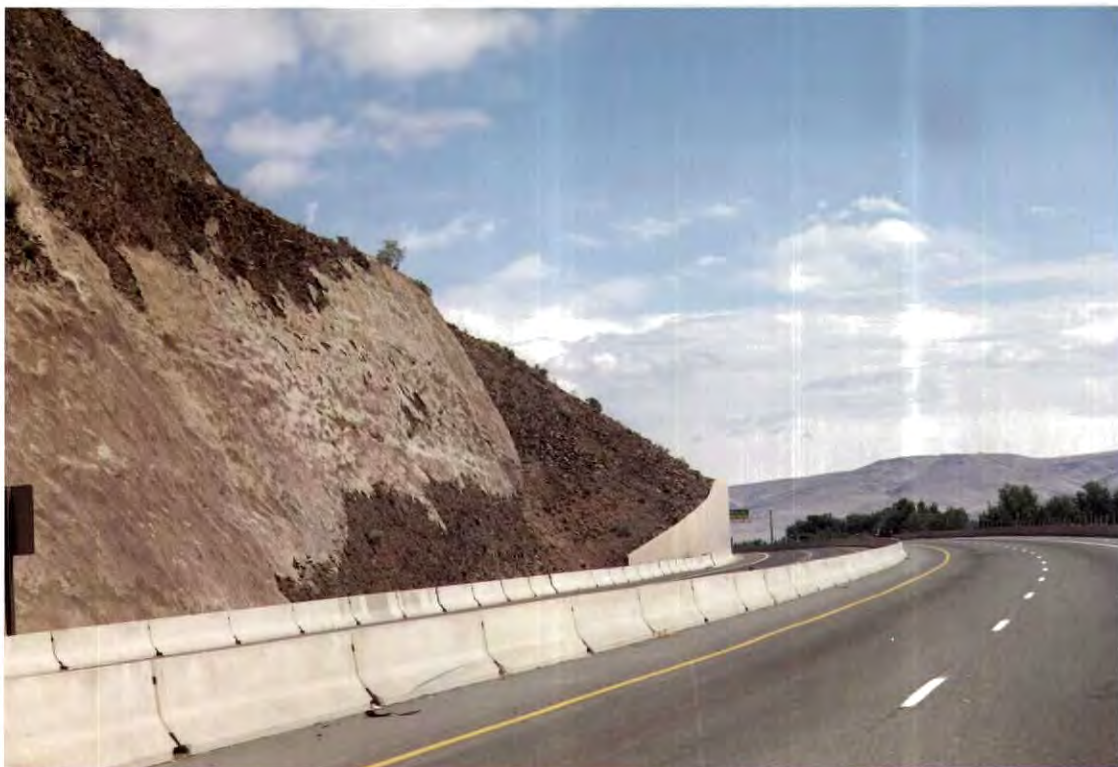
Photo II-20. Tinted shotcrete on rock cutslope.

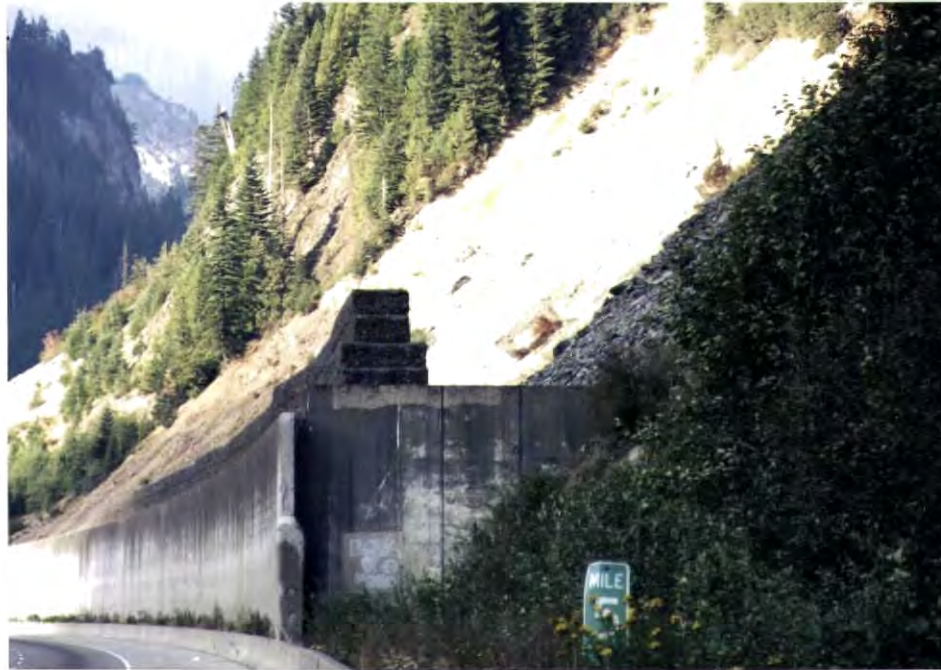
Photo II-21. Combination of concrete structure and gabions at toe of steep, ravelling slope.

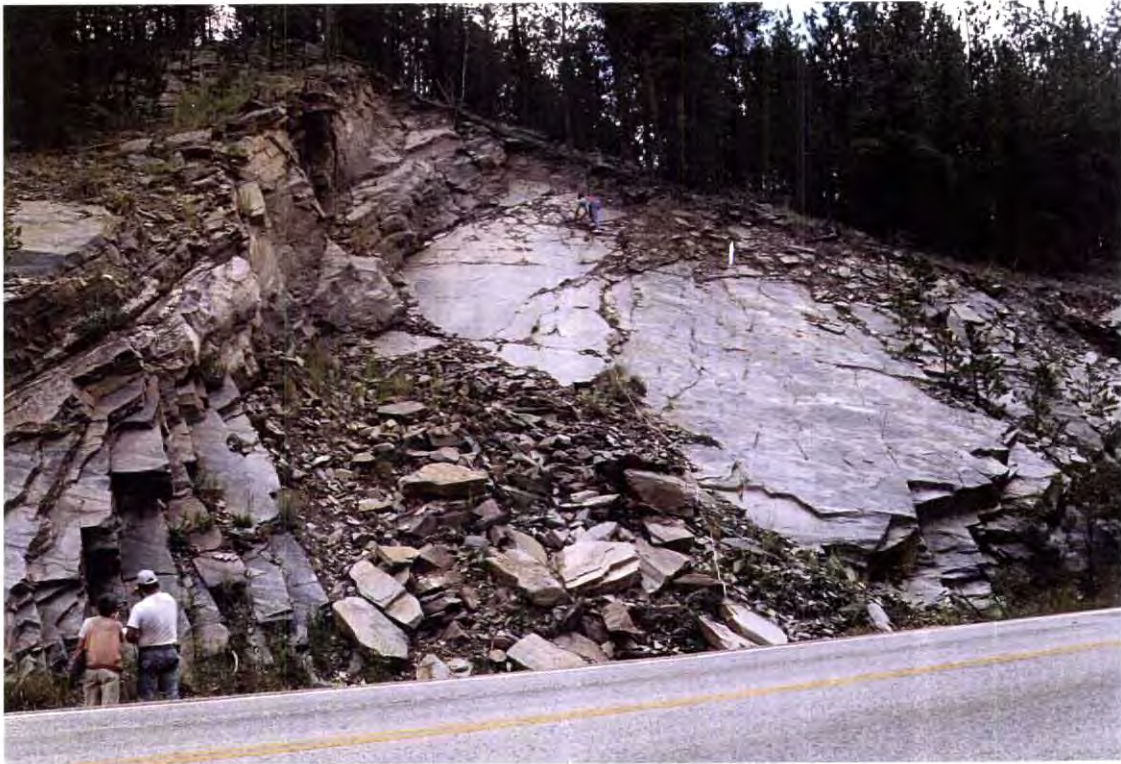
Photo 1: View of wedge failure.

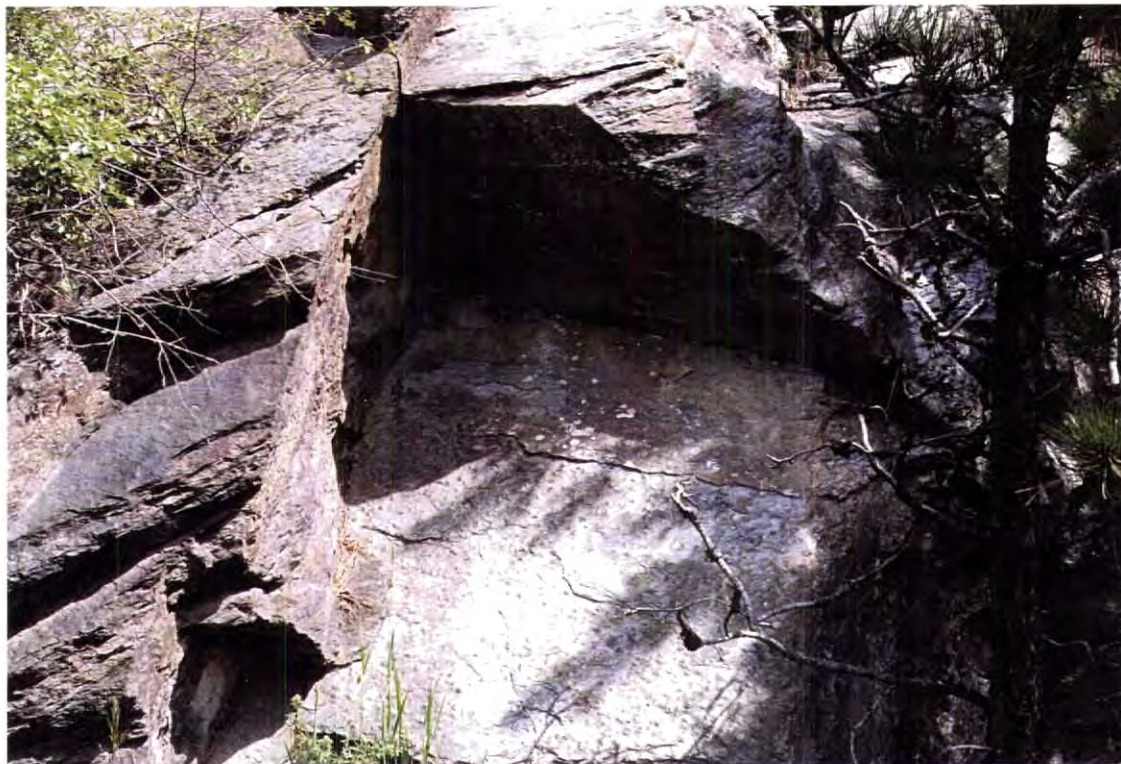
Photo 2: Close-up of small wedge failure showing discontinuity intersections similar to the large one in Photo 1.

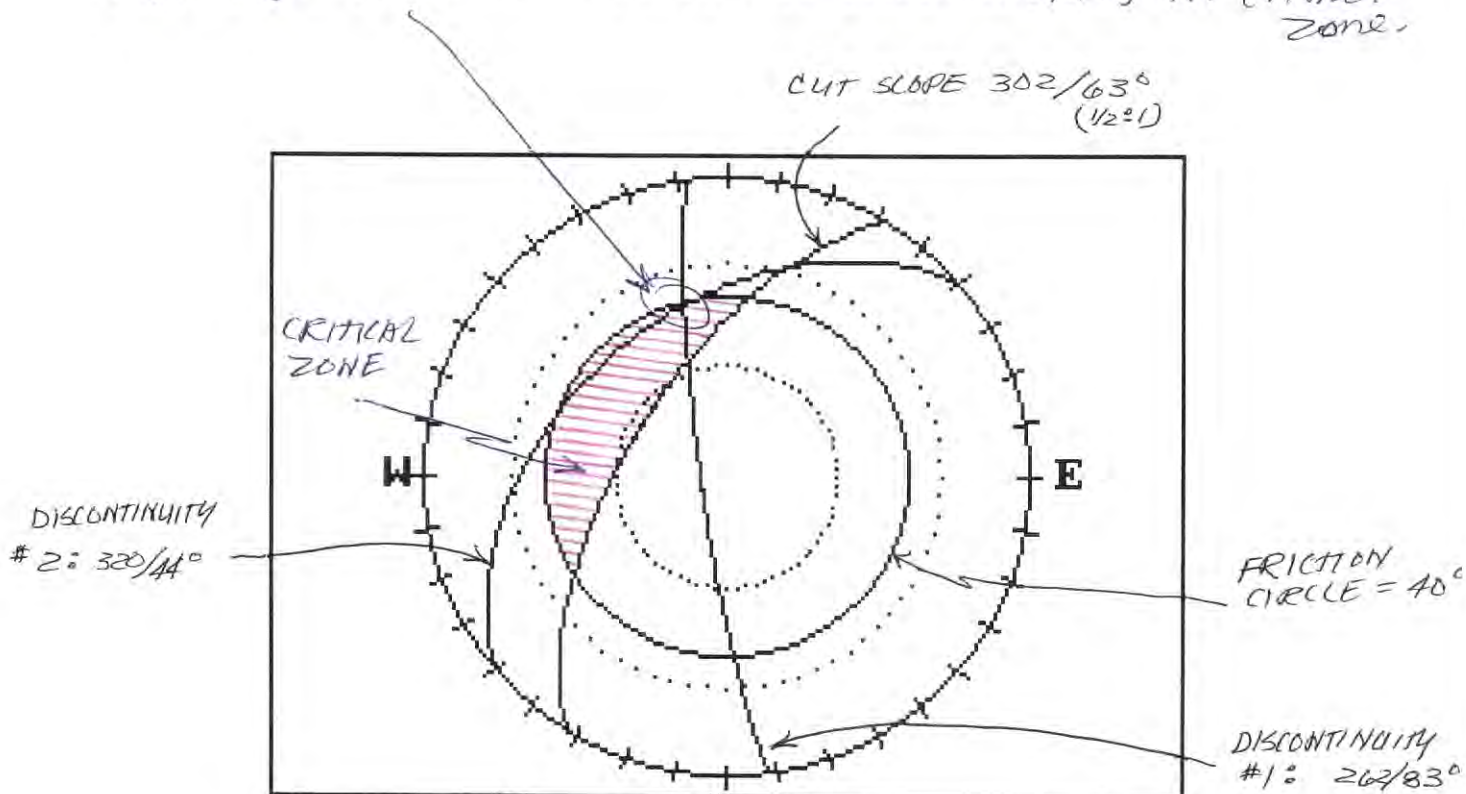
STEREONET ANALYSIS: Failure by "wedge" likely for 63° ($1/2:1$) cut slope with intersection of discontinuities in critical zone.

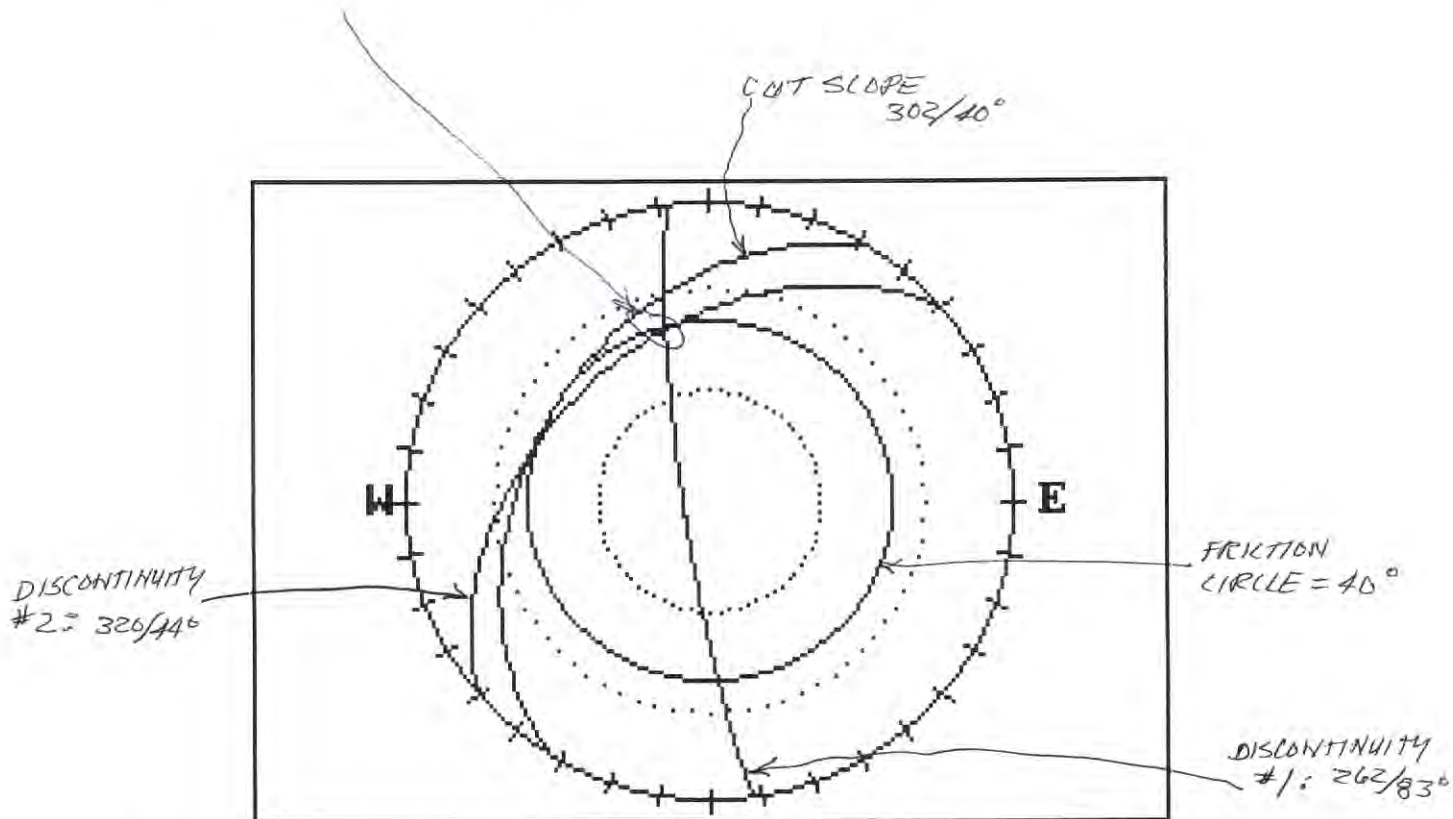
STEREONET ANALYSIS: No critical zone and failure by "wedge"
unlikely for cut slopes 40° or flatter.

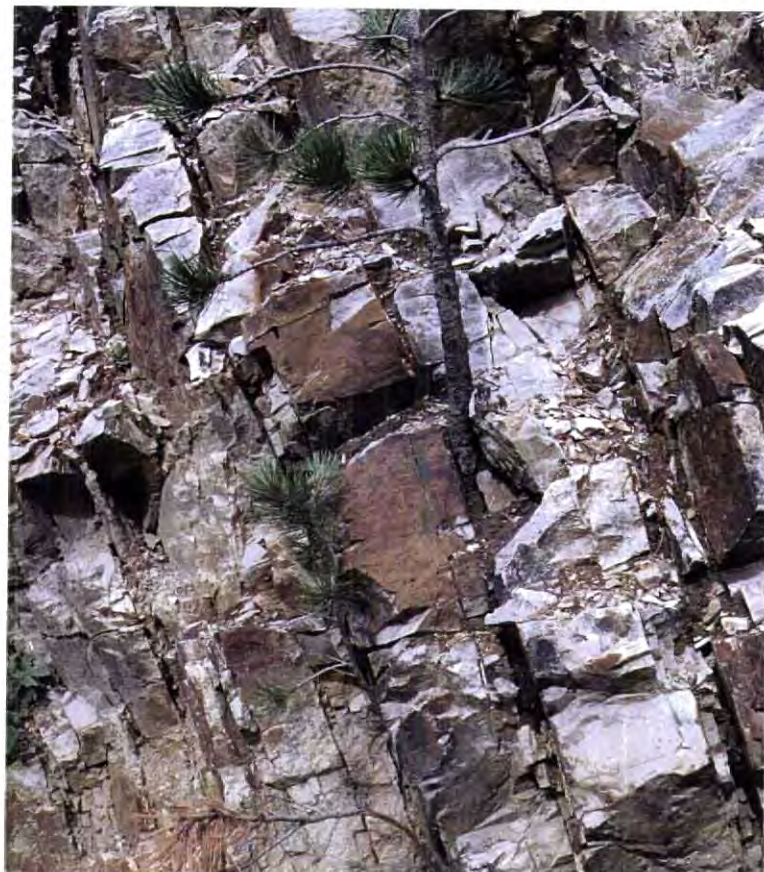
Photo 2: Close-up of face. Note how tree growth in open joints causes "root wedging." Root growth and expansion within joints wedges rocks further apart, causing rockfall failure.

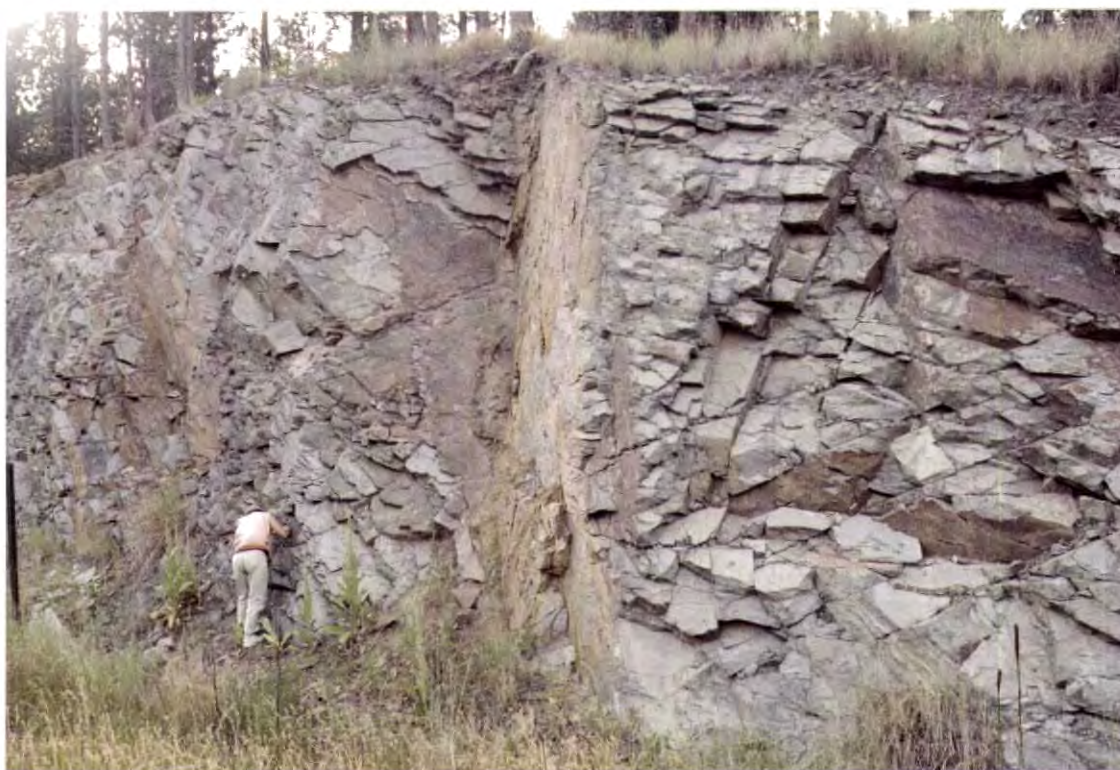
Photo 2: Close-up view of wedge failure.

IV. POSSIBLE STABILIZATION ALTERNATIVES: Anticipate failure occurred during construction. No stabilization appears necessary unless recut. In that event, use cut slope of 55° or flatter (see stereonet analysis) or rock bolt.

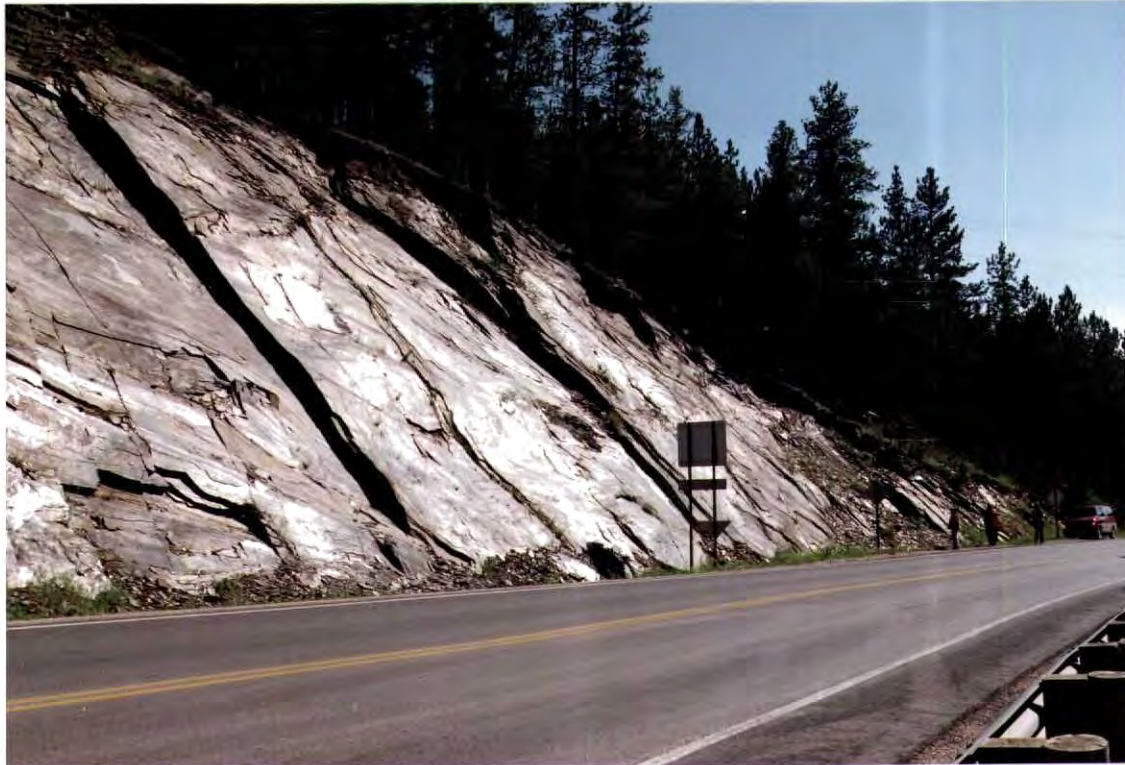
Photo 1: View of plane failure as viewed from across the road.

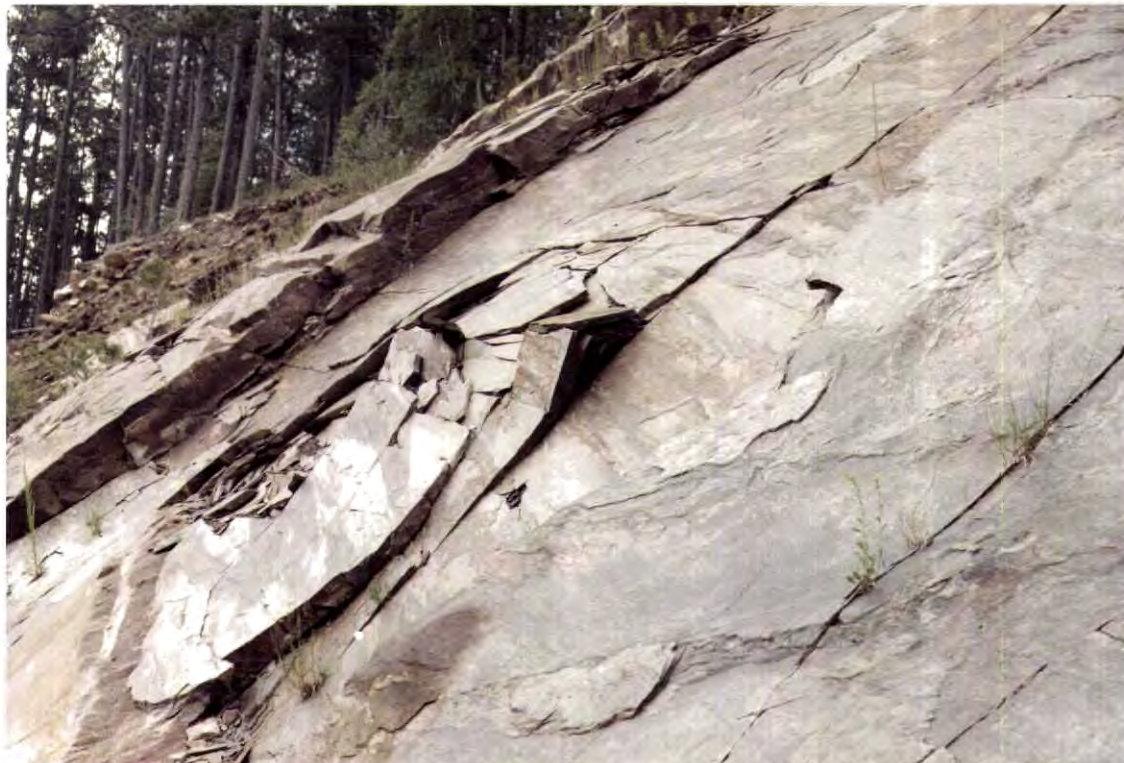
Photo 2: Close-up view of rock failure surface caused by "buckling."

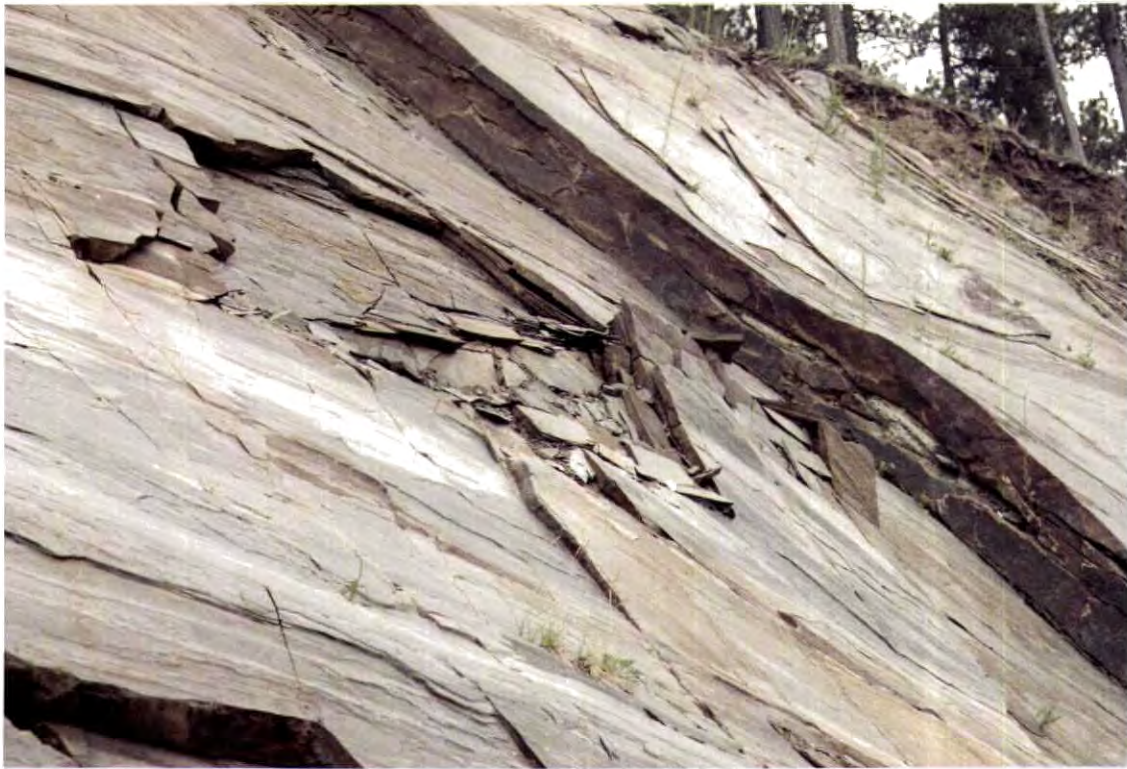
Photo 3: Close-up of "buckling" failure that is progressing up slope.

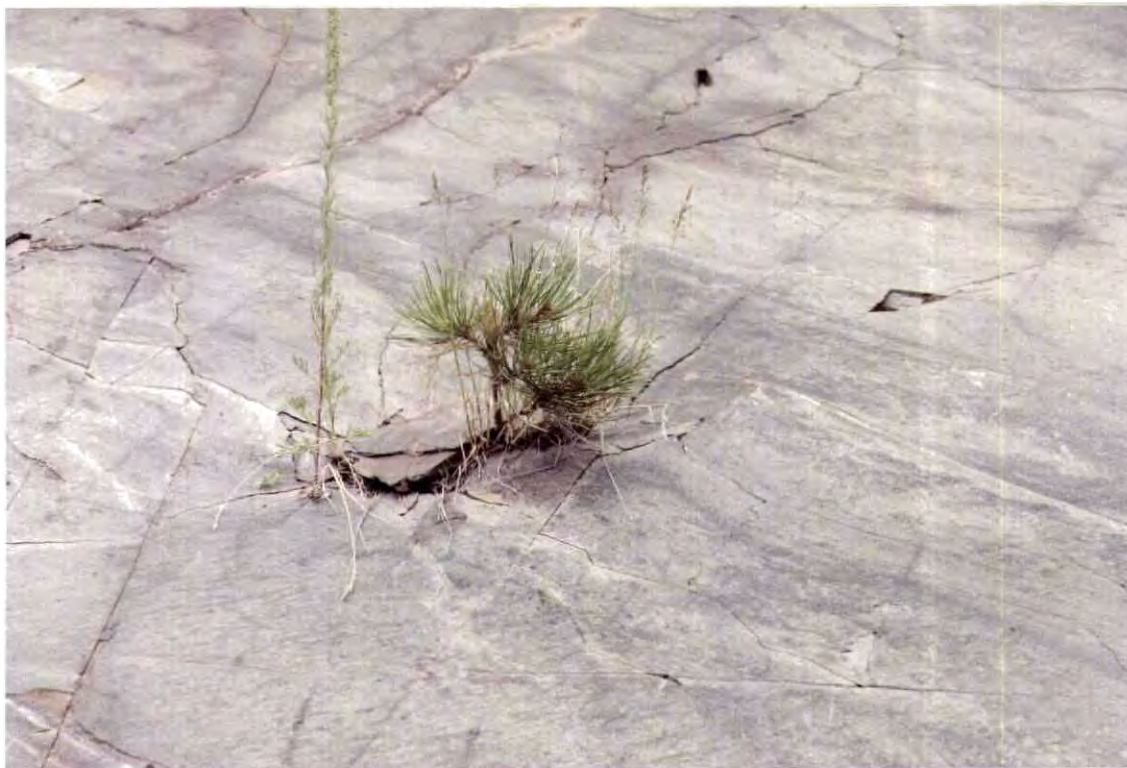
Photo 4: Close-up of a juvenile tree rooted in a failure surface. The growth of trees on this slope causes root wedging and is detrimental to slope stability.

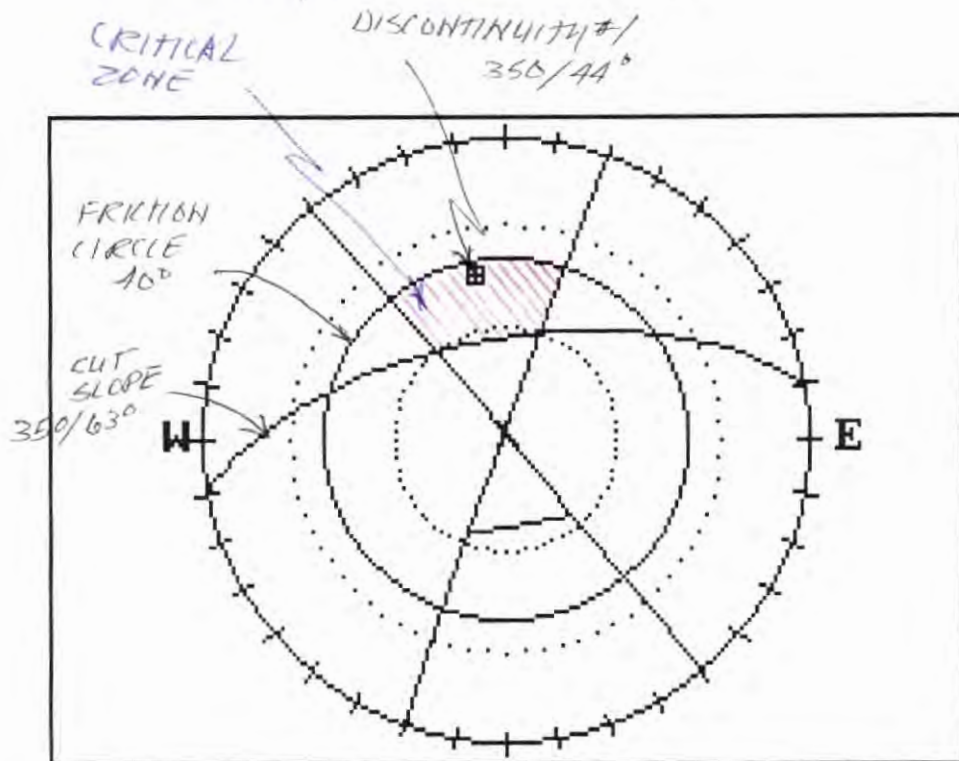
STEREONET: Plane failure likely for 112° cut slope (63°)
Since discontinuity is in critical zone.

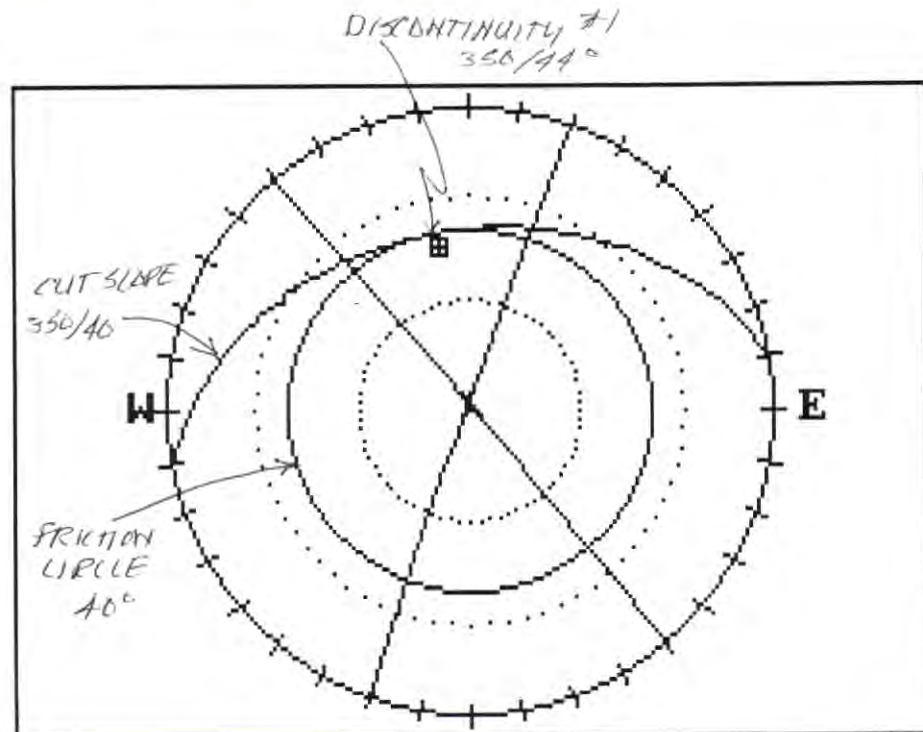
STEREONET = No critical zone and unlikely plane failure for cut slopes 40° or flatter.

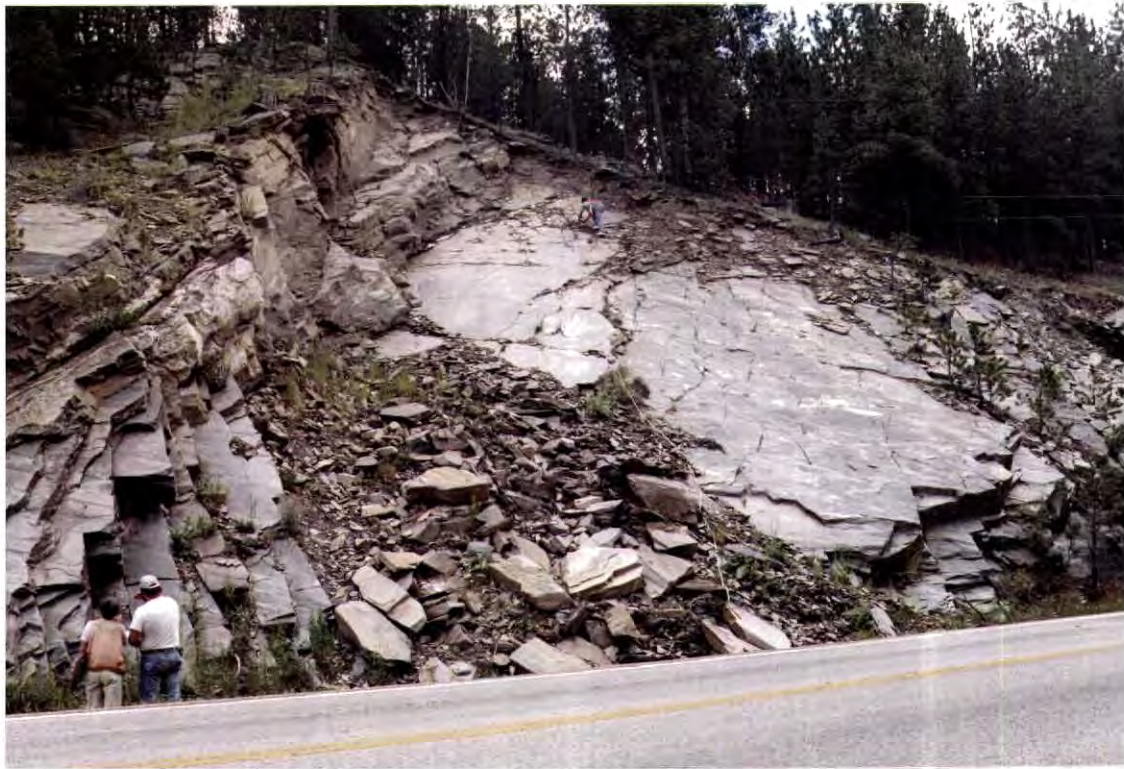
Photo 1: View of wedge failure.

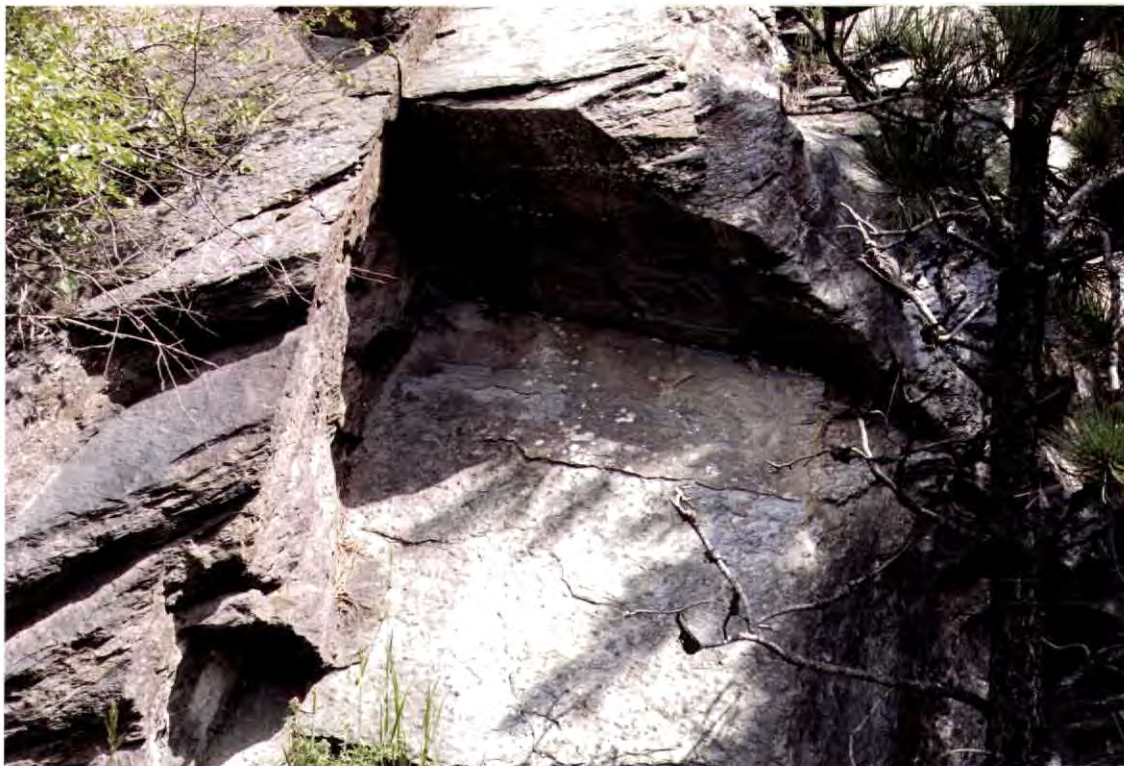
Photo 2: Close-up of small wedge failure showing discontinuity intersections similar to the large one in Photo 1.

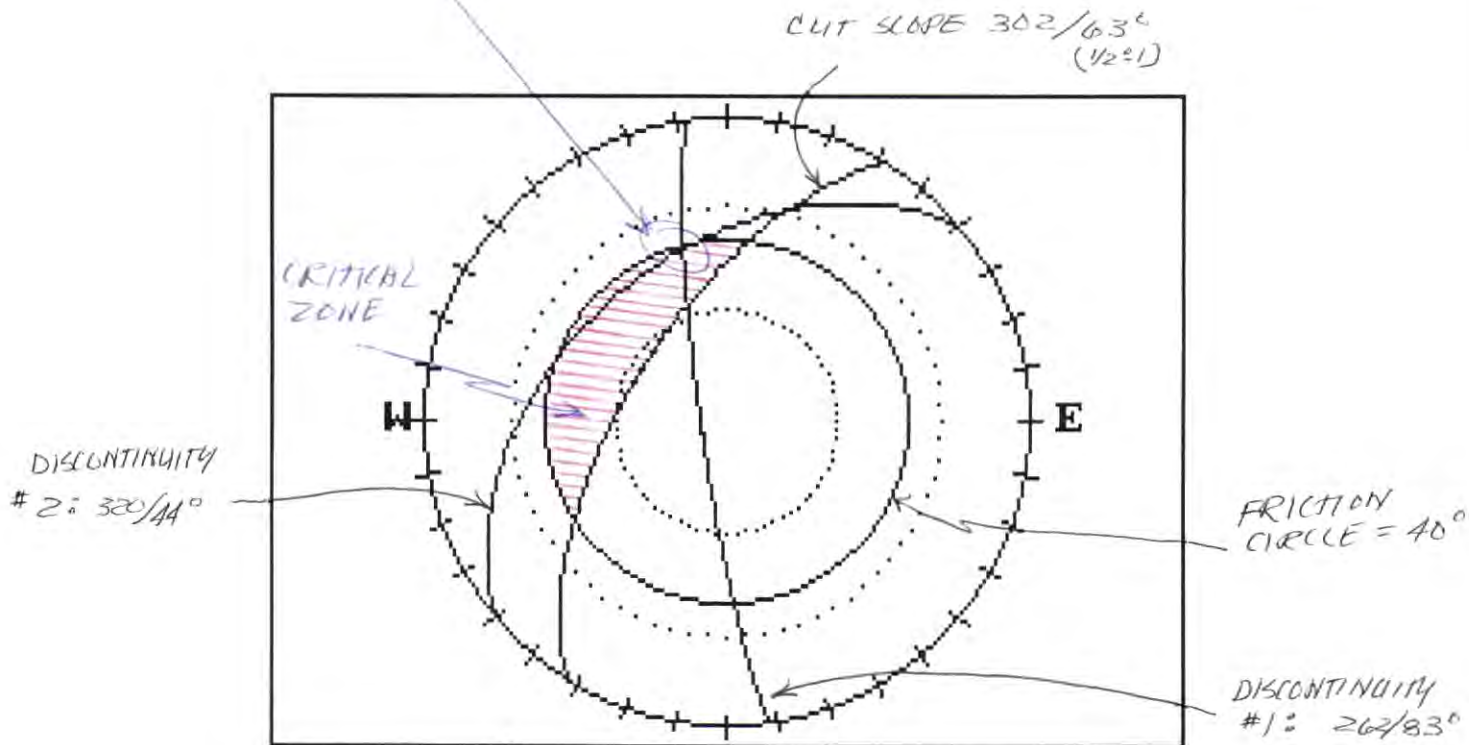
STEREONET ANALYSIS: Failure by "wedge" likely for 63° ($1\frac{1}{2}:1$) cut slope with intersection of discontinuities in critical zone.

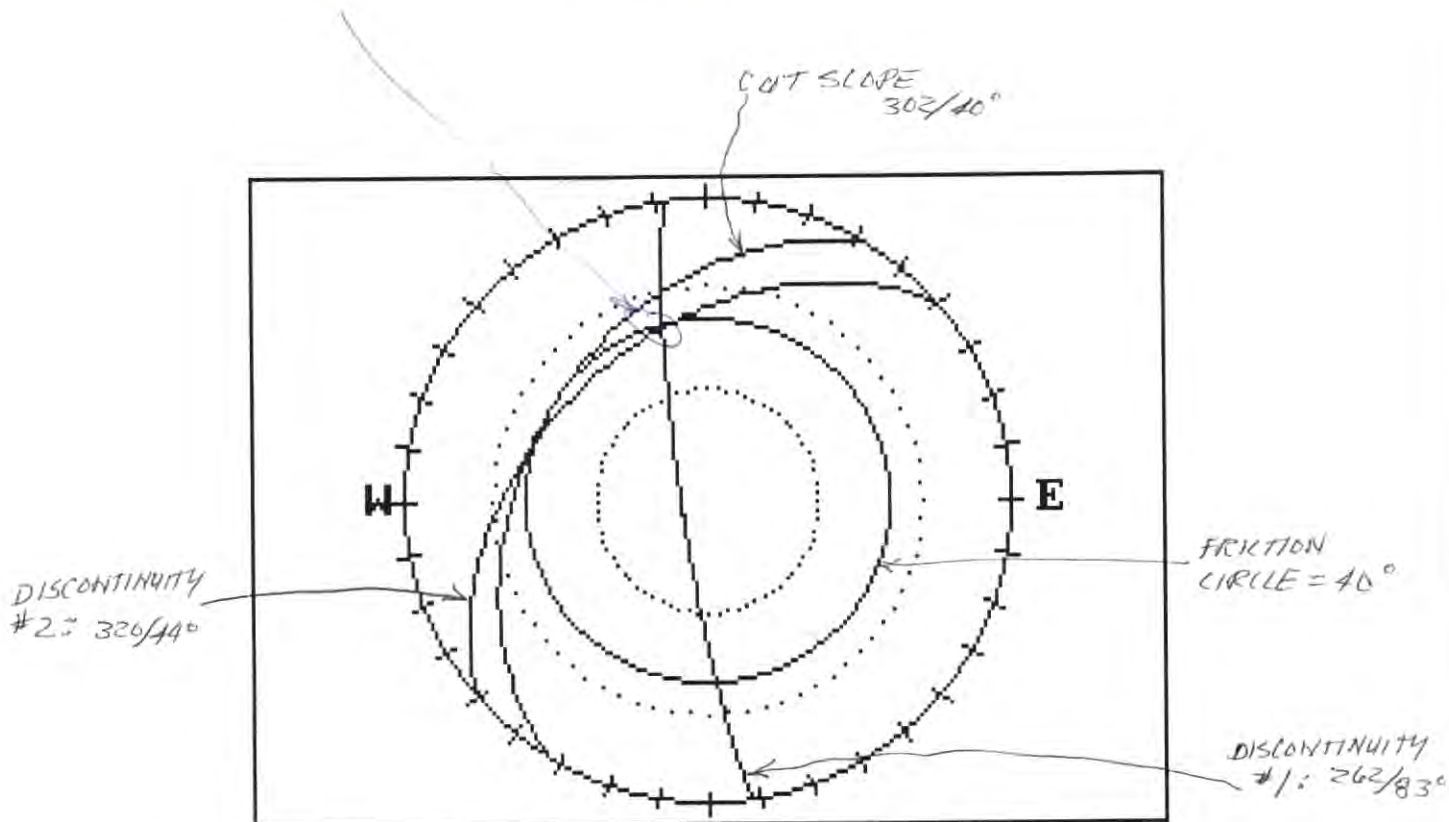
STEREONET ANALYSIS - No critical zone and failure by "wedge"
unlikely for cut slopes 40° or flatter.

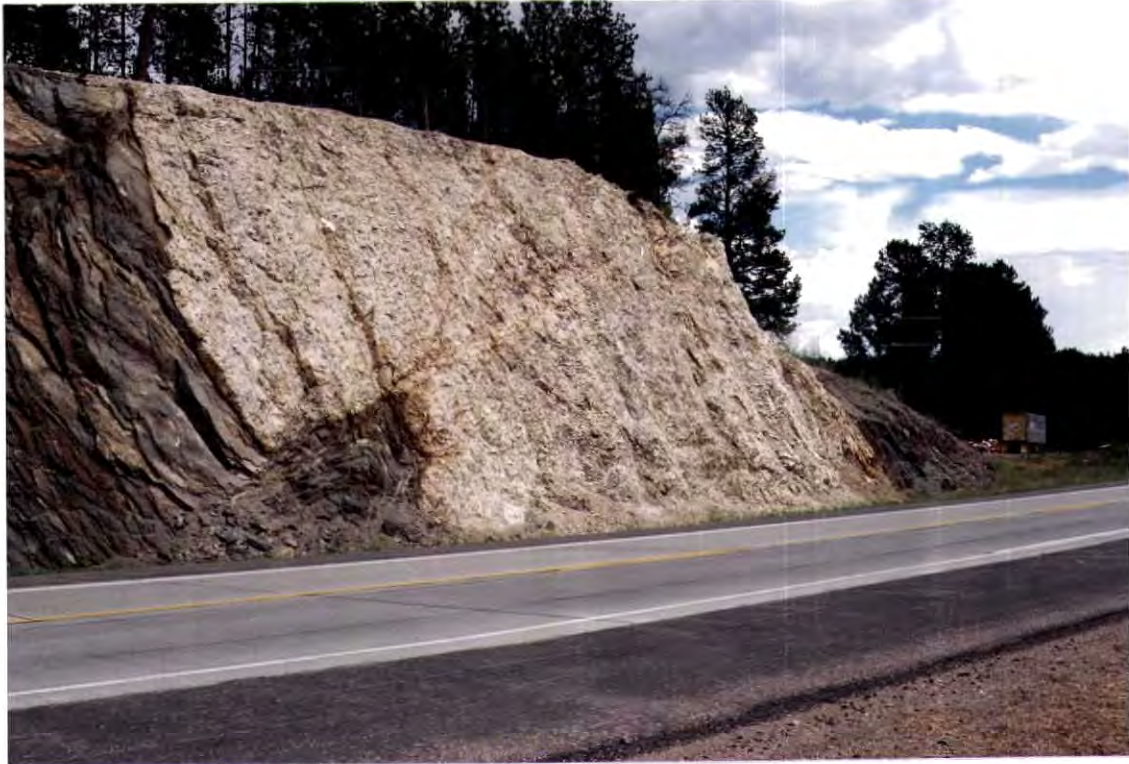
Photo 1: View of cut slope from across the highway. Note the minor plane failures at left.

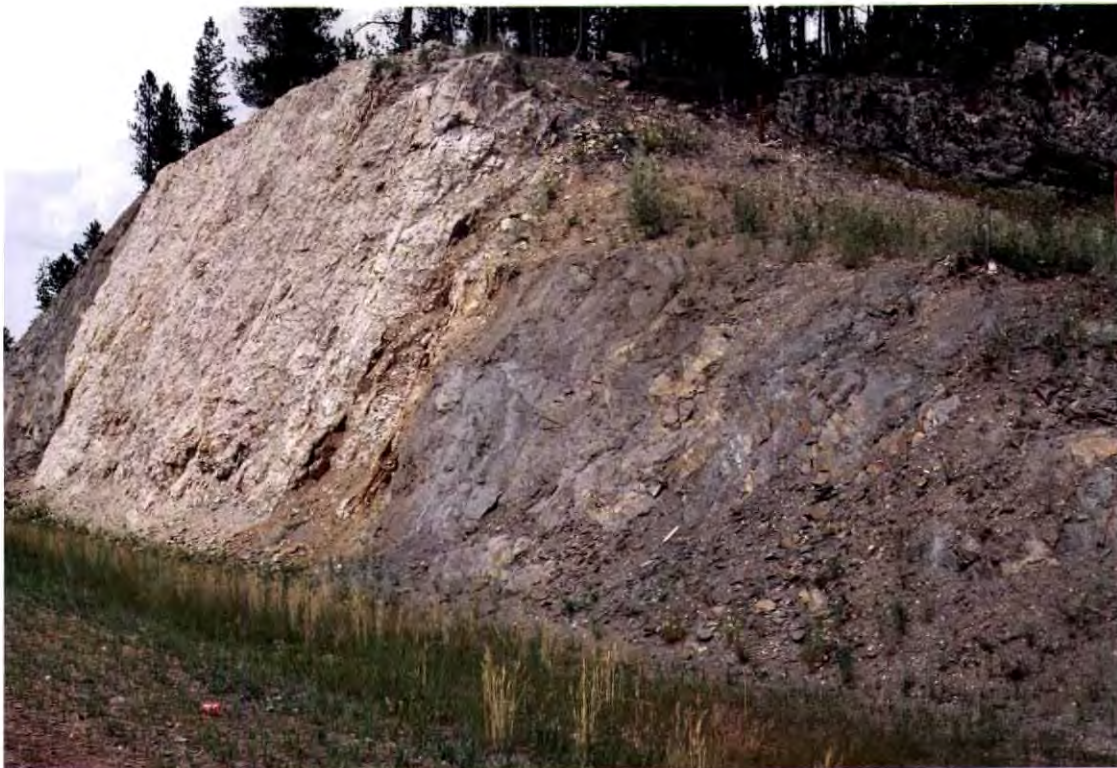
Photo 2: View of cut slope and revegetated ditch. Note the near absence of rockfall and dense growth of wheat in ditch.

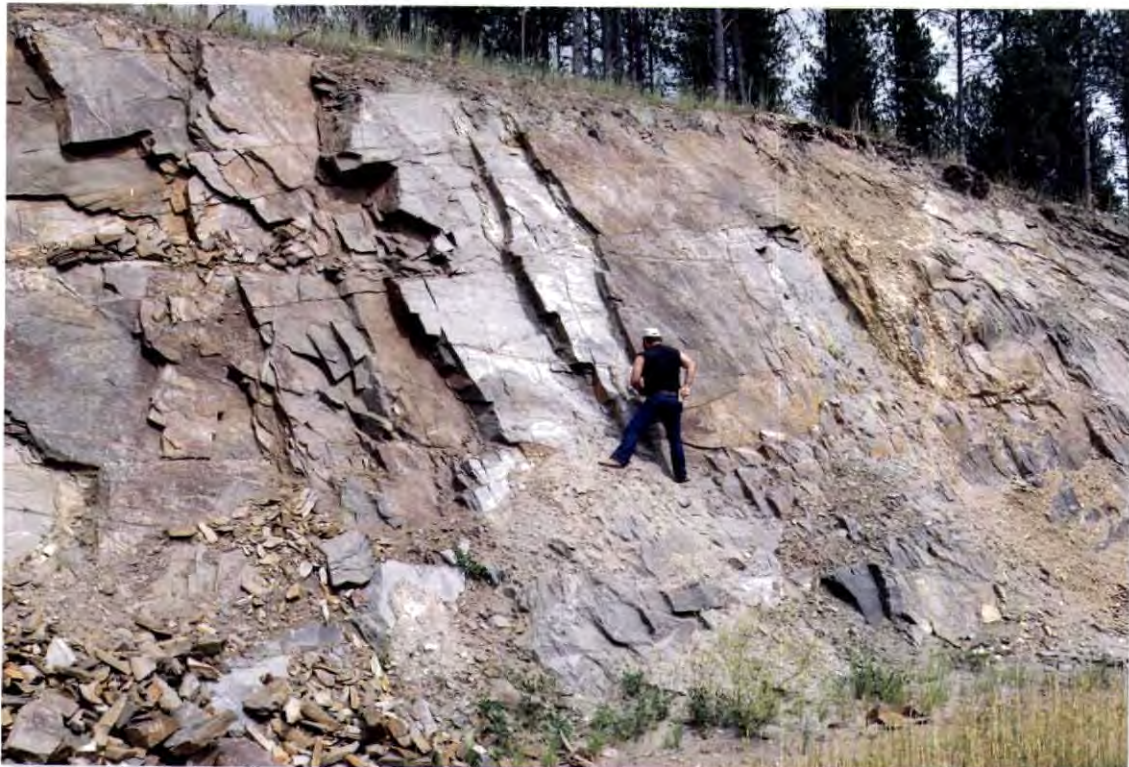
Photo 2: View of cut slope showing plane failures.

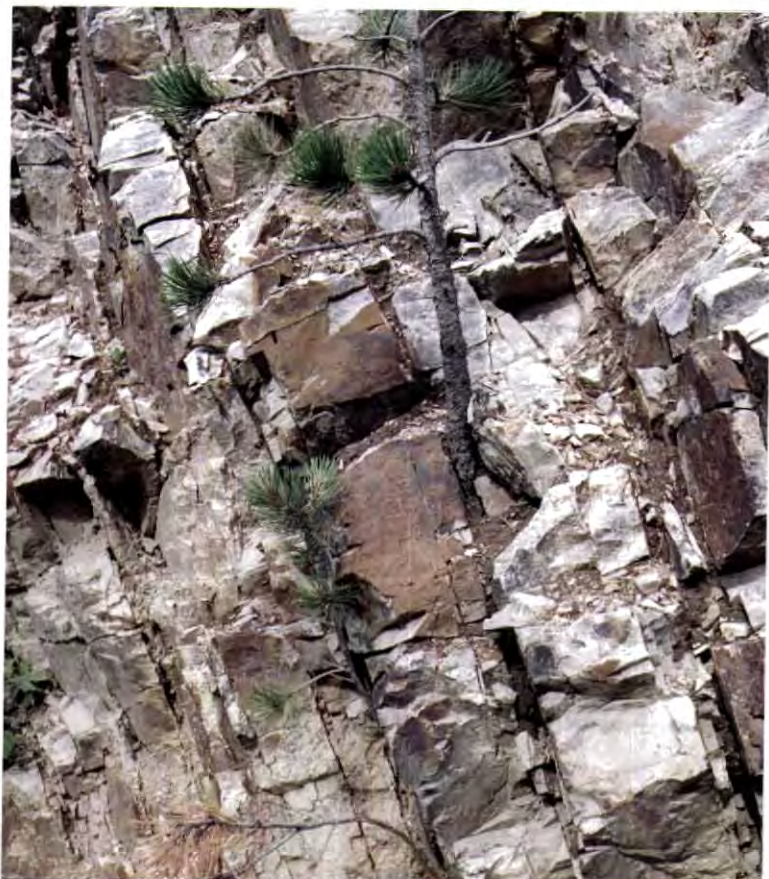
Photo 2: Close-up of face. Note how tree growth in open joints causes "root wedging." Root growth and expansion within joints wedges rocks further apart, causing rockfall failure.
