SD Department of Transportation
Office of Research

Highway Rock Slope Reclamation and Stabilization Black Hills Region South Dakota Part II, Guidelines

Study SD94-09-G
Final Report

Prepared by
GeoEngineers, Inc.
8410 154th Avenue Northeast
Redmond, Washington 98052

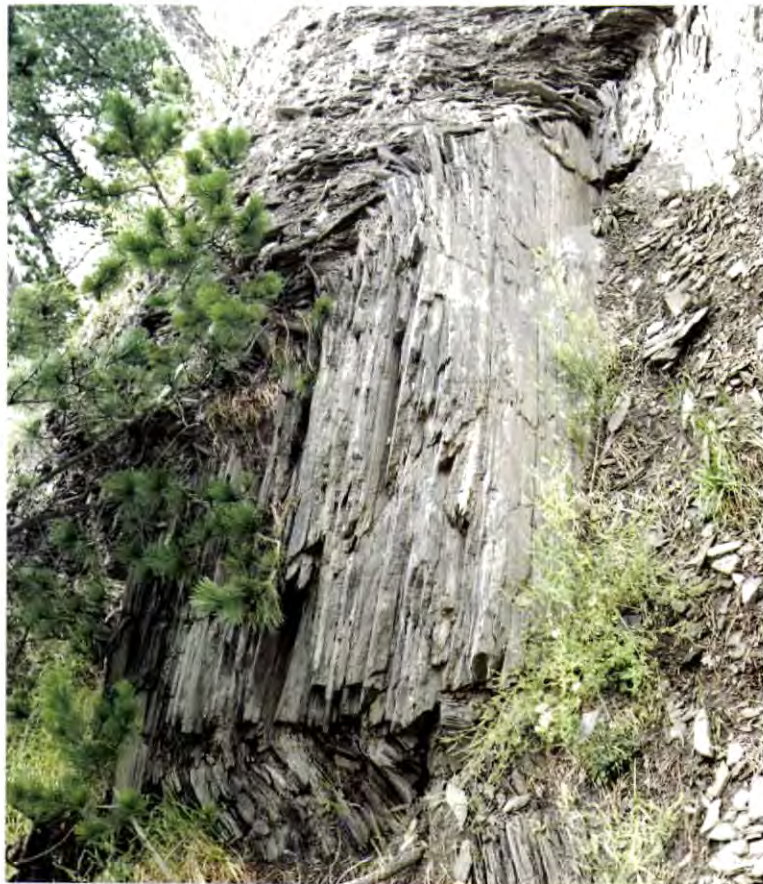
Photo 2: Close-up of overturned and broken structure in RUB.

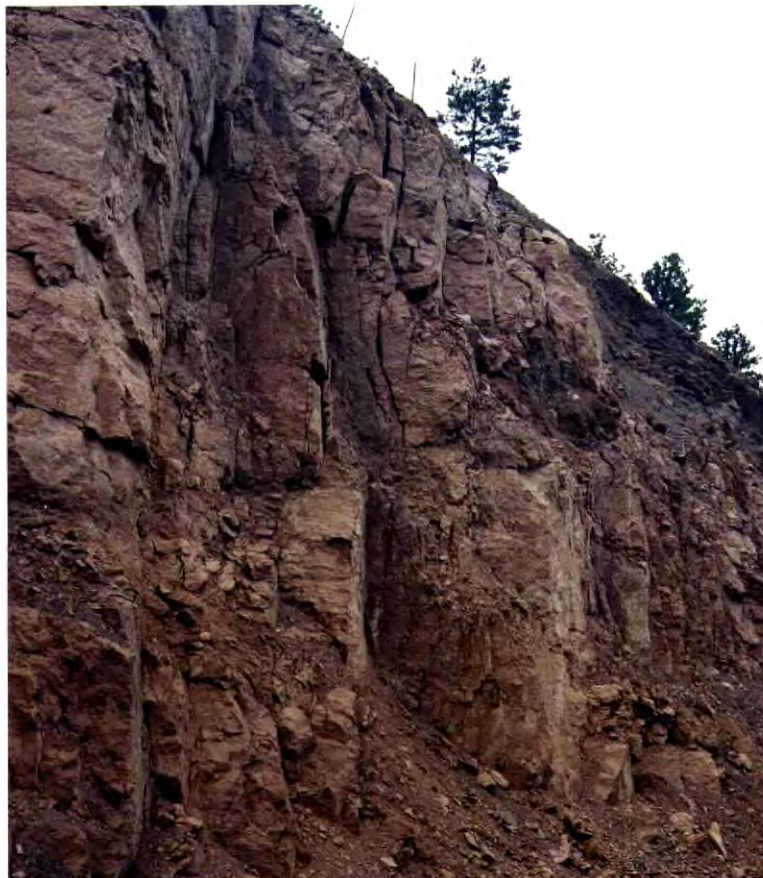
Photo 2: View of open joints in the massive rock section of the cut, indicating potential toppling failures.

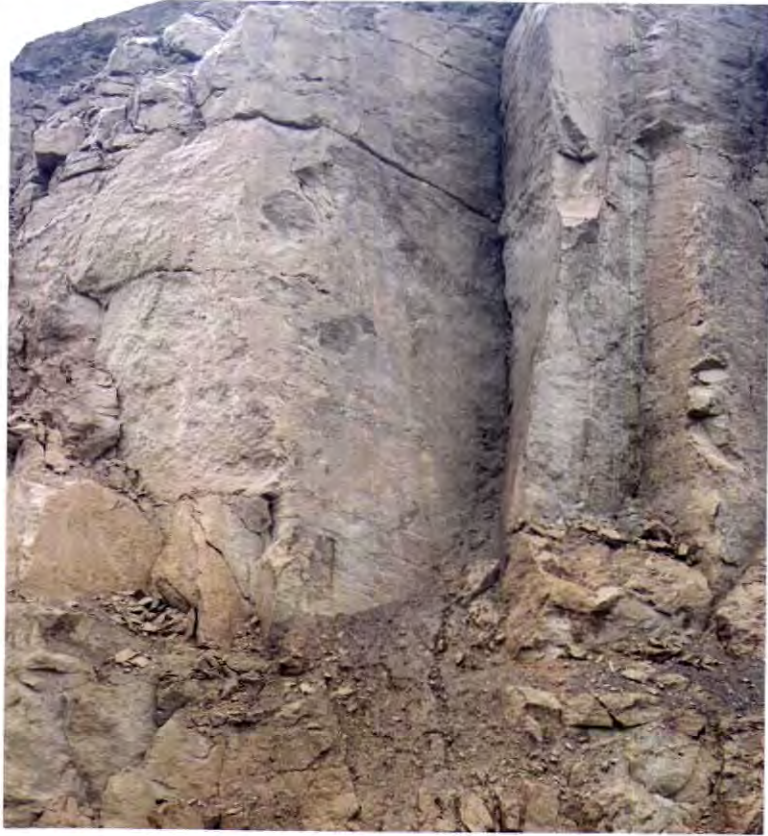
Photo 3: View of competent but jointed rock with low base angle (dip) overlying weak incompetent rock. These are ideal conditions for toppling or collapse failures.

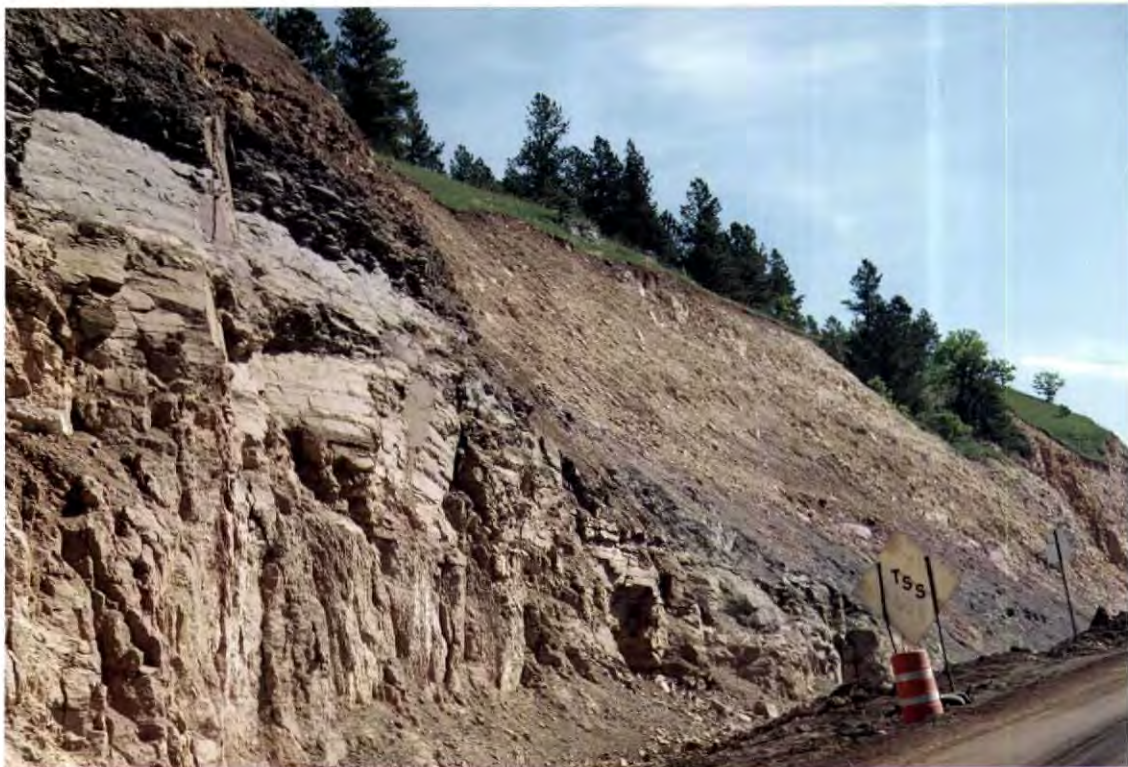
Photo 4: Relatively thick SUS colluvium overlying RUC rock. Note evidence of ground water seepage at the contact between SUS and RUC units.

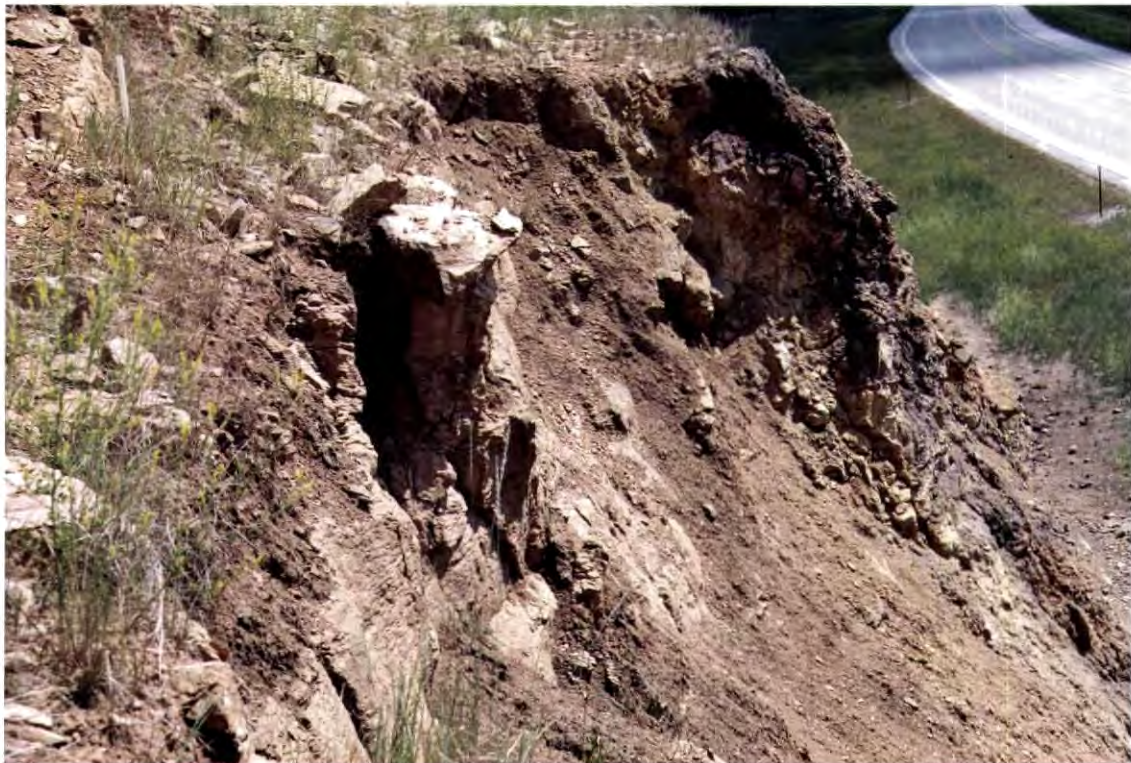
Photo 2: Close-up view of decomposed rock in RUD along the failed bench.

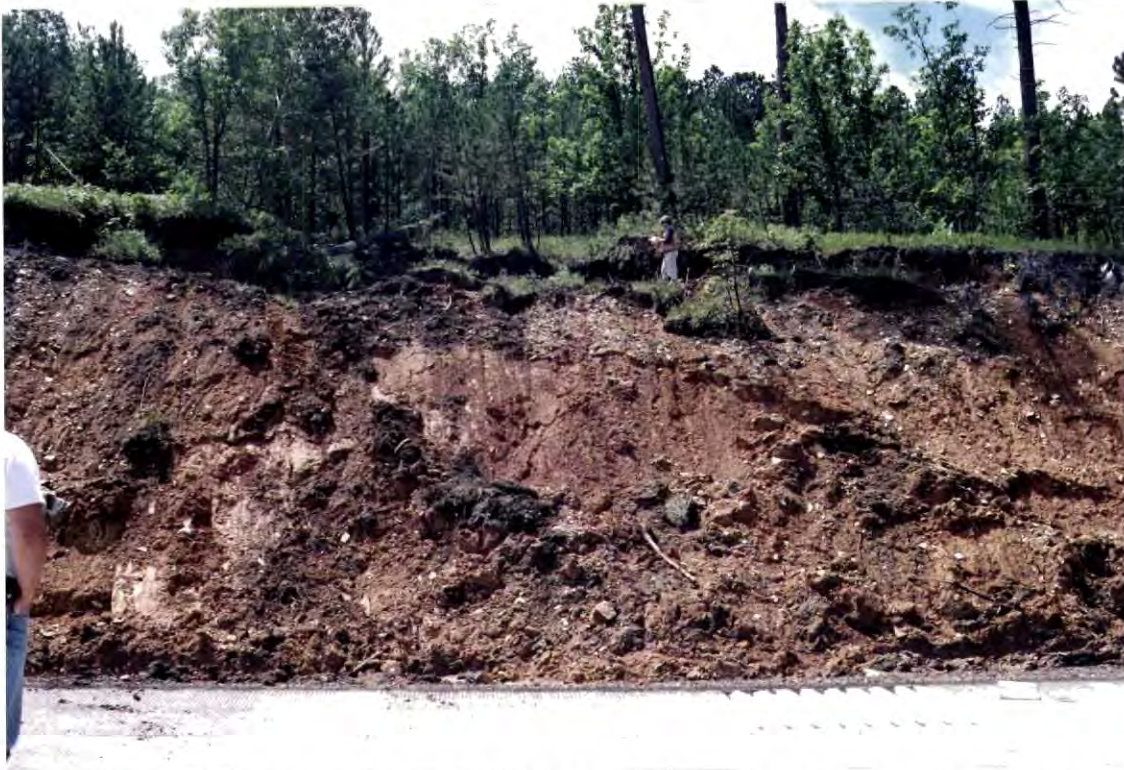
Photo 1: View of failed slope. Note SUS debris (red to brown) and weathered shale (tan) in original cut slope.

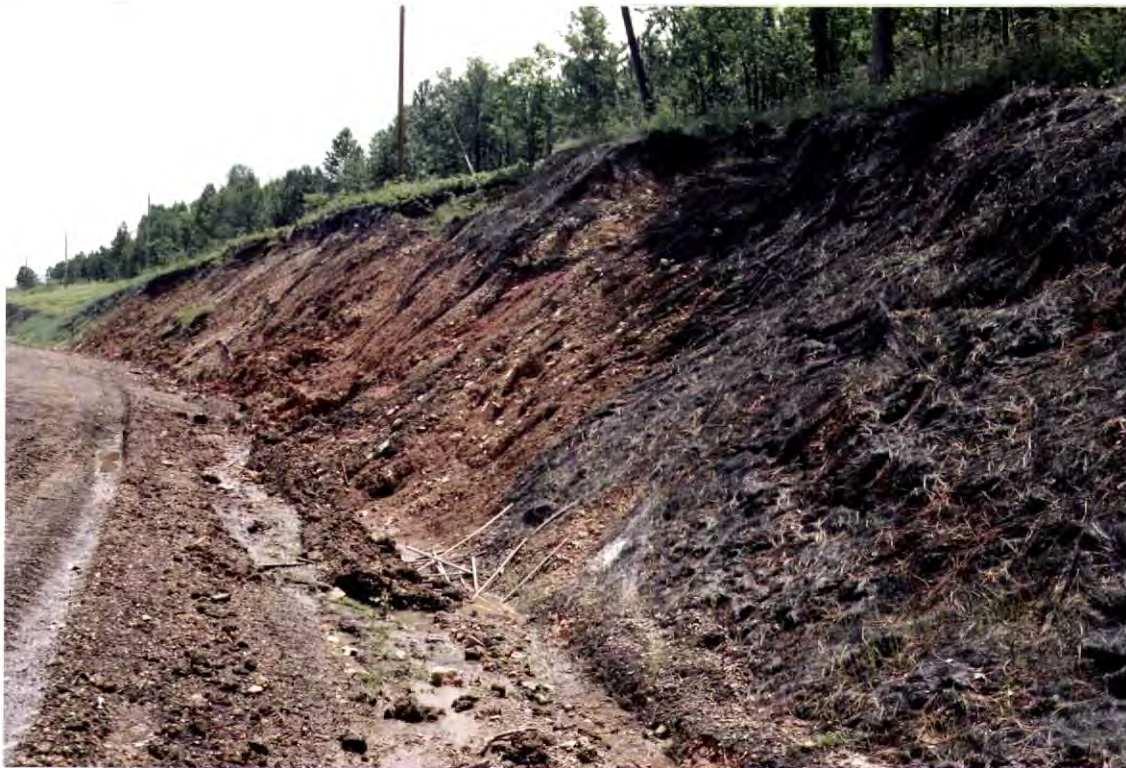
Photo 2: View of the ditch line. Note seepage in ditch and the damaging effects of the failure on roving and revegetation efforts (center and left).
