"MAILBOX BRACKET CRASH TESTS"

INTERIM REPORT

RESEARCH STUDY 7-1945

Hayes E. Ross, Jr., P.E.
Study Supervisor
Texas Transportation Institute

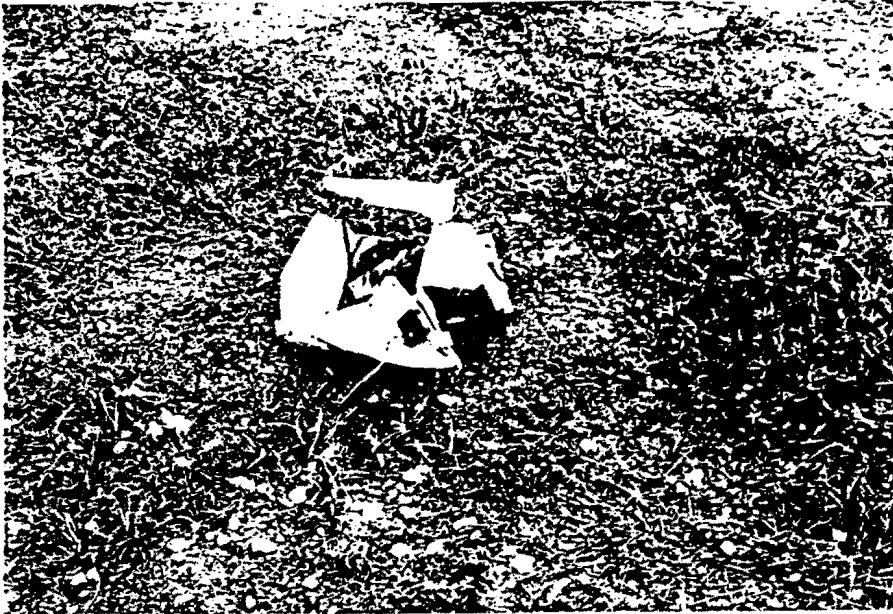
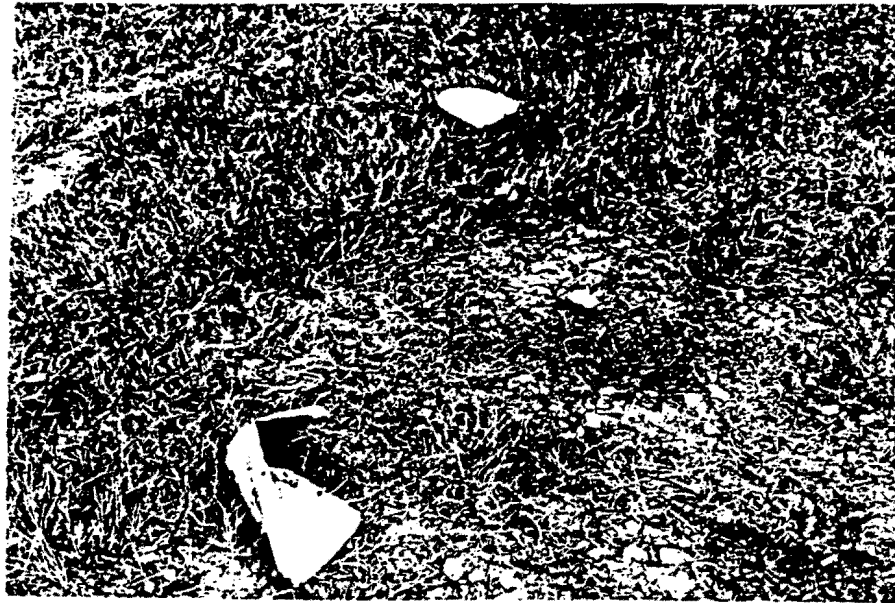
Figure . Damage to mailbox, test 19452-1.

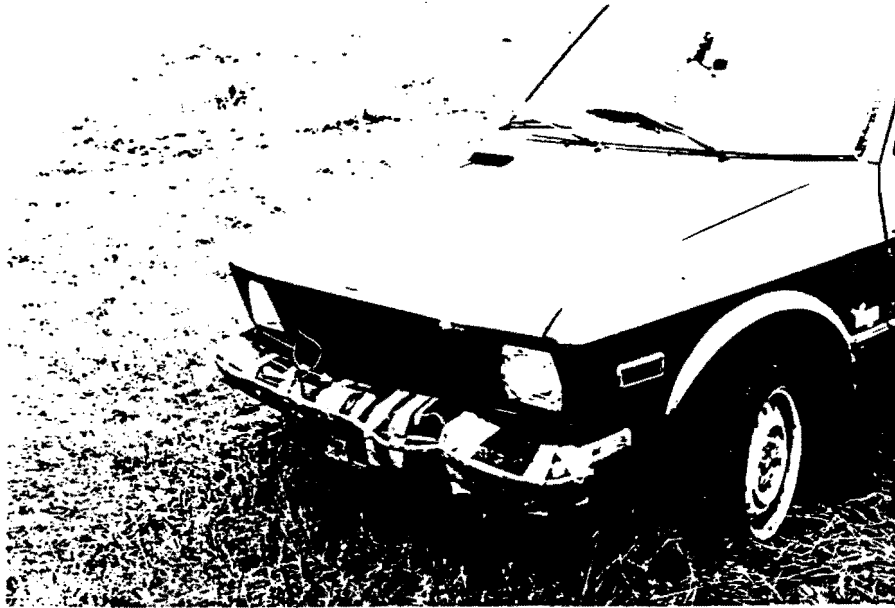
Figure . Vehicle after test 19452-1.

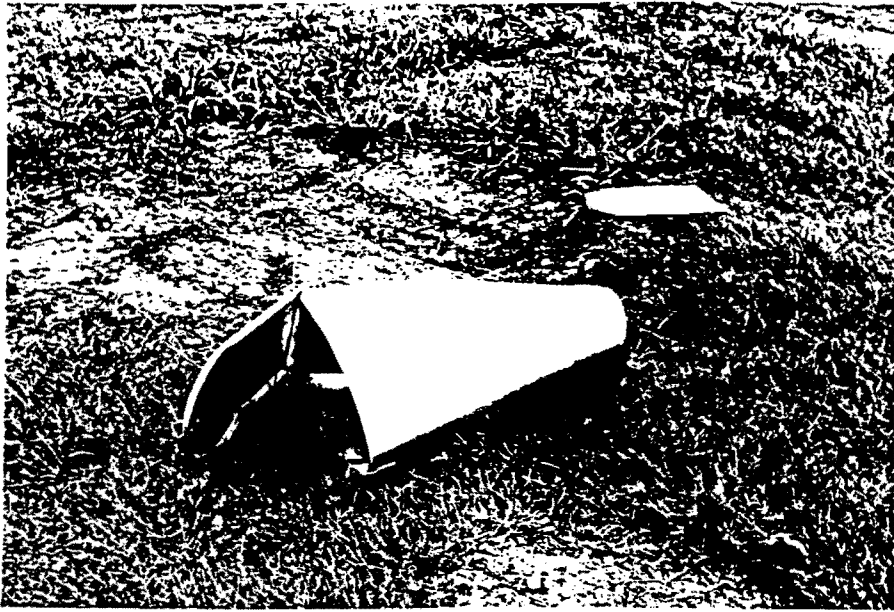
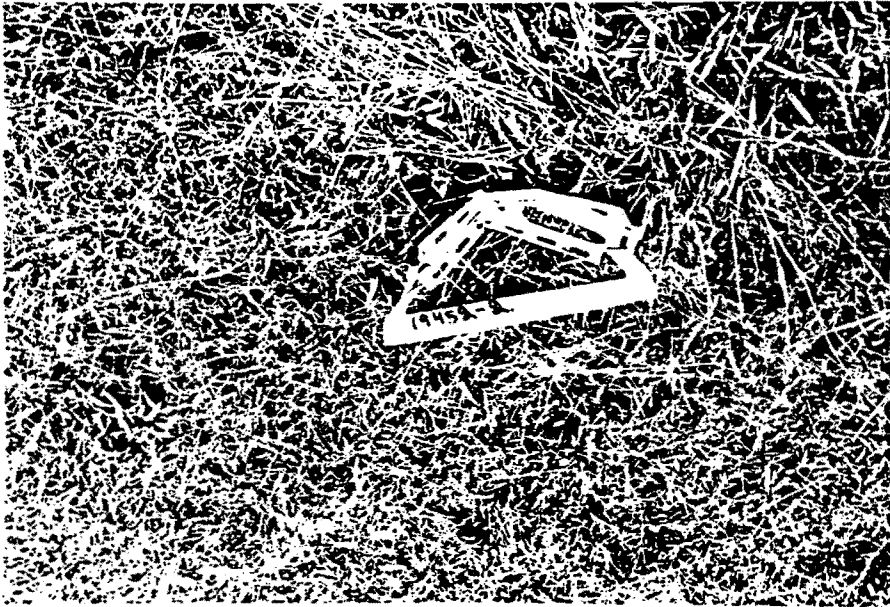
The mailbox separated from the bracket extensions and the bracket separated from the angles upon impact, then struck and dished the windshield, although it did not penetrate the windshield. Examination of the test article showed that separation occurred for two reasons: (1) the bolts connecting the angle to the mailbox bracket pulled out of the slot in the bracket, and (2) the bolts connecting the mailbox to the bracket extensions sheared through the mailbox sheet metal. It was decided that these problems could and should be corrected.

The installation yielded to the vehicle. The support was displaced over at ground level. The mailbox attachment bracket detached from the support and came to rest approximately 153.0 feet (46.6 m) from the point of impact. In addition, the mailbox components came to rest approximately 101.3 feet (30.9 m) from the point of impact. The vehicle sustained only minor damage to the bumper, hood and windshield as shown in Figure ***.

Figure . Damage to mailbox and brackett, test 19452-2.

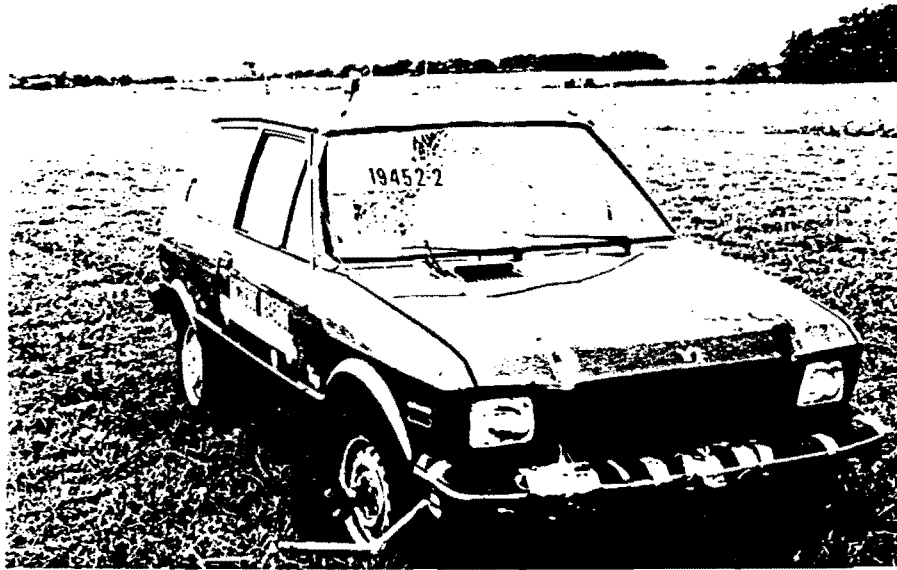
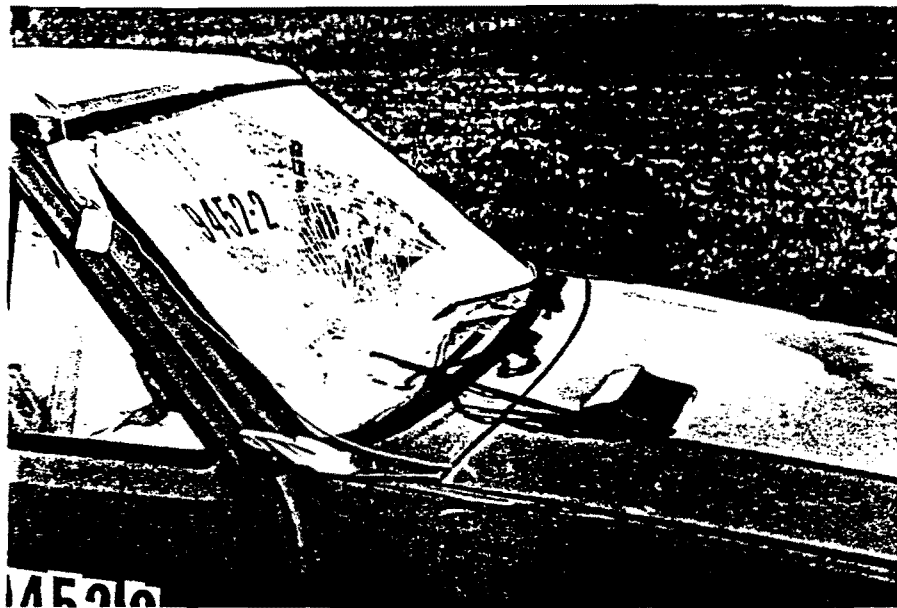
Figure . Vehicle after test 19452-2.

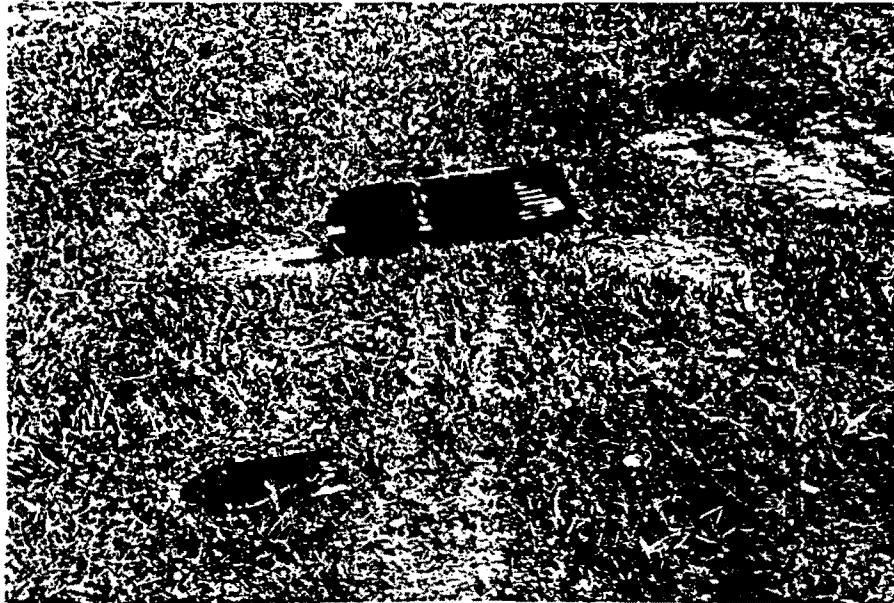
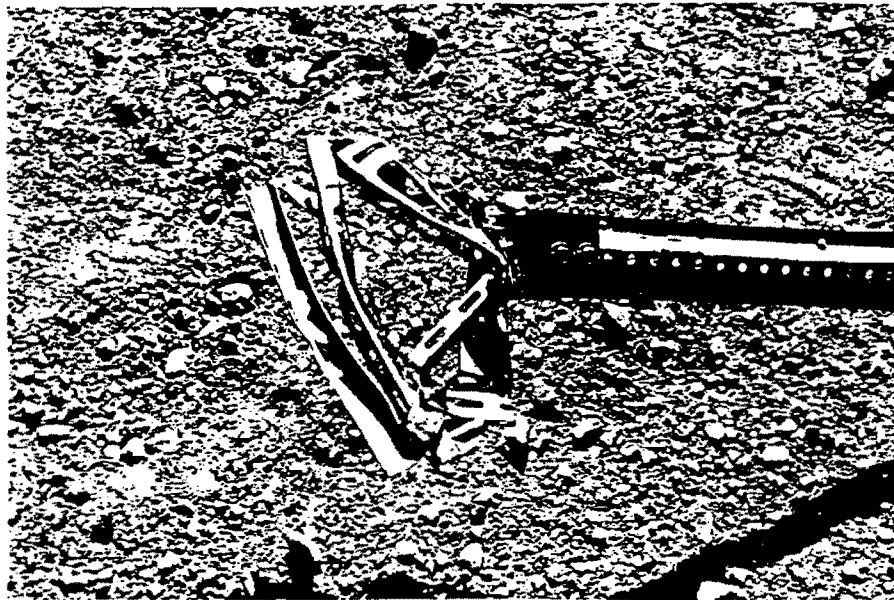
Behavior of the mailbox was similar to that in test 1945-2. However, a partial solution of the problems seen in test 1945-2 was achieved since the bracket and extensions remained with the angles and the support. Separation of the mailbox occurred when the six bolts connecting the box to the extensions sheared through the mailbox sheet metal. As before, it was concluded that this problem could and should be corrected.

Figure . Damage to mailbox and brackett after test 19452-3.

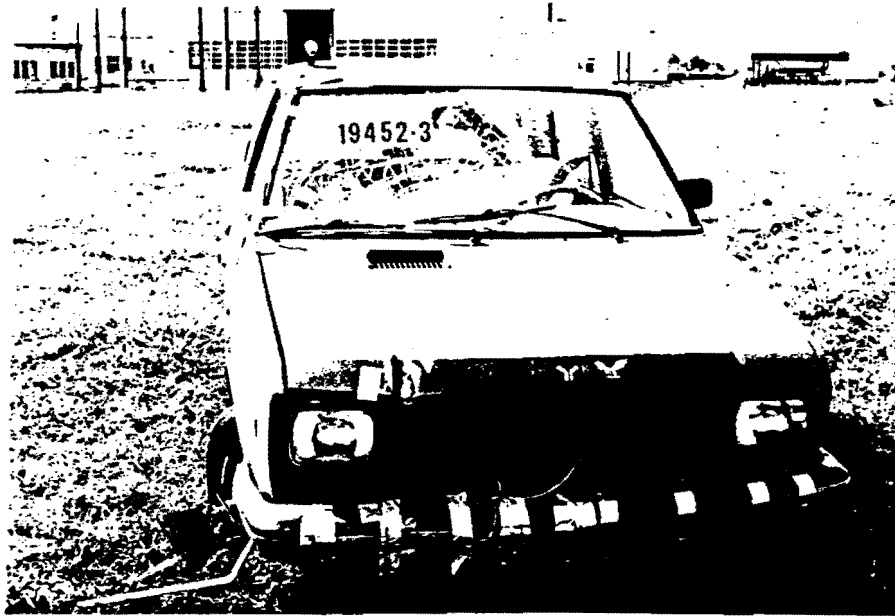
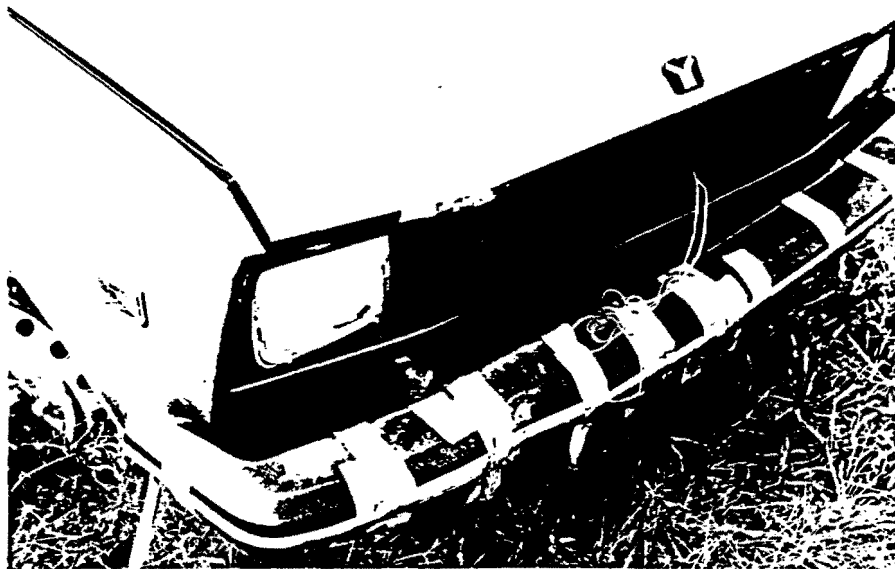
Figure . Vehicle after test 19452-3.

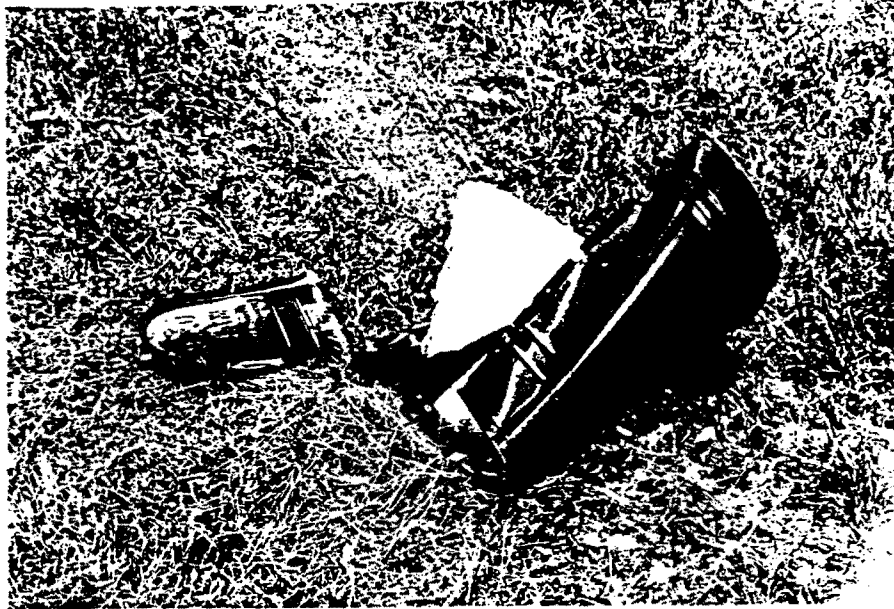
Although the mailbox again separated from the bracket extensions, the larger stove bolts kept the box attached for a sufficient duration of time to allow the box to obtain a velocity approximately equal to that of the vehicle. Consequently, the box did not hit the windshield, and the test met all evaluation criteria.

Figure . Damage to mailbox and brackett after test 19452-4.

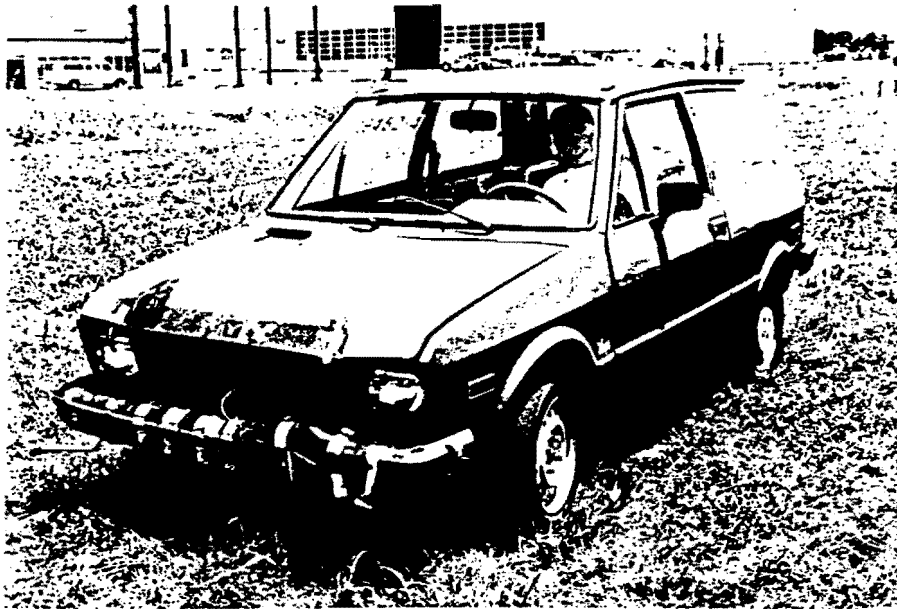
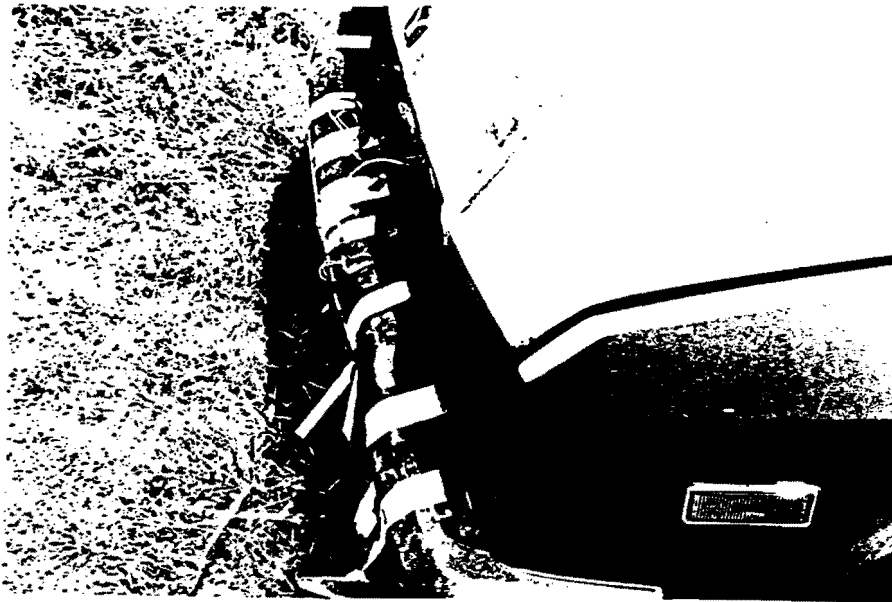
Figure . Vehicle after test 19452-4.

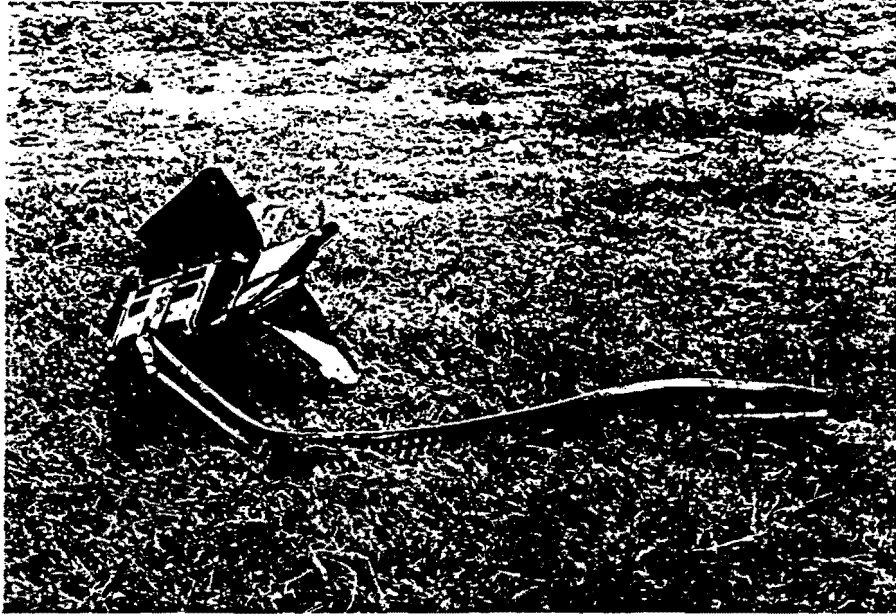
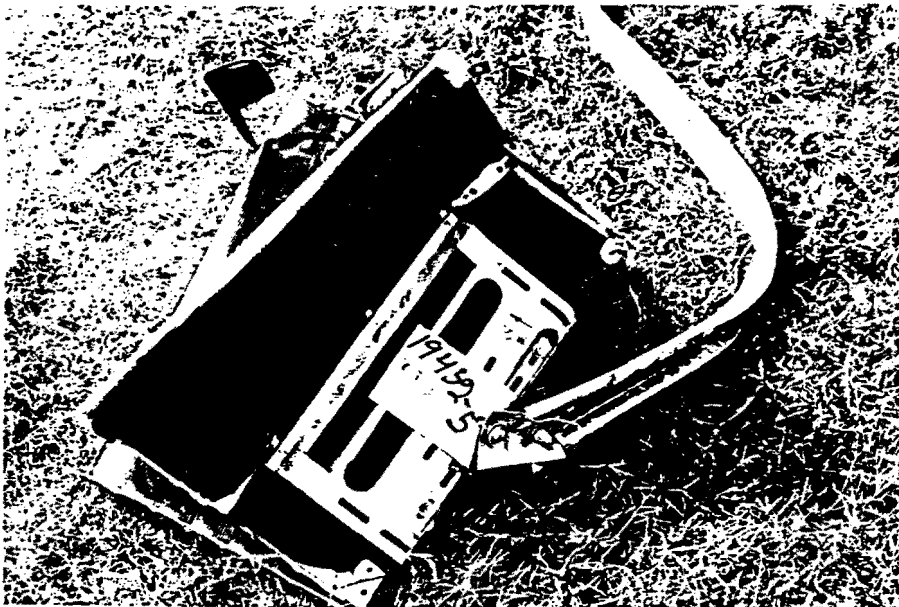
Figure . Damage to installation after test 19452-5.

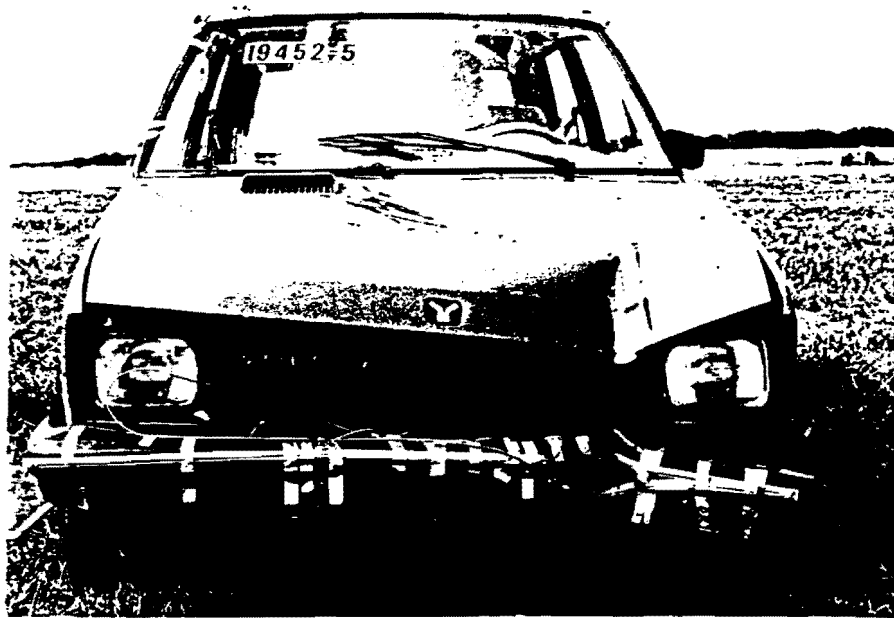
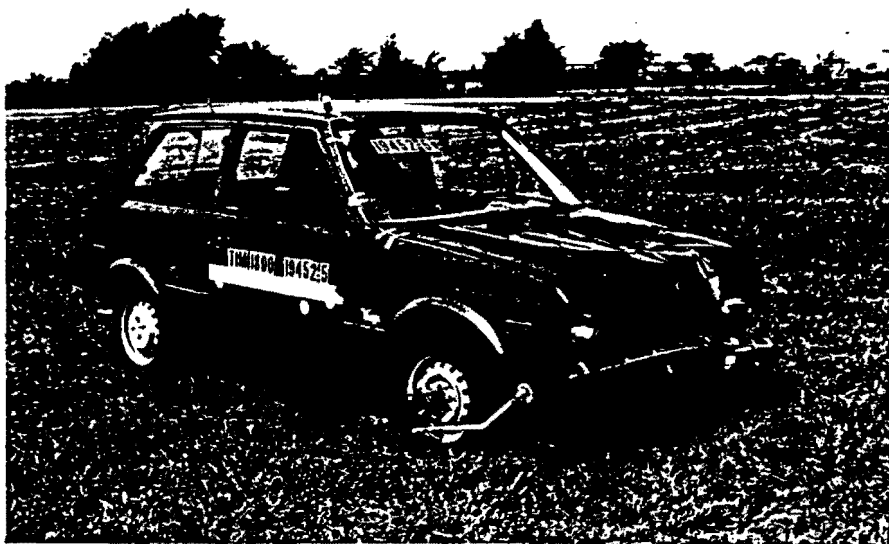
Figure . . . Vehicle after test 19452-5.

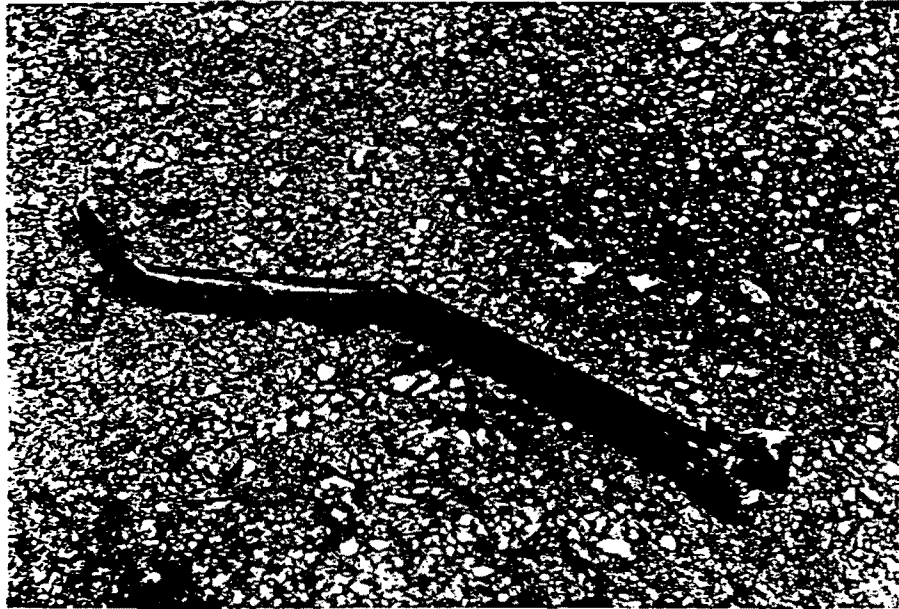
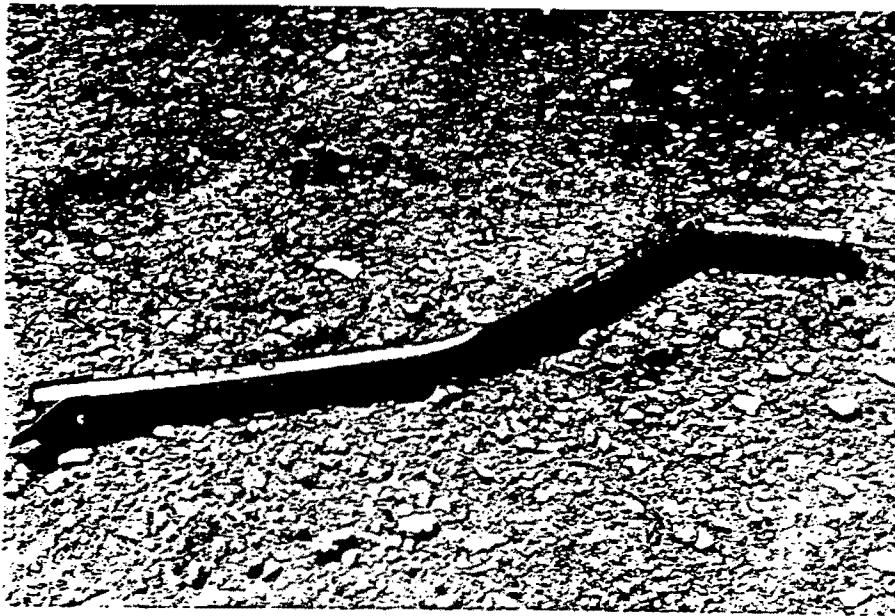
Figure . Damage to support after test 19452-6.

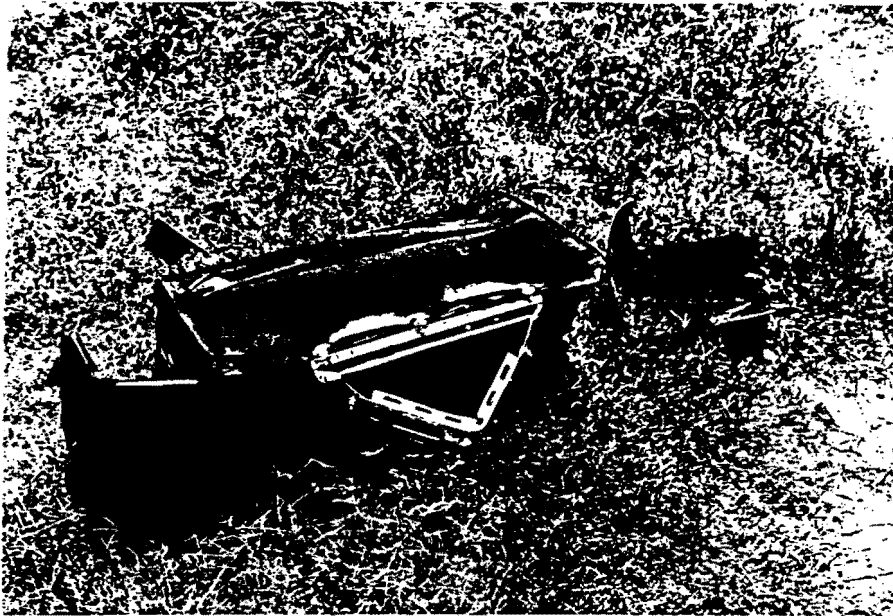
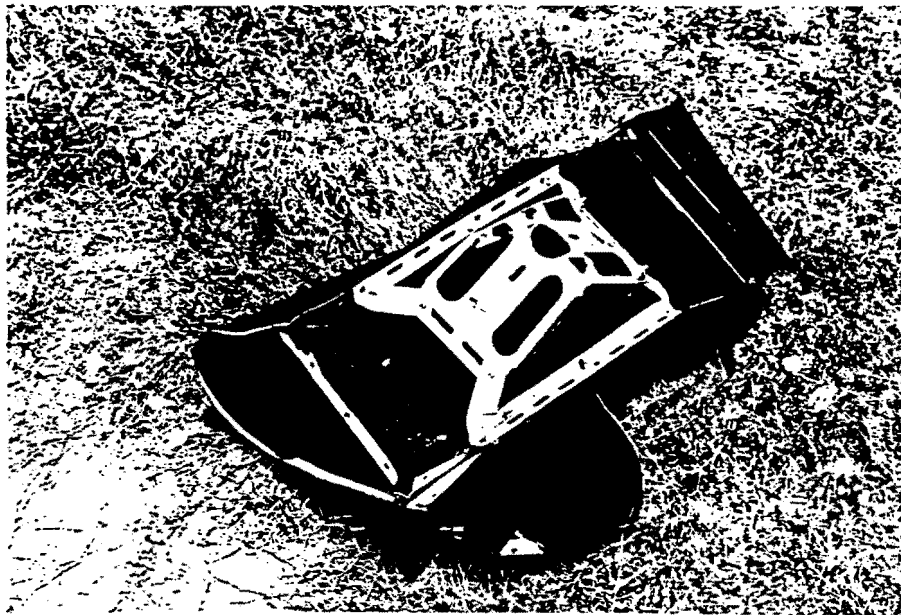
In this test the box and bracket separated from the angles, but only after the vehicle had knocked the installation to the ground and was riding over the installation. The test met all evaluation criteria.

Figure . Damage to mailbox and brackett, test 19452-6.

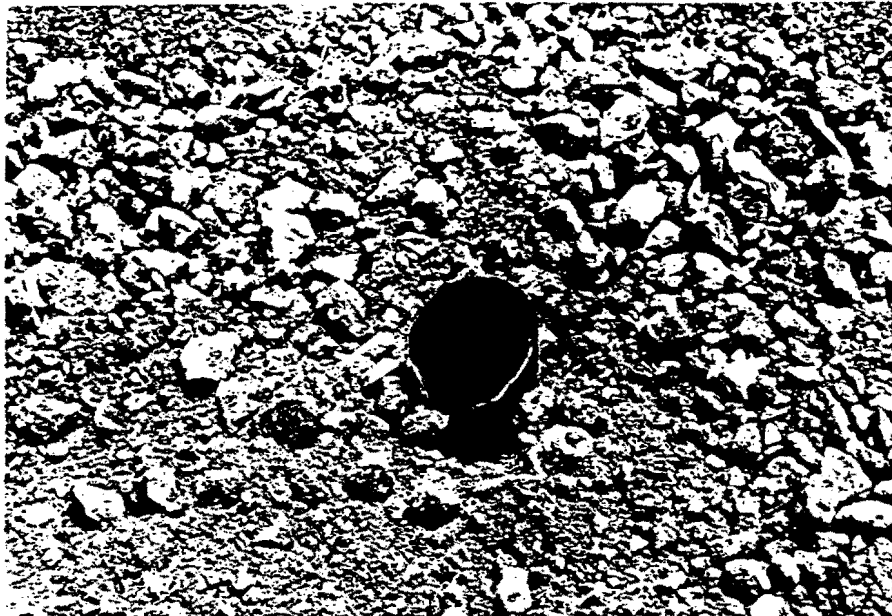
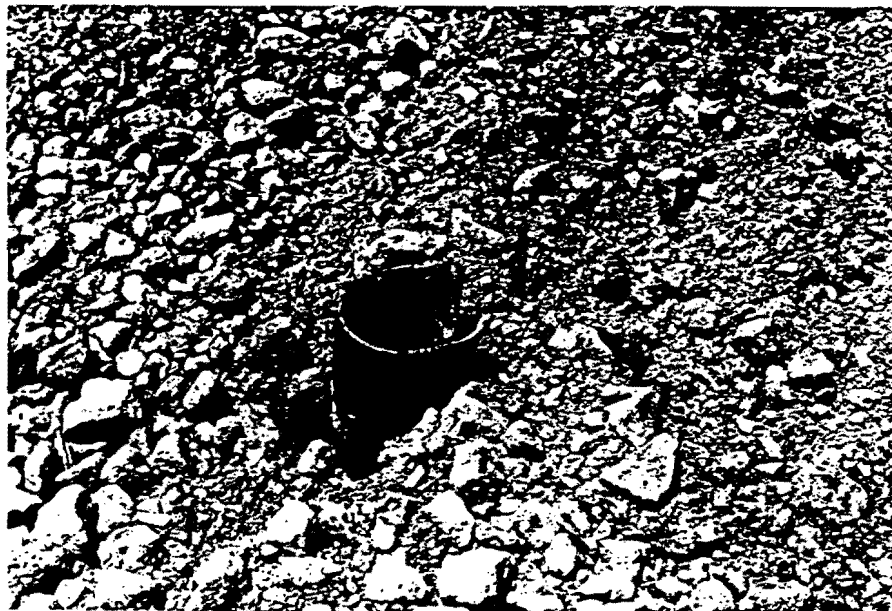
Figure . Damage to base after test 19452-6.

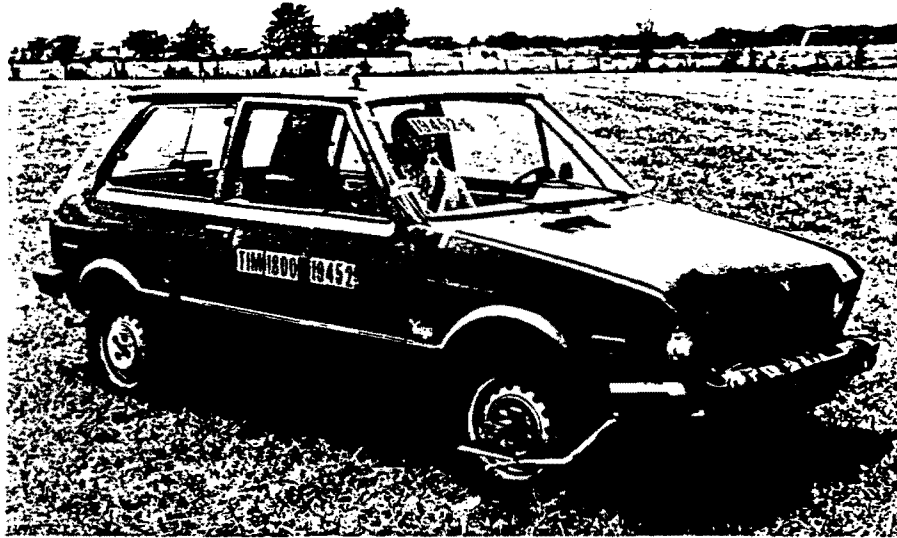
Figure . Vehicle after test 19452-6.
