# Field Evaluation of Reinforced Concrete Repairs Using Hydrodemolition, Galvanic Cathodic Protection, or Impressed Current Cathodic Protection

**Final Report VTRC 25-R22**

Virginia Transportation Research Council  
(A partnership of the Virginia Department of Transportation  
and the University of Virginia since 1948)

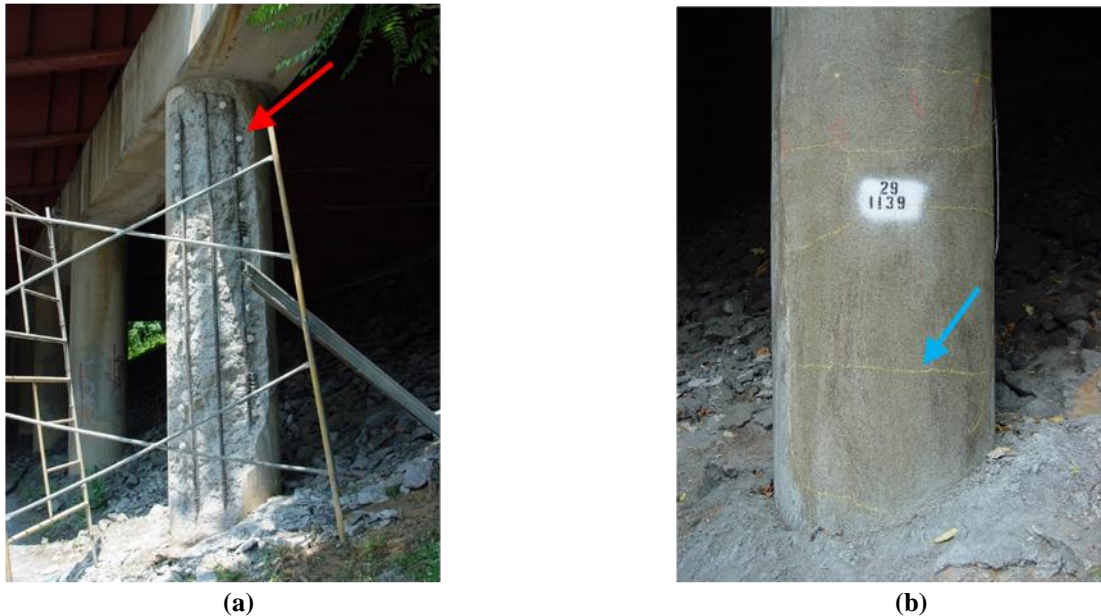
**Figure 1. Placement of Anodes in Shotcrete Repair Area: (a) Column with DPG anodes (red arrow) tied to steel prior to shotcrete repair and (b) after shotcrete hardens and exhibits shrinkage cracks (blue arrow) that were emphasized on the column using yellow crayon. The cracks widths marked in yellow are less than 0.01 inch (Brown and Sharp, 2005).**

proper placement, which makes it a specialized and costly repair system. Moreover, field experience of shotcrete repairs indicates variable performance for this type of repair, such as the cracks in the finished repair product (Figure 1b). Finally, in both VDOT A3 concrete and shotcrete repair systems, bonding of the repair material to the existing concrete is another concern and requires proper surface preparation of the existing concrete through removal of deteriorated concrete—a roughened surface that is saturated surface dry during the placement.

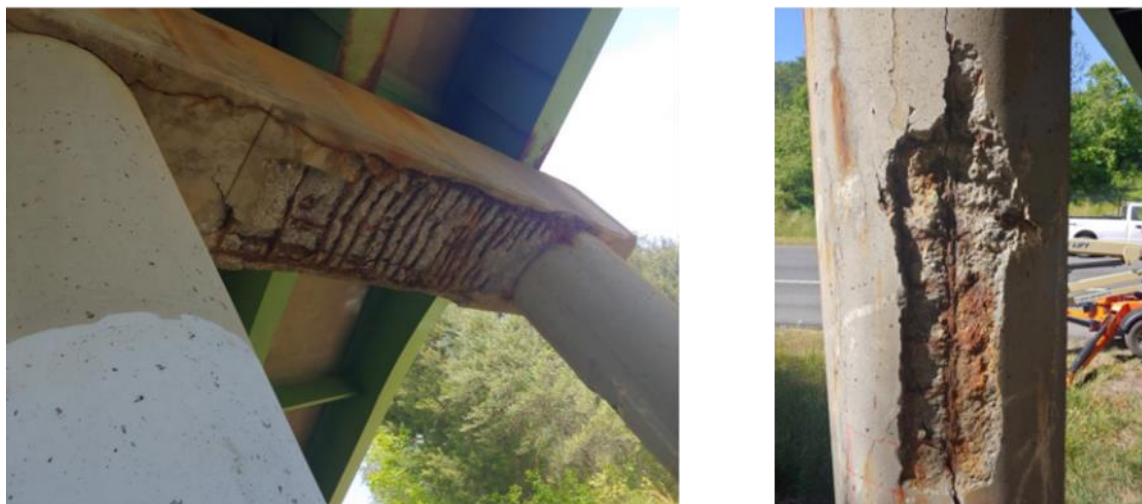
The visual survey of the Route 605 Bridge was conducted on Piers 1 and 3 prior to demolition and remediation work. Corrosion of the reinforcing steel was present in the caps and columns on Piers 1 and 3. Corrosion of the reinforcement resulted in staining, concrete spalling, and steel section loss, with typical examples shown in Figures 3 and 4.

**Figure 3. Corrosion on Pier 1 of the Route 605 Bridge**

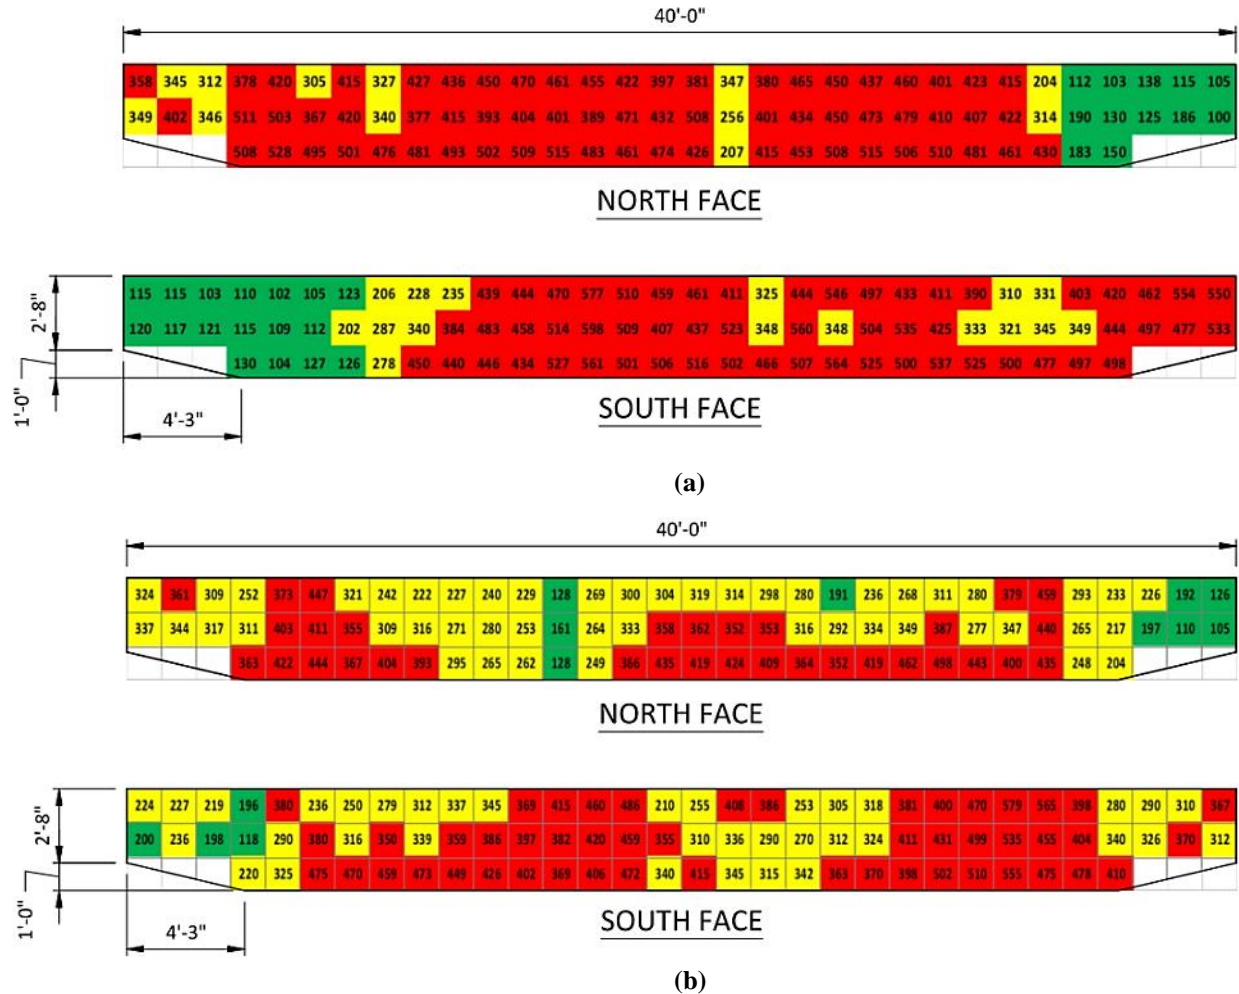
Half-cell potential testing was performed on caps and columns of Piers 1 and 3 (Figures 5 and 6). The half-cell measurements indicated that corrosion is occurring in a sizable portion of the structure as shown in Table 6 and observed in Figures 5 and 6. A half-cell range more positive than -0.20 V versus the copper sulfate electrode (CSE) indicates a low probability of corrosion activity and is shown in green; between -0.20 to -0.35 V versus CSE indicates that corrosion activity is uncertain and is shown in yellow; more negative than -0.35 V versus CSE indicates a high probability of corrosion activity occurring and is shown in red. The chloride and half-cell measurements also indicate that little exterior concrete is worth saving based on the measurements made because a high percentage of the half-cell measurements indicate a high probability of corrosion.

**Figure 5. Half-Cell Measurements Using a 16-x-16-Inch Grid Pattern Show a High Probability of Corrosion on the (a) Pier 1 and (b) Pier 3 Caps of the Route 605 Bridge. Numbers in each square are the magnitude of the half-cell measurement but are reported as positive values instead of the measured negative value (VDOT Contracted I-64 Bridge Substructure Studies Project, Route 605, 2021).**

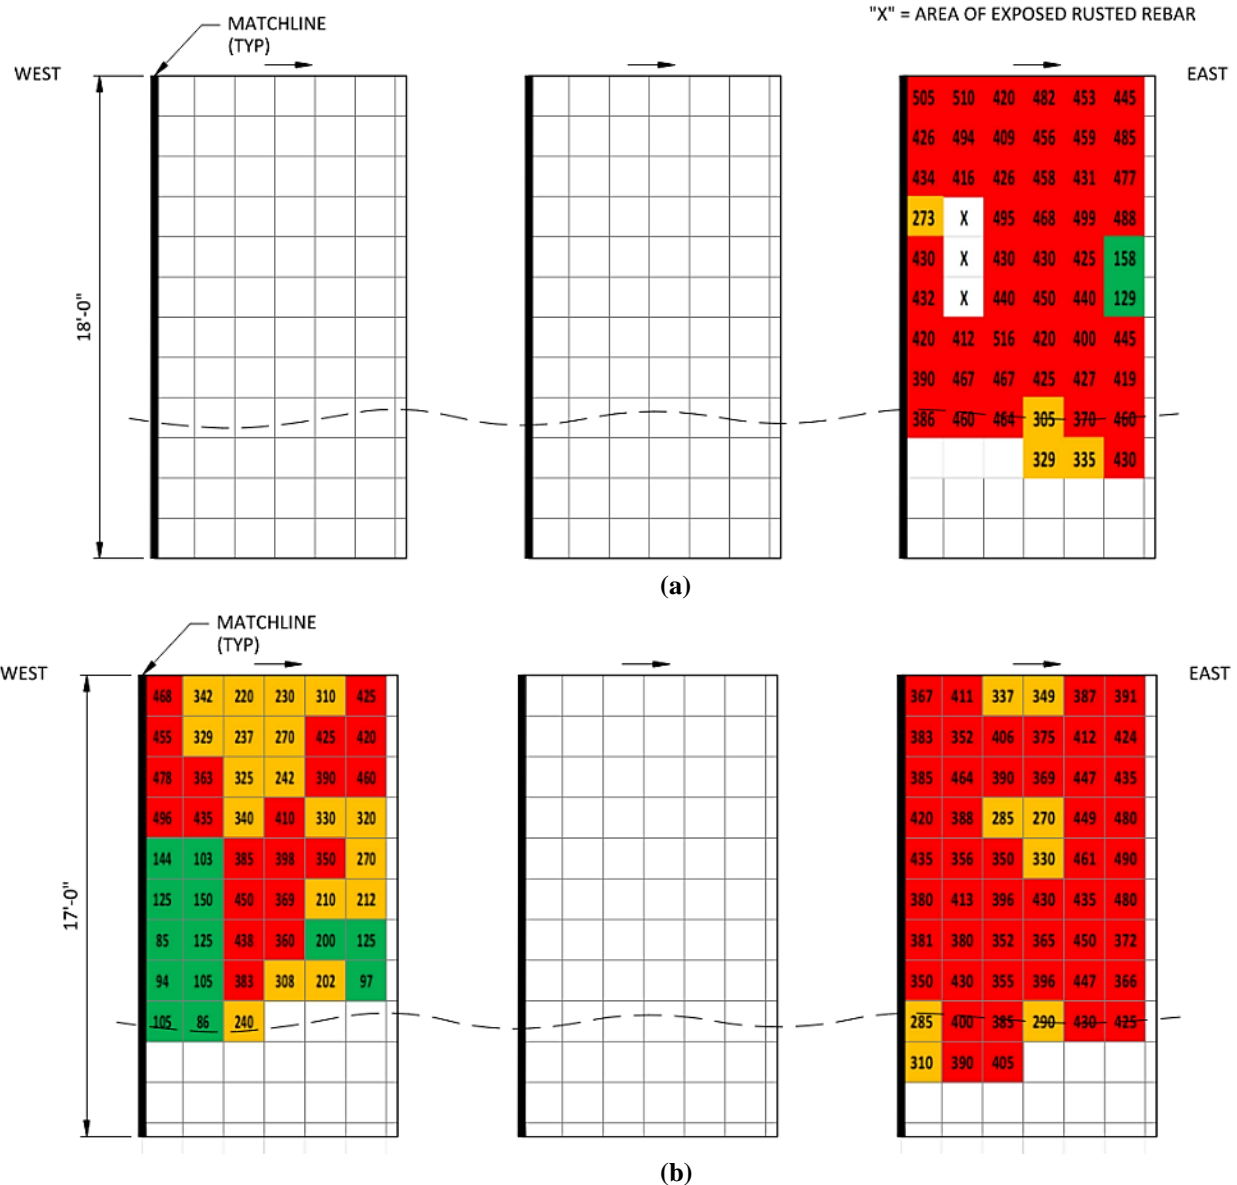
**Figure 6. Half-Cell Measurements Using a 16-x-16-Inch Grid Pattern Show a High Probability of Corrosion on the (a) Pier 1 and (b) Pier 3 Columns of the Route 605 Bridge. Numbers in each square are the magnitude of the half-cell measurement but are reported as positive values instead of the measured negative value. Dashed line indicates approximate ground-level location (VDOT Contracted I-64 Bridge Substructure Studies Project, Route 605, 2021).**

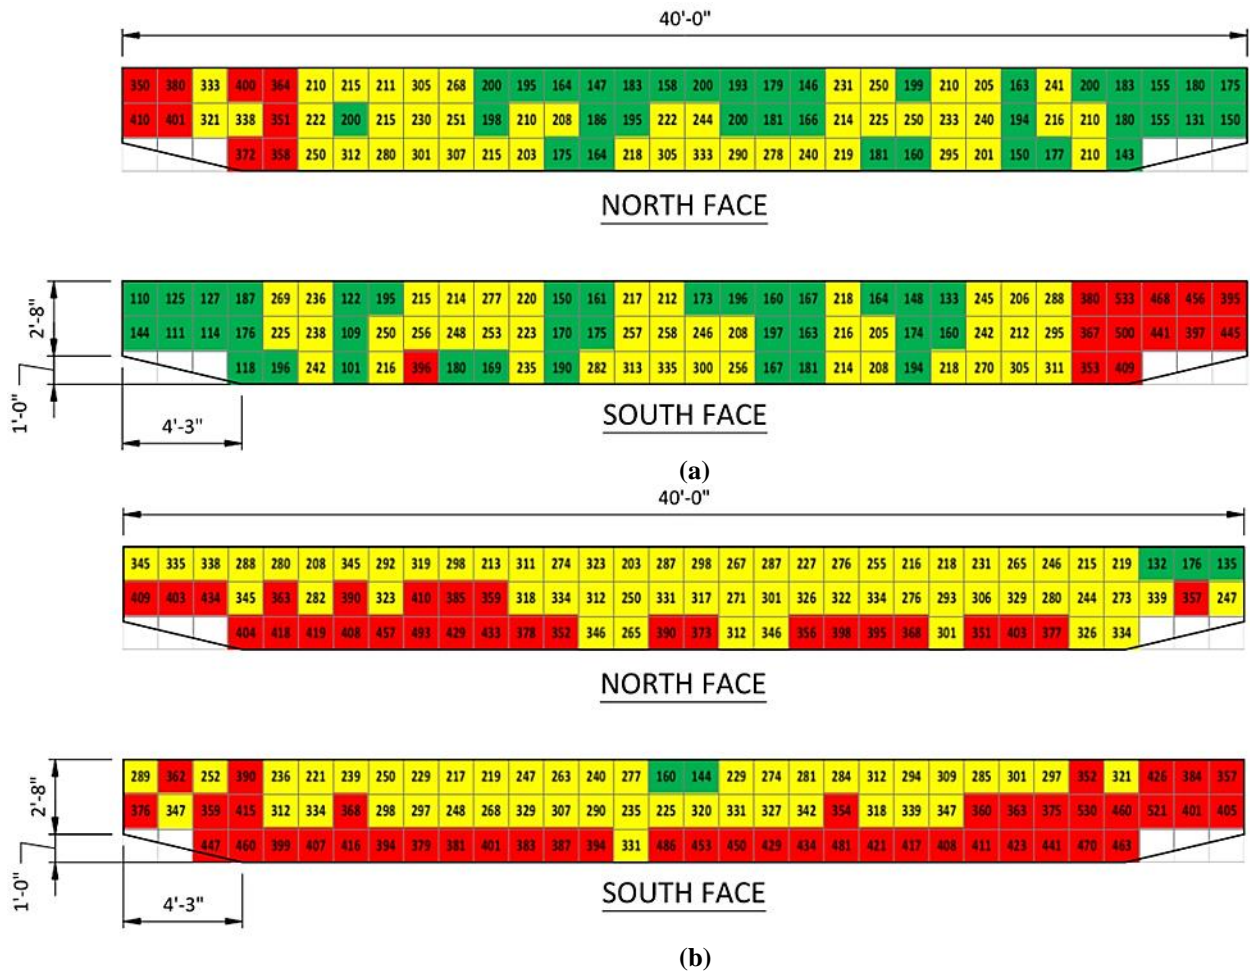
Figure 9. Half-Cell Measurements Using a 16-x-16-Inch Grid Pattern Show the Probability of Corrosion on the (a) Pier 1 and (b) Pier 3 Caps of the Route 629 Bridge. Numbers in each square are the magnitude of the half-cell measurement but are reported as positive values instead of the measured negative value (VDOT Contracted I-64 Bridge Substructure Studies Project, Route 629, 2021).

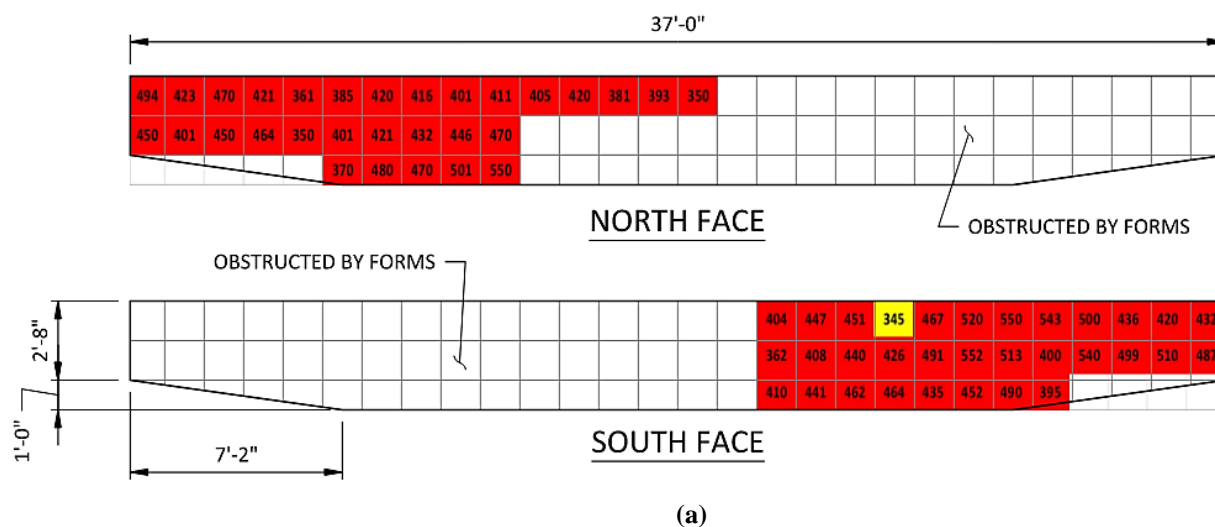
**Figure 13. Half-Cell Measurements Using a 16-x-16-Inch Grid Pattern Show a Probability of Corrosion on the (a) Pier 1 and (b) Pier 4 Caps of the Route 522 Bridge. Numbers in each square are the magnitude of the half-cell measurement but are reported as positive values instead of the measured negative value (VDOT Contracted I-64 Bridge Substructure Studies Project, Route 522, 2021).**

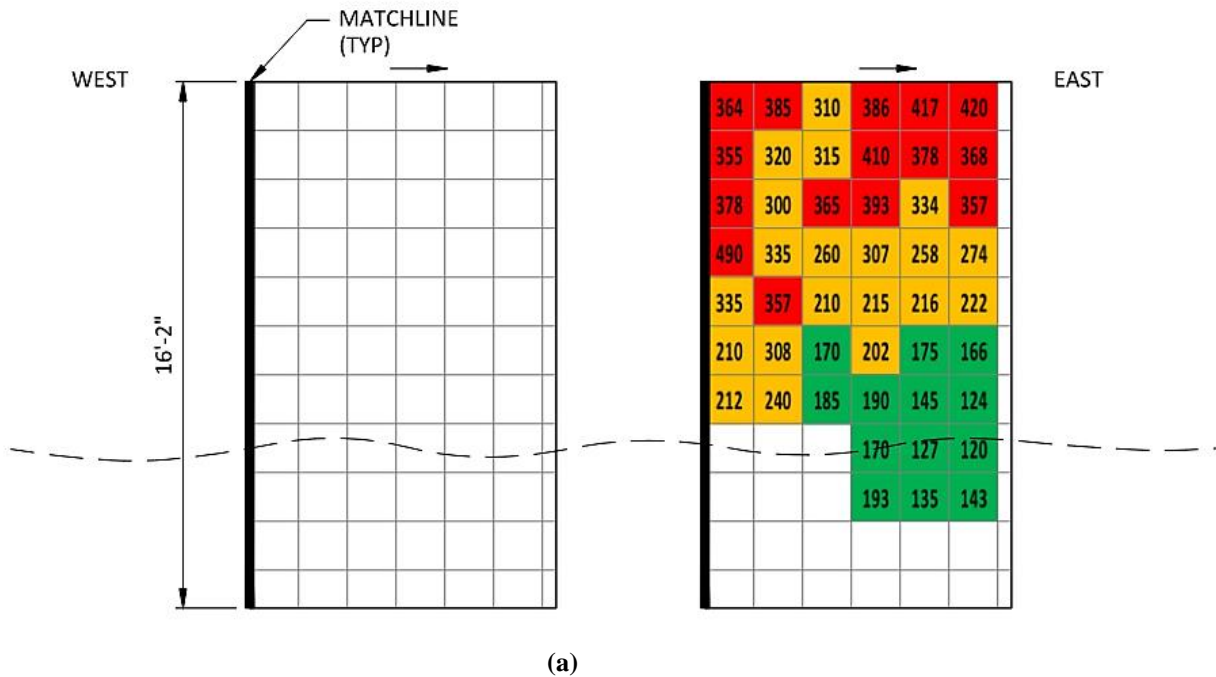
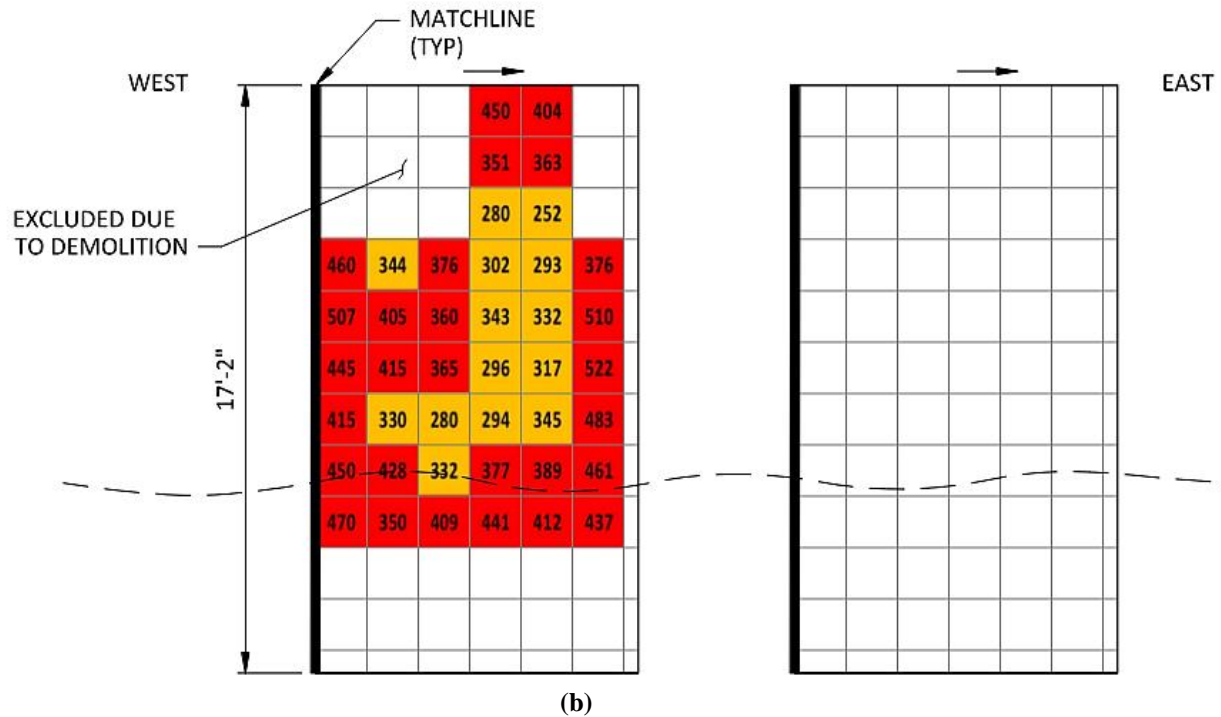
Figure 14. Half-Cell Measurements Using a 16-x-16-Inch Grid Pattern Show a Probability of Corrosion on the (a) Pier 1 and (b) Pier 4 Columns of the Route 522 Bridge. Numbers in each square are the magnitude of the half-cell measurement but are reported as positive values instead of the measured negative value. The dashed line indicates approximate ground level location (VDOT Contracted I-64 Bridge Substructure Studies Project, Route 522, 2021).

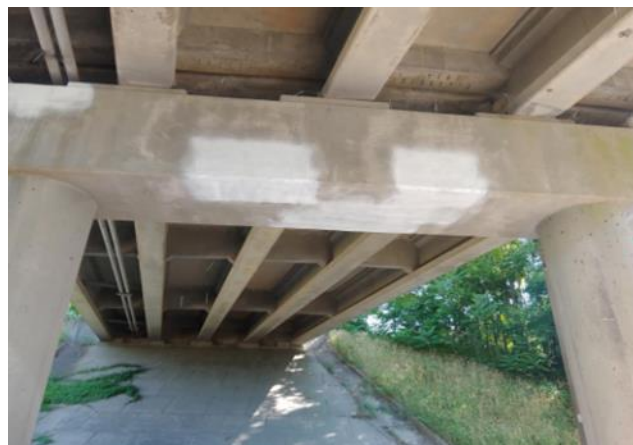
Figure 15. Condition after Remediation of Pier 1 of the Route 621 Bridge before Applying Epoxy Coating

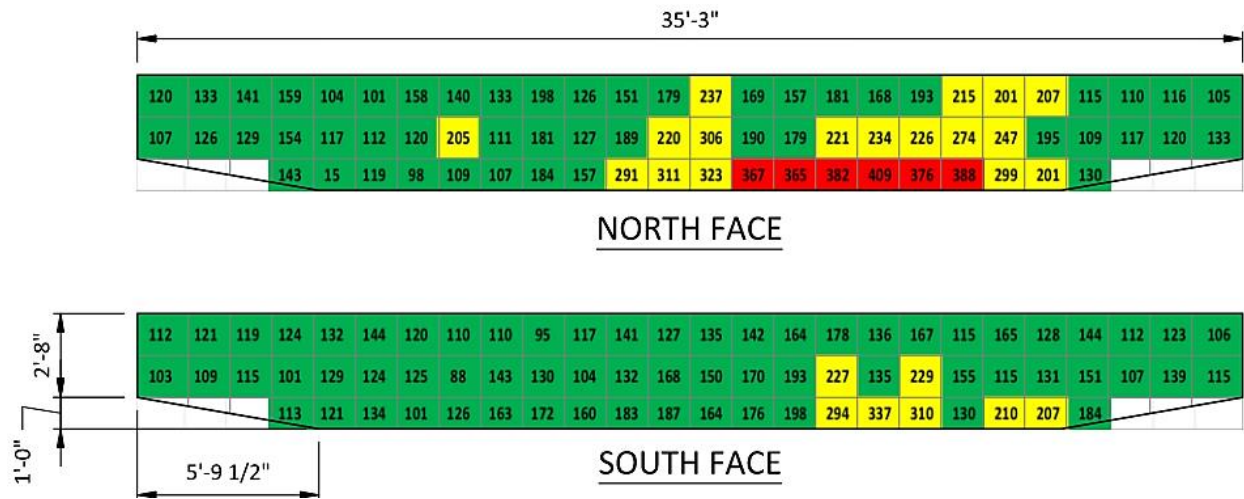
Figure 17. Half-Cell Measurements Using a 16-x-16-Inch Grid Pattern Show a Probability of Corrosion on the (a) Pier 1 and (b) Pier 4 Caps of the Route 621 Bridge. Numbers in each square are the magnitude of the half-cell measurement but are reported as positive values instead of the measured negative value (VDOT Contracted I-64 Bridge Substructure Studies Project, Route 621, 2021).

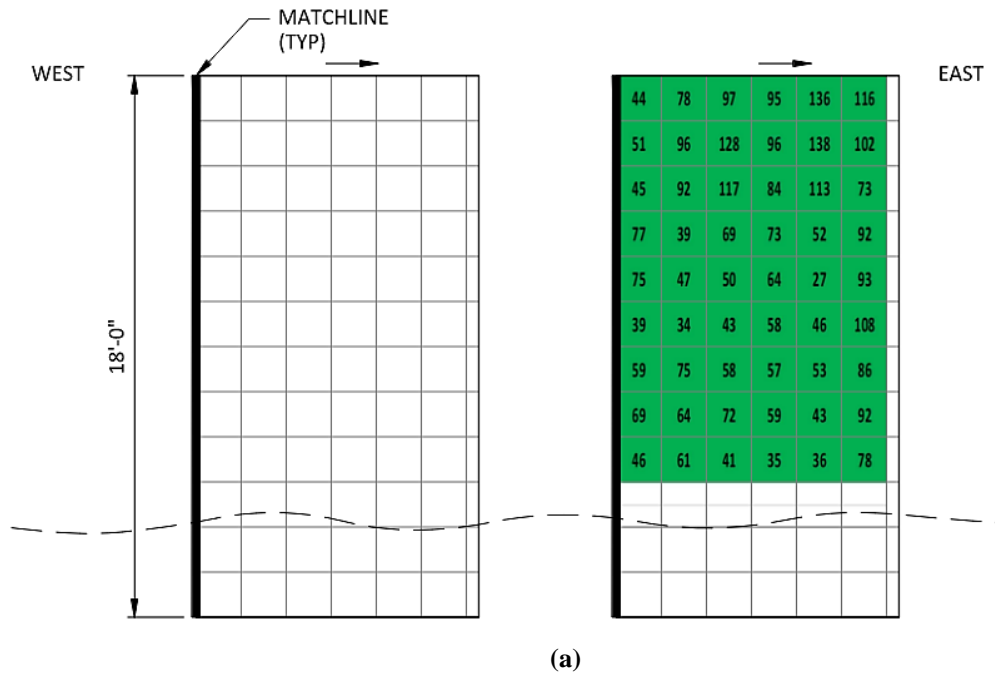
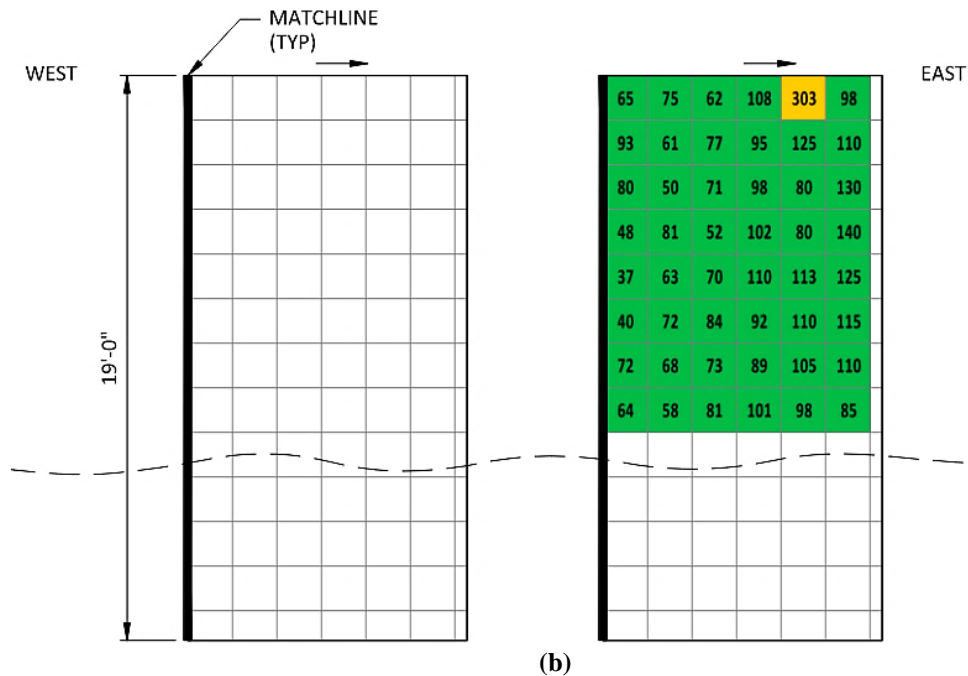
**Figure 18. Half-Cell Measurements Using a 16-x-16-Inch Grid Pattern Show a Probability of Corrosion on the (a) Pier 1 and (b) Pier 4 Columns of the Route 621 Bridge. Numbers in each square are the magnitude of the half-cell measurement but are reported as positive values instead of the measured negative value. The dashed line indicates approximate ground level location (VDOT Contracted I-64 Bridge Substructure Studies Project, Route 621, 2021).**

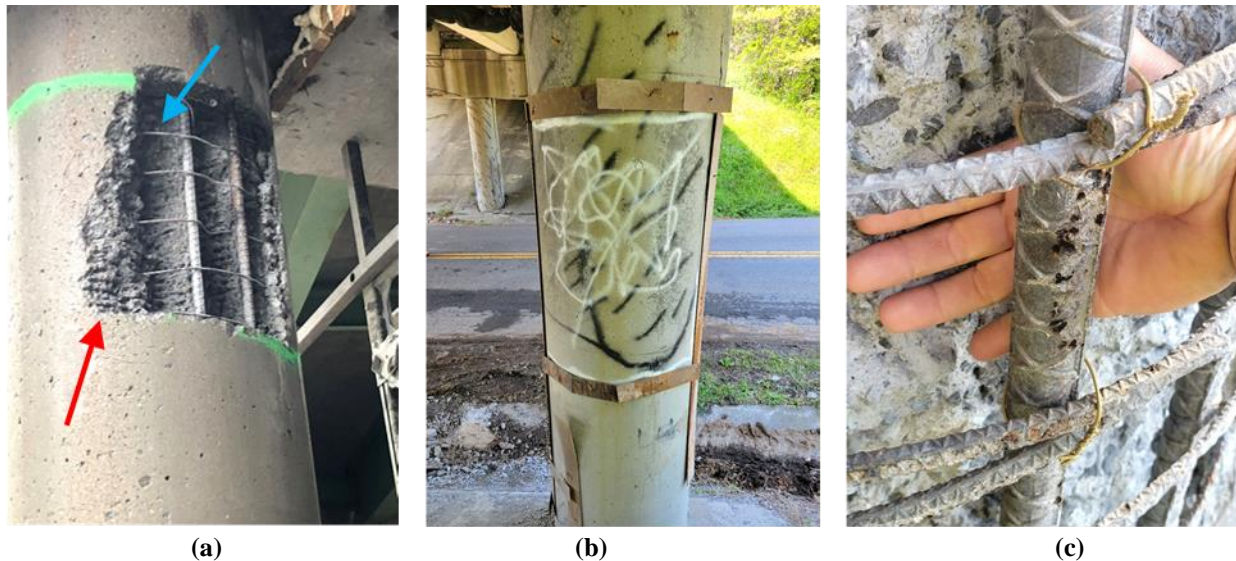
It was also difficult to get a smooth vertical cut at the edges of the Route 605 Bridge over I-64 (column along westbound lane shown in Figure 23). The water jet of the hydrodemolition unit provided direct water pressure, which left concrete behind the reinforcement and required manual removal. The high water pressure and the heterogeneous nature of concrete did prevented a sharp edge, leaving feather edges instead. The edge was saw cut about 3/4-inch to eliminate feather edging. The concrete along the perimeter was removed with hammers after the saw cut. In subsequent projects, improvements to vertical edge were achieved by placing straps around the perimeter (Figure 23). It is also possible that with new equipment and the lance, the operator can have smooth vertical faces to avoid feather edging without the straps. After completing hydrodemolition, the area must be pressure washed to remove the remaining cement slurry (Figure 24).

**Figure 23. Comparison of the I-64 Hydrodemolition and a Later Repair.** Photo (a) shows how equipment used on I-64 project did not provide a sharp edge (red arrow), and it was not able to remove concrete behind the reinforcing steel (blue arrow). More recent repair work in the Salem District (b) used straps along edges of the patch to help define a clean edge, and (c) the use of a lance allows for removal of concrete from behind the reinforcement because the lance can be tilted.

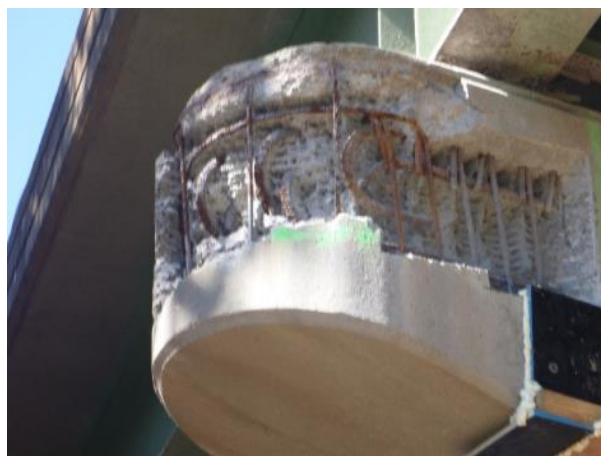
**Figure 24. Rout 605 Bridge over I-64 (Pier Cap along Eastbound Lane).** Concrete removed from the end of a pier cap using hydrodemolition. The area must be pressure washed to remove the cement slurry left after hydrodemolition.

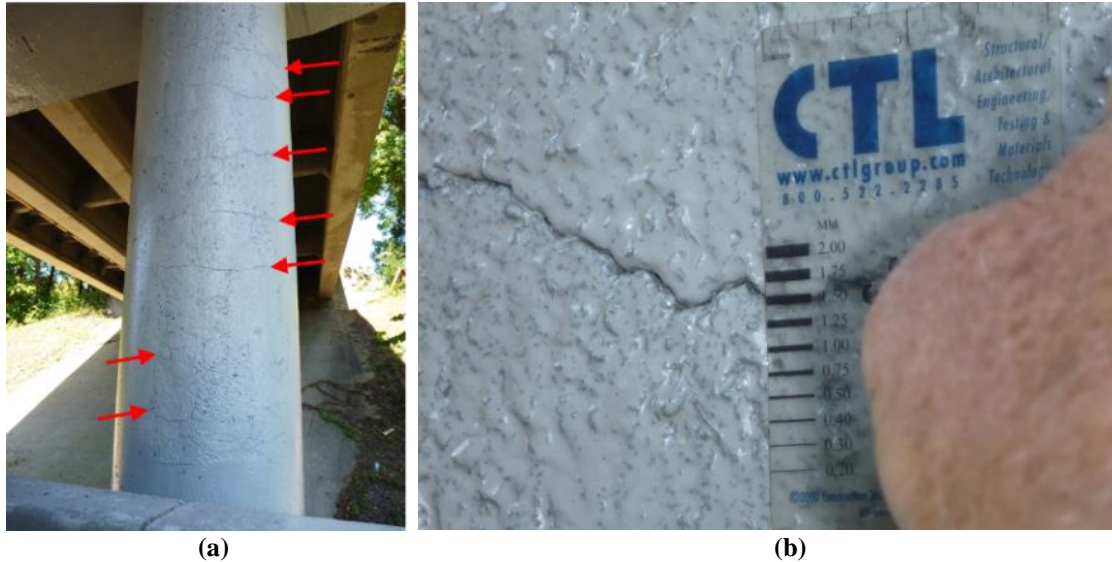
The first control bridge, Route 621 over I-64, was repaired using dry process shotcrete (Figure 30). An epoxy coating was applied to the repaired columns and pier caps for protection from the environment and elements. The column surface is rough, and it exhibits cracks which were 1 to 2 mm wide and are highlighted with red arrows. Separation along the edges of the repair area indicated excessive shrinkage. In the areas receiving shotcrete, a prepackaged material was used.

**Figure 30. Route 621 Bridge over I-64 (Column along Eastbound Lane). The red arrows (a) indicate cracks in the repair and (b) shows a closeup of a crack being measured.**

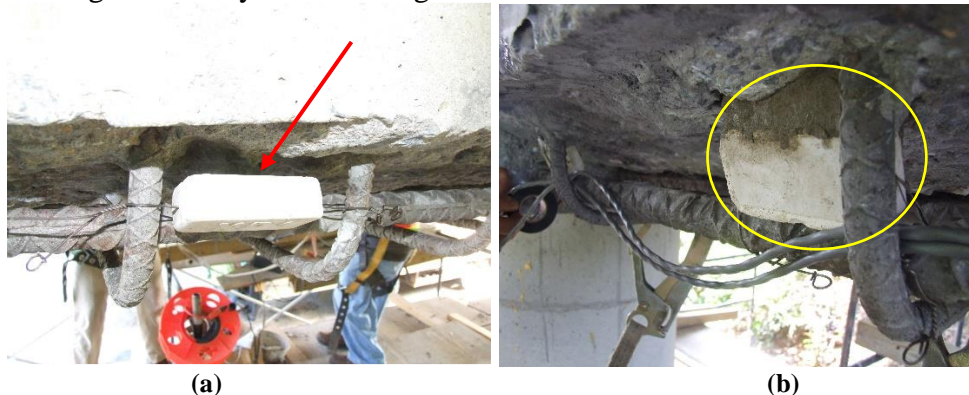
**Figure 32. (a) Anode Installed along the Perimeter of the Repair without Embedment Mortar between the Original Concrete and Anode as Indicated by the Arrow; (b) Anode Installed with Embedment Mortar (top of yellow circle) to Enhance Current Flow to the Original Concrete**
