Rail Passenger Equipment Accidents and the Evaluation of Crashworthiness Strategies

David C. Tyrell
Volpe National Transportation Systems Center
U.S. Department of Transportation

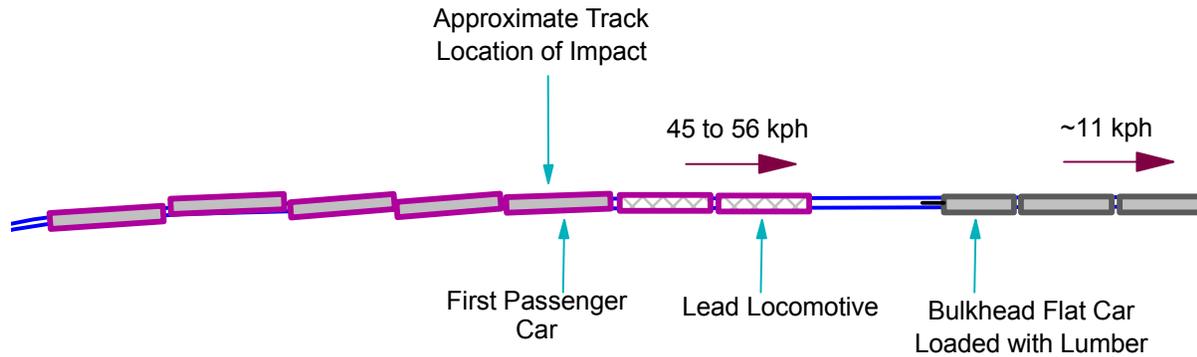
Figure 5 shows a post-accident schematic. The passenger train was made up of two General Motors/Electro-Motive Division F-40ph locomotives, a coach/dinette car, and four coach cars. Both locomotives were equipped with transit-style ribs on the anti-climber on the short-hood end. The freight train was made up of 88 loaded cars, four empty cars, and two locomotives. The trailing cars of the freight train were bulkhead flatcars carrying lumber. The last car of the freight train – the impacted car – was carrying a full load of framing lumber. This car was equipped with a hydraulic draft-cushioning device. At least two more cars of this type and load were ahead of the last car.

There was very little structural damage to the passenger cars. There was some damage to the flexible bellows between the cars closer to the lead end of the train, associated with the sawtooth lateral buckling of the first four passenger cars. There was also some scarring of the sides of the couplers and their lateral bump stops, also associated with the sawtooth buckling

of the cars. The freight cars remained in-line, and the track under them did not buckle. The hydraulic cushioning devices may have helped to prevent the cars from laterally buckling, as well as the longer shanks of the freight couplers (compared with passenger couplers) and the greater weight of the freight cars.

Figure 5. Post-collision schematic drawing, rear-end collision of a freight train by an inter-city passenger train, Syracuse, New York.

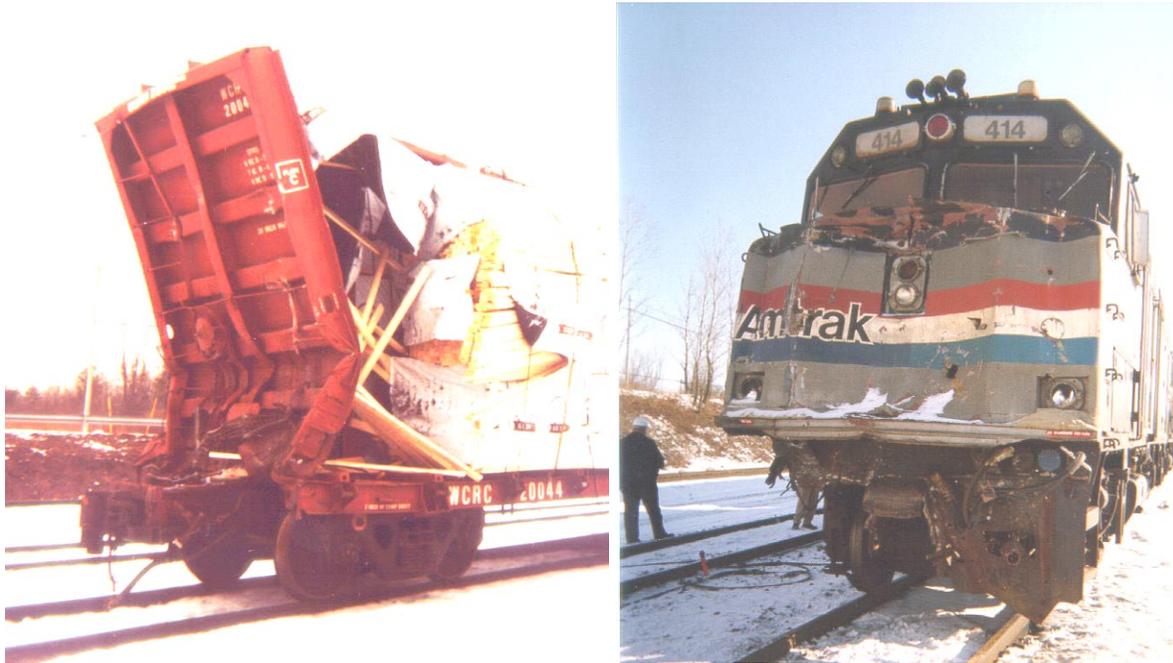
Figure 6 shows post-accident photographs of the inter-city passenger train's lead locomotive and the freight train's trailing bulkhead flatcar. It appears that crushing and displacing of the lumber on the loaded bulkhead flatcar absorbed most of the collision energy. The hydraulic cushioning devices on the trailing cars of the freight train also probably helped to dissipate some of the collision energy. (In effect, it appears that the hydraulic cushioning device and the lumber acted as a crash energy management system.) The body and lading of the bulkhead flatcar was crushed approximately 1.8 m (6 feet), from the trailing end of the carbody up to the trailing axle of the trailing truck. The draft sill and coupler of the bulkhead flatcar remained essentially intact, with the body and lading stripped off. The draft sill and coupler of the bulkhead flatcar acted as a battering ram which tore through the coupler and draft-gear box of the locomotive, which hang beneath the main sill structure of the locomotive. The coupler and the end of the draft sill of the flatcar impacted the front and top of the lead traction motor and front of the body bolster, helping to pry the truck from the locomotive and to push the truck back into the fuel tank. A lug on the lead truck punctured the fuel tank, causing a hole about the size of a baseball. The body of the locomotive began to climb the bulkhead flatcar, as the flatcar was crushing. Grooves from the ribs on the anti-climber can be seen on the bulkhead of the flatcar, 9 to 10 feet from top of rail. (The locomotive anti-climber normally sits approximately 5 feet above top of rail, at the end of the locomotive above the coupler.) The anti-climber engaged a transverse framing member of the bulkhead, which may have helped to stop the locomotive from climbing the bulkhead flatcar any further.

Figure 6. Post-accident photographs, passenger train lead locomotive and freight train trailing loaded bulkhead flatcar, Syracuse, New York collision.

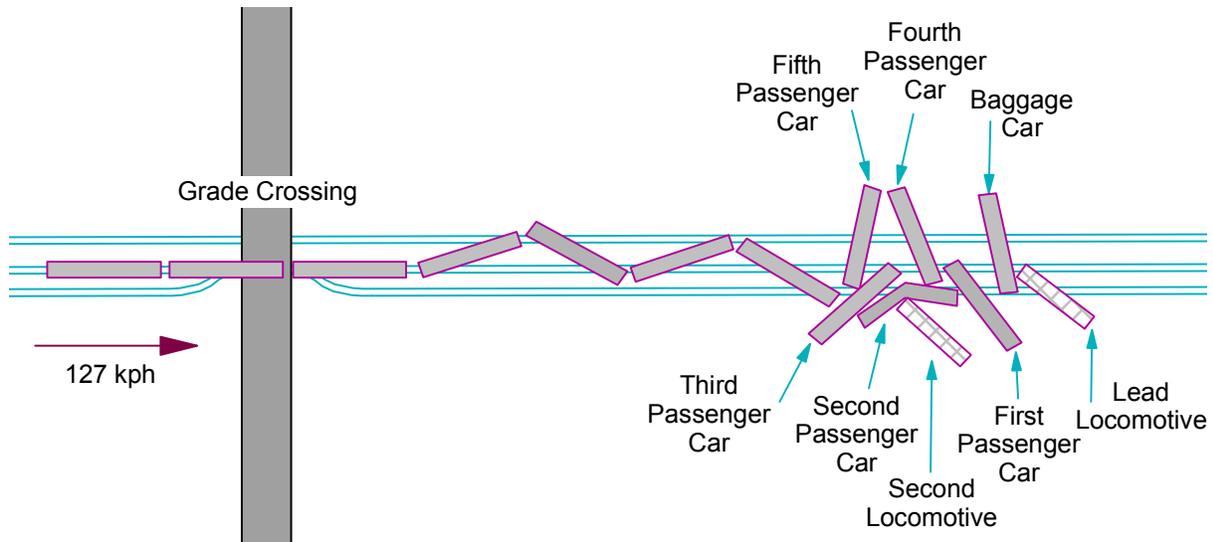
Figure 7 shows a post-collision schematic of the train. Because of the severity of the collision, it is very difficult to infer a likely sequence of events. The collision with the highway tractor-trailer likely resulted in little structural damage to the locomotive. The lead locomotive impacted the rear wheel of the trailer. The trailer was loaded with approximately 178 kN (40 kips) of steel rebar, a relatively light load. The principal impact was probably with the loaded freight cars.

Figure 7. Post-Collision schematic, passenger train collision with highway truck and subsequent collision with standing freight cars, Bourbonnais, Illinois.

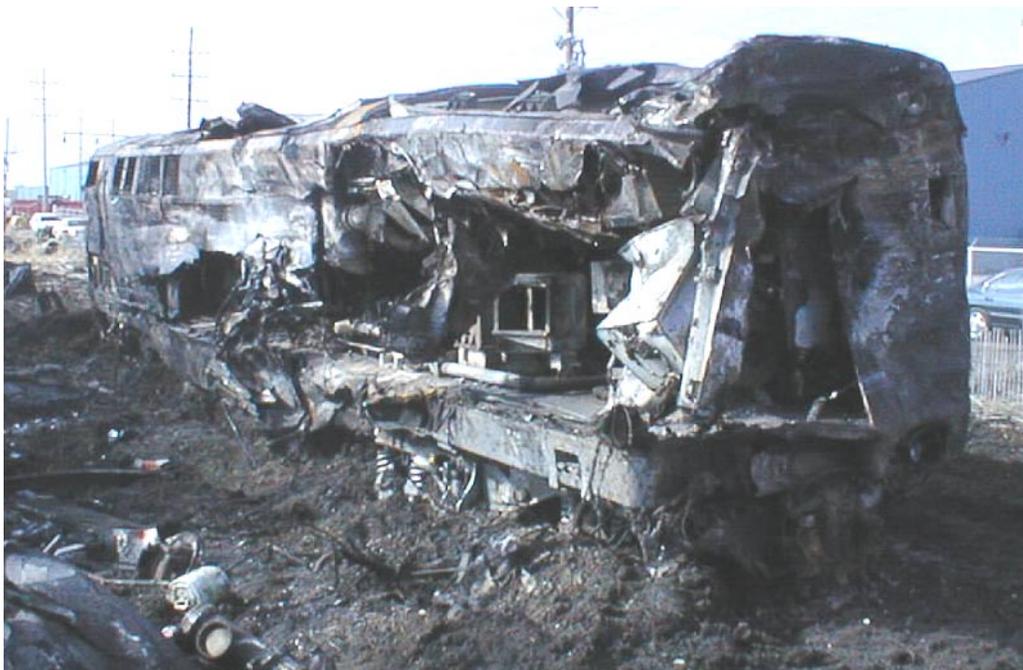
Significant structural damage occurred to the first and second locomotives, which are shown in Figures 8 and 9 respectively. The lead locomotive had significant damage on the left side, particularly near the rear. The fuel tank in this locomotive is integral with the center portion of the frame, i.e., the side sills between the trucks make up most of the fuel tank. There were several punctures and gashes in the fuel tank. The trailing locomotive was extensively damaged. The equipment in the rear third of the locomotive was stripped off, and the trailing third of the locomotive frame was bent into the shape of a 'W.'

Figure 8. Post-Accident Photograph, Lead Locomotive, Bourbonnais, Illinois Collision.

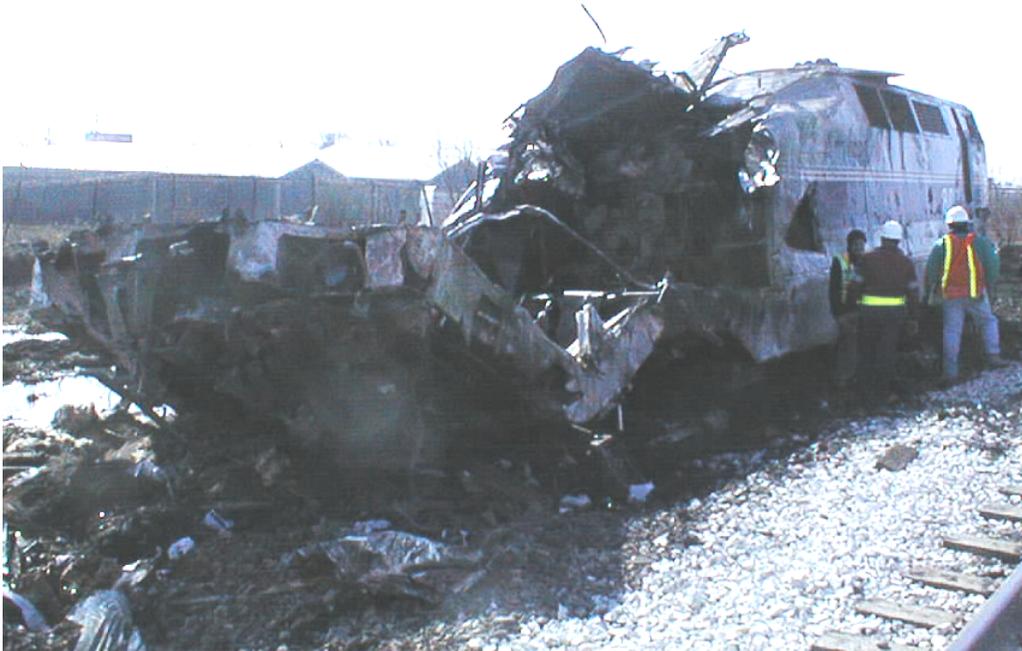
Figure 9. Post-accident photograph, second locomotive, Bourbonnais, Illinois collision.

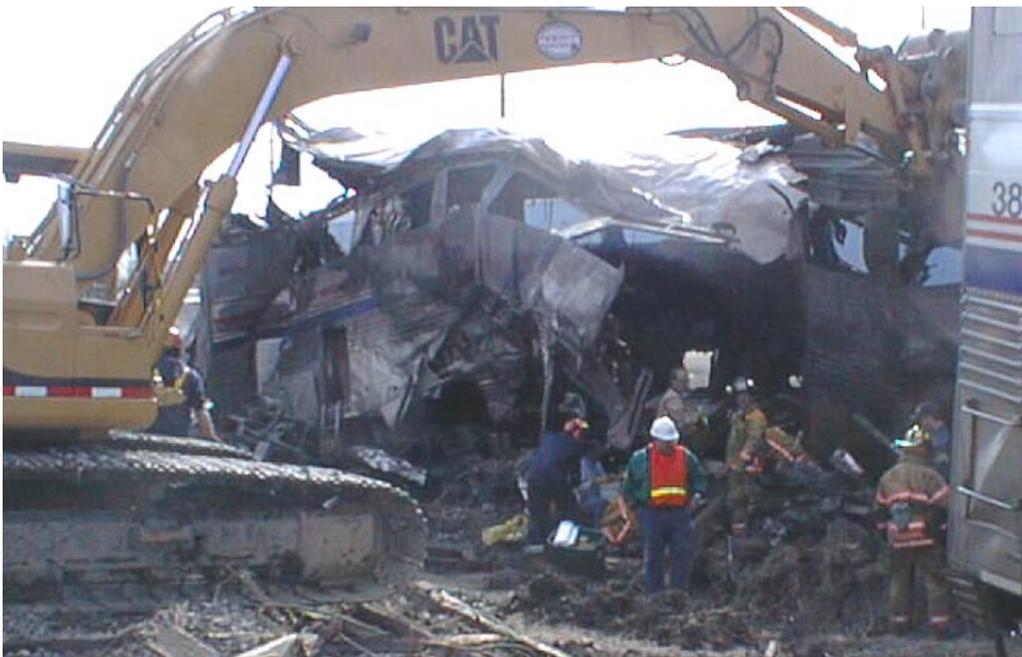
The most severely damaged passenger car was the second bi-level car, shown in Figure 10. In the pile-up, this car received lateral impacts from several other cars and the second locomotive. The rear of the second locomotive impacted it near the center of what is believed to have been the right side. There was a side-to-side impact with another bi-level car opposite the impact with the locomotive. The front of another bi-level car impacted it on the side near the lead truck.

Figure 10. Post-accident photograph, second bi-level passenger car, Bourbonnais, Illinois collision.

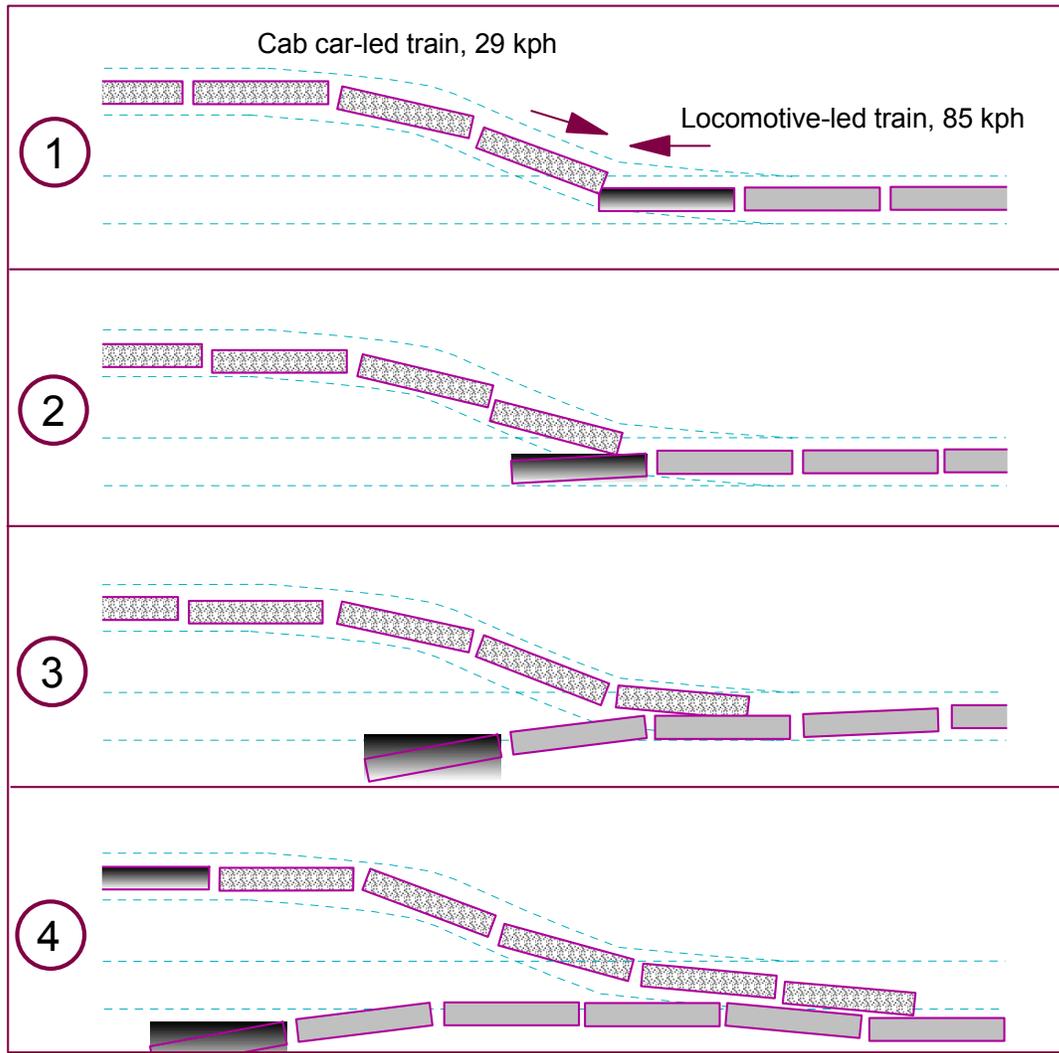
1. The cab car was traveling at approximately 29 kph (18 mph) when it struck the front, right corner of the locomotive, which was traveling at approximately 85 kph (53 mph) in the opposite direction. Based on the track geometry, the angle between the two vehicles at the instant of impact was approximately 7°. The corner post on the right side of the cab car struck the right side of the locomotive. Both collision posts on the cab car remained in place, though the right post incurred some structural damage. The right corner post was torn away from the cab car. The roof plate from the right side of the cab car broke away and penetrated the window of the locomotive.

2. The cab car raked down the side of the locomotive. The left rail (field side) under the locomotive rolled over and the locomotive derailed.
3. The derailed locomotive pulled the trailing cars off the track. The cab car continued to rake the cars trailing the locomotive, damaging stairwells as it went.

4. Most cars in the locomotive-led consist derailed (the last car may have stayed on the track). Only the cab car derailed in the cab car-led consist. The cab car-led consist was stopped by the collision at the switch. The locomotive-led consist slid to a stop on the ties and ballast.

Figure 11. Schematic of Secaucus, New Jersey, cab car/locomotive collision (hypothetical).

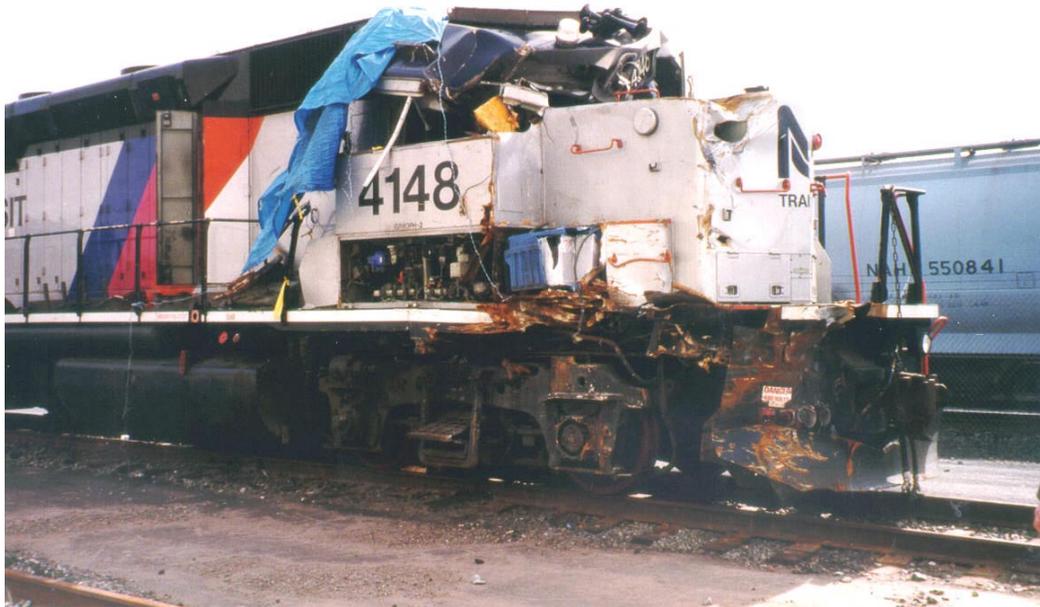
The roof plate of the cab car penetrated the operator's window of the locomotive. Damage to the hood of the locomotive appeared to be due to the roof plate riding up on the hood and through the window. Some superstructure damage to the front of the locomotive, approximately halfway between the coupler and the side of the locomotive, appeared to have been caused by the front of the cab car. The center sill and main structure of the locomotive remained essentially intact. A post-collision photograph of the locomotive is shown in Figure 12.

Figure 12. Post-accident photograph, impacted locomotive, Secaucus, New Jersey collision.

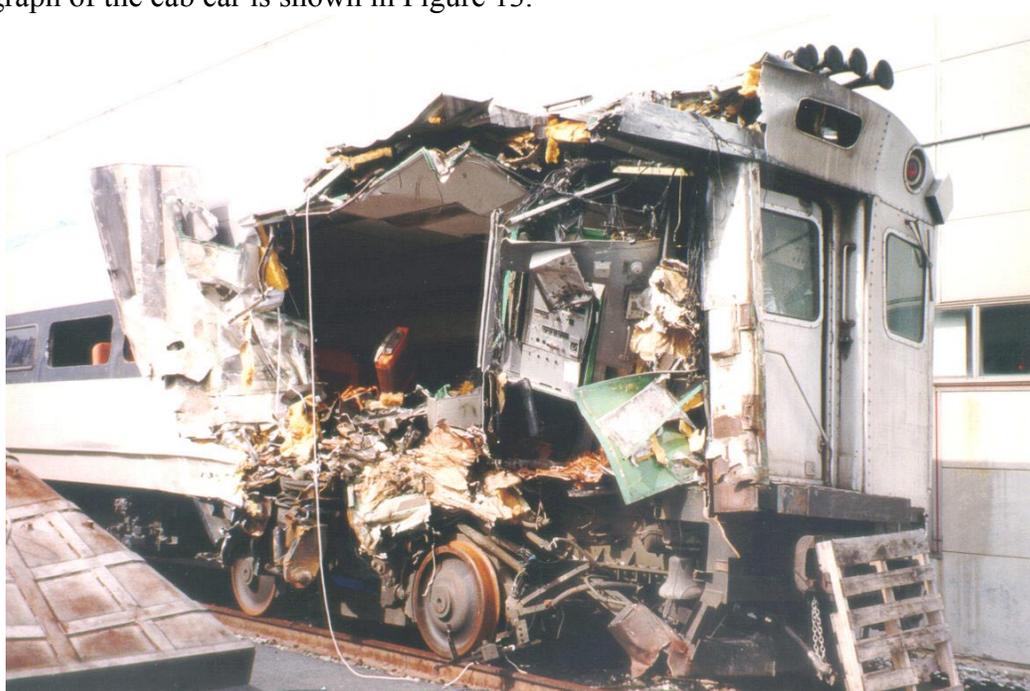
Damage to the lead cab car includes crushing of the right, front corner of the car from the end of the car to the body bolster. This area includes the operator's compartment and approximately five rows of seats. The right (track-side) collision post incurred substantial damage: there are several large cracks in and around the attachment point. This damage may have occurred when the end of the transverse floor member was torn off in the initial collision with the locomotive. The collision post itself may not have been loaded directly. The corner post and a portion of the roof plate were separated from the cab car. A post-collision photograph of the cab car is shown in Figure 13.

Figure 13. Post-accident photograph, lead cab car, Secaucus, New Jersey collision.

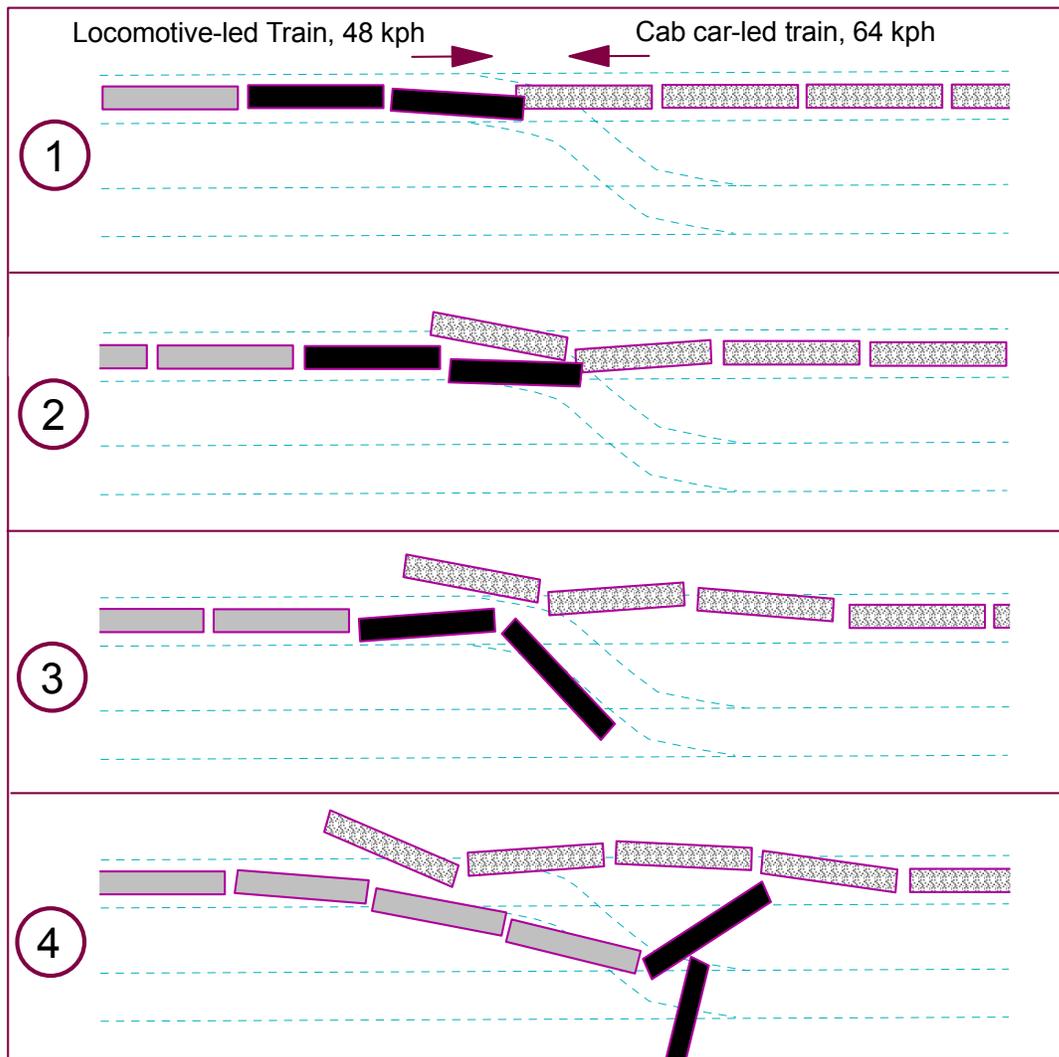
1. The lead cab car of the commuter train struck the front of the lead locomotive of the inter-city train. The locomotive of the inter-city train had just started to traverse a switch, and consequently the cab car and locomotive were misaligned when the collision started. The coupler of the cab car was approximately aligned with the side of the locomotive. The cab car subsequently raked along side of the locomotive, tearing off and rupturing the locomotive fuel tank. The difference in main structure heights between the locomotive and the cab car allowed the cab car underframe to shear off the equipment hung beneath the underframe of the locomotive and the locomotive underframe to tear the carbody skin above the side sill from the cab car.

2. The impact with the cab car nearly aligned the lead locomotive of the inter-city train with the direction of the track, but displaced the cab car laterally (to the right in the figure). The front of the lead locomotive of the inter-city train struck the front of the second car in the commuter train. This interaction started the front of the lead locomotive of the inter-city train moving to the side (toward the left in the figure)

3. The lead locomotive of the inter-city train separated from its lead truck and began to plow the earth while the second locomotive continues to push. The second locomotive of the inter-city train, in combination with the (small) lateral displacement due to the interaction with the second car of the commuter train, acted to turn the lead locomotive of the inter-city train clockwise. The impact between the lead locomotive of the inter-city train and the second car of the commuter train, in combination with the commuter train being pushed by its locomotive, resulted in the third car of the commuter train derailing (to the right in the figure).

4. The front of the lead locomotive of the inter-city train continued to plow; the couplers between the lead and second locomotives broke. The lead locomotive eventually turned clockwise approximately 270°. The remaining equipment slid to a stop.

Figure 16. Schematic of Silver Spring, Maryland, cab car/locomotive collision (hypothetical).

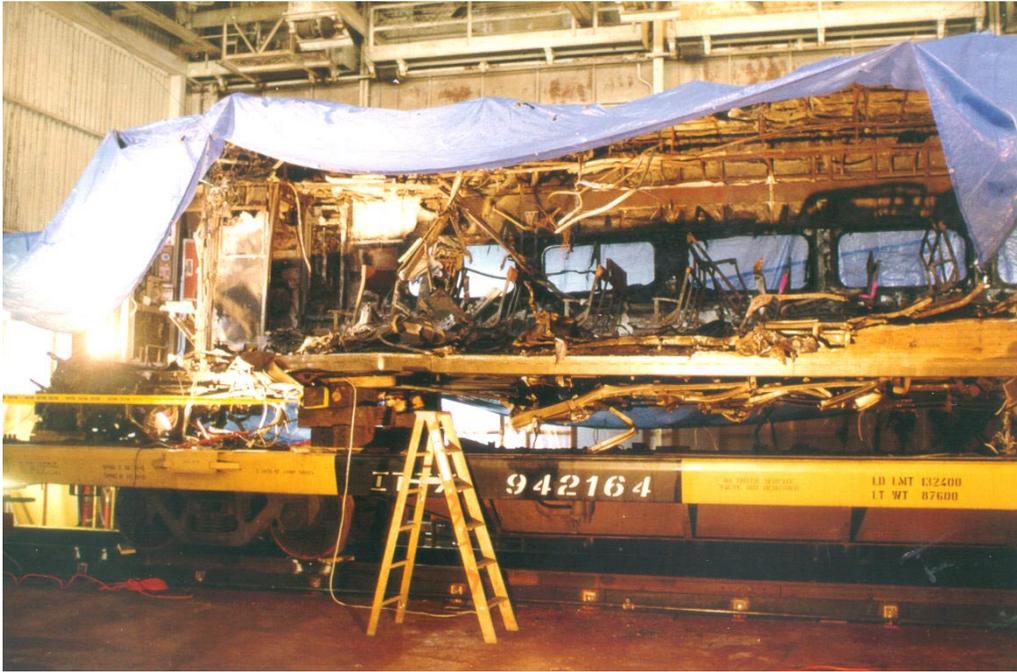
A post-collision photograph of the cab car is shown in Figure 17. In the photo, the cab car is sitting on a flatcar and the windows visible in the photo are on the far-side of the cab car. The wire frames in the photo are the metal remains of the seat frames and other interior fixtures; essentially all non-metal interior components were destroyed in the fire. There is extensive fire damage to the car, in addition to the collision damage. The structural damage to the second commuter car is similar to the damage done to the cab car, although there is little fire damage to the second car. The left side of the second car is crushed from the end of the car to the body bolster, although both collision posts are intact.

Figure 17. Post-accident photograph, lead cab car, commuter train, Silver Spring, Maryland collision.

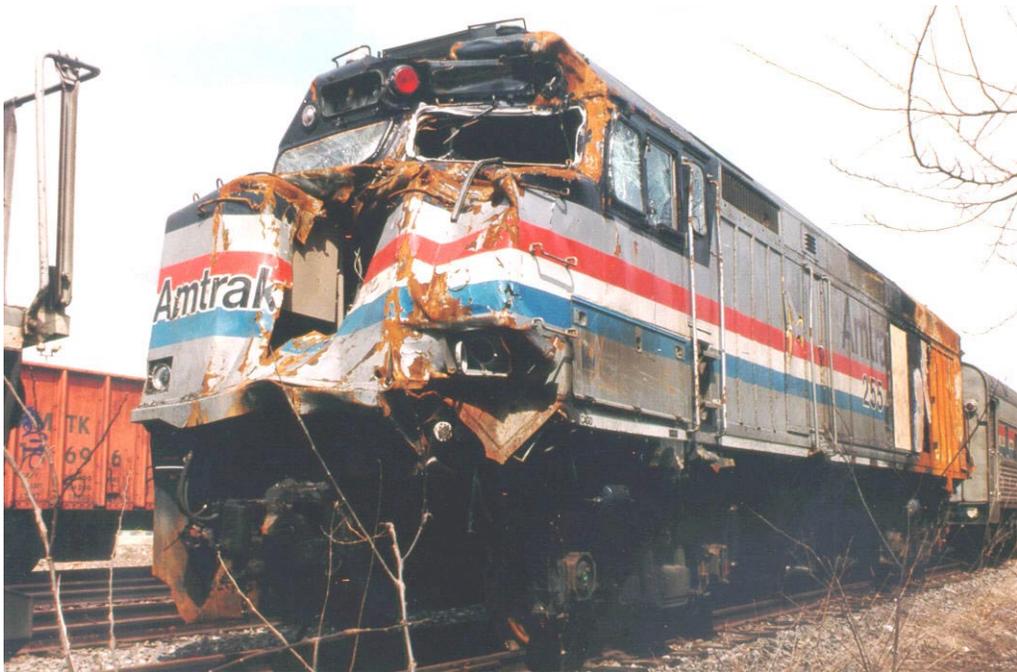
The damage done to the lead locomotive of the inter-city train includes puncture of the hood and removal of the equipment hung under the left (track) side of the locomotive, including the fuel tank. There is little damage to any of the main structural components of the locomotive. It is likely that the hood of the locomotive was punctured by the roof plate and corner post of the cab car. The operator's cab remained essentially intact, although both windshields were broken. A post-collision photograph of the lead locomotive is shown in Figure 18.

Figure 18. Post-accident photograph, lead locomotive, inter-city train, Silver Spring, Maryland collision.

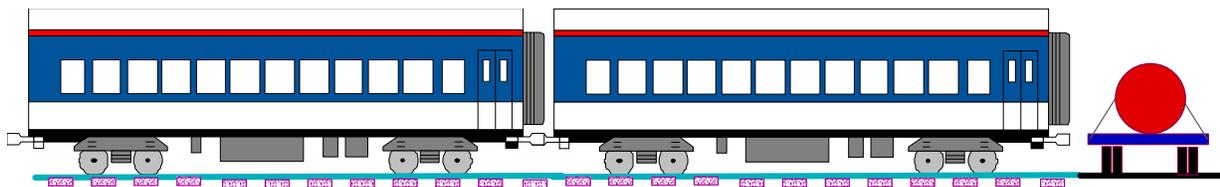
On June 18, 1998, a cab car led, two-car multiple-unit commuter train collided with a highway truck trapped at a grade crossing. The highway truck consisted of a tractor with two trailers. The trailers were loaded with coils of sheet steel. The second trailer, the one furthest from the tractor, was stopped on the tracks. The train collided with the second trailer, and during the impact a coil of steel broke free and punctured the end of the car. The train was traveling at a speed between 69 and 109 kph (43 and 68 mph) when it hit the highway truck. As a result of the collision, three people were killed: a deadheading railroad employee and two passengers. The initial conditions of the accident are shown schematically in Figure 19.

Figure 19. Schematic drawing of Portage, Indiana grade crossing collision.

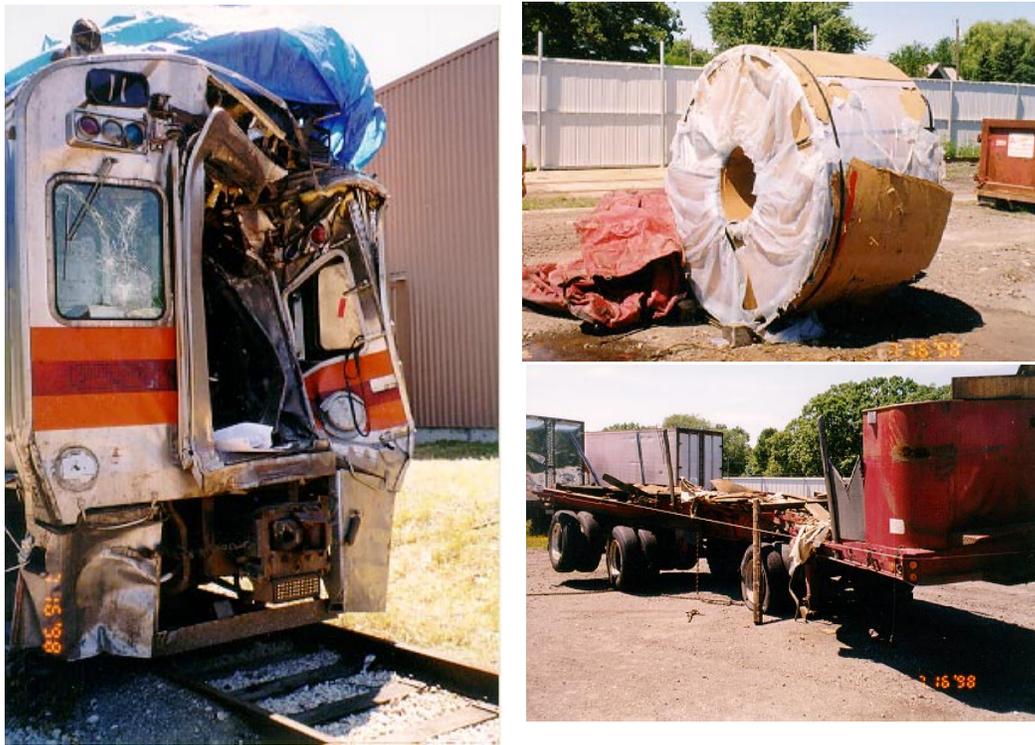
Figure 20 shows post-accident photographs of the cab car, the highway truck trailer, and the coil of steel. The coil of steel weighed approximately 178 kN (40 kips), and was about 1.8 m (6 feet) in diameter. It received little damage during the collision. Height of the floor of the trailer was several inches below the height of the floor of the cab car. Owing to the shape of the coil, it moved upward when it hit the end of the cab car. As shown in the photograph, the

coil of steel punctured the end of the cab car. The coil stopped inside the cab car after traveling about half its length, destroying about one-quarter of the passenger seats in the car.

Figure 20. Post-collision photographs, cab car, truck trailer, and steel coil involved in Portage, Indiana grade crossing collision.

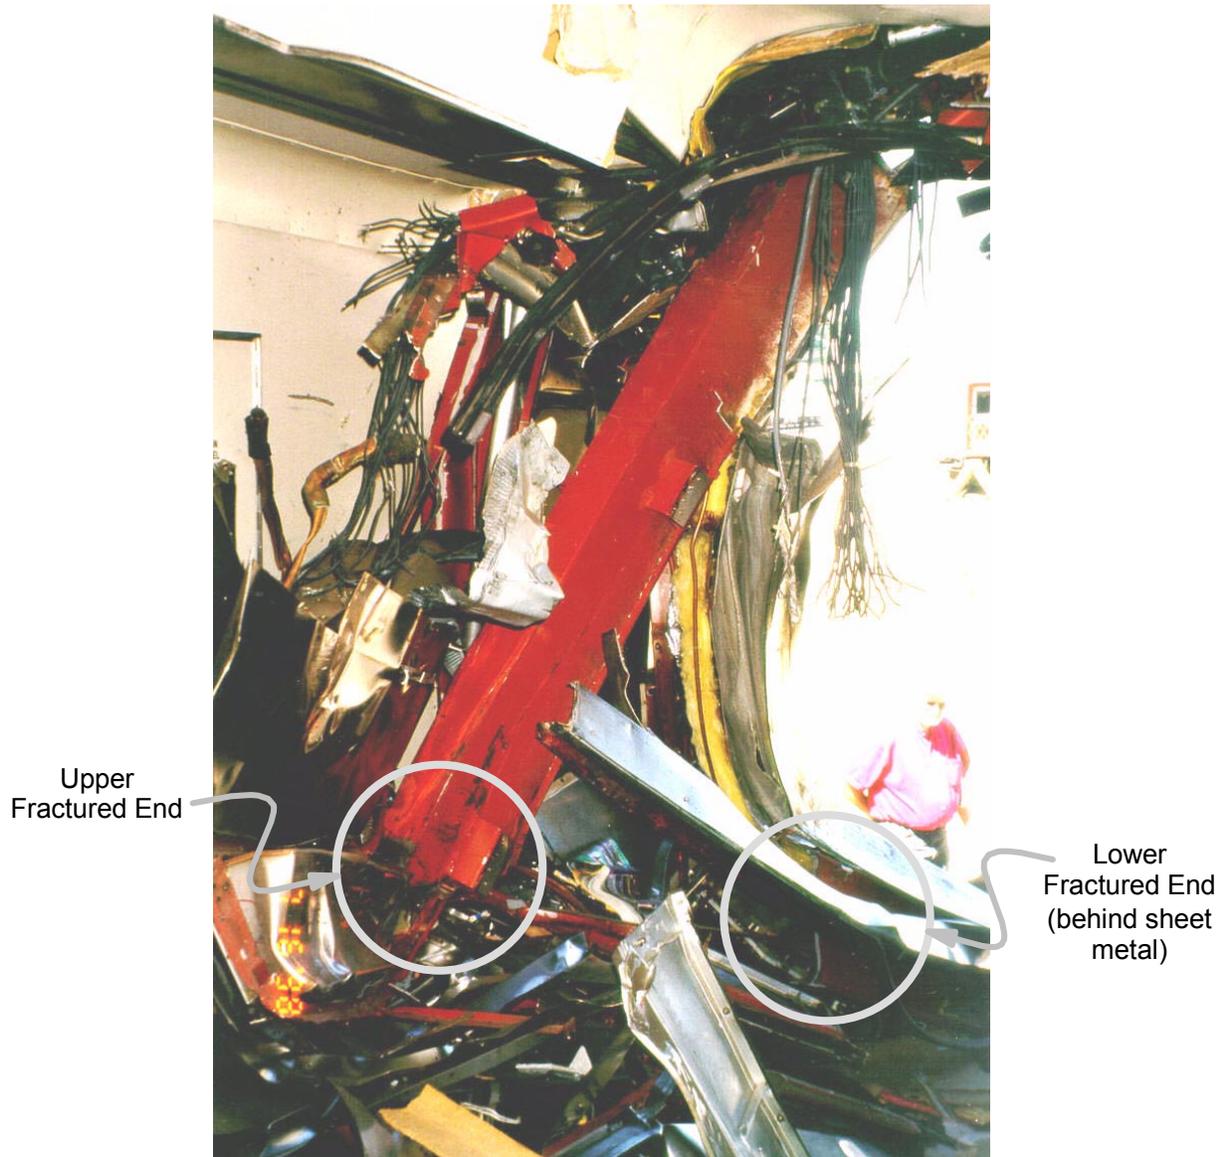
The coil struck one of the cab cars collision posts and it fractured. The fracture occurred near the impact point, which corresponds to the location where the doublers on the flanges ended. The fracture of the collision post is shown in Figure 22.

Figure 22. Post-collision photograph, cab car collision post fracture, Portage, Indiana grade crossing collision.

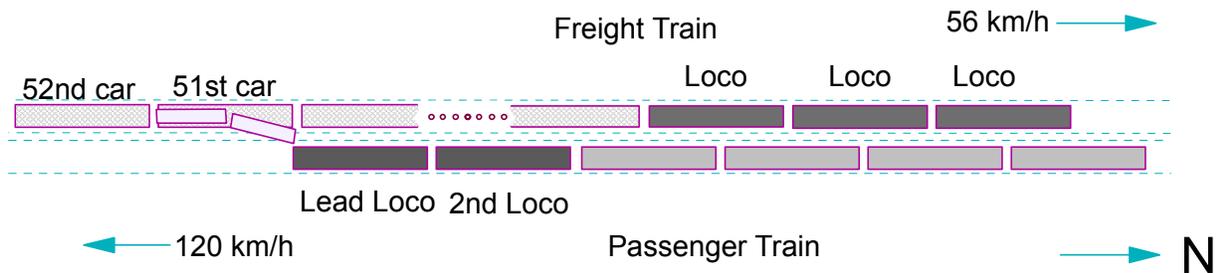
An overhanging intermodal trailer on the northbound freight train was obstructing the right of way of the southbound intercity passenger train. The northbound freight train was traveling approximately 56 km/h (35 mph) and the southbound passenger train was travelling about 120 km/h (75 mph). The forward trailer on the 51st car was overhanging the southbound track and engaged the lead locomotive of the passenger train. At the onset of contact, the trailer was above the deck and offset outside of the collision posts of the passenger train lead locomotive. The assistant engineer was killed during the accident and the engineer was severely injured. Figure 23 schematically depicts the conditions that initiated the oblique impact.

Figure 23. Schematic drawing, initial conditions of Selma, North Carolina oblique collision.

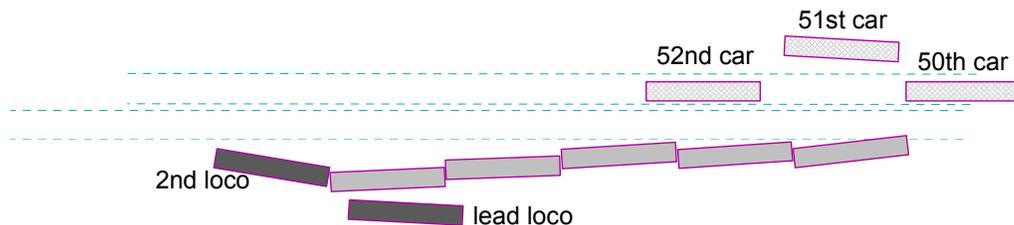
Damage to the short hood began at the right front corner and extended along the right side to the control compartment. The lead locomotive in the passenger train derailed and rolled over, coming to rest on its left side. All but one of the trailing cars, as well as the second locomotive, left the track, but remained upright. Only the last two cars in the freight train derailed and were damaged. The trailer, which was full of cat litter, burst open, spilling its contents along the track. The flatcar carrying the intruding trailer came to rest about 12 m (40 ft) off the track in an upright position with the deck and end bent. Figure 24 schematically depicts the conditions immediately after the accident.

Figure 24. Schematic drawing, final conditions of Selma North Carolina oblique collision.

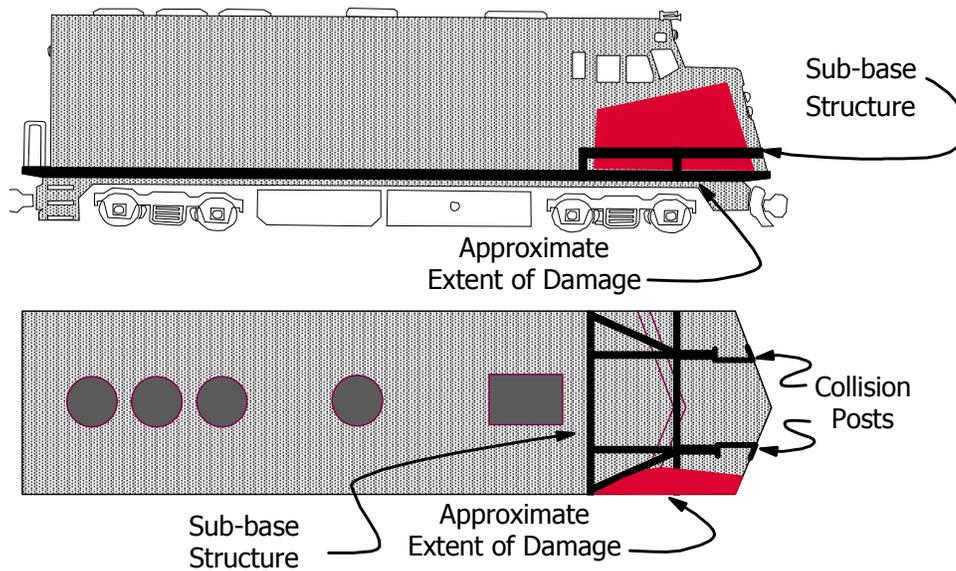
Figure 25 illustrates the damage to the locomotive from the impact with the container. The container initially impacted the sheet metal of the short hood approximately 229 mm (9 in) from the side of the locomotive. The damage extended back approximately 2.3 m (7.5 ft). For approximately the first 1.5 m (5 ft), the principal damage was to the short hood. For the remaining 0.8 m (2.5 ft) the principal damage included deformation of the sub-base and the sheet metal on the side of the operator's cab. The sub-base was the structure that provides the floor for the operator's cab and, beneath the floor, space for batteries and other ancillary

equipment. The locomotive in the accident was a General Motors/ElectroMotive Division F-40PH.

Figure 25. Schematic drawing, locomotive damage from impact with intermodal trailer, Selma, North Carolina oblique collision.

Potential modifications to improve the crashworthiness of locomotive designs have been evaluated with locomotive crush and train collision dynamics models, which simulate this oblique collision (26, 34, 35). The maximum safe closing speed for the locomotive operator can be increased from 56 to 153 kph (35 to 95 mph) by increasing the maximum strength crush strength of the short hood when it is loaded on the outboard corner from 445 to 1779 kN (100 to 400 kips).
