## **A Management Plan for Historic Bridges In Virginia: The 2024 Update**

**Final Report VTRC 26-R03**

**A MANAGEMENT PLAN FOR HISTORIC BRIDGES IN VIRGINIA:  
THE 2024 UPDATE**

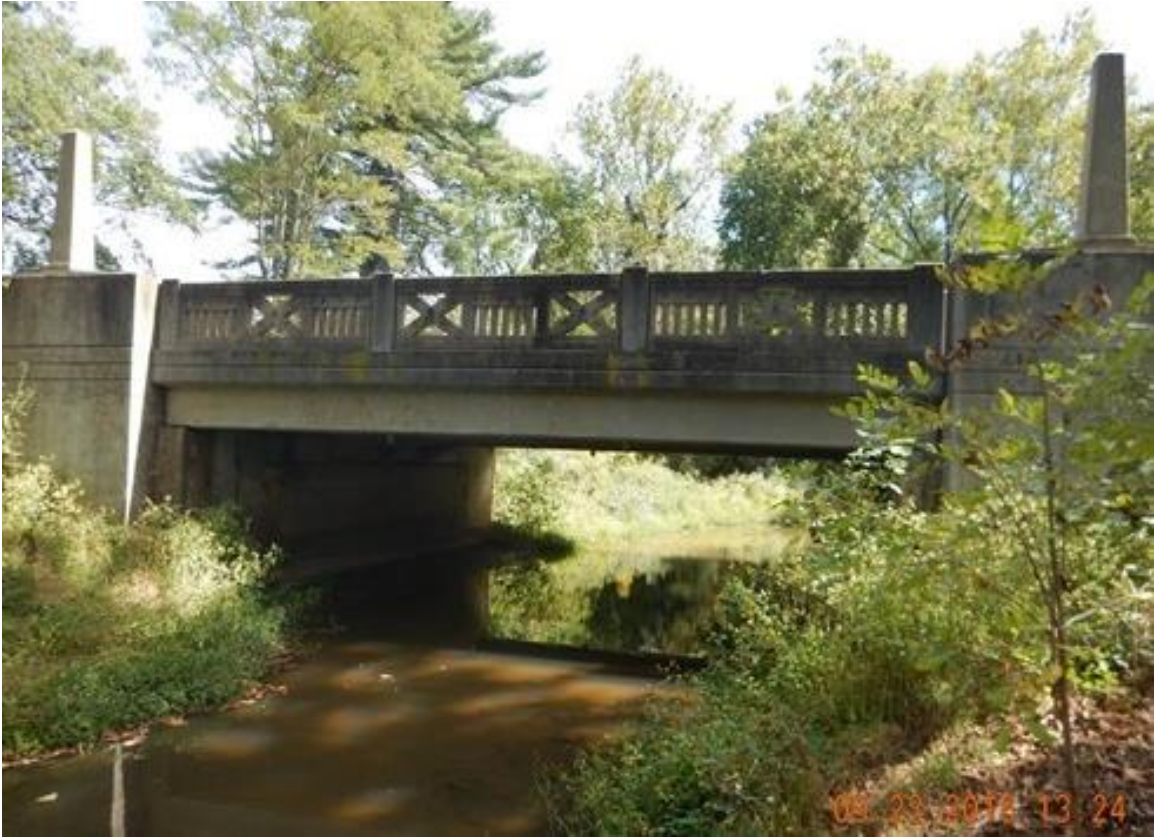
**Figure B1. Appomattox County Structure No. 1002**

*2024 Historic Structures Task Group Observations and Recommendations:* The current inspection report indicates that the bridge is in satisfactory condition. Previous and anticipated repairs are in accordance with Recommendation 1 in the 2001 Management Plan. The task group reiterates the recommendations of repair and maintain for vehicular use, with subsequent preventive maintenance as needed, in the 2001 Management Plan. This work should specifically continue to keep vegetation from encroaching on the bridge and repair areas of delaminated/spalled concrete.

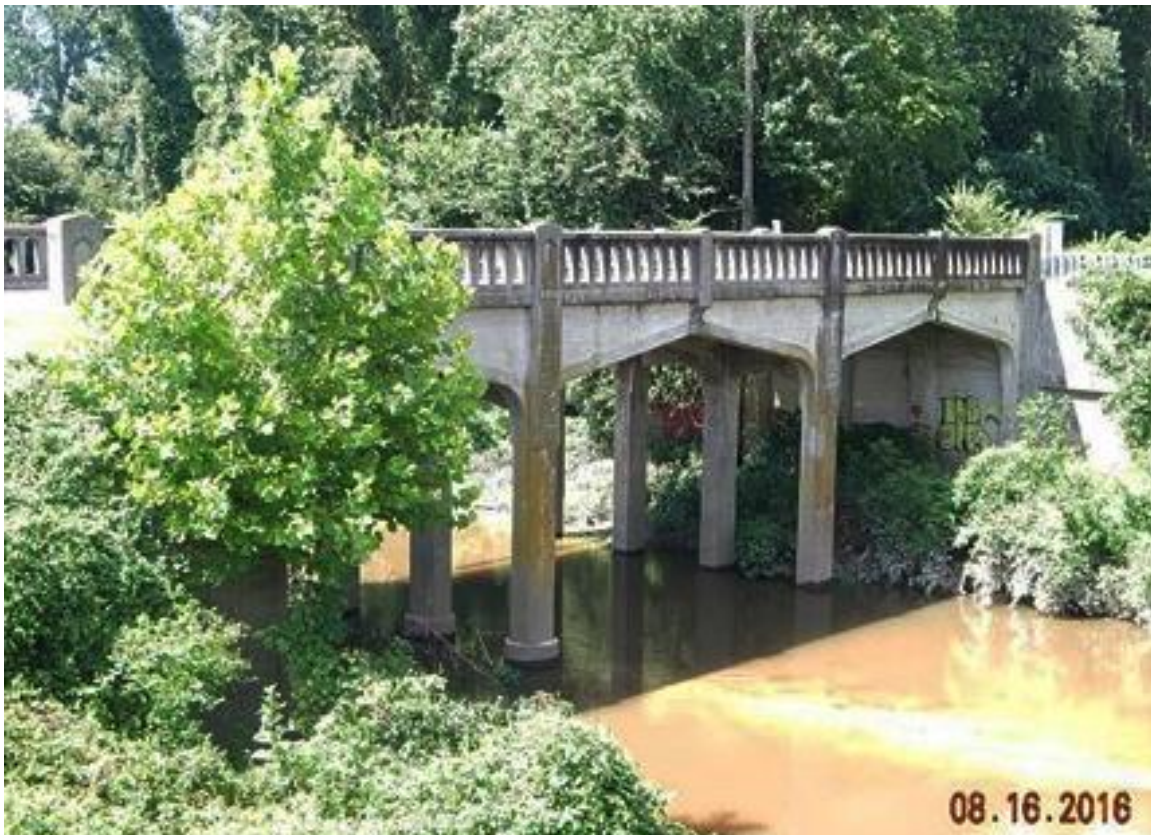
**Figure B2. Henrico County Structure No. 1001**

*Current Historic Structures Task Group Observations and Recommendations:* The current inspection report indicates that this structure is in satisfactory condition. Previous repairs are in accordance with the Recommended Treatment in the 2001 Management Plan. The task group reiterates the recommendations of (continued) repair and maintain for vehicular use, with subsequent preventive maintenance as needed, in the 2001 Management Plan.

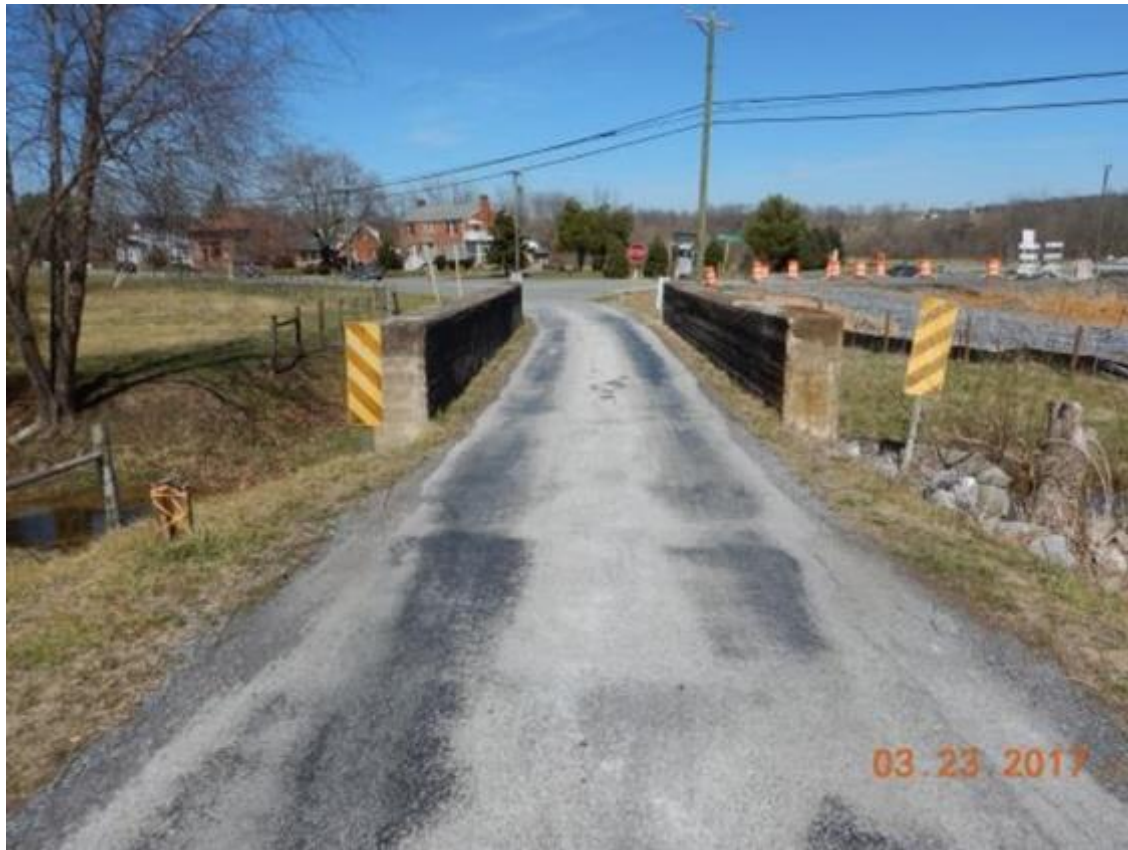
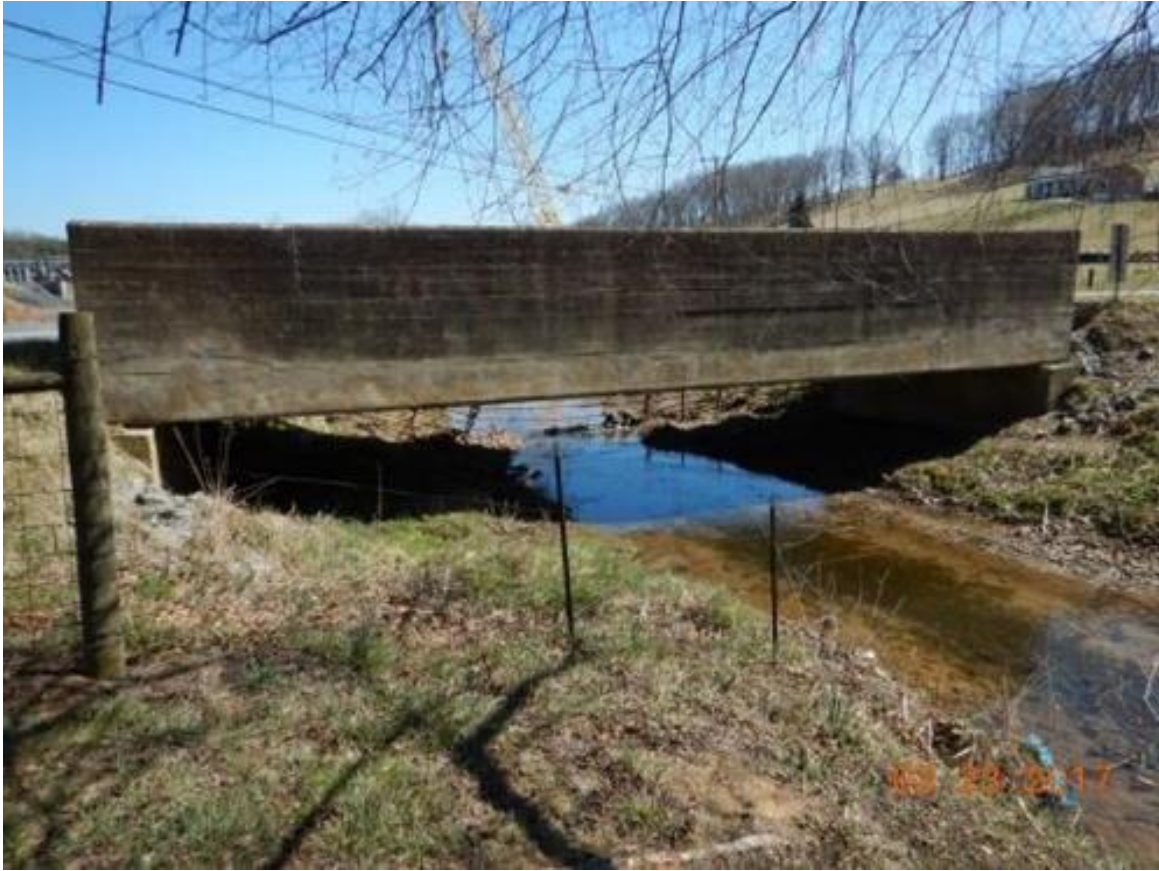
**Figure B3. Augusta County Structure No. 6113, End View**

*Current Historic Structures Task Group Observations and Recommendations:* The current inspection report indicates that this structure is in fair condition. Previous and planned repairs are in accordance with the Recommended Treatment in the 2001 Management Plan. The task group reiterates the recommendations of (continued) repair and maintain for vehicular use, with subsequent preventive maintenance as needed, in the 2001 Management Plan.

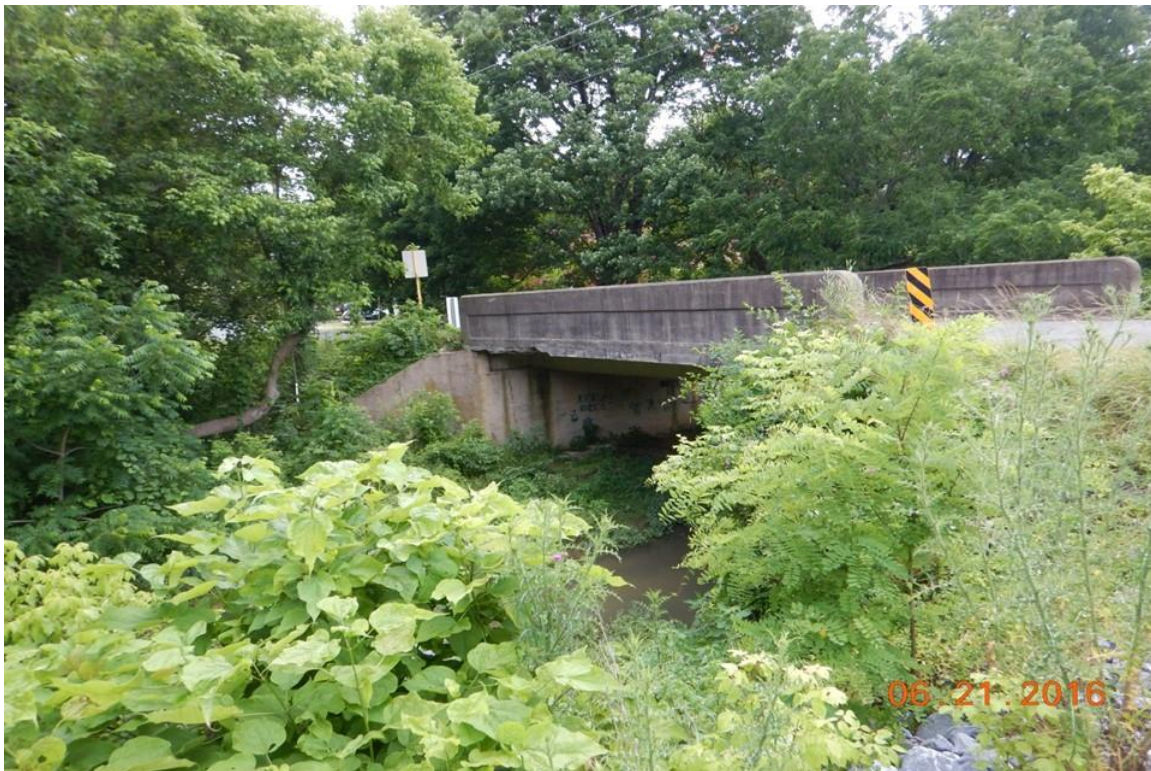
**Figure B5. Augusta County Structure No. 6553**

*Current Historic Structures Task Group Observations and Recommendations:* The current inspection report indicates that this structure is in fair condition. Previous and planned repairs are in accordance with the Recommended Treatment in the 2001 Management Plan. The task group reiterates the recommendations of (continued) repair and maintain for vehicular use, with subsequent preventive maintenance as needed, in the 2001 Management Plan.

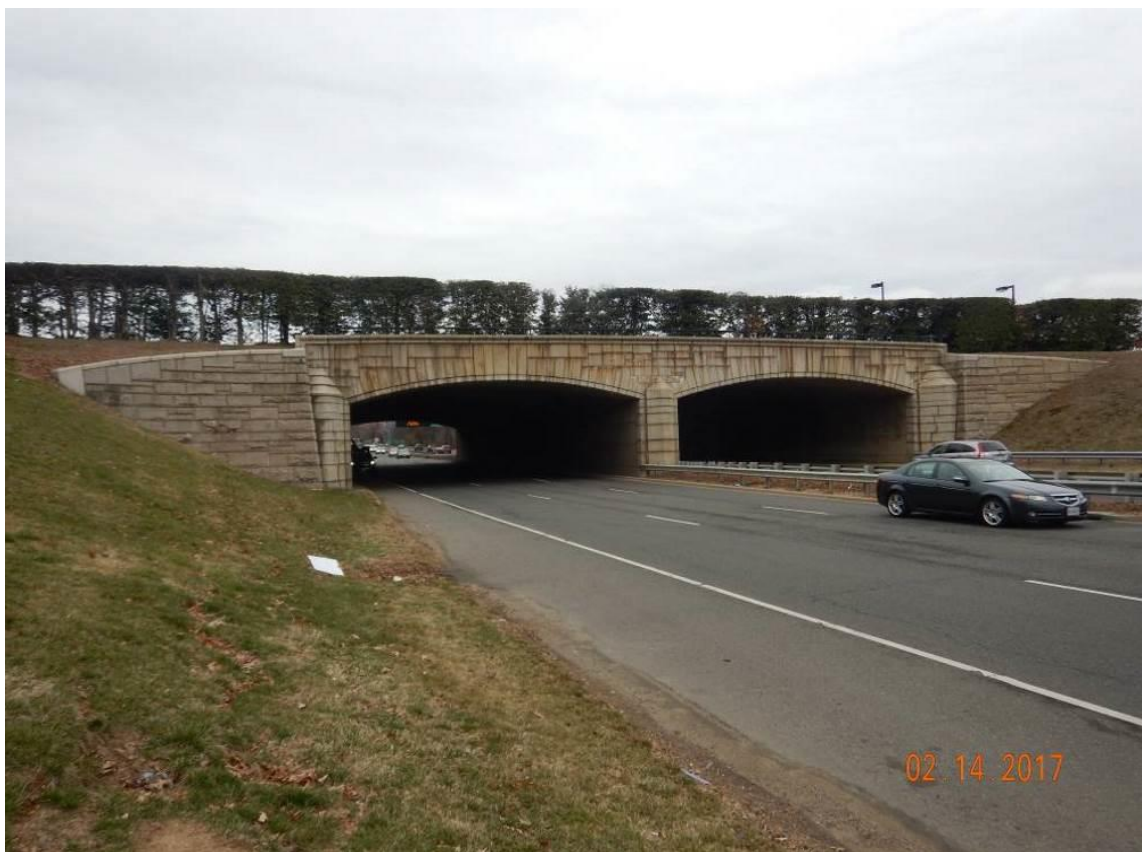
**Figure B6. Arlington County Structure No. 5020**

*Current Historic Structures Task Group Observations and Recommendations:* The current inspection report indicates that this structure is in fair condition. The task group reiterates the recommendations of repair and maintain for vehicular use, with subsequent preventive maintenance as needed, in the 2001 Management Plan.

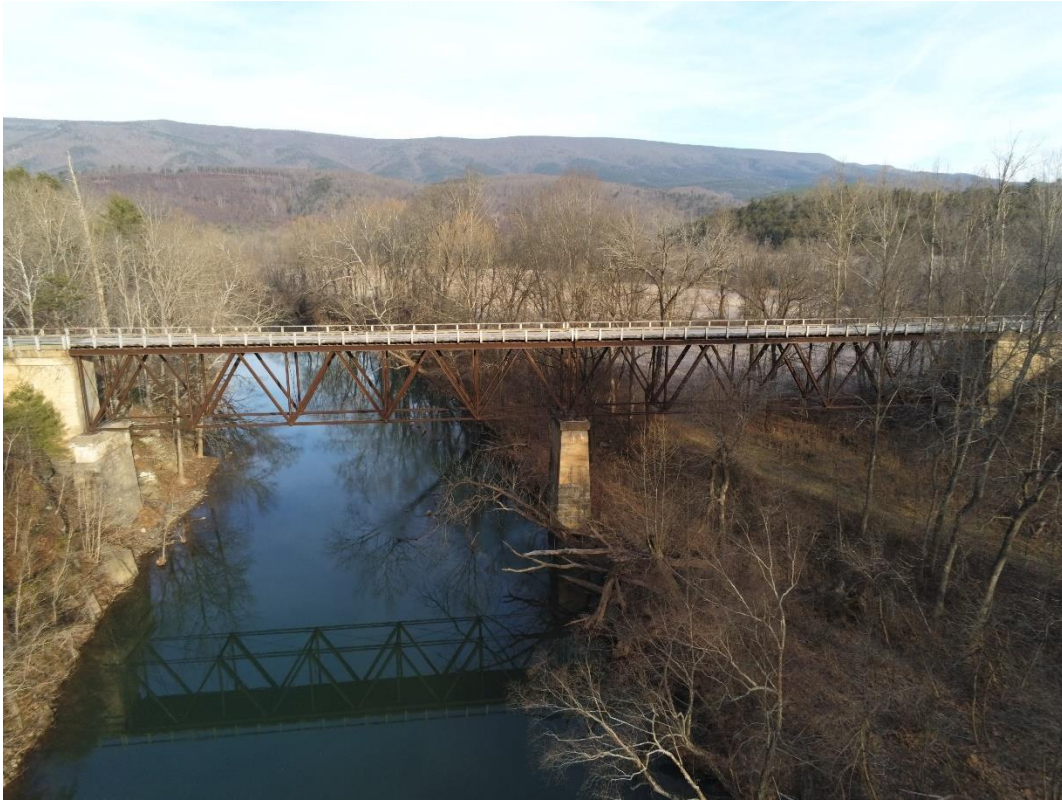
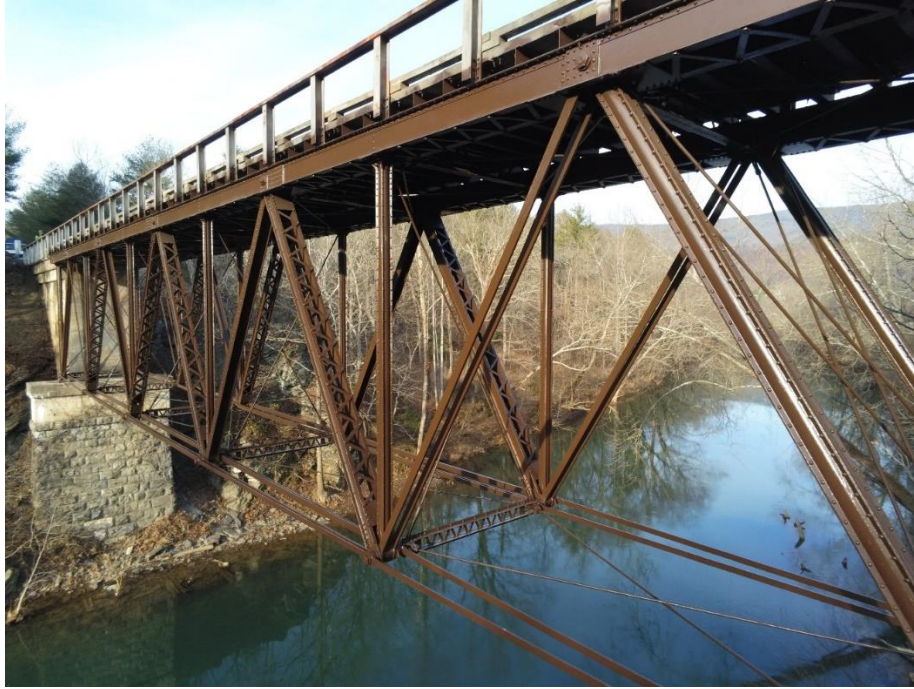
**Figure B10. Botetourt County Structure No. 6100**

*Current Historic Structures Task Group Observations and Recommendations:* The current inspection report indicates that this structure is in fair condition. Previous and planned repairs / maintenance are in accordance with Recommendation 1 in the 2001 Management Plan. The task group reiterates Recommendation 1, of (continued) repair and maintain for vehicular use, with subsequent preventive maintenance as needed, in the 2001 Management Plan.

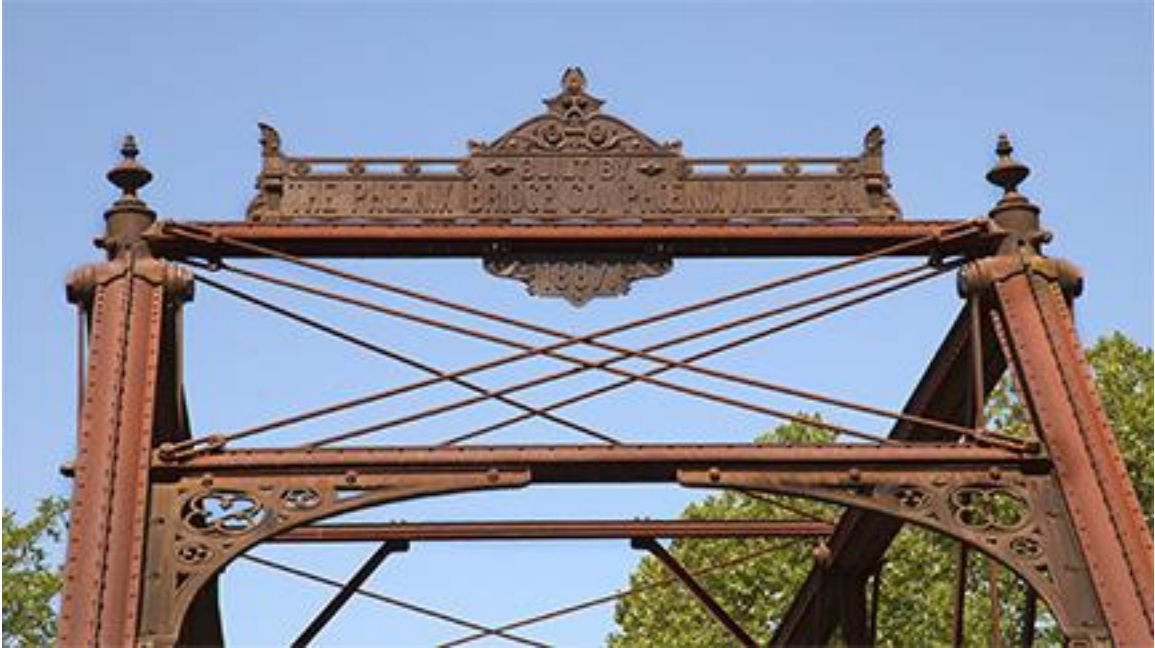
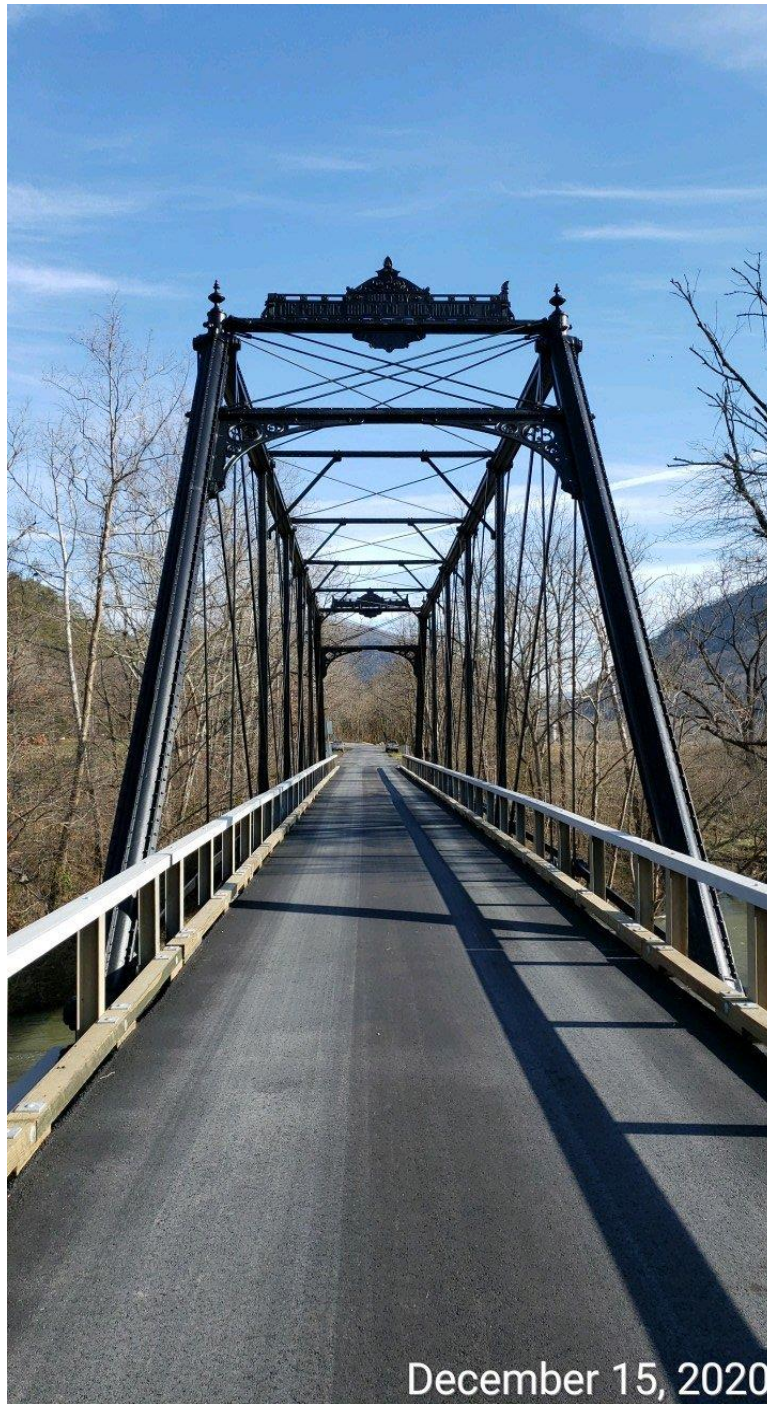
*Current Historic Structures Task Group Observations and Recommendations:* The structure has been rehabilitated. This work is in accordance with Recommendation 1 in the 2001 Management Plan. The current inspection report indicates that this structure is in satisfactory condition. The task group reiterates Recommendation 1, of (continued) repair and maintain for vehicular use, with subsequent preventive maintenance as needed, in the 2001 Management Plan.

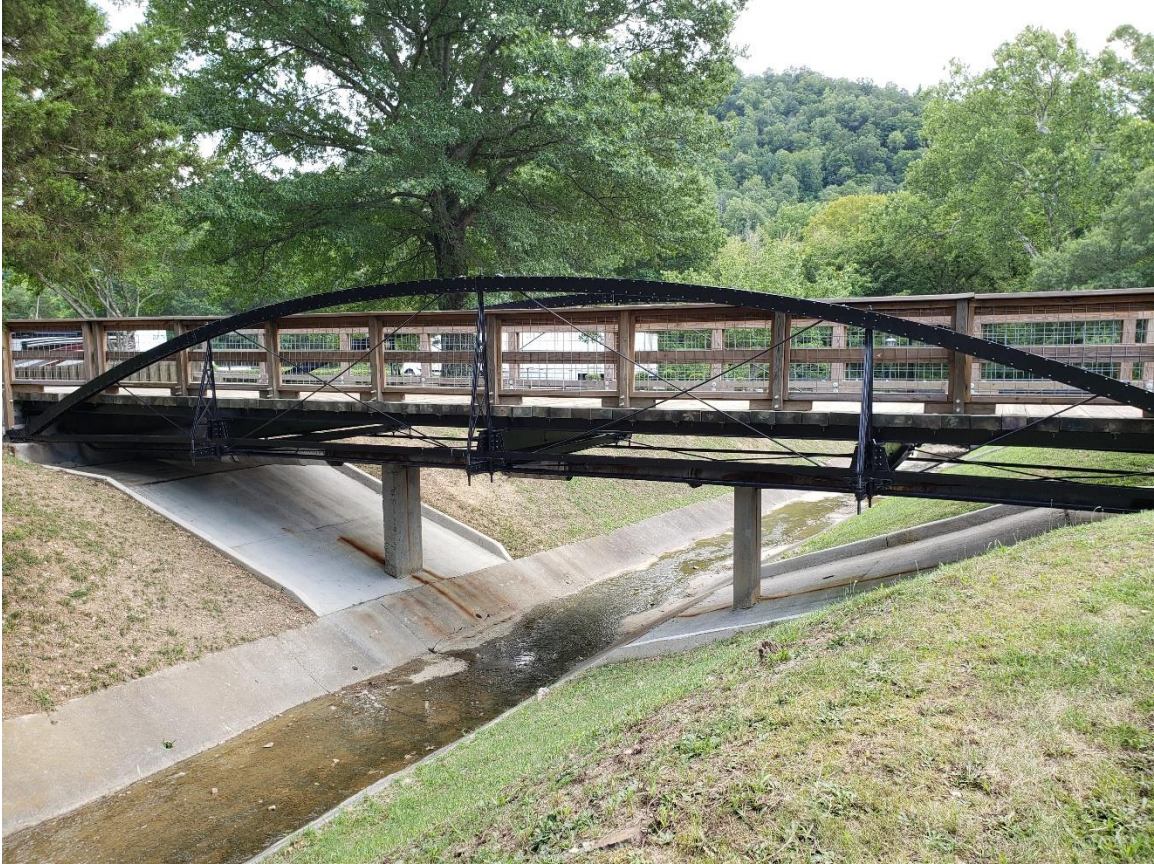
**Figure B14. Montgomery County Structure No. 9003**

*Current Historic Structures Task Group Observations and Recommendations:* The current inspection report indicates that this structure is in satisfactory condition. Previous repairs and the recent rehabilitation are in accordance with the Recommended Treatment in the 2018 addendum to the Management Plan. The task group reiterates the Recommended Treatment of (continued) repair and maintain for continued adaptive/alternative use, with subsequent preventive maintenance as needed, in the 2001 Management Plan.

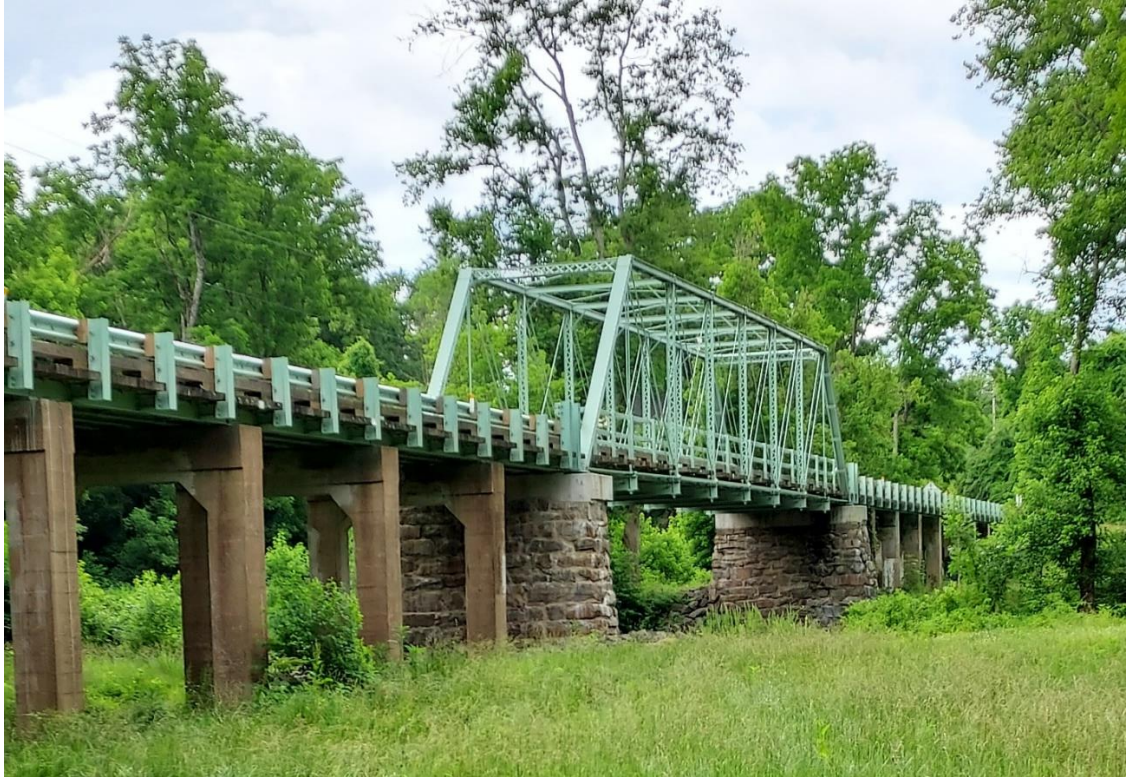
**Figure B16. Culpeper County Structure No. 6906**

*Current Historic Structures Task Group Observations and Recommendations:* The current inspection report indicates that this structure is in good condition. The recent rehabilitation was in accordance with the Recommended Treatment in the 2001 Management Plan (this structure was not considered for task group recommendations in the 2017 Management Plan update because of ongoing Section 106 review). The task group reiterates Recommendation 1, (continued) repair and maintain for vehicular use, with subsequent preventive maintenance as needed, in the 2001 Management Plan.

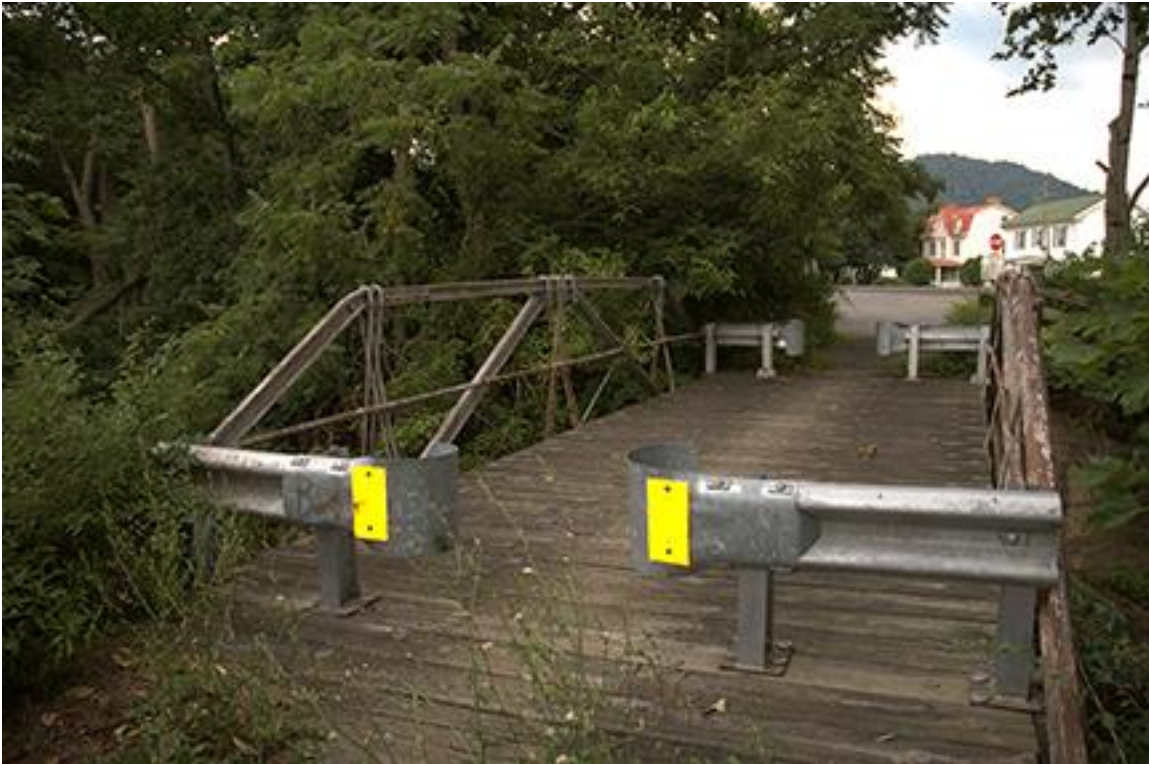
**Figure B17. Highland County Structure No. 6034**

*Current Historic Structures Task Group Observations and Recommendations:* The current inspection report indicates that this structure is in fair to poor condition. Previously discussed repairs would be in accordance with the Recommended Treatment in the 2001 Management Plan. The task group reiterates the recommendations of repair and maintain for continued adaptive use, with subsequent preventive maintenance as needed, in the 2001 Management Plan. The task group strongly supports making repairs to this important structure in the near future. Surviving Lane trusses are extremely rare: only four are known to be extant.

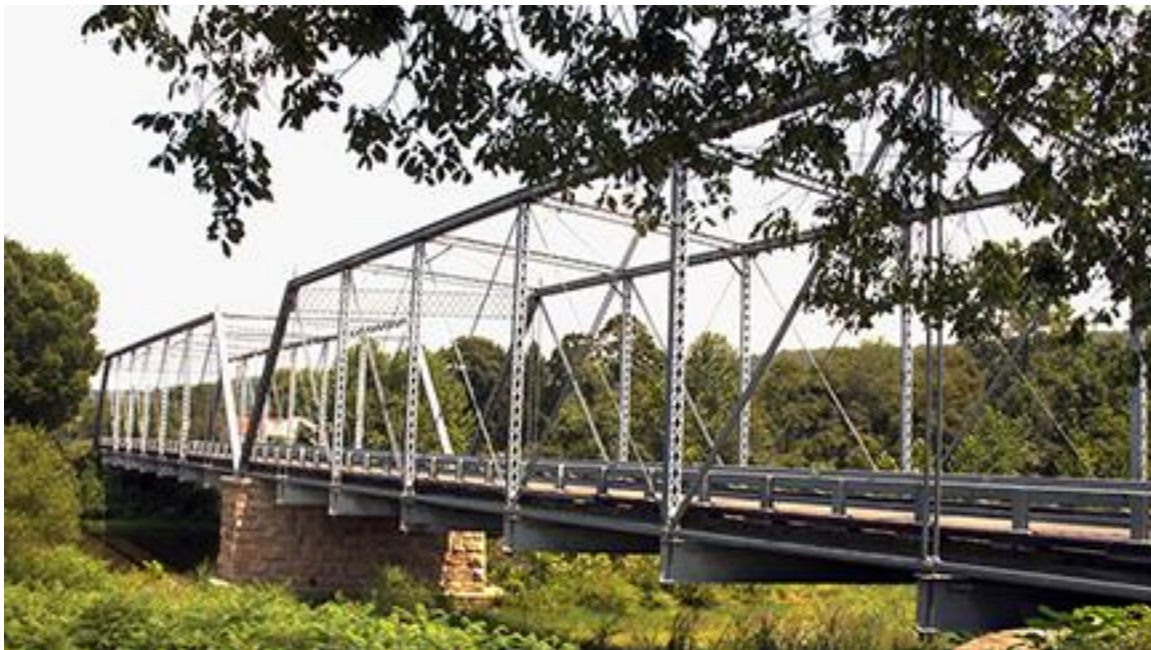
**Figure B19. Rockbridge County Structure No. 6145**

*Current Historic Structures Task Group Observations and Recommendations:* The current inspection report indicates that this structure is in good condition. The task group recommendation is to continue maintenance and repairs if needed for vehicular use, with subsequent preventive maintenance as needed.

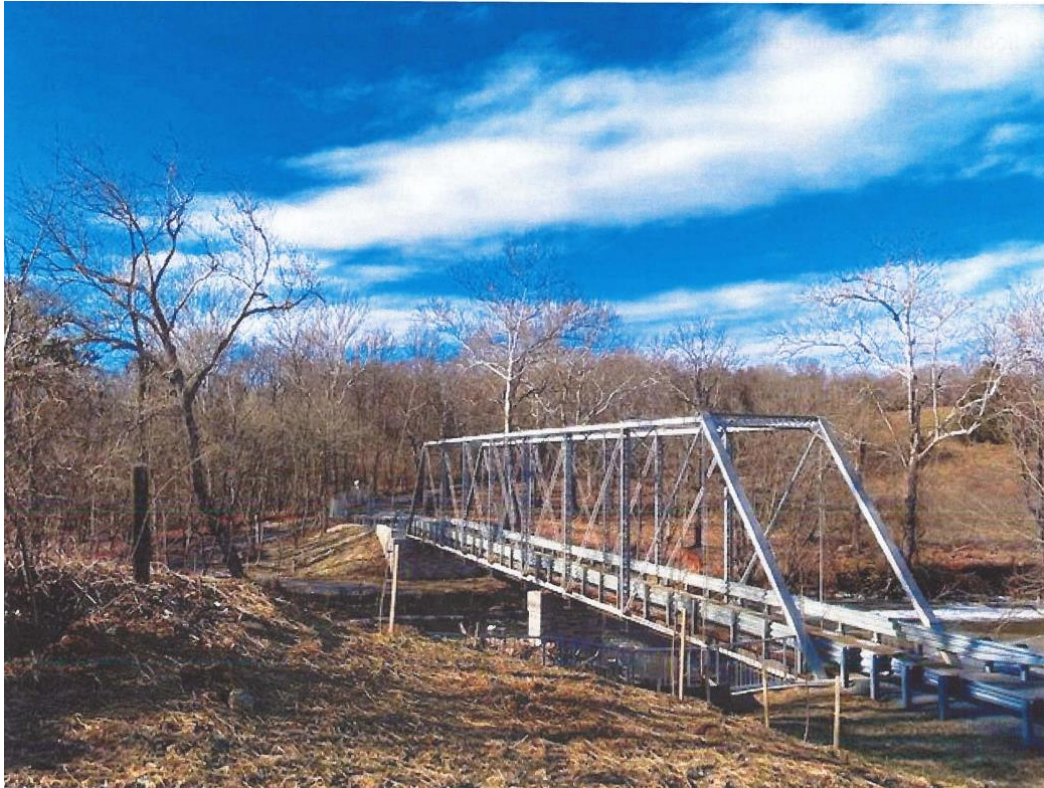
**Figure B20. Loudoun County Structure No. 6051**

*Current Historic Structures Task Group Observations and Recommendations:* The current inspection report indicates that this structure is in good condition. The recent rehabilitation was in accordance with the Recommended Treatment in the 2001 Management Plan (this structure was not considered for task group recommendations in the 2017 Management Plan update because of ongoing Section 106 review). The task group recommendation is to continue maintenance and repairs if needed for vehicular use, with subsequent preventive maintenance as needed.

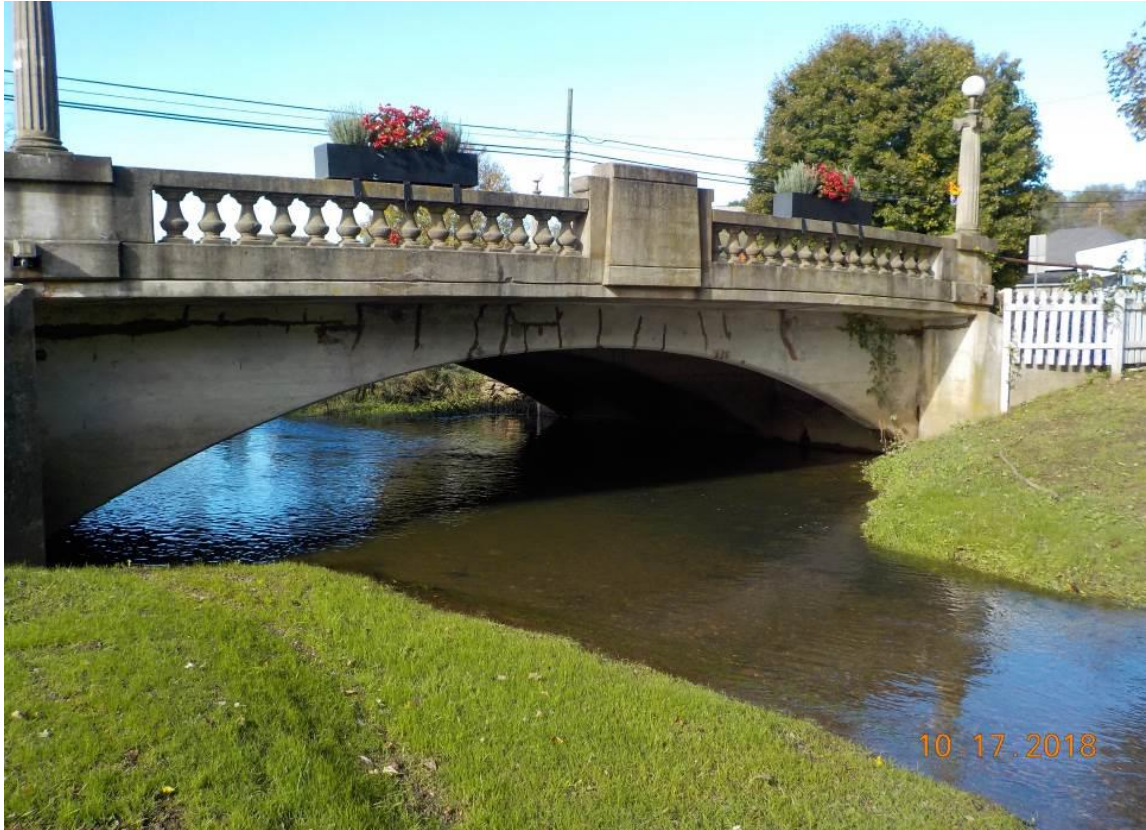
**Figure B22. Bland County Structure No. 1021**

*Current Historic Structures Task Group Observations and Recommendations:* The current inspection report indicates that this structure is in fair condition. Previous repairs are in accordance with Recommendation 1 in the 2001 Management Plan. The task group reiterates the recommendations of (continued) repair and maintain for vehicular use, with subsequent preventive maintenance as needed, in the 2001 Management Plan.

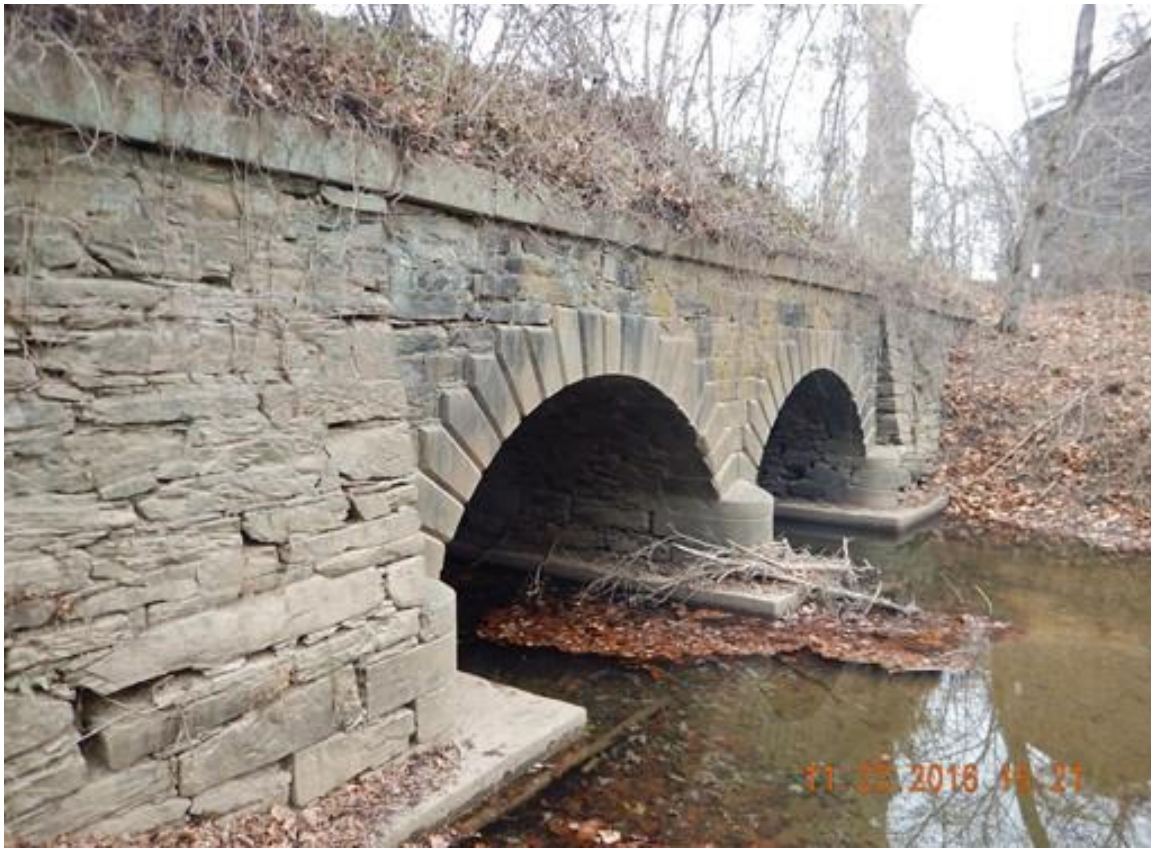
**Figure B24. Nelson County Structure No. 6070**

*Current Historic Structures Task Group Observations and Recommendations:* The current inspection report indicates that this structure is in fair condition. Previous repairs are in accordance with the Recommended Treatment in the 2001 Management Plan. The task group reiterates the recommendations of (continued) repair and maintain for vehicular use, with subsequent preventive maintenance as needed, in the 2001 Management Plan, and supports the proposed masonry repairs.

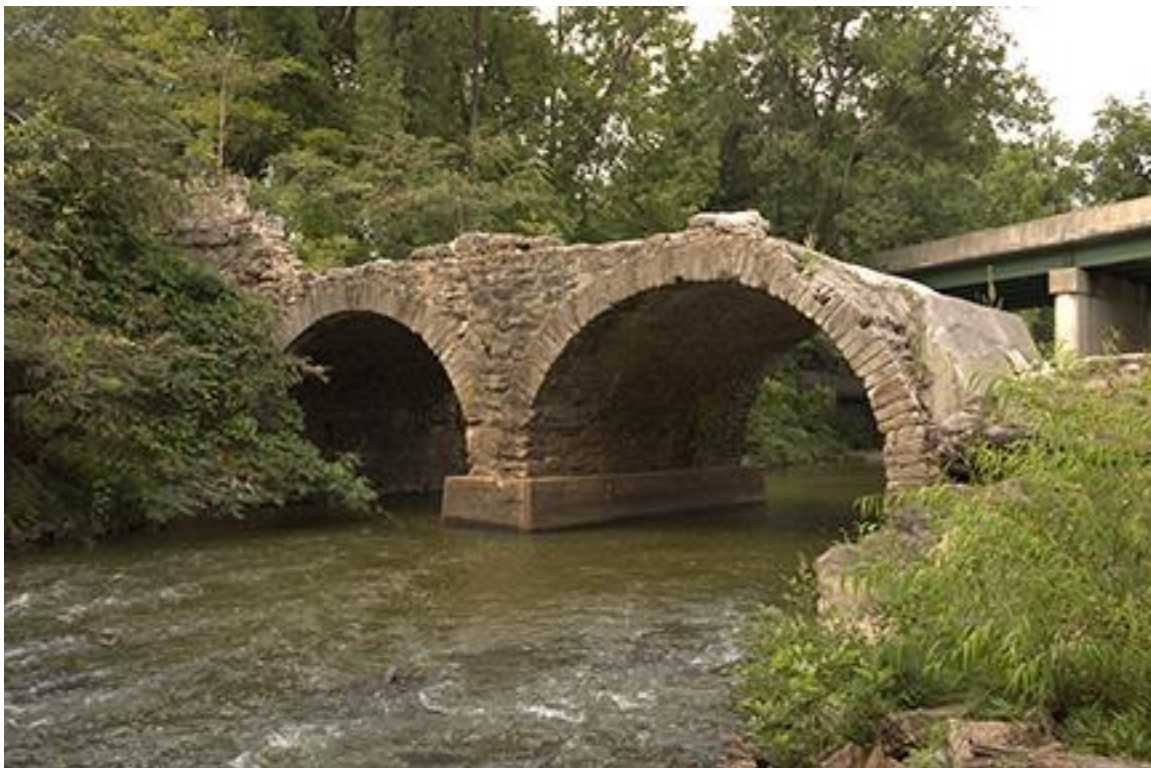
**Figure B25. Falling Creek Bridge, Chesterfield County**

*Current Historic Structures Task Group Observations and Recommendations:* The task group reiterates its previous recommendation of preserving the remains of the old bridge as a ruin, with further stabilization as needed. If a crossing over Falling Creek is needed within the wayside, a modern pedestrian footbridge could be erected. Interpretive signage to relate the history of the 1823 bridge is an additional recommended option. For the current update, the task group reiterates non-support for a restoration/reconstruction of the bridge because of the inadequate hydraulic opening and the fact that the bridge has sustained major damage from previous flooding at least twice.

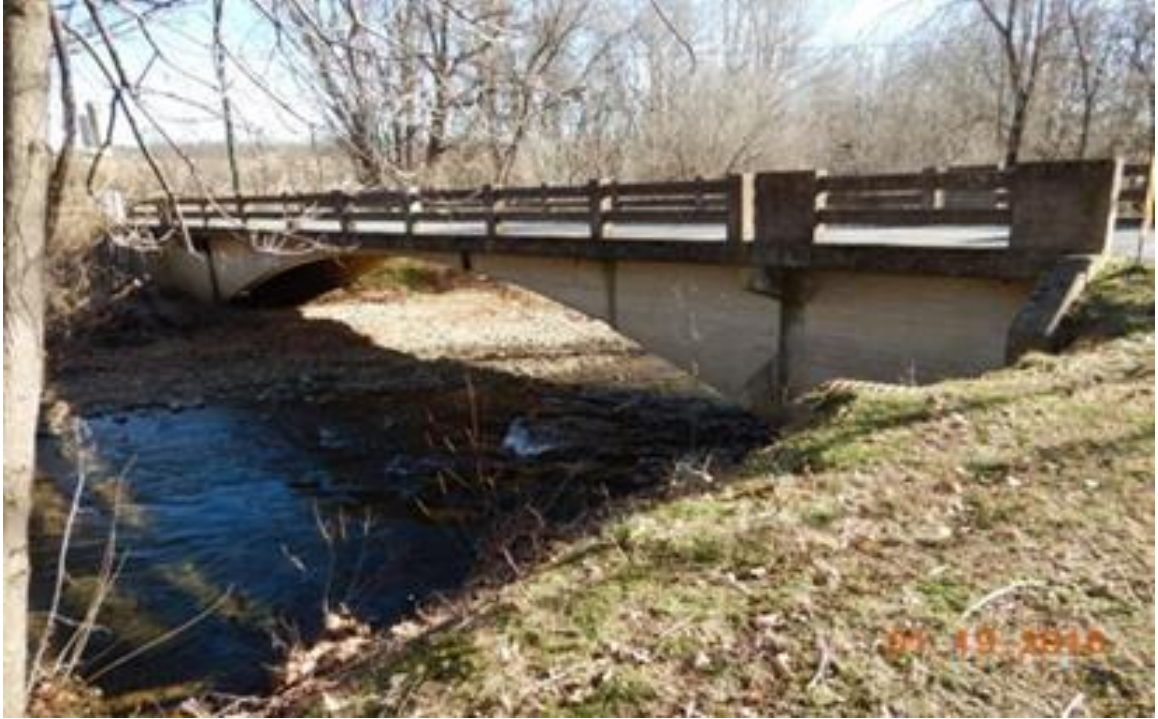
**Figure B28. Augusta County Structure No. 6165**

*Current Historic Structures Task Group Observations and Recommendations:* The current inspection report indicates that this structure is in fair condition. The task group reiterates the recommendations of (continued) repair and maintain for vehicular use, with subsequent preventive maintenance as needed, in the 2001 Management Plan.

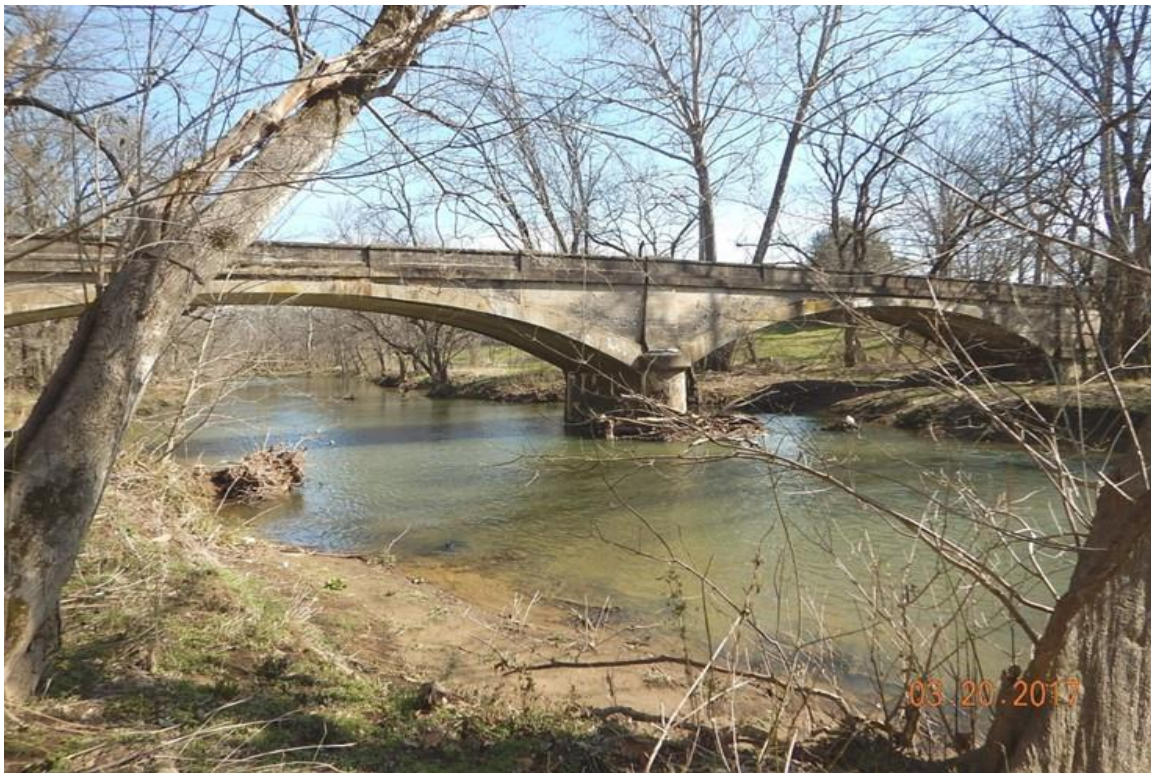
**Figure B30. Frederick County Structure No. 6903**

*Current Historic Structures Task Group Observations and Recommendations:* The current inspection report indicates that this structure is in fair condition. Previous and planned repairs are in accordance with Recommendation 1 in the 2001 Management Plan. The task group reiterates the recommendations of (continued) repair and maintain for vehicular use, with subsequent preventive maintenance as needed, in the 2001 Management Plan. The task group strongly recommends and supports the rehabilitation of this structure.

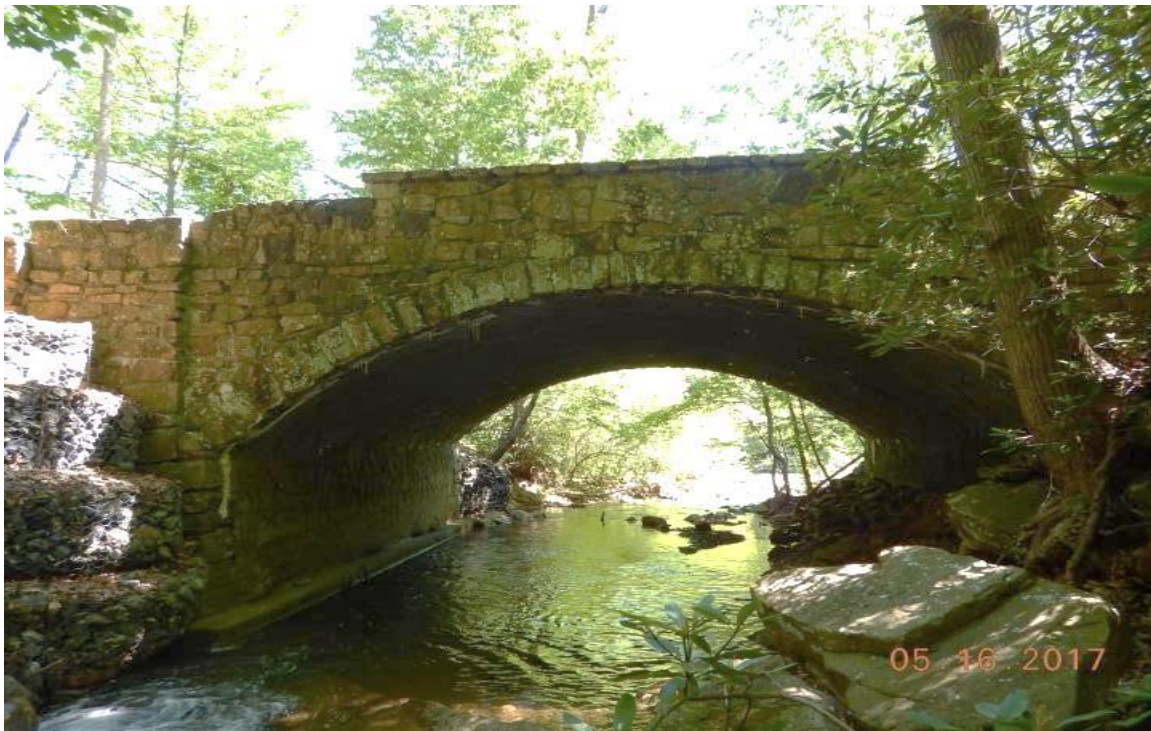
**Figure B31. Rockbridge County Structure No. 1012**

*Current Historic Structures Task Group Observations and Recommendations:* The current inspection report indicates that this structure is in good condition. Previous and planned repairs are in accordance with the Recommended Treatment in the 2001 Management Plan. The task group reiterates the recommendations of (continued) repair and maintain for vehicular use, with subsequent preventive maintenance as needed, in the 2001 Management Plan.

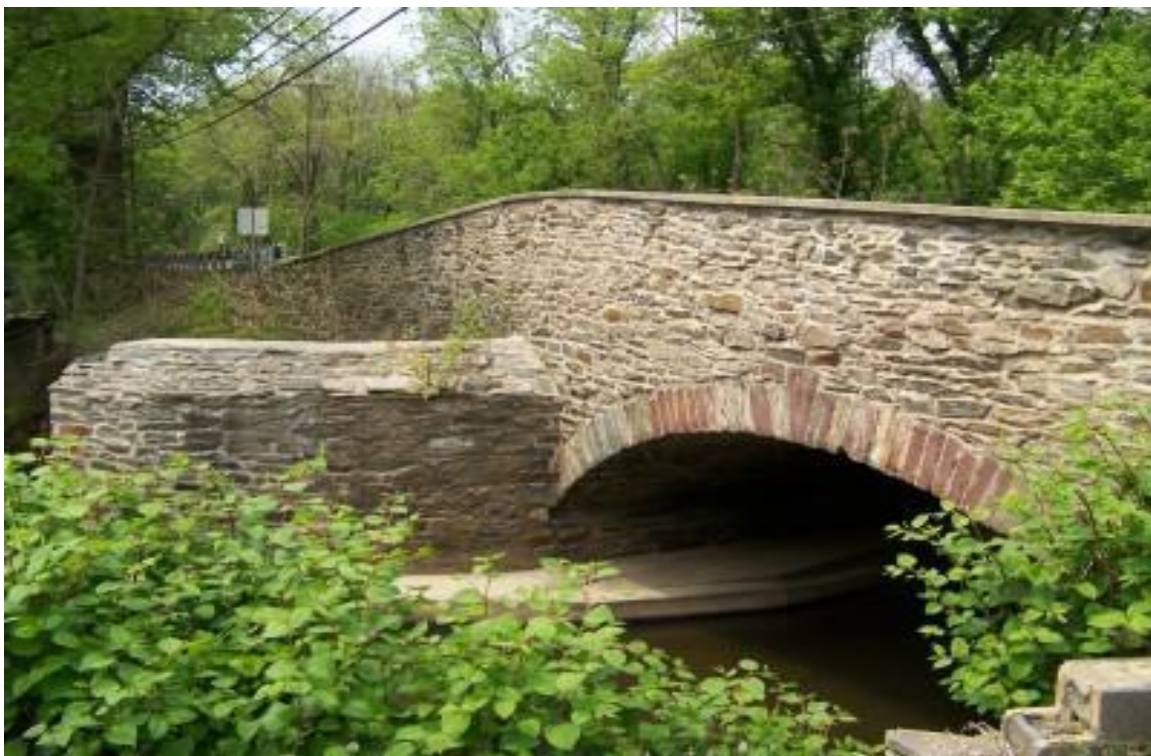
**Figure B32. Loudoun County Structure No. 1025**

*Current Historic Structures Task Group Observations and Recommendations:* The current inspection report indicates that this structure is in fair condition. Previous and planned repairs are in accordance with the Recommended Treatment in the 2001 Management Plan. The task group reiterates the recommendations of (continued) repair and maintain for vehicular use, with subsequent preventive maintenance as needed, in the 2001 Management Plan.
