## **A Management Plan for Historic Bridges In Virginia: The 2024 Update**

**Final Report VTRC 26-R03**

**A MANAGEMENT PLAN FOR HISTORIC BRIDGES IN VIRGINIA:  
THE 2024 UPDATE**

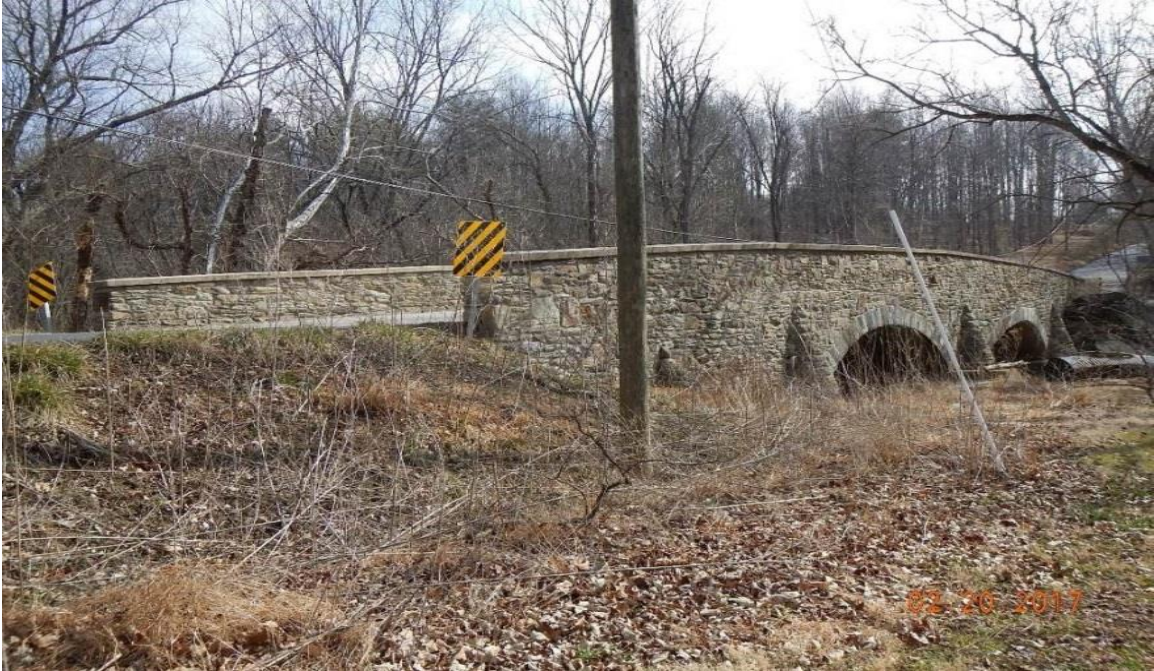
**Figure B33. Loudoun County Structure No. 6088**

*Current Historic Structures Task Group Observations and Recommendations:* The current inspection report indicates that this structure is in good condition. Previous and planned repairs are in accordance with Recommendation 2 in the 2001 Management Plan. The task group reiterates the recommendations (Recommendation 2) of (continued) repair and maintain for vehicular use, with subsequent preventive maintenance as needed, in the 2001 Management Plan.

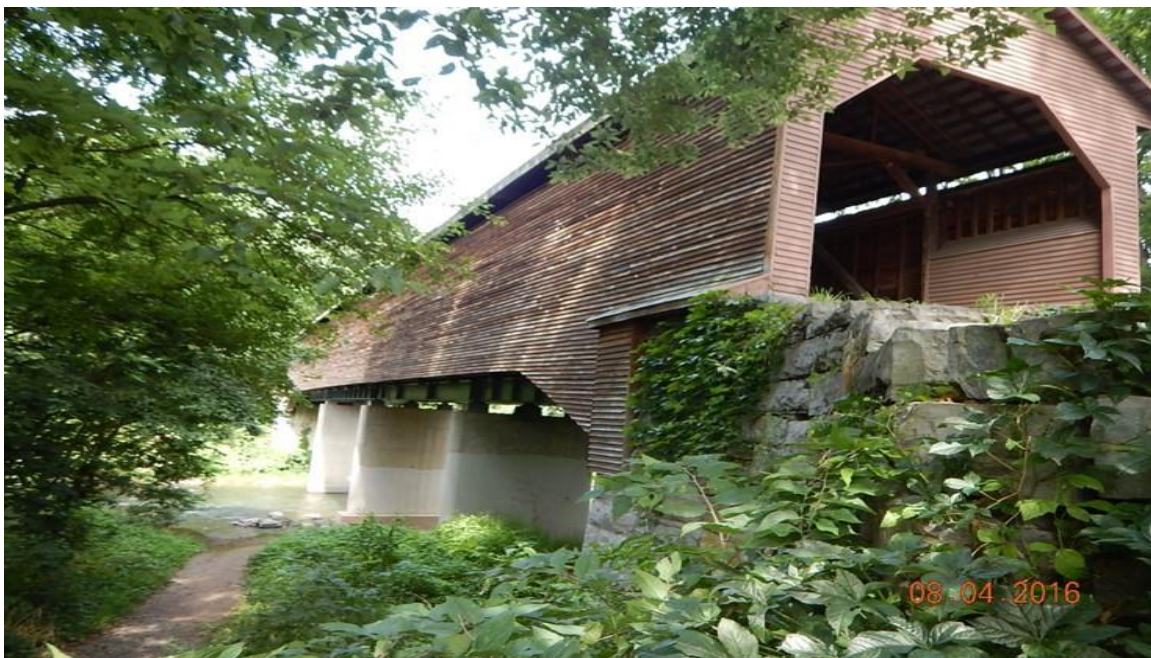
**Figure B35. Shenandoah County Structure No. 6078**

*Current Historic Structures Task Group Observations and Recommendations:* The current inspection report indicates that this structure is in good condition. Overweight and over-height and/or over-width vehicles must be prevented from accessing this bridge. Posted weight and height/width limitation signs have been repeatedly disregarded by drivers in the past. The task group reiterates the recommendation of (continued) repair and maintain for vehicular use, with subsequent preventive maintenance as needed, in the 2001 Management Plan. As a second option, adaptive use for non-vehicular use (Recommendation 2 in the 2001 Management Plan) could be considered by the district structure and bridge office. This would require funding, acquisition of a new right of way, and a new crossing for Route 720.

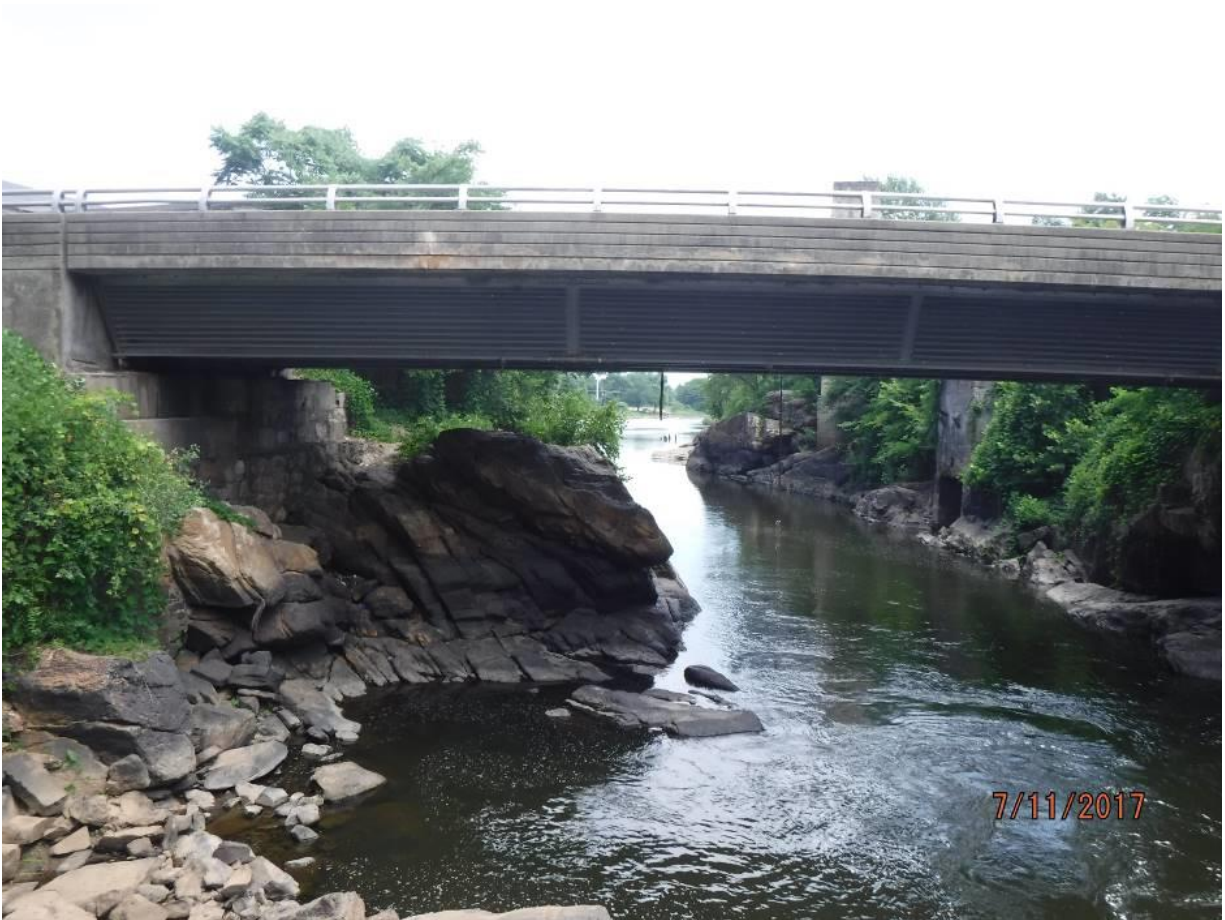
**Figure B36. Chesterfield County Structure No. 1900**

*Current Historic Structures Task Group Observations and Recommendations:* The current inspection report indicates that this structure is in satisfactory condition. The task group reiterates the Recommended Treatment of (continued) repair and maintain for vehicular use, with subsequent preventive maintenance as needed, in the 2018 addendum.

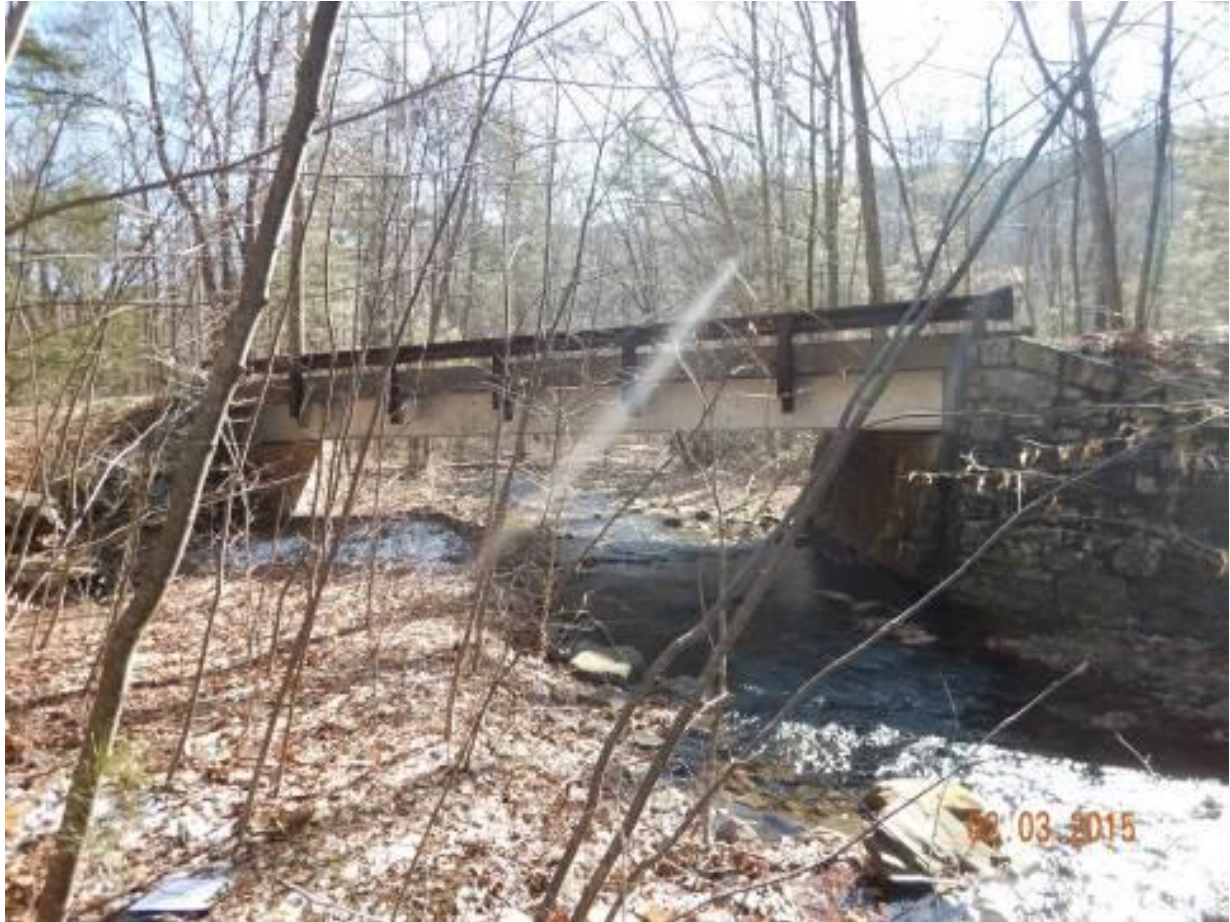
**Figure B37. Rockingham County Structure No. 6166**

*Current Historic Structures Task Group Observations and Recommendations:* The current inspection report indicates that this structure is in fair condition. The task group reiterates the recommendation of (continued) repair and maintain for vehicular use, with subsequent preventive maintenance as needed, in the 2018 addendum.
