CN R924060

**Zuni Bowl and One Rock Check Dam Research –
Phase 1**

Final Report

Rio Grande Return for the New Mexico Department of Transportation Research Bureau

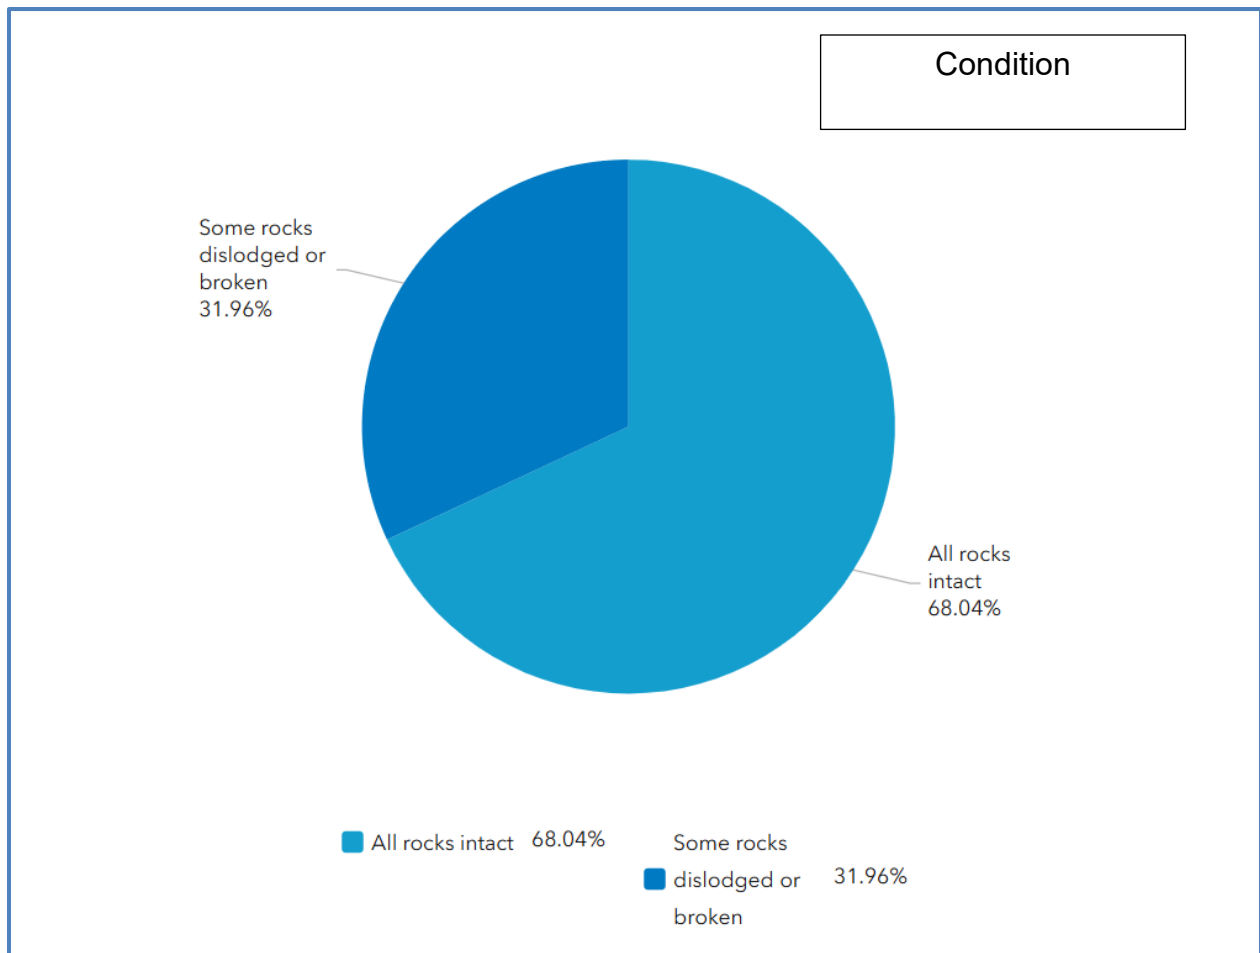
Figure 3-3. Condition (all rocks intact, some rocks dislodged or broken).

The majority of structures surveyed (68%) were entirely intact, whereas the remainder (32%) had at least one rock dislodged or broken. This is shown in Figure 3-3. This means that most of the structures have become integrated with the landscape and are likely functioning to arrest erosion. Dislodged rocks were deemed to be caused by water in all cases except one that was identified as human interference. RGR did not identify or survey any significantly deteriorated structures. Figure 3-4 shows a structure where some rocks were dislodged by water.

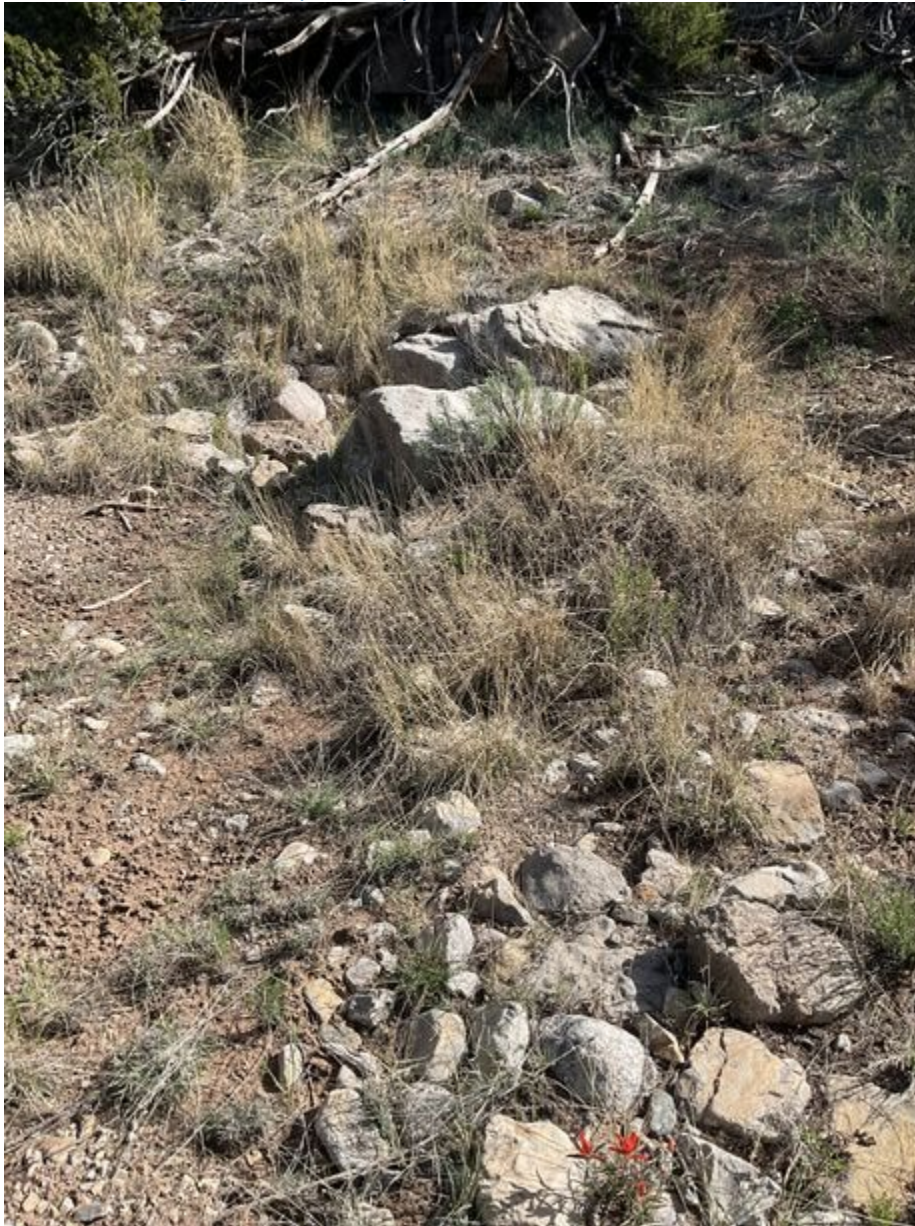
Condition

Some rocks dislodged or broken

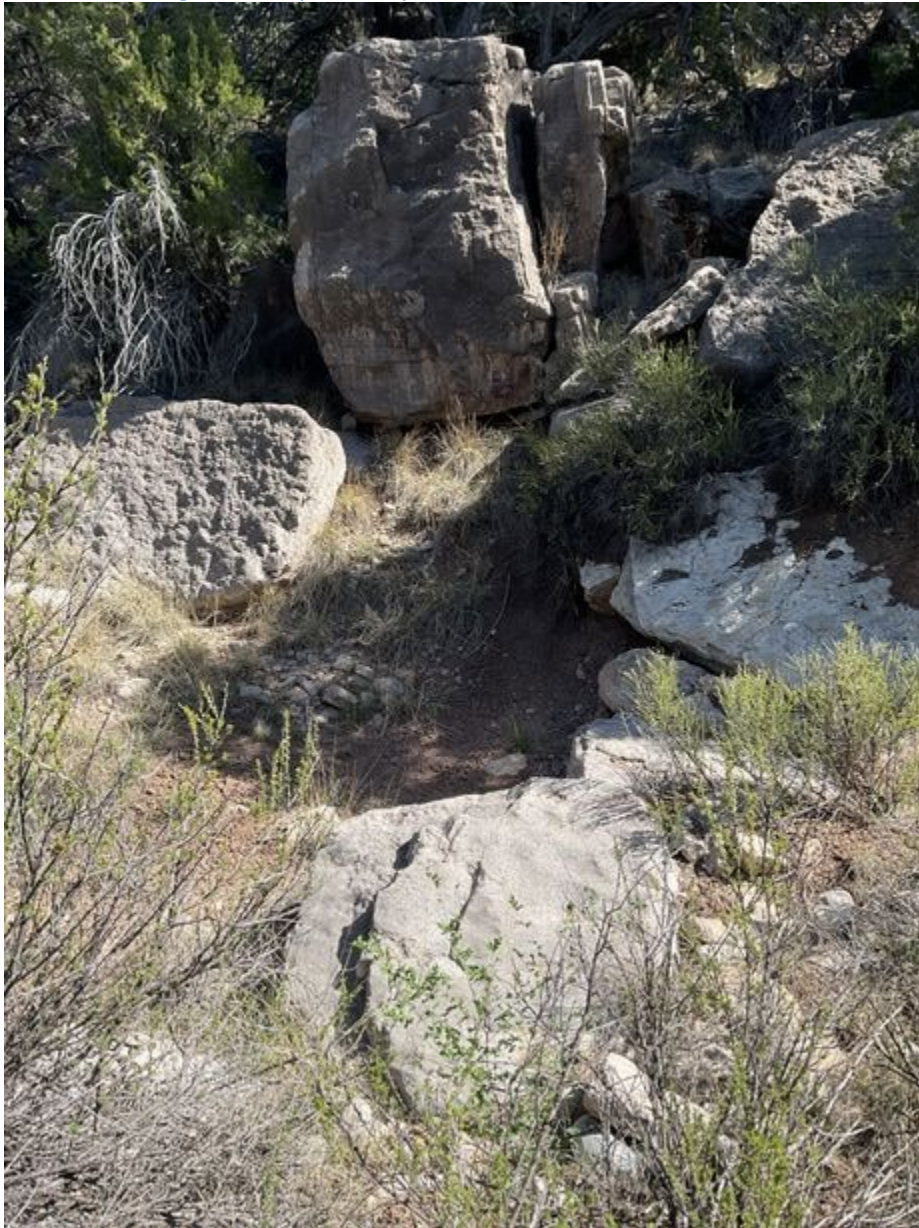
Condition

Some rocks dislodged or broken

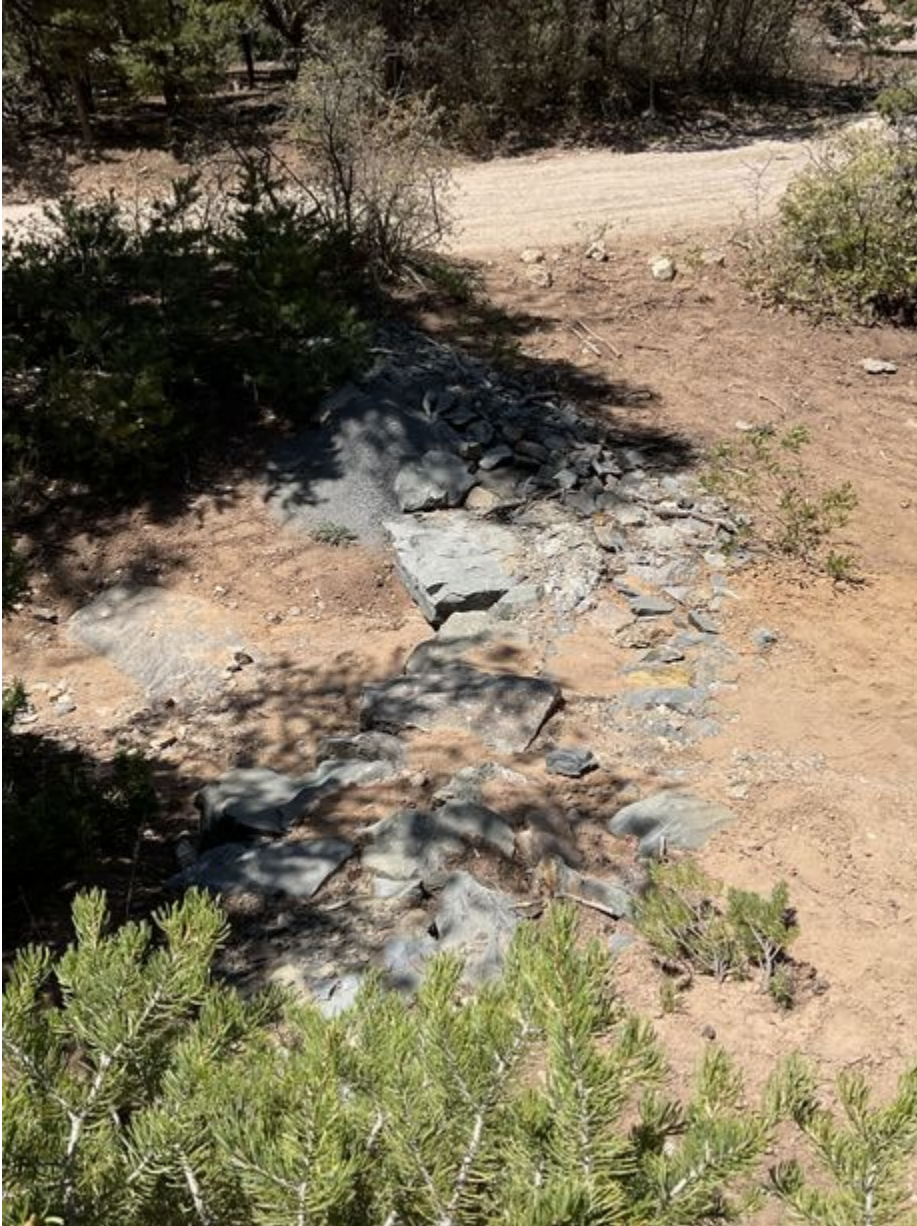
Condition

Some rocks dislodged or broken

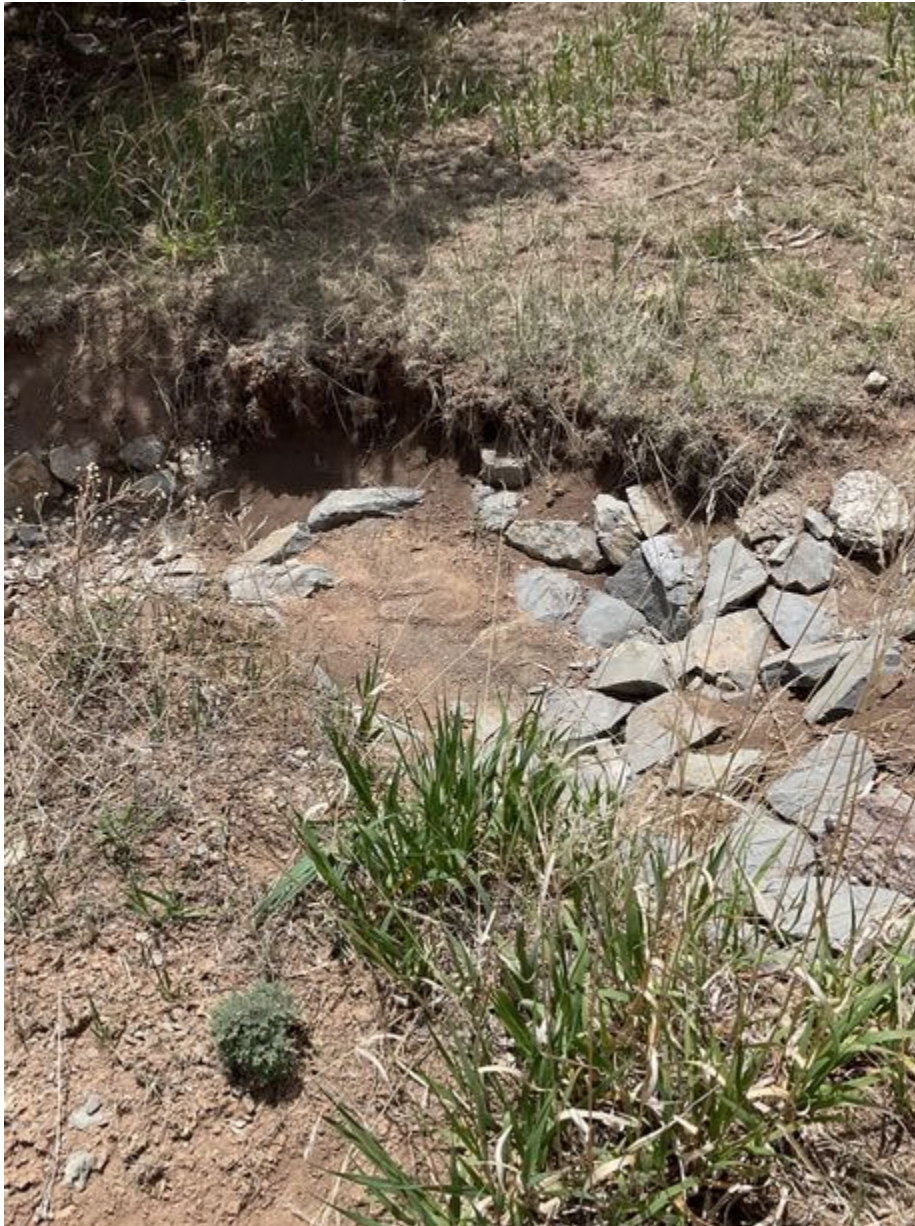
Condition

Some rocks dislodged or broken

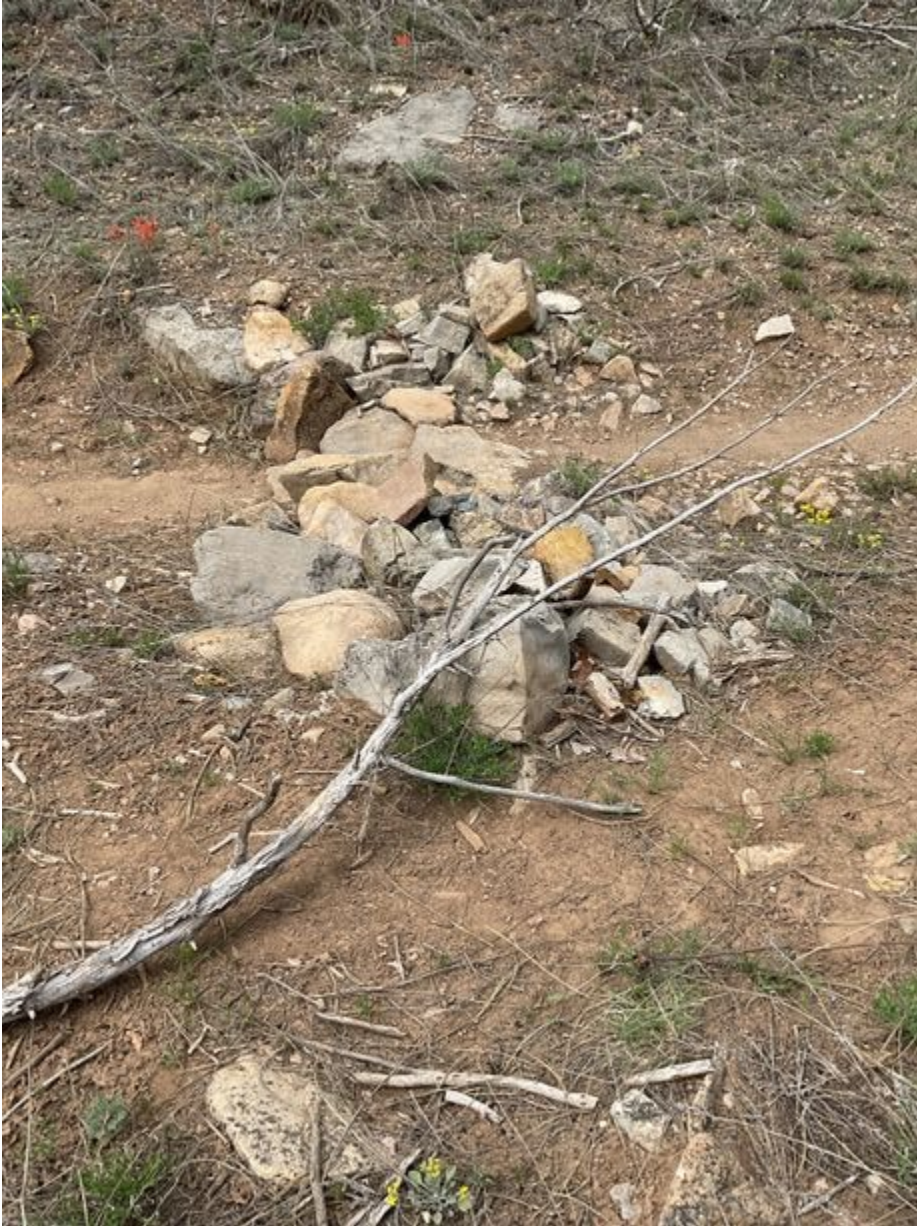
Condition

Some rocks dislodged or broken

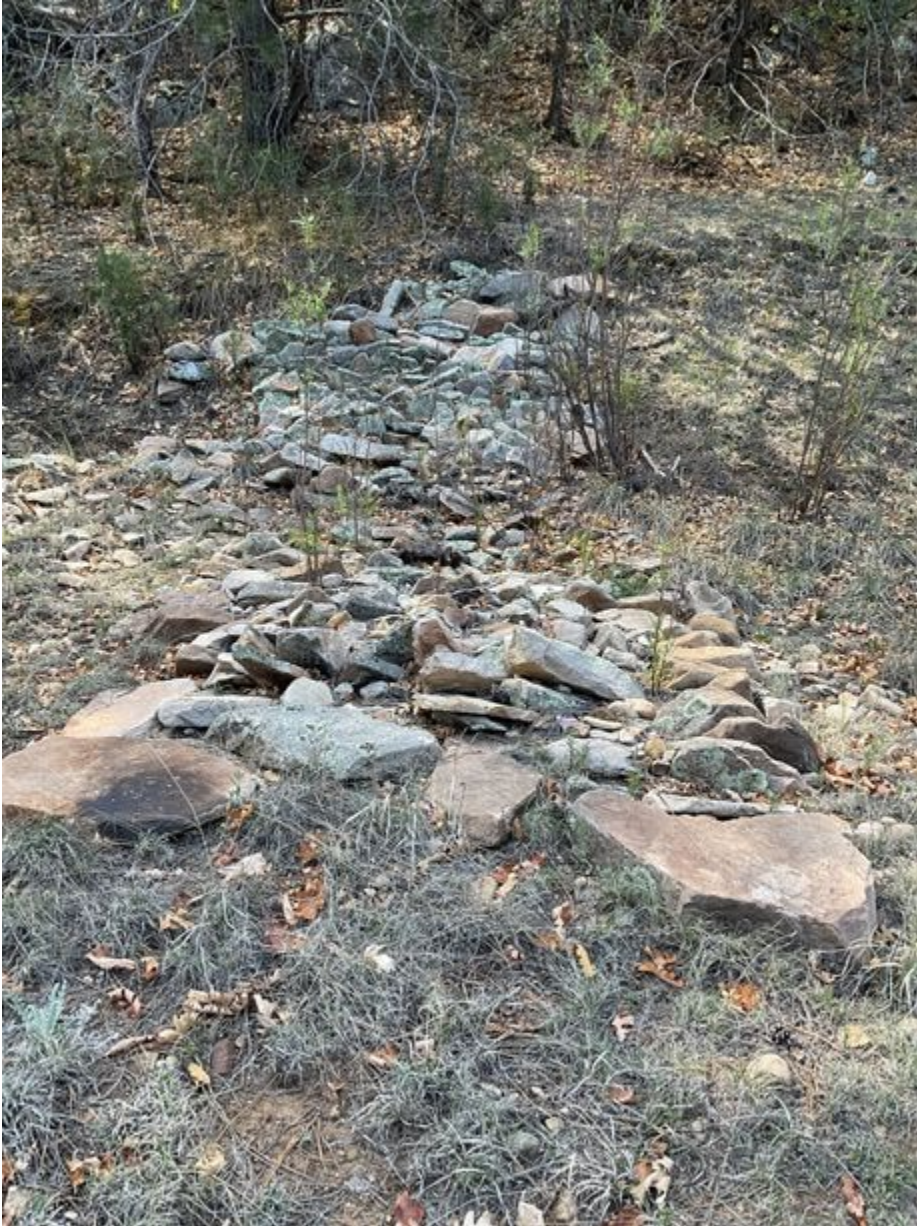
Condition

Some rocks dislodged or broken

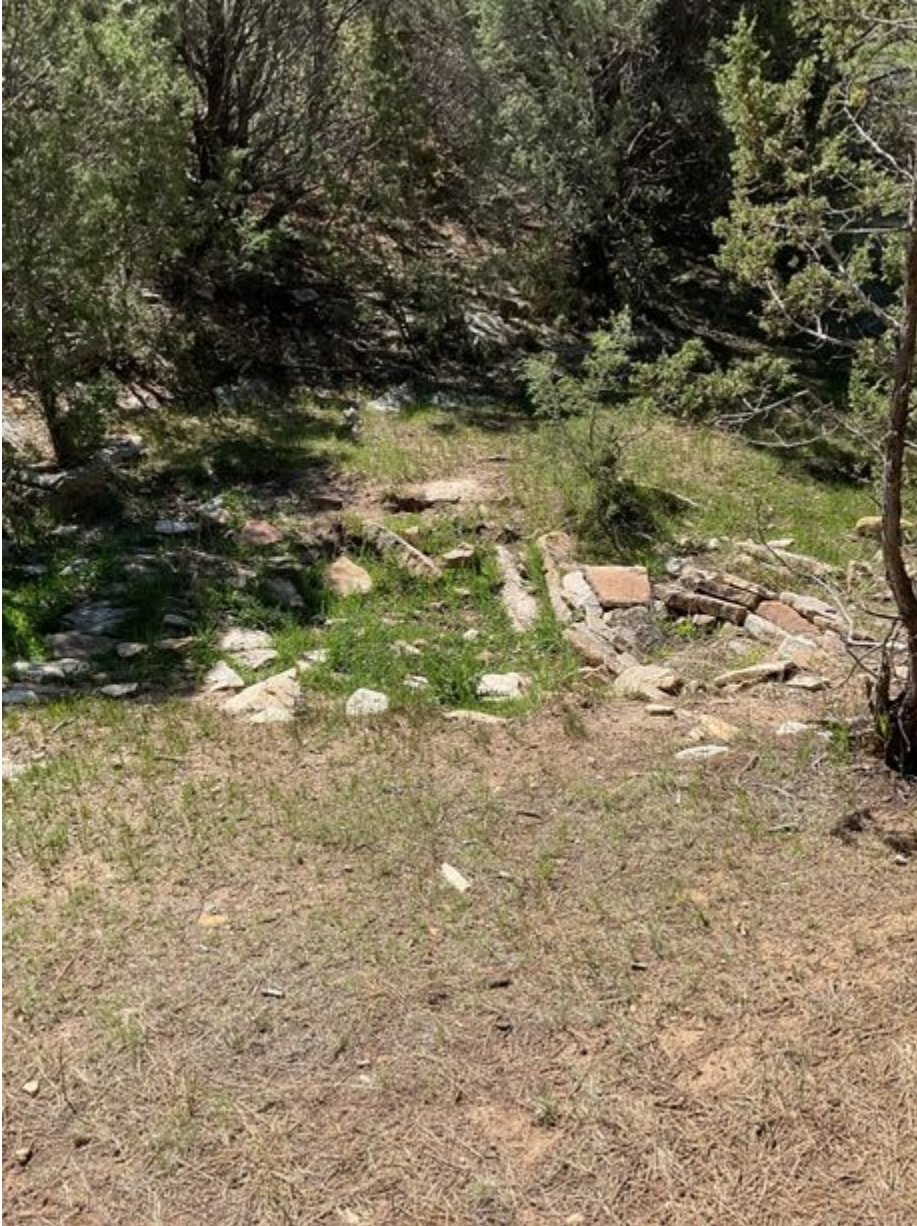
Condition

Some rocks dislodged or broken

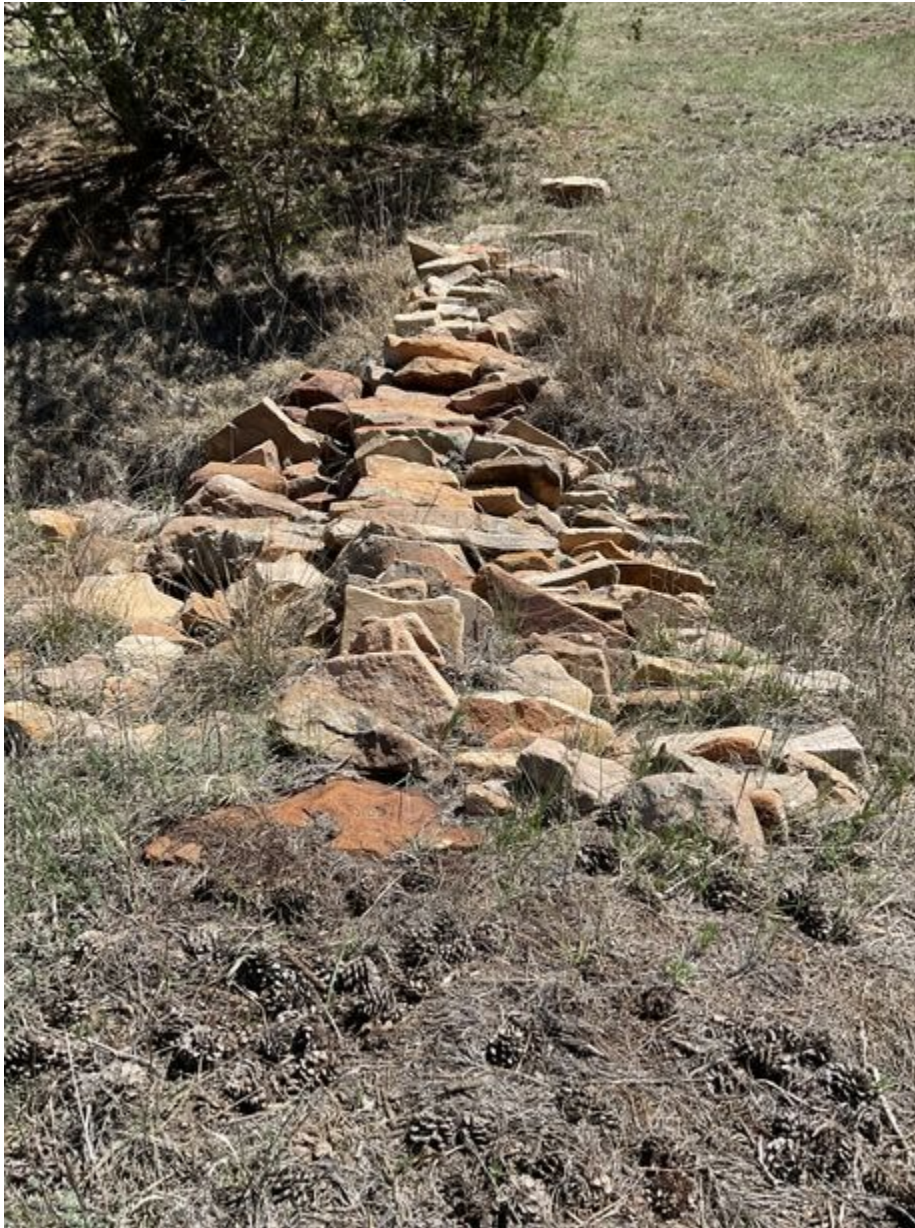
Condition

Some rocks dislodged or broken

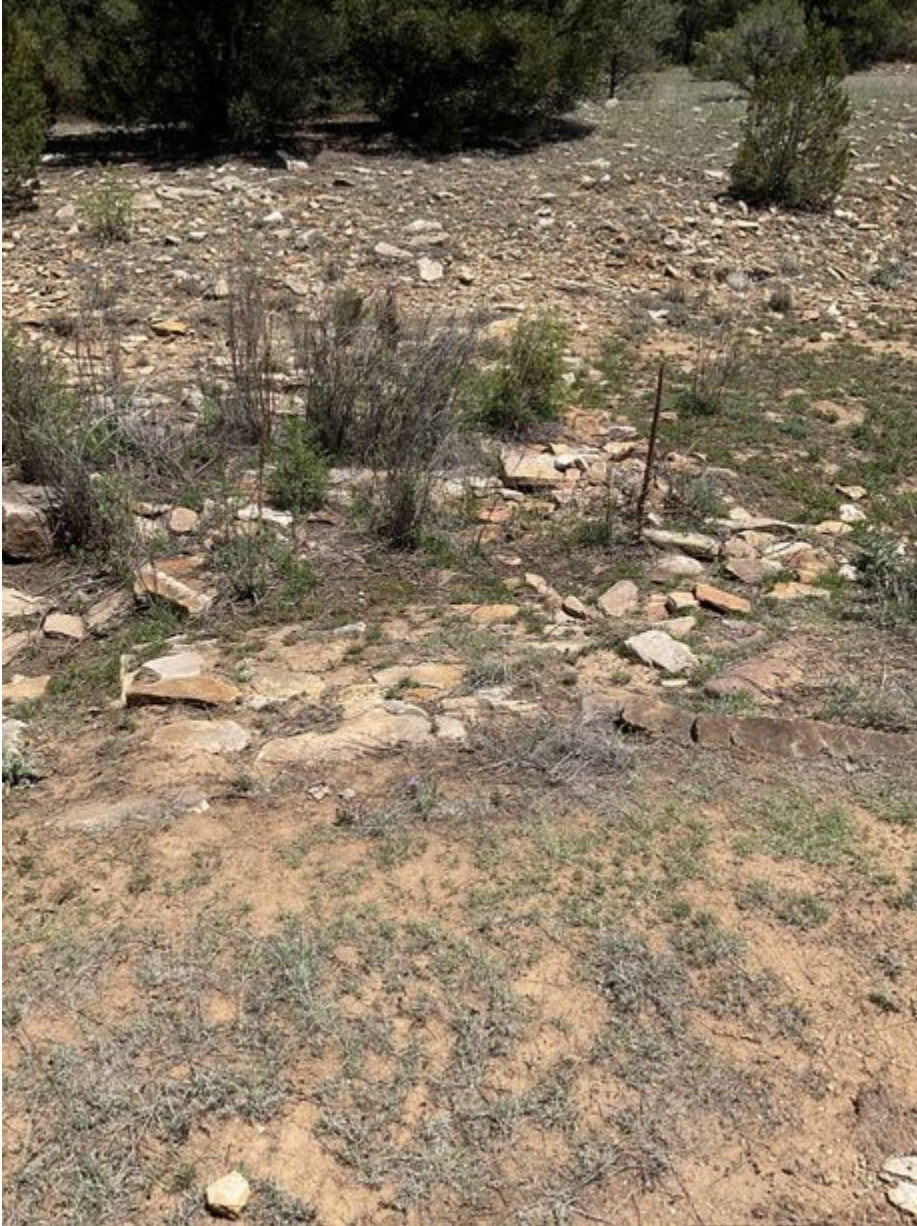
Condition

Some rocks dislodged or broken

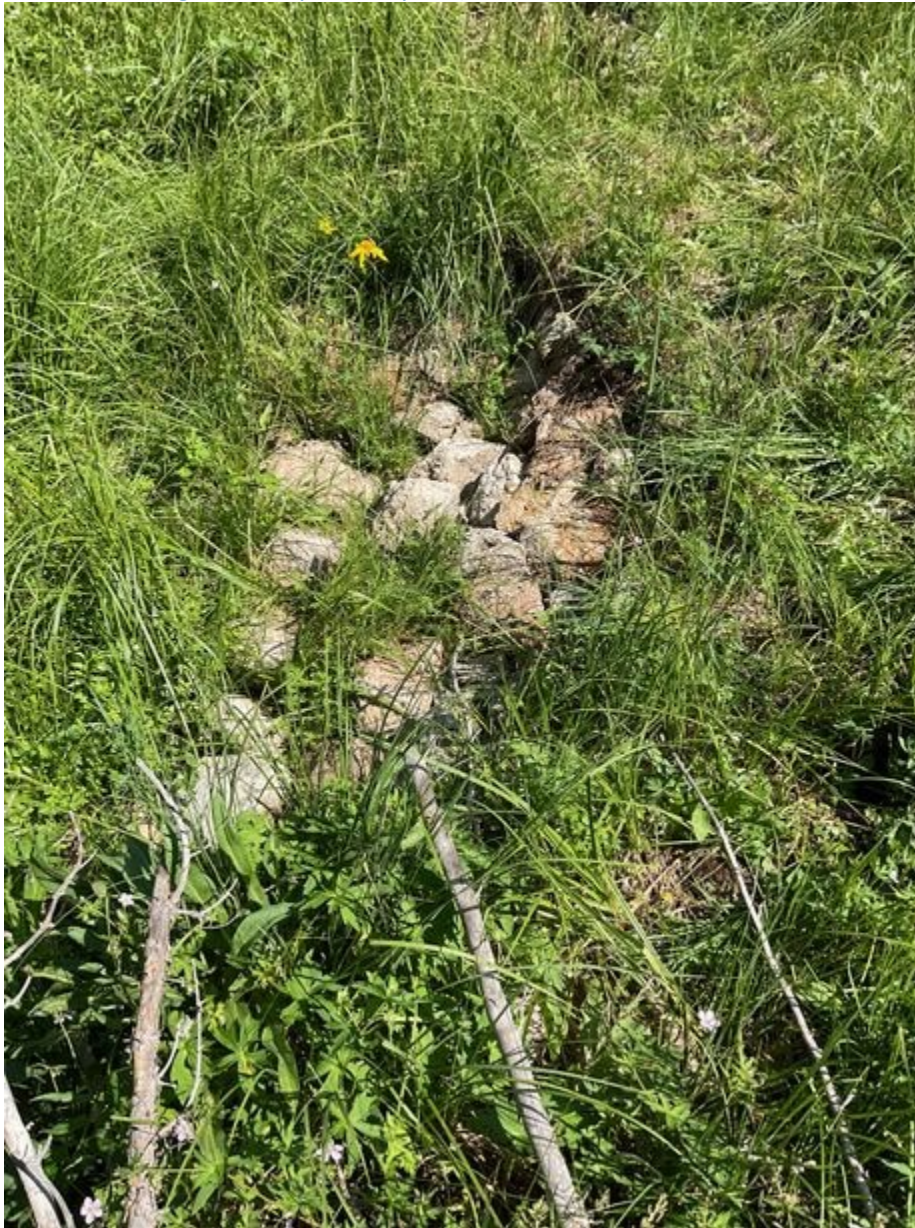
Condition

Some rocks dislodged or broken

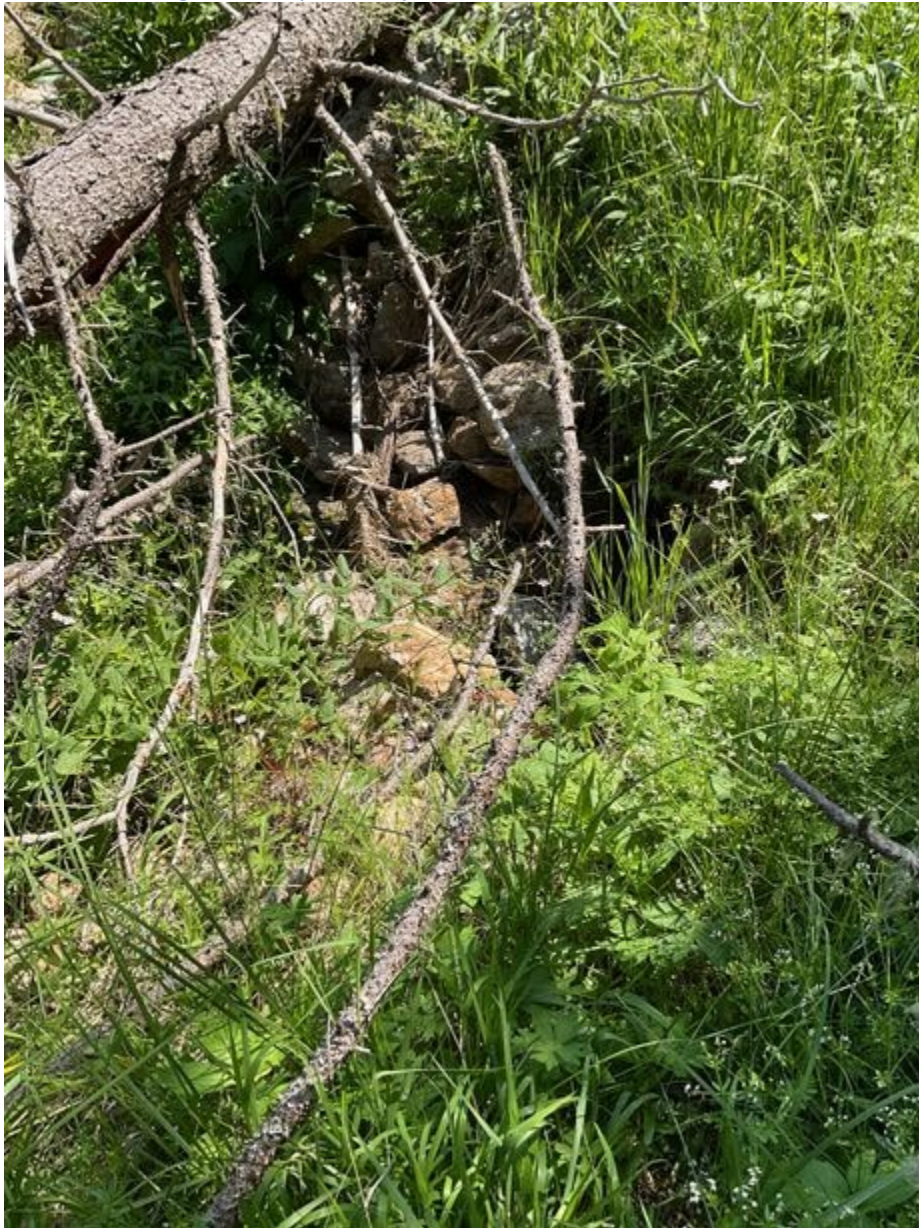
Condition

Some rocks dislodged or broken

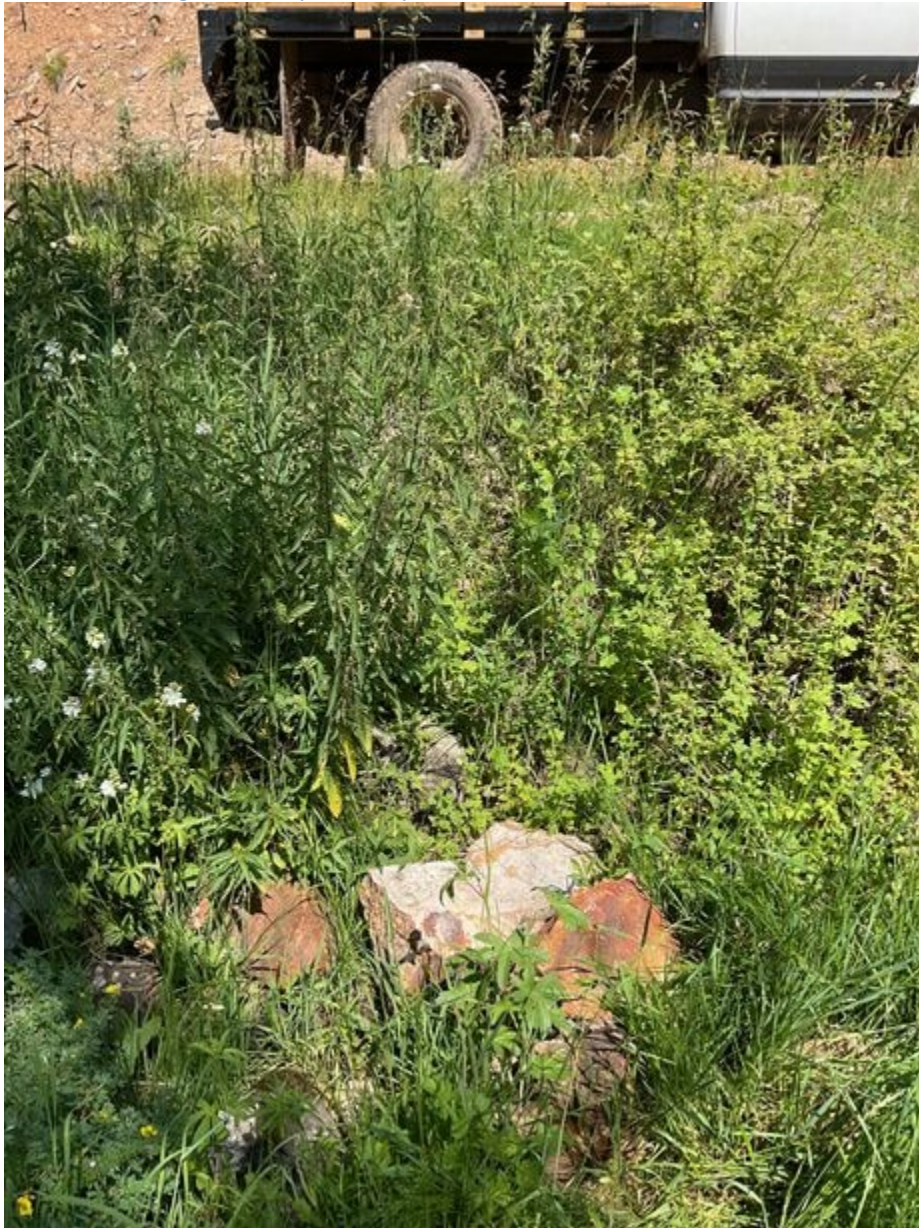
Condition

Some rocks dislodged or broken

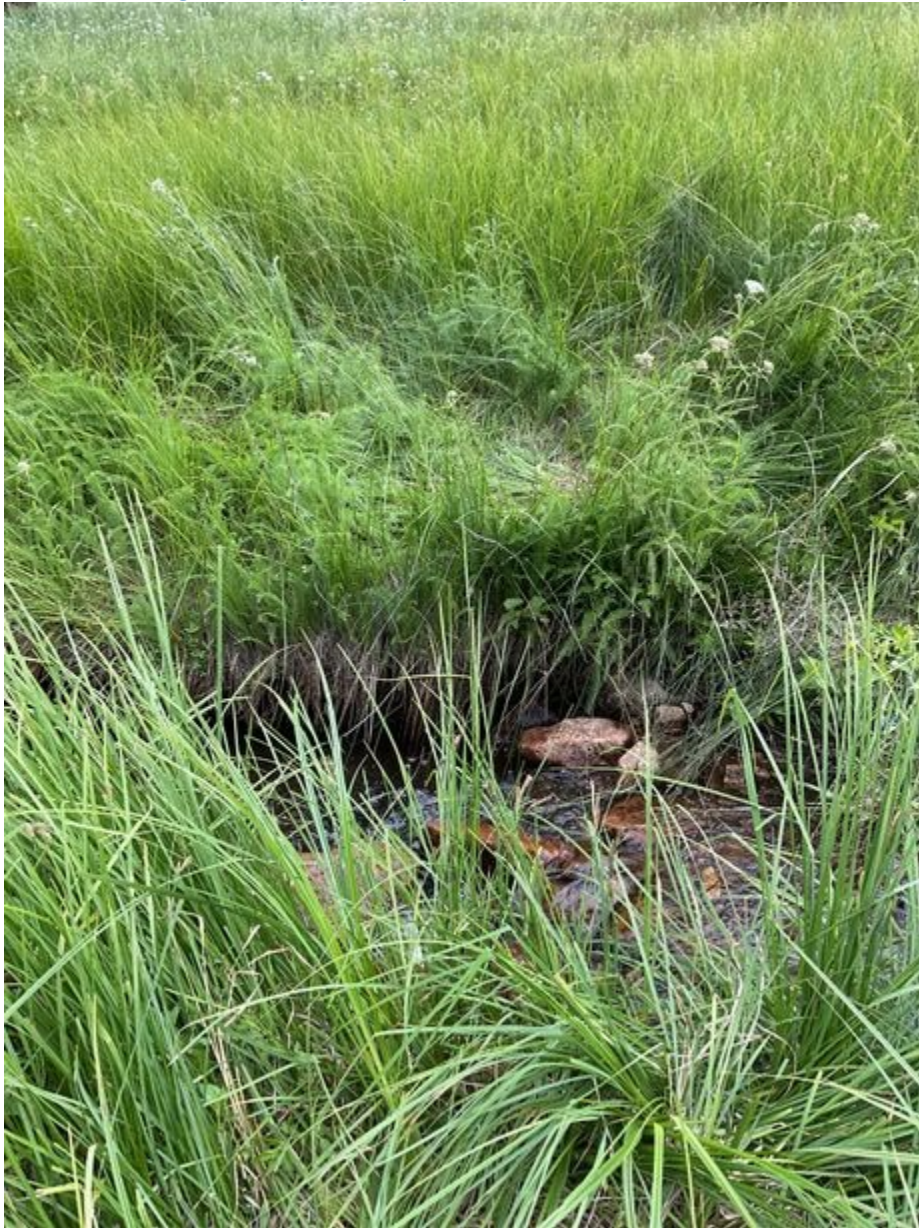
Condition

Some rocks dislodged or broken

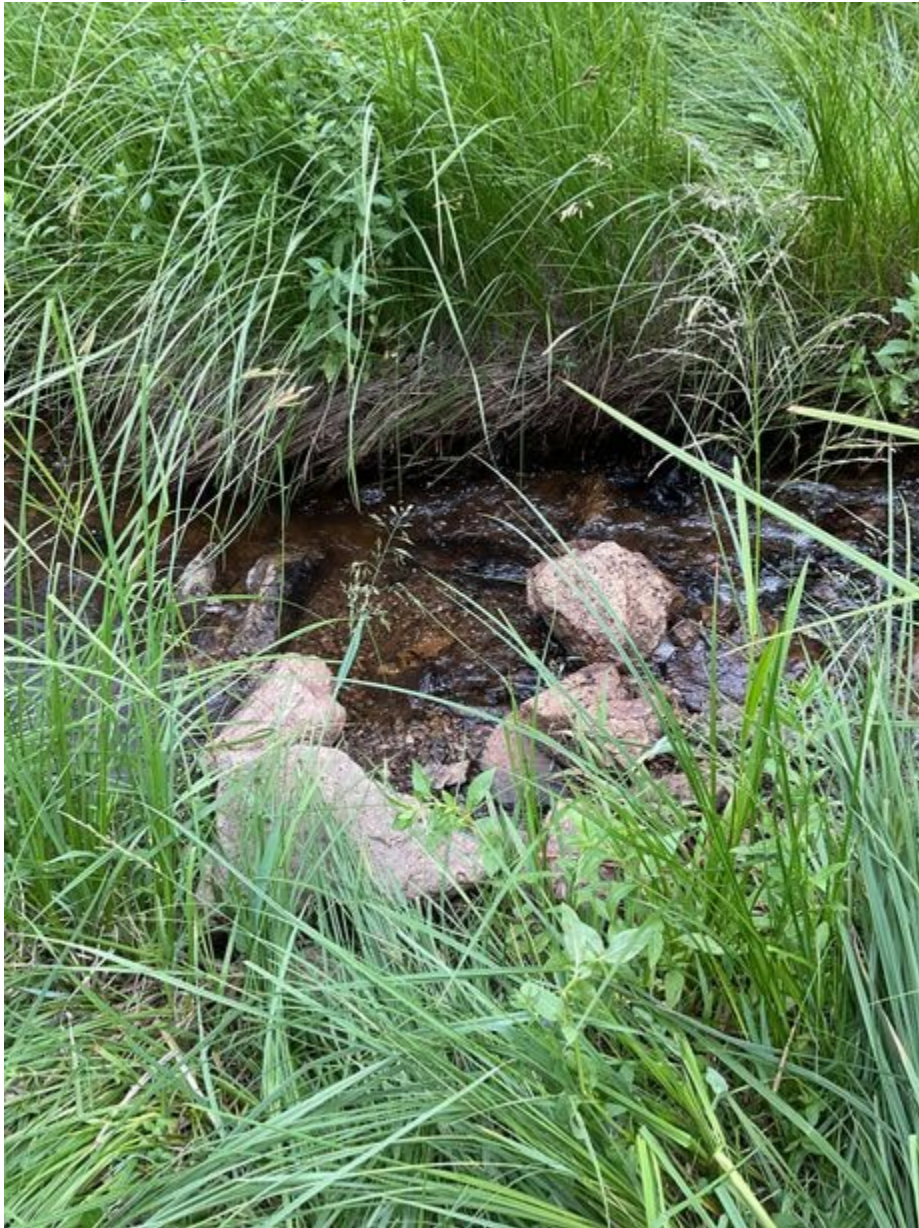
Condition

Some rocks dislodged or broken

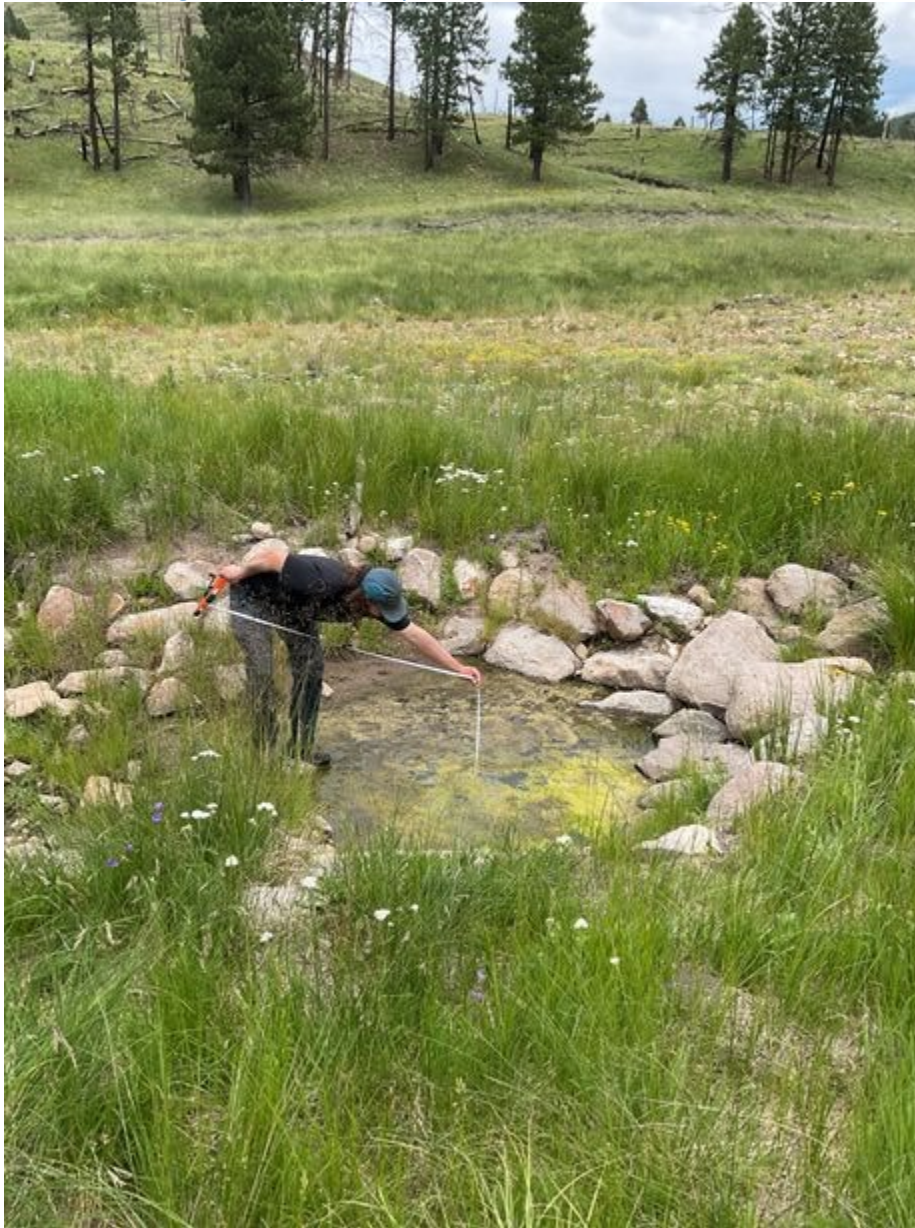
Condition

Some rocks dislodged or broken

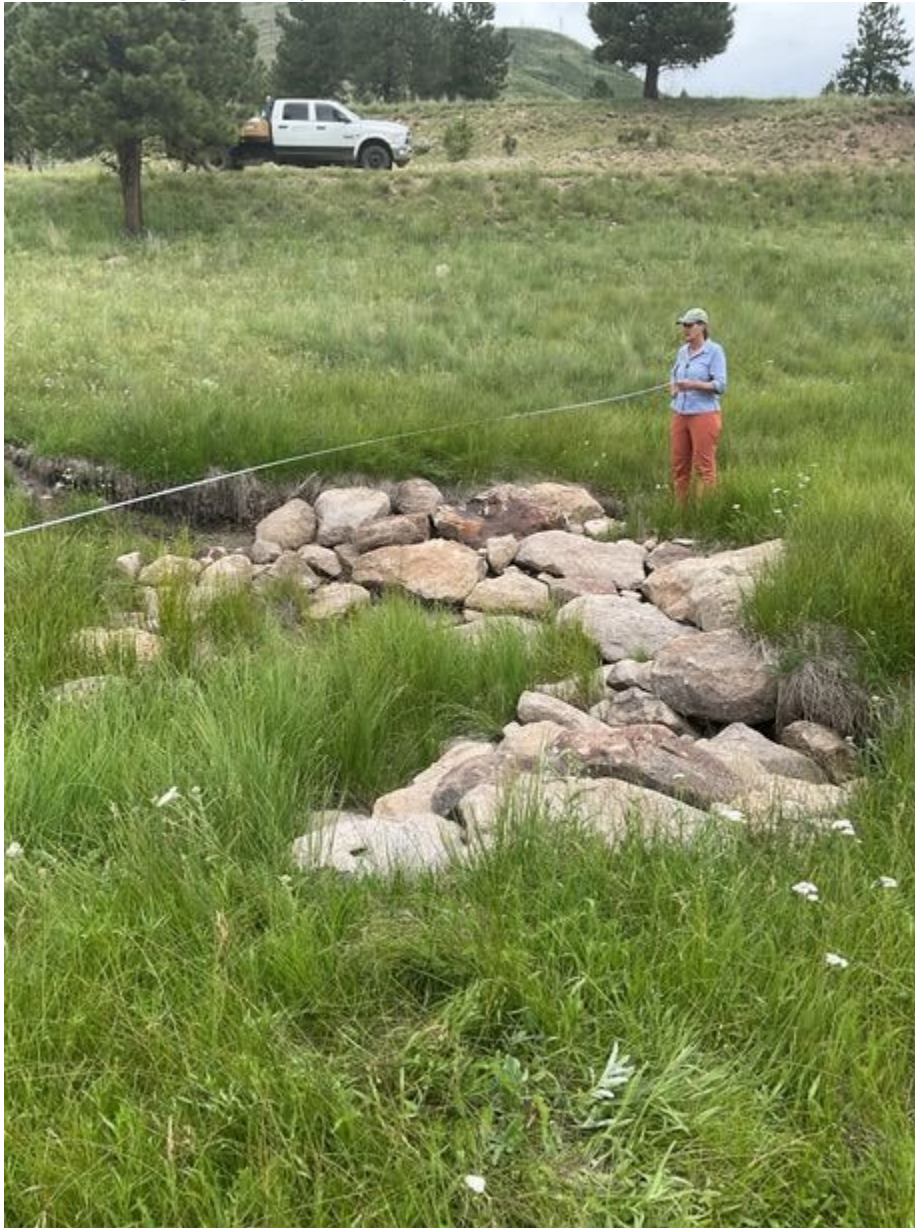
Condition

Some rocks dislodged or broken

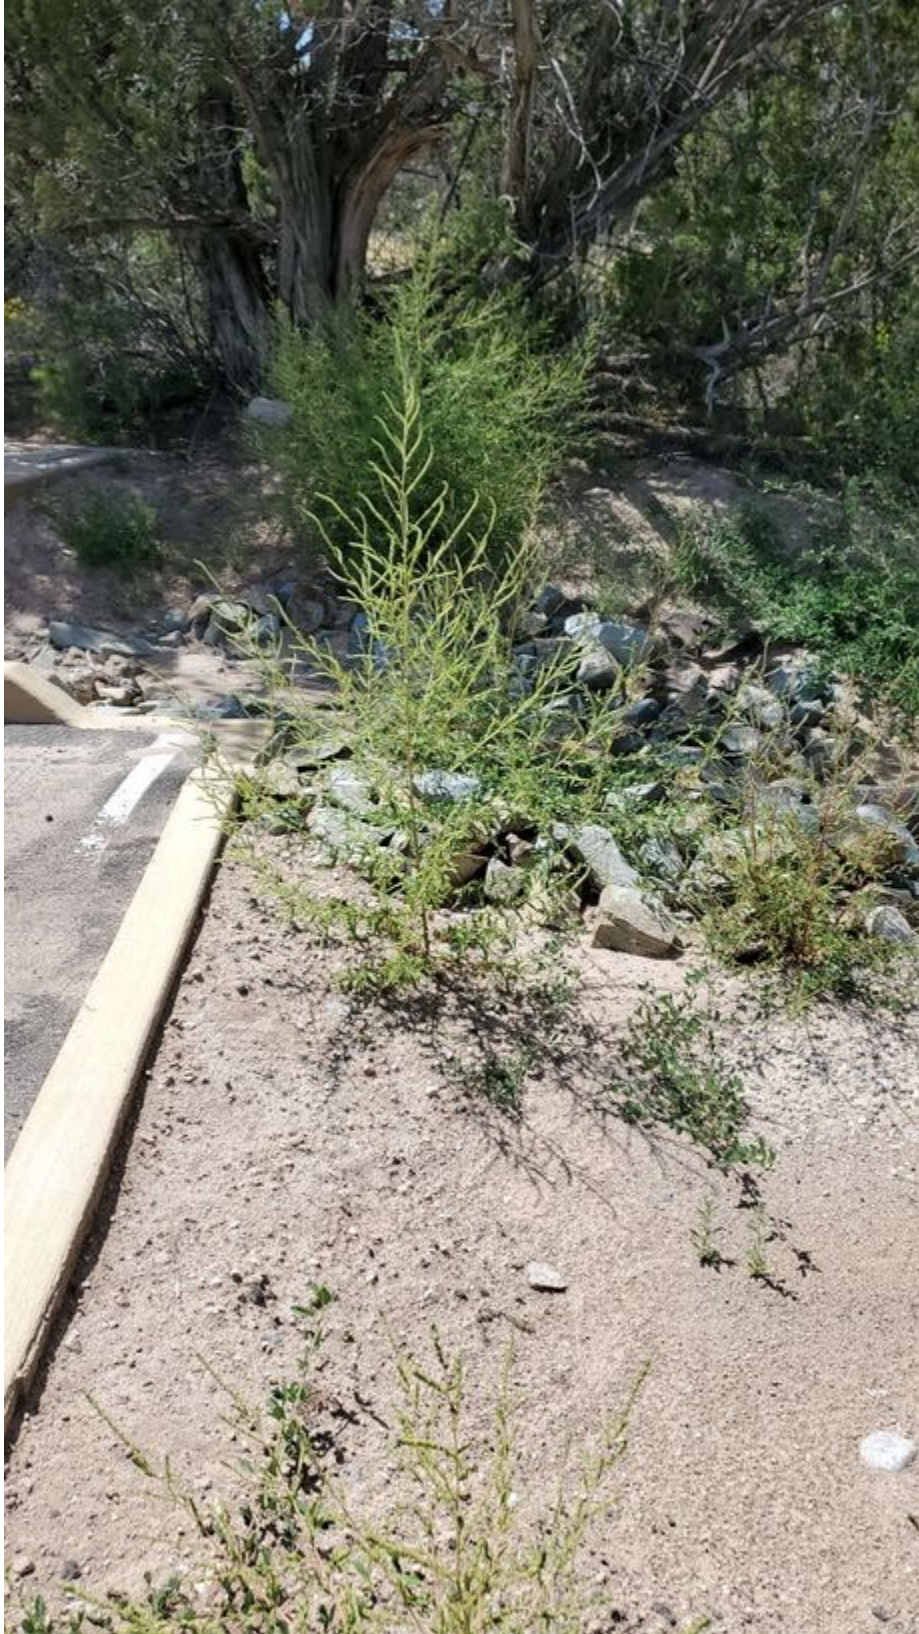
Condition

Some rocks dislodged or broken
