Report No. UT-25.12

ASSET CONDITION ASSESSMENT USING AI AND COMPUTER VISION

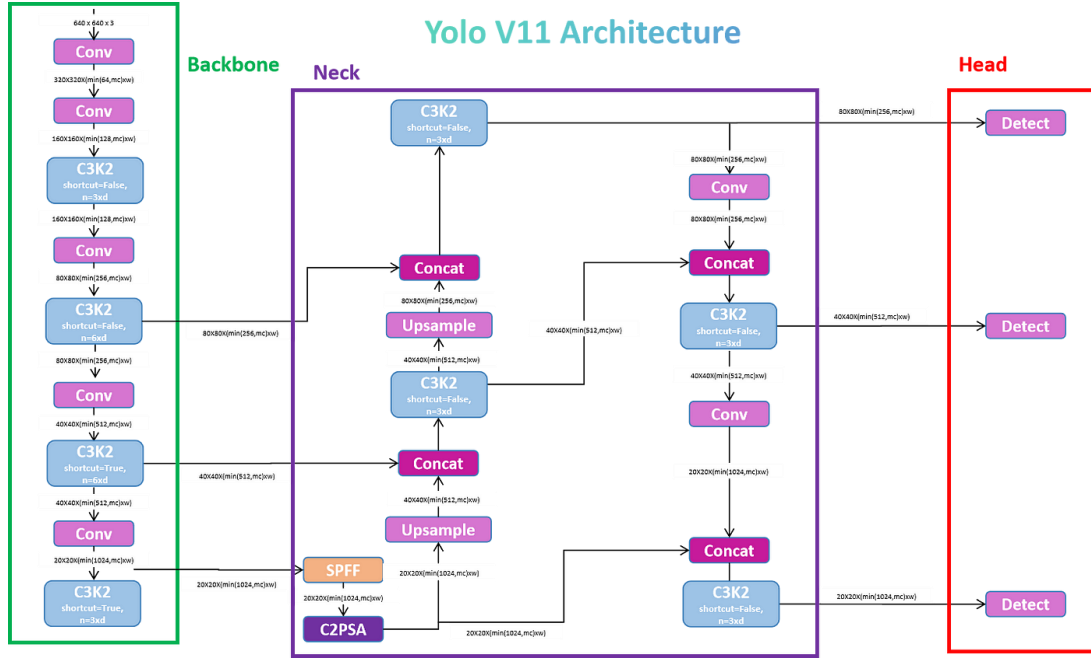
Figure 1. YOLOv11 Architecture Overview

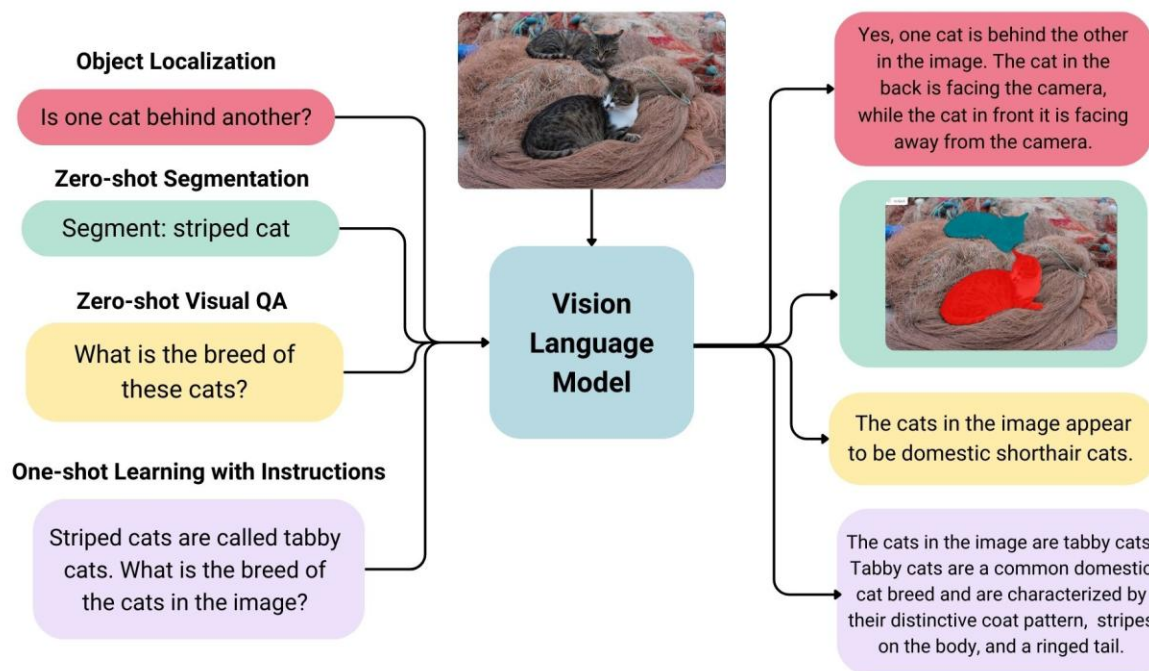
Figure 2. Vision Language Models Applications

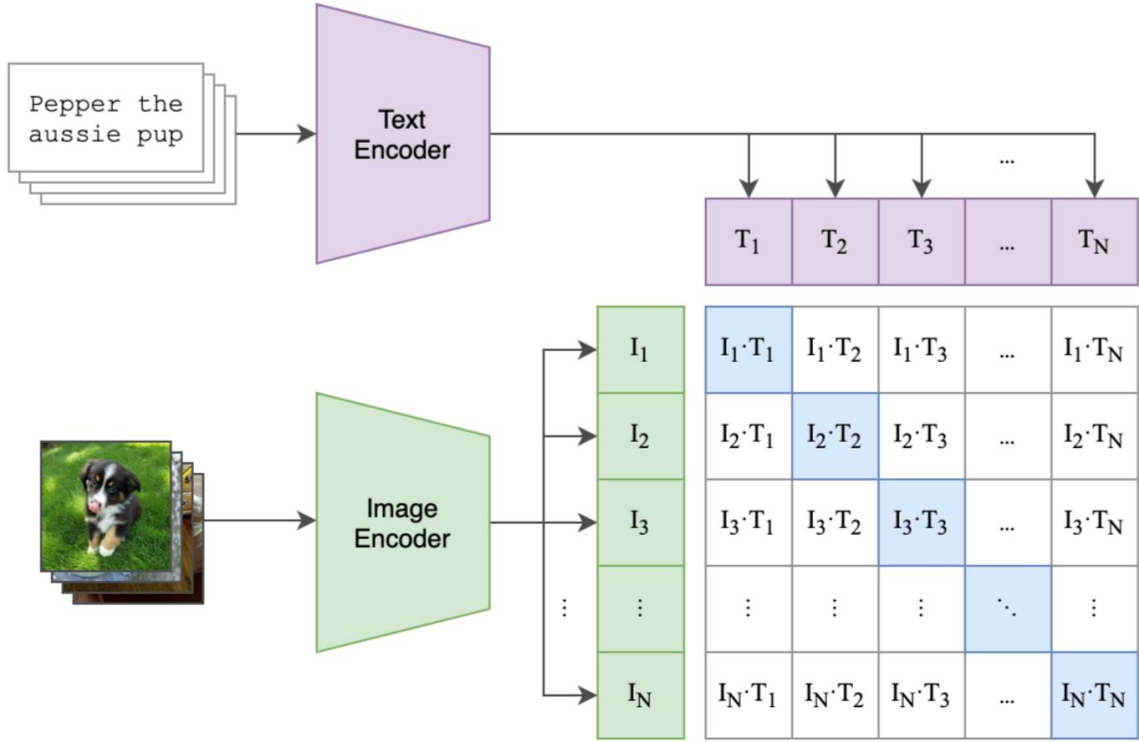
Figure 3. VLM Architecture Overview

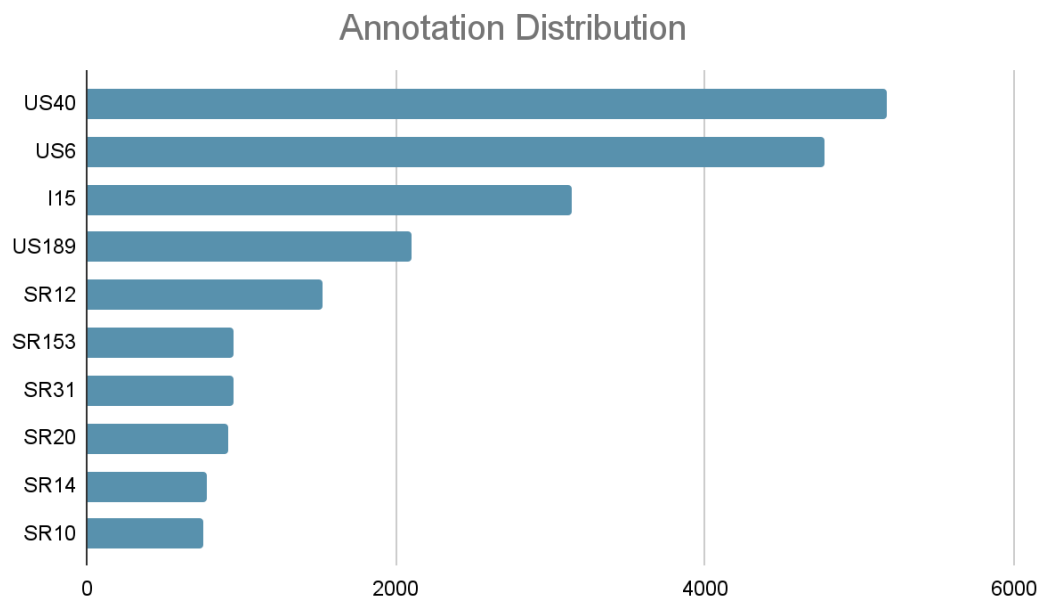
Figure 4. Annotated Images within Each Road

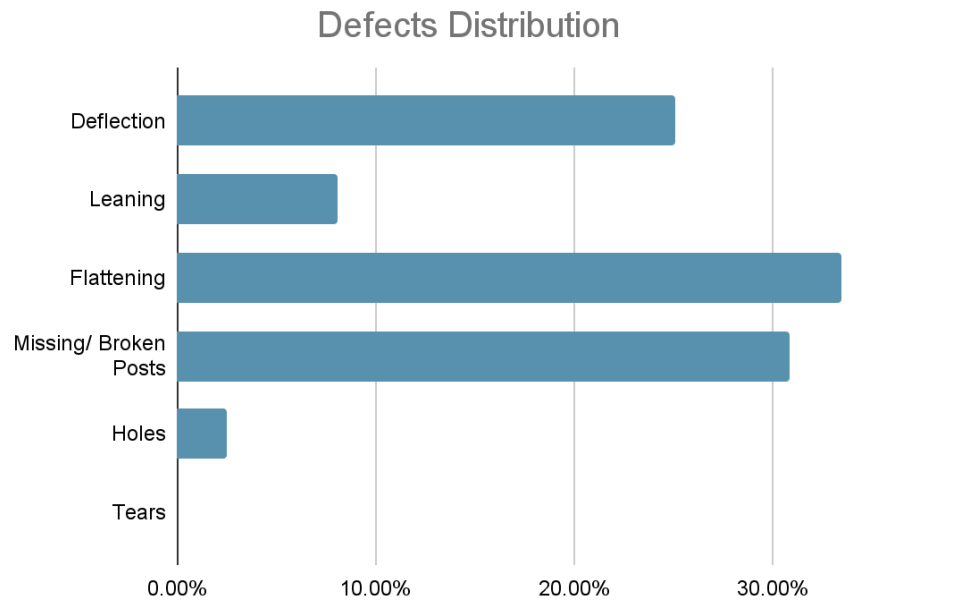
Figure 5. Distribution of Defects in Annotated Images

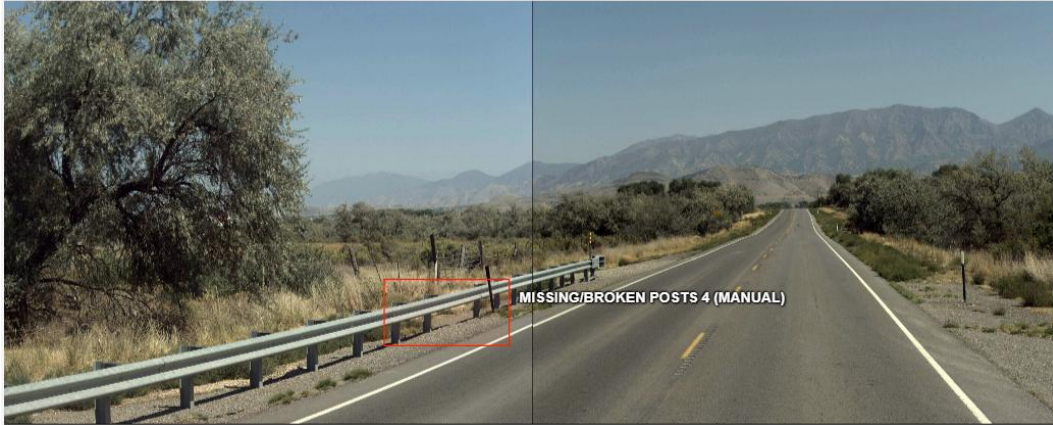
Figure 6. Example of an Annotated Image with a Missing/Broken Post

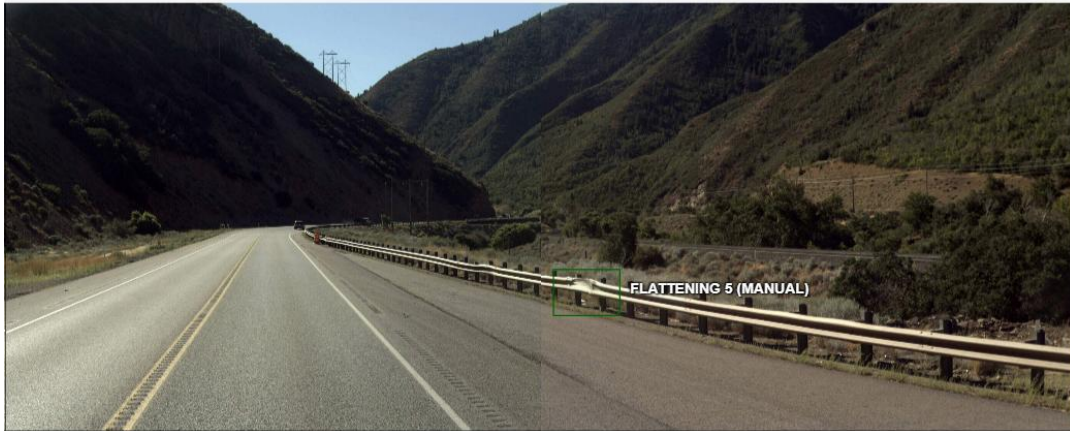
Figure 7. Example of an Annotated Image with a Flattening

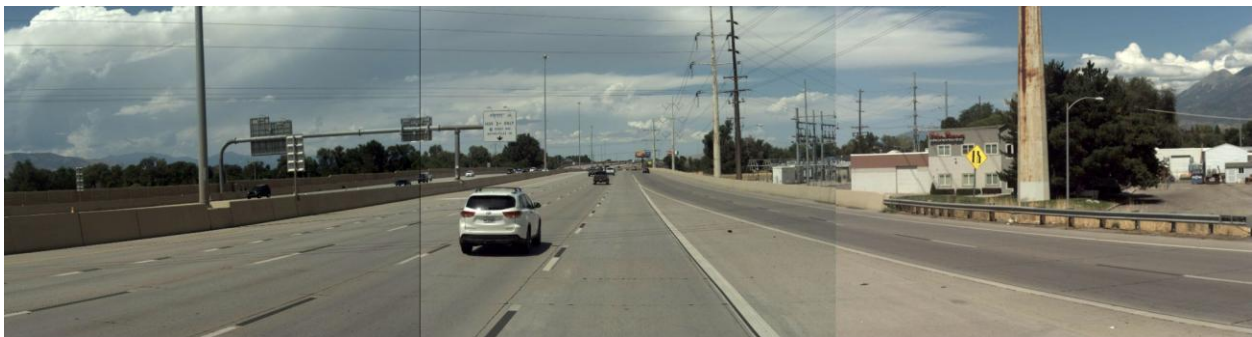
Figure 8. Example of a Challenging Image for Annotation

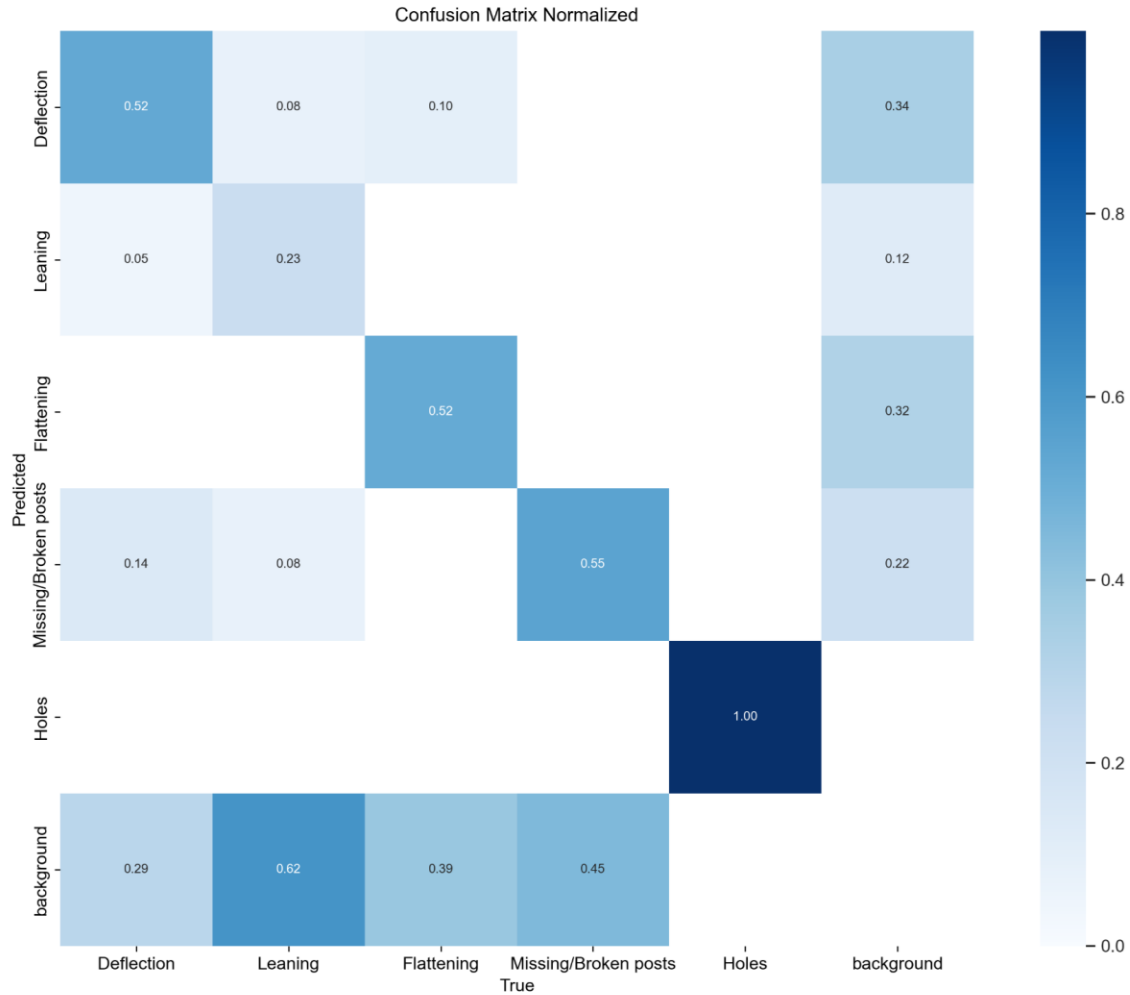
Figure 9. Confusion Matrix for Multiclass Classification

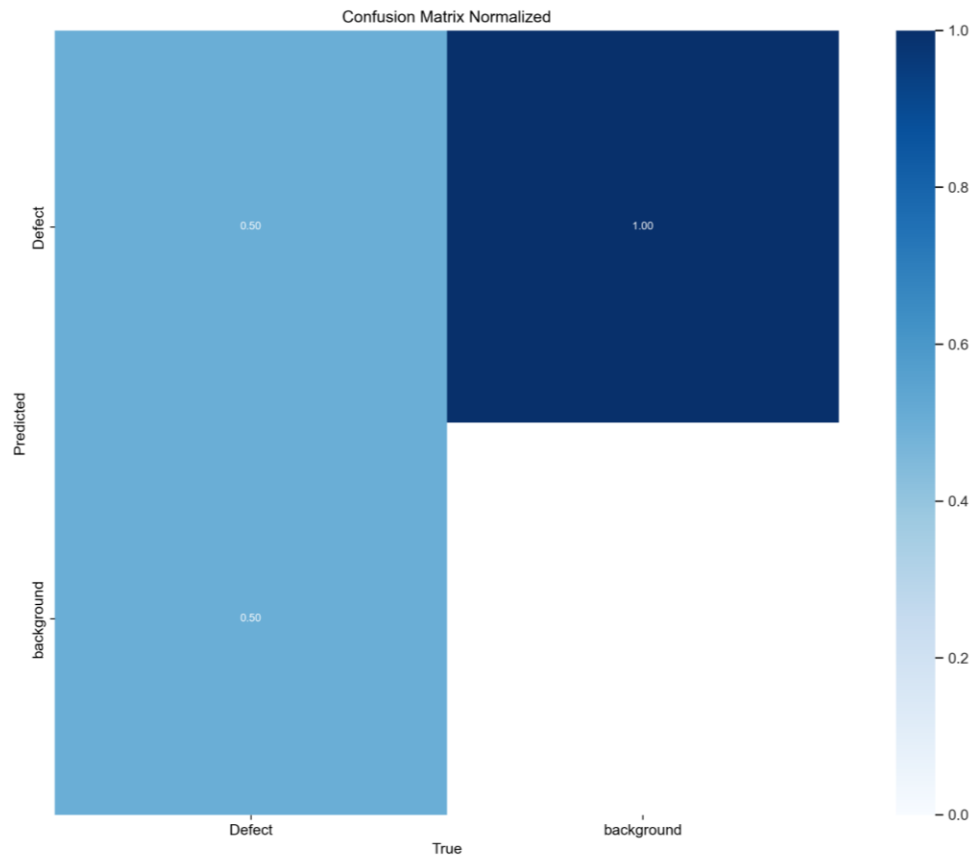
Figure 10. Confusion Matrix for Binary Classification

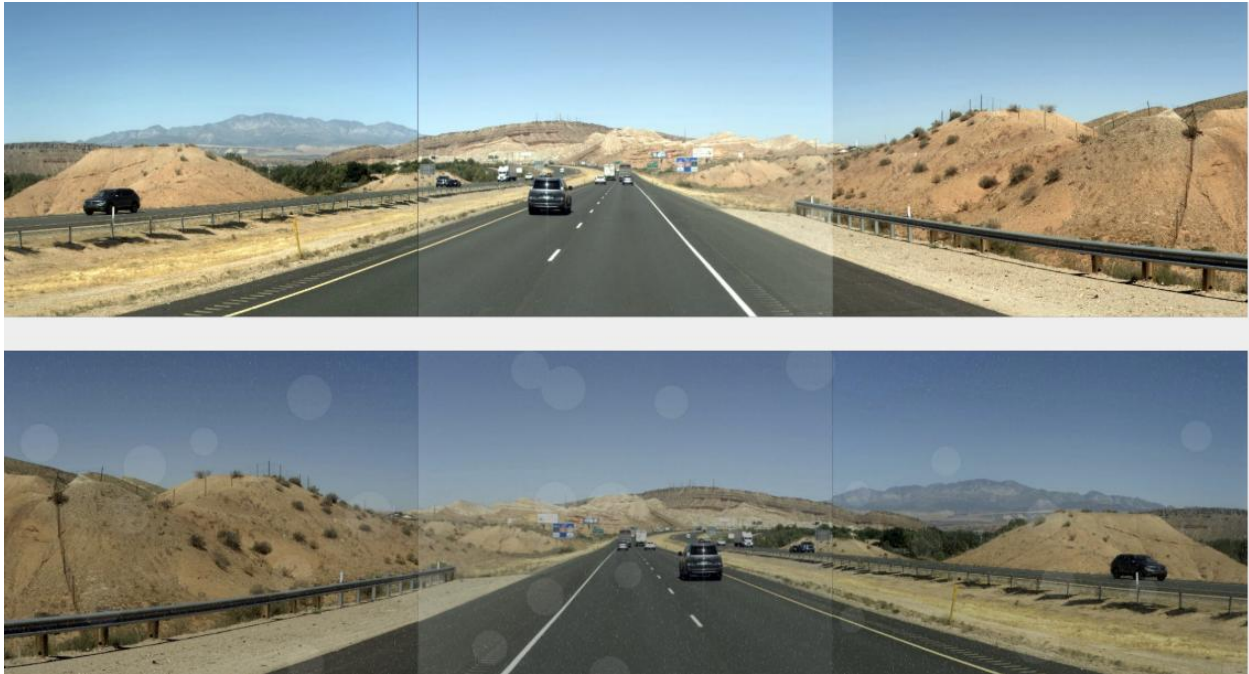
Figure 11. Example of Image Augmentation, Up: Actual Image, Down: Augmented Image

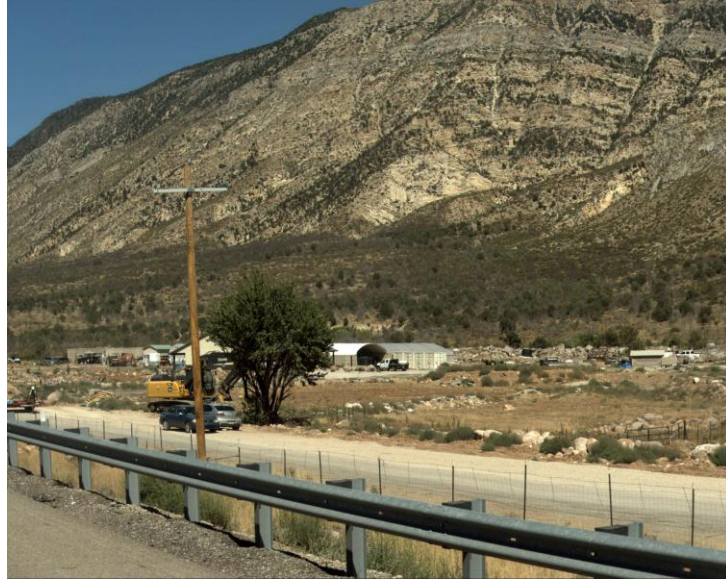
Figure 14. CLIP CASE #1

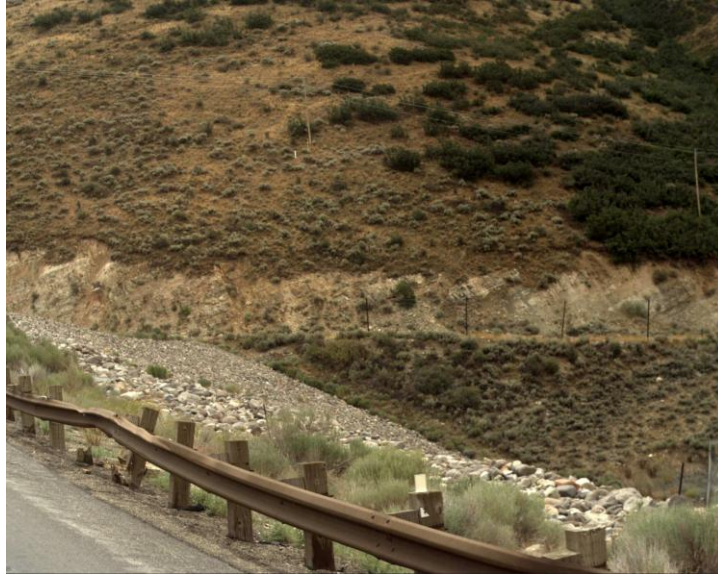
Figure 15. CLIP CASE #2

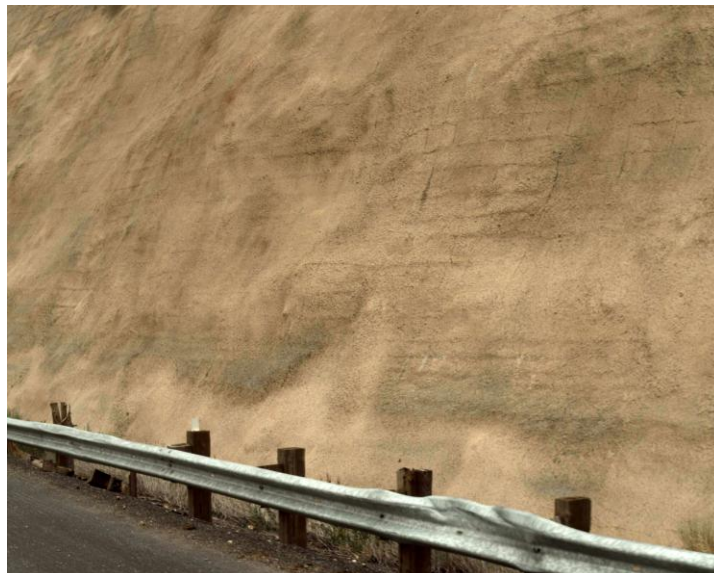
Figure 16. CLIP CASE #3

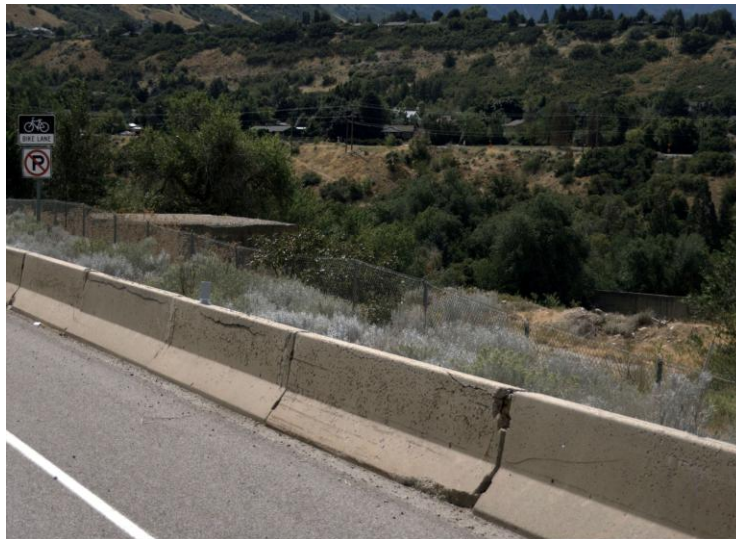
Figure 19. Llava CASE #2

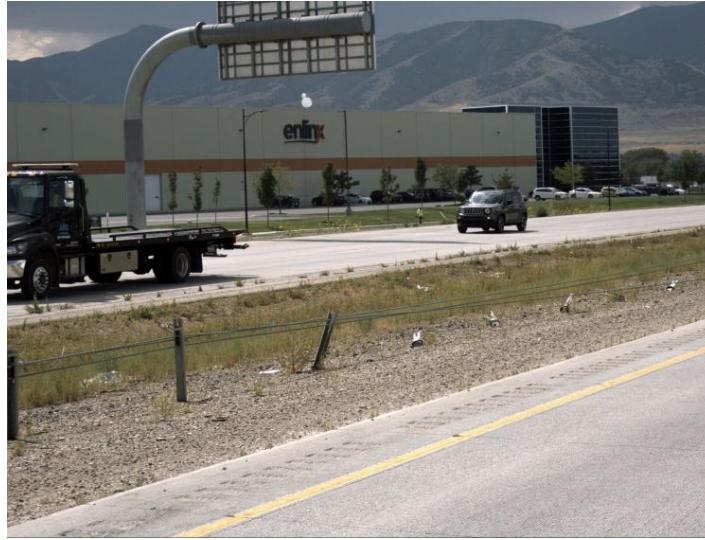
Figure 20. Llava CASE #3

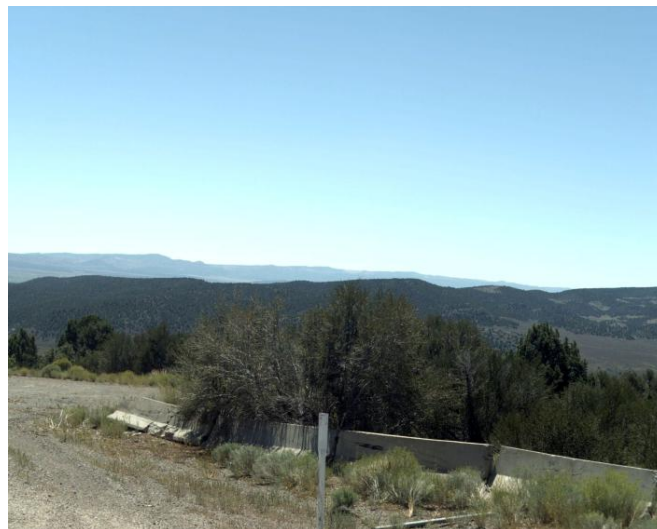
Figure 22. QWEN CASE #1, Image of a Spalled Precast Concrete Barrier

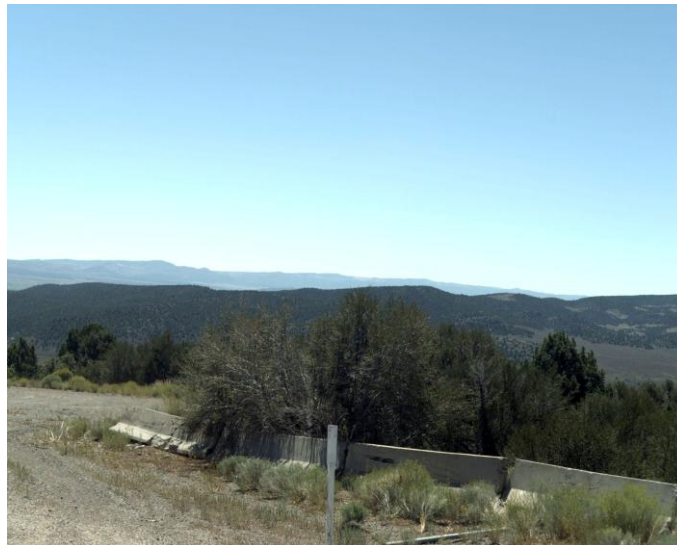
Figure 23. QWEN CASE #2, Image of a Spalled Precast Concrete Barrier

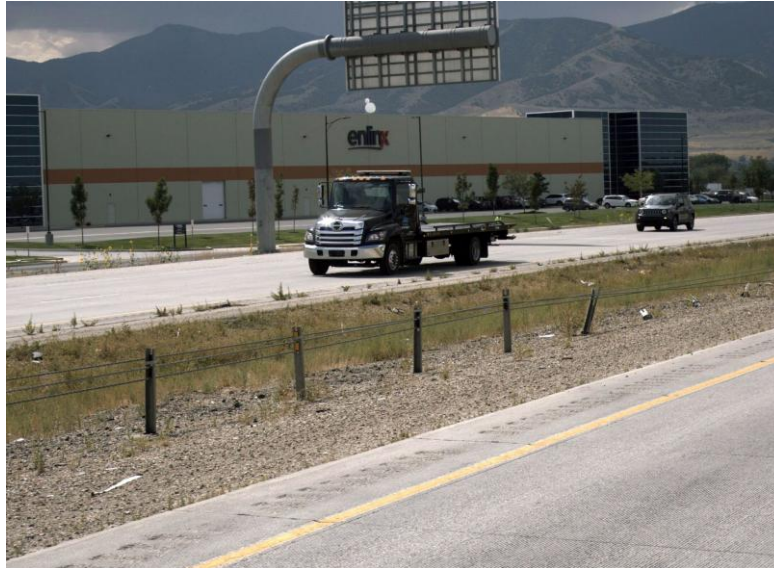
Figure 25. QWEN CASE #4, Image of Broken Cable Barrier Posts along a Road

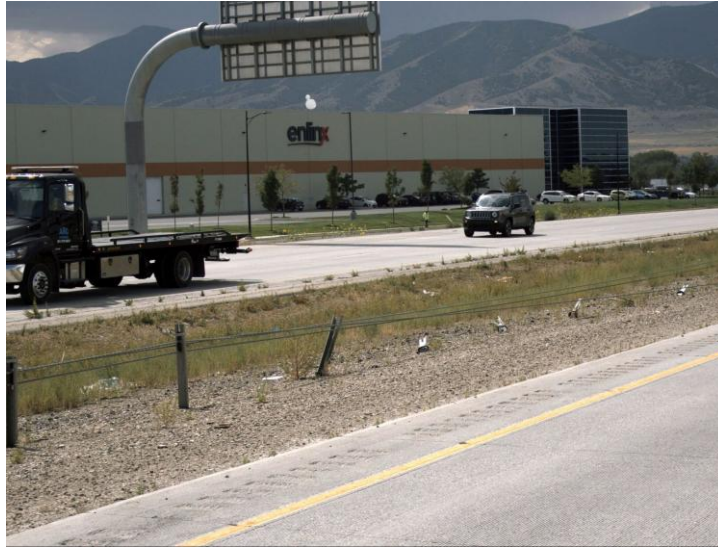
Figure 32. Llama CASE #4, Image of Broken Cable Barrier Posts along a Road

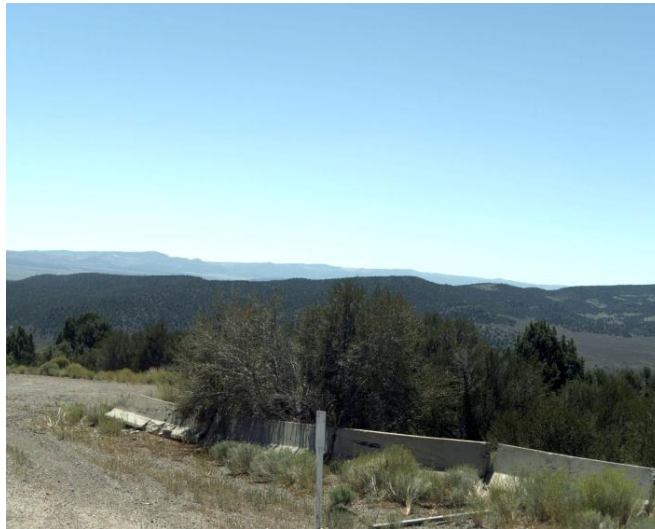
Figure 42. GEMMA CASE #2, Image of a Spalled Precast Concrete Barrier
