1. Report No. TX-98/2966-1	2. Government Accession No.	3. Recipient's Catalog No.	
4. Title and Subtitle FIELD PERFORMANCE EVALUATION OF HYDRATED, FLY ASH BASES IN THE ATLANTA DISTRICT - YEAR 1		5. Report Date November 1997

**FIELD PERFORMANCE EVALUATION OF HYDRATED,
FLY ASH BASES IN THE ATLANTA DISTRICT - YEAR 1**

Research Report 2966-1
Research Study Number 7-2966

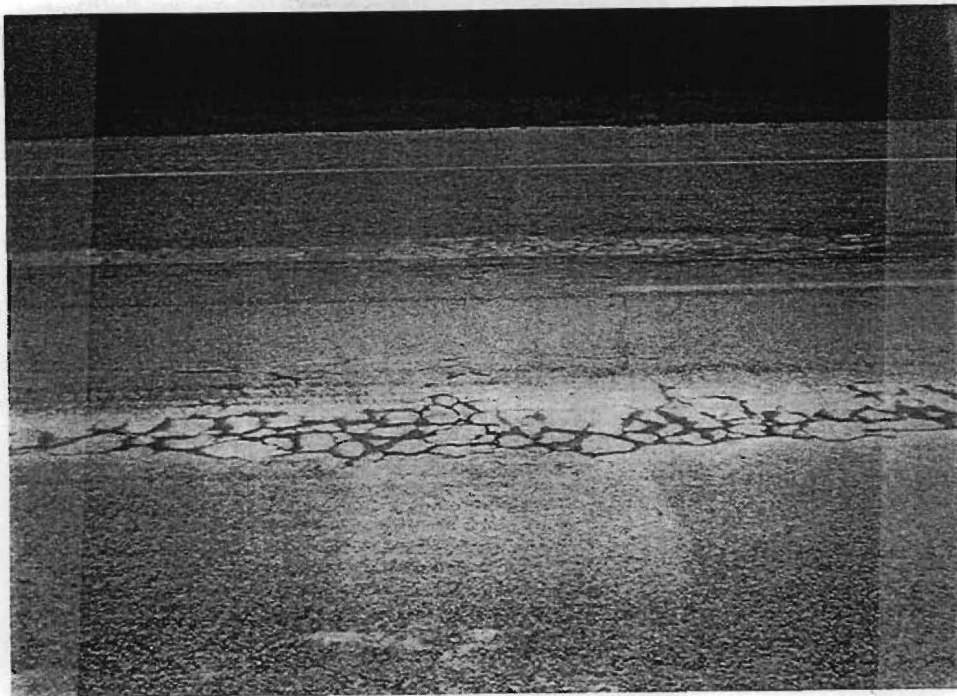
Figure 2. Alligator Cracking on Loop 390

This project begins at US 59 in Marshall and extends to 0.5 km south of SH 43. The total length of the project is about 4.0 km. For visual condition surveys, the project was evaluated at 13 locations (60 m survey length per location) in the eastbound lane. There were three types of distress beginning to be evident on Loop 390: alligator cracking, a slight flushing of the seal coat surface, and rutting. Quantities of distress at each survey location are shown below in Table 2. A typical photograph of the alligator cracking is shown in Figure 2.

- Two of the six hydrated fly ash test pavements are exhibiting distress which might be attributable to deficiencies in the fly ash base material. Loop 390 is exhibiting a small amount of alligator cracking in an area where the FWD data indicates the base is weak. SH 154 is exhibiting transverse cracking (which appears to be from shrinkage of the base) and the FWD data indicates this pavement is excessively stiff.

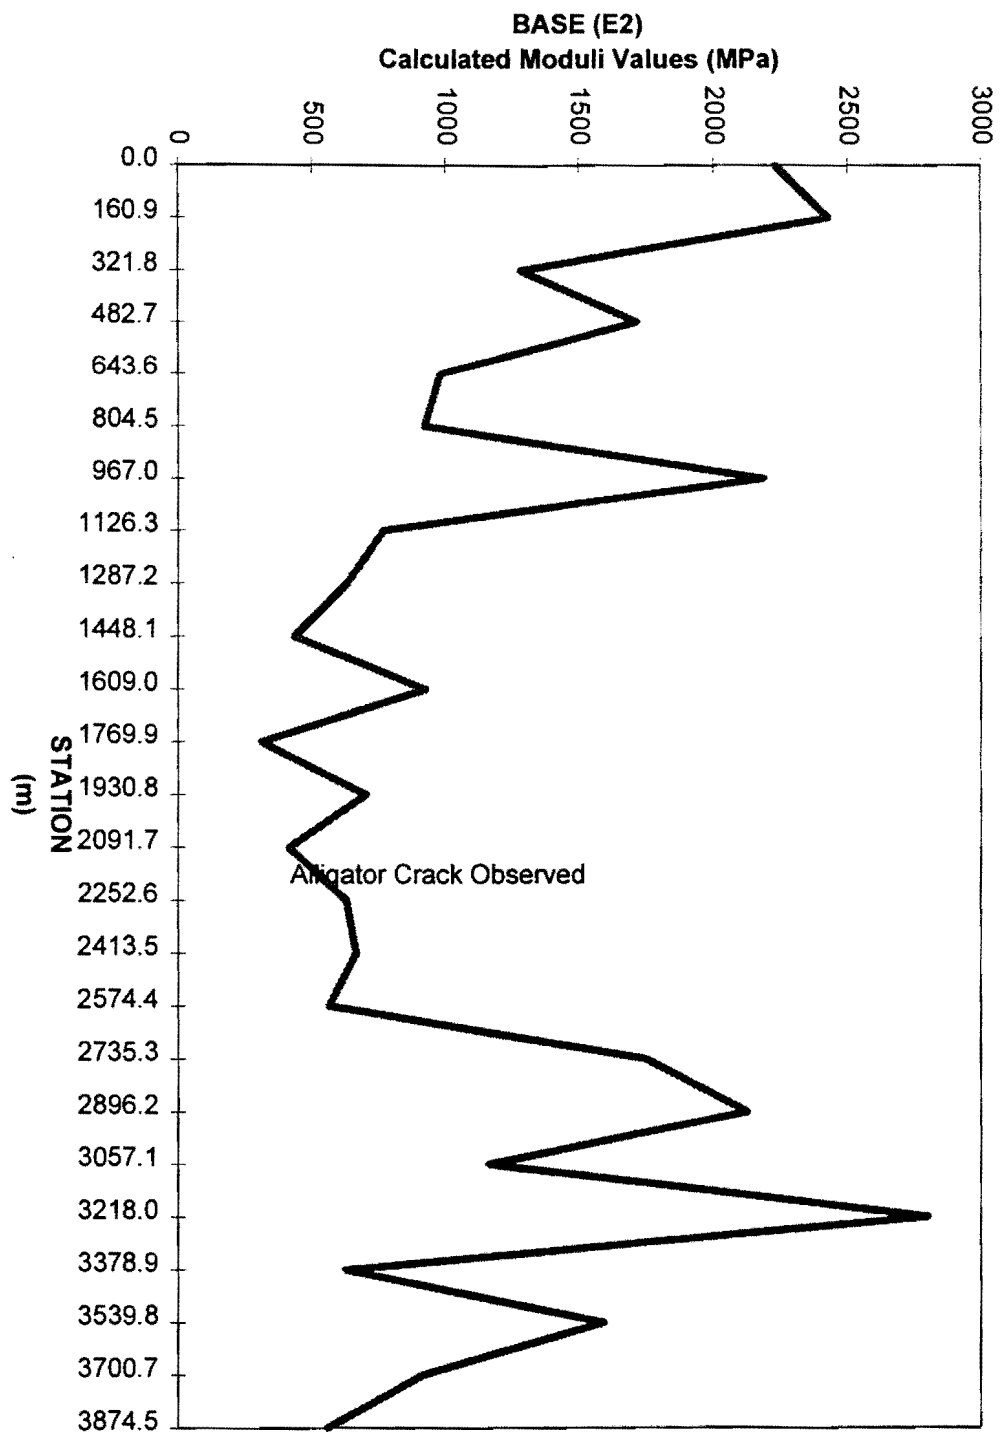
Figure 3. Base Moduli Values for Loop 390

FWD data shown in Table 8 and Figure 3 indicate that the base layer is weak in some areas which also happens to coincide with areas where alligator cracking is observed. Another concern here and on most of the other test pavements is the variability in moduli along the length of the pavement.

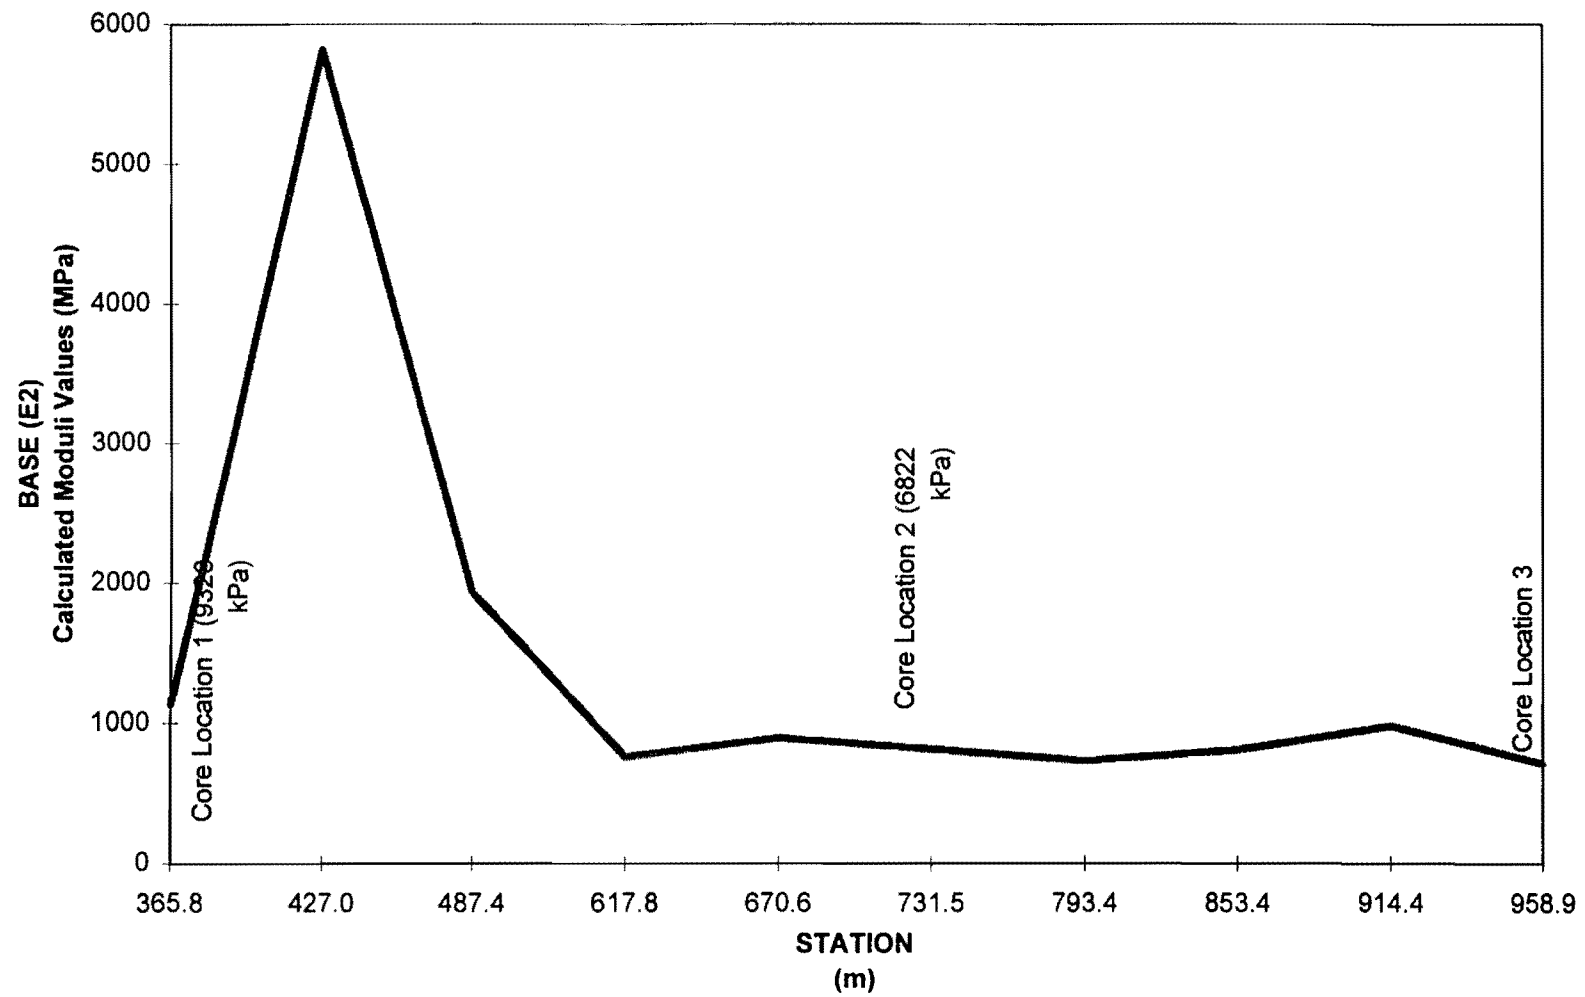
Figure 4. Base Moduli Values for IH 20 Frontage Road

The first four data points and last data point on the FWD (Table 9) show extremely high moduli values for the base material (seemingly uncharacteristic for this material). Therefore, researchers conclude that the data points at each end of the section are another type of pavement so these data points are excluded from Figure 4. The moduli values are not as variable on this pavement but are generally on the border or below that which is desired of at least 1000 MPa; however, this does not correlate with the high compressive strengths of the cores.

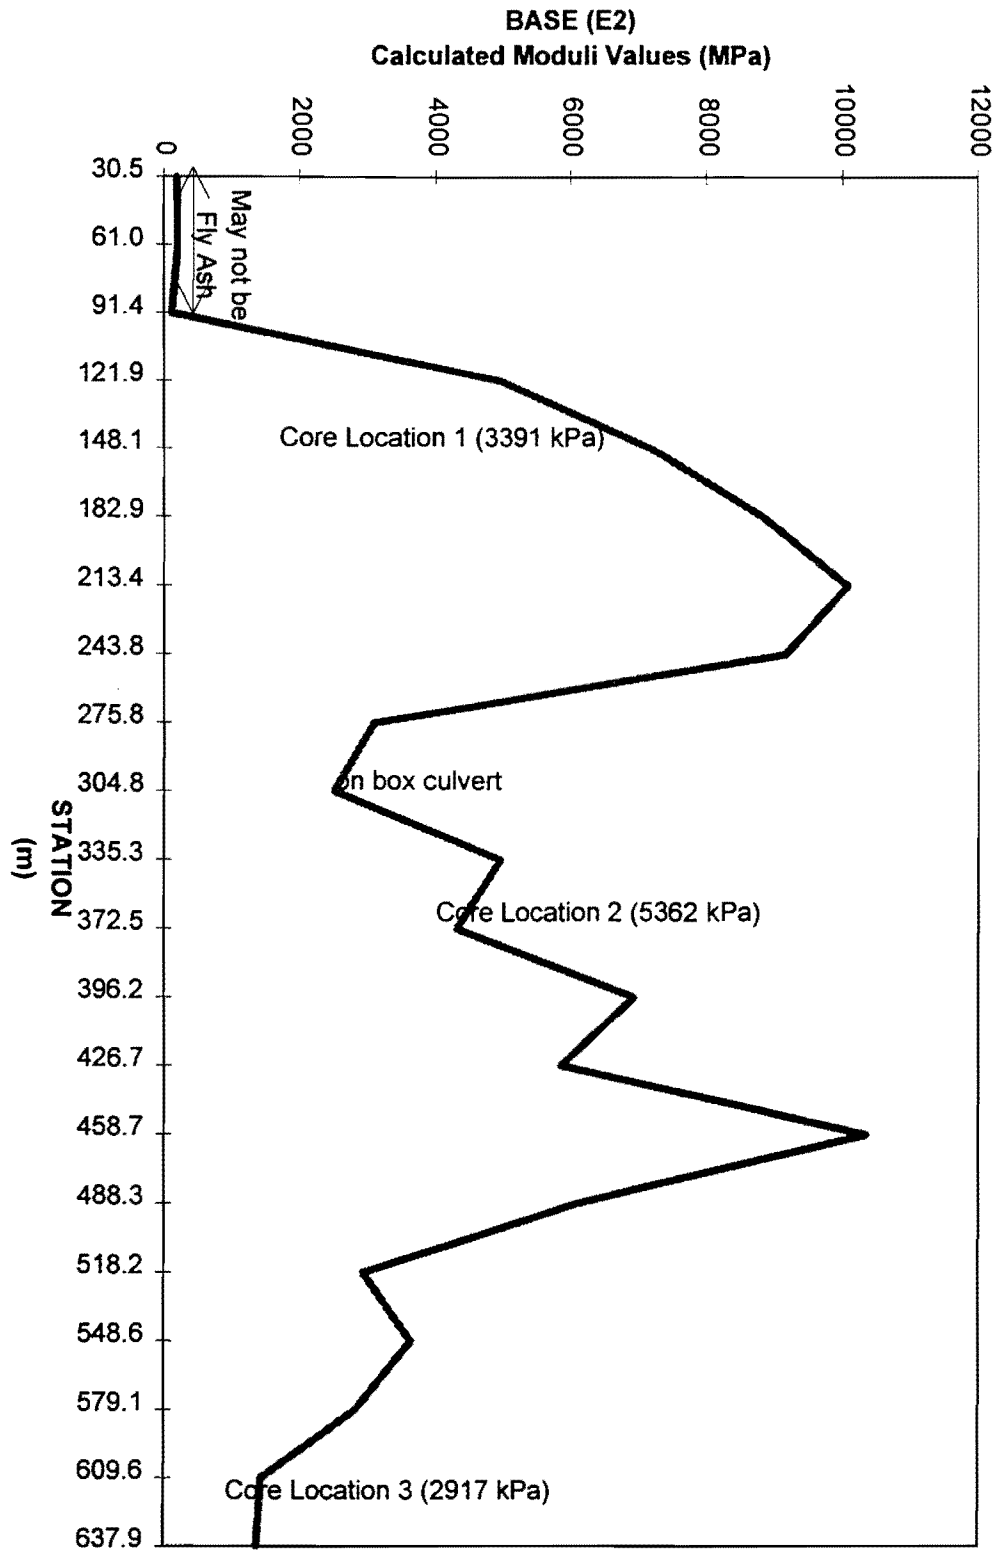
Figure 5. Base Moduli Values for SH 154

With indications of what appears to be shrinkage cracking, one would expect this pavement to be the stiffest of the six. This is true in terms of FWD data (Table 10). Base moduli values along the pavement exceed 7000 MPa in some locations. Also note the variability in the moduli values as shown in Figure 5. Average compressive strength of the three field cores was 4090 kPa.

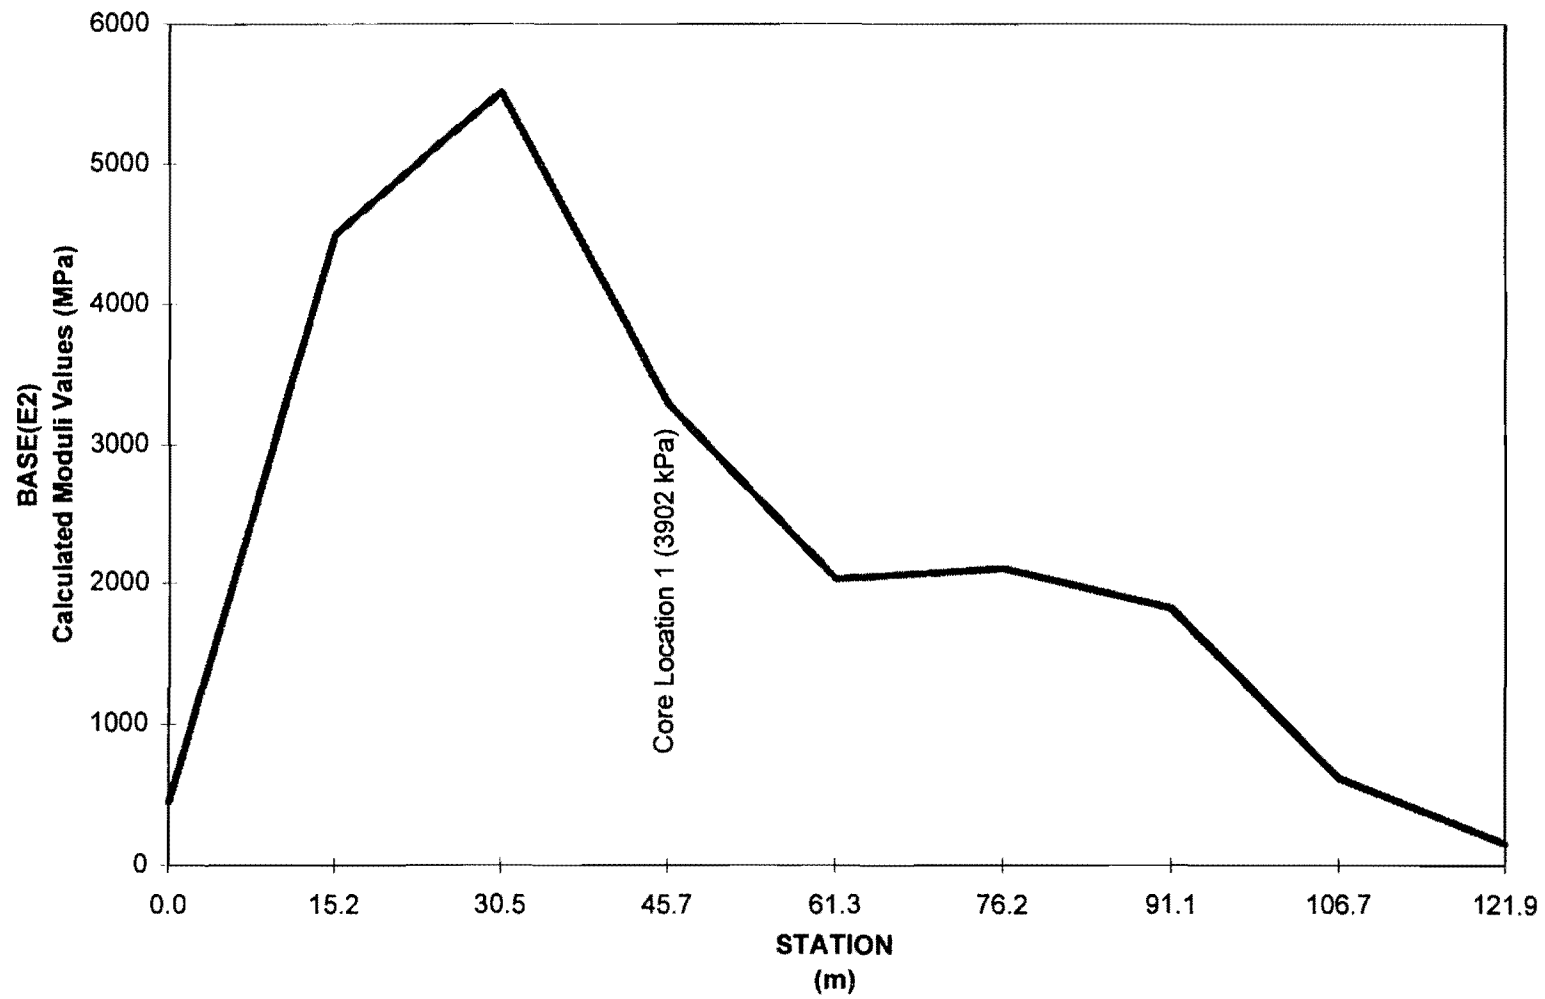
Figure 6. Base Moduli Values for FM 1326

One core was obtained from FM 1326 which could be tested and its compressive strength was 3902 kPa. FWD data (Table 11 and Figure 6) indicate some weak spots in the base layer but also some variability.

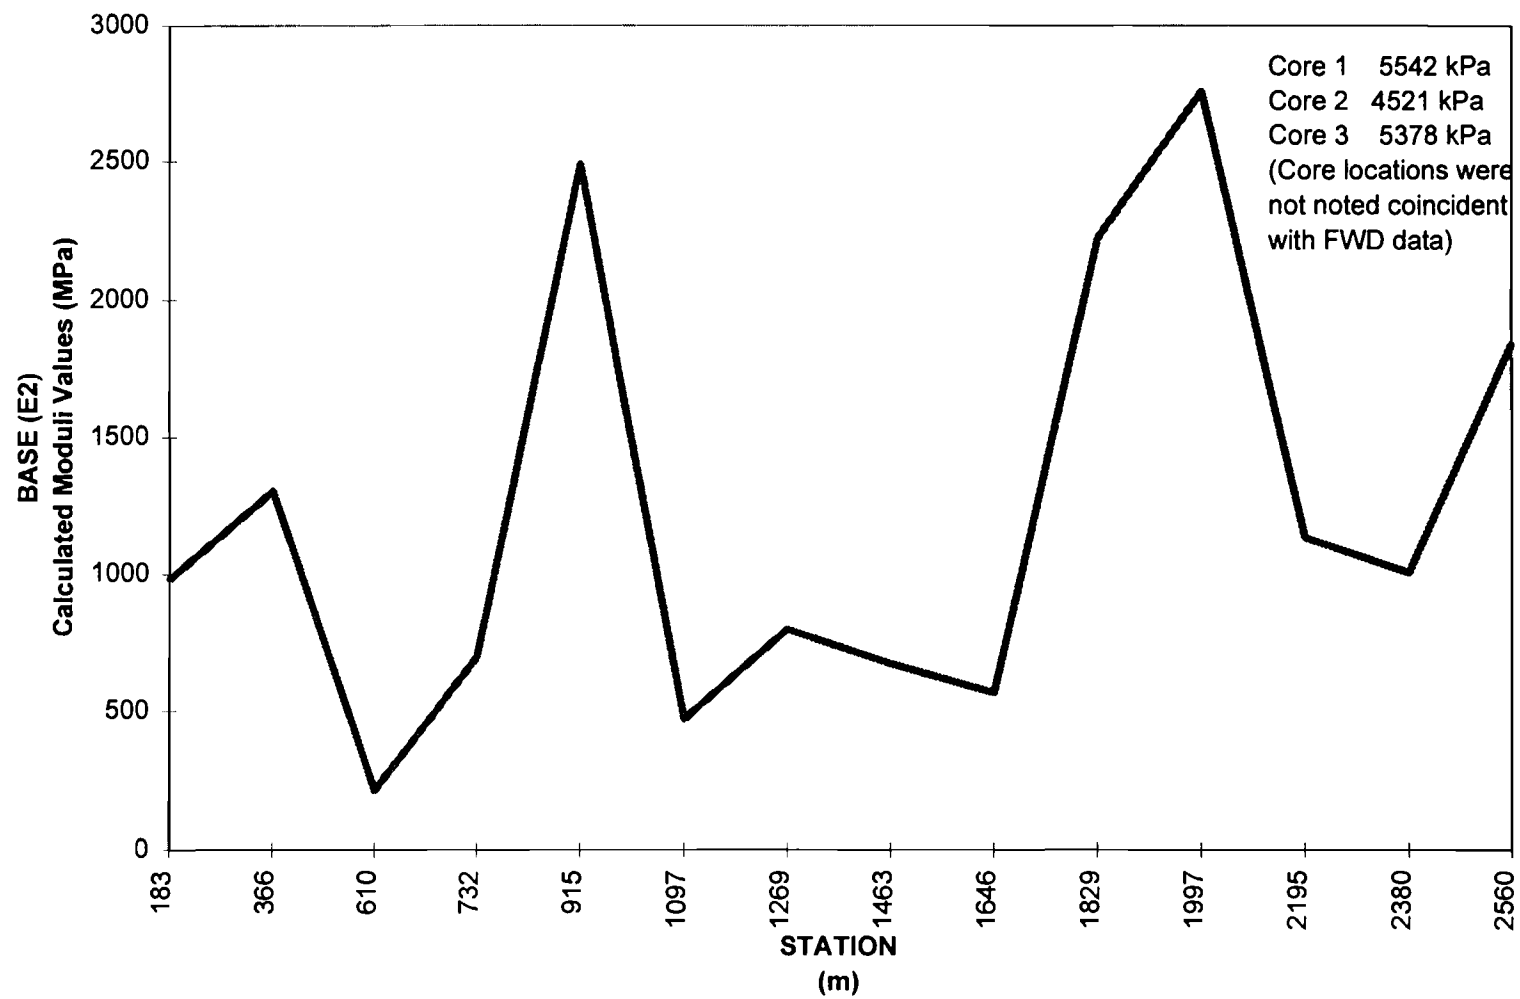
Figure 7. Base Moduli Values for FM 1520

Three cores were obtained from FM 1520 with an average compressive strength of 5147 kPa. FWD data on this pavement also indicates that there are some weak areas where the moduli values drop below the minimum desired value of 1000 MPa, and again, there is variability along the length of the pavement (Table 12 and Figure 7).

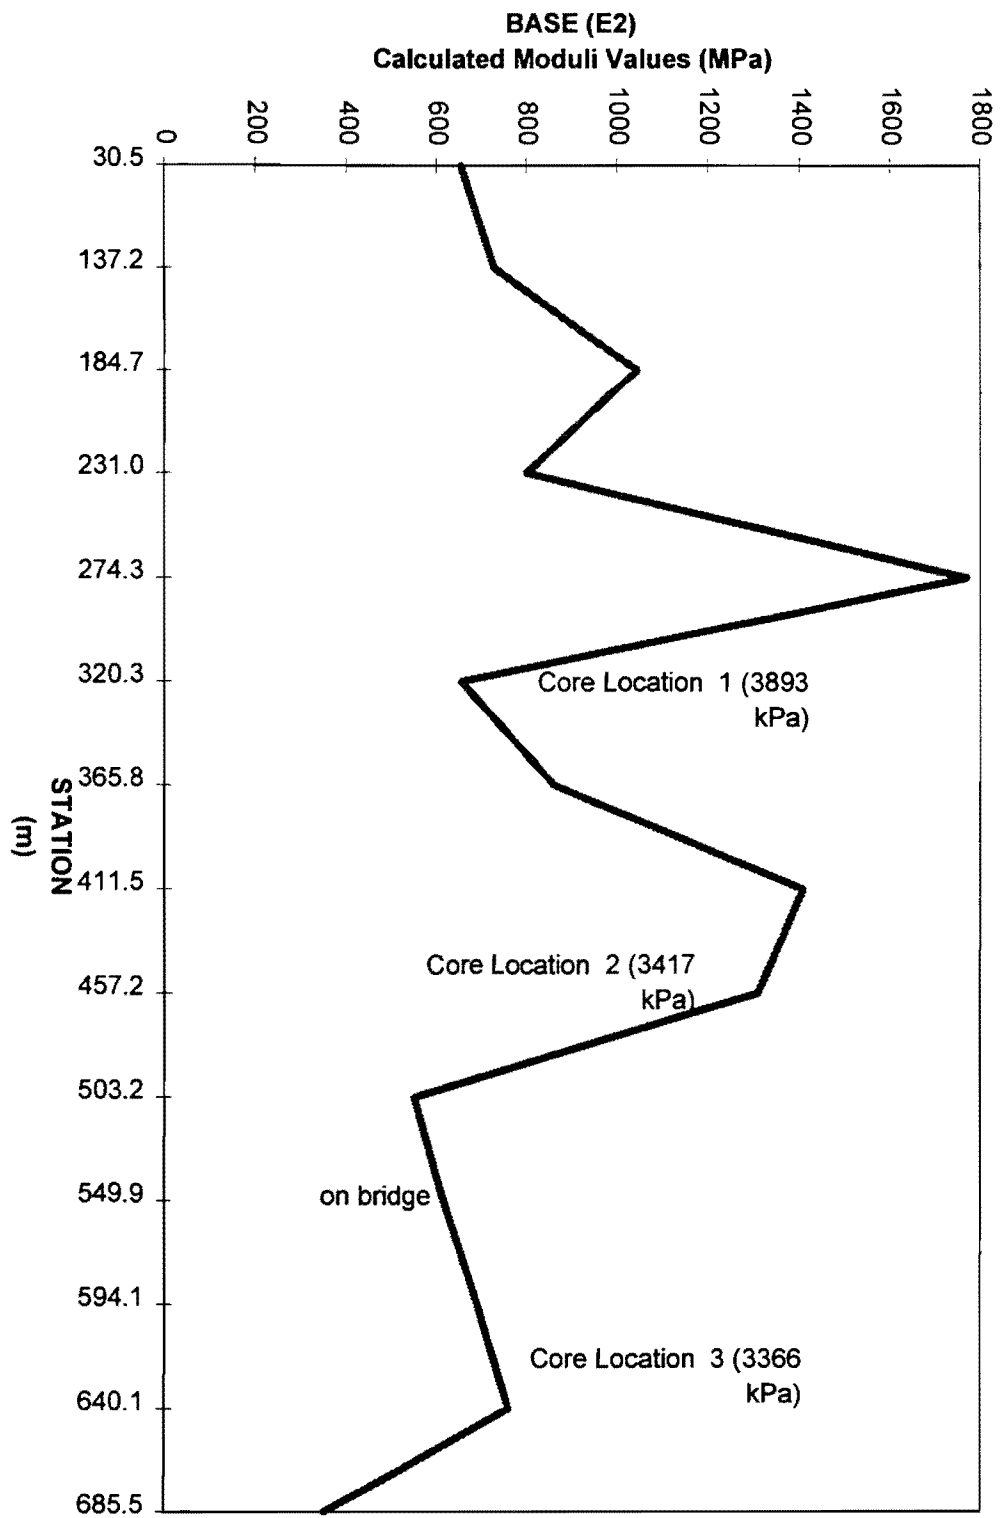
Figure 8. Base Moduli Values for FM 560

Three cores were obtained from FM 560 with an average compressive strength of 3359 kPa. The base on this pavement has two different thicknesses along its length: 24 cm and 16 cm. Because of the difference in thicknesses, two separate FWD analyses were performed as shown in Table 13. Results from both analyses, however, were combined for Figure 8. The data point at station 96.3 is not shown in Figure 8 because it appears that it may not be representative. Moduli values for this pavement do not appear to be as variable as on some of the others; however, the values are lower than the desired minimum of 1000 Mpa.

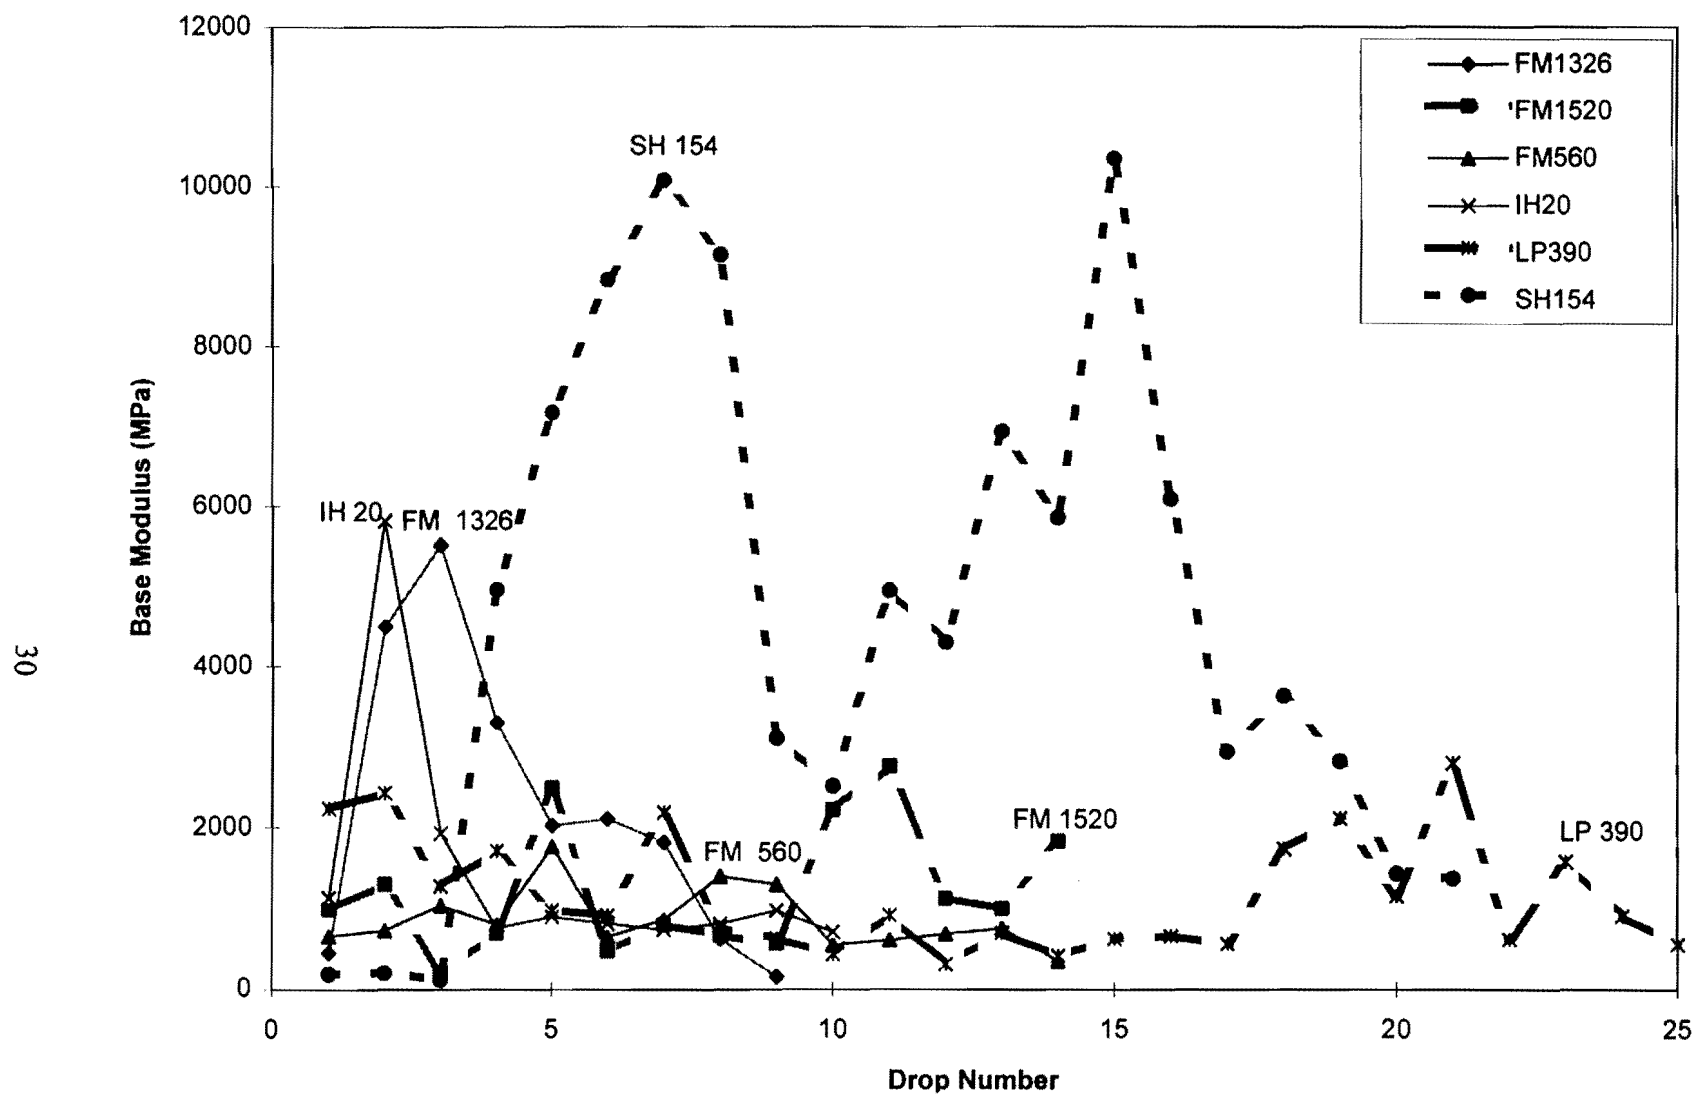
Figure 9. Base Moduli Values for All 6 Pavement Sections.

- Concern is warranted regarding the fly ash material variability as exhibited in moduli values from FWD data. There is variability along a single pavement length, as well as between different pavements (i.e., SH 154 is much stiffer overall than any other pavement). This variability is evident in Figure 9. Reasons for this variability are unknown but should be investigated. The material may have been inconsistent in its *as-received* condition, or the effect of the fly ash as a stabilizer may be deteriorating over time (perhaps due to water infiltrating the base in certain areas).

It is also recommended that this year's monitoring program employ the use of ground penetrating radar (GPR) on all six test pavements. It is possible that the reason for the moduli variation in the base materials is due to the presence of water in the base which is causing a *weakening* of that layer. If so, this will be revealed through GPR. This additional work will not require any new allocation of research funds.
