1. Report No. TX-99/2966-2	2. Government Accession No.	3. Recipient's Catalog No.	
4. Title and Subtitle FLY-ASH BASES IN THE ATLANTA DISTRICT: EVALUATION OF SURFACE TREATMENT BOND AND YEAR-TWO FIELD PERFORMANCE EVALUATIONS		5. Report Date December 1998

**FLY-ASH BASES IN THE ATLANTA DISTRICT:
EVALUATION OF SURFACE TREATMENT BOND
AND
YEAR-TWO FIELD PERFORMANCE EVALUATIONS**

Report 2966-2
Project Number 7-2966
Research Project:
Durability of Surface Treatments as the Wearing Course
Placed on Crushed Fly Ash and Long-Term Performance
of Crushed Fly Ash for Flexible Base

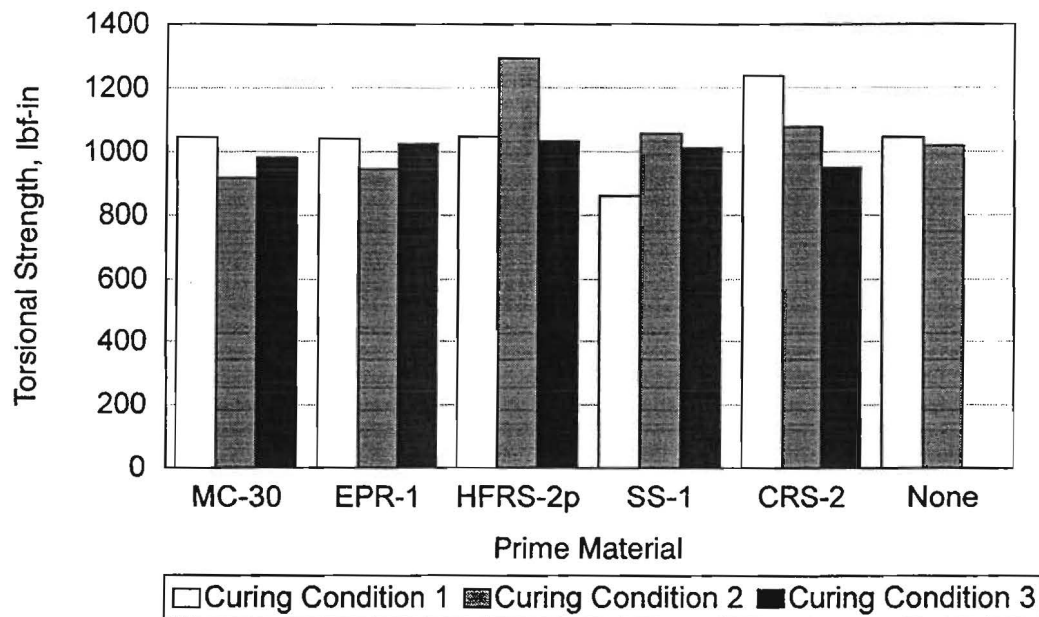
Figure 4. Torsional Strength at Interface of Different Types of Prime and Fly-Ash Base Cured Under Different Conditions

Results of the torsional shear strength tests are shown below in Table 2. A statistical analysis was performed to analyze the data in this table. Results of an analysis of variance revealed that there is no statistical difference between the different curing conditions and no significant difference in the priming materials. A visual plot of the data in Table 2 is shown in Figure 4. In this figure, each bar represents the mean of the two values shown in Table 2. As in the statistical analysis, this plot also does not reveal a clear distinction between any of the prime materials or curing conditions.

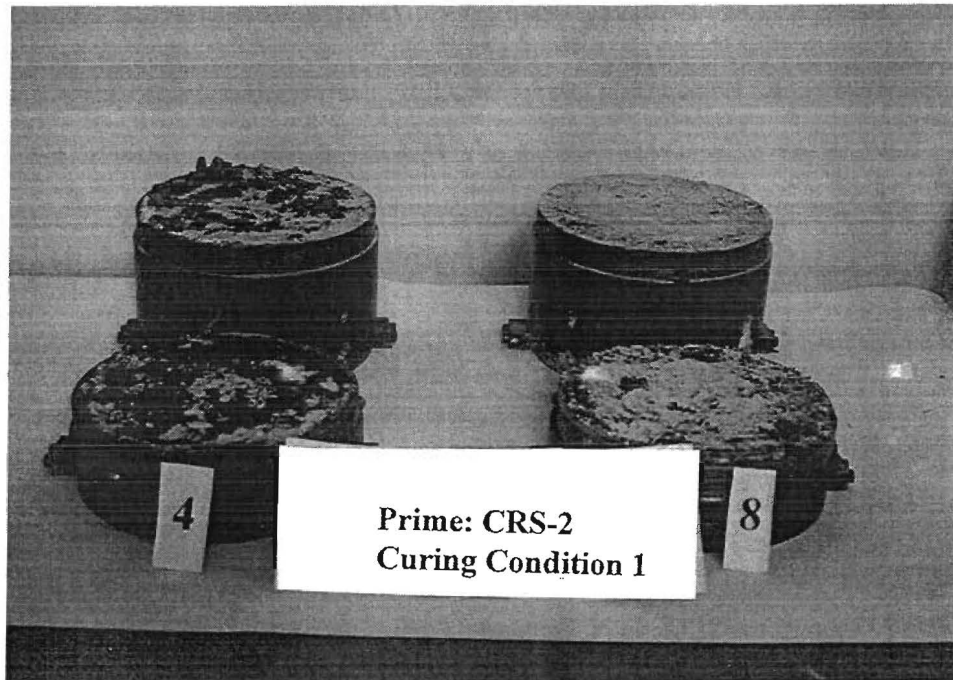
Figure 5. Failed Torsional Shear Test Specimens - CRS-2, Curing Condition 1.

A typical photograph of two of the failed specimens is shown in Figure 5 below. This photo shows the specimens for the CRS-2 prime material and curing condition 1. As shown in the photograph, failure occurred just below or at the interface of the prime and the base material. Note that the shorter specimens in front were sheared from specimens in back, i.e., failure plane is shown in photograph.

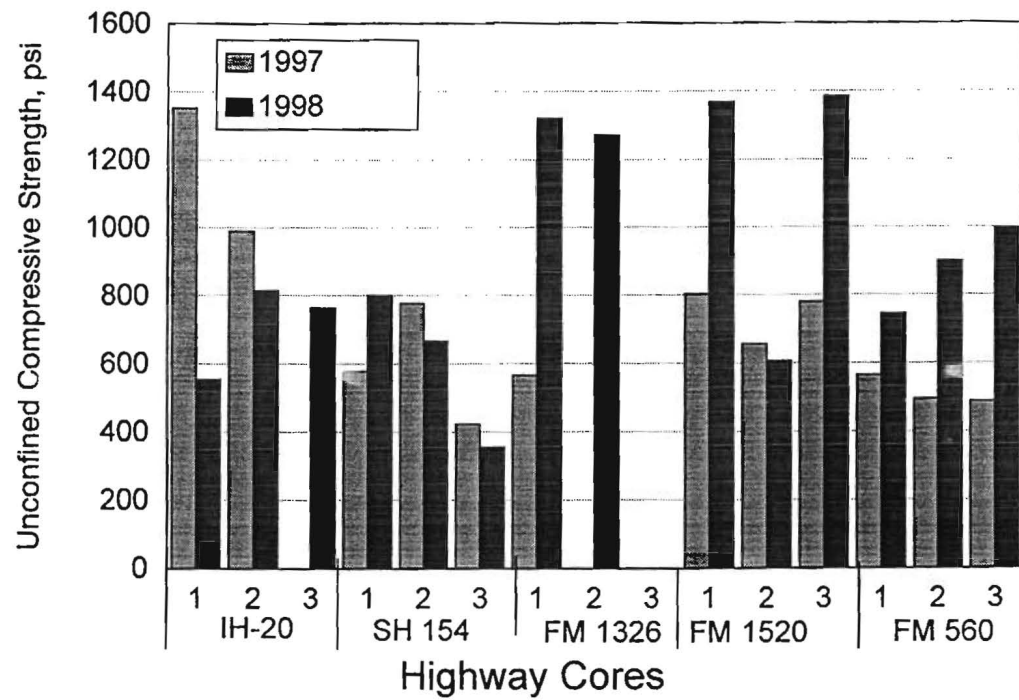
Figure 6. Unconfined Compressive Strength of Highway Cores

Three cores were obtained from this pavement as shown in Figure 6. Last year, this pavement exhibited the highest compressive strength but there was a loss in strength as noted with the cores taken in 1998. However, there doesn't seem to be an appreciable difference in the base moduli values from 1997 to 1998 (Figure 8). Note in Figure 8, that the last data point may coincide with the beginning of a different type of pavement section.

With indications of what appears to be shrinkage cracking, one would expect this pavement to be the stiffest of the six. This is true in terms of FWD data (Figure 9). Base moduli values along the pavement exceed 1,000,000 psi in some locations. Base moduli values in 1998 appear to be similar to that in 1997 with some places showing significantly higher moduli than the previous year. Compressive strength of the cores is also close to the values obtained the previous year (Figure 6).

Two cores were obtained from FM 1326 which could be tested and the compressive strength was significantly higher than the single core which was tested in 1997. FWD data (Table 12 and Figure 10) indicate that the base is not deteriorating but exhibits an overall similar or better modulus than the previous year.

All three cores obtained from FM 560 had a higher compressive strength than the cores obtained the previous year. The base on this pavement has two different thicknesses along its length: 9 inches and 16 inches. Because of the difference in thicknesses, two separate FWD analyses were performed as shown in Table 14. Results from both analyses, however, were combined for Figure 12. Moduli values for this pavement do not appear to be as variable as on some of the others; however, the values are lower than the desired minimum of 145,000 psi. Also, however, there seems to be little change in moduli values between 1997 and 1998.

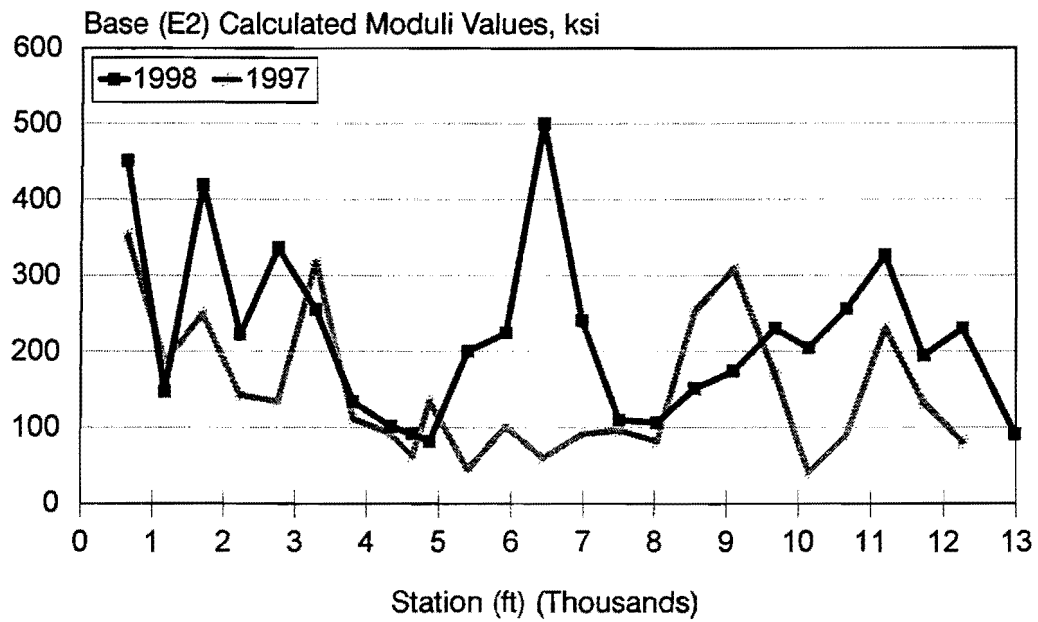
Figure 7. Base Moduli Values for Loop 390

FWD data shown in Table 8 and Figure 7 indicate that the base layer is weak in some areas which also coincided with areas where alligator cracking was observed in 1997. As shown in Figure 7, there is some variation in the moduli values between 1997 and 1998; however, the difference does not seem to warrant concern that the base is exhibiting a deteriorating strength.
