# **FRA/Volpe Center Task Force Observation of Operations at TVE Transrapid Test Facility, Addendum**

**April 5 to June 4, 1993**

DOT-VNTSC-RR493-PM-93-1A  
December 1993

Prepared by the Federal Railroad Administration/Volpe National Transportation  
Systems Center High Speed Guided Ground Transportation Safety Task Force

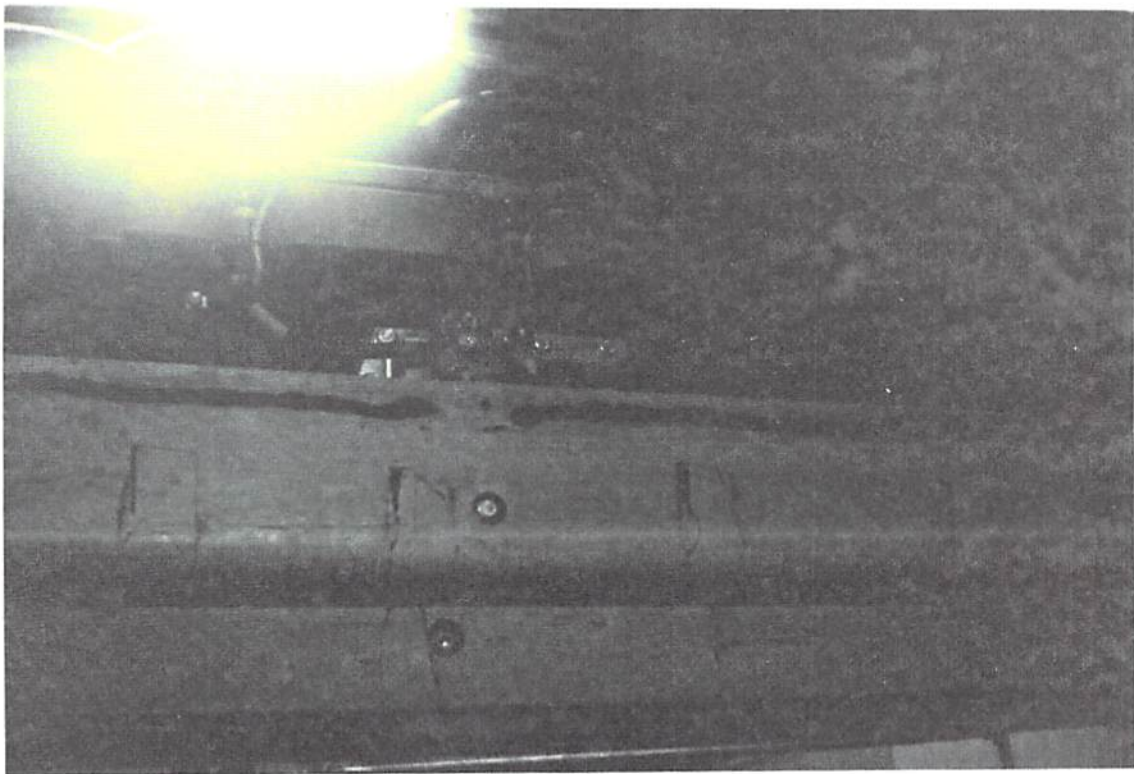
Figure 1 shows the TR07 vehicle with its new BMFT logo, replacing the Transrapid logo. New front magnets with new gap sensors and sloped leading edge have been installed, as shown in Figure 2. The new magnets have improved the vehicle's ability to detect and avoid any loose stators along the guideway. Replacement of all of the remaining magnets is planned for late this year. All of the stators in the guideway have now been examined, and the southern loop is fully operative. However, a better way to attach the "nutstein" to the guideway, using various mechanical devices, is being studied; two options are shown in Figure 3.

Figure 2. New Gap Sensors at Front Magnet

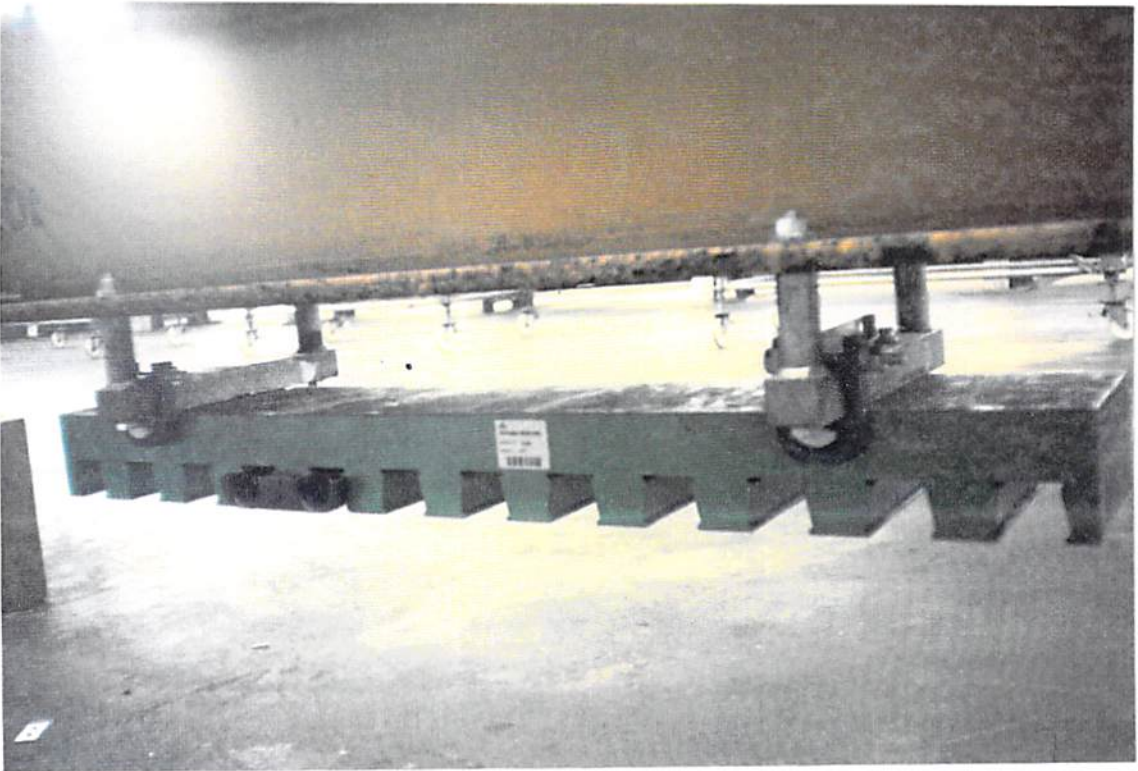
Figure 3. Options for Nutstein Design

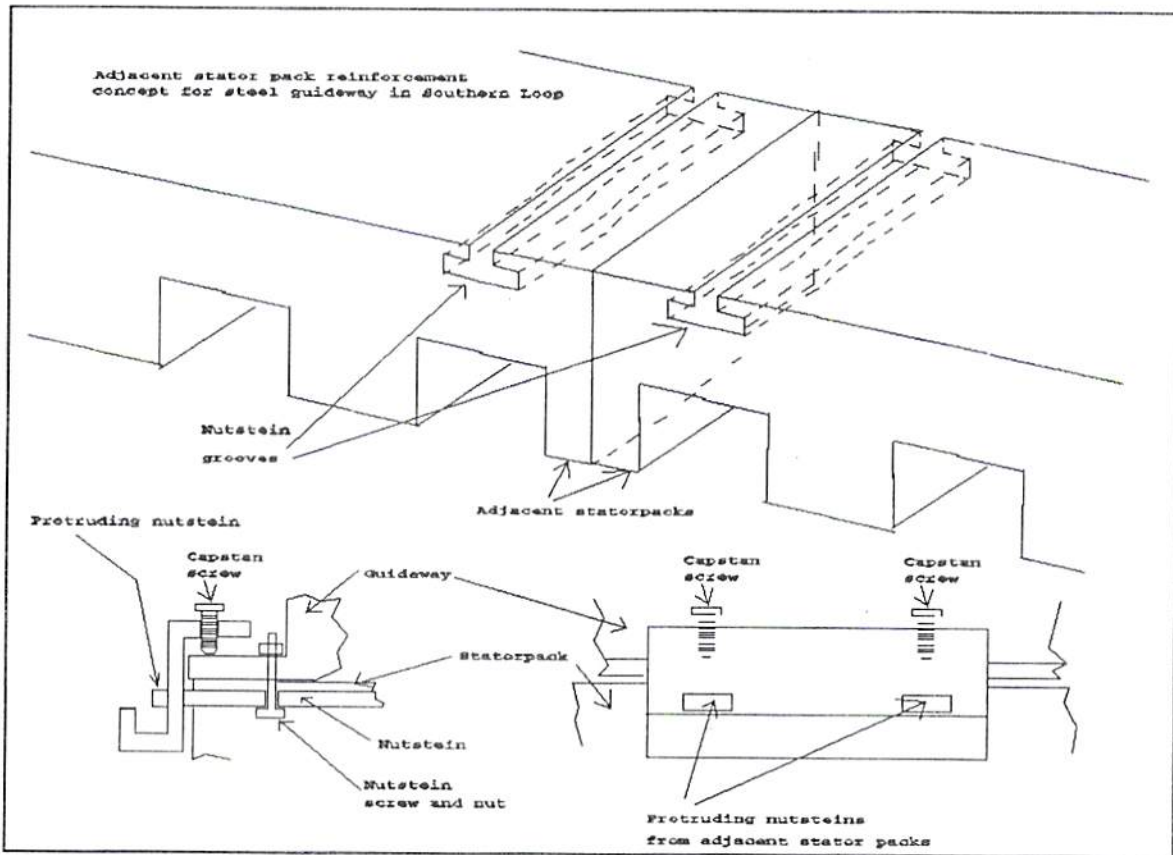
Figure 13. Stator Pack Dropaway Prevention Concept for Steel Guideway on Southern Loop

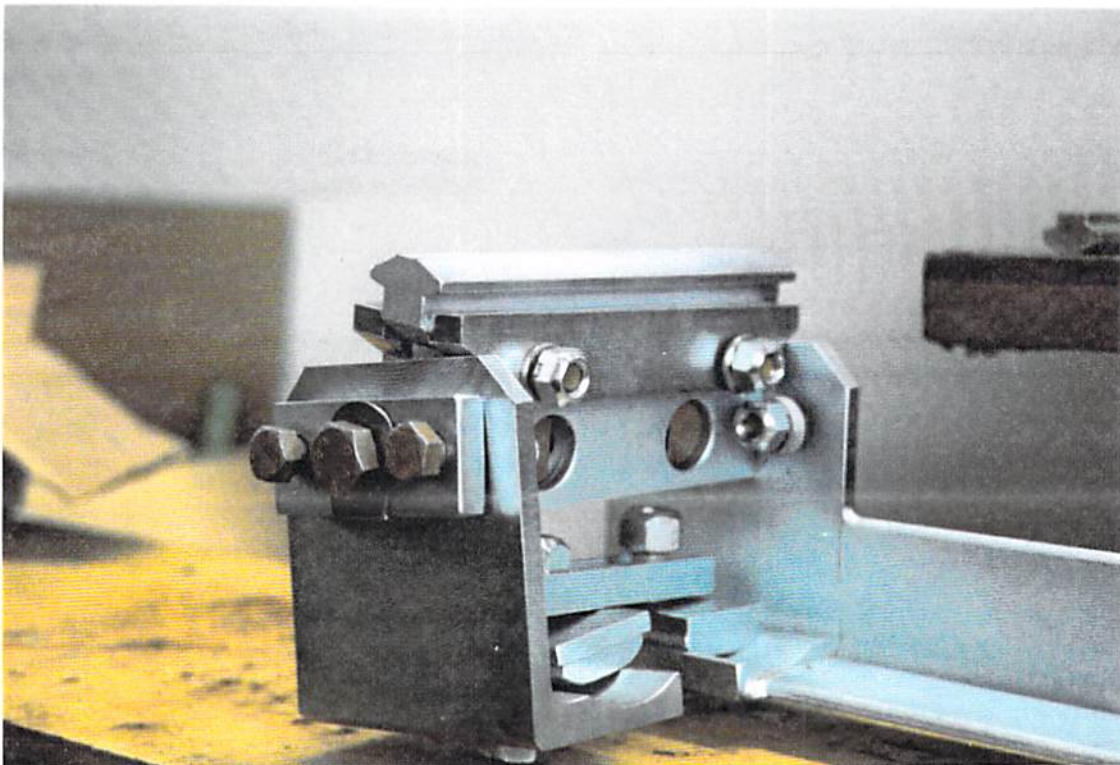
Figure 14. Lufthansa's Stator Pack Fastening System for Use on Steel Guideway
