Evaluation of Unbonded Jointed Concrete Overlays

ICT Project R27-SP74

September 2025

ICT Series Report No. 25-009

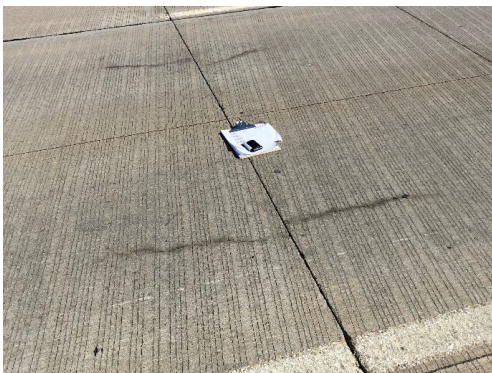
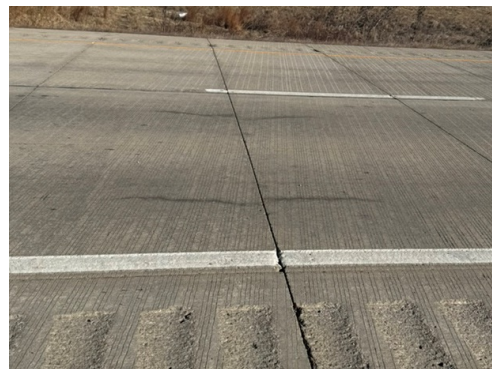
Figure 1. Photo. Longitudinal cracking in the wheel path of the driving lane on I-72 EB (left: August 5, 2020, right: February 25, 2025).

A detailed distress survey performed in August 2020 showed the predominant distress in the EB direction was low severity longitudinal cracking in the wheel path (inner and outer) of the driving lane. Moreover, distress surveys conducted as early as 2016 showed signs of this same longitudinal distress just starting to develop from a limited number of transverse joints. The observed longitudinal cracking had not occurred in the WB lanes (NWGF) based on the last survey by DeSantis and Roesler (2022a). However, their survey noted faulting was observed across the longitudinal lane-shoulder joint (between the driving lane and the shoulder) in both directions. One important objective of this study was to document the development of distresses in this I-72 experimental concrete overlay since the 2020 observations.

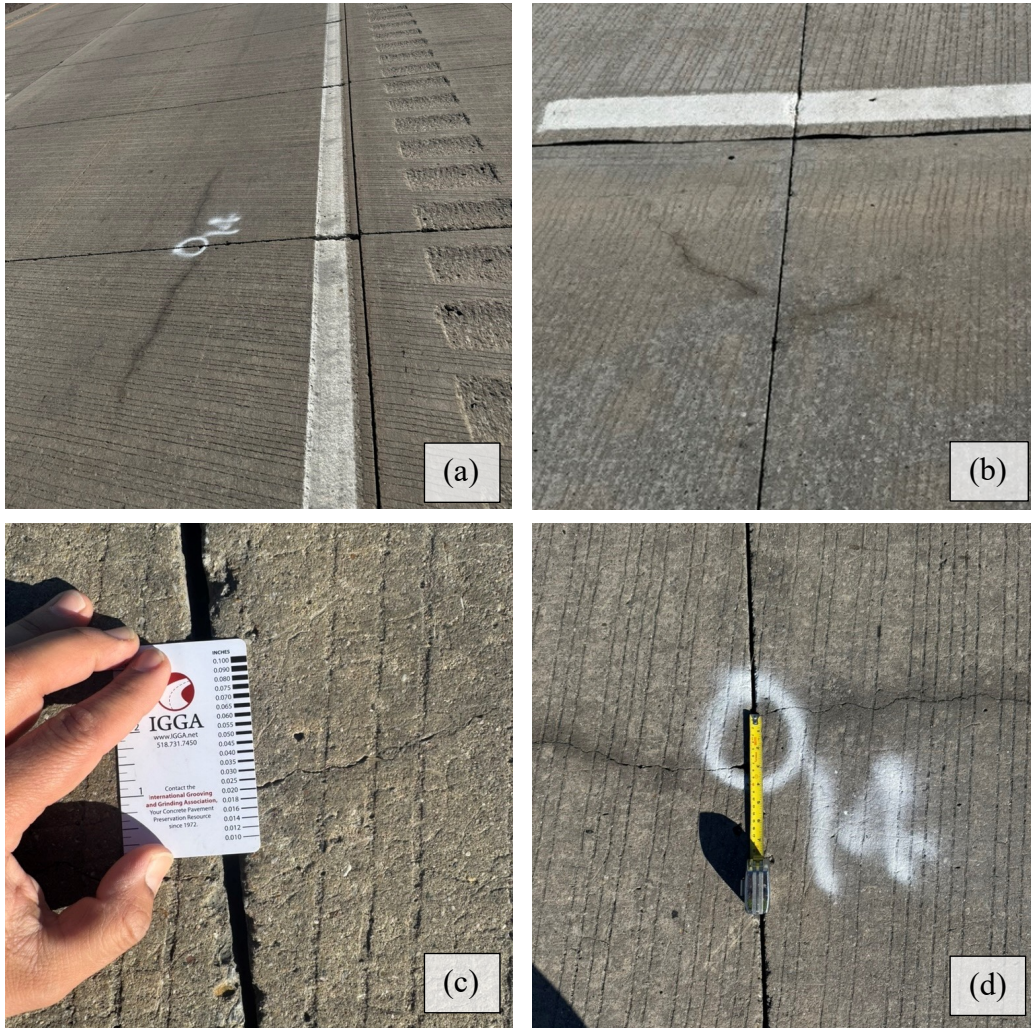
Distress surveys conducted in 2016 by IDOT, and in 2020 by DeSantis and Roesler, indicated that partial length longitudinal cracks were present in I-72 EB just one year after construction. The initial hypothesis that the longitudinal cracks were a result of reflective cracking from the CRCP has been dismissed by DeSantis and Roesler in 2022. In addition to the distresses summarized in Table 5, longitudinal faulting across the lane-shoulder joint continues throughout the EB direction with varying magnitudes. The shoulder elevation was on average measured at 0.25 in. (6 mm) higher than the driving lane, as seen in Figure 10. The working hypothesis is water drainage out of the driving lane transverse joints might be partially blocked at the lane-shoulder joint, which may lead to pumping and erosion of the asphalt interlayer. This has been further confirmed with observations from the cores extracted at the lane-shoulder joint. The complete field survey map, including the station, distribution, and classification of distresses in sections 10+00 to 20+00, 74+15 to 84+15, and 142+50 to 152+50, can be found in Appendix A.

Figure 9. Photo. Types of distresses in driving lane: (a) longitudinal cracks in wheel paths, (b) corner break, (c) typical longitudinal crack width measurement, and (d) discontinuity of longitudinal cracks across a transverse joint.

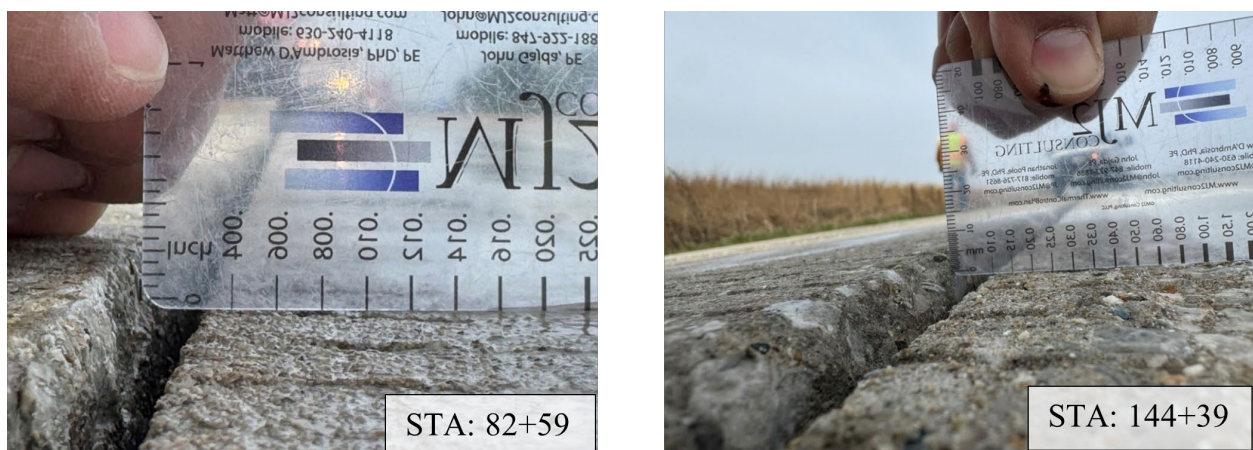
Figure 10. Photo. Example of faulting along driving lane-shoulder joint of 0.25 in. (6 mm) on I-72 EB.

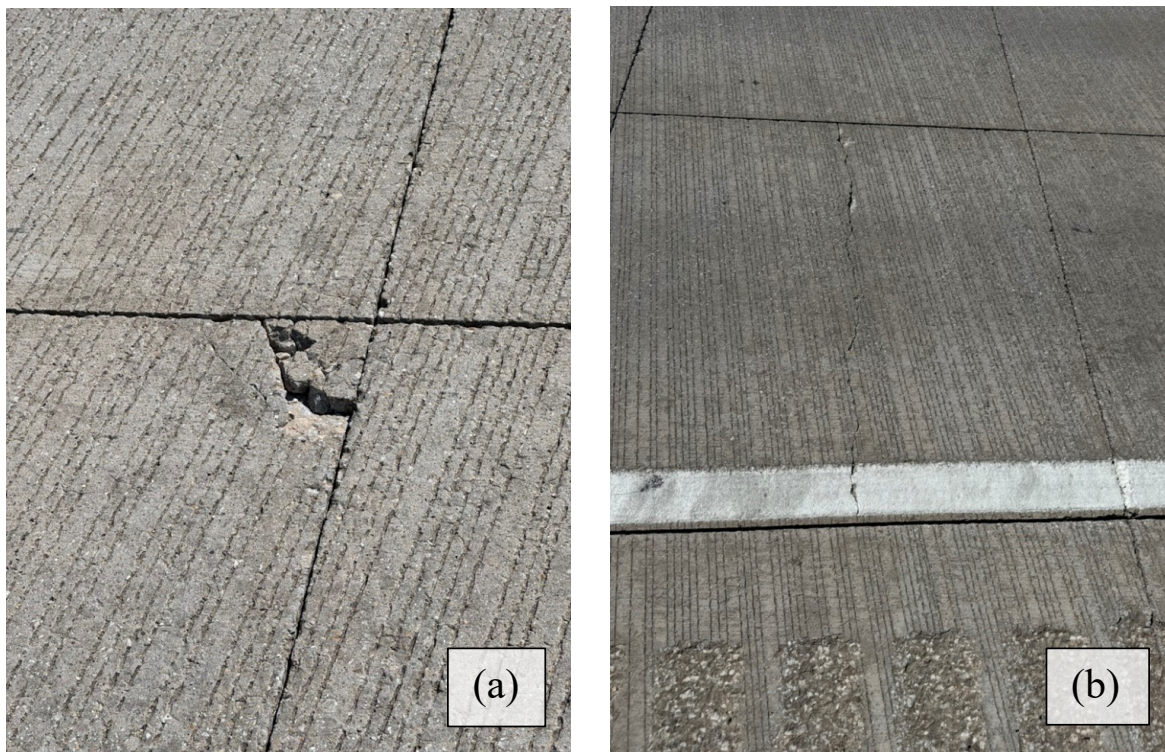
either asphalt interlayer or debris entering the joints. This will be later discussed with observations from the extracted cores. The complete field survey map, including the station, distribution, and classification of distresses in segments 152+50 to 142+50, 112+50 to 102+50, and 20+00 to 10+00, are documented in Appendix A.

Figure 11. Photo. (a) Typical corner spall in I-72 WB and (b) transverse crack across full-width panel.

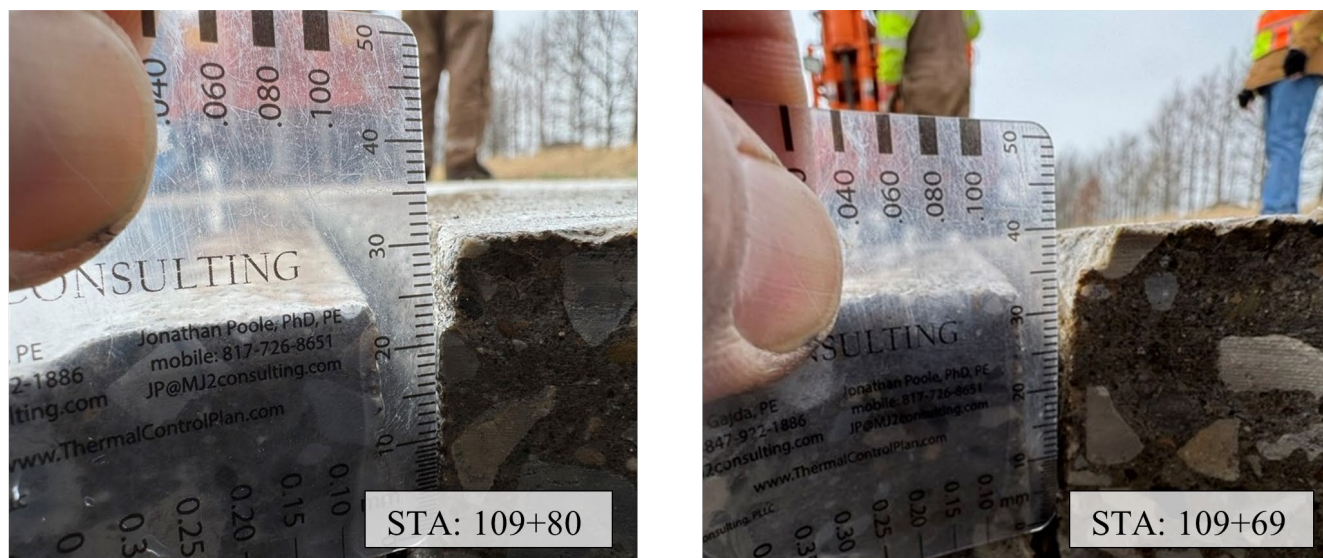
Figure 12. Photo. Faulting along driving lane-shoulder joint at approximately 0.25 in. (6 mm) on I-72 WB.

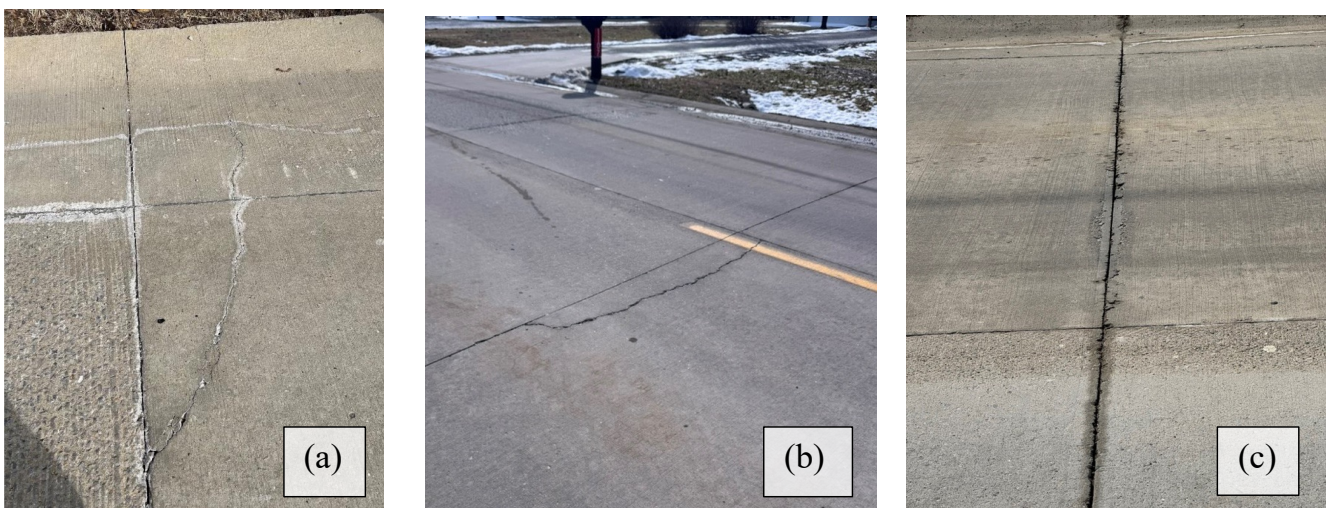
Figure 14. Photo. Types of distresses observed on East Grand Road: (a) corner cracks, (b) transverse crack parallel to transverse joint, and (c) raveling on transverse joint.

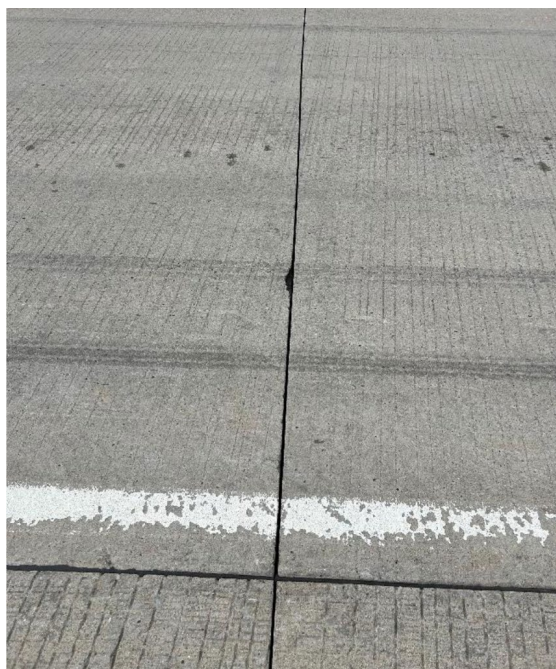
A pavement distress assessment survey was conducted along a segment of northbound I-57 between stations 27+150 and 28+660 on February 24, 2025. Due to limited traffic control measures and active, high-volume traffic, a full walking survey was not performed. Observations were limited to visual inspection from the shoulder in randomly selected areas. No significant distresses were observed other than minor localized transverse joint raveling/spalling, as seen in Figure 15.

Figure 15. Photo. Transverse joint spalling/raveling in I-57 northbound between stations 27+150 and 28+660.

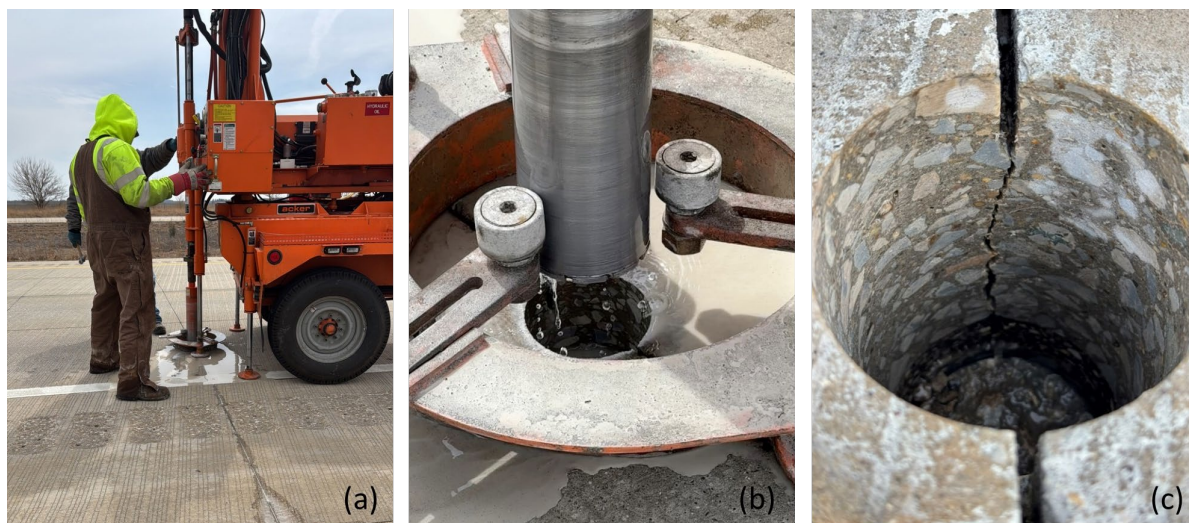
Figure 61. Photo. Core extraction at the middle of a transverse joint showing (a) coring rig operation, (b) borehole after core removal, and (c) inspection of borehole for joint activation.

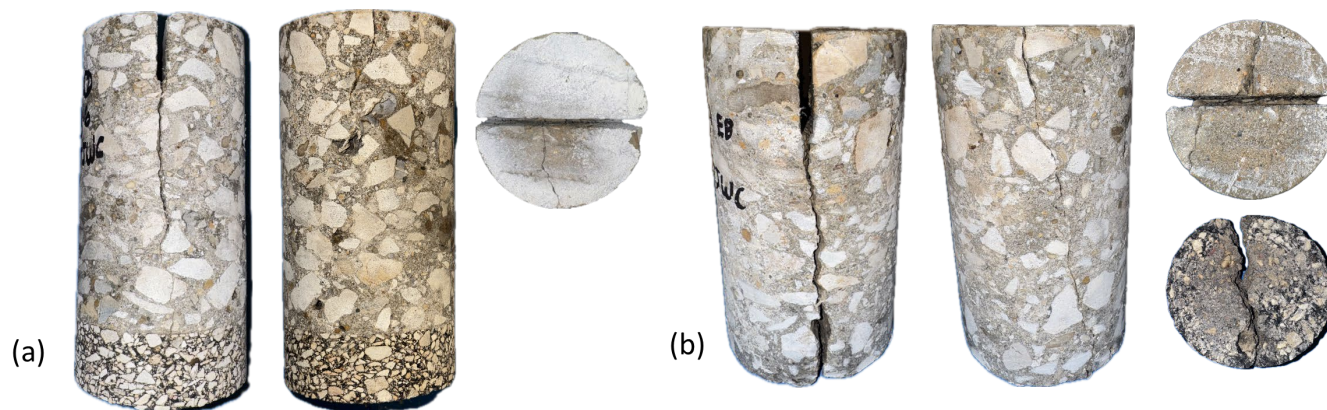
Figure 63. Photo. Examples of cores from transverse joints with longitudinal cracking. (a) Complete joint activation and partial longitudinal crack activation with bonded HMA layer. (b) Core with full-depth activation of both the longitudinal crack and joint but completely unbonded from the HMA interlayer. Each core is shown in front view (aligned with the transverse joint), side view (aligned with the longitudinal crack), top view, and bottom view (included only when interlayer was unbonded).

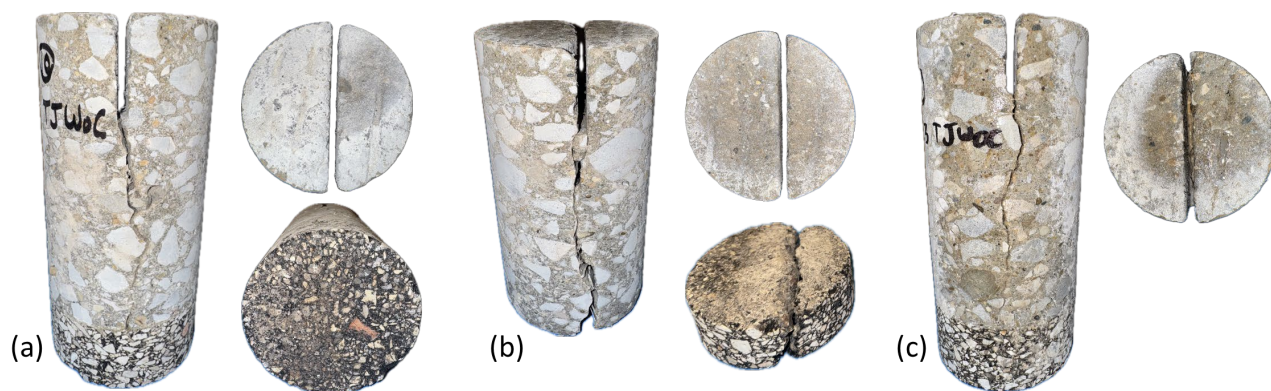
Figure 64. Photo. Cores extracted from transverse joint without longitudinal cracking (a,c). Cores with full-depth joint activation and bonded HMA interlayer. (b) Core with full-depth joint activation and unbonded HMA interlayer, showing degradation at the concrete overlay-HMA interface near the joint. Images include front view (aligned with joint), top view, and bottom view when applicable.

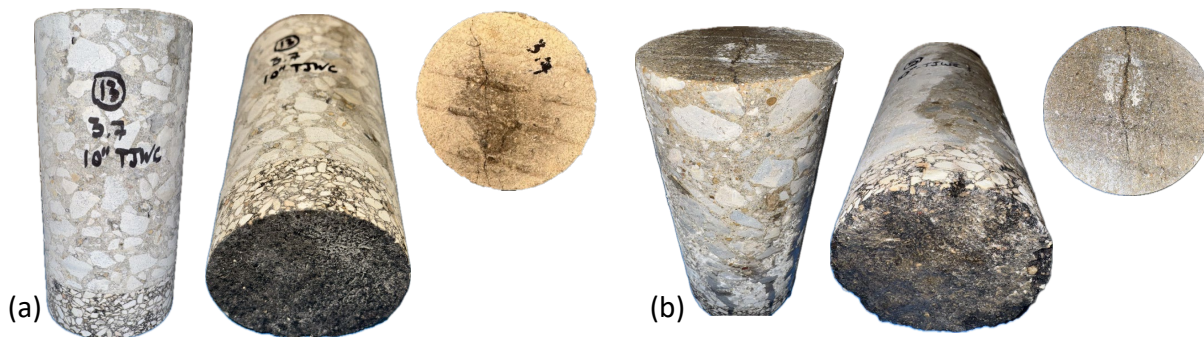
Figure 65. Photo. Cores extracted 10 in. from transverse joint along longitudinal crack path. (a) Cores showed full bonding to the HMA interlayer with crack depths between 1 and 1.5 in. at station 144+71 and (b) and at station 15+03.

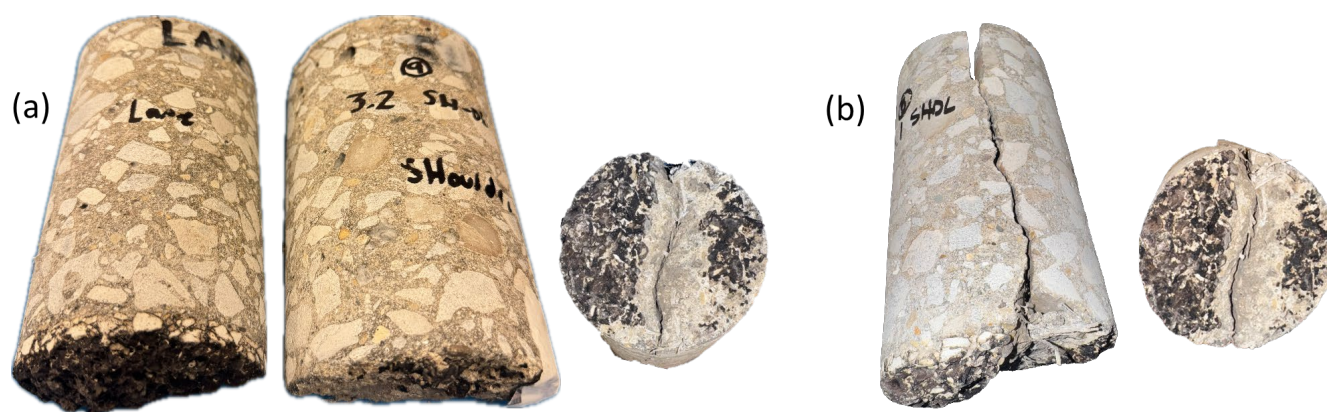
Figure 66. Photo. Example of cores extracted from driving lane-shoulder longitudinal joints showing full-depth joint activation and an advanced HMA interlayer degradation. (a) Core split along longitudinal joint. (b) Core that remained held together by only a few macrofibers.
