Assessment and Repair of Prestressed Bridge Girders Subjected to Over-height Truck Impacts

September 2025 Final Report Project number TR202011/TPF-5(462)

MoDOT Research Report number cmr 25-013

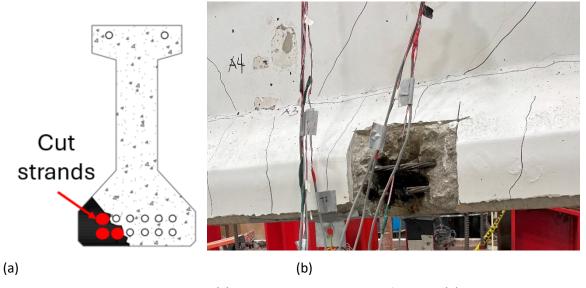
Figure 5-5. Girder G03 strands cut, (a) Cross section showing loss of strands, (b) The section along the girder where strands were cut (before the flexural test)

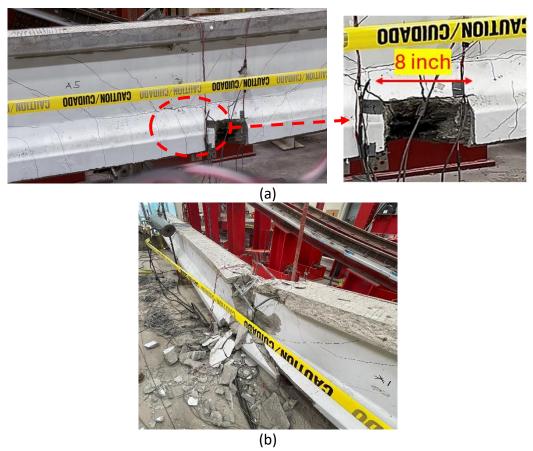
Shear cracks developed outside the constant moment zone at 108 kips, reflecting significant shear stress. Testing continued until a deflection of 4.27 inches, at which point the load dropped suddenly. The girder ultimately failed in a brittle manner, splitting at midspan. Vertical cracks widened due to the loss of prestress, leaving the concrete to bear tensile stresses alone. The ultimate failure load was recorded at 118 kips, corresponding to a failure moment of 855 kips-ft (Figure 5-6). The flexural capacity was almost equal to the AASHTO LRFD estimate (Table 5-1).

Figure 5-6. Girder G03 (a) The testing of the girder, (b) Failure of the girder.

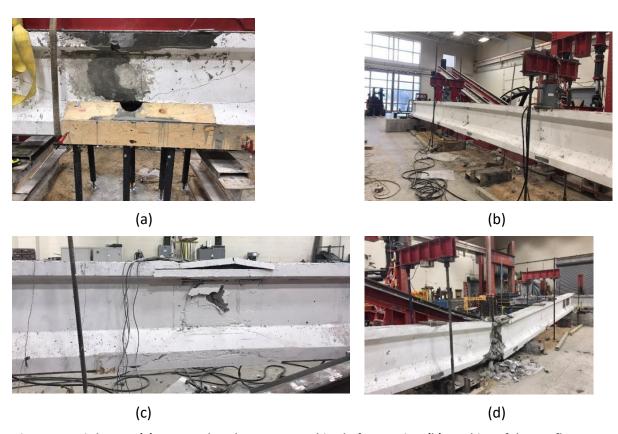
At a load of 68 kips, these cracks propagated into the upper flange, indicating imminent failure. By 70 kips, vertical cracks widened and deepened, marking the onset of failure. The test continued until the girder deflected by 0.5 inches, at which point the load dropped abruptly to 75 kips due to the crushing of the top flange (Figure 5-9c). The failure applied load corresponds to a bending moment of 521 kips-ft. The girder's flexural capacity exceeded the AASHTO LRFD estimate by 9.4%, based on the measured residual prestress forces in the strands, as described in Section 5.3.

Figure 5-9. Girder G06 (a) Formwork and concrete patching before testing, (b) Crushing of the top flange at 75 kips, (c) Complete failure of the girder

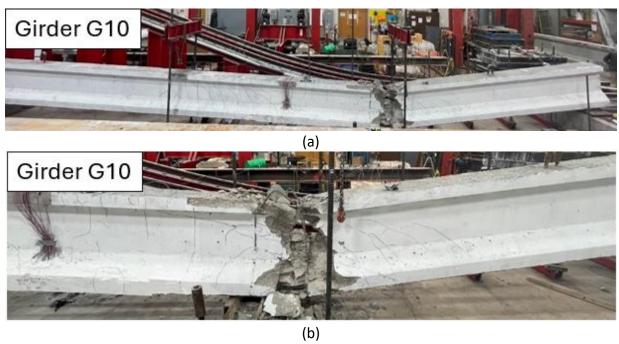
Figure 6-4. Girder G10 (a) Overall view of the girder at failure, (b) Close-up view of the girder at failure

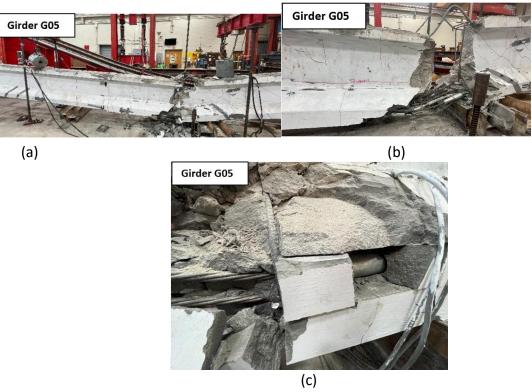
Figure 6-14. Girder G05 failure (a) Failure at the splicing location, (b) Close-up to the splicing after concrete removal, (c) Splice chuck causing a horizontal crack

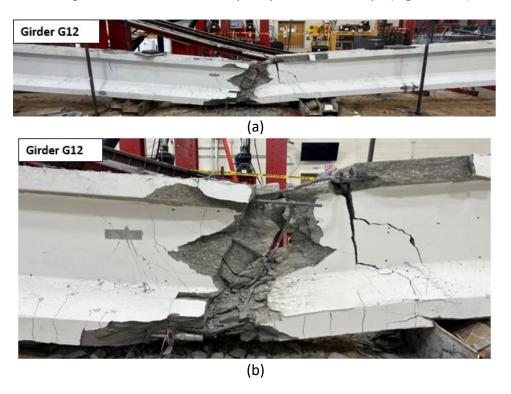
prestress in the repaired section. As shown in Figure 6-15, the girder reached its structural limit at 145 kips, achieving a maximum moment capacity of 1024.4 ft-kips (Figure 6-17).

Figure 6-17. Photographs of G12 showing (a) Failure of 33% damage repaired girder at midspan (b) Close-up view of girder failure

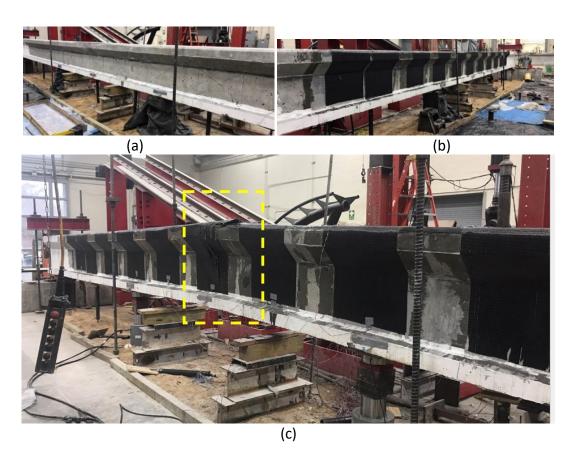
Figure 6-26. (a) Surface preparation, (b) CFRP curing, (c) Failure of the girder

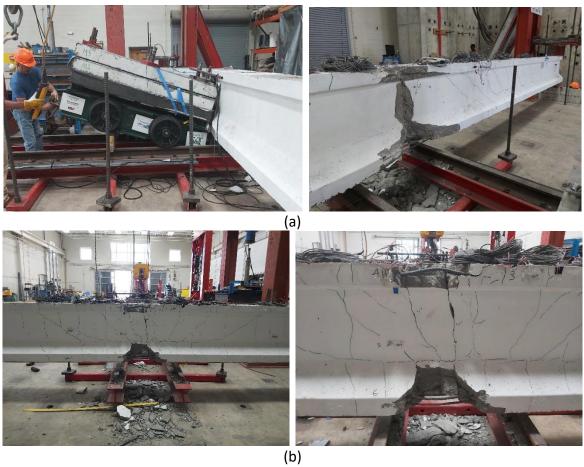
Figure C-36. Damaged photographs of Girder G01 impact (a) Impact side, (b) Back side

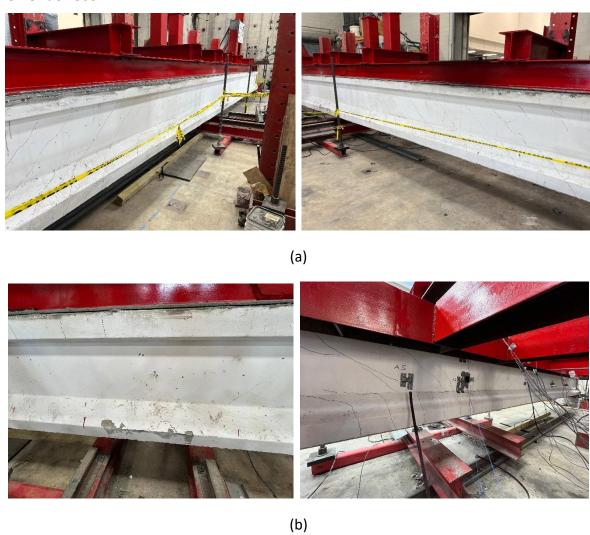
Figure C-38. Damage photographs of Girder G03 (a) Impact side, (b) Back side

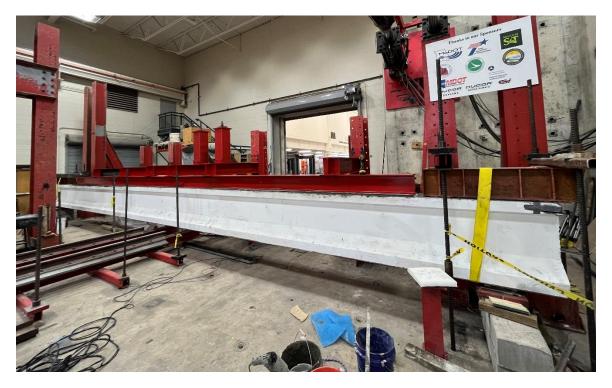
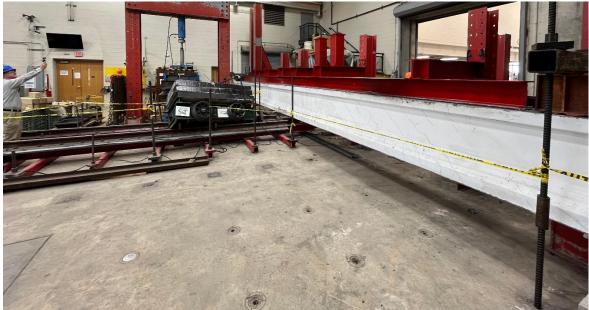
Figure C-40. Cracking of the girder after impact

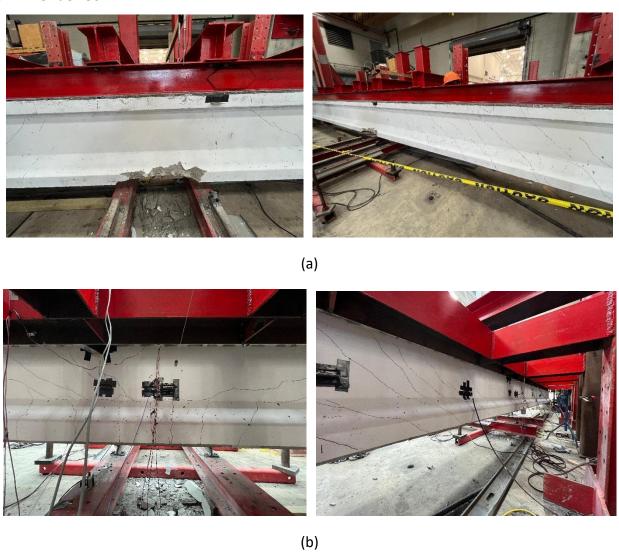
Figure C-42. Damage photographs of Girder G04 (a) Impact side, (b) Back side

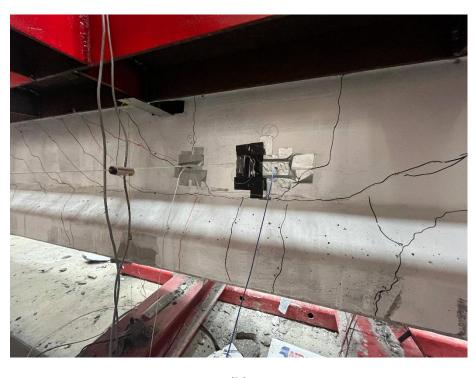
Figure C-43. Damage photographs of Girder G05-first impact (a) Impact side, (b) Back side

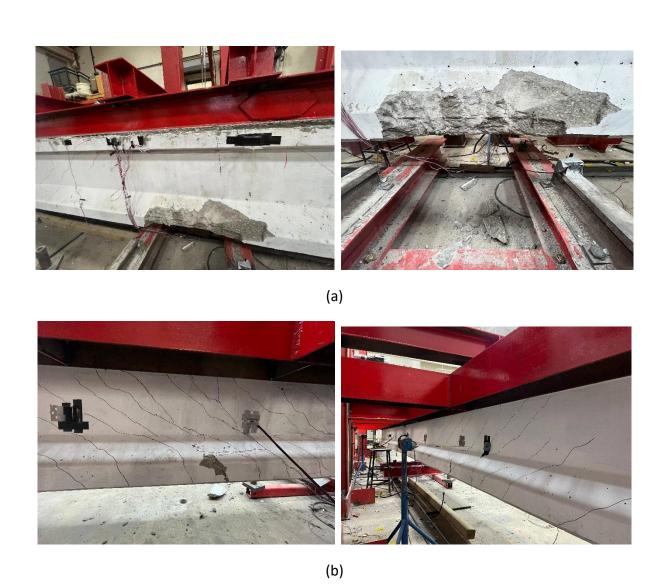
Figure C-44. Damage photographs of Girder G05-second impact (a) Impact side, (b) Back side

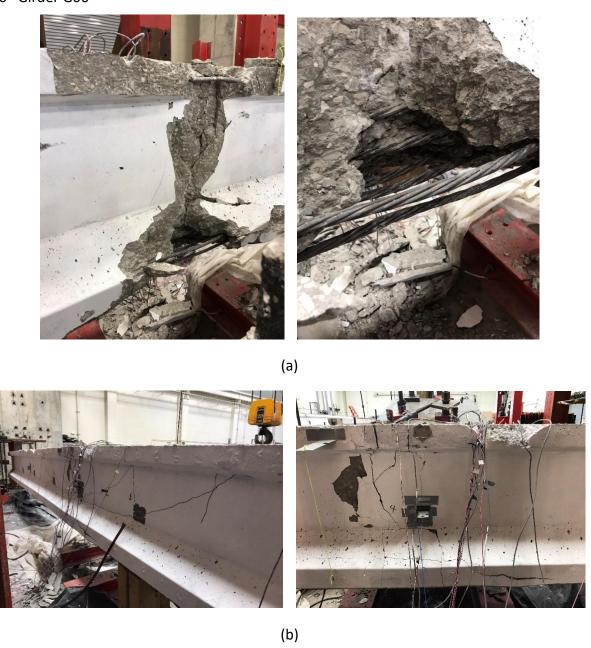
Figure C-45. Damage photographs of Girder G06-second impact (a) Impact side, (b) Back side

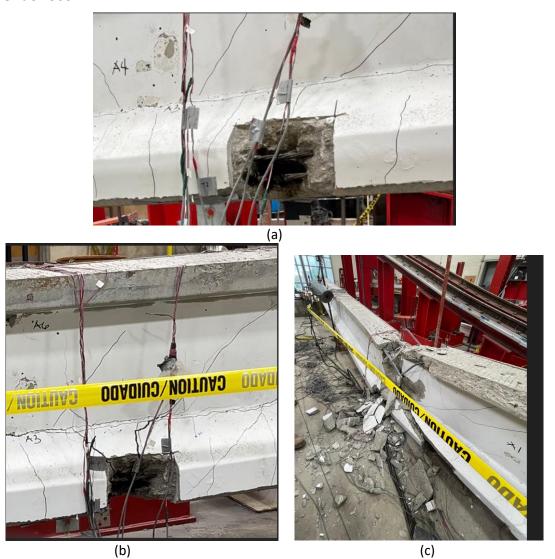
Figure F-5. Photographs of the girder 25% residual strength (a) Cutting the strands, (b) Flexural vertical cracking during testing, (c) Failure of the girder

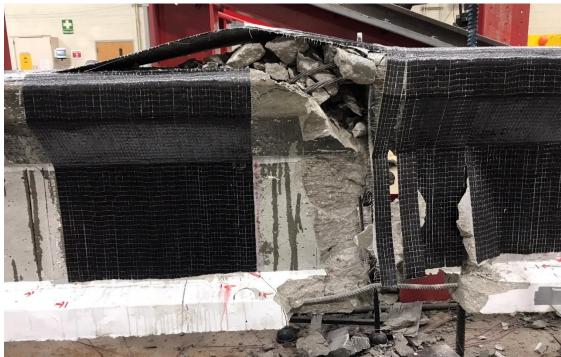
Figure G-21. Rupture of CFRP longitudinal plies
