Traffic Disruption-free Bridge Inspection Initiative with Robotic Systems

September 2025
Final Report

Project number TR202004/TPF-5(462)
MoDOT Research Report number cmr 25-011

Missouri University of Science and Technology

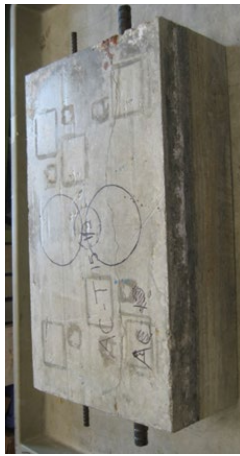
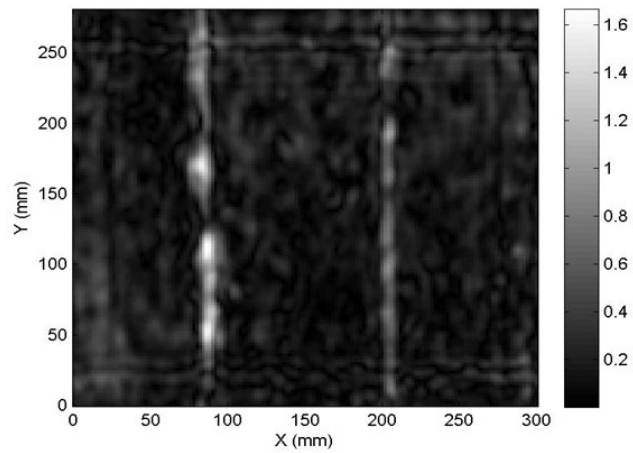
Figure 2. Corroded RC Slab and its Corresponding Microwave Image (25.4 mm = 1 in)

To demonstrate the roles of NDE and sensing in data-driven decision-making, microwave imaging and corrosion sensing technologies are compared for the assessment of steel rebar corrosion conditions in RC slabs (Liu et al., 2020). Figure 2 shows a RC slab of 12 in × 12 in (300 mm × 300

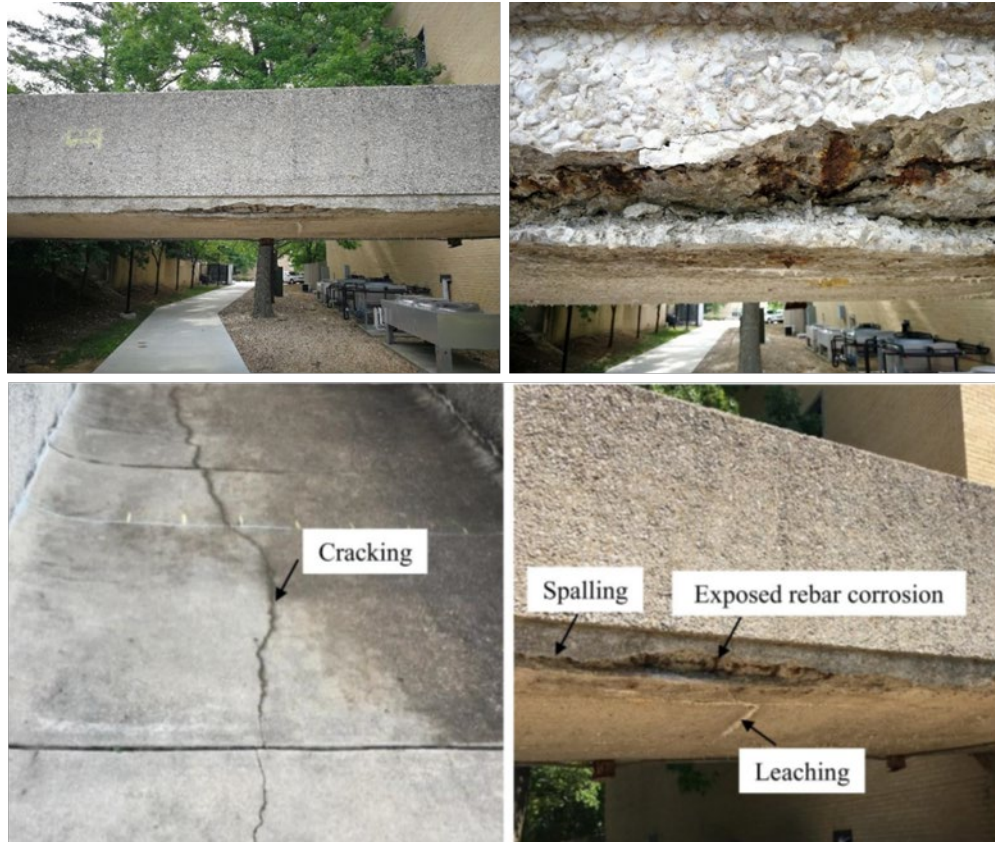
Figure 37. Various Types of Deterioration in the Pedestrian Bridge

The pedestrian bridge was used for nondestructive testing (Alhaj et al., 2019). An area of approximately 10×9 ft (3.05×2.74 m) was surveyed using GPR, IE, USW, and SAR imaging methods at the bridge surfaces of the RC bridge deck for condition assessment. This study was conducted to investigate the effectiveness of nondestructive testing (NDT) methods from the topside and underside of the bridge deck.

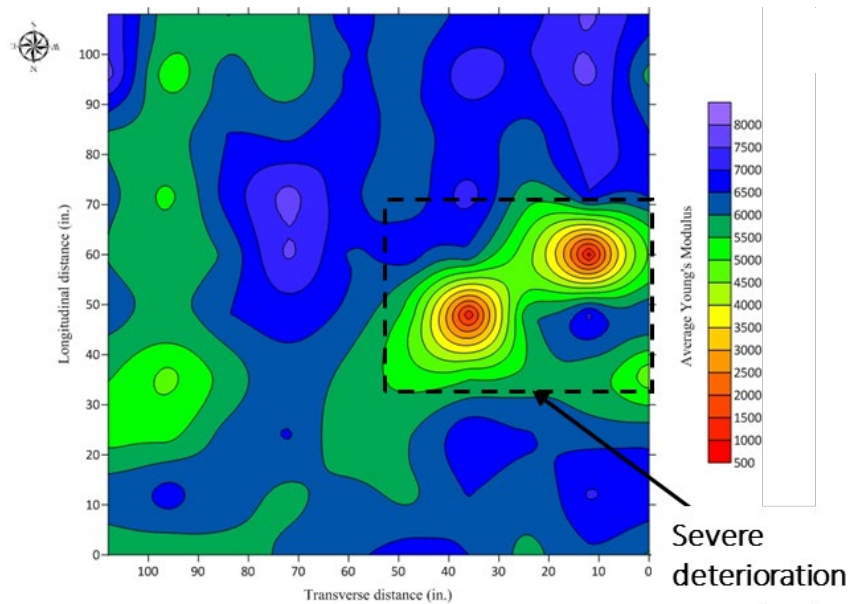
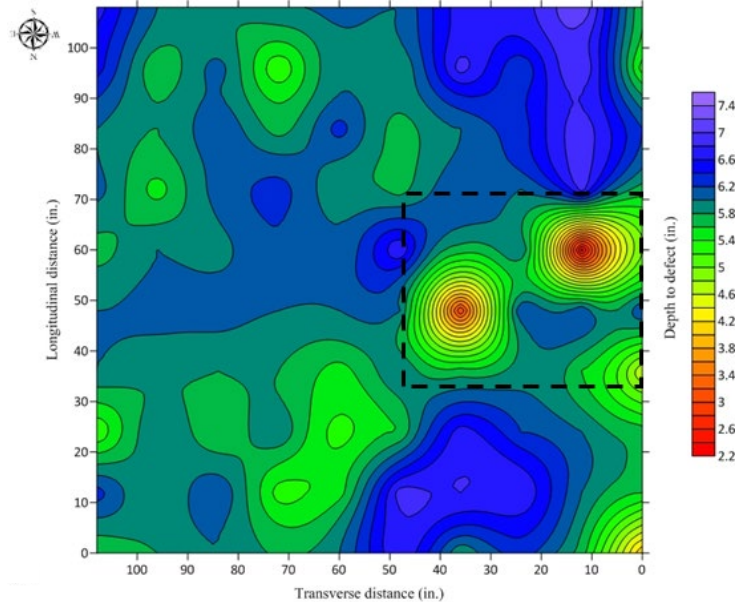
Figure 44. Topside Deck Survey: (a) USV and (b) IE Variation Map

surveys. At the top section as shown in Figure 44, areas of high deterioration indicated by a low range of average Young's Modulus, less than 2901 ksi (20 GPa), and a high range of depth to defects 2 – 5 in (5.1-12.5 cm). At the bottom section as shown in Figure 45, areas of high deterioration indicated by a low range of average Young's Modulus, less than 2901 ksi (20 GPa), and a high range of depth to defects 2 – 4 in (5.1-10.2 cm). An extensive deterioration area was observed approximately at the western part of the bottom section near the exposed reinforcement corrosion area.

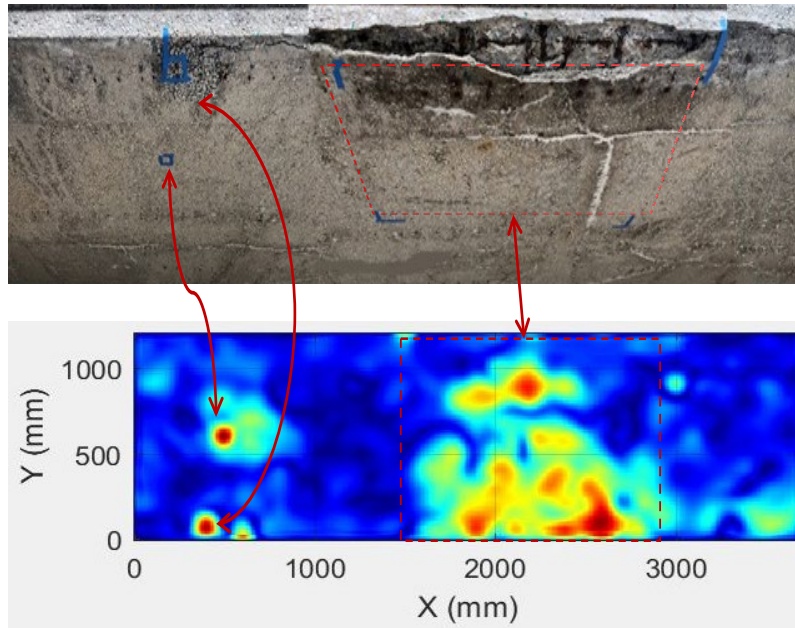
Figure 46. SAR Image of Underside Deck Corresponding to Damage Areas

The middle section of this bridge was manually scanned using a wideband horn antenna connected to a field-portable vector network analyzer (VNA). Custom-made software programs on a PC read the data from the VNA as it measured the reflection coefficient across a frequency band of 1 to 4 GHz (matching the specifications of the antenna). These measurements were conducted on a 2D measurement grid with 4 in (10 cm) spacing. The antenna, which had an aperture of approximately 9 × 7 in (230 × 180 mm), was manually moved across this grid. However, an optimally designed robotic automated scanning platform can also be used along with antenna arrays to speed up the data collection process and to reach inaccessible areas (Ghaser et al., 2017). The collected data were then processed using the SAR algorithm to form 3D images. Two-dimensional (2D) image slices at depths of interest were then produced. Figure 46 shows the image produced from the underside of the bridge and focused on a depth of 1.57 in (40 mm) inside the concrete (closely corresponding to the location of rebar). This image shows more severe delamination near the edge of the bridge and its extent and spread towards the middle section of the bridge. Also visible in this image are two indications near X = 20 in (500 mm): one which corresponds to a location in the concrete with signs of deterioration and another which does not correspond to any visible distress. This latter indication may correspond to a void, pocket of high moisture, or an unknown embedded structure (e.g., drainage pipe) inside the bridge, which can be verified with additional testing or better yet with destructive testing.

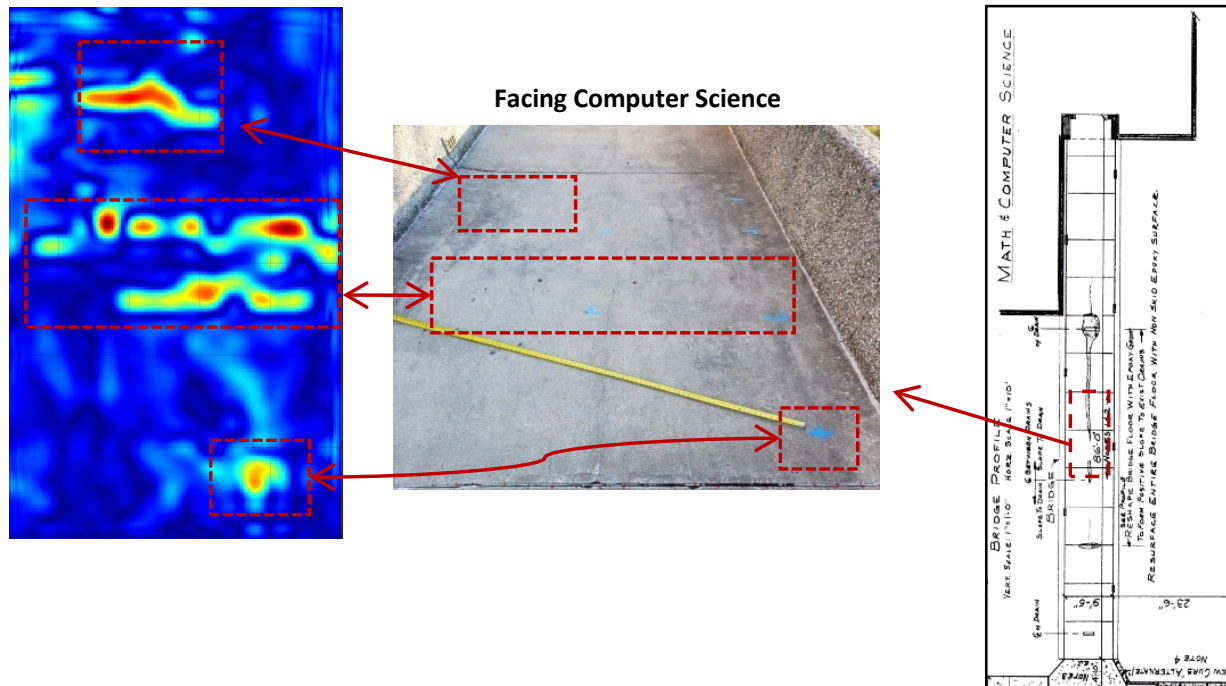
Figure 47. SAR Image of a Section of the Topside of the Bridge

Another scan was performed on the top side of the bridge deck, as shown in Figure 47, corresponding to a depth of approximately 3.15 in (80 mm) inside the concrete. Due to the repair and resurfacing work, the exact depth of the first rebar layer could not be ascertained. It was uncertain whether additional rebar mesh was placed on top of the original top rebar layer. The image in Figure 47 shows indications of degradation in multiple areas of the bridge. These can be due to rebar corrosion and concrete delamination or features in the bridge deck from the repair work conducted in the past.

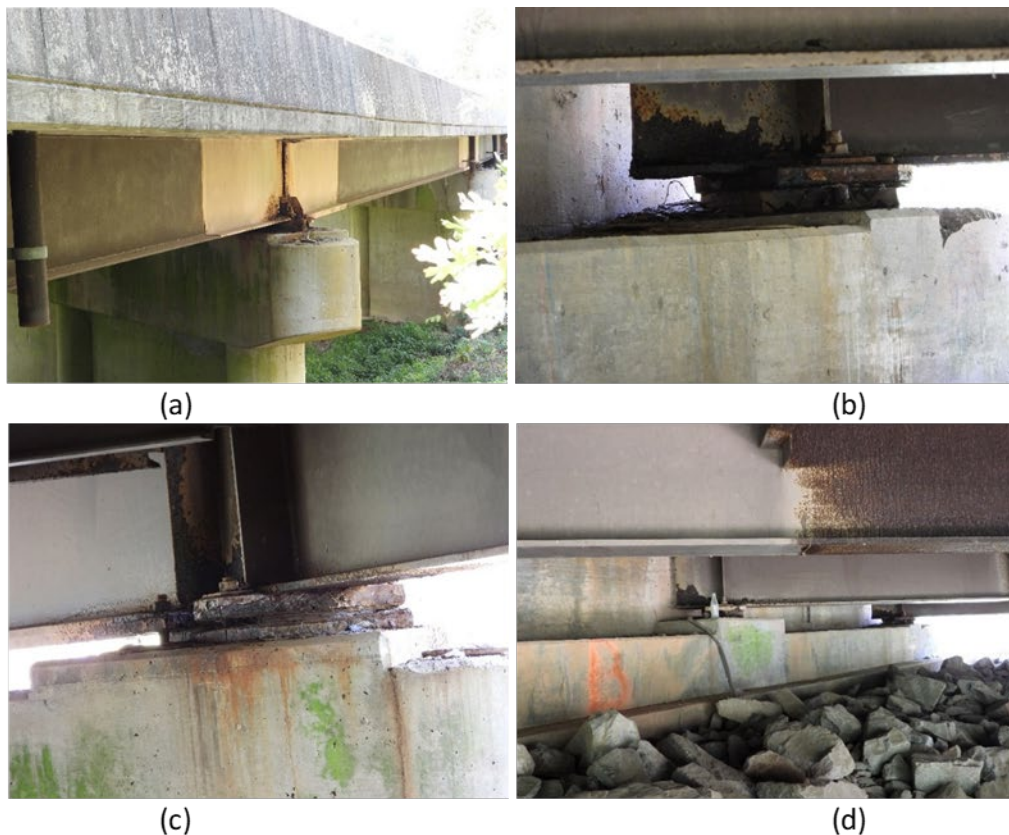
Figure 69. Virginia Bridge 11562 (Nikon)

Figure 69 shows images taken from the Nikon camera. Corrosion issues and deterioration at the support can be noticed clearly. Spreading of the corrosion on the steel girders can also be noticed, which is consistent with the observations from the Skydio 2 and the Elios 2. Figure 70 shows images taken from the Elios 2. These images further reveal the corrosion issue at the supports, and the drainage issue at the concrete caps which may be a cause for the corrosion. Corrosion patterns can be noticed at the steel girders. The inner side of the exterior girder shows good condition of the paint, while interior girders show rust at the mid-span. In general, bridge supports present a consistent corrosion issue. Figure 71 presents a 3D thermal model of the bridge generated from individual thermal images using photogrammetry. Such a 3D thermal model enables an overview of the bridge from any angle in top view as the DJI M600 drone collects data above the bridge only. Major patch issues and asphalt surface changes can be noticed at the approach spans. Note that thermal imaging is effective for subsurface delamination, but it requires a temperature change. The best time would be 10 am – 2 pm with sunny conditions for rising temperature data collection and after sundown for decreasing temperature data collection.

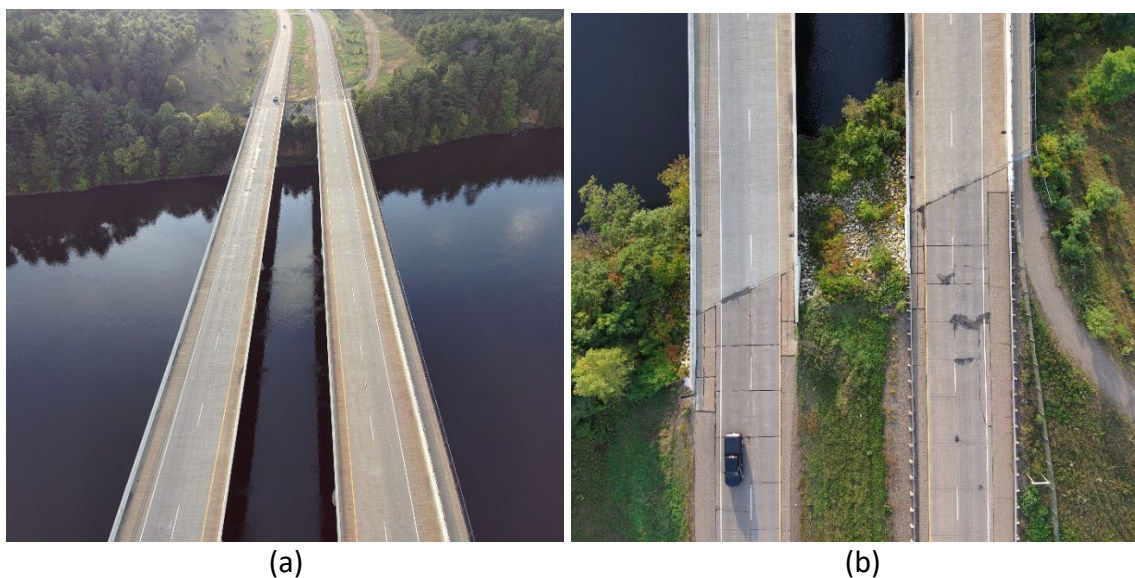
Figure 75. Wisconsin Bridge B090209 (Skydio 2)

This subsection presents the representative data for Wisconsin state bridge B090209 in the age range of 15-20 years. Overall, the bridge is in good condition except minor corrosion at the approach span support, cracks at the abutment, and dense roadway cracks before the approach spans. Figure 75 presents an overview (top view) of the bridge deck and approach slab with noticeable cracks. Figure 76 presents close-up views underneath the bridge from the Nikon camera on the ground. It includes the Elios 2 drone in the upward view. The flashlight on the Elios 2 drone provides sufficient lighting for inspecting the girder channels with dim lighting conditions. A part of the steel girder appears unpainted. Figure 77 shows additional close-up views on the underside of the bridge deck and cross frame taken from the Elios 2 drone. Figure 78 shows several FLIR thermal images. Along with regular RGB images, the cracks and construction joints before the approach spans can be clearly noticed in the thermal images. Figure 79 shows the point cloud of Wisconsin bridge B090209.
