A Follow-up Evaluation of the Concrete Pavements (U.S. 58) Rehabilitated in 2012

Final Report VTRC 26-R16

FINAL REPORT
A FOLLOW-UP EVALUATION OF THE CONCRETE PAVEMENTS (U.S. 58)
REHABILITATED IN 2012

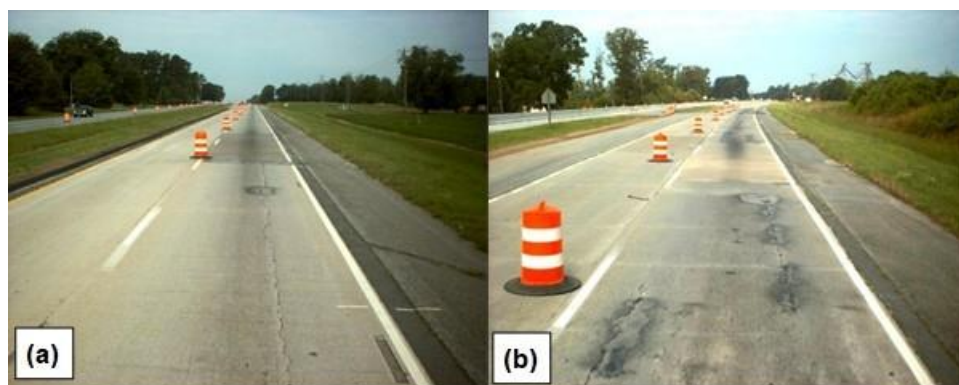
Visually, the unbonded section was more distressed than the bonded section (Figure 2). The design was based on these observations by selecting the highly distressed areas for the unbonded section.

Figure 2. Distresses before Overlay, Travel (Outside) Lane: (a) Bonded and (b) Unbonded

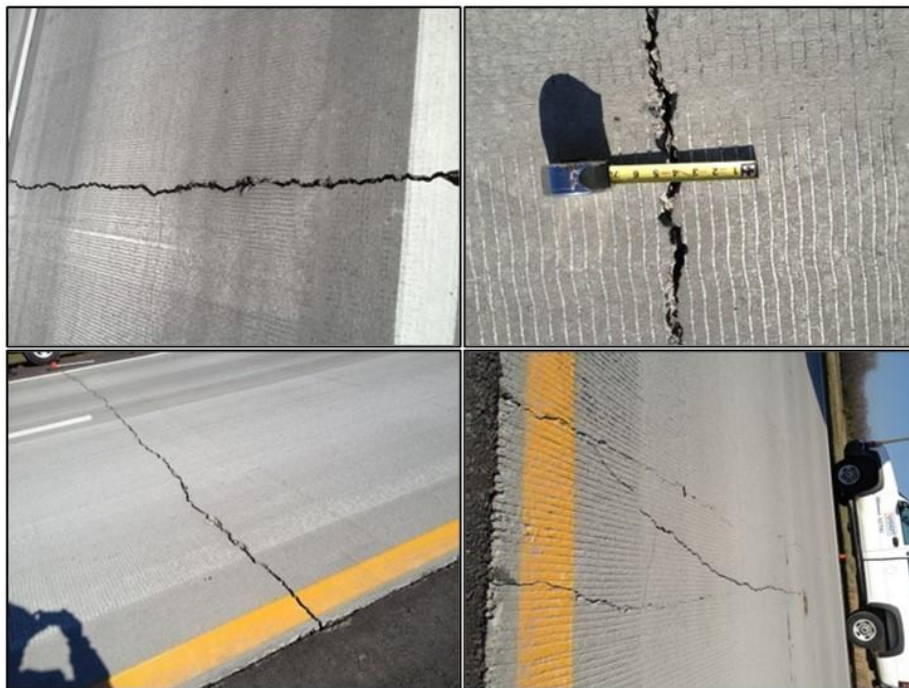
The unbonded concrete and asphalt overlay sections did not receive any major maintenance work because the overlaid but bonded concrete overlay section needed some repair. A few wide transverse cracks showed within 6 months after construction (Figure 7), pictures taken in January 2013. One crack was 0.75 inch wide, and others varied from 0.1 inch to 0.4 inch, and some were clustered together. Subsequent coring, as seen in Figure 8, revealed that all the cracks reflected from the underlaying old concrete layer and were affected by the shrinkage of the bonded overlay concrete on the surface. Severely distressed old concrete occurred at the bottom but was not apparent at the surface. From the cores, moisture damage was evident by the corrosion of steel and severely broken concrete at the bottom.

Figure 7. Bonded Concrete Surface—Wide Cracks, January 2013

These distressed areas were repaired with concrete patches in 2014. Sixteen patches were installed: 14 on the travel lane and 2 on the passing lane within 2 years after the overlay placement. A few more patches have been done in recent years since the overlay, but no major repair has been done.

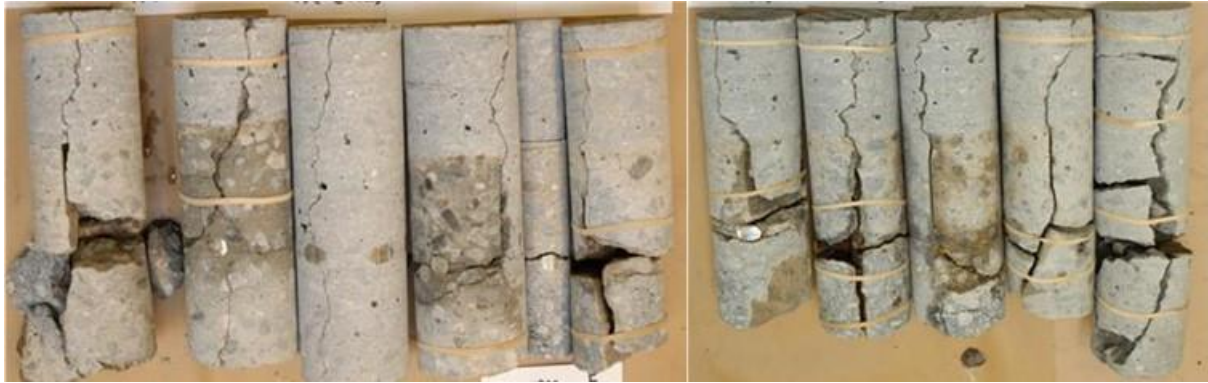
Figure 8. Cores from the Distressed Area of the Bonded Overlay Section

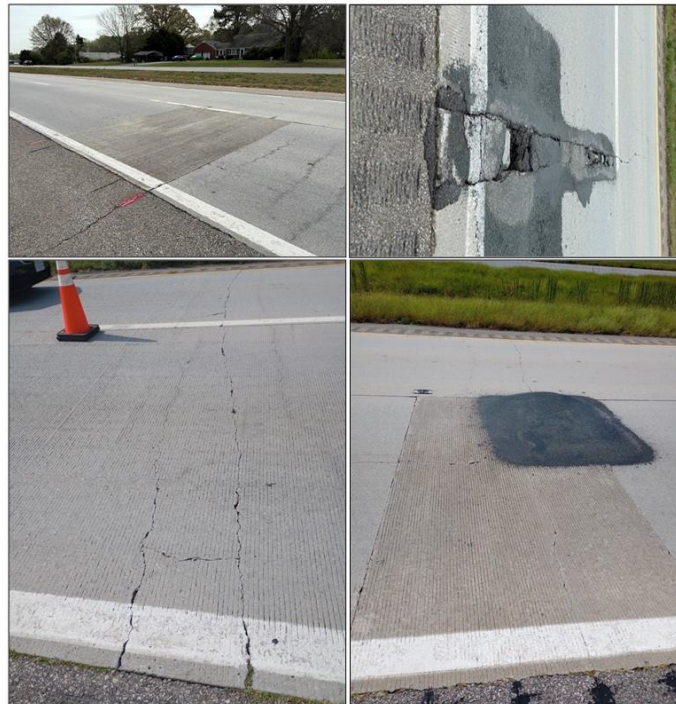
**Figure 11. Surface Distresses on Bonded Section in 2025**

This bonded section had a few visibly distressed areas. Table 5 summarizes the distresses for a 0.1-mile section. The bonded section had wide transverse cracks and localized punchouts. Here are the highlights of the distresses from PMS for the whole 2.6-mile section:

- Average Spacing of Transverse Cracks: 7.76 feet.
 - Severity 1: 56%; and severity 2: 44%.
- Longitudinal Cracks.
 - Severity 1: 254 feet.
 - Severity 2: 180 feet.
 - Severity 3: 11 feet.
- Clustered Cracking Severity 1.
 - 18 clusters with a total area of 714 square feet.
- Longitudinal Joint Spalling.
 - 98 linear feet.
- Punchouts and Spalled Y-cracks—most of which are within a 0.3-mile section.
 - 126 punchouts totaling 787 square feet.
- PCC Patch—Severity 1: 962 square feet.
- Asphalt Patching—91 square feet.

Longitudinal and transverse cracks and spalled areas can be sealed with Mastic One (a hot-applied, pourable, self-adhesive patching material used for filling wide cracks and joints), and smaller width cracks can be repaired by applying hot asphalt binder. Some areas of high punchouts are present around county milepost 19, which need to be patched full depth with good-quality concrete. Other options of overlay (such as unbonded or asphalt) could also be considered if damage becomes significant.

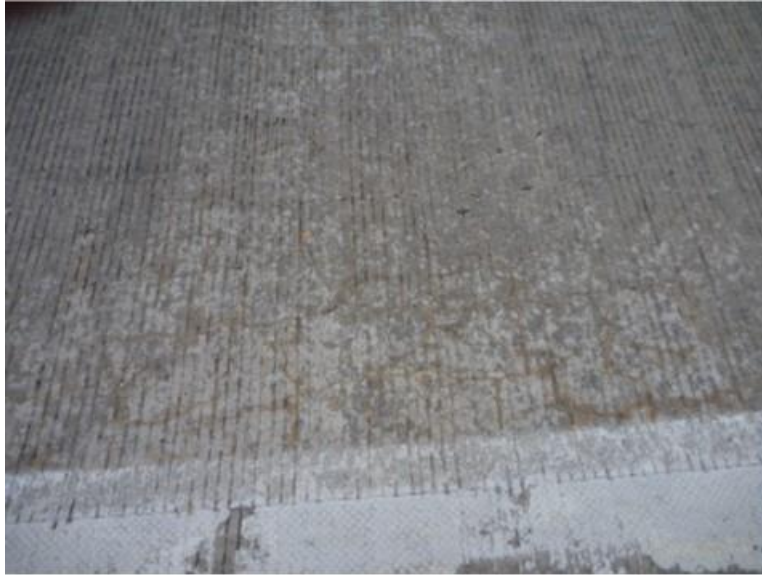
Figure 12. Map Cracks on the Patches

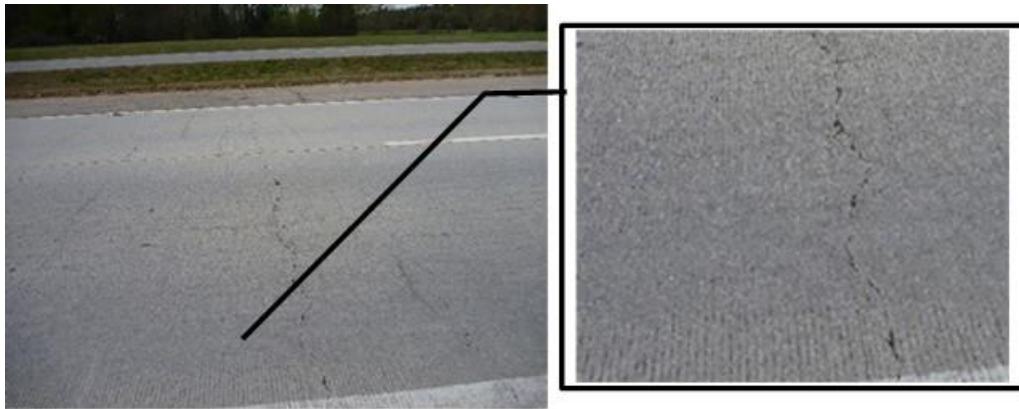
Figure 13. Polished Surface on the Concrete Overlay in 2025

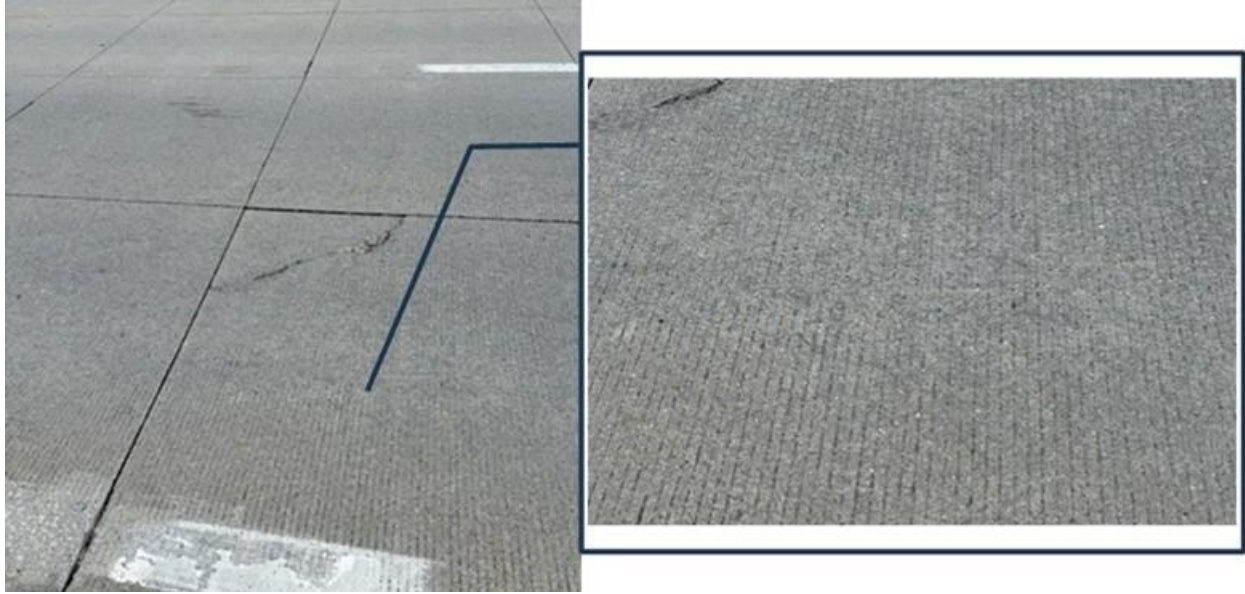
The unbonded concrete overlay is performing satisfactorily after 12 years of service, with minor distresses on the surface, such as low-severity faulting, some joint sealant loss, and a few corner breaks. Figure 14 shows some of the distressed areas. Corner breaks are mostly associated with the settlement of the slab. One of the probable causes of settlement might be the underlying asphalt separation layer, which might have settled or disintegrated. The separation layer was PFC, which is an open-graded asphalt layer. A few joints are missing sealants, and moisture could easily enter the system and damage the PFC through asphalt stripping. Although the low-severity faulting was consistent across all the joints, the amount of faulting is very low at only 0.03 inches. It may also be attributed to the PFC separation layer. It is also important to note that these joints do not have any dowels. Overall, the pavement condition is excellent, with CCI of 99. The ride quality is between good and fair, with a value from 99 to 100 inches/mile. Like bonded concrete, this section also showed some polishing on the wheel path (Figure 14), but the average skid number (SN40S) was above 40.

Figure 14. Pavement Surface Condition for Unbonded Concrete Overlay in 2025

- Transverse Joint Spalled: Total seven slabs.
- Longitudinal Joint Spalled: Only one slab.
- Corner Breaks Severity 2: Only one slab (three observed during field visit on April 2, 2025).

The measured faulting was only 0.03 inch, and good load transfer was observed across the joints. More than 90% of the joints have LTE of 75% or more. The low-level faulting might have affected the ride quality, and the average IRI in 2025 was 99 inches/mile. Some corner breaks were present that could be attributed to the moisture damage or the settlement of the separation layer (PFC). Joint seals were missing in a few places, which can cause moisture intrusion and subsequent stripping of the asphalt separation layer, hence loss of support and corner break. Maintenance suggestions to extend the life of the overlay include:

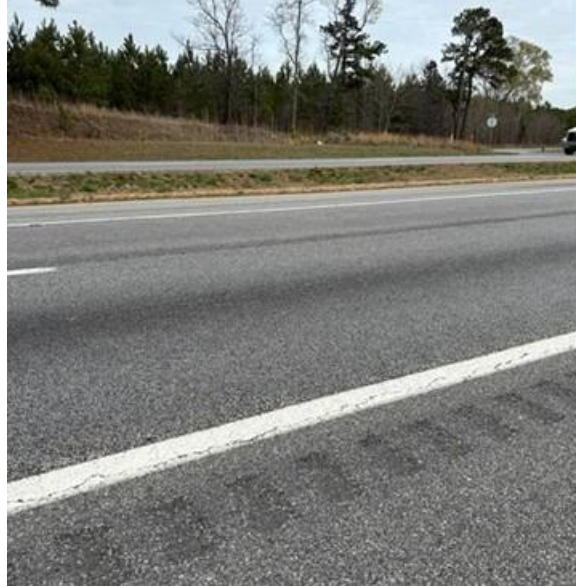
After 12 years of service, the asphalt overlay surface has no major distresses except for significant rutting of approximately 0.35 inch (Figure 15). Figure 16 shows the progression of rutting during the years. Along with the current surface condition in 2025, it appears to be dual wheel rutting, indicating ruts only in the asphalt layer. The asphalt layer is also placed directly on top of the rigid concrete, which usually does not rut. Rutting had increased until 2021 and then stayed around 0.35 inches for the past few years. Because of this high rutting value, the pavement condition index dropped to 66. Rutting has a significant effect on the VDOT load-related distress rating. For example, just the average rut depth of 0.3, 0.4, and 0.5 inches would result in a deduction of 22, 42, and 60 points out of 100 in load-related distress rating, respectively. It is obvious from the traffic data in Figure 6 that the percentage of truck traffic has increased from 12 to 20% right after the overlay construction and might have contributed to rutting. No indication of polishing is present, and the measured skid resistance (SN40S) is around 40, indicating adequate friction like a concrete overlay surface in the westbound lanes.

Figure 15. Asphalt Overlay Surface Condition in 2025

- No transverse or longitudinal cracks.
- Longitudinal Lane Joint—Severity 1: 374 feet (whole 9.8-mile section).
- Reflective Transverse Cracking—whole 9.8-mile section.
 - Severity 1: 953 linear feet.
 - Severity 2: 341 linear feet.
- Reflective Longitudinal Cracking—whole 9.8-mile section.
 - Severity 1: 16 linear feet.
- Alligator Cracking—whole 9.8-mile section.
 - Severity 1: 424 square feet.
 - Severity 2: 3 square feet.
- Patching Area—whole 9.8-mile section.
 - Wheel path: 12,273 square feet (1% of whole section).
 - Non-wheel path: 7,148 square feet (0.5% of whole section).
- Average rut depth.
 - Straight-edge: 0.34 inches.
 - Wire method: 0.36 inches.

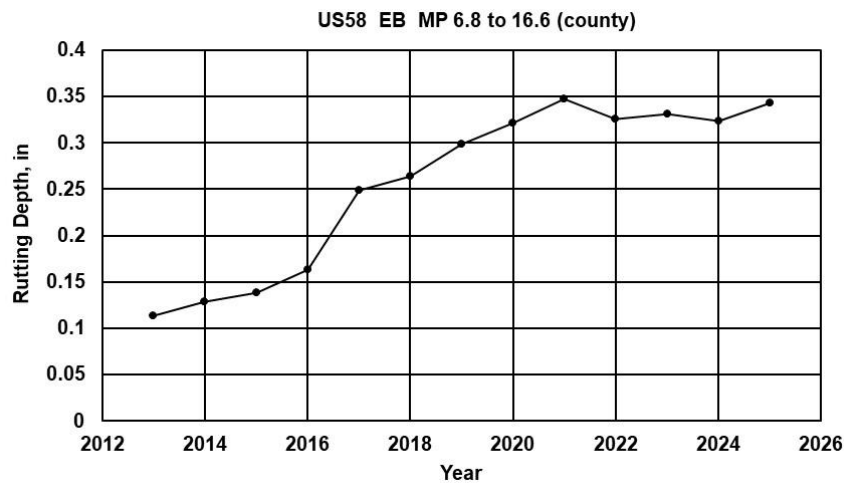
Figure 16. Progression of Rutting on Asphalt Overlay. EB = eastbound; MP = milepost.
