Evaluation of Bridge Fiber Optic Sensor Systems

NM12SP-07-012

EVALUATION OF BRIDGE FIBER OPTIC SENSOR SYSTEMS

Final Report
July 15, 2016

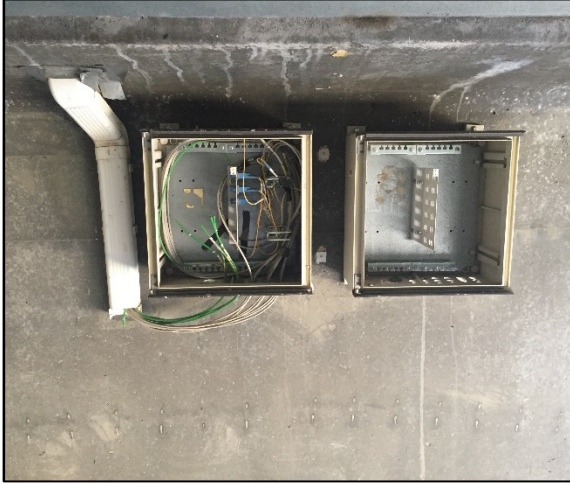
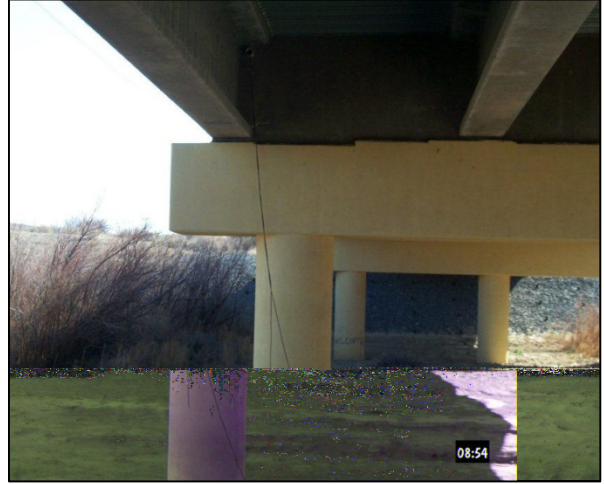
While most of the sensor in the bridge are still functioning, there has been a significant amount of vandalism to the instrumentation boxes and connection cables. Due to this damage and time restrictions, limited data was collected for Bridge 9234. To evaluate the sensors, the data acquisition system had to be connected to each junction box which housed approximately 10 fiber optic sensors. When repaired, measurements will be taken for all gauges from a single location. Figure 4 shows some of the damage to the instrumentation system. Pictures of the evaluation of the sensors are shown in Figure 5.

Figure 4: Bridge 9234 – (a) damaged instrumentation boxes and cables;
(b) broken fiber optic cables.

- Replace multifiber cable from junction box on girder AC to the central monitoring point;
- Replace multifiber cable from junction box on girder BC to the central monitoring point;
- Replace the mating of junction box on girder AW to the junction box on girder BW;
- Replace the cable for the data communication from all ADAM modules (thermocouple input modules) to the central monitoring point;
- Replace ADAM module in junction box on girder AW;
- Replace ADAM module in junction box on girder AC; and
- Repair or replace the junction box on girder AW (door is missing).

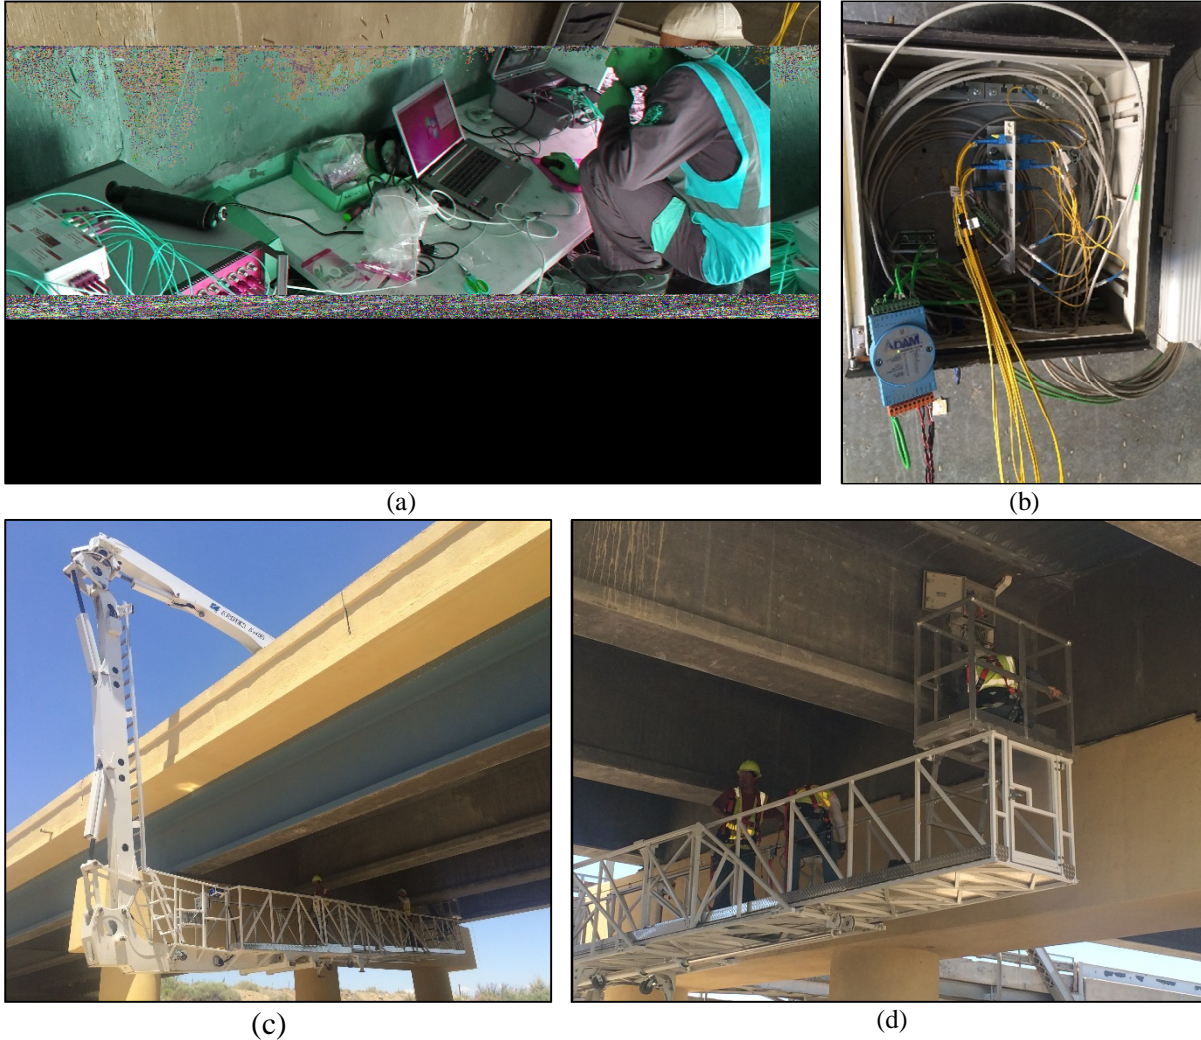
Figure 5: Bridge 9234 sensor evaluation – (a) dynamic evaluation; (b) repaired connections; (c) and (d) under-bridge access unit.

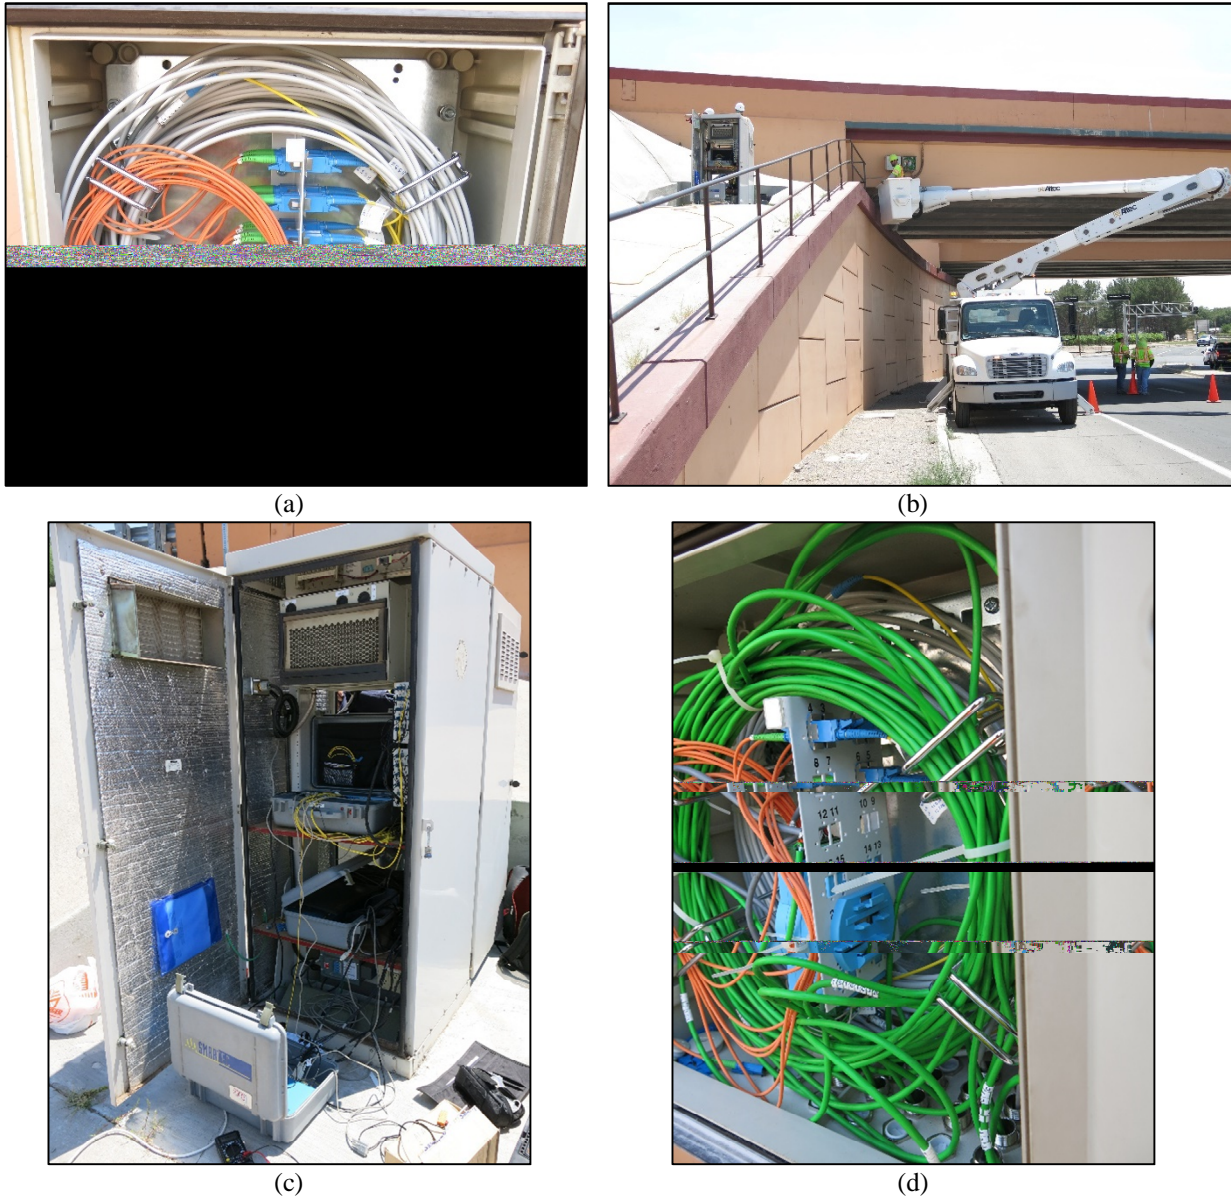
Tables 3 and 42 provide information on the current state of the sensors in Bridge 9266. Of the 72 fiber optic sensors originally installed, 67 sensors are currently still functioning properly. All thermocouples are still viable; however, all ADAM input modules need to be replaced on Bridge 9266. It was unclear why all modules stopped working; therefore, one ADAM module was sent to Smartec for investigation.

Figure 13: Bridge 9266 evaluation – (a) typical junction box; (b) under-bridge access lift; (c) central monitoring tower; (d) thermocouple cables in junction box.

- Replace all ADAM modules (thermocouple input modules), 8 total;
- SOFO bridge or ADAM convertor to communication with ADAM modules;
- Repair central monitoring housing cooling/heating system; and
- Power turned back on at facility.

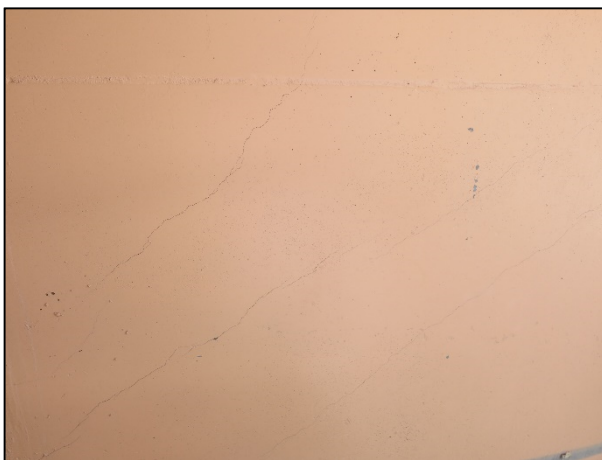
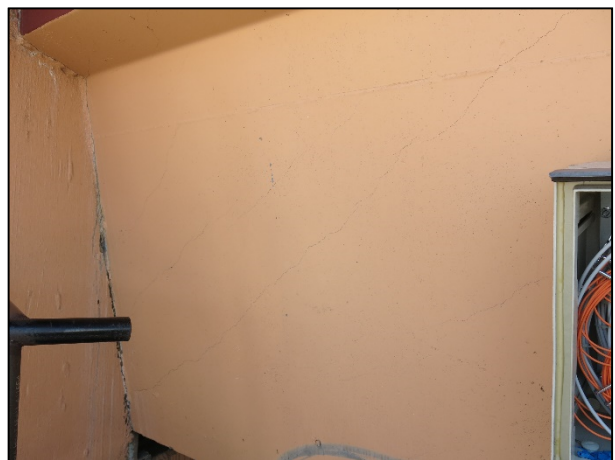
Figure 13 shows pictures during the evaluation including pictures of the junction boxes and central monitoring tower. Additionally, Figure 14 shows pictures from a modified load test. Due to traffic remaining on the bridge, further investigation is needed; however, data was collected under load to potentially investigate the behavior of the bridge particularly in the shear region. Bridge 9266 has a significant number of large shear cracks (see Figure 15). Further data collection

and analysis could provide insight into the behavior of the bridge leading to formation of the shear cracks.

Figure 15: Shear cracks on Girder 1.
