# **Investigation of Rack and Pinion**

## **Alignment of the Cass Street**

### **Movable Bridge in Joliet, Illinois**

**Physical Research Report No.129**

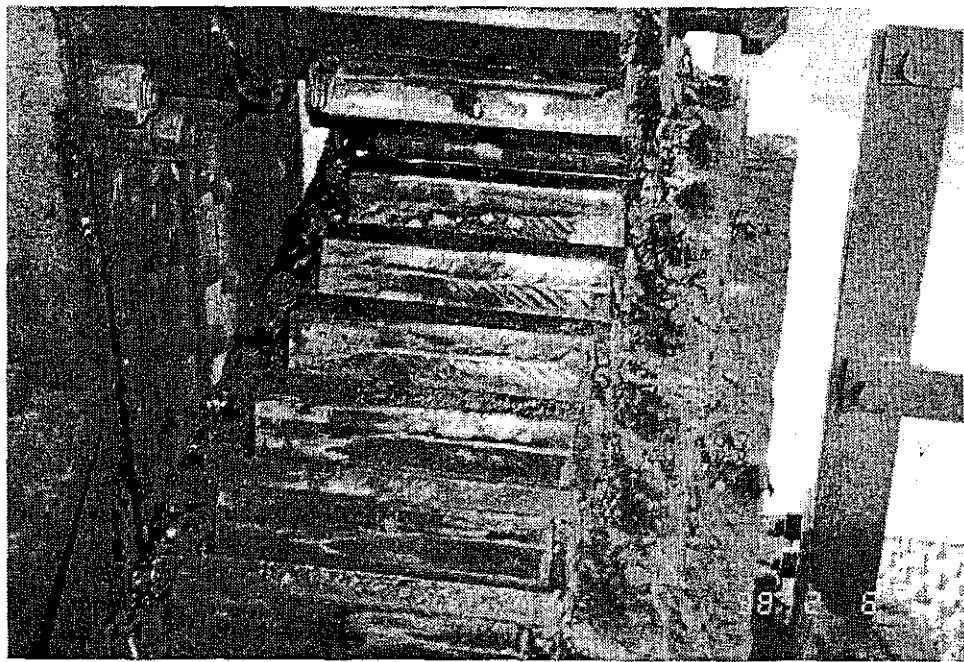
Based on the wear pattern as shown in *Figure 4*, the pinion is not correctly aligned with respect to the rack. Pinion orientation changed after the shims used in the retrofit of 1985-6 had fallen out, because the bolt holes had enlarged and bolt preload had dissipated. The steel shims were C-shaped, and were not passively captured by use of any epoxy or silicone rubber sealants. The collar was bolted to a series of rough, hot-rolled structural plates. These plates were not machined flat, nor were they spot-faced (made flat only in area of contact), nor was the bearing collar apparently reworked during the 1986 retrofit. Coincident with the 1997 rack and pinion problems were center lock misfit problems. Subsequent work in late 1997 apparently corrected the center lock interference problem, but the rack wear problem still remains.

**a. Abnormal Wear on Rack Teeth.** The racks, particularly in the northeast corner of the bridge, have experienced abnormal wear after the pinion bushing collar bolts were replaced due to hole expansion and incidental bolt breakage in 1997. The west side collars were welded into place with capture plates. The west side racks have not experienced significant wear damage like the east side. Broken collar bolts on the east side were removed, replaced and tightened in late 1997. Afterwards, the northeast rack developed a grooved wear pattern developed on the forward rack elements within a few weeks, as shown in *Figure 4*.

**Figure 4.** Wear pattern on the northeast forward (river side) rack segment which sustained the greatest wear pattern. Pattern indicates poor tooth contact and pinion misalignment.

Exchange the essentially unused rearward 17-tooth rack segment with the worn forward (river side) rack segment. Place the forward rack segment to the rear, with worn teeth at the end of the rack.

- a. The worn river side 17-tooth rack element should be exchanged with the virtually unused rearward rack element on the NE corner of the bridge.
- b. The newly-exchanged forward rack element should be leveled with a master precision level and serve as the reference platform for the pinion gear alignment.

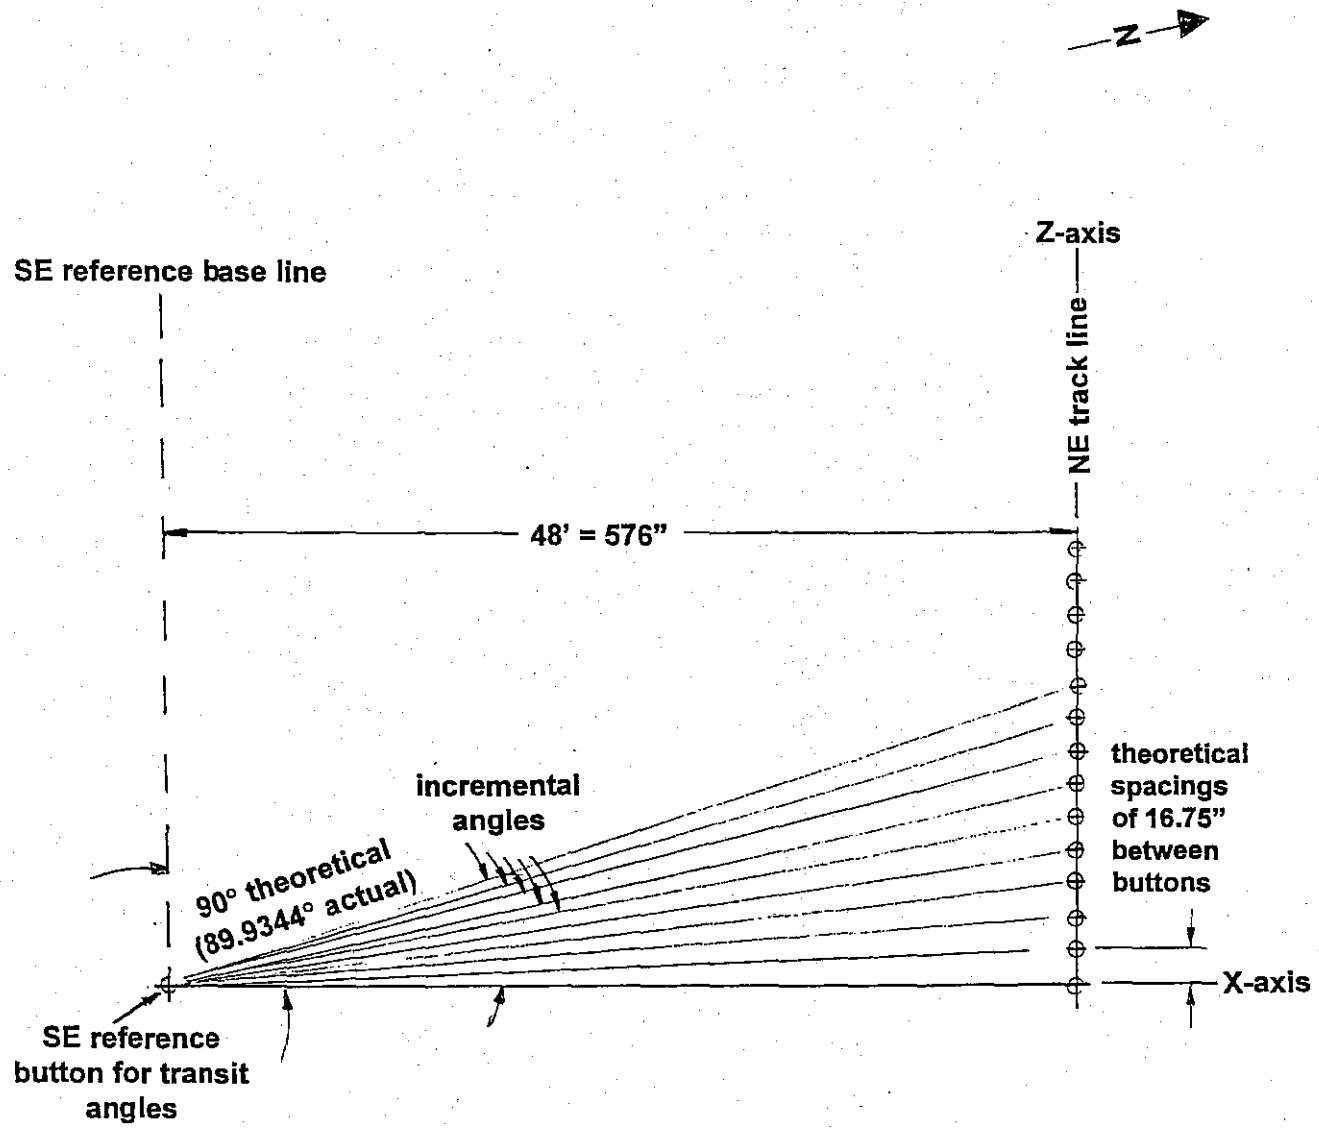
**c. Survey Results.** Key results are summarized in *Table 1*. The track survey indicates that the buttons were set in a straight line, with their centers deviating from linearity by no more than 2 mm. Spacing between each button center hole should be 16.75"; however, measurable variances in spacing were found. The range of spacing error for the NE track was +0.032" to -0.089"; for the SE track, +0.031" to +0.119". The maximum amount of shift of 0.121" can be accommodated by the 0.250" oversizing of the tread plate sockets.

*Figure 5.* A Geodometer Model 600 transit accurate to 1 second was centered over the SE corner button tooth bolt and angles turned for respective buttons on the opposite track. Procedure was reversed on the NE corner bolt. Linearity of SE and NE bolt lines was also measured. Average deviation from a straight line was approximately 2 mm.

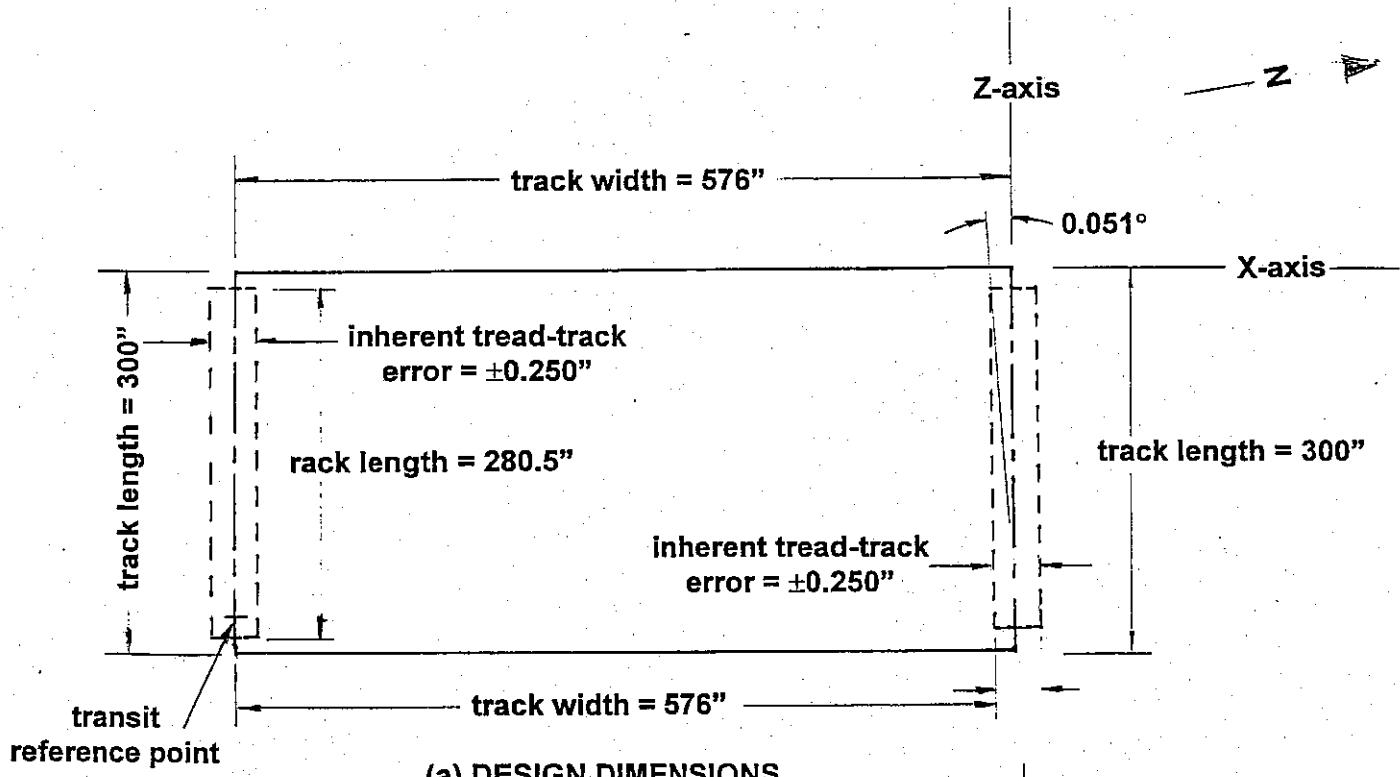
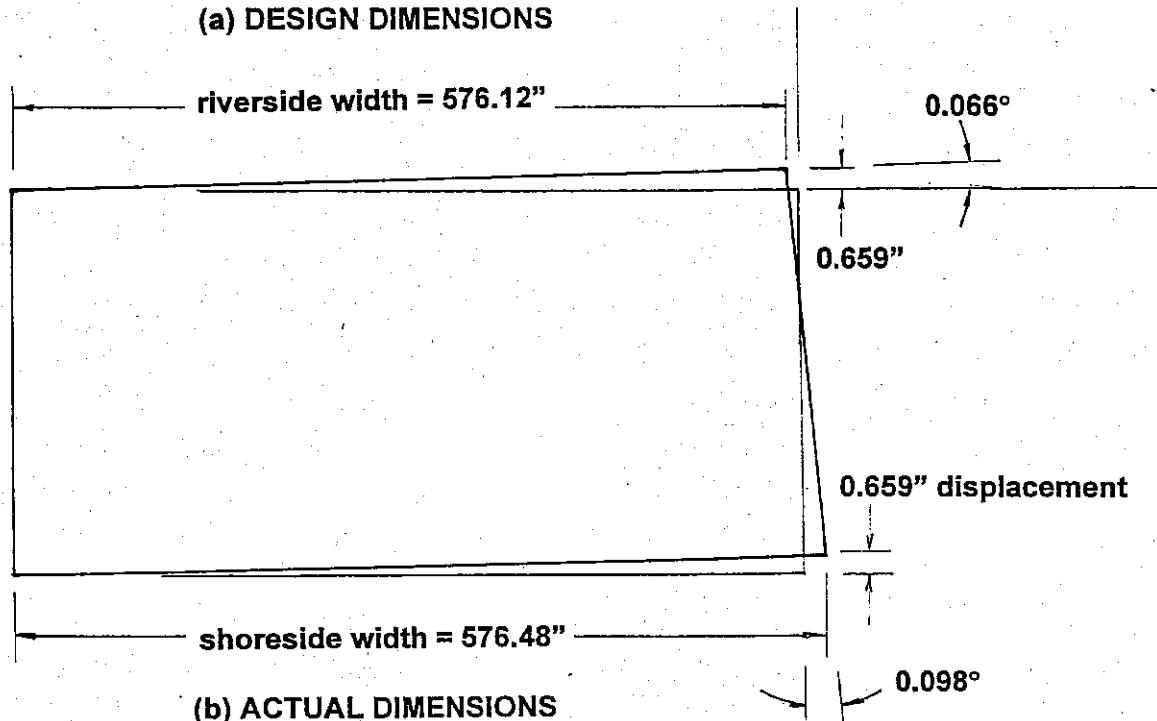
Lastly, a 100 ft tape in 0.01' increments was stretched across both ends of the NE and SE tracks. The width dimension should be 48' = 576"; however, the riverside dimension was 576.12" and the shoreside was 576.48". Dimensional variations from design geometry are shown in *Figure 6*.

The oversized tread socket holes generate an inherent misalignment of 0.051°, based on 0.250" lateral deviation over 280.5" of rack length. The difference in width of 0.36" from 576.12" to 576.48" adds another potential 0.074° of misalignment along the rack's long axis (the Z-axis). These dimensional variations could cause a cumulative potential misalignment of 0.125° along the Z-axis.

**Figure 6.** Design dimensions for the track (a) are compared with actual dimensions as measured by direct survey (b). Scale of distortion in (b) is greatly magnified for effect. Because of the oversize of the tread sockets by 0.250", the tread can deviate from true linearity by  $\pm 0.250"$ .

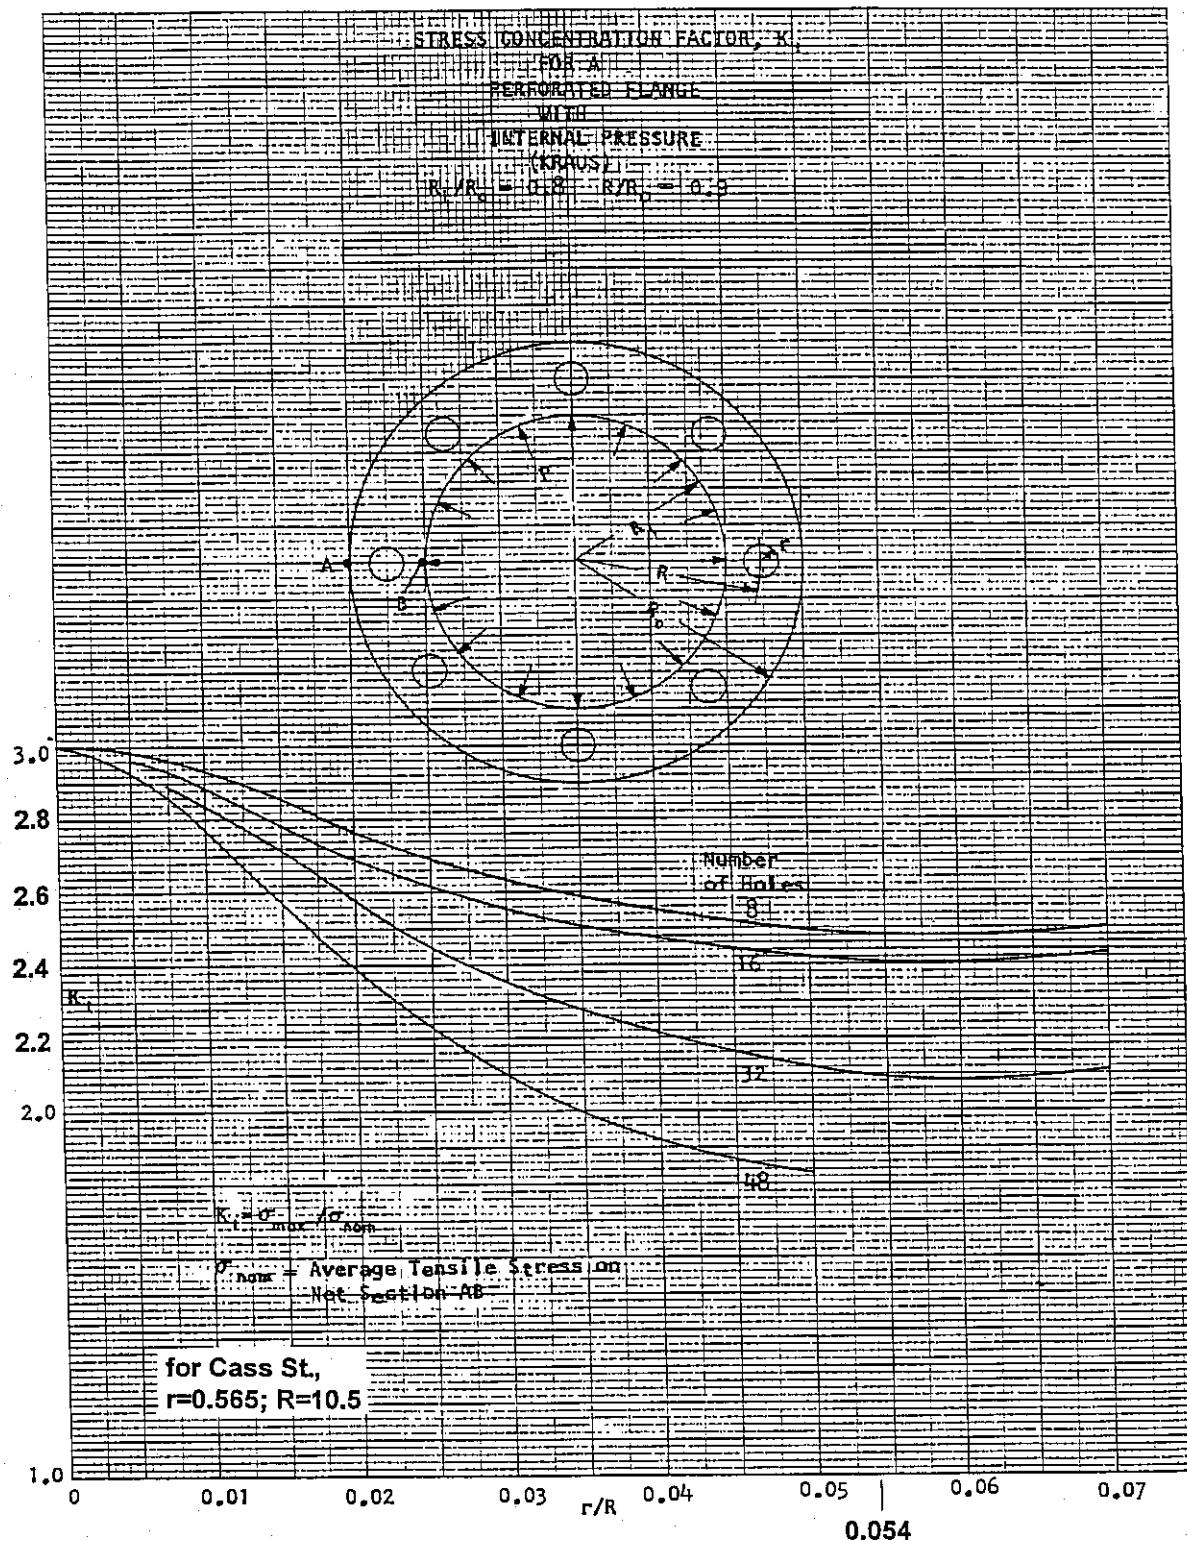
Stress concentrations in a perforated flange with internal pressure have been studied by Kraus (as summarized by Peterson) [Reference 6]. The graphical solution for the Cass St. Bridge conditions is shown in *Figure 8*. For the Cass St. Bridge, the bolt hole radius  $r$  is 0.565", and the bolt circle radius  $R$  is 10.50", resulting in an  $r/R$  ratio of 0.054. For six bolts, the stress concentration factor  $K_t$  is about 2.5 in the collar bolt holes.

Uniformly distributing 105,830 lbs of force among six bolt holes results in 17,638 lbs/hole. If this force exerts pressure on one side of a 1.125" diameter hole of 1.5" depth, 23,455 psi bearing pressure results. Because of stress concentrations, peak stresses can potentially rise to 58,600 psi, which exceeds the probable yield strength of 35,000 psi for the casting and plates. Holes on the castings and plates for both Cass St.

*Figure 8.* The graphical solution of Kraus for stress concentrations in a perforated flange with internal pressure. In the Cass St. Bridge pinion bearing, the shear and bending forces on the shaft provide the internal pressure. The  $K_t$  for 6 bolt holes was estimated as 2.5; and for 11 bolt holes,  $K_t \approx 2.4$ . Source: R. Petersen, *Stress Concentration Factors*, Wiley-Interscience, New York, 1974, p 192.

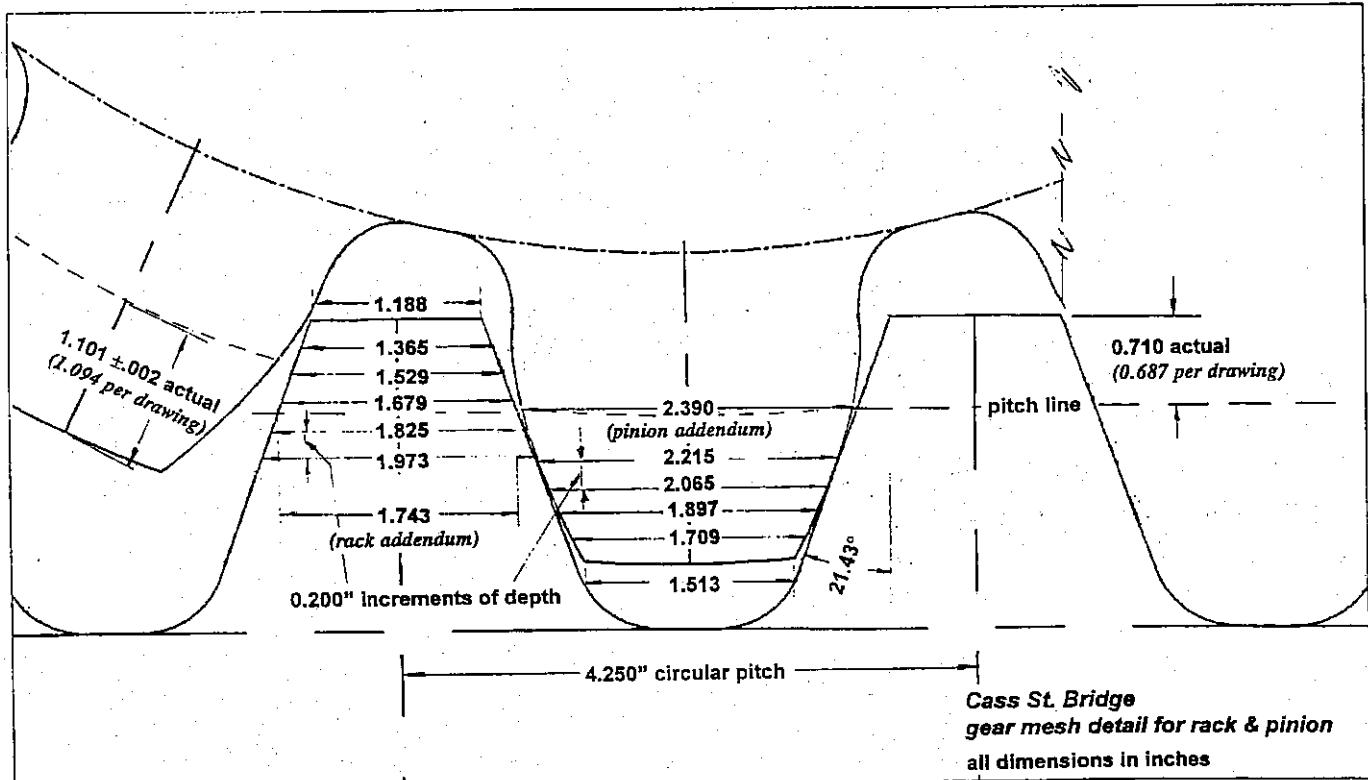
Figure 10. Actual gear mesh at the original design pitch line, showing actual dimensions taken by a tooth thickness vernier of the racks and pinions retrofitted in 1986 at various depths.

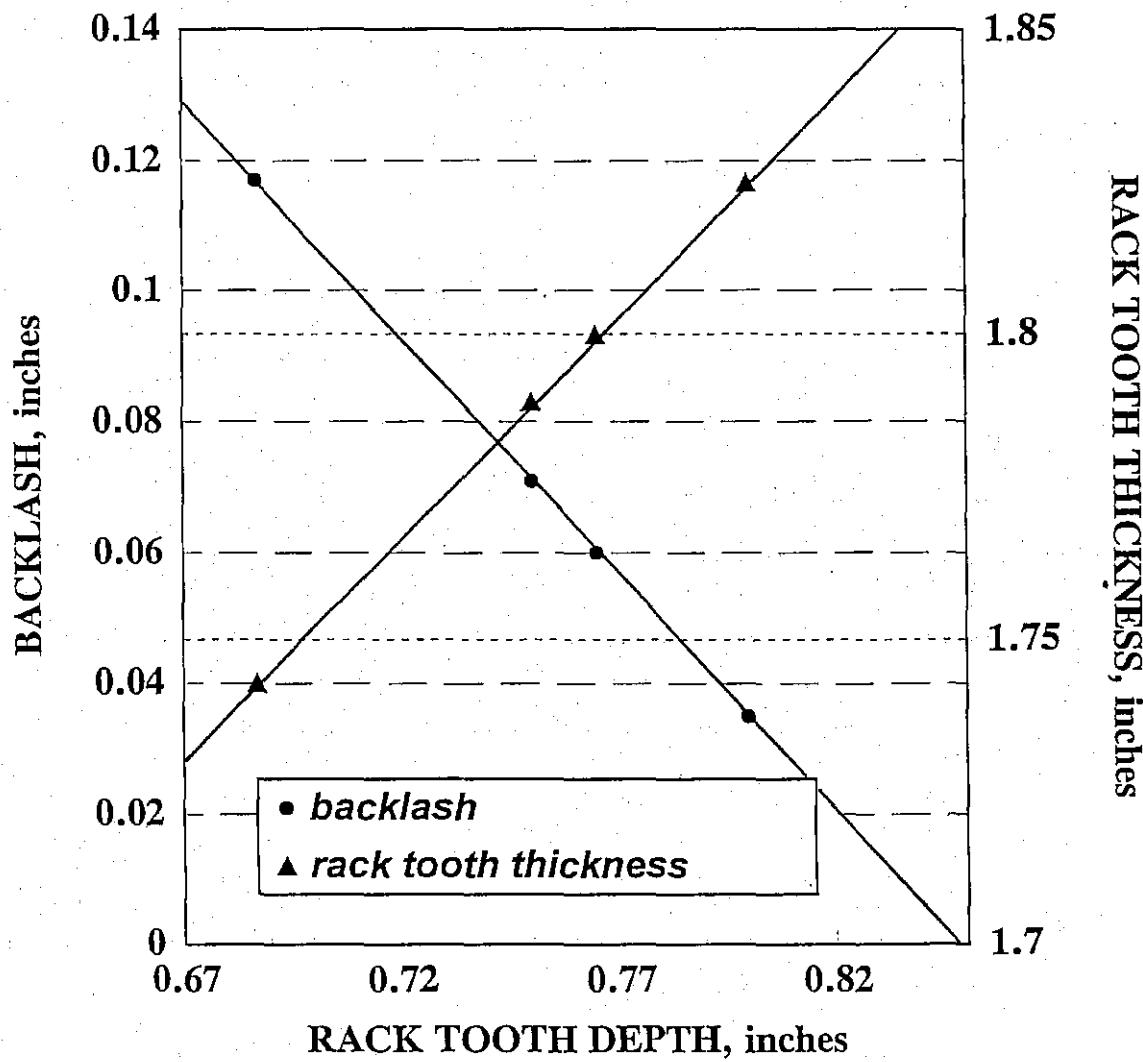
Figure 11. Plot of the amount of backlash available as the pinion addendum progressively moves downward below the rack pitch line. This graph assumes that the thickness of the pinion addendum is 2.390", the actual mean dimension obtained from field measurements with a geartooth thickness vernier.
