# Whitetopping Performance in Illinois

**FINAL REPORT**  
**PHYSICAL RESEARCH REPORT NO. 148**  
**JANUARY 2005**

**Illinois Department of Transportation**

# Final Report

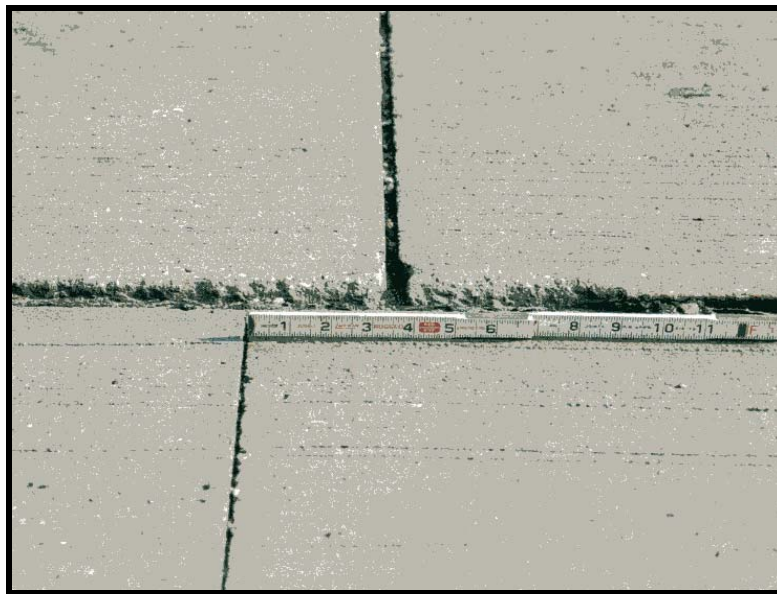
Figure 1  
Whitetopping Panel Shifting

This project has shown one very peculiar distress during the evaluation period. The panels of the driving and passing lane which are considered ultrathin whitetopping are shifting and “growing” uphill towards the intersection. The panels adjacent to the curb which are considered a bonded inlay are not shifting. The current belief is that as traffic approaches the intersection and slows to a stop, they are shoving the whitetopping through the intersection. As can be seen in Figure 1 below, the amount of accumulated movement of the whitetopping compared to the bonded inlay was nearly four inches at the close of the evaluation period. This type and amount of movement would suggest that the entire inlay is debonded and moving; however, the sounding test indicates otherwise. It is believed that the failure plane may be within the underlying HMA layer. If so, the HMA may be shearing without any debonding from the whitetopping inlay. Further evaluation of this phenomenon is recommended when the intersection is eventually removed and rehabilitated.

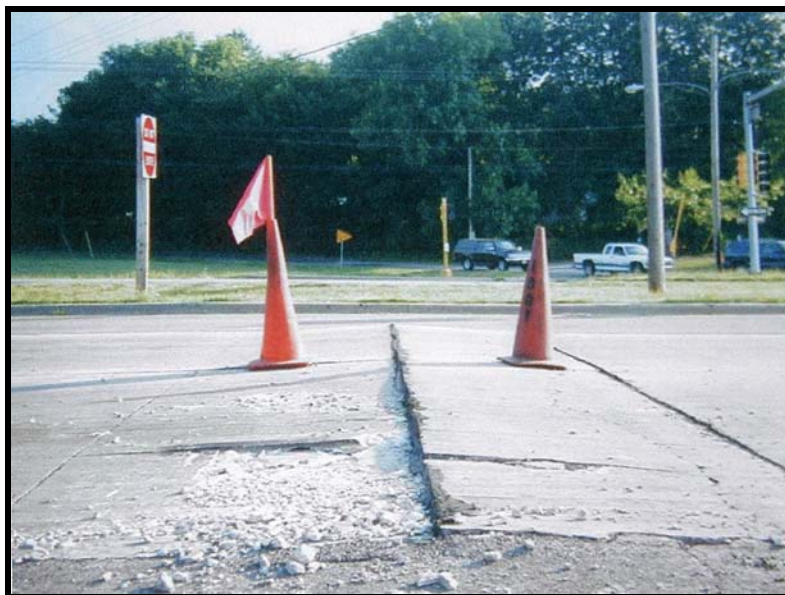
Figure 2  
Bonded Concrete Inlay “Blow-Up” Failure

Two large patches have also been placed on this project due to isolated and unrelated failures. The first patch was placed in August of 2001, just three years after construction. This patch occurred in the westbound driving and passing lanes at the location of an old traffic indicator loop in the original concrete pavement. The concrete inlay appeared to heave or “tent” at a full-depth relief joint as can be seen in Figure 2. The appearance of the failure gives evidence that this may have been a pavement “blow-up” due to hot summer temperatures and increased thermal expansion of the concrete inlay.

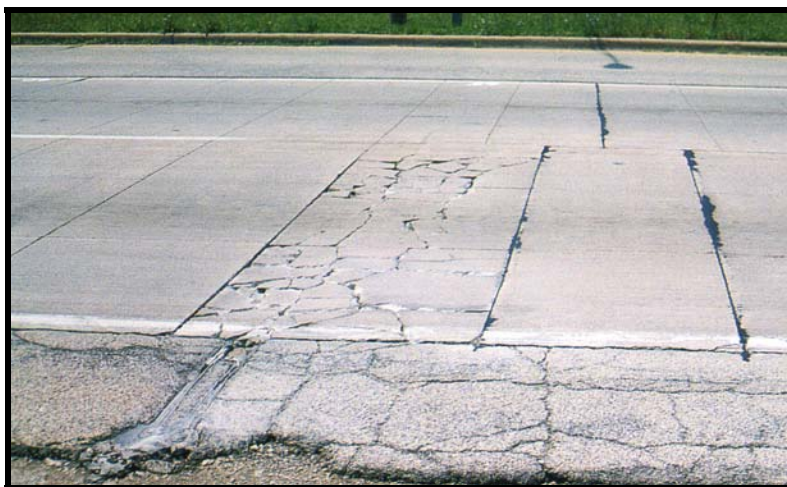
Figure 7  
Distress at Traffic Indicator Loop

This project has also displayed a significant number of additional distresses that should be noted. The most prominent of these is the occurrence of high severity cracks in the concrete inlay at the location of an existing traffic indicator loop which was left in place. An example of this may be found in Figure 7. Secondly, the majority of the cracking distress noted was transverse mid-panel cracks versus the more traditional corner break cracks associated with whitetopping. Finally, those distressed panels which were not merely mid-panel cracked were cracked in several random directions. The majority of the panels with this type of distress occurred at the pavement centerline, which also served as the longitudinal construction cold joint.

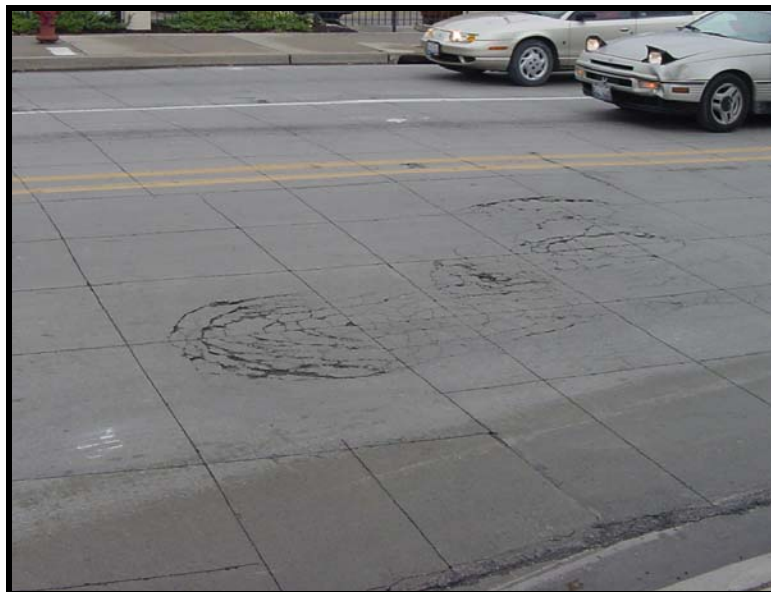
Figure 18  
Anna Whitetopping Area of Distress

There is one area of high severity distress in the eastbound driving lane as seen in Figure 18. The area appears to be a slight depression; however, there is no noticeable deflection under the loaded axle of a tractor trailer. In addition, there is no evidence of an underlying defect in the original pavement at this area.
