# Experimental Joint Sealants for Hot Mix Asphalt Pavements and Overlays

**CONSTRUCTION REPORT**  
**PHYSICAL RESEARCH REPORT NO. 169**  
**April 2019**

**Illinois Department of Transportation**

## EXPERIMENTAL JOINT SEALANTS FOR HOT MIX ASPHALT PAVEMENTS AND OVERLAYS

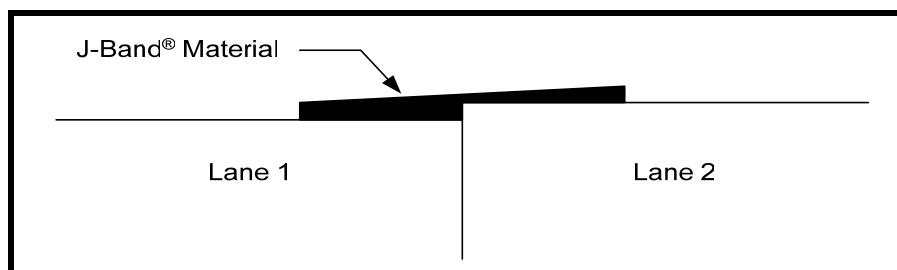
Figure 5  
Lane to Lane Elevation Difference With J-Band® Placement

The placement of the J-Band® material presented a couple of problems. Even with sweeping the pavement surface at the joint, sand sized rocks remained that caught the strike-off plate and left a track mark in the material. More critical, however, was the difference in elevation between the two lanes of leveling binder on either side of the longitudinal joint. This difference in elevation resulted in thick and thin areas of material placement depending on the location of the strike-off plate with relation to the joint. Figure 5 illustrates the elevation difference and the resultant problems with the sealant material placement.

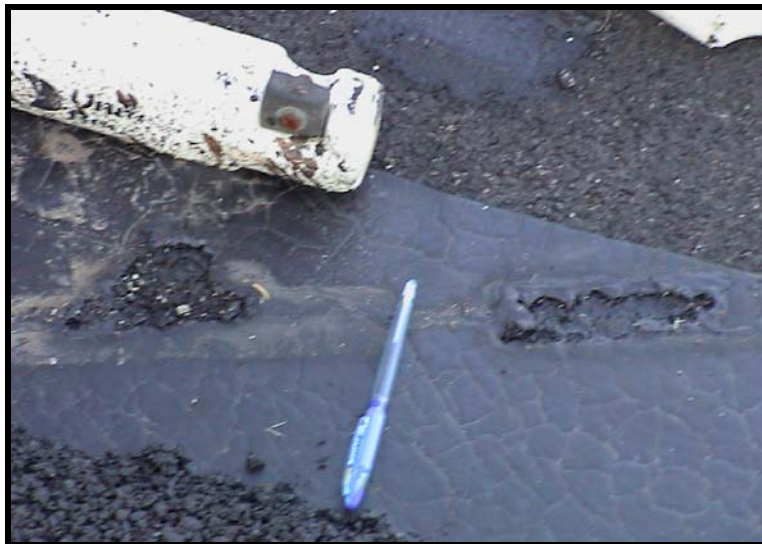
It was also noted that once placed, and cooled, the material remained pliable enough to deform and pick up under the static weight of a traffic barricade. Figure 6 illustrates how the material deformed and picked up in chunks once adhered to another surface.

J-Band® Material Pick Up Under Traffic Barricade

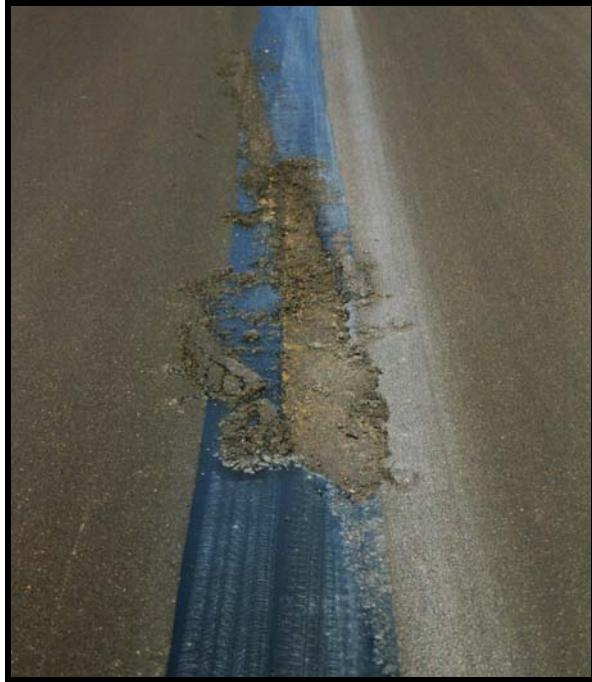
Figure 8  
Tracking of J-Band<sup>®</sup> material

The J-Band<sup>®</sup> material was placed at approximately 300° Fahrenheit and required about 10 to 15 minutes to cool. Flagmen were used to control traffic and prevent vehicles from crossing the material before it was solidified. However, at a couple of locations a vehicle did manage to cross the material before it cooled, and the material did track onto the vehicle tires. Figure 8 illustrates the amount and condition of the material when it tracks onto a vehicle tire. A thin layer of lime dust was spread over the material at all cross roads and driveway entrances to prevent tracking when vehicles did cross the material. Figure 9 illustrates the application of lime dust at a crossroad intersection to prevent tracking.

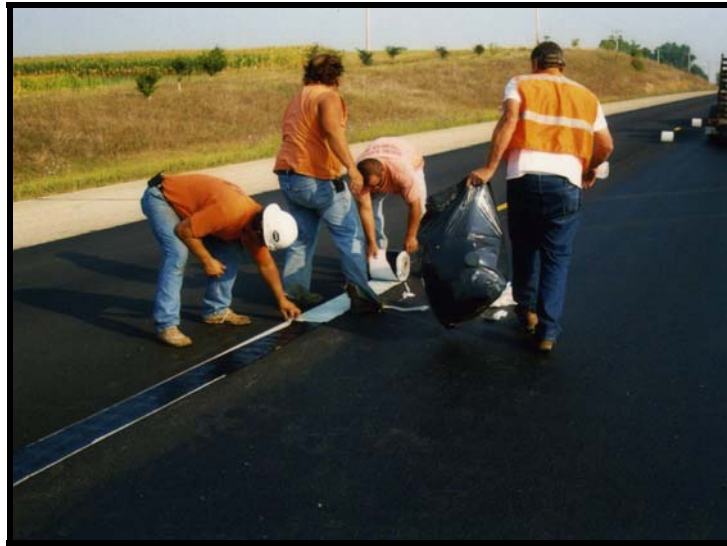
Figure 11  
Removal of QuickSeam<sup>®</sup> plastic backing

Placement began in a fashion similar to that on Illinois Route 50. The wax paper backing was removed from the material as it was unrolled and placed on the pavement. This process was very cumbersome, and the deformed edges from the stacked rolls made it very difficult to remove the wax paper backing. The wax paper ripped and left small fragments of the paper stuck to the QuickSeam® material. The removal of these small

pieces of wax paper was extremely tedious and time consuming, however, necessary to prevent impurities and the creation of a slippage plane for the overlay materials. Once the wax paper was removed and the material was positioned along the centerline joint, the plastic backing material was removed from the top of the material. Again, this material ripped and left small fragments behind that had to be cleaned off. The tedious, time consuming, effort to remove the small fragments of plastic may be seen in Figure 11.

A trial and error process was used to establish a better method for removing the plastic backing once the material was placed on the pavement. Eventually, a utility knife was used to cut the plastic backing into two separate halves. The halves were then easily peeled off the material from the center towards the outer edges. This process eliminated the small fragments of plastic that were left on the material at the material edges. This process also increased the placement rate for the QuickSeam<sup>®</sup> material. The average placement rate for the first pass of the material was approximately 800 linear feet per hour. The entire first pass took approximately six hours to place.

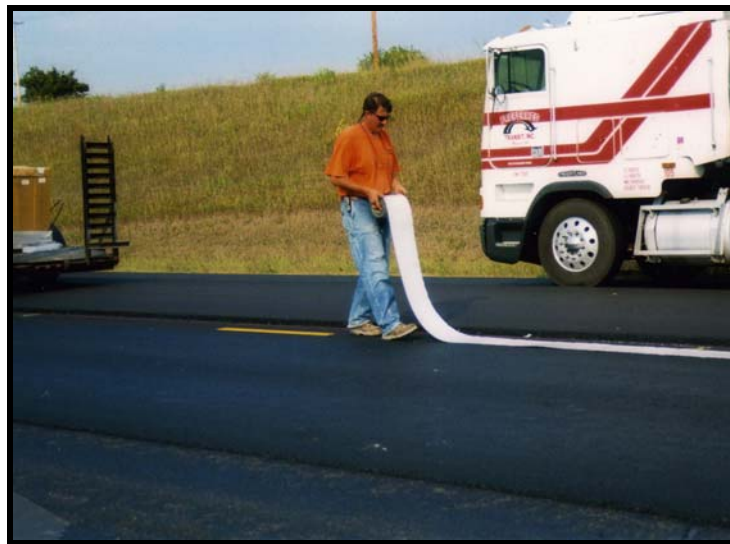
Figure 12

Preparation of the QuickSeam® material for placement

The problem still remained of peeling the wax paper backing off the material before placing it onto the pavement. Eventually, it was determined that the material could be completely unrolled upside down and the wax paper backing cut into halves with the utility knife. Once cut, the two halves of wax paper were peeled off from the center towards the outer edges. Three to four people were then used to flip the material right side up and place it along the centerline joint all at once. This process dramatically improved the placement rate. Placement of the second pass of the sealant material was done at a rate of approximately 1,500 feet per hour. The second pass of the material was placed in approximately three hours. Illustrations of this placement method may be found in Figures 12 and 13.
