**EVALUATION OF HIGH PERFORMANCE  
CONCRETE BRIDGE DECKS  
AND  
OTHER EXPERIMENTAL BRIDGE  
DECKS THROUGHOUT ILLINOIS**

**PHYSICAL RESEARCH REPORT NO. 166  
December 2017**

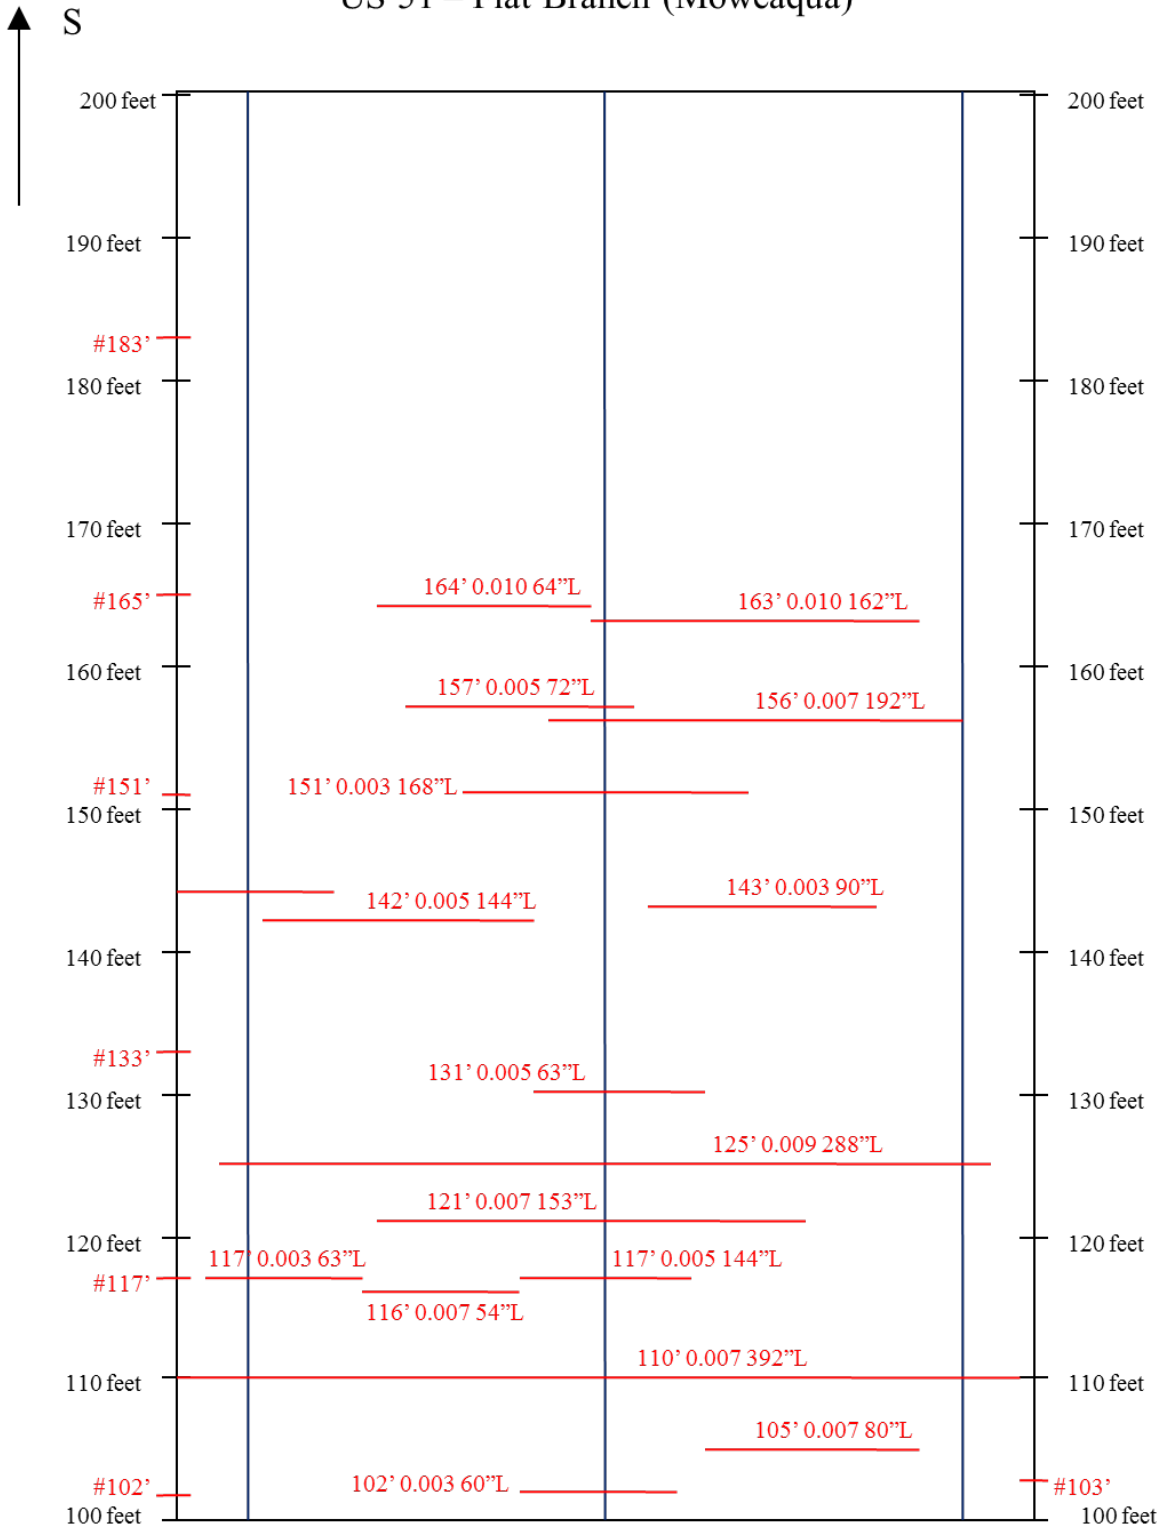
Figure 2.1-2 (continued)

Average Transverse Crack Distance: Transverse cracking was observed every 6' on average between beams. On top of the bridge deck, transverse cracking was observed every 4' – 5'.

Longitudinal Cracking: More longitudinal cracking observed on this deck than 011-0035.

Bridge Joint Cracking / Integral Abutment Cracking: “Integral Abutment” restraint cracking observed with more pronounced cracking near the approach slab.

Christian County – SN#011-0036 – surveyed 9/19/2003  
 The “#” symbol represents cracks in the parapet only.

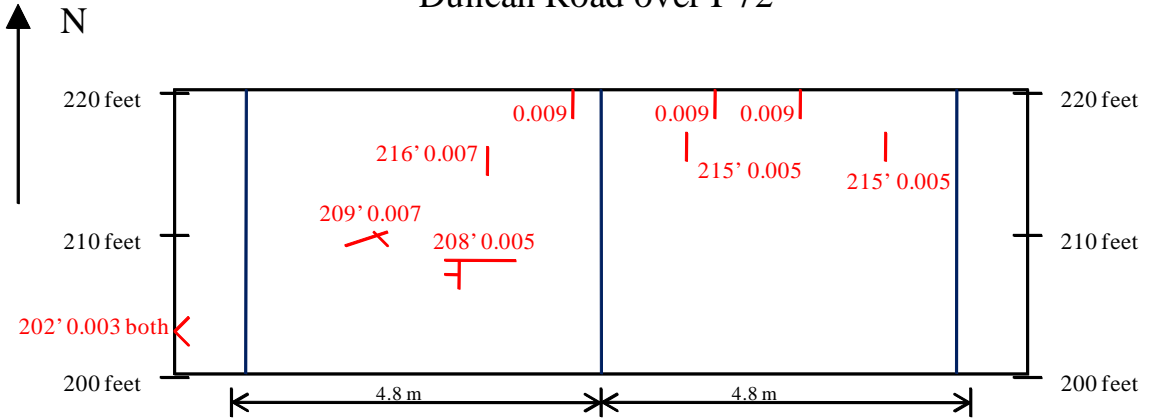
# Duncan Road over I-72

Champaign County – SN# 010-0170 – Surveyed 10/6/2003

\* Denotes areas showing map cracking.

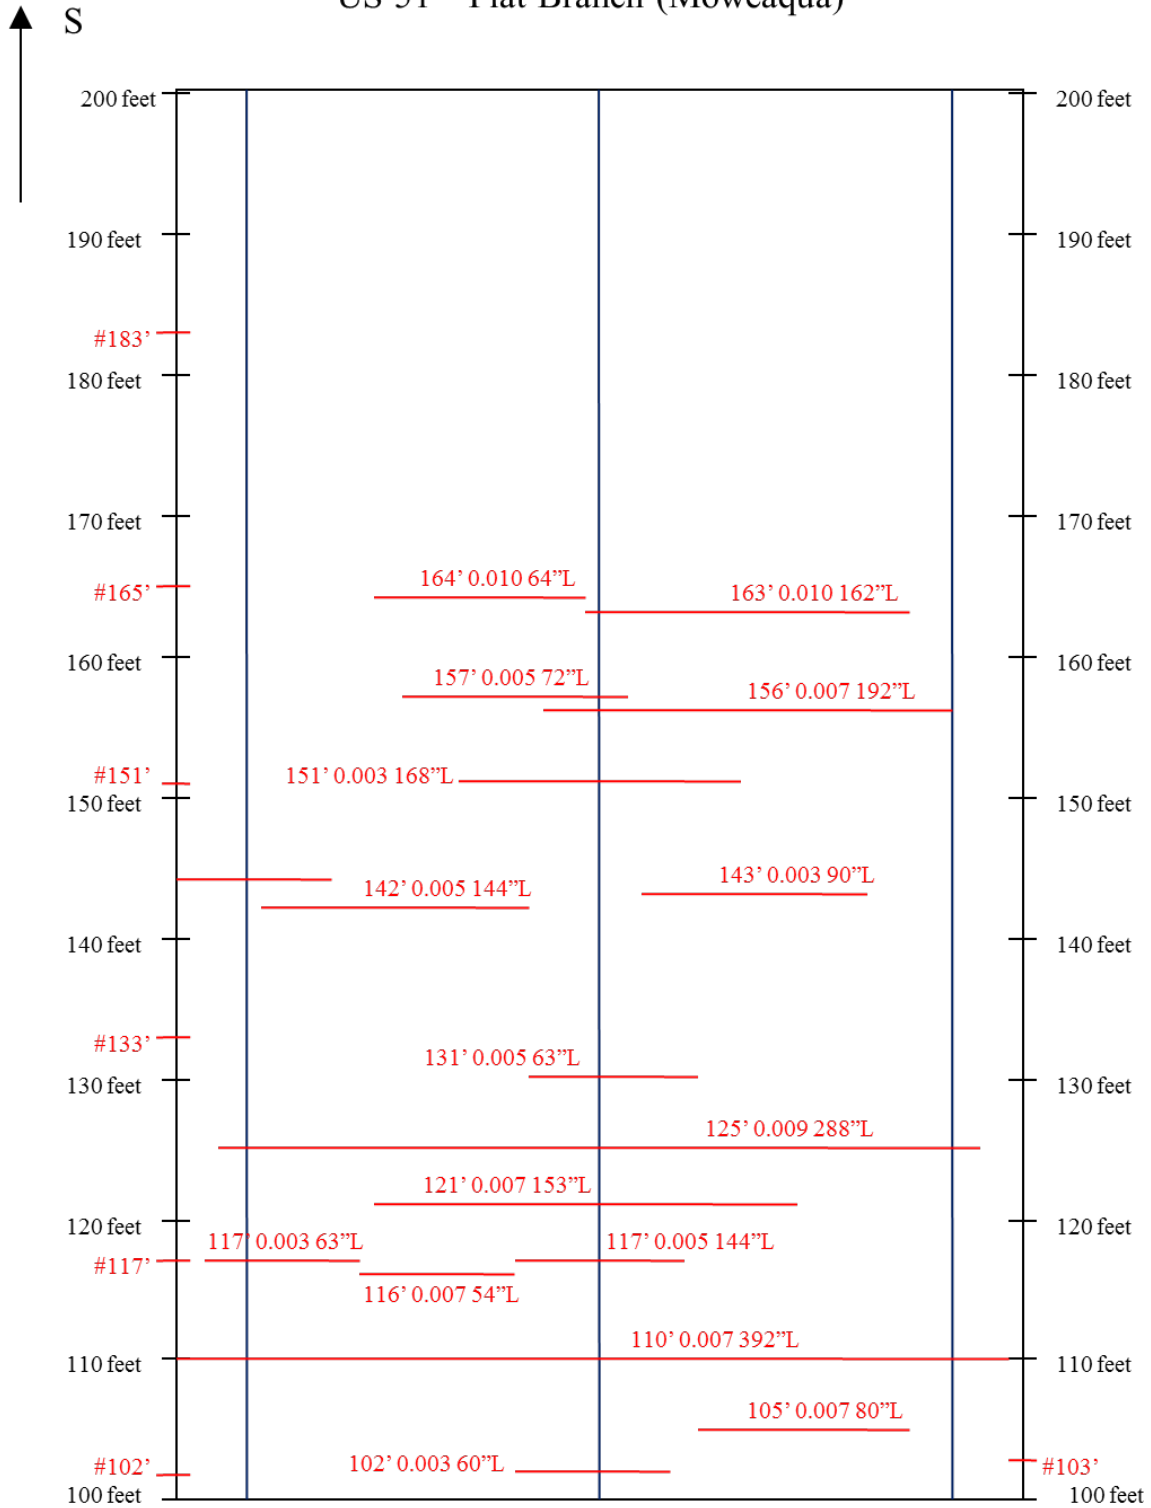
# US 51 – Flat Branch (Moweaqua)

Christian County – SN#011-0036 – 9/19/2003  
 The “#” symbol represents cracks in the parapet only.

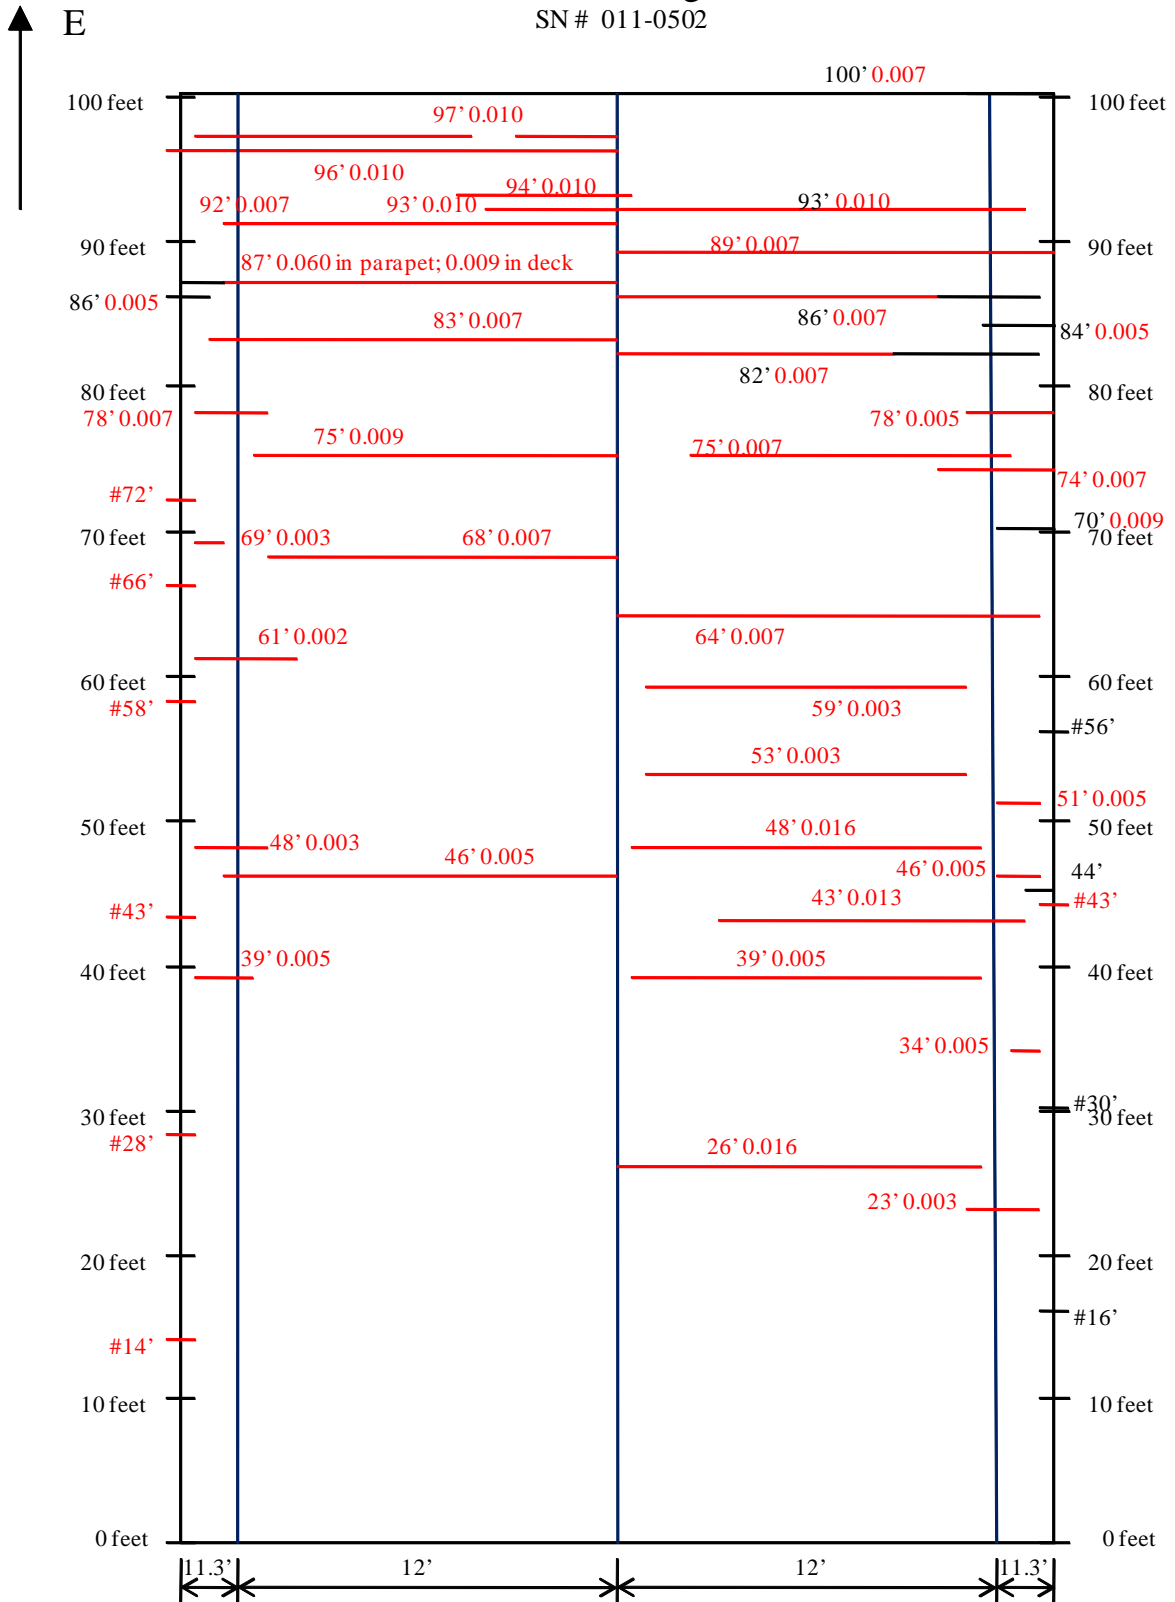
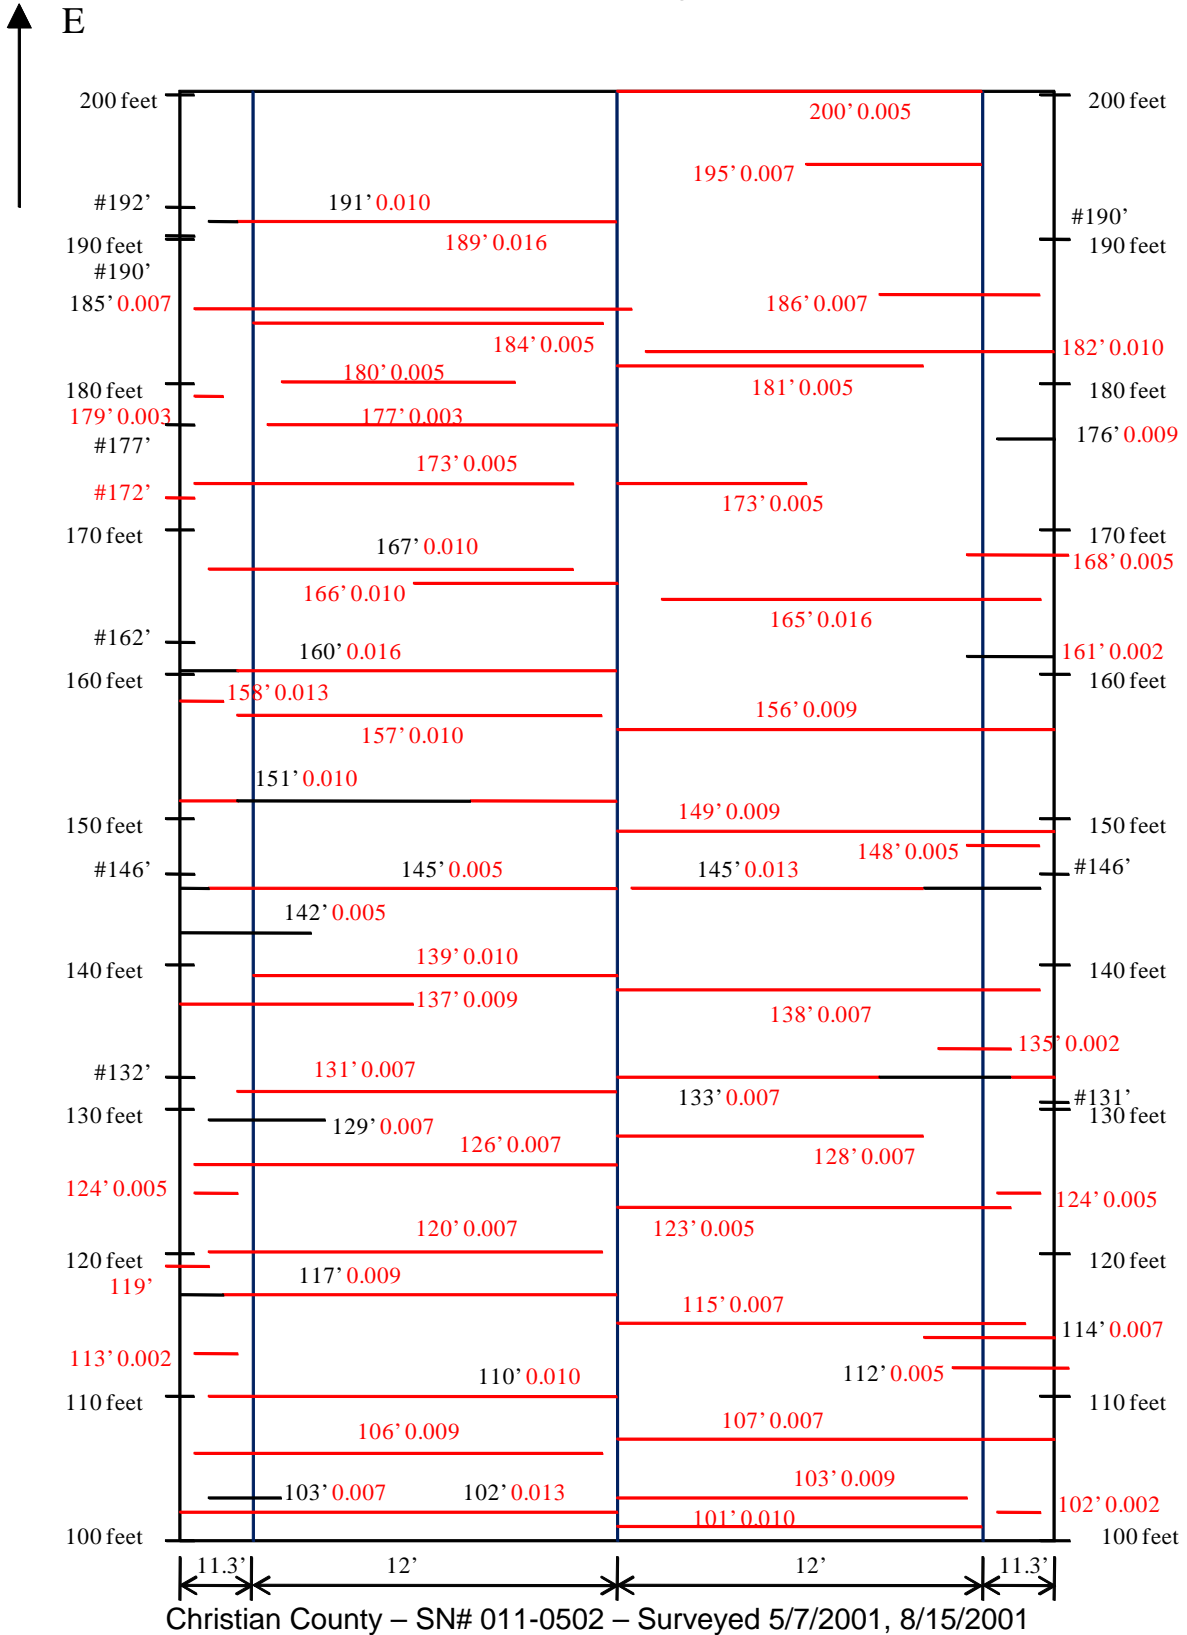
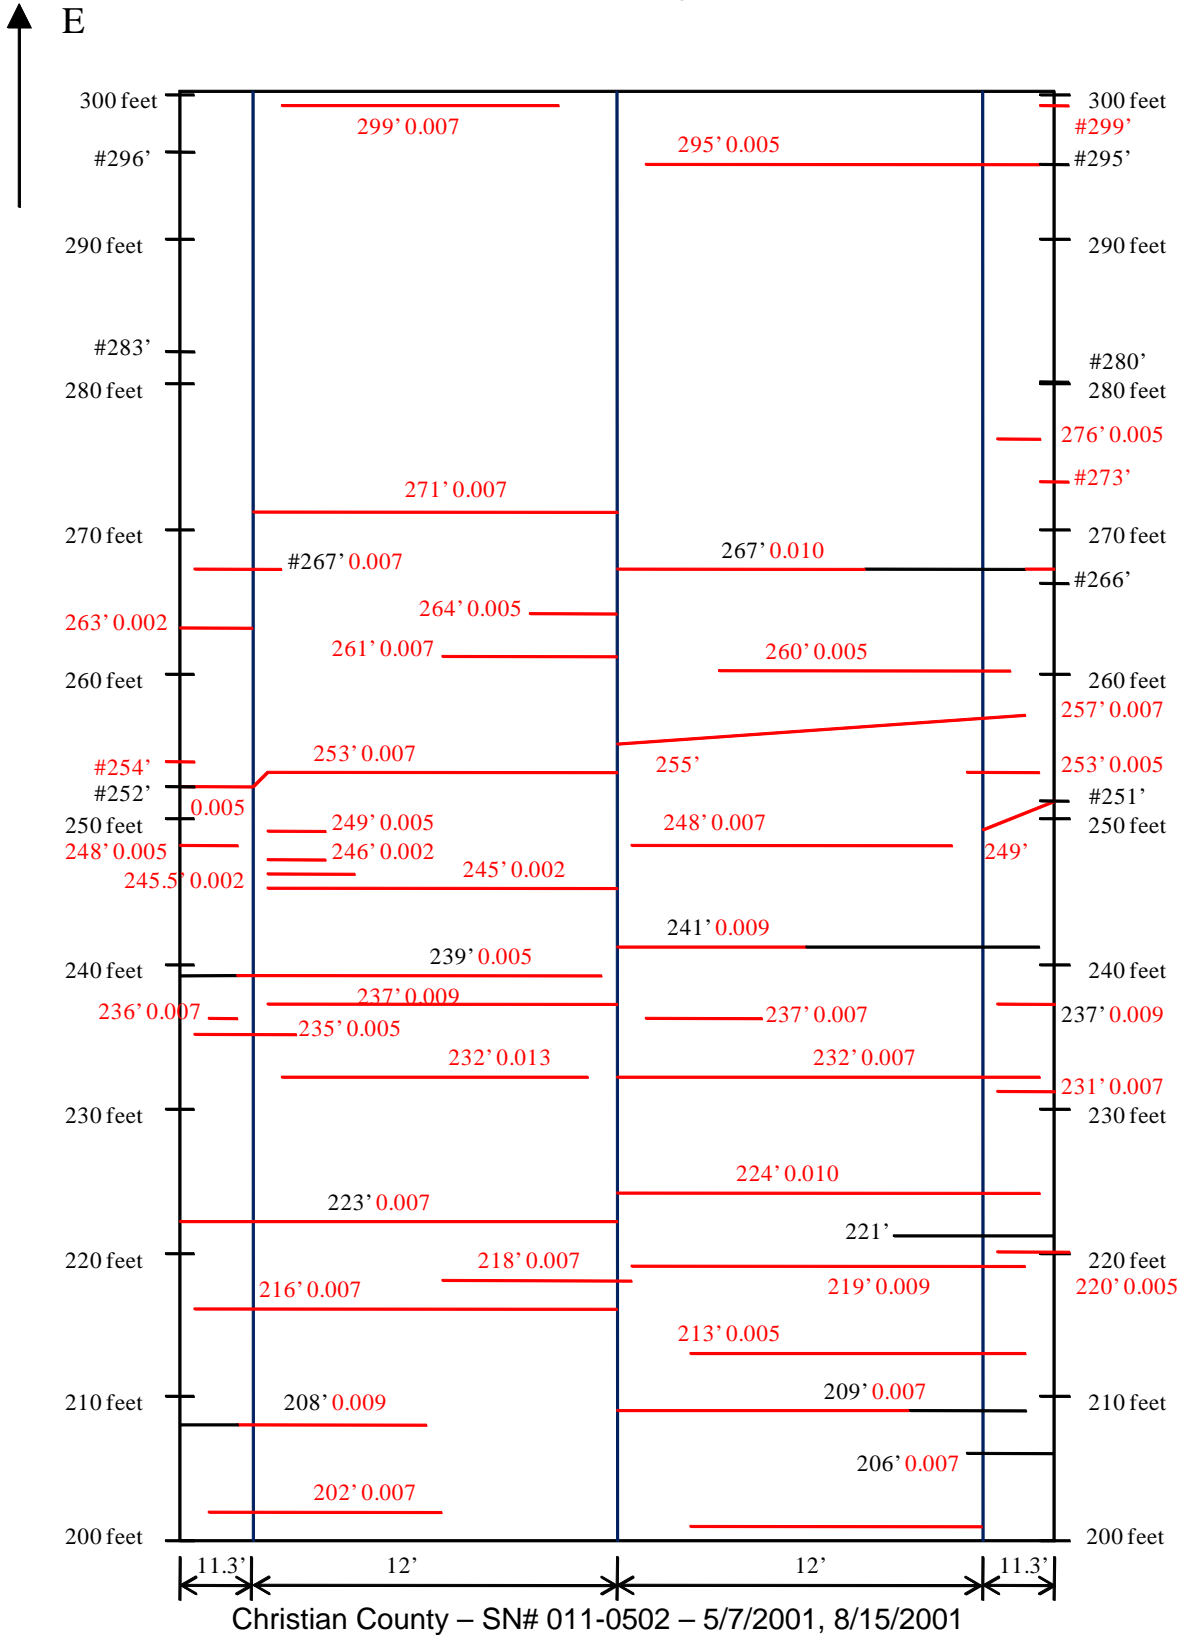
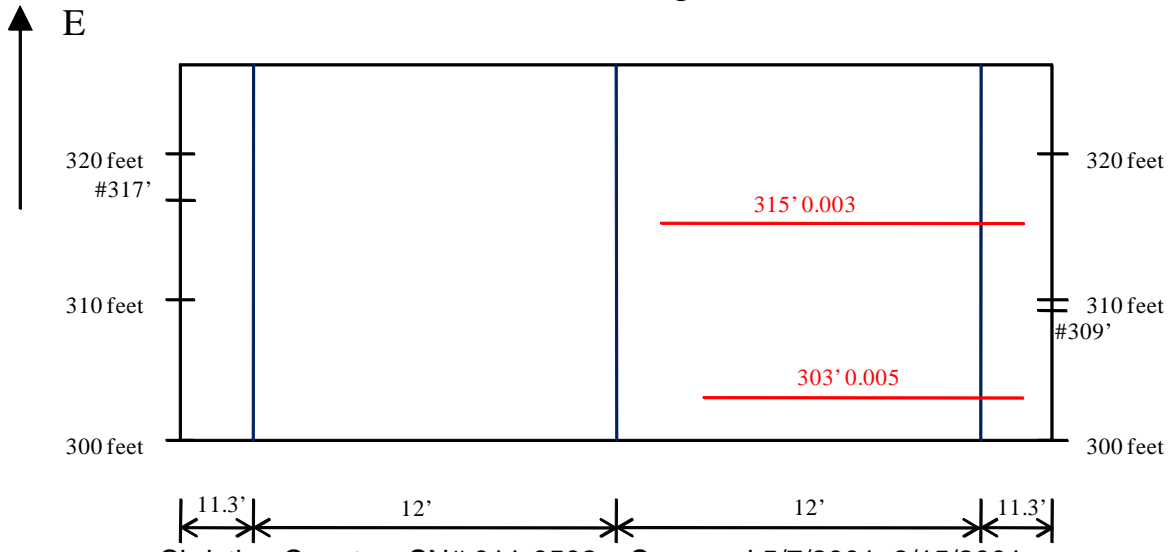
# 104 over S. Fork Sangamon River

Christian County – SN# 011-0502 – Surveyed 5/7/2001, 8/15/2001

SN# 011-0502 was poured 10/12/2000 and the initial survey showed three hairline cracks.  
The “#” symbol represents cracks in the parapet only.

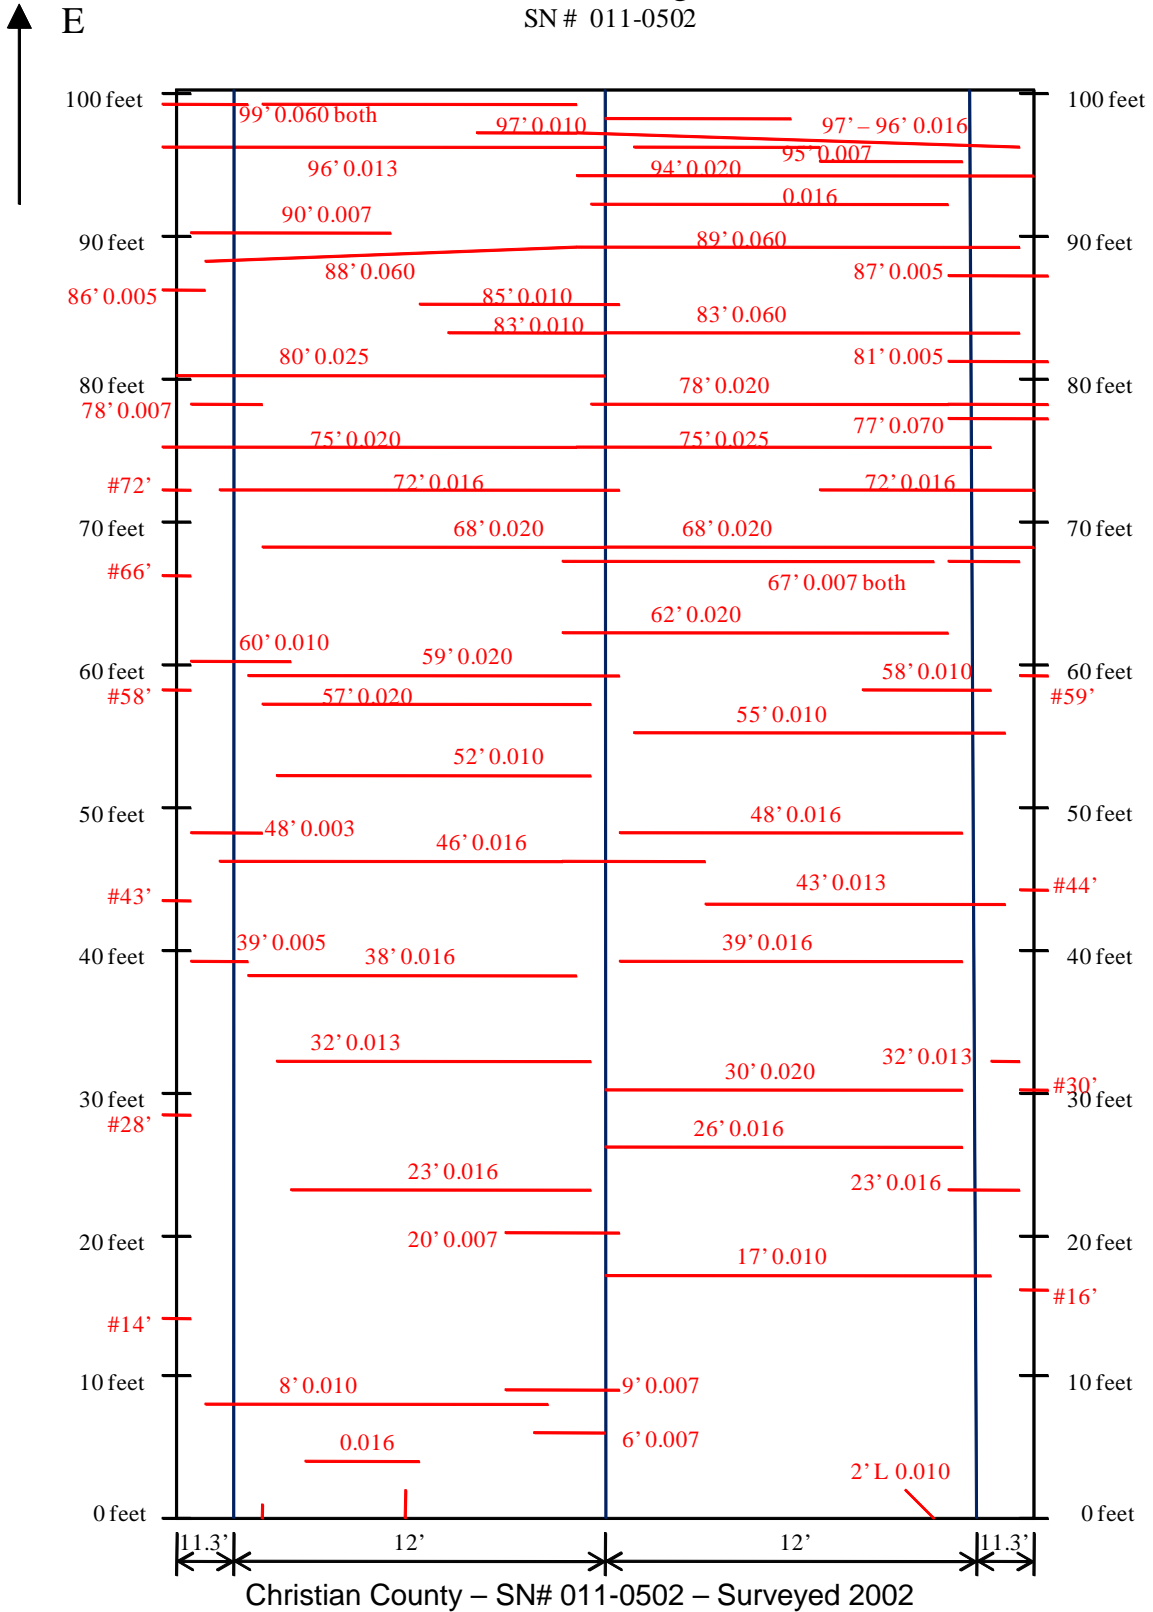
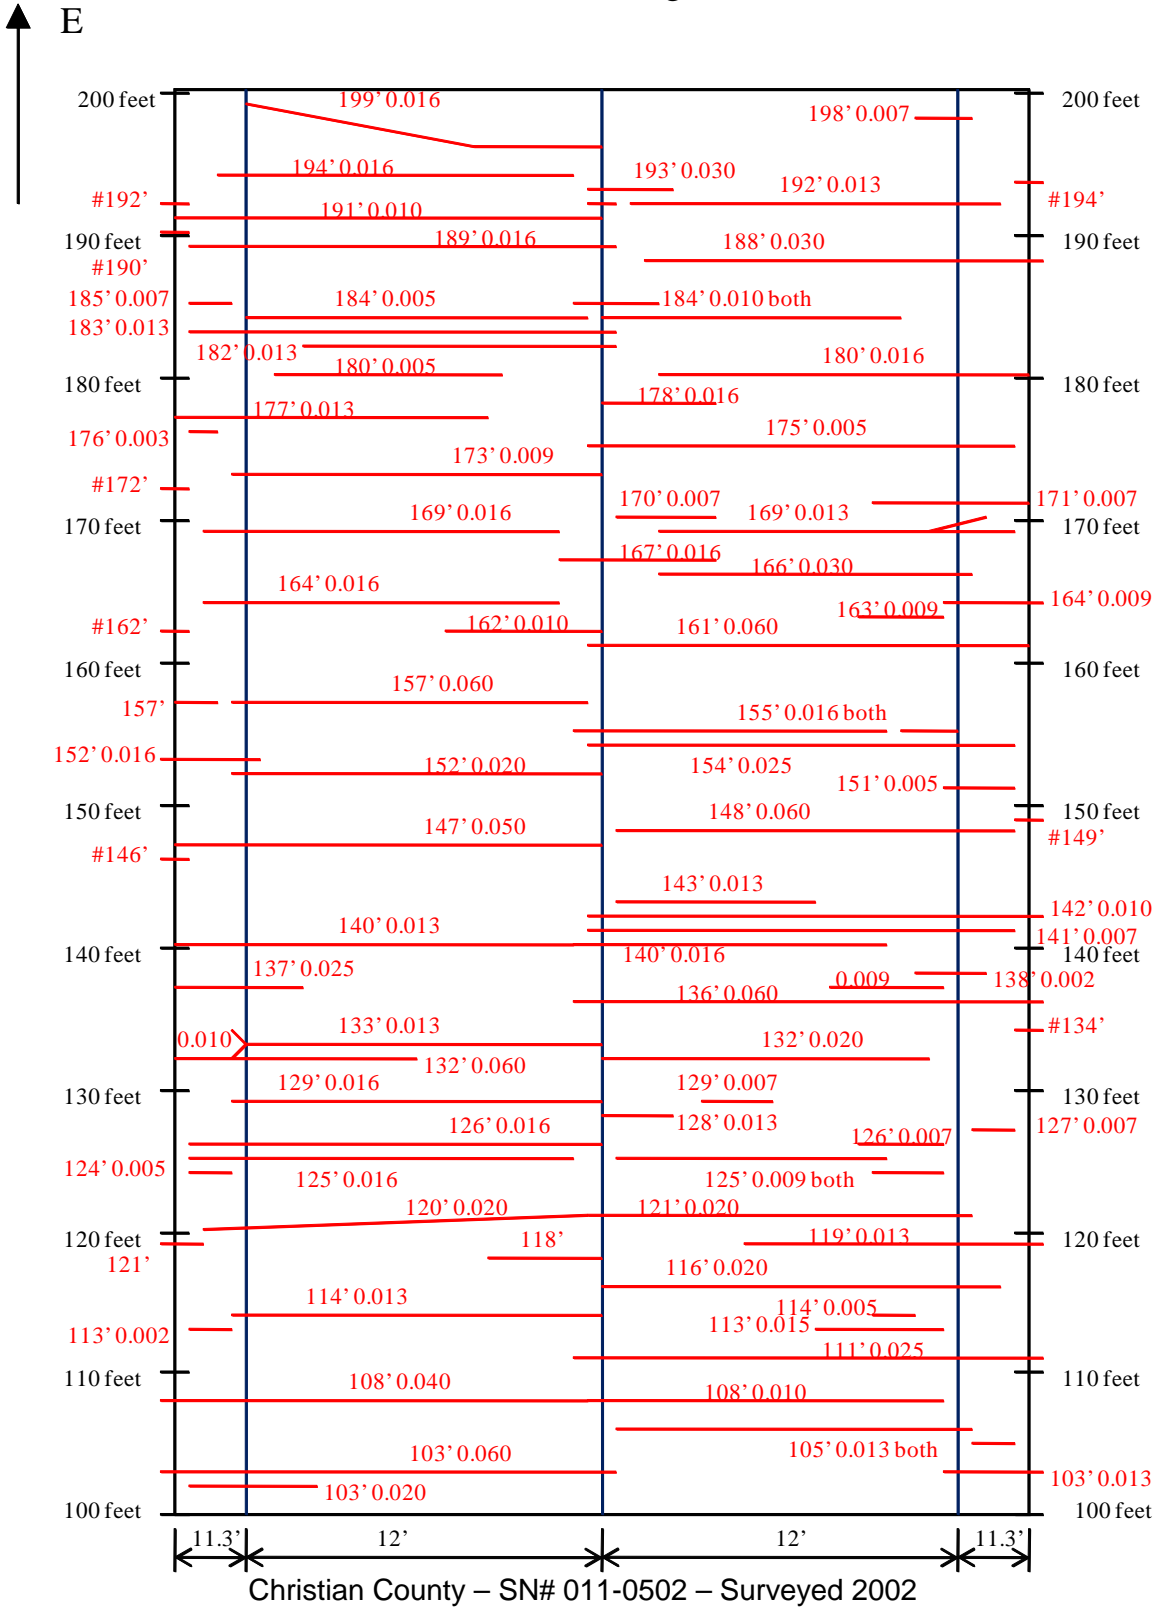
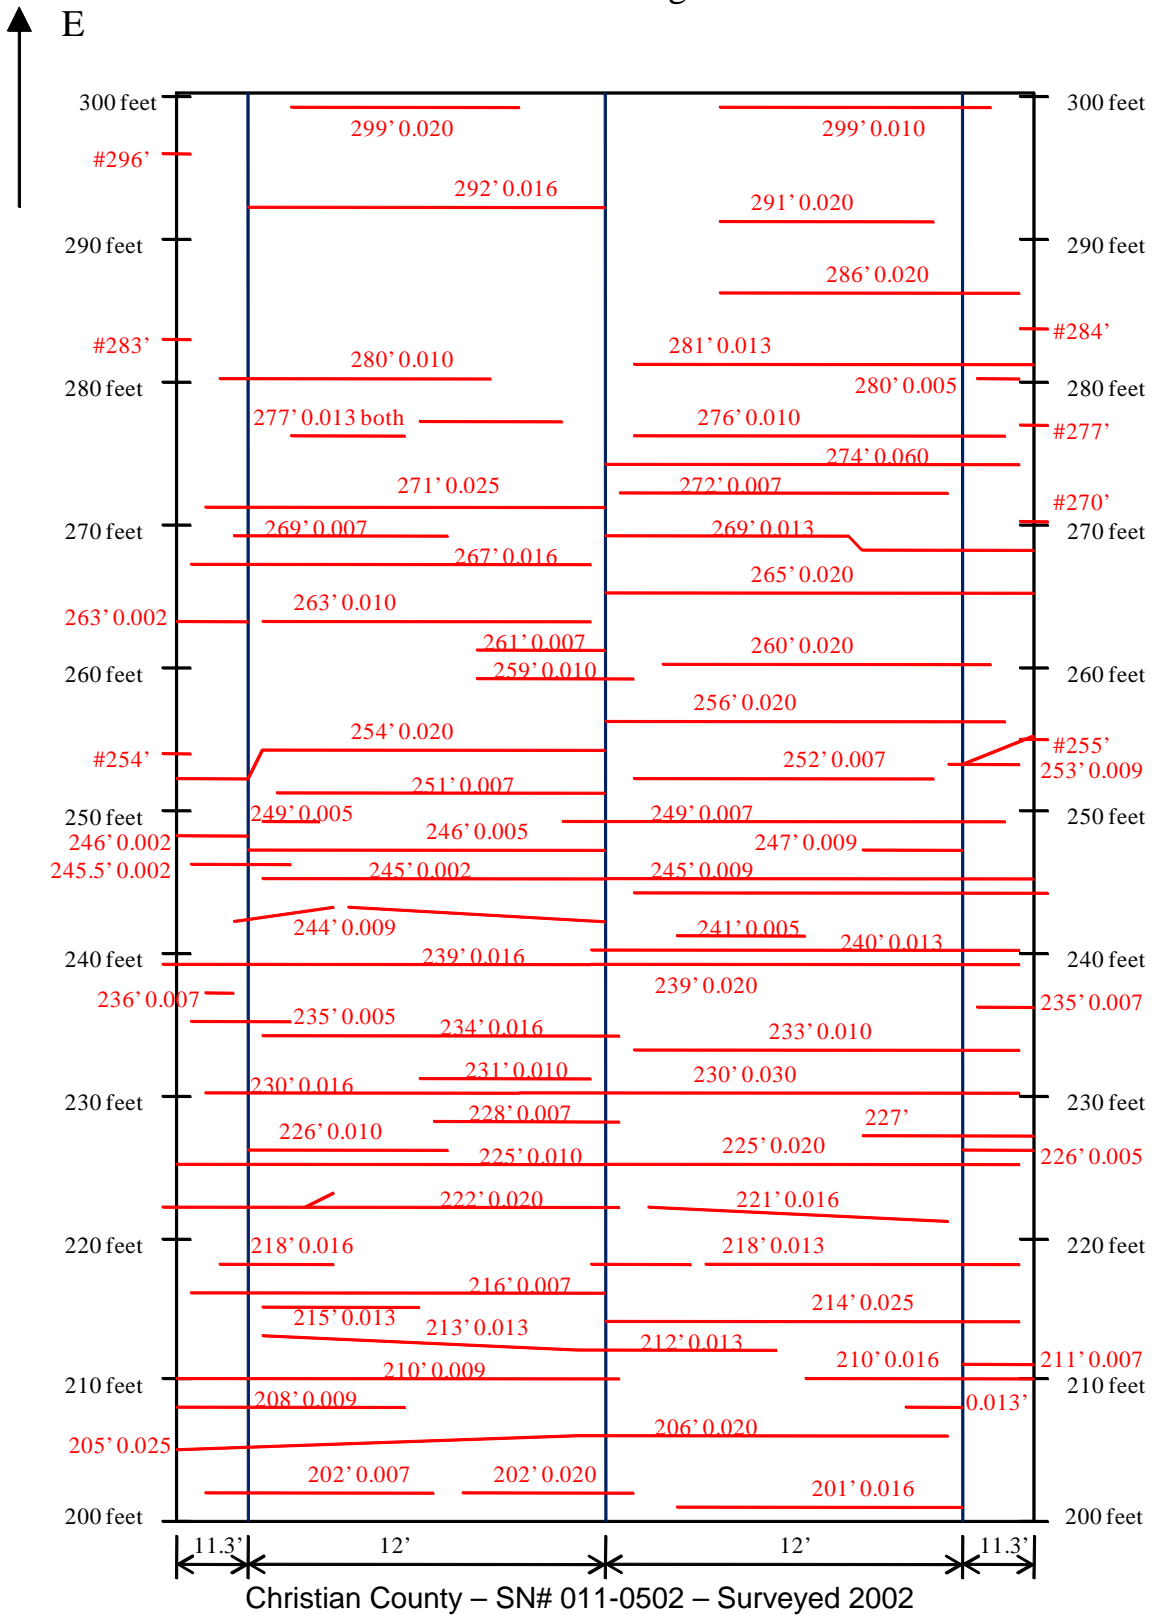
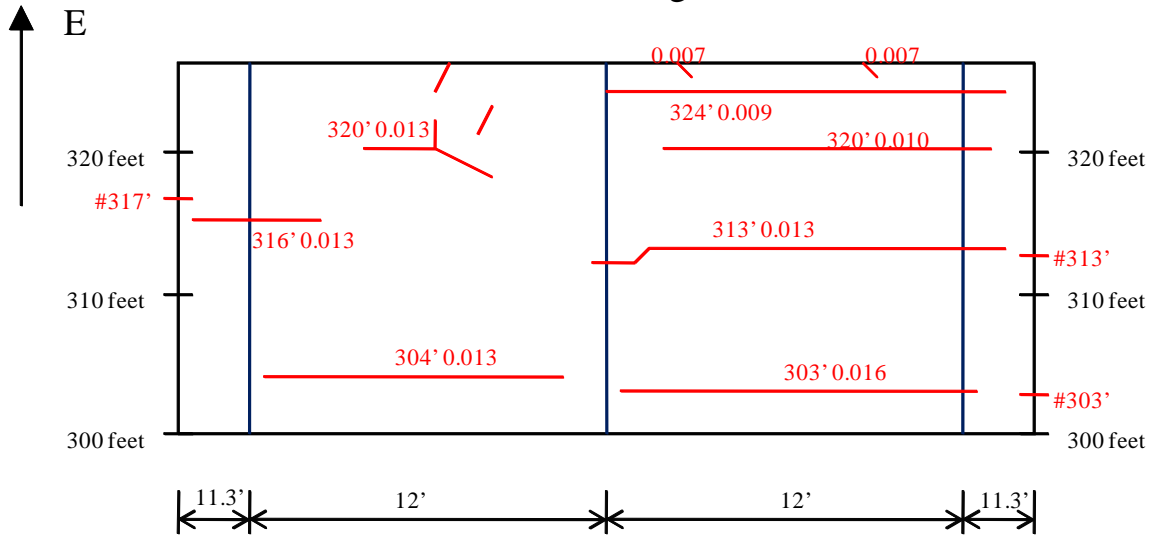
# 104 over S. Fork Sangamon River

Christian County – SN# 011-0502 – Surveyed 2002  
 The “#” symbol represents cracks in the parapet only.
