**EVALUATION OF HIGH PERFORMANCE  
CONCRETE BRIDGE DECKS  
AND  
OTHER EXPERIMENTAL BRIDGE  
DECKS THROUGHOUT ILLINOIS**

**PHYSICAL RESEARCH REPORT NO. 166  
December 2017**

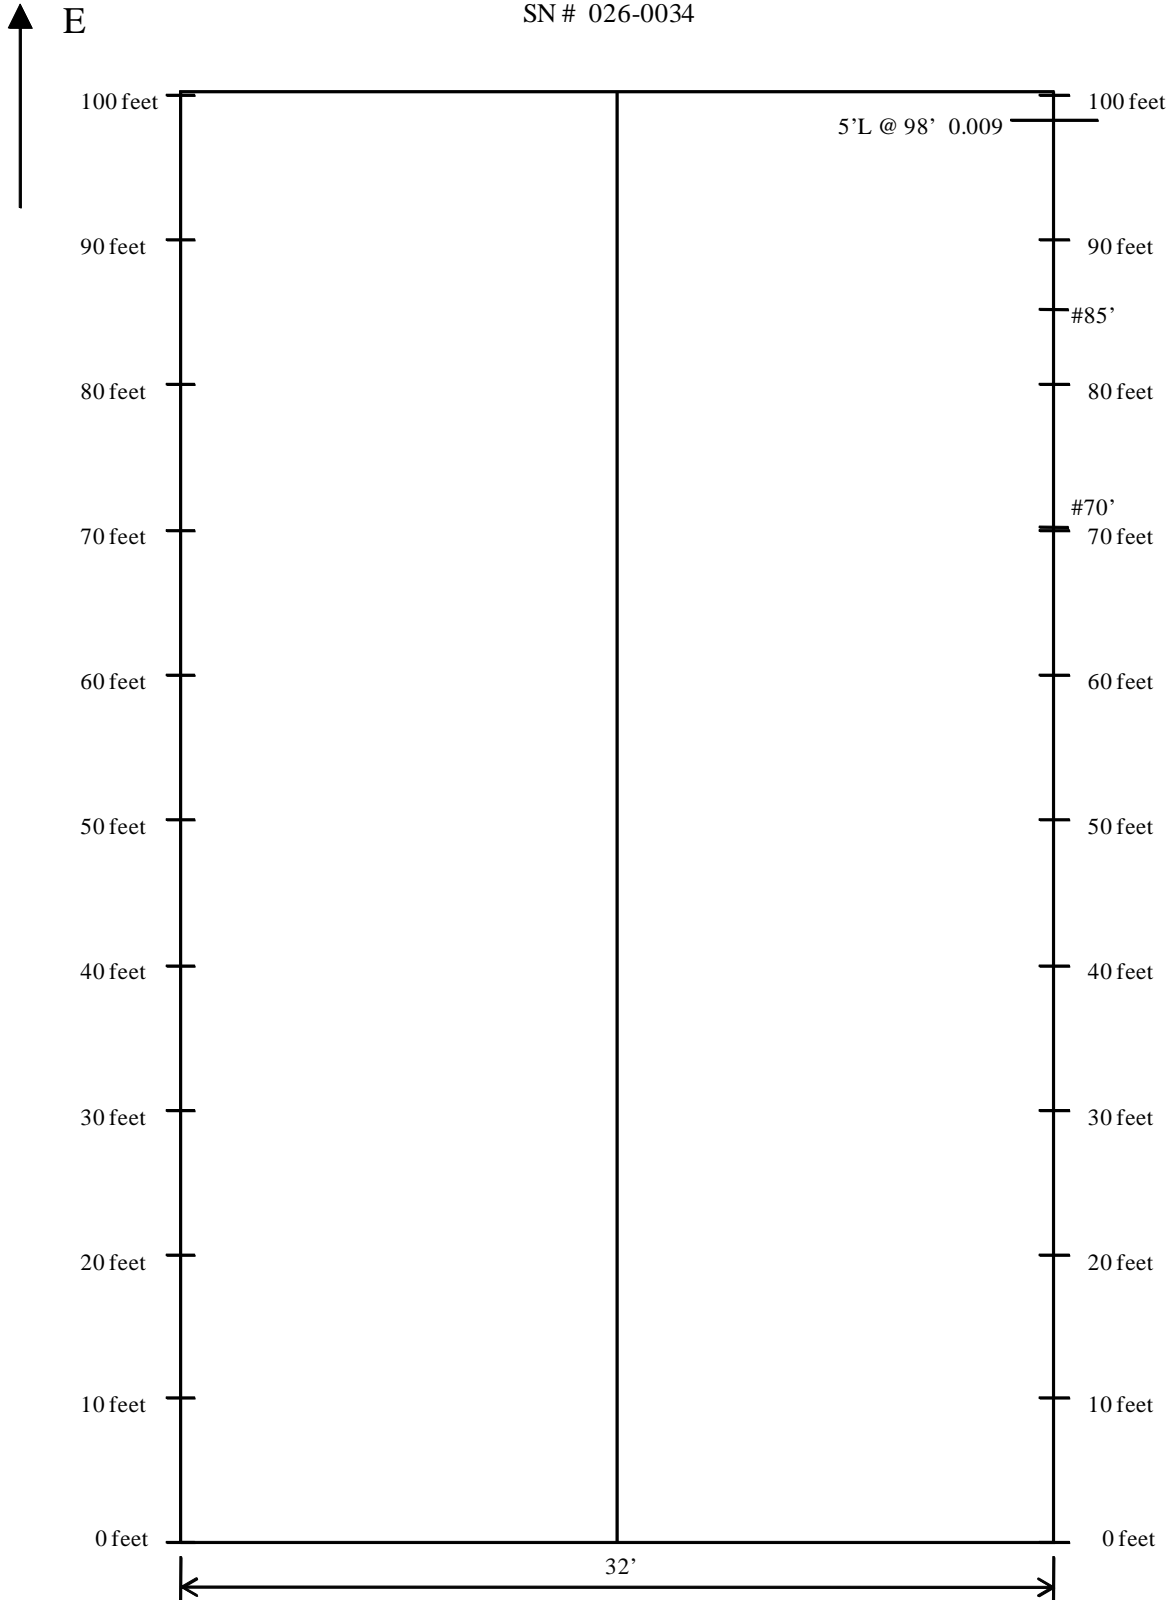
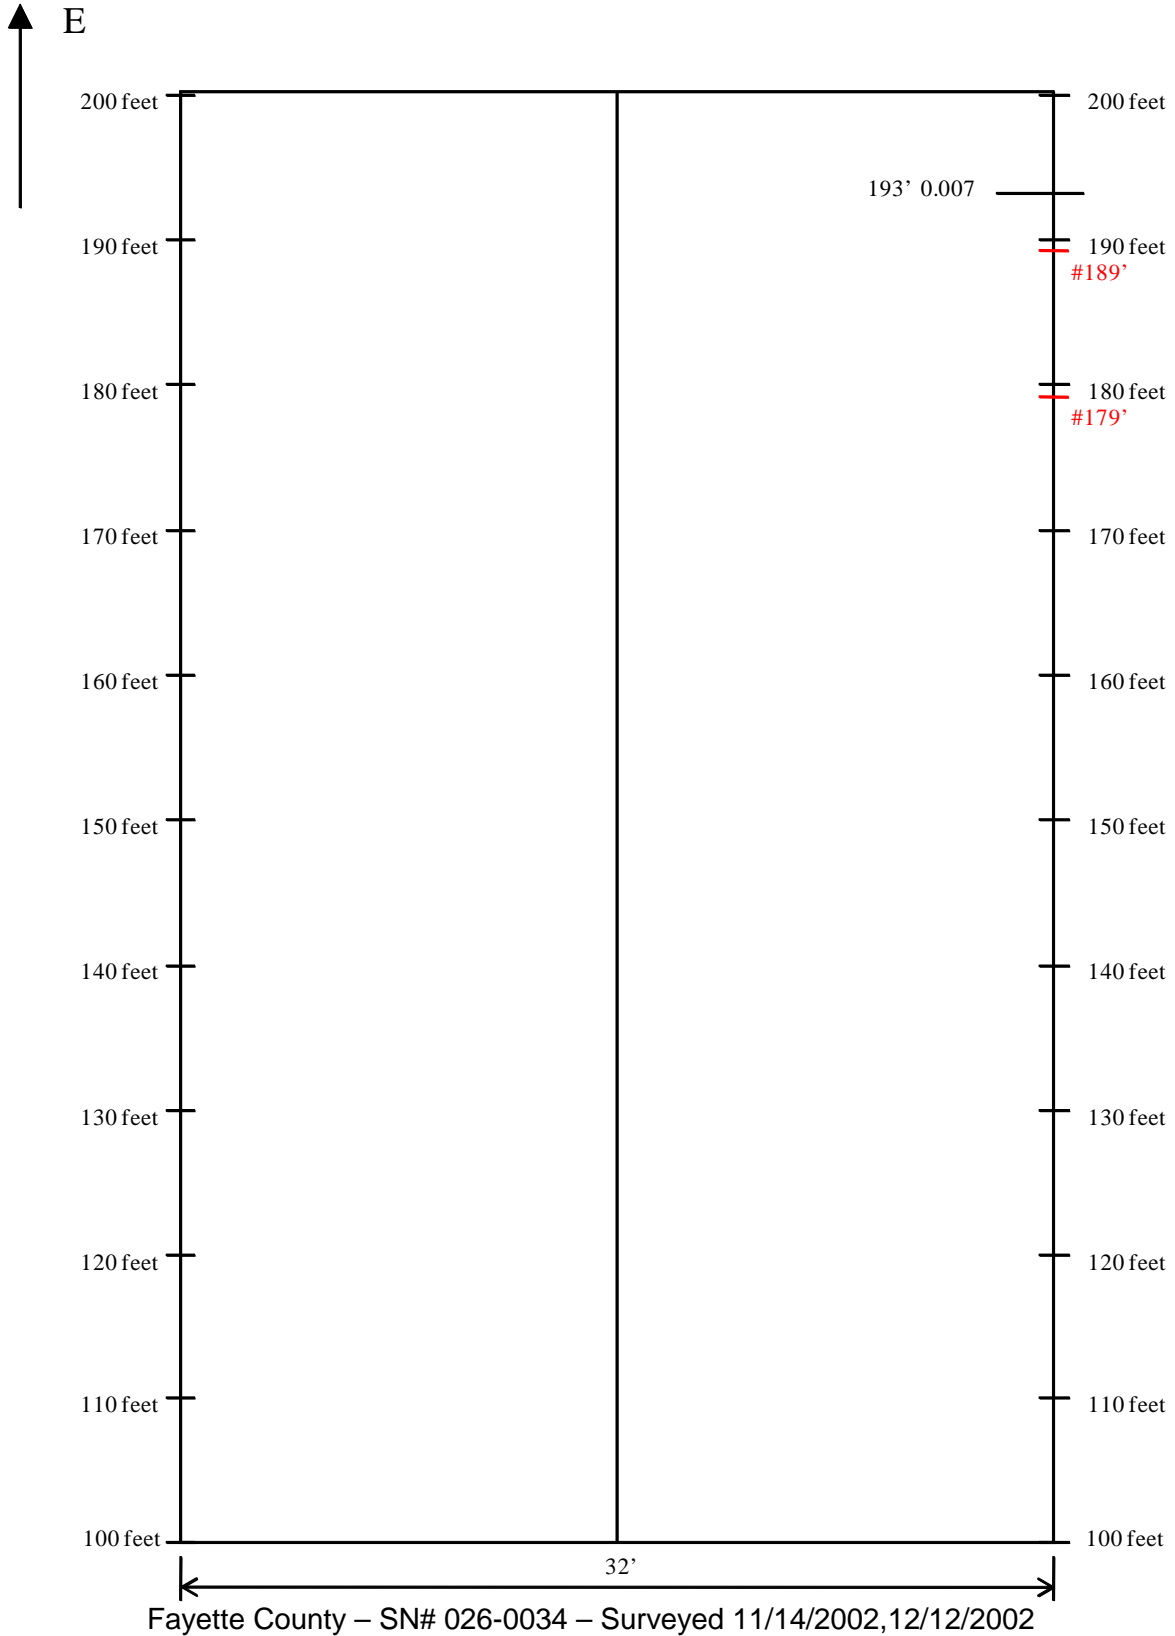
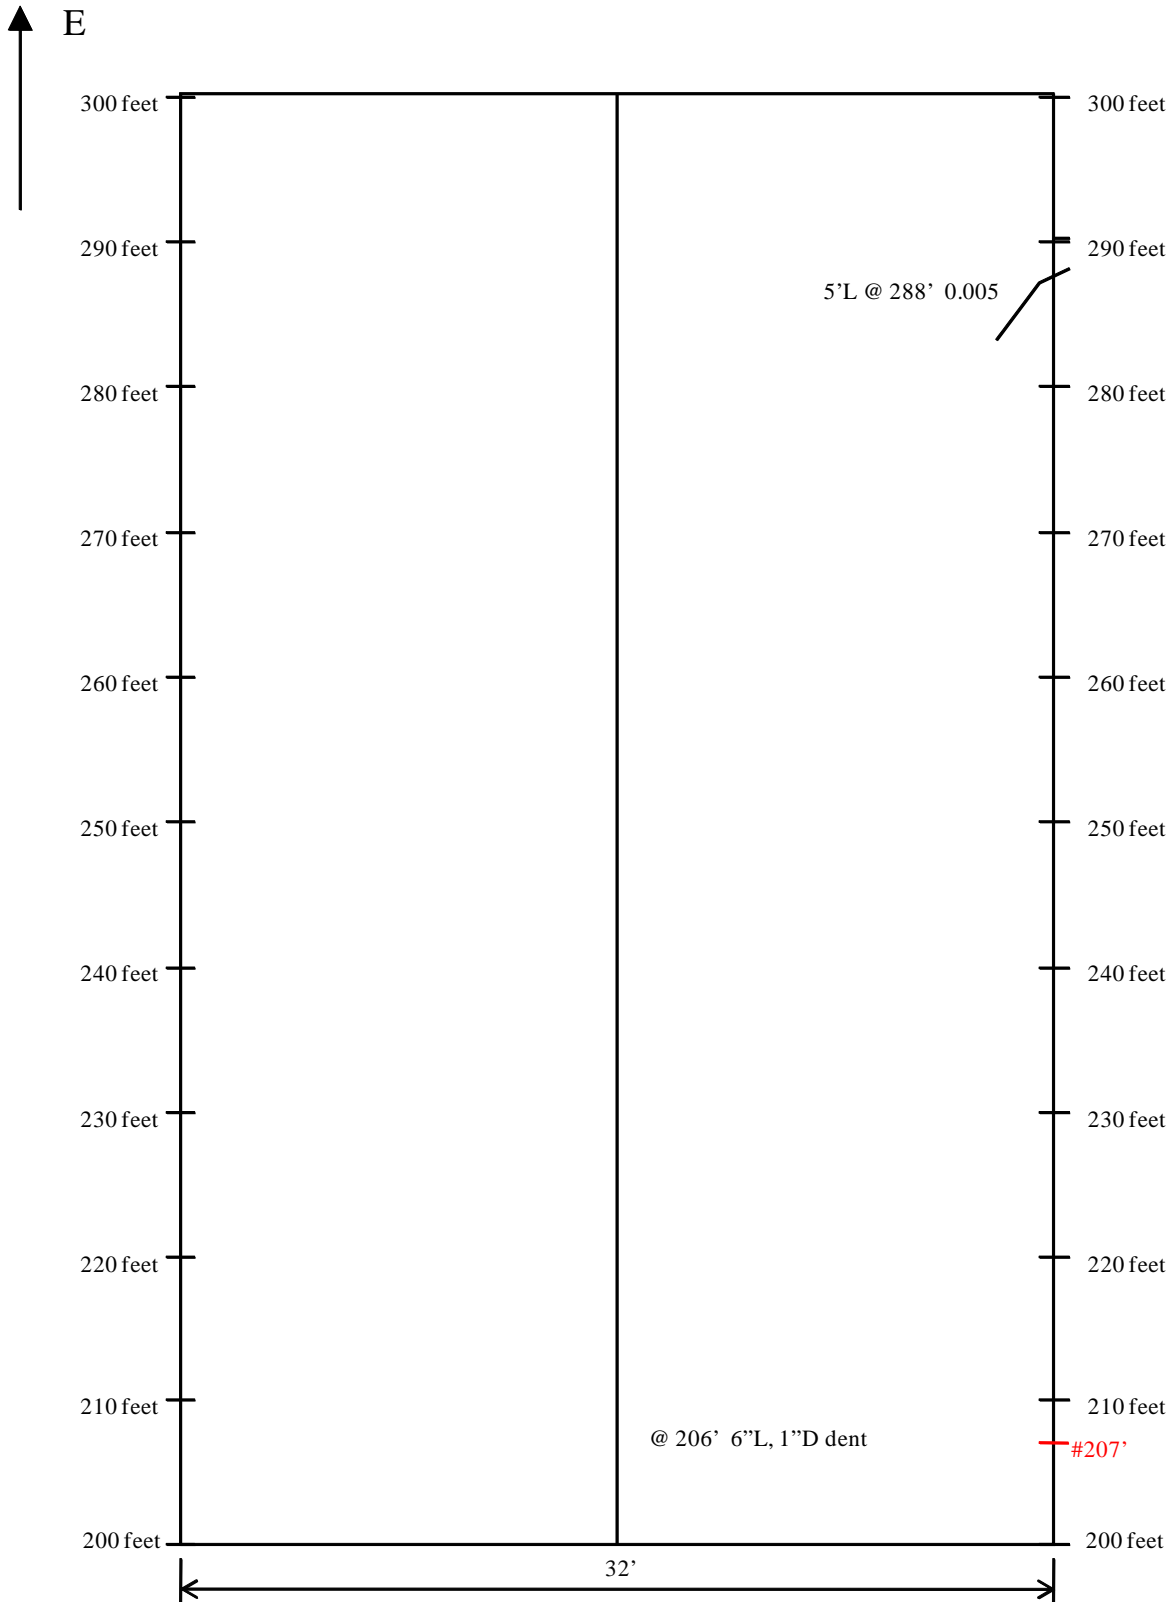
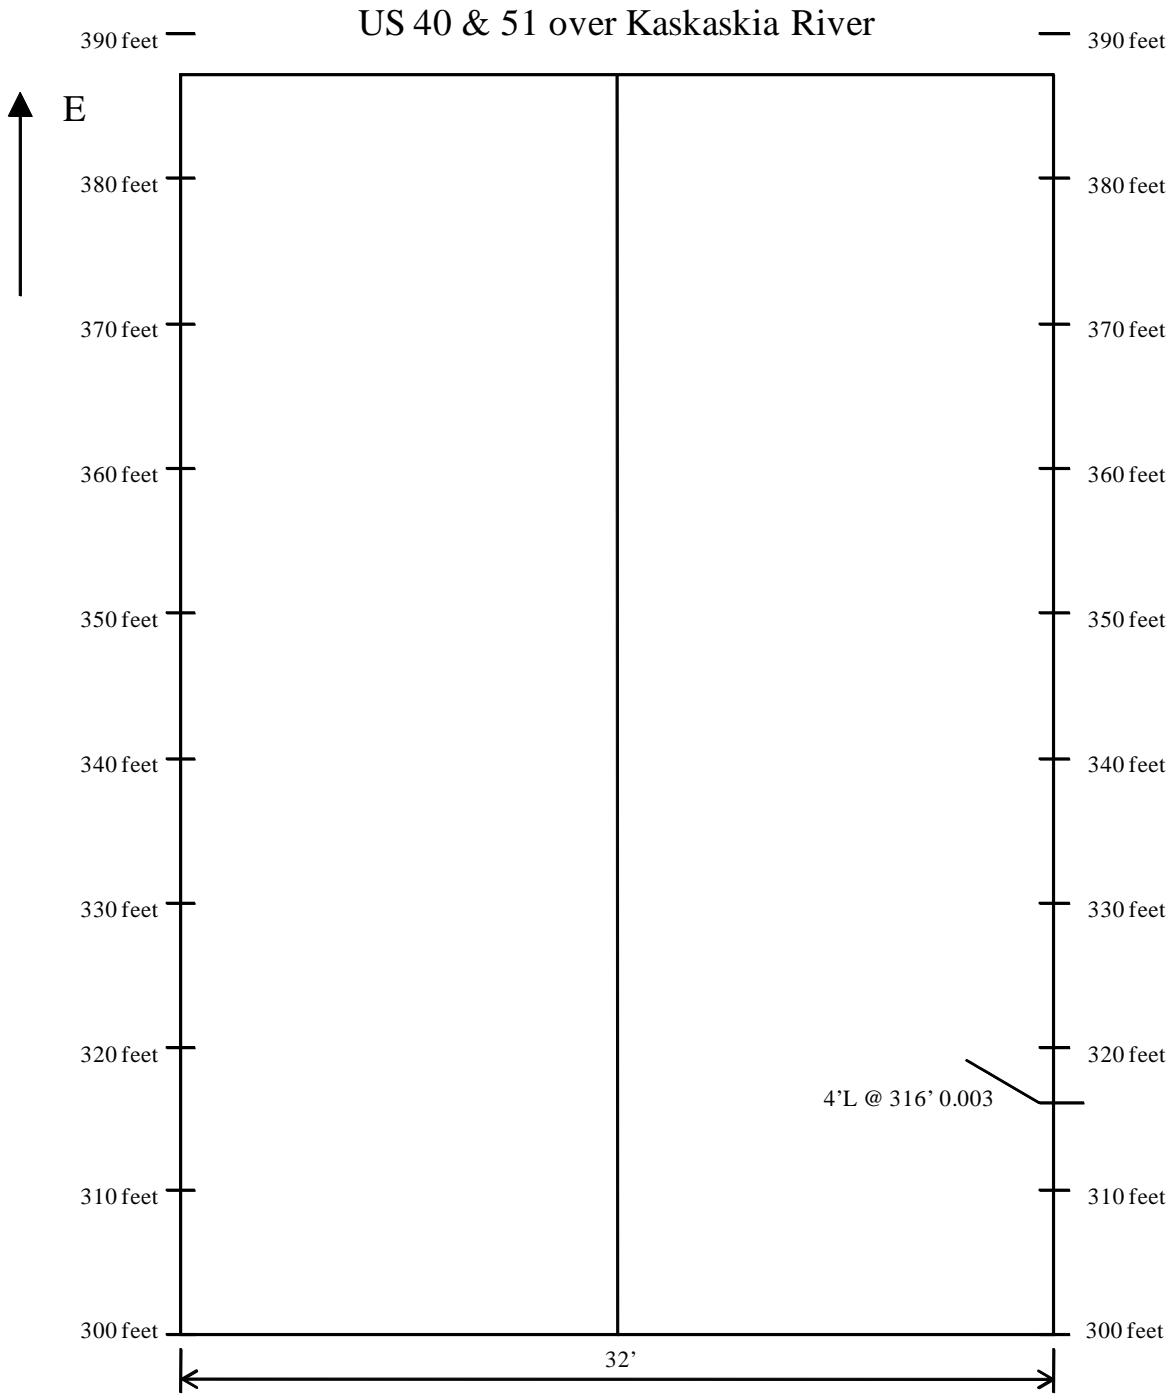
# US 40 & 51 over Kaskaskia River

The structure numbered 026-0034 showed transverse and longitudinal cracking on the bottom of the bridge deck. Severe transverse cracking was visible at 2' - 3' spacing in the eastbound lanes with a low temperature differential and faint transverse cracking was visible at 7' - 8' spacing with a high temperature differential in the westbound lanes. Both the eastbound and westbound lanes exhibited longitudinal cracking at 4' or more spacing on the bottom of the deck. On top of the deck, cracking was observed at 3' - 5' spacing near the middle of the bridge.

Fayette County – SN# 026-0034 – Surveyed 11/14/2002, 12/12/2002  
 This bridge deck was surveyed on November 14, 2002, fulfilling a 28 day survey requirement.  
 This bridge deck was surveyed on December 12, 2002.  
 The “#” symbol represents cracks in the parapet only.

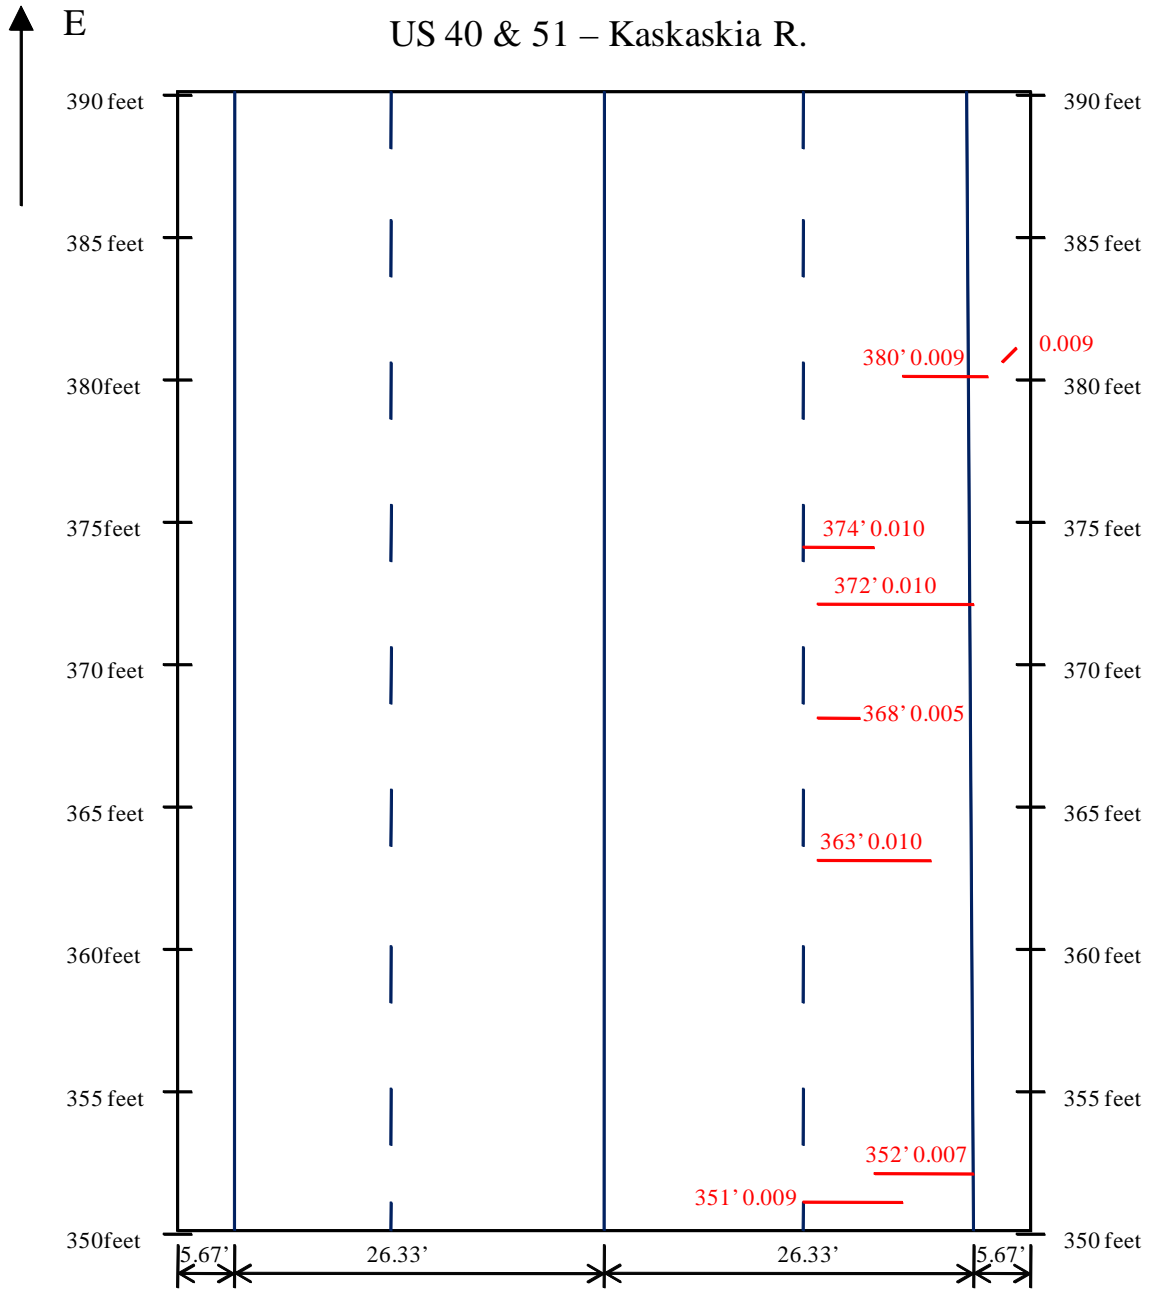
Fayette County – SN# 026-0034 – Surveyed 2003

Only the driving lanes of this bridge deck were surveyed because of time constraints and traffic safety concerns. Numerous cracks extended from the driving lanes into the passing lanes.

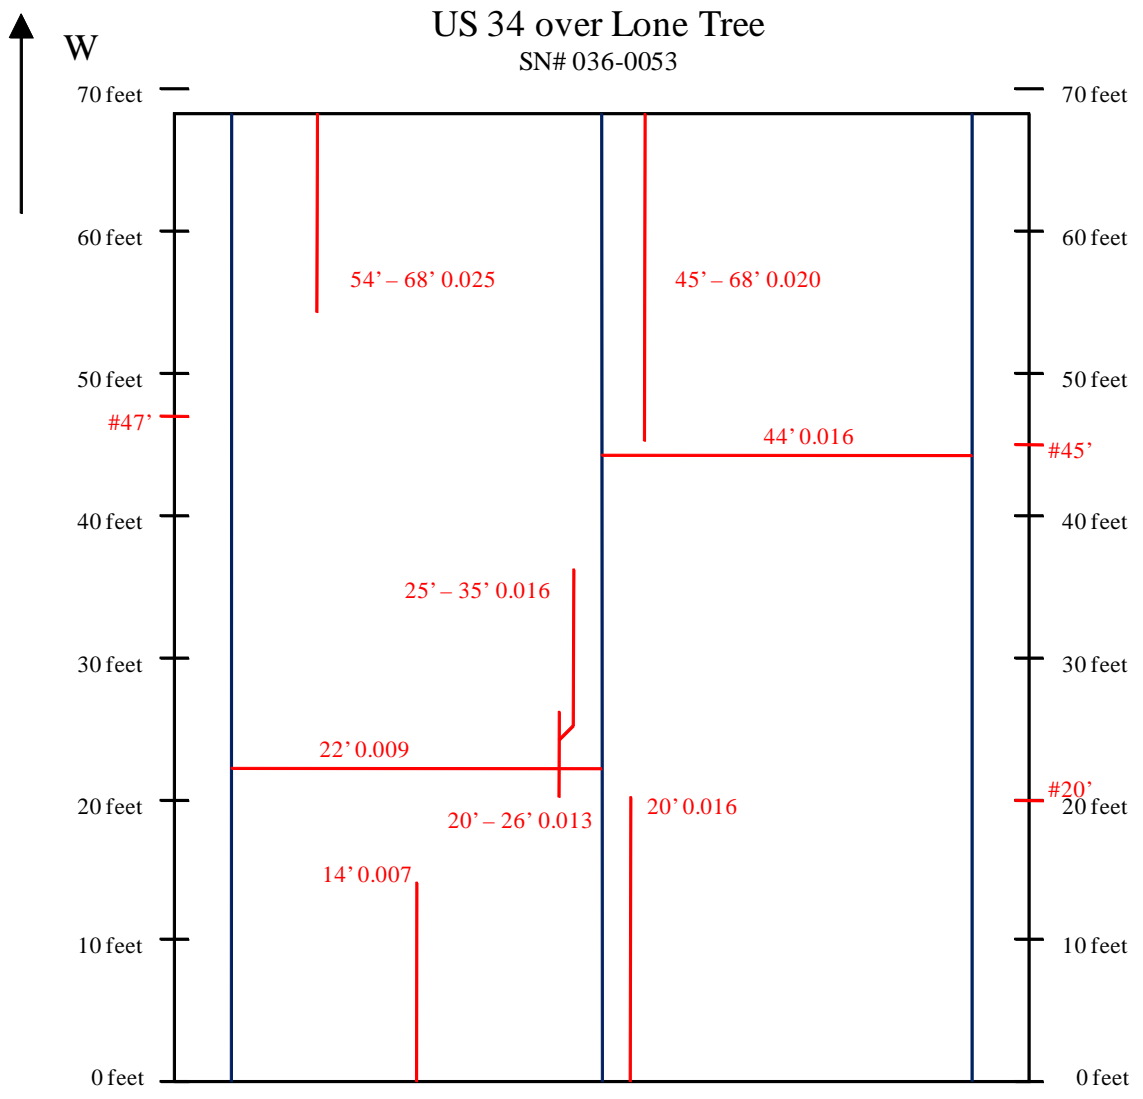
Henderson County – SN# 036-0053 – Surveyed 10/20/2003  
The “#” symbol represents cracks in the parapet only.

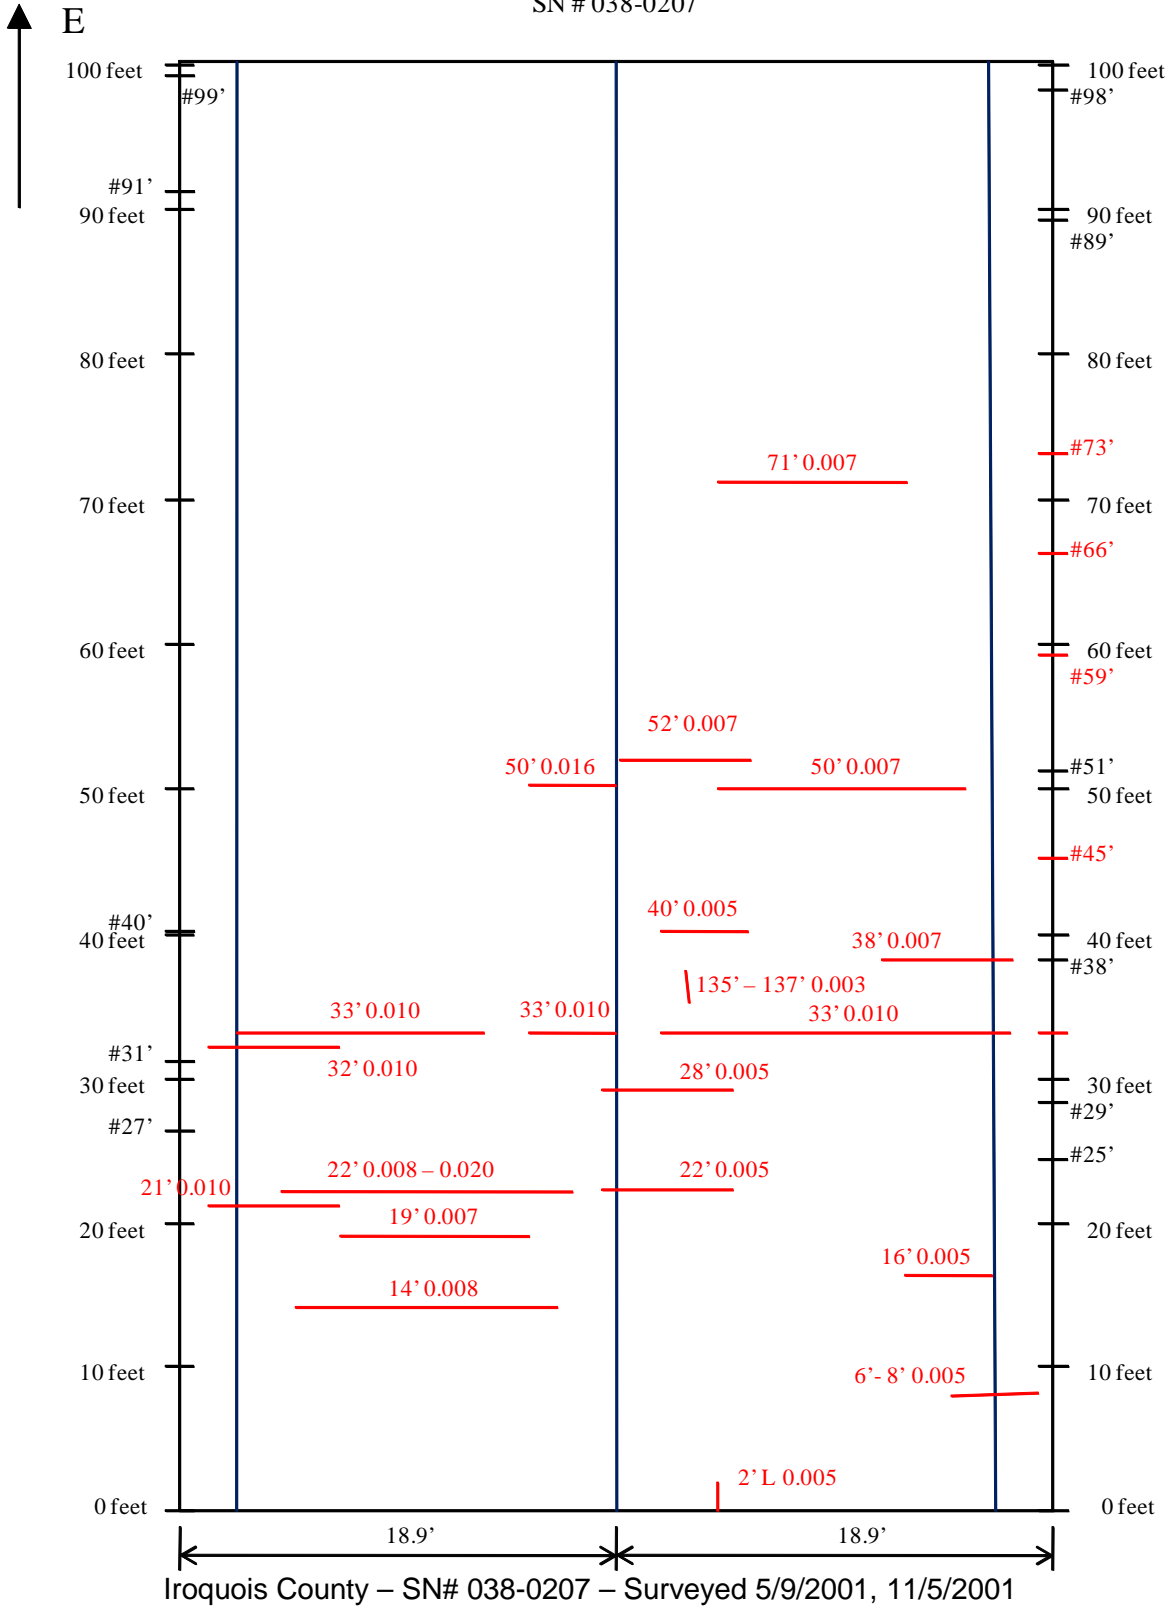
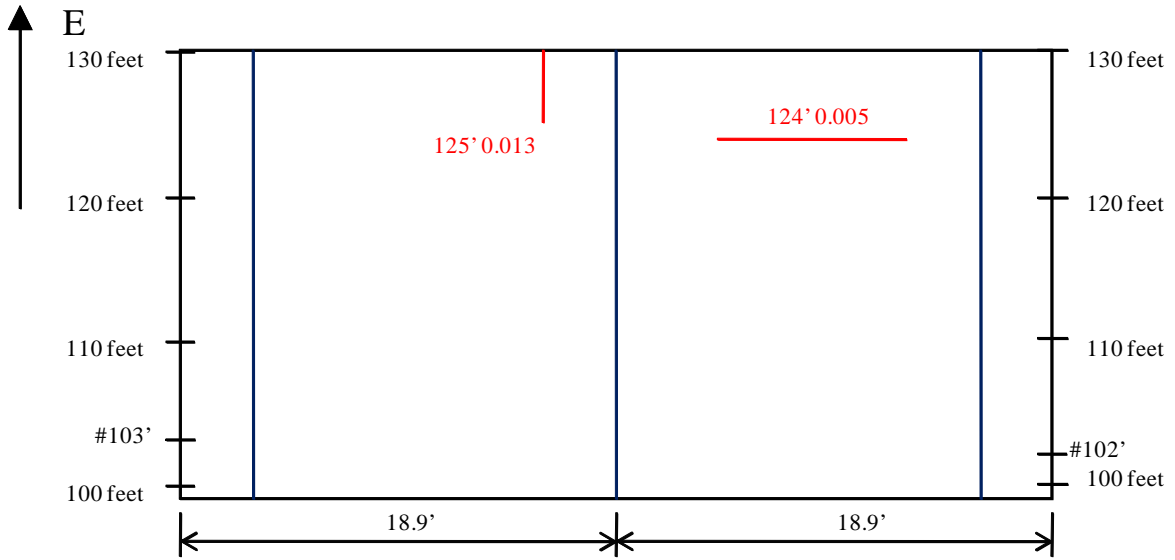
Rte 54 Thawville  
SN # 038-0207

Iroquois County – SN# 038-0207 – Surveyed 5/9/2001, 11/5/2001

Deck poured on November 03, 2000. The initial survey of this structure showed little to no cracking.

The “#” symbol represents cracks in the parapet only.

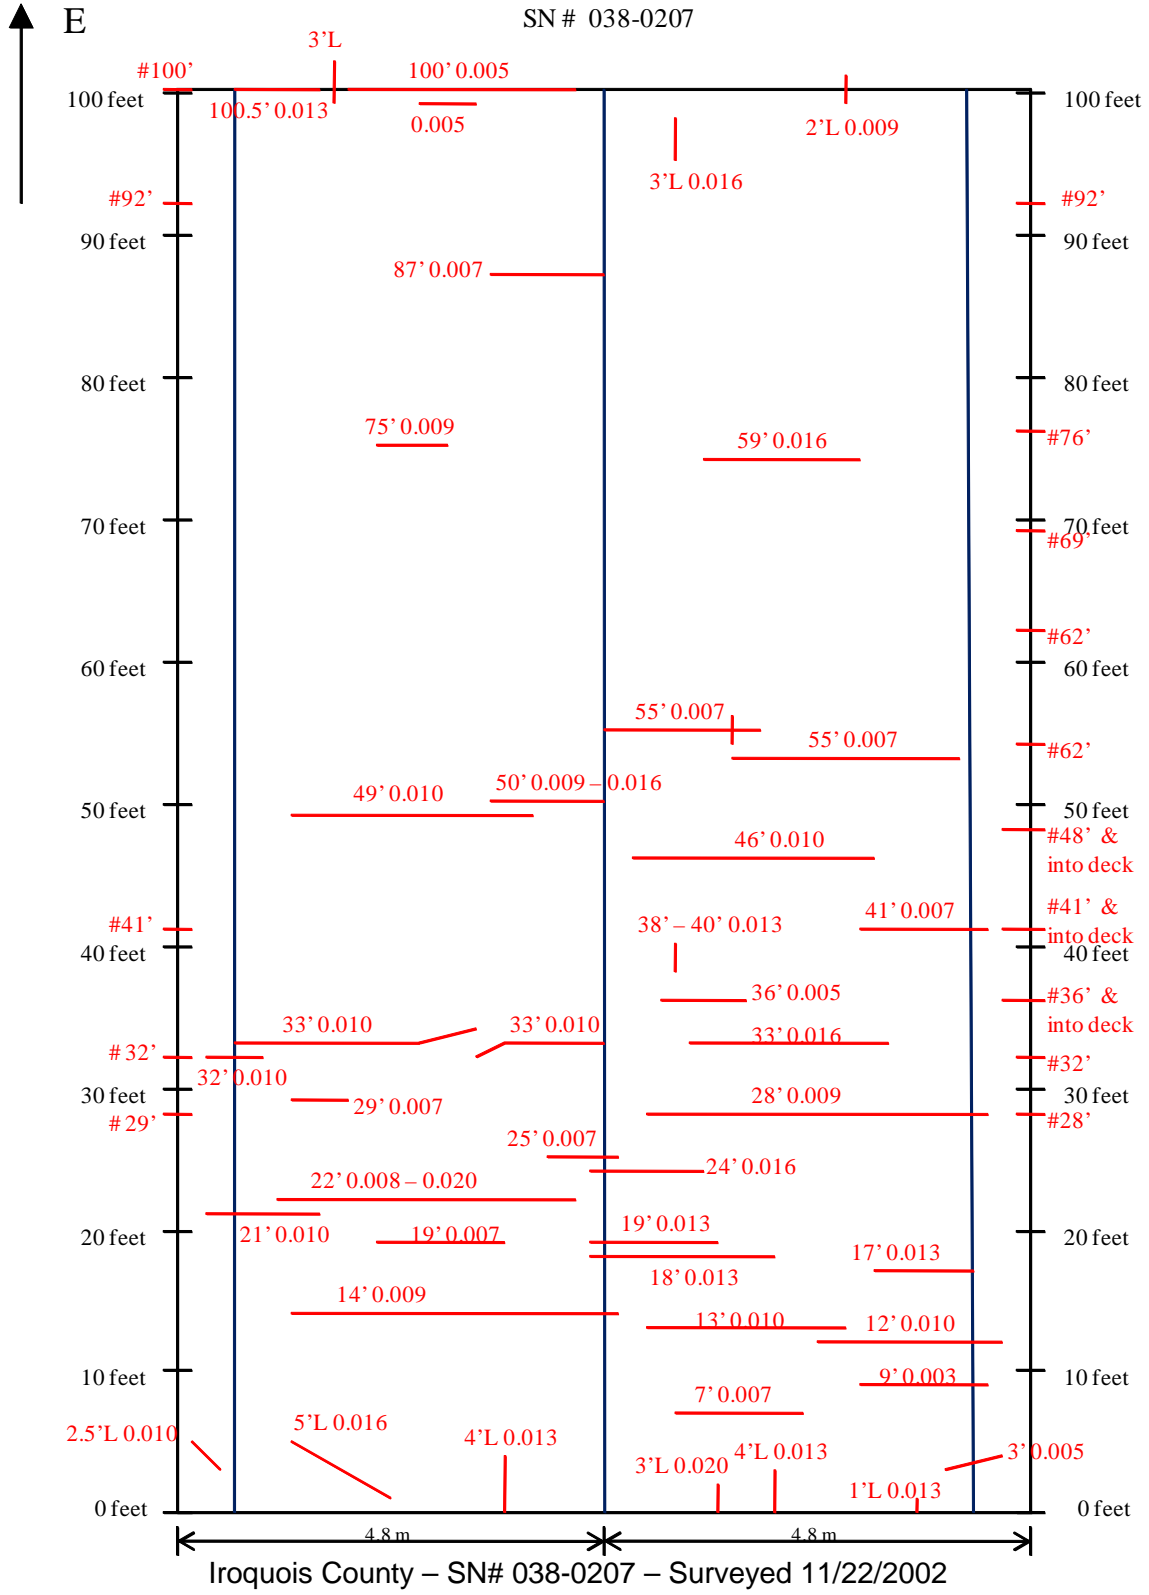
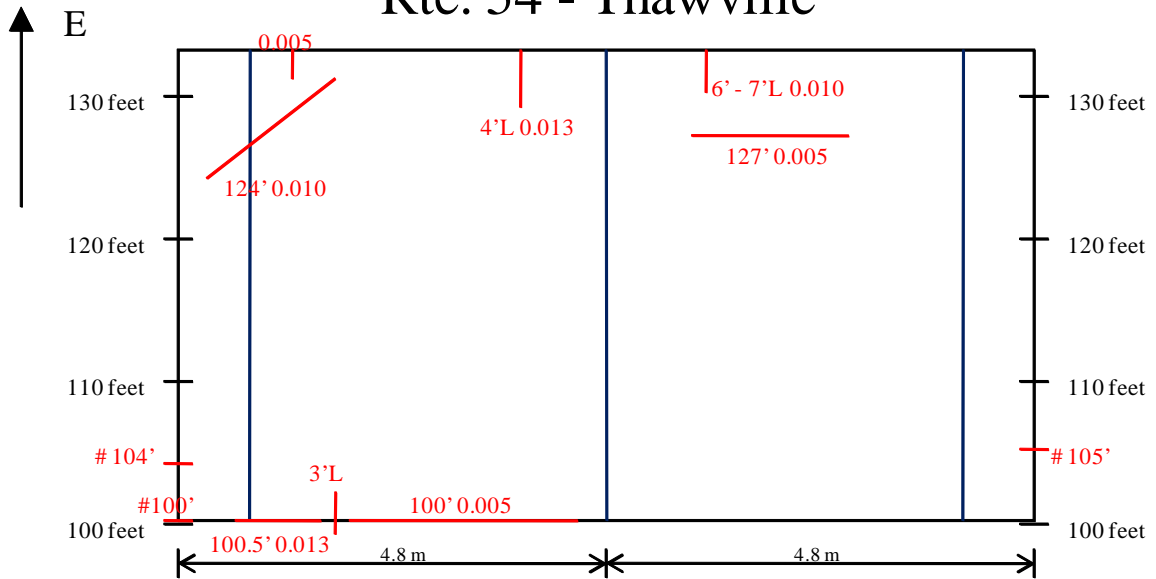
Thawville - Rte. 54  
SN # 038-0207

Iroquois County – SN# 038-0207 – Surveyed 11/22/2002

The “#” symbol represents cracks in the parapet only unless otherwise specified.

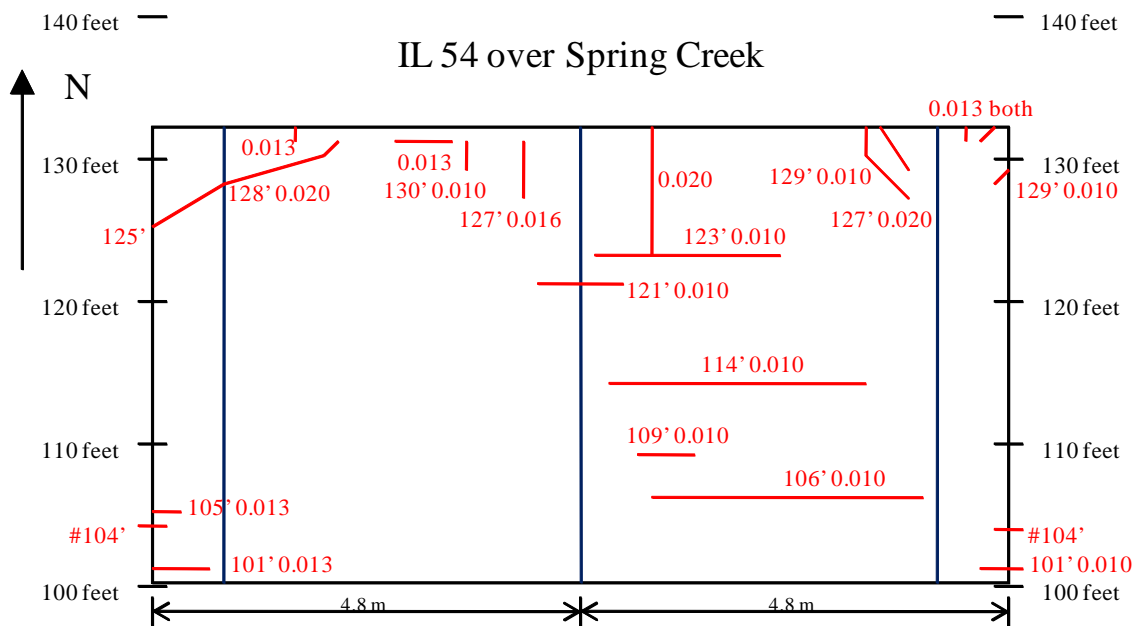
Iroquois County – SN# 038-0207 – Surveyed 10/28/2005  
 The “#” symbol represents cracks in the parapet only.

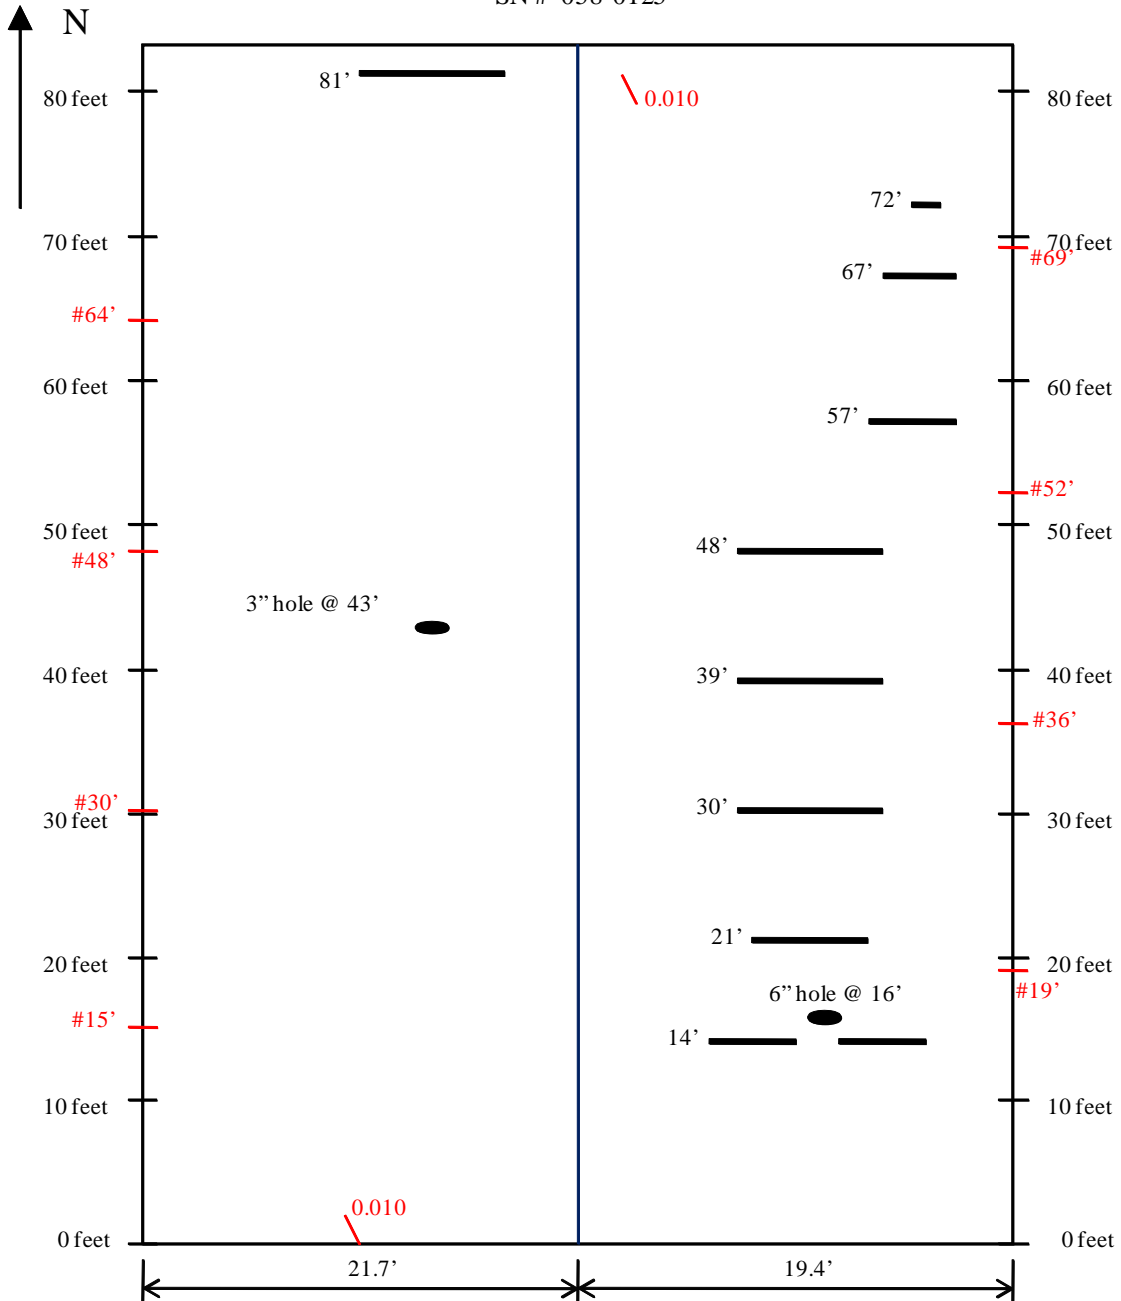
Macon U. S. 51 – NB  
SN# 058-0125

The structure numbered 058-0125 exhibited cracking on the bottom of the deck at 4' - 6' spacing. The structure numbered 058-0126 showed less cracking than the structure numbered 058-0125. From Tables 4.3-3 and 4.3-4, the structure numbered 058-0125 experienced a larger temperature fluctuation in the first 72 hours after the pour than the structure numbered 058-0126. These structures are a dual structure.

Macon County – SN# 058-0125 – Surveyed 5/7/2001, 10/19/2001

This bridge deck was poured on October 12, 2000. The initial survey showed no cracking. The thicker lines represent areas of popped out aggregate. The “#” symbol represents cracks in the parapet only.

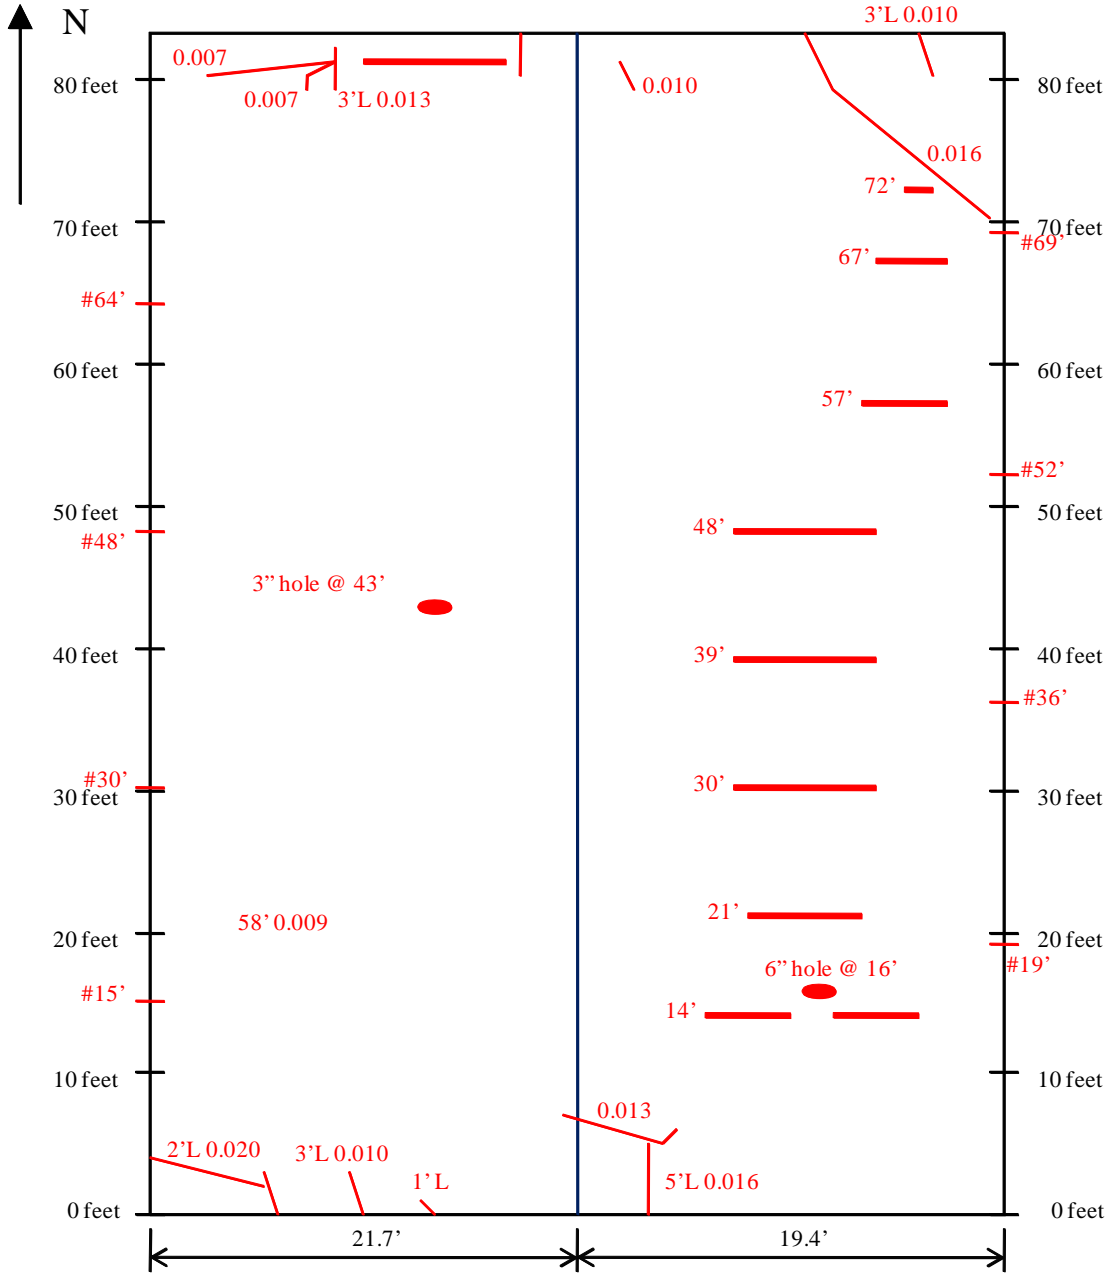
Macon U. S. 51 – NB  
SN # 058-0125

Macon County – SN# 058-0125 – Surveyed 10/31/2002

The “#” symbol represents cracks in the parapet only. The thicker lines represent areas of popped out aggregate.

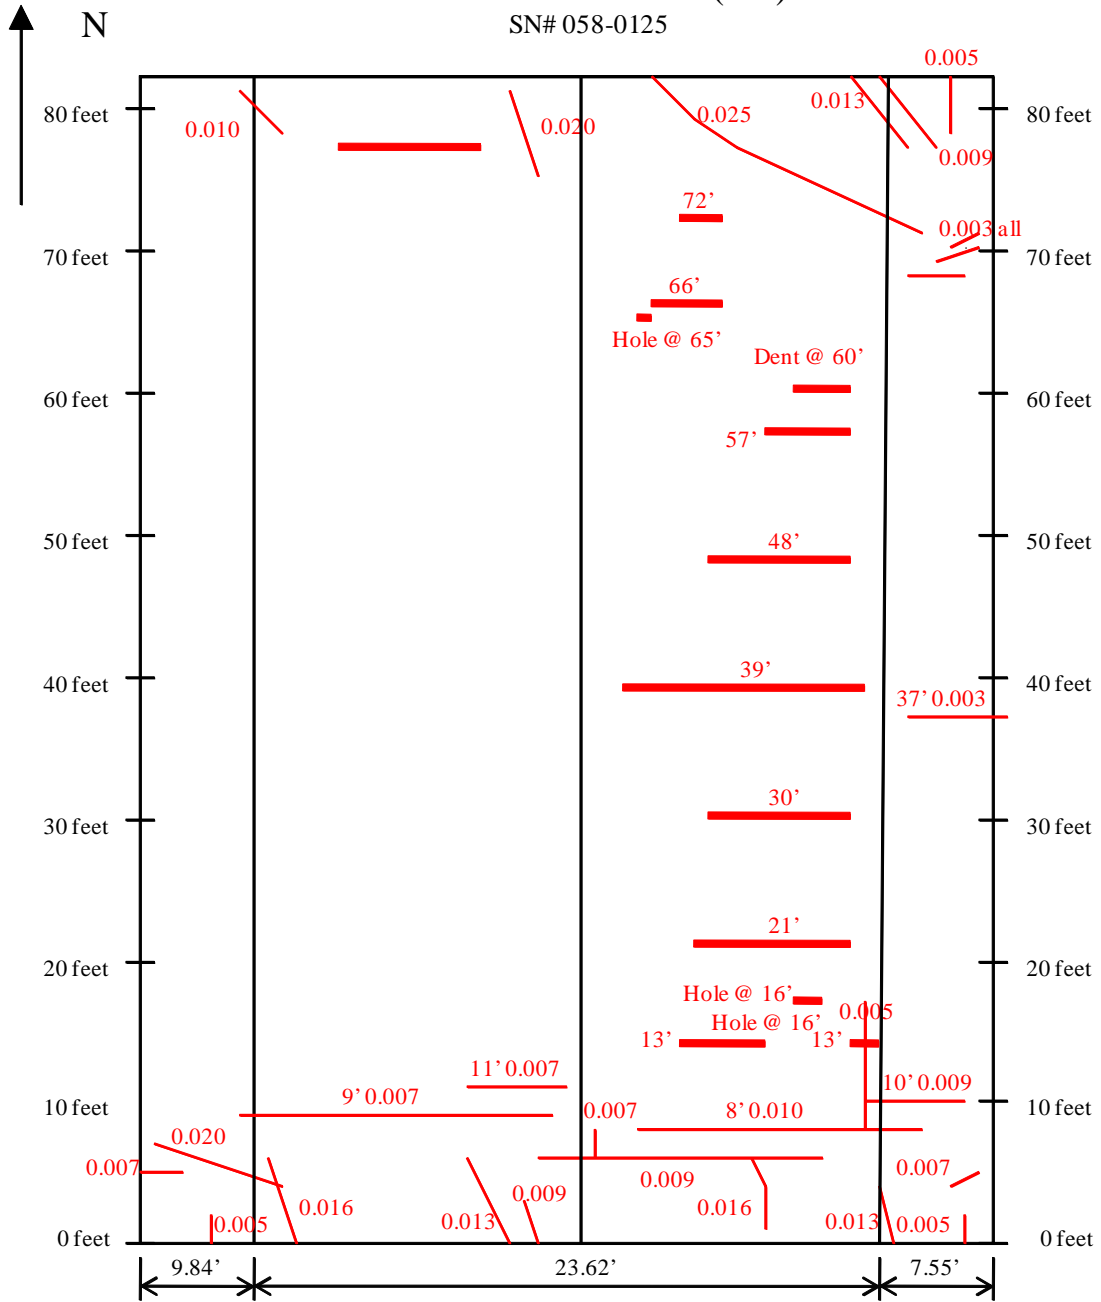
US 51-Branch Creek (NB)  
SN# 058-0125

Macon County – SN# 058-0125 – Surveyed 10/7/2003  
The thick red lines represent portions popped out unless otherwise noted.
