**EVALUATION OF HIGH PERFORMANCE  
CONCRETE BRIDGE DECKS  
AND  
OTHER EXPERIMENTAL BRIDGE  
DECKS THROUGHOUT ILLINOIS**

**PHYSICAL RESEARCH REPORT NO. 166  
December 2017**

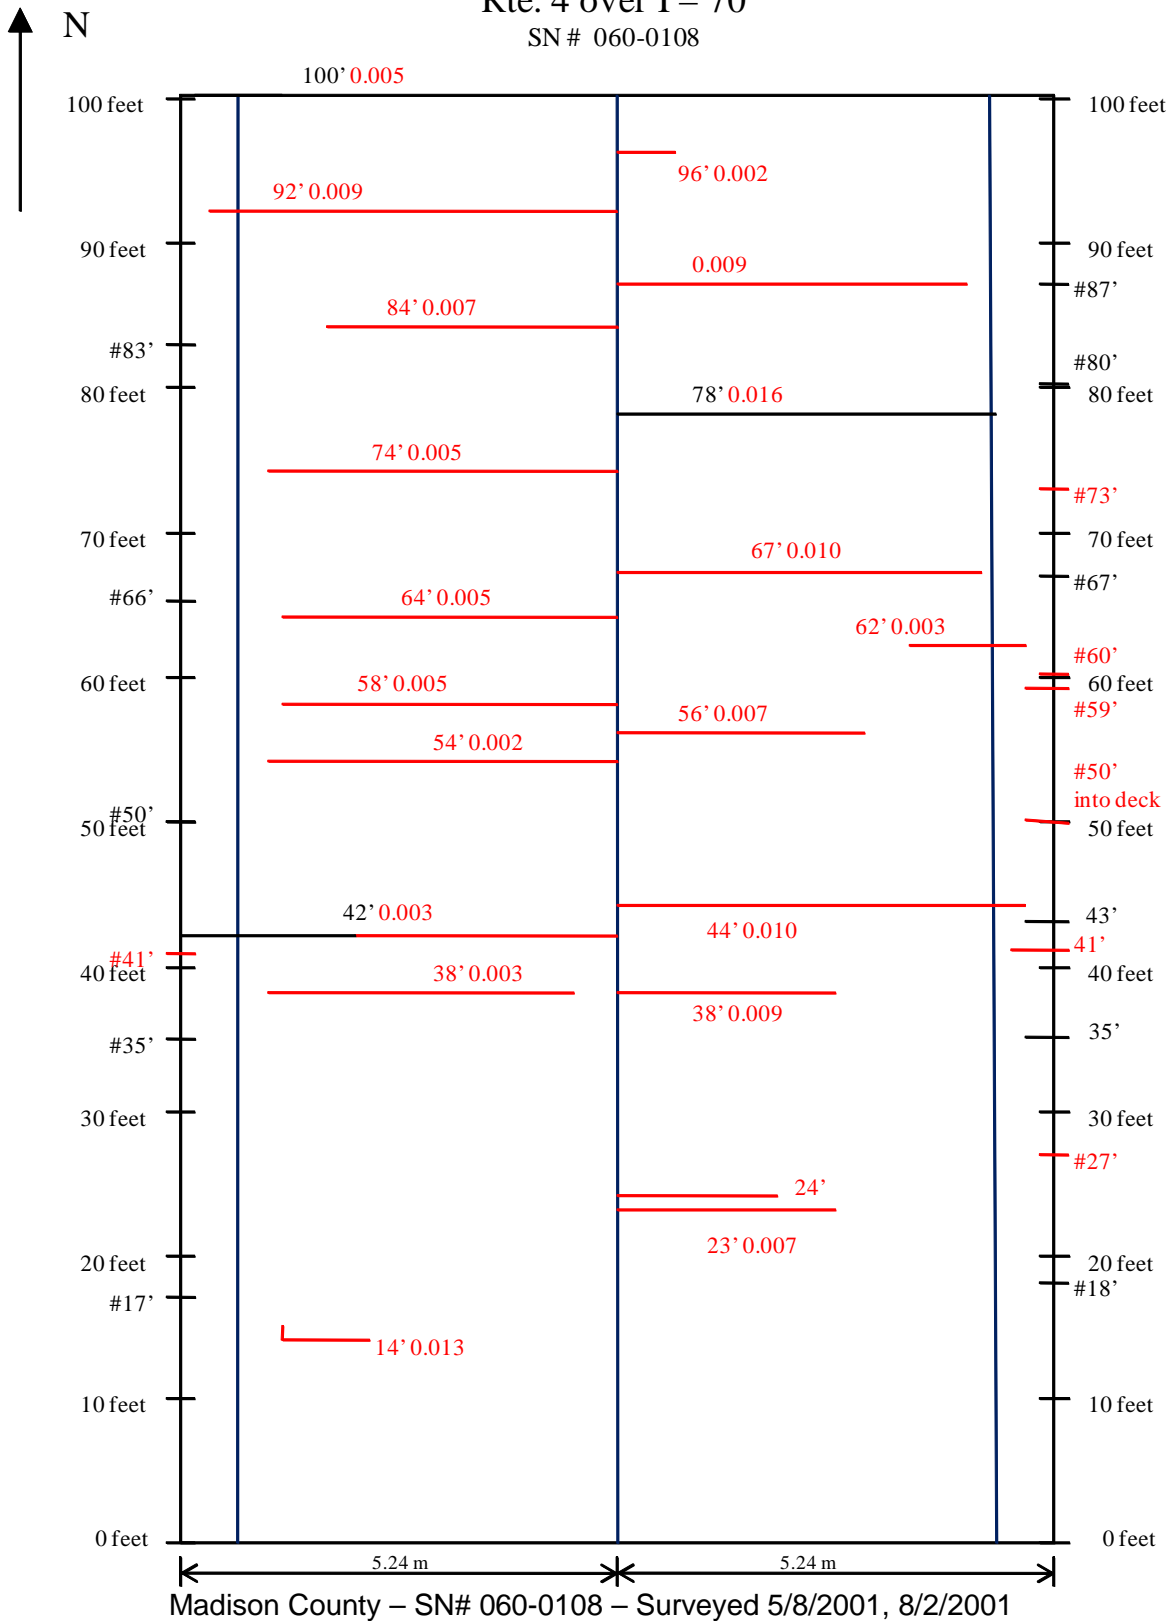
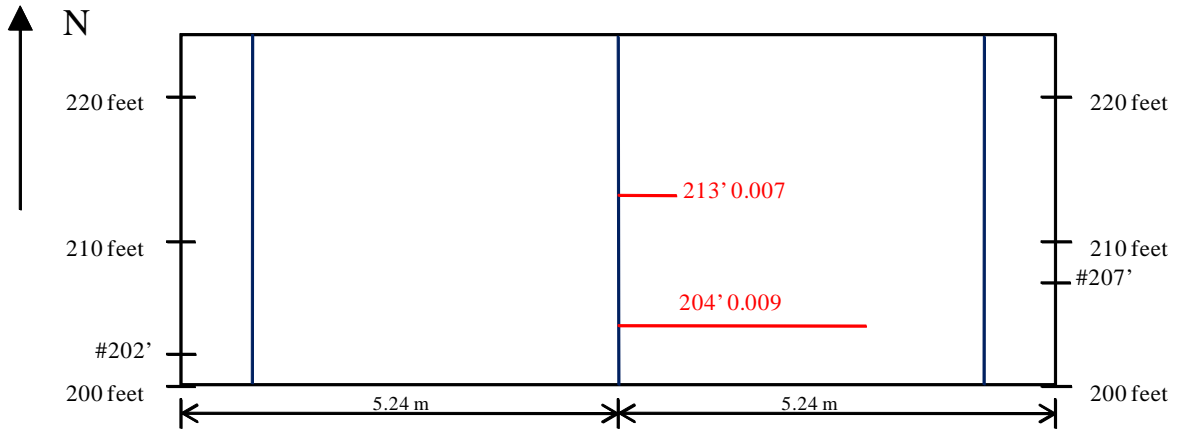
Rte. 4 over I – 70  
SN # 060-0108

Madison County – SN# 060-0108 – Surveyed 5/8/2001, 8/2/2001

The initial survey of the southbound lane showed only one transverse crack.  
The initial survey of the northbound lane showed five hairline transverse cracks.

The “#” symbol represents cracks in the parapet only.

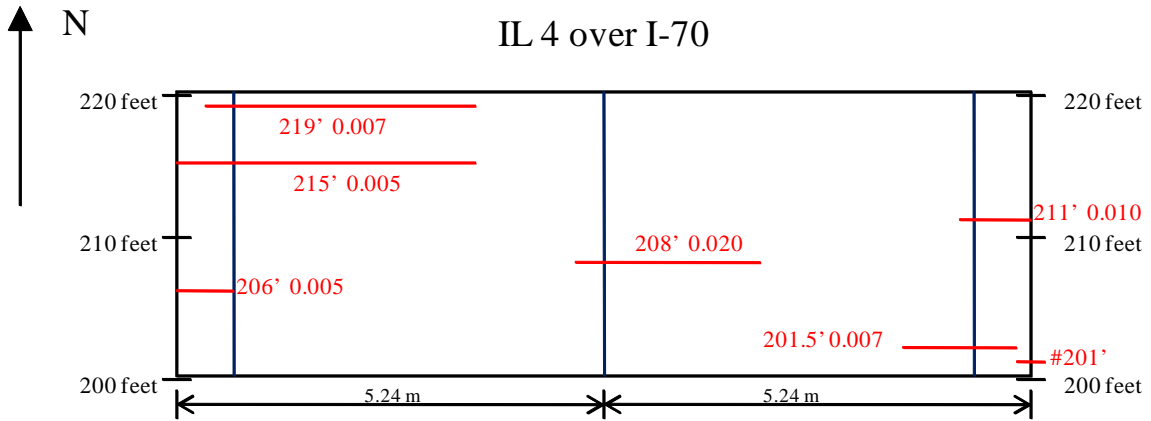
# IL 4 over I-70

Madison County – SN# 060-0108 – Surveyed 9/29/2003

This was a partial deck survey due to time constraints and traffic conditions.

The “#” symbol represents cracks in the parapet only.

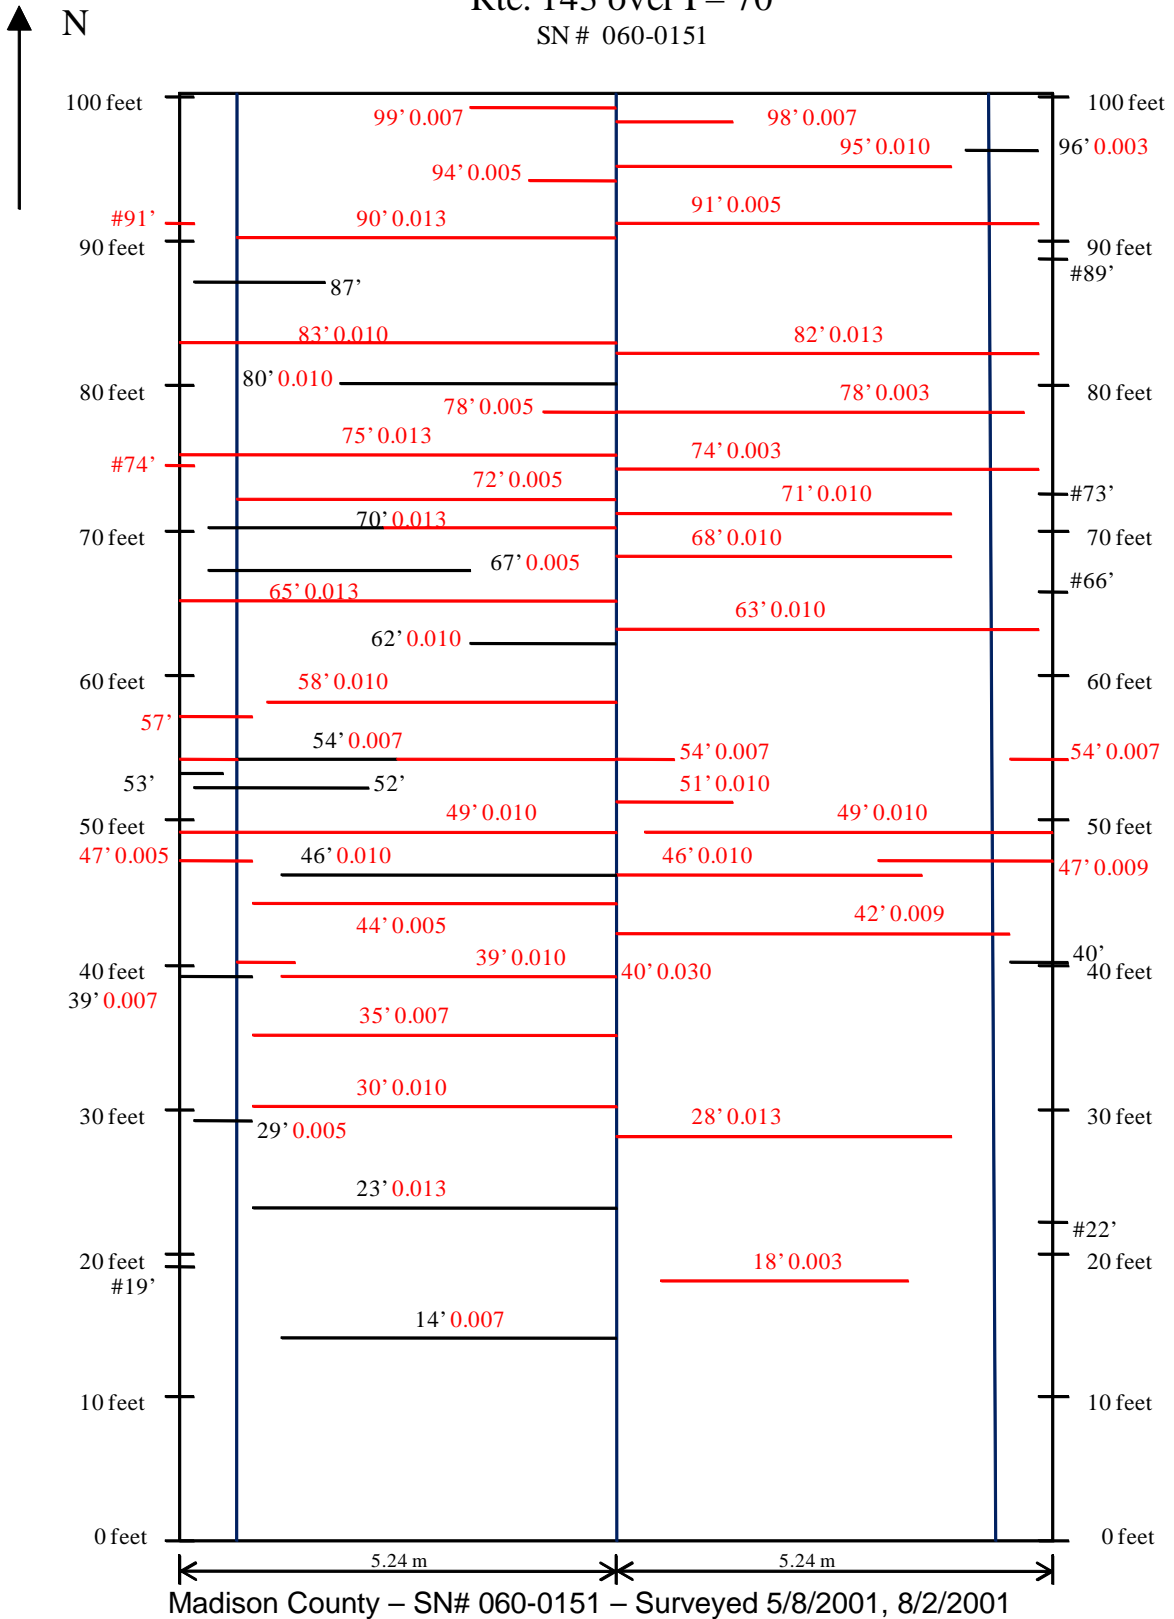
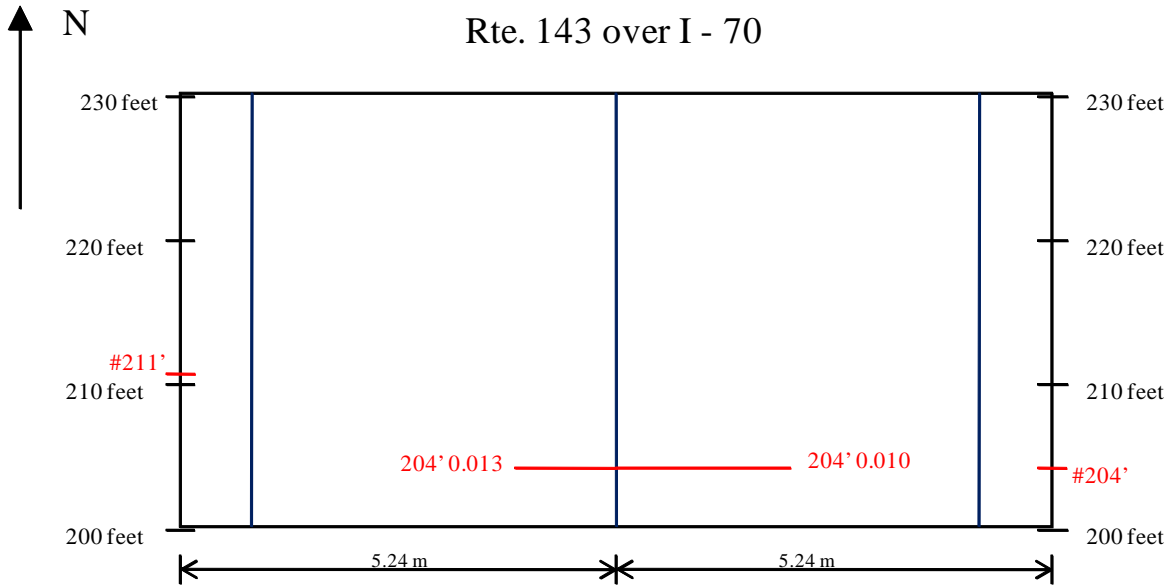
Rte. 143 over I – 70  
SN # 060-0151

Madison County – SN# 060-0151 – Surveyed 5/8/2001, 8/2/2001  
 The initial bridge deck survey showed five hairline transverse cracks.  
 The “#” symbol represents cracks in the parapet only.

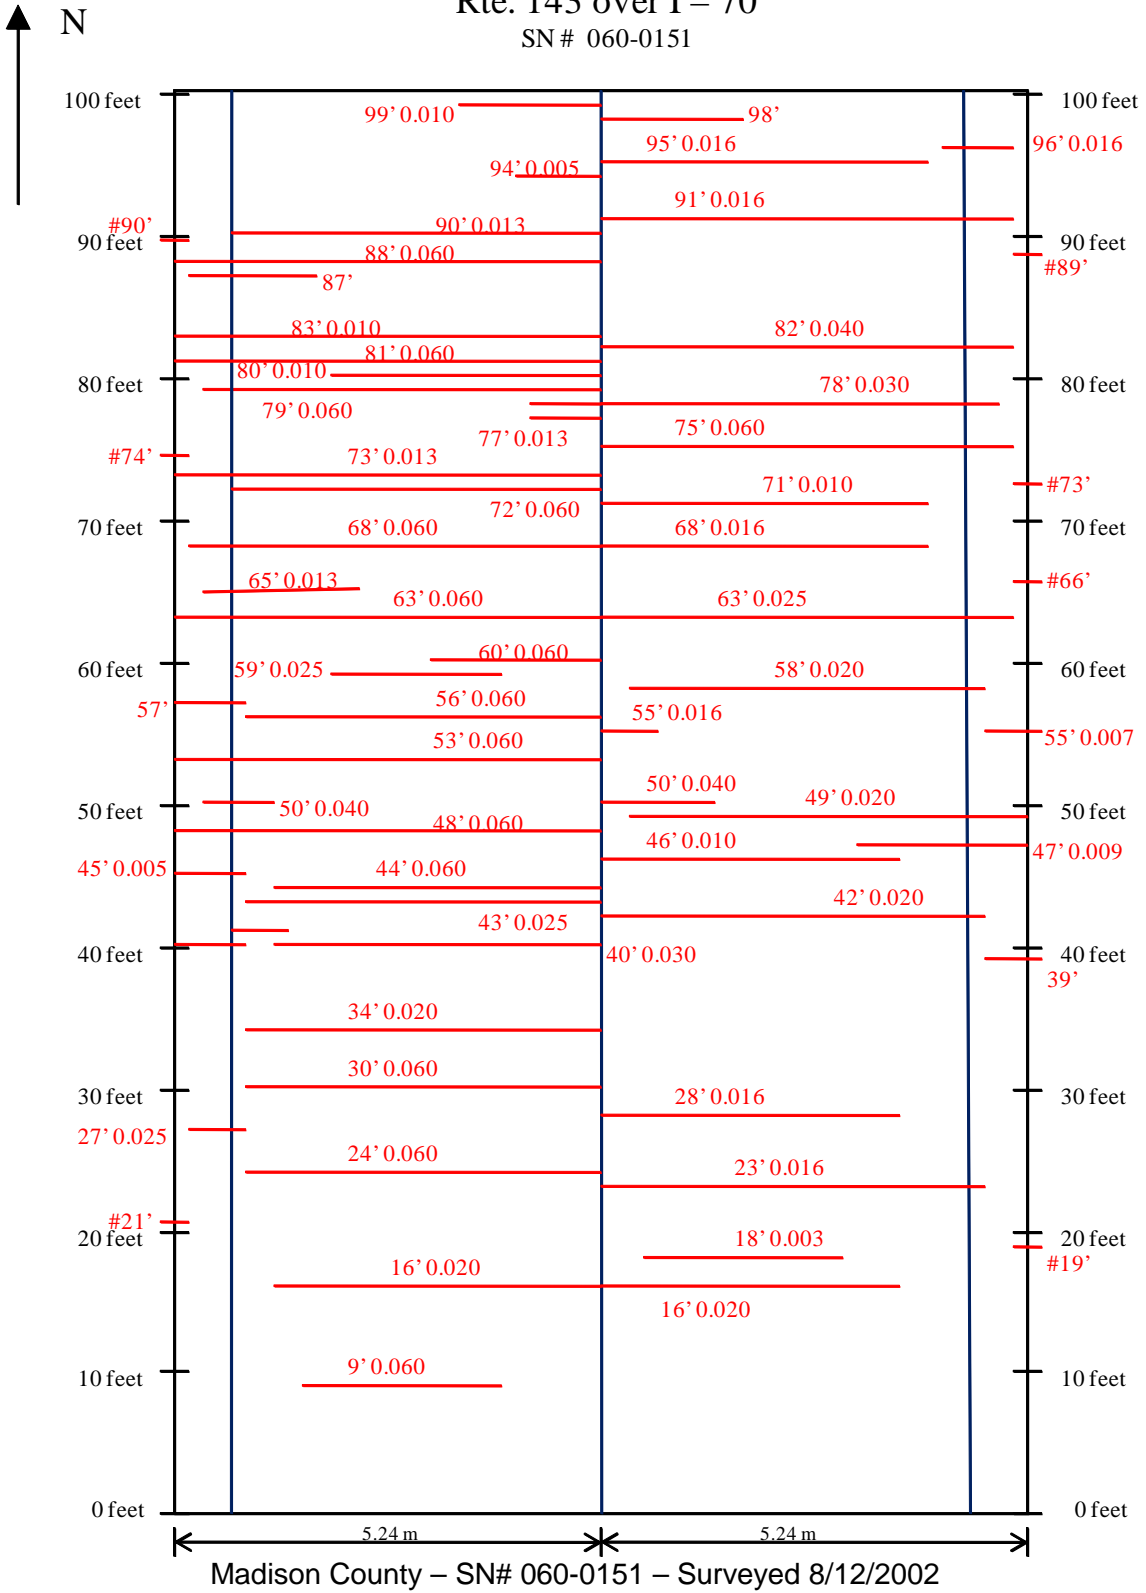
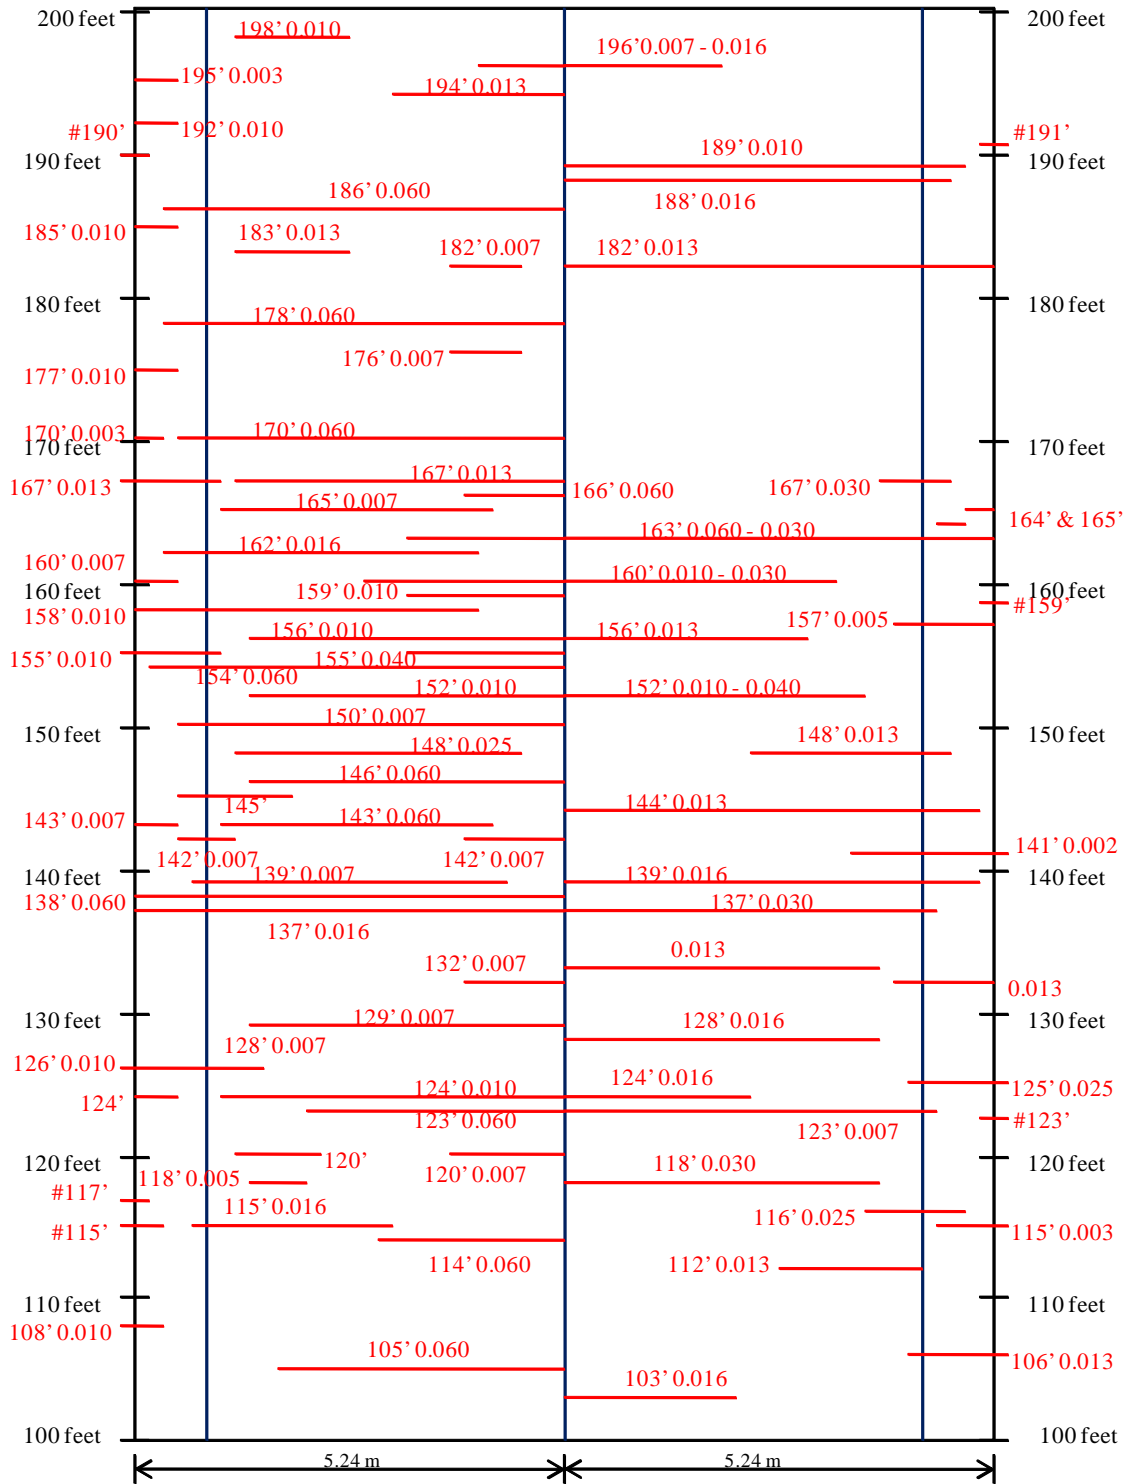
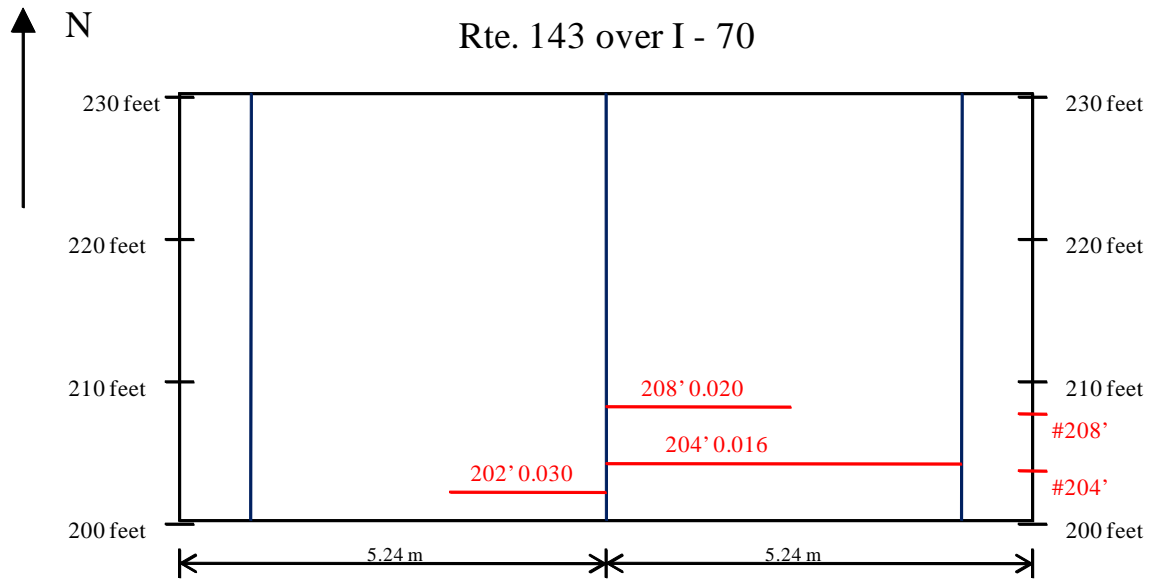
Rte. 143 over I – 70  
SN# 060-0151

Madison County – SN# 060-0151 – Surveyed 8/12/2002  
 The “#” symbol represents cracks in the parapet only.

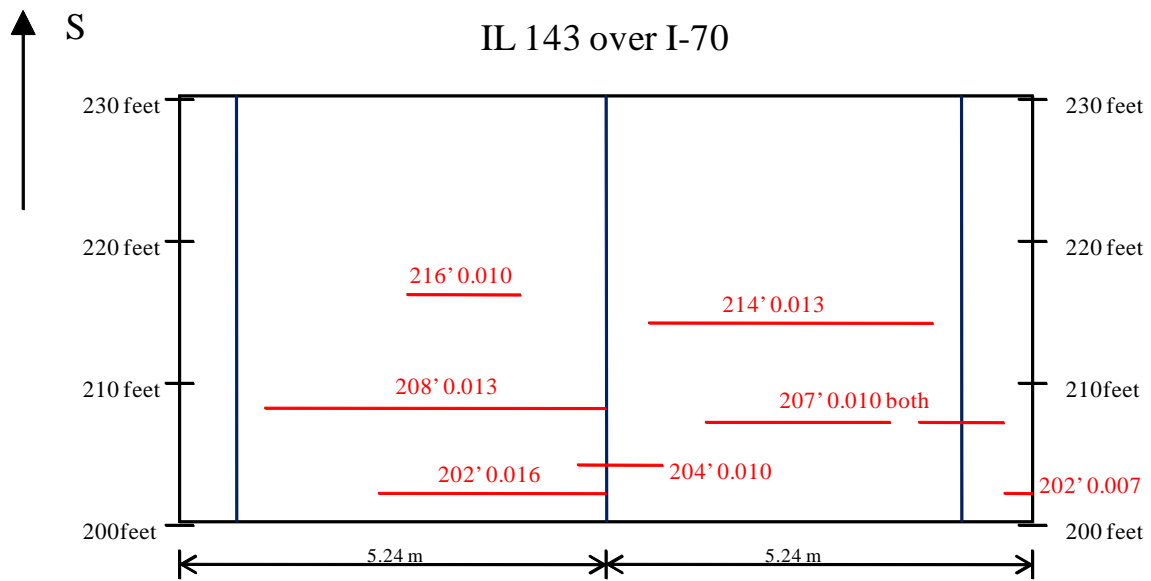
Madison County – SN# 060-0151 – Surveyed 9/29/2003  
 The “#” symbol represents cracks in the parapet only.

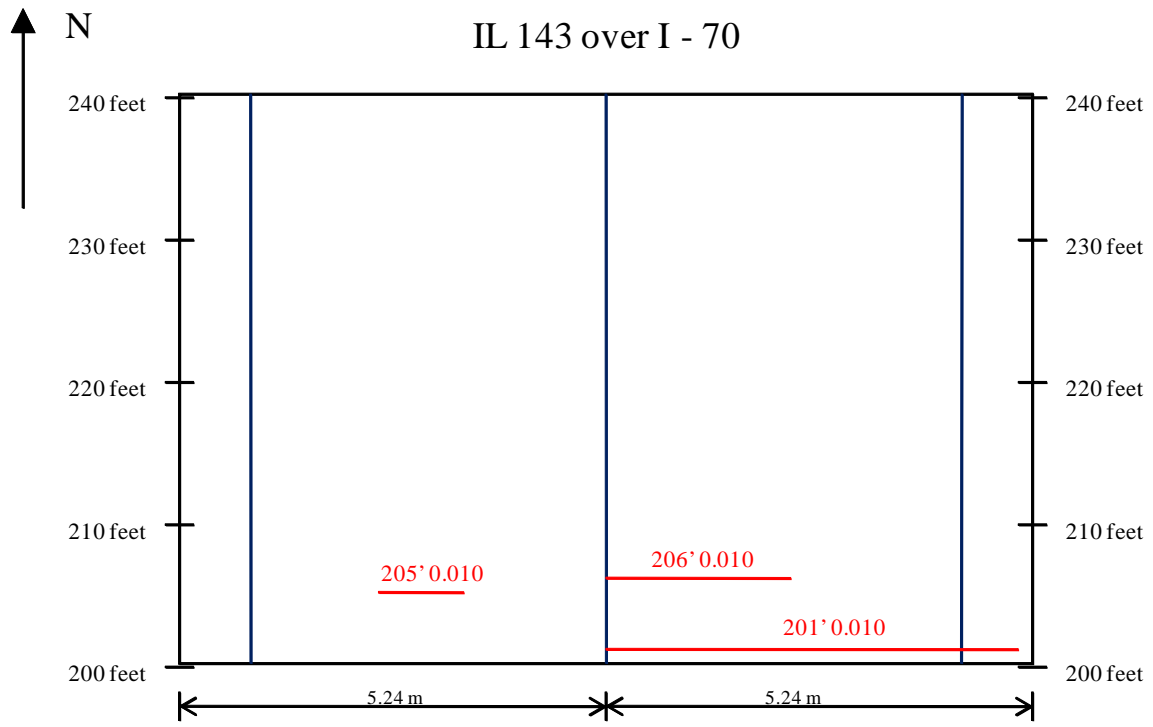
Madison County – SN# 060-0151 – Surveyed 9/28/2005  
 The “#” symbol represents cracks in the parapet only.

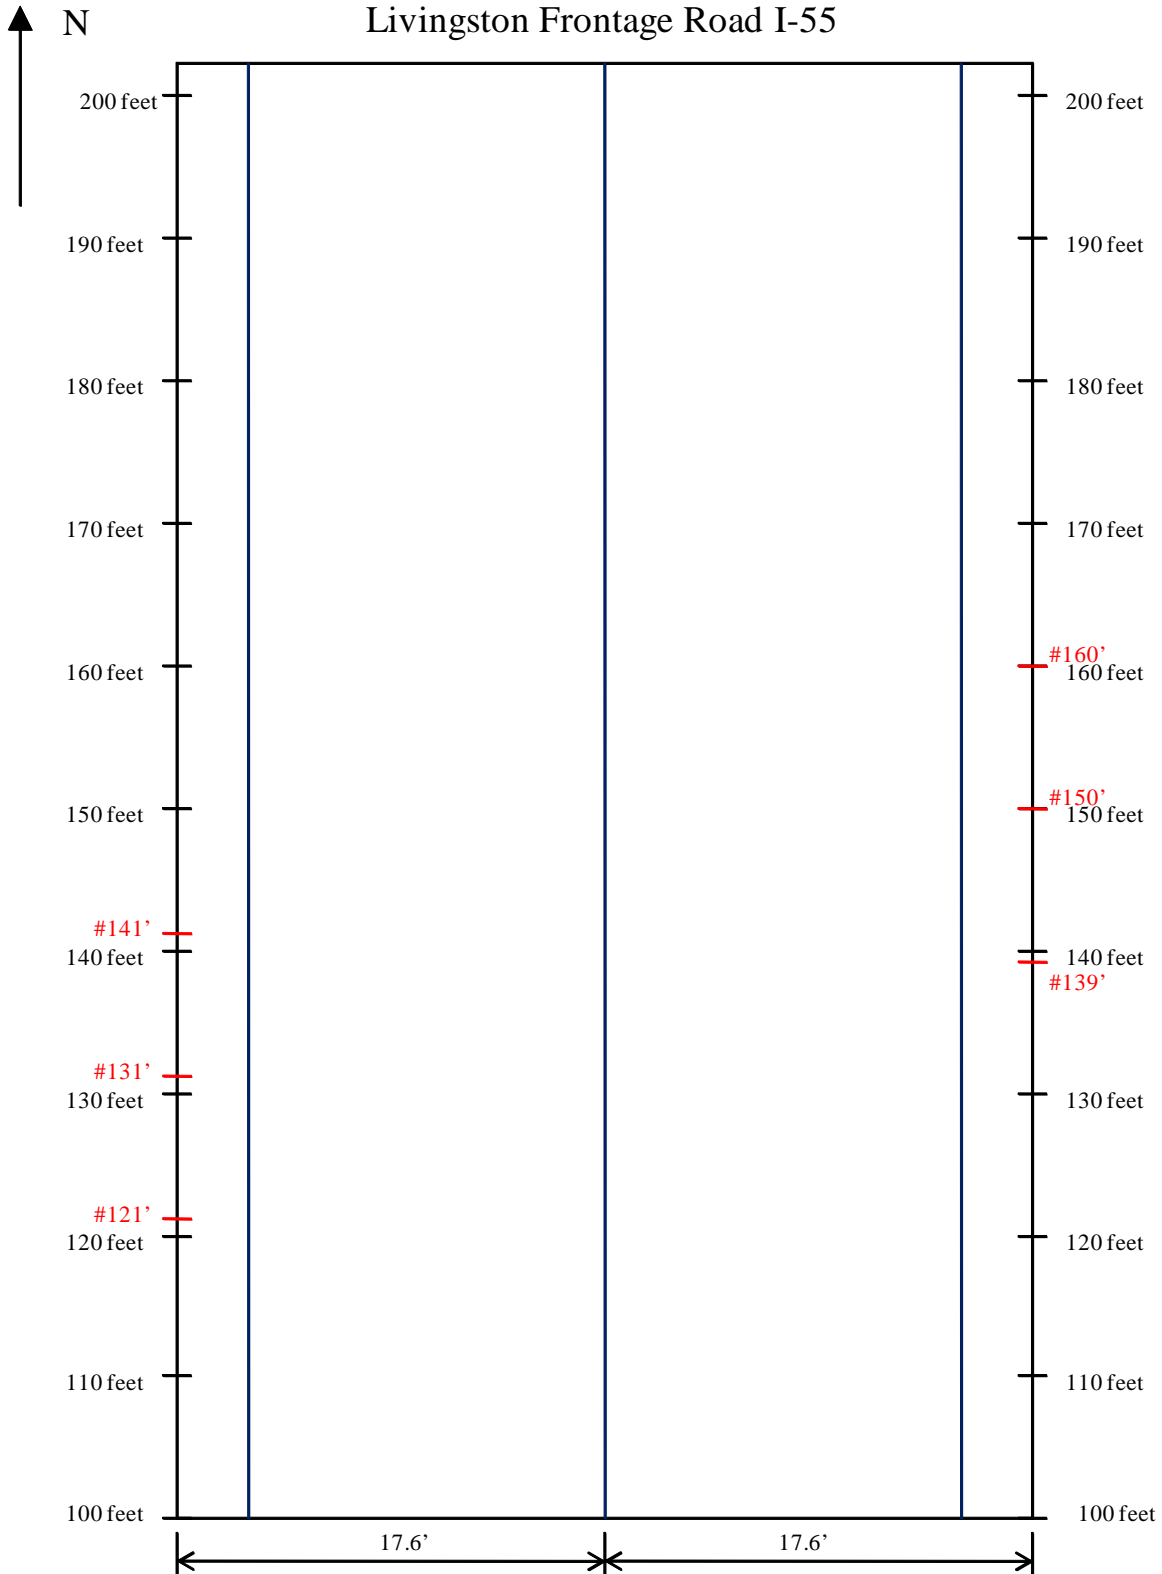
The structure numbered 060-0004 exhibited transverse cracking on the top of the deck at 1' - 3' spacing, and on the bottom of the deck at 3' - 5' spacing in the middle and northern spans despite a mild temperature differential. The HPC structure numbered 060-0004 has a low ADT of 126.

Madison County – SN# 060-0004 – Surveyed 8/12/2002  
 The “#” symbol represents cracks in the parapet only.

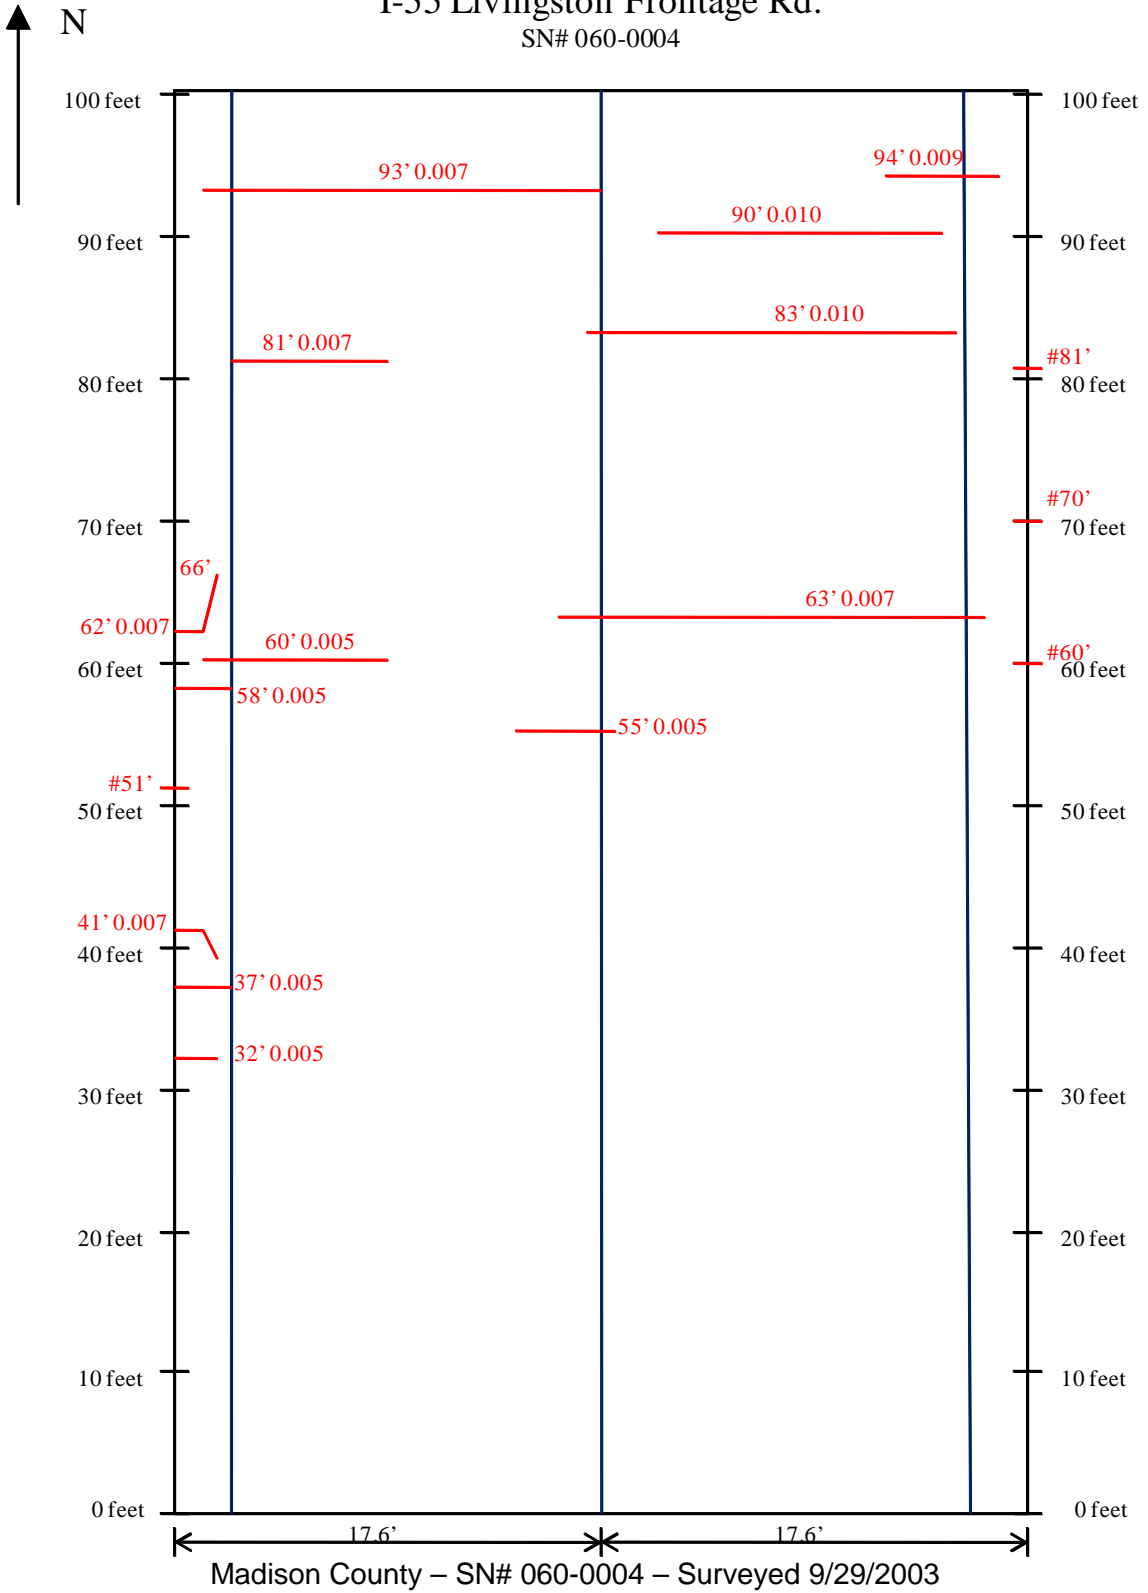
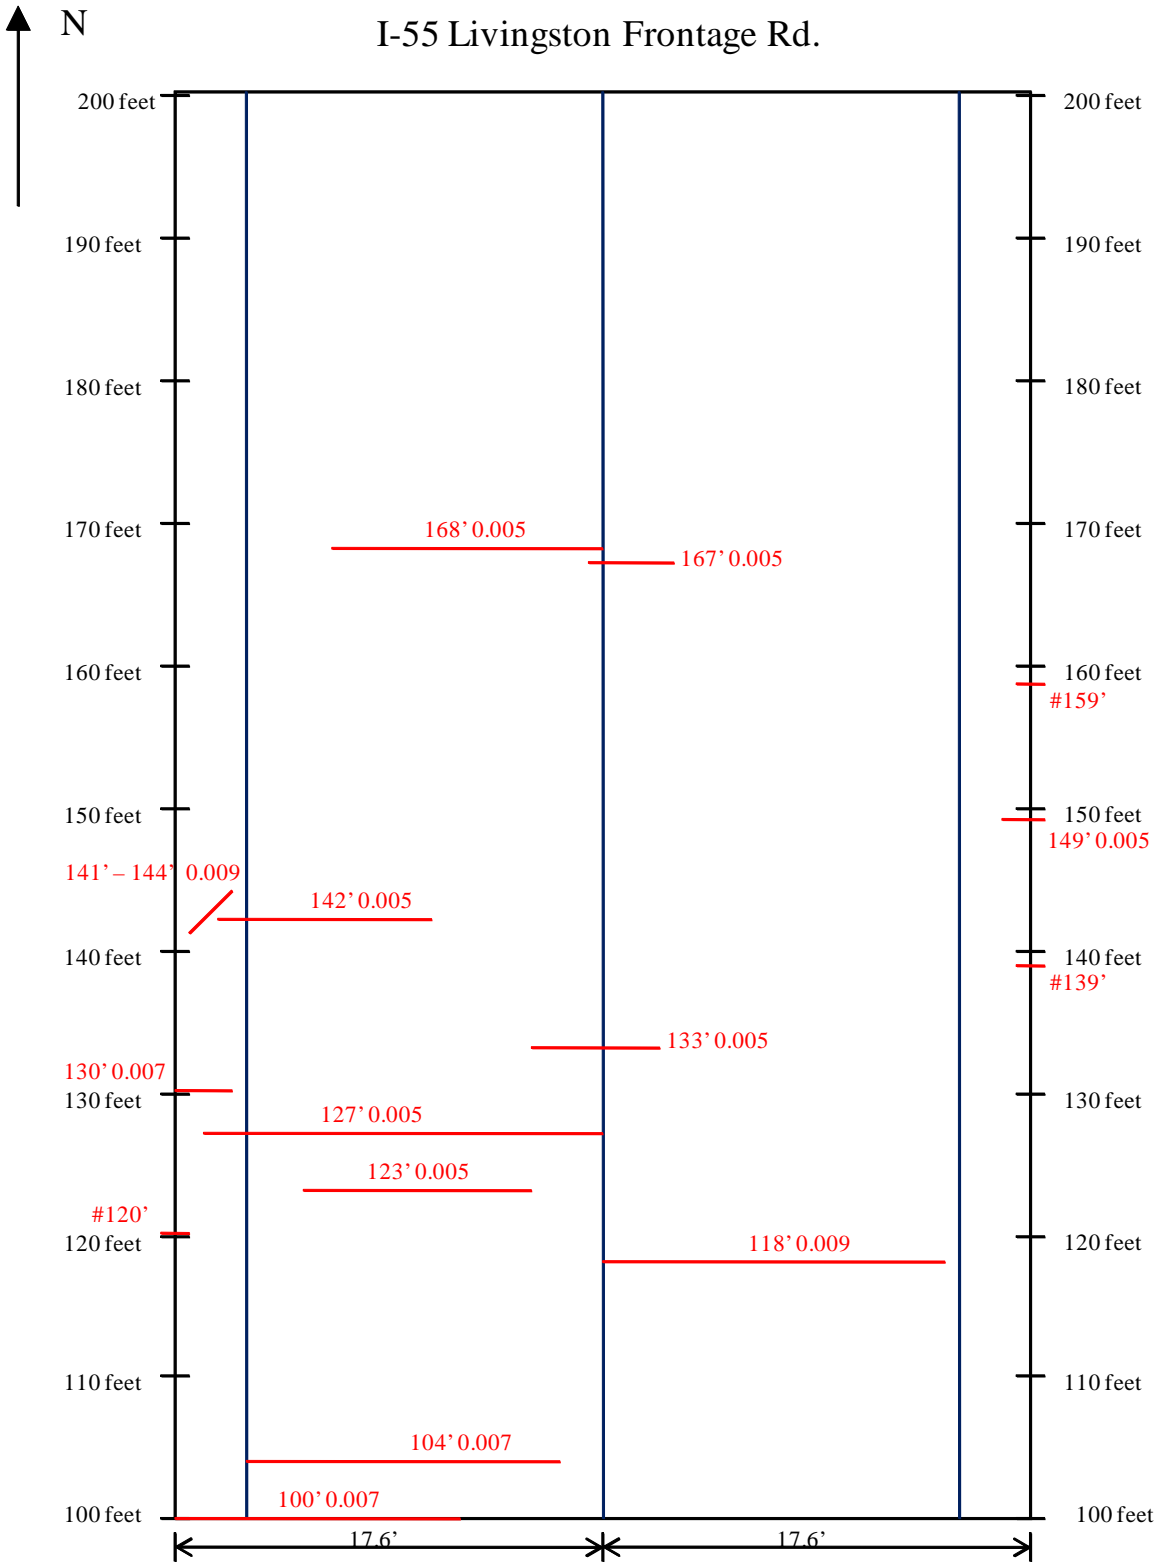
I-55 Livingston Frontage Rd.  
SN# 060-0004

Madison County – SN# 060-0004 – Surveyed 9/29/2003  
 The “#” symbol represents cracks in the parapet only.

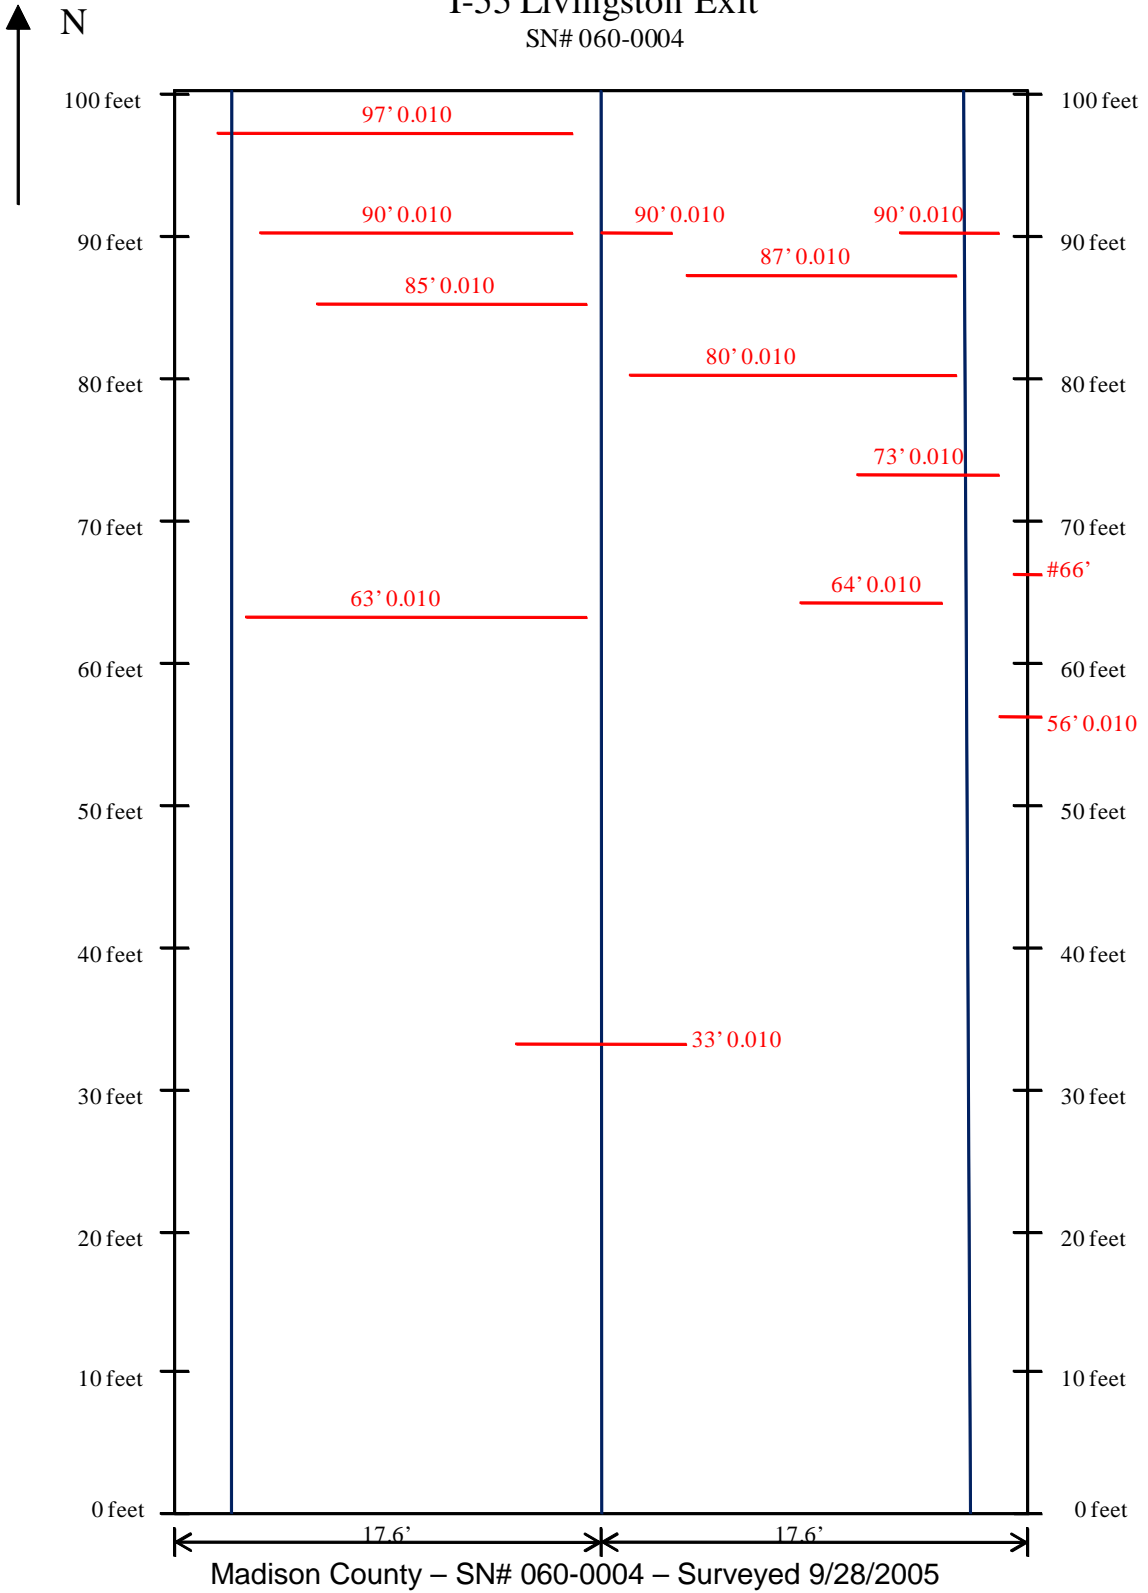
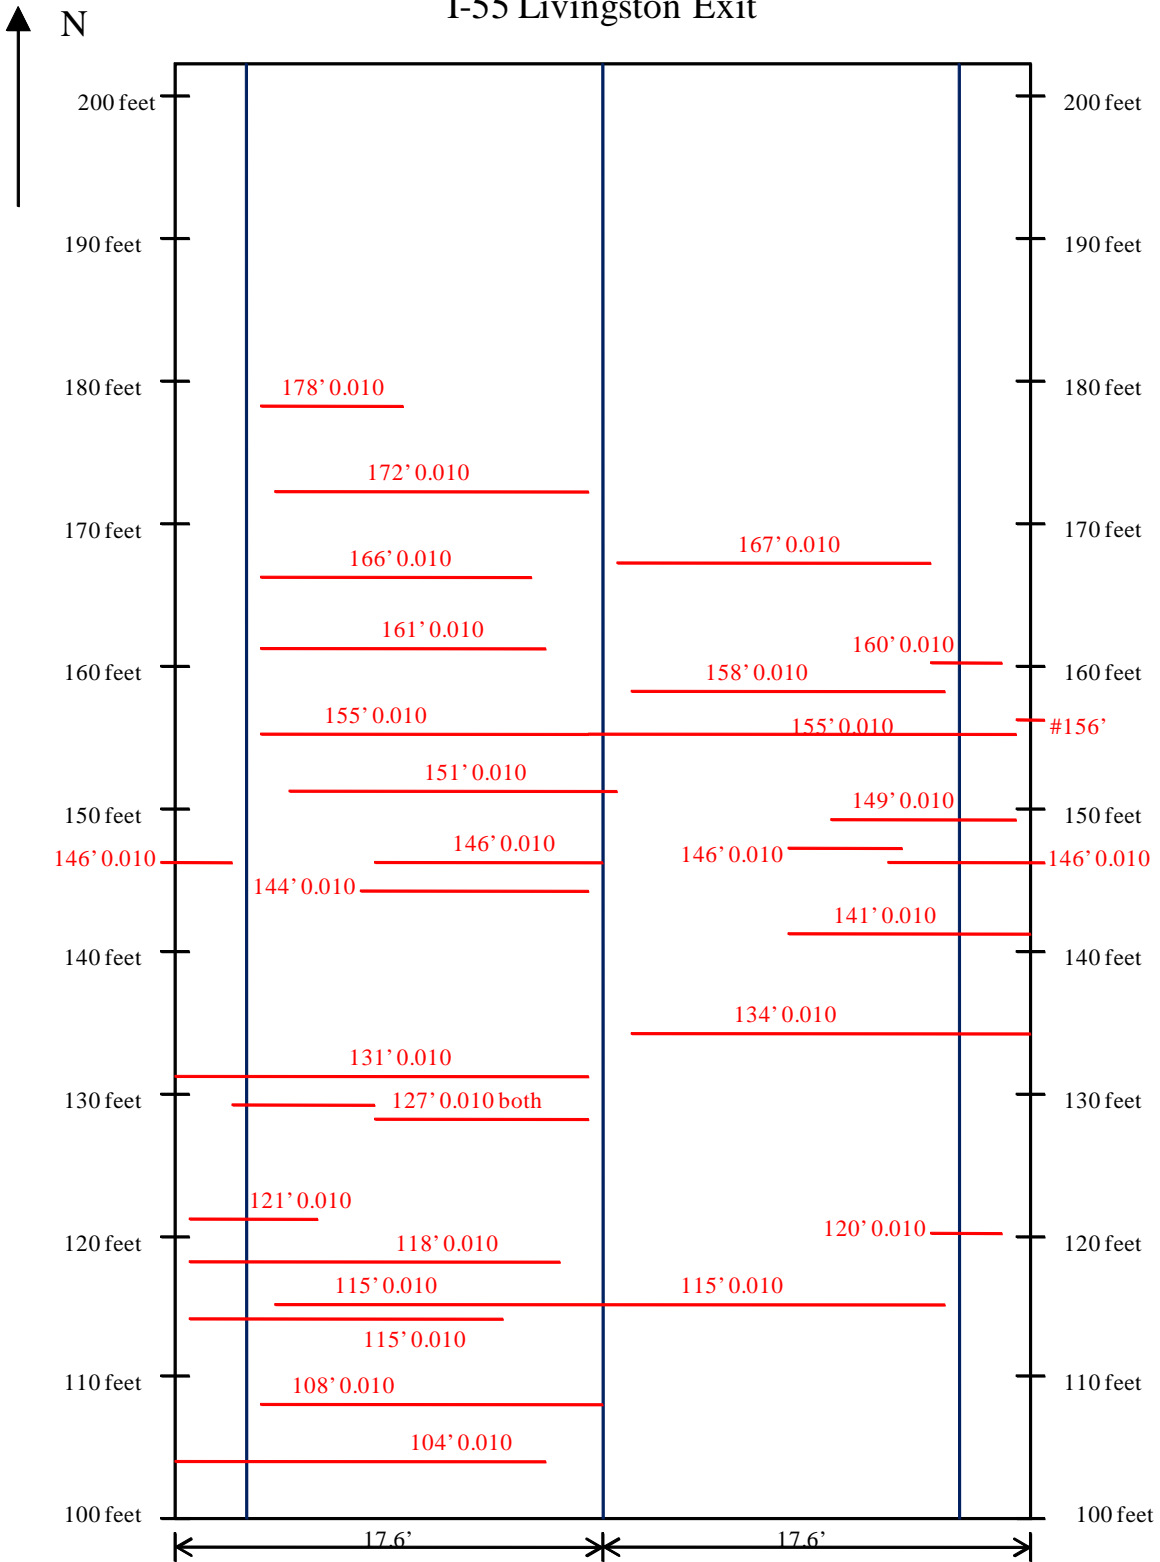
I-55 Livingston Exit  
SN# 060-0004

Madison County – SN# 060-0004 – Surveyed 9/28/2005  
 The “#” symbol represents cracks in the parapet only.

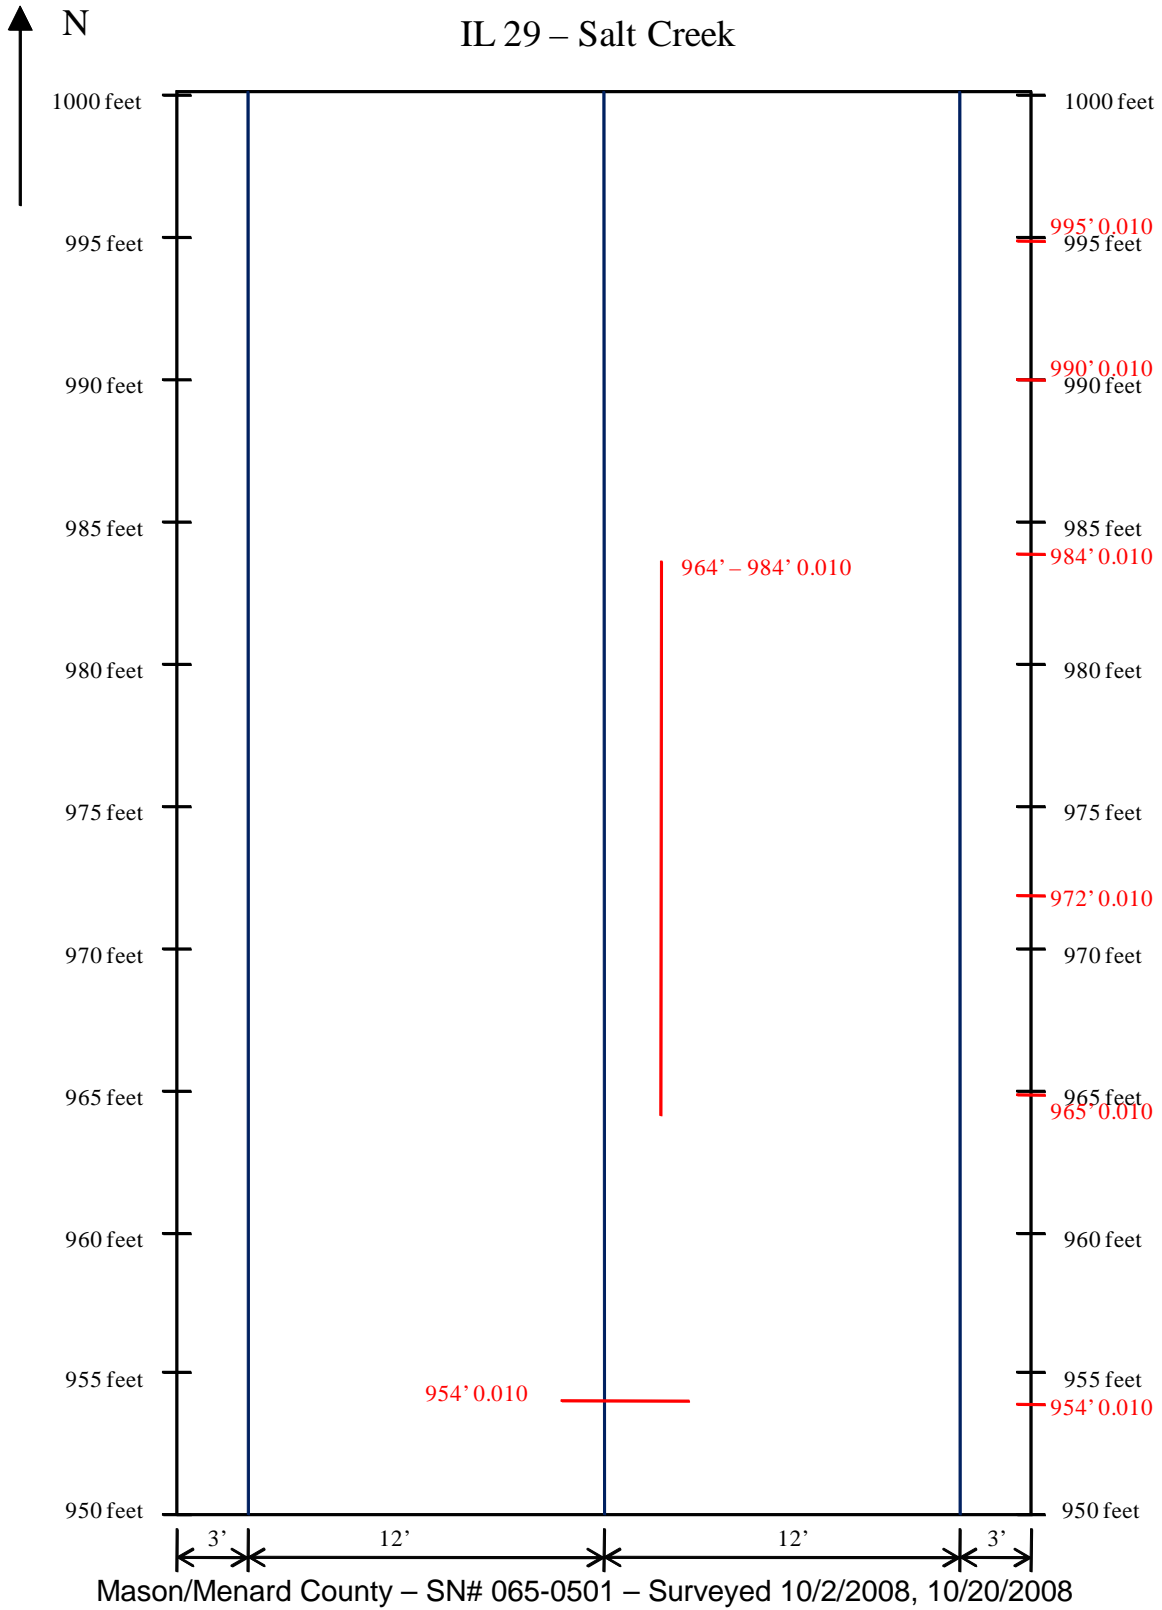
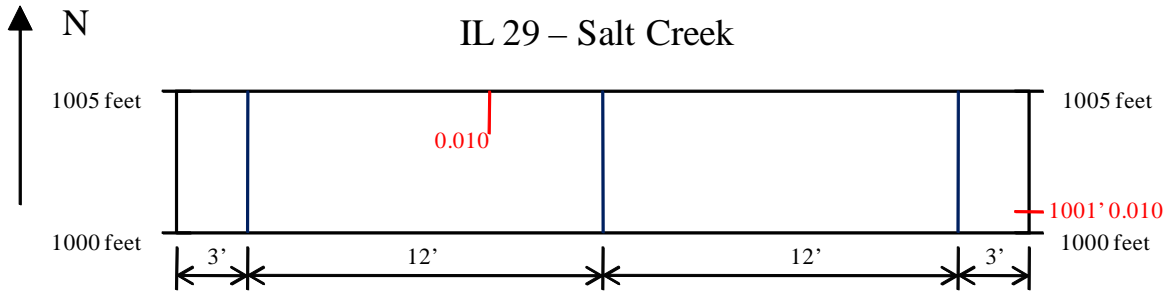
Mason/Menard County – SN# 065-0501 – Surveyed 10/2/2008, 10/20/2008

The “#” symbol represents cracks in the parapet only.
