**EVALUATION OF HIGH PERFORMANCE  
CONCRETE BRIDGE DECKS  
AND  
OTHER EXPERIMENTAL BRIDGE  
DECKS THROUGHOUT ILLINOIS**

**PHYSICAL RESEARCH REPORT NO. 166  
December 2017**

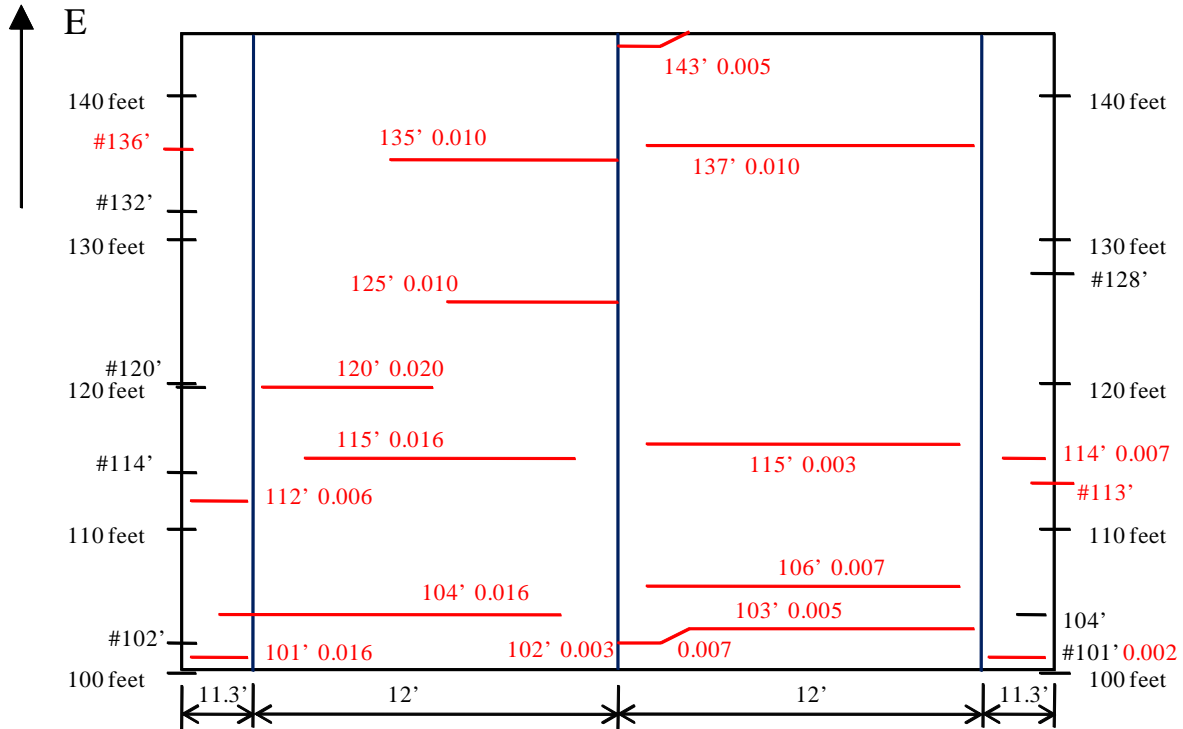
## IL 104 over Brush Creek

Sangamon County – SN# 084-065 – Surveyed 5/7/2001, 8/15/2001

The initial survey of the westbound lane showed 33 hairline transverse cracks.

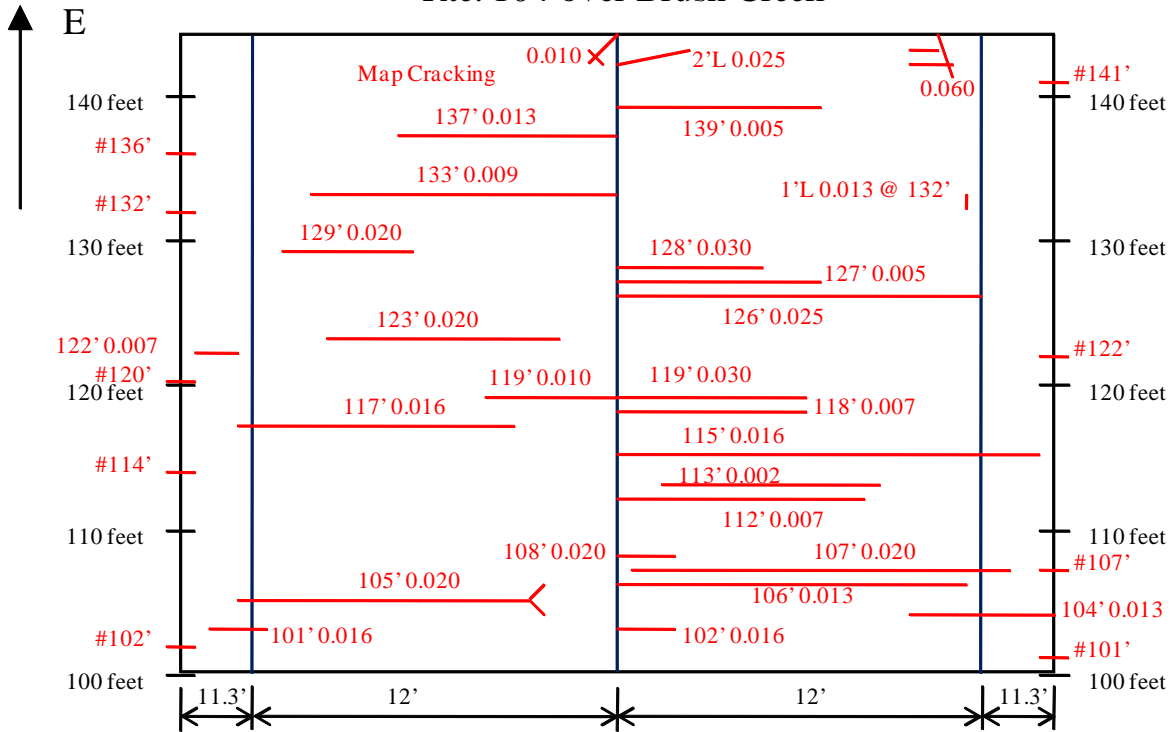
# Rte. 104 over Brush Creek

Sangamon County – SN# 084-0065 – Surveyed 9/3/2002

The “#” symbol represents cracks in the parapet only.

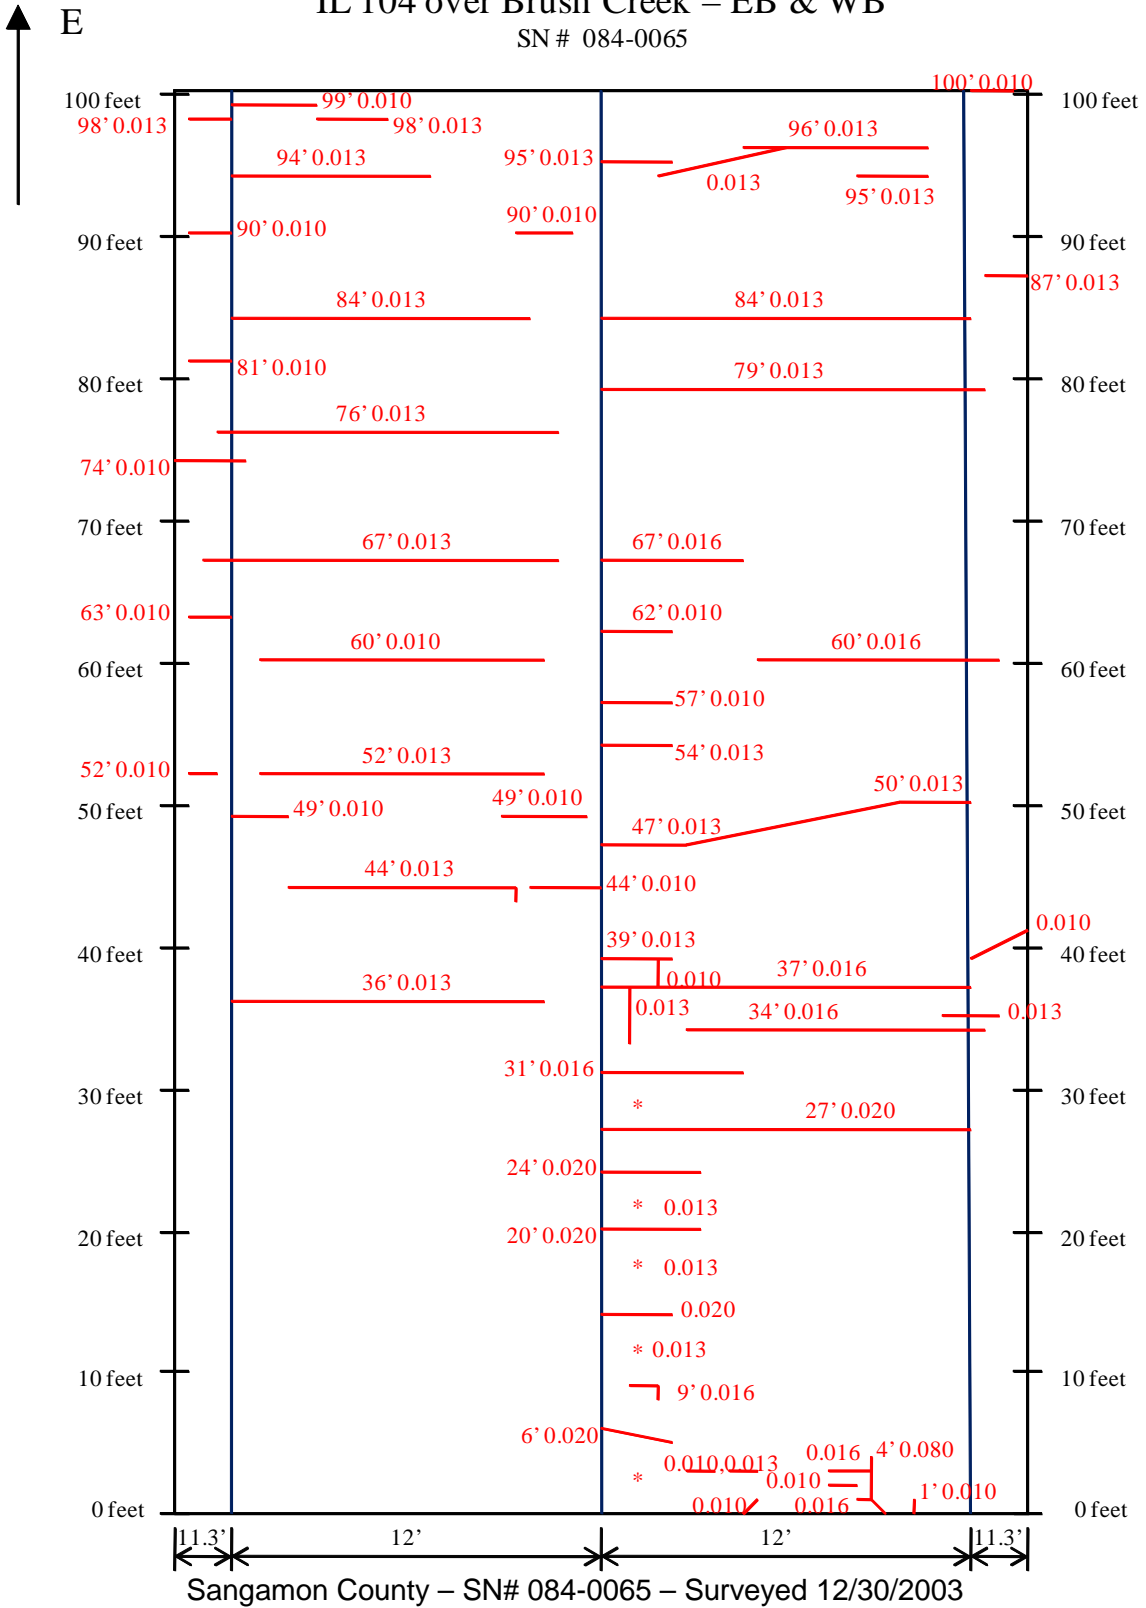
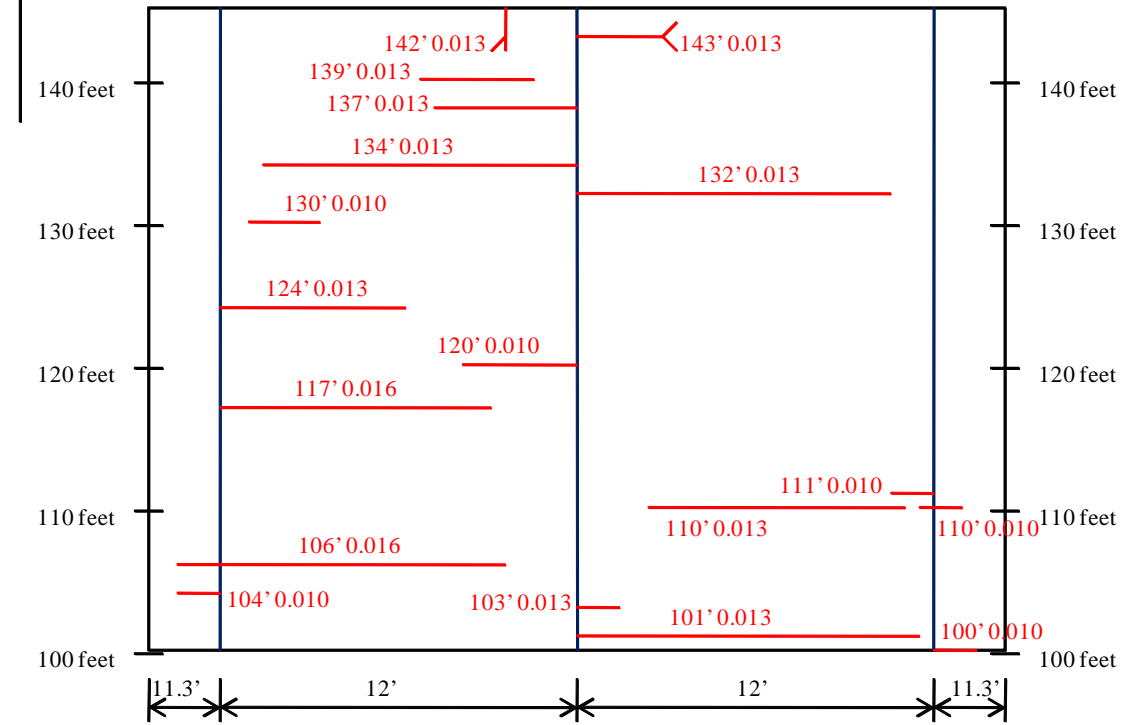
IL 104 over Brush Creek – EB & WB  
SN # 084-0065

Sangamon County – SN# 084-0065 – Surveyed 12/30/2003

\* Denotes areas of interconnected hairline cracks, sometimes resembling a spider web.

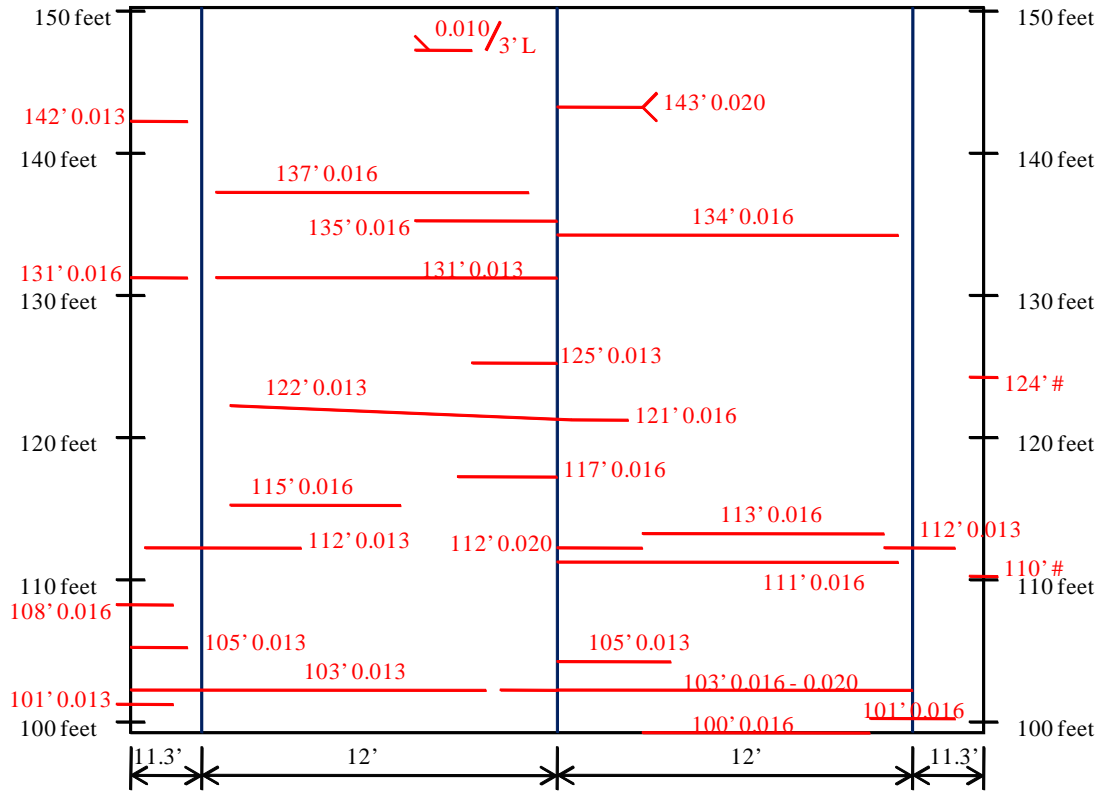
### IL 104 over Brush Creek

Sangamon County – SN# 084-0065 – Surveyed 9/26/2005

Map cracking was observed in the eastbound lane near the centerline from 9' to 89'.

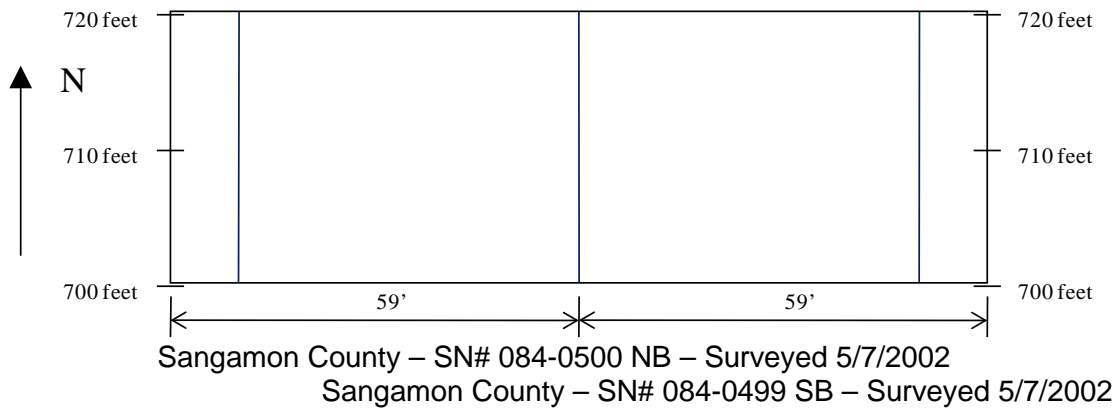
## I-55 over Lake Springfield

The “#” symbol represents cracks in the parapet only.

This bridge deck was poured on various days. The last pour date was 4/5/2002.

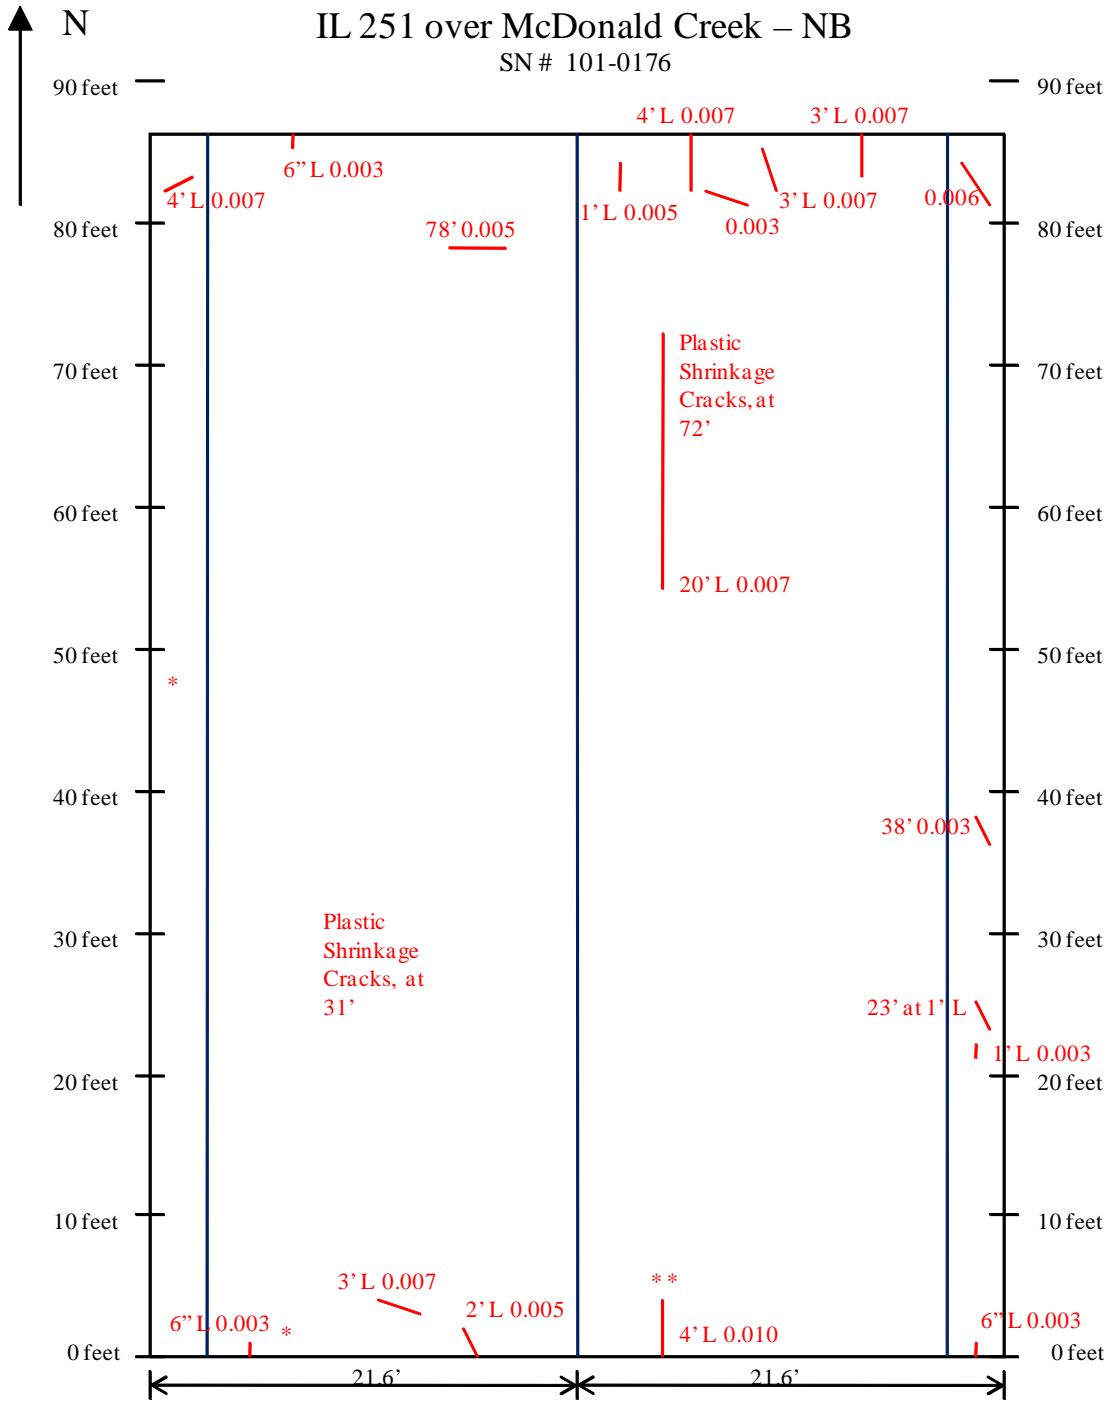
\* Denotes areas of plastic shrinkage cracking  
 \*\* Area with baseball sized popout.
